NBSIR 74-605

Crush Characteristics of Automobile Structural Components

Final Report

Prepared for
National Highway Traffic Safety Administration
Department of Transportation
400 7th Street, S.W.
Washington, D. C. 20590

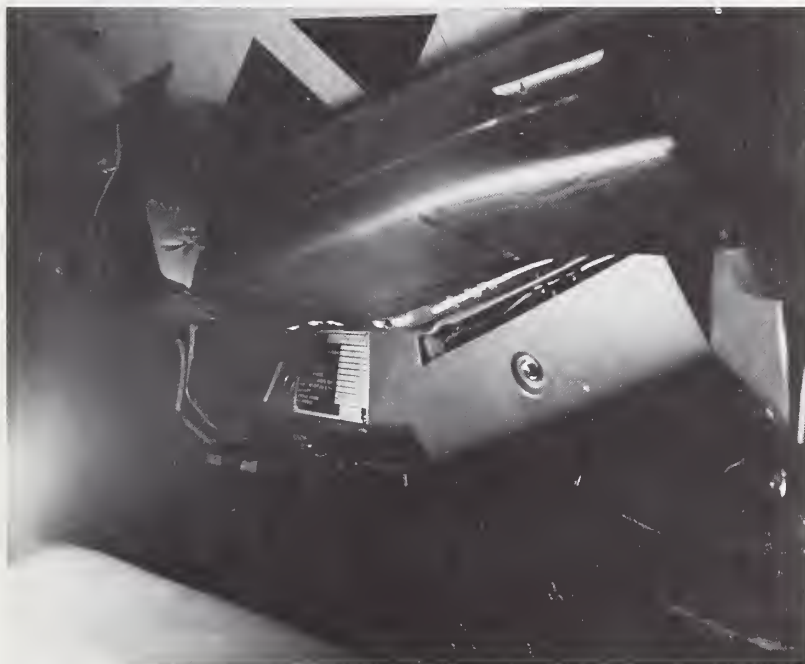
Figure 30 - BUCKLING DEVELOPED IN DASH DURING STATIC CRUSH TEST OF VEHICLE "A"

Considerable buckling occurred across the dash during the test of the Vehicle "A" right side, as shown in Figure 30. Since no significant deformation of the dash was observed for loads up to 15,000 lbf (66.7 kN), the dash buckling developed somewhere between this load and the maximum applied load of 20,000 lbf (89.0 kN). The deformation which initially occurred in the middle of the dash precipitated a fracture at the base of the windshield adjacent to the dash, and the large deformations which occurred later caused fracture of the front glass adjacent to the A pillar.

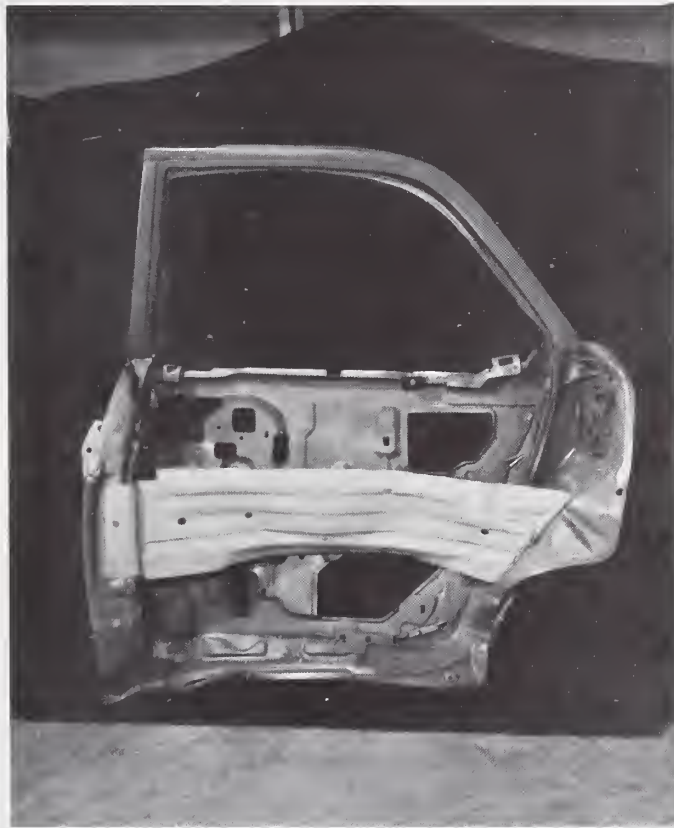
**Figure 32 – DEFORMATION OF REAR DOOR SIDE GUARD BEAM AFTER STATIC CRUSH TEST
OF VEHICLE "B-1"**

Several methods can be employed to compare the static and dynamic crush test results. Figure 34 shows the overall damage incurred in the side door structure during the static test of Vehicle "B-1" and the dynamic test of Vehicle "B-2". A plot of the exterior deformation of the vehicle left side after the two tests is shown in Figure 35. An examination of the permanently deformed rear door side guard beam after the drop test for Vehicle "B-2" is shown in Figure 36, which can be compared with the corresponding damage produced during the static crush test of Vehicle "B-1" which was shown in Figure 32.

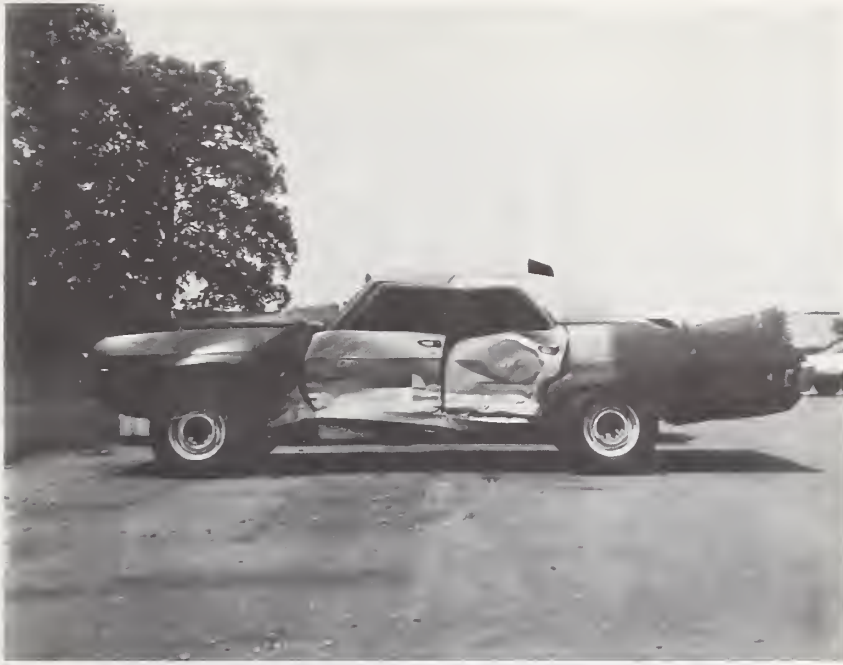
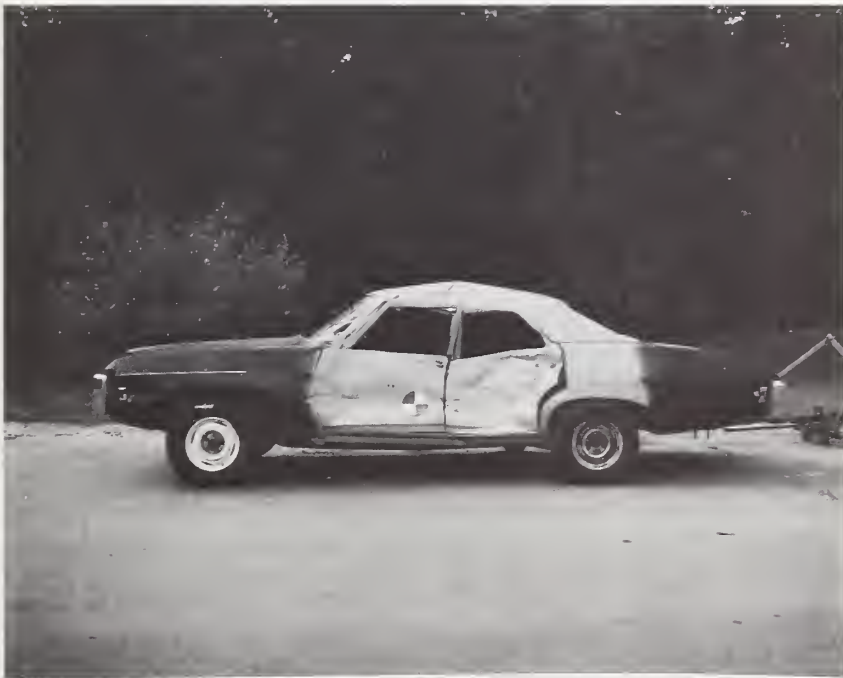
Figure 34 - EXTERNAL SIDE DEFORMATION AFTER STATIC TEST OF VEHICLE "B-1" (UPPER) AND DYNAMIC TEST OF VEHICLE "B-2" (LOWER)
