NBSIR 75-641

# Performance of Mobile Homes Data Acquisition and Analysis Methodology

February 1975

Interim Report

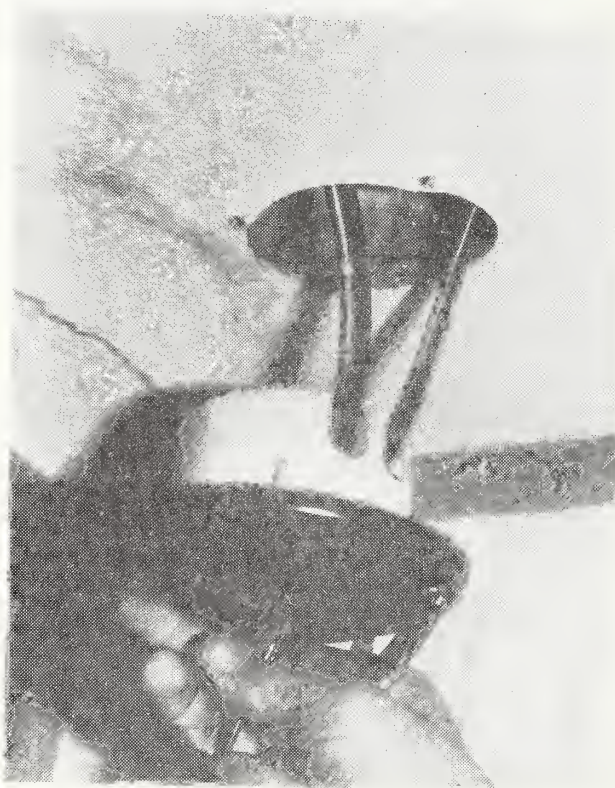
Figure 2 - Light Fixture in Area of Water Damage  
Pulled Loose from Ceiling

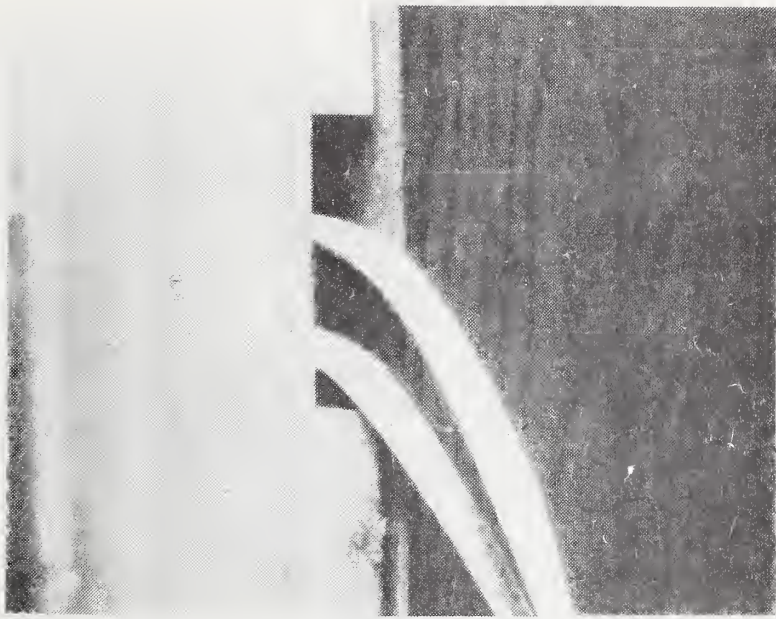
Figure 3 - Electrical Wiring Passing Through Stud Unprotected
