NBSIR 75-655

Report No. 5

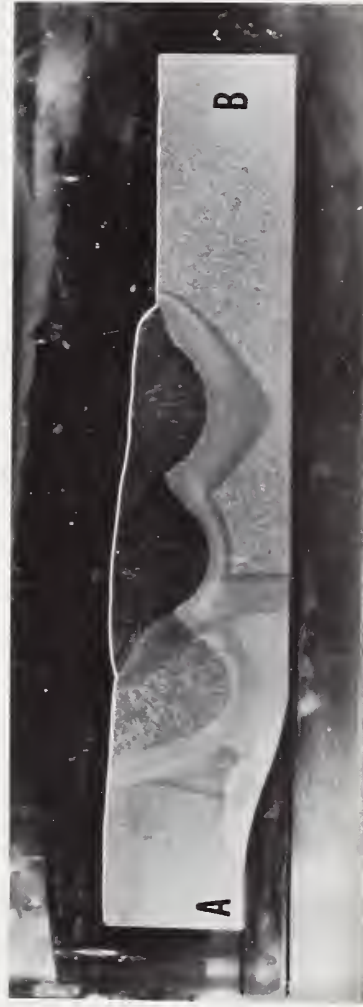
Figure 3. Weld Cross-Section Taken from Callao Sample K-11 at the Weld Between Shell Courses 4 and 5.

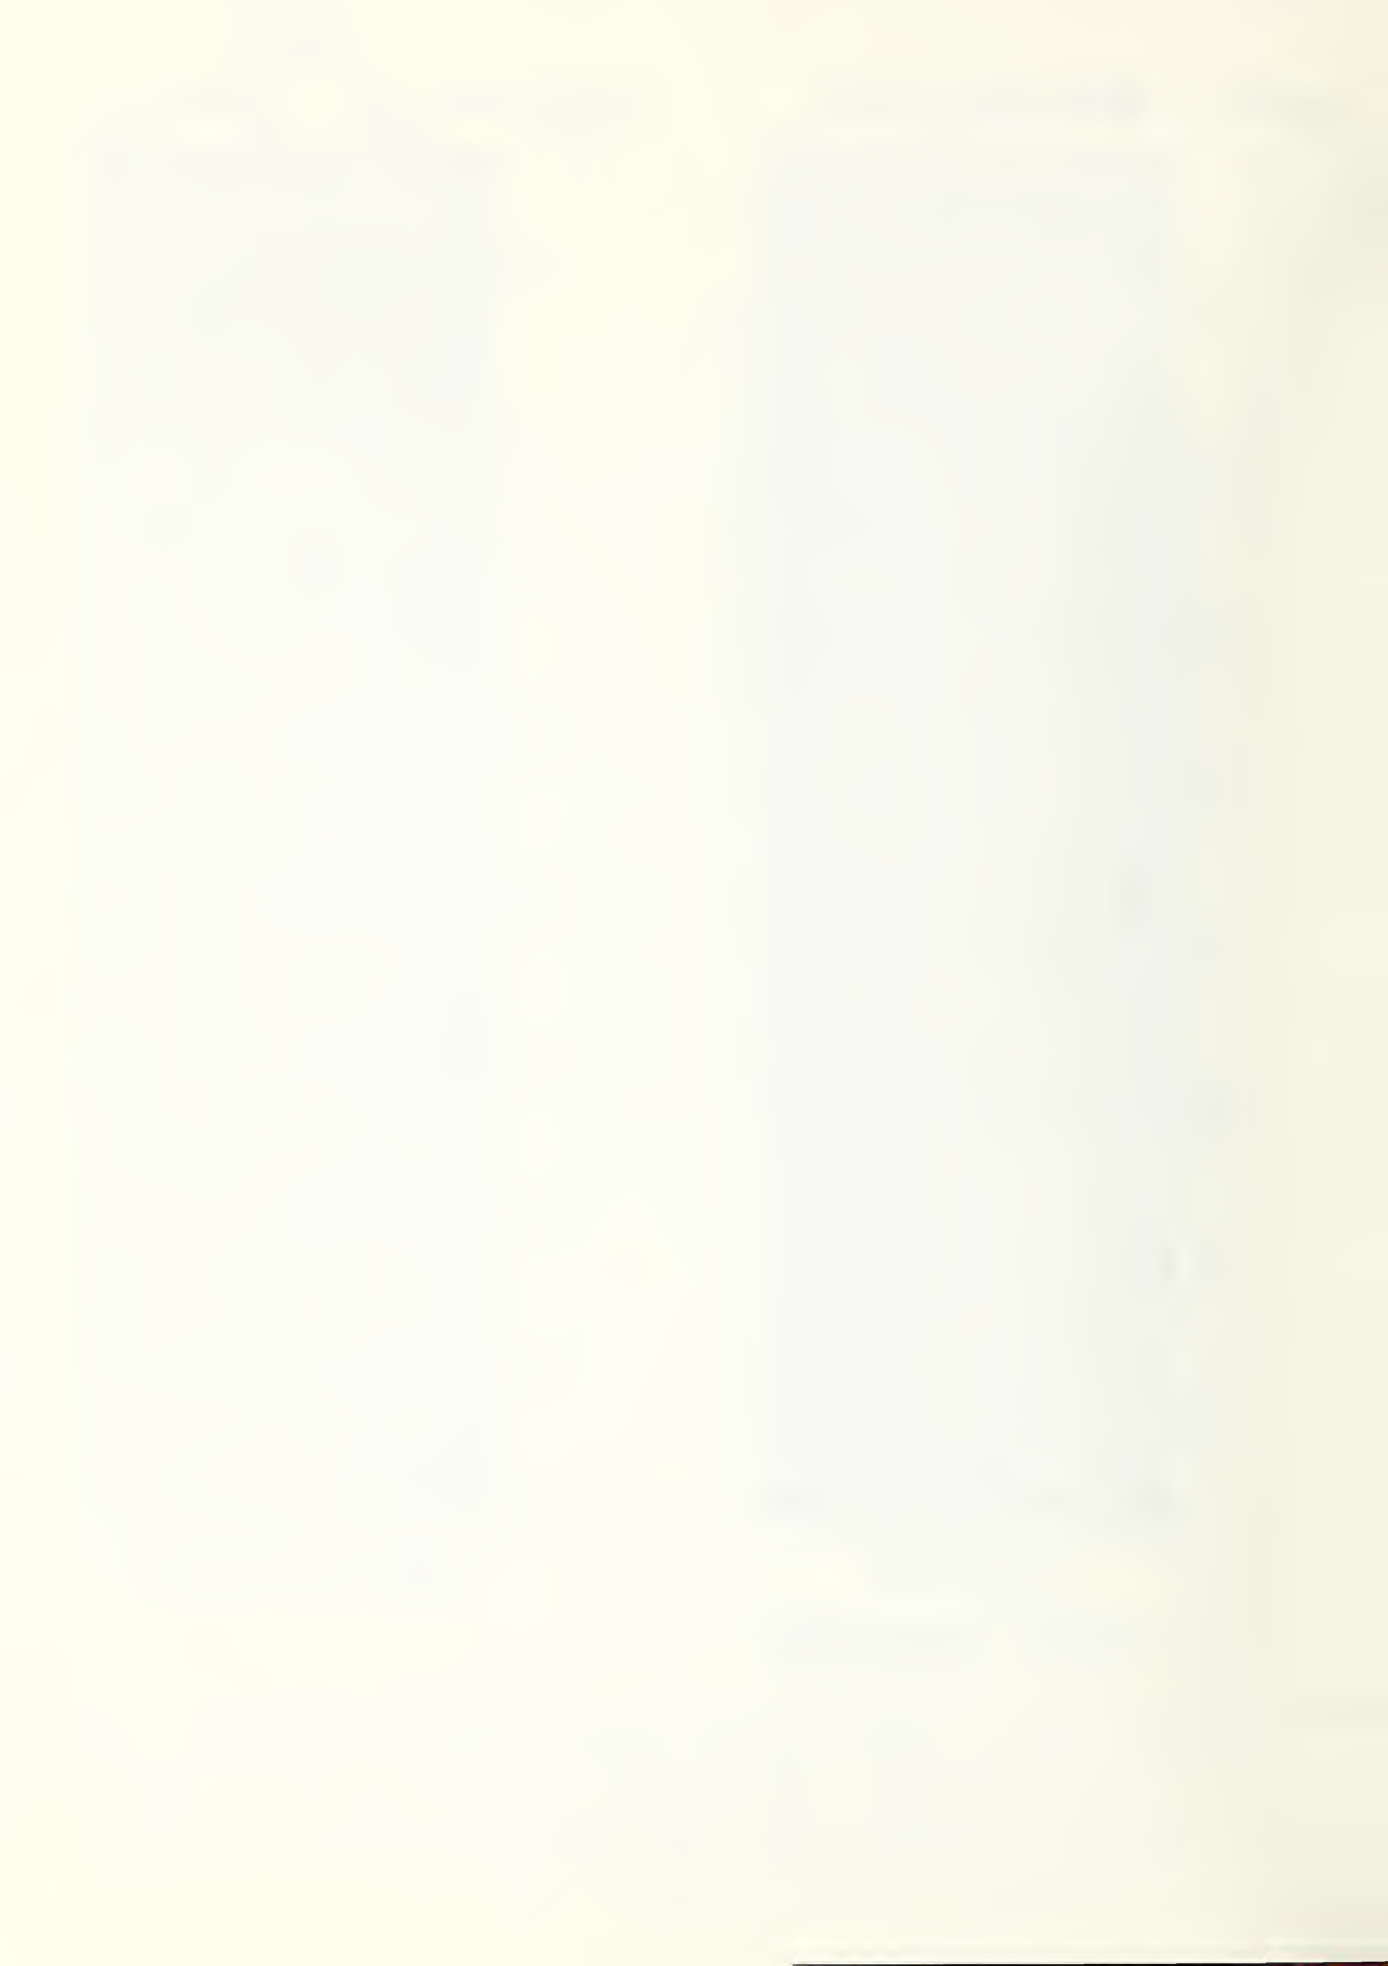
The microstructure varies across the thickness with large amounts of pearlite near the inside of the plate and equal amounts of pearlite and ferrite near the outside surface of the plate. Etched: 1% nital. X30

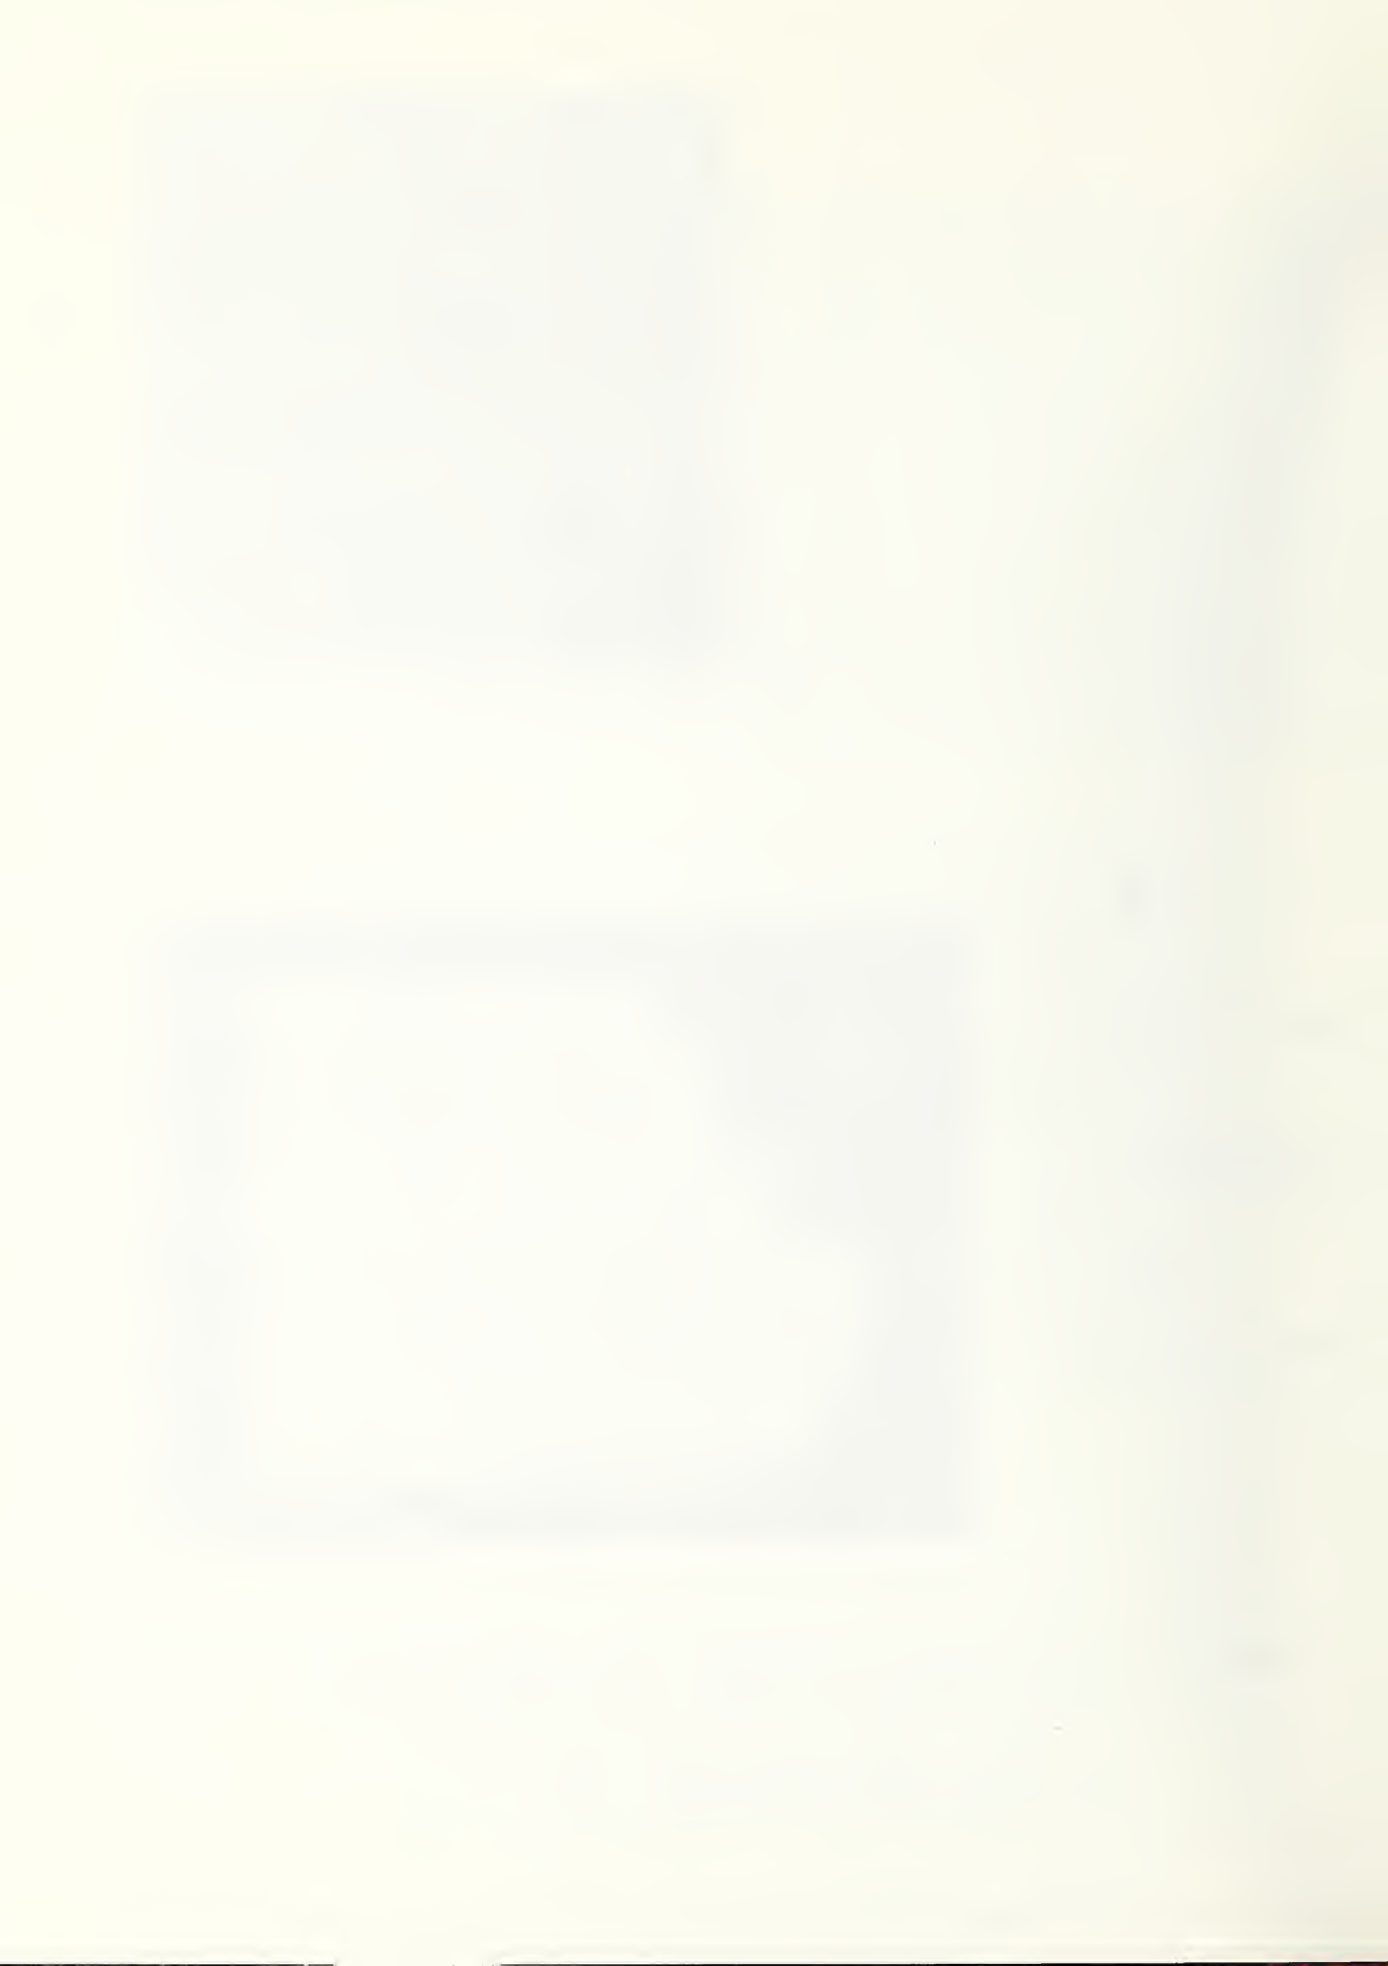
- (a) NP - nearly perpendicular fracture. X4
- (b) mixed mode fracture. X4

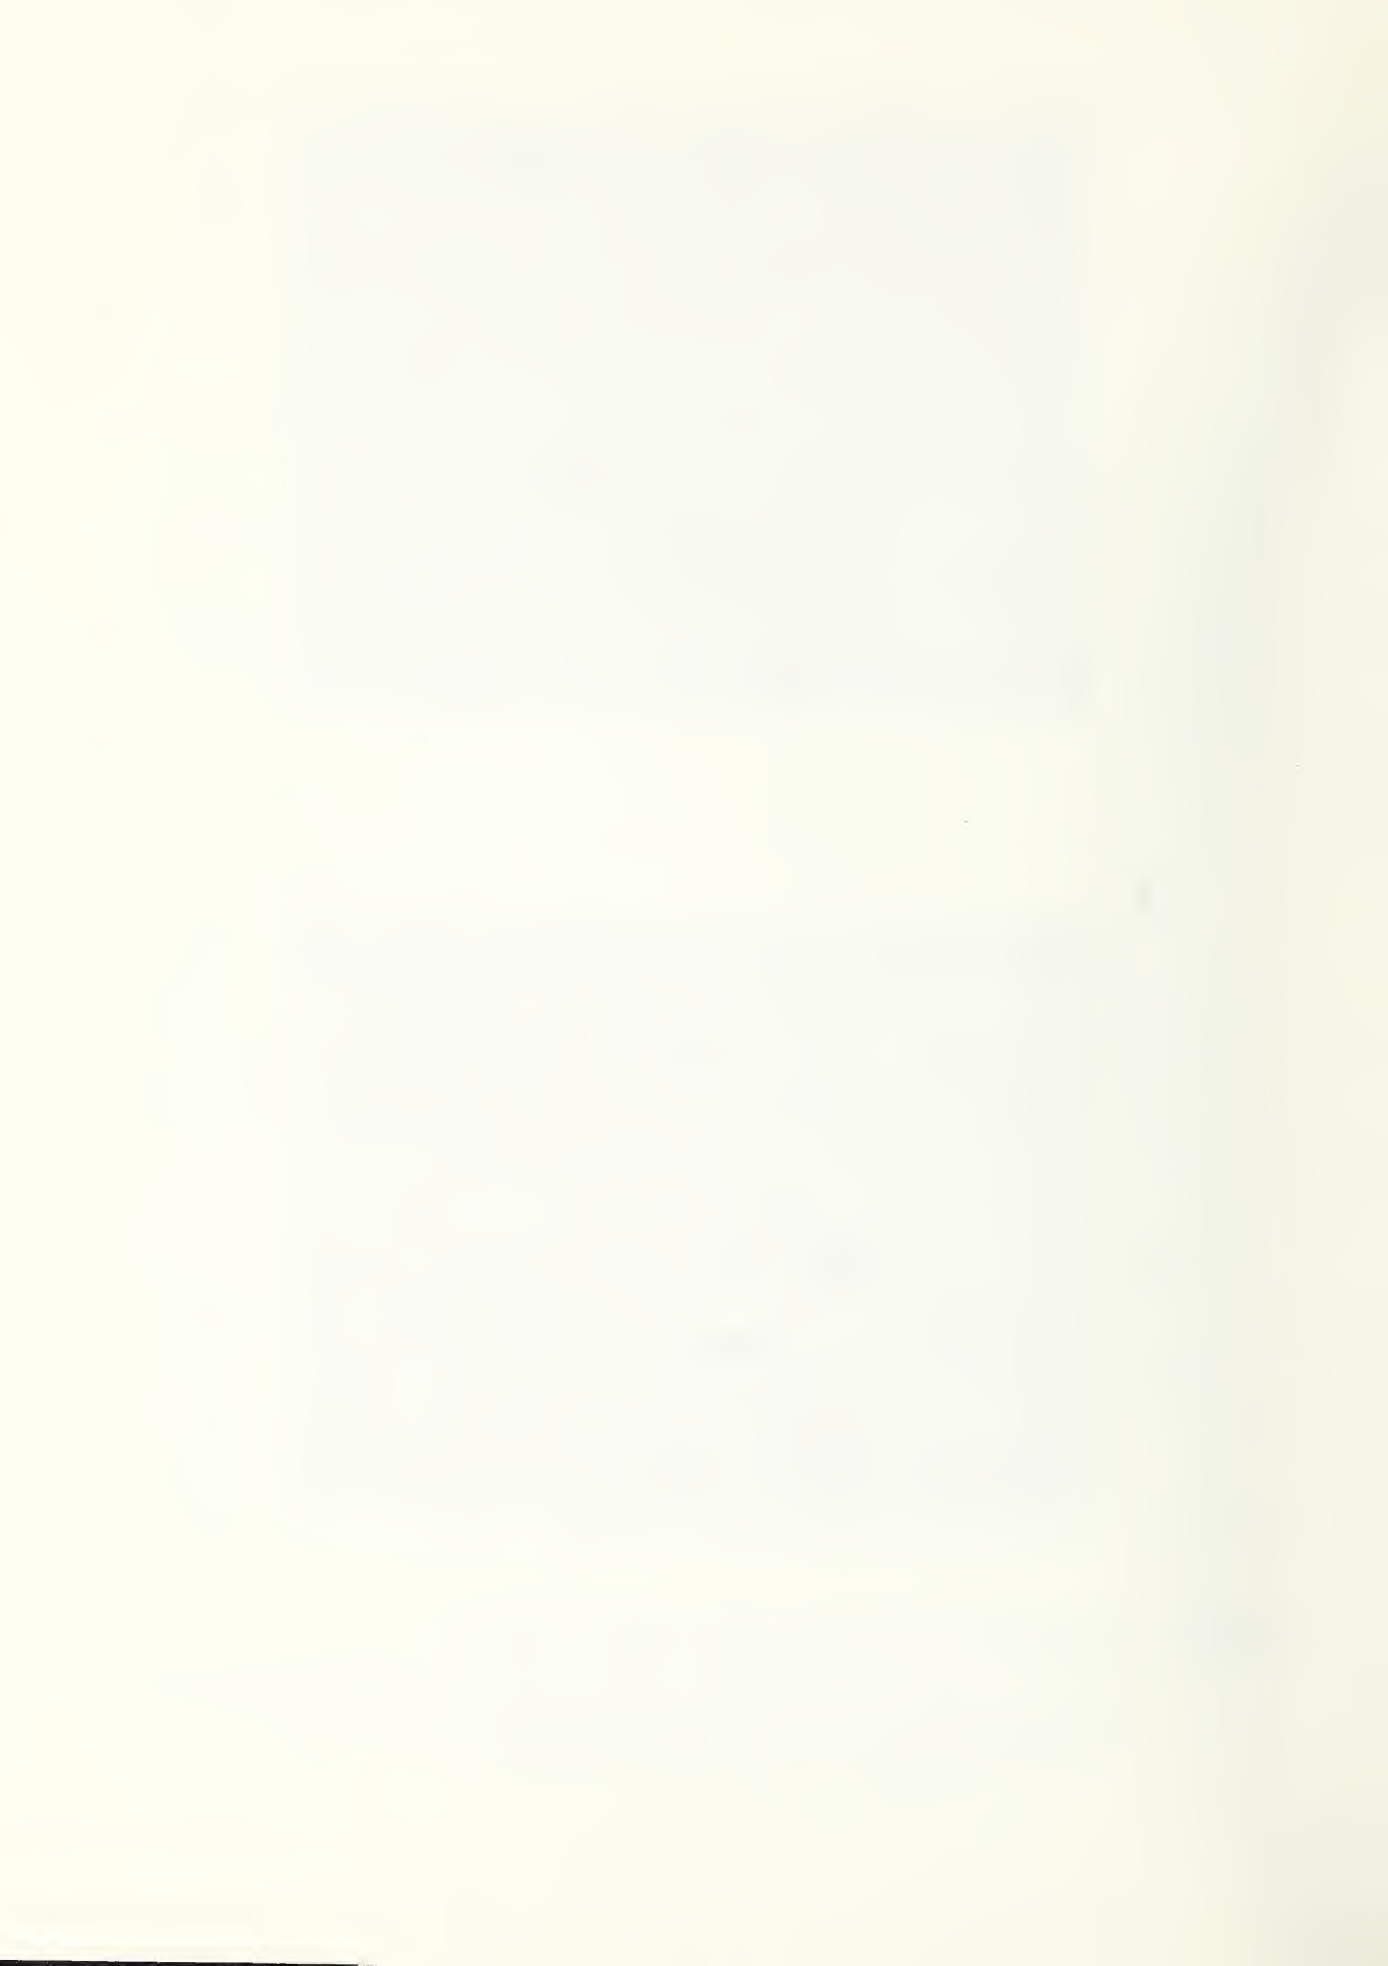
The plane is oriented approximately longitudinally in the head plate of AAR TC128-A steel with a ferrite grain size of 8 and finer.

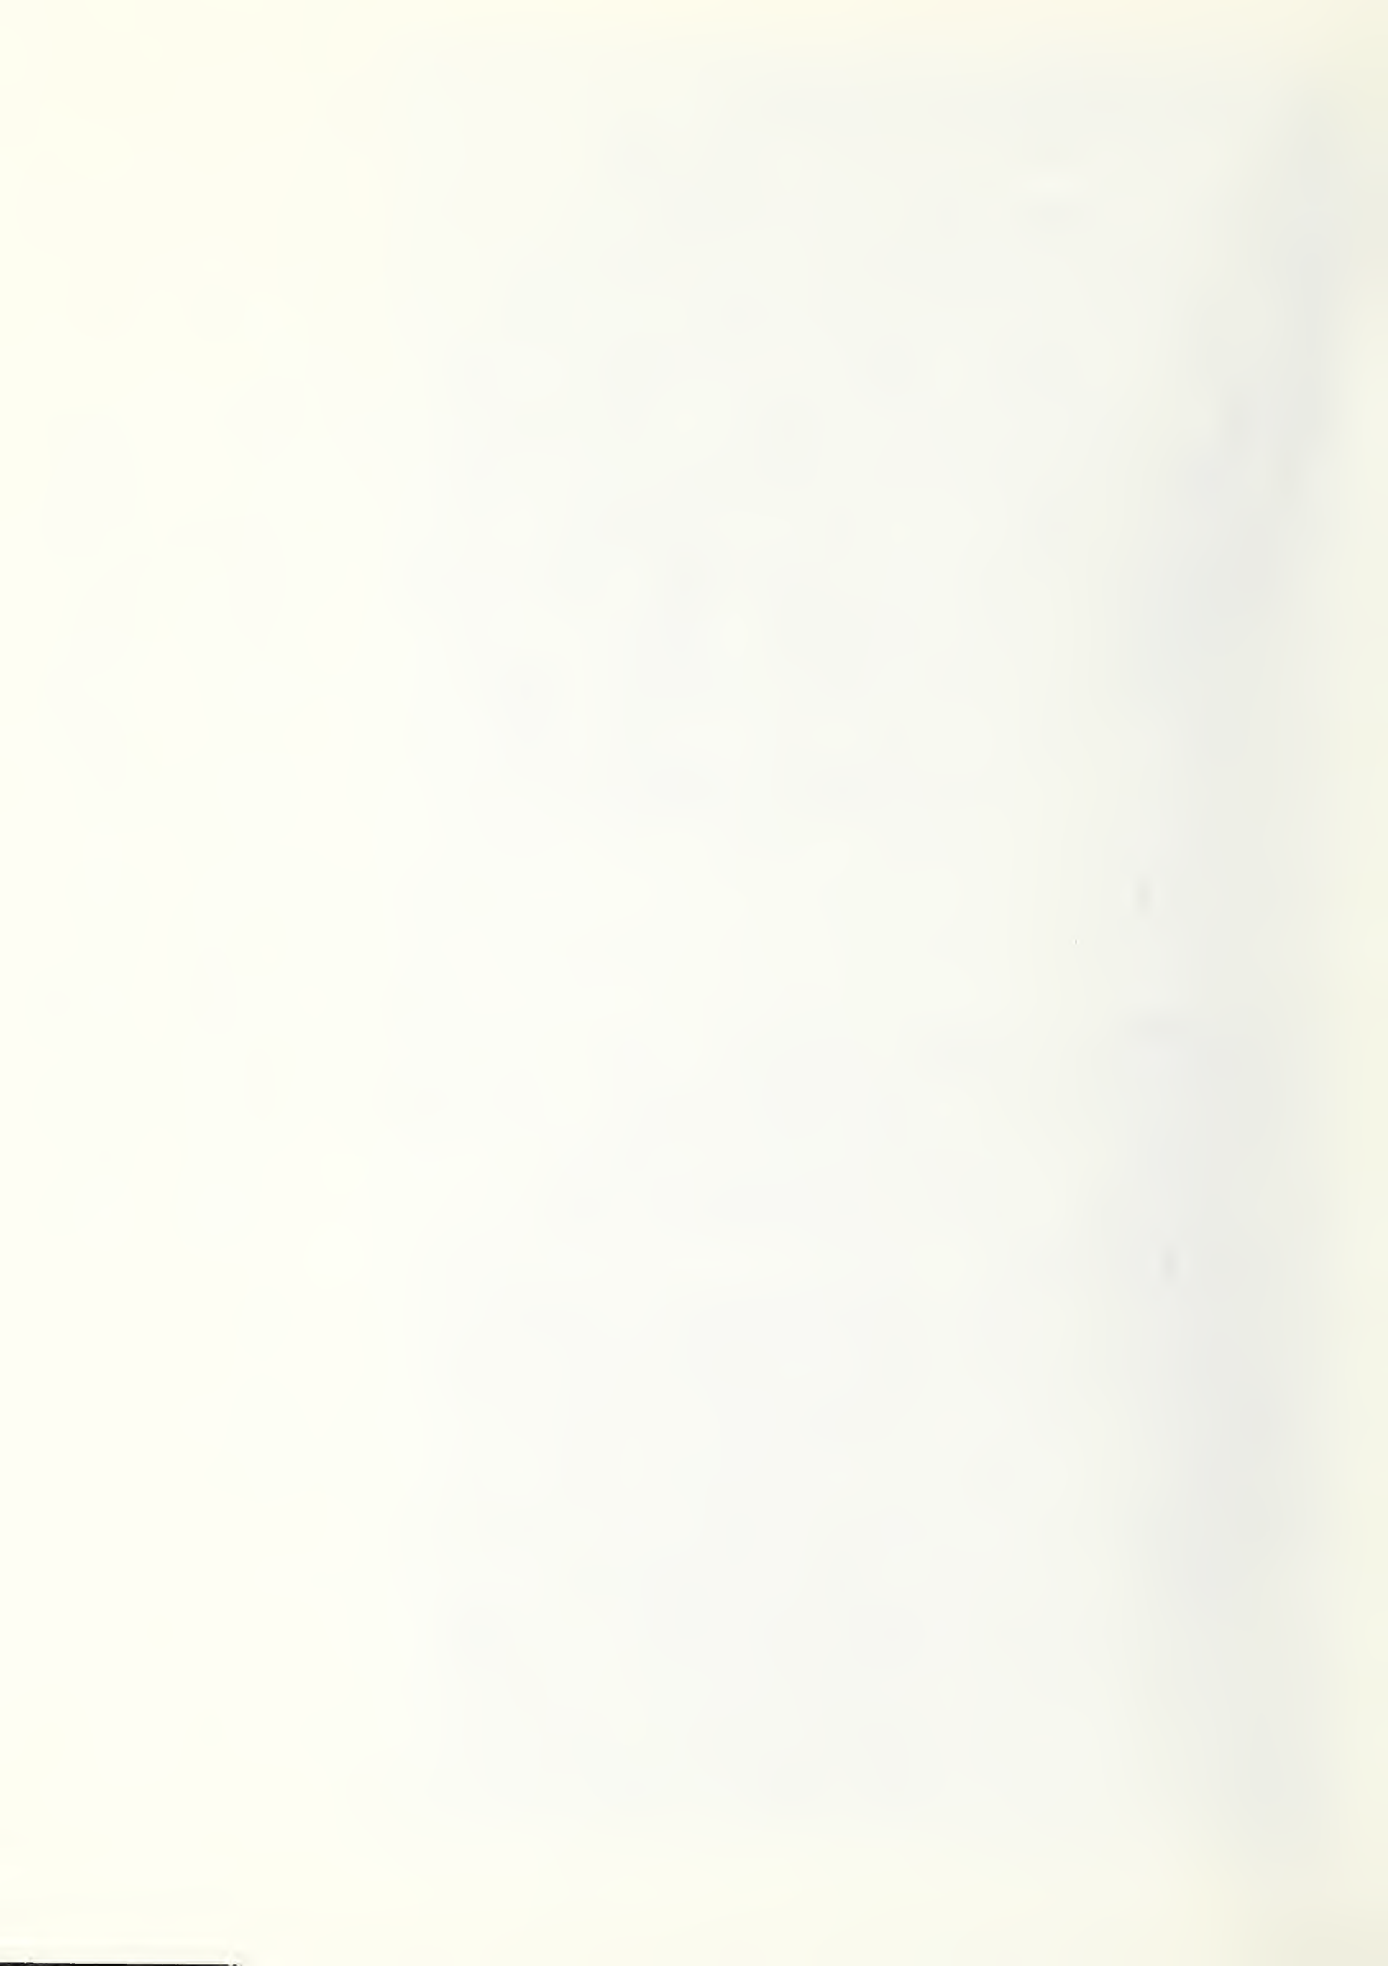
The A, B, and C planes are oriented as in Figure 9. AAR TC128-B steel with a ferrite grain size number of 8. Etched with picral.

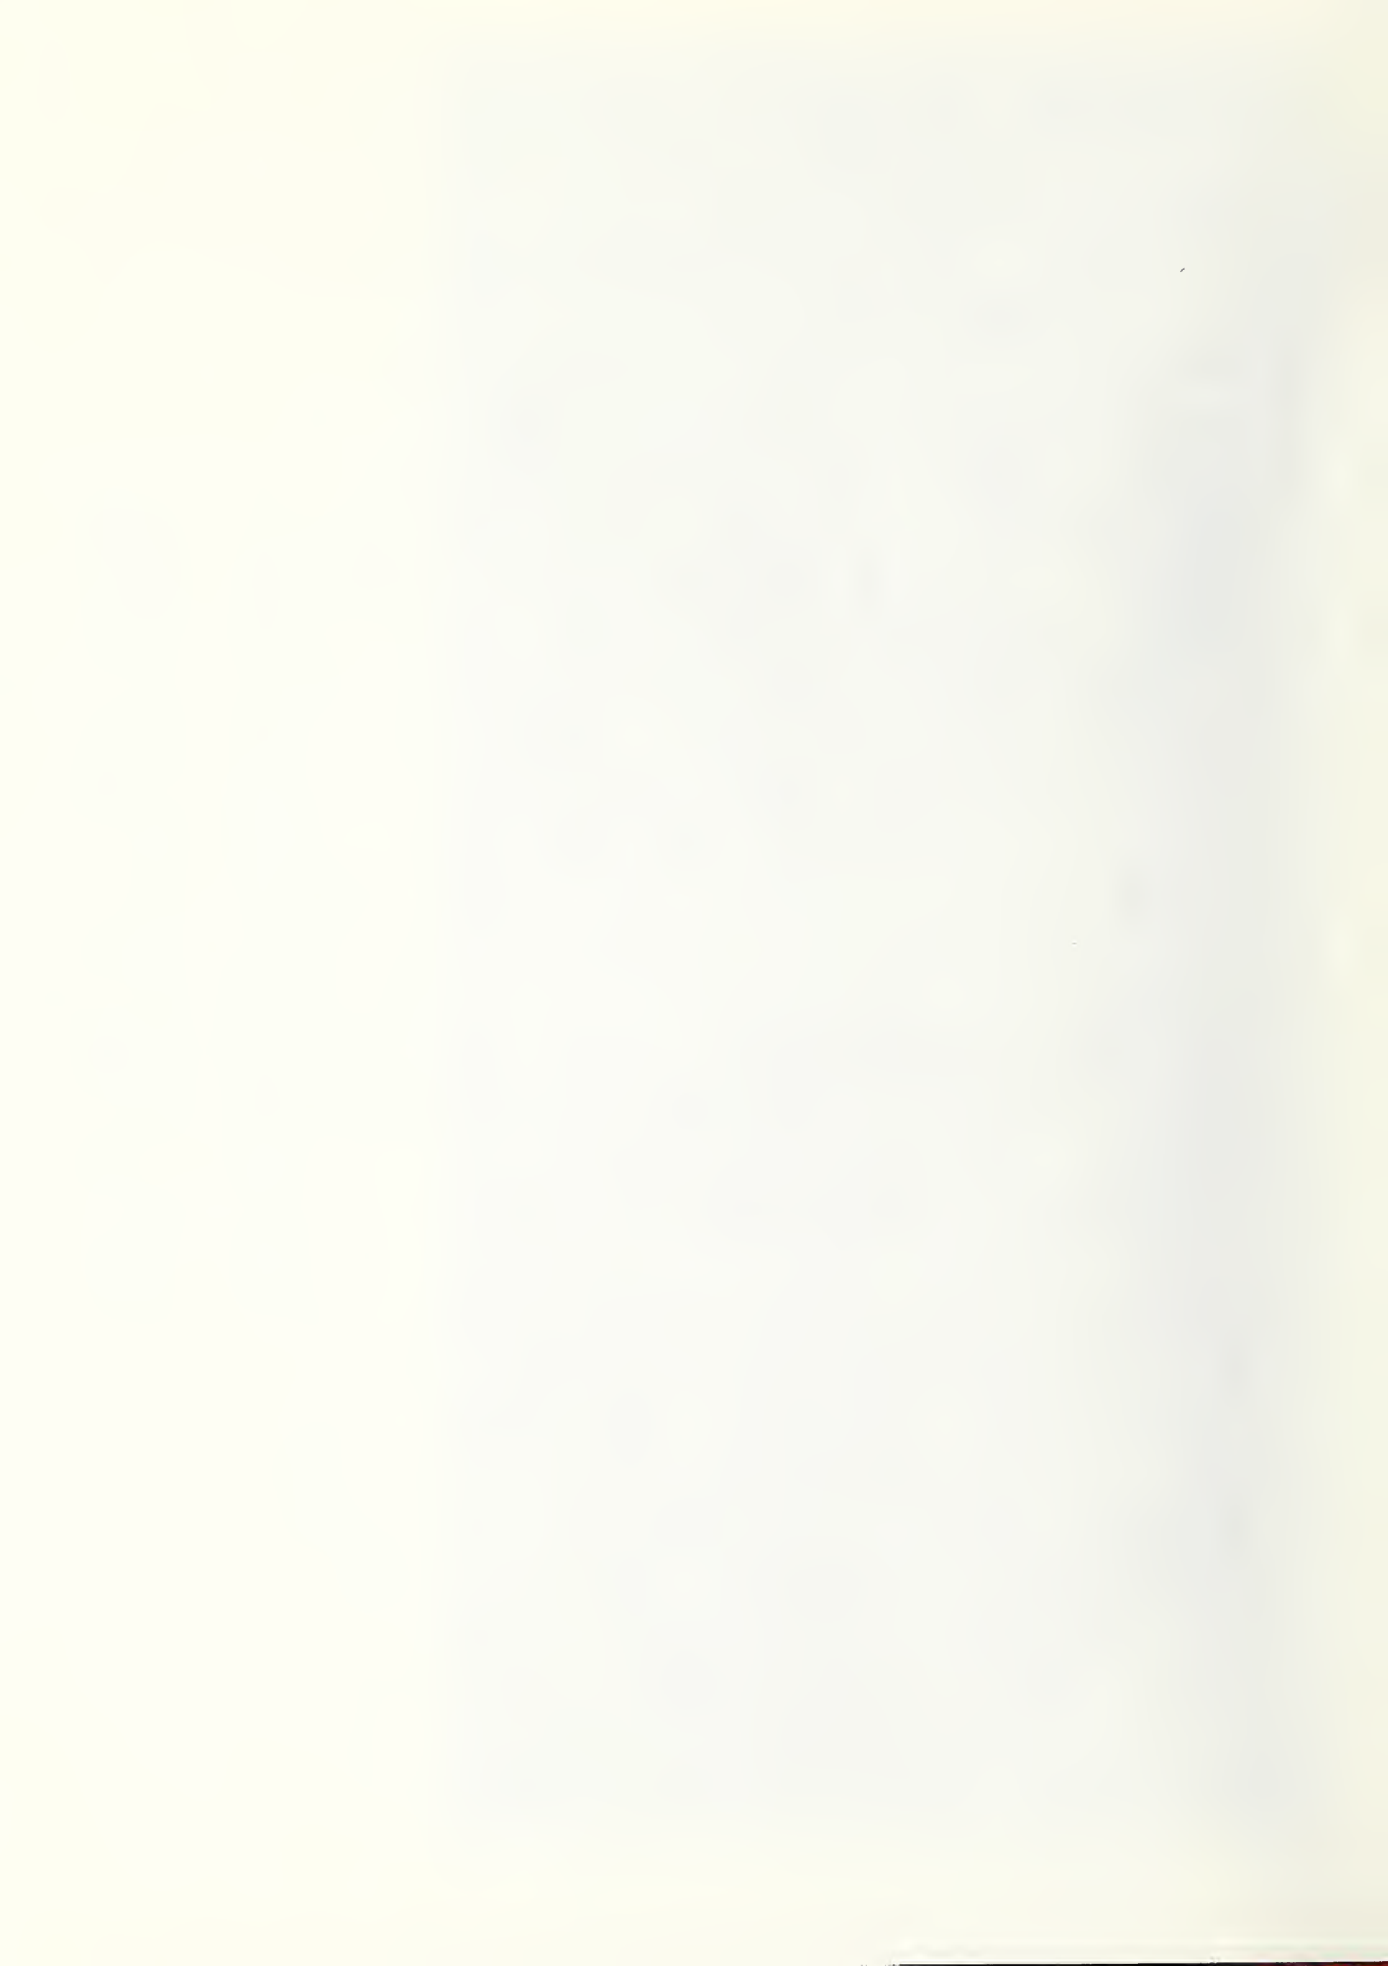
Figure 11. Microstructure of the Crescent City Shell Plate Sample FRA-2, as Observed on Three Mutually Perpendicular Planes.
 The A, B, and C planes are oriented as in Figure 9. ASTM A212-B steel with a ferrite grain size number of 7. Etched with picral.

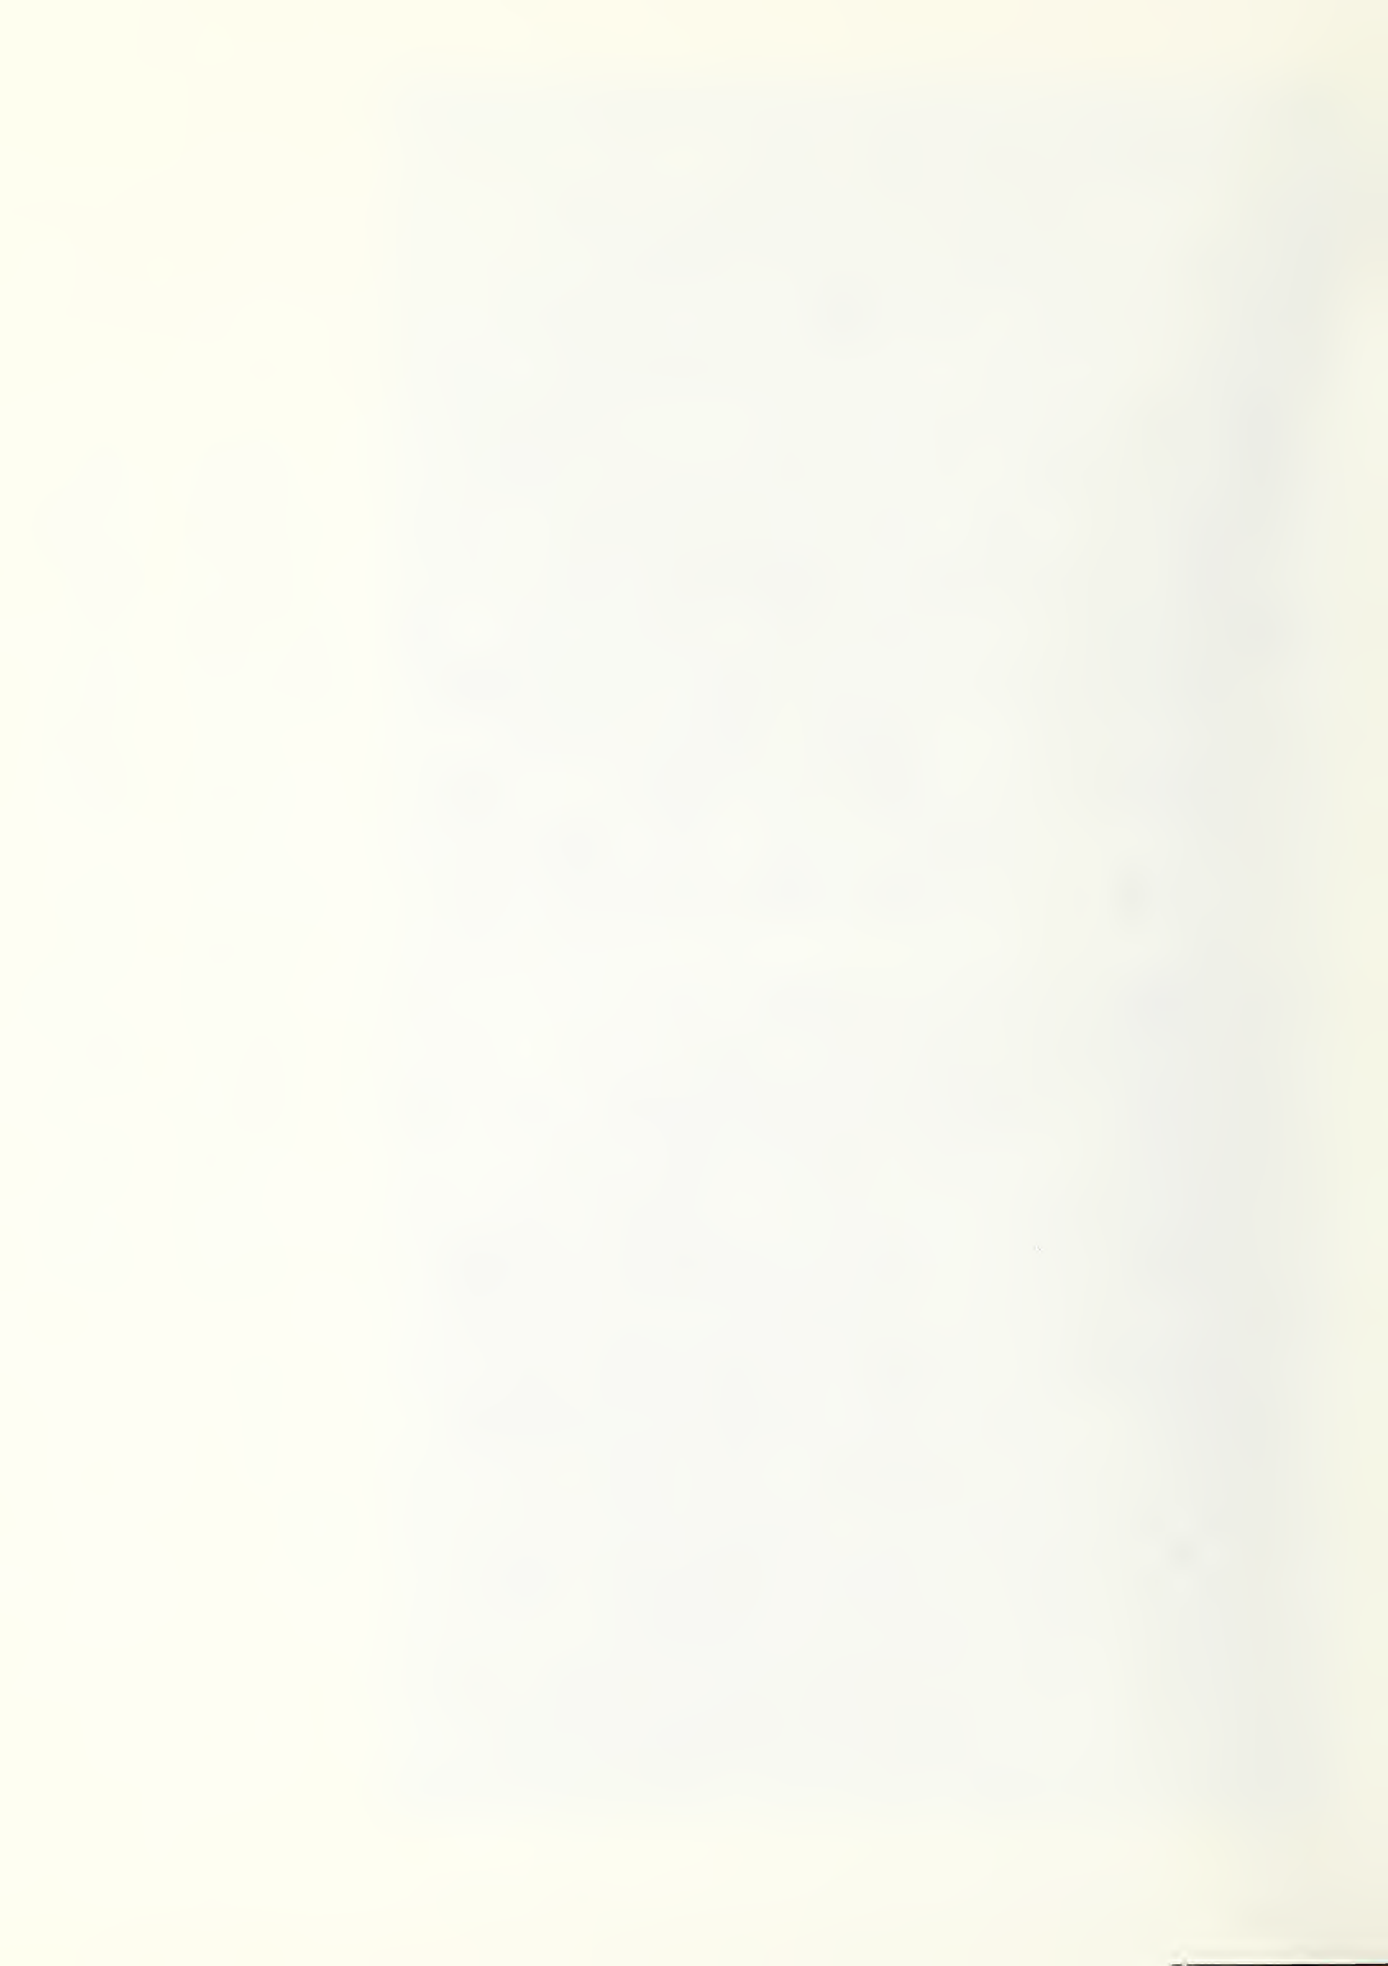
AAR M128-65, -69 and -70; ASTM A212-65

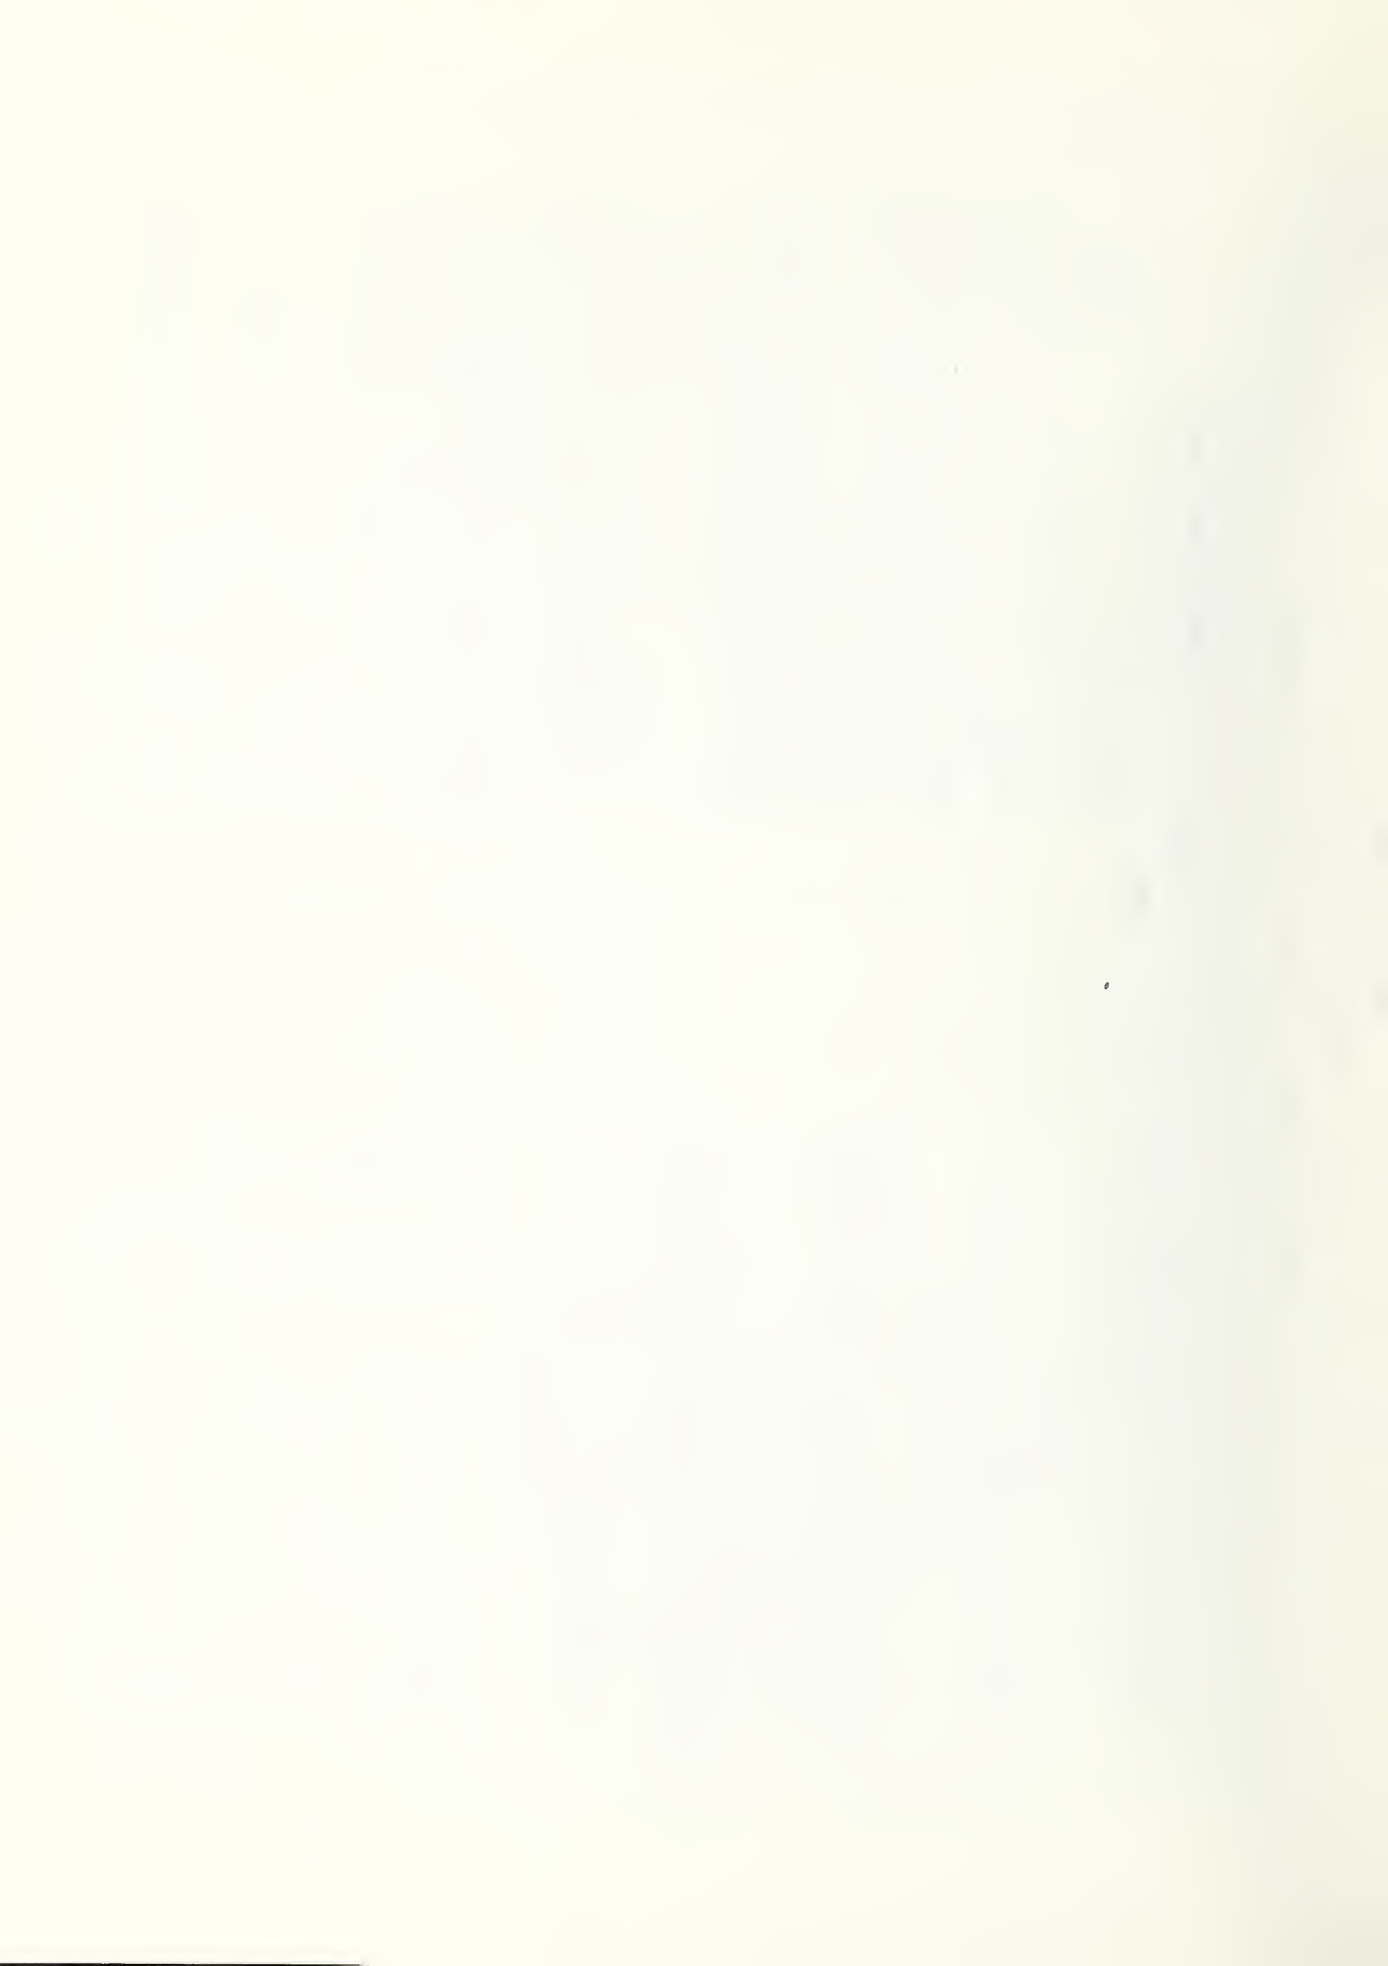
Appendix A Specifications
