# **A Study of Air-Gap Breakdown at 28.5 Kilohertz**

F. Ralph Kotter

Electricity Division  
Institute for Basic Standards  
National Bureau of Standards  
Washington, D. C. 20234

Final Report  
Requisition Number N00039-3316-7105

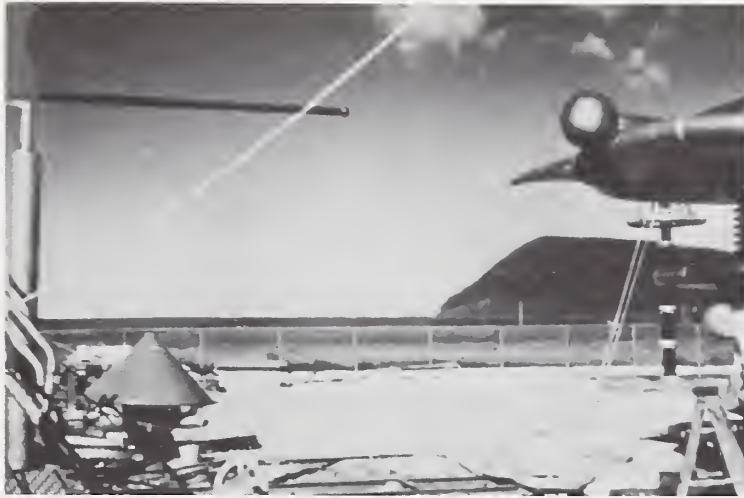
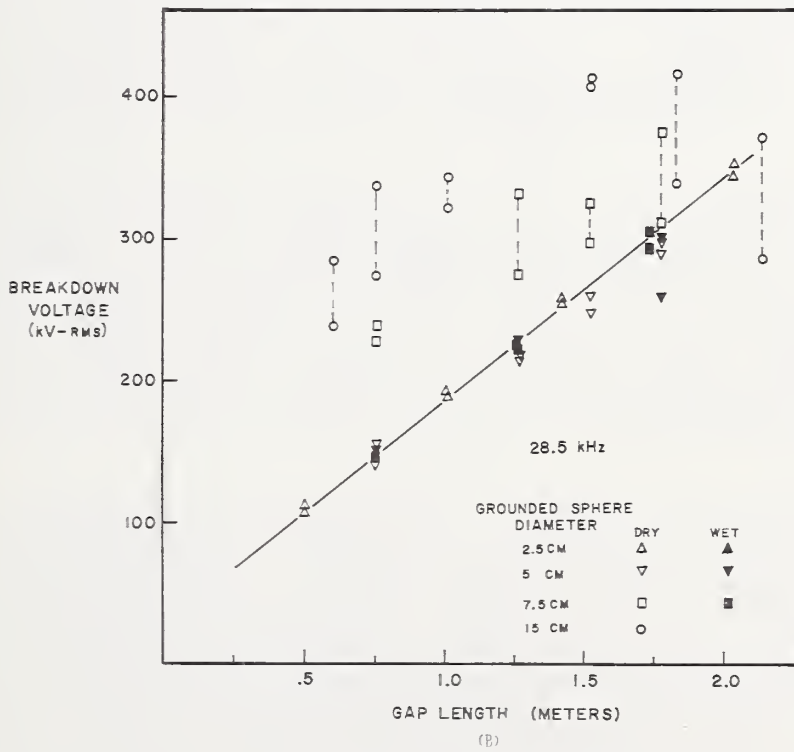
FIGURE 7 PROTECTIVE GAP, ASYMMETRIC SPHERES. (A) MOUNTING ARRANGEMENT. (B) BREAKDOWN CHARACTERISTICS

Several modifications of an asymmetrical sphere-gap system in which the high voltage electrode was one of the 45.7-cm spheres and the ground electrode a much smaller sphere were investigated at 28.5 kHz only. Figure 7 (a) shows a typical arrangement and Figure 7 (b) presents the results.

It is believed that the quite consistent performance exhibited when the grounded sphere was 2.5 or 5 centimeters diameter resulted from an ample supply of ions in the gap. Audible corona from the small ball prior to breakdown was always present. Note that under dry conditions with grounded sphere diameters of 7.5 and 15 centimeters, the scatter in values was comparable to that observed with the symmetrical sphere gap. Under wet conditions where water droplets on the spheres distorted the surfaces, the breakdown voltages appeared to be very nearly independent of the diameter of the grounded sphere.

In the course of the redesign of the base insulator assembly, several different protective gap configurations were studied. Two of them, the 45.8-cm sphere gap and the horn gap were investigated both at 60 Hz and at VLF with the results indicated in Figures 5 and 6. Several gaps in which the electrodes were spheres but of unequal diameters were also investigated at VLF (see Figure 7).

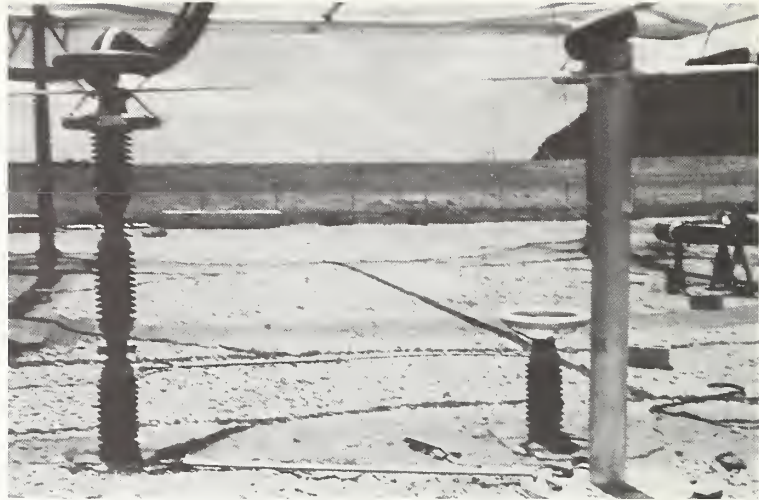
FIGURE 9 "STANDARD" (1/2-INCH SQUARE) ROD-ROD GAP: (A) MOUNTING ARRANGEMENT, (B) BREAKDOWN CHARACTERISTIC

This good agreement between the VLF and 60-Hz performance was not found in the case of "standard" rod gaps as Figure 9 (b) indicates. Figure 9 (a) shows the physical arrangement which met the clearance specifications for a standard rod gap (C68.1, p. 24) up to 1 meter gap length. The reduction in breakdown strength at 28.5 kHz relative to that at 60 Hz increases markedly with increasing gap spacing for gaps more than a few centimeters in length. It appears that the copious supply of ionizing electrons resulting from the corona discharge at the ends of the rods is adequate to produce significant space-charge field distortion.

Over this range of gap settings, the breakdown voltage is demonstrated to be independent of frequency as could have been predicted from the results plotted in Figure 9 which show a marked effect of gap length on the frequency influence.

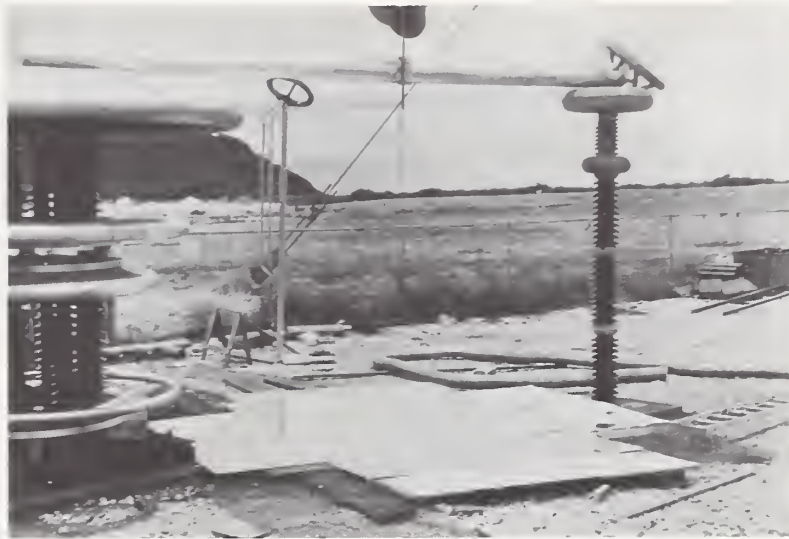
FIGURE 11 "STANDARD" (1/2 INCH SQUARE) ROD-PLANE (A) MOUNTING ARRANGEMENT. (B) CHARACTERISTIC. (ROD-ROD CURVES REPLOTTED FROM FIG. 9 FOR COMPARISON. 60 HZ ROD-PLANE DATA FROM BELLASCHI AND TEAGUE<sup>9</sup>)

VLF breakdown data for several rod-plane and sphere-plane gap configurations were obtained. The physical arrangements and the results obtained are shown in Figures 11 and 12. In those cases where 60 Hz data are available for essentially identical geometries, they are included for comparison.

The rod-rod characteristic could not be extended above about 170 kV since at higher voltages the flashover was preferentially over the longer path from the high voltage rod to the ground plane rather than to the grounded rod. Similar problems set an upper limit to the range of sphere-plane spacings for which data could be obtained. At higher voltages than those shown in Figure 12, the flashover path terminated on the sphere support rather than on the sphere itself. These results, together with those shown in Figure 13 for round rods with hemispherical ends which showed approximately sphere-gap characteristics up to spacings and voltages at which significant pre-breakdown discharges developed, and the "standard" rod-gap results at the higher voltages, are in accord with the space-charge field-distortion theory already discussed.

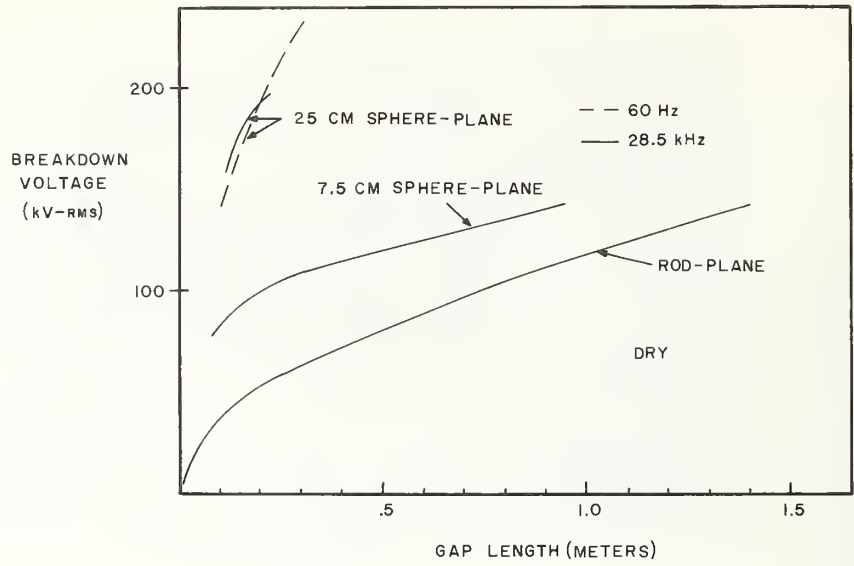
FIGURE 12 SPHERE-PLANE CHARACTERISTICS (ROD-PLANE CHARACTERISTIC REPLOTTED FROM FIGURE 11 FOR COMPARISON. 60 HZ DATA FROM BELLASCHI AND TEAGUE<sup>9</sup>)

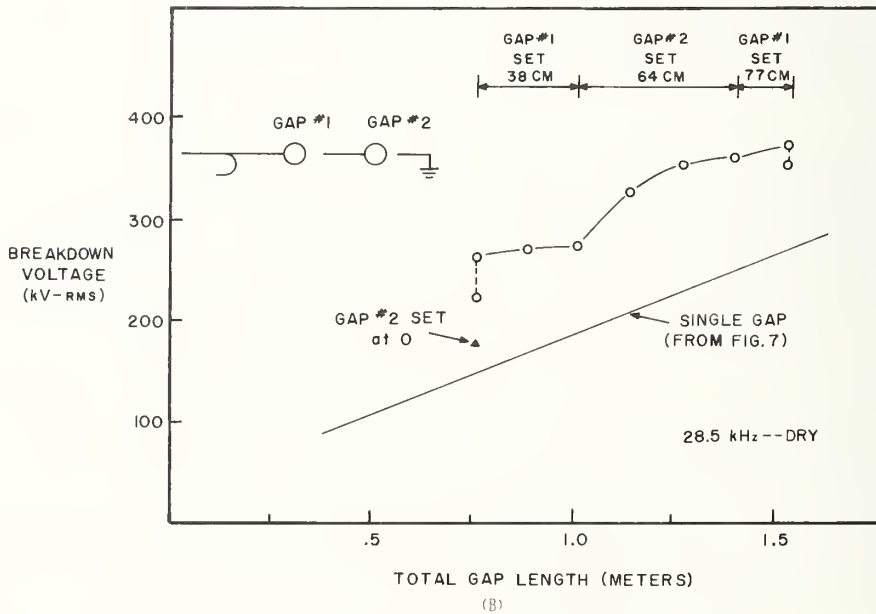
FIGURE 14 DOUBLE ASYMMETRIC GAP ASSEMBLY: (A) MOUNTING ARRANGEMENT, (B) BREAKDOWN CHARACTERISTICS

The performance of the gap assembly consisting of a 47.5-cm diameter sphere as one electrode and a 2.5-cm or 5-cm sphere as the other was such as to nearly meet the requirements and suggested investigation of two such gaps in series. The dry flashover results of this investigation are shown in Figure 14. The limitation appeared to be the radius of curvature of the high voltage electrode which under rain conditions resulted in streamer formation from water droplets. However, all flashovers were in the gaps and, as shown in the figure, it was successfully demonstrated that the breakdown voltage for two such gaps in series is significantly higher than for a similar single gap of equivalent total length. It is believed the fact that the effect on breakdown voltage of the same incremental change in gap length was different for the two gaps resulted from lack of equal division of the total voltage between them. Further study of this configuration was discouraged by the results of a wet test during which there was extensive streamer development from water droplets on the high-voltage sphere at about 250 kV with flashovers occasionally to the ground plane as well as across the gap assembly.
