NBSIR 75-788

Evaluation of the Fire Hazard in a Mobile Home Resulting from an Ignition on the Kitchen Range

Interim Report

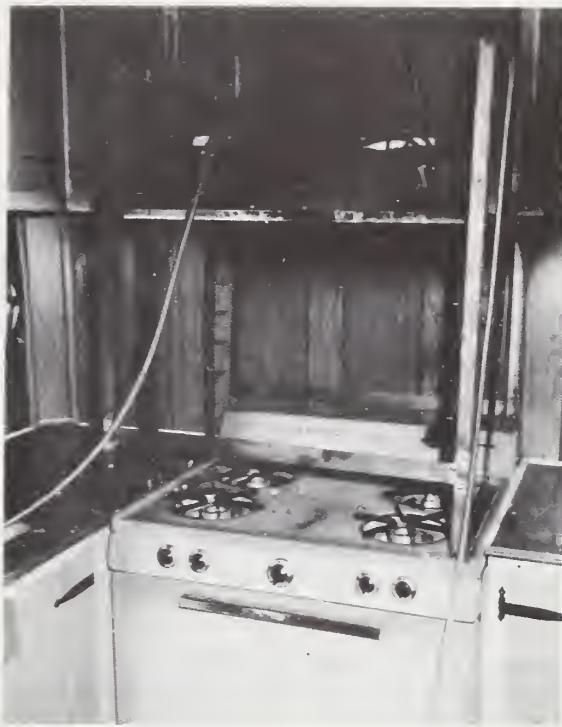
Figure 5. Test Apparatus for Measuring Incident Heat Flux

The equipment included an asbestos sample 24.5 in x 27 in (62.2 cm x 68.9 cm) with 4 holes provided for installation of heat flux transducers to measure radiant and convective heat directly above the range burners (see fig. 5).

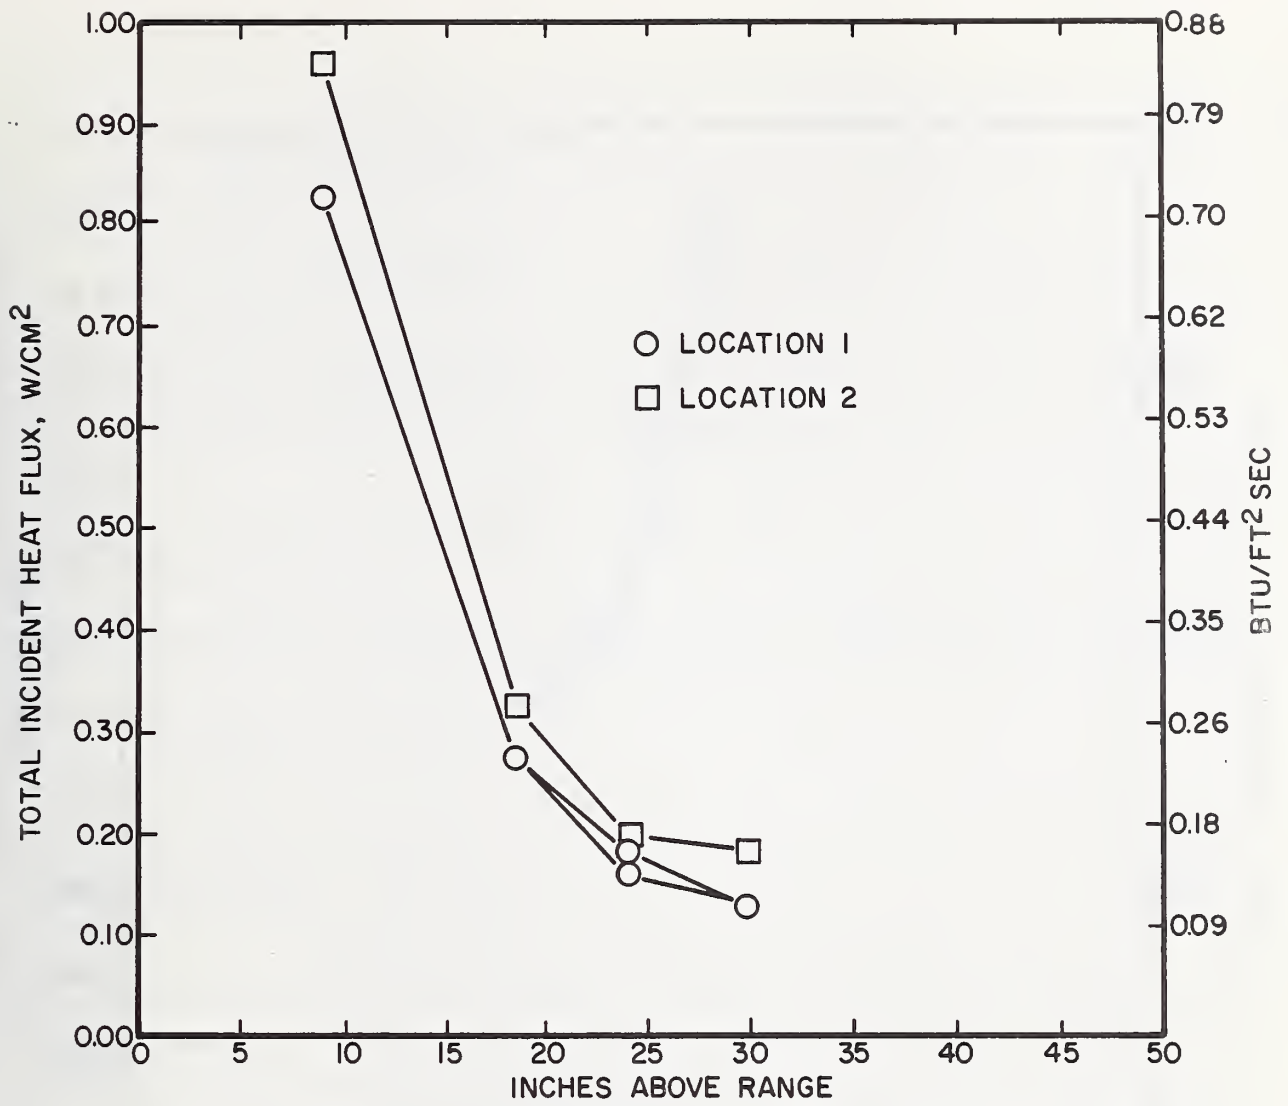
Figure 6. Incident Heat Flux from Maximum Output of Two Back Burners of an LP-Gas Fired Kitchen Range

The combination which provided the maximum total incident heat flux of 0.8 Btu/ft² s (0.96 W/cm²) was the two back burners in a state of maximum output. When this source was held constant and the height of the sample was varied, the total incident heat flux ranged from 0.85 Btu/ft² s (0.97 W/cm²) at 9 inches (22.9 cm) to 0.11 Btu/ft² s (0.12 W/cm²) at 30 inches (76.2 cm). Figure 6 shows these results.

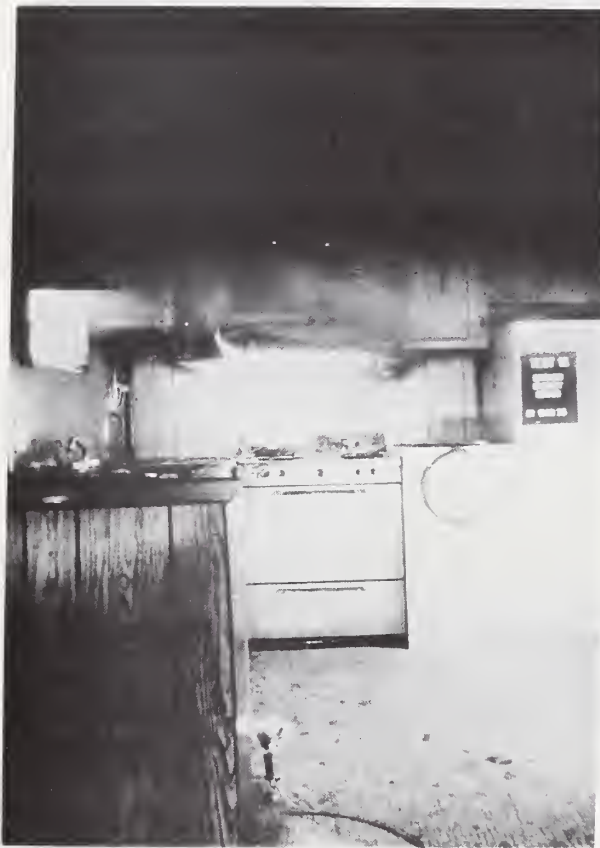
Figure 9. Illustrates the Extent of Involvement of a Cabinet With a Metal Range Hood (Time: 2 min-20 s)

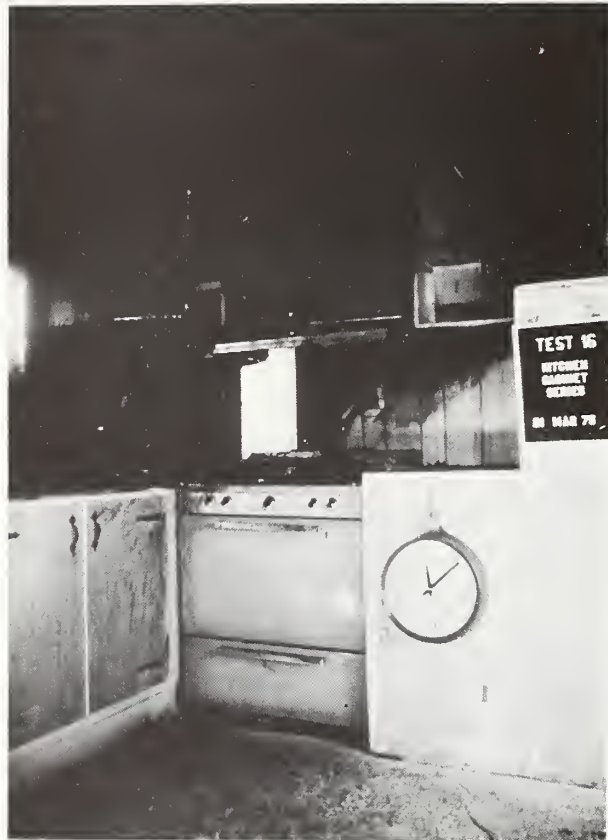
Figure 10. Illustrates Burn-Through of the Back Wall in Test 16; the Wall was Constructed of 5/32-inch Printed Lauan Plywood

In Tests 1, 5, and 16, the use of 5/32-inch lauan plywood with an ASTM E-84 flame spread rating of Class C (76-200) resulted in burn-through to the adjacent bedroom (see fig. 10) exposing the electrical wiring in the wall partition as well as providing the flames with a vertical path into the ceiling cavity. The Class C material also allowed lateral propagation, including flame impingement on the refrigerator. Observations from Test 16 indicate that impingement on the refrigerator occurred at 1 min-35 s. This test was, however, somewhat more dramatic than Tests 1 and 5, and it appears as though the low relative humidity in Test 16 may have contributed to this. The time recorded for Test 1 was 4 minutes, which was under more normal environmental conditions.

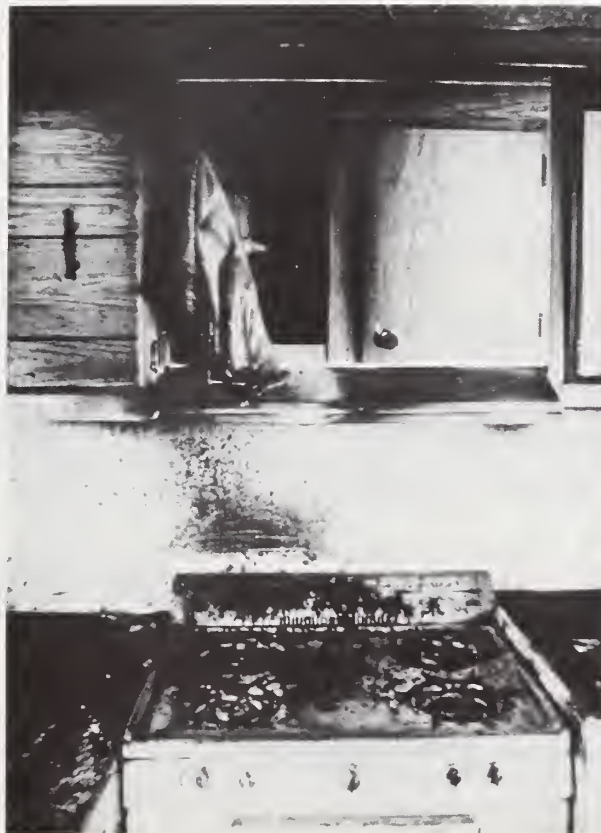
Figure 11. Illustrates the Performance of a Molded Polystyrene Cabinet Door (left) and a Printed Particle Board Cabinet Door (right) to a Test Fire. In this Test a Metal Range Hood was Installed.

In all three tests in which polystyrene doors were tested, the door assemblies failed (see fig. 11), resulting in greater temperatures inside the cabinet and ignition of the countertops and the vinyl flooring due to direct exposure from the melting and burning cabinet door debris. However, as the doors melted and dripped away from the cabinet assemblies, ceiling temperatures were reduced. Greater quantities of smoke and irritants were noted by observers during the tests which included the molded polystyrene doors than during the other tests.
