# Evaluation of A New Hardening Process for Steel Transfer Materials

Failure Analysis Report

Prepared for  
**Office of Engraving**  
**Bureau of Engraving and Printing**  
Washington, D. C.

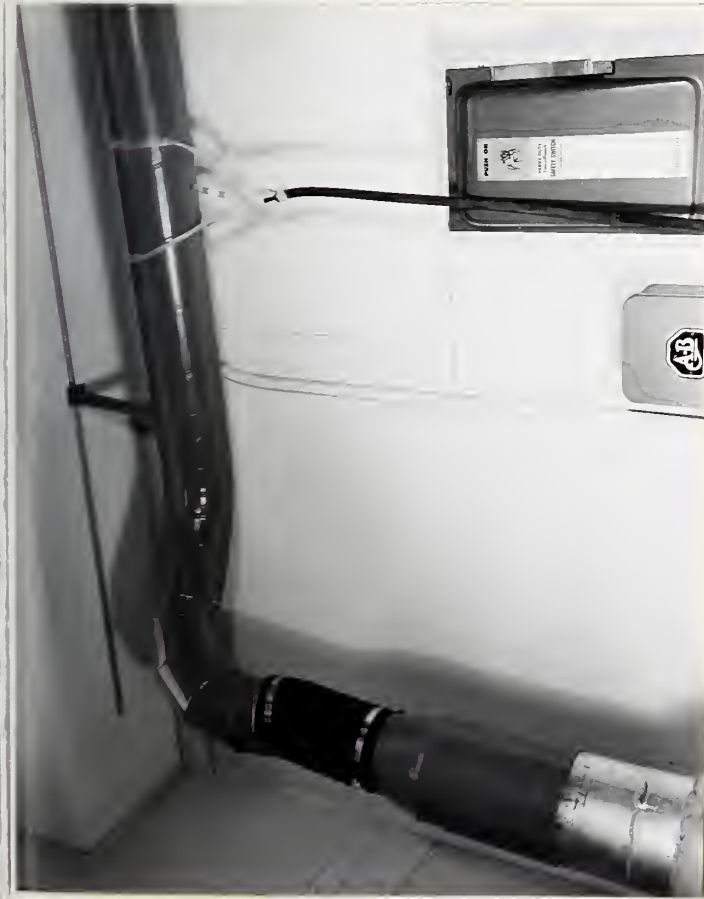
Figure 4. Equipment arrangement for exhaust air analysis.

a. Shows location of tap in exhaust air duct

b. Shows vacuum sampling apparatus

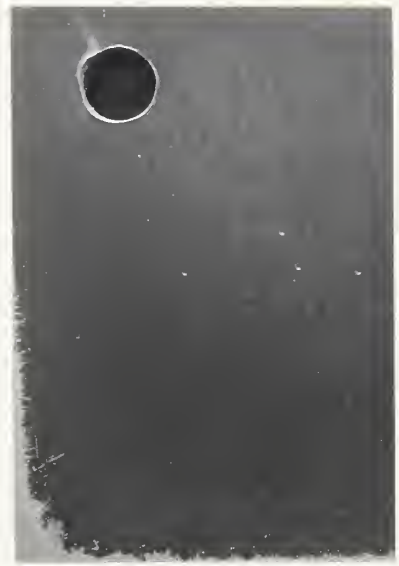
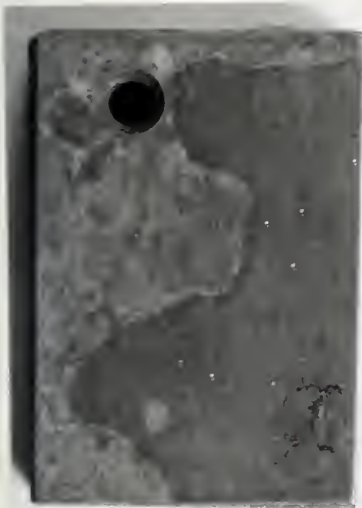
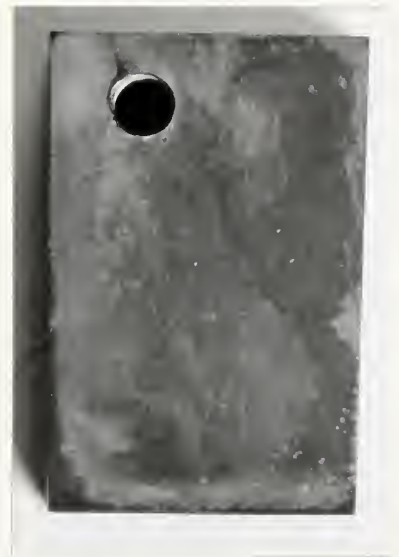
Figure 5. Appearance of polished surfaces of hardened specimens.

The surfaces of specimens hardened at the manufacturers laboratory were clean after hardening. However, some of the specimens hardened at NBS had a black, adherent coating after hardening. The coatings observed on the polished surfaces of hardened specimens 1031-14 and 1045-12 are shown in Figures 5a and 5b, respectively. It was found that the coatings could be removed by immersion of the specimens in a 10 percent solution of sulfamic acid ( $\text{NH}_2\text{SO}_3\text{H}$ ) at room temperature for from fifteen to thirty minutes, followed by swabbing with a soft bristle brush and a clear water rinse. The appearance of the polished surfaces of hardened specimens 1031-14 and 1045-12 after the sulfamic acid cleaning treatment are shown in Figures 5c and 5d, respectively. The black, adherent coating was observed on some of the specimens with low surface hardness reported in 5.2. It is uncertain as to whether the coating formed on specimens while they were in the salt bath; or was picked-up by specimens from a residual, substance on the surface of the bath, when specimens were being removed for quenching.

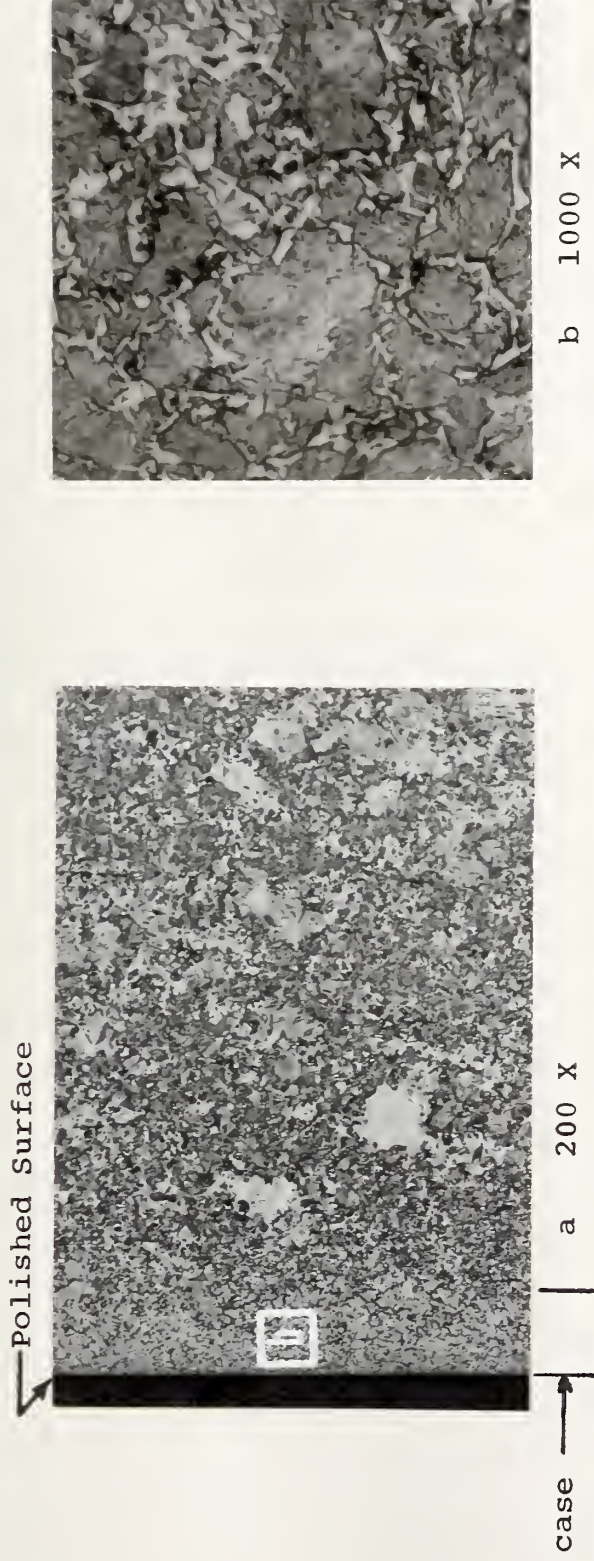
Figure 6. Specimen 1031-2

Austenitized at 1550F 36 minutes, oil quenched, double tempered 90 minutes at 400F. Specimen hardened at manufacturer's laboratory. No salt replenishment.

Case: Essentially tempered martensite with some grain boundary ferrite (white).

Core: Ferrite (white) in a matrix of tempered martensite (dark) large white areas are unresolved martensite.

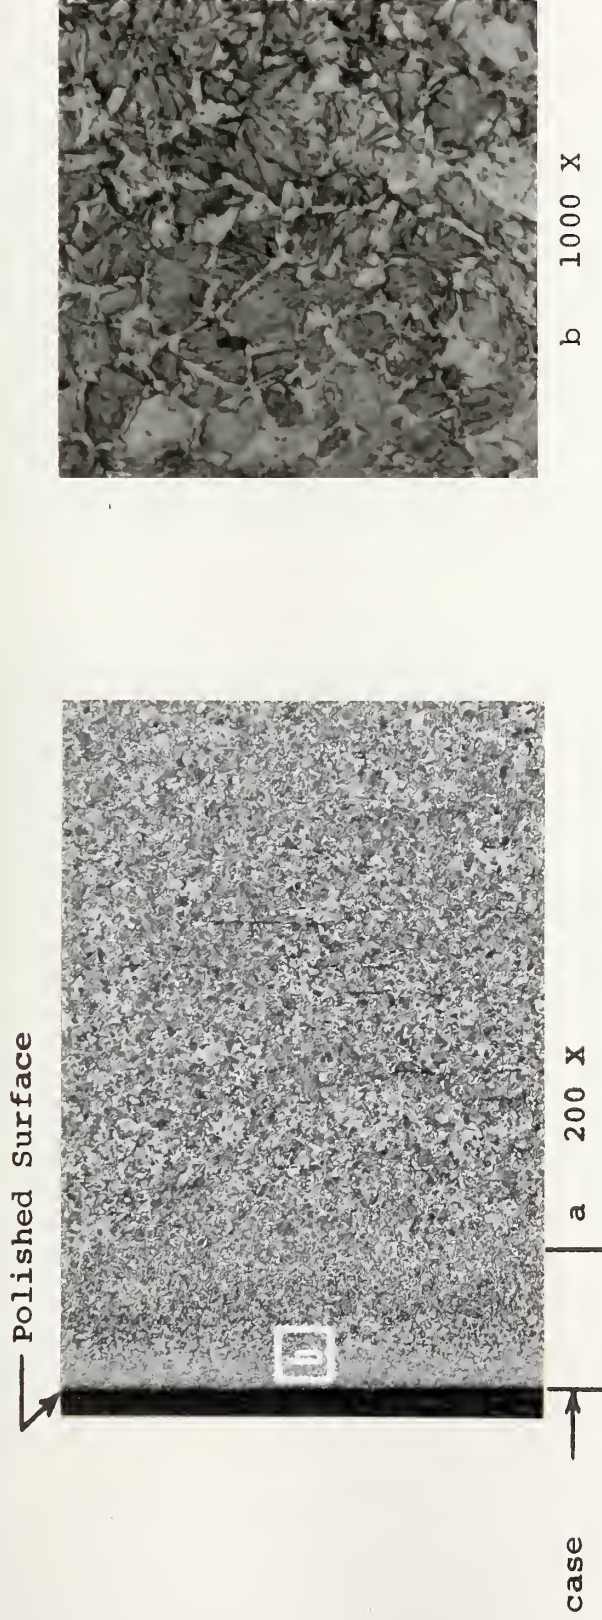
Figure 7. Specimen 1031-3

Austenitized at 1550F 45 minutes, oil quenched, double tempered 90 minutes at 400F. Hardening time extended to determine effect on case depth. Hardened at manufacturer's laboratory. No salt replenishment.

Case: Predominantly tempered martensite with ferrite (white) in grain boundaries. Light area adjacent to polished surface is probably due to a carbonitridding effect.

Core: Essentially tempered martensite with ferrite (white) in grain boundaries. Large white areas are unresolved martensite.

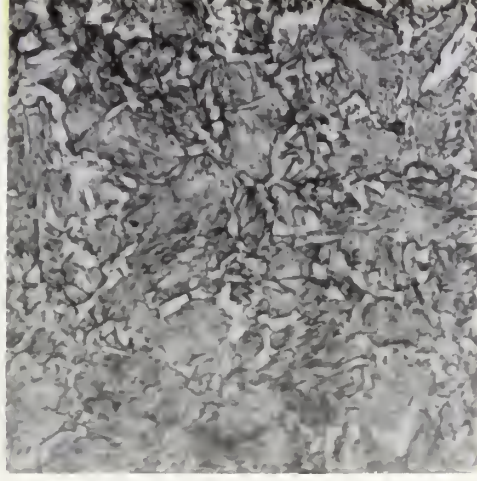
Austenitized at 1550F 40 minutes; oil quenched; double tempered 75 minutes at 450F, 75 minutes at 425F. Hardened at NBS. Fresh salt bath.

Case: Essentially tempered martensite (dark) with ferrite (white) in grain boundaries. Ferrite grain boundary network is prominent in transition zone.

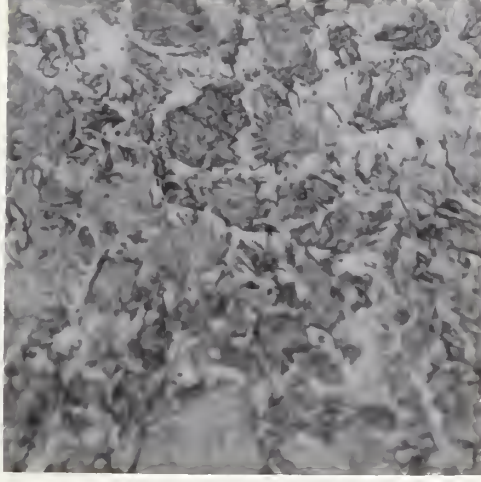
Austenitized at 1575F 40 minutes; oil quenched; double tempered, 75 minutes at 400F, 75 minutes at 375F. Hardened at NBS. LOCY additive and LOCYN pellets added to salt bath in replenishment.

Case depth, from hardness traverse: 0.004 inch.

Hardness: 71.5 HRL5N on polished surface. Range in case, 76.5 - 78 HRL5N.

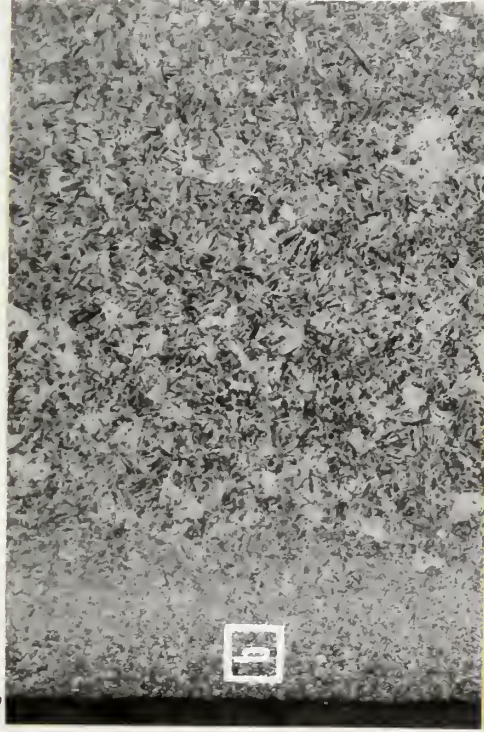
Figure 10. Specimen 1031-9

Austenitized at 1585F 36 minutes; brine quenched; double tempered, 75 minutes at 450F, 75 minutes at 425F. Hardened at NBS. No salt replenishment.

Case: Essentially tempered martensite.

Case depth, from hardness traverse: 0.004 inch.

Hardness: 86 HRI15N on polished surface. Range in case, 85 - 86.5 HRI15N.

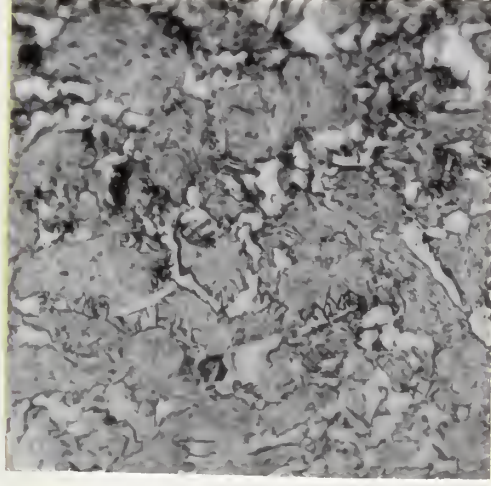
Figure 12. Specimen 1031-15

Austenitized at 1550F 36 minutes; oil quenched; double tempered, 75 minutes at 450F, 75 minutes at 425F. Hardened at NBS. LOCYN pellets added to salt bath for replenishment.

Case: Tempered martensite (dark) and ferrite (white) in grain boundaries.

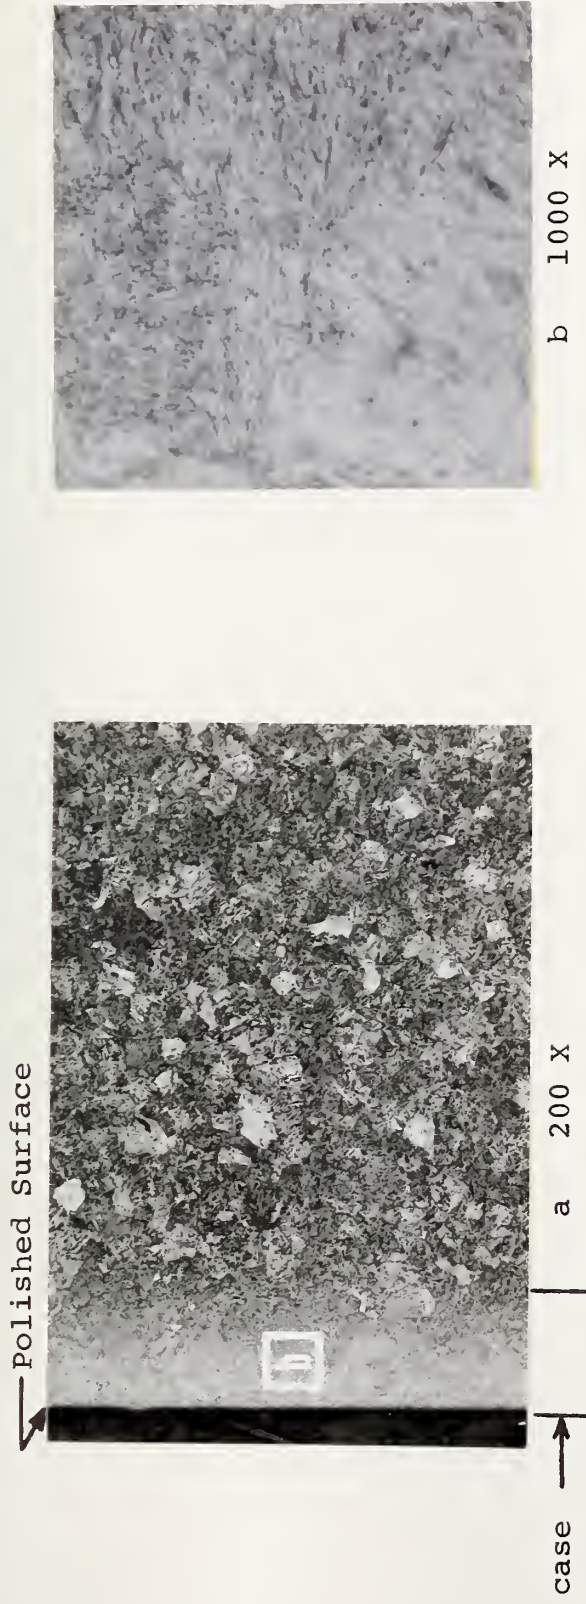
Figure 13. Specimen 1045-2

Austenitized at 1500F 30 minutes; brine quenched; tempered 90 minutes at 400F. Hardened at manufacturer's laboratory. Fresh salt bath.

Case: Essentially tempered martensite.

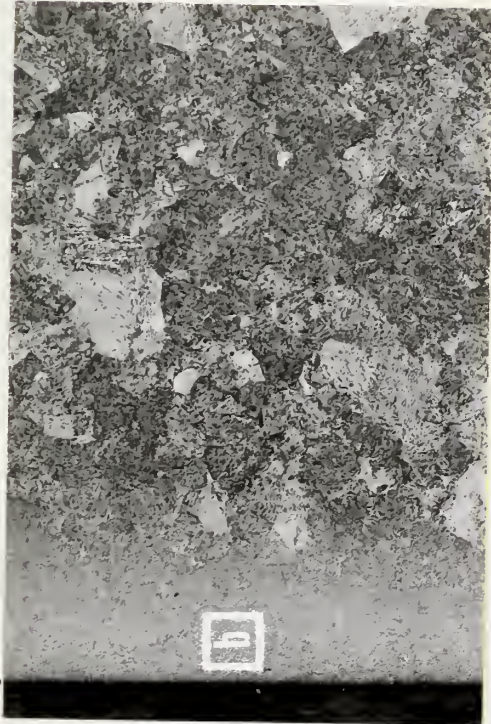
Austenitized at 1500F 45 minutes; brine quenched; tempered 90 minutes at 400F. Hardened at manufacturer's laboratory. LOCYN pellets added to salt bath for replenishment.

Case: Tempered martensite.

Case depth, from hardness traverse: 0.004 inch.

Hardness: 76 HR30N on polished surface. Case hardness, 74 HR30N.

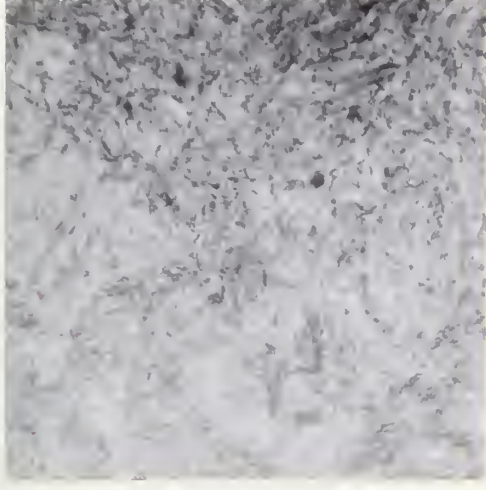
Austenitized at 1500F 30 minutes; brine quenched; tempered 75 minutes at 400F. Hardened at NBS. NOCY additive and LOCYN pellets added to salt bath for replenishment.

Case depth, from hardness traverse: 0.004 inch.

Hardness: 69.5 HR30N on polished surface. Range in case, 72 - 75 HR30N.

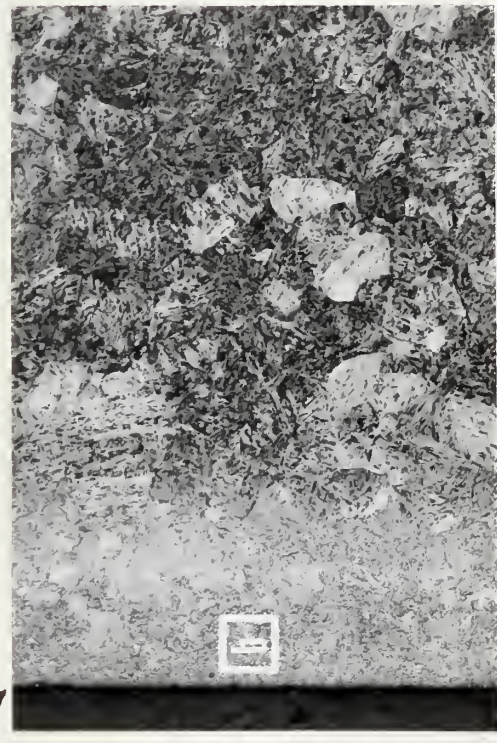
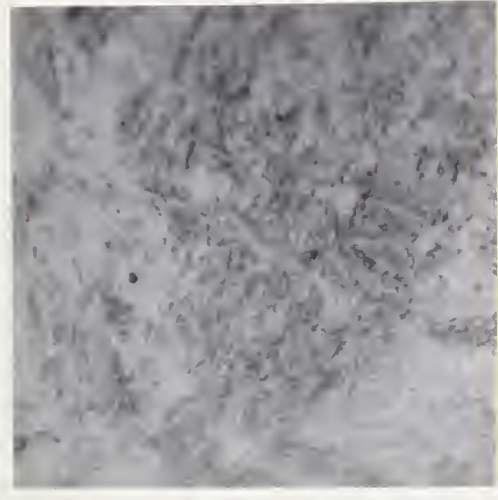
Figure 17. Specimen 1045-12

Austenitized at 1480F 30 minutes; brine quenched; tempered 90 minutes at 400 F. Hardened at NBS. LOCYN pellets added to salt bath for replenishment.

Case: Essentially tempered martensite.

Case depth, from hardness traverse: 0.0045 inch.

Hardness: 75 HR30N on polished surface. Range in case, 73 - 74.5 HR30N.

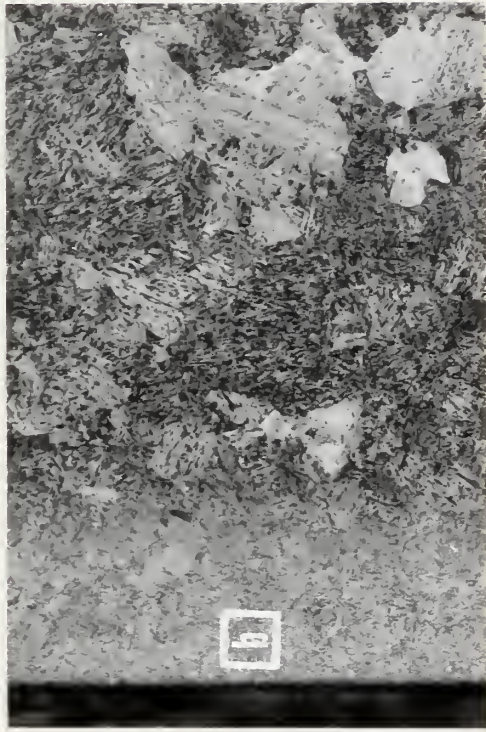
Austenitized at 1480F 30 minutes; brine quenched; tempered 90 minutes at 400F. Hardened at NBS. LOCYN pellets added to salt bath for replenishment.

Case: Essentially tempered martensite.

Case depth, from hardness traverse: 0.0045 inch.

Hardness: 75.5 HR30N on polished surface. Range in case, 74 - 75 HR30N.

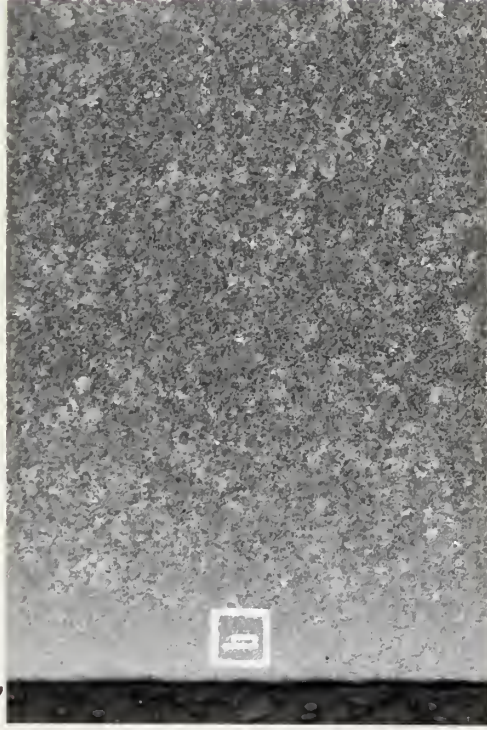
Figure 20. Specimen W2-2

Austenitized at 1550F 60 minutes; brine quenched; tempered 90 minutes at 400F. Hardened at manufacturer's laboratory. No salt replenishment.

Case: Carbides (dark) in a ferrite matrix (light).

Case depth, from hardness traverse: 0.006 inch.

Hardness: 75 HR30N on polished surface. Range in case, 64.5 - 66 HR30N.

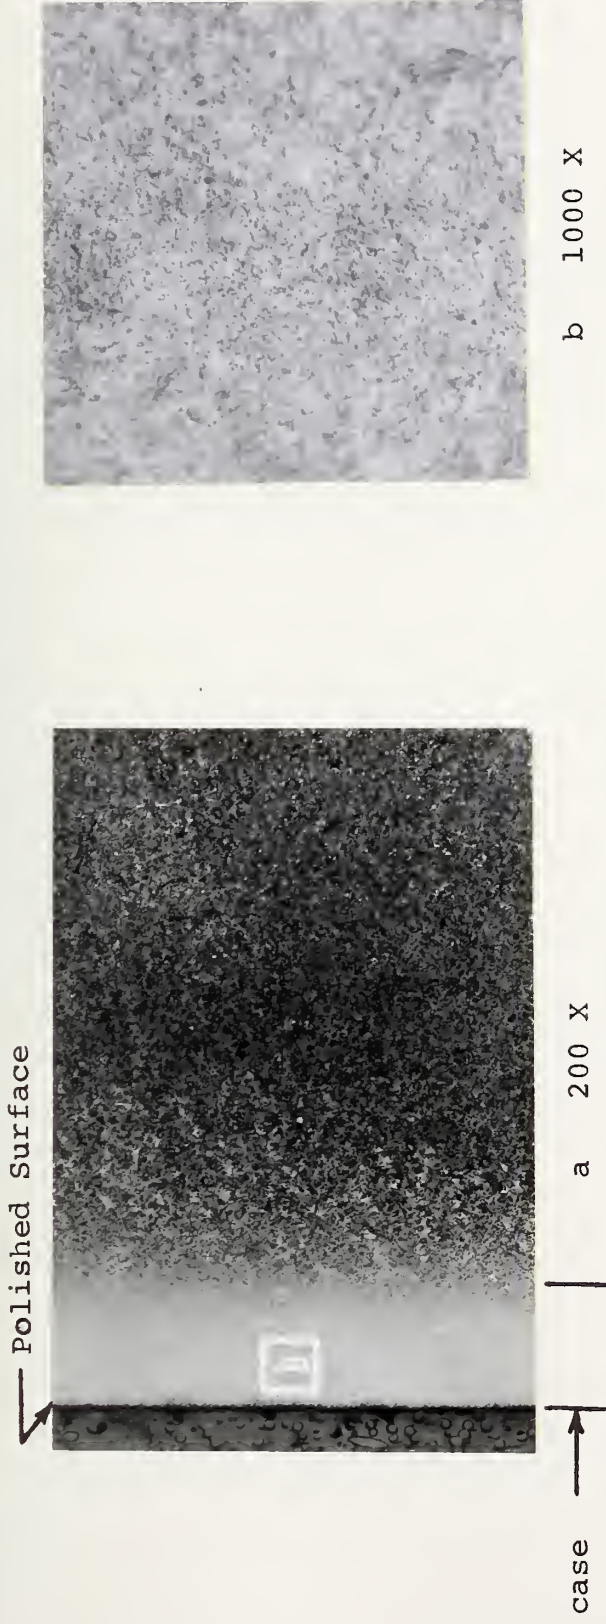
Figure 21. Specimen W2-3

Austenitized at 1500F 60 minutes; brine quenched; tempered 90 minutes at 400F. Hardened at manufacturer's laboratory. LOCYN pellets added to salt bath for replenishment.

Case: Carbides (dark) in a ferrite matrix (light).

Core: Essentially tempered martensite.

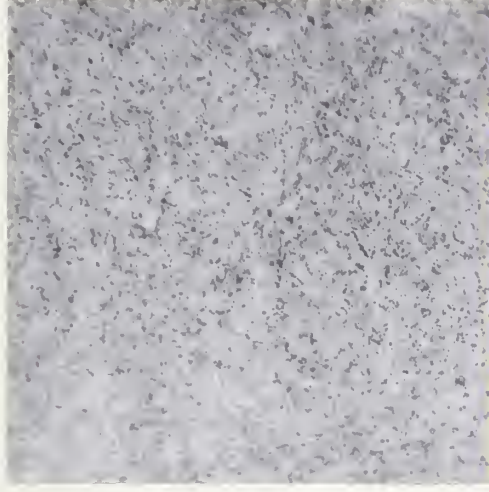
Austenitized at 1550F 60 minutes; brine quenched; tempered 90 minutes at 375F. Hardened at NBS. NOCY additive and LOCYN pellets added to salt bath for replenishment.

Case: Carbides (dark) in a ferrite matrix (light).
