NBSIR 76-1178

Air Leakage and Thermal Performance of a Mark III Relocatable Lewis Building

Final Report

Prepared for
U.S. Naval Facilities Engineering Command
Naval Civil Engineering Laboratory
Port Hueneme, California 93041

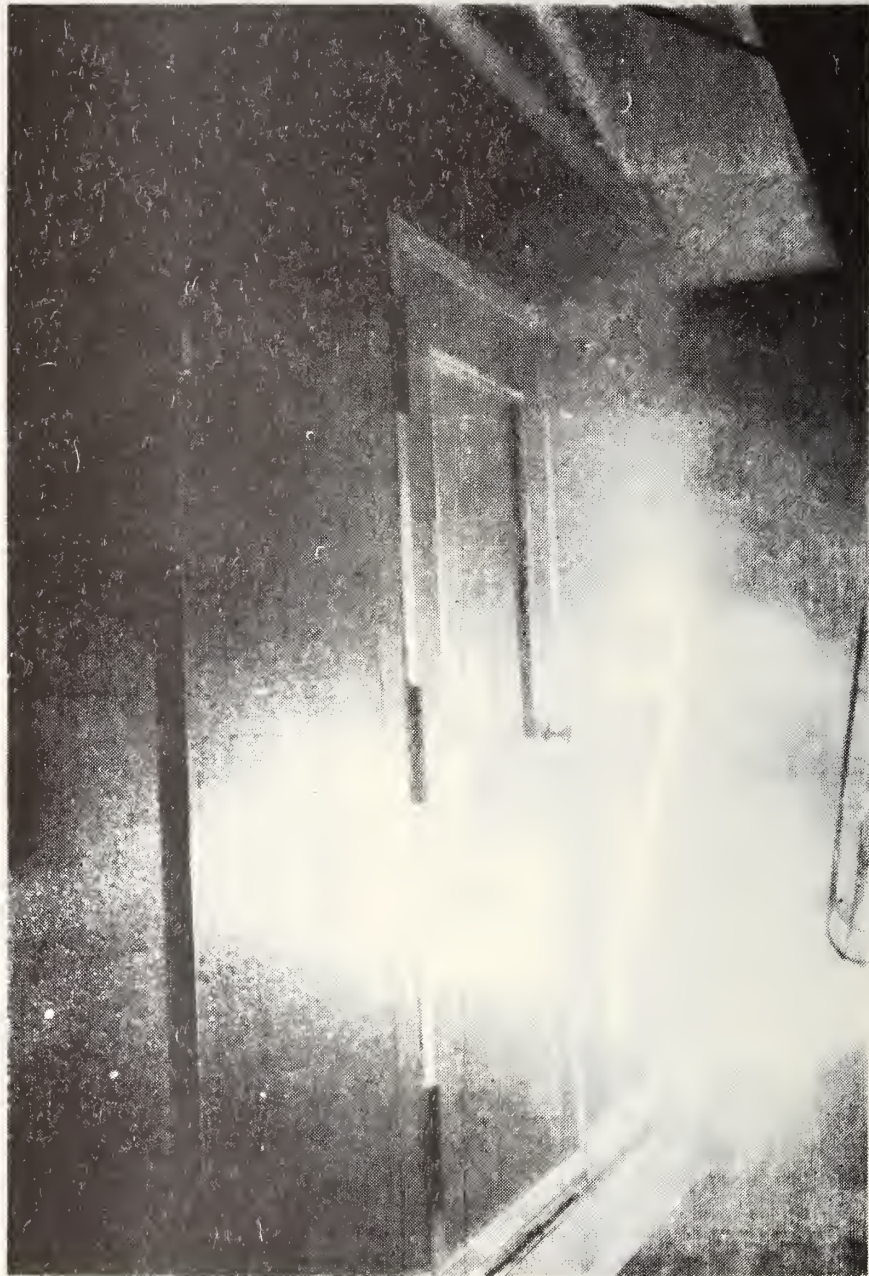
Figure 3. Typical Door Installation

Certain of the wall panels, as they were supplied, came with built-in windows and doors. Figures 3 and 4, respectively, show a typical door and window assembly. A vinyl latex caulk was applied to all the horizontal joints between panel skins and aluminum extrusions, but no sealer was used where vertical panel to panel joints were made with the plastic connector strips. The seams between adjacent wall and roof panels had no sealer applied after assembly.

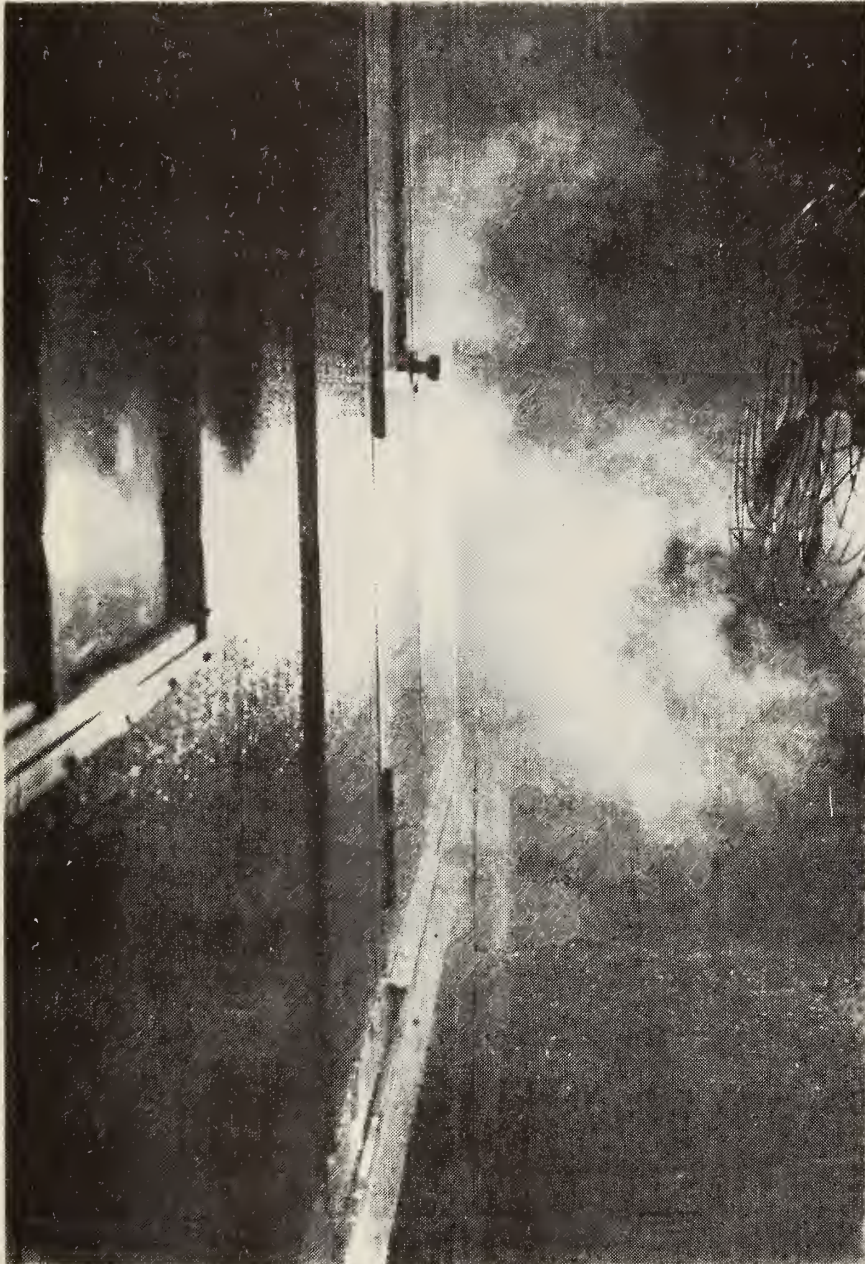
Figure 5. Smoke Leaks at Rear Door

Preliminary tests were used to determine the suitable techniques to photographically record the leaks. Sixteen-millimeter color motion pictures, color slides, and black-and-white and color negatives were used in attempts to record the more significant air leaks. Figure 5 shows white smoke leaking around the rear door.

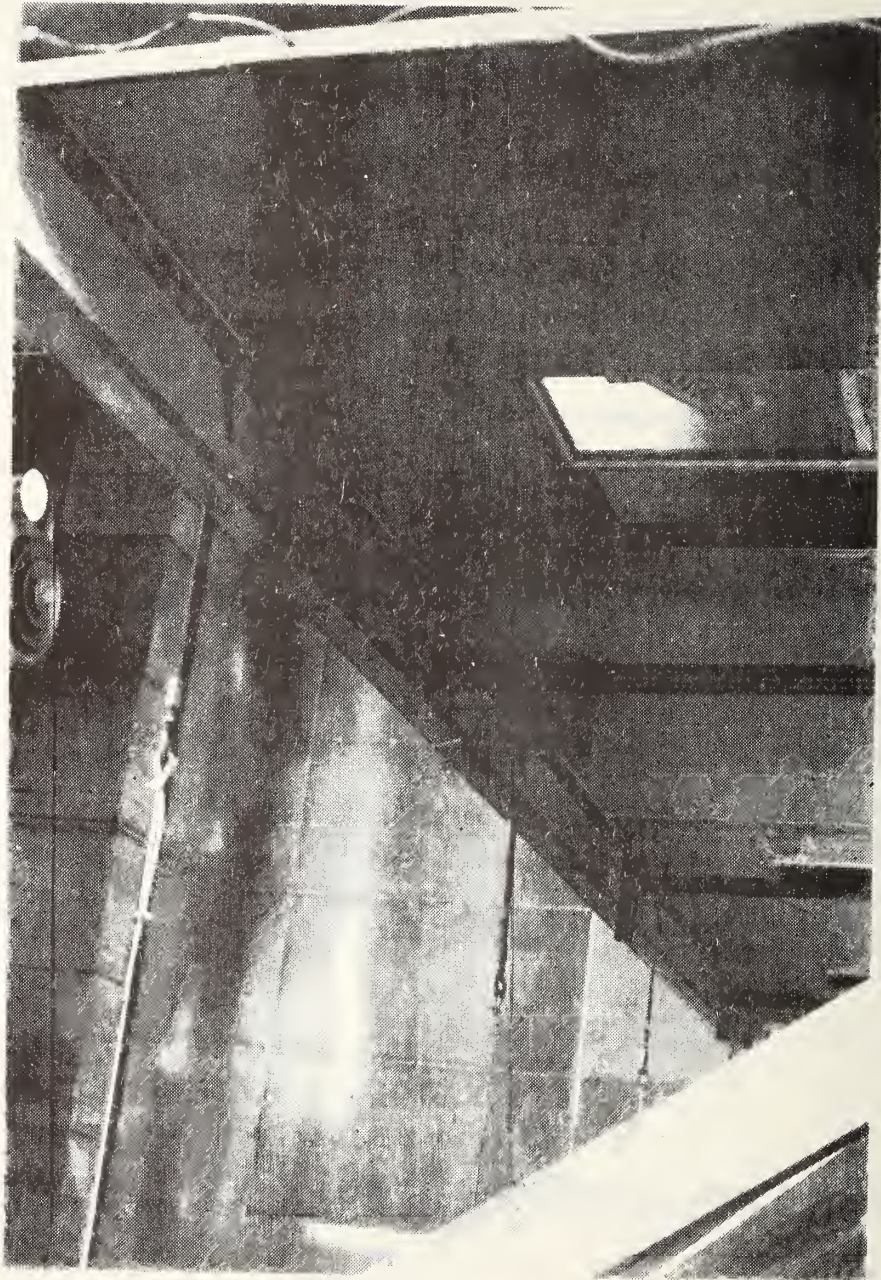
Figure 12. Method of Applying Racking Load

The racking forces were applied to the building by four hydraulic devices connected to the building by cables, wood 2 x 4's and eye bolts as shown in figure 12 and described in detail in another report [2].
