MATERIALS RESEARCH FOR CLEAN UTILIZATION OF COAL

QUARTERLY PROGRESS REPORT

January - March 1977

Institute for Materials Research
National Bureau of Standards
Washington, D. C. 20234

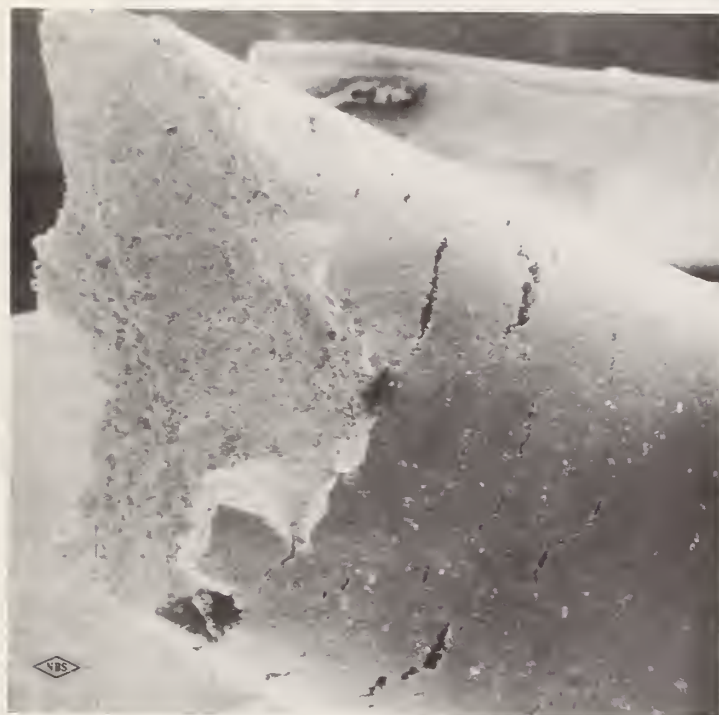
Fig. 5. Scanning electron micrograph of the fracture of a 310 stainless steel specimen tested at 540°C (1000°F) in H₂ at a strain rate of $8.4 \times 10^{-7} \text{s}^{-1}$. 20 X.

Table 2 is a compilation of the rest of the data collected on the alloys 310, 310 S, 347 SS, and Incoloy 800 at various temperatures and environments during the preliminary testing of these alloys before testing in coal gasification environments. Here again it should be noted that the properties for the 310 SS decrease with decreasing strain rate independent of environment but at temperatures above 454°C (850°F). Some of the final tests were made on 310 SS in H₂ to further determine the effect of environment. The first 310 SS specimen was tested at 540°C (1000°F) at a strain rate of $8.4 \times 10^{-7} \text{ s}^{-1}$. The H₂ was passed through hot copper turnings, two liquid N₂ traps, and P₂O₅ to trap moisture before entering the test chamber. The resulting reduction in area was 23.3%. Secondary cracking was apparent on the reduced area near the fracture as seen in Figs. 5 and 6. Fig. 7 is a higher magnification of one of the intergranular cracks seen in Fig. 6. Fig. 8 shows the intergranular cracking on the edge on the fracture surface of Fig. 5.

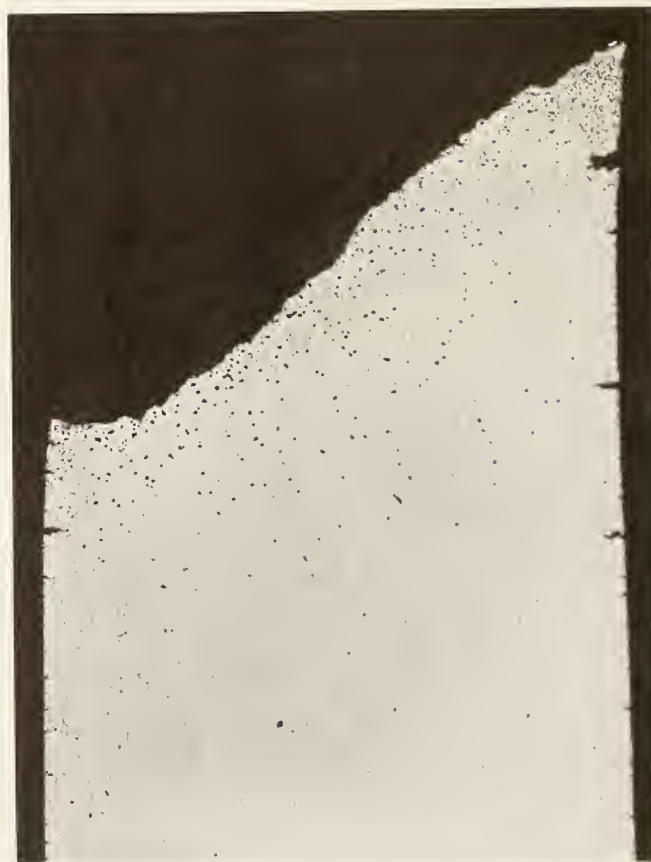
Fig. 6. Photomicrograph of the cross-section of the 310 stainless steel specimen in Fig. 5 tested at 540°C (1000°F) in H₂ at a strain rate of $8.4 \times 10^{-7} \text{s}^{-1}$. 20 X

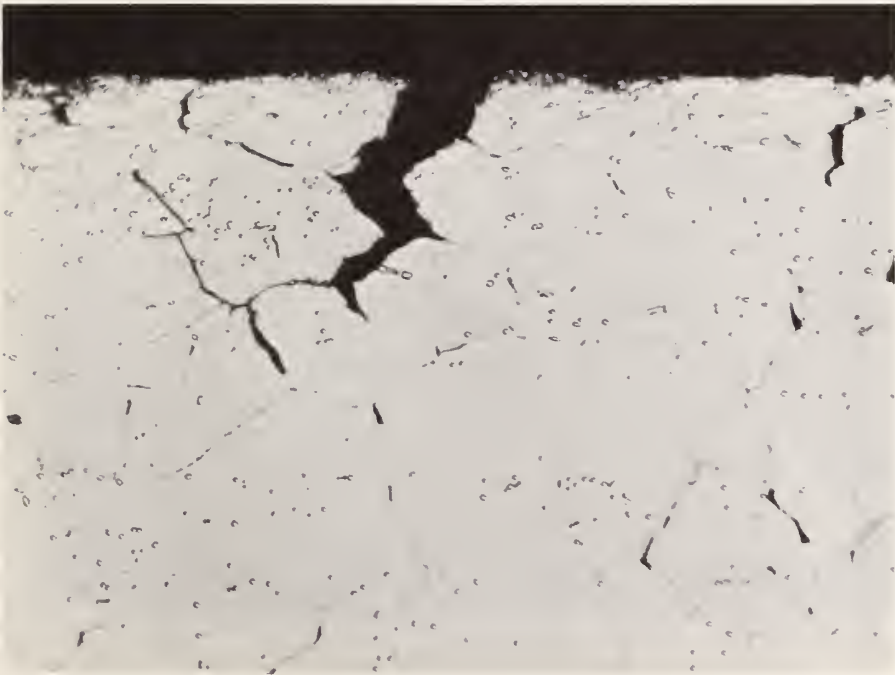
Fig. 7. Photomicrograph of one of the cracks penetrating into the 310 SS specimen in Fig. 6. 500 X.

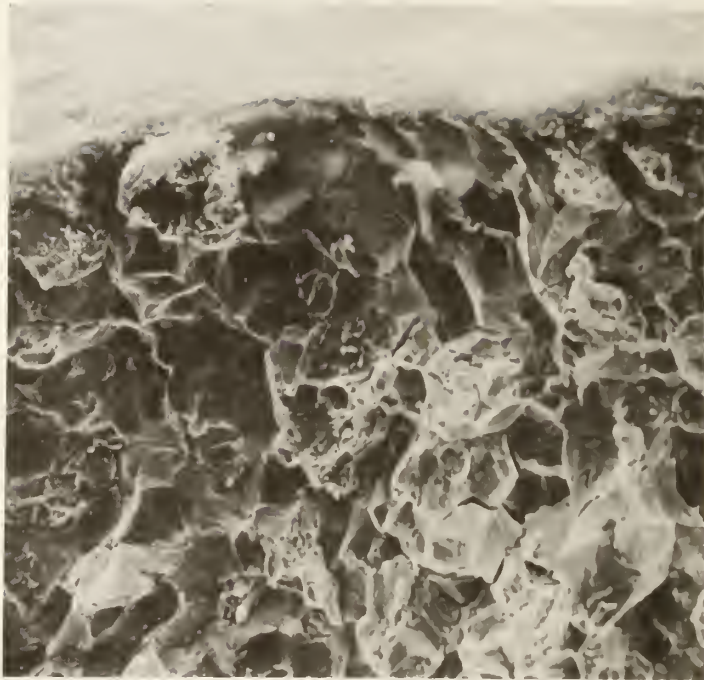
Fig. 8. Scanning electron micrograph of an area near the edge of the fracture surface of the 310 SS specimen in Fig. 5. 700 X.

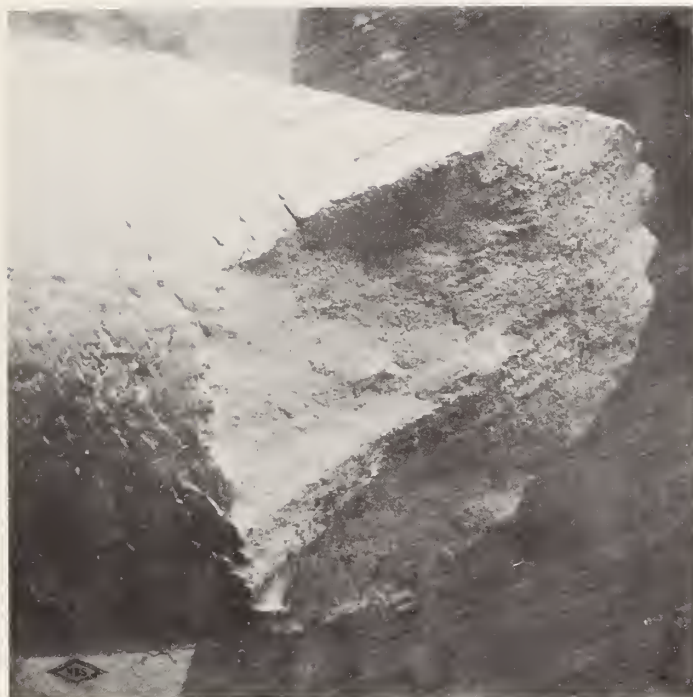
Fig. 9. Scanning electron micrograph of the fracture of a 310 SS specimen tested at 454°C (850°F) in H₂ at a strain rate of $8.4 \times 10^{-7} \text{s}^{-1}$. 20 X.

The second 310 specimen was first allowed to soak at 540°C (1000°F) with no load applied for 67.5 hours. This was done to sensitize the material. The specimen was then tested at 454°C (850°F) at $8.4 \times 10^{-7} \text{ s}^{-1}$ in H₂. This temperature was selected since it was below any creep temperature for 310 SS but was still in the sensitizing zone (454-870°C) (958-1600°F) for 310 SS. The resulting elongation was 35% and the reduction in area was 49%. This compares to the 18% elongation and 23% reduction in area when tested at 540°C (1000°F) in the same environment and strain rate. Figs. 9 and 10 show that there is no secondary cracking. While Fig. 11 shows that the edge of the fracture surface is ductile.

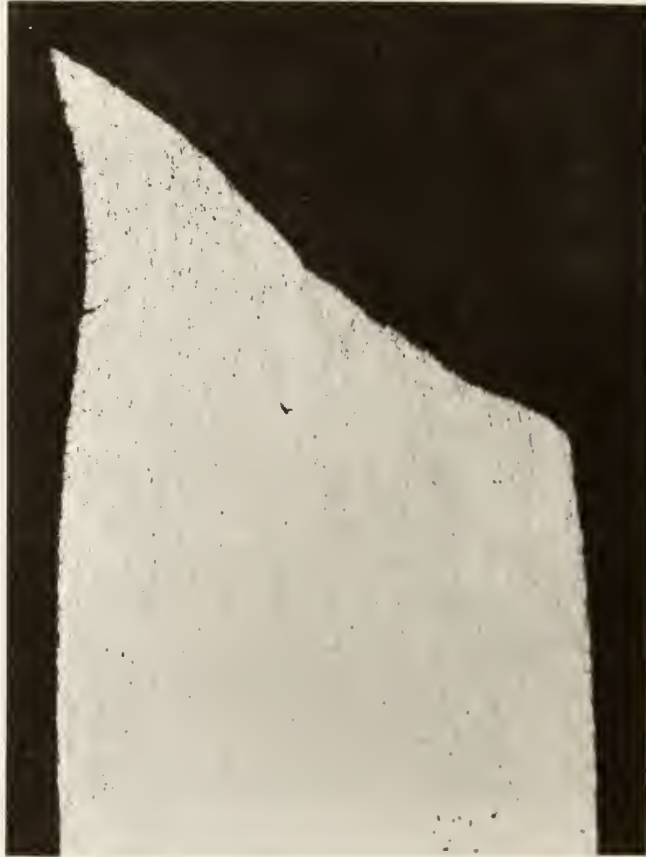
Fig. 10. Photomicrograph of the cross-section of the 310 SS specimen in Fig. 9. 20 X.

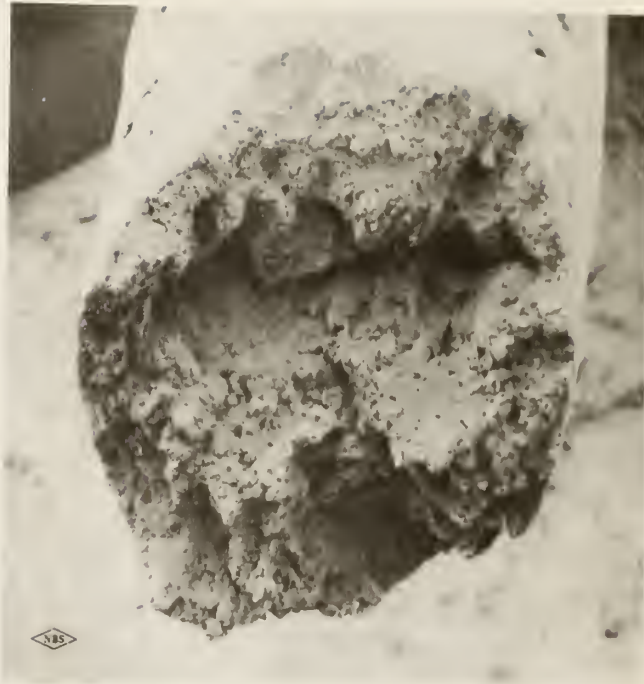
Fig. 12. Scanning electron micrograph of the fracture of an Incoloy 800 specimen tested in H_2 at $700^\circ C$ ($1300^\circ F$) at a strain rate of $1 \times 10^{-6} s^{-1}$. 20 X.

Since Incoloy 800 is susceptible to sensitization, specimens were tested at temperatures where creep occurs in order to investigate the possibility of producing the same cracking problem and loss of ductility that has been seen in 310 SS. An Incoloy 800 specimen was tested at $\approx 1 \times 10^{-6} \text{s}^{-1}$ at 700°C (1300°F) in H_2 with resulting elongation of 32% and reduction in area of 54.5%. The 700°C (1300°F) temperature was chosen so that the test would be well into the creep and sensitization region. Some surface cracks appeared (Fig. 12) but they seemed to be fissures opened by ductile tearing; whereas, the cracks seen on the surface of the 310 SS specimens were more distinctive with sharp and jagged edges. Fig. 13 does not show any large cracks propagating from the surface into the bulk of the specimen but does show large voids or separations within the bulk of the specimen.

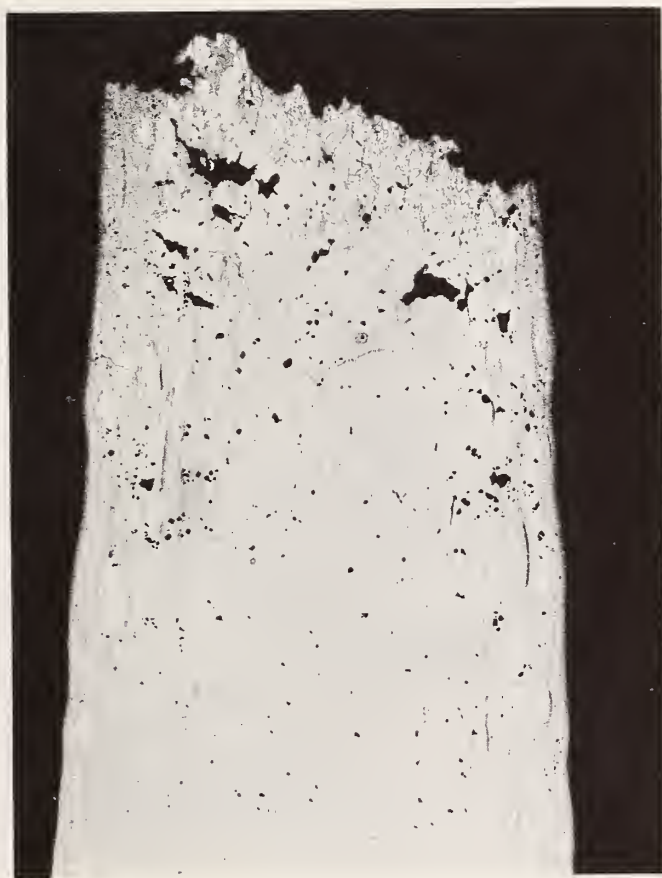
Fig. 13. Photomicrograph of the cross-section of the Incoloy 800 specimen in Fig. 12. 20 X.

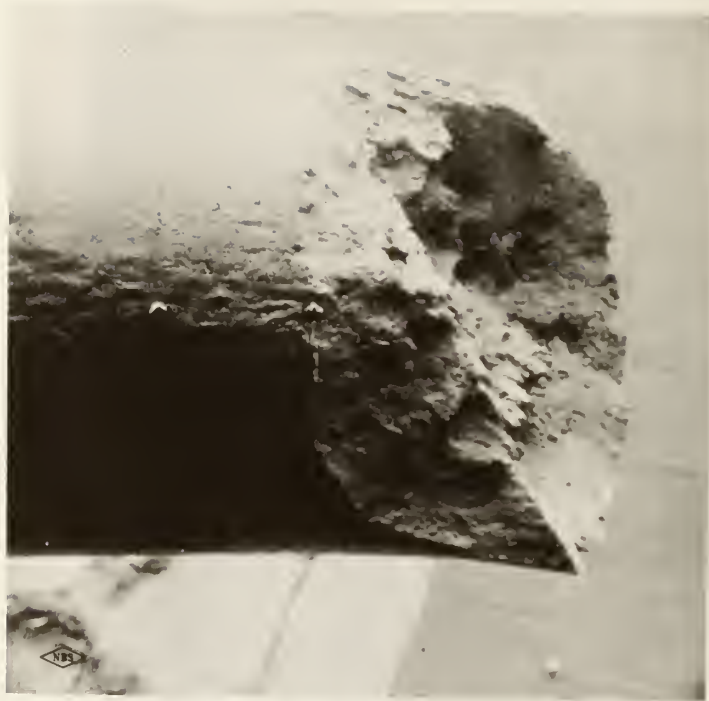
Fig. 14. Scanning electron micrograph of the fracture of an Incoloy 800 specimen tested in H_2 at $540^\circ C$ ($1000^\circ F$) at a strain rate of $1 \times 10^{-6} s^{-1}$. 20 X.

Another Incoloy 800 specimen was allowed to soak at 700°C (1300°F) in H_2 for 72 hours under a no load condition and then tested at $\approx 1 \times 10^{-6} \text{s}^{-1}$ at 540°C (1000°F) in H_2 with resulting elongation of 30% and reduction in area of 58%. No cracking and no loss of ductility was apparent as seen from Figs. 14 and 15. From the data collected, we conclude that the Incoloy 800 does not have the same susceptibility to cracking that the 310 SS has when tested under sensitizing conditions.

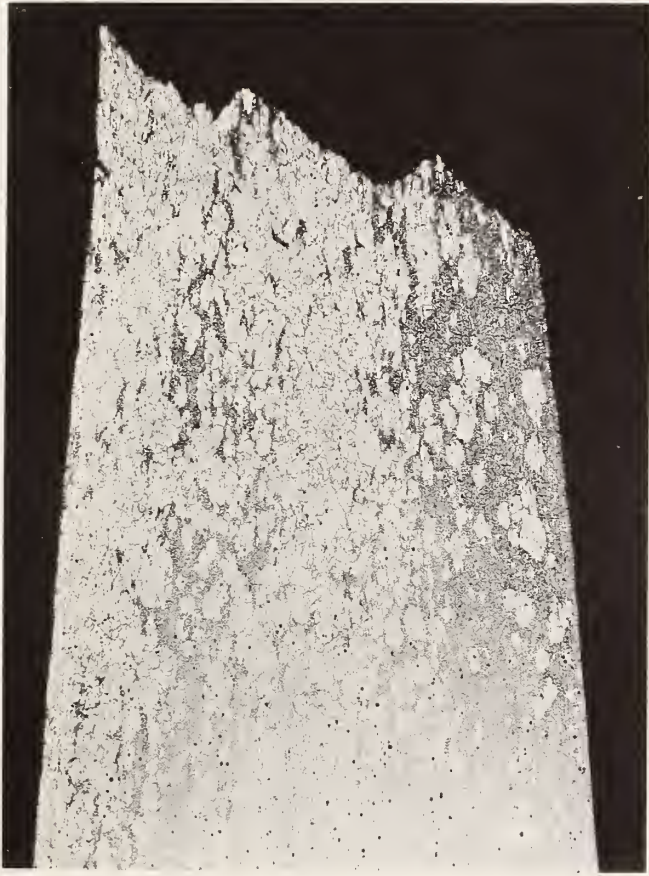
Fig. 15. Photomicrograph of the cross-section of the Incoloy 800 specimen in Fig. 14. 20 X.

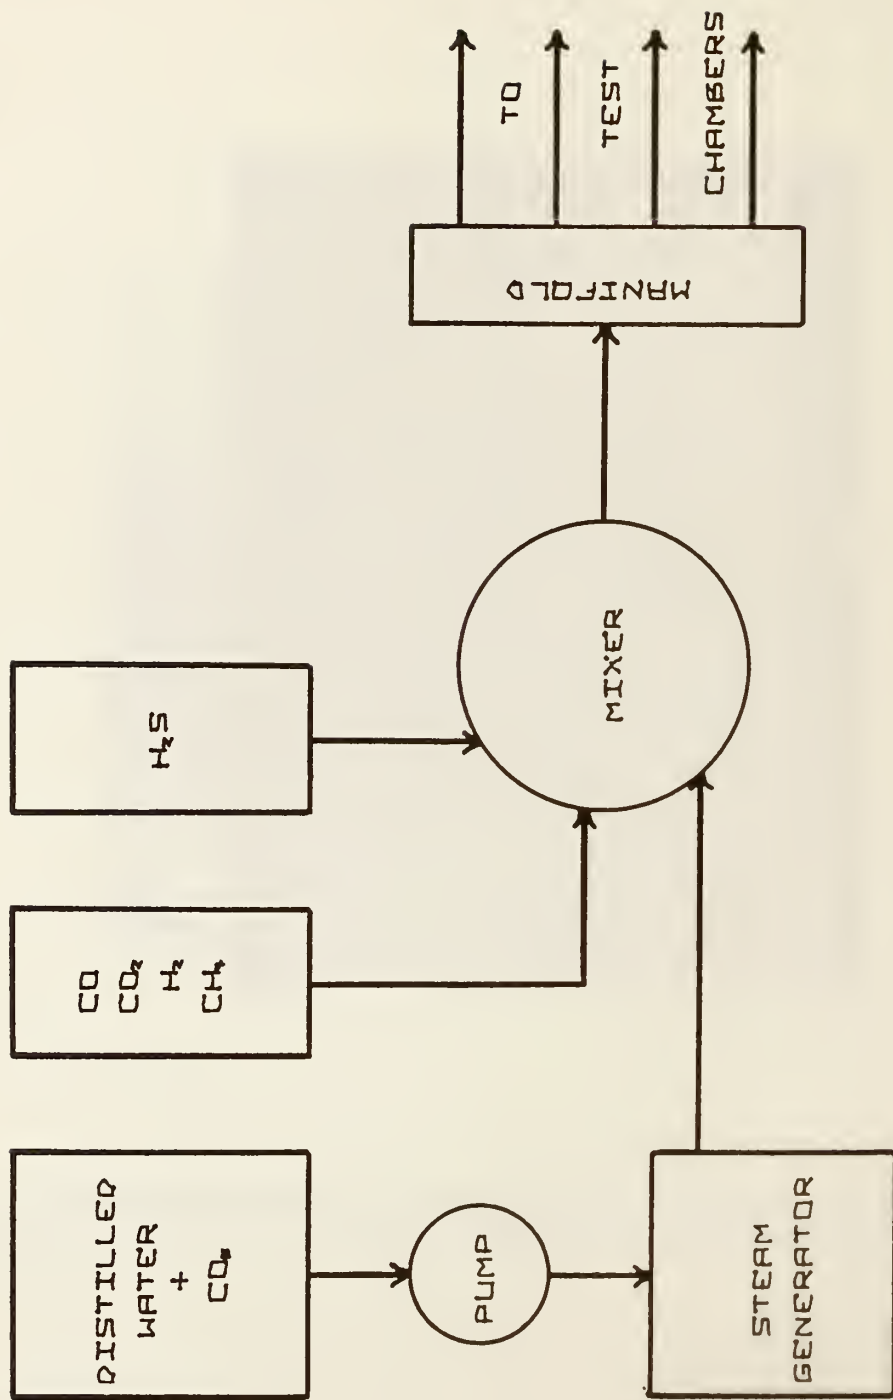
Fig. 16. Flow diagram of the generation of the coal gasification environments.

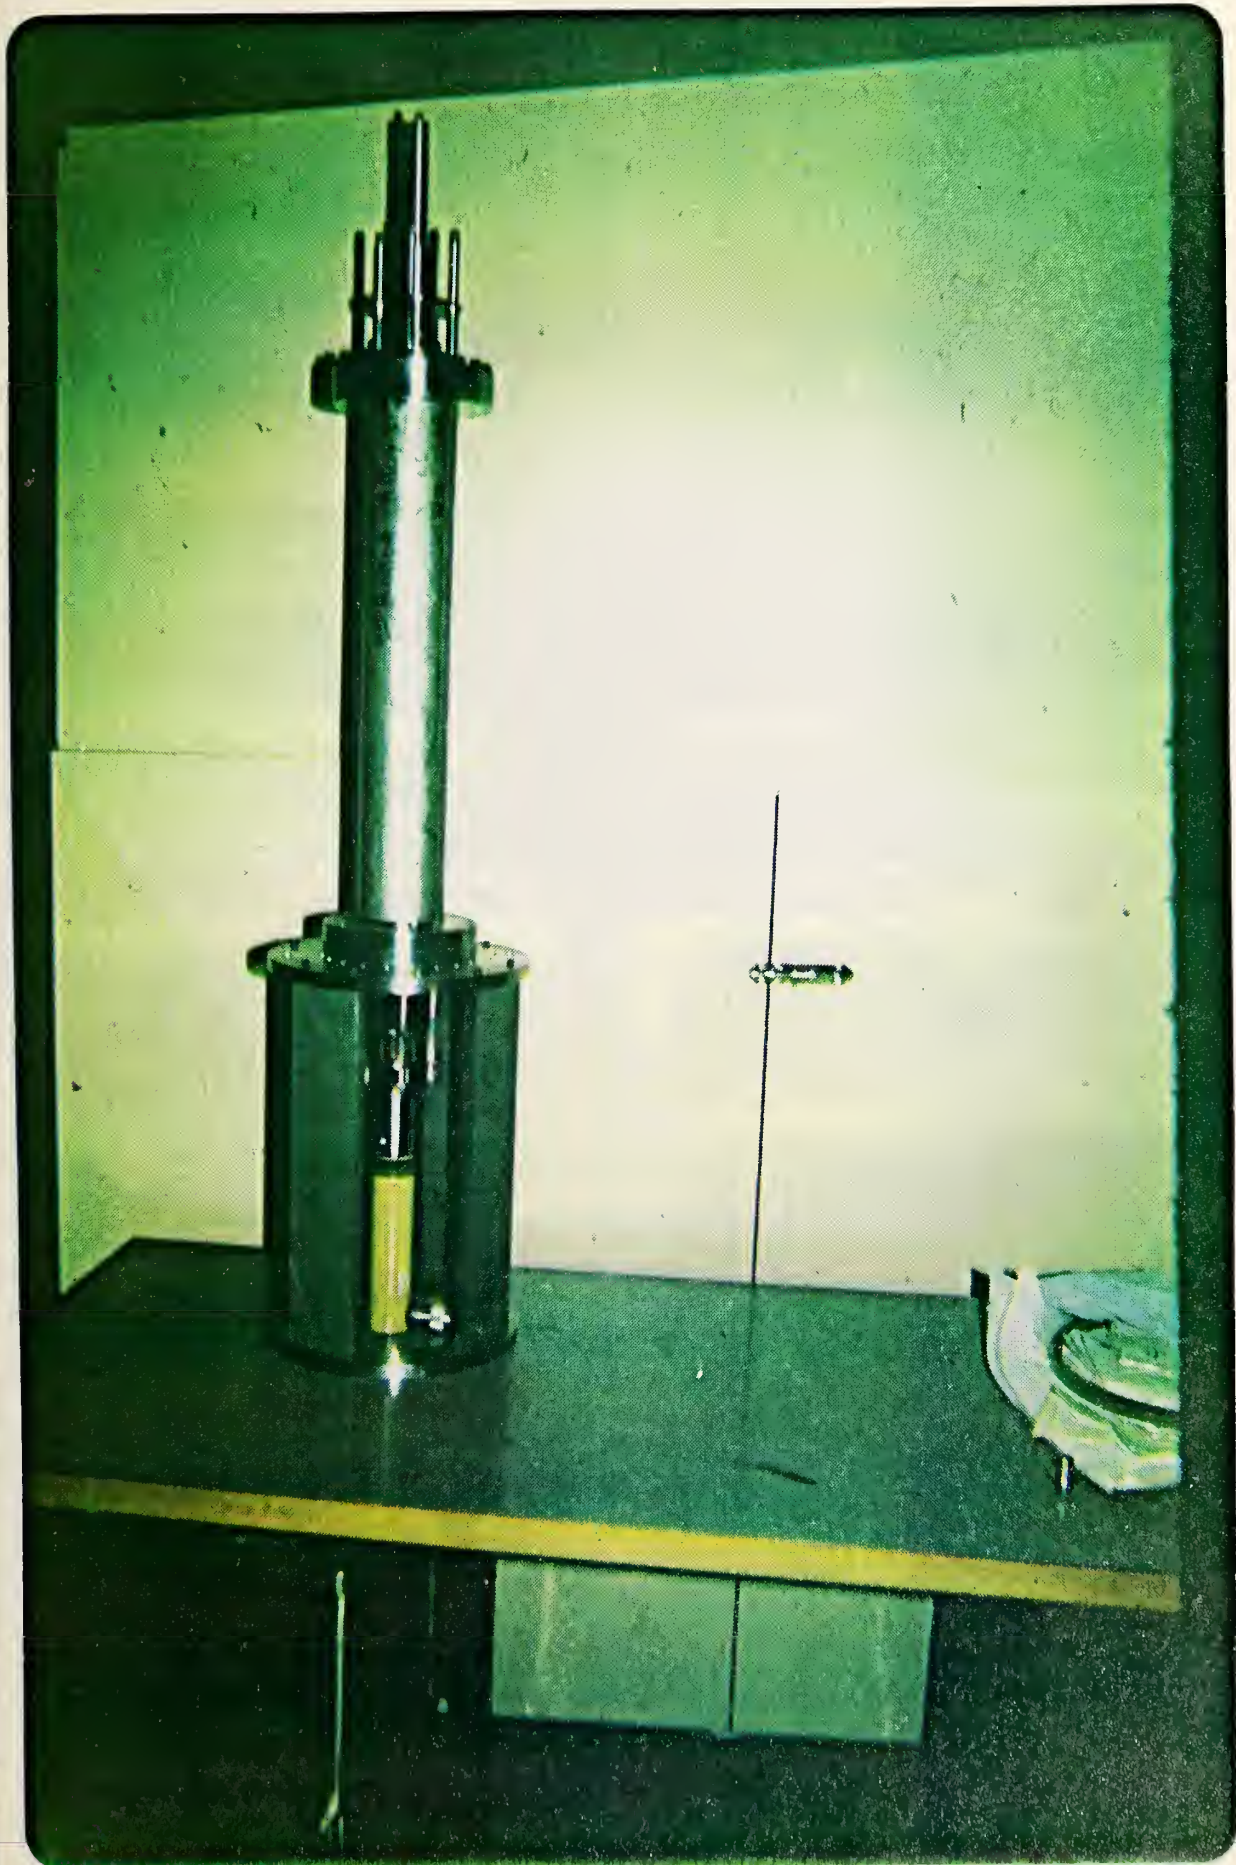
Figure 3. Environmental chamber assembly.

The internal parts of the test facilities, the environment chamber and the loading ram are shown in figure 3. This part of the test equipment has an overall height of approximately 62" and so will completely fill the pressure vessel. The pressure chamber is mounted on a stainless steel stand in order to locate the chamber in a central position in the pressure vessel and to provide an adequate working distance for the loading system. The hydraulic ram and the push rods can be seen at the bottom of the figure, and the push rods that attach to the load cell can be seen at the upper part of the figure. The bellows assembly are shown in greater detail in figure 4. The interior of the vessel contains loading fixtures that will be capable of testing castable ceramic bars in three point bending. To accelerate the rate of testing the loading fixture will be capable of consecutively testing four specimens. This is accomplished by using the fixture shown in figure 5. The loading bars on the fixture are unevenly spaced so that the specimens are broken in sequence, each broken specimen falling to the bottom of the test chamber after breakage. A test fixture of similar design has been successfully used previously at NBS to study the fracture of ceramics.

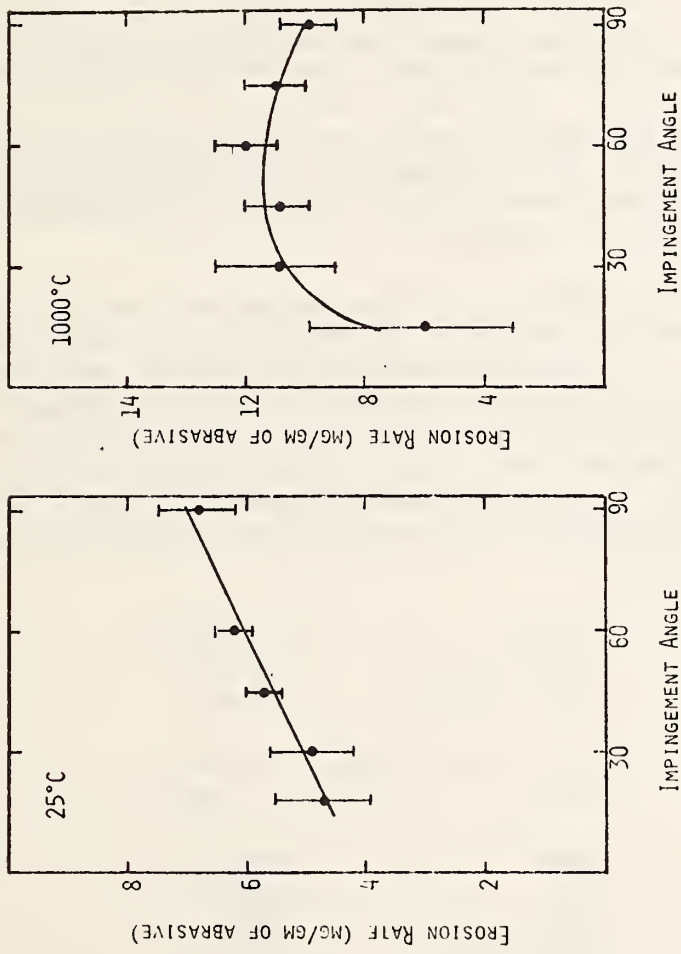
Figure 13. Effect of impingement angle on erosion rate: high purity alumina refractory.
