Retrofitting an Existing Wood Frame Residence for Energy Conservation--an Experimental Study

D. M. Burch
C. M. Hunt

Thermal Engineering Section
Center for Building Technology
Institute for Applied Technology
National Bureau of Standards
Washington, D.C. 20234

July 1977

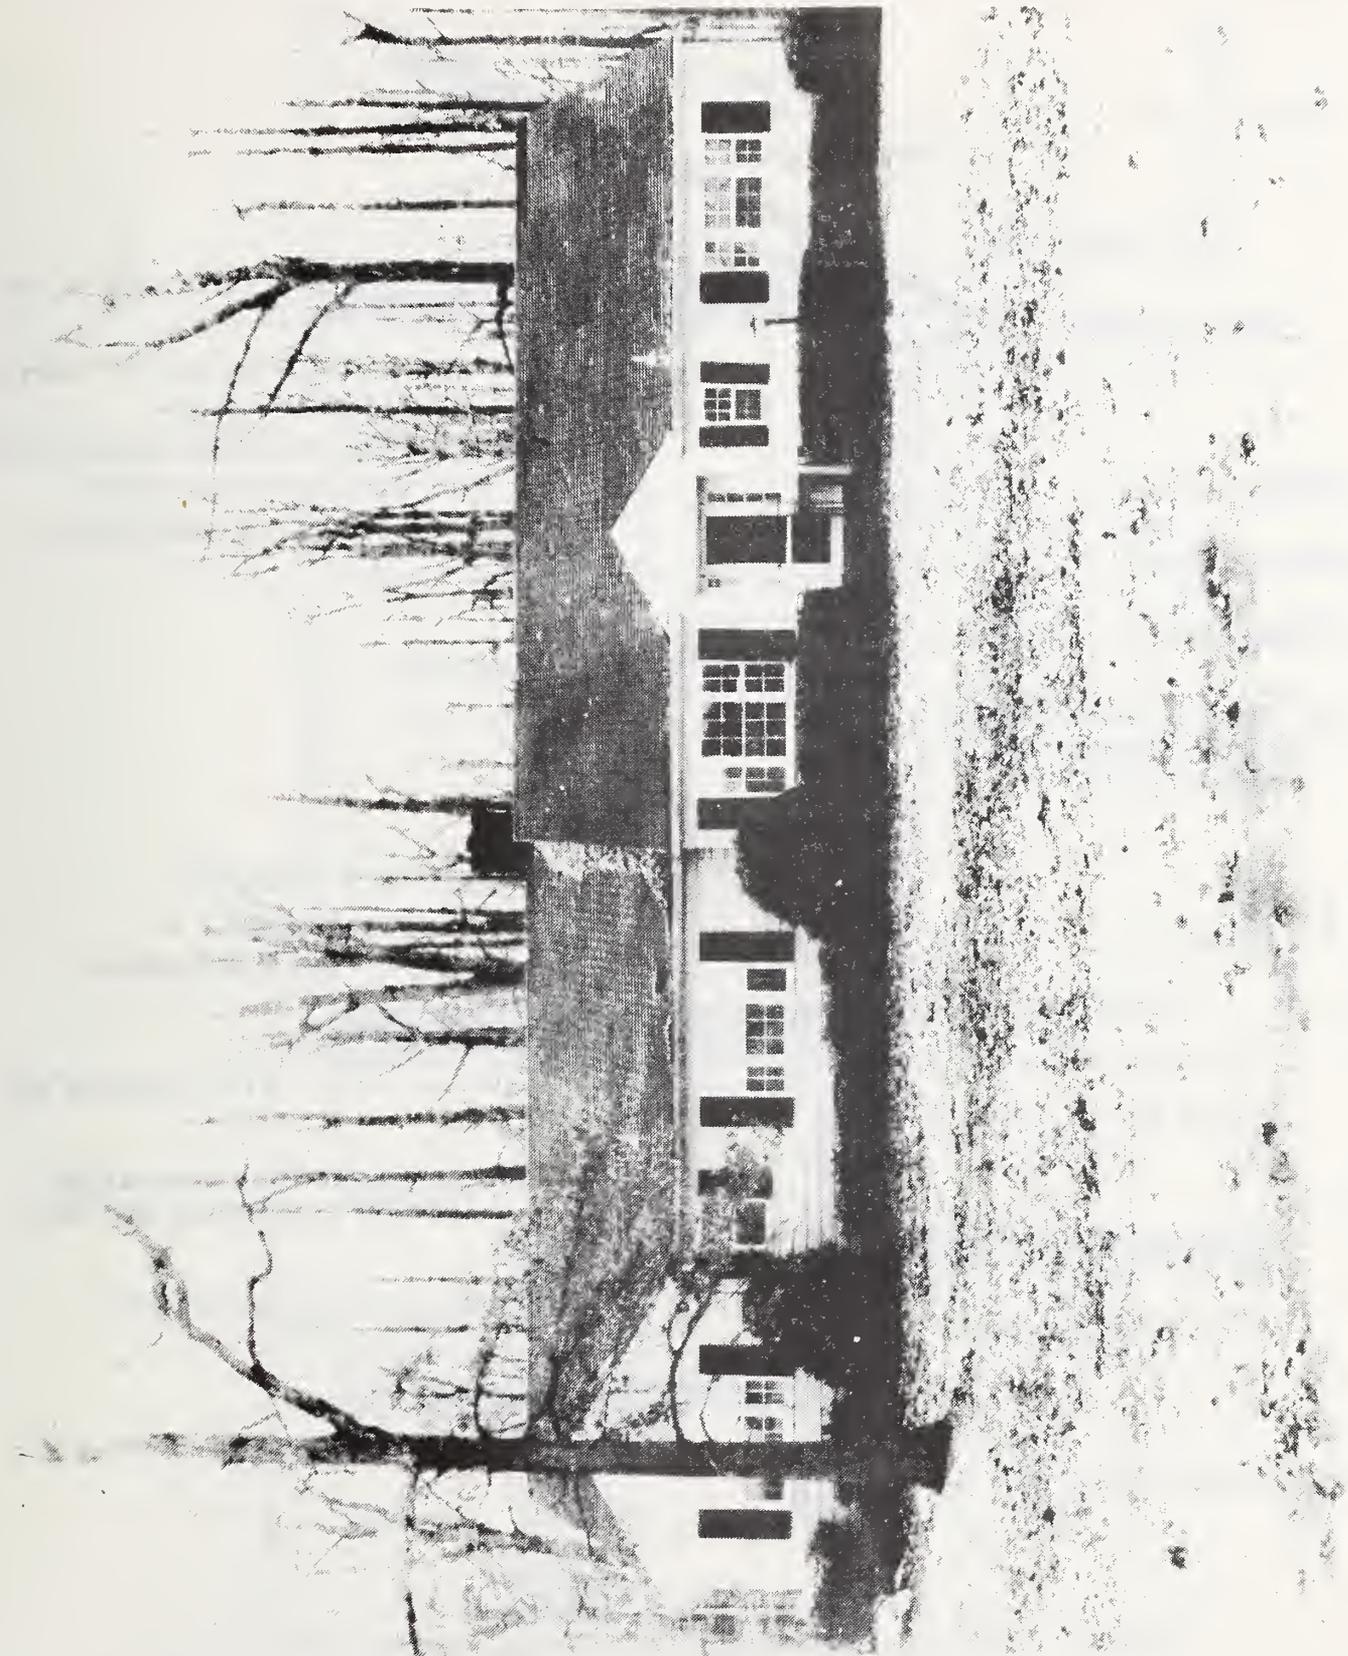
Figure 1. Photograph of the test house.

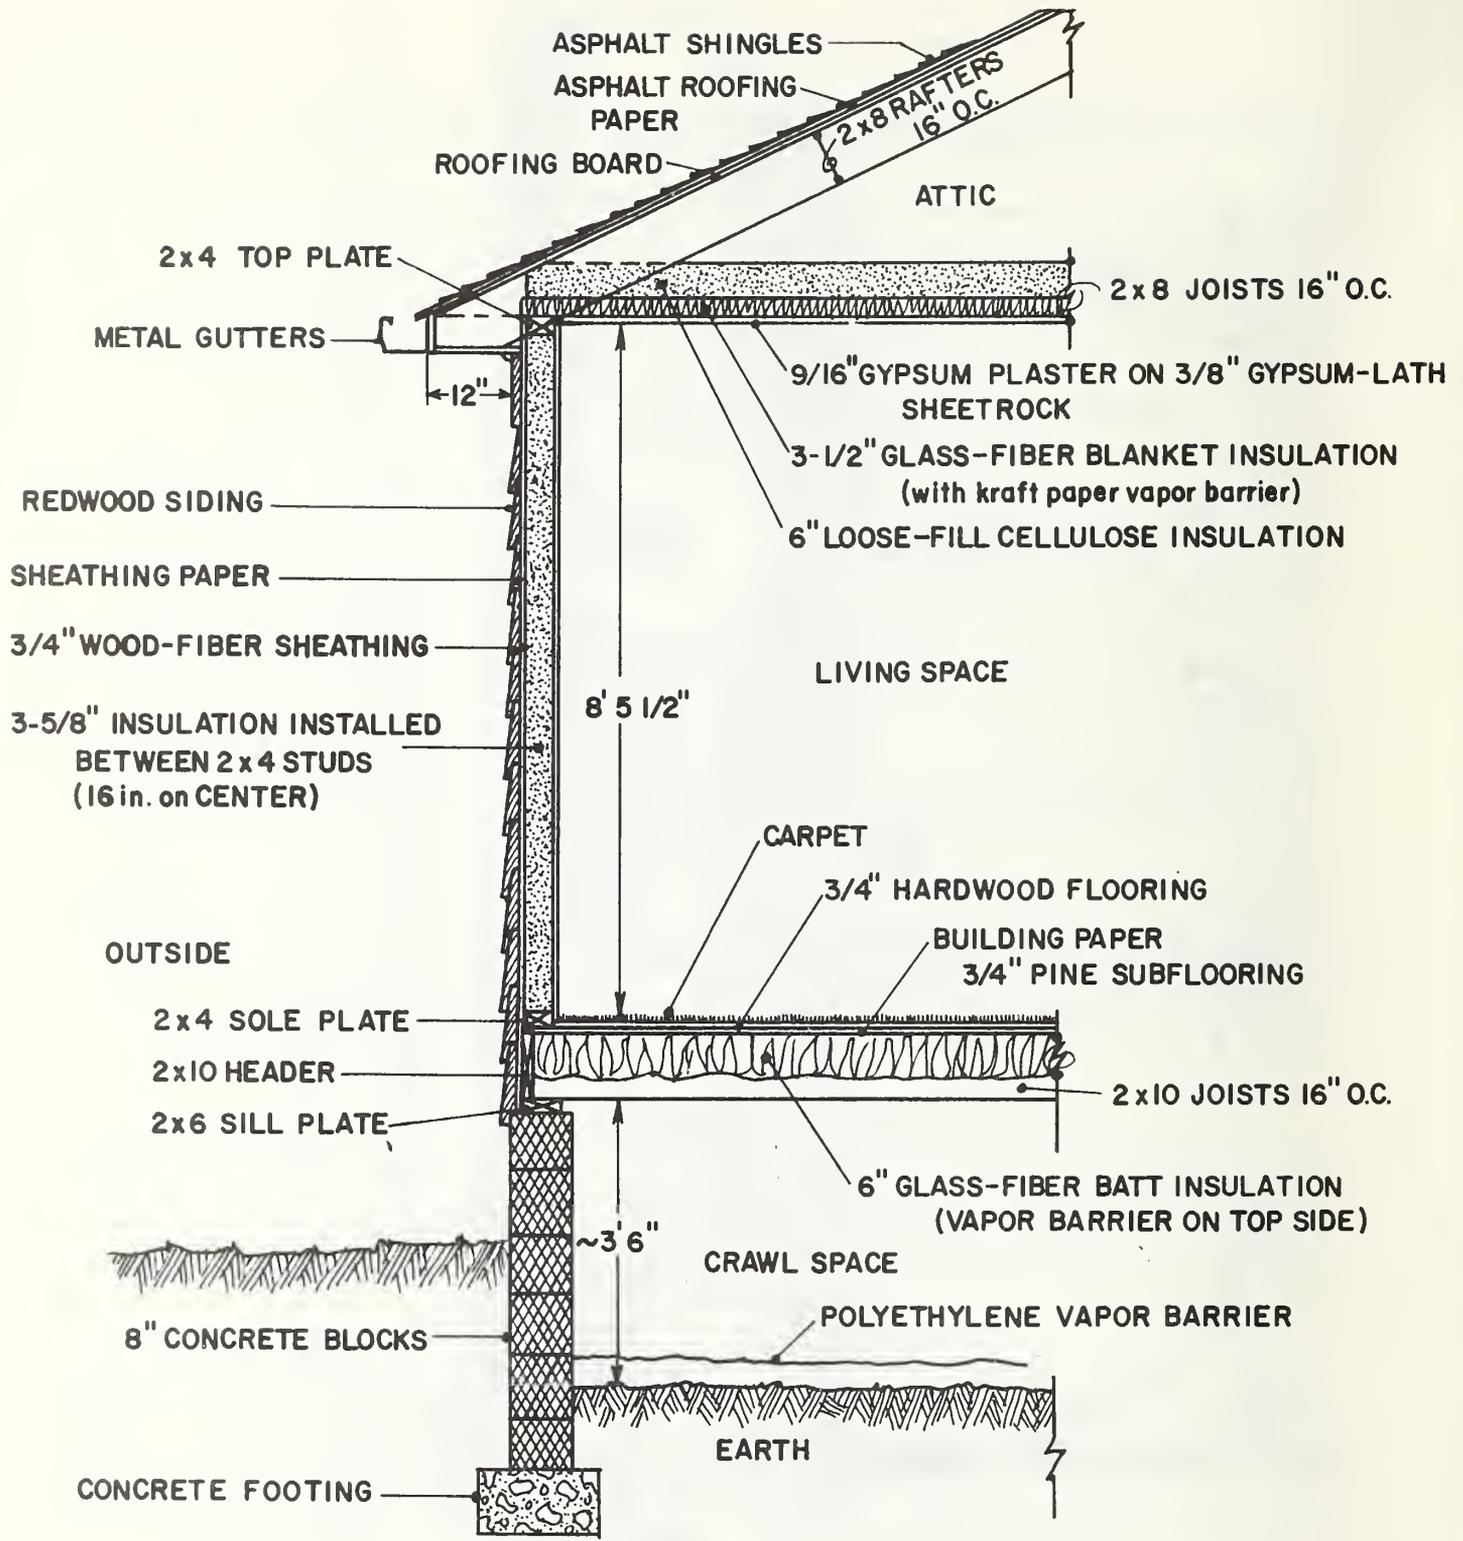
Figure 2. Typical cross-section of the house after retrofitting.

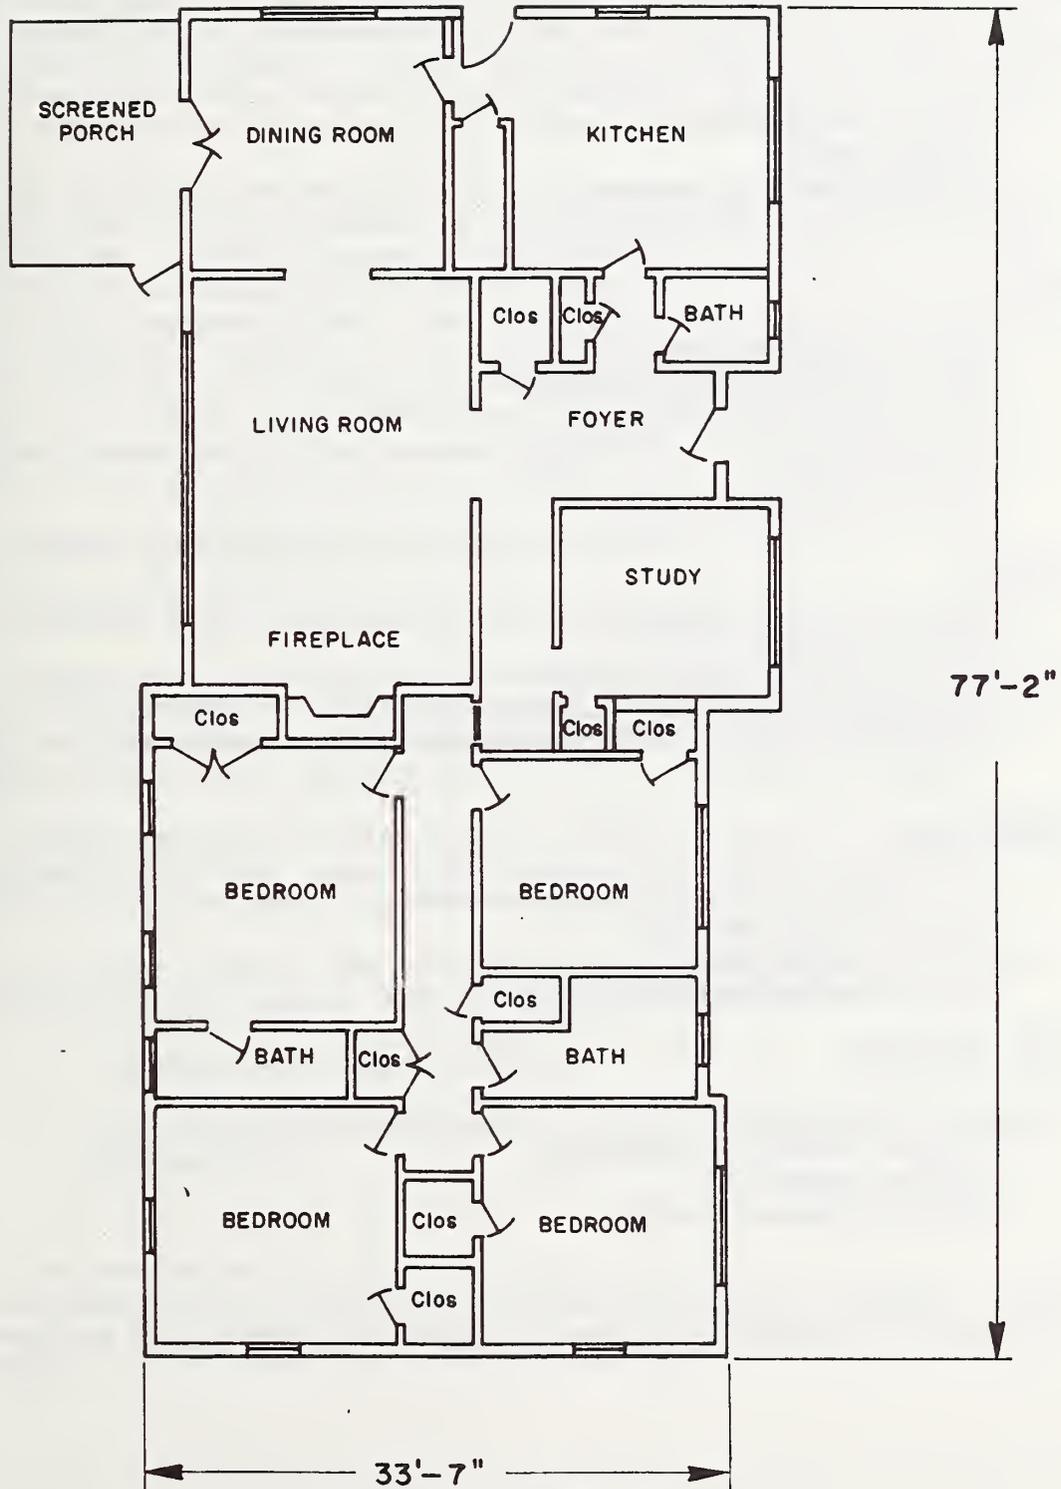
Figure 3. Floor plan of the test house.

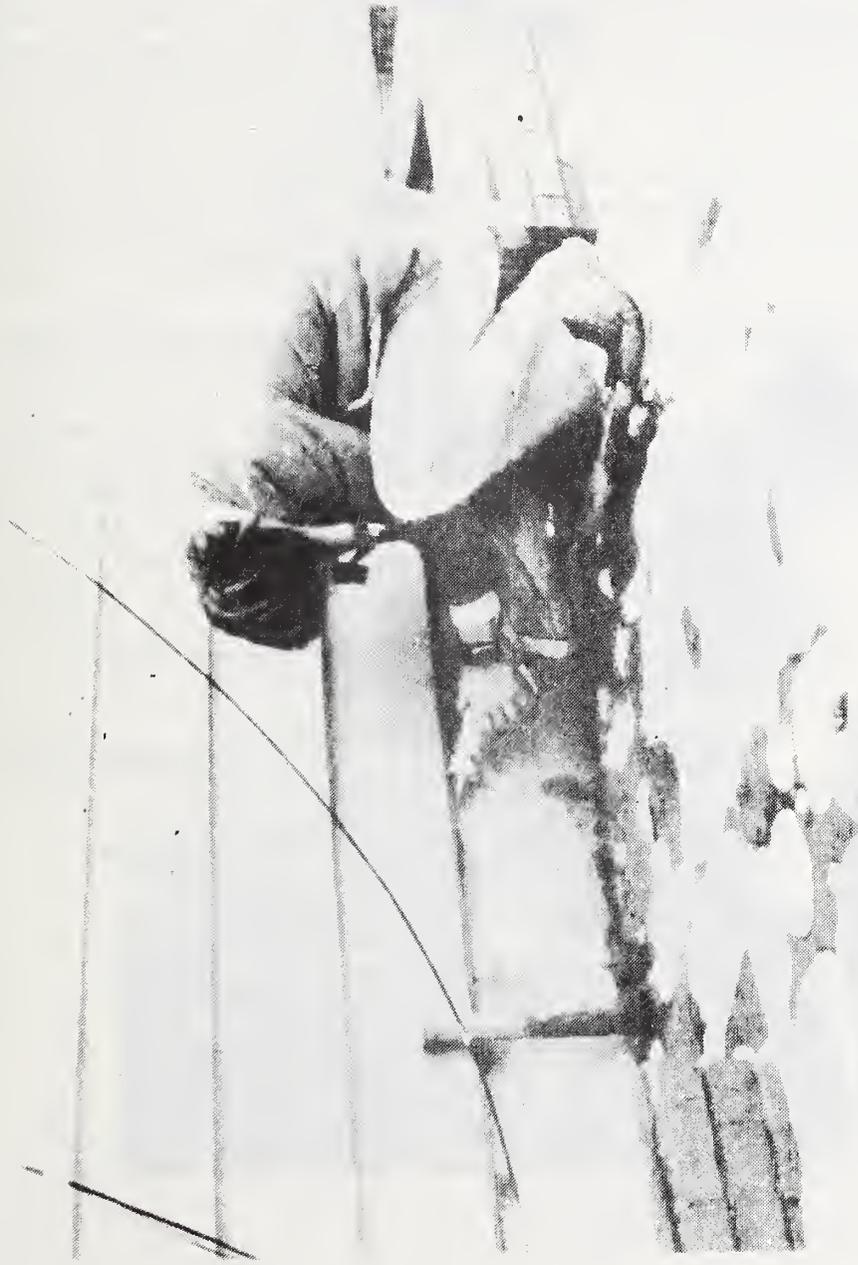
Figure 4. Caulking compound being applied to foundation sill.

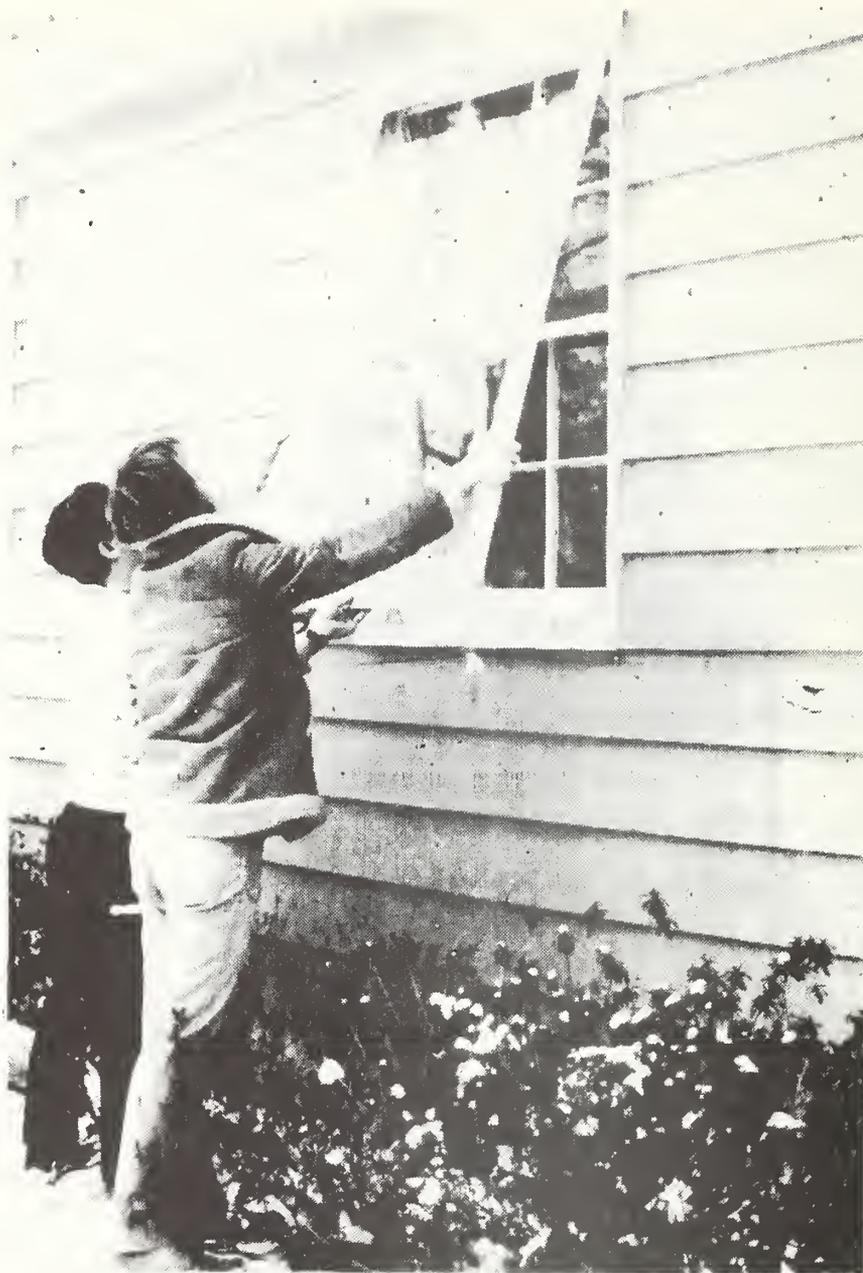
Figure 5. Storm window being installed.

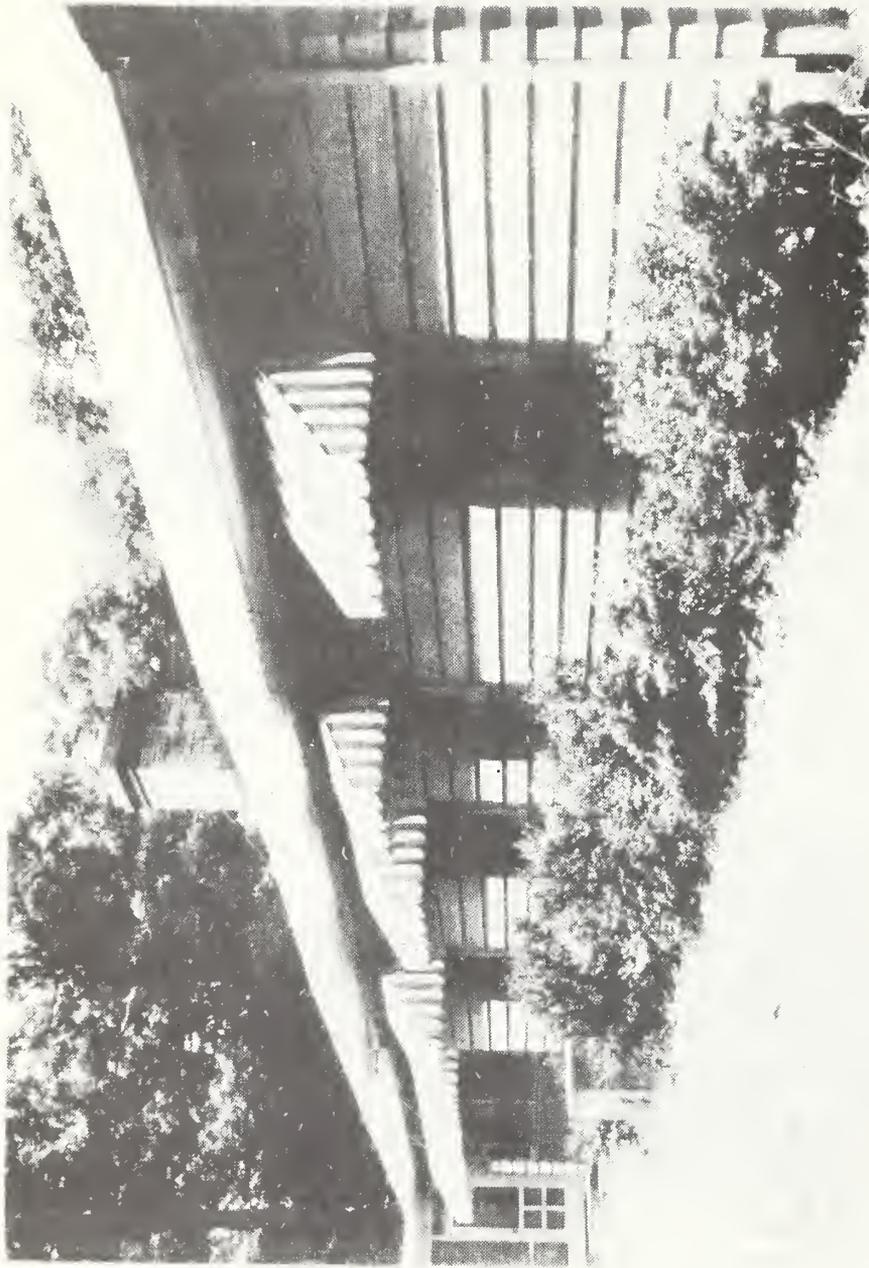
Figure 6 . A photograph of the south side of the test house showing the awnings .

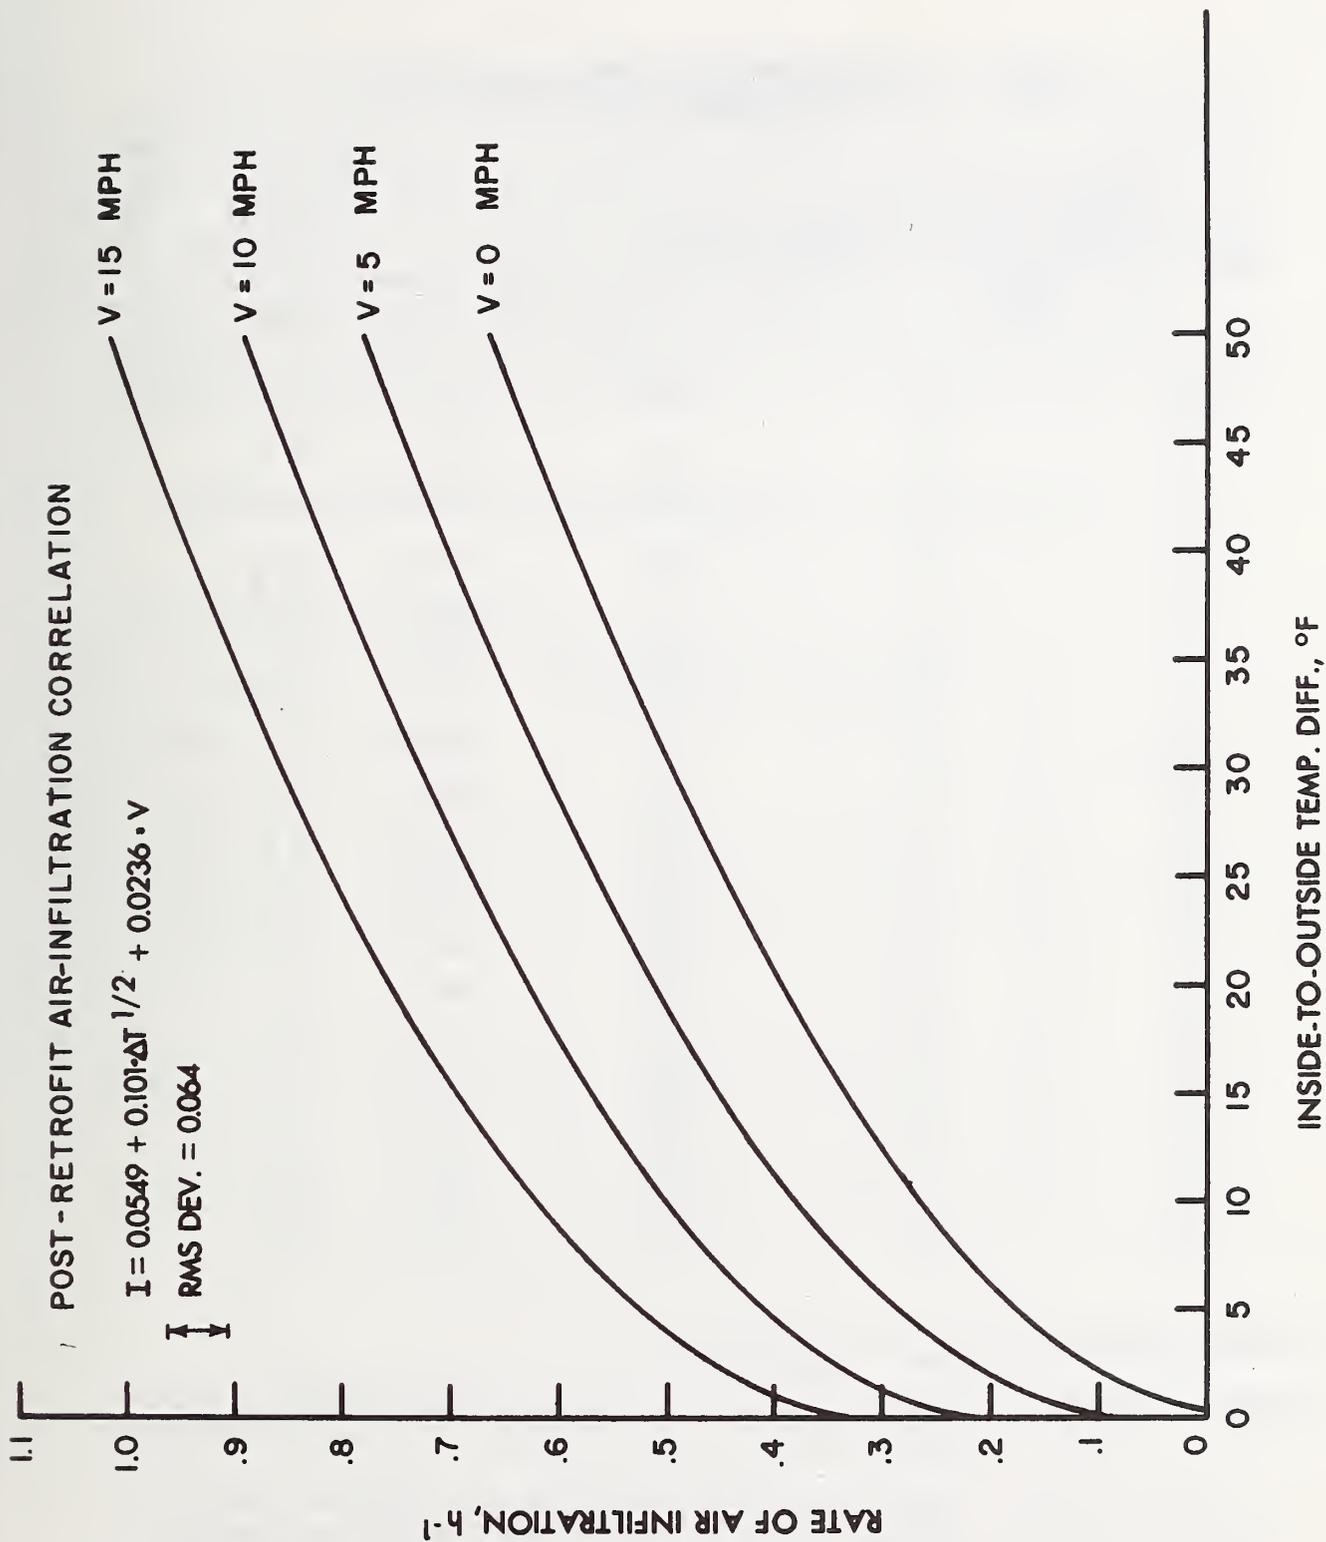
Figure 9. Post-retrofit air-infiltration correlation.

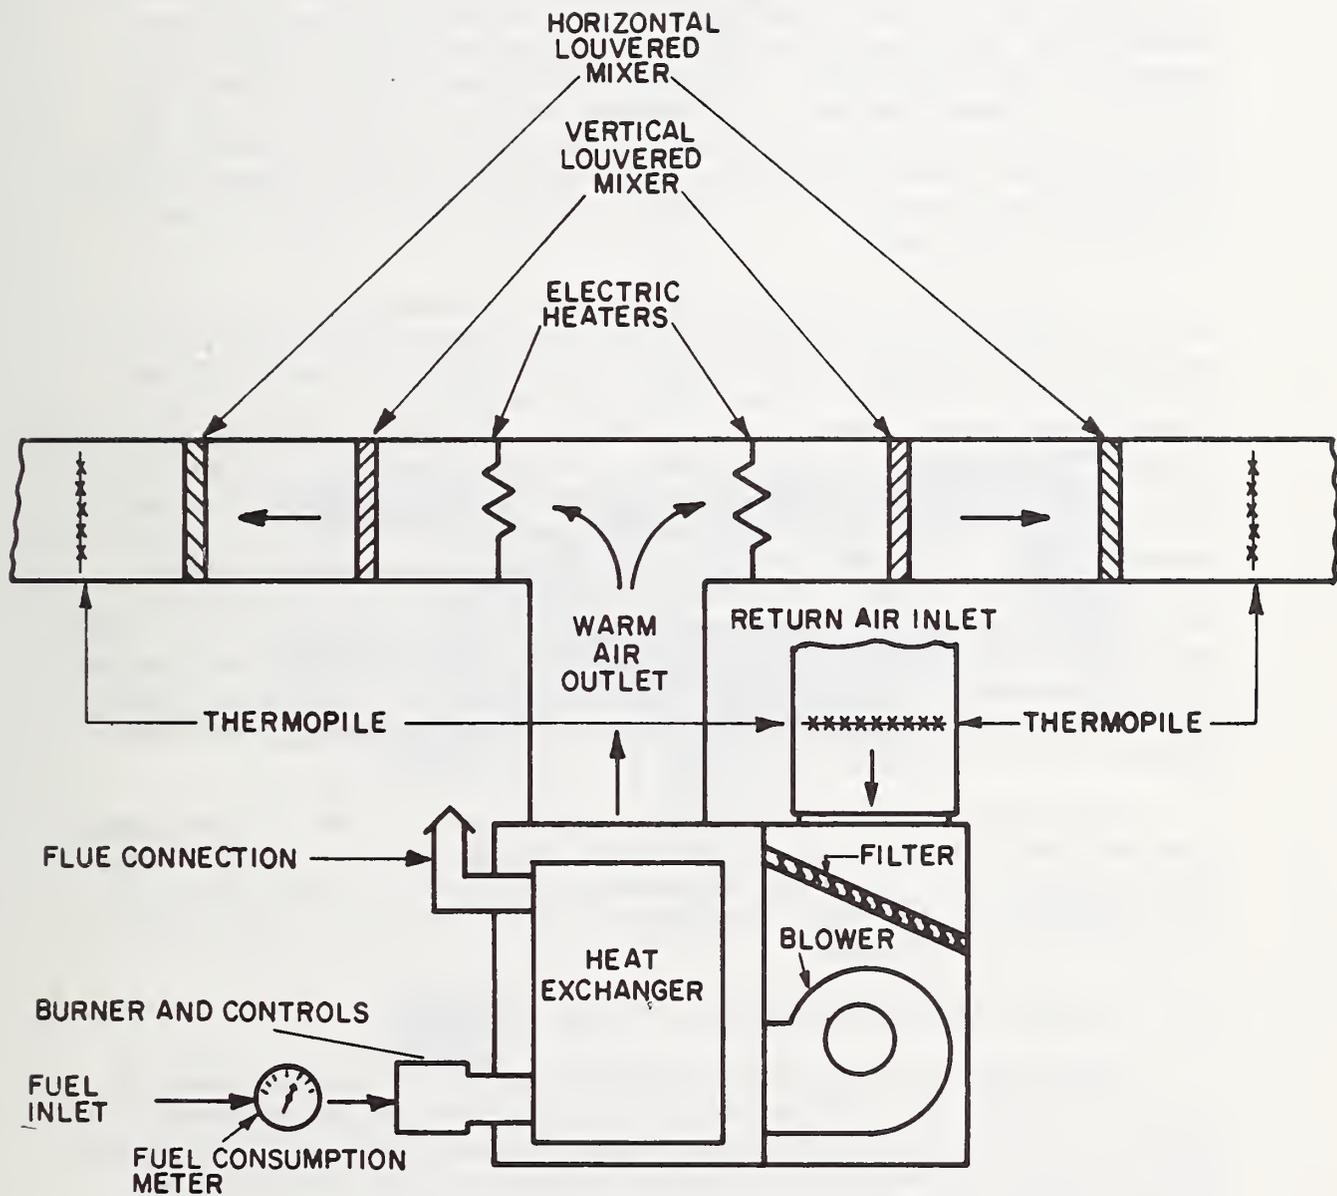
Figure 10. Schematic diagram of furnace system showing the location of measuring transducers.

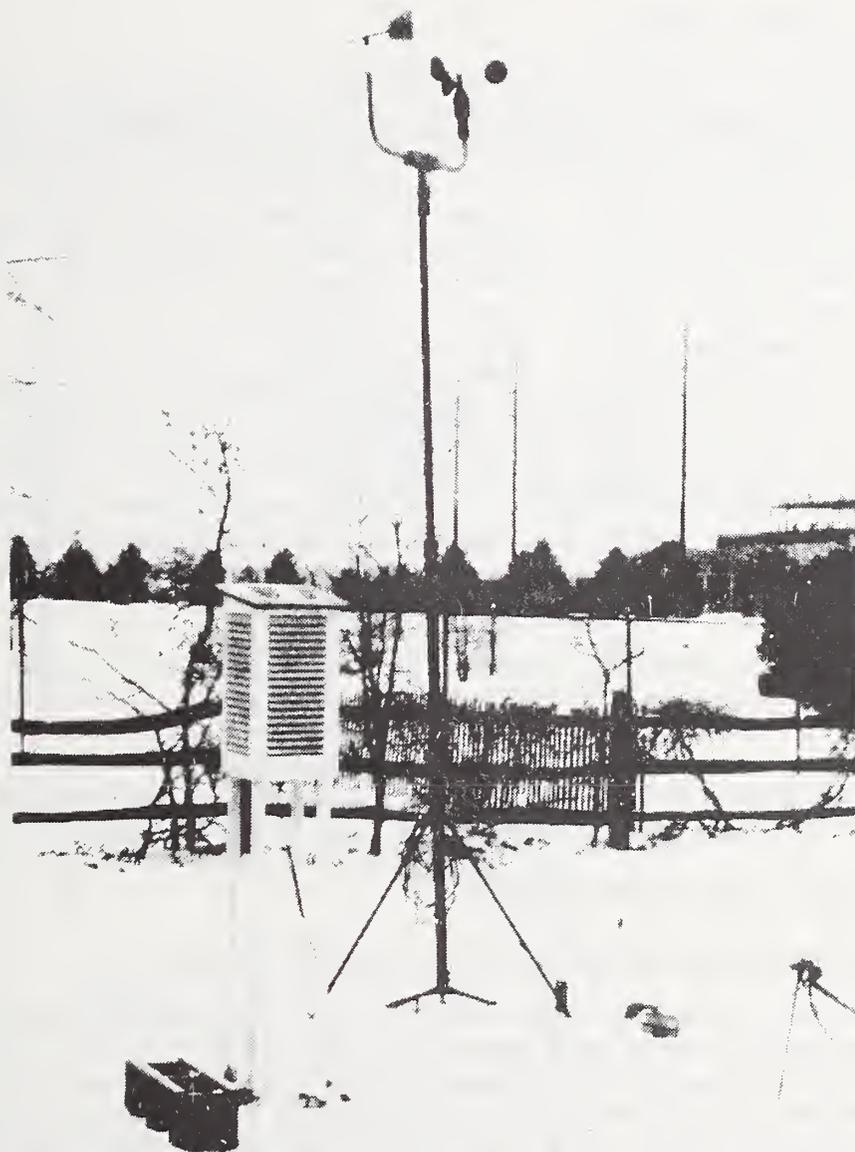
Figure 11. Photograph of the weather station.

A photograph of the weather station used in the present study is shown in figure 11. This weather station was located approximately 60 ft (18.3 m) in front of and in line with the west end of the test house. This particular location was selected so that the wind direction and velocity sensors, mounted at the 18-ft (5.5 m) level, would be exposed to the prevailing winter northwest wind. Wind velocity was measured with a rotating-cup anemometer, and wind direction was measured with a wind-direction vane. The louvered enclosure shown in figure 11 contained a copper-constantan thermocouple for measuring outdoor temperature and a humidity sensing element which produced a millivolt signal proportional to relative humidity. During the pre-retrofit heating energy measurements, the total solar radiation incident on a horizontal surface was measured with a pyranometer mounted on top of the louvered

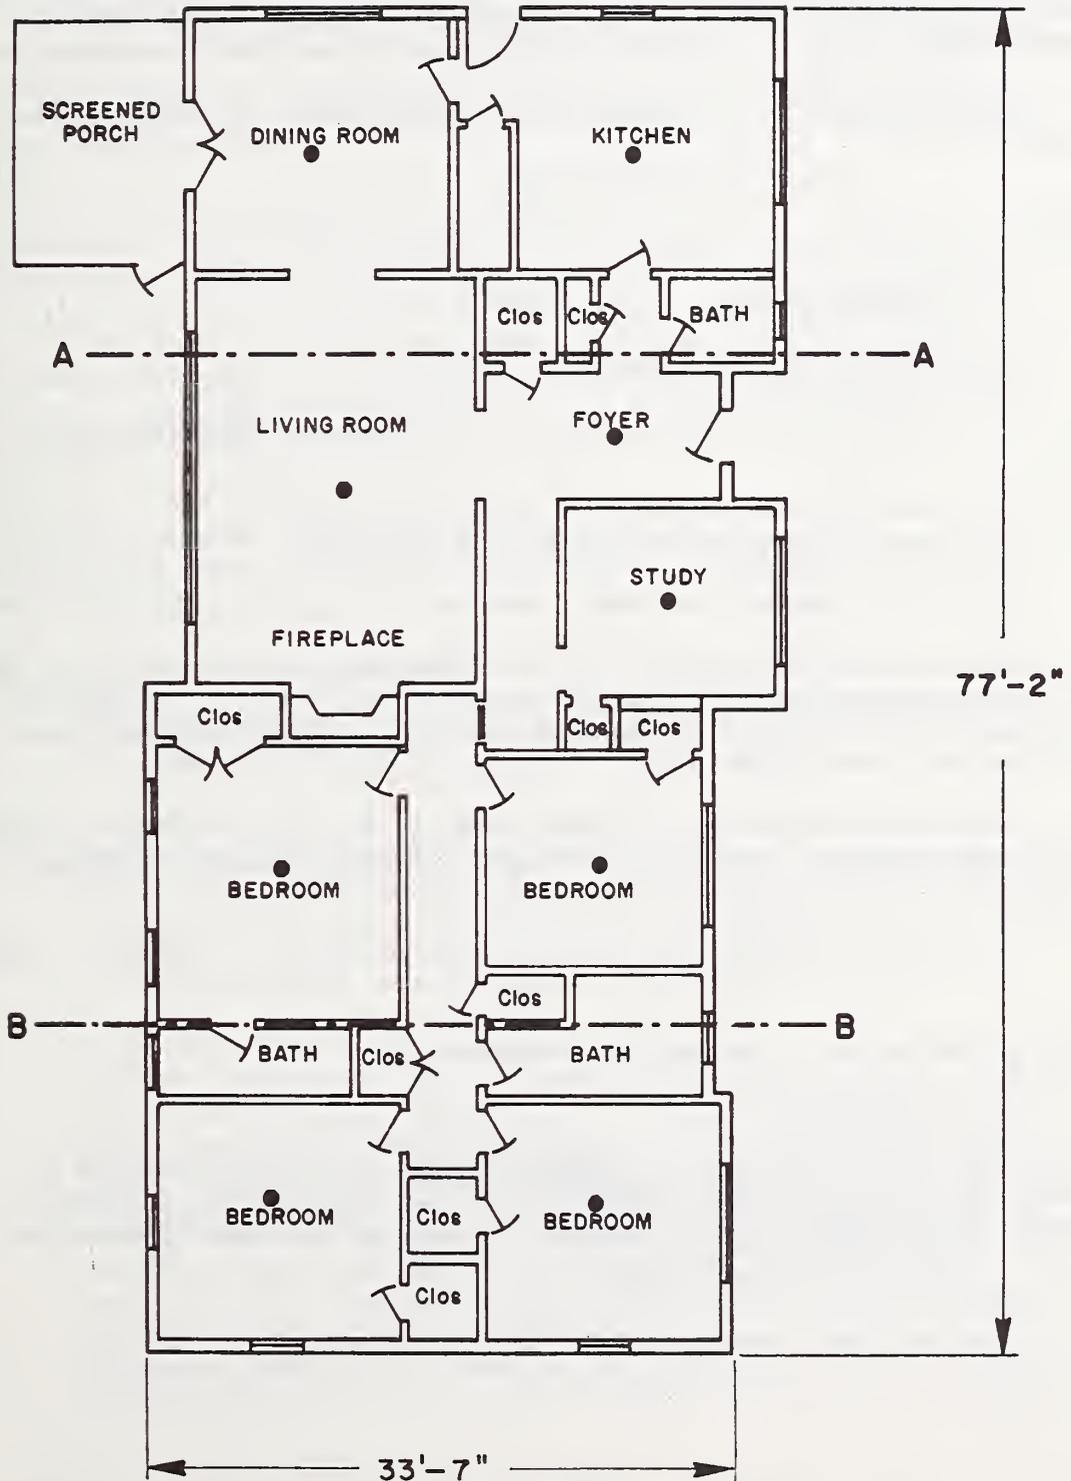
Figure 12. Floor plan of test house showing location of temperature sensors.

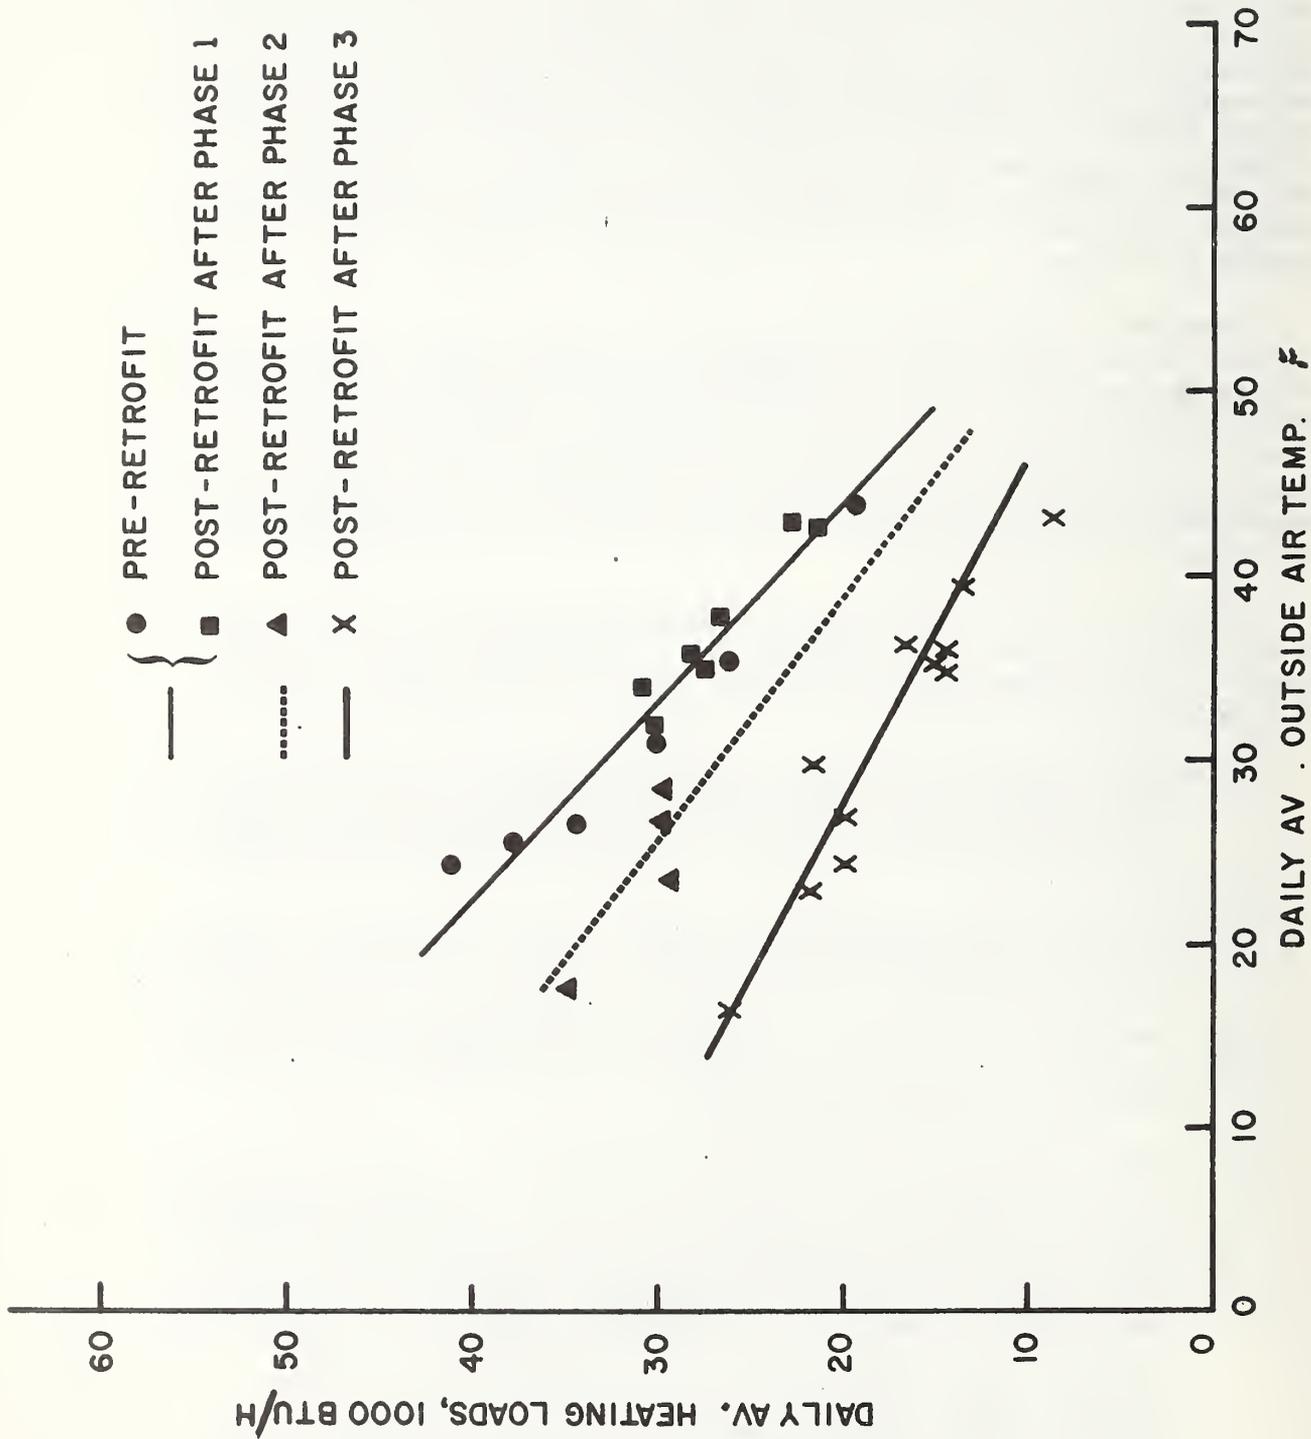
Figure 13. Measured heating loads for the unoccupied test house after various stages of the retrofit.

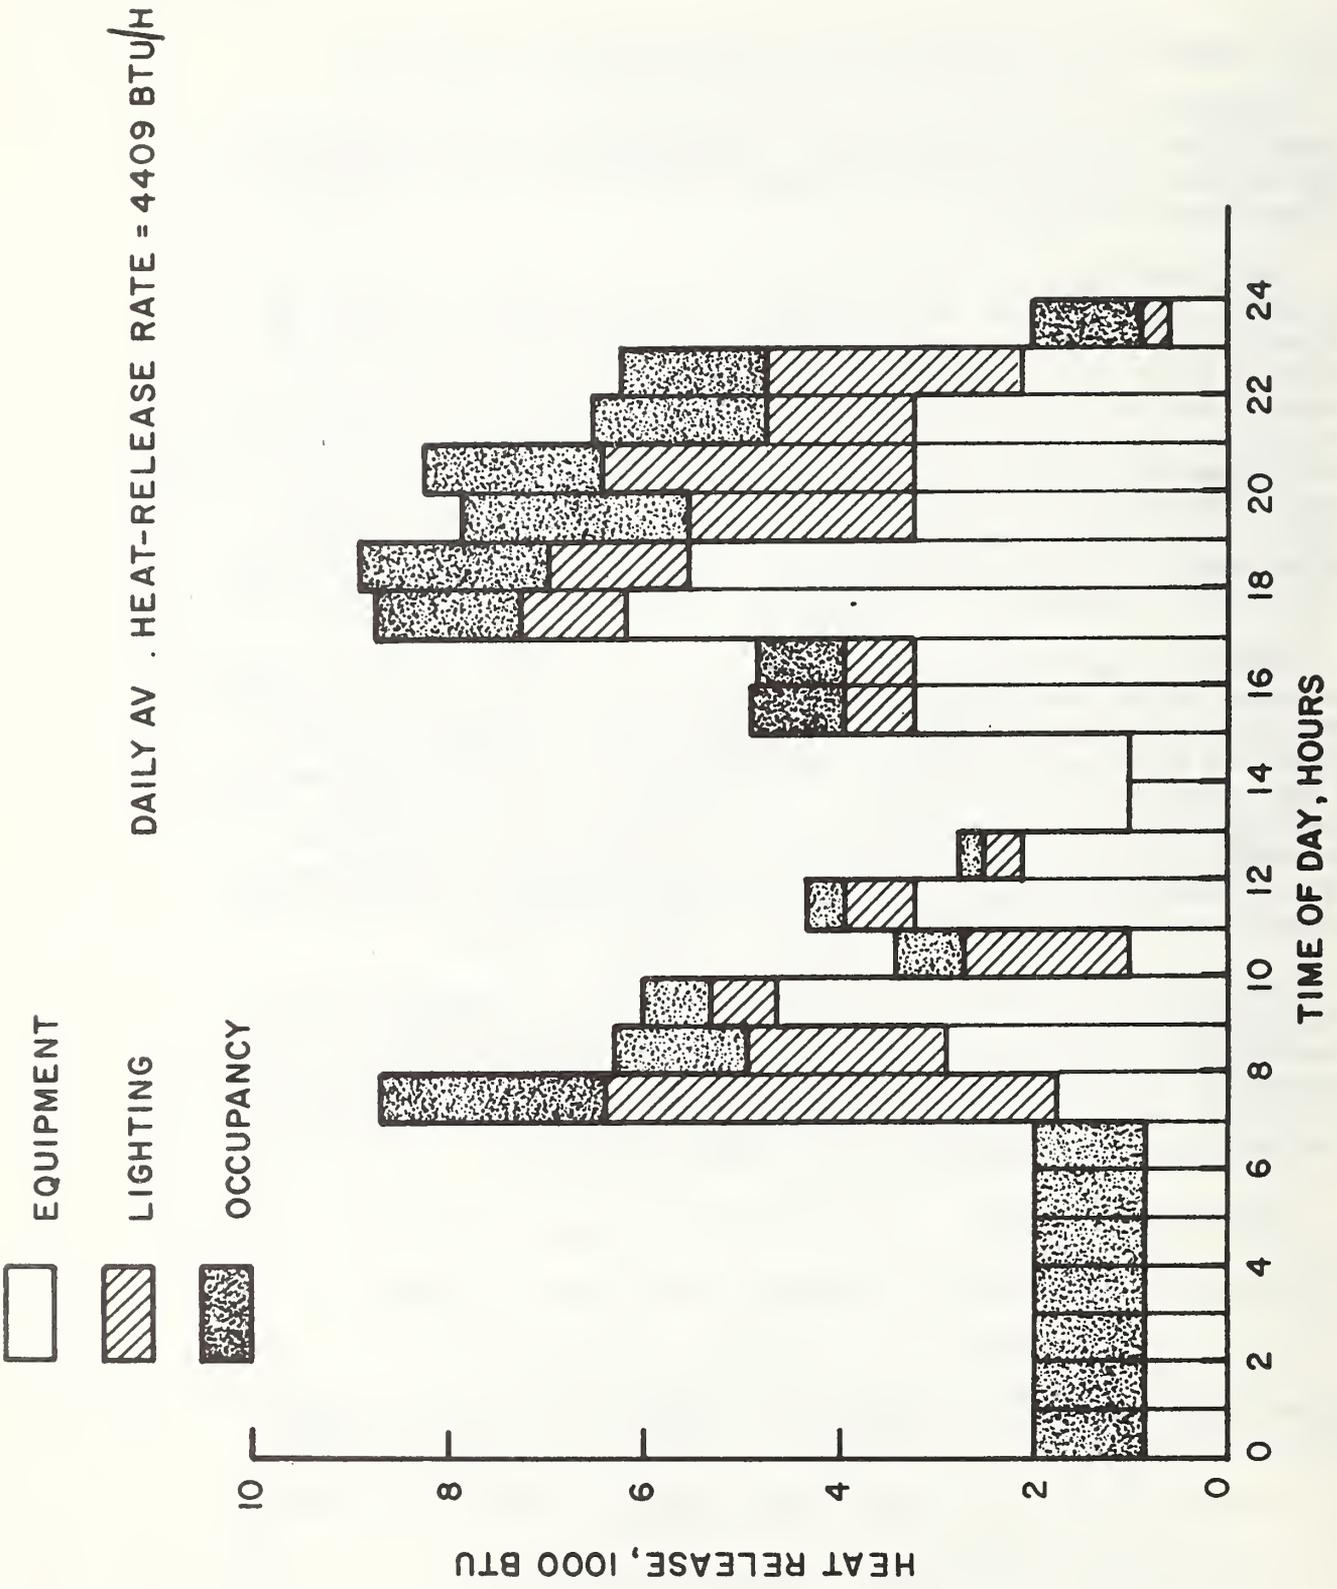
Figure 14. Energy-release rates for equipment, lighting, and occupancy.

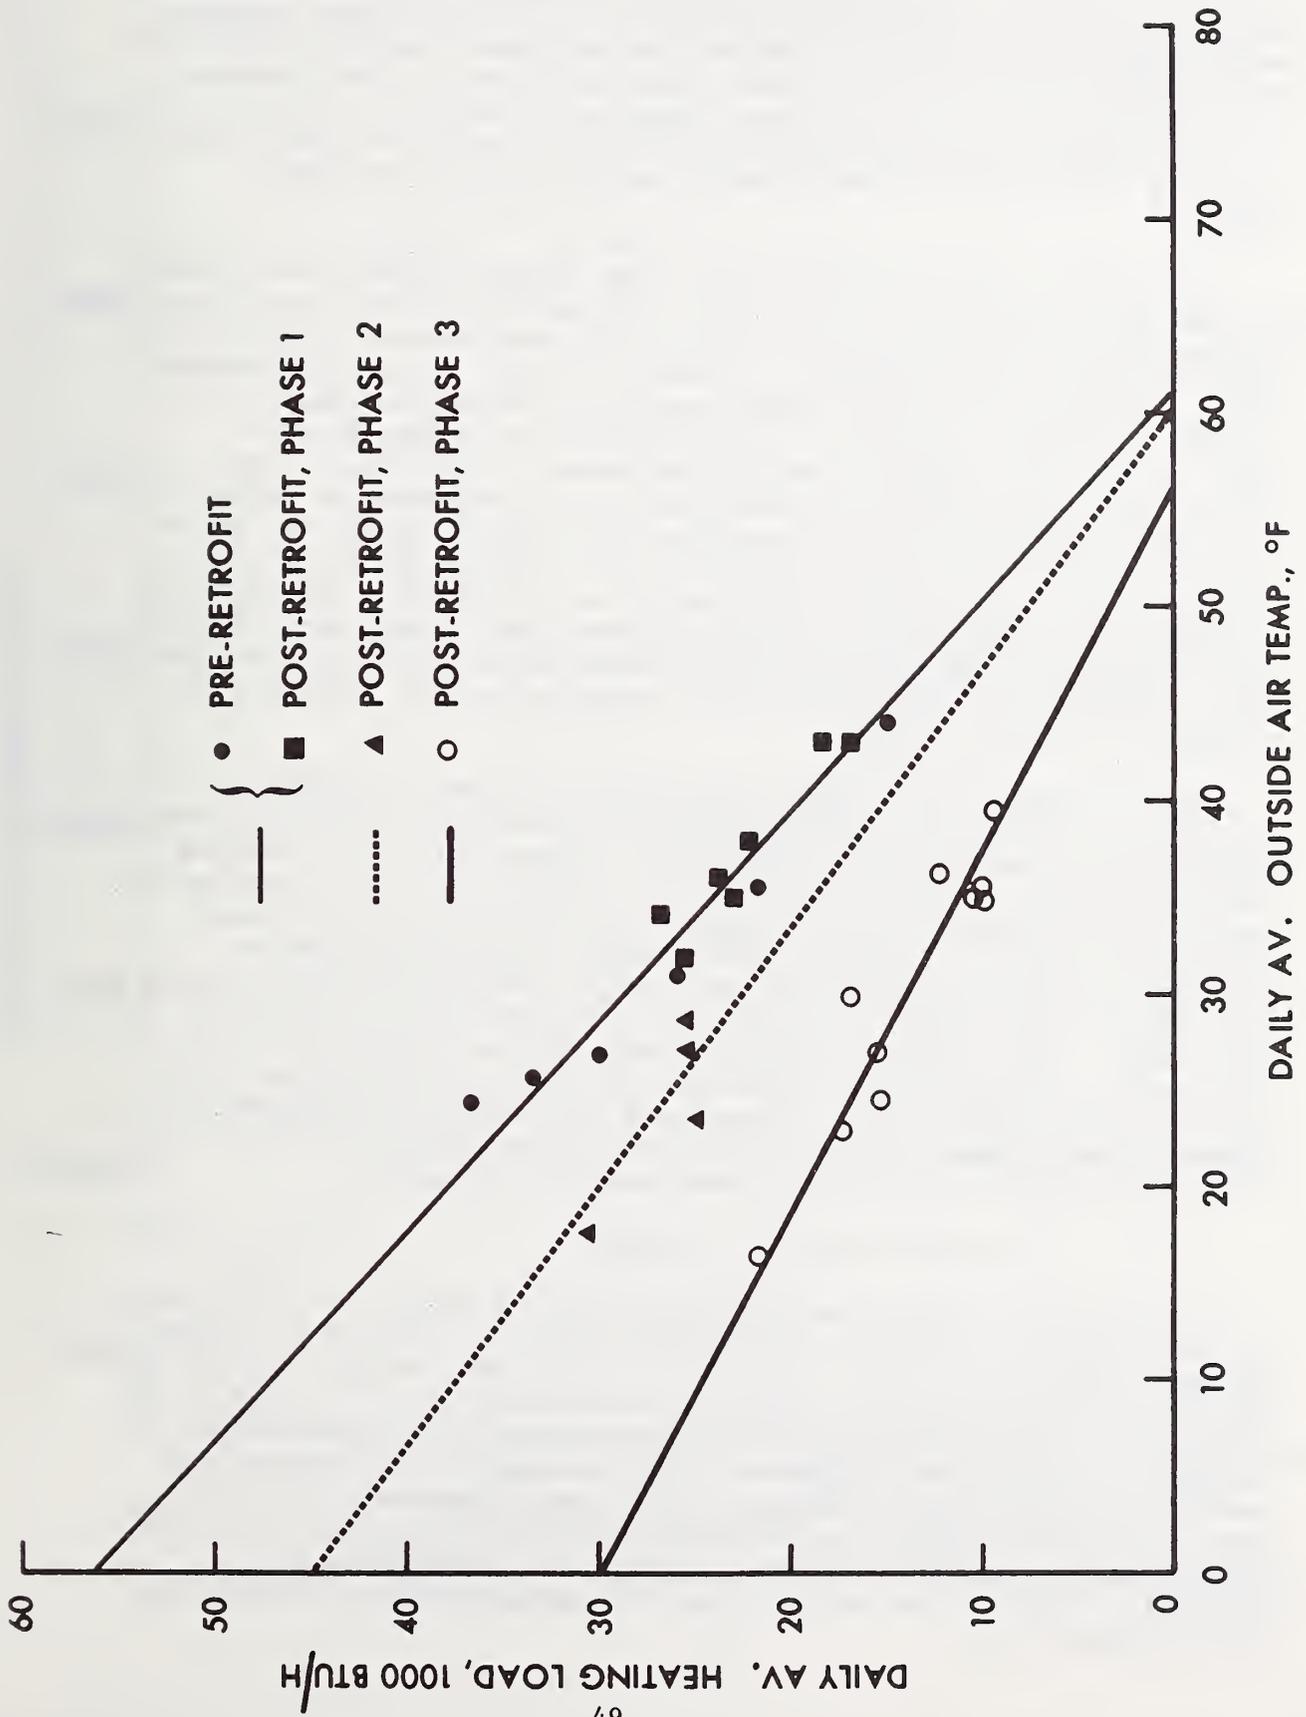
Figure 15. Heating-load correlations for the occupied test house after various stages of the retrofit.
