Retrofitting an Existing Wood Frame Residence for Energy Conservation--an Experimental Study

D. M. Burch
C. M. Hunt

Thermal Engineering Section
Center for Building Technology
Institute for Applied Technology
National Bureau of Standards
Washington, D.C. 20234

July 1977

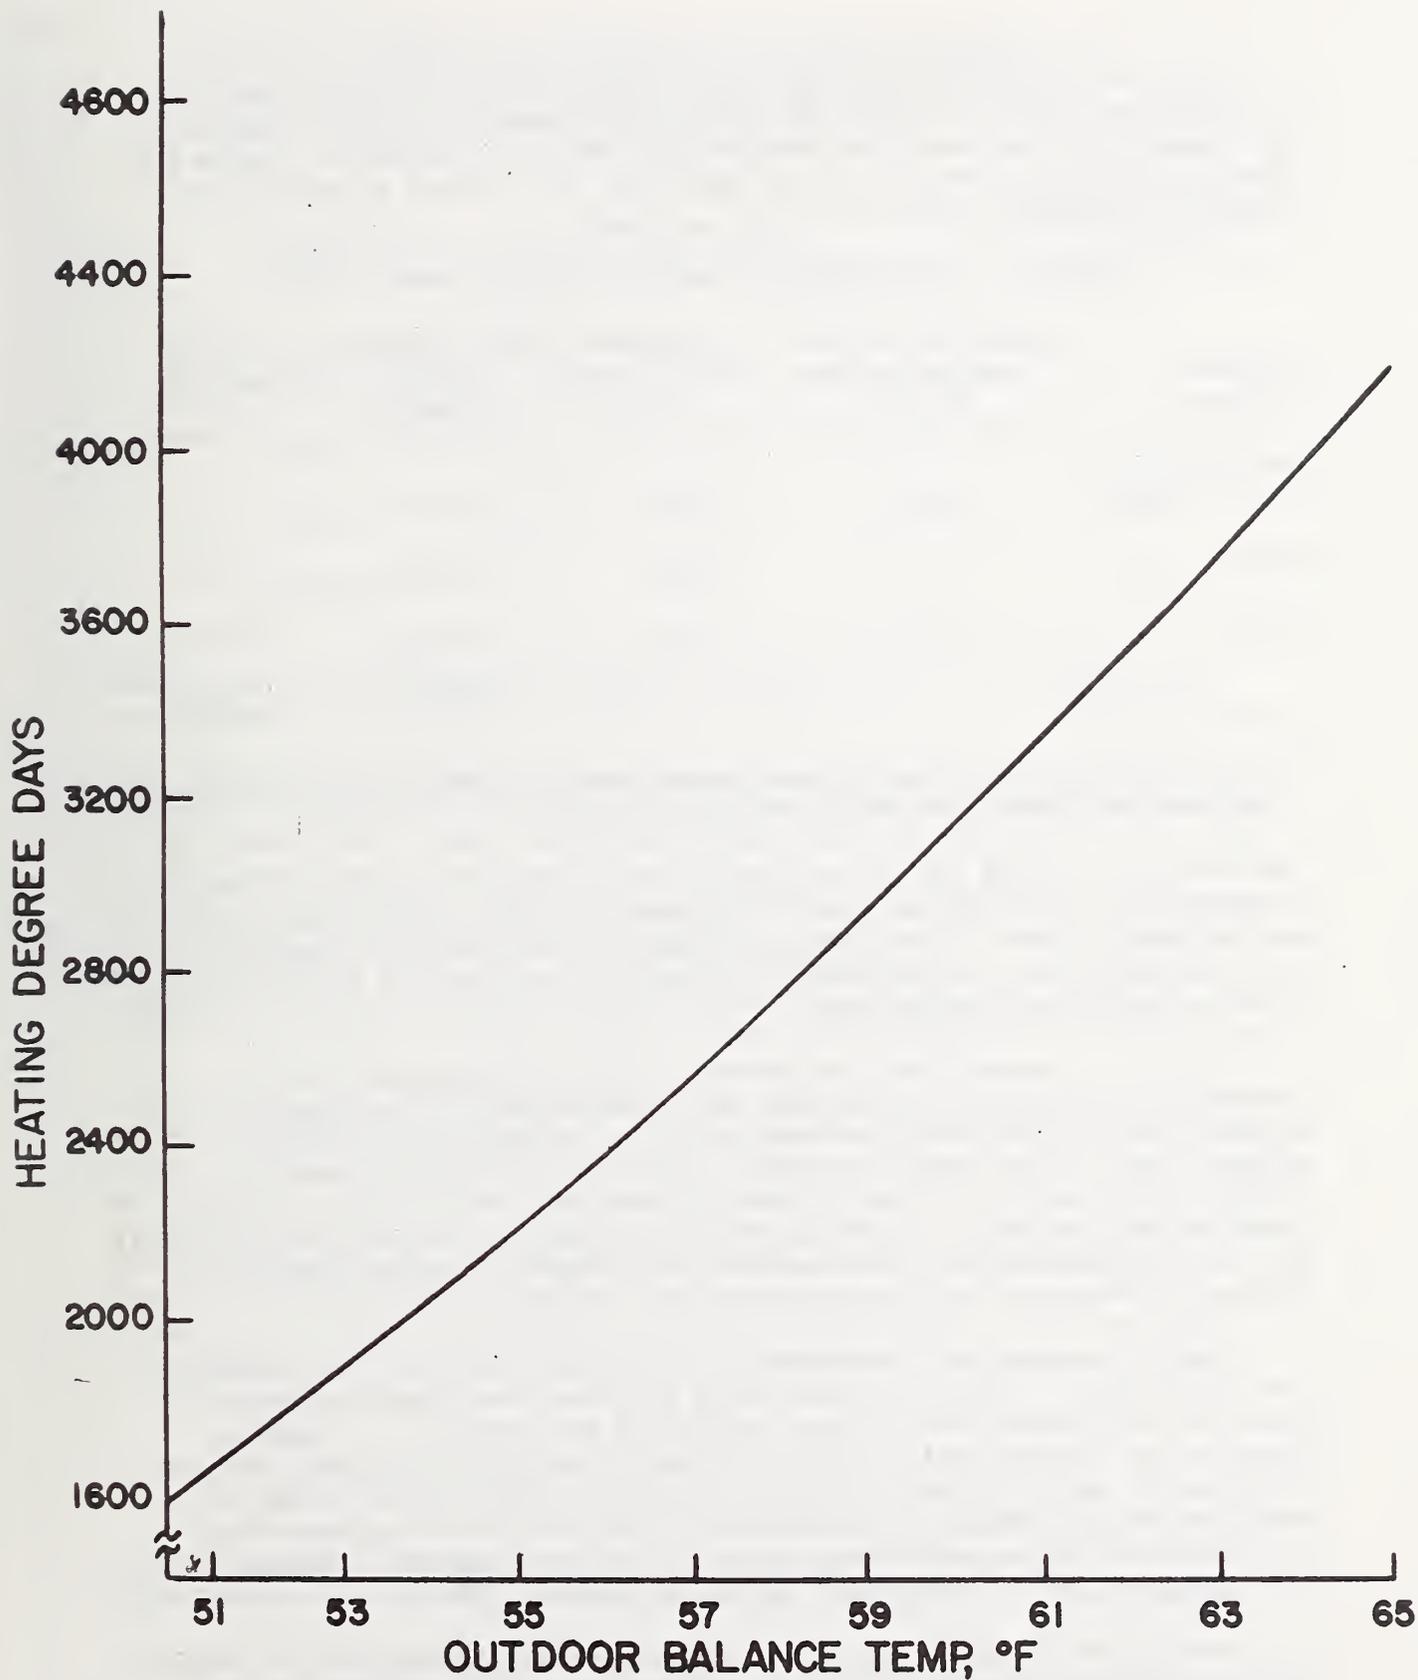
Figure 16. Heating degree days as a function of outdoor balance temperature for Washington, D.C. 51

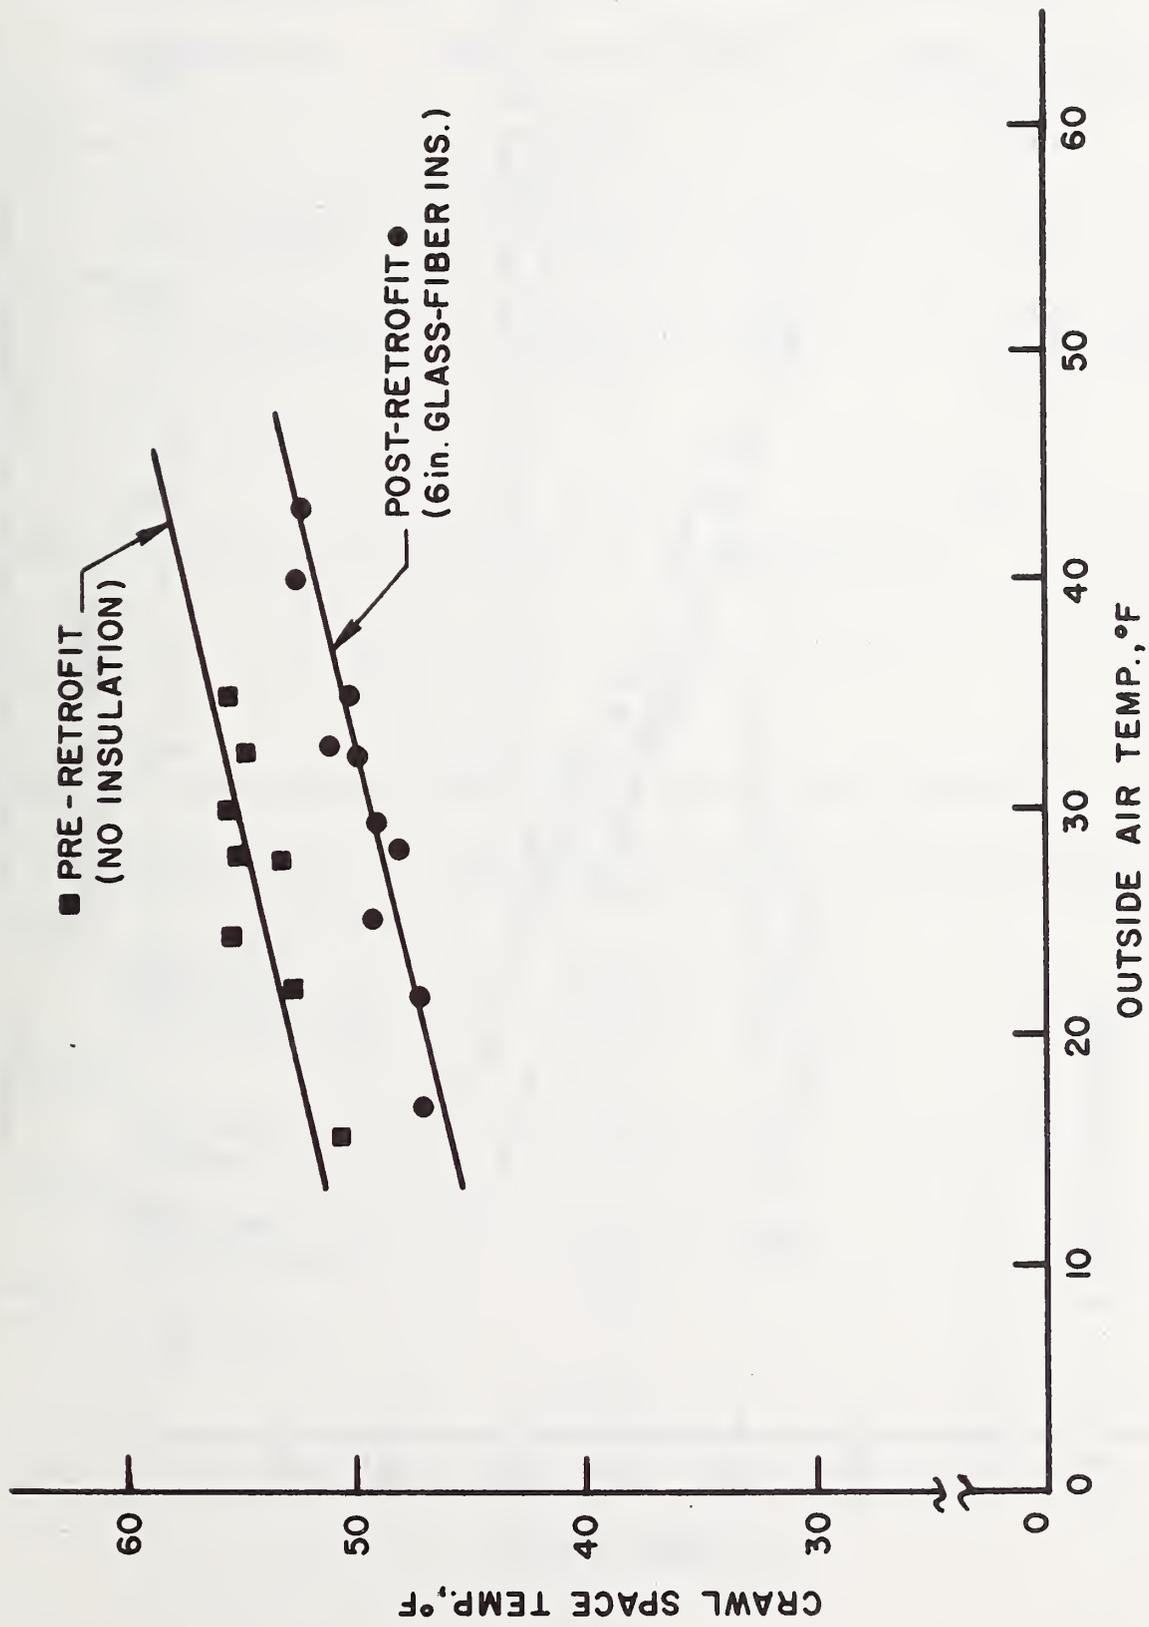
Figure 17. Pre- and post-retrofit winter crawl-space temperatures.

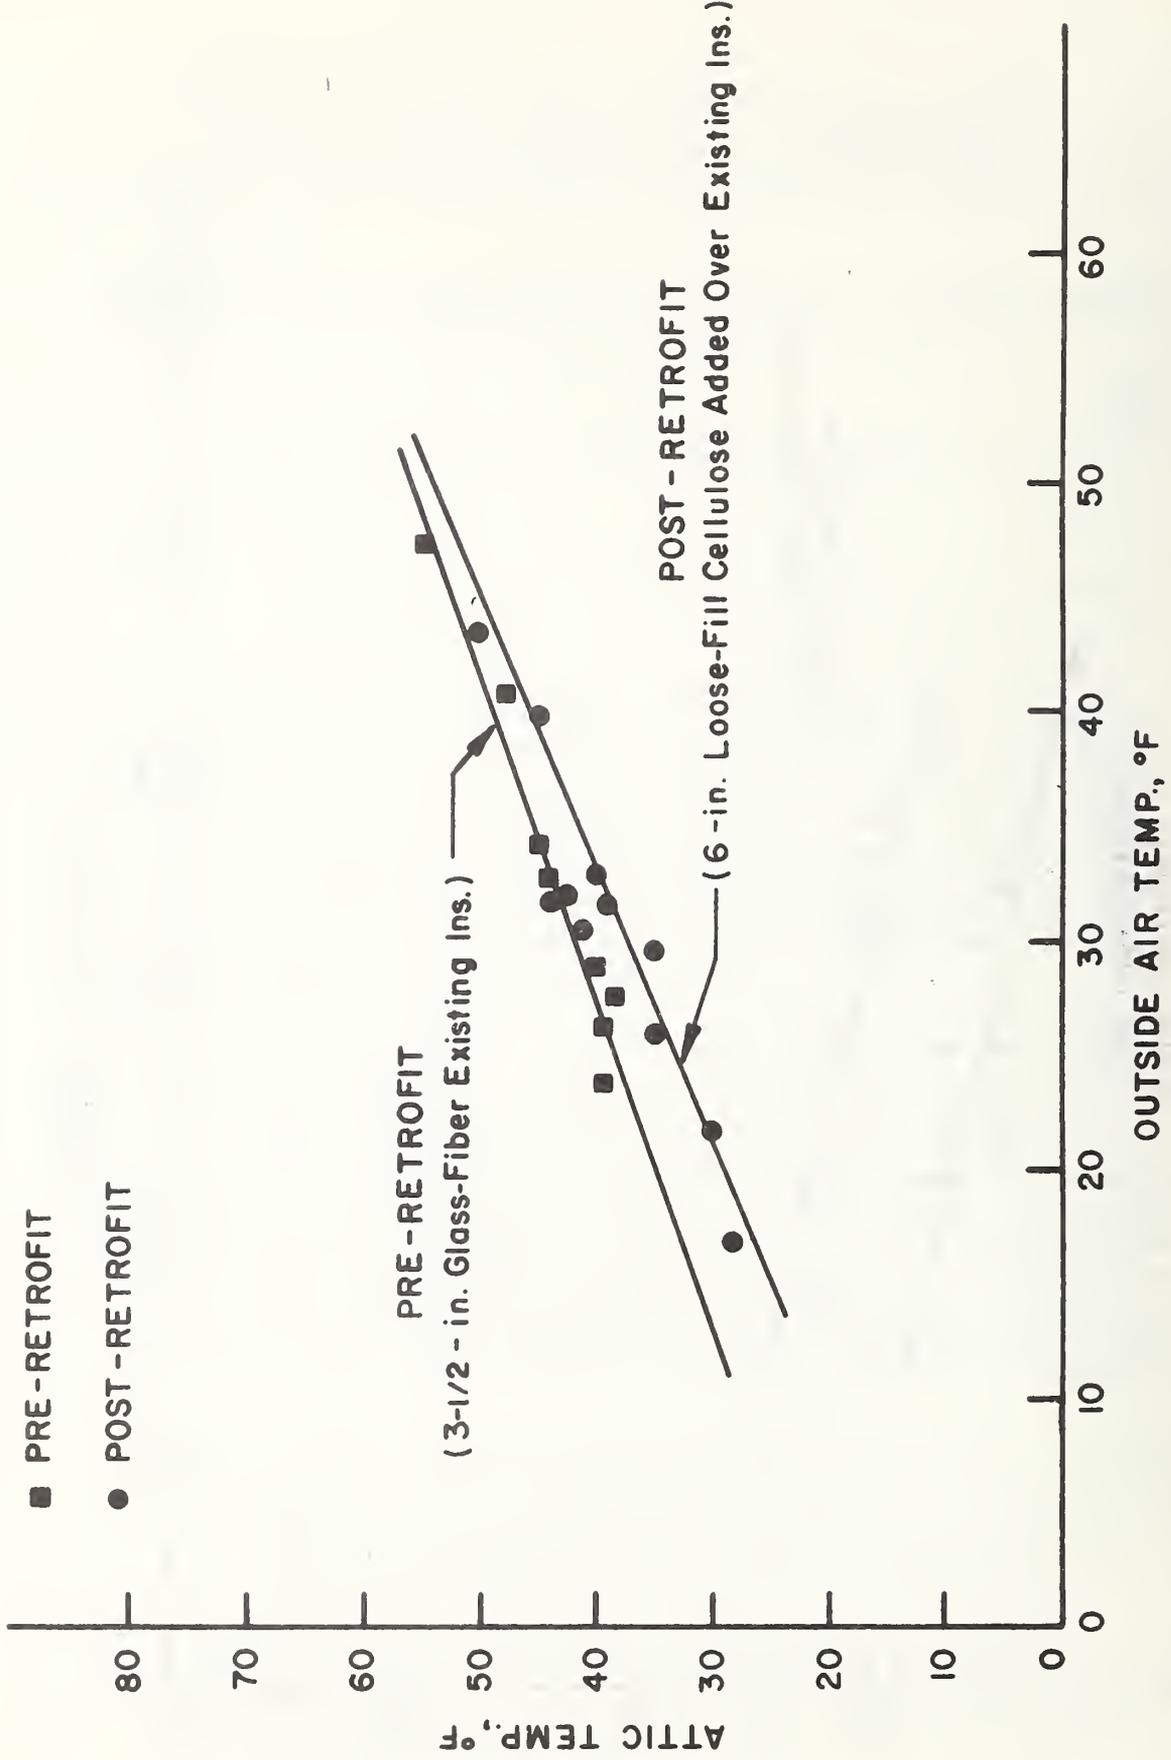
Figure 18. Pre- and post retrofit winter attic temperatures.

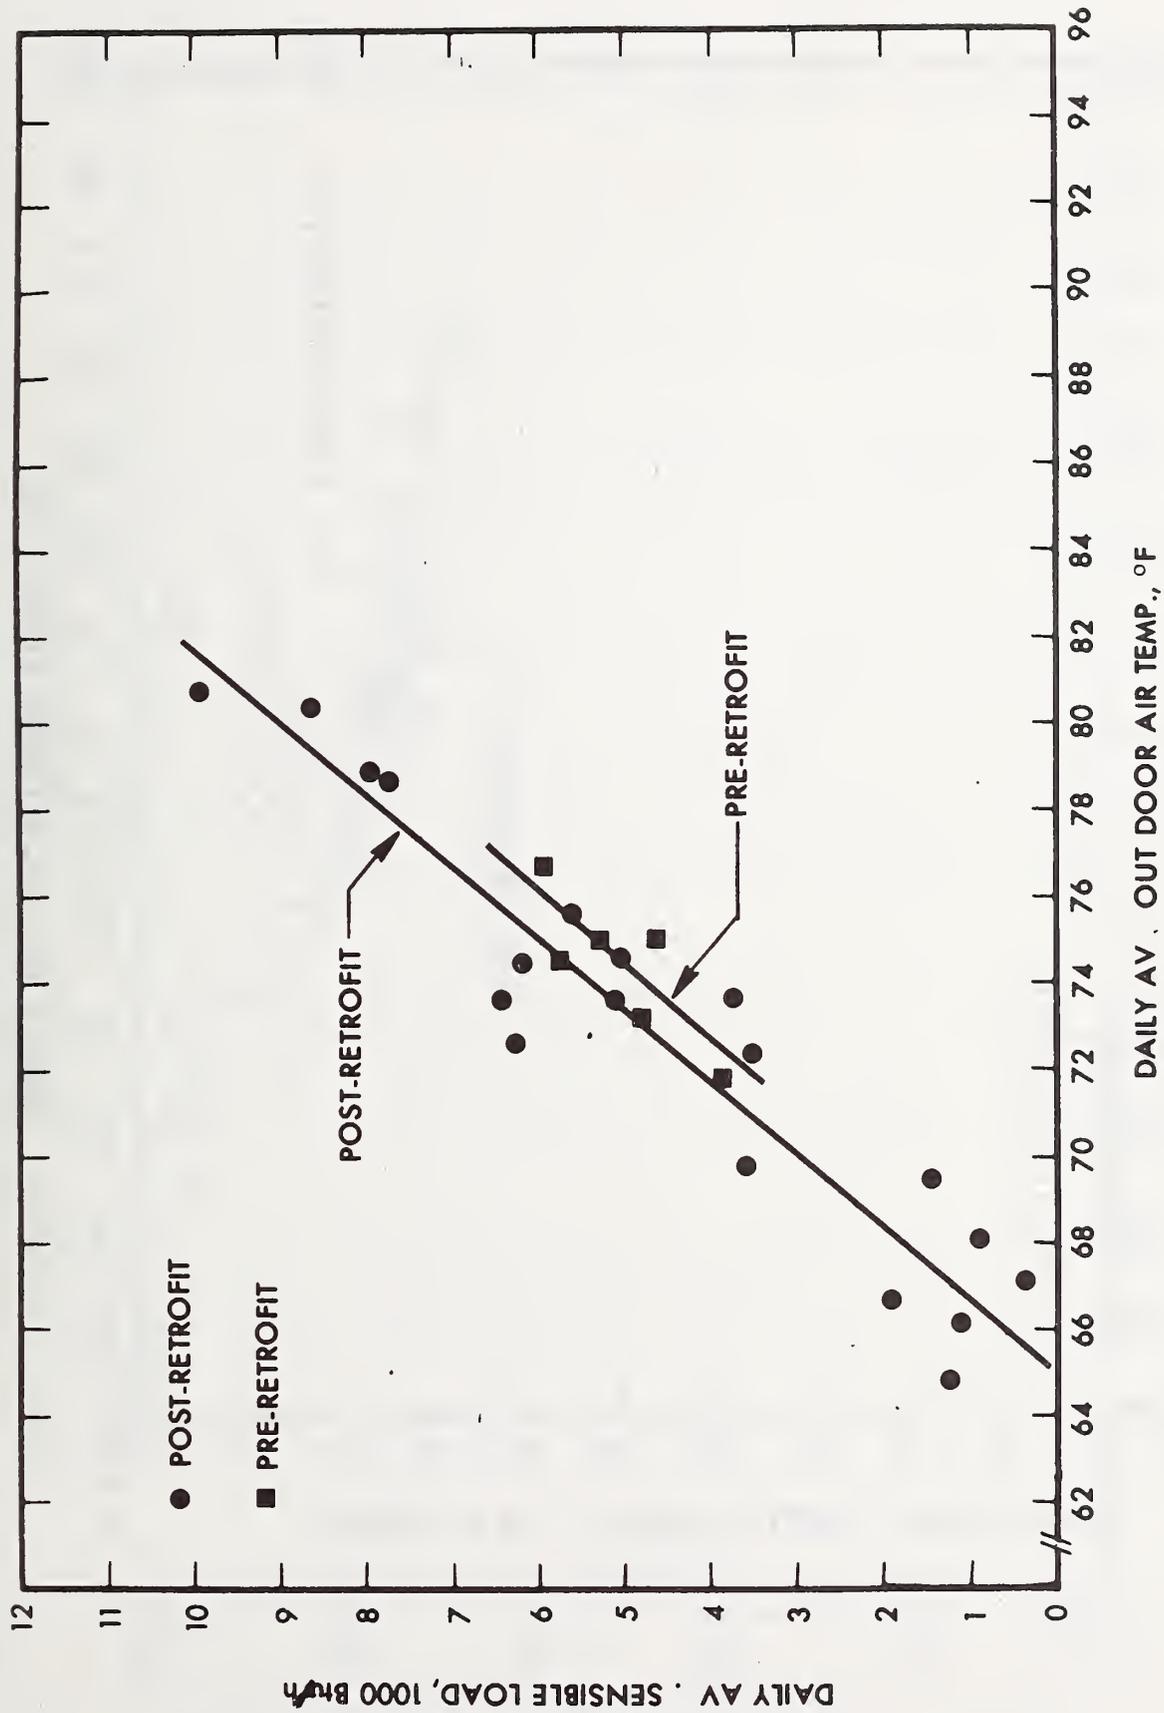
Figure 19. Pre- and post-retrofit sensible cooling loads.

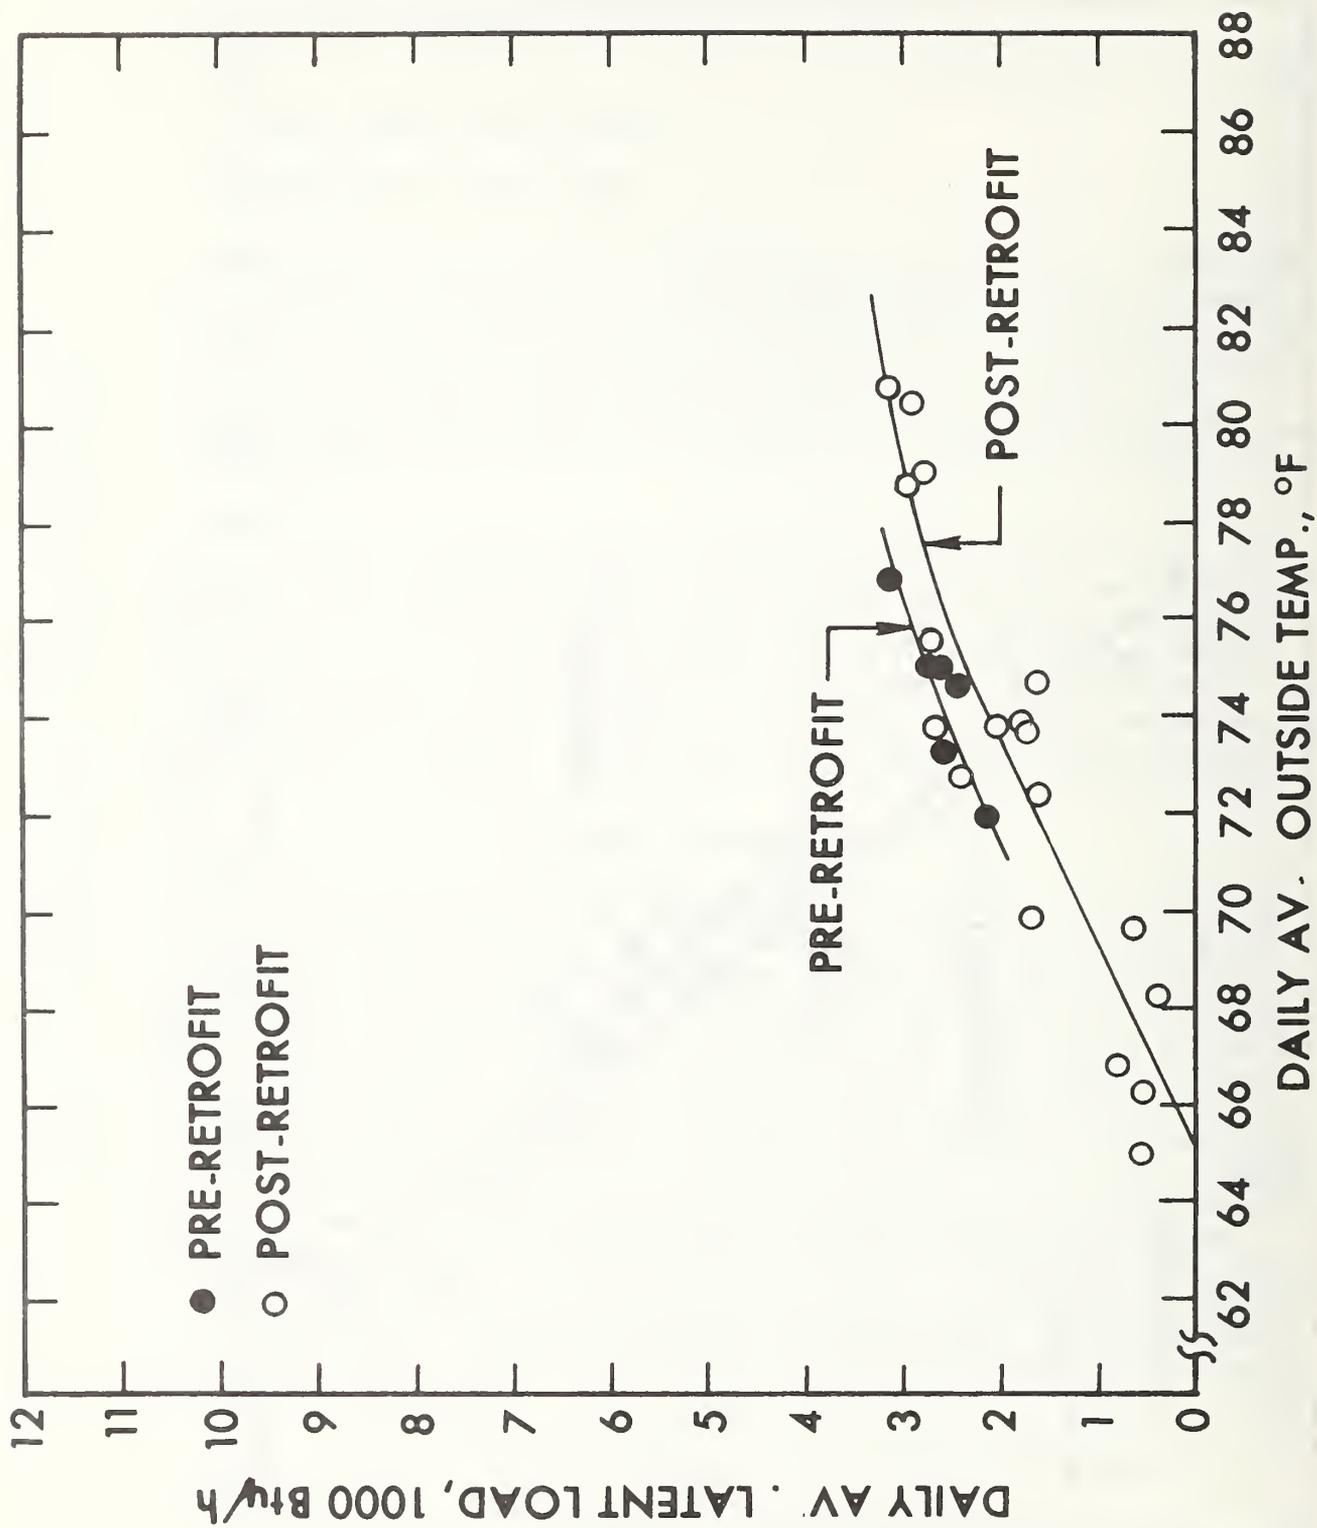
Figure 20. Pre- and post-retrofit latent cooling loads.

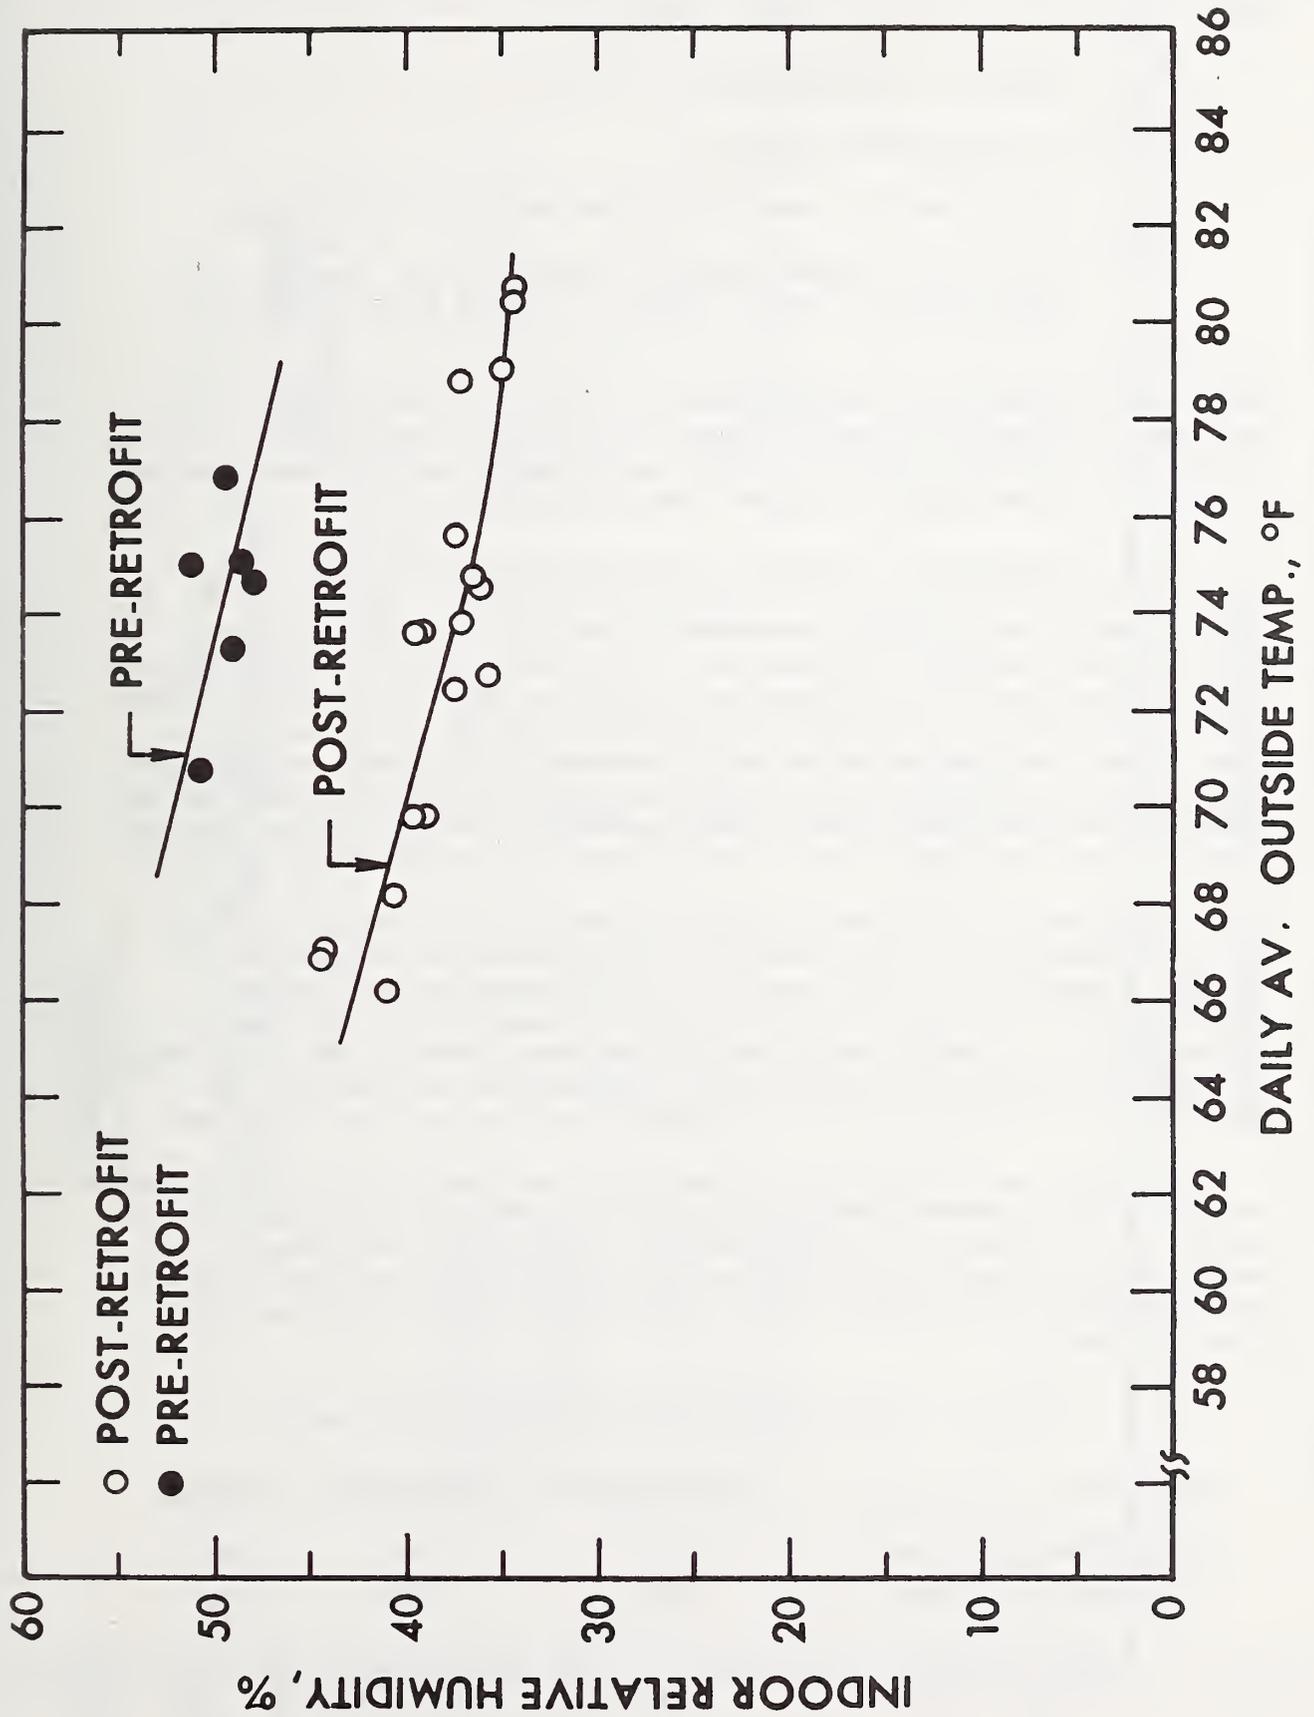
Figure 21. Pre- and post-retrofit summer indoor relative humidities.

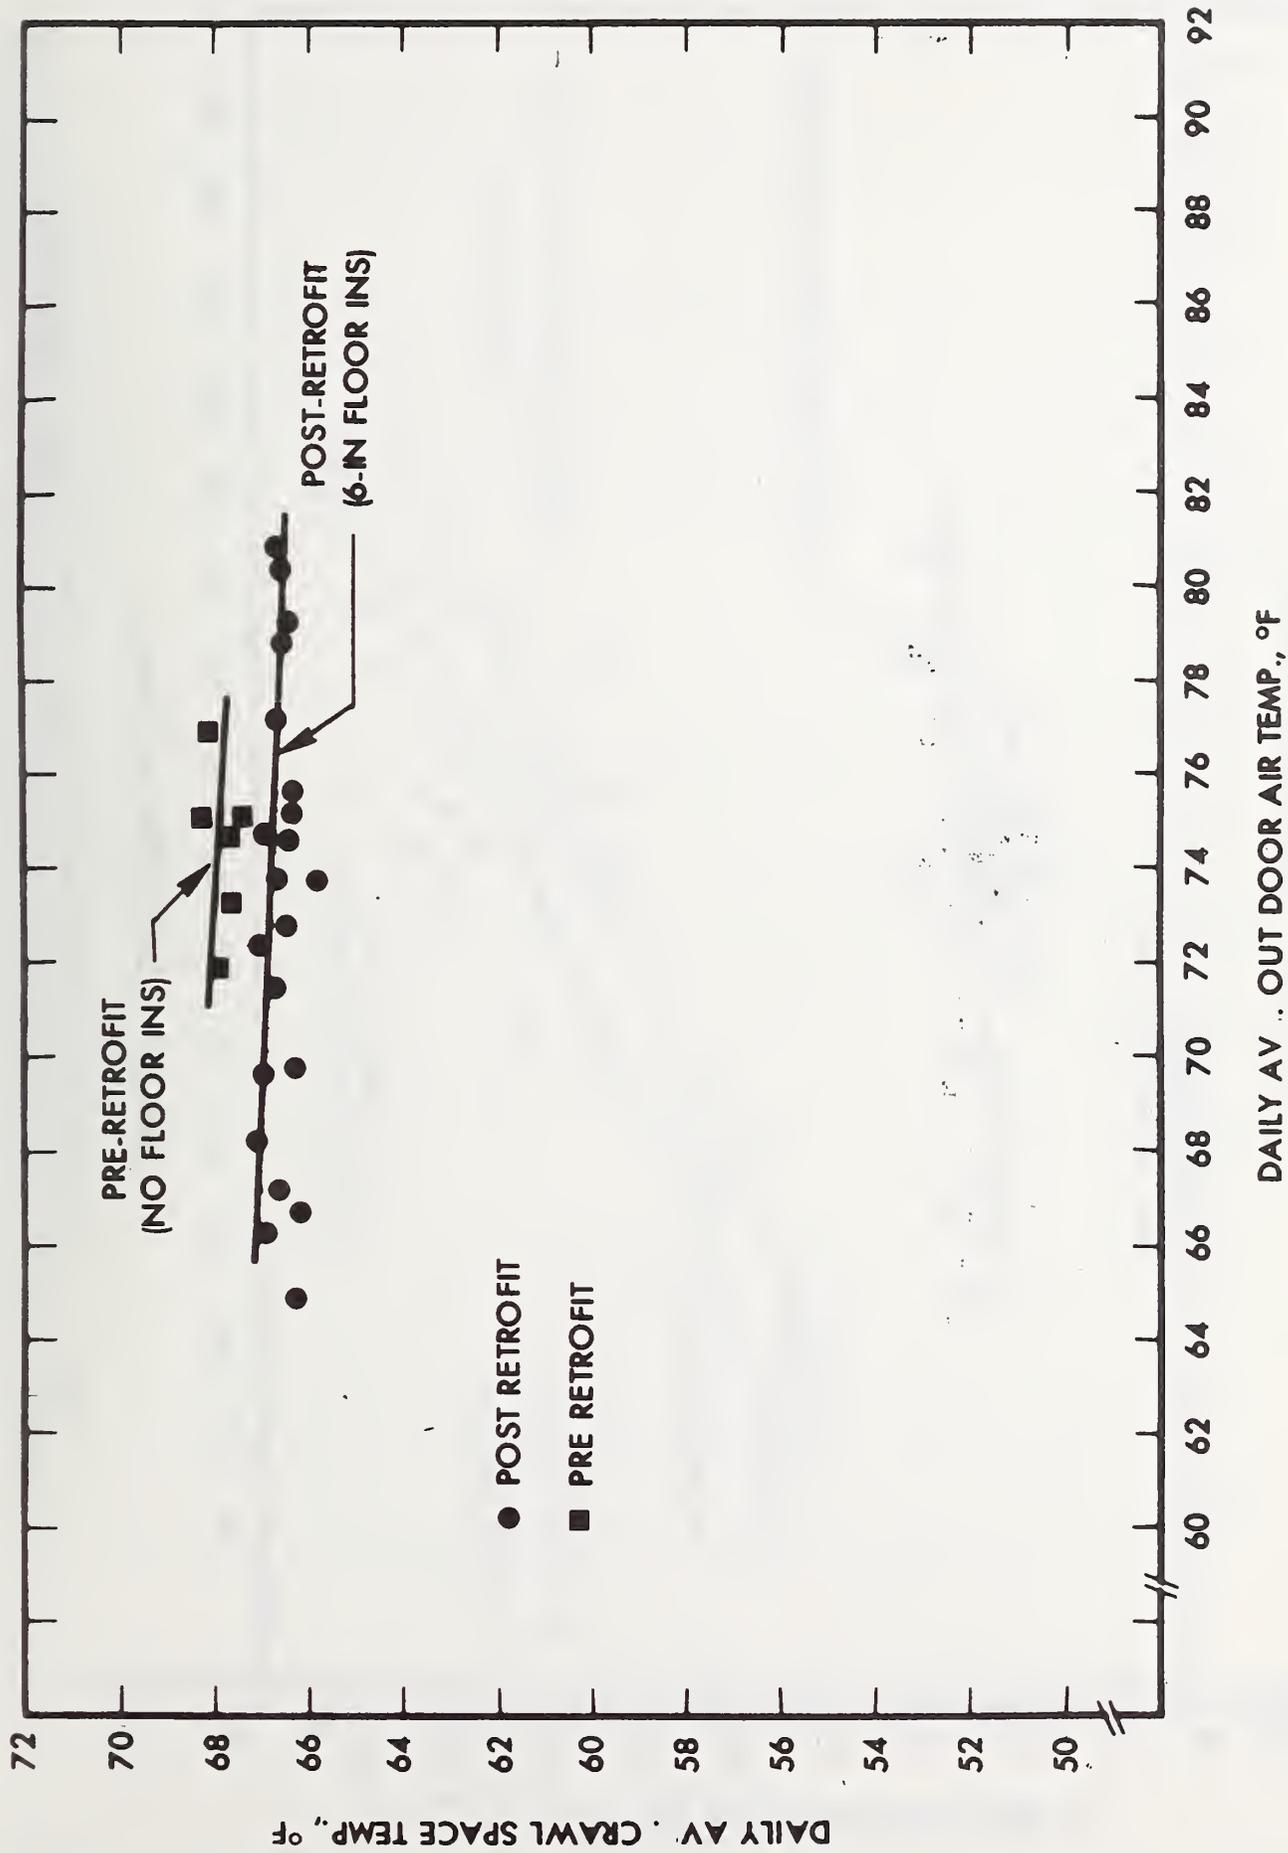
Figure 22. Pre- and post-retrofit daily average summer crawl space temperatures.

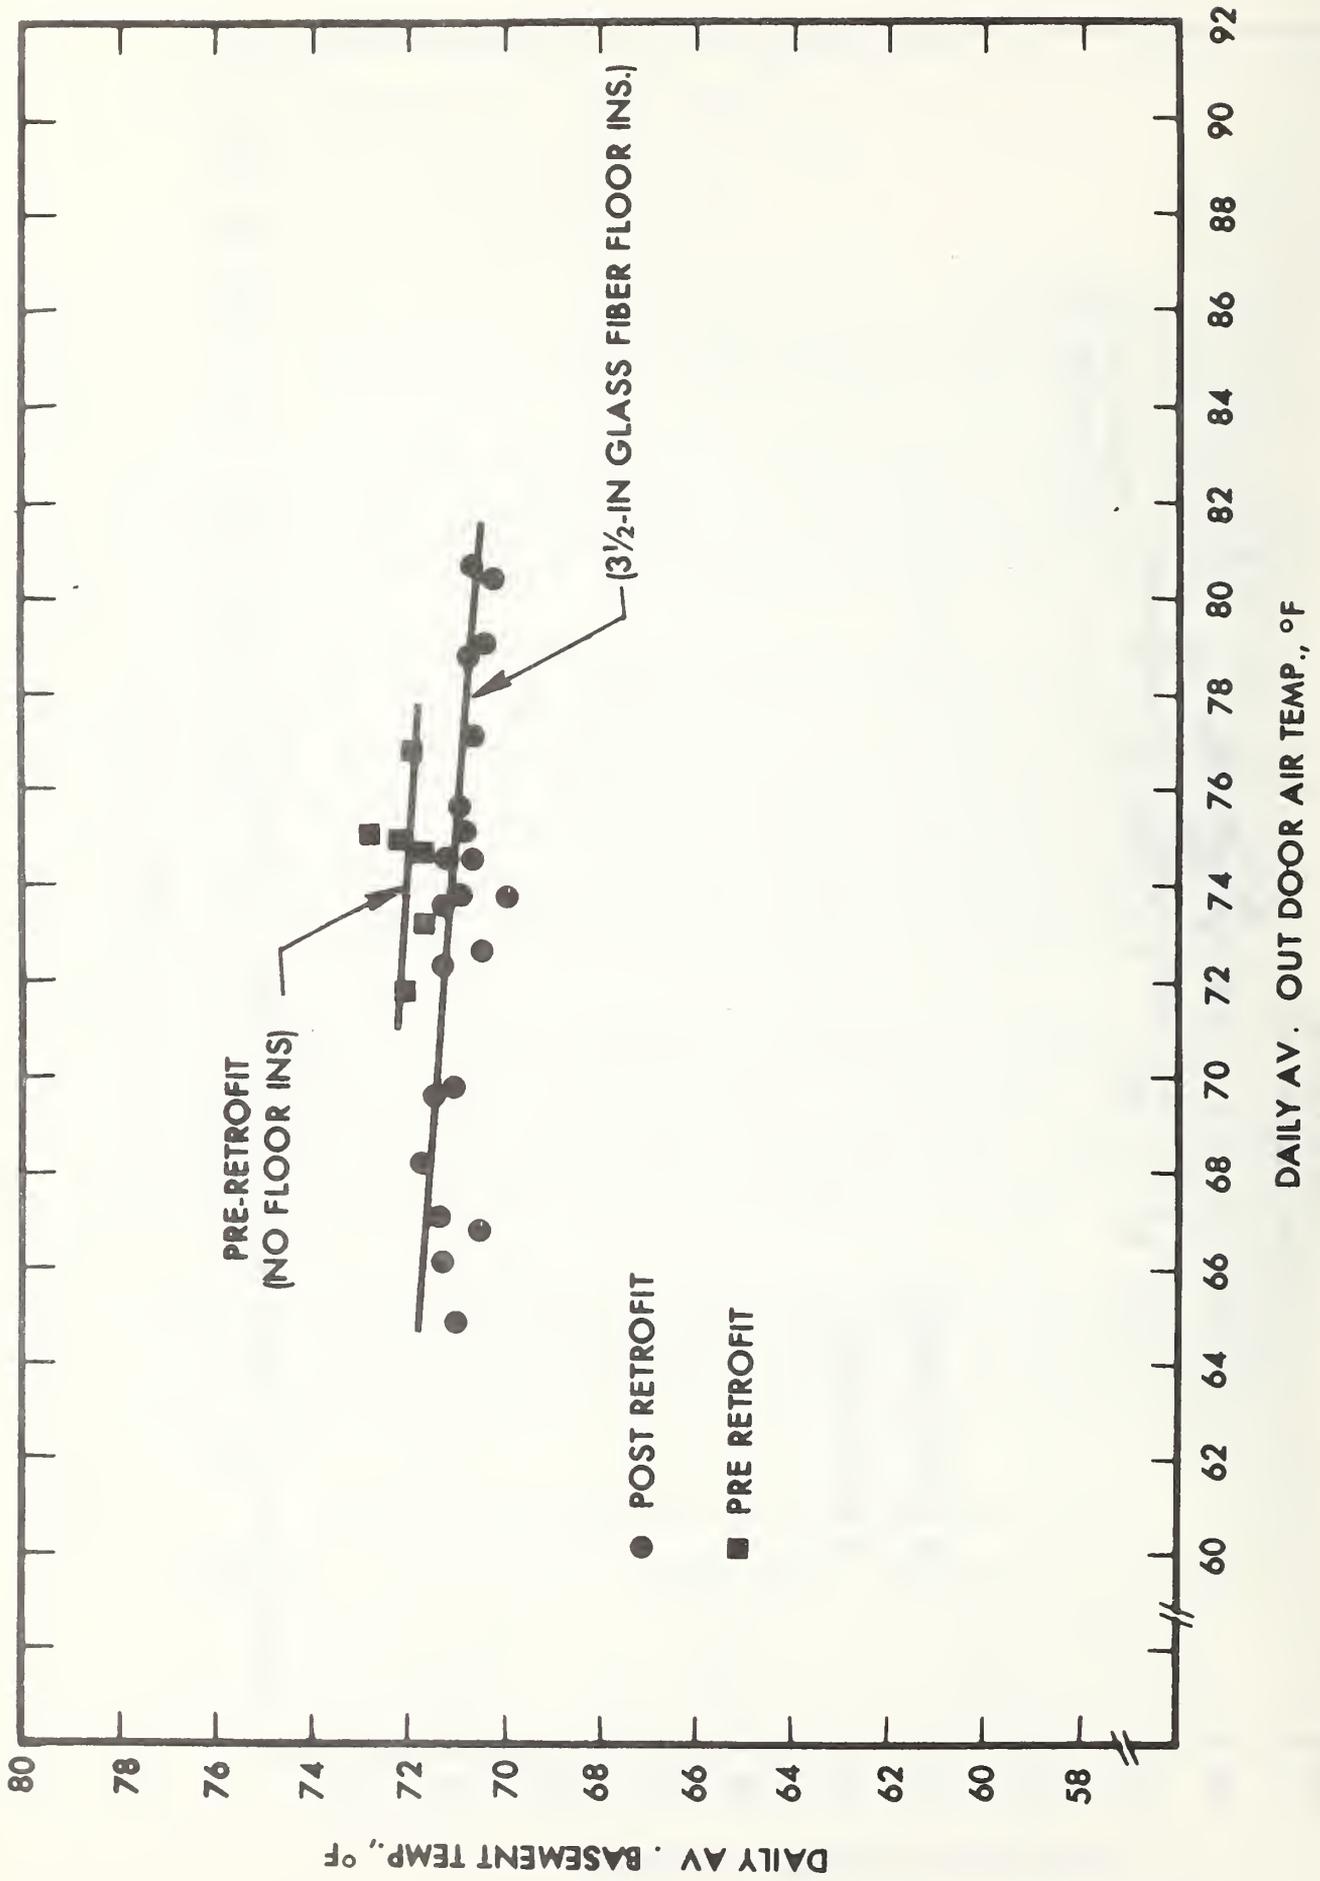
Figure 23. Pre- and post-retrofit daily average summer basement temperatures.

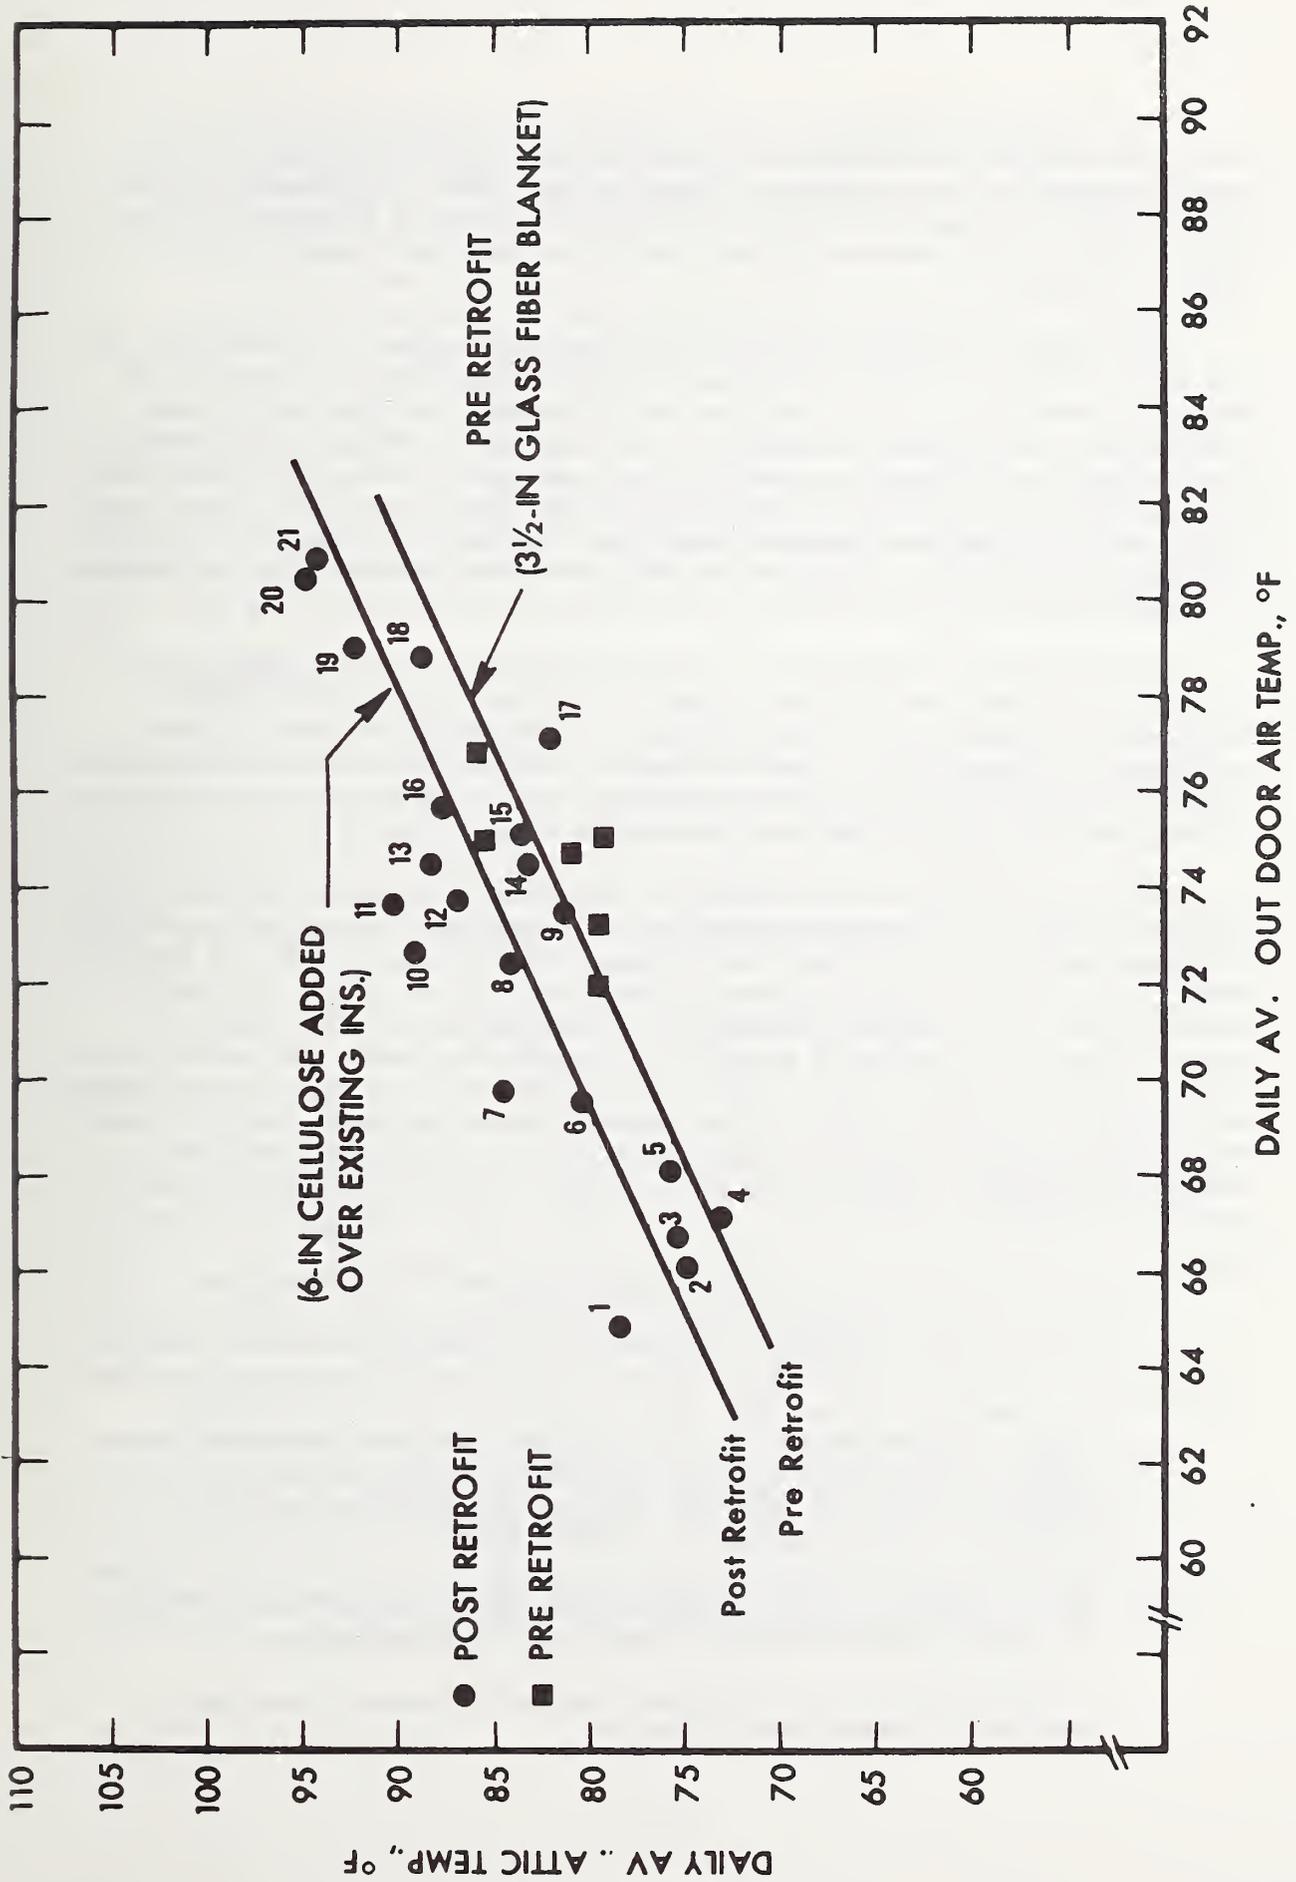
Figure 24. Pre- and post-retrofit daily-average summer attic temperatures.

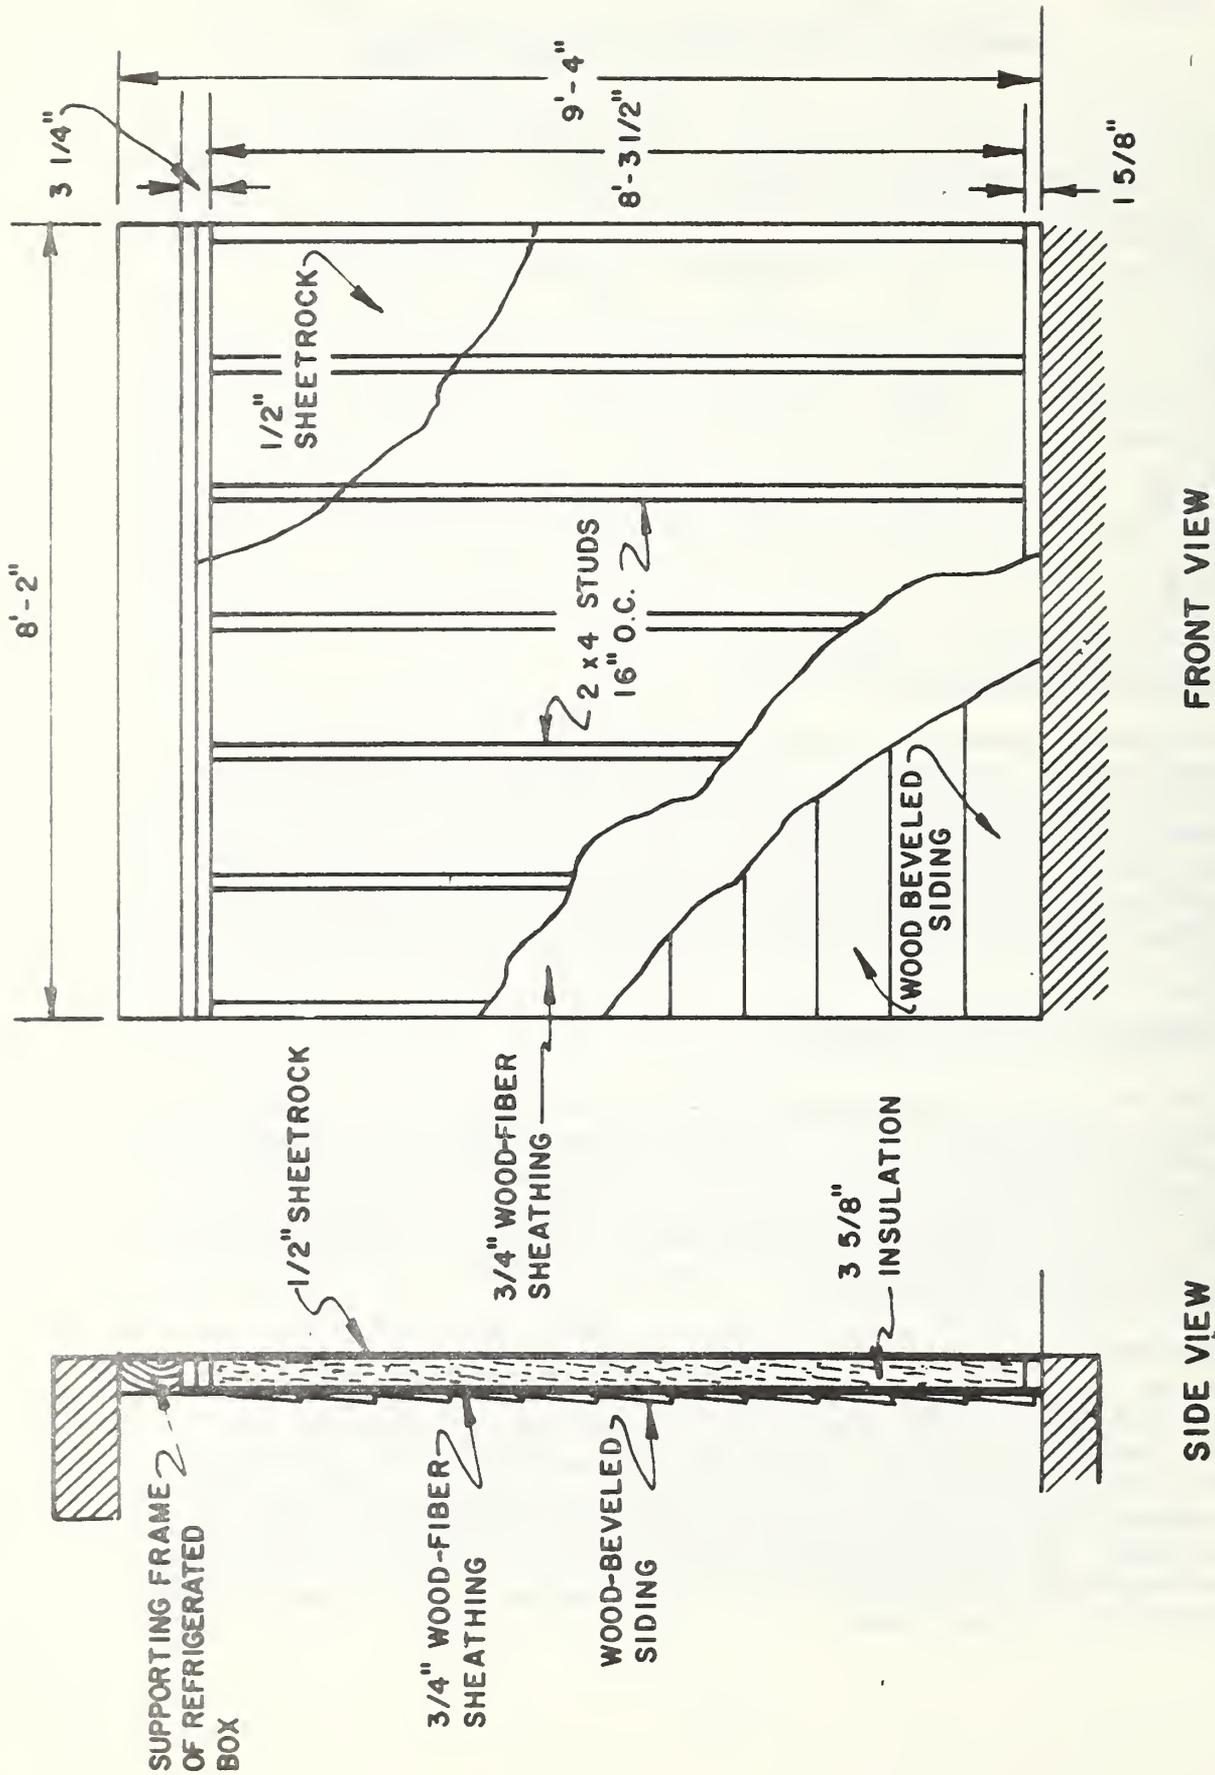
Figure 25. Construction details of laboratory test wall.

As viewed from the inside surface, cellulose fiber was blown into the first two wall cavities on the left, fibrous glass wool into the two center cavities, and U-F foam into the remaining two cavities on the right. When the U-F foam was installed, the redwood siding was not attached to the wall for about a week, to permit some of the original water contained in the foam to escape through the comparatively permeable sheathing. The same procedures were used for installing each of the insulation materials into the laboratory test walls as were used for the wall sections of the test house.

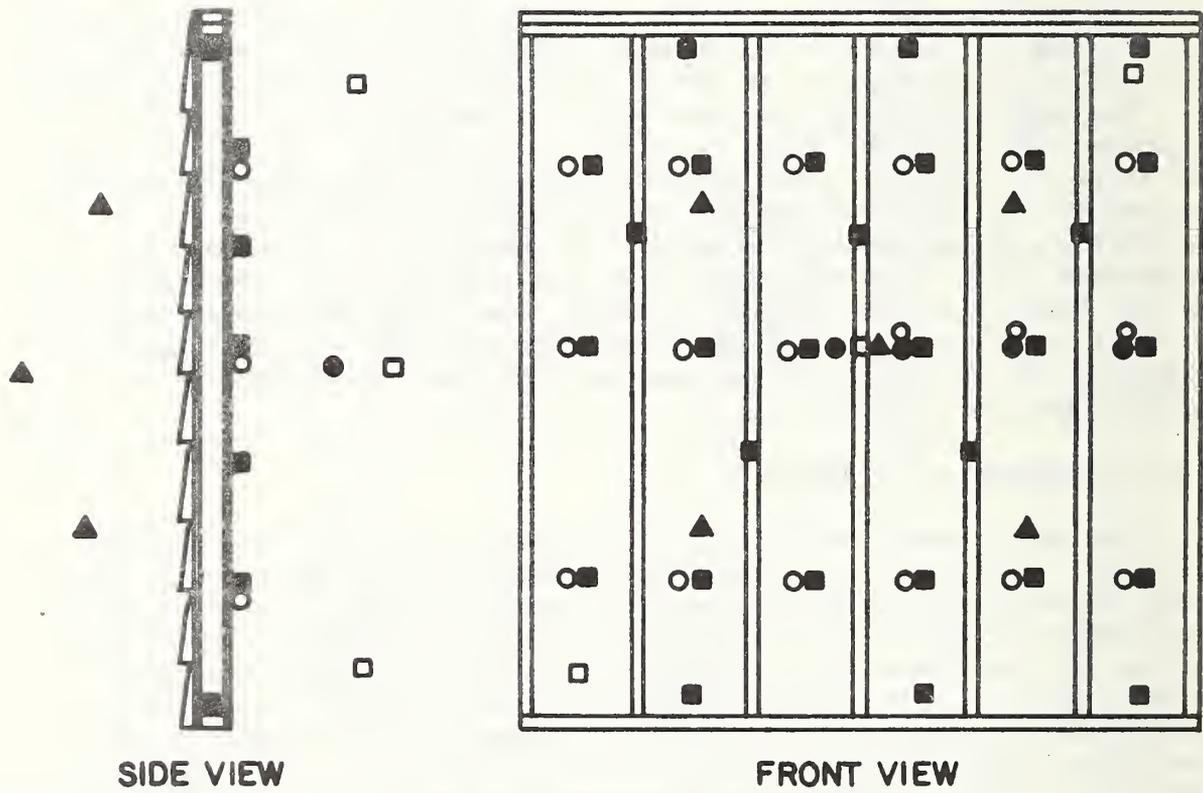
Figure 26. Location of measurement transducers on laboratory test wall.
