Retrofitting an Existing Wood Frame Residence for Energy Conservation--an Experimental Study

D. M. Burch
C. M. Hunt

Thermal Engineering Section
Center for Building Technology
Institute for Applied Technology
National Bureau of Standards
Washington, D.C. 20234

July 1977

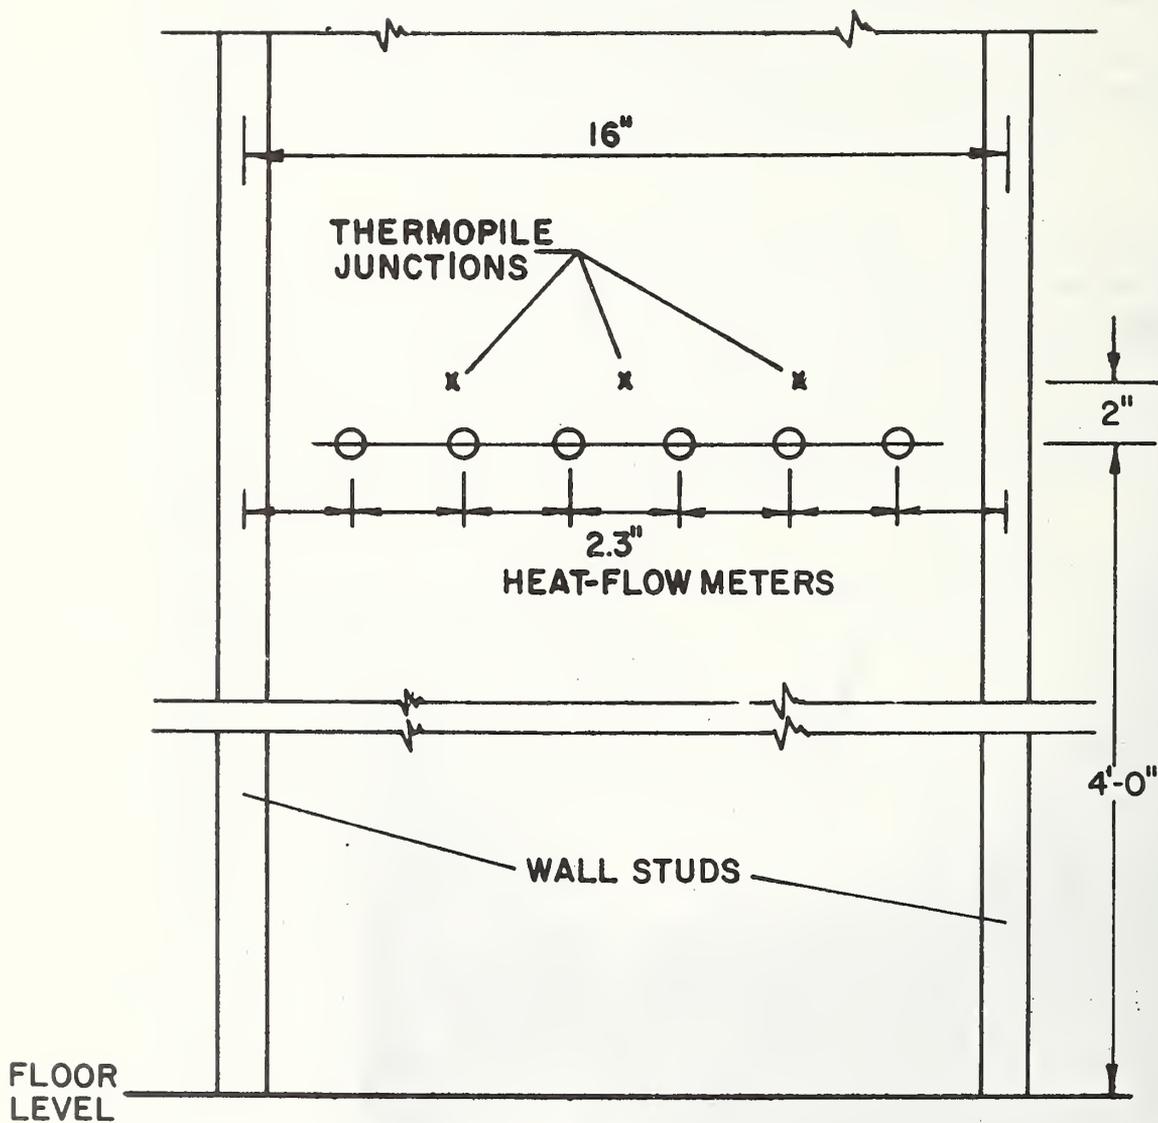
Figure 28. Elevation view of wall section of the test house showing heat-flow measuring station.

The heat-flow rates through wall sections of the test house insulated with the three types of insulating materials were measured with heat-flow meters. The heat-flow meters were circular disks 2.0 in (5.08 cm) in diameter and 0.13 in (0.33 cm) thick, made of polyvinylchloride filler material, each having an embedded thermopile. Heat flux, upon passing through the wafer, caused a temperature difference to be developed across the wafer, which in turn caused a millivolt signal to be produced proportional to the heat-flow rate. At a station 4 feet above the bottom of the wall section, six heat-flow meters were spot-glued to the inside wall surface and equally spaced between adjacent wall studs, as shown in figure 28. The six heat-flow meters were series-connected and the output signal was fed into an analog integrator. The integration of the heat-flow signal was necessary because instantaneous heat-flow rates were observed to possess large fluctuations due to the cyclic operation of the heating plant. The heat-flow measuring station also contained a

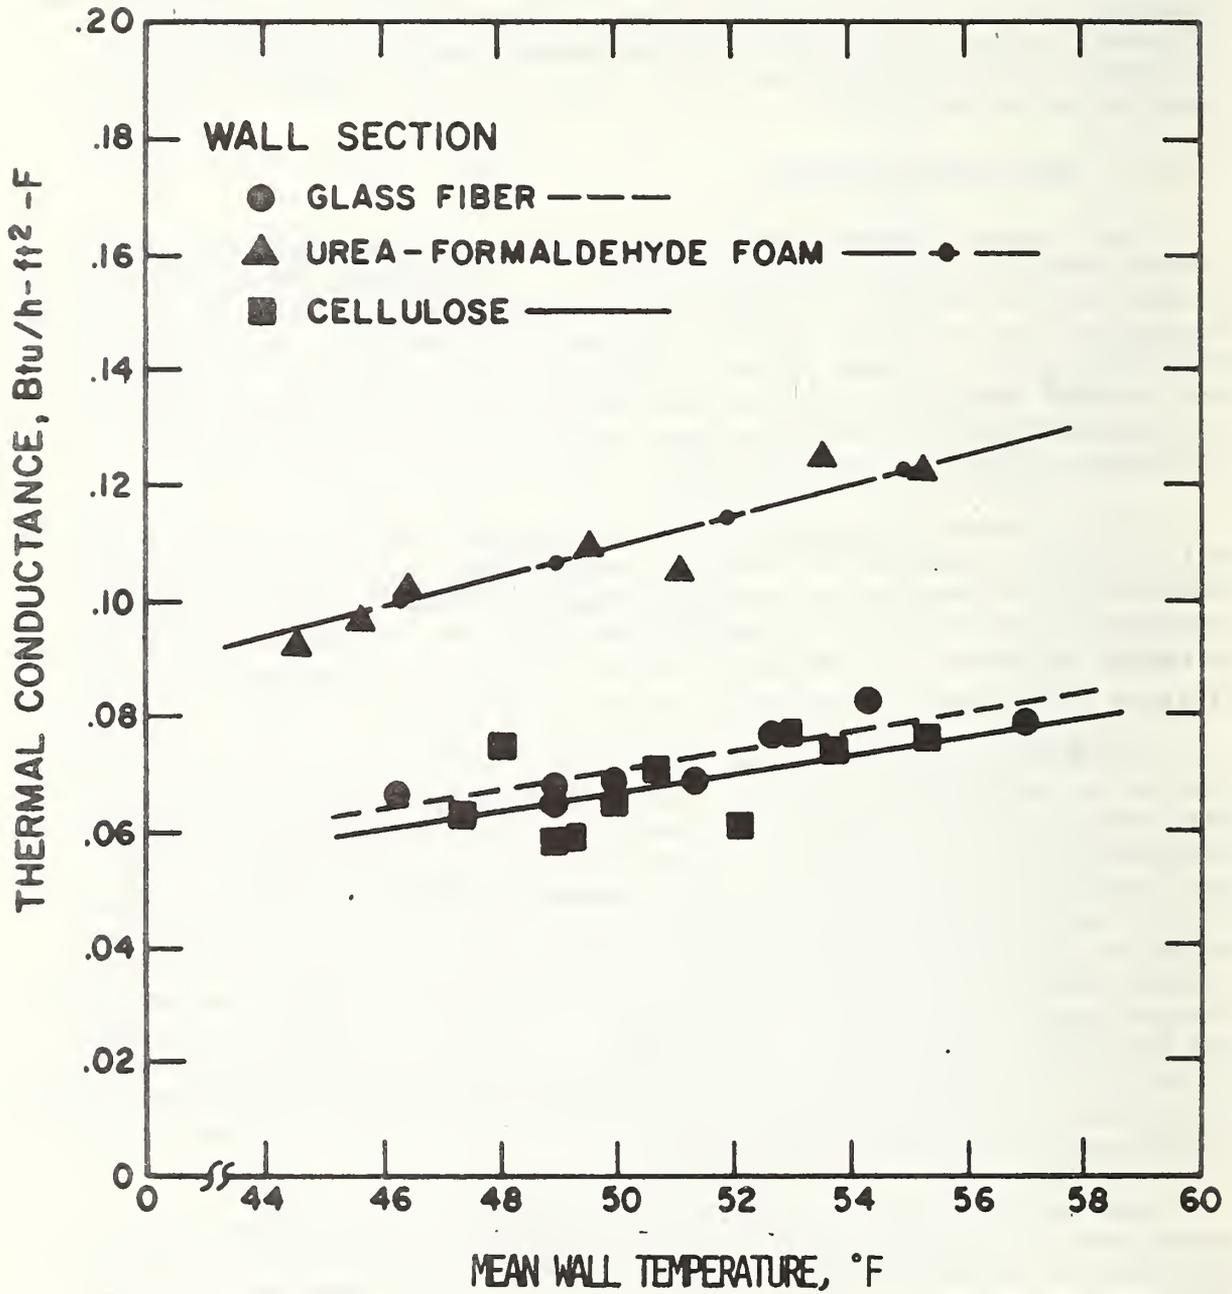
Figure 29. The effect of mean wall temperature on the thermal conductance of the three separate wall sections.

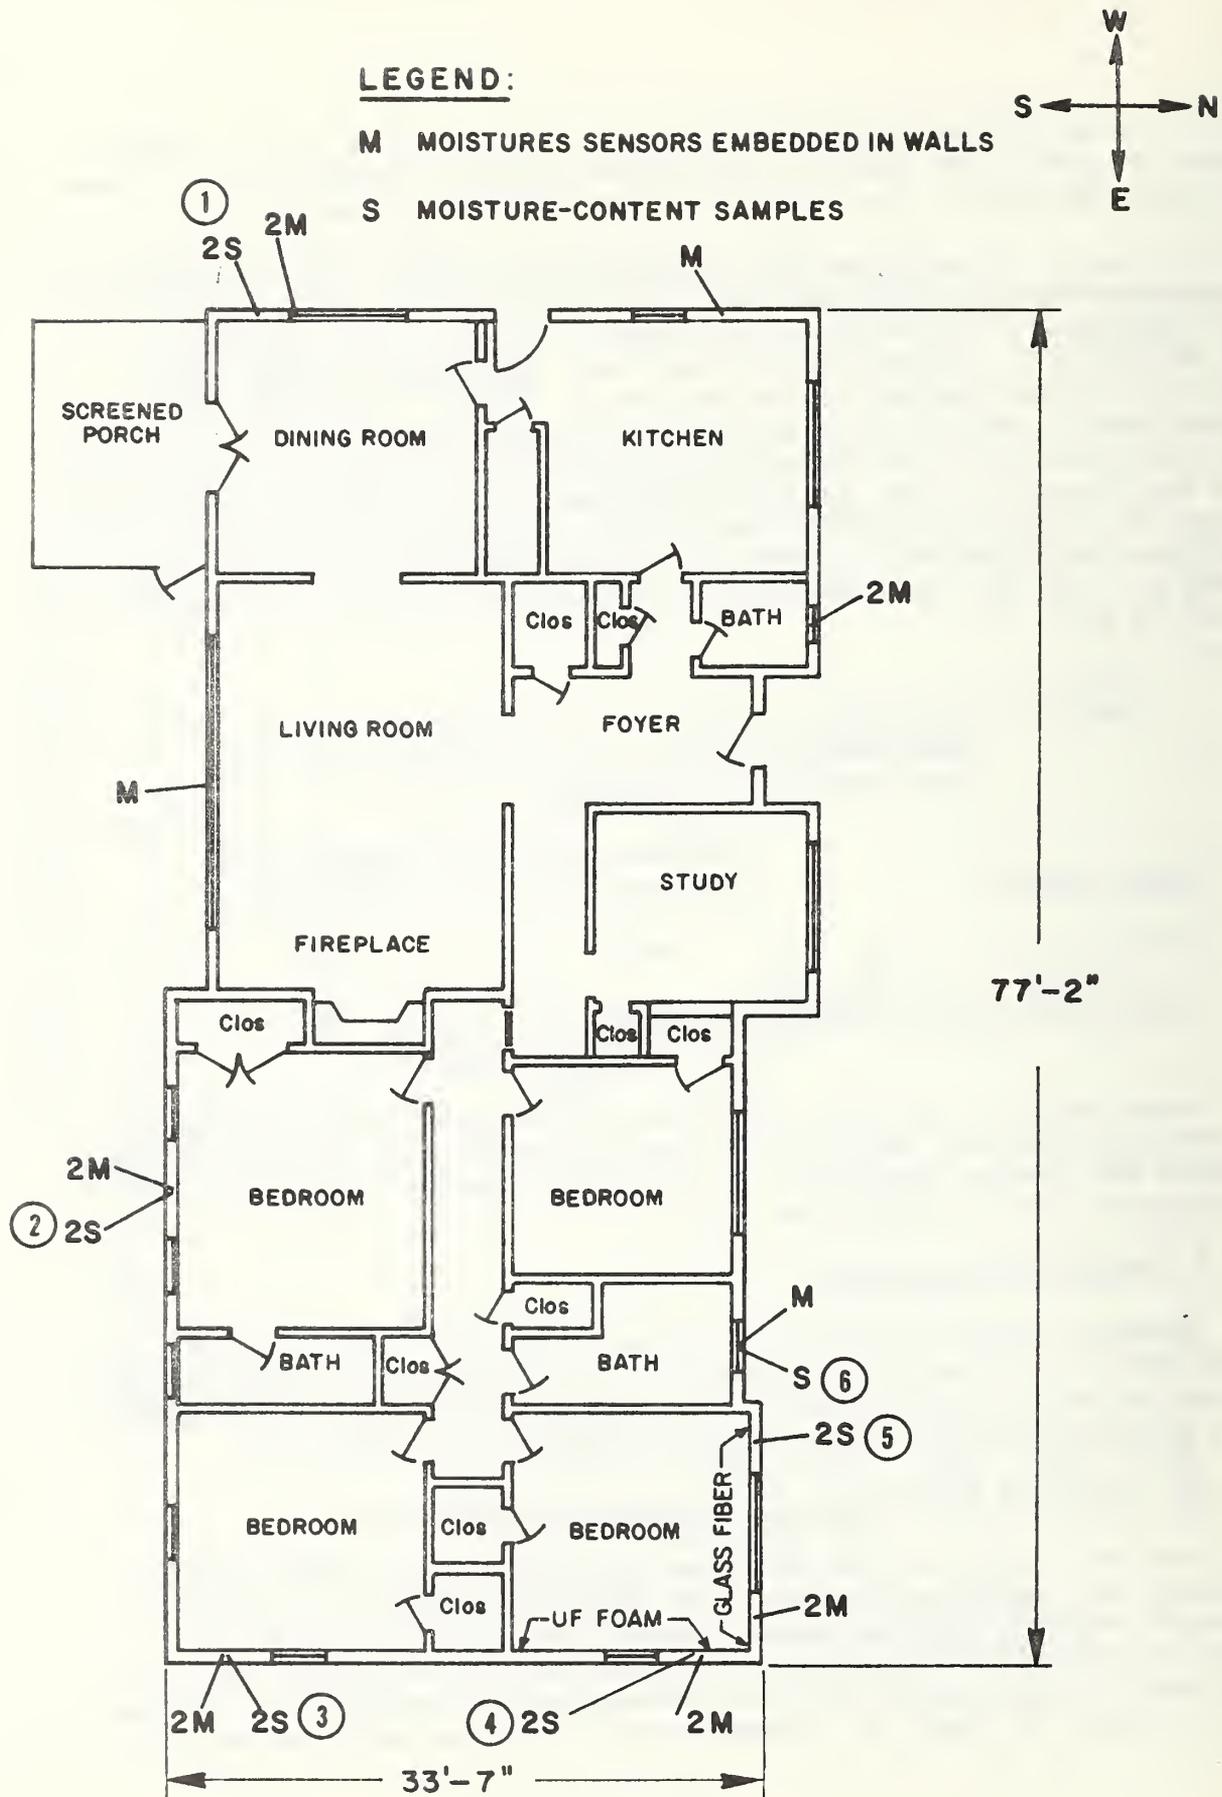
Figure 30. Floor plan of the test house showing location of humidity sensors and places where moisture content samples were cored out.

Ten days after the test house was insulated, small narrow-range humidity and temperature sensors were installed between the insulating material and the sheathing midway between the studs. The specific location of these humidity sensors is denoted with the symbol "M" on the floor plan in figure 30. The U-F foam and glass-fiber wall sections are indicated on figure 30. Other parts of the wall were insulated with

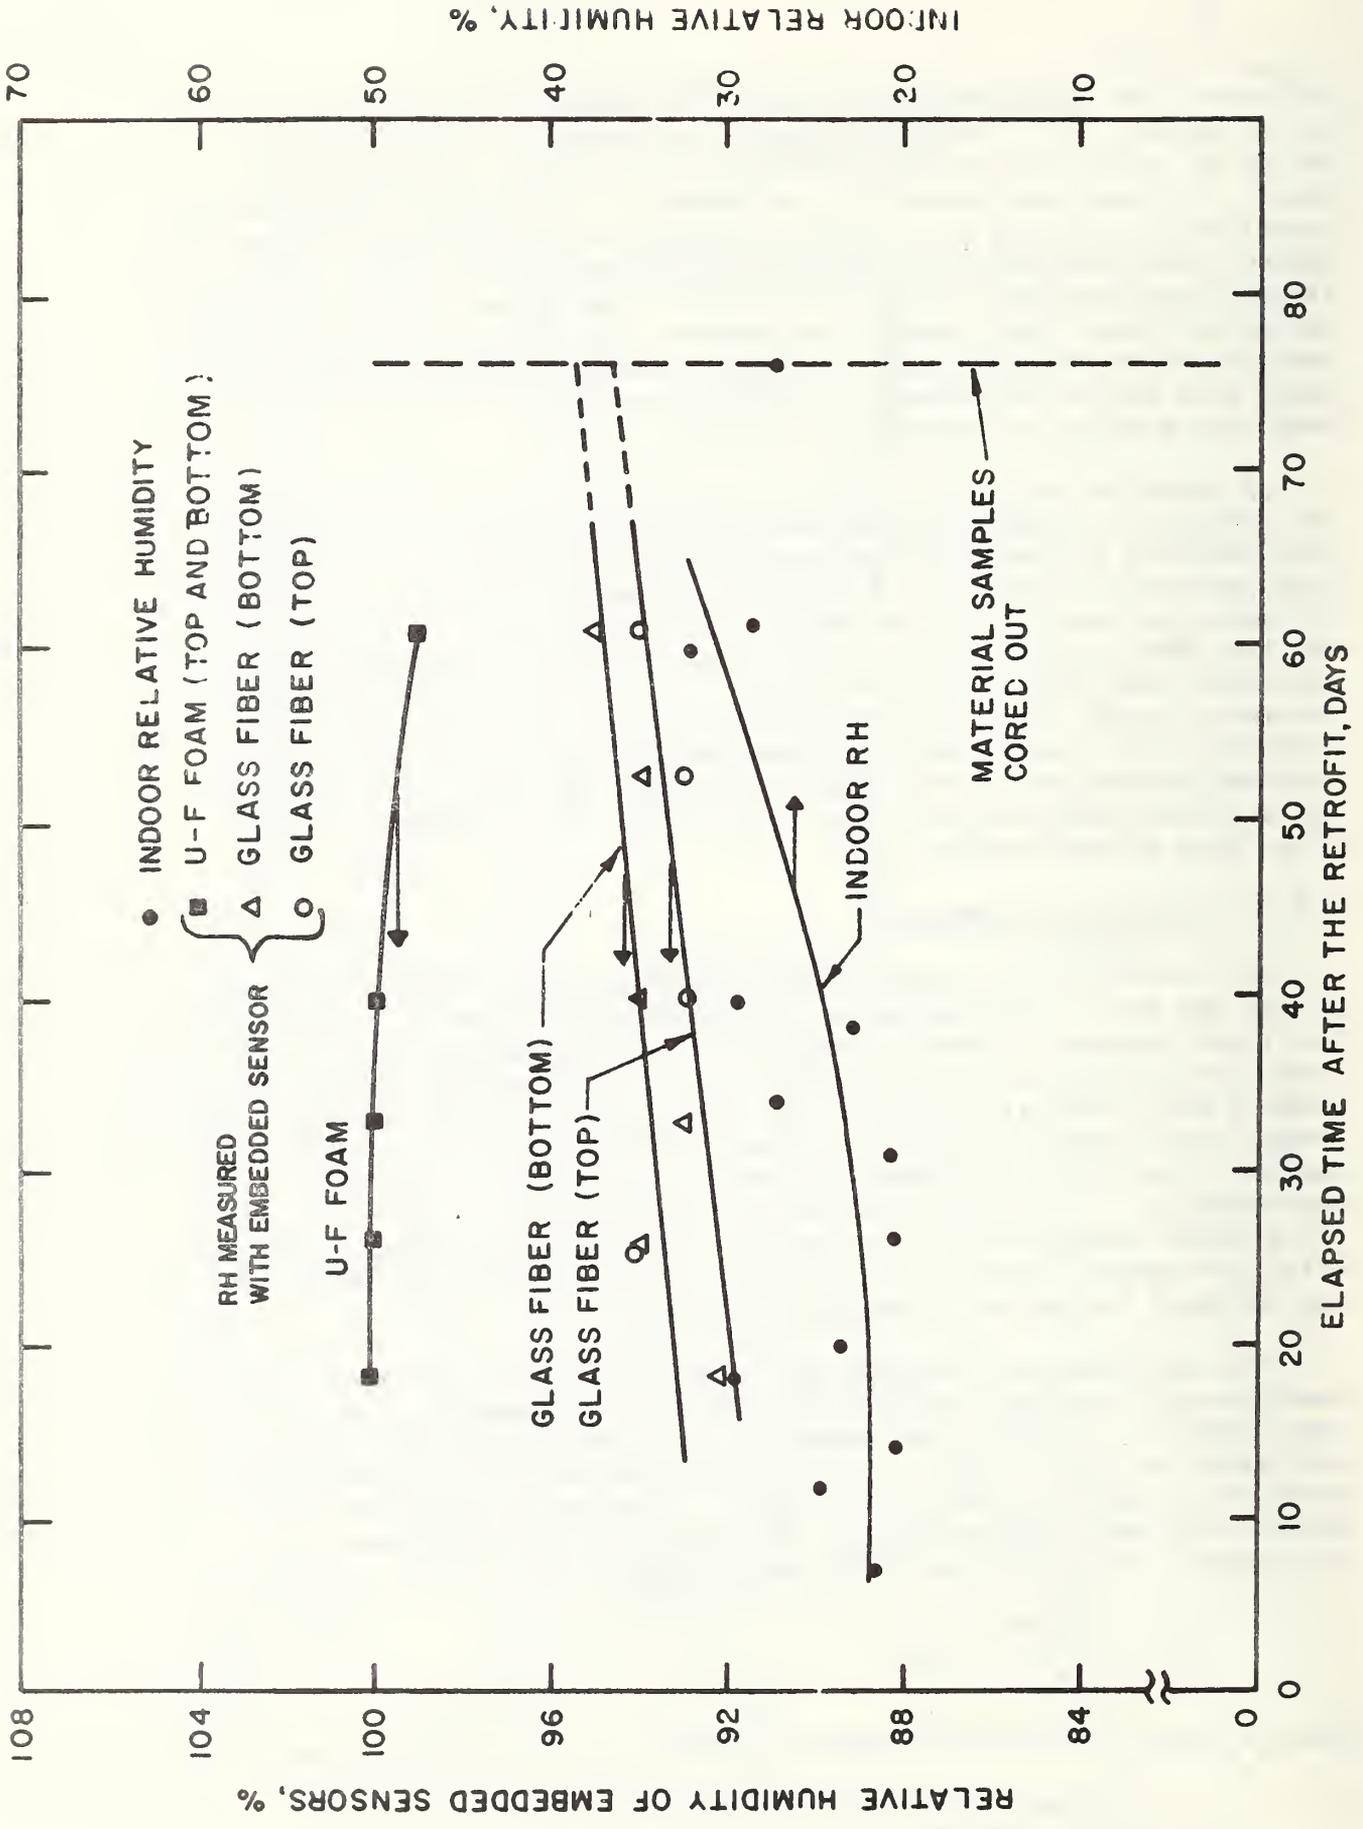
Figure 31. Variation of indoor relative humidity and relative humidities of embedded sensors.

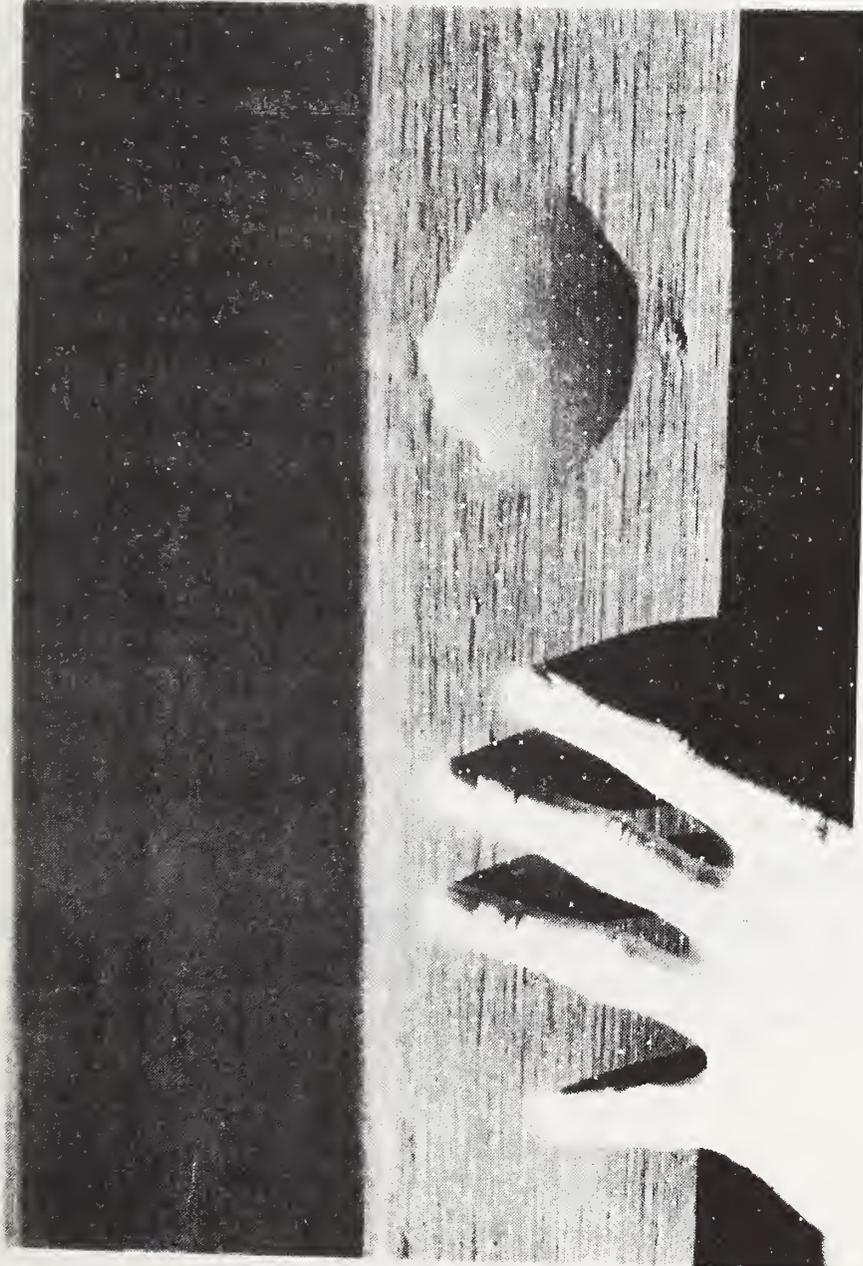
Figure 32. Water blister at exterior surface of U-F wall section.

The foregoing experimental results show that when U-F is blown into wood-frame cavity walls during the winter, the water originally contained in the foam will move outward into the wood siding and sheathing. When a vapor-impermeable paint system is applied to the exterior surface, this moisture may not be able to escape to the outdoor environment and

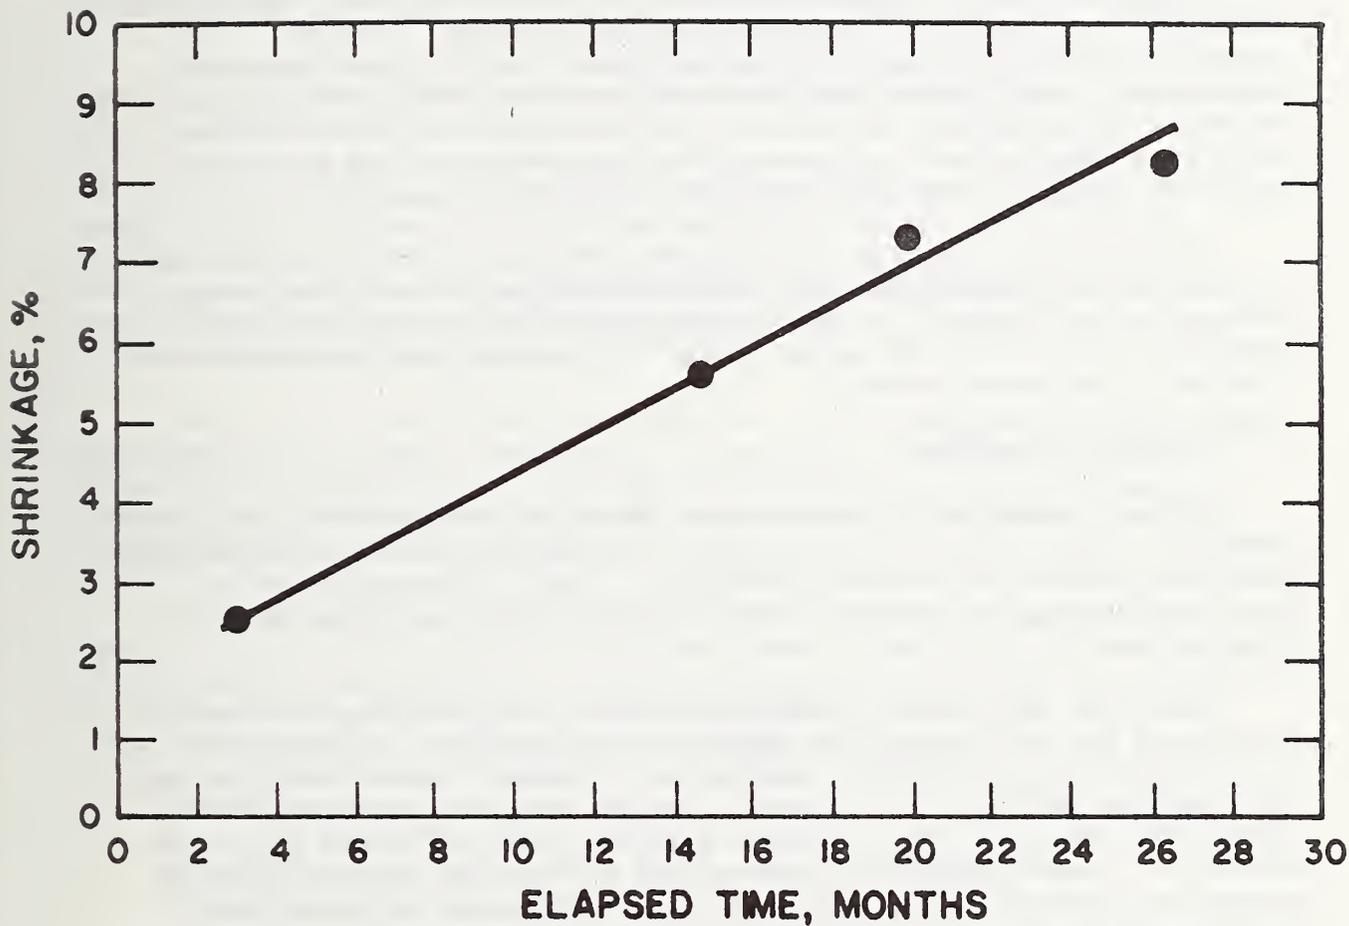
Figure 33. Percent linear shrinkage of urea-formaldehyde foam insulation as a function of elapsed time.

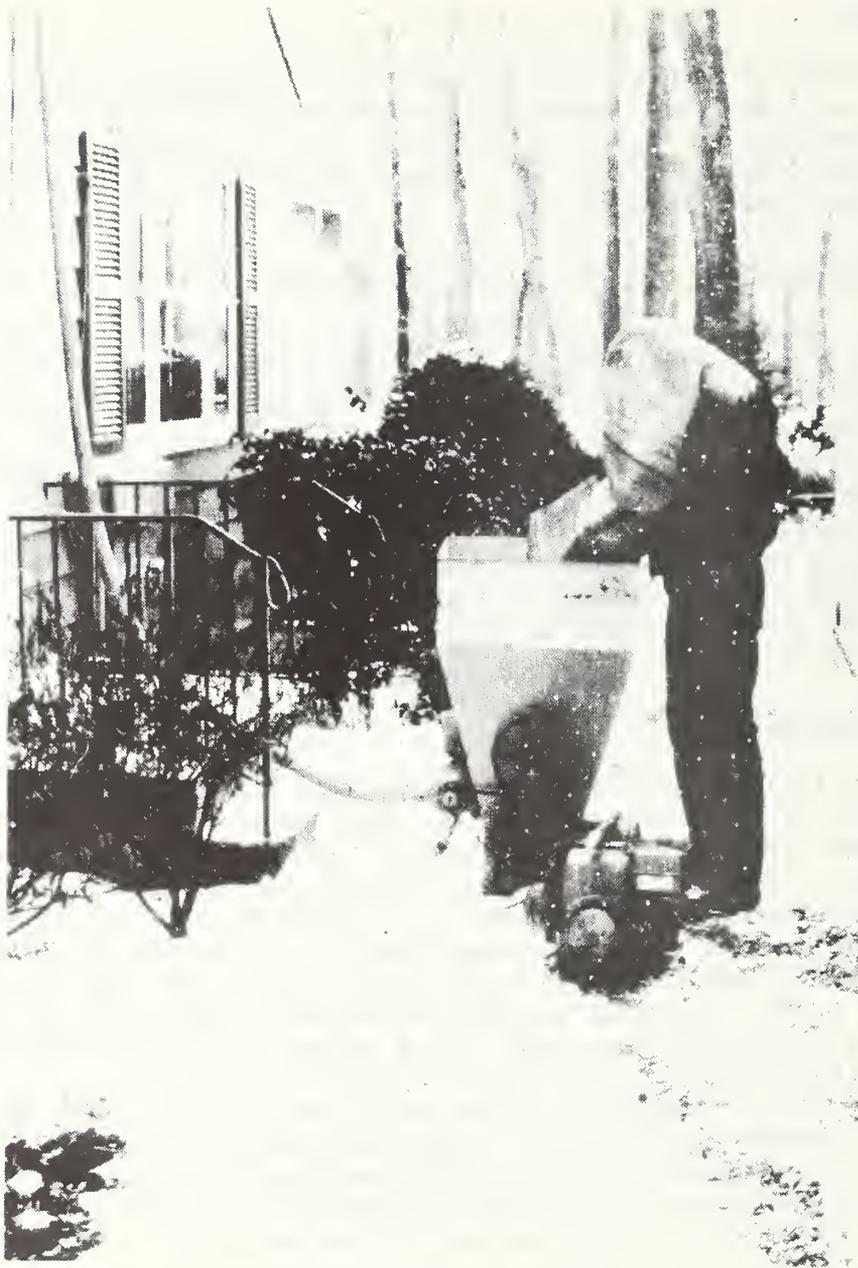
Figure A-1. Loose-fill cellulose insulation being poured into blowing machine.

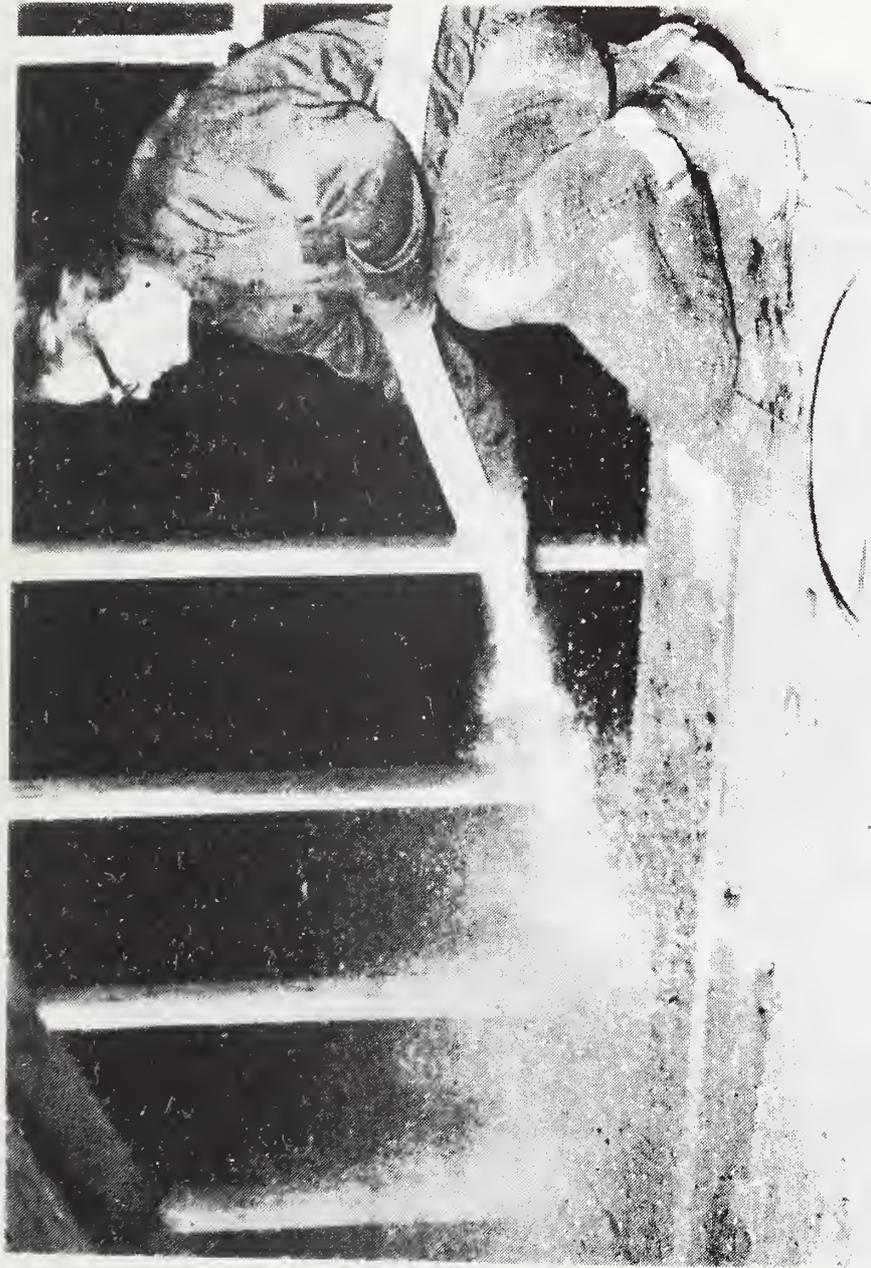
Figure A-2. Loose-fill cellulose being blown on top of the existing ceiling insulation.

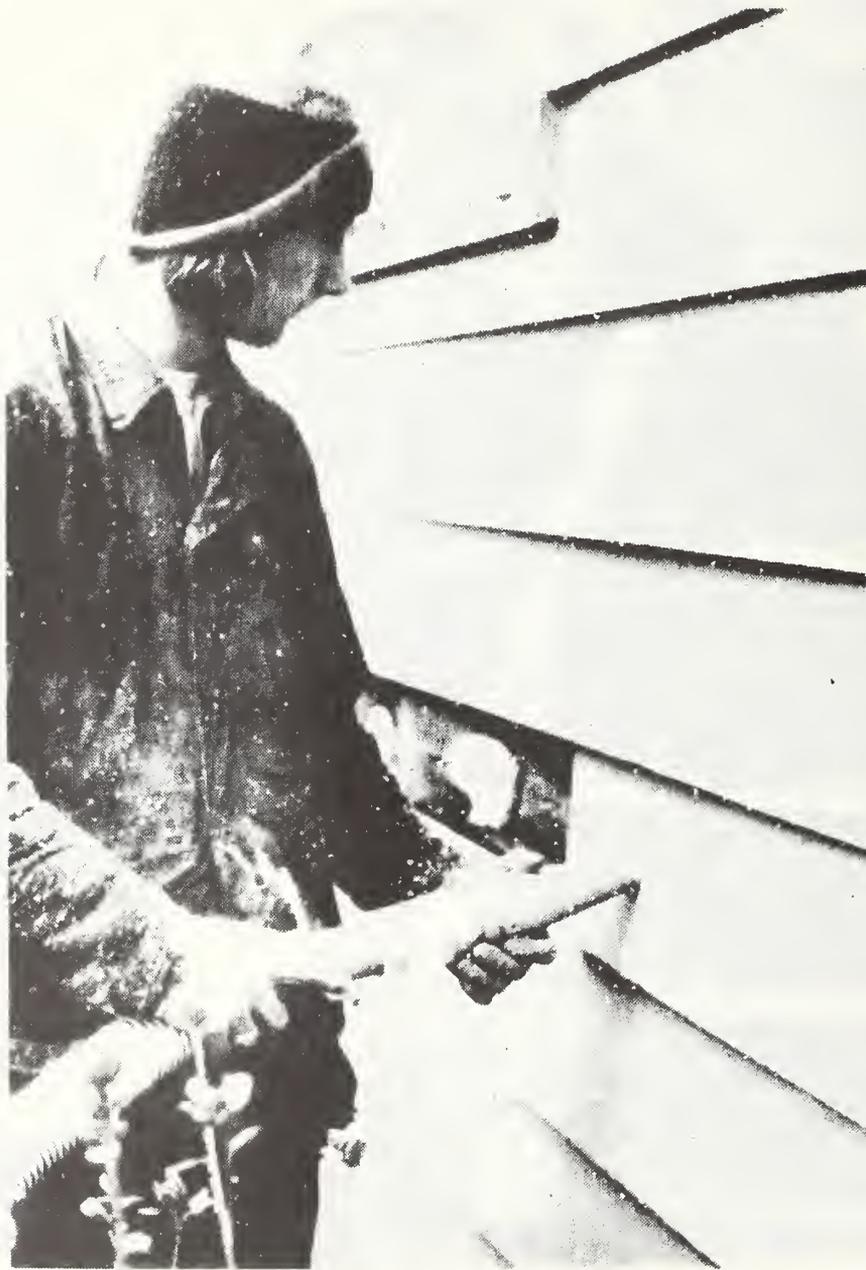
Figure A-3. Cellulosic fiber being blown into the walls of the test house.

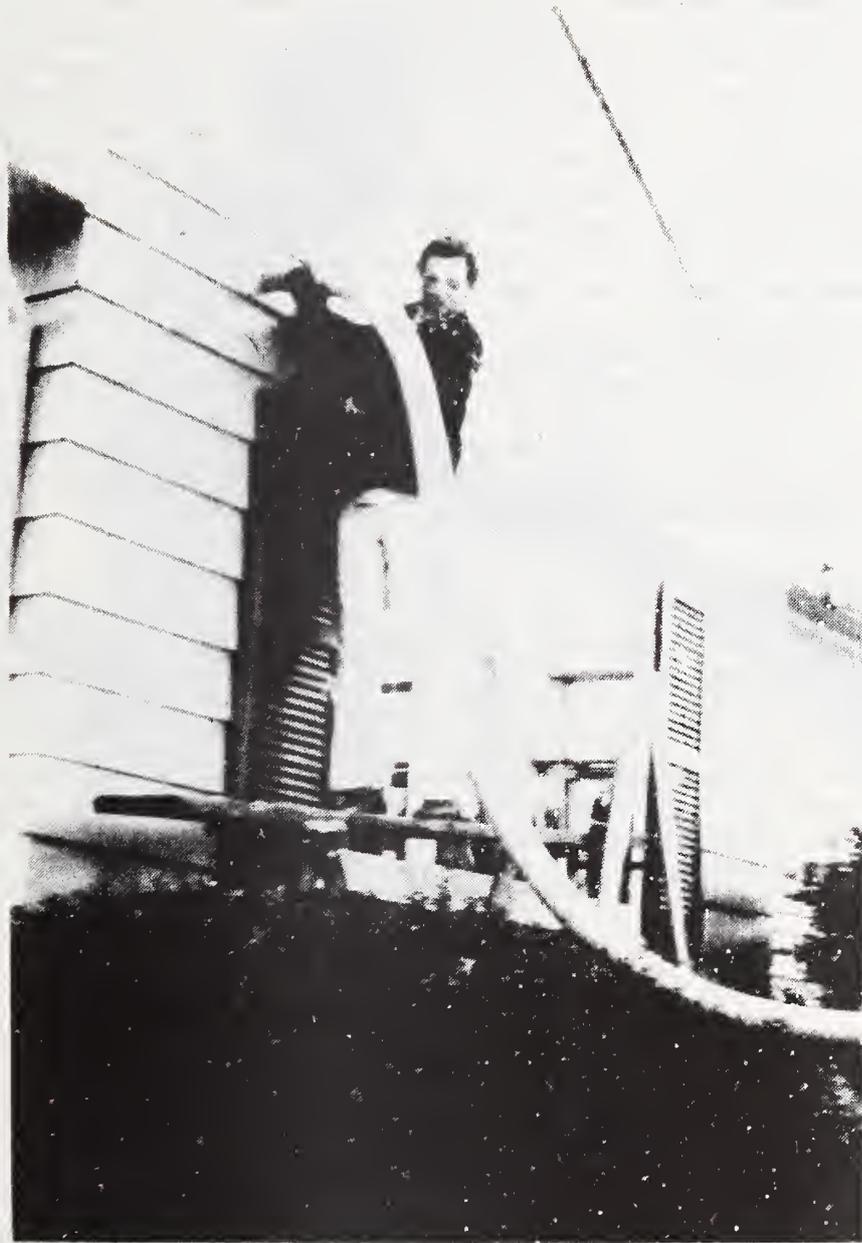
Figure A-4. Glass fiber being blown into a wall section.

Loose-fill glass-fiber insulation was blown into the north wall of the northeast bedroom. The application technique was to drill a 2-9/16 in (6.51-cm) hole through the siding and the sheathing at the bottom and top of each wall cavity. Insulating material was pumped through a 3-in (7.62-cm) diameter flexible hose into a 2-1/2 in (6.35 cm) nozzle which was inserted into the hole as shown in figure A-4. Blowing loose-fill

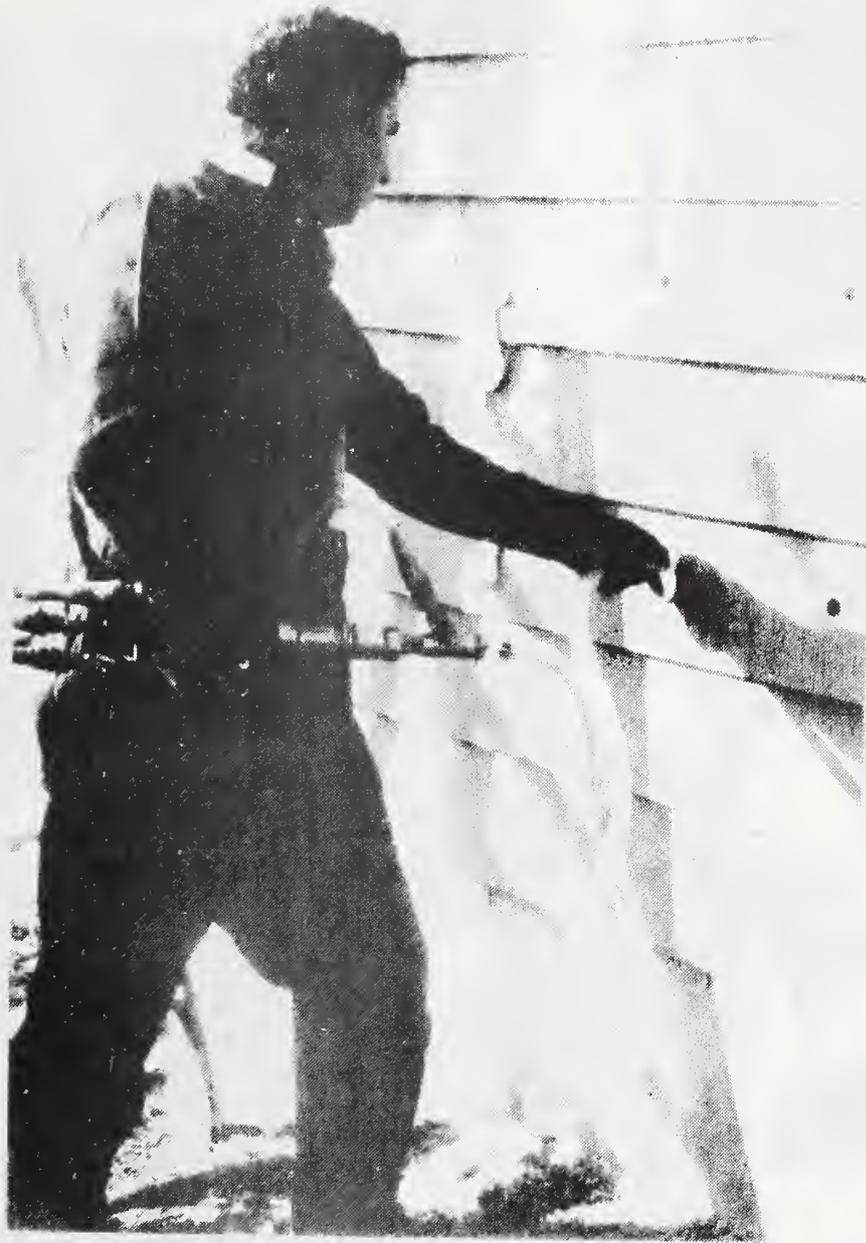
Figure A-5. Urea-formaldehyde foam being blown into a wall section.

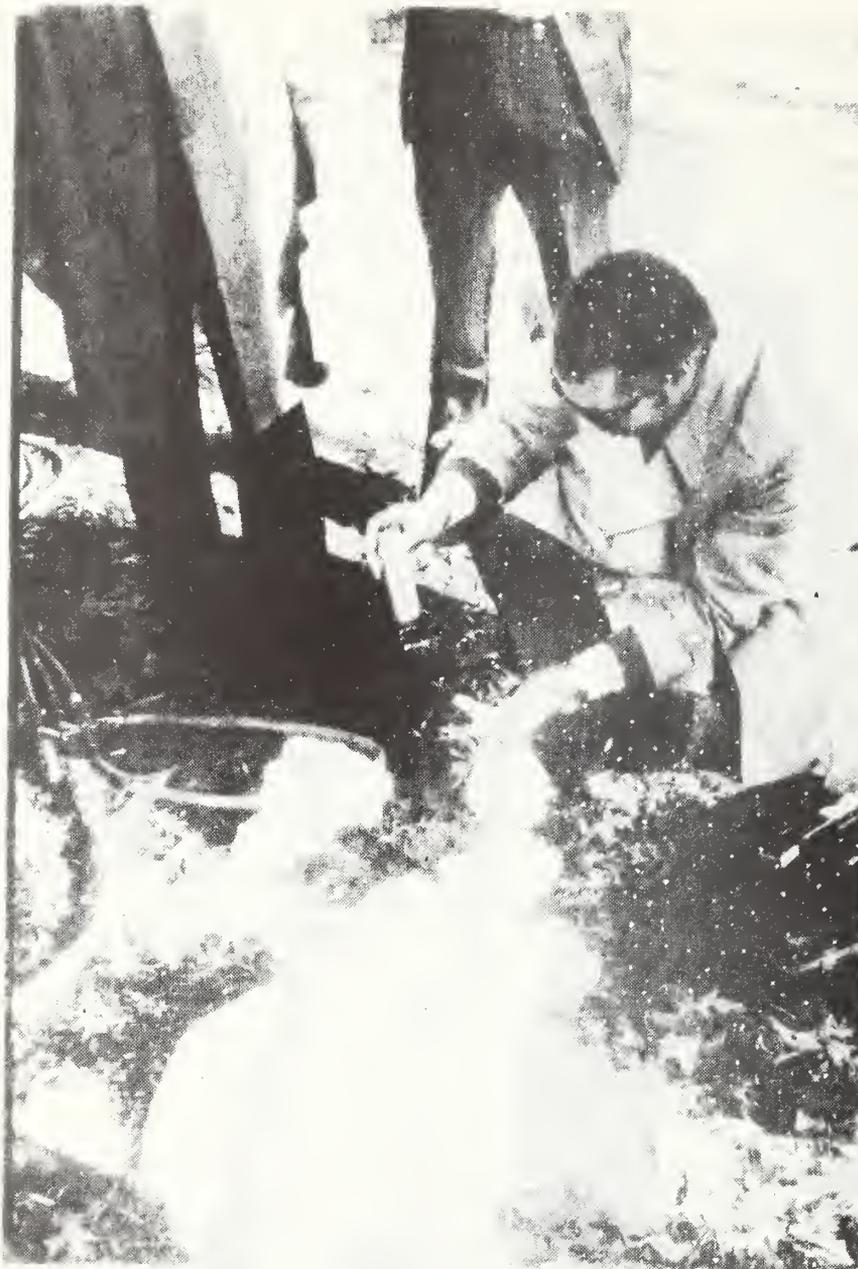
Figure A-6. Technical representative measuring wet density of the U-F foam.

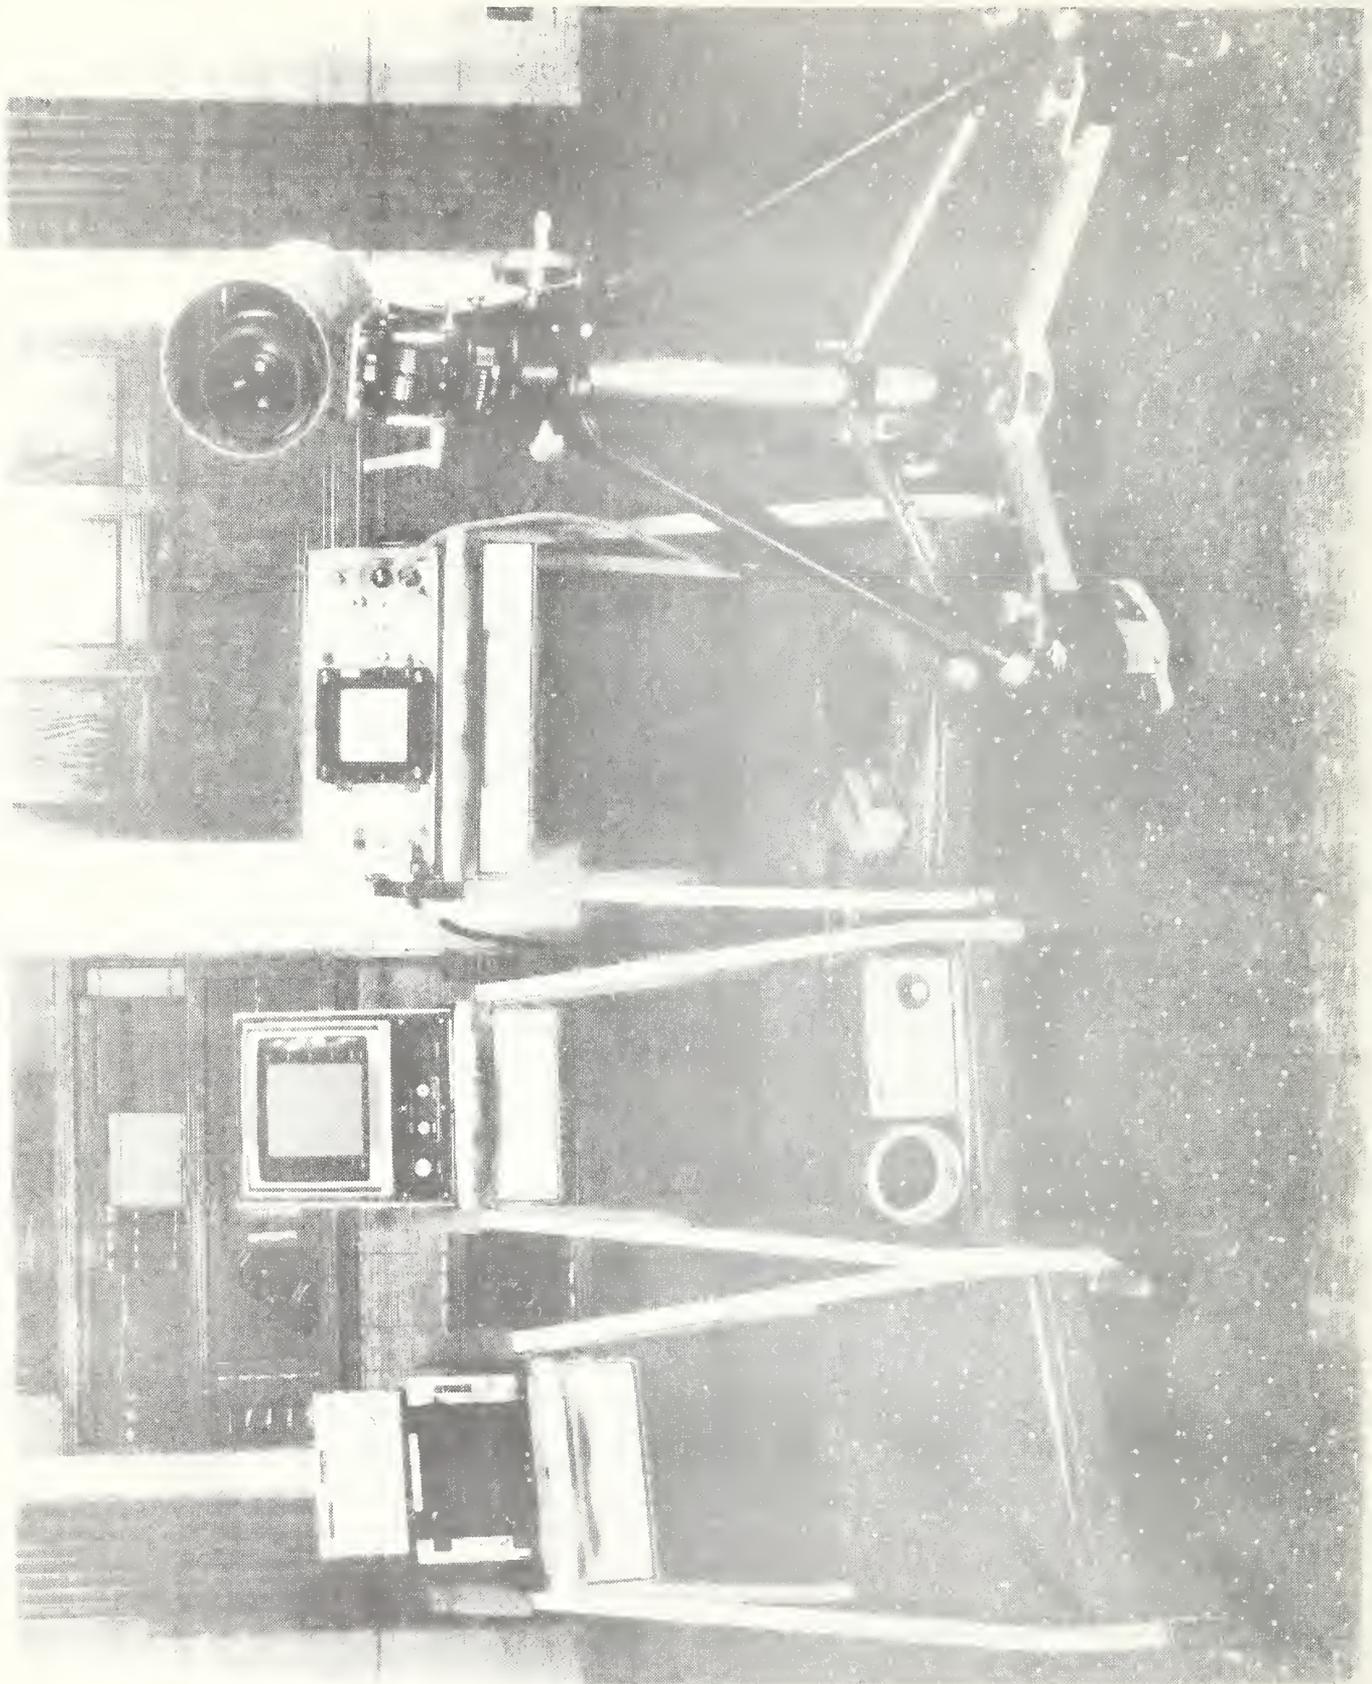
Figure B-1. Infrared television system.

The video signal from the IR camera is processed in the black-and-white television monitor where it is converted into a thermal picture in

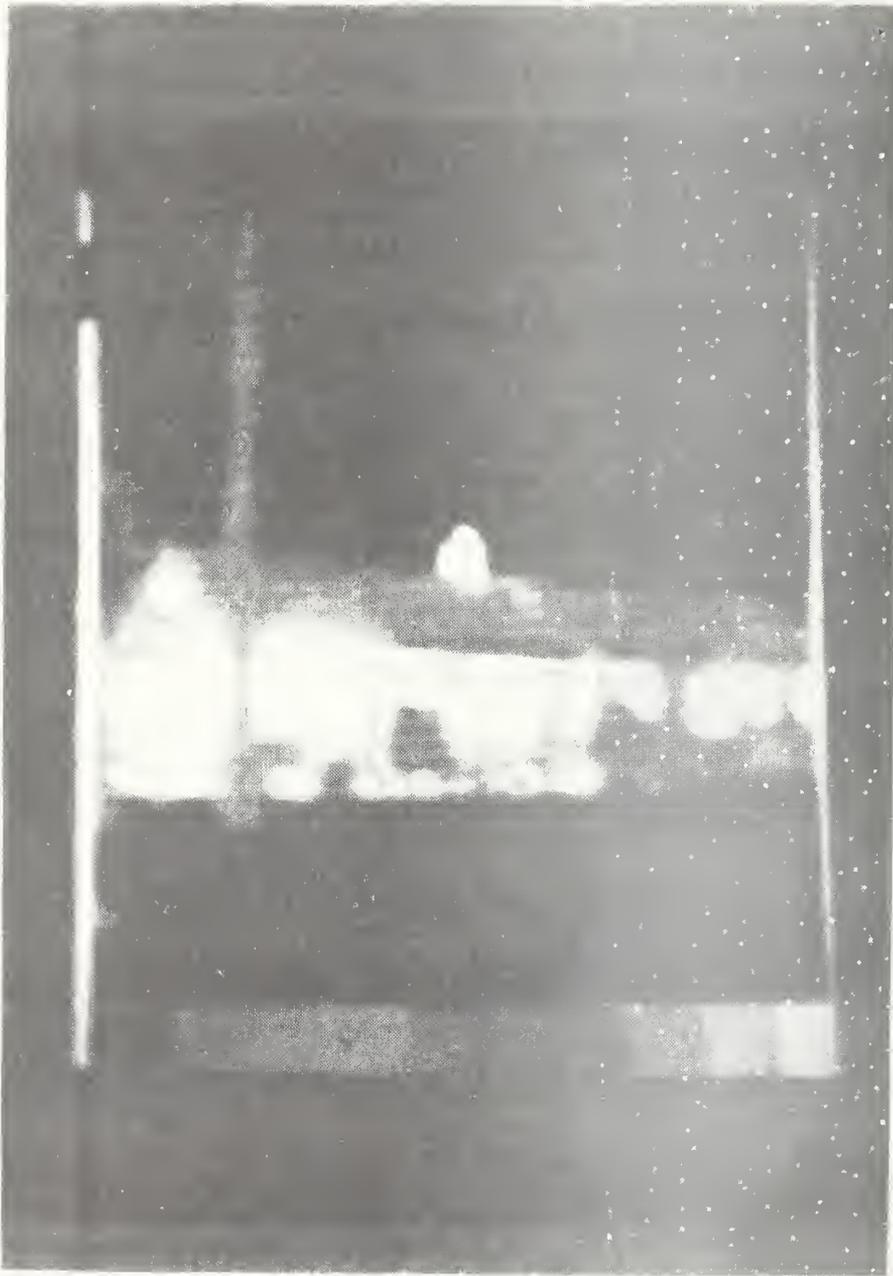
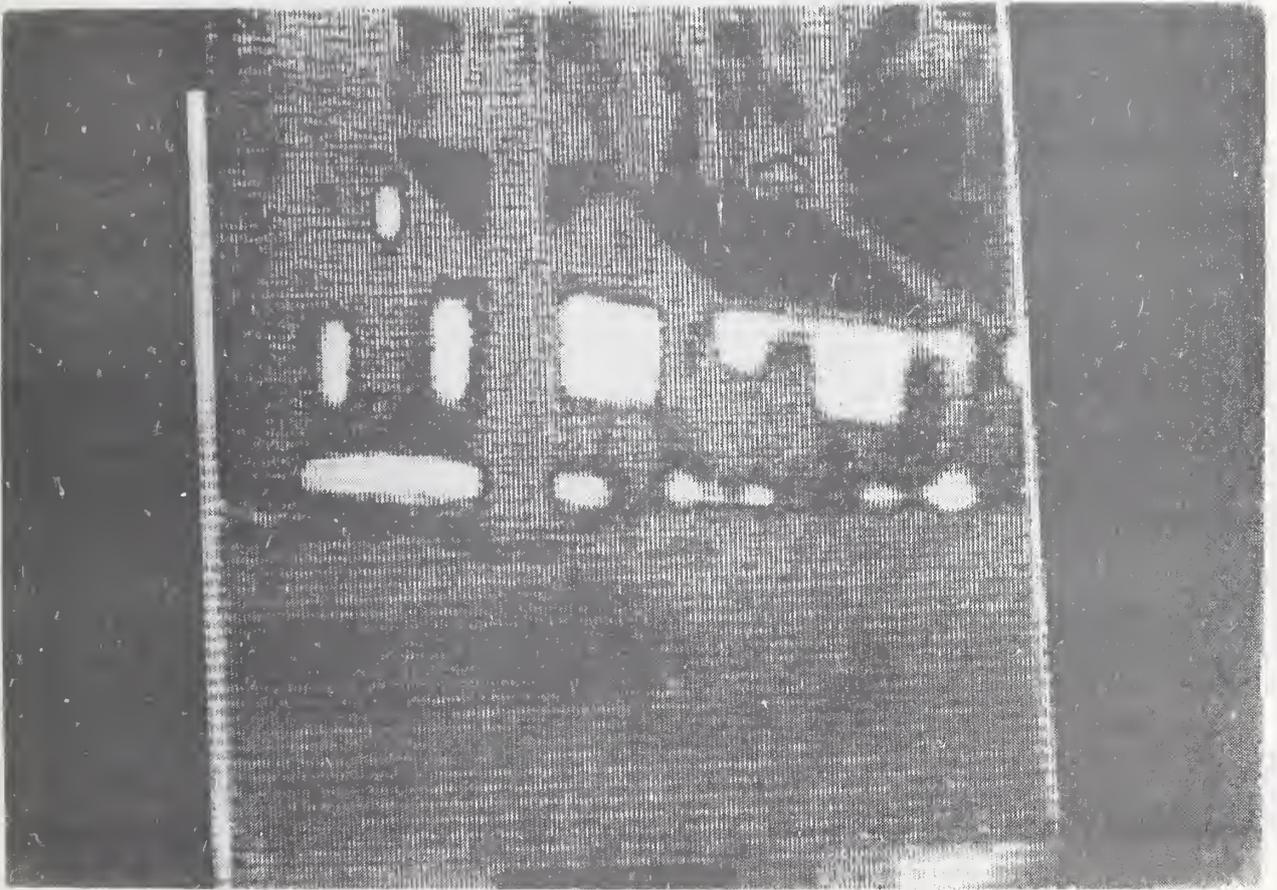
Figure B-2. Overall view of exterior surfaces of the test house.

(b) Thermogram before retrofit.

Figure B-2. Overall view of exterior surfaces of the test house.
(c) Thermogram after retrofit.
