Retrofitting an Existing Wood Frame Residence for Energy Conservation--an Experimental Study

D. M. Burch
C. M. Hunt

Thermal Engineering Section
Center for Building Technology
Institute for Applied Technology
National Bureau of Standards
Washington, D.C. 20234

July 1977

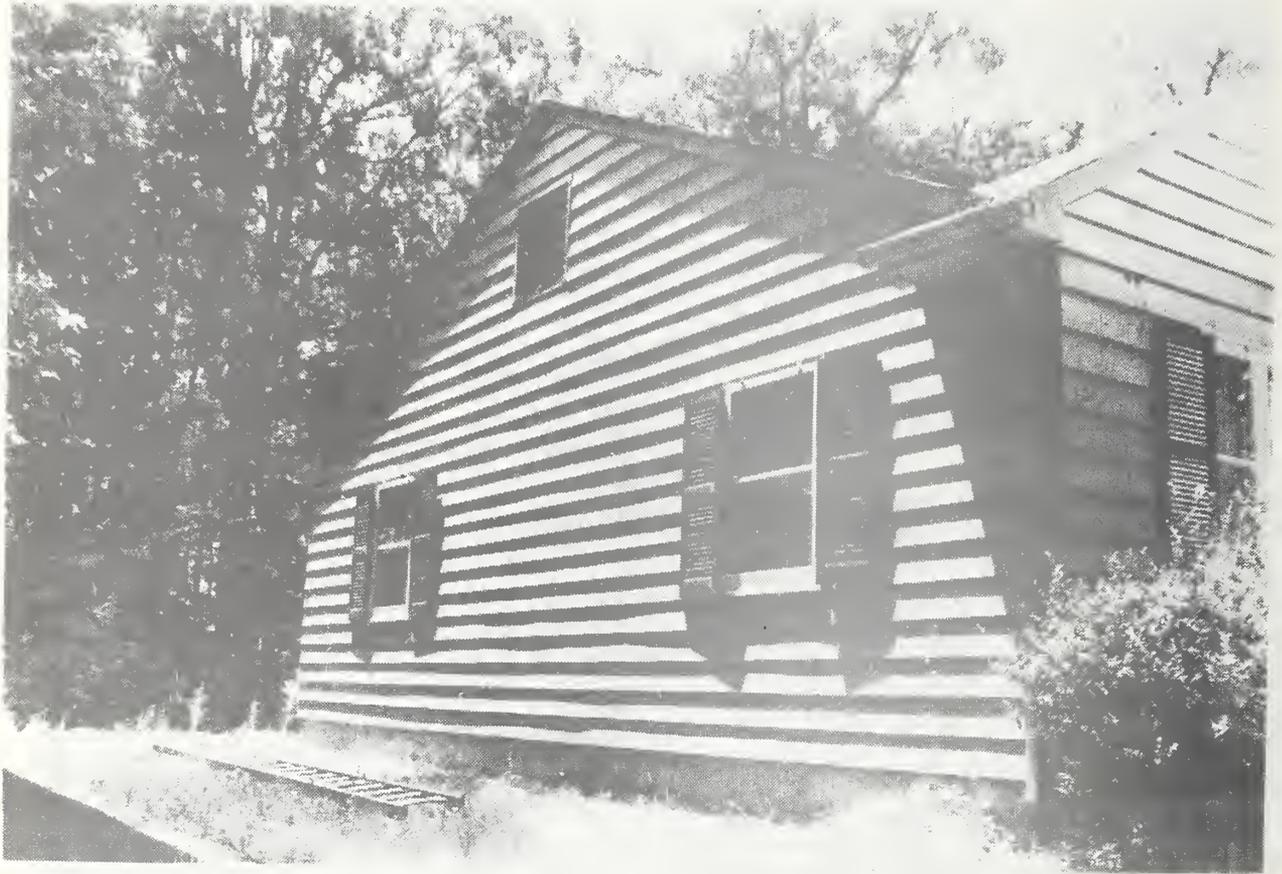
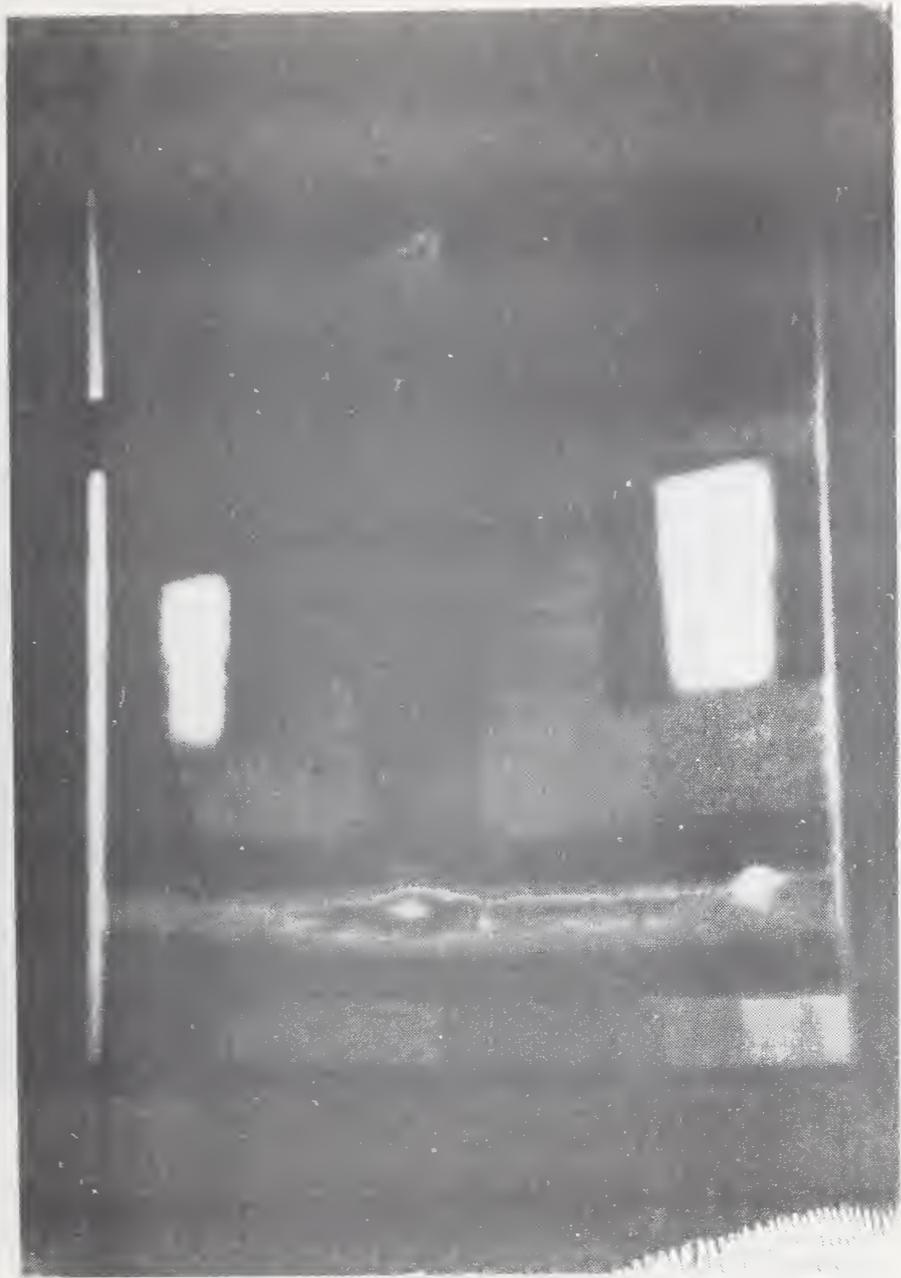
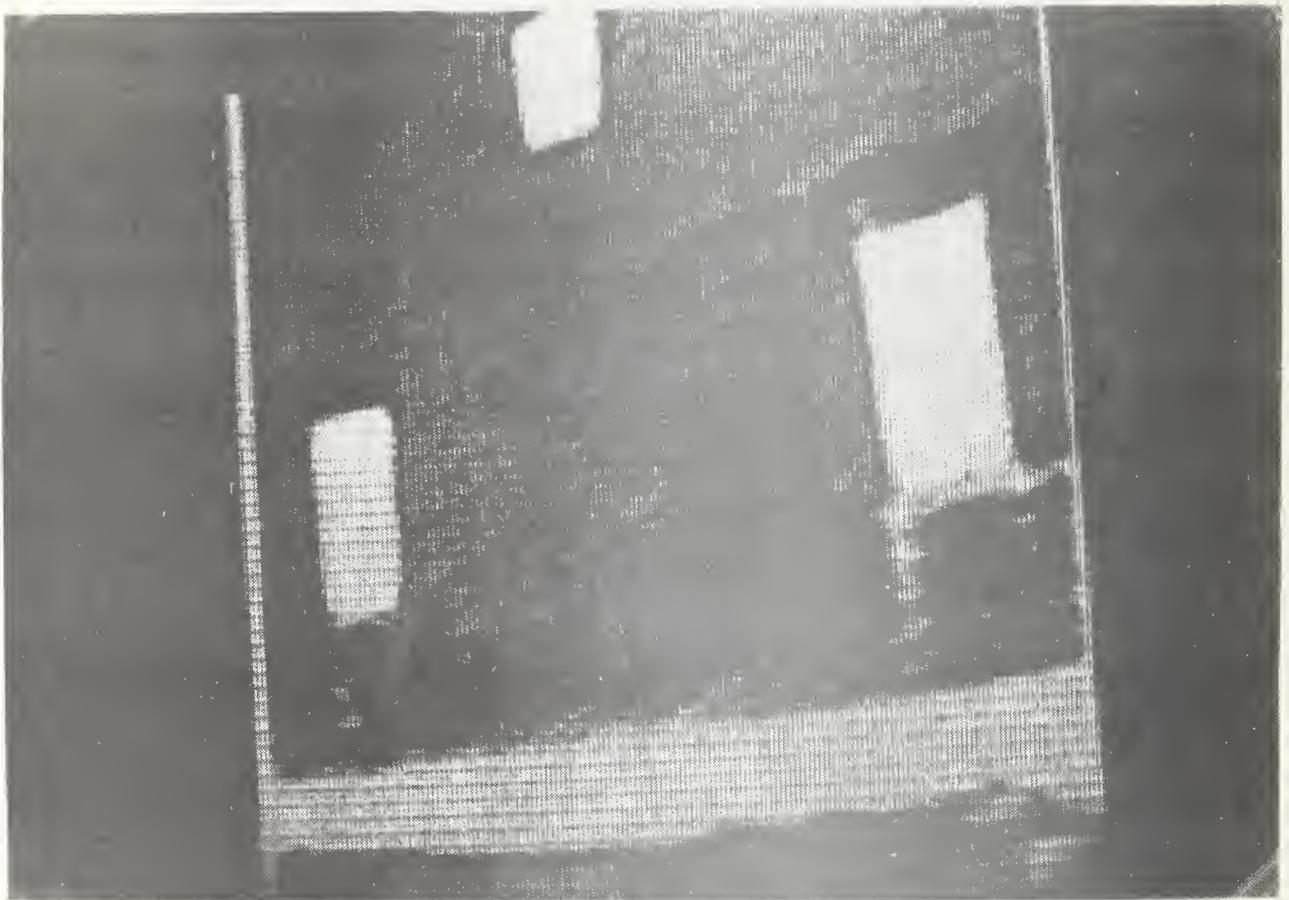
Figure B-3. East end of test house.

(a) Conventional photograph.

(b) Thermogram before retrofit.

Thermographic surveys of the east end of the test house before and after the retrofit are presented in figures B-3a, b, c. In the post-retrofit thermogram the contrast (temperature difference) between the left and right parts of the wall section is due to the difference in the heat loss characteristics of wall sections insulated with different insulating materials. The wall section on the left is insulated with loose-fill cellulose, whereas the wall section on the right is insulated with urea-formaldehyde foam. It can be seen that the cellulose wall section is approximately two color-coded isotherm units colder than the U-F wall section. The lower outside surface temperature of the cellulose wall section clearly demonstrates that, at the time this particular thermogram was taken, the insulating properties of the cellulose material were better than those of the urea-formaldehyde foam. It should be pointed out that the post-retrofit thermogram was taken only 17 days after the U-F foam was installed, when the U-F material still contained significant residual moisture which may have considerably reduced its insulating properties. The embedded relative humidity transducer mounted inside the wall between the U-F foam and the sheathing showed a saturated condition at the time this infrared picture was taken. The rectangularly shaped dark region between the windows on the pre-retrofit thermogram is a closet. Since the interior of the closet is an unheated space, less heat is lost through the exterior wall where the closet is located, resulting in lower exterior surface temperatures at this location. Note, however, after insulation is added to the walls, it is no longer possible to distinguish the closet in the thermogram. This suggests that for thermograms taken at an inside-to-outside temperature difference

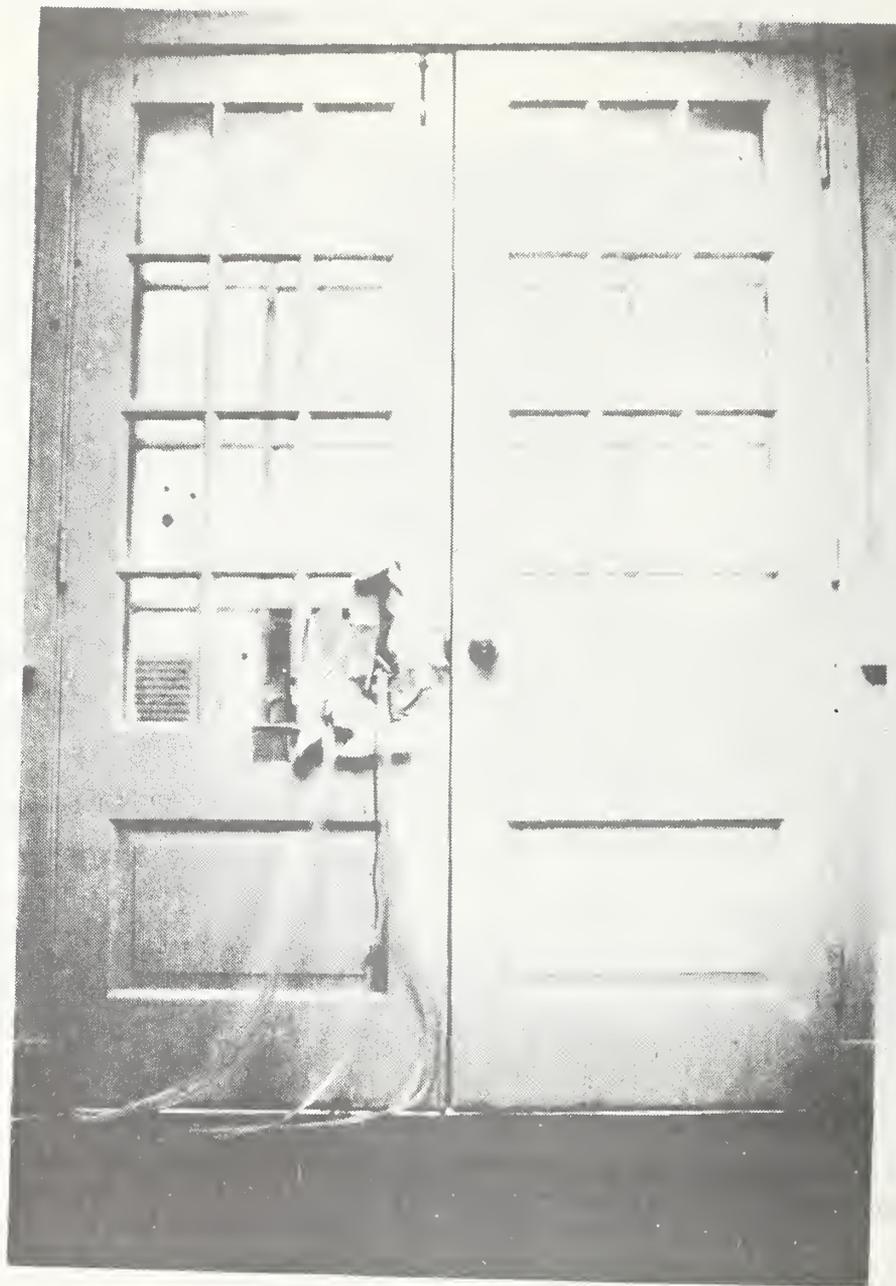
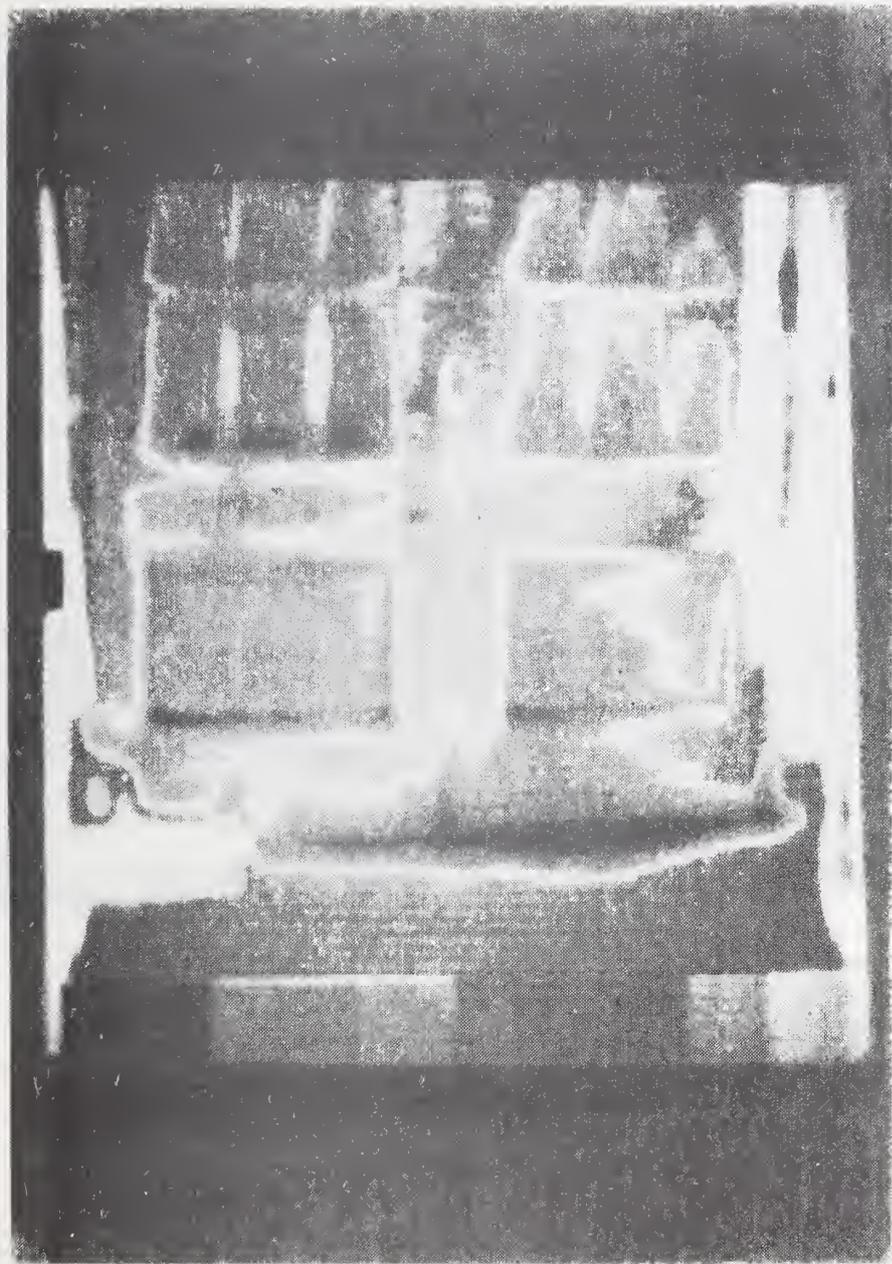
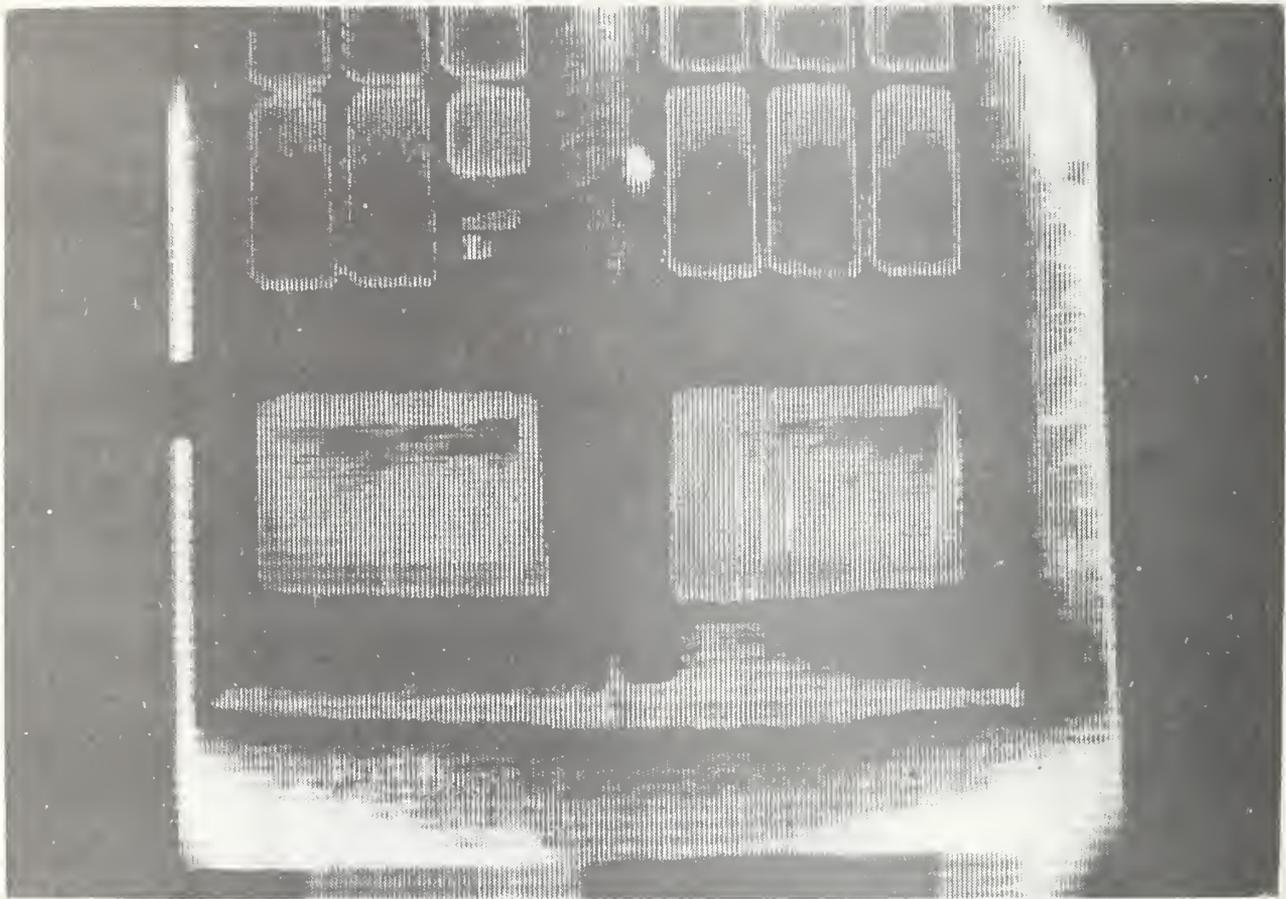
Figure B-4. Interior surface of dining room door.

(a) Conventional photograph.

(b) Thermogram after retrofit.

(c) Thermogram after retrofit.

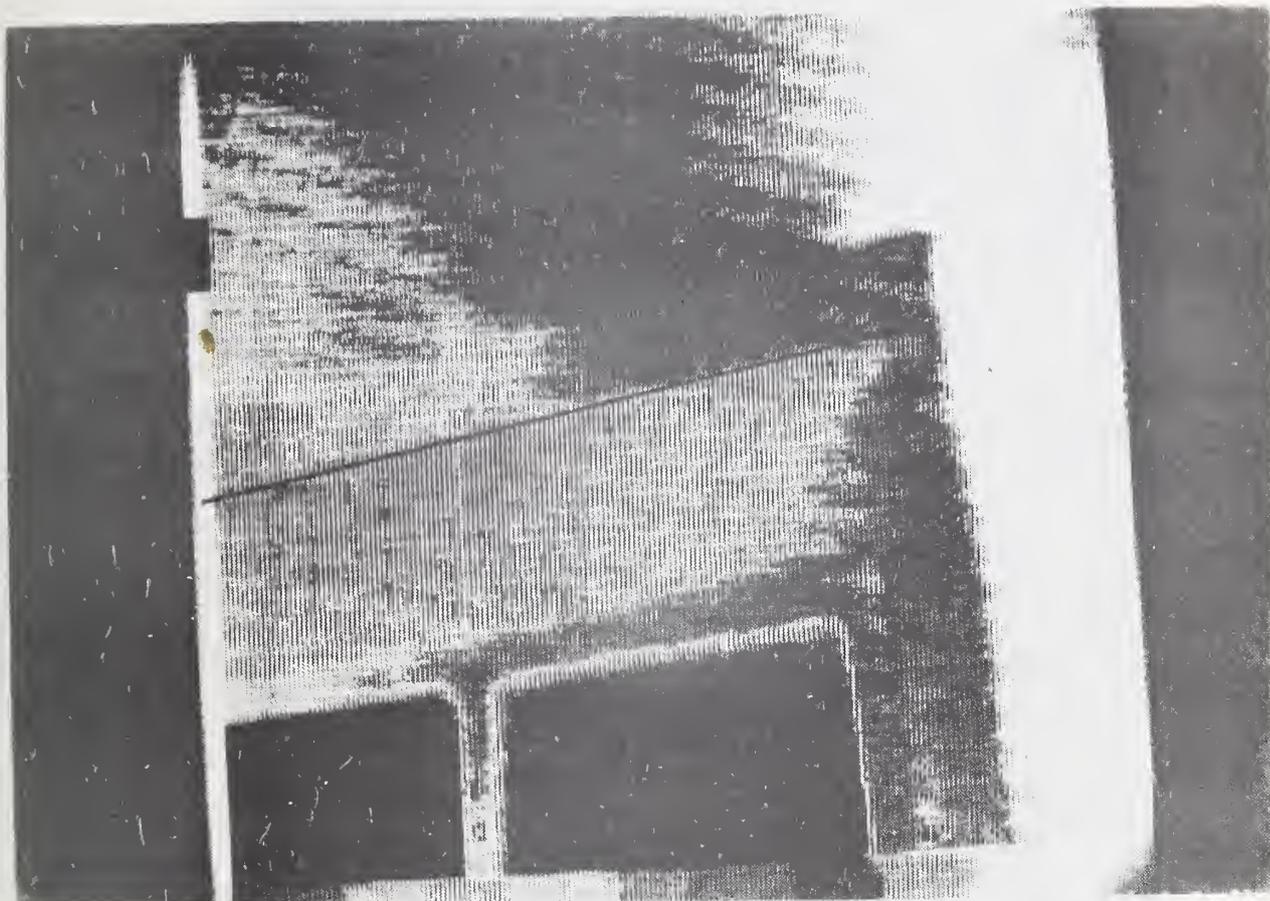
Figure B-5. Interior view of ceiling-wall interface above the bay window in living room.

(a) Conventional photograph.

(b) Thermogram before retrofit.

(c) Thermogram after retrofit.

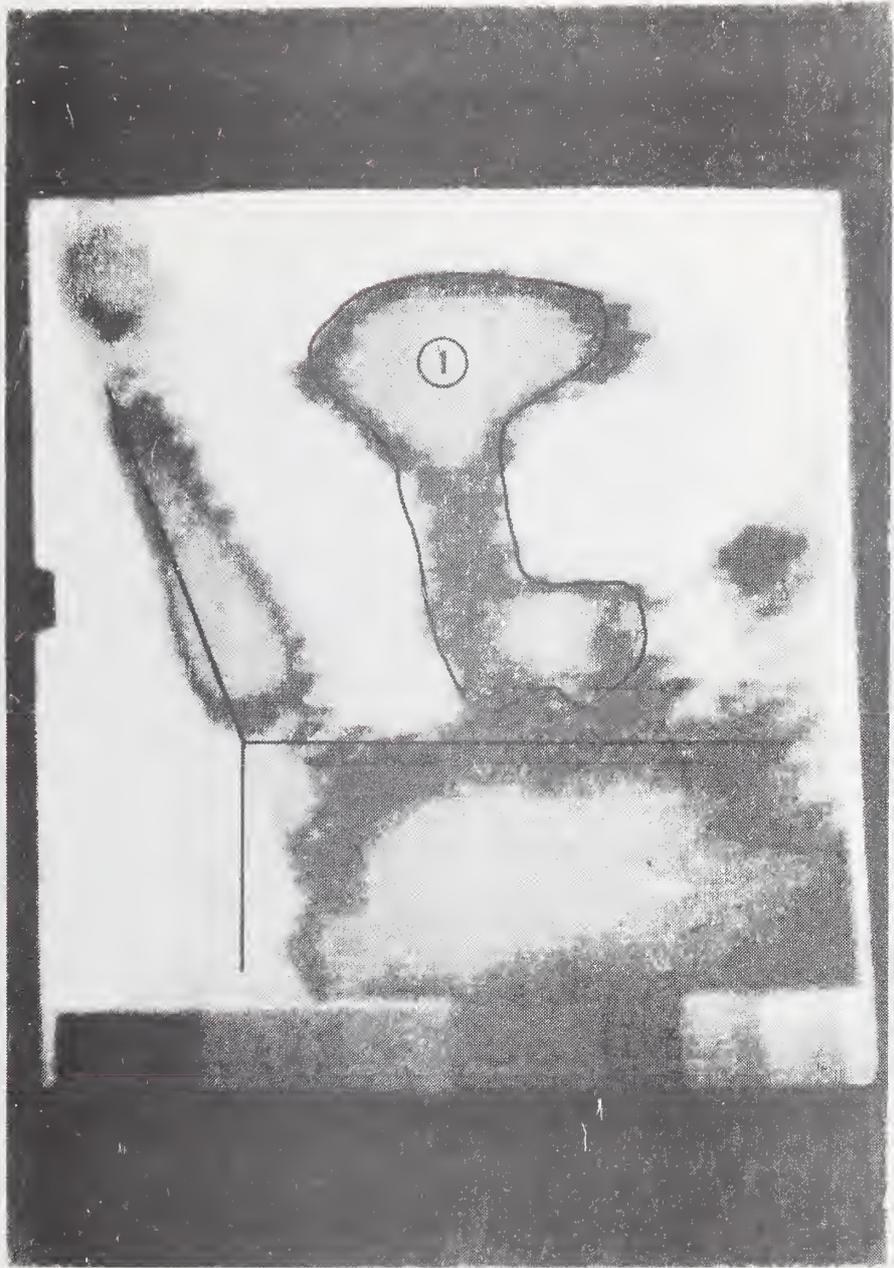
Figure B-6. Interior view of upper corner of northeast bedroom.

(a) Conventional photograph.

(b) Thermogram before retrofit.

Figures B-6a, b, and c are a thermographic survey of an upper corner of the northeast bedroom. A dark line has been superimposed on these photographs to assist in identifying the interface of various surfaces of the room. The red and pink regions (region 1) shown in the pre-retrofit thermogram (figure B-6b) are cold spots on the ceiling due to compressed glass-fiber ceiling insulation. When blanket insulation is compressed, it loses some of its insulating properties and allows

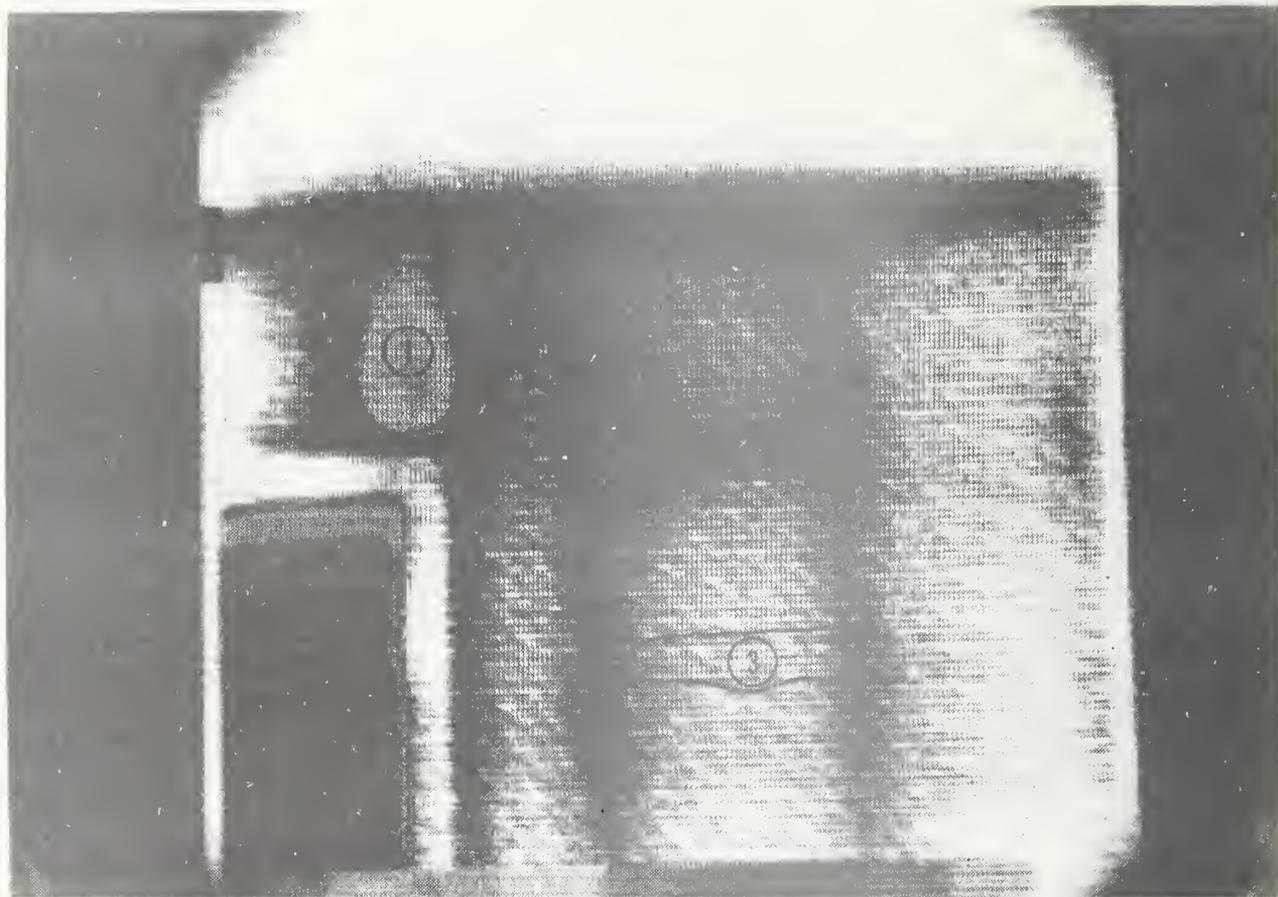
Figure B-7. Winter thermogram of inside surface of U-F wall section.

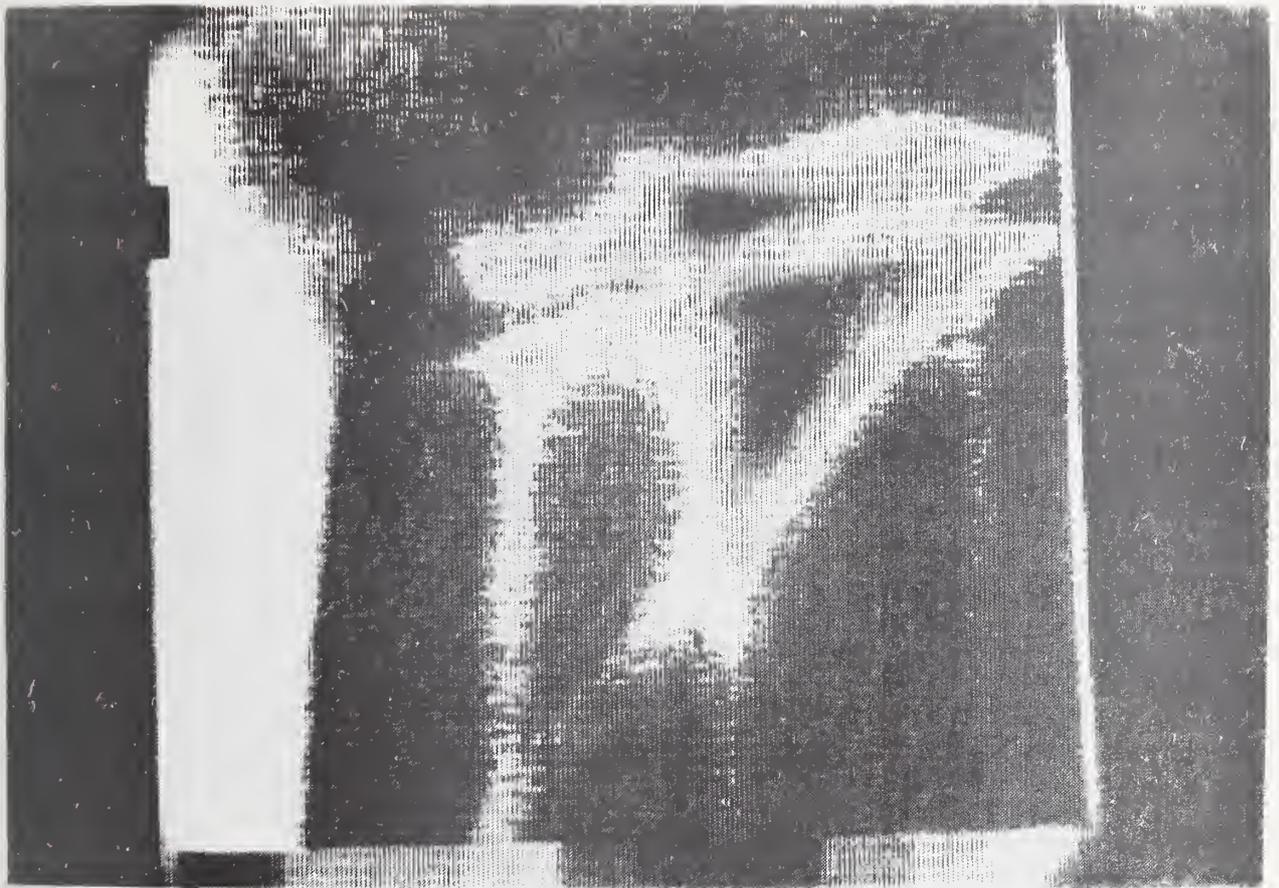
Figure B-8. Winter thermogram of inside surface of cellulose wall section in dining room.

In the thermograms of inside surfaces shown in figures B-8 through B-10, it can be seen that wall studs can be distinguished in the thermal picture. In the pre-retrofit thermographic survey, it was difficult to see wall studs for inside-to-outside temperature differences at approximately 40° F (22.7° C). Thus, the ability to see wall studs in thermograms of inside wall surfaces of a wood-frame house may be used to distinguish between insulated and uninsulated wood-frame cavity walls.

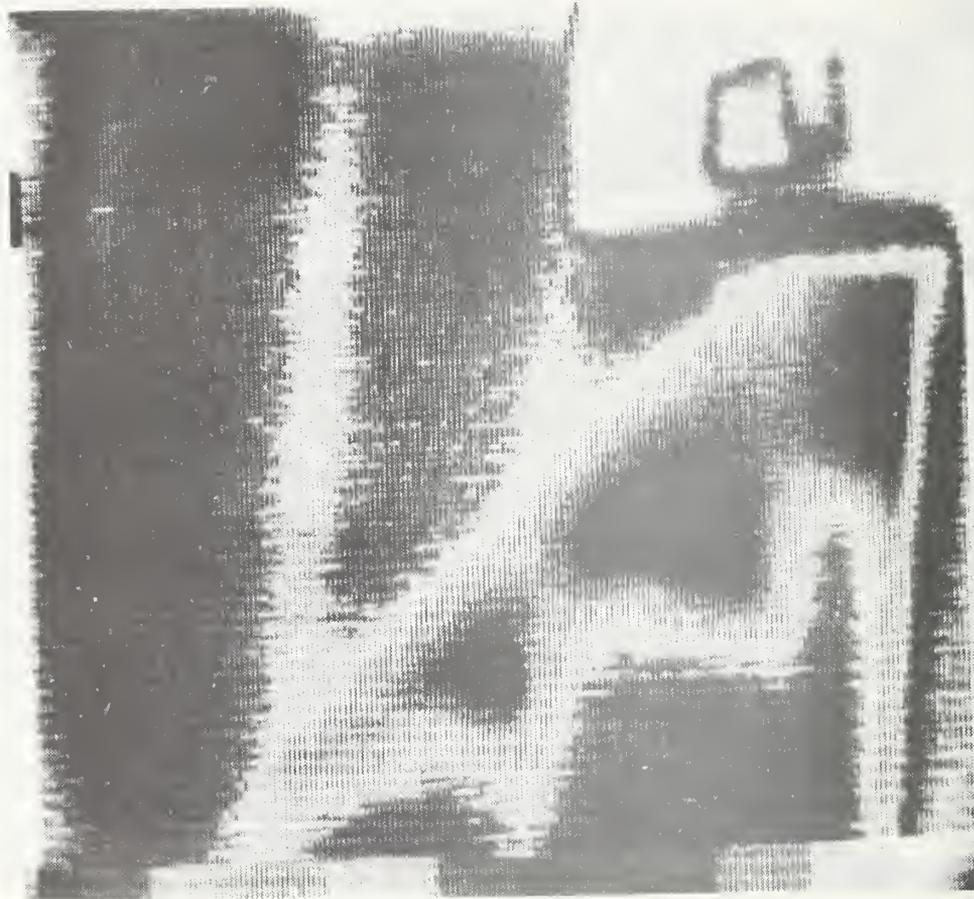
Figure B-9. Winter thermogram of inside surface of cellulose wall section in southeast bedroom.

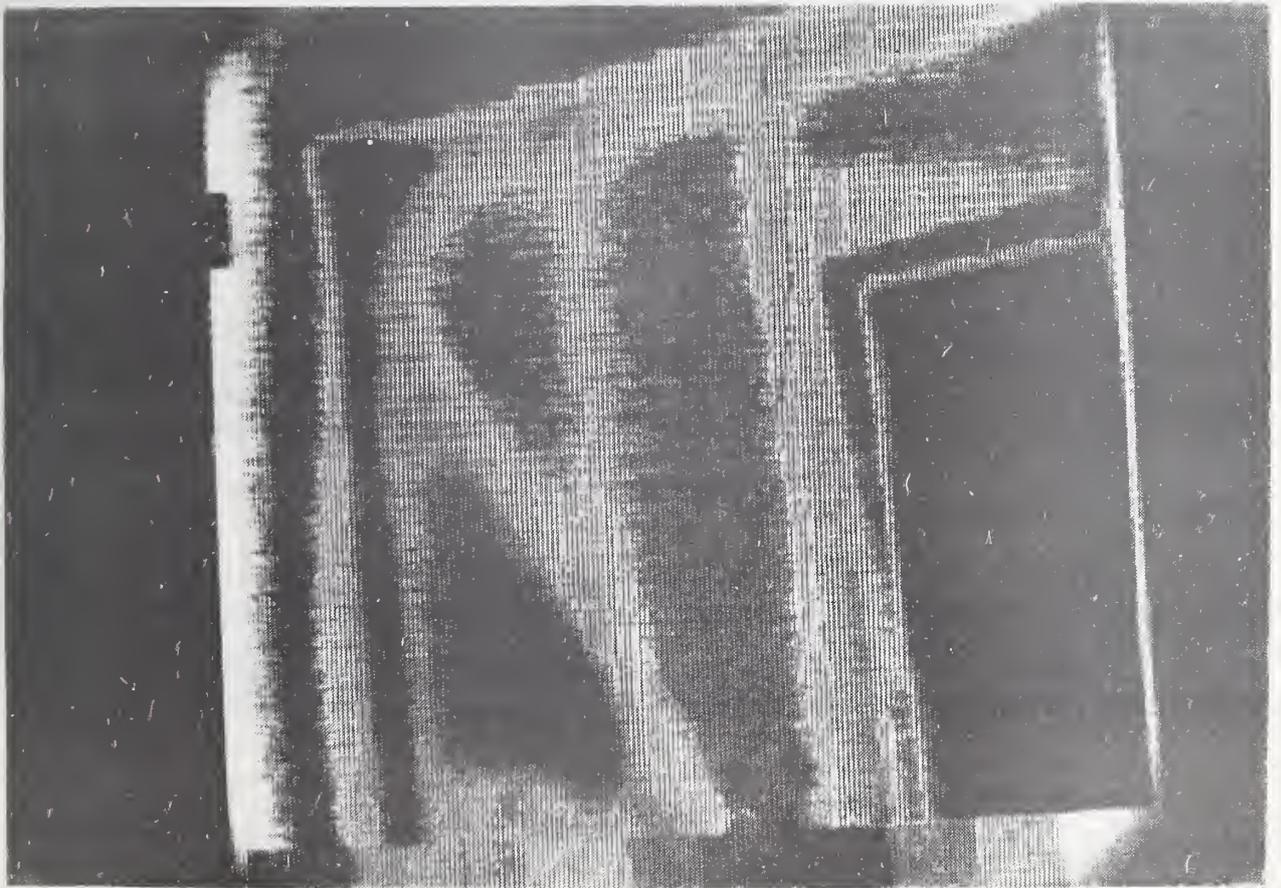
Figure B-10. Winter thermogram of inside surface of glass-fiber wall section in northeast bedroom.

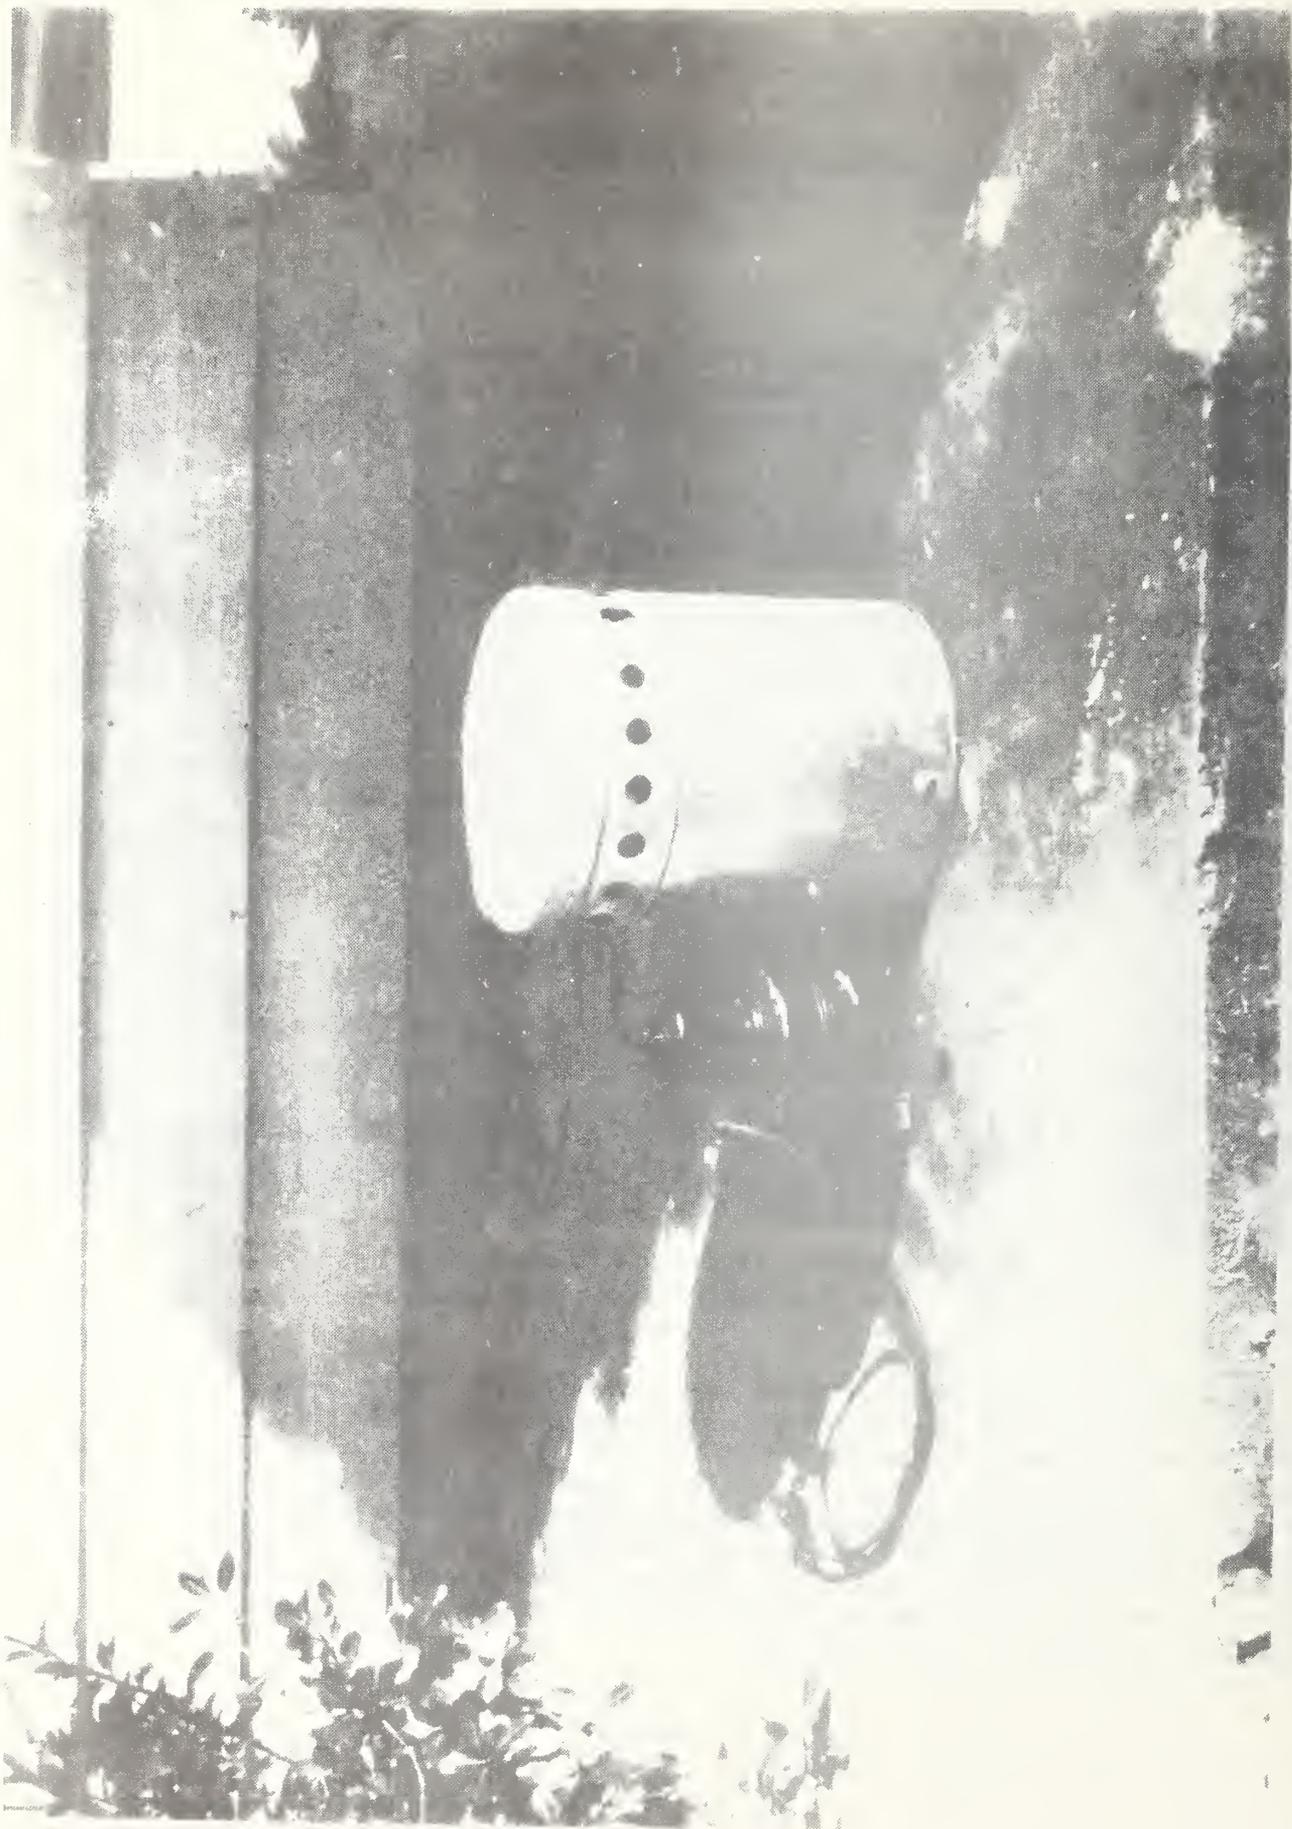
Figure C-1. Drum-type smoke distributor.

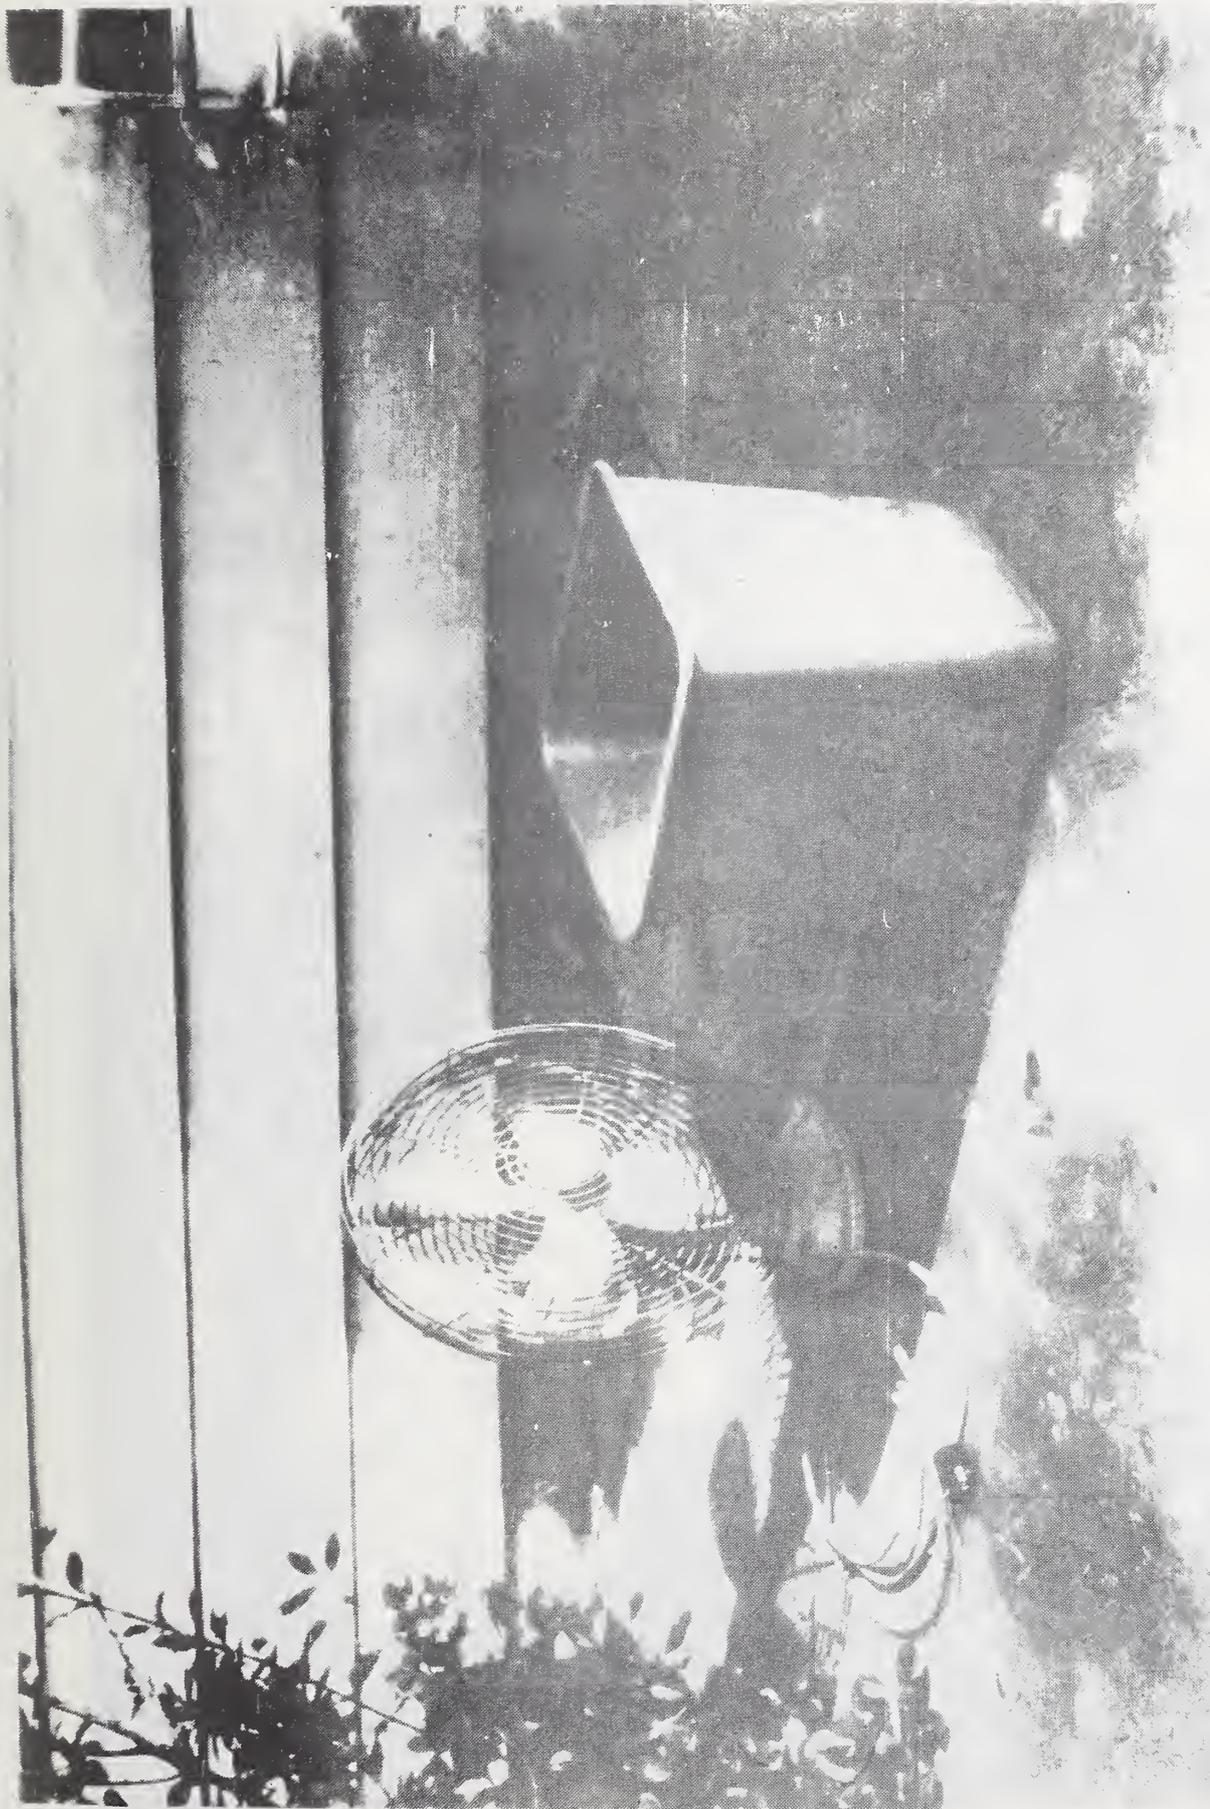
Figure C-2. Fan and metal trash basket used to distribute white pyrotechnic smoke.

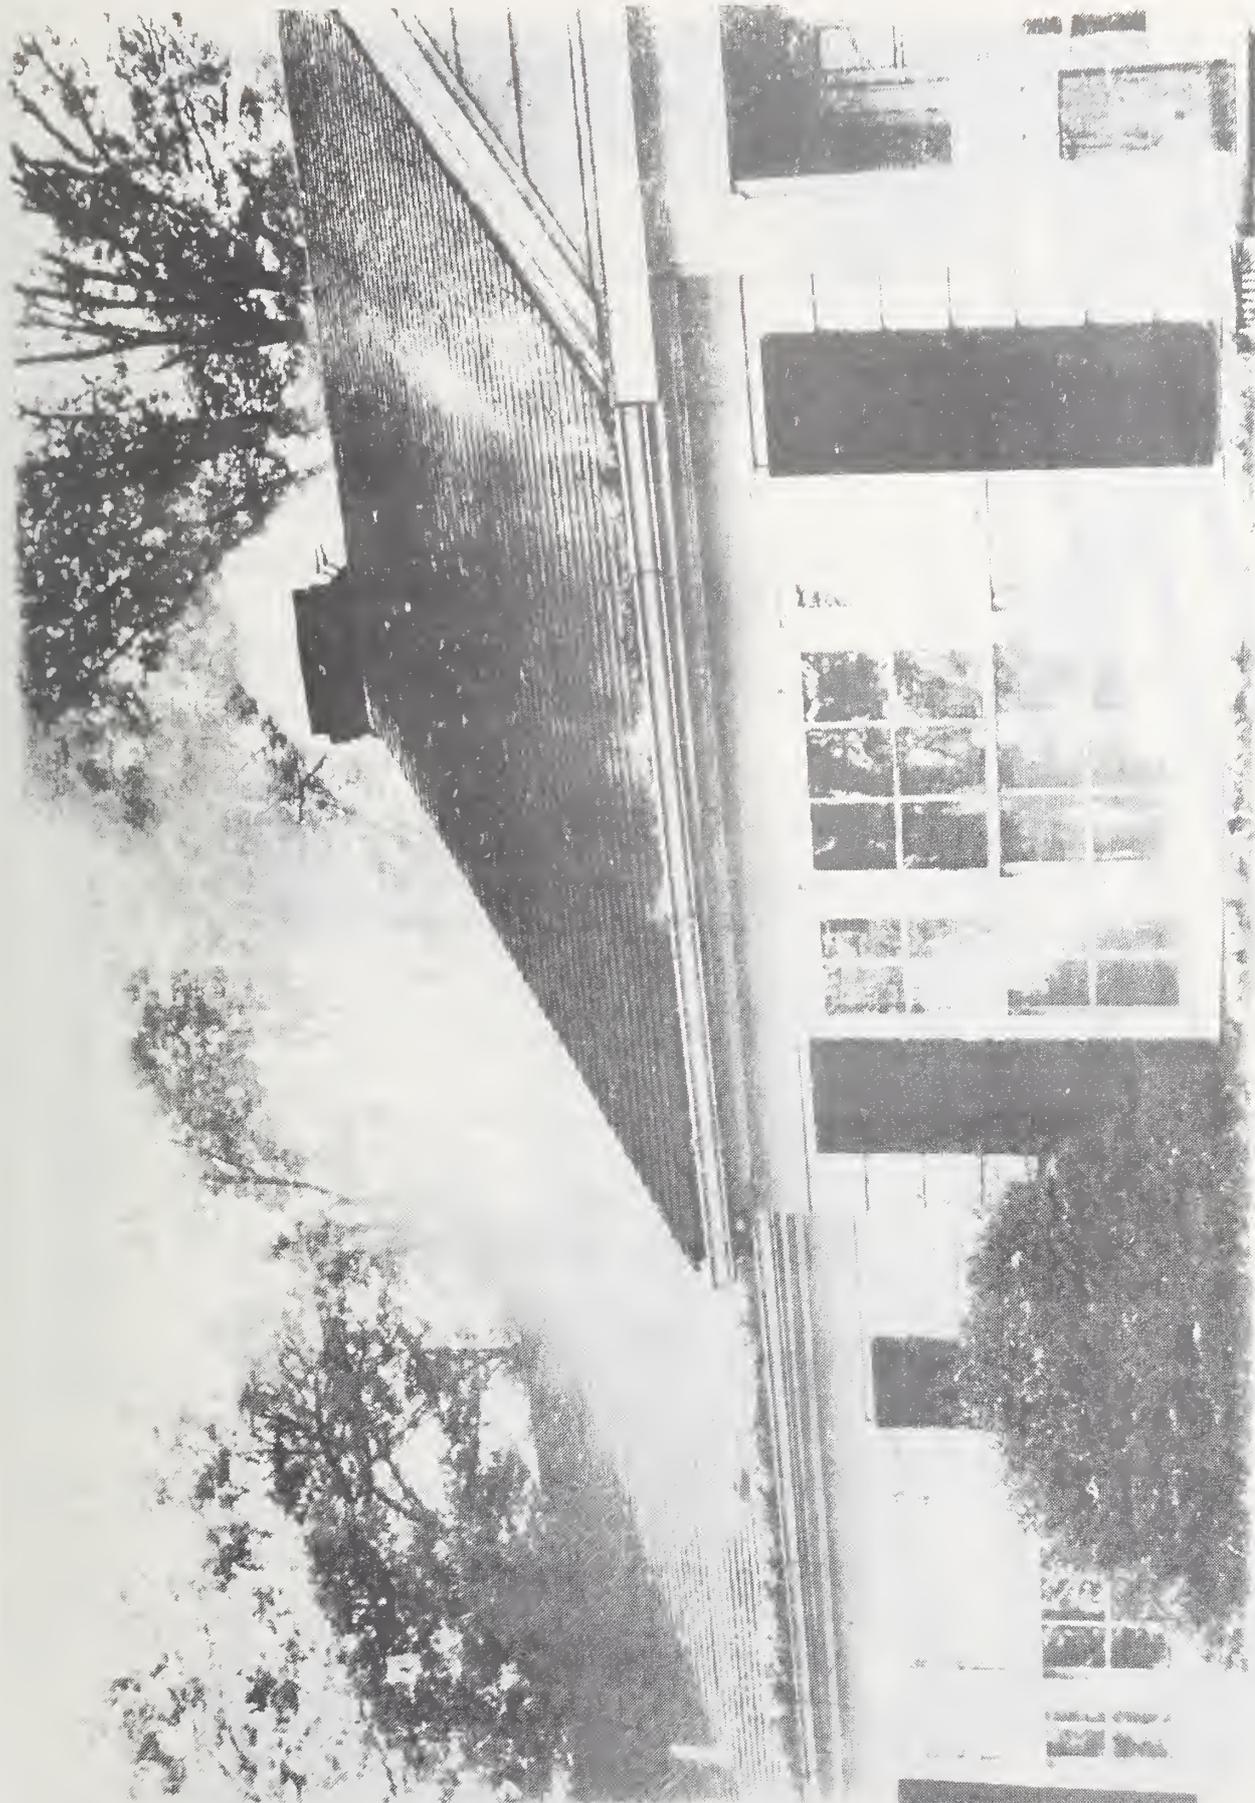
Figure C-4. Major air leakage path through the chimney.
