# **Solar Energy Systems - Survey of Materials Performance**

Final Report

The field inspection phase of the project included visits to twenty-five active solar system installations. The period of operation for the systems visited was from a few months to over three years. The inspections revealed that many materials problems had been encountered and that field expedient fixes had had to be made. In some cases, no adequate fixes were possible because of basic design deficiencies. In retrospect, it was obvious that design and materials performance can rarely be separated. In most cases, field expedient fixes for failures were accomplished with readily available materials which were not always the optimum solution to a problem. Unfortunately, some of the projects visited, which were sponsored by the National Science Foundation, were built this way originally, i.e. readily available materials were used which did not always perform satisfactorily.

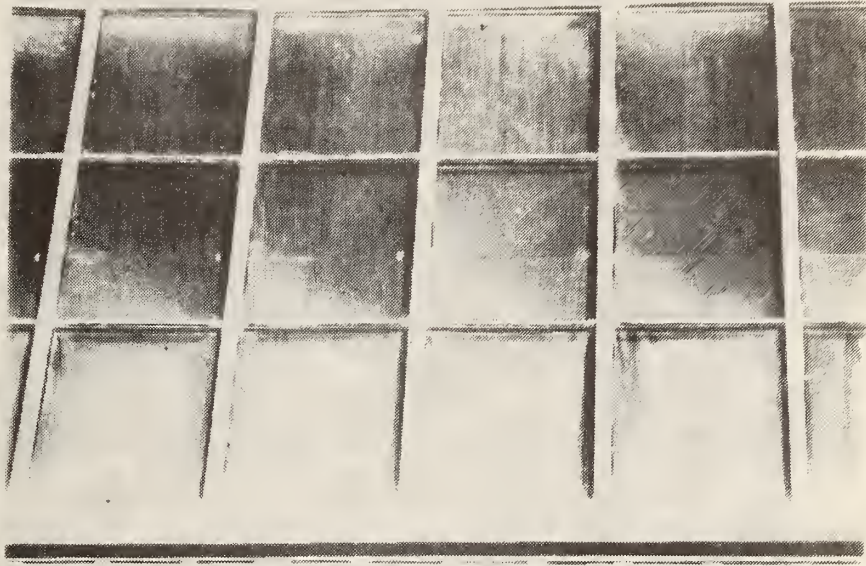
4. In one system, there was substantial dirt retention on the underside of the cover plate due to improper sealing. The collectors were purposely not sealed to prevent formation of condensation and allow the collectors to breathe (see fig. 2-5.)

Figure 2-5. Dirt on Cover Plate Interior Surface

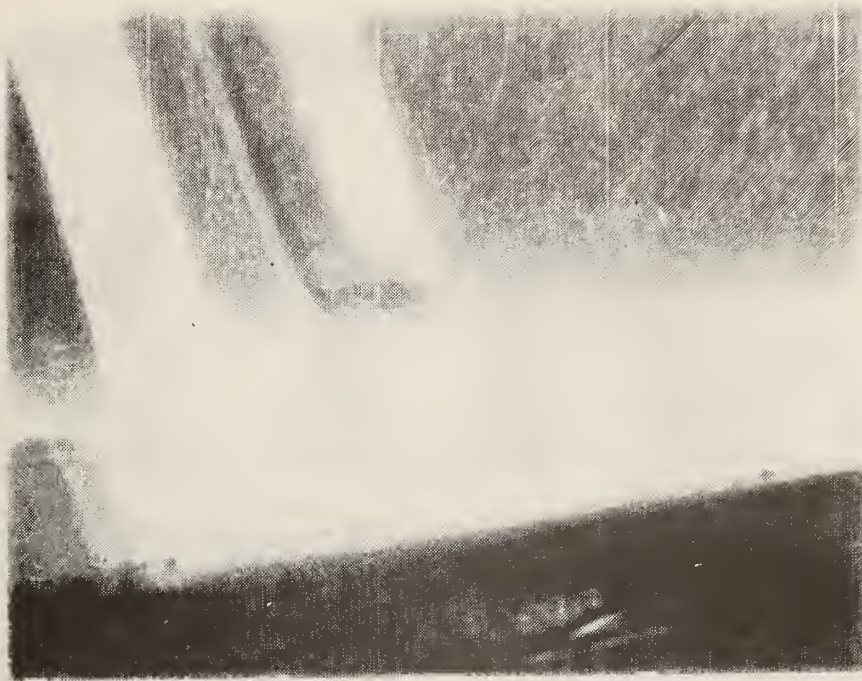
2. Stress cracking of polycarbonate cover plates that had been designed with indented sections to provide structural rigidity was observed. Approximately 60 to 70% of the indentations exhibited stress cracking to a greater or lesser extent (see fig. 2-13).

Figure 2-13. Cracking of Polycarbonate  
Cover Plates at Edge of  
Indented Stiffening Ribs

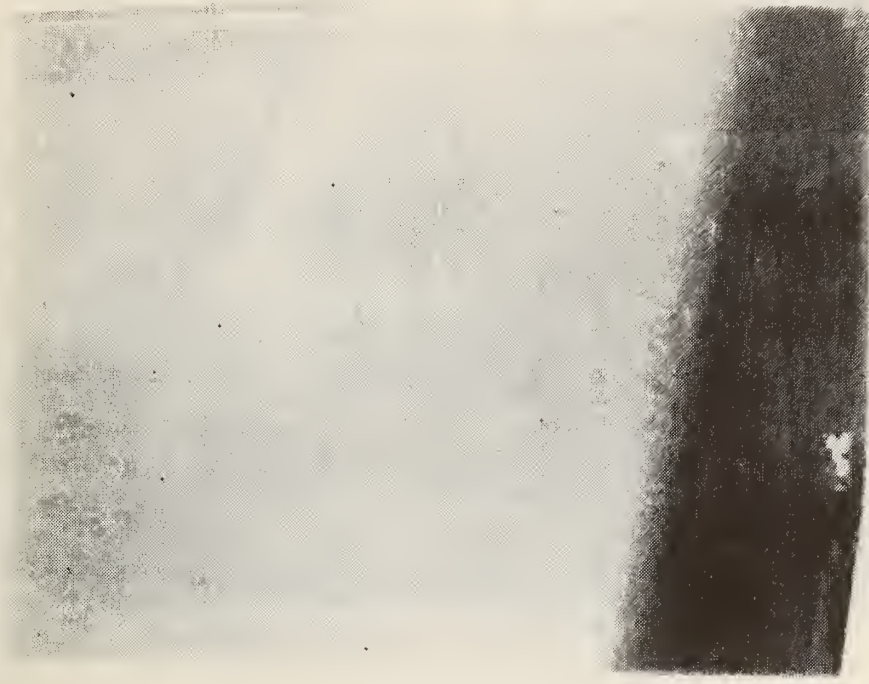
In a majority of systems where selective coatings had been in service for a year or more color changes were apparent. The range of color change was from minor discoloration to complete changes that gave the appearance of light tan colors (see fig. 2-15). One system that had been subjected to rain leakage as well as transfer fluid leakage exhibited changes from black to light tan (see fig. 2-16). It is not known, at this time, what affect the color change has on the optical properties. Another system had extensive white deposits on the selective coating that was not possible to identify. These deposits may have been coating failures, effects of outgassing or transfer fluid leakage as a result of corrosion (see fig. 2-17).

Figure 2-17. Formation of Deposits on Absorber Coating

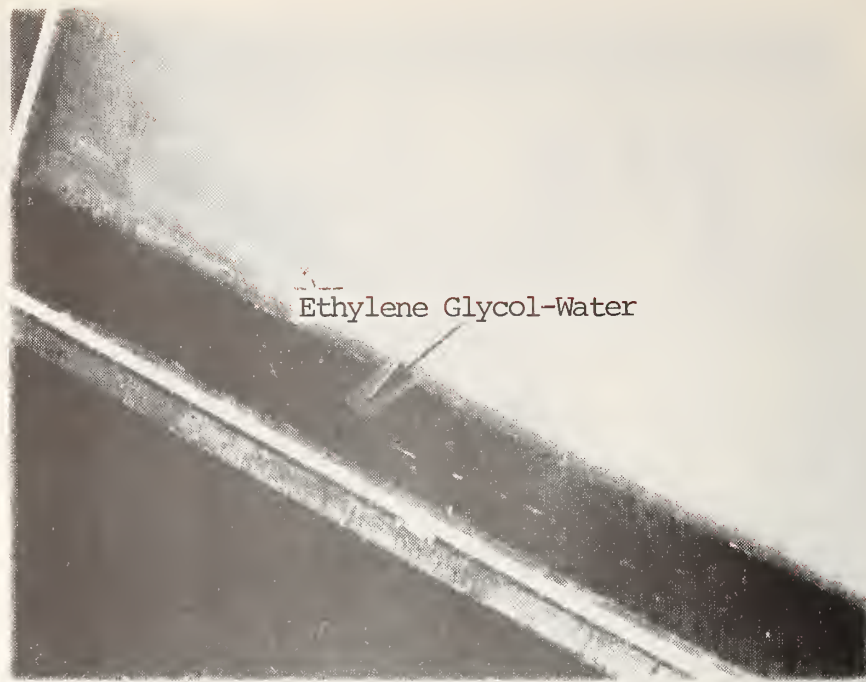
1. Leakage resulting from corrosion has been observed in several systems utilizing aluminum absorber plates with integral fluid flow passages. These observed leakages may not be the fault of the absorber plate itself and the cause of the corrosive action may well originate in some other component of the system (see fig. 2-19).

Figure 2-19. Leaking Aluminum Absorber Plate

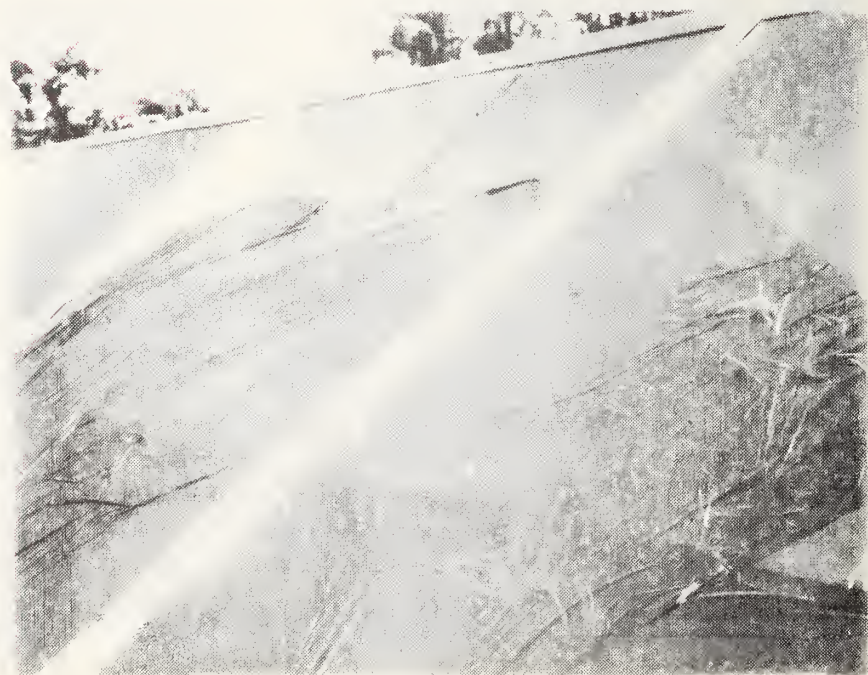
Two flat plate collector systems were inspected which used reflective surfaces. Figure 2-28 shows problems observed on one of the reflective systems. The surface irregularity resulted from difficulties in applying self-adhering aluminized film. Subsequent loss of adhesion required the addition of batten strips.

Figure 2-28. Reflective Surfaces

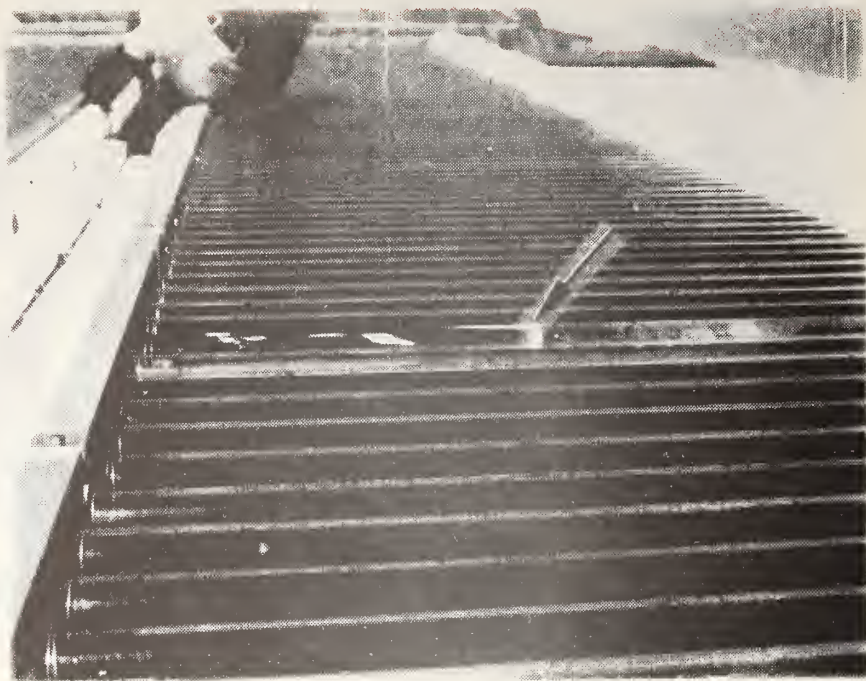
Two systems utilizing evacuated tube collectors were visited. Of the problems encountered and those described by the owners, the primary cause of failures can most generally be attributed to over temperature of materials or components during operation or during times of stagnation conditions. Problems encountered include leakage, gasket hardening, dimensional tolerances, tube breakage, tube coating discoloration, dirt accumulation in filter tubes, air entrapment, pump cavitation, manifold insulation discoloration, and system operational control problems (see fig. 2-31).

Figure 2-31. Evacuated Tube Breakage

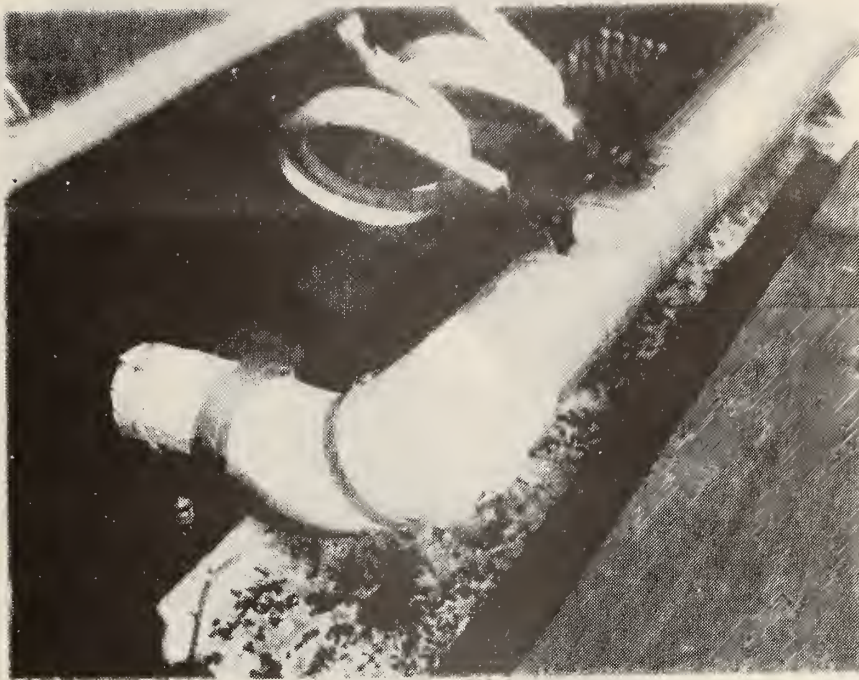
Figure 2-33. Copper Coil Replacement of Flexible Hoses

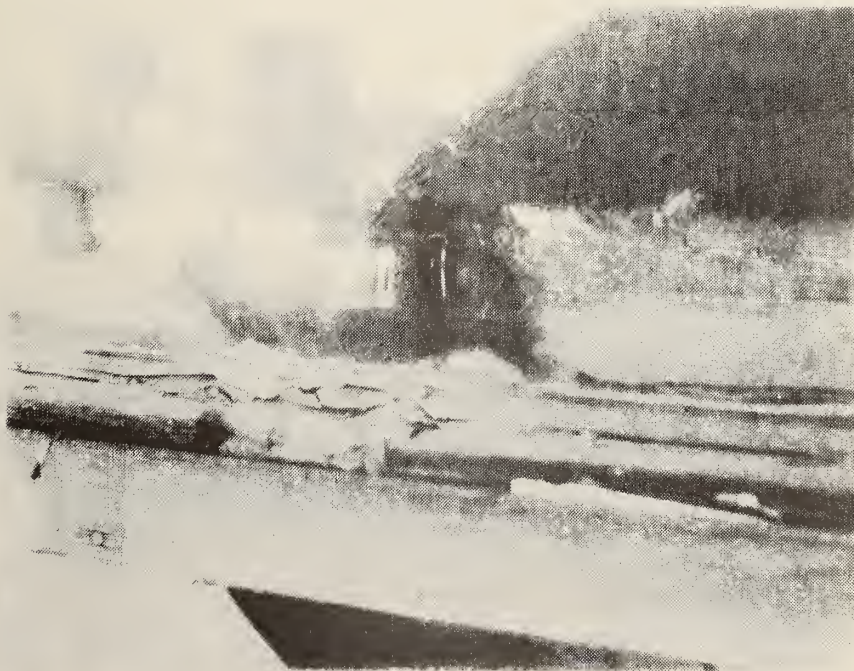
The greatest single problem encountered in regards to transport piping was the flexible hoses at inlet and outlet couplings of flat plate liquid collectors. At every site visited where flexible coupling hoses were used, leakage problems have occurred to a greater or lesser degree. Causes for leakage have been attributed to age hardening and loss of elasticity, plastic flow of hose materials through slotted holes of gear-type clamps resulting in reduced clamping forces, cumulative slippage of hoses due to thermal movements of collectors and ozone or ultraviolet attack of hoses exposed to weathering. Also, it was reported that it is sometimes difficult to replace collectors that are attached with rubber hoses because of the tightness of the hose/metal bond. Attempts to solve these problems ranged from application of sealants and adhesives to the exterior of leaking hoses to the complete replacement of organic hoses with metallic couplers (see figs. 2-32 and 2-33). Figure 2-34 illustrates a design problem. The hose to collector connection was placed inside the collector enclosure making it difficult to tighten the hose connection or replace the hose.

Figure 2-34. Inaccessible Hose Connection

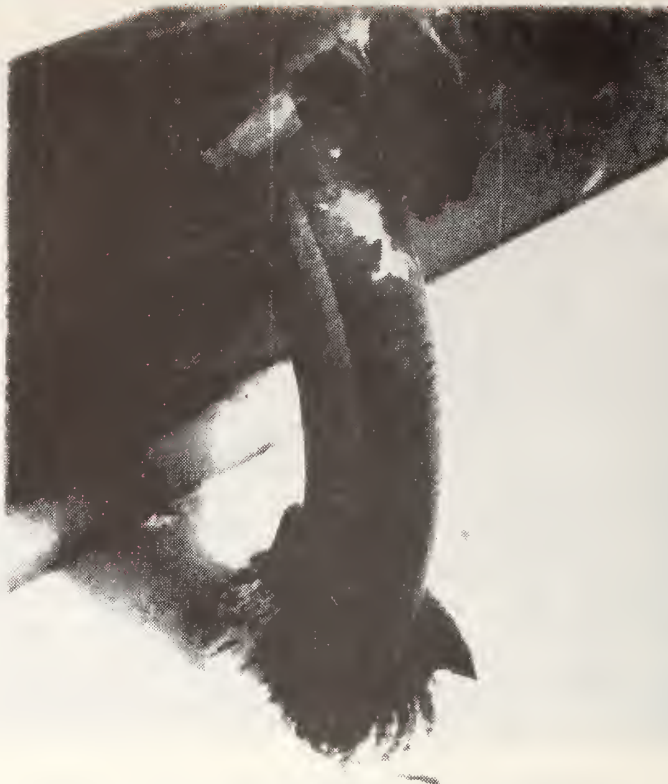
Several other problems were apparent as regards flexible hose couplings. In many cases the hoses were not insulated resulting in heat losses and weathering deterioration (see fig. 2-35). In one case, where coiled copper connections were used to replace flexible hoses, the insulation at the transport piping was not sealed allowing water to enter the insulation resulting in additional heat losses (see fig. 2-33). At another site, different paint coating systems were used to protect the cellular insulation surrounding the hose connections. In one case, the insulation became embrittled and cracked while the same insulation coated with a different material remained flexible with no damage to the insulation (see figs. 2-36 and 2-37).

Figure 2-35. Uninsulated Flexible Coupling

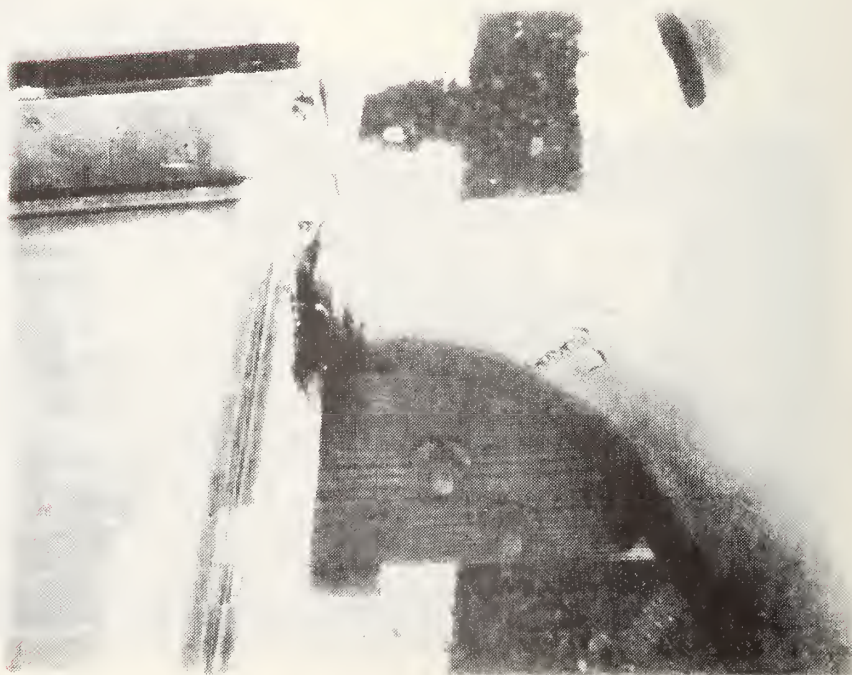
Figure 2-36. Surface Cracking on Cellular Insulation
