NBSIR 78-1418 (NASC)(R)

Stress Corrosion Behavior of X2048 T851 Aluminum Alloy

Life Test Development for Clothes Dryers

NBSIR 78-1419

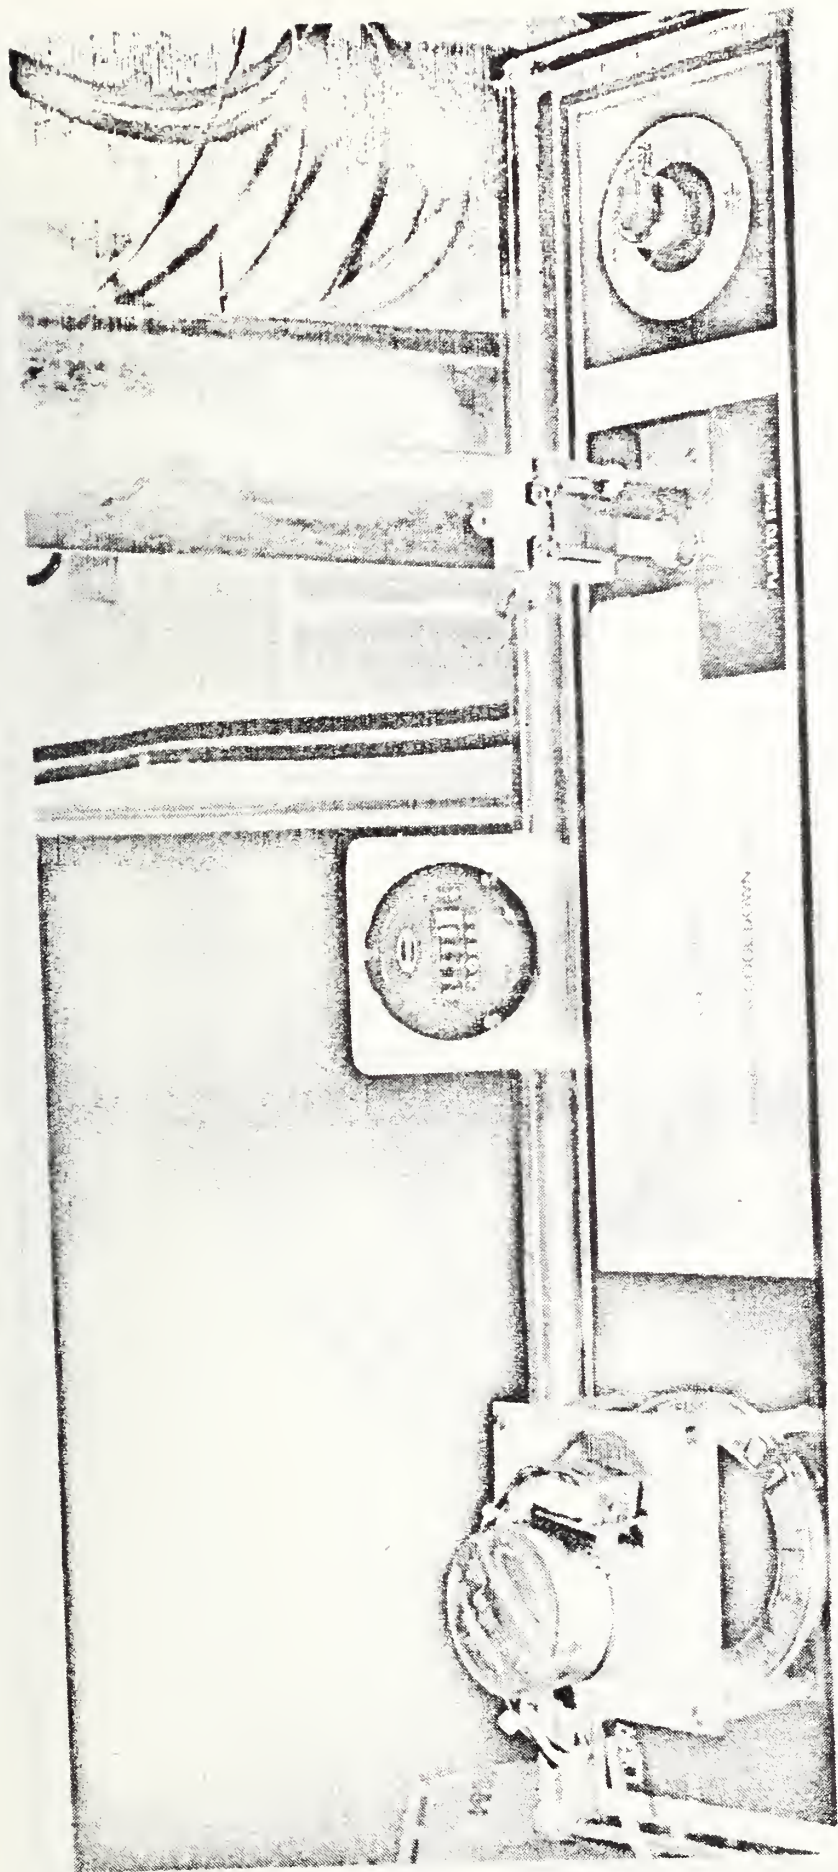
FIGURE 2 Driver control panel equipped for automatic recycling -- make-A.

1) Figure 2 is a photograph of the control panel of dryer make-A, as equipped for automatic recycling. A motor mounted above the timer knob (left) advances the timer to the desired setting and a solenoid above the start button pushes down. Figure 3 is a more detailed view of the mechanism used to advance the timer. When activated by the control box, a one rpm electric motor turns the dryer timer knob through a mechanical coupling. The angular displacement, or time setting, is determined by means of an adjustable cam which actuates a microswitch to stop the motor. For the starting operation, a solenoid is used to depress a plunger which rests on the start push button.

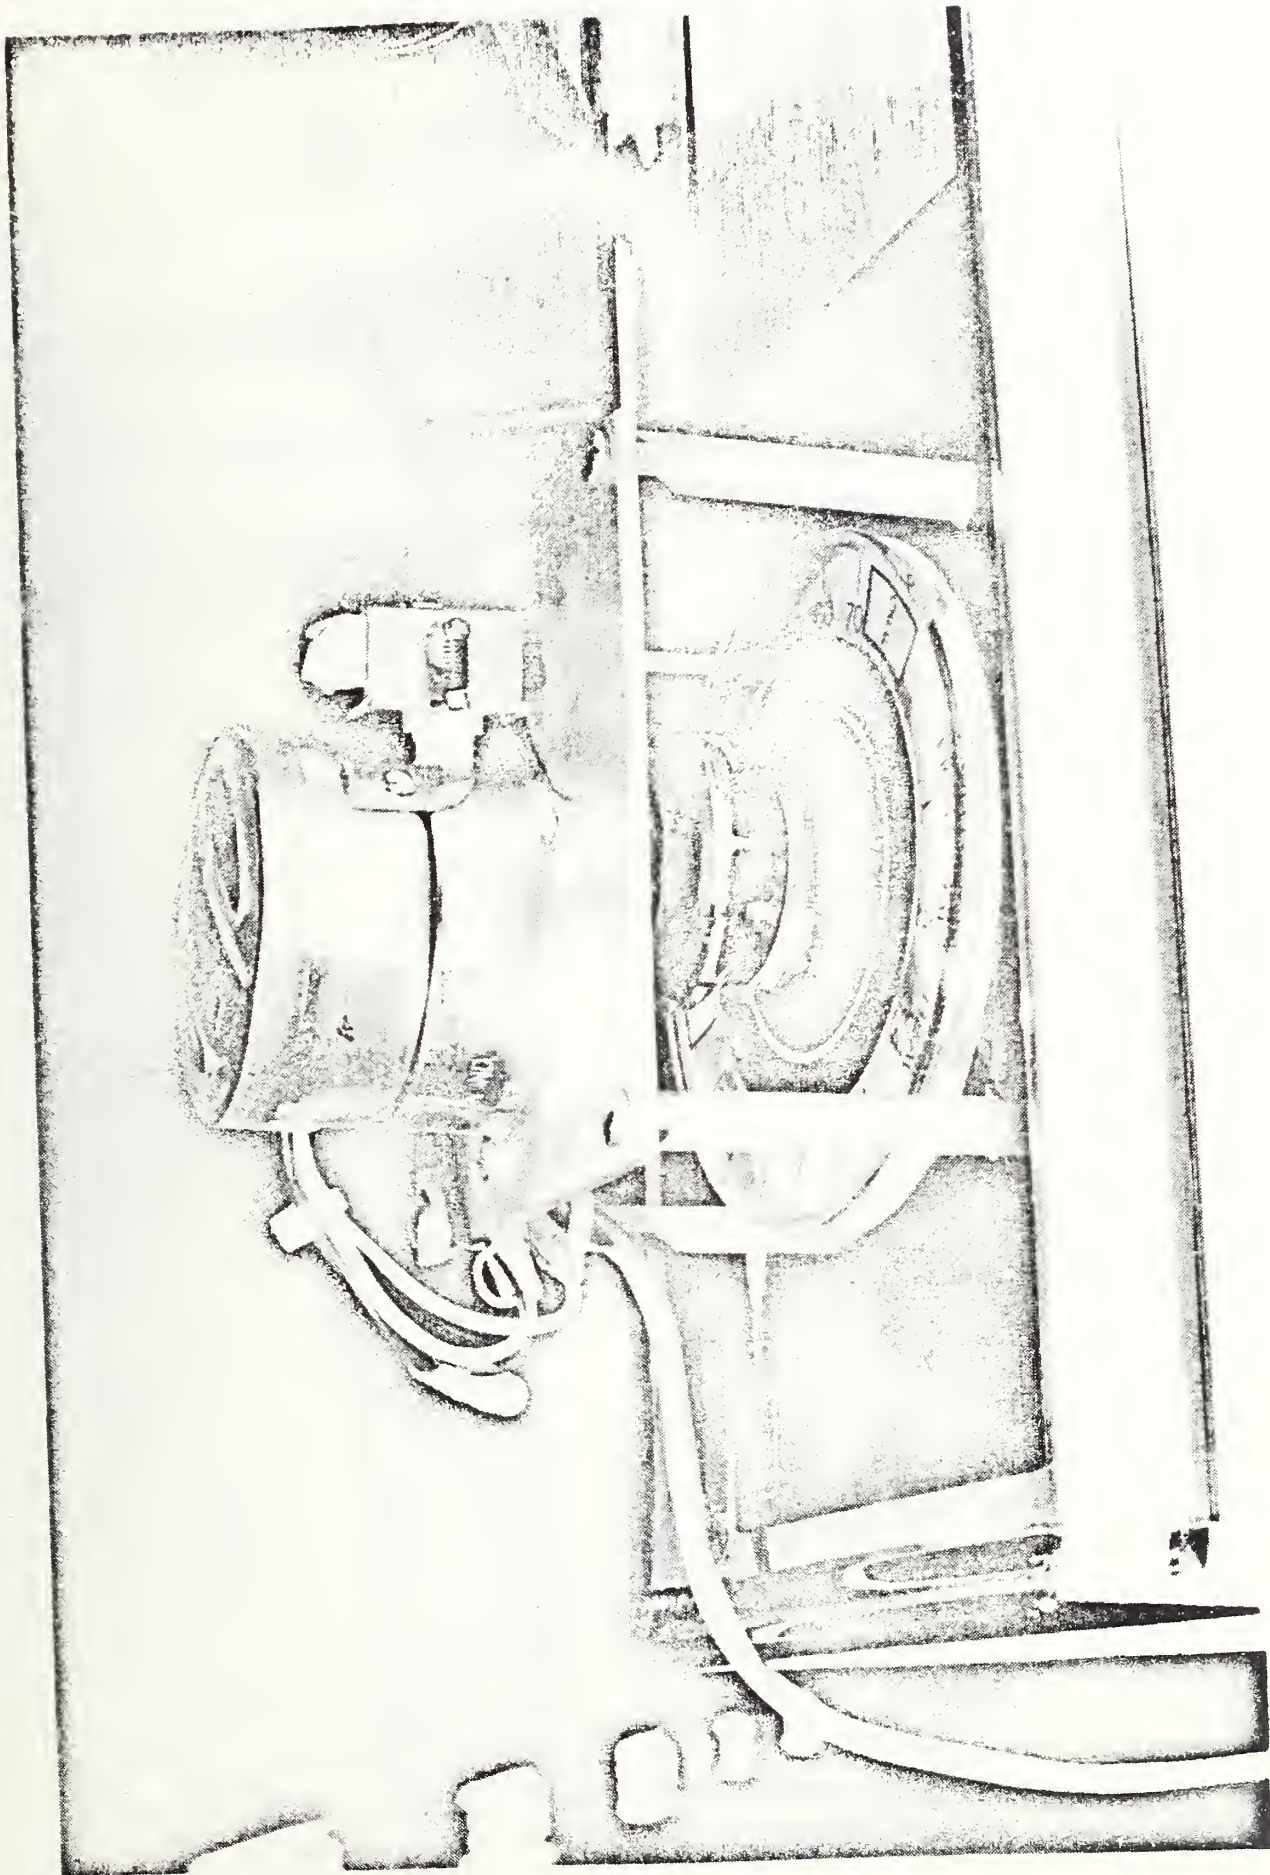
Figure 3. Close-up view of timer-advancer.

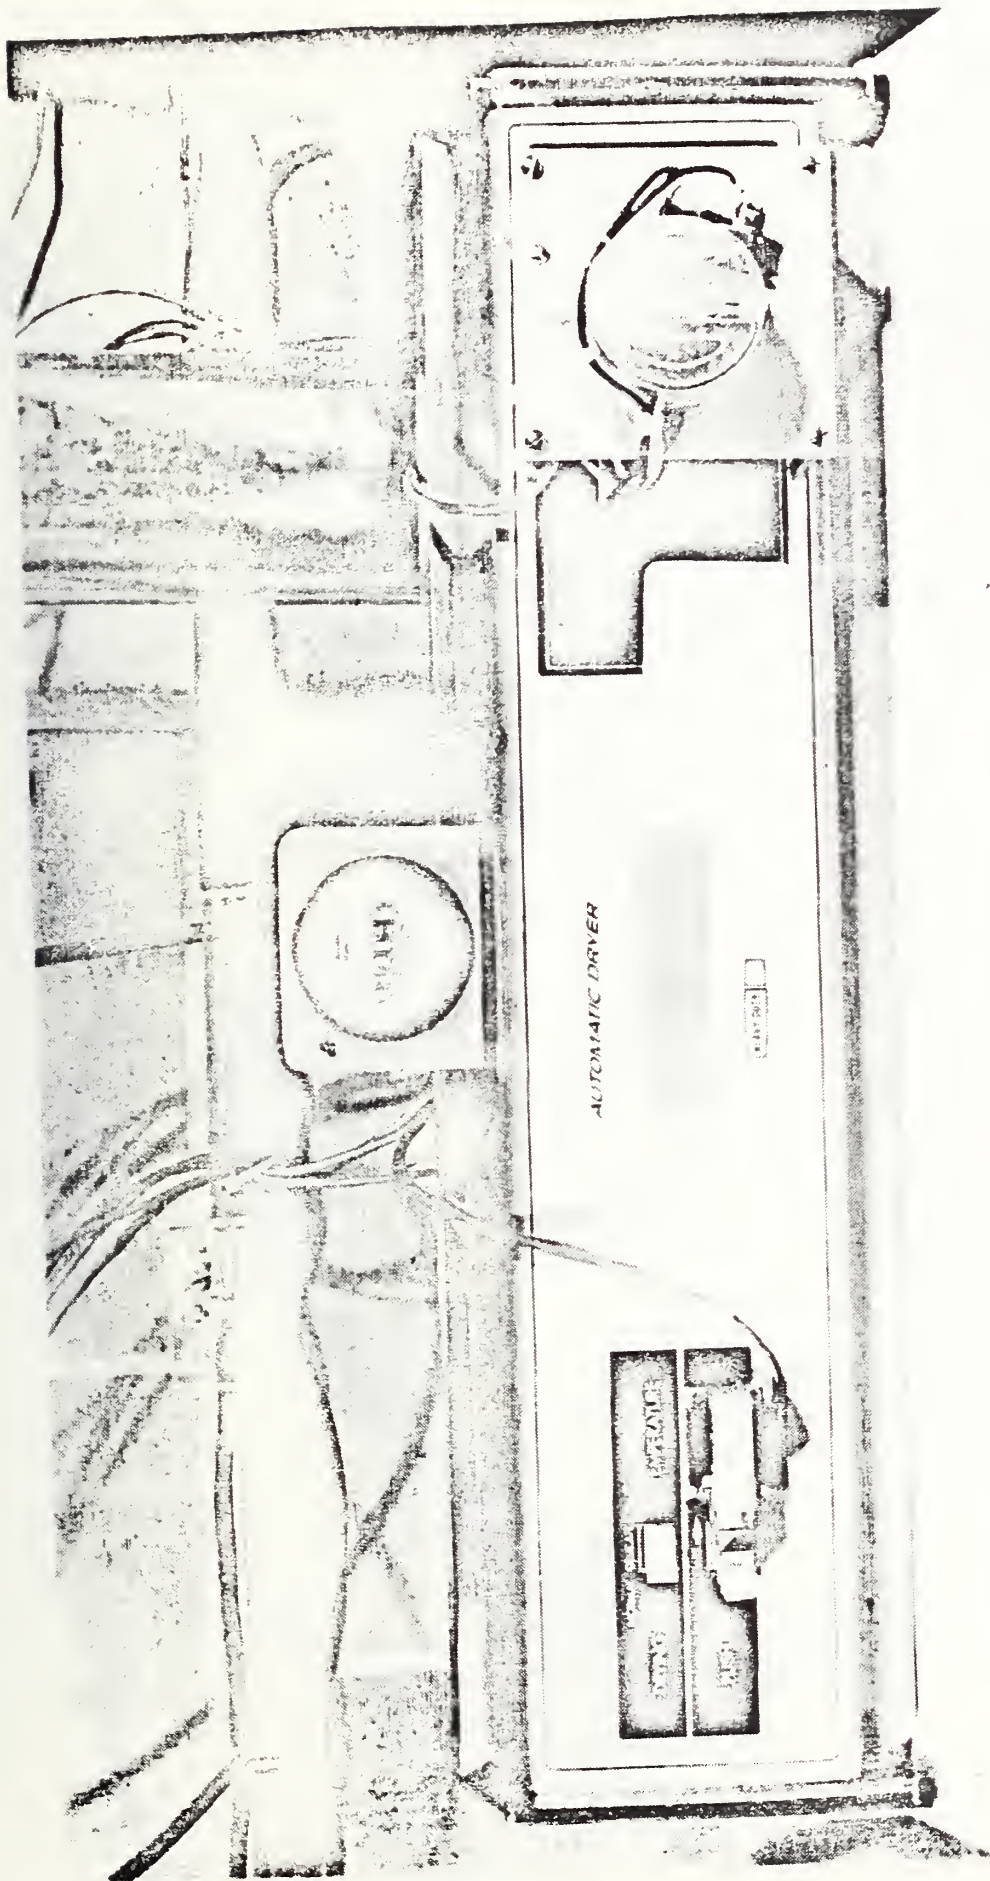
Figure 4. Dryer control panel equipped for automatic recycling -- make-B.

Figure 4 is a photograph of the control panel of dryer make-B, as equipped for automatic recycling; the timer is at the right, and the start switch at the left. The automation instrumentation is similar to

that used for make-A, except for starting, the solenoid is mechanically coupled to pull the start switch instead of pushing down.

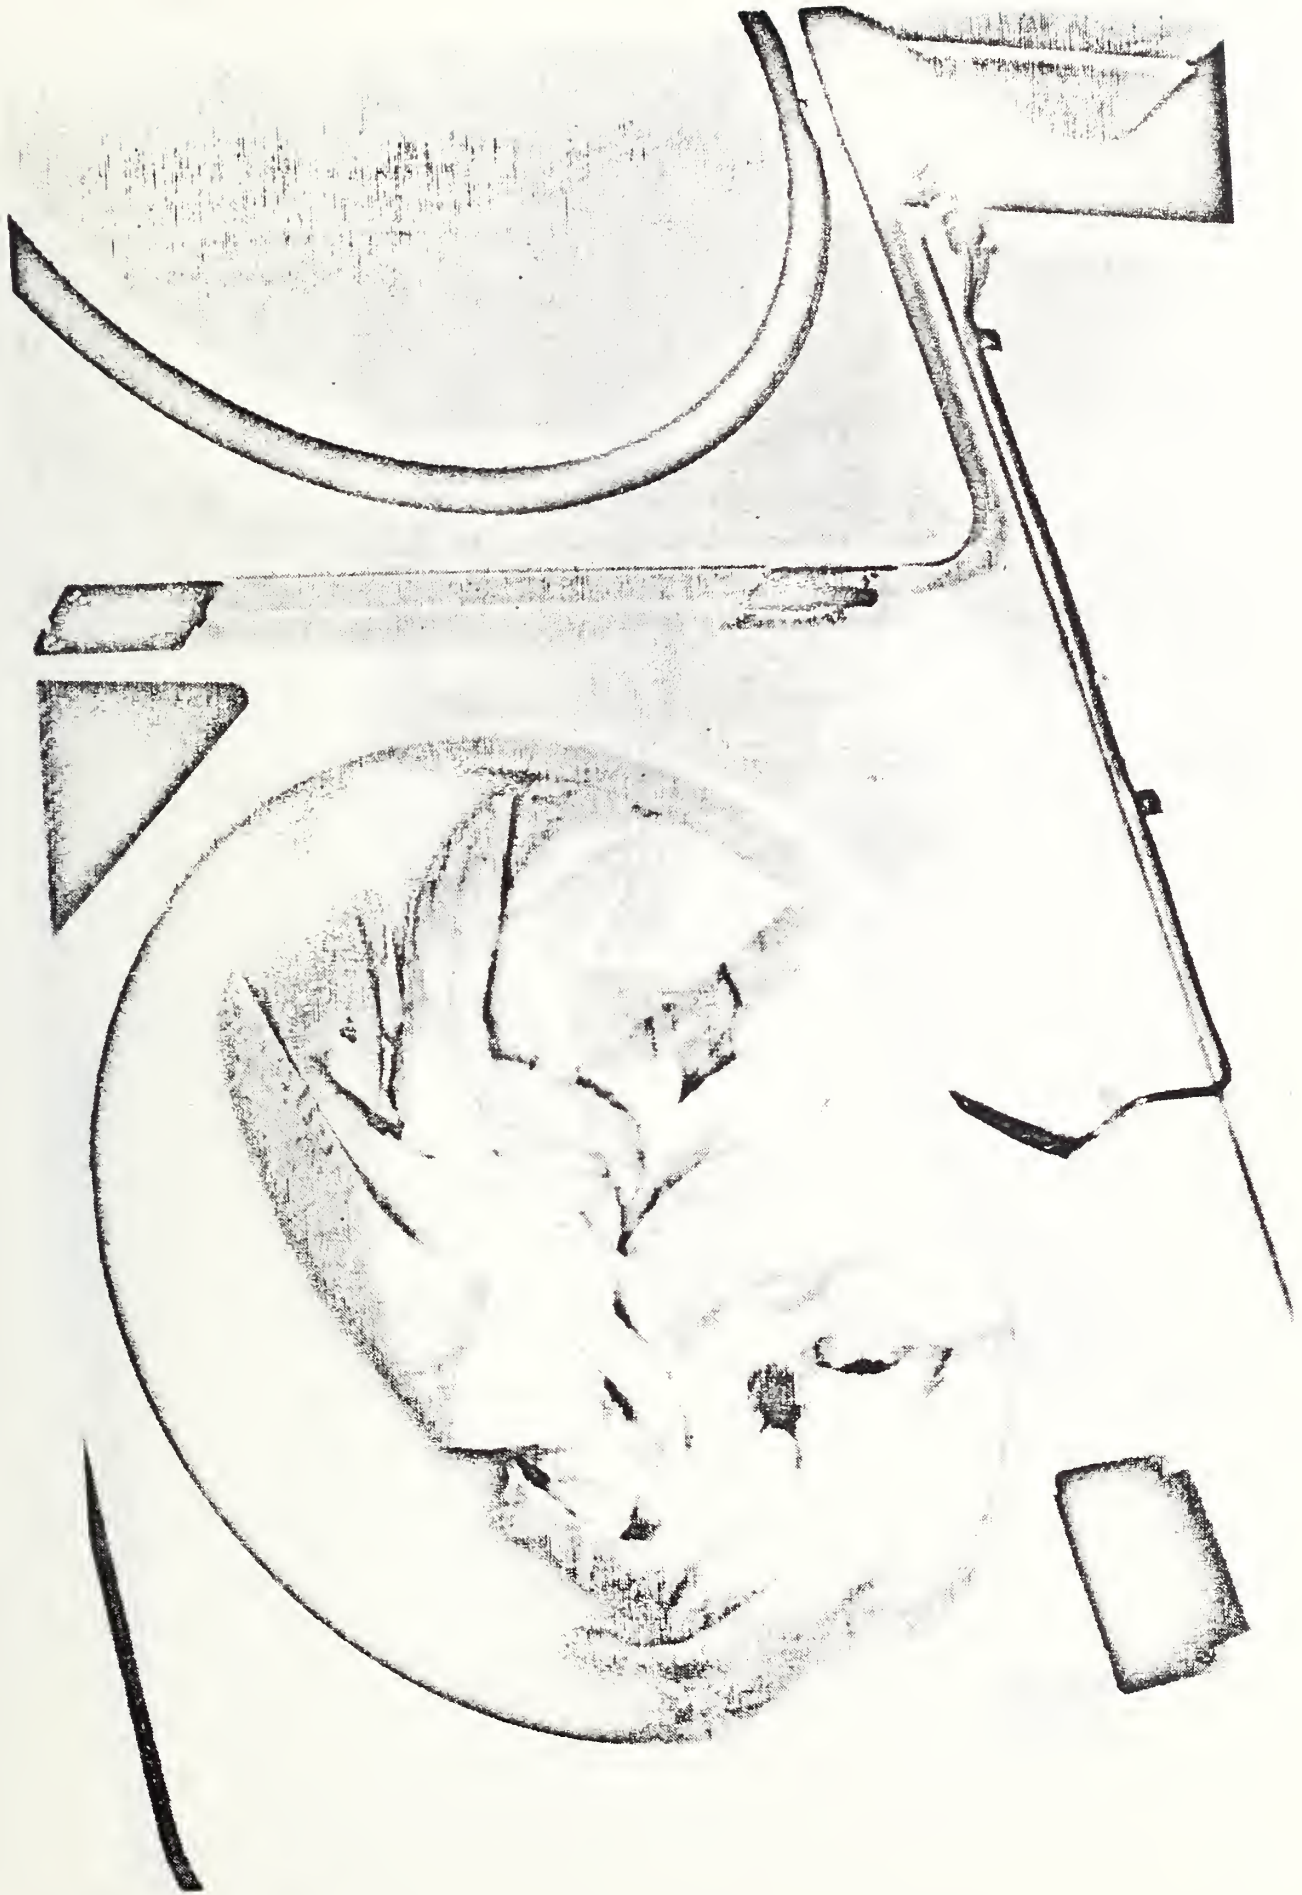
Figure 5. Make-A dryer equipped for squirting water onto loads.
(Normally the door is closed; it is open here for illustration).

Figures 5 and 6 show respectively, makes A and B equipped for squirting. (Normally doors are closed; they are opened here for illustration.) For make-A, the tubing enters at the bottom (for ease of installation); approaches, but does not extend to the rim of the drum; and is directed to squirt upwards and to the right into the tumbling load. The copper tubing is terminated with neoprene tubing to prevent possible load damage. For make-B, on the other hand, the tubing enters at the top and is directed to squirt downward and to the right into the drum. (A prior arrangement similar to that used for make-A was found to be unsatisfactory because water from the squirt tube would be deflected by the tumbling load into the lint filter and blower assembly, as well as out the door.)
