NBSIR 78-1433

Low Velocity Performance of a Bronze Bearing Vane Anemometer

Task Report

on
Contract No. HO166198
Evaluation of the BEhavior of Mine Anemometers in the NBS Low
Velocity Calibration Facility

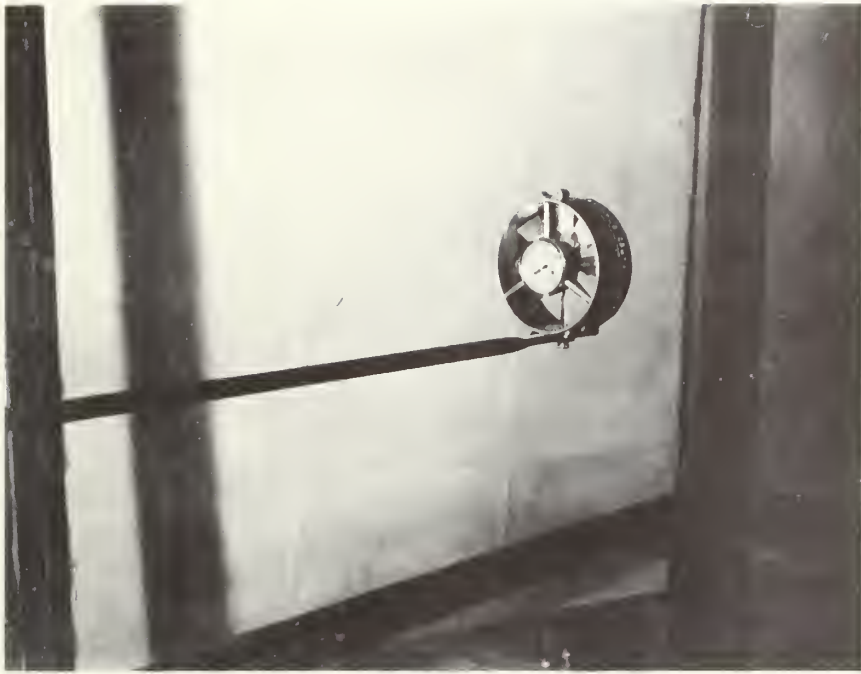
FIGURE 1. THE ANEMOMETER MOUNTED IN THE TUNNEL.

The vane anemometer was mounted on the centerline of the tunnel test section one meter downstream of the entrance to the test section in a manner to minimize the effect of the support on the air stream around the anemometer (Figure 1). Since the anemometer itself modifies the airflow in the tunnel, the velocity should be measured at a location in the flow which has the same velocity in the presence of the anemometer as it does in the absence of the anemometer. Thus the velocity upstream of the anemometer on the centerline was measured to find the position where deceleration of the flow due to the presence of the anemometer was no longer perceptible. These measurements were performed at two free-stream speeds, 700 and 72 fpm, and as predicted by ideal flow theory the variation of the ratio of the local velocity to the free-stream velocity with distance upstream of the anemometer is independent of free-stream velocity (Figure 2). A distance of 30 cm upstream of the anemometer was chosen as the position for velocity measurement by the laser velocimeter. With no anemometer in the tunnel, variation in velocity along the centerline is imperceptible over the distance traversed (30 cm).

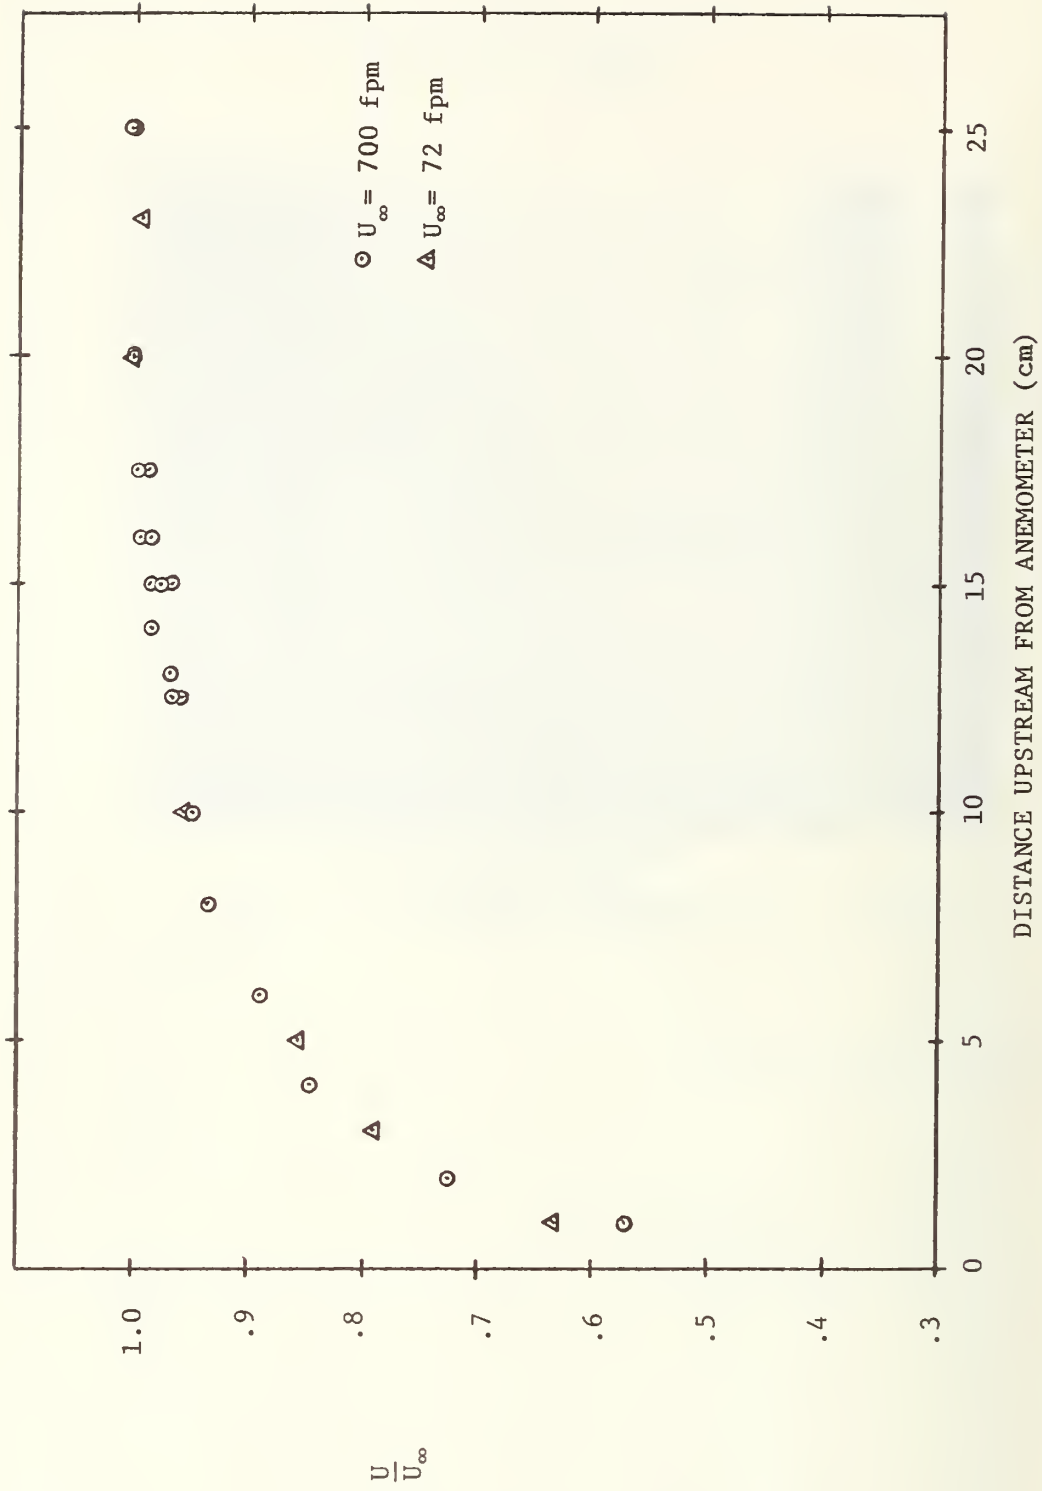
FIGURE 2. VARIATION IN VELOCITY WITH DISTANCE UPSTREAM FROM ANEMOMETER .

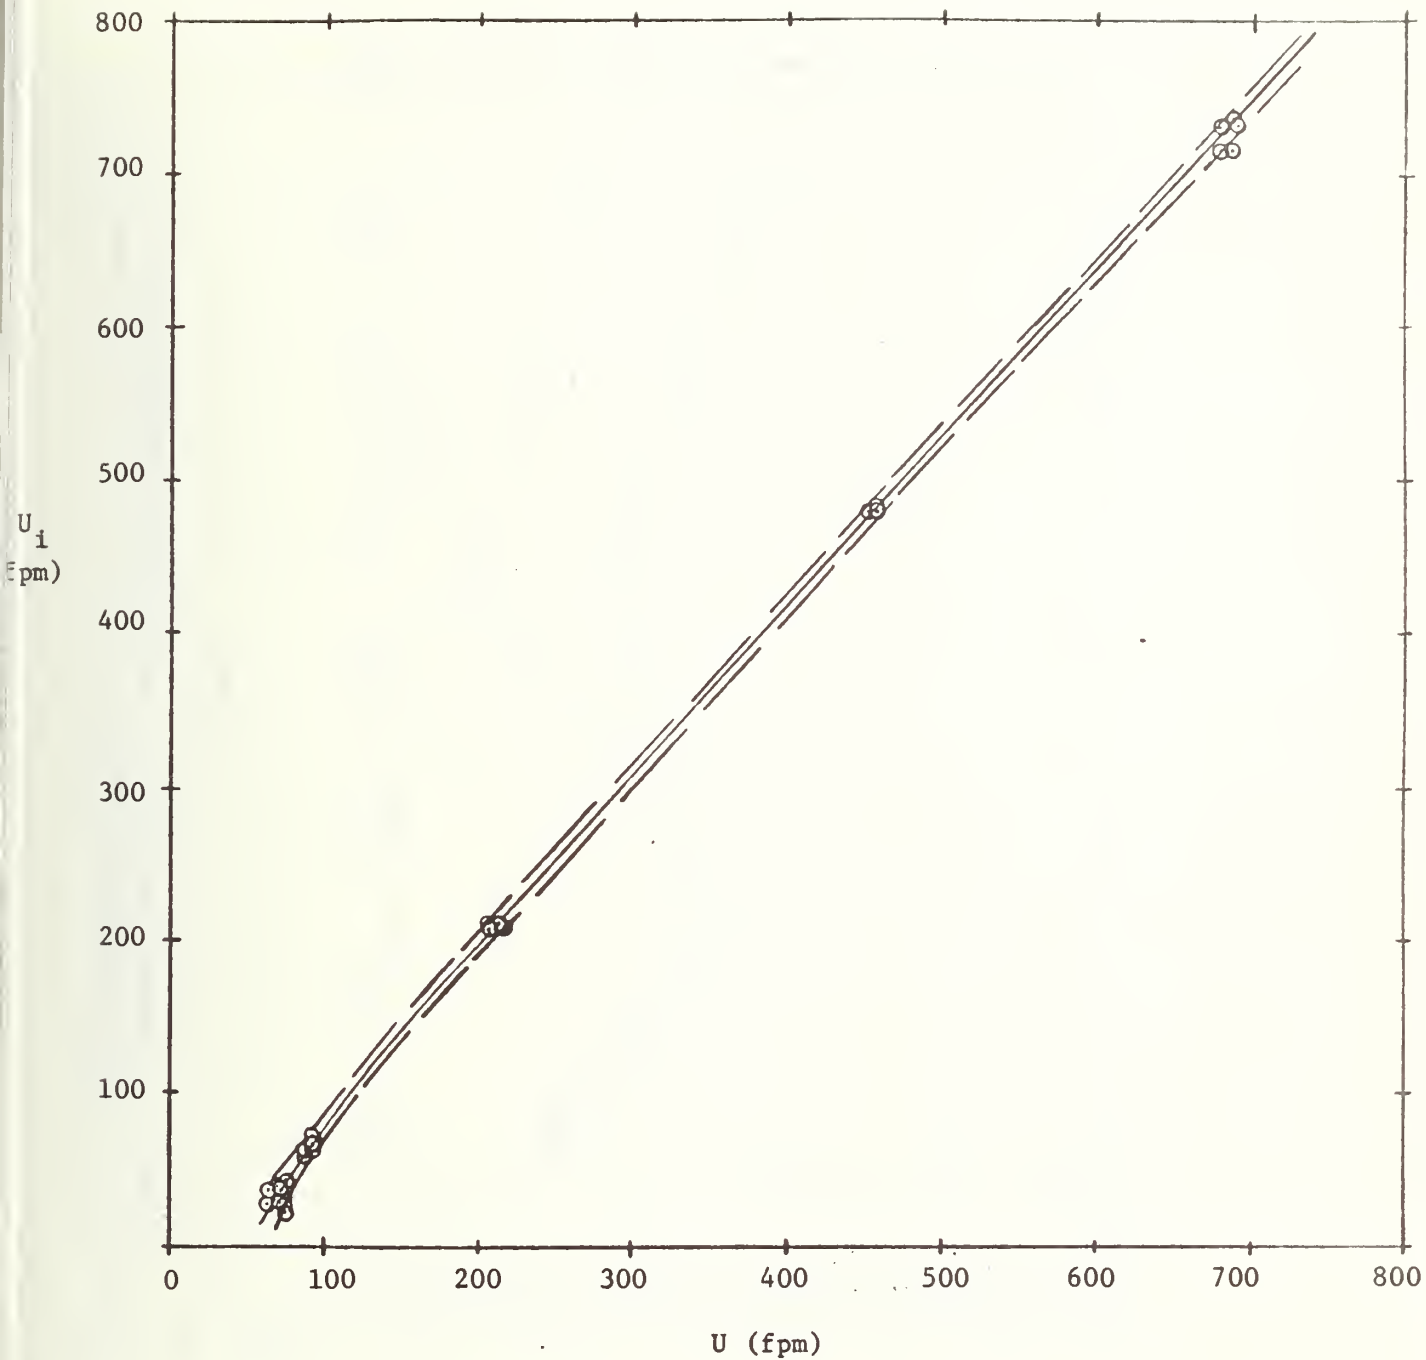
FIGURE 3. INDICATED VERSUS TRUE VELOCITY WITH $\pm 2\sigma$ CURVES.

One data point, the first in Table 1E, was omitted from these calculations because it lies outside the 3σ limit. No explanation for this large deviation can be offered. The fitted curve and the data are presented in Figure 3.

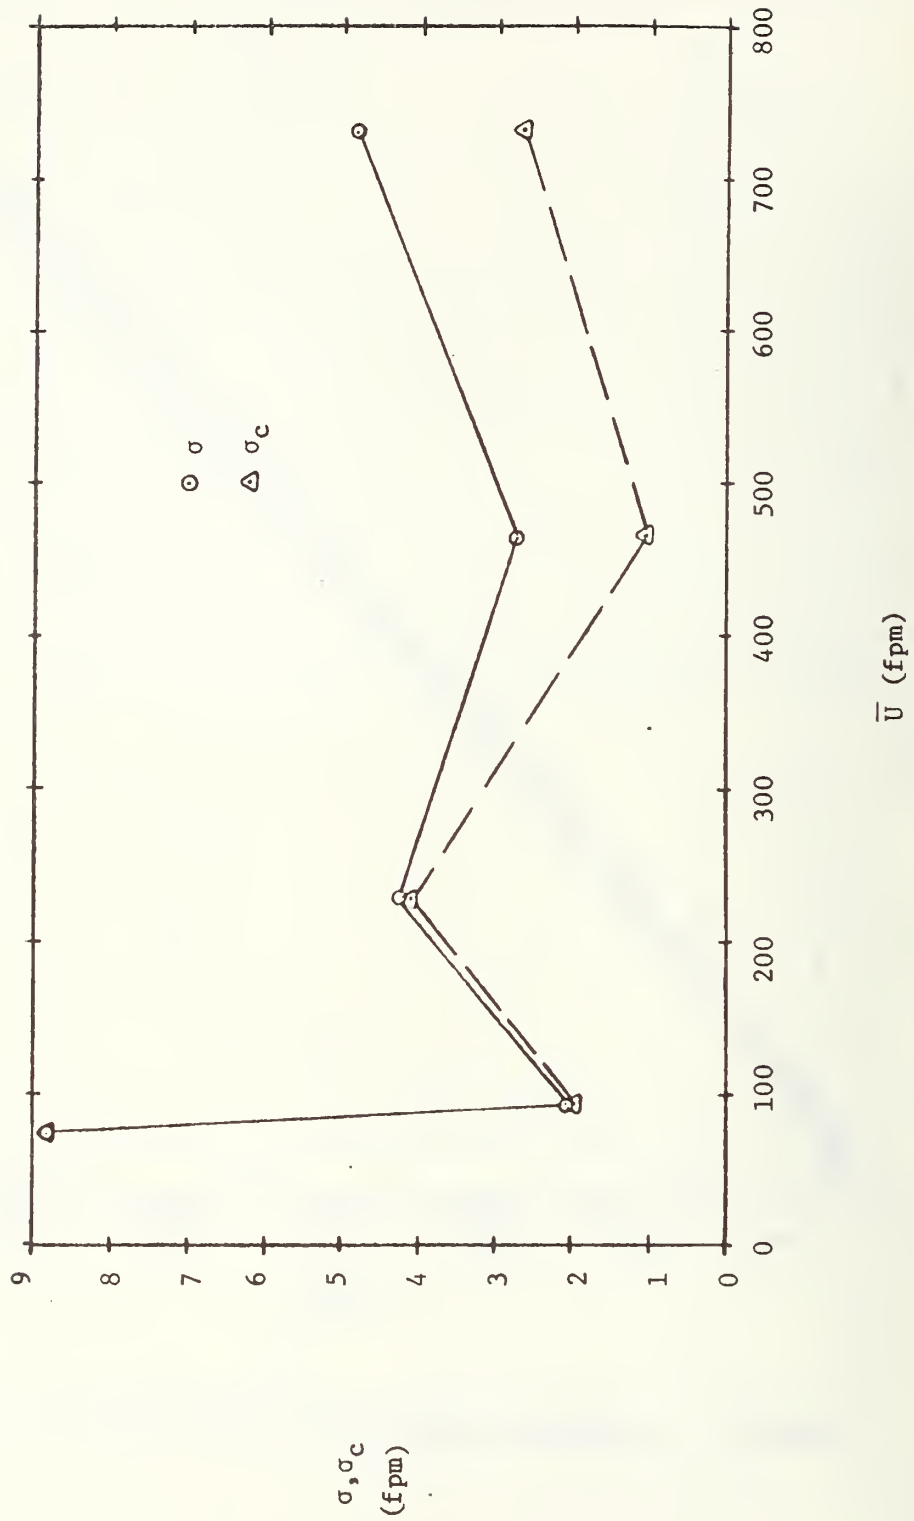
FIGURE 4. STANDARD DEVIATION, σ , AND CORRECTED STANDARD DEVIATION, σ_c , OF INDICATED VELOCITY.

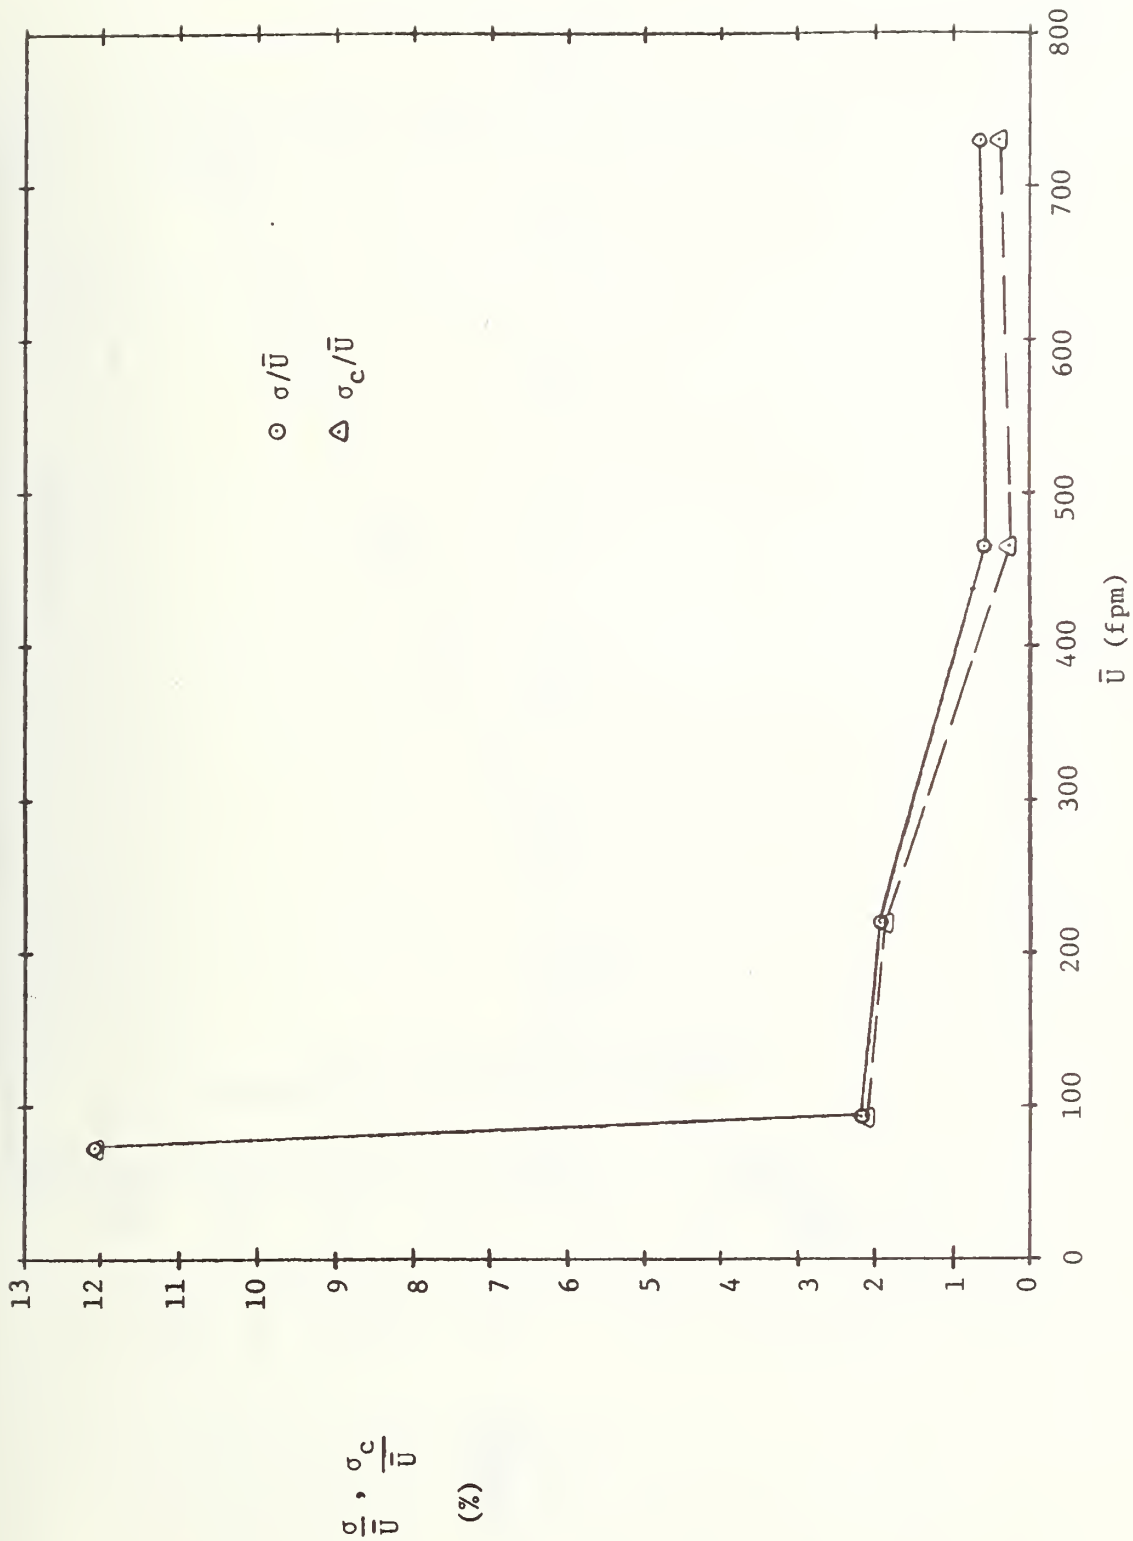
FIGURE 5. STANDARD DEVIATION, σ , AND CORRECTED STANDARD DEVIATION, σ_c , AS PERCENT OF GROUP MEAN VELOCITY.

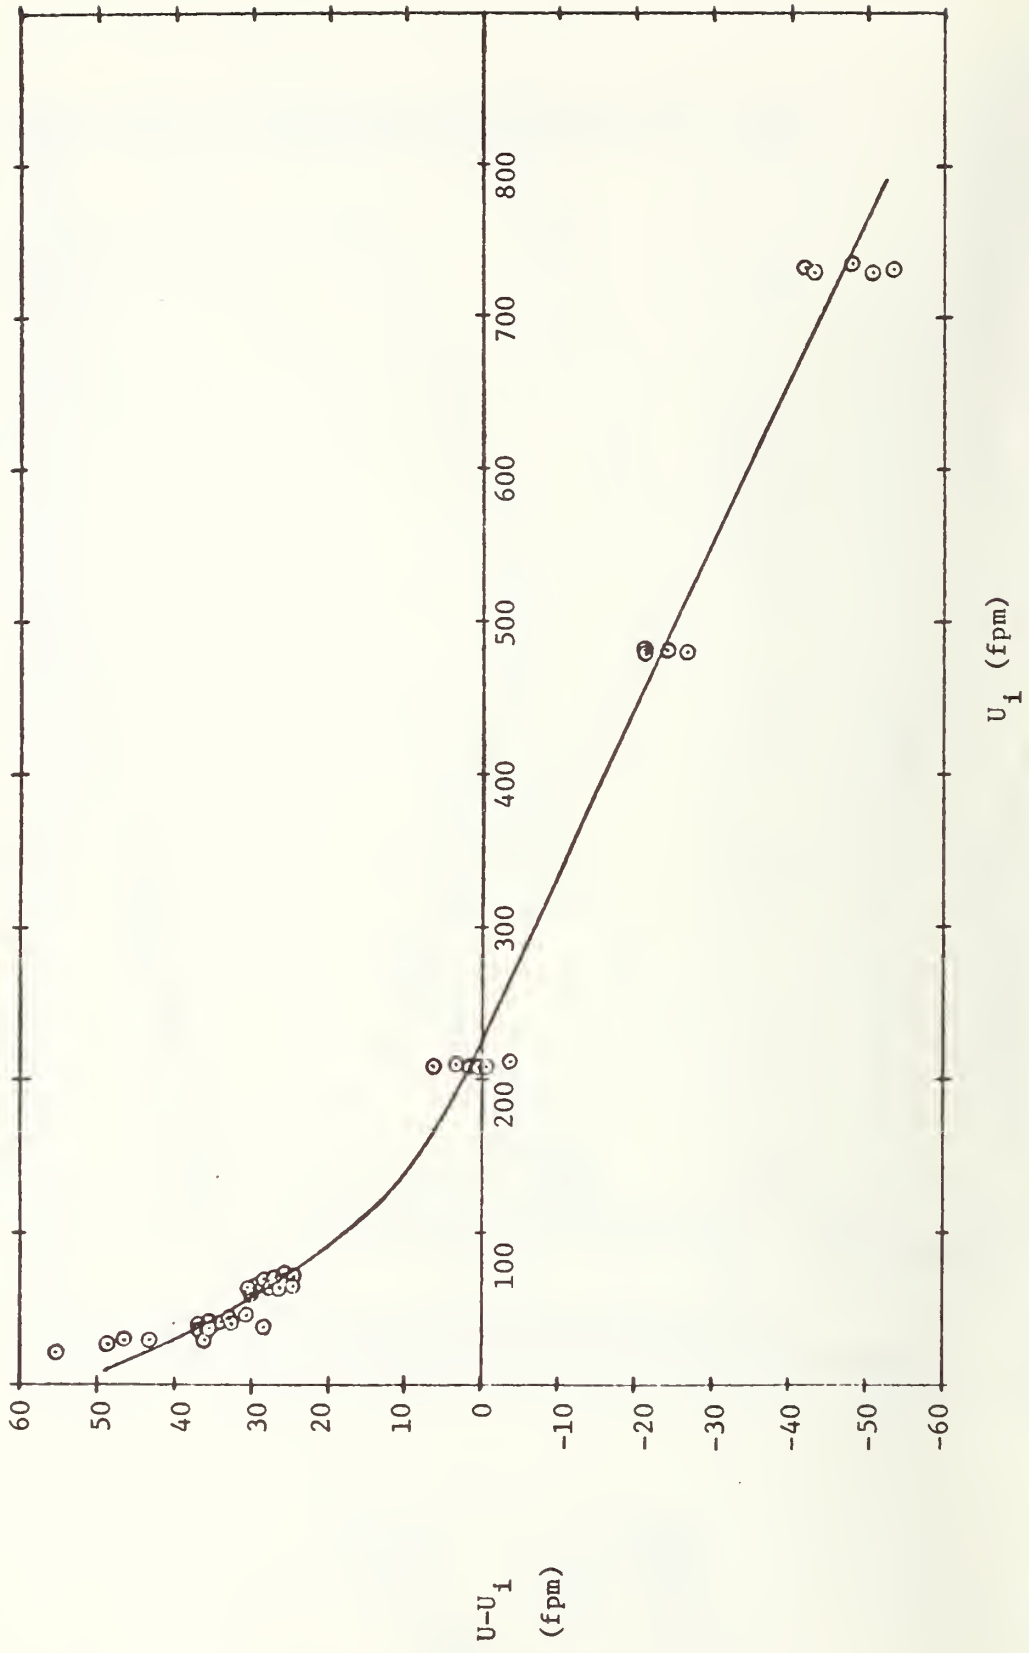
FIGURE 6. DEVIATION OF INDICATED VELOCITY FROM TRUE VELOCITY.

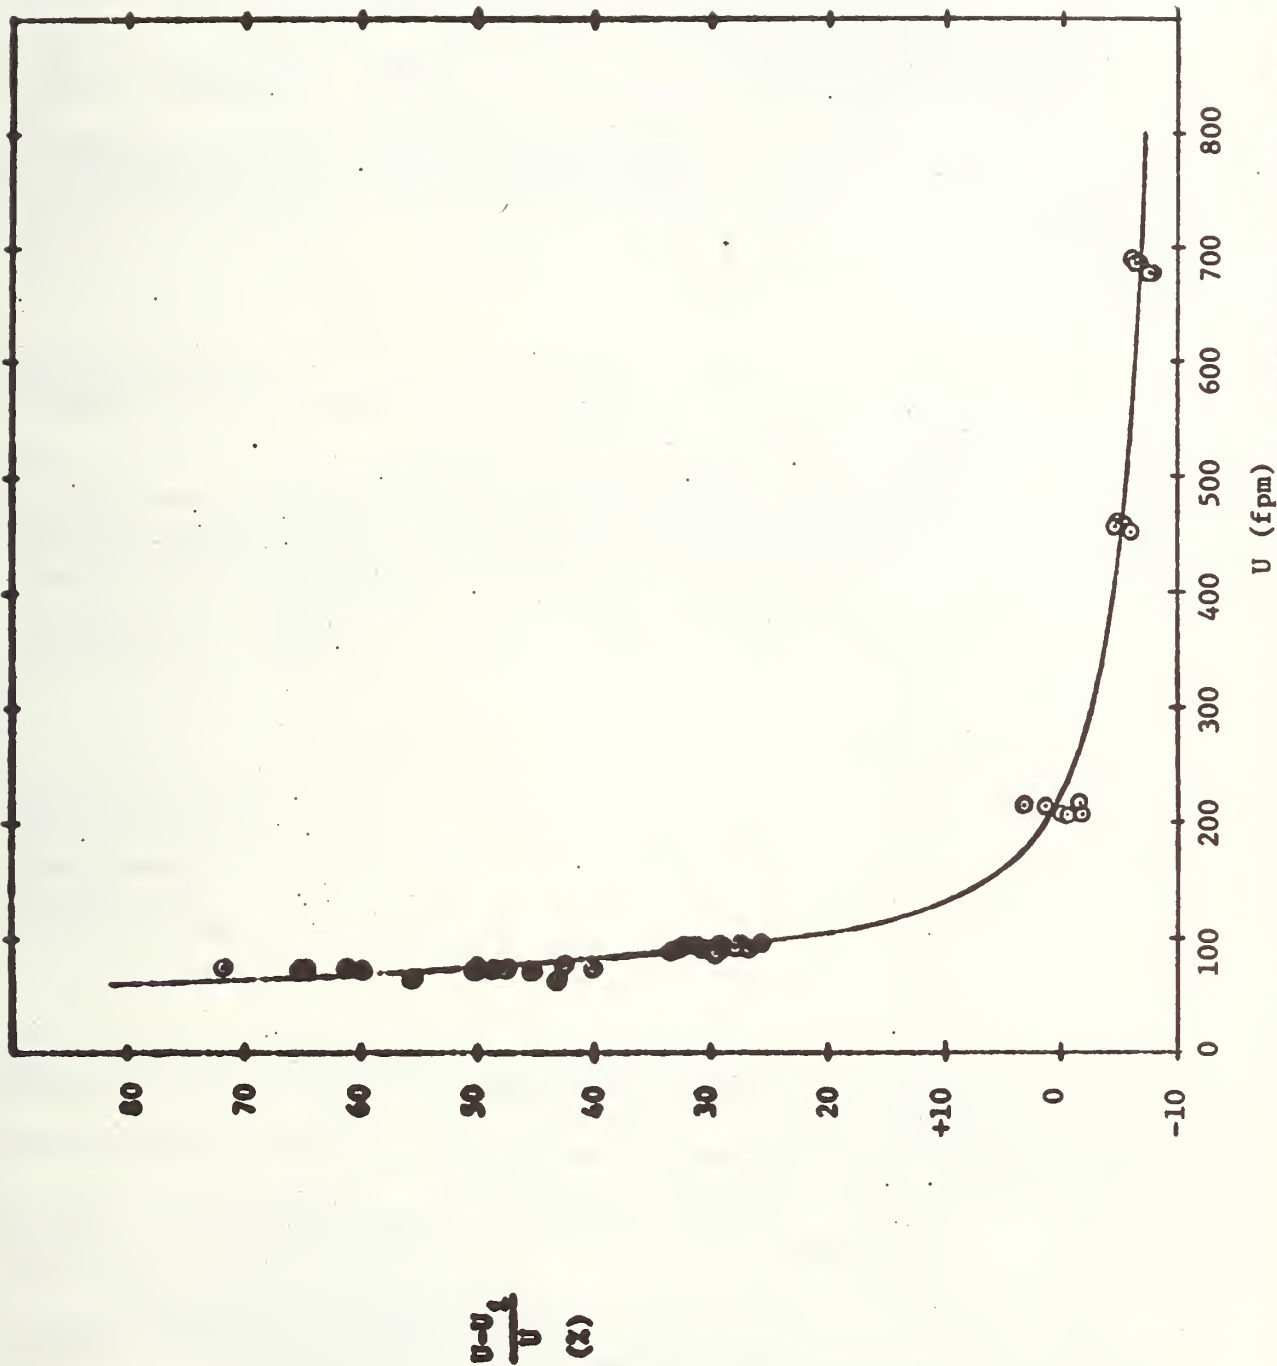
FIGURE 7. PERCENT DEVIATION OF INDICATED VELOCITY FROM TRUE VELOCITY .

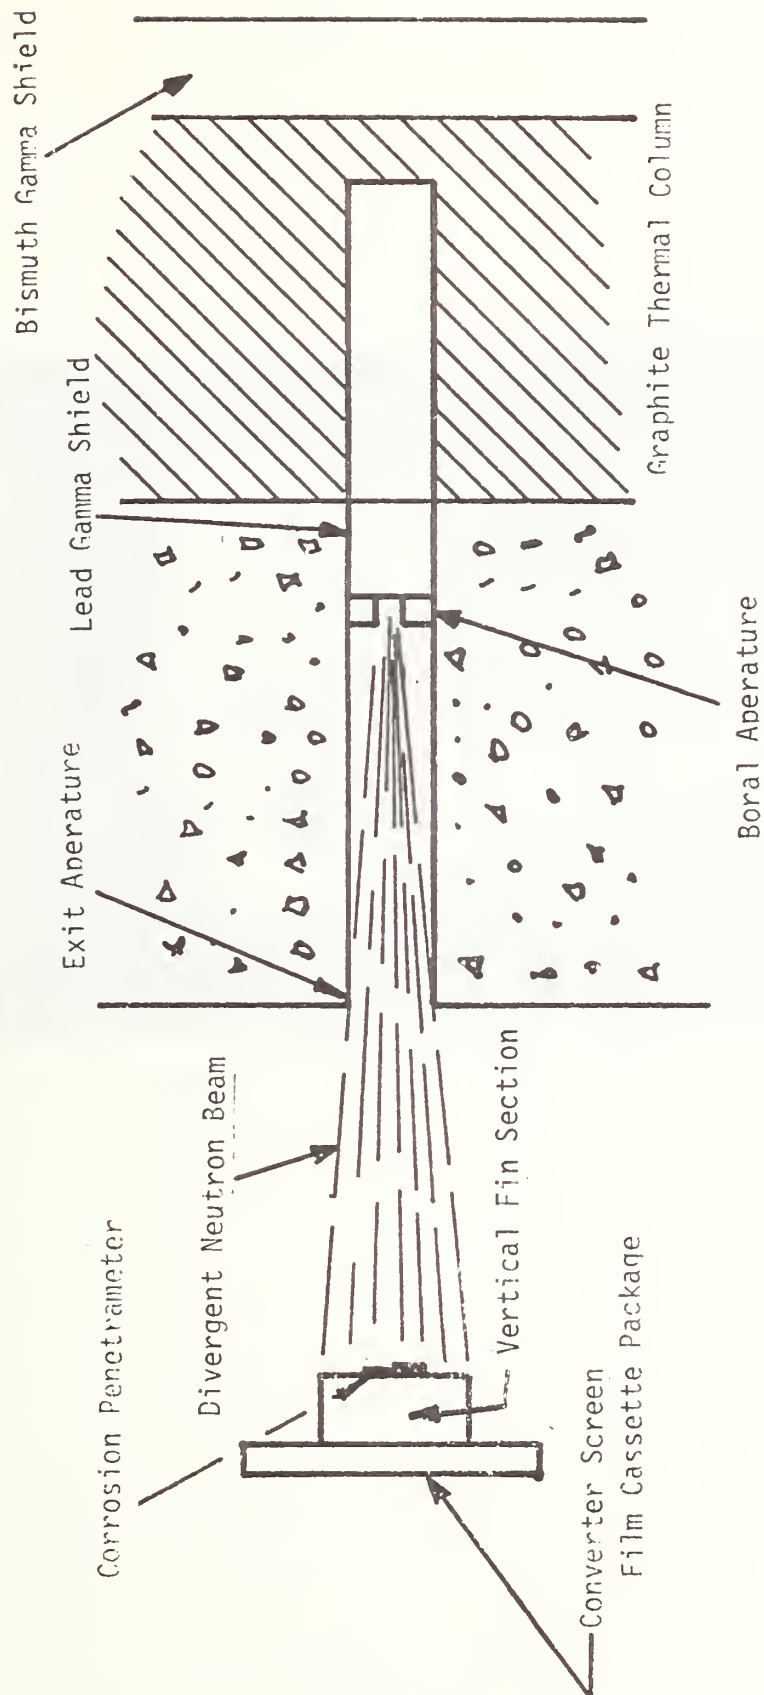
FIGURE 1. SCHEMATIC DIAGRAM OF THE NBS THERMAL NEUTRON RADIOGRAPHY FACILITY

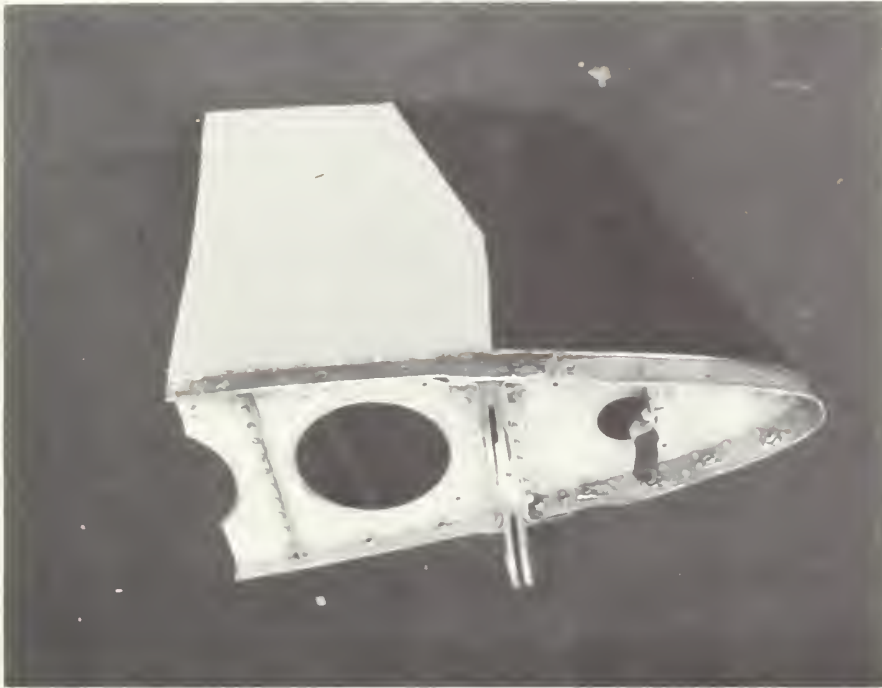
FIGURE 2. C-2 VERTICAL AIRFOIL

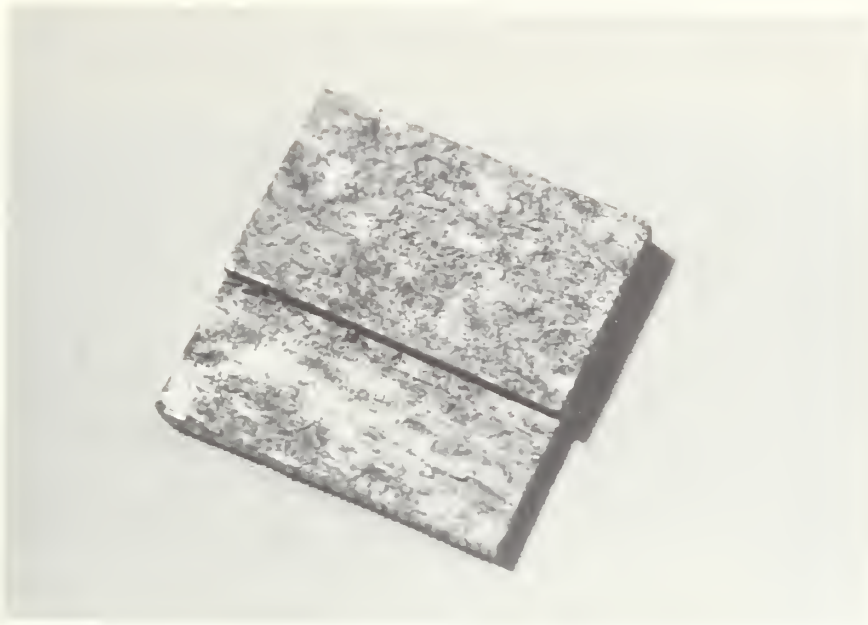
FIGURE 3A. ALUMINUM CORROSION PENETRAMETER

The first was fabricated from aircraft-grade aluminum which had been subjected to a super-saturated salt water spray for 6.5 hrs. Nominal step thicknesses were 0.125 in. and 0.87 in. Two views of this penetrometer are illustrated in Figures 3A and 3B. This penetrometer will be referred to as P-1 in this report.

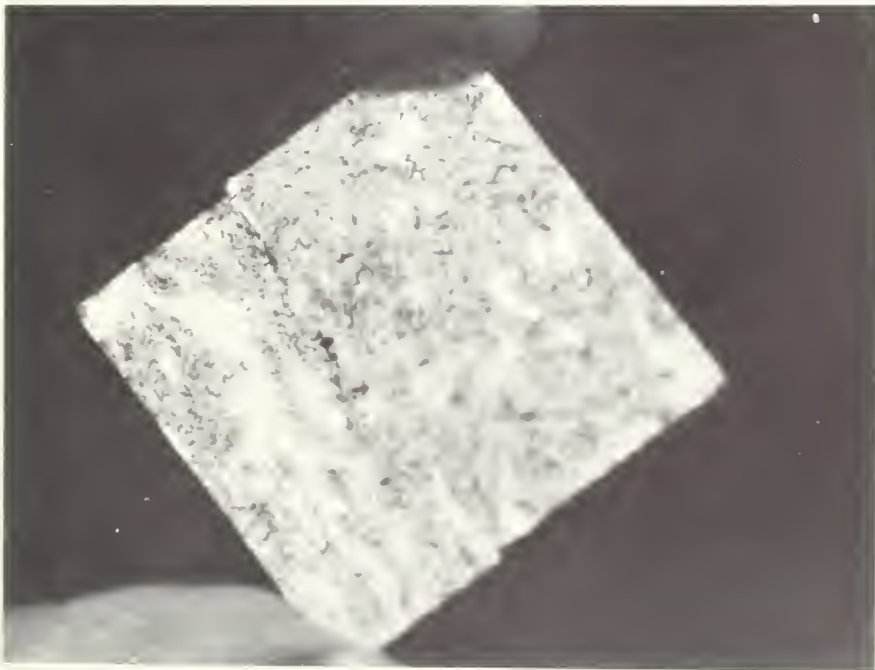
FIGURE 3B. ALUMINUM CORROSION PENETRAMETER CLOSE-UP VIEW

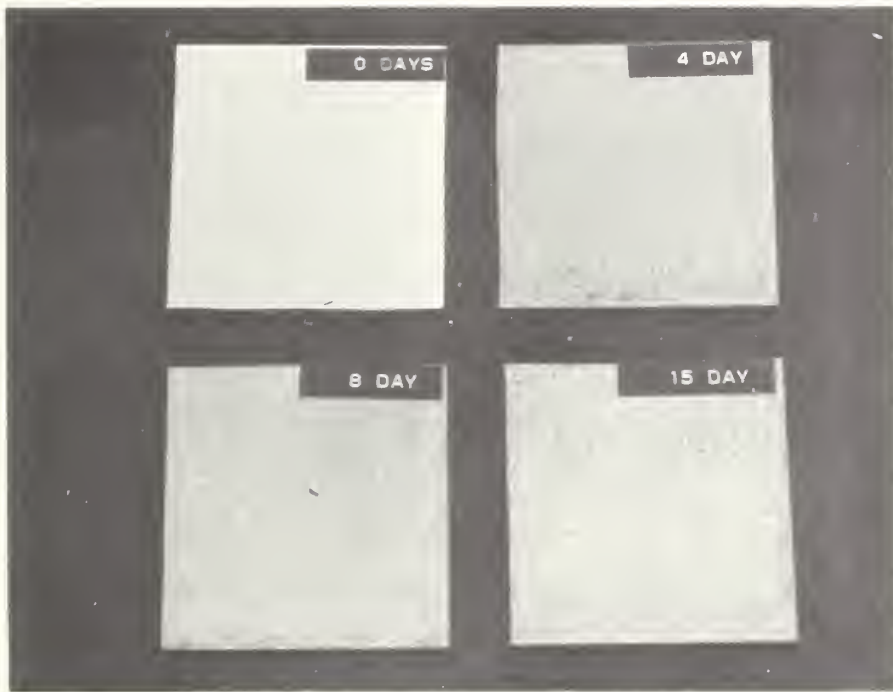
FIGURE 4. ALUMINUM CORROSION PENETRAMETERS P-2-1 THROUGH P-2-4

The second set of four penetrometers was fabricated from 0.062 in.-thick aircraft-grade aluminum plates which had been subjected to a salt water spray/SO₂ gas environment for zero, four, eight and fifteen days. This set which will be referred to as P-2-1 through P-2-4 in this report, is illustrated in Figure 4. No effort was made to correlate the corrosion penetrometers with real life conditions. They were employed only to provide corrosion under standardized conditions.
