The Macroscopic Detection of Corrosion
in Aluminum Aircraft Structures With
Thermal Neutron Beams and Film
Imaging Methods

A Report
Submitted to the U.S. Naval Air
Systems Command, Washington, DC
USN Contract No. N00019-76-IP-69007

December 7, 1977

Donald A. Garrett
Reactor Radiation Division
Institute for Materials Research
National Bureau of Standards
Washington, DC 20234

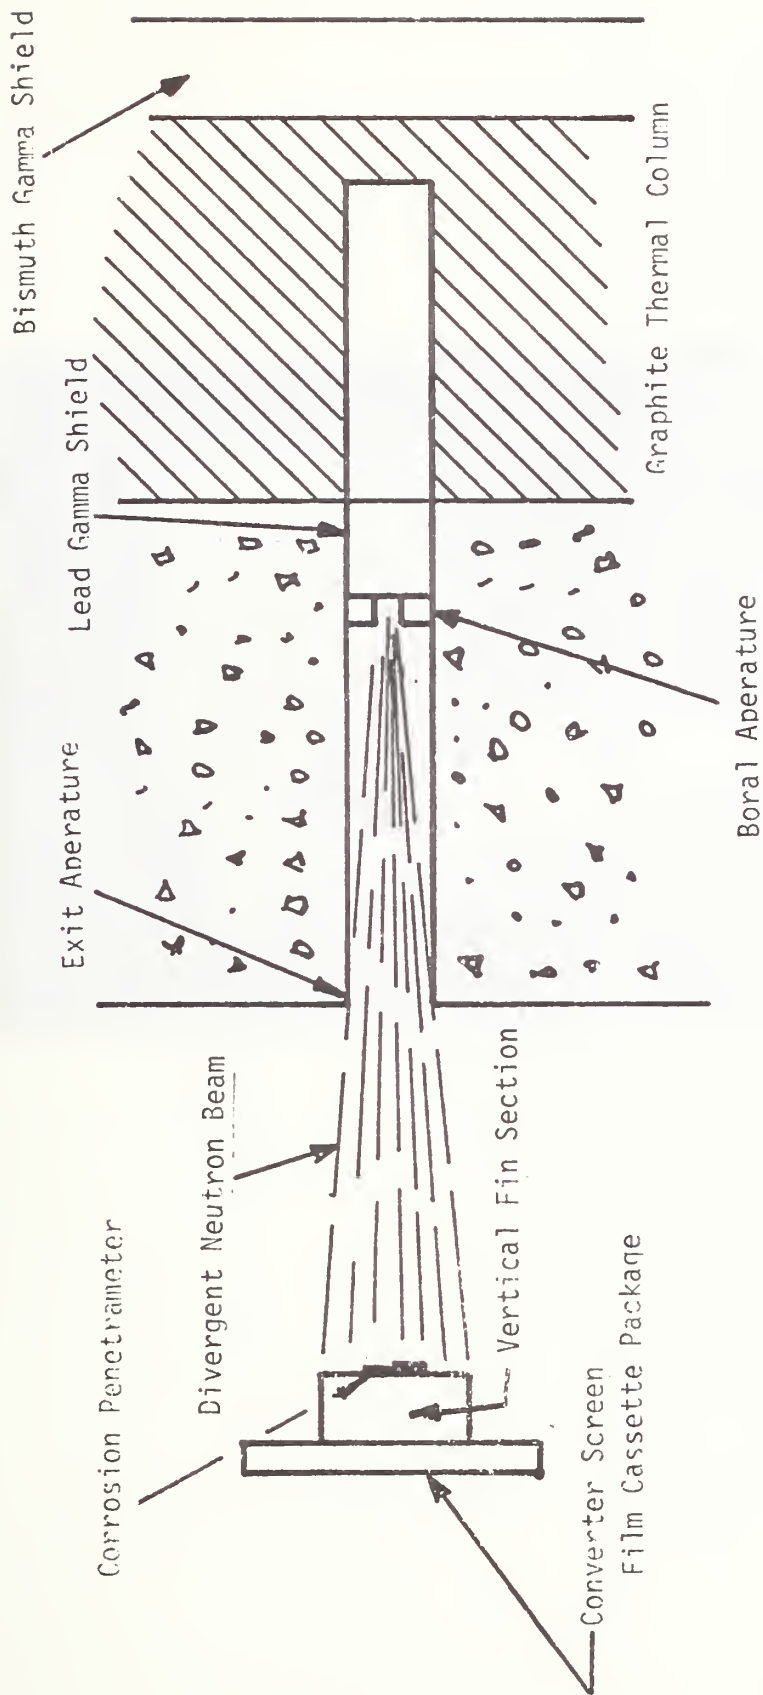
FIGURE 1. SCHEMATIC DIAGRAM OF THE NBS THERMAL NEUTRON RADIOGRAPHY FACILITY

The Thermal Neutron Radiography Facility (TNRF) at the NBS 10MW Research Reactor was employed for these investigations. At a power level of 10MW, the reactor provided a thermal neutron flux of 10^7 n-cm⁻²-sec⁻¹ at the image plane for an L/D ratio of 40:1. The L/D ratio of the facility was variable from a minimum of 40:1 to a maximum of 500:1. The neutron beam is highly thermalized, having a gold-cadmium ratio of 500:1. During the course of these studies, the neutron beam shutter was manually operated. A schematic diagram of the facility is illustrated in Figure 1.

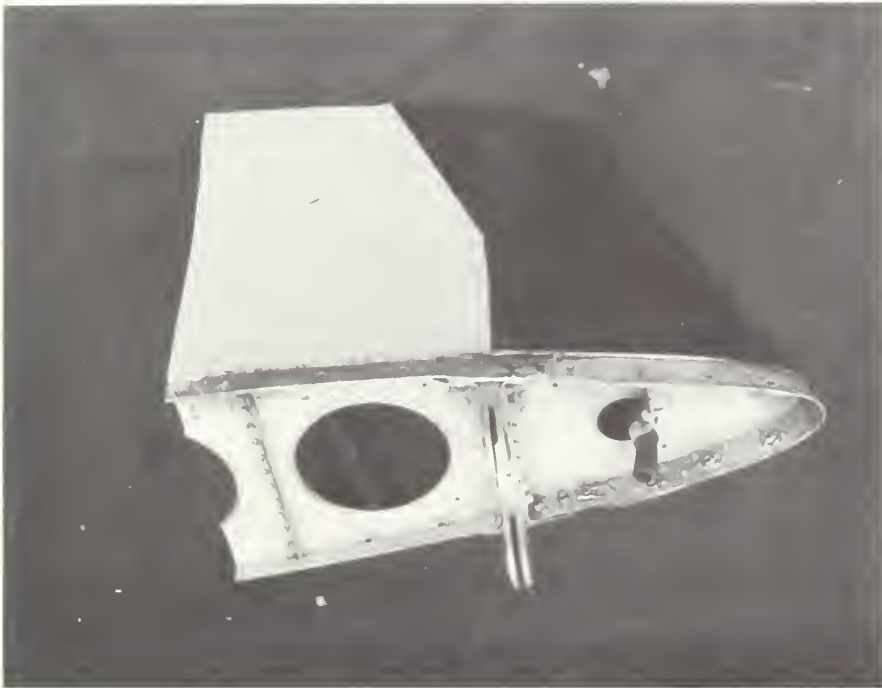
FIGURE 2. C-2 VERTICAL AIRFOIL

All radiographic data generated in these investigations was obtained using direct neutron imaging methods. Manual film development was performed throughout with Eastman Kodak standard industrial radiography chemistry. A 7 in.-thick section cut from an uncorroded C-2 aircraft vertical fin was used as a standard object to be radiographed. The fin, which was obtained from the NAVAIR Rework Facility at North Island, San Diego, CA is illustrated in Figure 2.

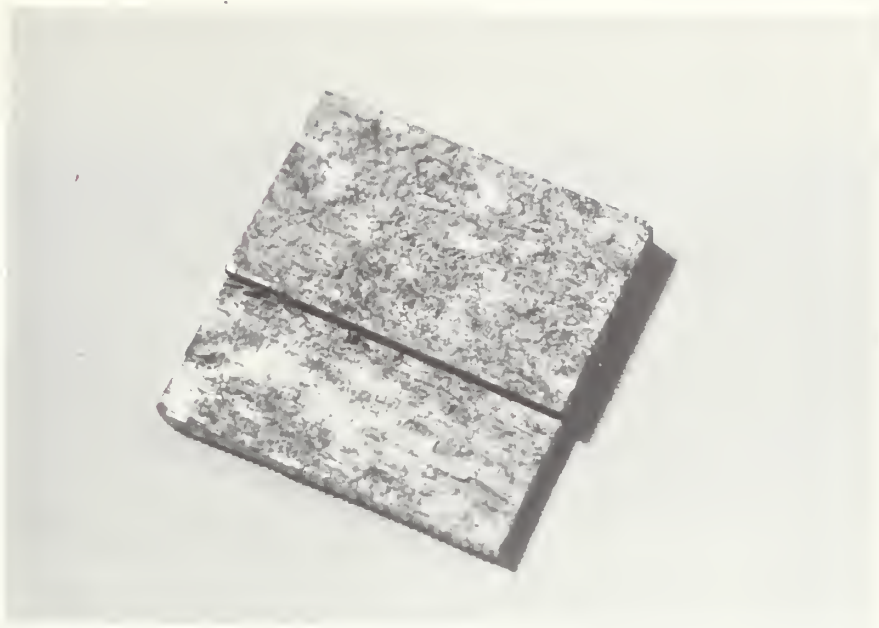
FIGURE 3A. ALUMINUM CORROSION PENETRAMETER

The first was fabricated from aircraft-grade aluminum which had been subjected to a super-saturated salt water spray for 6.5 hrs. Nominal step thicknesses were 0.125 in. and 0.87 in. Two views of this penetrometer are illustrated in Figures 3A and 3B. This penetrometer will be referred to as P-1 in this report.

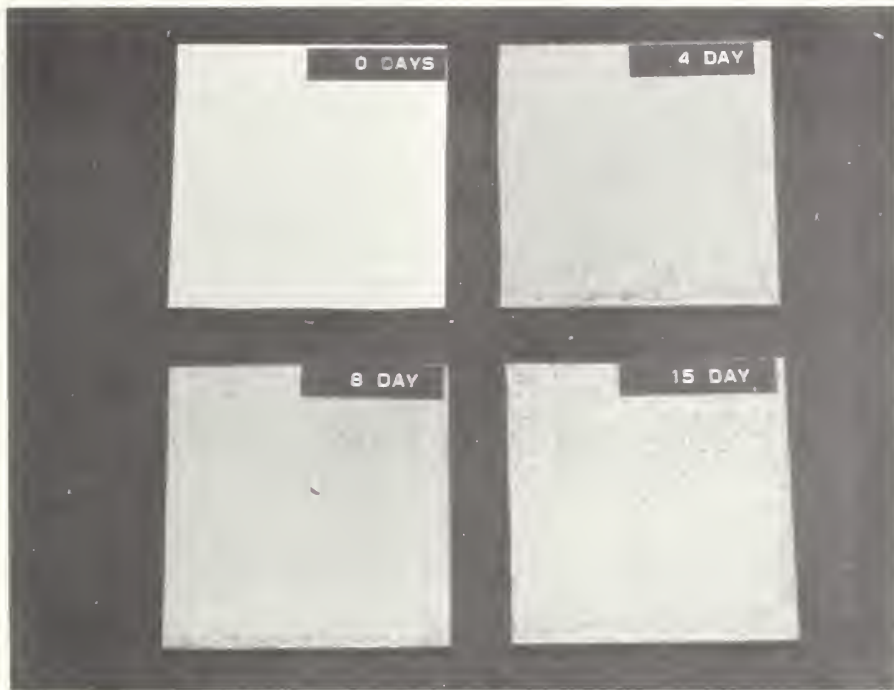
FIGURE 4. ALUMINUM CORROSION PENETRAMETERS P-2-1 THROUGH P-2-4

The second set of four penetrometers was fabricated from 0.062 in.-thick aircraft-grade aluminum plates which had been subjected to a salt water spray/SO₂ gas environment for zero, four, eight and fifteen days. This set which will be referred to as P-2-1 through P-2-4 in this report, is illustrated in Figure 4. No effort was made to correlate the corrosion penetrometers with real life conditions. They were employed only to provide corrosion under standardized conditions.

Penetrameter Number	Exposure Period to Salt Water Spray/SO ₂ Gas Environment (Days)
P-2-1	0
P-2-2	4
P-2-3	8
P-2-4	15

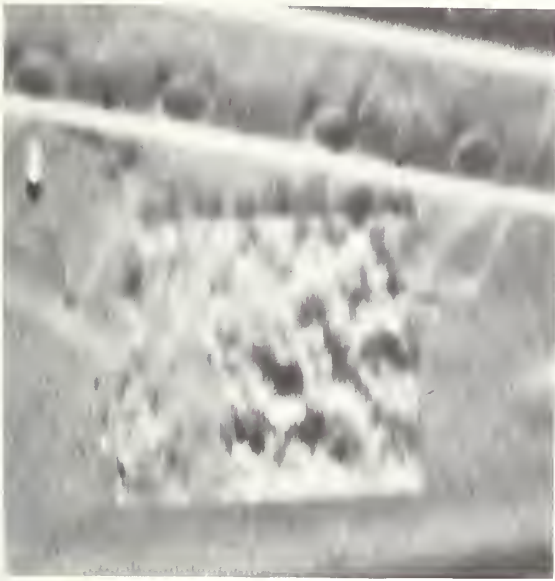
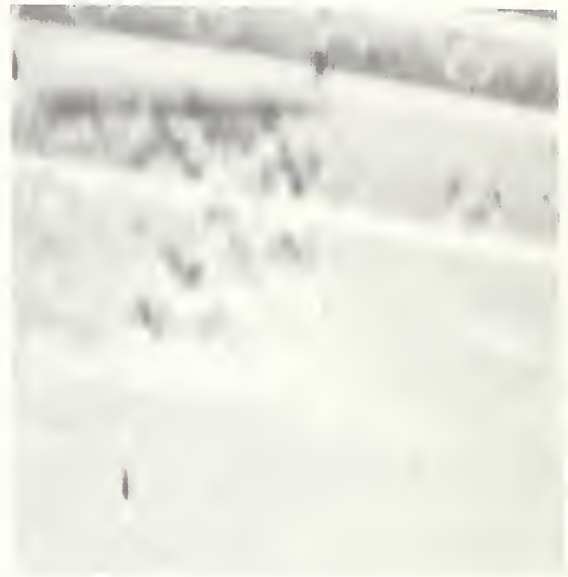
The radiographic parameters employed in the Exposure Series 1A are outlined in Table 1A below. This series of exposures serves to illustrate the radiographic data obtained utilizing a reactor-based system having a high (200:1) L/D ratio and employing medium-contrast (Kodak Type M) film. The radiographic data are illustrated in Figures 5A through 5F.

- (a) Salt water induced corrosion signatures in aircraft-grade aluminum can be visualized with neutron radiography using a 200:1 L/D ratio. The effect of the 7 in.-thick fin thickness is to degrade the image quality. However, the signature can still be discerned as illustrated in Figures 5C and 5D.

Photographic reproduction of high density radiographs was very difficult to accomplish for this report, e.g., the overexposure of Figure 5 compared to Figure 6 is not real, but is due to the photographic reproduction.

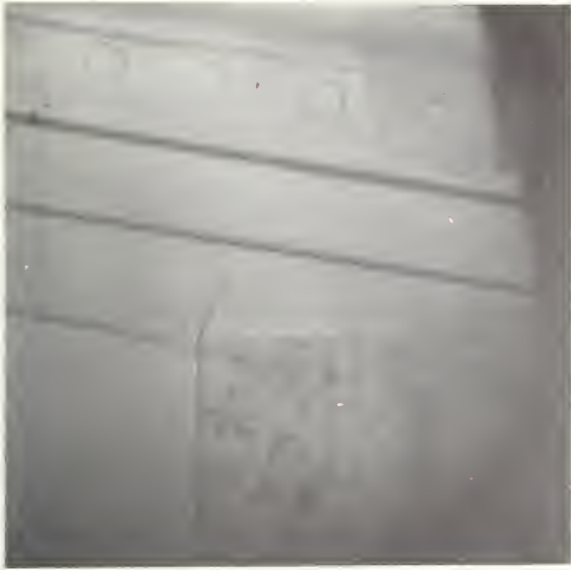
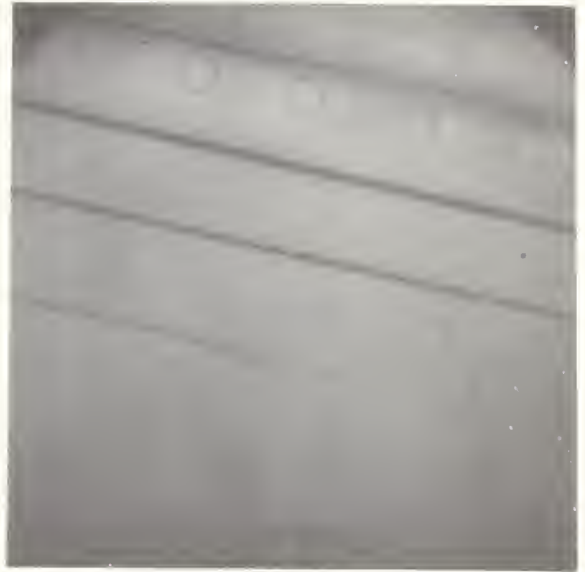
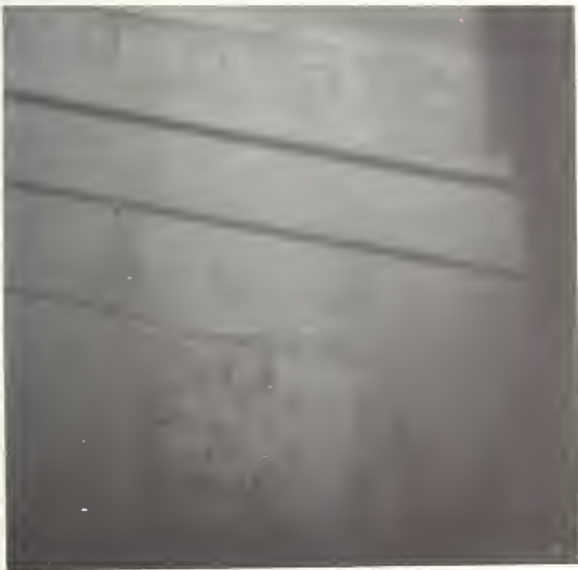
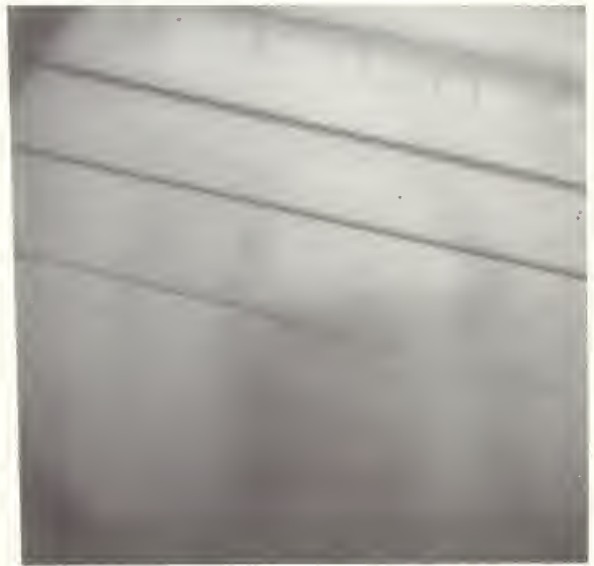
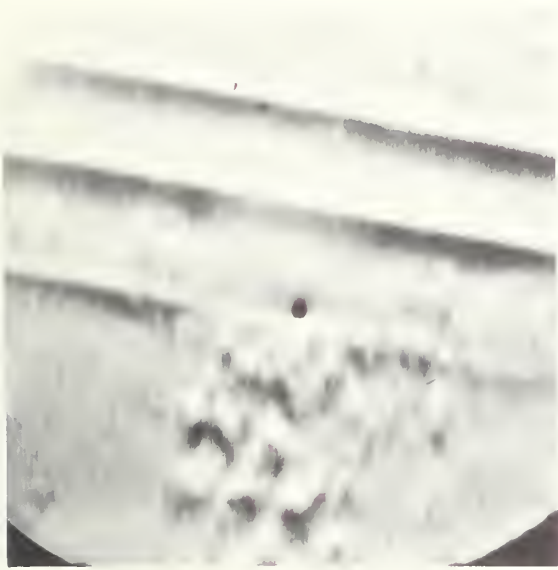
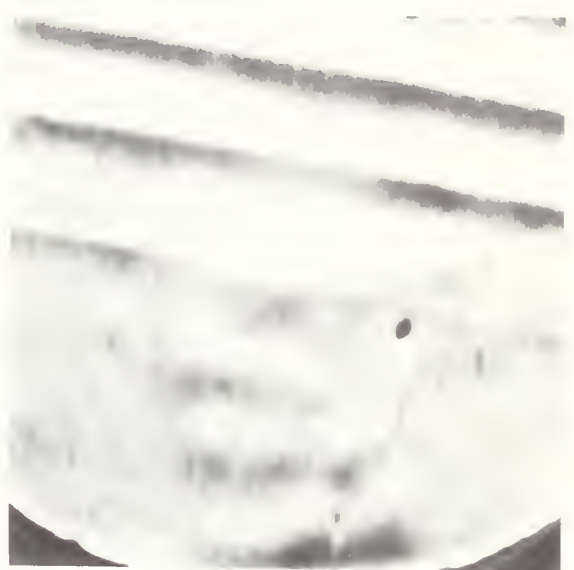
The radiographic data derived from Exposure Series 1B are illustrated in Figures 6A through 6F.

- (b) The time required for the exposure was 50 min. for a L/D ratio of 200:1.
- (c) With the penetrometer on either side of the fin, analog edge enhancement aids in identifying the corrosion signature.
- (d) When the L/D ratio is reduced to that of a field system, e.g., 43:1, The corrosion signature can only be visualized when the penetrometer was placed on the cassette side of the fin as shown in Figures 6C and 6D, making it necessary to inspect each side of an airfoil of 7 in. thickness individually.
- (e) The time required for the exposure was 90 sec. for a L/D ratio of 43:1.
- (f) With a L/D ratio of 43:1, image edge enhancement aids in visualizing the corrosion penetrometer when placed on the source side of the film, however, paint could possibly produce a similar signature.

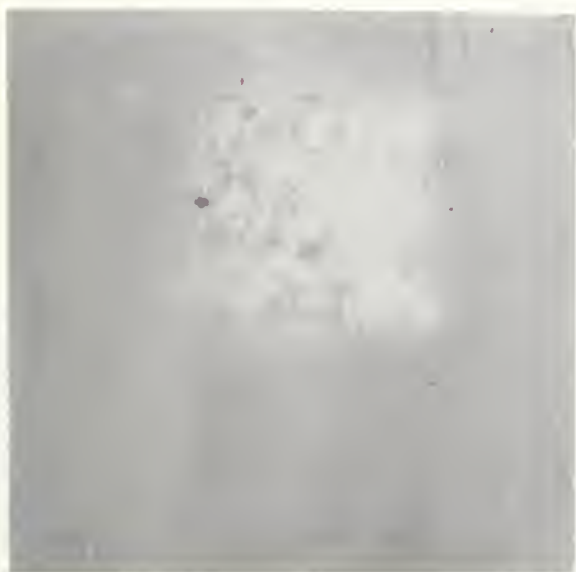
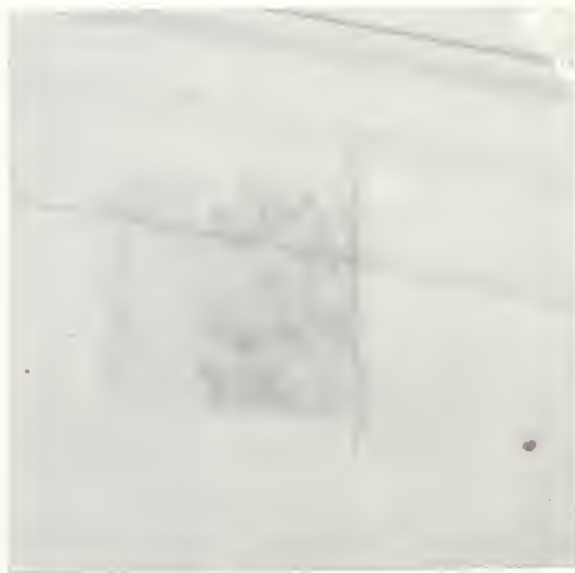
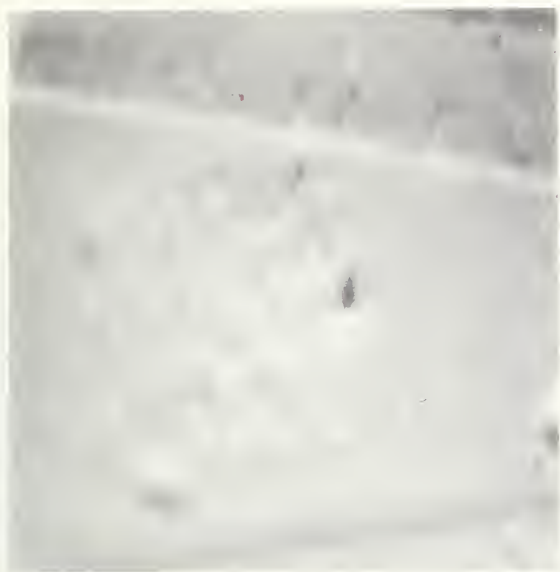
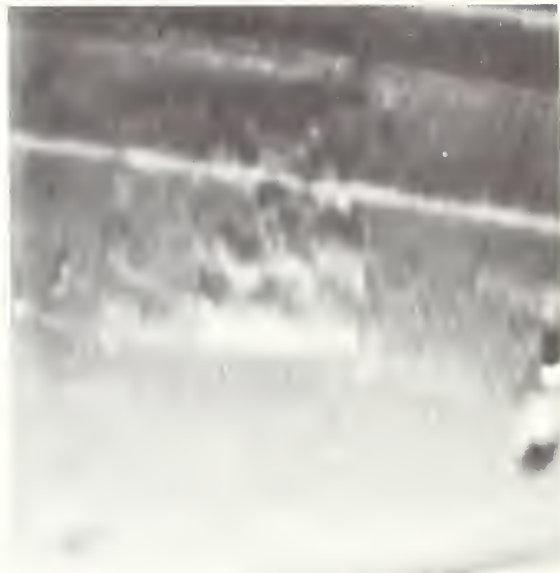
Fig. 7: Exposure Series 2A: Radiographic Data

The radiographic data resulting from exposure series 2A are illustrated in Figures 7A through 7F.

- (a) Corrosion signatures can be visualized using Gd_2O_2S converters with the penetrometer placed on either side of the 7 in.-thick fin, using an L/D ratio of 200:1. The apparent contrast was not as high as that obtained with Gd foil, as illustrated in Figures 7C and 7D.

- (b) The exposure time required using a Gd_2O_2S converter was 15 min. for a L/D ratio of 200:1.
- (c) Image edge enhancement aided in identifying the corrosion signature on either side of the fin with a L/D ratio of 200:1.

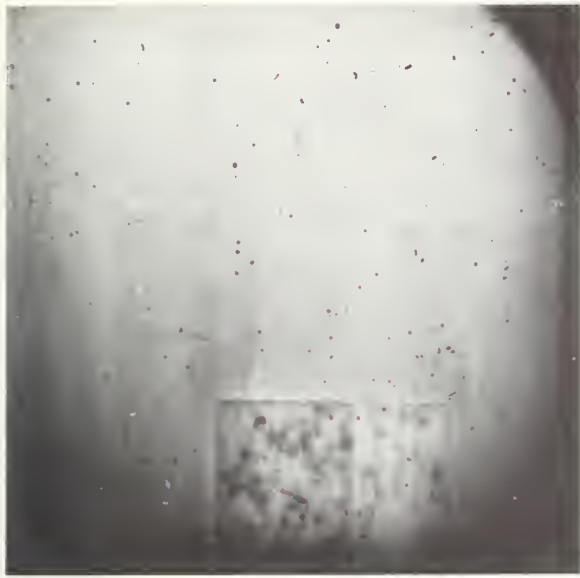
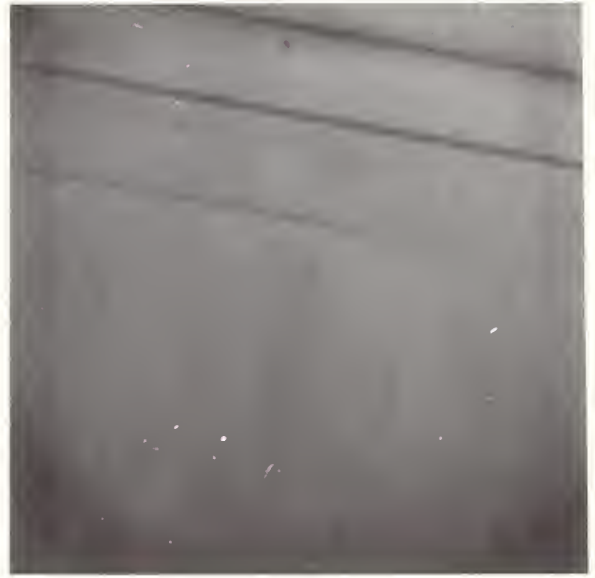
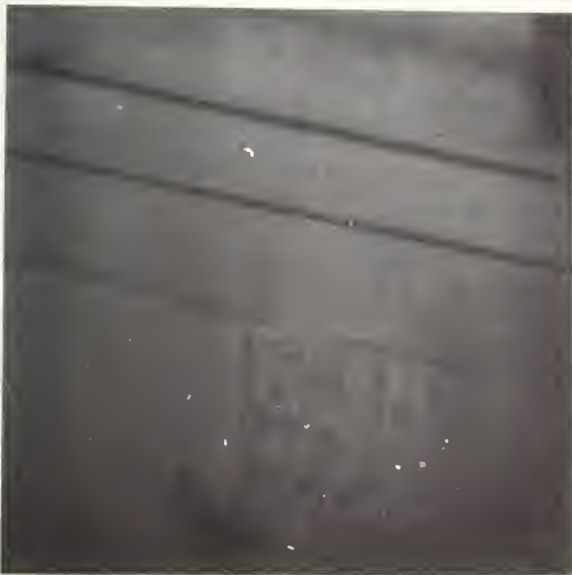
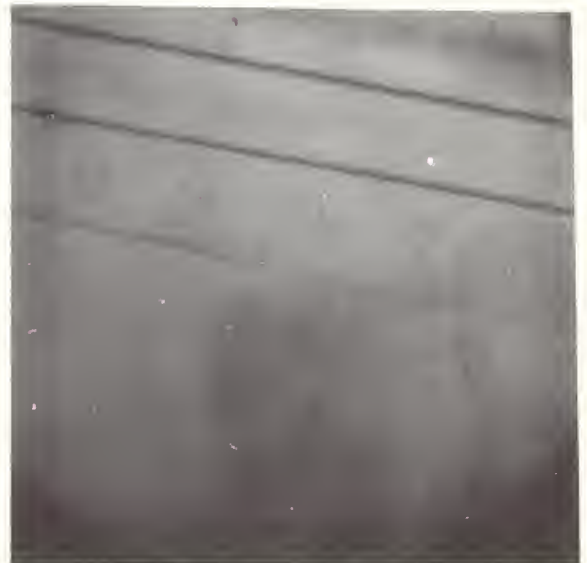
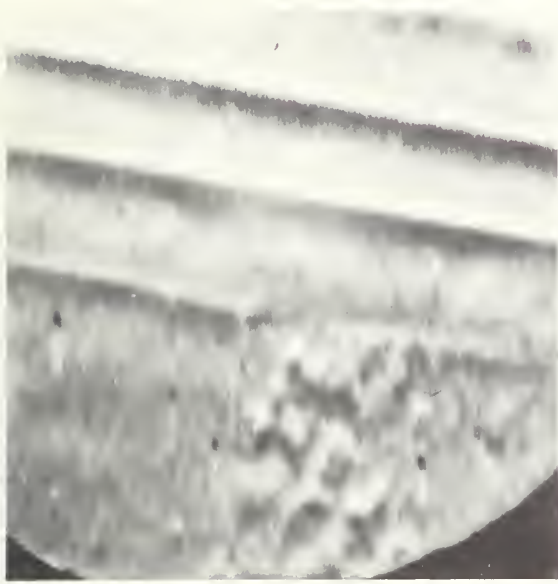
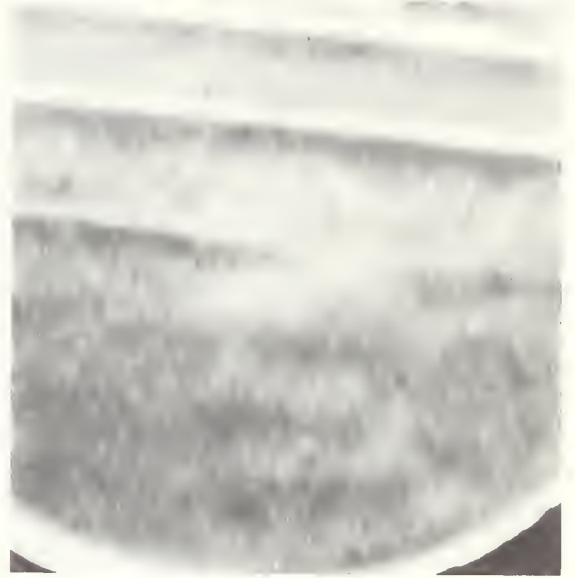
The radiographic data from this exposure series are illustrated in Figures 8A through 8F.

- (d) When the L/D ratio was reduced to 43:1 using a Gd_2O_2S converter, the corrosion signature could only be visualized with the penetrometer placed between the cassette and the fin as illustrated in Figure 8C. All image detail was eliminated due to geometrical unsharpness when the corrosion penetrometer was placed on the source side of the fin as shown in Figure 8D.

- (e) The exposure required 45 sec. to complete.
- (f) Edge enhancement did aid in the visualization of the penetrometer when it was placed between the fin and cassette, however, played little role in the detection of the corrosion signature when the penetrometer was placed on the source side of the cassette.

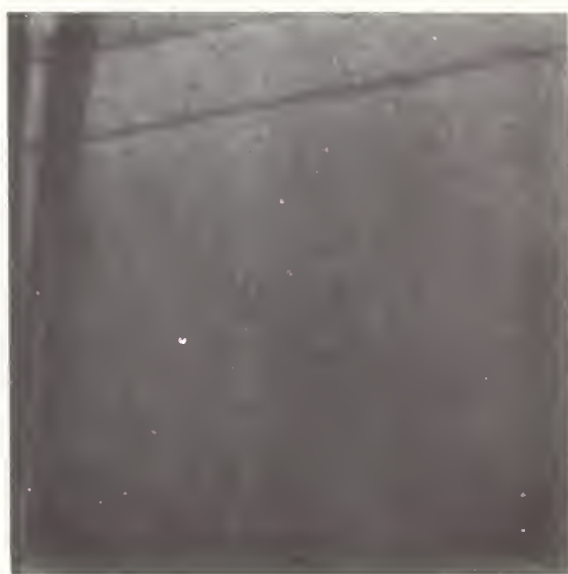
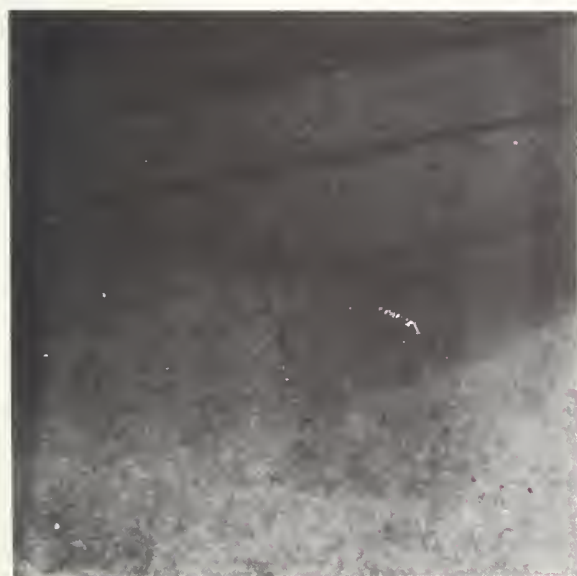
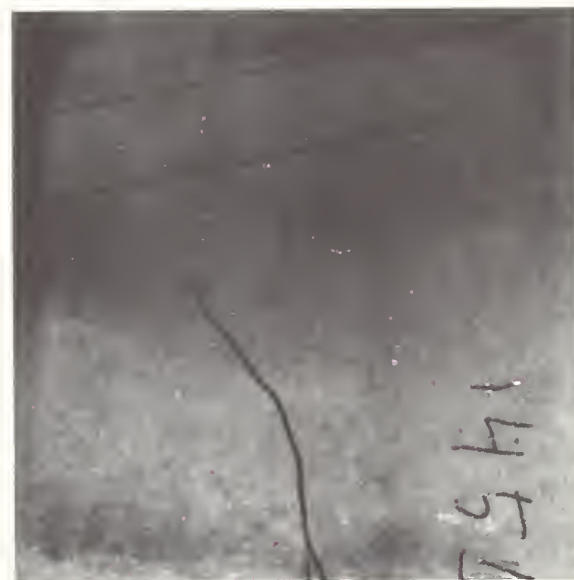
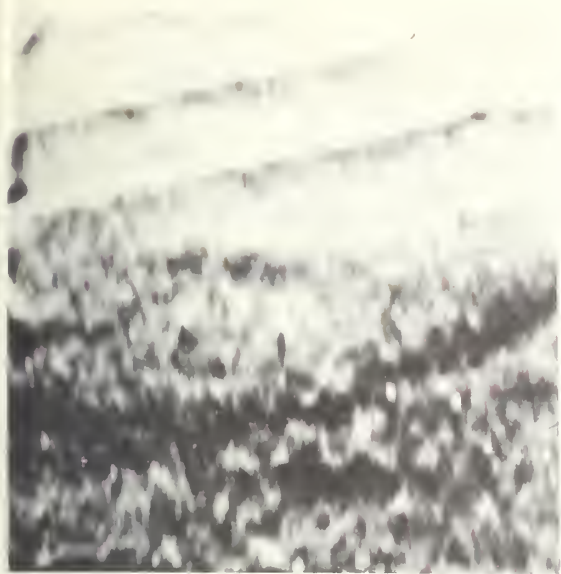
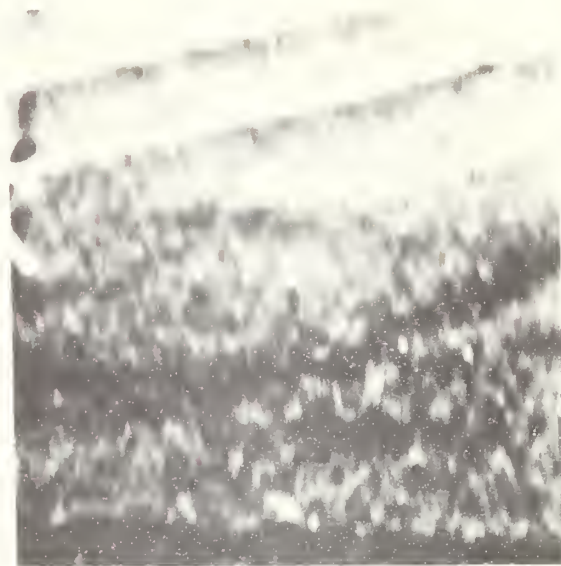
Radiographic data from Exposure 3A are illustrated in Figure 9A through 9F.

- (a) Using a Nuclear Enterprise NE 421 $^6\text{LiF/Zns}$ light-emitting converter in conjunction with Kodak Blue Brand film and a L/D ratio of 200:1, it was possible to visualize the corrosion signature when the penetrameter was placed between the vertical fin and cassette. The image quality was so poor however, that it could easily be confused with the scintillator mottling as illustrated in Figure 9C.
- (b) The exposure time required was 5 sec.
- (c) When the corrosion penetrameter was placed on the source side of the fin section, it was impossible to differentiate accurately between the corrosion signature and the background mottling.
- (d) Edge image enhancement provided no useful purpose in the visualization of the corrosion signature with the penetrameter on either side of the film.

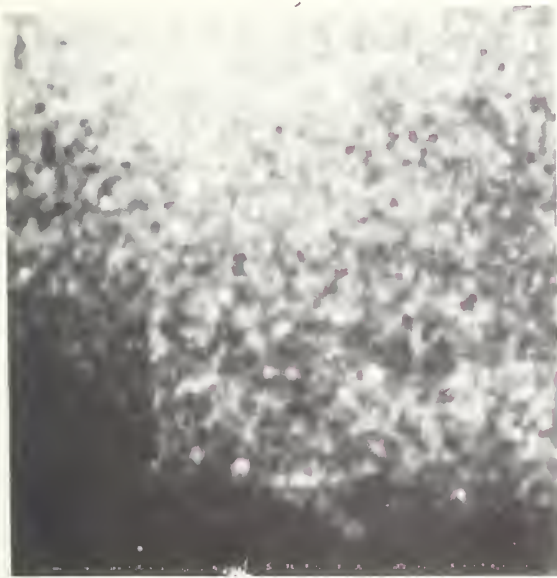
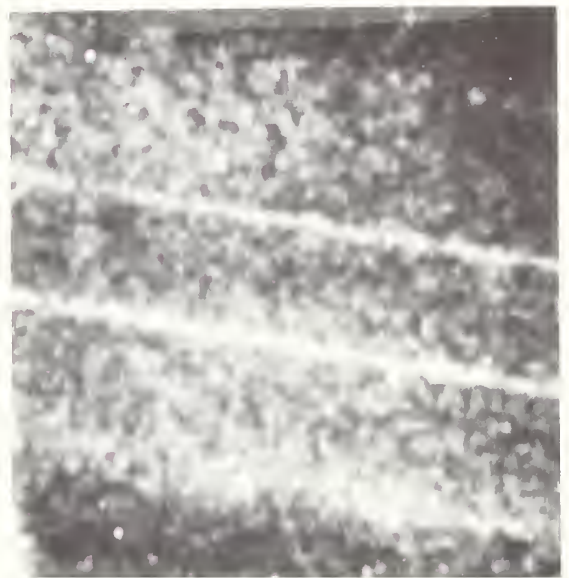
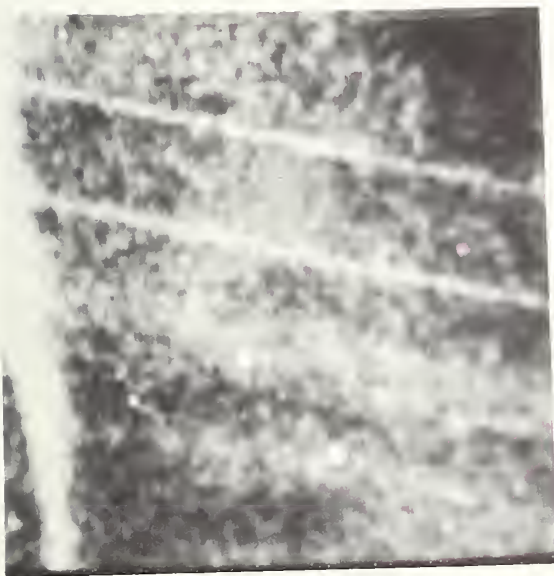
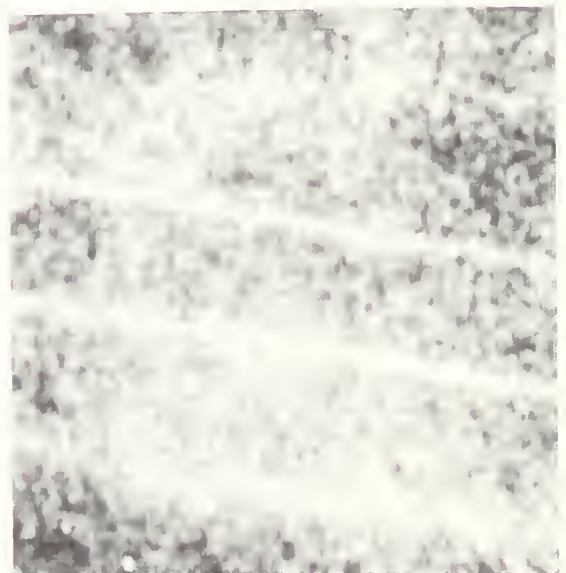
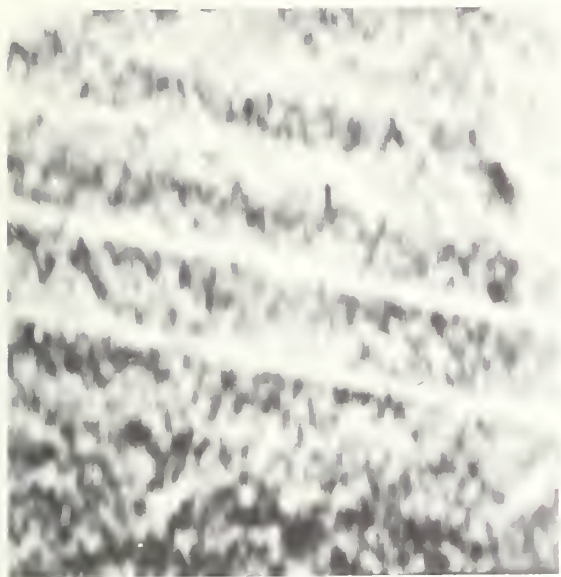
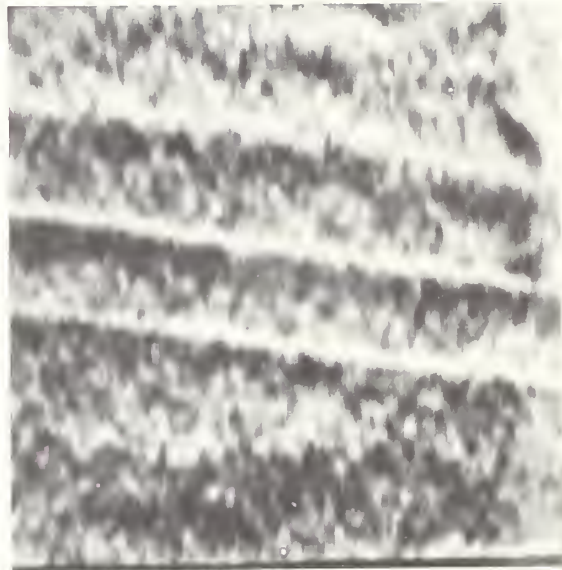
Fig. 10: Exposure Series 3B: Radiographic Data

The radiographic data derived from these exposures is illustrated in Figures 10A through 10F.

- (e) When the L/D ratio was reduced to 43:1, it was impossible to accurately distinguish between the corrosion signature and the background mottling with the penetrometer on either side of the vertical fin.
- (f) The exposure time required for this radiograph was approximately 0.2 sec.

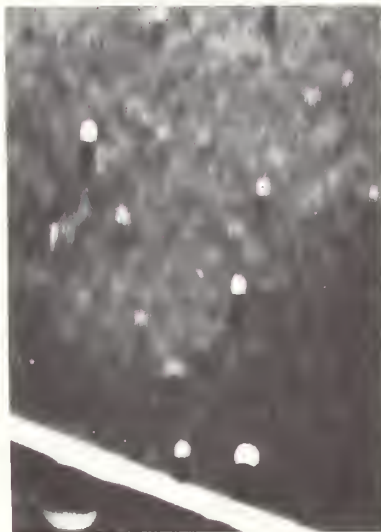
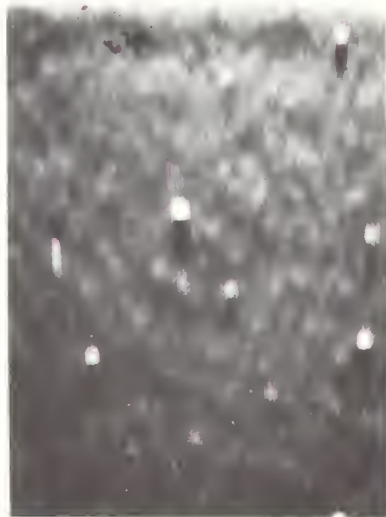
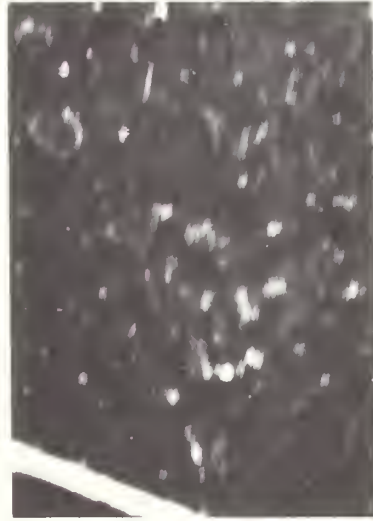
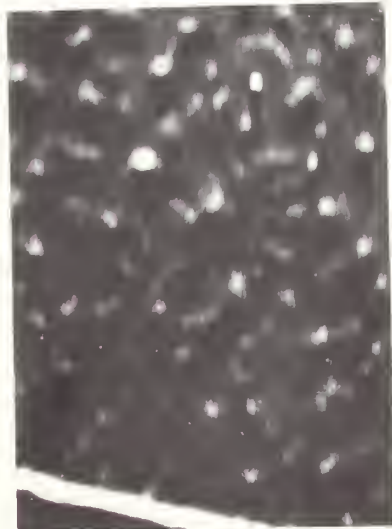
Fig. 11: Exposure Series: Radiographic Data

The radiographic data illustrated in Figures 11A, 11C, 11E and 11G are video reproductions of penetrameters subjected to the corrosive environment for periods of 0, 4, 8 and 15 days respectively. The data illustrated in Figures 11B, 11D, 11E and 11G illustrate the edge enhanced reproductions respectively of these radiographs. It should be noted that the artifacts which appear as white dots in the neutron radiographic images were the result of dirt or other foreign neutron absorbing matter on the inside of the airfoil and were not images of the corrosion penetrameter.

- (a) Thermal neutron radiographs of the four calibrated corrosion penetrameters P-2-1 through P-2-4 are illustrated in Figures 11A, 11B, 11C and 11D. These penetrameters were corroded with a salt water spray/SO₂ gas mixture for periods of 0, 4, 8 and 15 days respectively.
- (b) In the corrosion radiographs illustrated in Figures 11A and 11C, the corrosion cannot be distinguished from the background noise as shown in the edge enhanced illustrations in

Figures 11E and 11F. It is likely that the mottled background noise is due to the neutron response to the fin paint.

(c) Environment induced corrosion can be observed without image enhancement in the 8 and 15 day samples illustrated in Figures 11C and 11D respectively. Image enhancement serves to render the corrosion images more observable as illustrated in Figures 11G and 11H.
