NBS
Publications

A 11104 498807

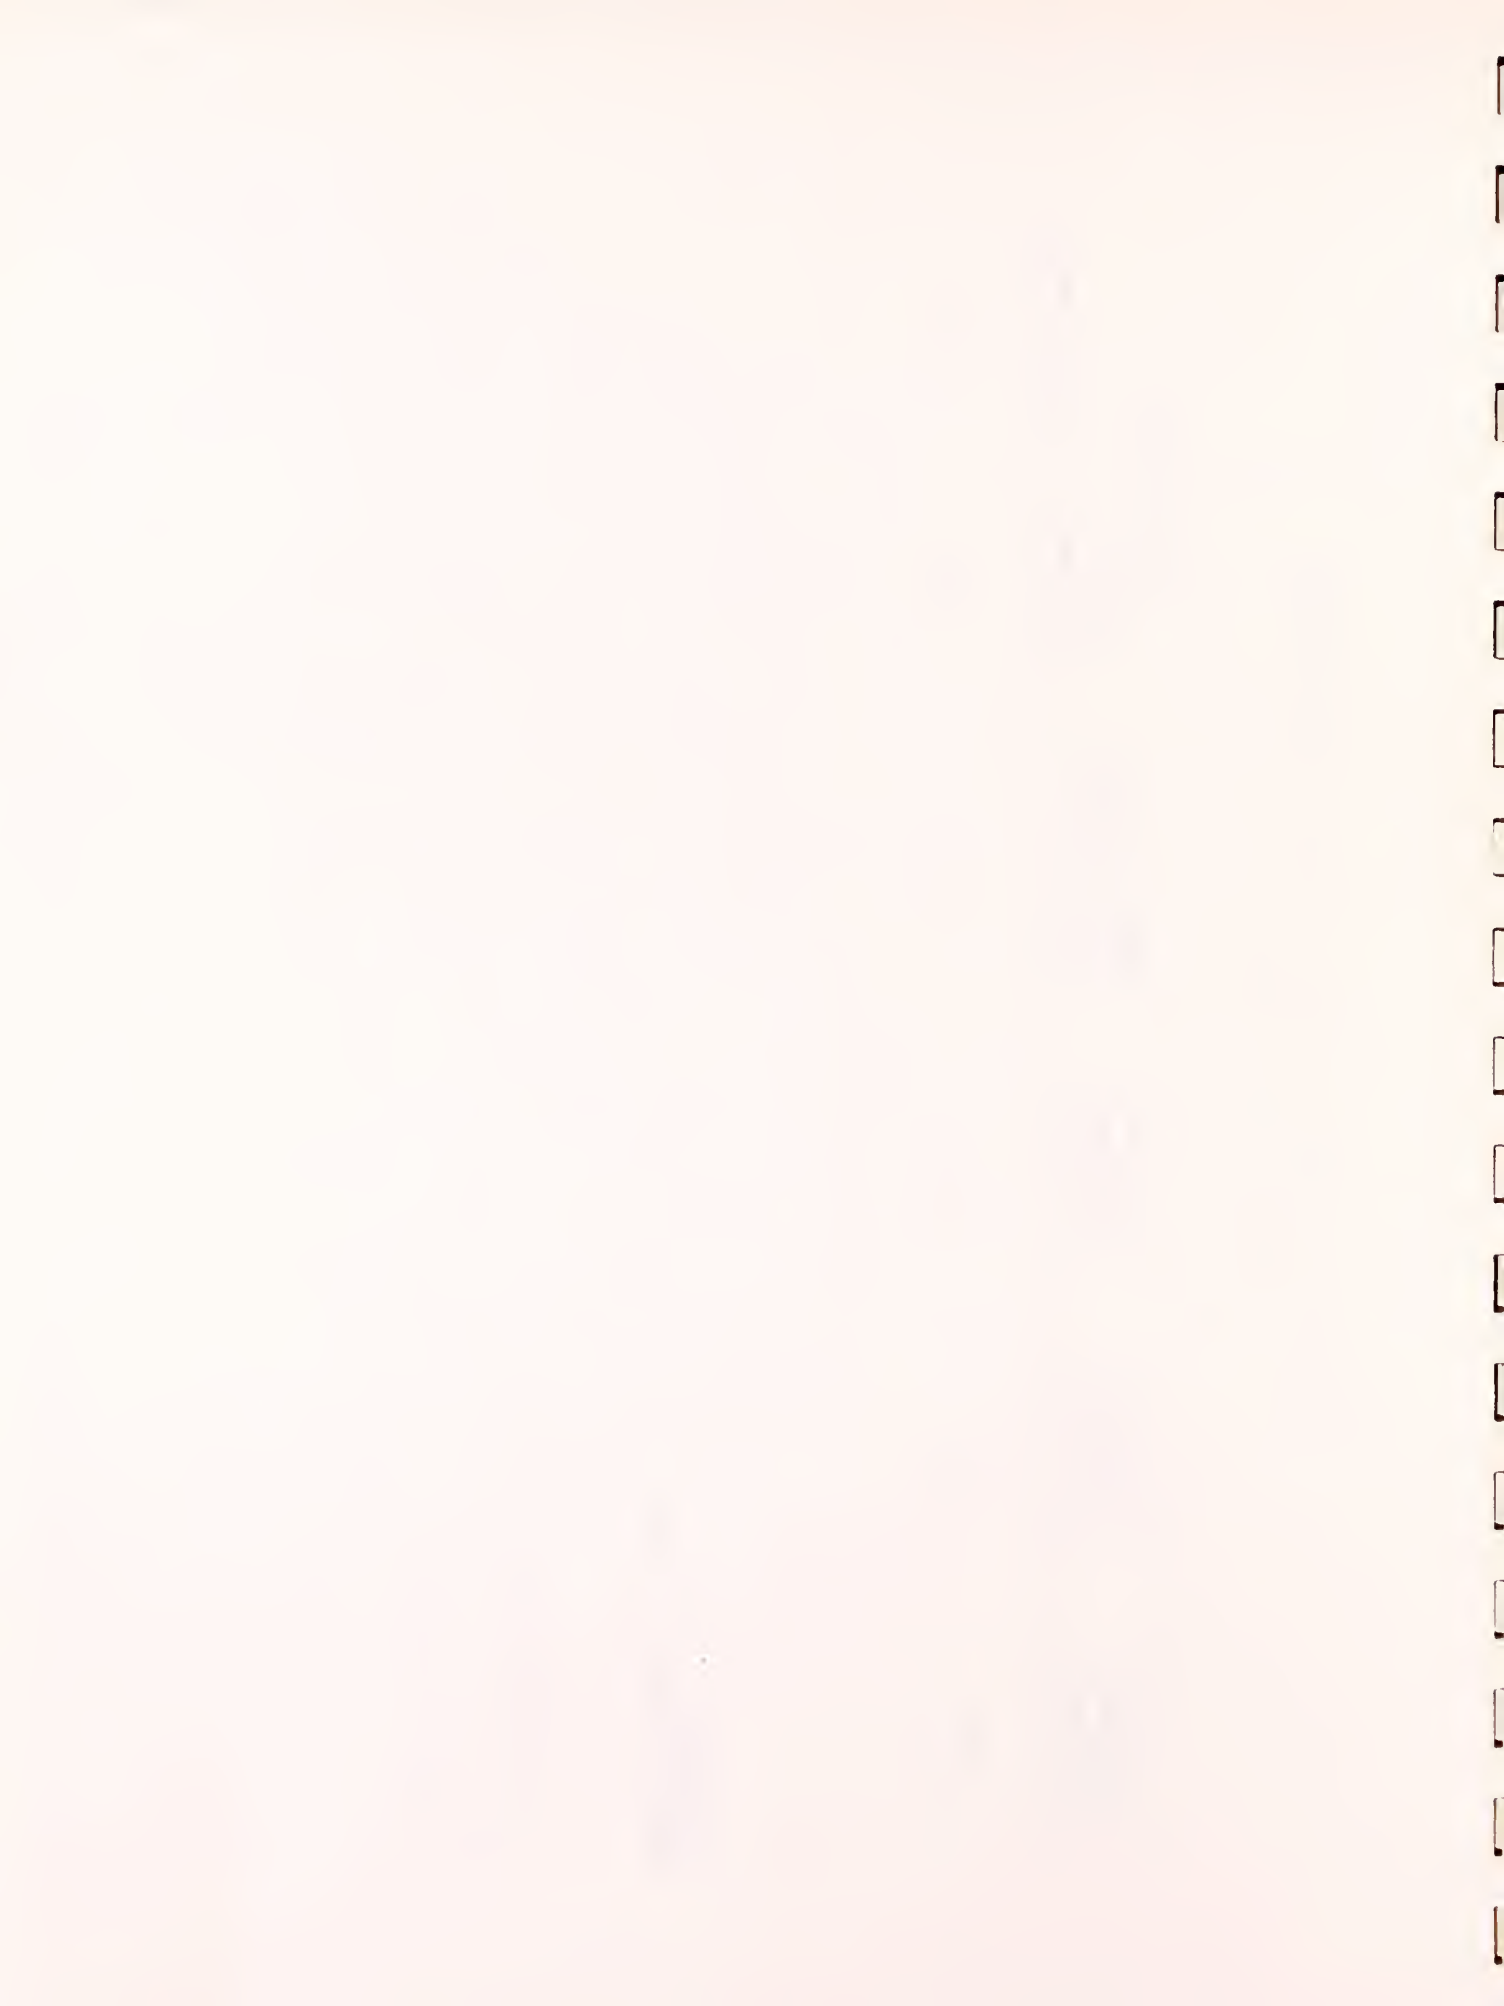
Table V Drop-Weight Test Behavior of Winder Plate

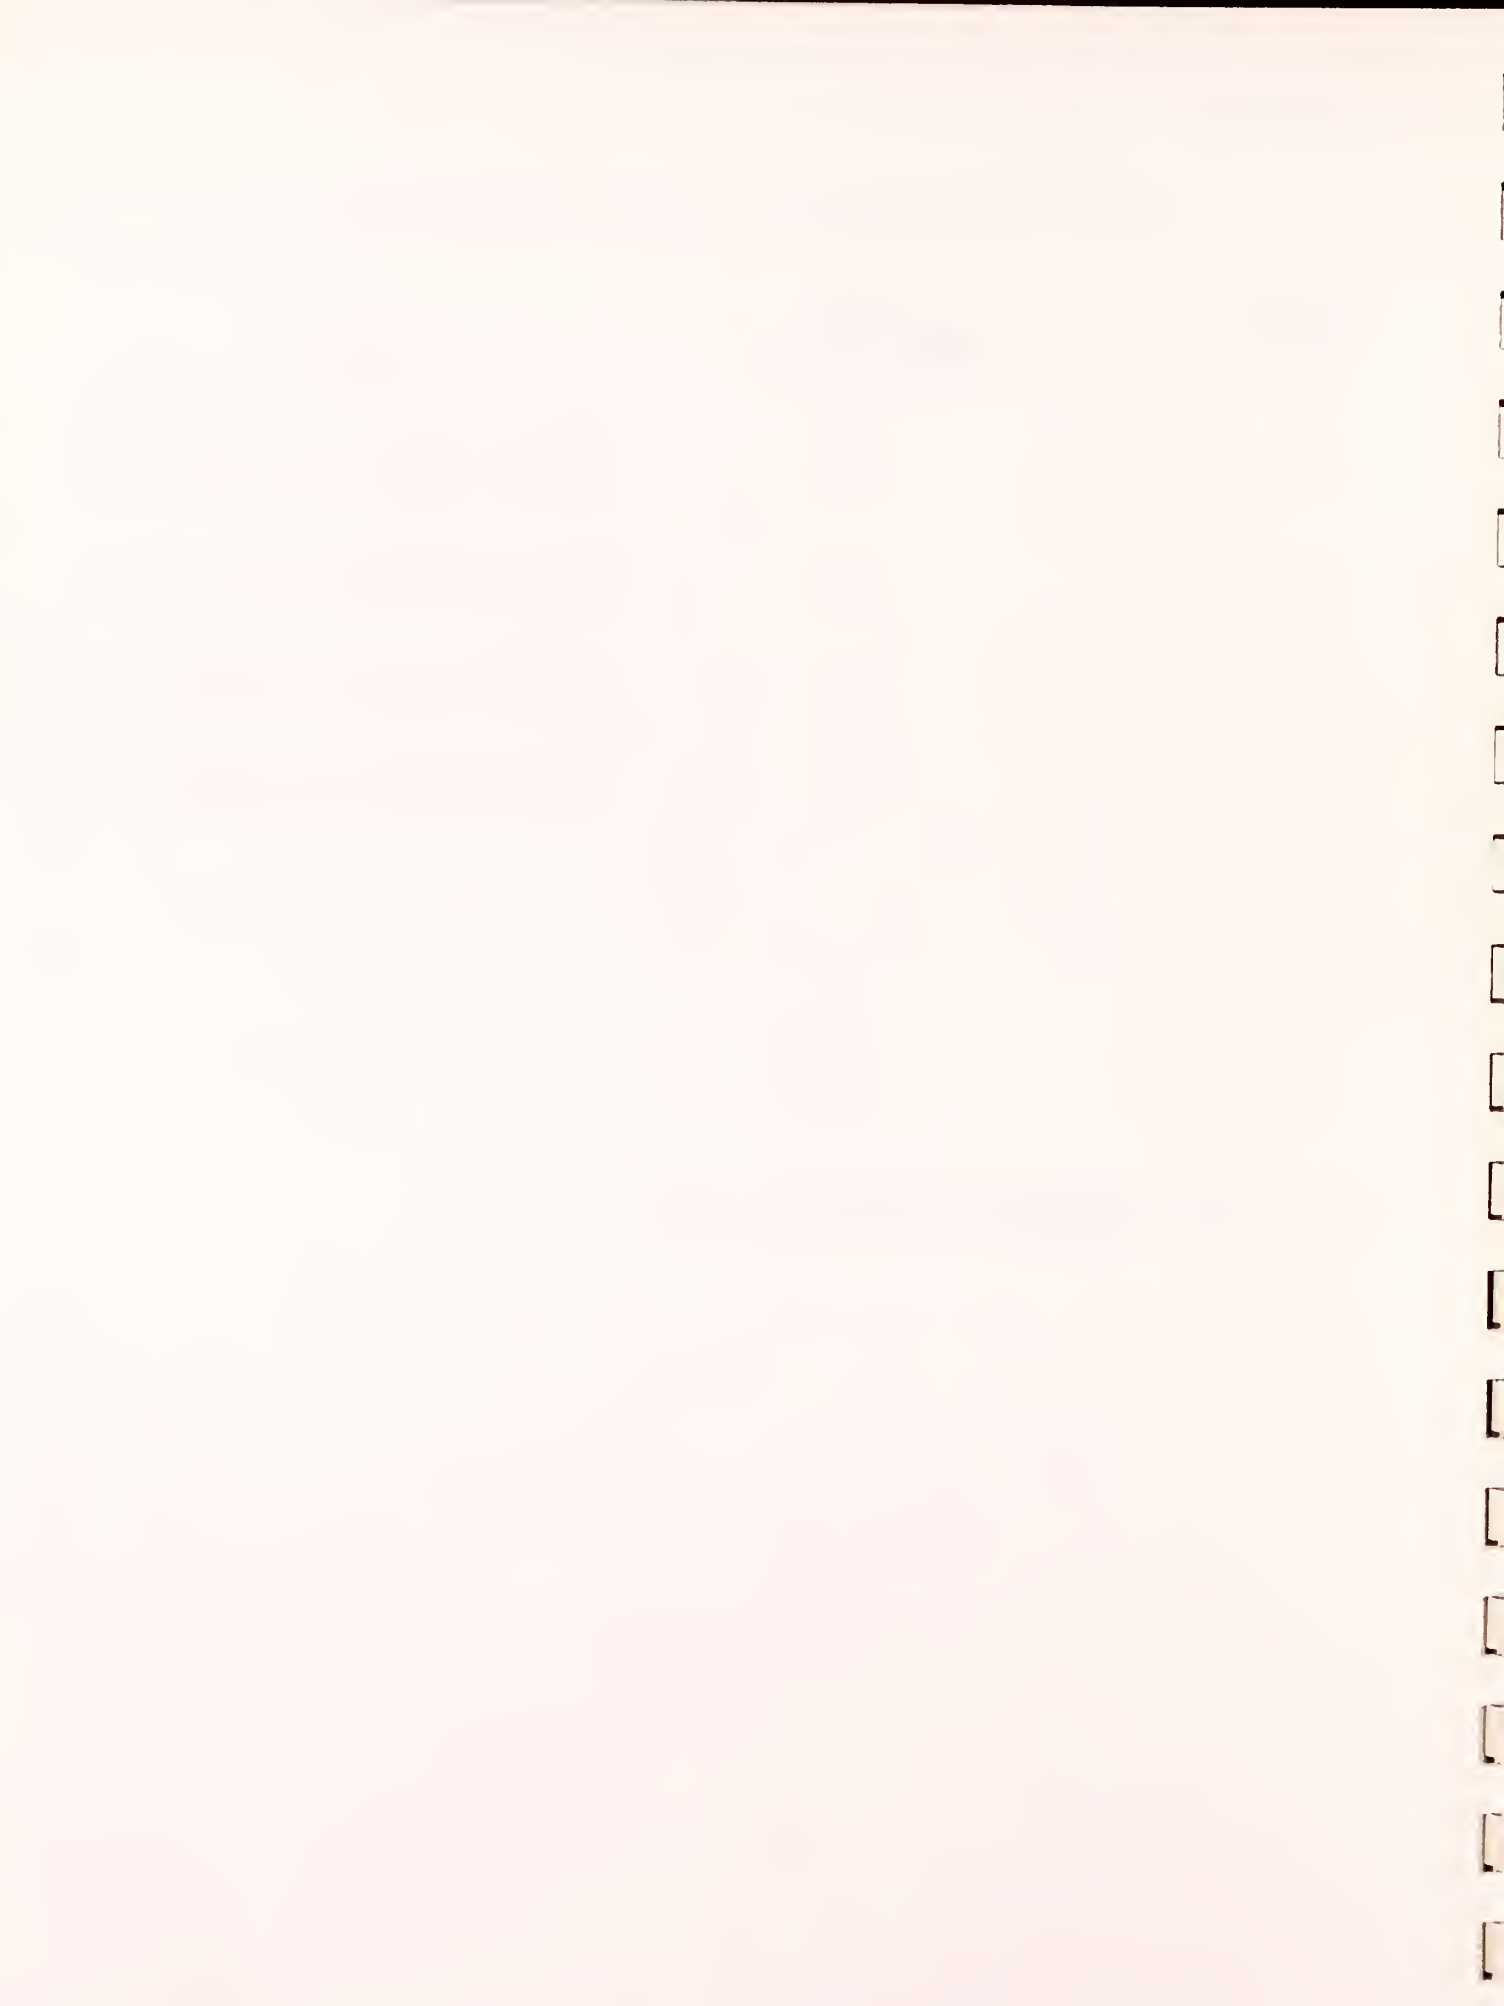
Table VI Charpy V-notch Impact Transition Temperatures
For Four Head Plate Steels Tested at NBS

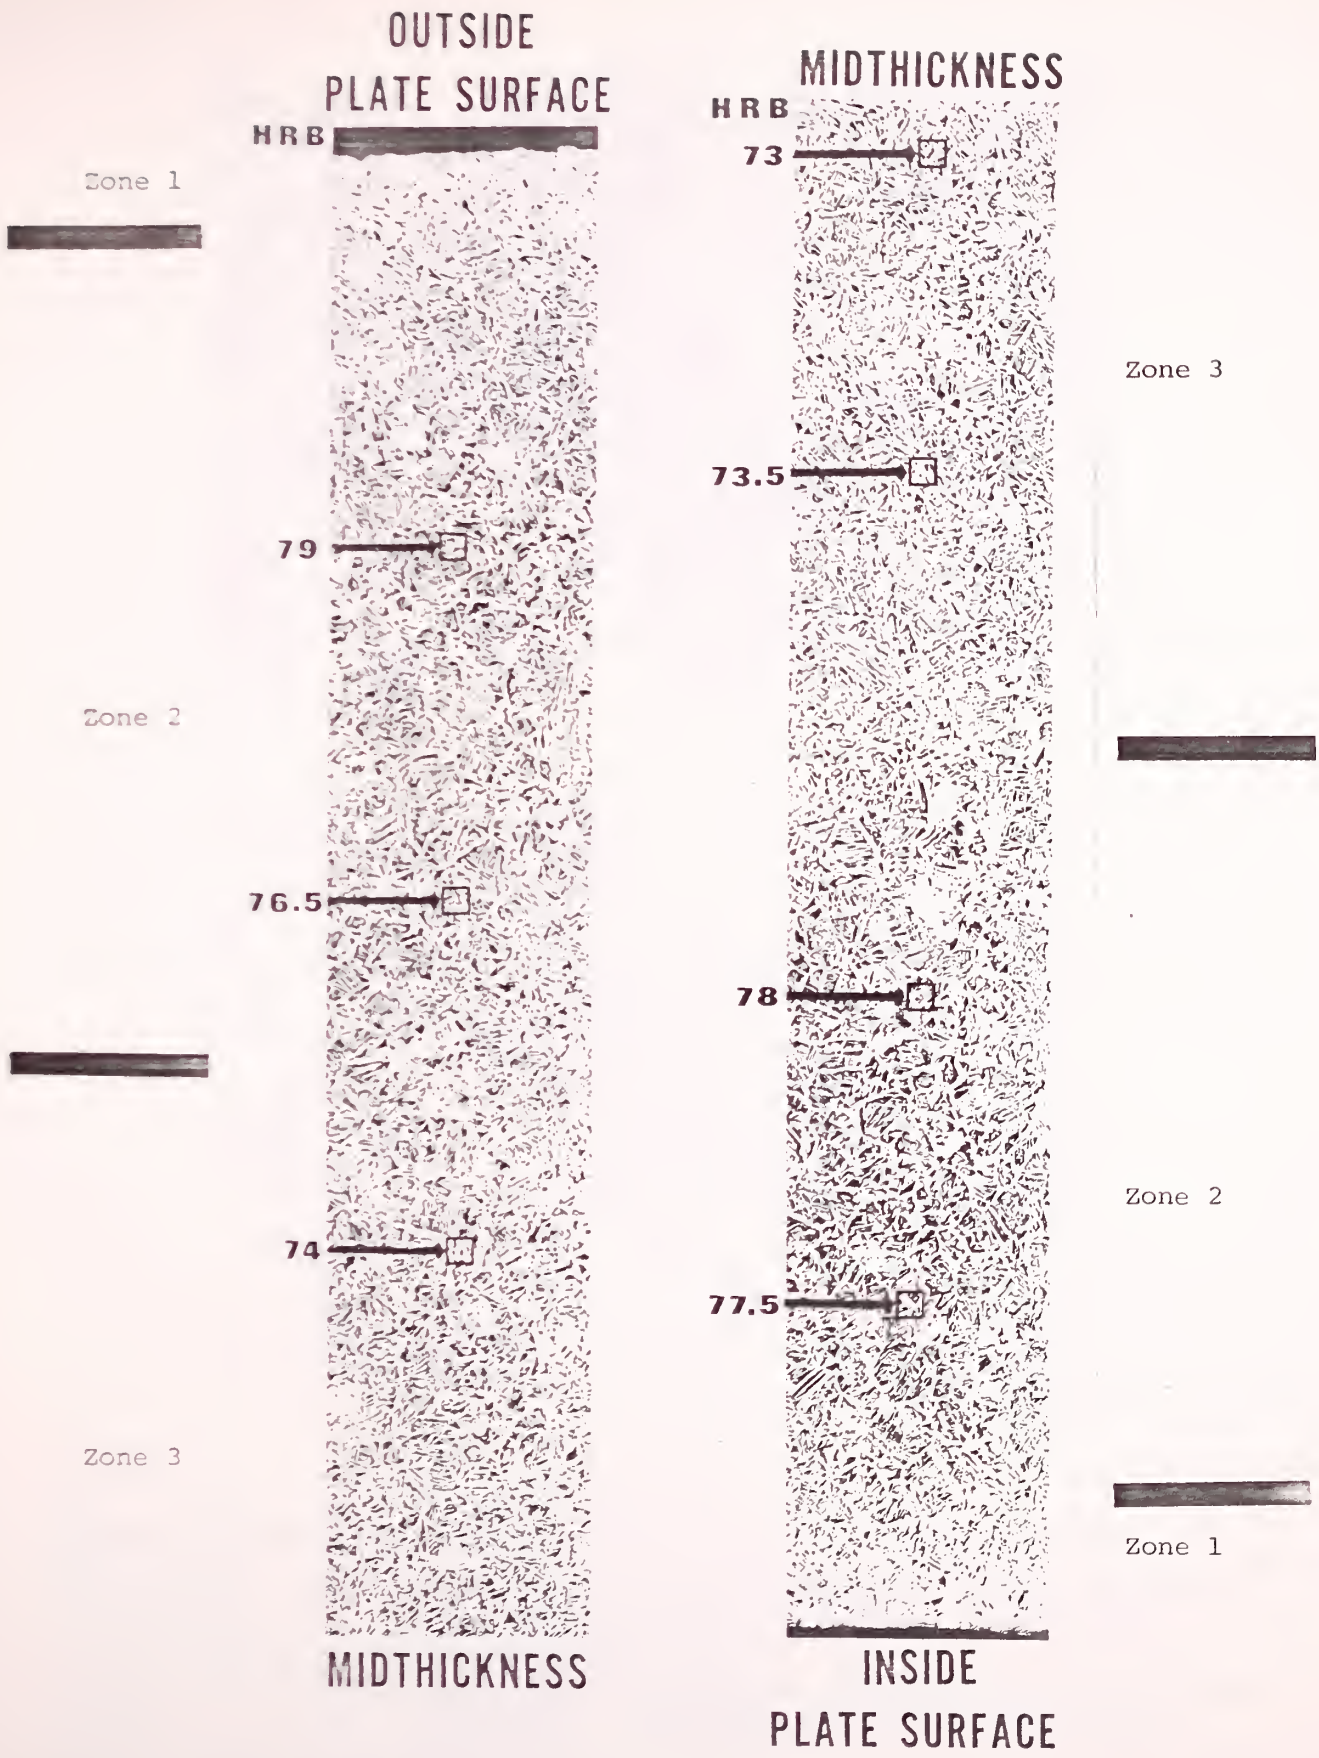
Figure 7. Montage of Microstructure Through Cross-Section of the Plate. Hardness values are representative of the locations shown.

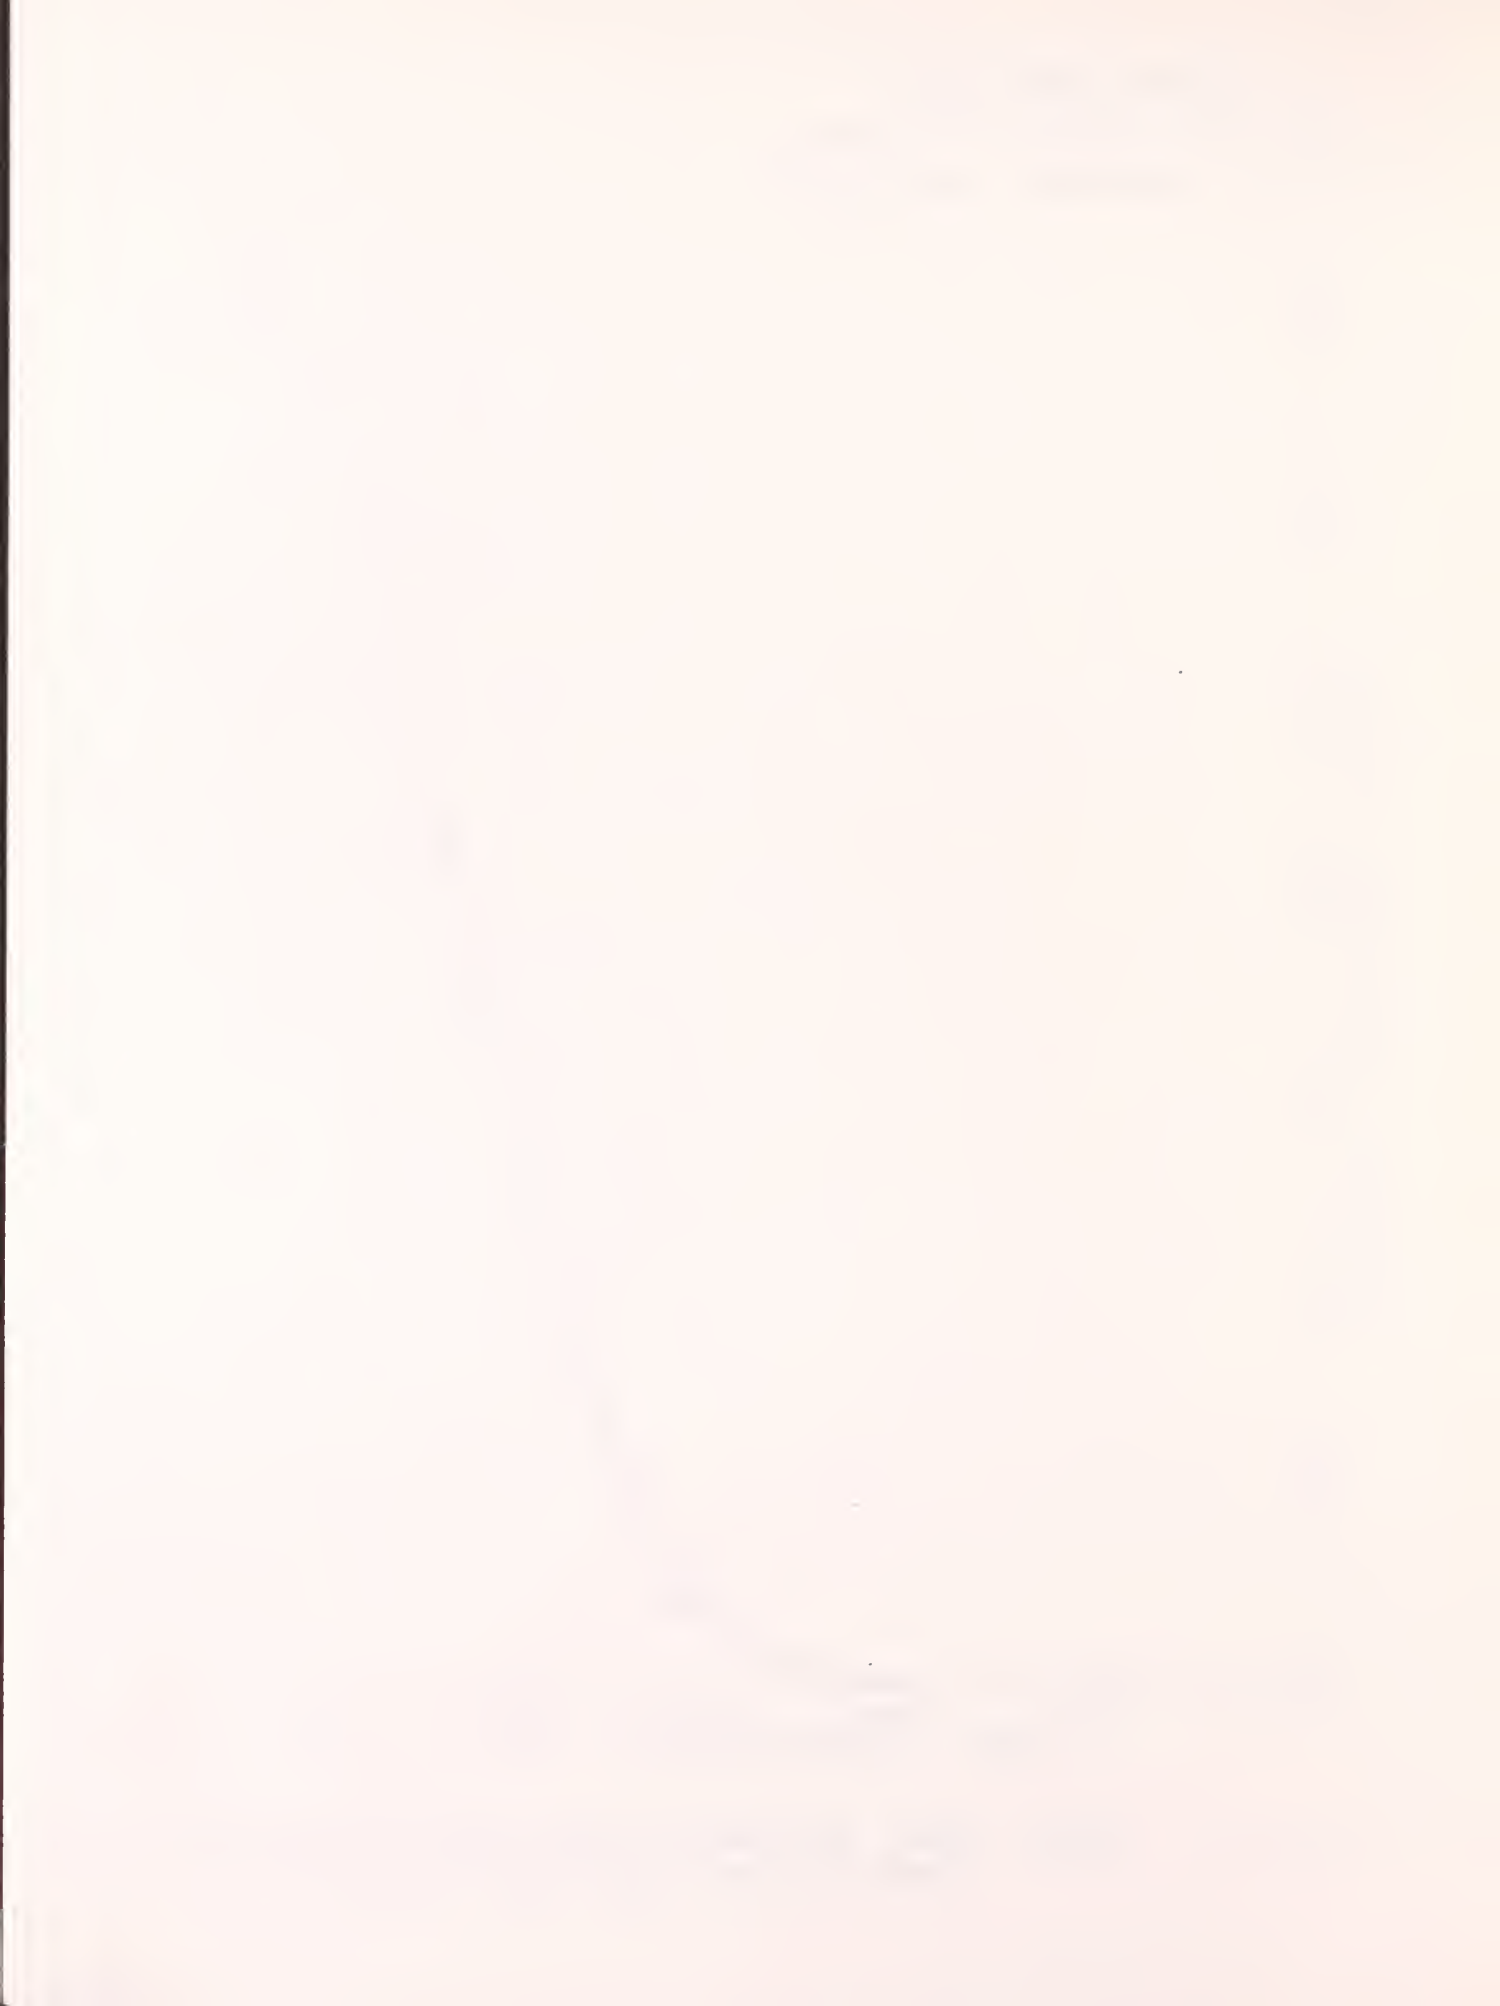
Transverse Longitudinal

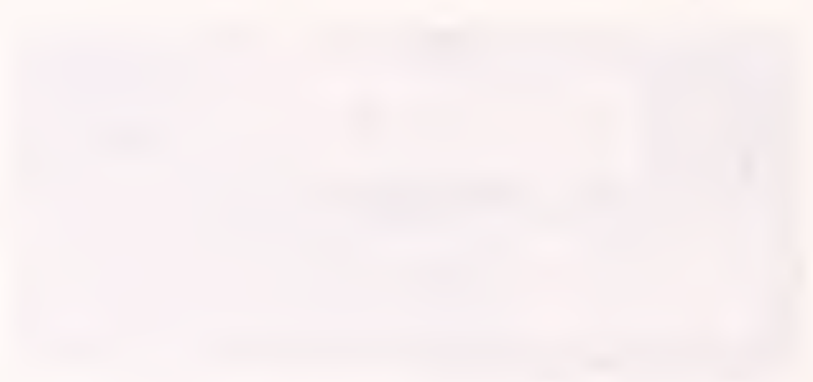
Appendix A, Table A1

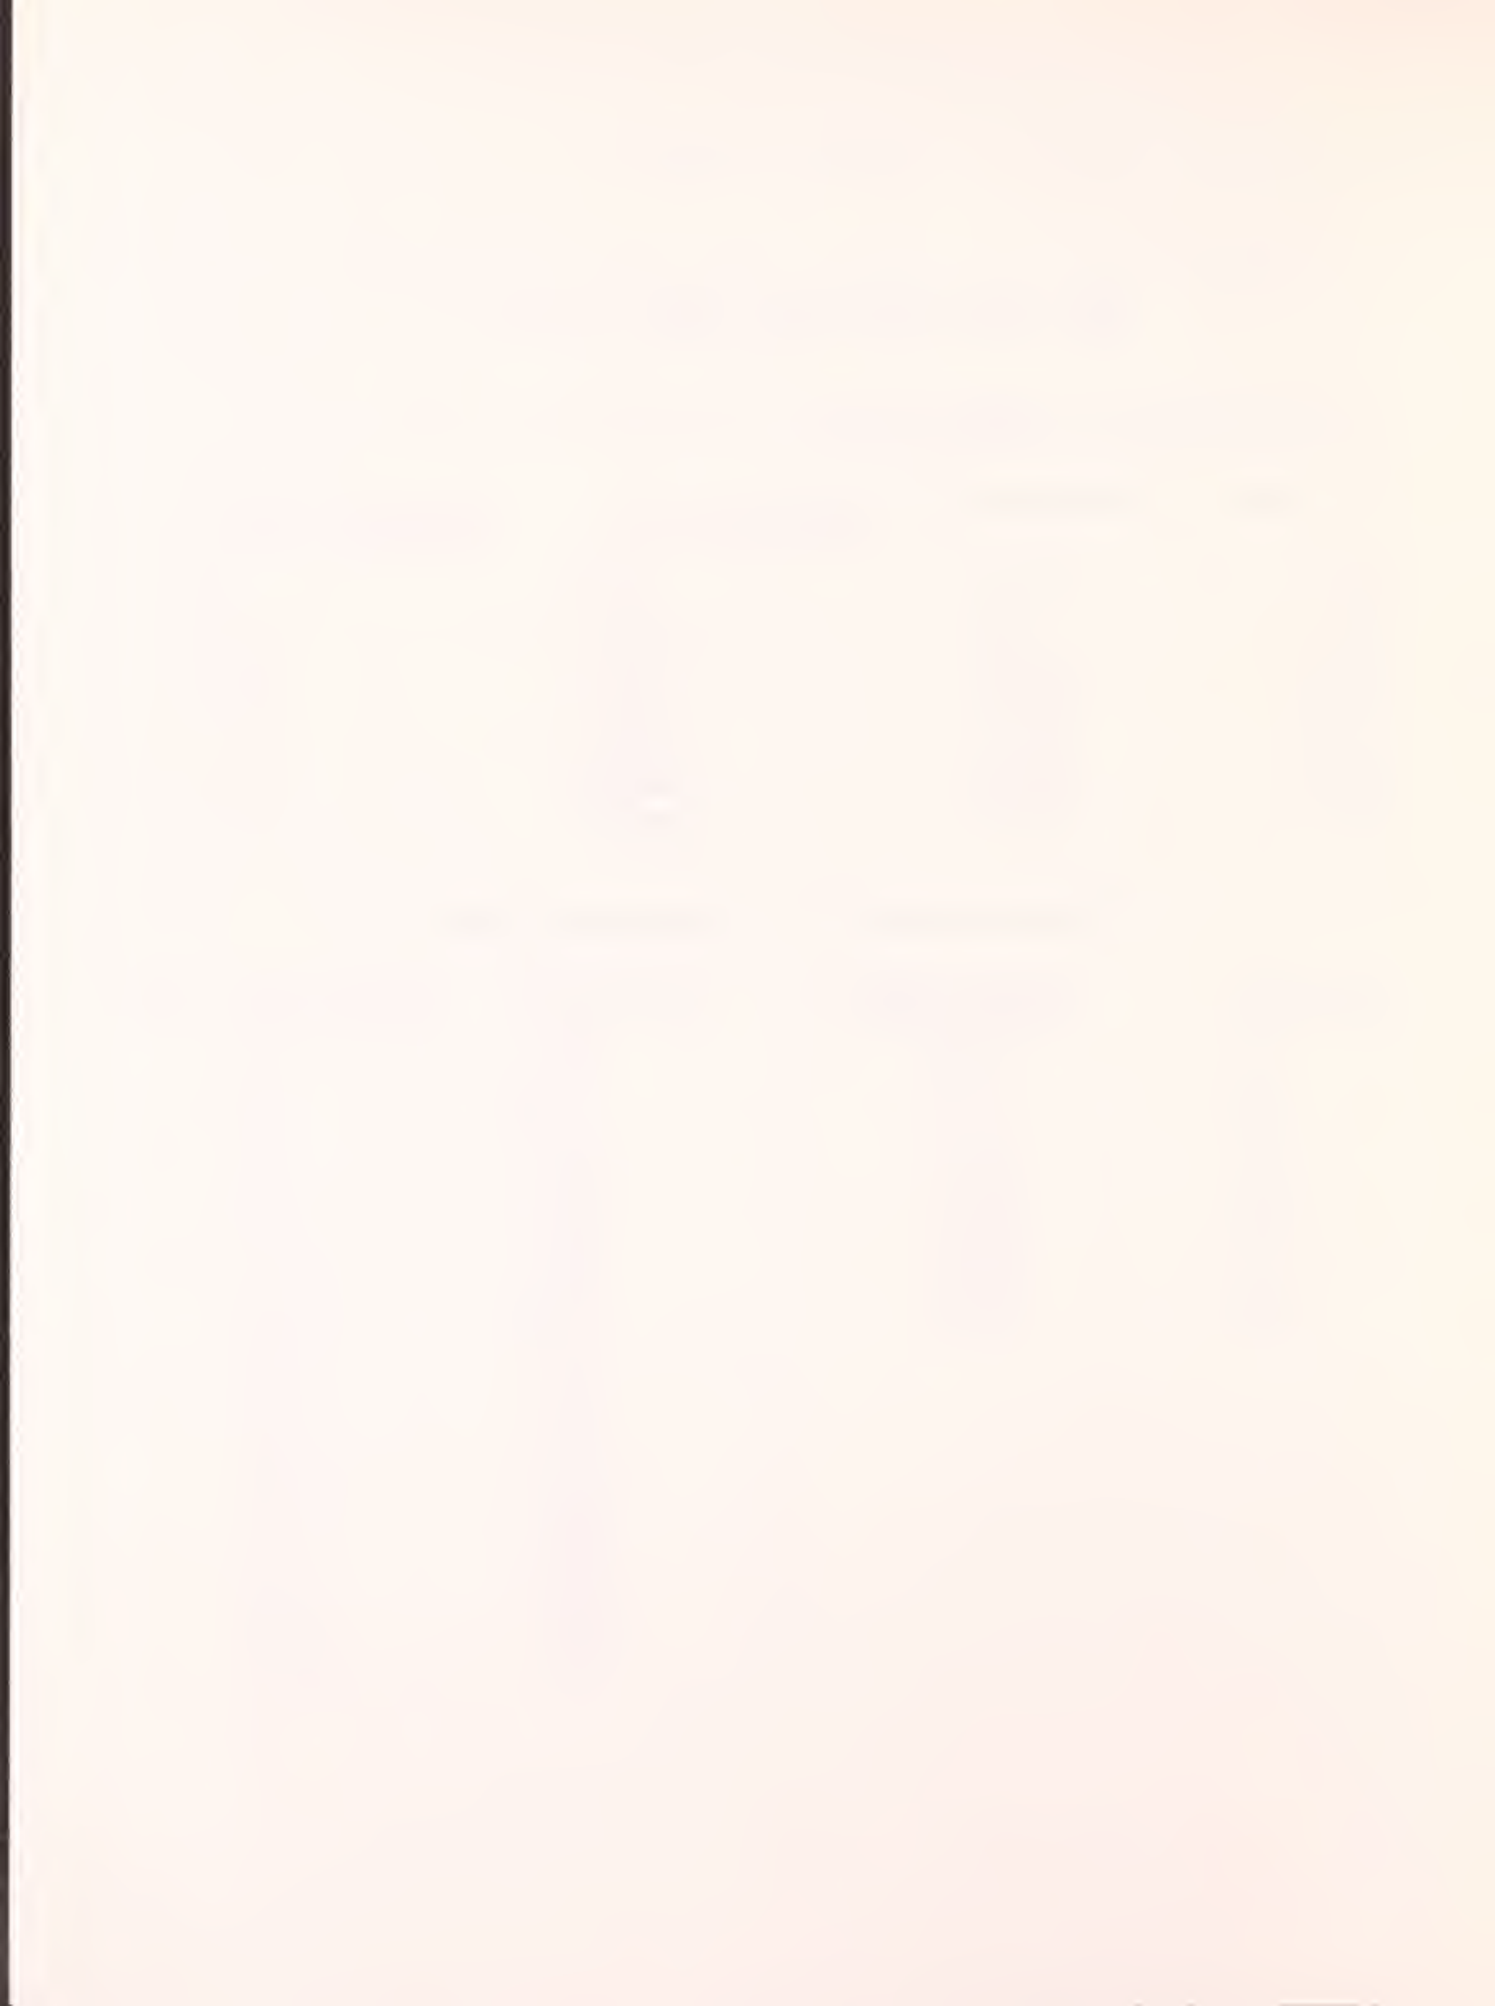
Appendix A, Table A4

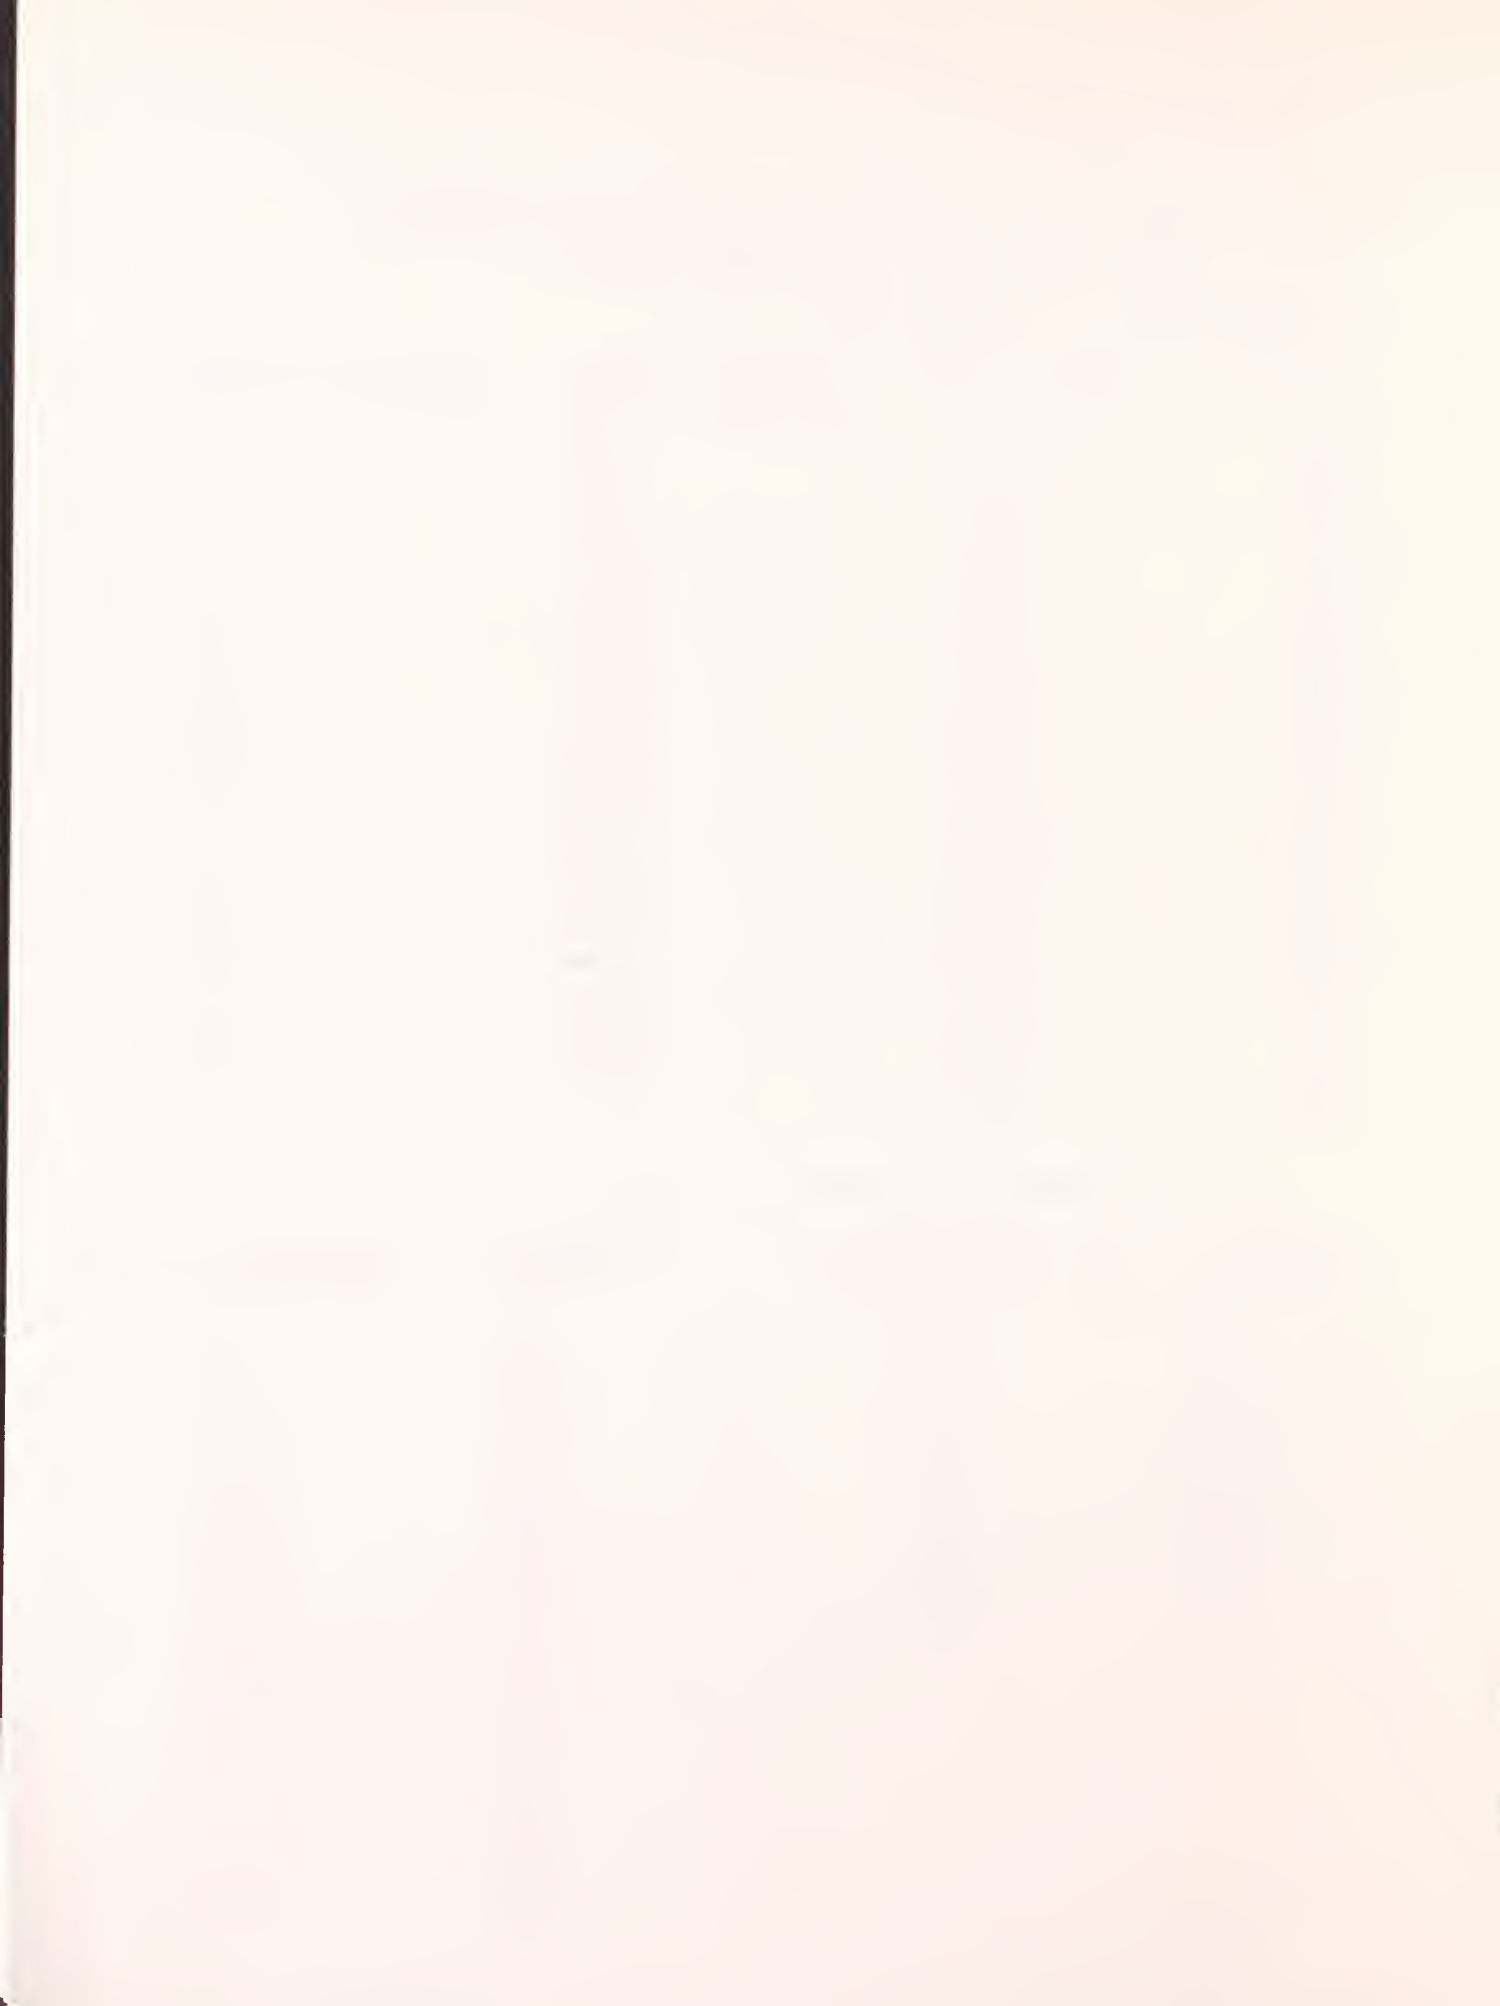
Appendix A, Table A6

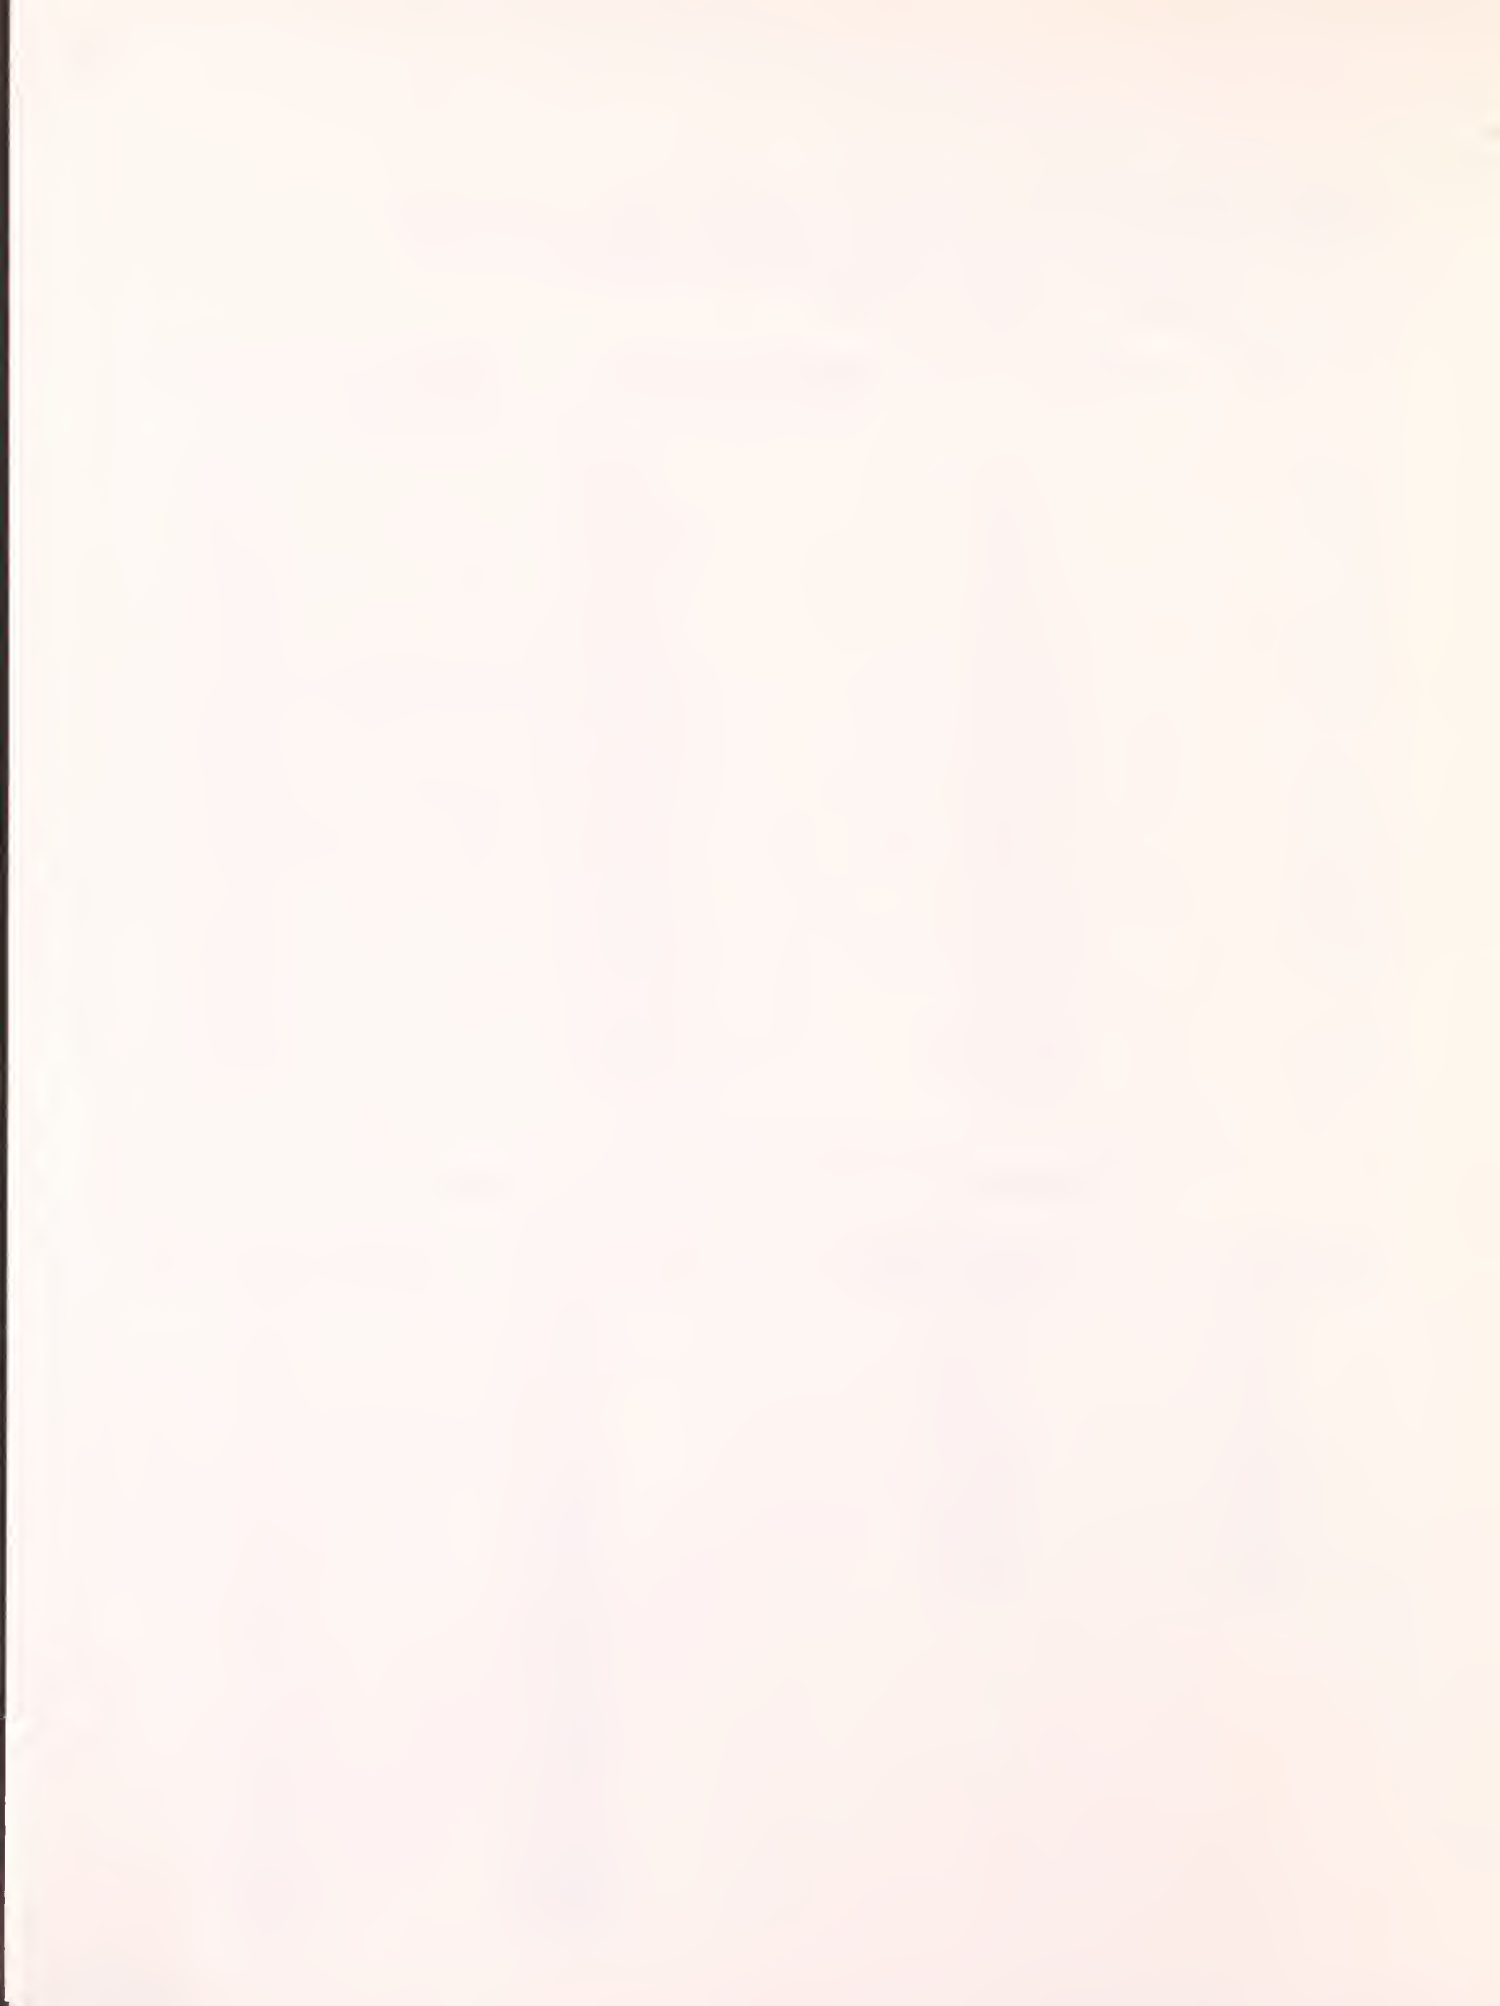
U.S. DEPT. OF COMM BIBLIOGRAPHIC DATA SHEET	1. PUBLICATION OR REPORT NO.	2. Gov't Accession No.	3. Recipient's Accession No.
4. TITLE AND SUBTITLE A METALLURGICAL ANALYSIS OF AN ASTM A212-B STEEL TANK CAR HEAD PLATE REPORT NO. 9		5. Publication Date August 1978	6. Performing Organization Code
