## NBSIR 79-1773

# Protective Coatings for Steel Structures: Part 1 - Survey of Air Force Coating Problems and Development of an Interim Guide Specification

June 1979

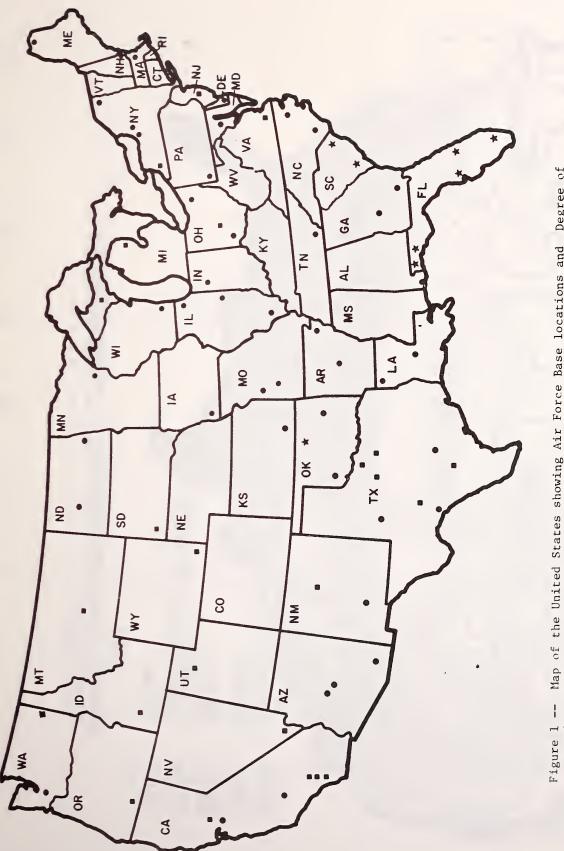
Figure 1 -- Map of the United States showing Air Force Base locations and Degree of Coating/Corrosion Problems.

Based upon the questionnaire responses, each base's corrosion/coating problems were arbitrarily assigned into three categories: 1) no coatings/ corrosion problems reported or performance reported as being normal, 2) some coatings/corrosion problems, and 3) extensive coatings/corrosion problems. The responding Air Force Base locations and degree of coatings/corrosion problems are depicted in Figure 1.

In general, coatings/corrosion problems were reported throughout all of the contiguous United States although most of the extensive problem areas were concentrated along the sea coast of the southeastern states.

• = some coating/corrosion problems; = no coating/corrosion problems. \* = extensive coating/corrosion problems;

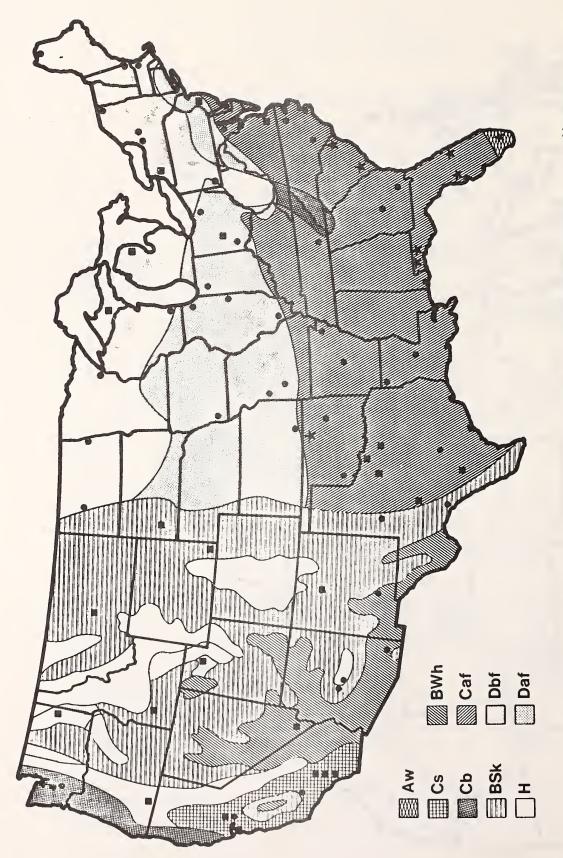
In a study of corrosion costs of Air Force and Army facilities, Hahin [4] established the validity of predicting corrosion costs from climatic, topographic, geographic and environmental sources. Superimposing the Air Force sites onto Trewarths's [5] climatological map of the United States illustrates the relationship between climate and coating/corrosion problems (see Figure 2). With regard to climate and base locations 31 bases were located in a  $Ca_f$  climate (humid subtropical, no dry season), 14 bases were located in a  $Da_f$  climate (humid continental, warm summer, no dry season), 14 bases were located in a  $Db_f$  climate (humid continental, cool summer, no dry season), 7 bases were located in a  $C_s$  climate mediterranean), 7 bases located in a BsK (middle latitude desert), 6 bases were located in a H climate (highland), 2 bases were located in a Cb climate (Marine West Coast), 2 bases were located in an A<sub>f</sub> (tropical

Figure 2 -- Map of the contigious United States showing Climatic Conditions according to Trewartha [5] and the locations of the Air Force Bases responding to questionnaire (symbols describing Base Coating/Corrosion Problems defined in Figure 2).

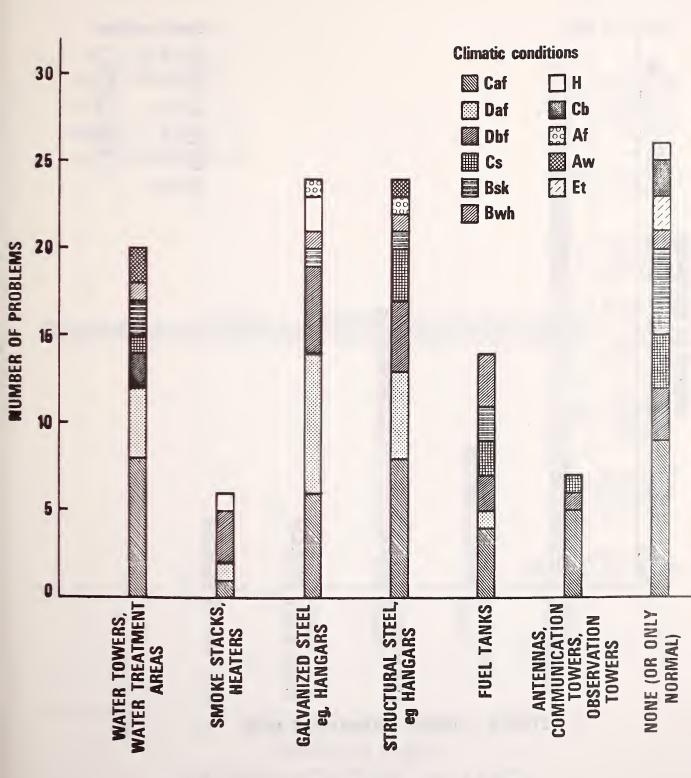
The questionnaire results relating coating/corrosion problems to the type of steel structure involved are listed in Figure 3. It may be noted that the responses from each base will differ depending on the number of reported problem structures or even whether the base has any problem with their steel structures. The structures most commonly reported as having coating/corrosion problems were of galvanized steel and structural steel. The buildings affected were generally hangars, nose docks, warehouses, etc. where the exterior siding of the facility was galvanized steel, asphalt coated galvanized steel, or steel which was supported by structural steel. Also, hangar doors, railings, steel swimming pool walls, missile launch facilities, galvanized steel walkways, etc. were covered in these categories. As expected, most of the problems occurred in climatic regions where there was appreciable moisture present e.g. Ca<sub>f</sub>, Da<sub>f</sub>, Db<sub>f</sub>, Aw. Of interest, there were almost as many problems reported in bases in the Daf (humid continental. warm summer, no dry season) and  $Db_f$  (humid continental, cool summer, no dry season) climates as bases in the  $Ca_f$  (humid subtropical, no dry season) climate although there were 31 responding bases in the Ca<sub>f</sub> climate region and 14 bases each in the Daf and Dbf regions. Next in frequency of coating/corrosion problems reported were water towers and water treatment facilities. Most of the problems were on the exterior surfaces and this could be directly related to the predominant use of an oil, alkyd primer topcoat system.

Figure 3 -- Coating/Corrosion Problems versus Type of Steel Structure.

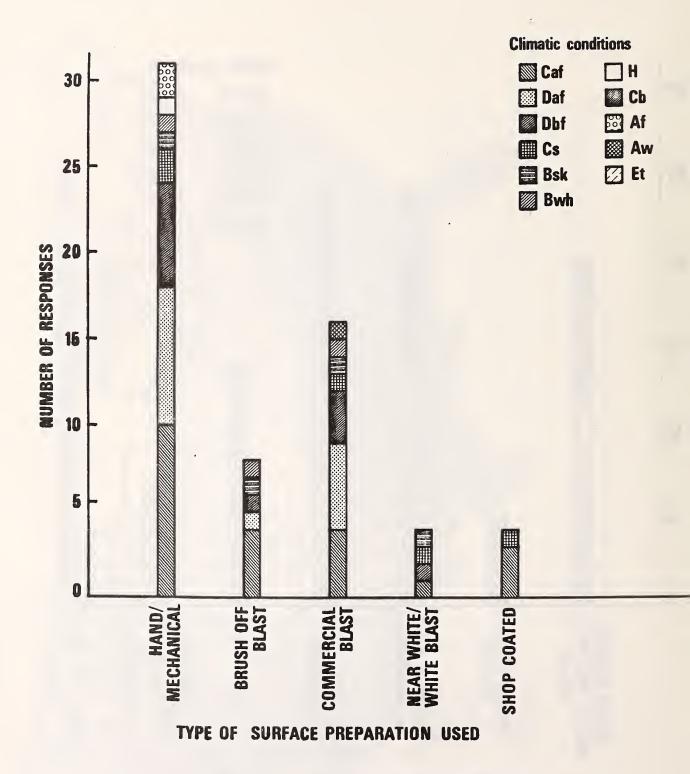
The coating/corrosion problems reported were also related to the type of surface preparation used. The types of surface preparation used by most bases corresponded to the following Steel Stuctures Painting Council (SSPC) specifications [6]: SSPC-SP-2 Hand Tool Cleaning; SSPC-SP-3 Power Tool Cleaning; SSPC-SP-5 White Metal Blast Cleaning; SSPC-SP-6 Commercial Blast Cleaning; SSPC-SP-7 Brush-off Blast Cleaning; SSPC-SP-10 Near-white Blast Cleaning. The number of problems versus the type of surface preparation are illustrated in Figure 4. Most of the coating/corrosion problems occurred on surfaces where hand/mechanical cleaning was used. Many surfaces prepared by commercial blast cleaning also failed. Undoubtedly, the number of problems reported for Air Force structures cleaned by hand/ mechanical methods, i.e., SSPC-SP-2, 3, indicated that the preponderance of steel structures were prepared for painting this way; but it may be possible that structures prepared for painting by near white/white metal blast cleaning may not have had as many coating/corrosion problems. Of interest, most of the problems occurring where hand/mechanical cleaning was used, also were in humid climate areas, e.g., Caf, Daf, Dbf.

Figure 4 -- Coating/Corrosion Problems versus Type of Surface Preparation Used Prior to Painting.

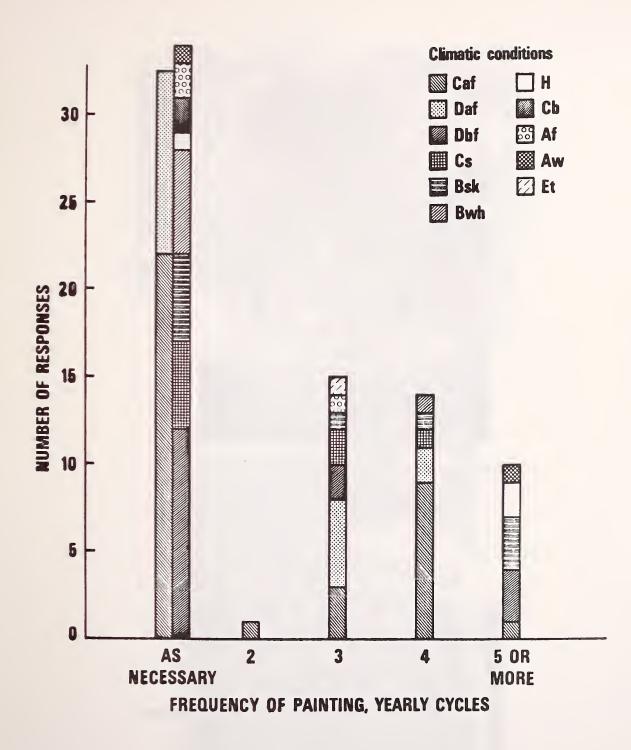
The questionnaire responses also reported the frequency of painting at the Air Force bases. Most maintenance painting was on an "as necessary" basis while many bases painted on a three and four year cycle (See Figure 7). However, it may be noted that often a base would paint some of its steel structures "as necessary" but would maintain a periodic painting cycle for other structures.

Figure 7 -- Frequency of Air Force Base Painting.

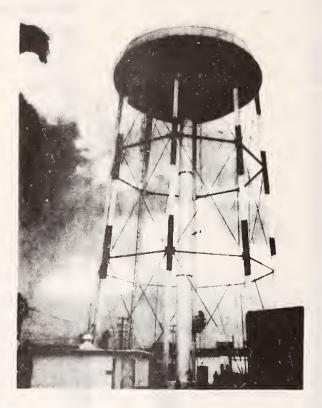
Water towers were inspected at each base and each tower had coating/ corrosion problems. At Patrick AFB, a water tower about to be demolished was examined. Another water tower that was undergoing extensive repair (Figure 8, 9, 10 & 11), and one that had just been painted (Figure 12) were also examined. Typically, an oil/alkyd primer topcoat system was used. Over the years, extensive corrosion of the steel was apparent as the steel stud at the base of the recently painted water tower (Figure 13) indicates. The design of the anchorage of the water towers was typical of older units, since a tower at Tyndall AFB which was erected in 1941 and repainted last in 1976 had accumulated dirt and mildew and was rusting in the same general area (Figure 14). At Mac Dill AFB, a water tower was inspected which had been white metal blast cleaned before applying a zinc rich inorganic primer and a vinyl topcoat. The time interval between application of the primer over the blast cleaned surface was 3-4 hours and the surface preparation had been closely inspected. This water tower is in excellent condition after 6 years exposure (Figure 15). A new riser had been installed a year ago and the tie rods had some rust areas at the bolt ends due to mechanical damage to the coating. At the same base, a water tower had just been repainted a few months ago and painting of this tower was on a 2-3 year cycle. Surface preparation was by scraper and wire brush and an oil, alkyd primer/topcoat system was used.

Figure 8 -- Water Tower, Patrick AFB, Overall View of Tower Undergoing Repair.

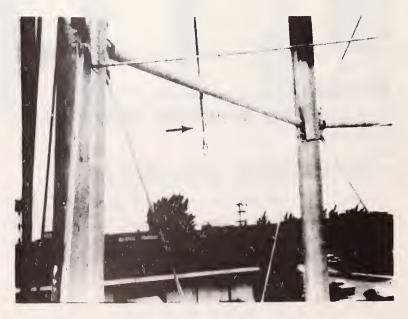
Figure 9 -- Water Tower, Patrick AFB, Loose Support.

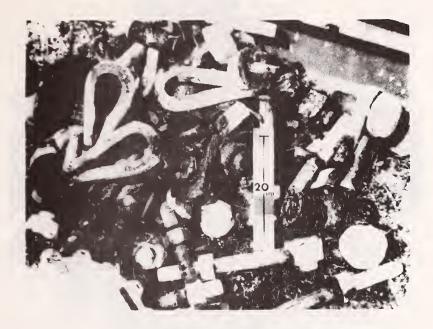
Figure 10 -- Water Tower, Patrick AFB, Corroded Bolts Removed During Repair of Tower.

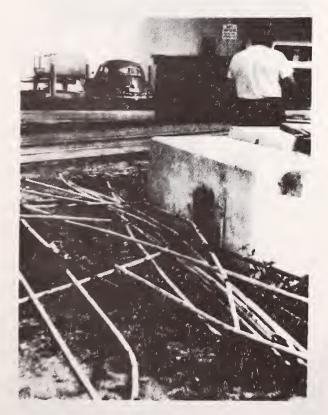
Figure 11 -- Water Tower, Patrick AFB, Corroded Support Rods Removed During Repair of Tower.

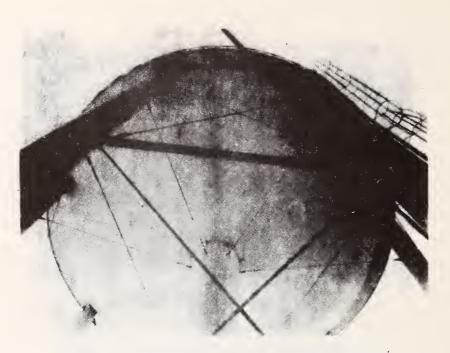
Figure 12 -- Water Tower, Patrick AFB, Recently Painted Tower.

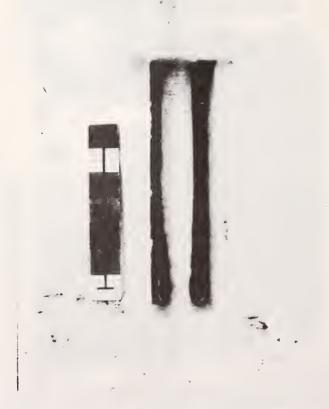
Figure 13 -- Water Tower, Patrick AFB, Base of Recently Painted Tower.

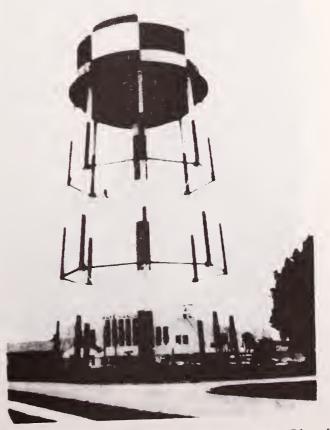
Figure 15 -- Water Tower, MacDill AFB, Zinc Rich Inorganic Primer with Vinyl Topcoat.

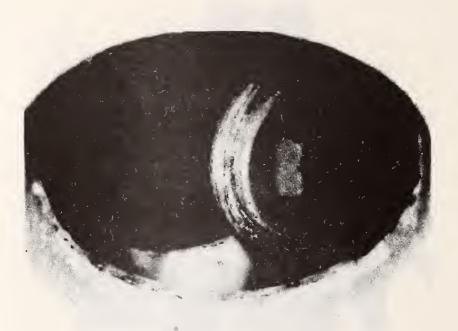
While most of the problems of water towers were concerned with exterior surfaces, Eglin AFB had a problem with interior surfaces with a vinyl system (VR-3) which had failed in the water storage area. However, inspection of the riser interior which had been painted at the same time with the same material, indicated no failures (Figure 16). We surmise that inspection of the surface preparation and application of the material within the tank area contributed to the premature failure.

Figure 16 -- Water Tower, Eglin AFB, Interior View of Vinyl Coated Riser.

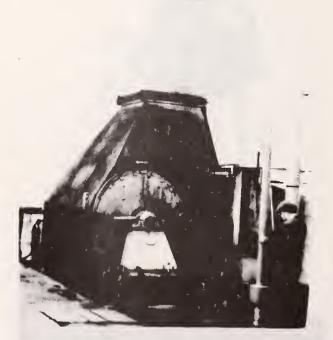
Figure 17 -- Heating Stack, Dover AFB.

Heat resistant coatings on smoke stacks or heaters were not inspected during our visit to the Florida bases, but we had inspected these types of structure previously and in particular the power plant at Dover AFB as part of this project. Previously, six bases had reported on the questionnaire that they had corrosion problems with steel exposed to high temperatures. Coatings used for these applications are generally exposed in a polluting environment, exposed to extreme temperature cycling, and often require high temperature cure to perform effectively; any of which may explain the continuing problems of protecting the steel substrate. Also, Dover AFB is experimenting with a proprietary zinc rich epoxy polyamide system with only limited success. Figure 17 illustrates the rusted stack and the proprietary coating at the base. Galvanized steel examined on the inspection trip consisted mainly of exterior surfaces of hangars, nose docks, and other buildings, fencing, conduits, and railings. Frequently, the building's exterior cladding consisted of a factory-applied asphalt-asbestos coating on galvanized steel or simply painted galvanized steel. Often, the asphalt-asbestos coatings were badly alligatored while the galvanized steel substrate was still in excellent condition. Figure 18 illustrates a coating failure on galvanized steel cladding where the galvanized steel substrate is in good condition. Figure 19 illustrates a galvanized steel nose dock at Patrick AFB where the exposed uncoated galvanized fasteners on the ocean side appeared to be more corroded than those facing inland. In this regard, one of the hangars at Mac Dill AFB had some replacement panels fastened with vinyl coated fasteners which were performing well. At Mac Dill AFB, a series of nose docks of galvanized steel cladding had been cocooned in 1966-67. Apparently, the cocooning operation consisted of taping fiberglass fabric over the joints, applying a blue wash primer (MIL-P-15328?) and an elastomeric coating (19-23 mils). The coating was delaminating off in sheets and exposing the galvanized steel substrate (Figure 20, 21). As might be expected most of the failures were observed on the roof decks. Interestingly, the elastomeric coating was still flexible. A typical failure of the galvanized steel cladding was observed at Dover AFB at the cladding-concrete masonry block interface where the sealant used entrapped and accelerated rusting (See Figure 22). Respondents to the questionnaire often cited problems with conventional hangar doors and other overhead flexible doors on buildings. These doors are moved frequently on tracks and are also subject to mechanical damage. Most of the doors examined were either hot dip galvanized or electroplated zinc. The doors are painted not only for appearance but also for safety coding. Failures appeared to be caused by mechanical damage, lack of pretreatment primer, adequate surface preparation or poor application techniques. Photographs (Figures 23, 24) taken at Tyndall AFB show the hangar doors painted in 1976. Rust seemed to be breaking through in many painted areas and the doors had not been completely painted near where they overlapped other doors creating a rusting condition. Also at Tyndall AFB, galvanized railings on communication towers were observed to have paint failures which was attributed to the paint applied being apparently an iron oxide primer (TT-P-57) with no topcoat or wash primer pretreatment application.

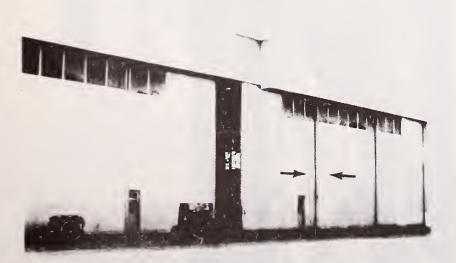
Figure 23 -- Hanger Doors, Tyndall AFB (arrows indicate area shown as close-up in Figure 24).

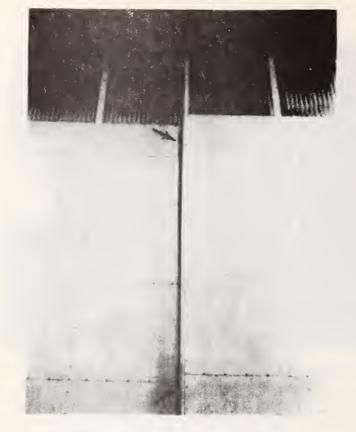
Figure 24 -- Hanger Doors, Tyndall AFB, Detail of Unpainted Area of Door Overlap (indicated by Arrows)

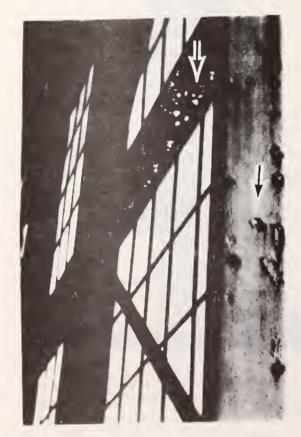
Structural steel examined on the inspection trip consisted primarily of the interior supporting members of hangars, nose docks, etc. and also some exterior cladding (Figures 25, 26). An exhibit of rockets and missiles at Patrick AFB was extremely interesting, historically. While not directly related to the purpose of the trip, the coating/corrosion problems of the steel supporting structures detracted from the appearance of the exhibit (Figure 27). Inspection of hangar interiors generally revealed extensive rusting of the supporting structure. At Mac Dill AFB, daylight could be seen through rust holes in the roof. The interior structural members were rusting so as to a degree that the airmen complained that rust removal from equipment and parts bins was a daily necessity before work operations could start (Figure 18).

Figure 25 -- Steel Support Beams, Patrick AFB (arrows indicate areas of steel corrosion).

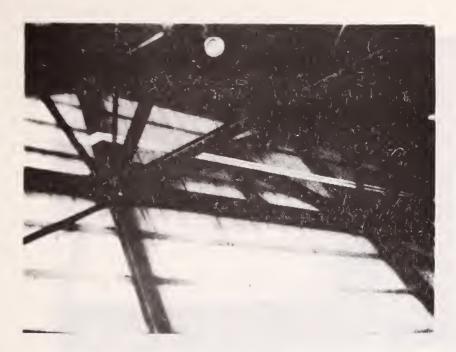
Figure 26 -- Steel Support Beams, Dover AFB.

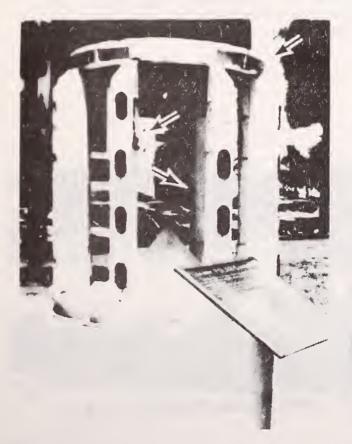
Figure 27 -- Steel Support Beams, Patrick AFB, Outdoor Exhibit of Polaris Missile (arrows indicate areas of paint failure and steel corrosion).

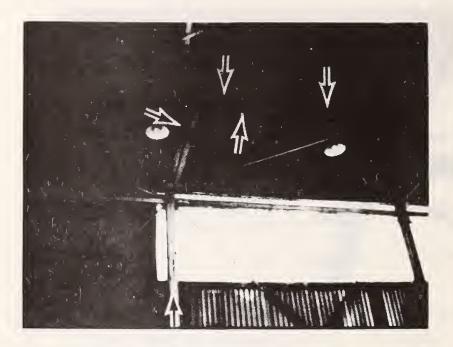
Figure 28 -- Steel Support Beam, MacDill AFB (arrows indicate corrosion of steel beams and roofing panels).

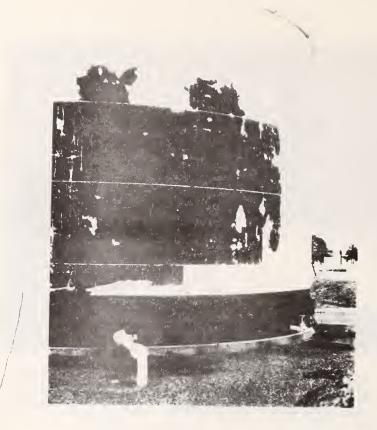
Figure 32 -- Fuel Tank, Seymour Johnson AFB.

In February, 1978, the fuel tanks at Seymour Johnson AFB were inspected for of premature failures and because of the interesting type of failure it is included in this report. The coating system used was red lead primer, TT-P-86, and alkyd topcoat, TT-E-489, and paint was applied during the period of October 15, 1974 to November 1974. In December 1975, base personnel took photographs of extensive intercoat adhesion failures on two of the tanks. These failures were located on the north and northwest sides of the tanks (See Figure 32). During our inspection, ice (1/4 inch) was scraped off in the area of the intercoat adhesion failures; the ice remained during the day of our inspection. Since the primer coat had not failed and primer topcoat resins were compatible, it is possible that the topcoat was applied to a cold damp surface. It is known that certain combinations of surface temperatures, ambient temperatures, surface moisture and dew point can often cause premature paint failure.

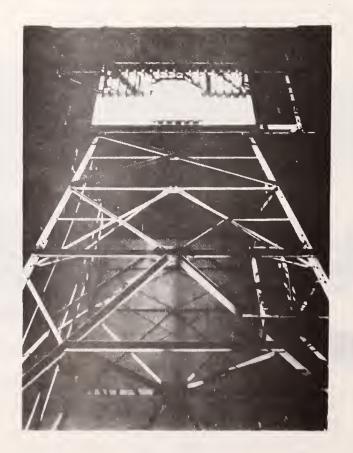
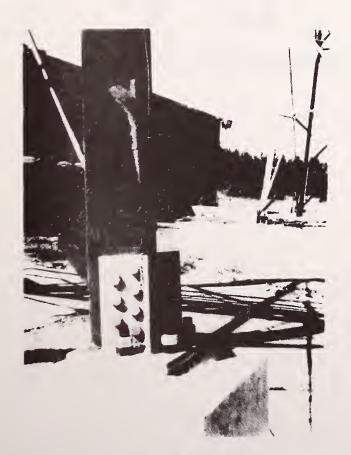
The communication towers inspected at Tyndall AFB were perhaps atypical with regards to coating/corrosion protection. One tower appeared to be painted with only an iron oxide primer, TT-P-57, whether on structural steel members or the galvanized steel railing. Another tower had a zinc chromate primer, TT-P-645, as a coating with a white spray paint application at the welded joints. Also, some fasteners at the base were cadmium plated steel while others were rusting steel (See Figures 33-36).
