**NBSIR 79-1915**

October 1979

**INVESTIGATION OF THE EFFECTS OF HEATING AND AIR CONDITIONING ON THE PERFORMANCE OF SMOKE DETECTORS IN MOBILE HOMES**

Richard W. Bukowski

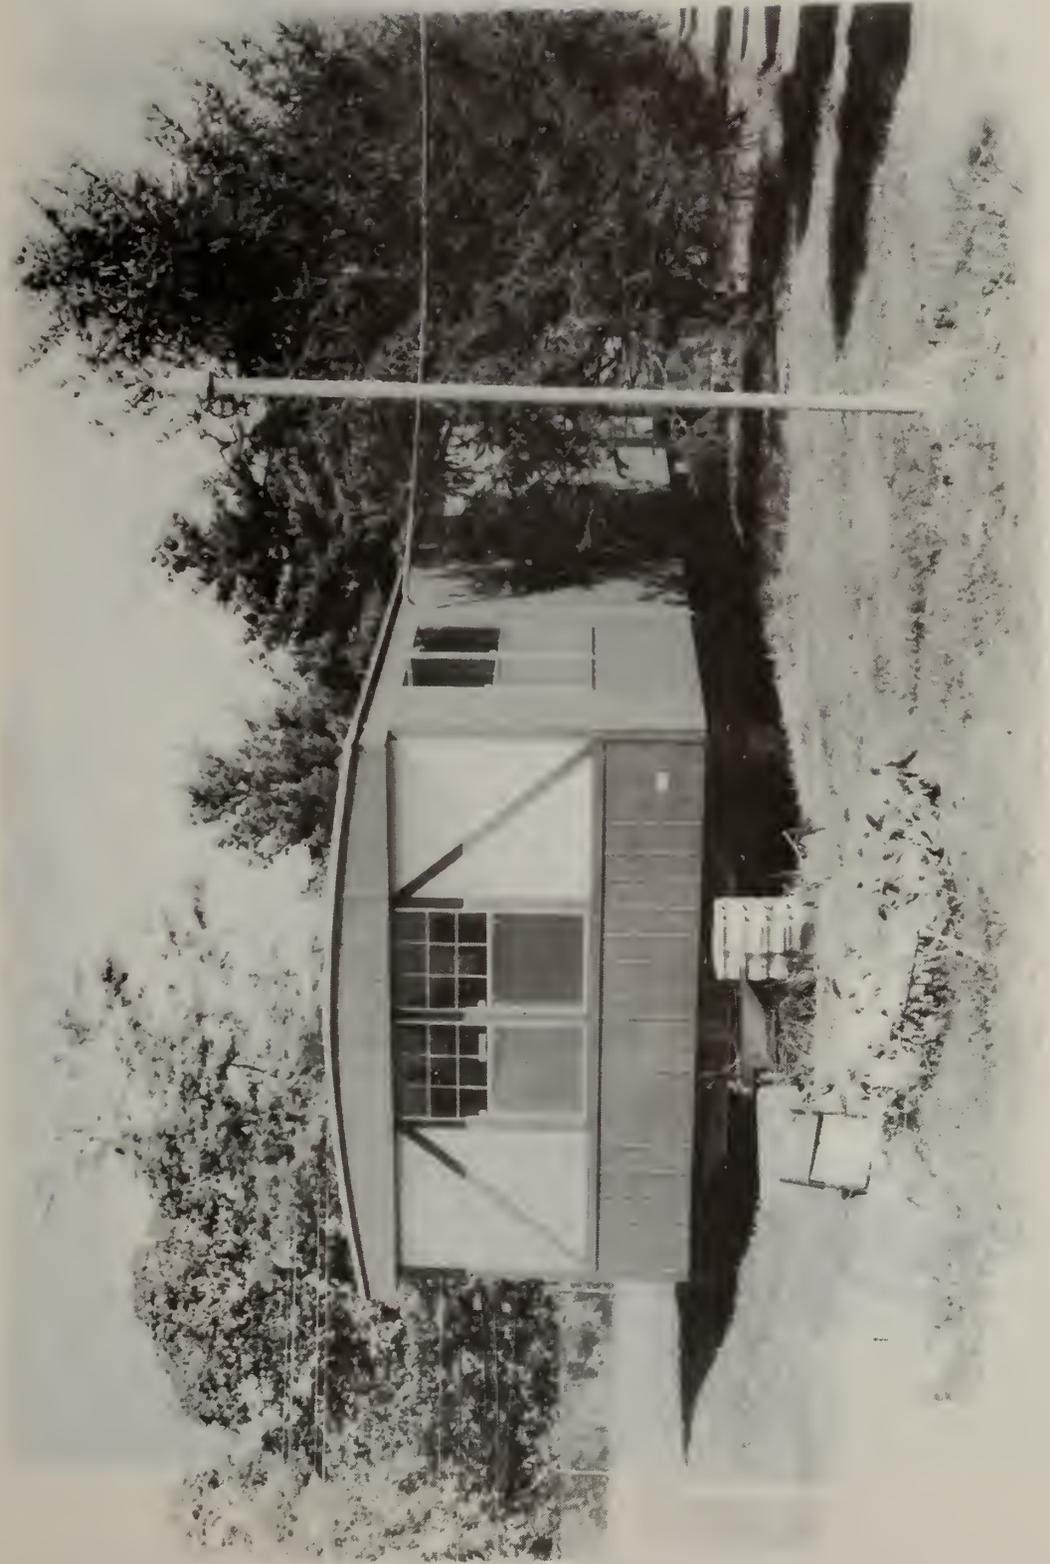
Figure 2. Mobile home test unit showing south wall of living room

The single-wide mobile home purchased for use in this test program was a 4.3 by 17 m (14 by 56 ft), two bedroom unit with front living room, central kitchen, and both bedrooms in the rear (see figures 1 thru 4). The mobile home was equipped with an oil-fired, hot-air furnace and an electric central air conditioning unit. It was constructed and certified in accordance the current edition of the FMHCSS, and included the standard exterior wall and ceiling insulation.

The mobile home was installed on the grounds at the NBS Annex facilities and oriented such that the long exterior wall of the corridor leading to the bedrooms was facing south. Since this exterior wall was painted a dark green color, the southern exposure resulted in maximum heating from the sun during the summer test conditions. This was done to provide the maximum possible temperature difference between the interior wall surface of the outside walls and ceiling and the interior air temperature.

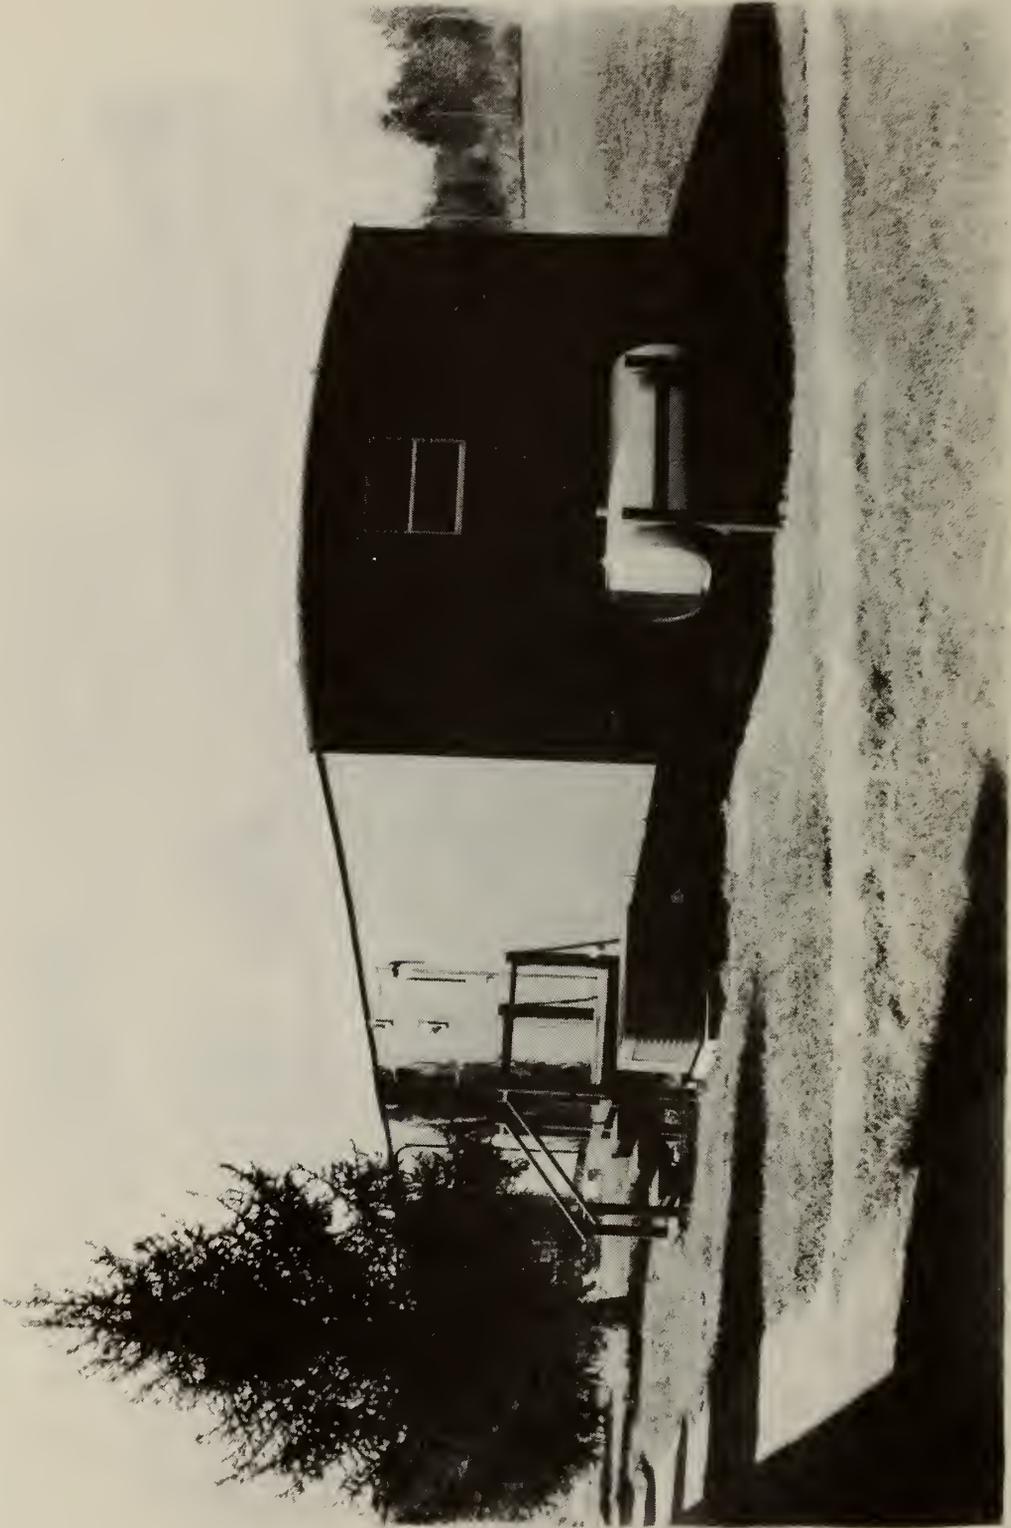
Figure 3. Mobile home showing southern exposure of corridor and bedroom end

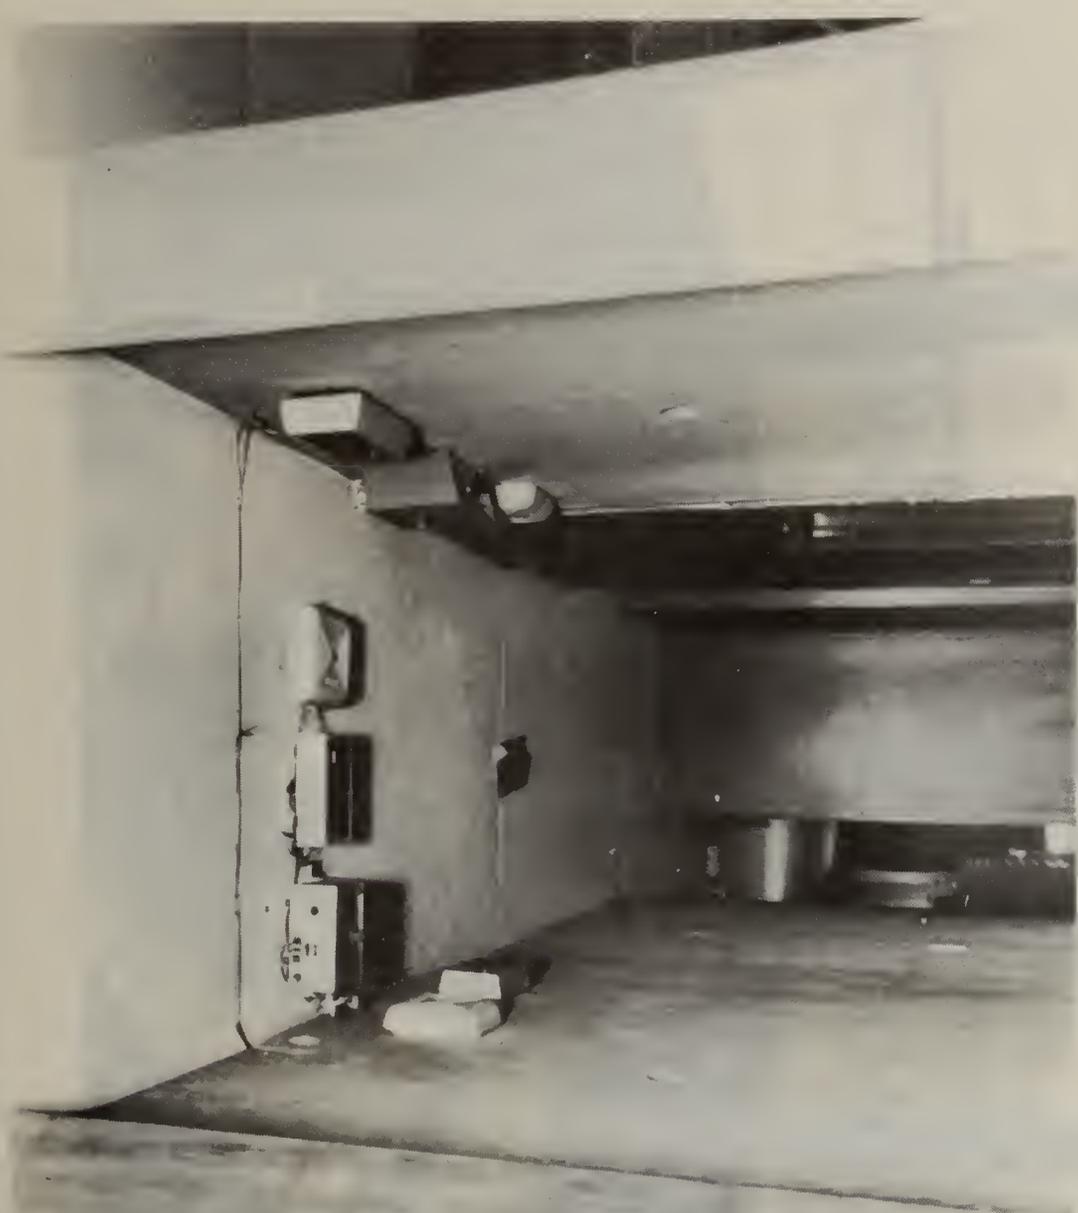
Figure 6. Test detectors mounted in hallway extension at rear of corridor
