MATERIALS RESEARCH FOR THE CLEAN UTILIZATION OF COAL

QUARTERLY PROGRESS REPORT

July - September 1979

Center for Materials Science  
National Bureau of Standards  
Washington, D.C. 20234

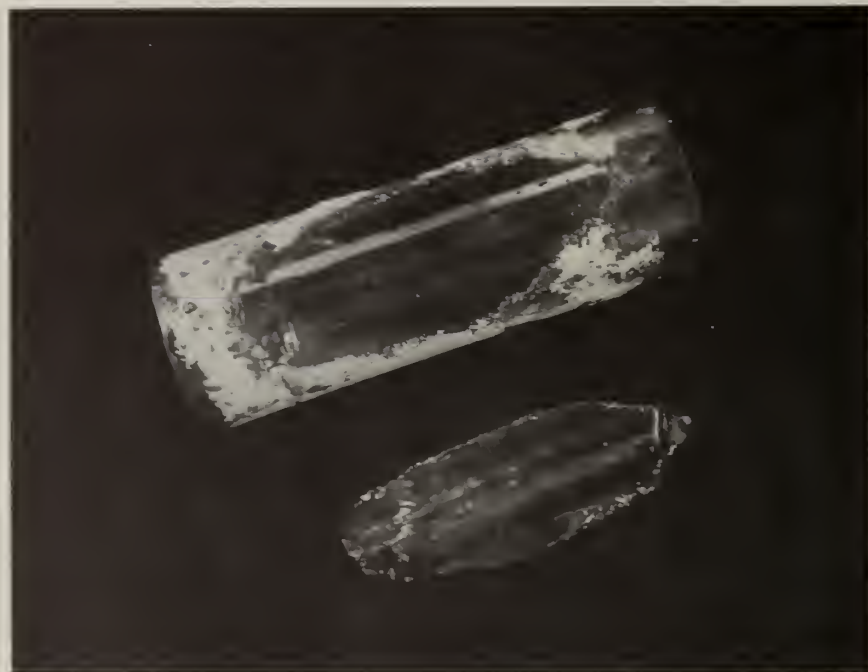
Figure 1. Burn out pattern of the platinum heater.

In experiment four, a new batch of material previously heated as described above was placed in the viscometer for viscosity measurements. The platinum heater was controlling properly at 1420°C but burned out prior to the introduction of the viscosity measuring bob. From figure 1 it can be seen that the burn out pattern on the platinum cylinder is near the position where the platinum electrode fin had been welded to the heater. In the design the position of the electrodes are fixed therefore fixing the platinum fins which are clamped to the electrodes. Thus, thermal expansion is accomplished by changes in the geometry of the platinum heater cylinder. It is most likely that the platinum was "work hardened" by repeated movement caused by such geometry changes and burned out where the metal endured maximum flexing.

These massive fins were removed from the cylinder and were welded to a new cylinder of 60%Pt and 40%Rh. Two layers of insulating material were cast about the heater. The inner layer was fabricated from green cast 97 and the outer layer from VSL 50.

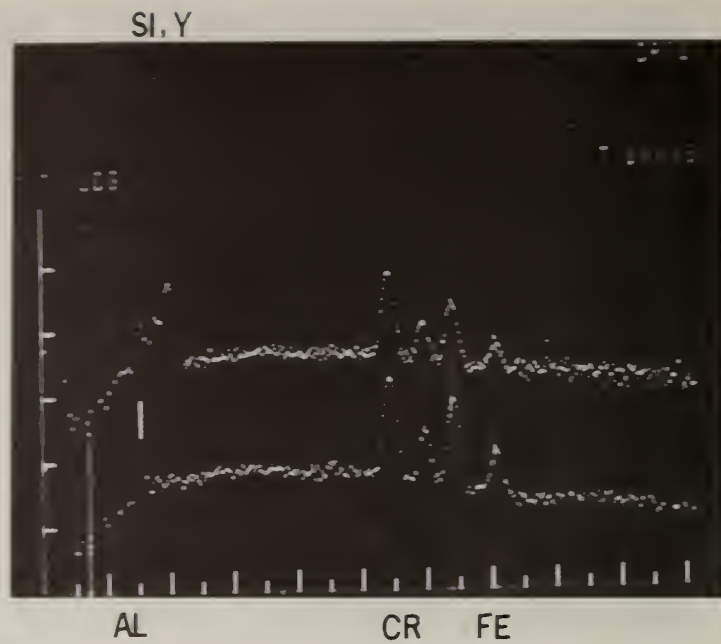
Figure 5 - Dual spectra of elements of zone 1 (lower spectrum) and zone 2 (upper spectrum) shown in Figure 3.

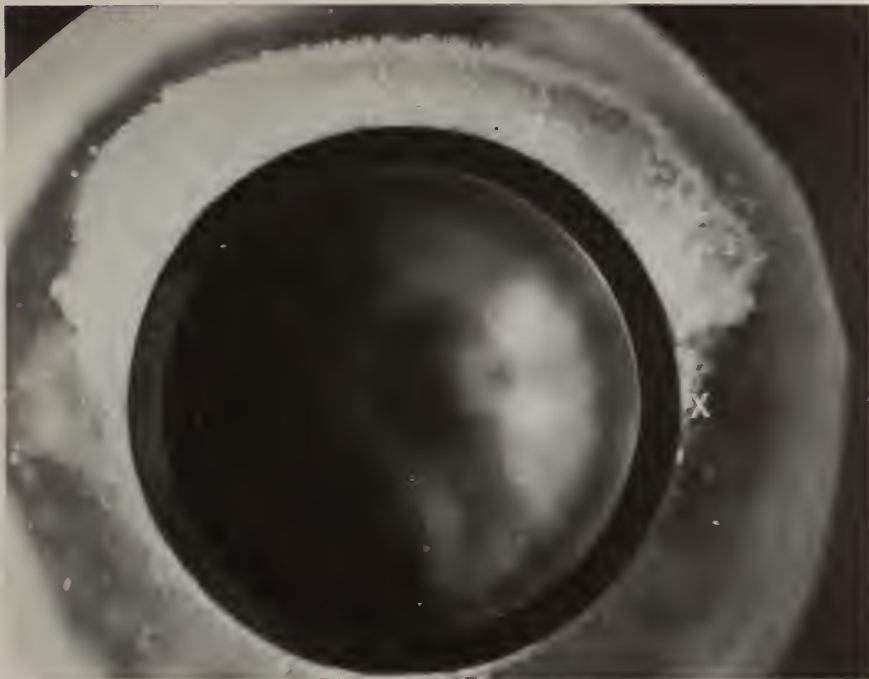
Figure 3. Section of Type 304 stainless steel tubing after exposure to  $K_2SO_4$  seeded oxygen rich hot gas stream. Note formation of thick deposit on upper surface. Tube temperature  $590^\circ C$ . 6 X.

On each of the three Type 304 stainless steel tubes run under oxygen rich conditions a thick white, somewhat columnar deposit was formed on the upper surface of the specimens, figures 1, 2, and 3, while a thin powdery deposit formed on the remainder of the surface. The columnar deposit was approximately 2 mm thick; the powdery deposit 0.1 mm to 0.2 mm thick. SEM examination and EDX analysis of the metal-deposit interface showed what appears to be corrosion or reaction bands that increase in thickness with temperature and vary in thickness with respect to location; the thickest band being noted in the merge region of the columnar-powdery deposit at 590°C. The reaction band thicknesses range from 3  $\mu\text{m}$  to 20  $\mu\text{m}$ .

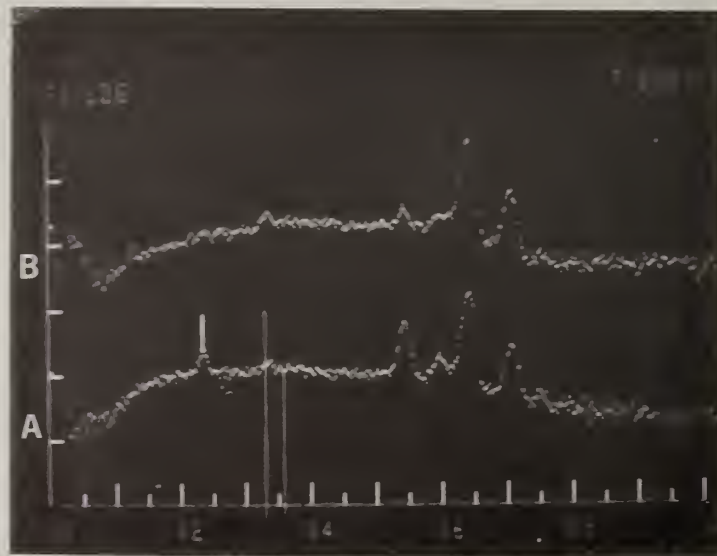
Figure 5. EDX spectra of regions A and B of Figure 4 showing absence or trace of Ni.

SEM micrograph (figure 4) is typical of the reaction bands formed in the metal-columnar deposit interface. The accompanying EDX spectra, figures 5, 6, 7, and 8 indicate a narrow band immediately adjacent to the stainless steel that is high in Ni. In this band and beyond it, going away from the metal, is a region high in Cr followed by a band high in Fe with virtually no Ni. Figure 9 shows the reaction bands in the metal interface columnar deposit powdery deposit merge zone. Figures 10 and 11 are the EDX spectra for those bands. The analysis is the same as given above. It should be noted that sulfur is markedly present in the bands adjacent to the metal showing high Ni and high Cr peaks.

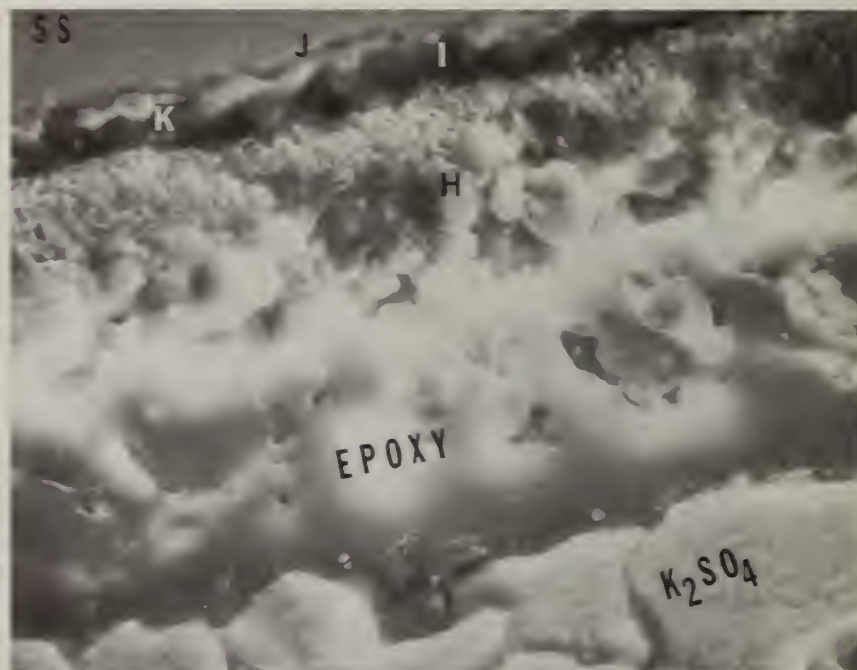
Figure 9. SEM micrograph, 1800 X, of reaction bands formed in the metal interface-columnar deposit powdery merge zone, location X of Figure 3. Lettered regions correspond to EDX spectra of Figures 10 and 11.

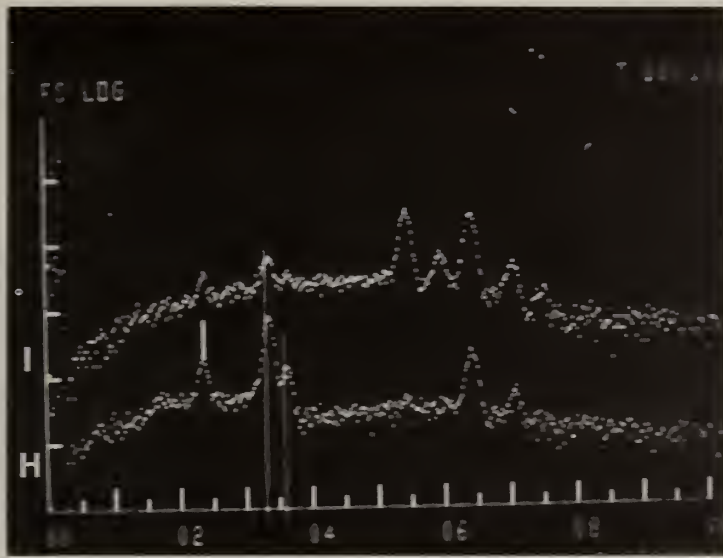
Figure 10. EDX spectra of regions H and I of Figure 9 showing Fe with the absence of both Cr and Ni (H) and high Cr and Fe with the absence of Ni(L).

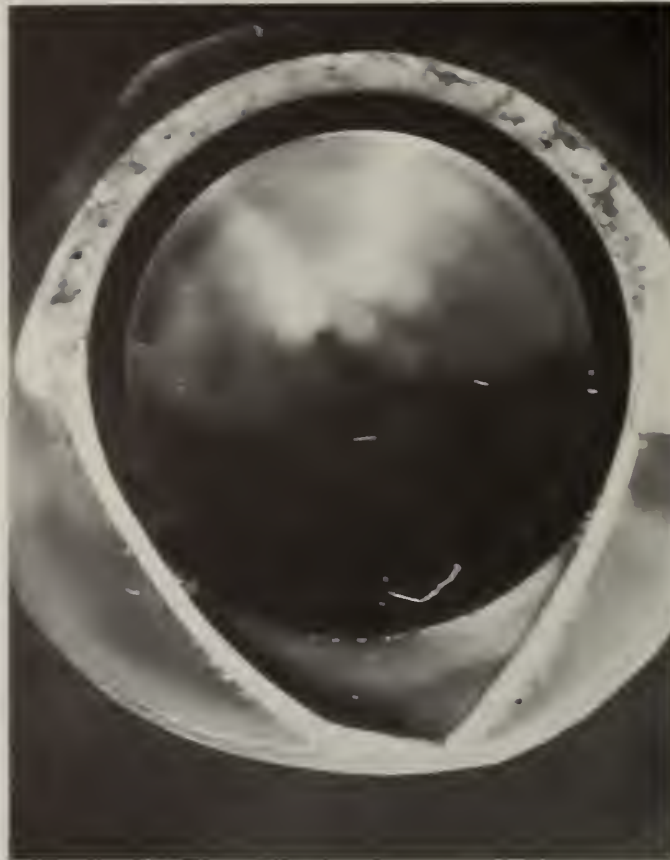
Figure 12. Section of Type 304 stainless steel tubing after exposure to  $K_2SO_4$  seeded fuel rich hot gas stream. Note formation of thin solid deposit on upper surface. Tube temperature  $400^{\circ}C$ . 6 X.

Under fuel rich conditions, a thin (compared to oxygen rich conditions) less columnar type deposit formed on the upper surface of the specimens. Deposit thicknesses ranged from 0.3 mm to 0.8 mm. By contrast the powdery deposit formed on the under surface was thicker than in the oxygen rich condition, being about 0.3 mm thick, figures 12, 13, and 14. It was noted that the deposits were of a grayish cast indicating the possible presence of carbon. It was also observed that with an increase in specimen temperature the upper deposit appeared to thin, the merge region of the upper deposit with the powdery deposit appeared to descend and the powdery deposit appeared to increase in thickness. Again the metal deposit interface showed what appears to be corrosion or reaction bands that increase in reaction width with temperature and vary in thickness with location. These reaction bands range in thickness from 7  $\mu\text{m}$  to perhaps 160  $\mu\text{m}$ . SEM micrographs, figures 15 and 16, taken at a metal-columnar deposit interface show two distinct reaction sub-bands. EDX spectra on this region, figures 17, 18, 19, 20, 21, and 22 show high Cr peaks in the sub-band immediately adjacent to the metal-deposit interface with very little, if any, Ni present. The other sub-band shows high Fe peaks with some Ni rich zones or Cr rich zones. It should be noted that high sulfur peaks are associated with the Ni rich zones and moderate K peaks in the Fe rich zones.

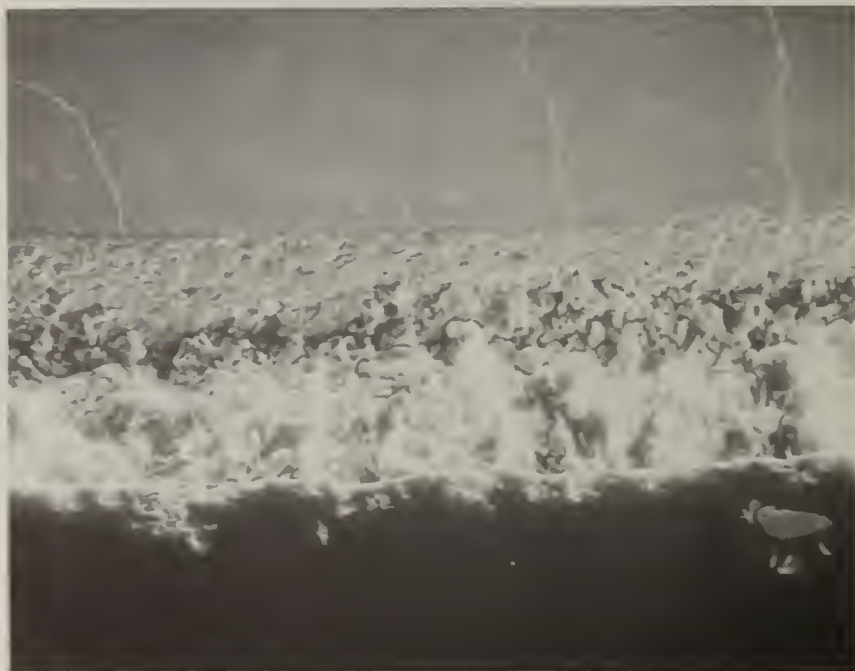
Figure 15. SEM micrograph, 190 X of reaction bands formed in the metal deposit interface of region Y of Figure 14.

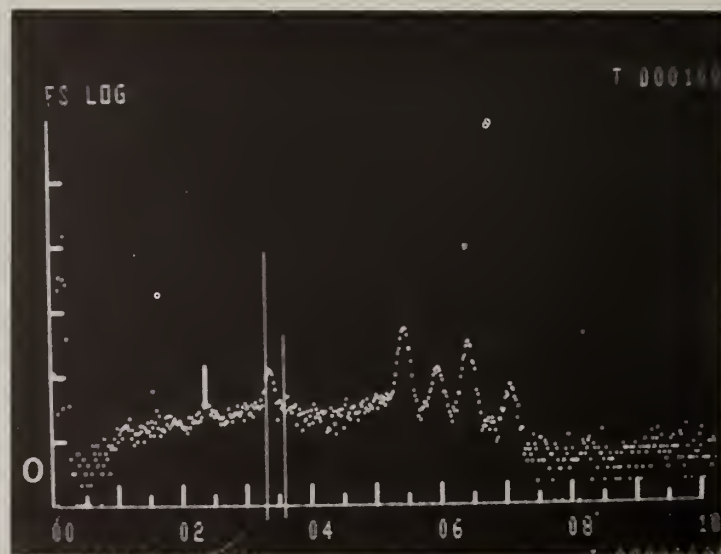
Figure 19. EDX spectrum of region 0 of Figure 16 showing high Cr and Fe and absence of Ni.

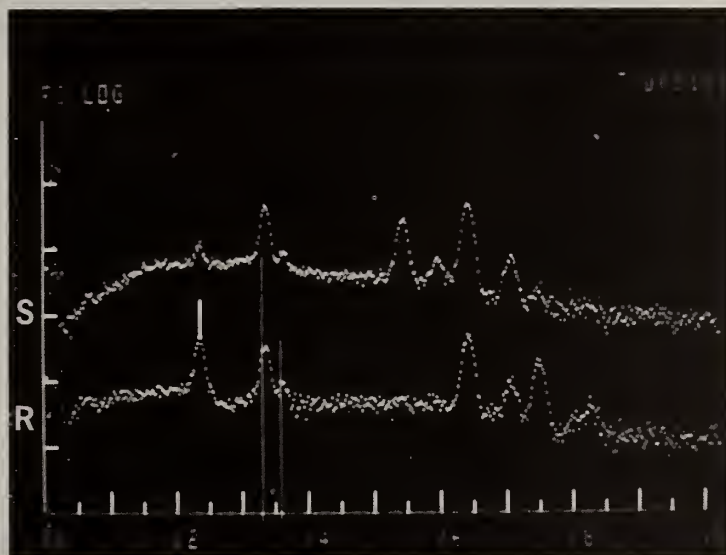
Figure 21. EDX spectra of regions R and S of Figure 16 showing Cr and Fe with a trace of Ni (S) and high Fe with Ni with no Cr, also high S and K, (R).
