MATERIALS RESEARCH FOR THE CLEAN UTILIZATION OF COAL

QUARTERLY PROGRESS REPORT

January - March 1980

Center for Materials Science  
National Bureau of Standards  
U. S. Department of Commerce  
Washington, D. C. 20234

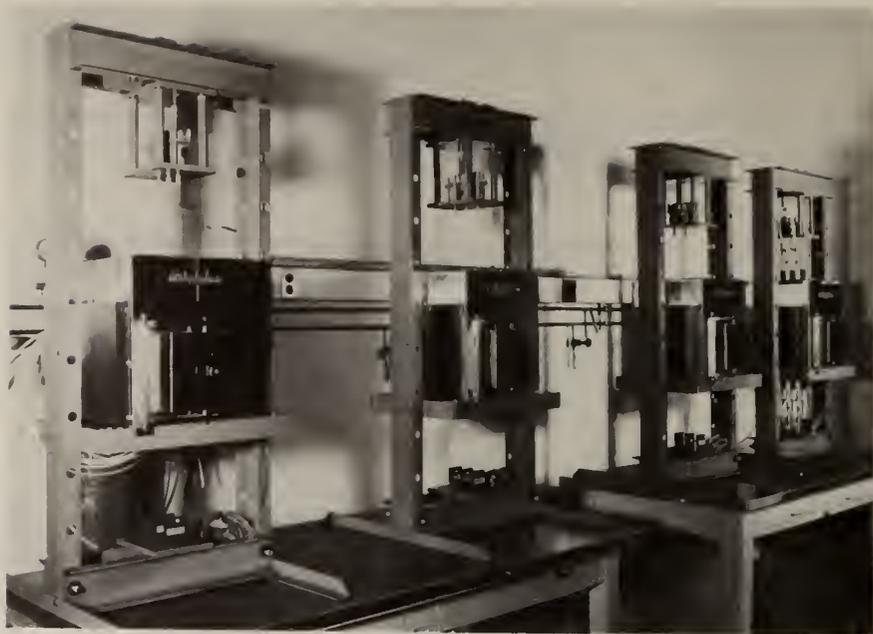
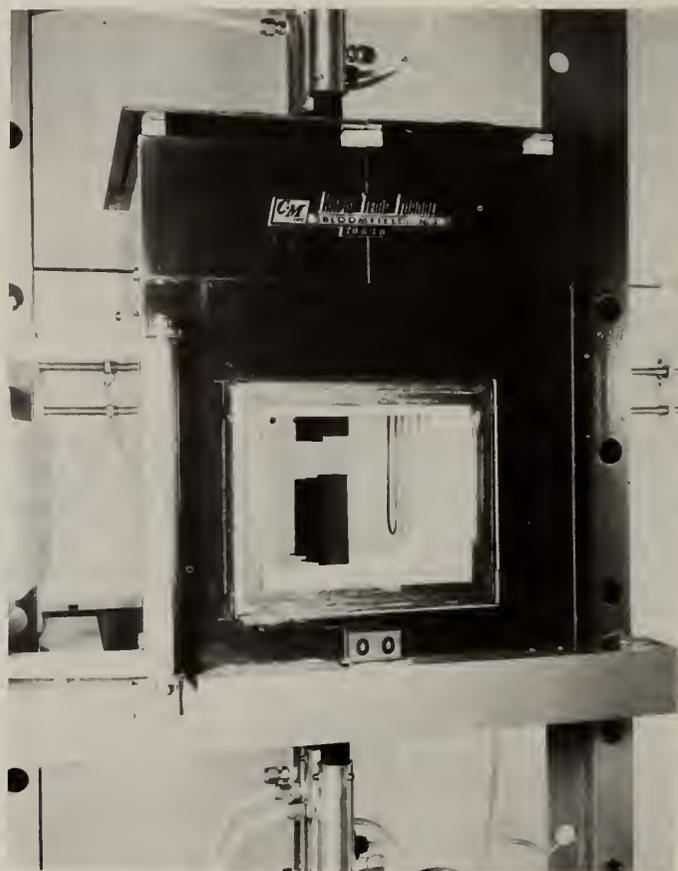
Figure 1. The 12 station creep assembly showing: (a) arrangement of the four furnaces, (b) arrangement of the loading furnace, and load cells.

Plans: The creep stations should be completed during the next quarter and long-term creep tests can be started. The relevance of the present choice of materials for the creep tests will be discussed with members of the MHD materials group. A paper covering the results of our creep tests and micro-structural analysis of the chrome-magnesite refractory designated RFG will be presented at the Annual Meeting of the American Ceramic Society in April 1980.

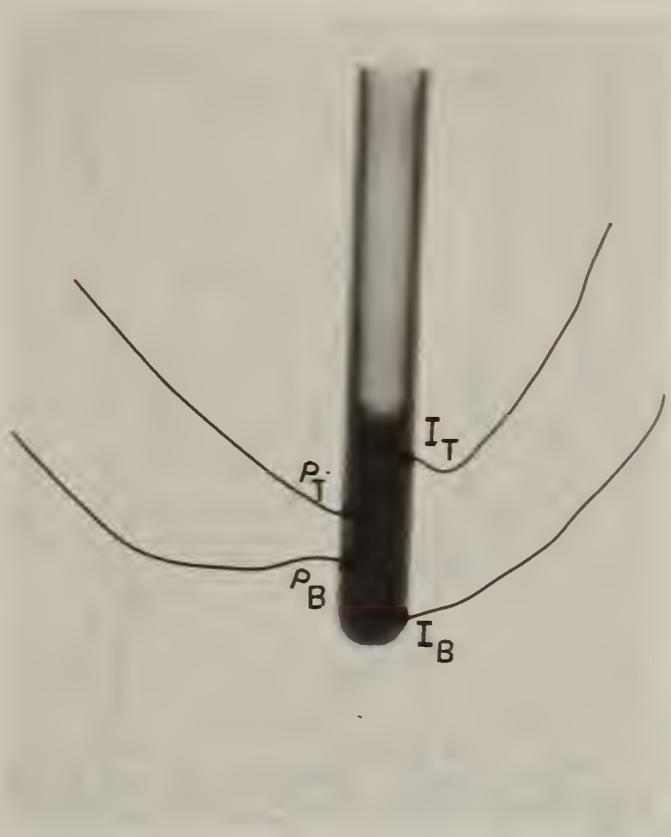
Figure 1. Radiograph of the electrochemical cell showing the arrangement of the platinum electrodes.

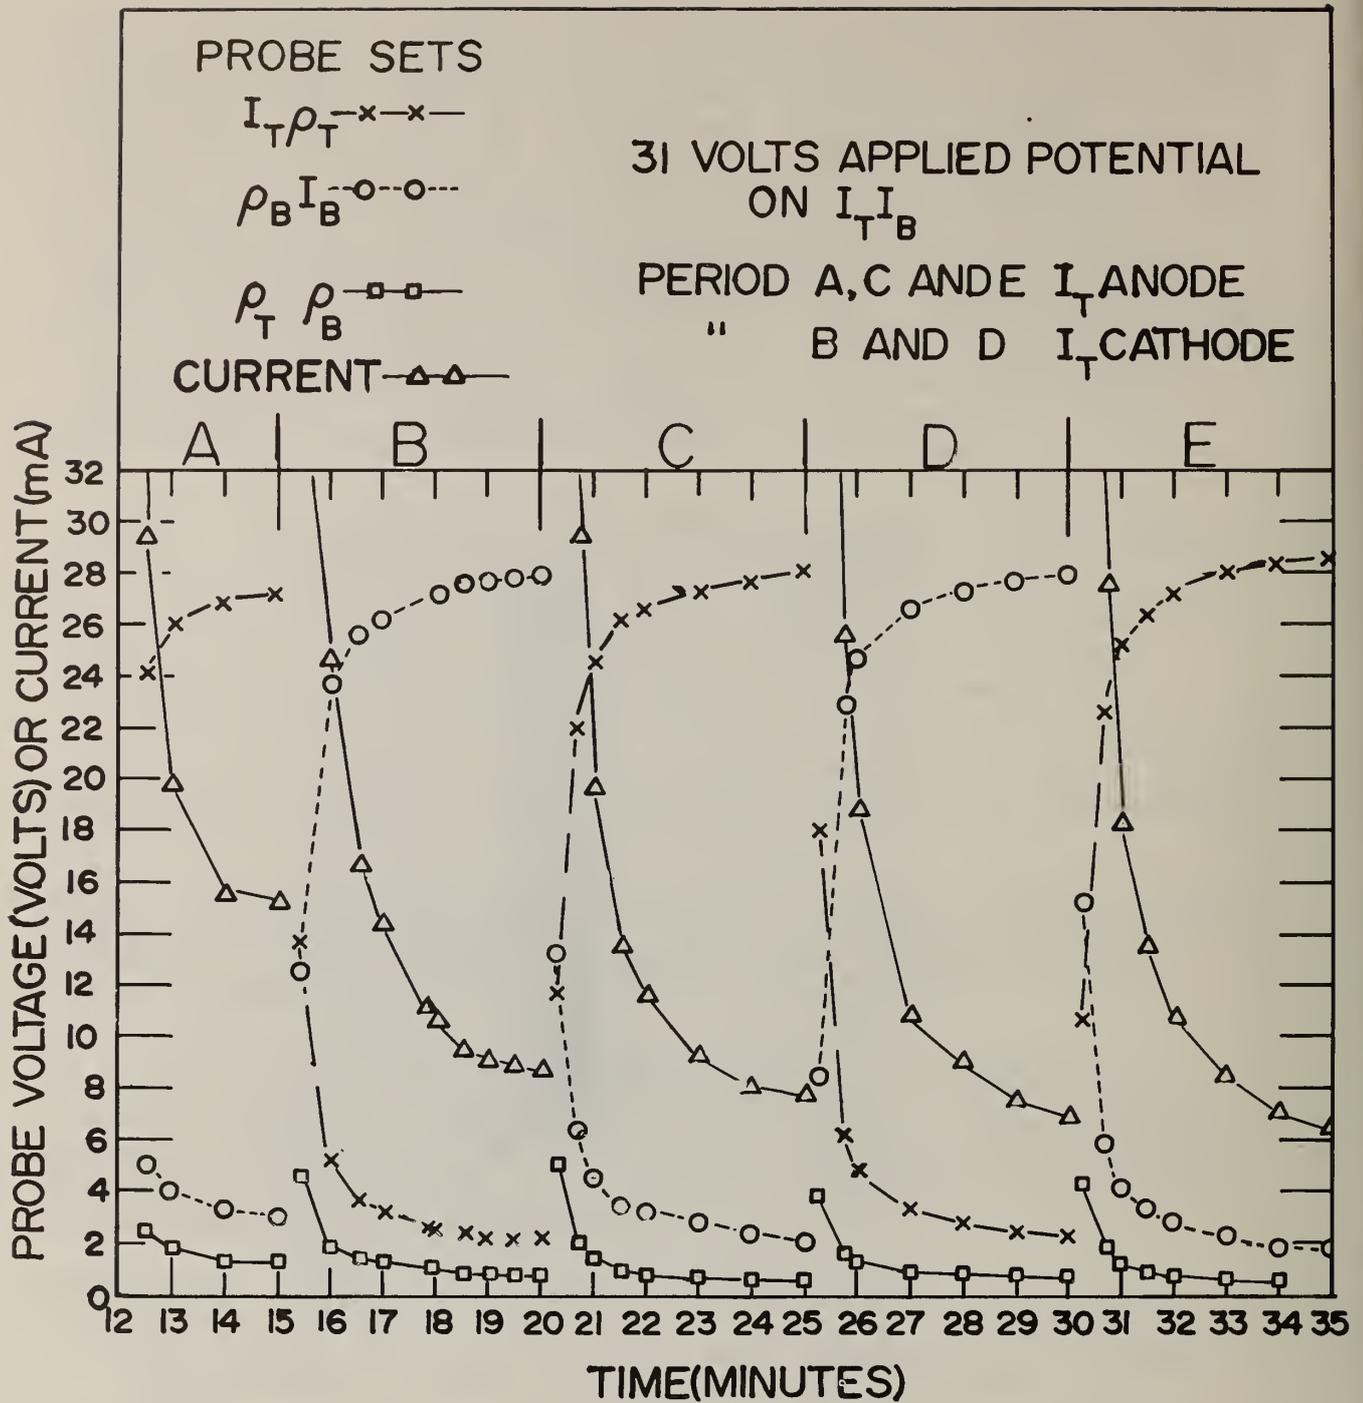
Figure 2. Probe set voltages and current as a function of time with periodic applied voltage polarity reversal. The applied voltage magnitude was constant during the run. Cell temperature 1250 °C.

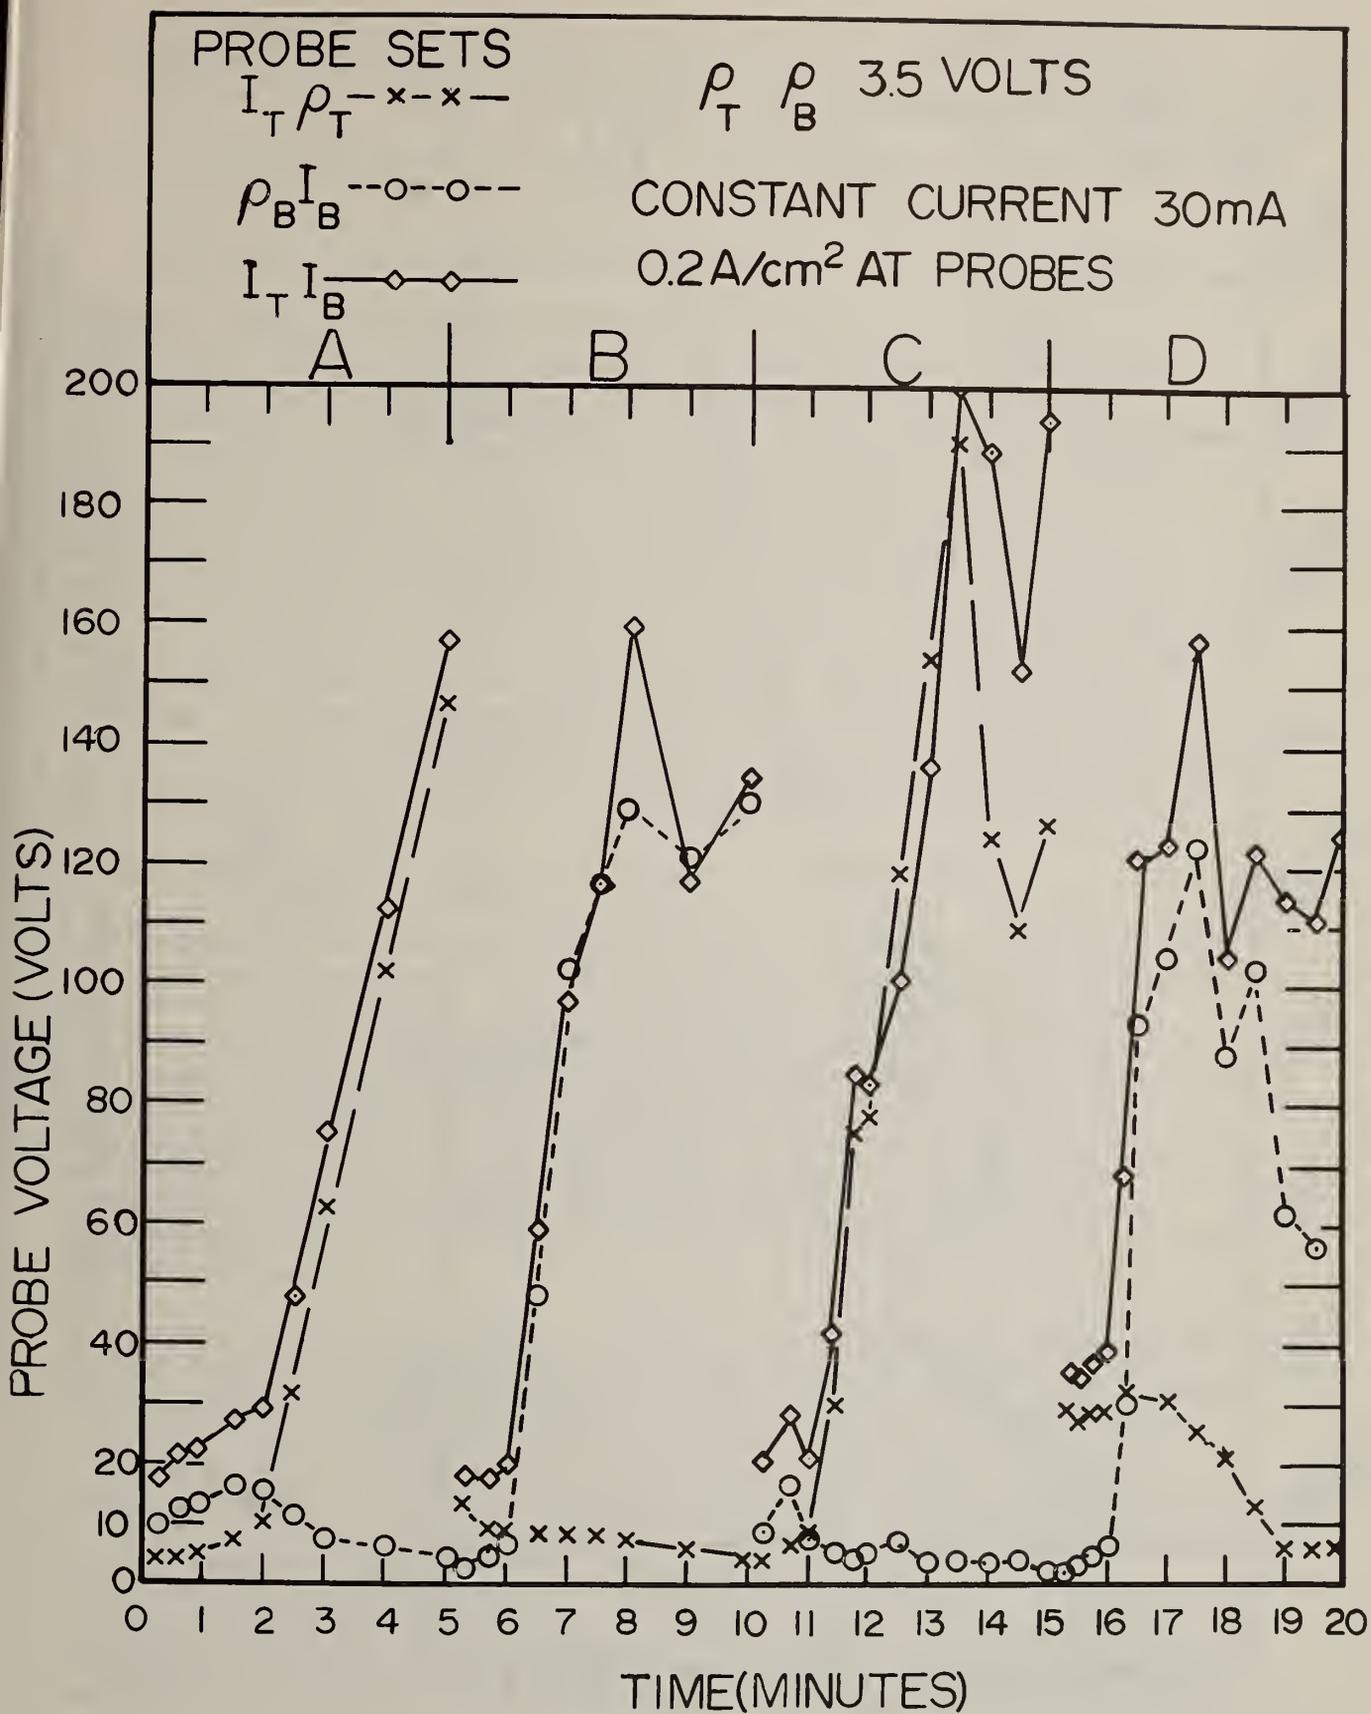
Figure 3. Probe set voltages as a function of time with periodic applied voltage polarity reversal. The current magnitude was constant during the run. During breakdown, recorded voltage magnitudes do not represent systematic cell behavior. Period A and C,  $I_T$  was anode. Period B and D,  $I_B$  was anode. Cell temperature 1250 °C.

A second experiment on this same cell was performed using a constant current (30 mA) mode but reversing the current periodically (five minute intervals). Figure 3 shows that data obtained over a 20 minute period in the experiment. Although the experiment was run for 1½ hours, only slight changes were observed with time on reversal of the current. Breakdown in the current conducting mechanisms after a current reversal appears to occur earlier when the  $I_B$  probe is an anode as in period B and D (1.5 to 2.0 minutes) than when the  $I_T$  probe is an anode as in periods A and C (four to five minutes). Since the experiment was run at 1250 °C, there could be a difference in the oxidation state of the iron between the top and bottom of the cell and this might cause a difference in the breakdown potential when the anode is at the bottom of the cell (away from ambient atmospheres). Also with the top of the cell as anode for a five minute period followed by a five minute period with the current off (these periods not shown in figure) the cell returns to its original state, i.e., the potentials are distributed evenly along the length of the cell showing that any depletion layer has been repaired. However, with the bottom of the cell as anode, and the same procedure followed, the depletion layer is not repaired completely even after a period of 50 minutes. A measurement of all probe voltages with current off yields zero potential indicating that there is no measurable battery effect present. In this constant current mode, the high potential develops between the anode and its adjacent conductivity probe as was also observed in the constant voltage mode. Breakdown occurs also at the anode. The corresponding cathode potential decreases with time after a slight initial increase after reversal. The slag bulk conductivity decreased (potential on  $\rho$  probes increased) slightly during the course of the experiment which may be due to iron diffusion into the platinum electrodes.

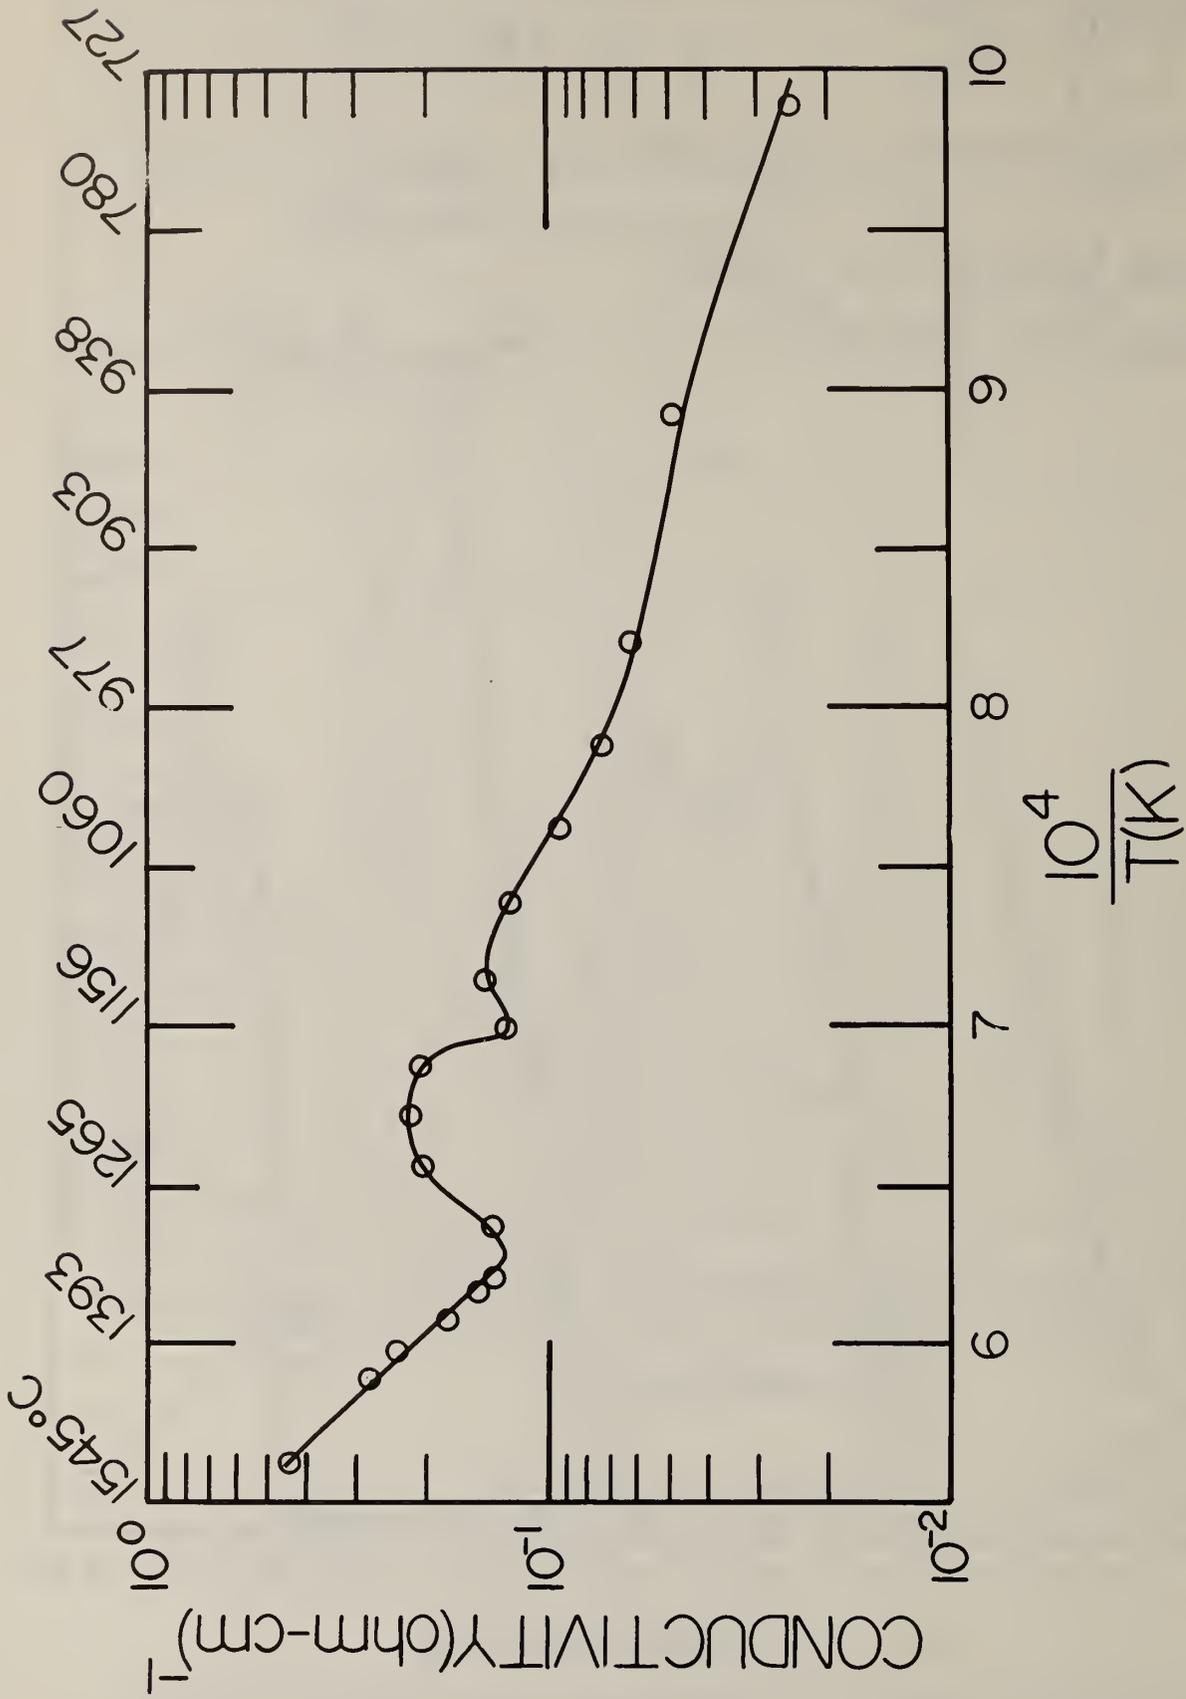
Figure 4. Electrical conductivity of Bow, NH slag with an added 20 w/o  $K_2SO_4$  and with 34.6 w/o  $Fe_2O_3$  (24.3 w/o Fe) as a function of temperature. These measurements were done in air.

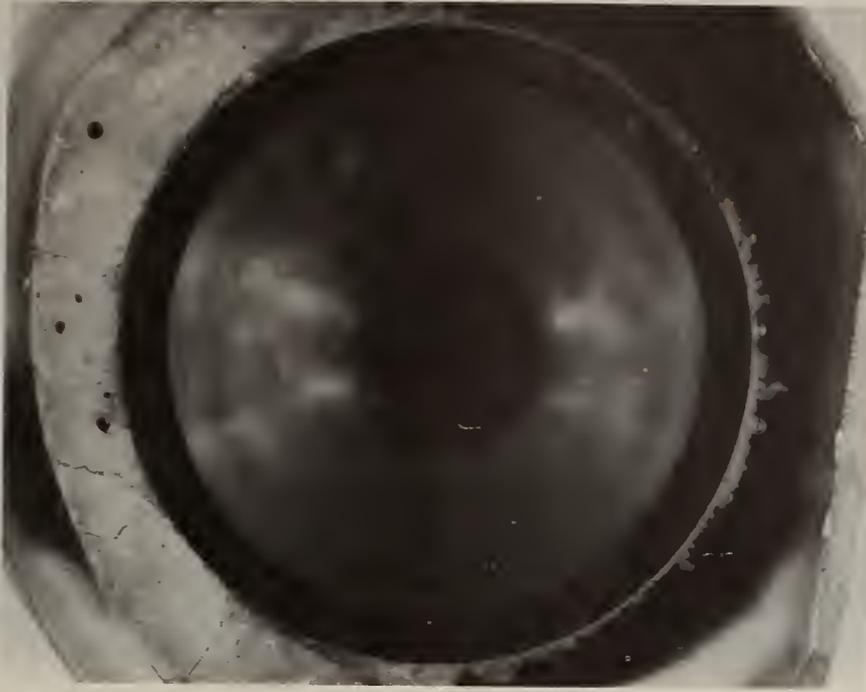
Fig. 1. Section of Type 316 stainless steel tubing after exposure to  $K_2SO_4$  seeded oxygen rich hot gas stream. Note formation of deposit on the upper surface. Tube temperature 590 °C.

On all the specimens, a compact, somewhat columnar deposit formed on the surface facing the gas stream. The thickness of this deposit varied slightly with tube temperature and is approximately 1.7 mm. A much thinner, almost undetectable deposit, probably from fume, formed on the trailing surface. These deposits are in the 0.2 mm range. At the boundary, where the surface deposit and the fume deposit intersected a thicker drip zone formed, see Figs. 1, 2 and 3. SEM micrograph, Fig. 4, shows a  $K_2SO_4$  deposit on the leading surface of a Type 316 stainless steel tube held at 590 °C. This type of deposit is typical of that produced from  $K_2SO_4$  seeding and was seen on specimens of Type 304 stainless steel tested previously under these conditions. EDX analysis indicates that potassium and sulfur is uniformly distributed through

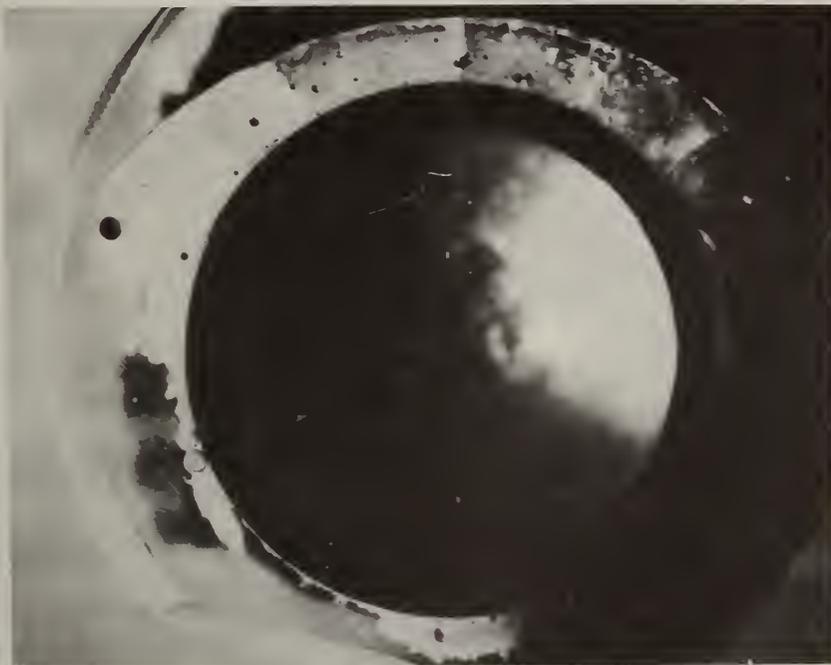
Fig. 2. Section of Type 316 stainless steel tubing after exposure to  $K_2SO_4$  seeded oxygen rich hot gas stream. Note formation of deposit on the upper surface. Tube temperature 500 °C.

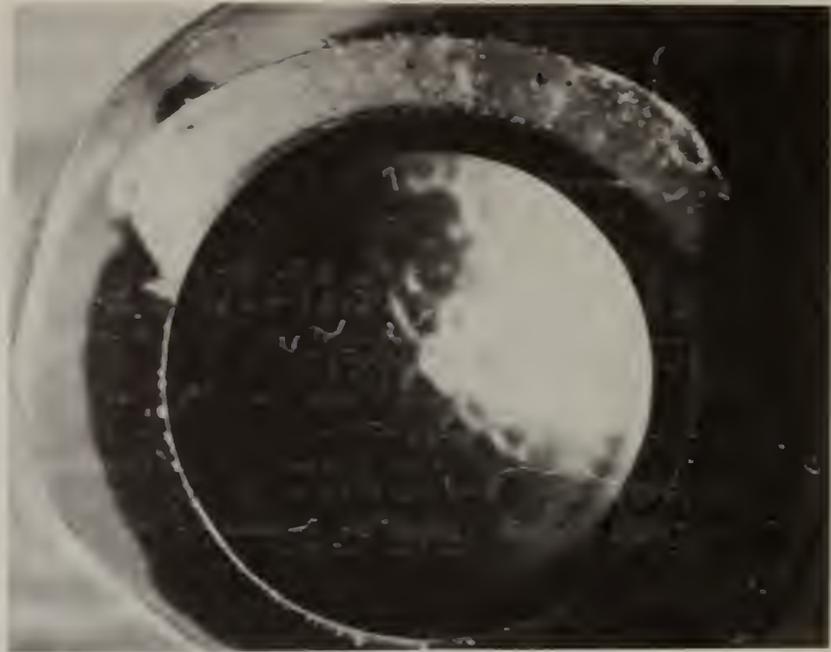
Fig. 3. Section of Type 316 stainless steel tubing after exposure to K<sub>2</sub>SO<sub>4</sub> seeded oxygen rich hot gas stream. Note formation of coating on the upper surface. Tube temperature 400 °C.

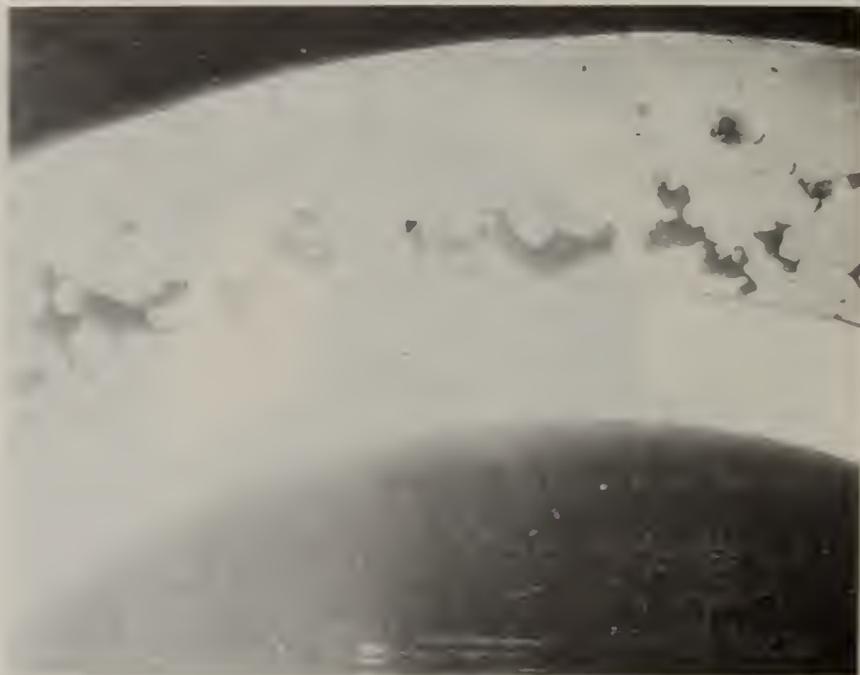
Fig. 4. SEM micrograph, 20 X, of K<sub>2</sub>SO<sub>4</sub> deposit on leading surface of Type 316 stainless steel. Specimen temperature 590 °C gas stream oxygen rich.

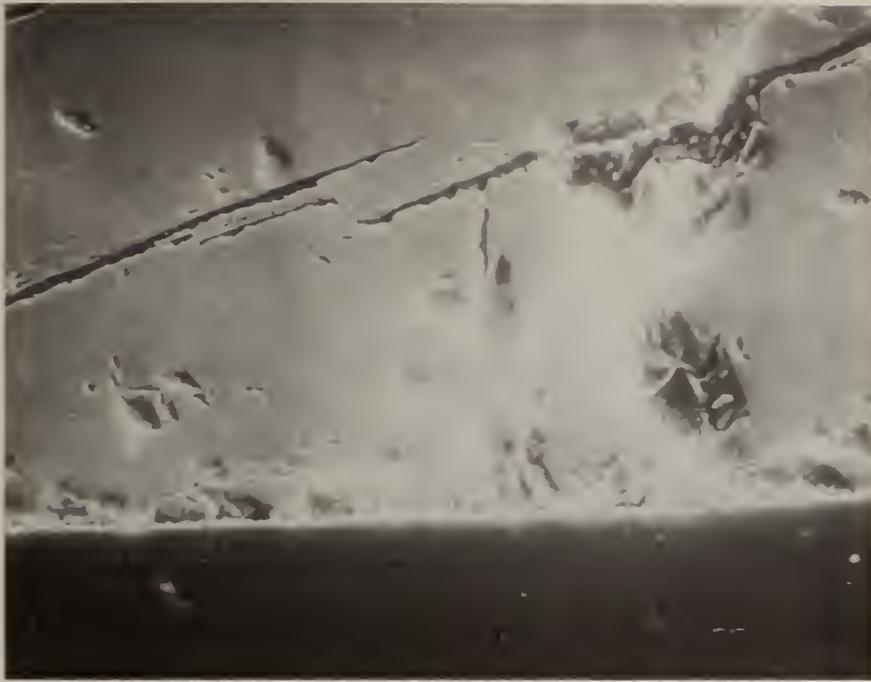
Fig. 5. SEM micrograph, 200 X, of gas stream-deposit interface showing potassium rich band.

the bulk of the deposit. SEM micrograph, Fig. 5, shows the top of the salt deposit with a fine whitish band on the surface. This band contains a higher proportion of potassium than the bulk of the deposit possibly due to vaporization of some sulfur at the deposit-gas stream interface. The stainless steel deposit interface is seen in SEM micrograph, Fig. 6. Note that the adhesion is rather poor as epoxy fills a gap in the interface region. A reaction area at the interface is shown in SEM micrograph, Fig. 7. At the metal edge, areas of low chromium and low nickel concentration are found dotted with regions of high nickel concentration, Figs. 7a - 7d. A loss of iron is also associated with these areas. At the deposit edge, concentrations of iron, chromium, potassium, and sulfur are found indicating some degradation of the metal surface and formation of a reaction zone between the metal and the deposit, Figs. 7e - 7h. The SEM/EDX analysis seems to indicate a preferential leaching of the metal cations from the bulk material (Type 316 stainless steel) in a somewhat orderly fashion as in the case of Type 304 stainless steel. However, the extent of corrosion is not as great as in the case of Type 304 stainless steel. This is corroborated by wastage (weight loss) experiments also described in this report.

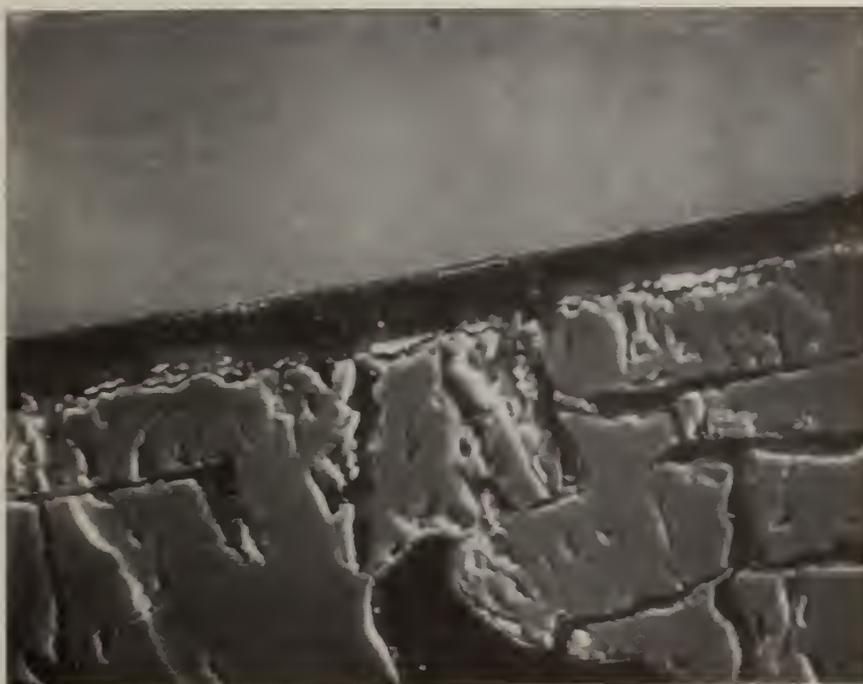
Fig. 6. SEM micrograph, 500 X of Type 316 stainless steel-deposit interface. Specimen temperature 590 °C gas stream, oxygen rich.

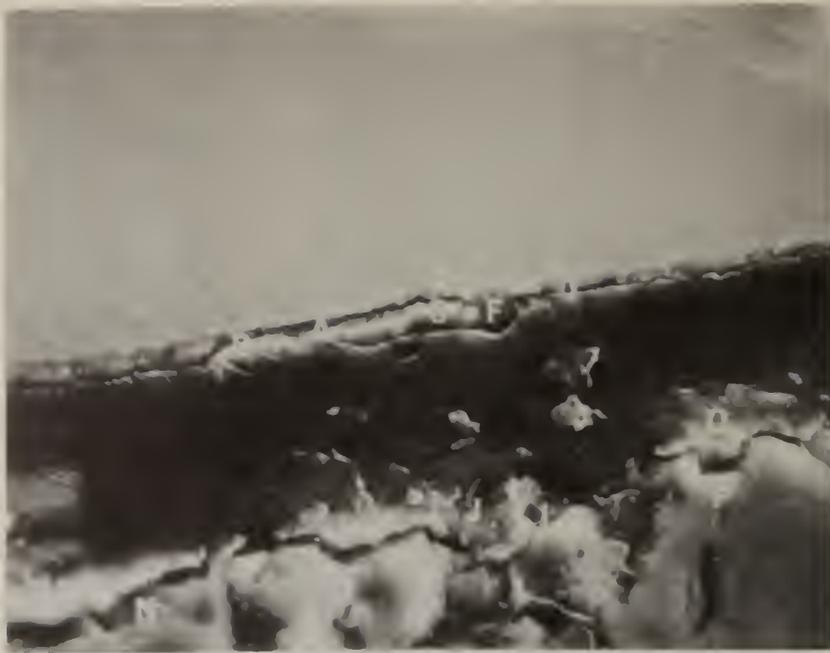
Fig. 7. SEM micrograph, 2000 X, of center region of Fig. 6 showing reaction area at interface. Lettered regions correspond to labeled EDX spectra, Figs. 7a-7h. Specimen temperature 590 °C, gas stream oxygen rich.

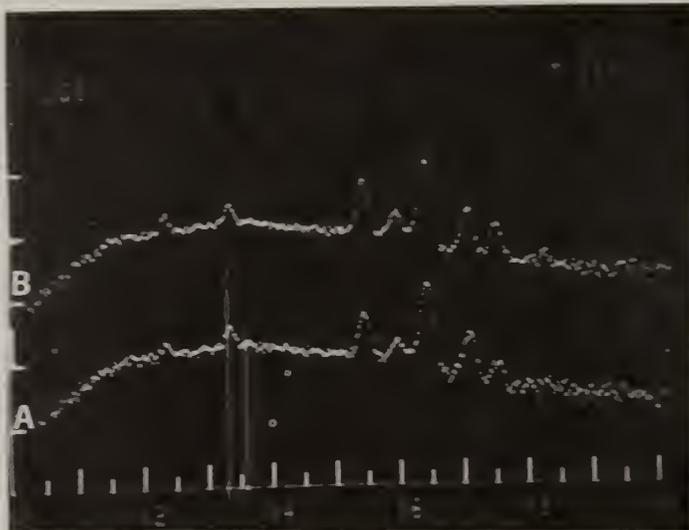
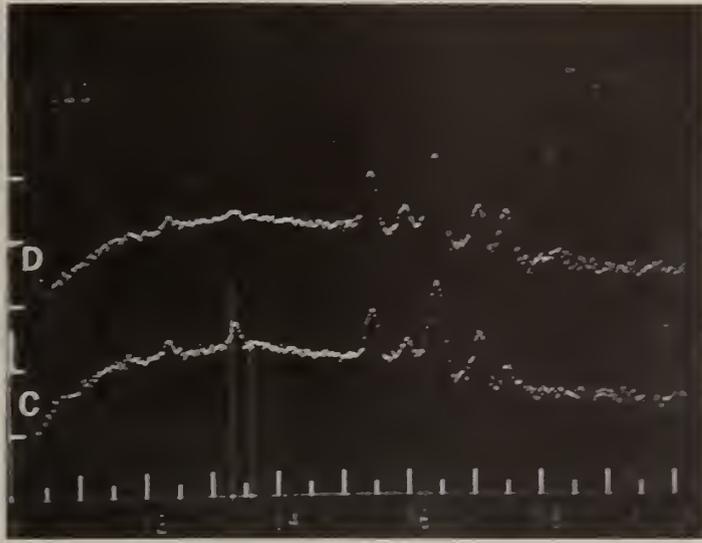
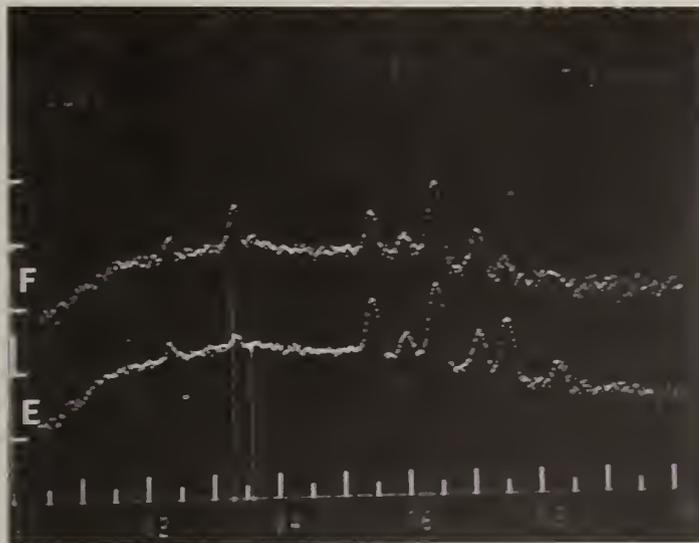
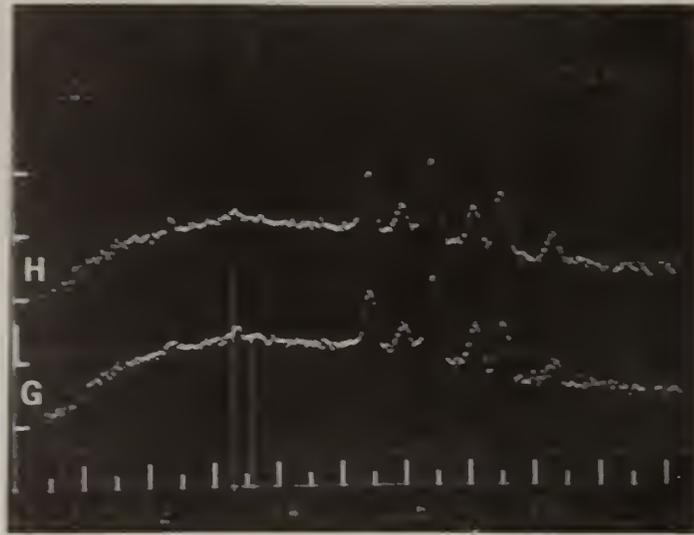
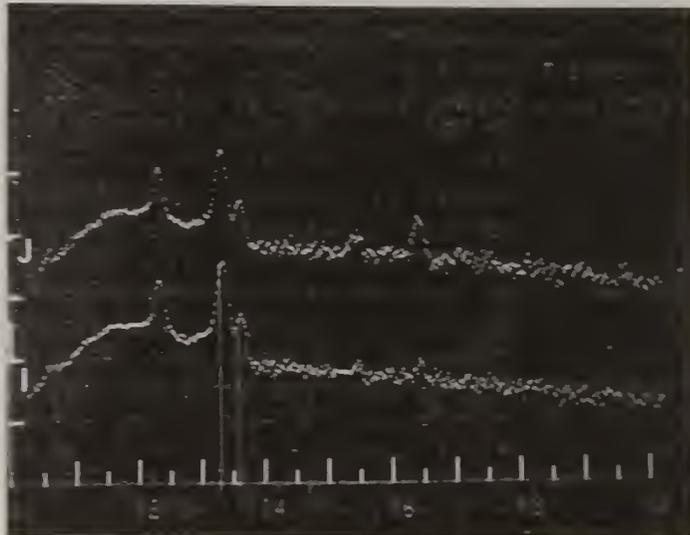
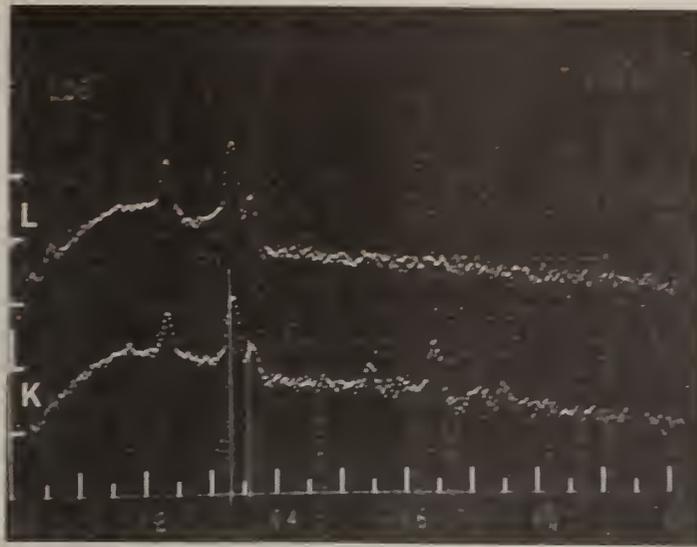
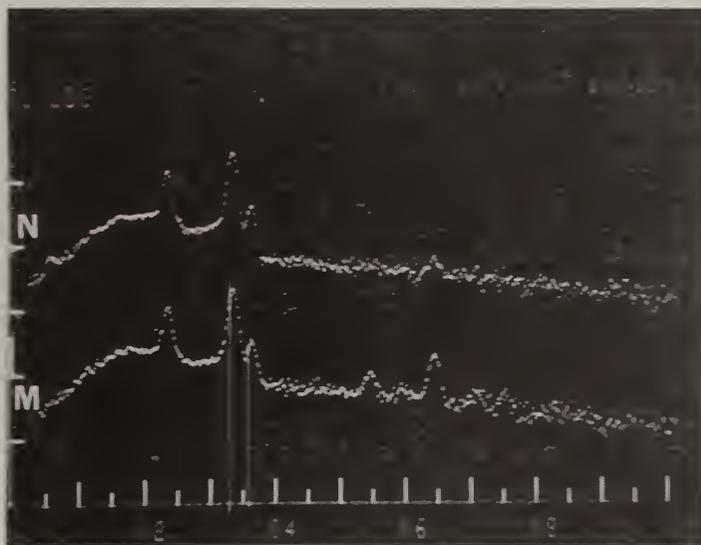
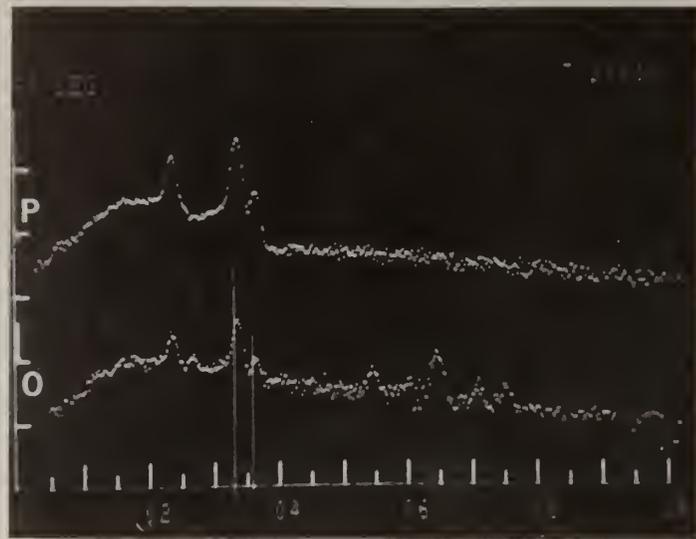
Fig. 7a. EDX spectra of regions A and B of Fig. 7 showing low Ni concentration areas. Specie positions and designations on all spectra in this section of this report are as indicated above.

Fig. 7b. EDX spectra of regions C and D of Fig. 7 showing low Cr and low Ni concentrations in the reaction zone.

Fig. 7c. EDX spectra of regions E and F of Fig. 7 showing high Ni and low Cr concentrations.

Fig. 7d. EDX spectra of regions G and H of Fig. 7 showing high Ni at the metal edge.

Fig. 7e. EDX spectra of regions I and J of Fig. 7 showing Fe penetration into the deposit.

Fig. 7f. EDX spectra of regions K and L of Fig. 7 showing Fe and Cr penetration into the deposit.

Fig. 7g. EDX spectra of regions M and N of Fig. 7 showing again Fe and Cr penetration into the potassium-sulfur deposit.

Fig. 7h. EDX spectra of regions O and P of Fig. 7 showing penetration of all three species, Fe and Cr and Ni into the deposit.

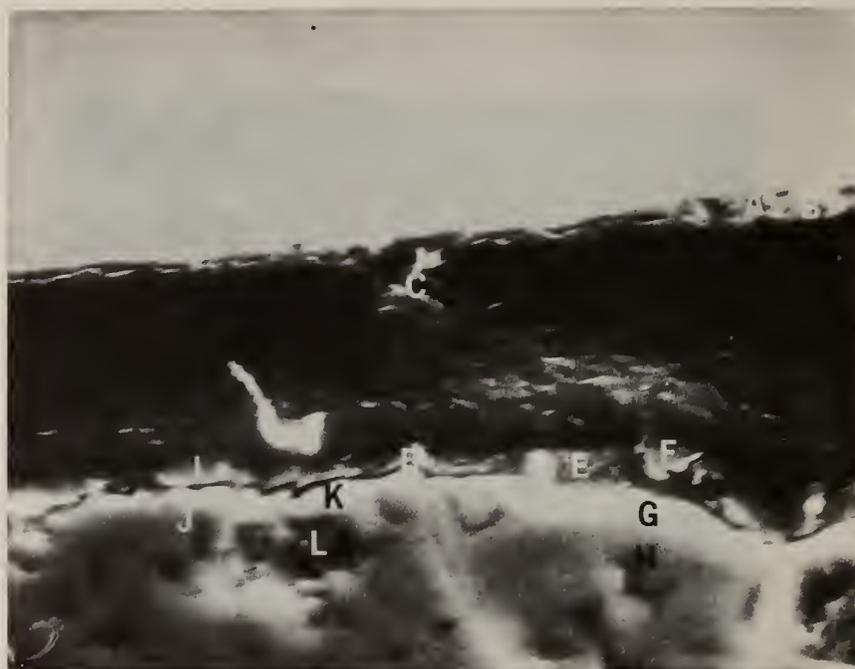
Fig. 8. SEM micrograph, 2000 X, of Type 316 stainless steel-deposit interface. Lettered regions correspond to labeled EDX spectra, Figs. 8a-8e. Specimen temperature 590 °C, gas stream oxygen rich.

As found in previous specimens, though nickel loss is readily detected, its displacement to other areas is difficult to follow. Few areas are found where nickel has migrated even though its concentration is low. Fig. 8 shows a reaction area where low chromium and low nickel concentration are found at the metal edge, Figs. 8a and 8b, and metal cations are found at the edge of the deposit, Figs. 8c - 8e. Migration of the iron, Fig. 9, is farther back in the deposit and generally parallels previous results in which iron was preferentially leached out of the bulk stainless steel and into the deposit.

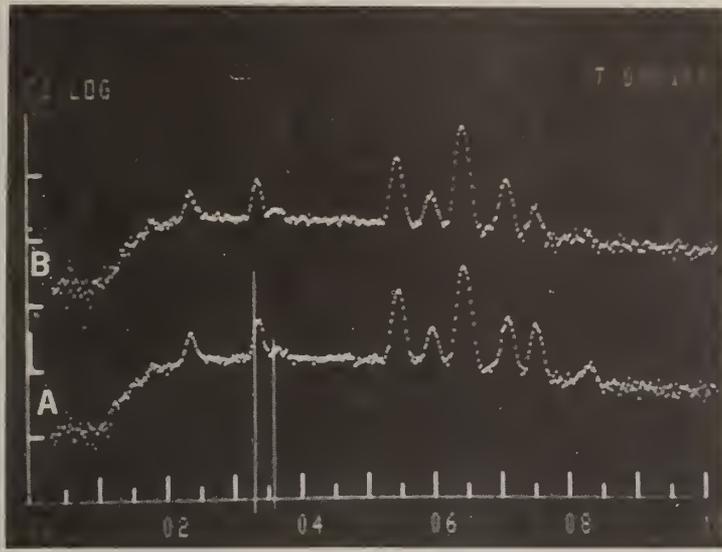
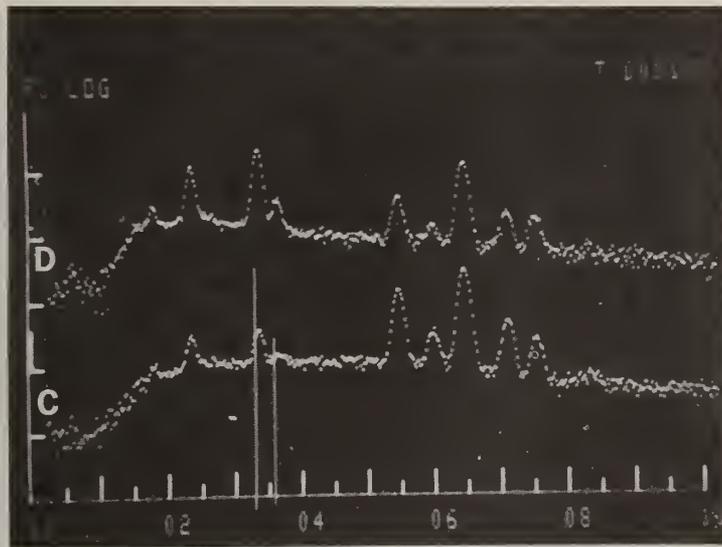
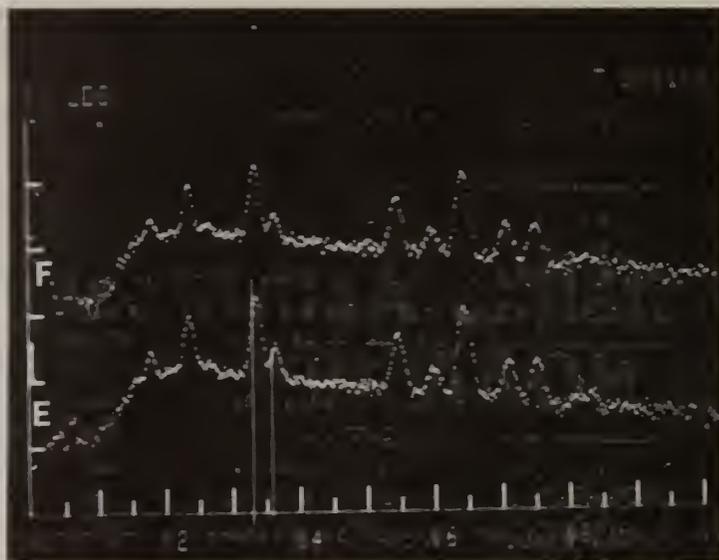
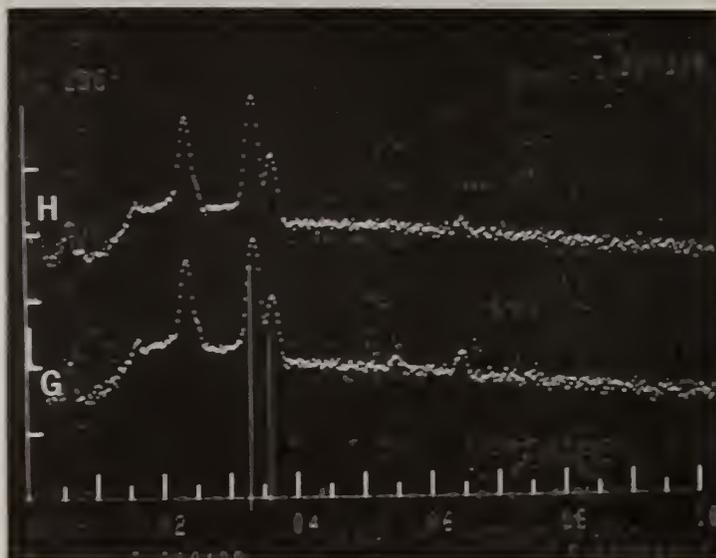
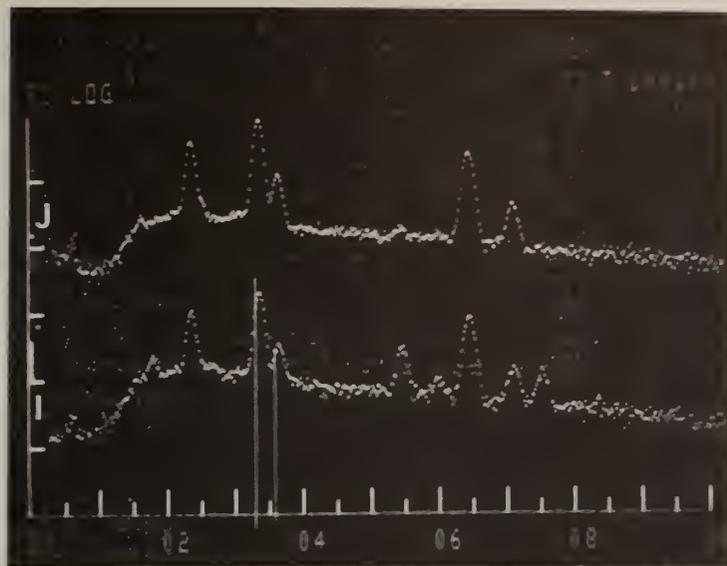
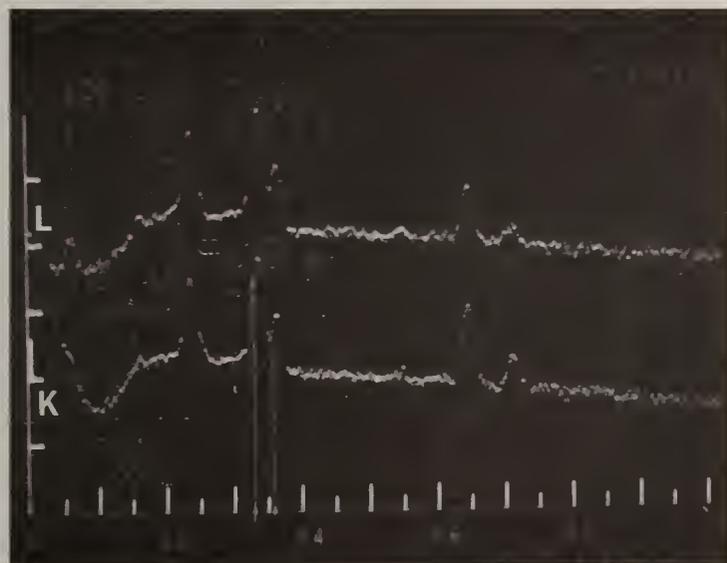
Fig. 8a. EDX spectra of regions A and B of Fig. 8 showing low Ni and low Cr concentrations at the metal edge.

Fig. 8b. EDX spectra of regions C and D of Fig. 8 showing low Ni and low Cr concentrations at the metal edge.

Fig. 8c. EDX spectra of regions E and F of Fig. 8 showing metal cations in the reaction zone of the deposit.

Fig. 8d. EDX spectra of regions G and H of Fig. 8 showing metal cations in the reaction zone of the deposit.

Fig. 8e. EDX spectra of regions I and J of Fig. 8 showing metal cations in the reaction zone of the deposit.

Fig. 9. EDX spectra of regions K and L of Fig. 8 showing Fe farther back in the deposit.

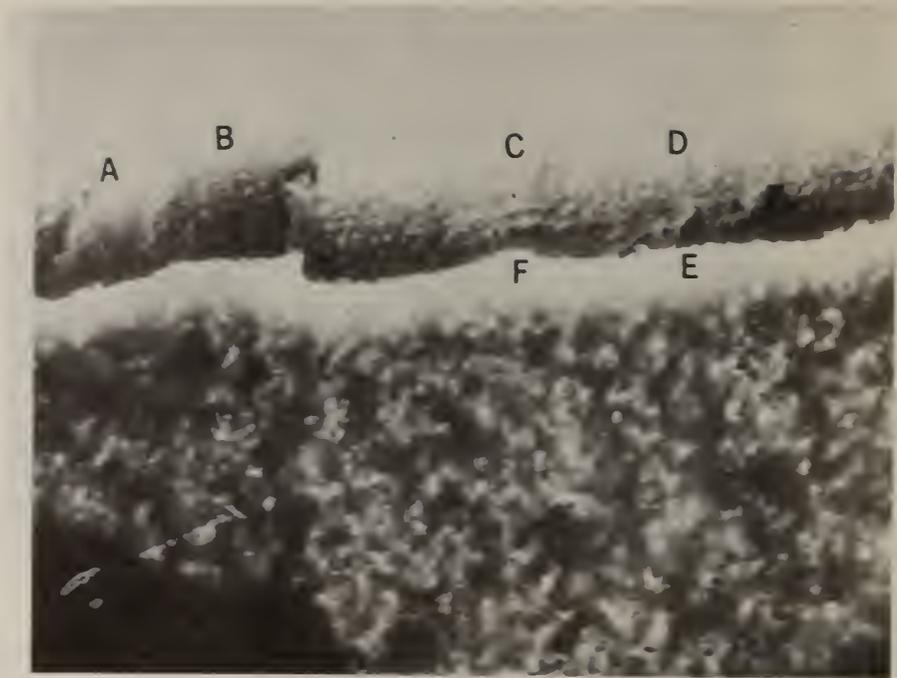
Fig. 10. SEM micrograph, 2000 X, of Type 316 stainless steel-fume deposit interface. Lettered regions correspond to labeled EDX spectra Figs. 10a-10c.

Fig. 10 shows a portion in the fume deposit area where the corrosion process seems to be evident. On the metal edge low nickel areas are found, Figs. 10a - 10c, while areas of chromium, iron, potassium, and sulfur are found in the reaction zone. Again nickel is the elusive element. Though it is found in low concentration in the reaction zone, it is not really found to have migrated into the deposit region.

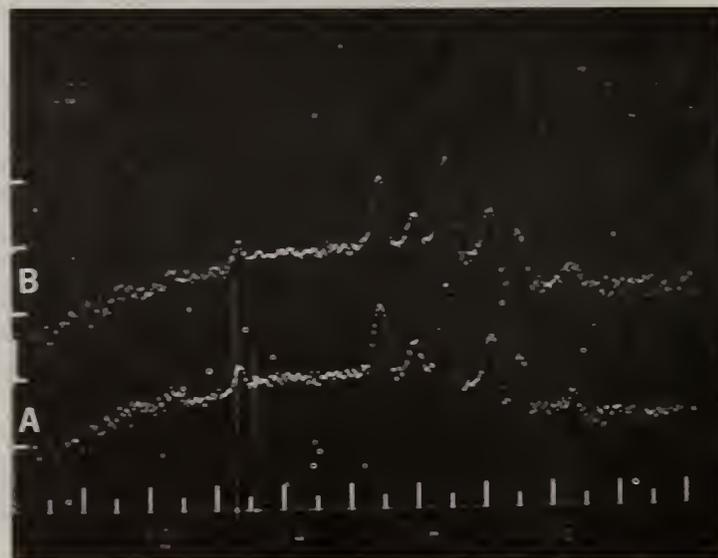
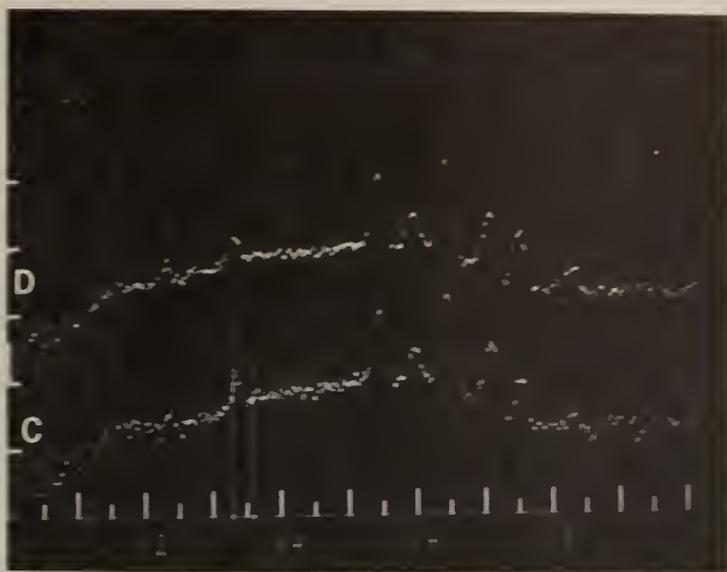
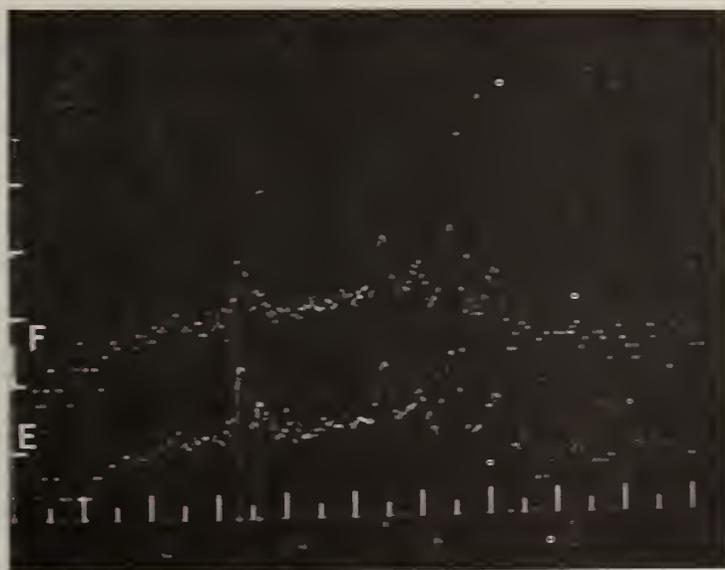
Fig. 10a. EDX spectra of regions A and B of Fig. 10 showing distribution of Cr, Fe and Ni at the stainless steel edge.

Fig. 10b. EDX spectra of regions C and D of Fig. 10 showing distribution of Cr, Fe and Ni at the stainless steel edge.

Fig. 10c. EDX spectra of regions E and F of Fig. 10 showing absence of Ni in the reaction zone.
