MATERIALS RESEARCH FOR THE CLEAN UTILIZATION OF COAL

QUARTERLY PROGRESS REPORT

January - March 1980

Center for Materials Science  
National Bureau of Standards  
U. S. Department of Commerce  
Washington, D. C. 20234

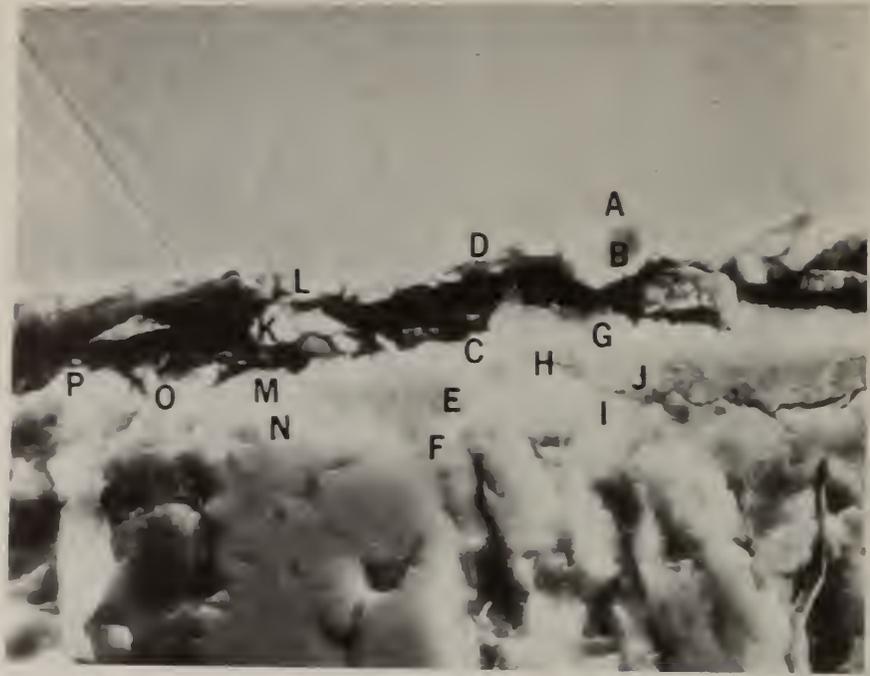
Fig. 11. SEM micrograph, 2000 X of Type 316 stainless steel-deposit interface. Lettered regions correspond to labeled EDX spectra Figs. 11a-11h. Specimen temperature 500 °C, gas stream oxygen rich.

At a lower temperature, 500 °C, corrosion is still observed in Type 316 stainless steel. Fig. 11 shows a region of corrosion at the metal-deposit interface. EDX analysis of the region, Figs. 11a - 11h, indicate areas of low metal cation concentration at the metal edge and metal cation migration into the deposit. The same can be said at the still lower specimen temperature of 400 °C but to a much lesser extent.

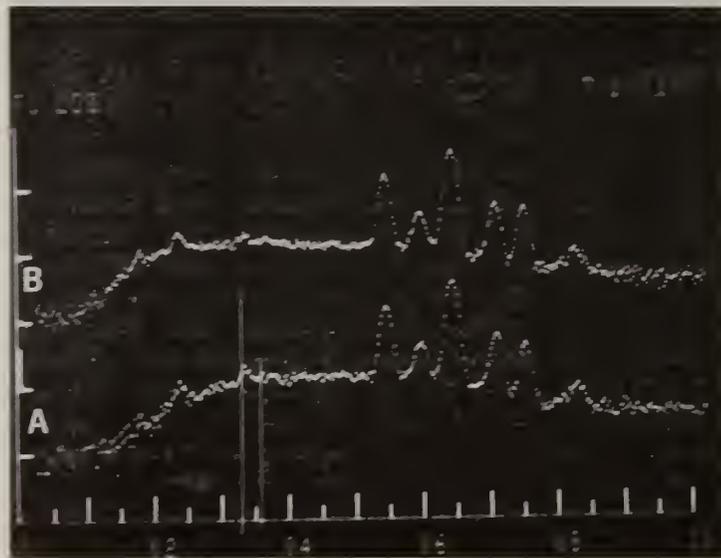
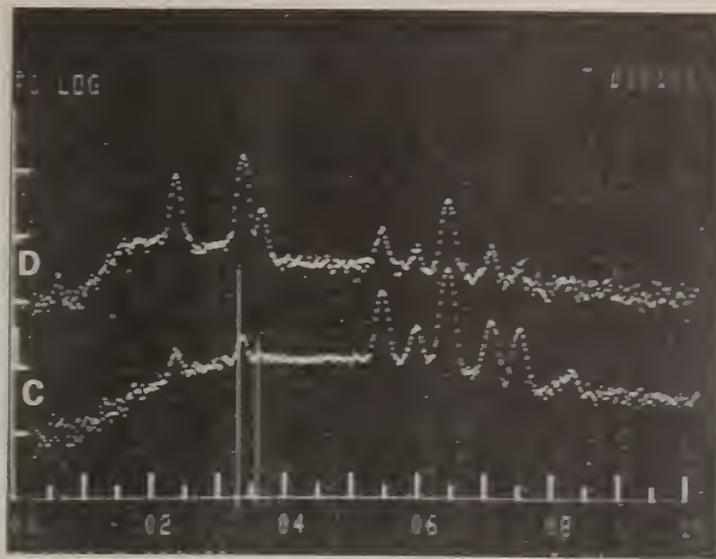
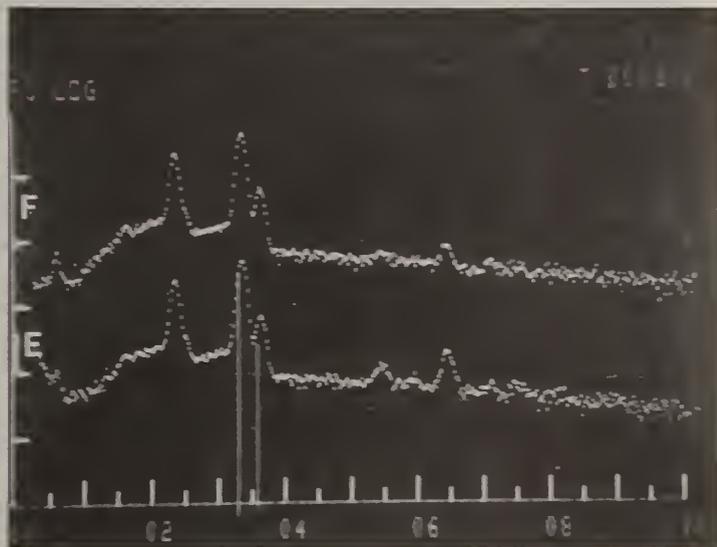
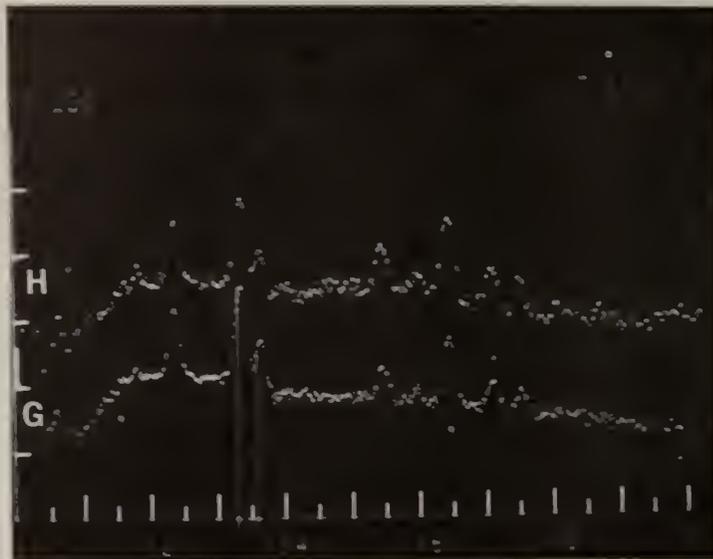
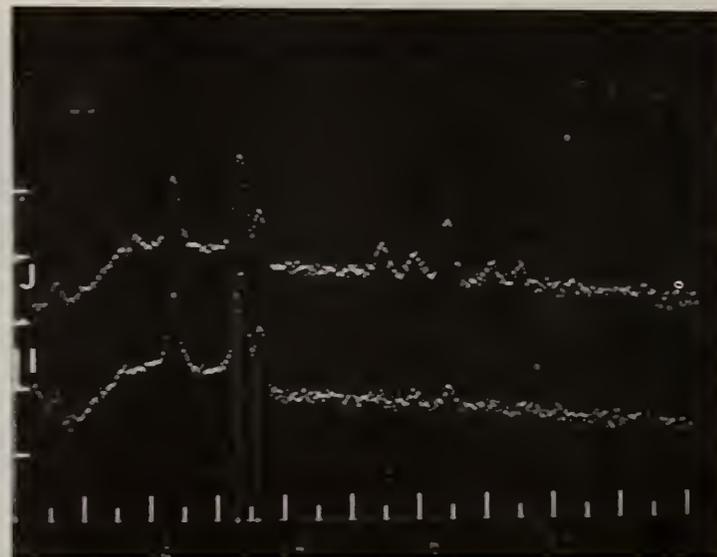
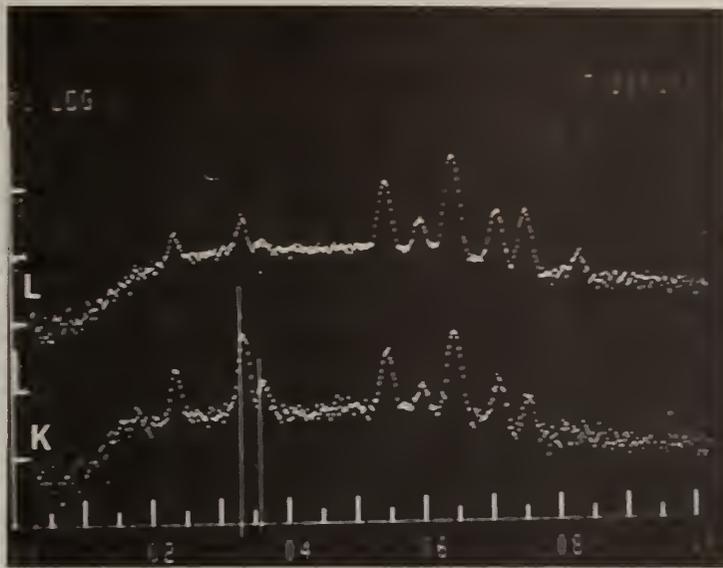
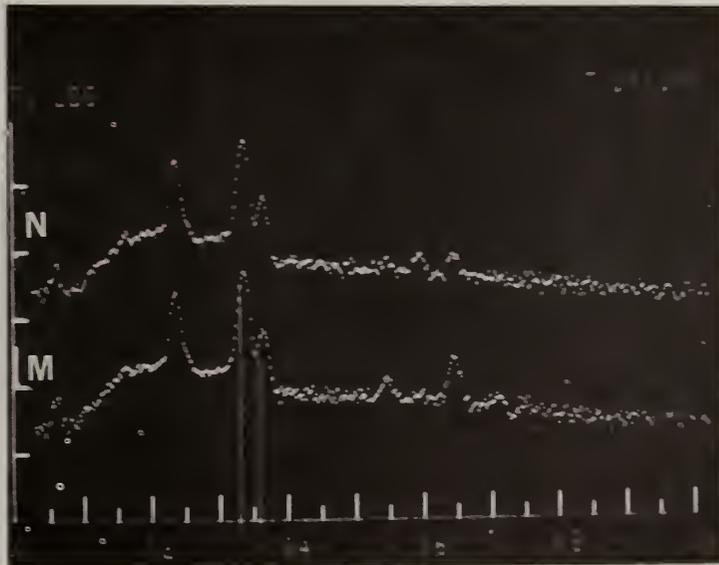
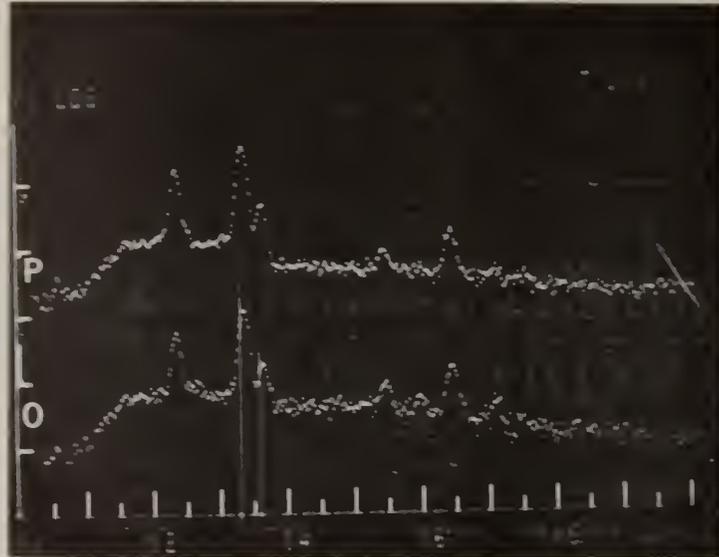
Fig. 11a. EDX spectra of regions A and B of Fig. 11 showing slight loss of Ni at stainless steel edge as compared to the bulk.

Fig. 11b. EDX spectra of regions C and D of Fig. 11 showing high Fe and low Cr and Ni concentrations in reaction zone.

Fig. 11c. EDX spectra of regions E and F of Fig. 11 showing the penetration of Fe in the deposit.

Fig. 11d. EDX spectra of regions G and H of Fig. 11 showing concentrations of Fe, Cr and Ni in the reaction zone of the stainless steel-deposit interface.

Fig. 11e. EDX spectra of regions I and J of Fig. 11 showing penetration of Fe, Cr and Ni in the deposit.

Fig. 11f. EDX spectra of regions K and L of Fig. 11 showing concentration of Fe, Cr and Ni at the metal edge.

Fig. 11g. EDX spectra of regions M and N of Fig. 11 showing low concentration of Fe in reaction zone.

Fig. 11h. EDX spectra of regions O and P of Fig. 11 showing concentrations of Fe, Cr and Ni in the reaction zone.

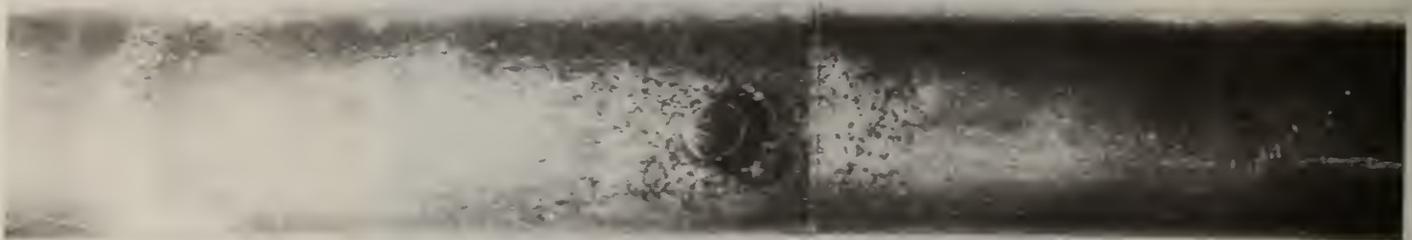
Fig. 12. Type 316 stainless steel after exposure for 4 hours at 590 °C to K<sub>2</sub>SO<sub>4</sub> seeded, oxygen rich hot gas stream and subsequent cleaning. Approximately 2 X.

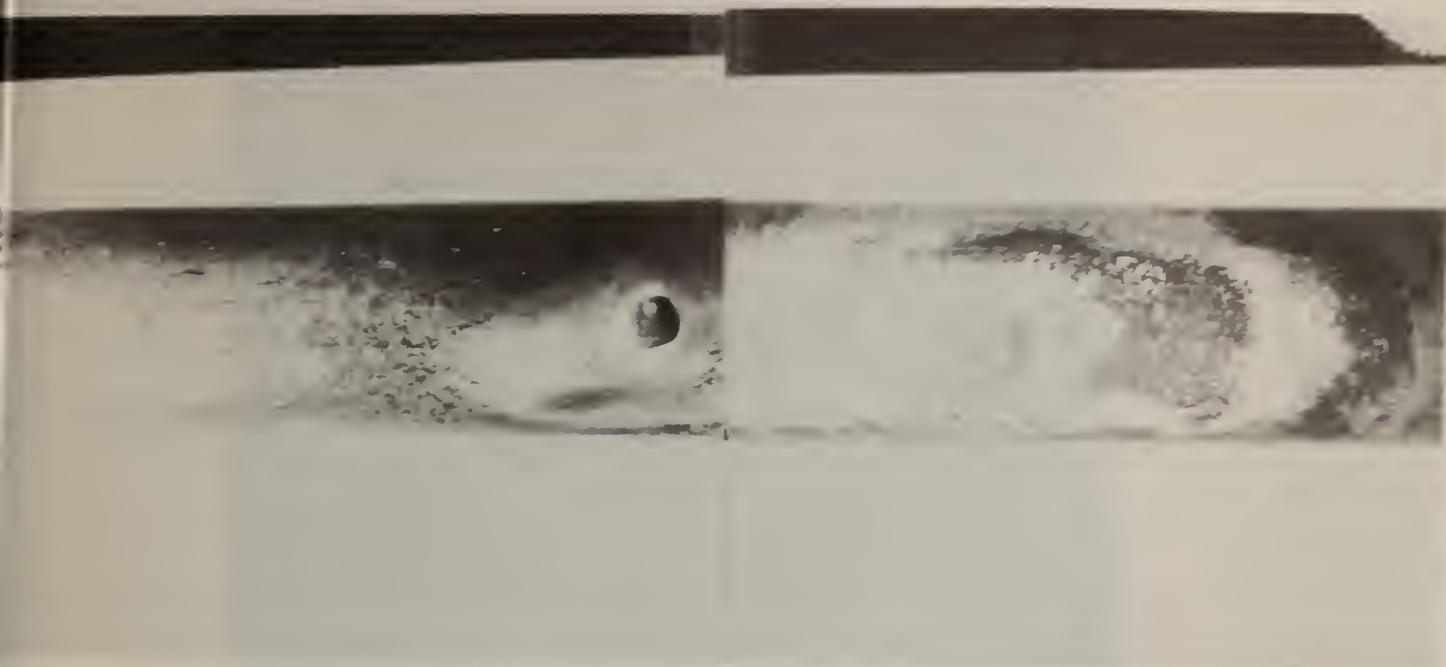
Fig. 13. Type 304 stainless steel after exposure for 4 hours at 590 °C to  $K_2SO_4$  seeded, oxygen rich hot gas stream and subsequent cleaning. Approximately 2 X.

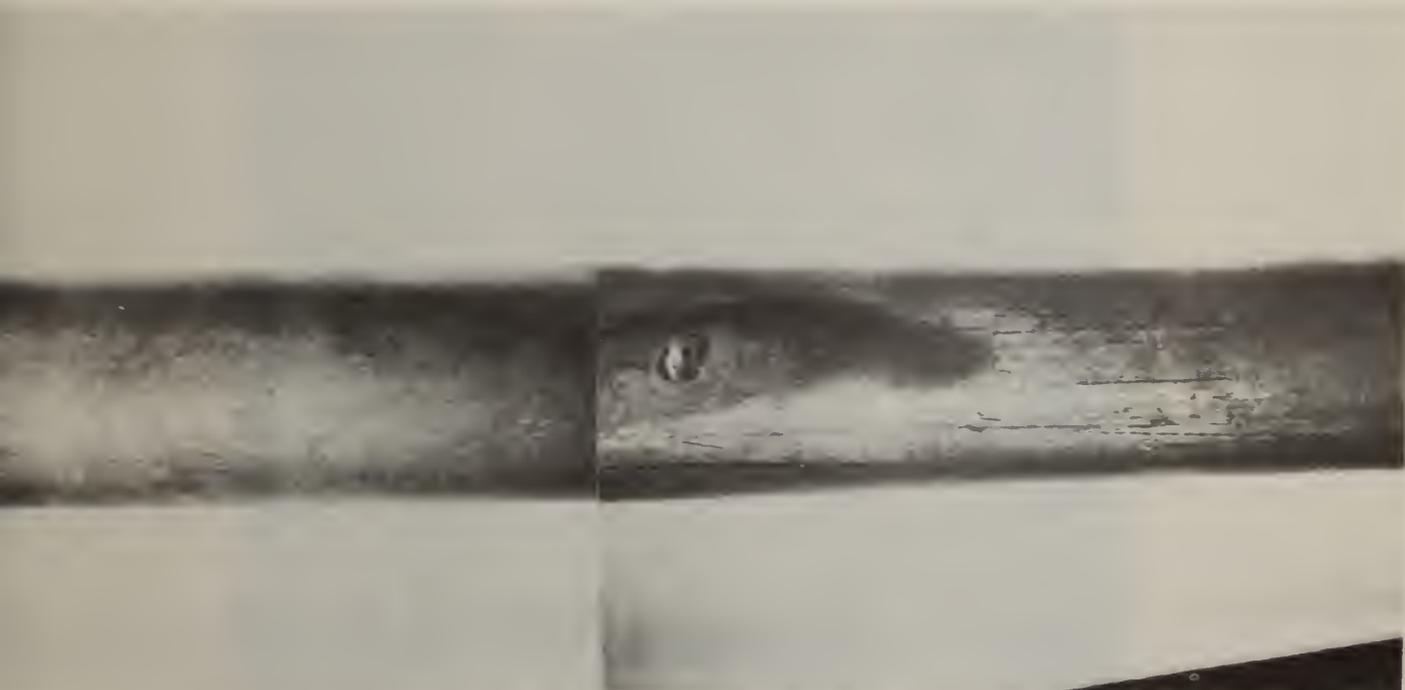
Fig. 14. Type 304 stainless steel after exposure for 4 hours at 400 °C to  $K_2SO_4$  seeded, oxygen rich hot gas stream and subsequent cleaning. Approximately 2 X.

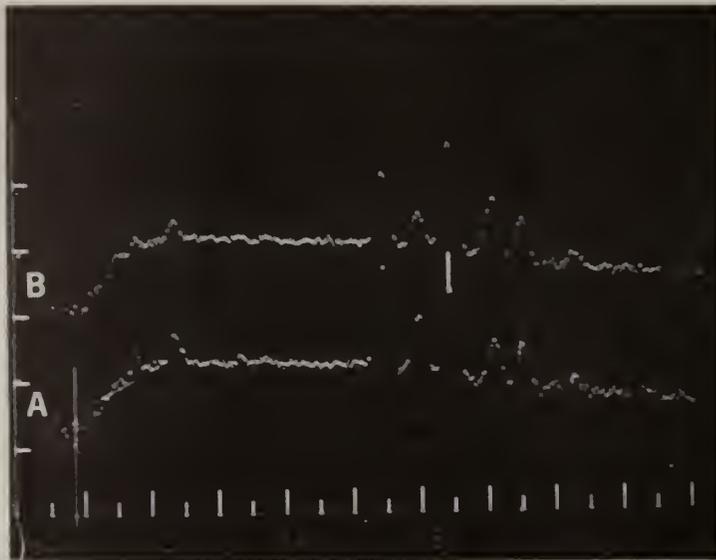
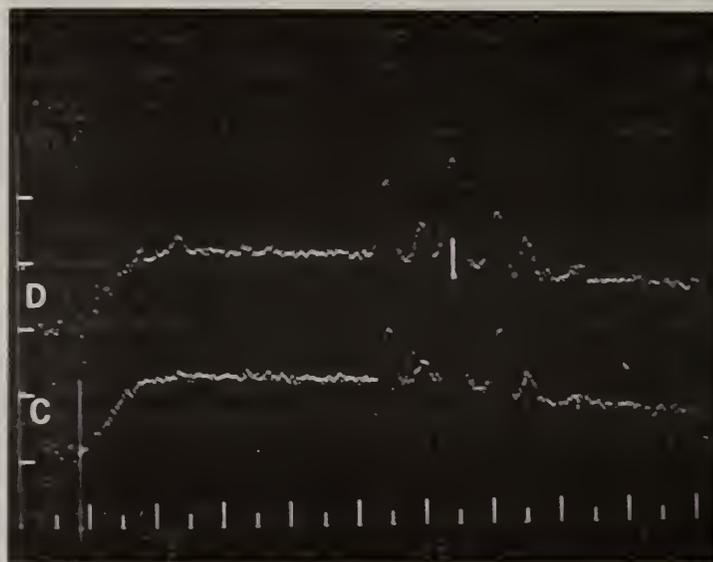
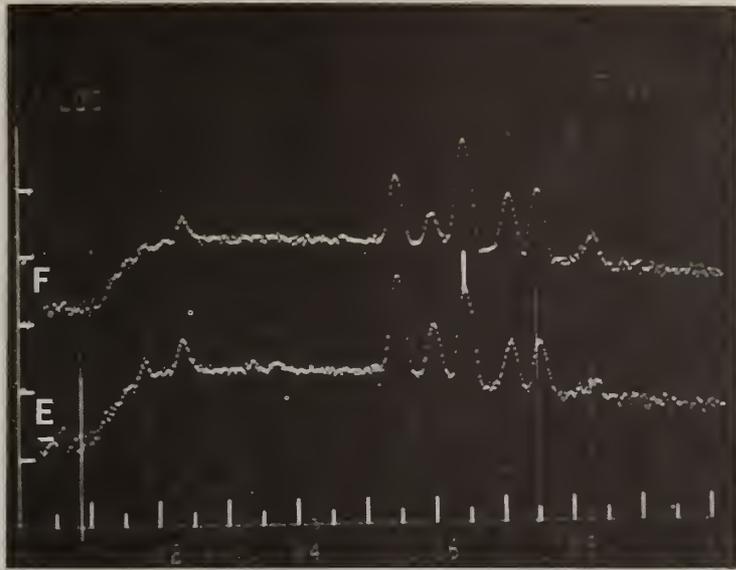
Fig. 18a. EDX spectra of regions A and B of Fig. 18 showing low Ni and high Cr concentrations.

Fig. 18b. EDX spectra of regions C and D of Fig. 18 showing high Ni and high Cr concentrations.

Fig. 18c. EDX spectra of regions E and F of Fig. 18 showing low Ni and high Fe concentrations.

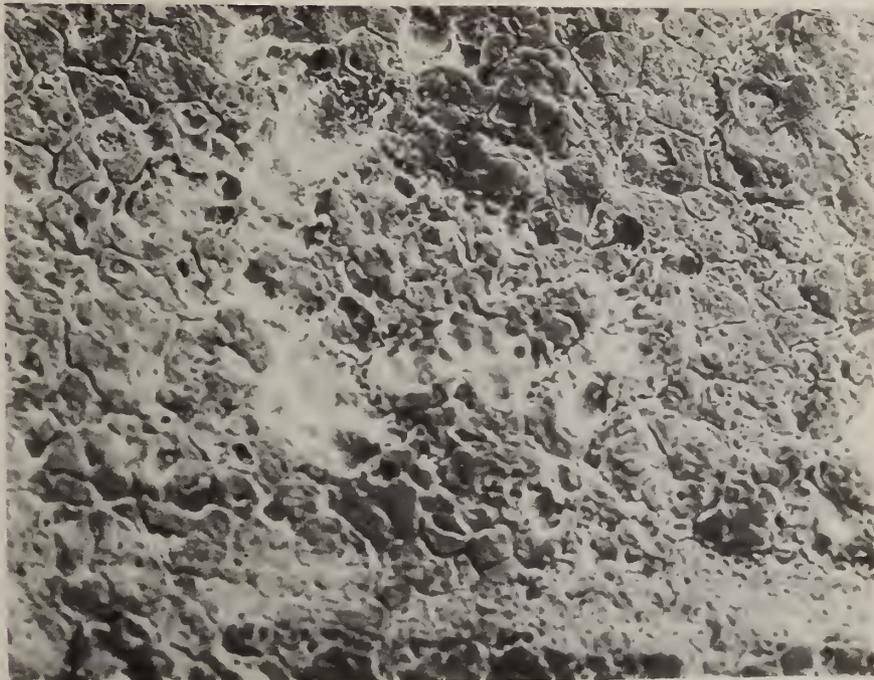
Fig. 19. SEM micrograph, 450 X, of Type 304 stainless steel exposed for 4 hours at 590 °C to a  $K_2SO_4$  seeded, oxygen rich hot gas stream.

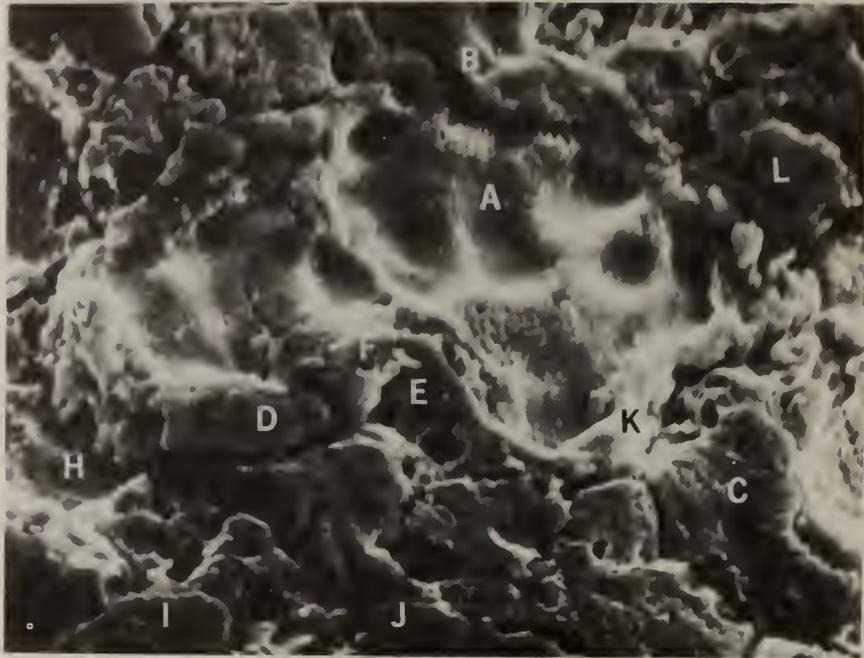
Fig. 20. SEM micrograph, 1900 X, of the mid region of Fig. 19 showing surface attack. Labeled regions correspond to labeled EDX spectra, Figs. 20a-20f.

In samples 13-4 and 14-4 a comparison evaluation can be made of the same type of stainless steel exposed at two different temperatures. The greatest change in weight (wastage) was observed in sample 13-4, while a minimal amount was lost in sample 14-4, see Table 1. Fig. 19 exhibits an area of sample 13-4 riddled with holes and depressions between grains. Figs. 20, 20a - 20f show metal cation concentration or loss in this area.

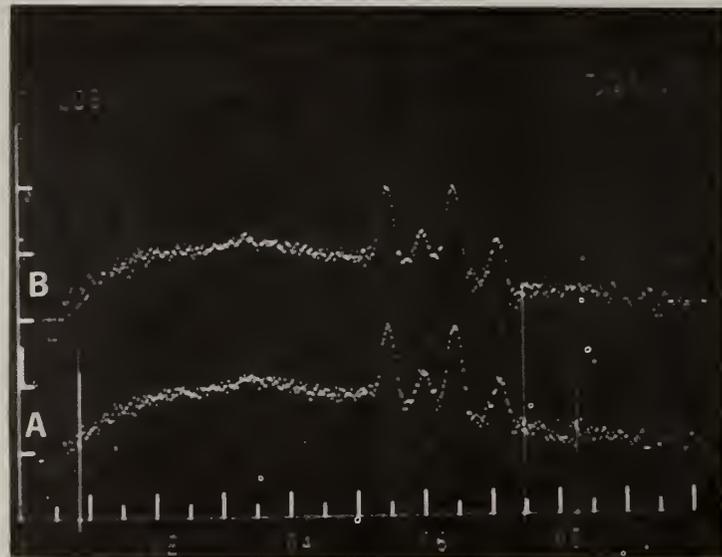
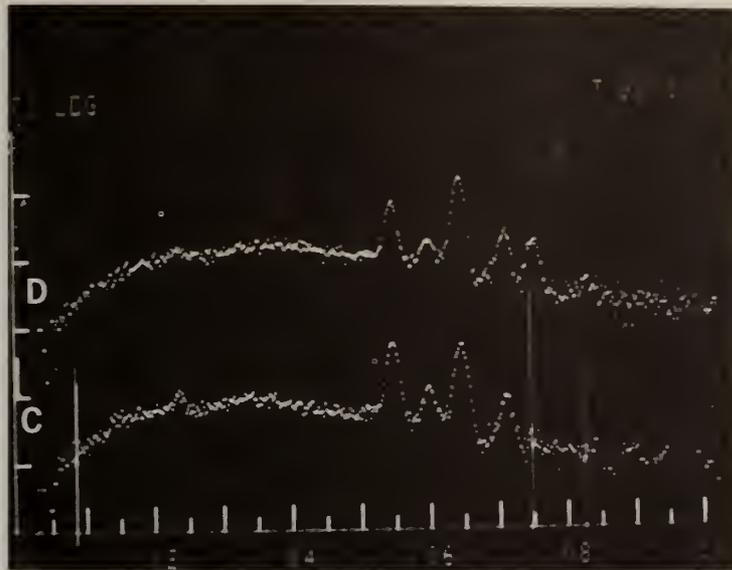
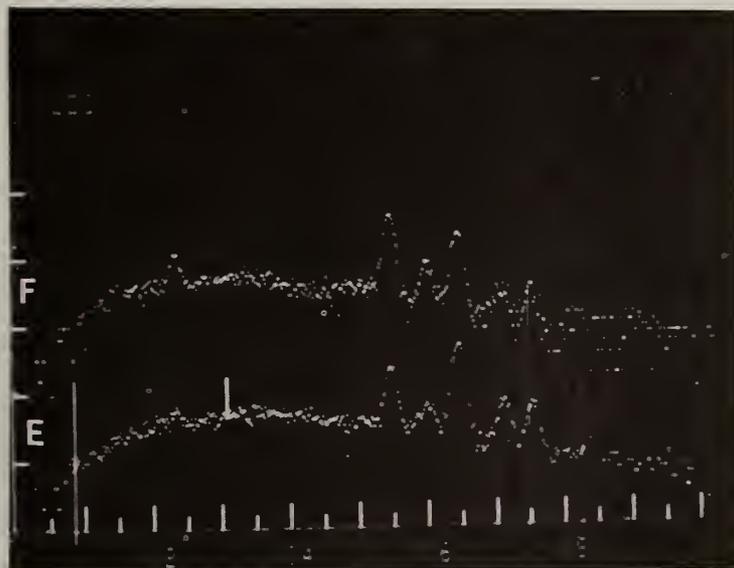
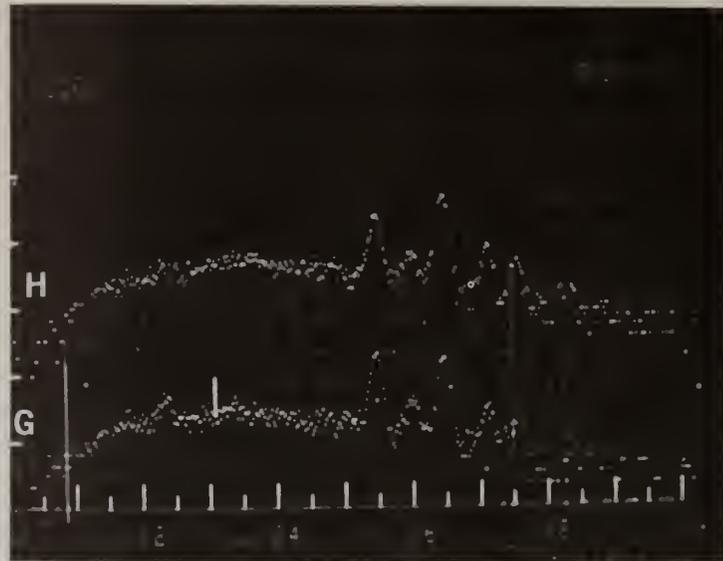
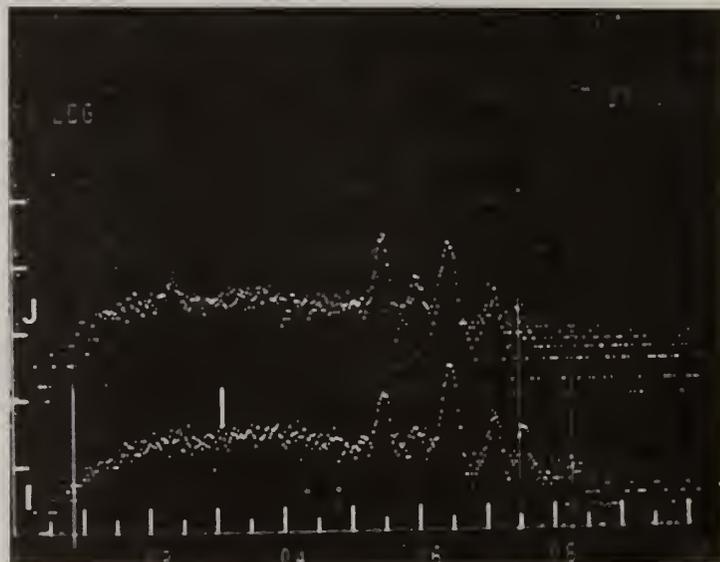
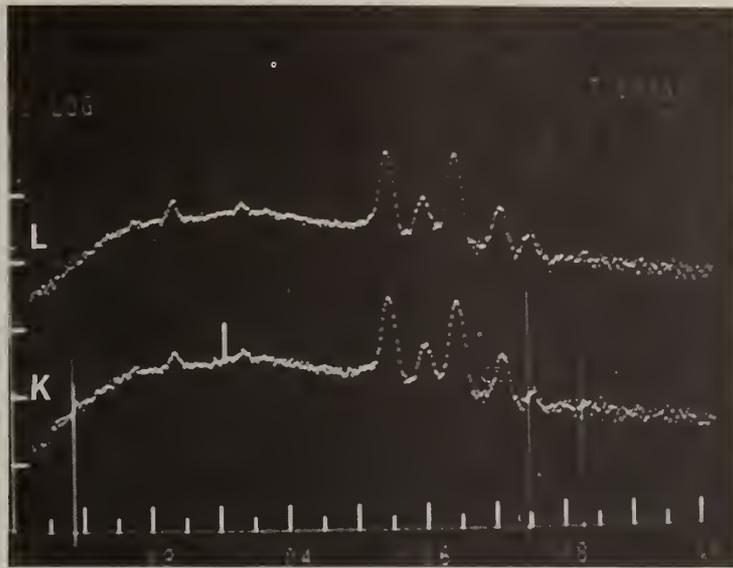
Fig. 20a. EDX spectra of regions A and B of Fig. 20 showing Ni depleted regions.

Fig. 20b. EDX spectra of regions C and D of Fig. 20 showing another Ni depleted region.

Fig. 20c. EDX spectra of regions E and F of Fig. 20 showing a region of high Cr concentration.

Fig. 20d. EDX spectra of regions G and H of Fig. 20 showing another region of high Cr concentration.

Fig. 20e. EDX spectra of regions I and J of Fig. 20 showing another region of high Cr concentration.

Fig. 20f. EDX spectra of regions K and L of Fig. 20 showing regions of high Cr and low Ni concentrations.

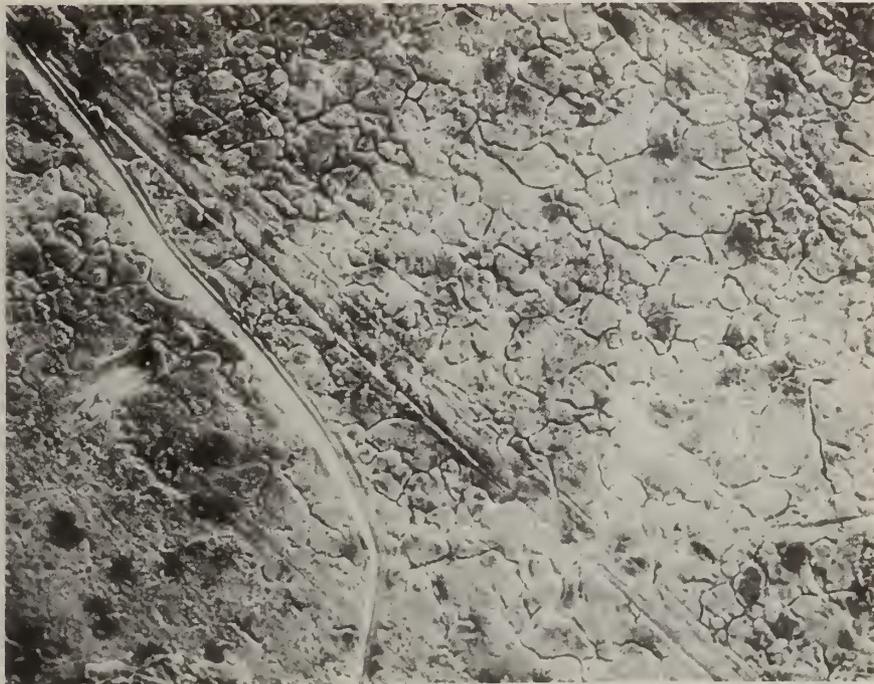
Fig. 21. SEM micrograph, 350 X, of Type 304 stainless steel specimen 14-4, exposed for 4 hours to a  $K_2SO_4$  seeded oxygen rich hot gas stream.

In sample 14-4 grain boundaries and grain forms are evident, see Fig. 21; however, there are not as many pores or holes showing. Black spot regions, though, are prevalent on the grain surfaces. Fig. 22 shows these areas rather vividly; SEM/EDX analysis indicates them to be areas of low chromium, low nickel, and high iron concentration associated with potassium and sulfur. These areas are probably the beginning of reaction sites on the stainless steel surface. Fig. 23 is a high magnification micrograph of one such spot. EDX analysis, Figs. 23a and 23b, indicate low chromium and low nickel along with potassium and sulfur in that spot with high metal cation concentration surrounding blackish area.

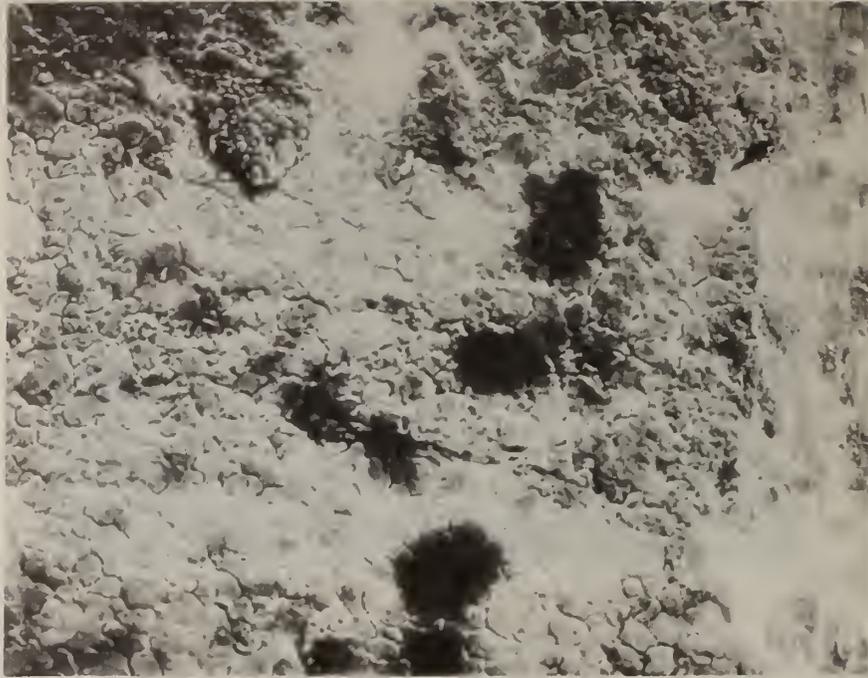
Fig. 22. SEM micrograph, 375 X, of another region specimen 14-4 showing what appears to be the onset of corrosion.

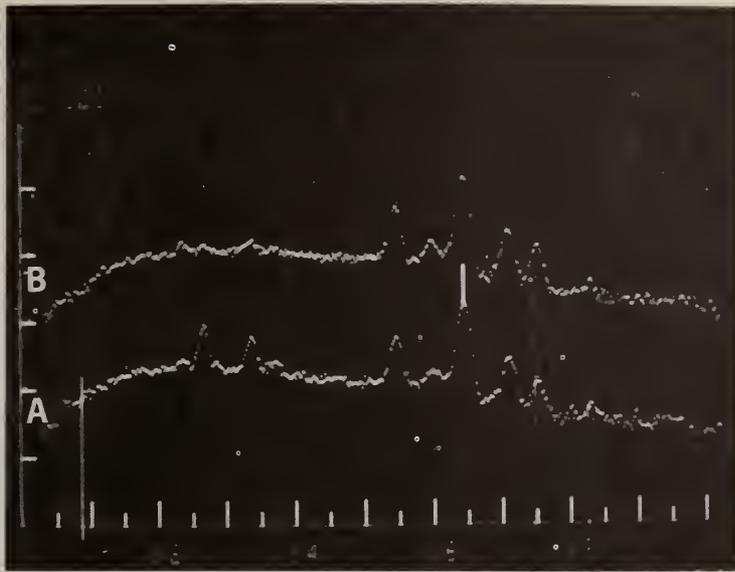
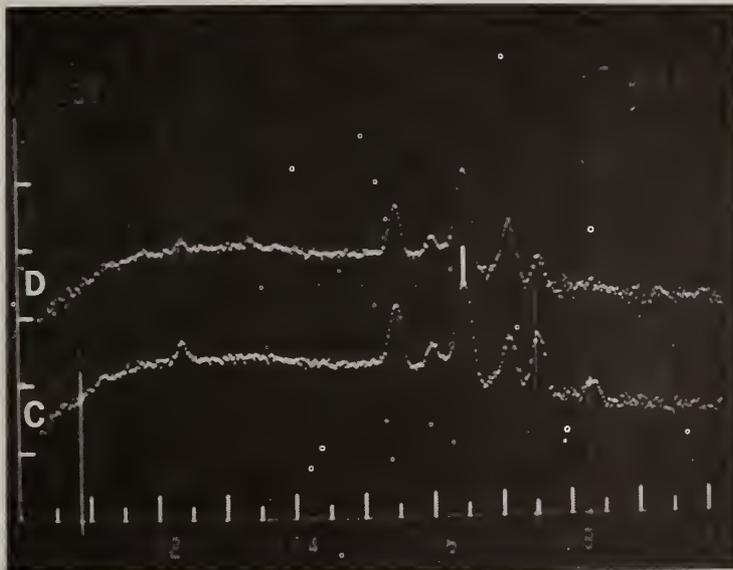
Fig. 23a. EDX spectra of regions A and B of Fig. 23 showing nickel depletion in a dark region.

Fig. 23b. EDX spectra of regions C and D of Fig. 23 showing a Ni depleted region C and a region of high Ni and high Cr concentration, as well as low Cr.

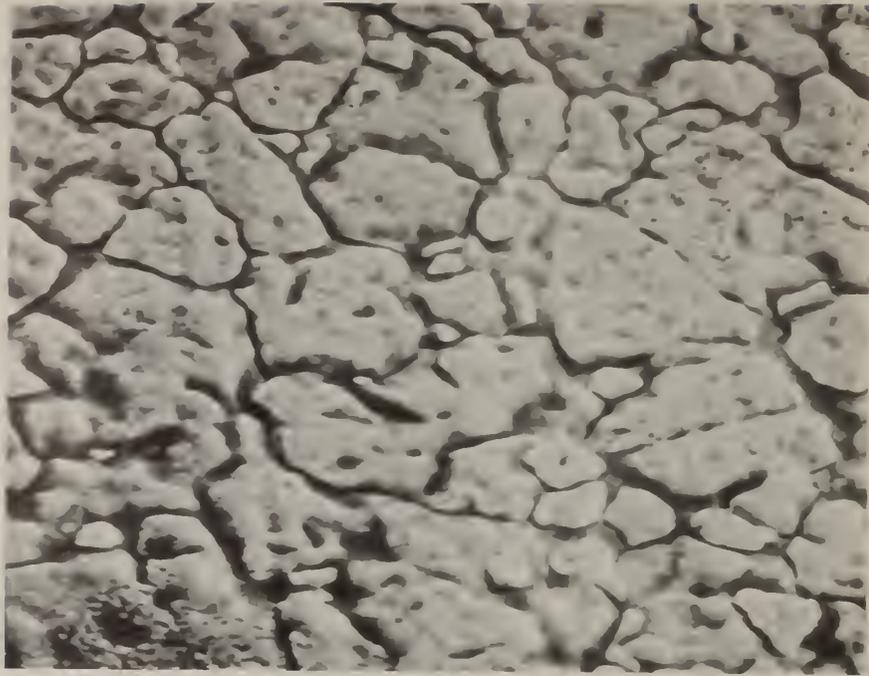
Fig. 24. SEM micrograph of Type 304 stainless steel, unexposed but cleaned. Note grains and grain boundaries, 1600 X.

A random sample of 304 stainless steel was selected for SEM/EDX analysis and used as a comparison to the specimens placed in the corrosive environment. Prior to sectioning the sample was cleaned with 10 percent HNO<sub>3</sub> at 50 °C for 20 minute cycles in an ultrasonic bath. A comparison of this surface to the surfaces exposed to the corrosive environment

shows that while grain boundaries are evident in both cases, figures 24-26, intergranular and surface attack seems to be occurring in the latter cases. EDX examination of the surface of the unexposed specimen revealed no non-uniform distribution of nickel, chromium, or iron.

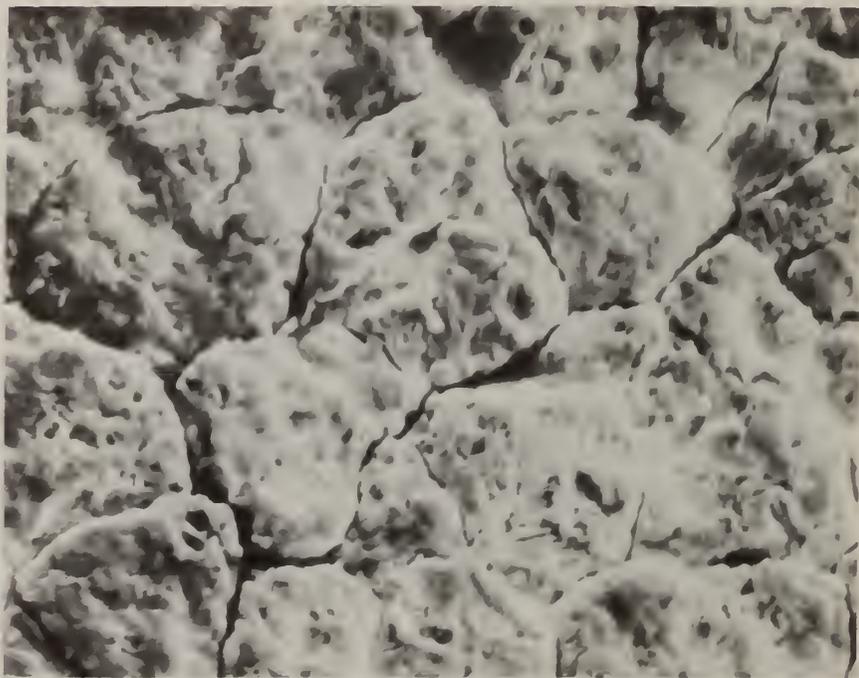
Fig. 25. SEM micrograph, 1900 X, of Type 304 stainless steel after exposure for 4 hours at 590 °C to a K<sub>2</sub>SO<sub>4</sub> seeded hot gas stream and subsequent cleaning. Note grain boundaries and grain surface.

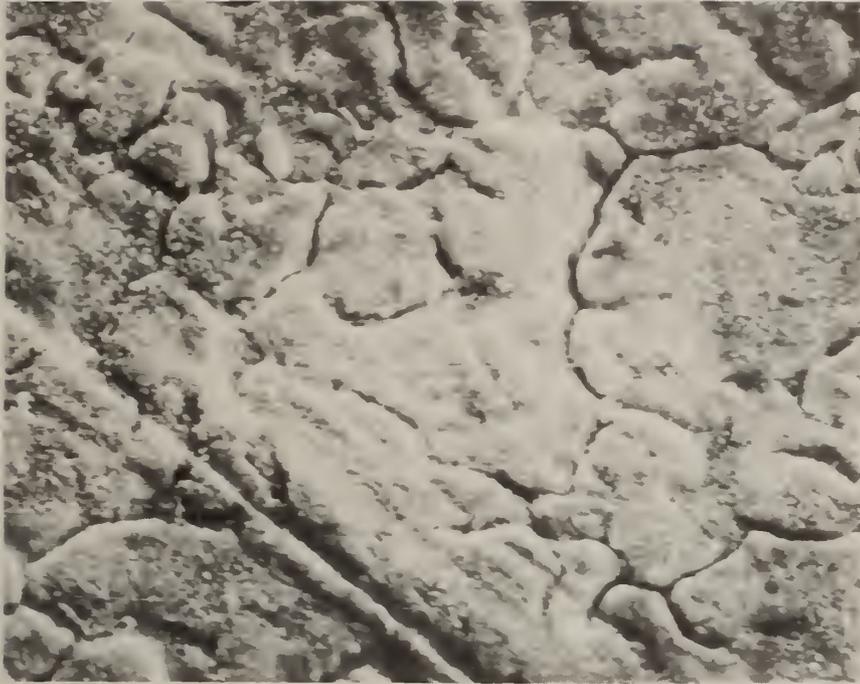
Fig. 26. SEM micrograph, 1400 X, of Type 304 stainless steel after exposure for 4 hours at 400 °C to a  $K_2SO_4$  seeded hot gas stream and subsequent cleaning. Note grain boundaries and grain surface.
