Thermal Resistance Measurements of A Built-Up Roof System

NBSIR 80-2100

THERMAL RESISTANCE MEASUREMENTS OF A BUILT-UP SYSTEM

S. J. Treado

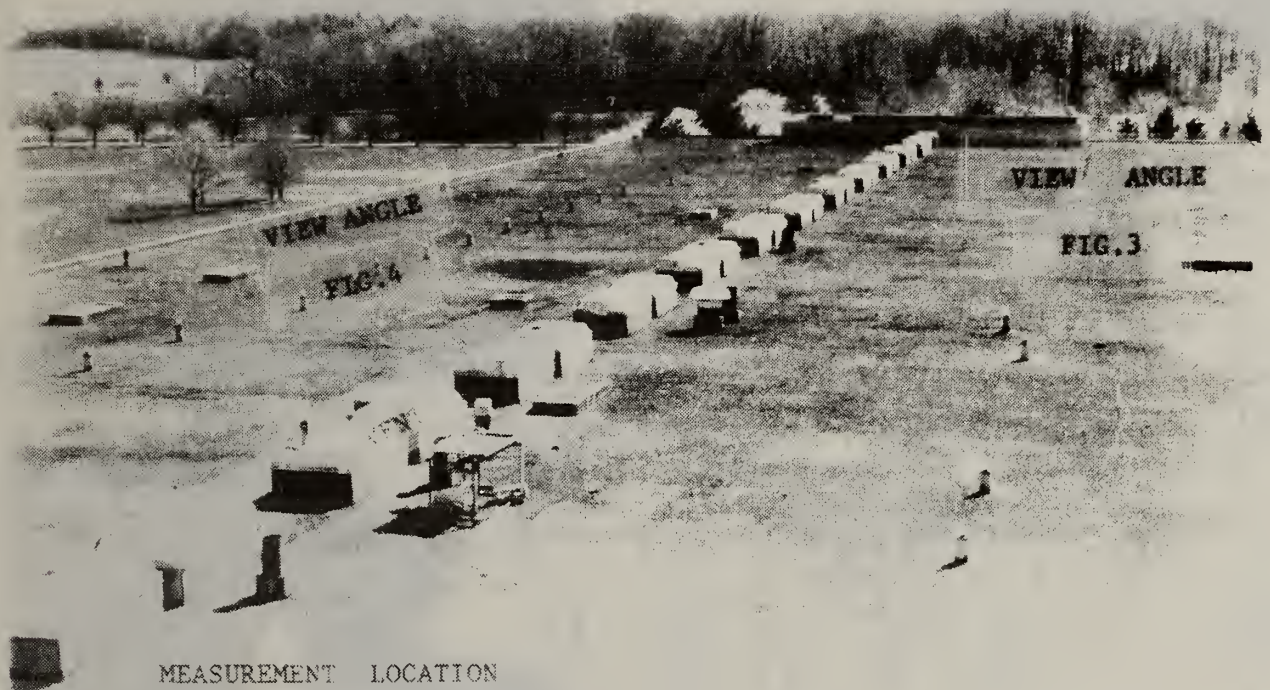
Figure 2. Photograph of roof surface

Measurements were made on the roof of Building 226 at the National Bureau of Standards. The building was constructed in 1963 with a 40,000 ft² (2716 m²) BUR system consisting of a concrete deck, glass fiber insulation and built-up roofing. A photograph of the roof surface is shown in figure 2. Details of the construction design of the BUR system were utilized to compute its thermal resistance. The components of the BUR system and their thermal resistances are listed in table 1.

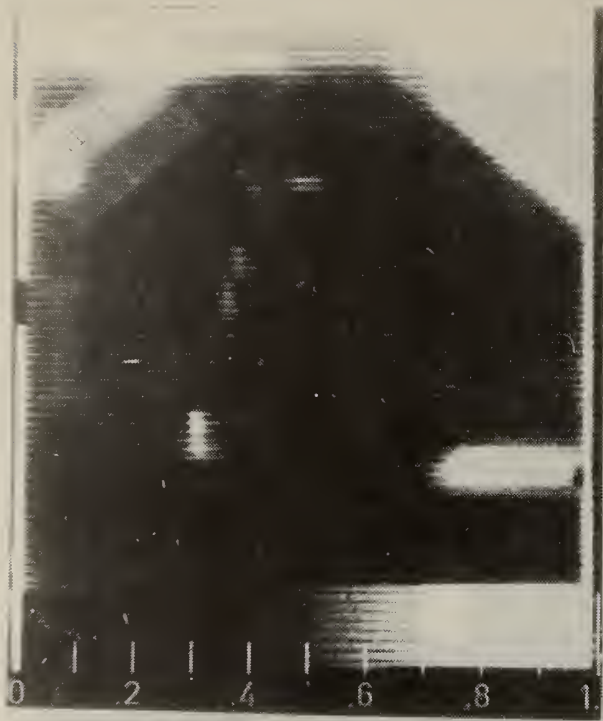
Figure 3. Roof thermogram

A thermographic scan of the roof surface was performed to obtain an apparent temperature map. The scan was performed on a cold night, 29°F (-1.6°C) during December under partially overcast sky conditions. Wind speed was less than 5 mph (8 km/h) and the average roof surface temperature was 25°F (-4°C). The major portion of the roof surface appeared to be fairly uniform in temperature, varying by less than 0.9°F (0.5°C) (See figure 3). Roof surface areas surrounding the large central vents are seen to be warmer than the majority of the roof. This is more apparent in figure 4. In the color thermograms, the warmest area of the roof surface appears to be 1.8°F (1°C) warmer than the remaining areas. Visual inspection of the warmer portions of the roof surface did not reveal any obvious differences in roof construction materials from the majority of the roof surface, and no differences in emittance were believed to be present which might be causing warmer apparent surface temperature. One of the warmer areas of the roof surface was chosen as the location for the installation of the heat flow meter and thermopile. This location is shown in figure 5. The cylindrical object in the center of the thermogram is a liquid nitrogen Dewar flask being used as a marker.

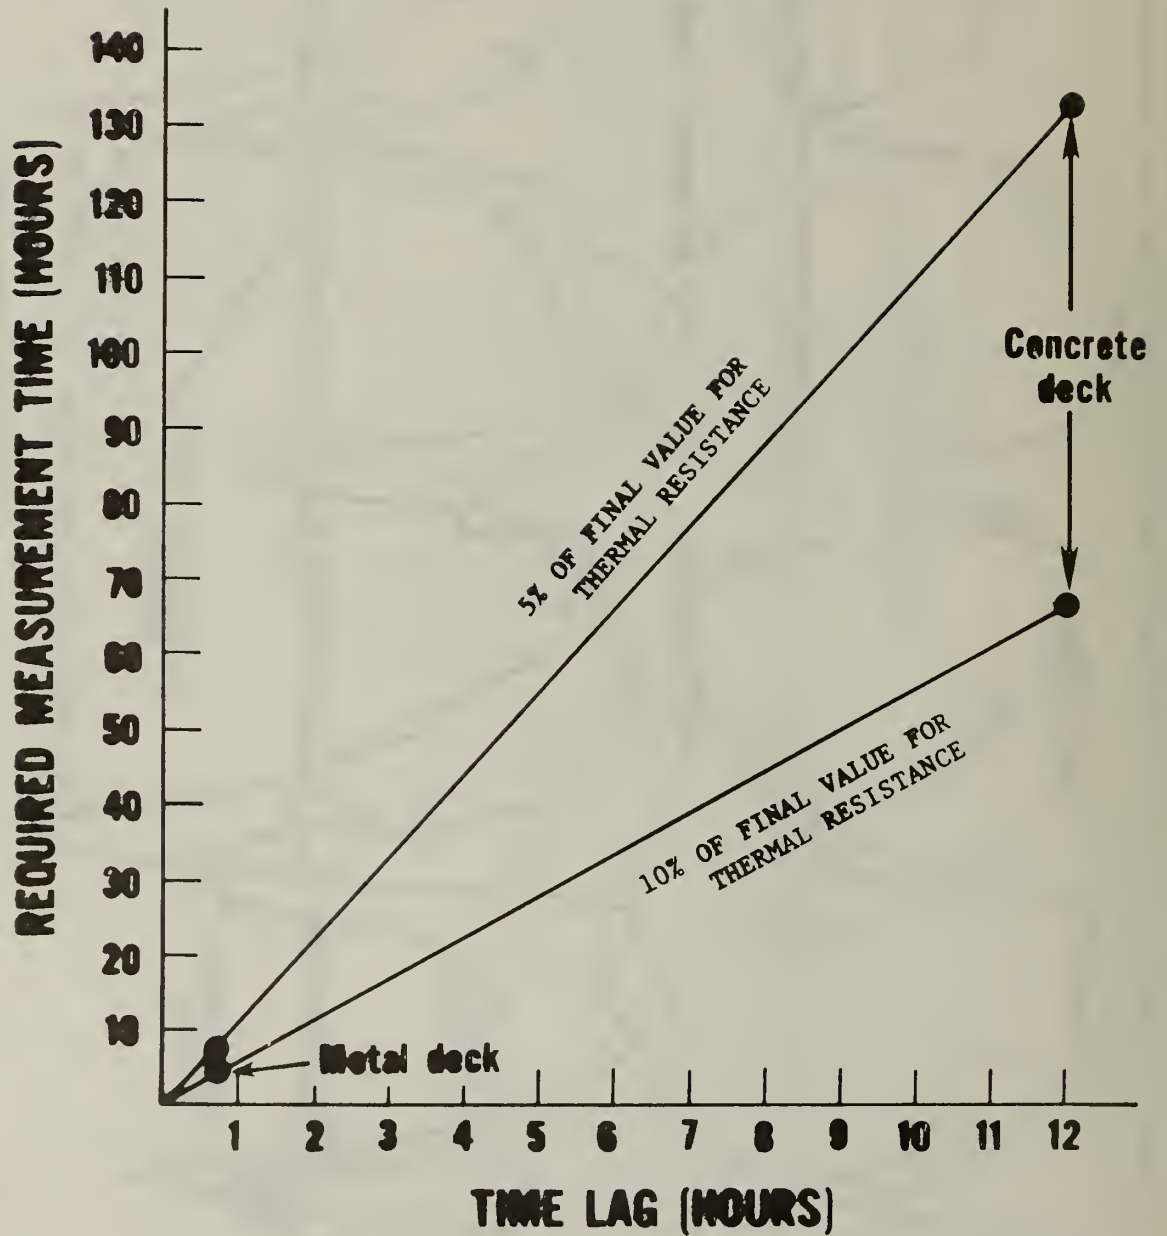
Figure 9. Required elapsed measurement time as a function of BUR system thermal time lag

Based on the thermal resistance measurements performed on the BUR system with a concrete deck, and the results of the simulation of a BUR system with a steel deck, the required elapsed measurement time is presented in figure 9 as a function of roof system time lag. Time lag for the steel deck system was estimated to be $3/4$ of an hour, although an exact determination was difficult due to the fact that measurements were stepped in hourly increments.
