NBSIR 80-2122

# Development of Guide Specifications for the 1980 Exterior Restoration of the White House

Structures and Materials Division  
Center for Building Technology  
National Engineering Laboratory  
National Bureau of Standards  
U.S. Department of Commerce  
Washington, DC 20234

October 1980

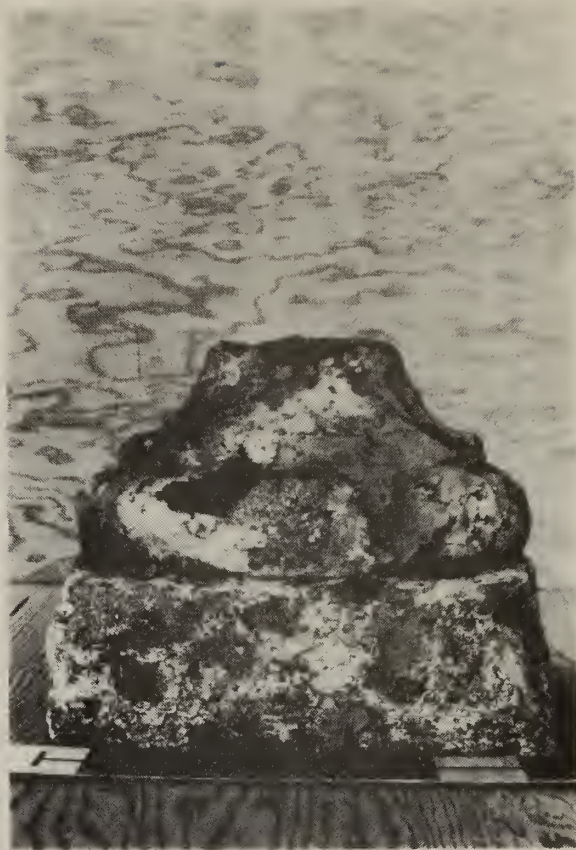
FIGURE 10. STONE SPECIMEN 4, BEFORE PAINT REMOVAL

Figures 10-17 illustrate that all four paint removal methods evaluated in the preliminary tests were effective in removing paint from the balustrades of the Capitol, although the commercial firms did not all attempt to remove all of the paint. Since the balustrades had been stored in the open in Rock Creek Park since the expansion of the east front of the Capitol, part

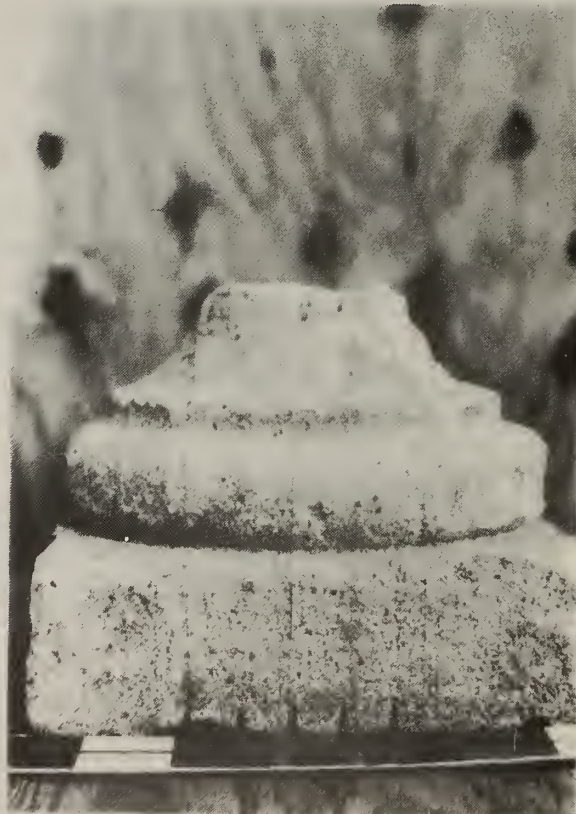
FIGURE 11. STONE SPECIMEN 4, AFTER PAINT REMOVAL BY METHOD 1

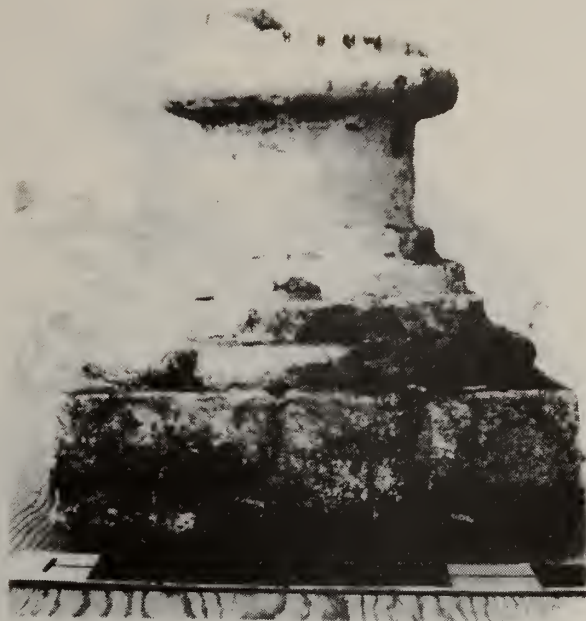
FIGURE 12. STONE SPECIMEN 3, BEFORE PAINT REMOVAL

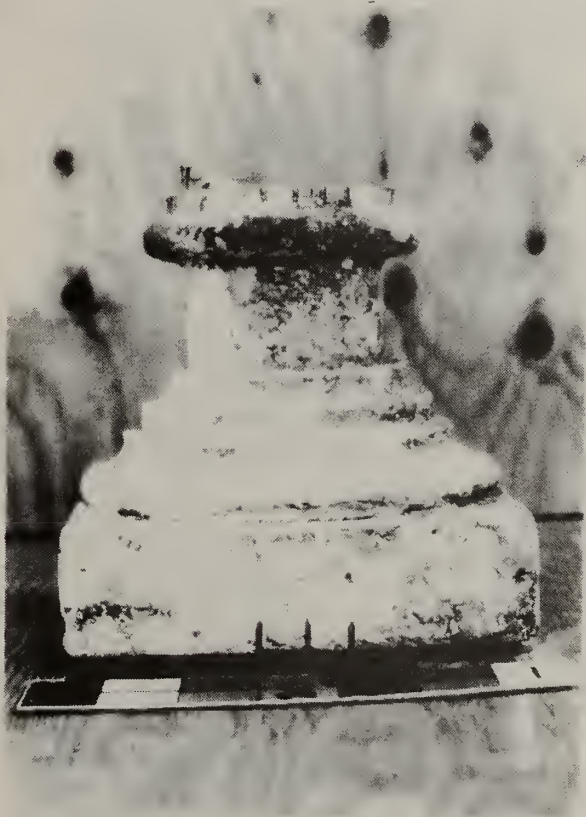
FIGURE 13. STONE SPECIMEN 3, AFTER PAINT REMOVAL BY METHOD 2

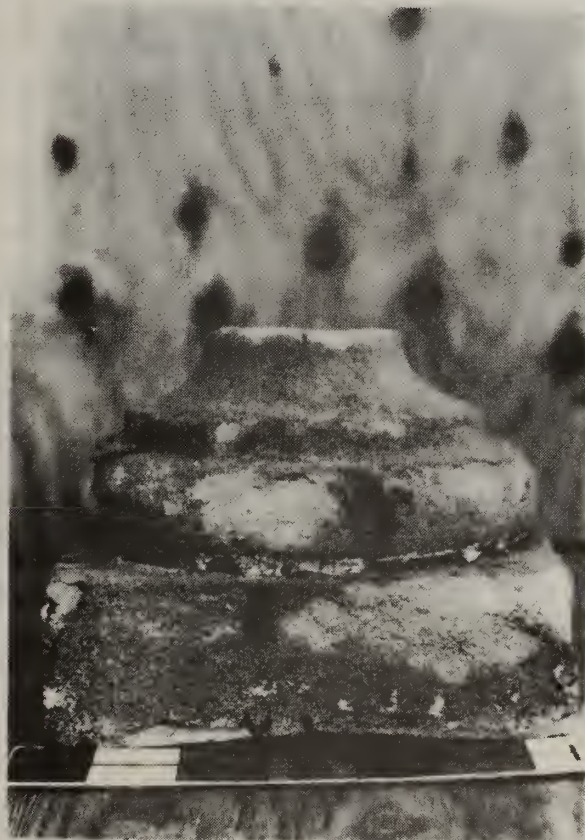
The fourth method evaluated (Method 4) was a prototype system using a special pressure-adjustable nozzle to project a mixture of water, sand, and air. Figures 16 and 17 illustrate the balustrade before and after paint removal by Method 4.

FIGURE 17. STONE SPECIMEN 6, AFTER PAINT REMOVAL BY METHOD 4

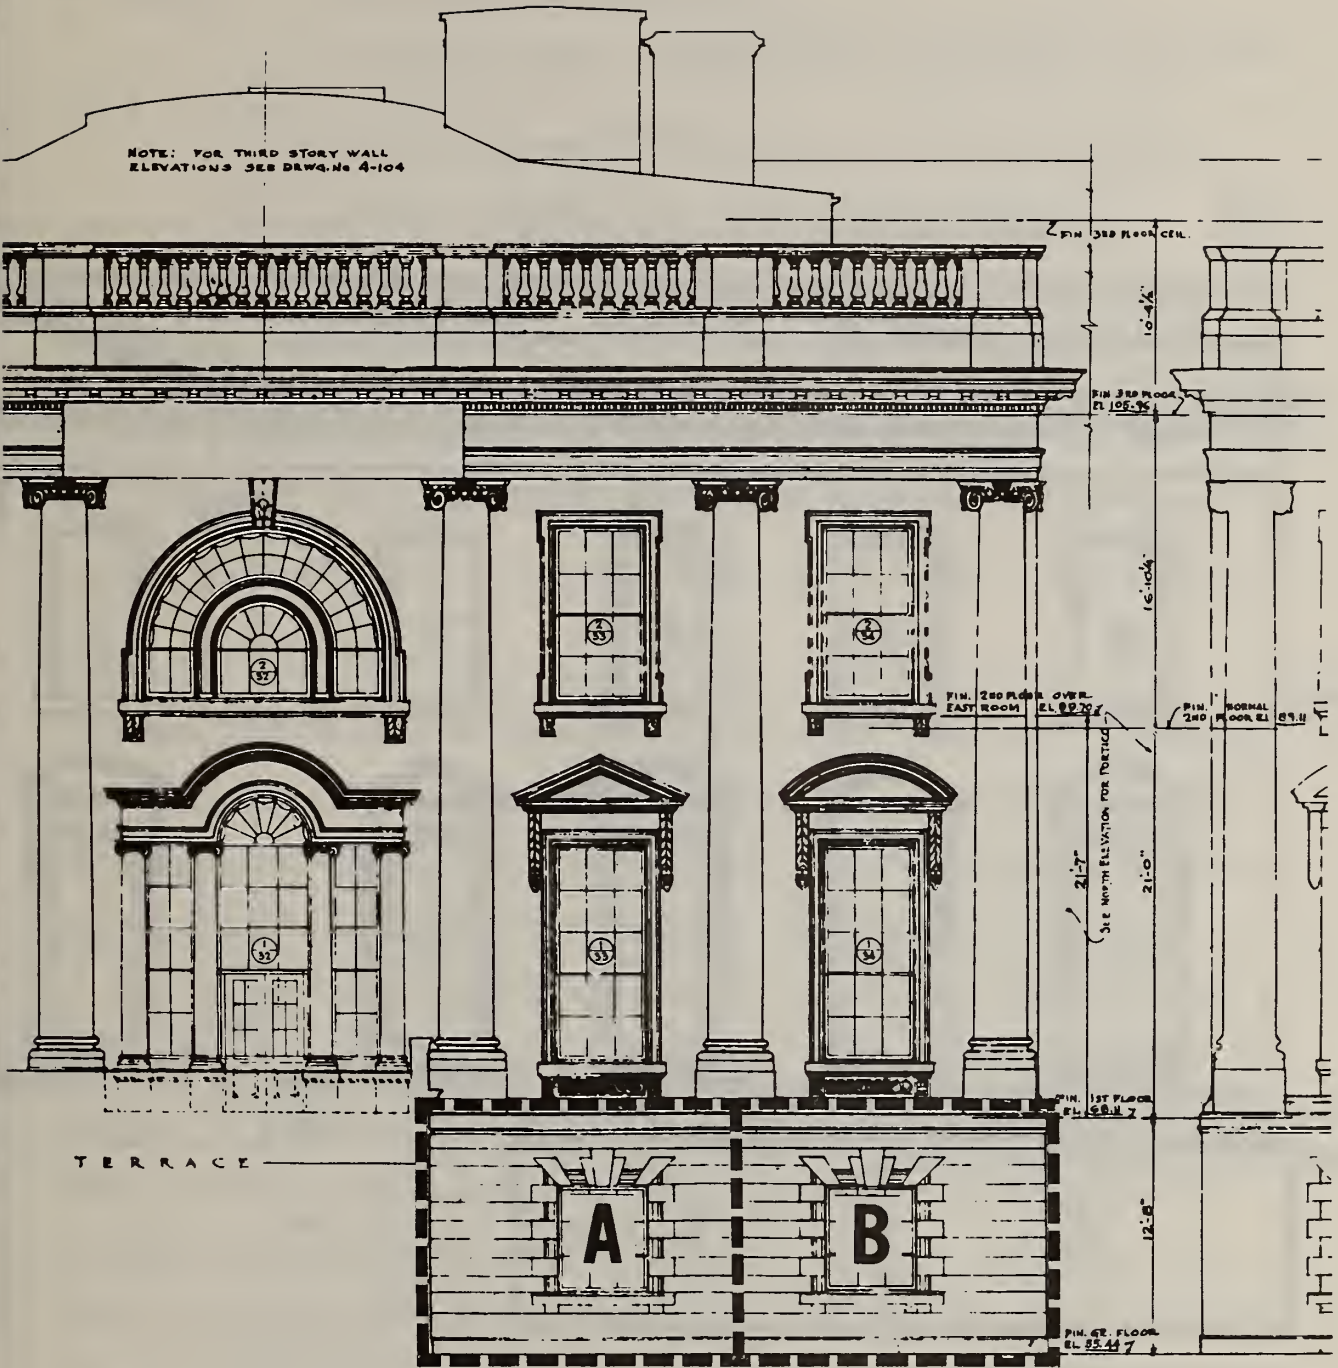
FIGURE 18. WHITE HOUSE - EAST ELEVATION TEST AREA

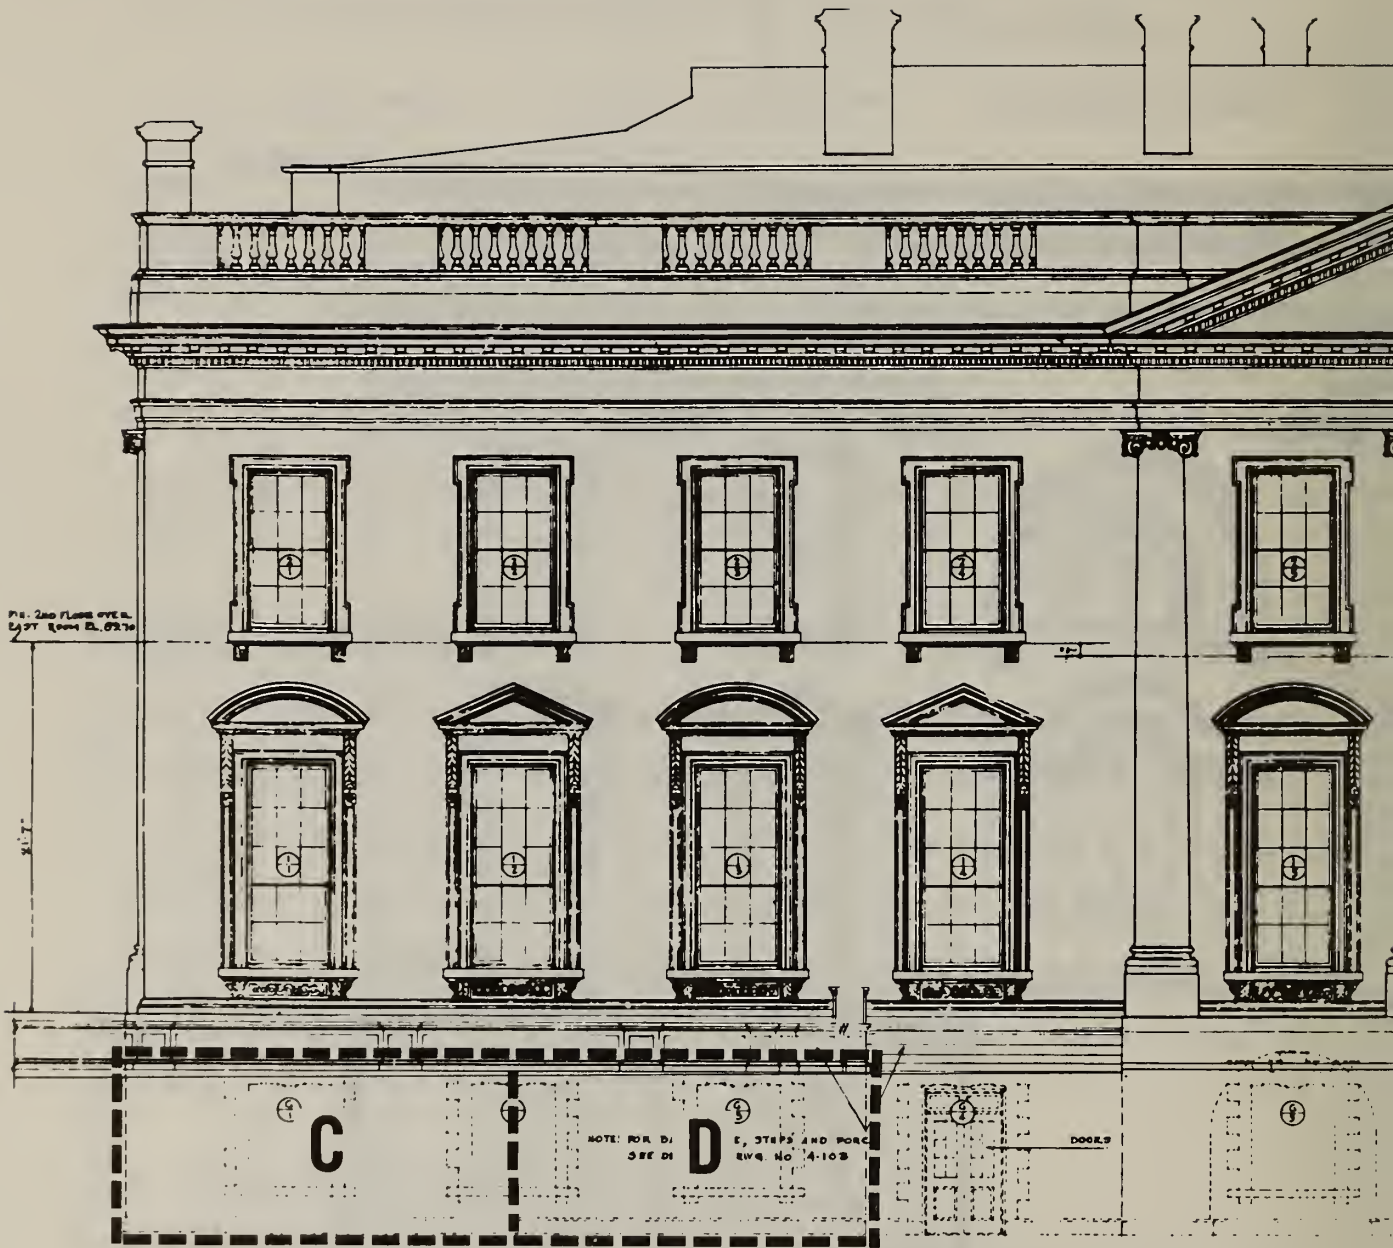
FIGURE 19. WHITE HOUSE - NORTH ELEVATION TEST AREA

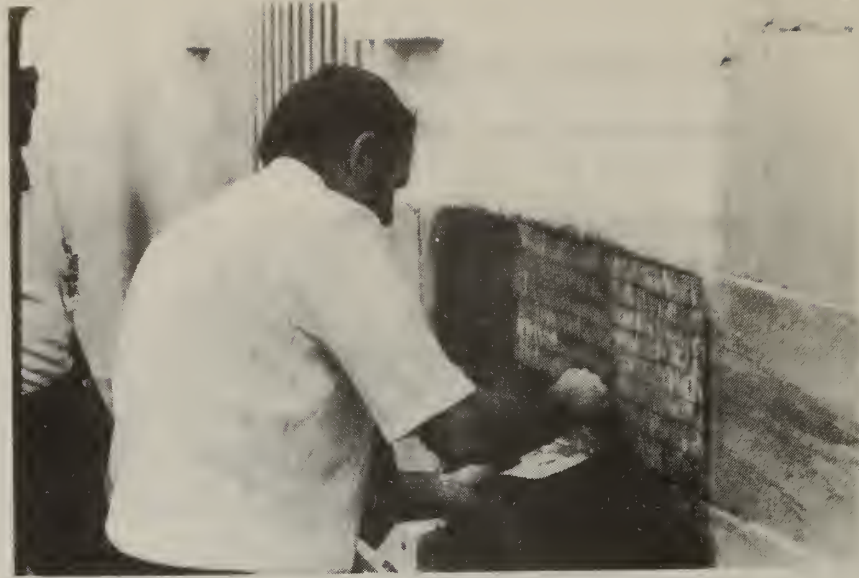
FIGURE 20. PAINT REMOVAL IN AREA A, SCRAPING OFF PAINT AFTER SOFTENING WITH PAINT REMOVER

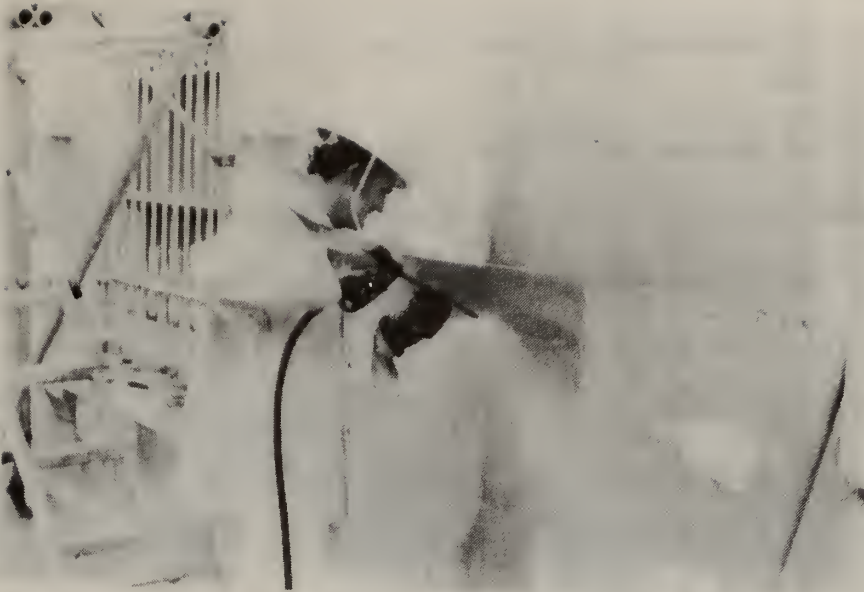
FIGURE 22. PAINT REMOVAL IN AREA A, USING HIGH PRESSURE WATER SPRAY

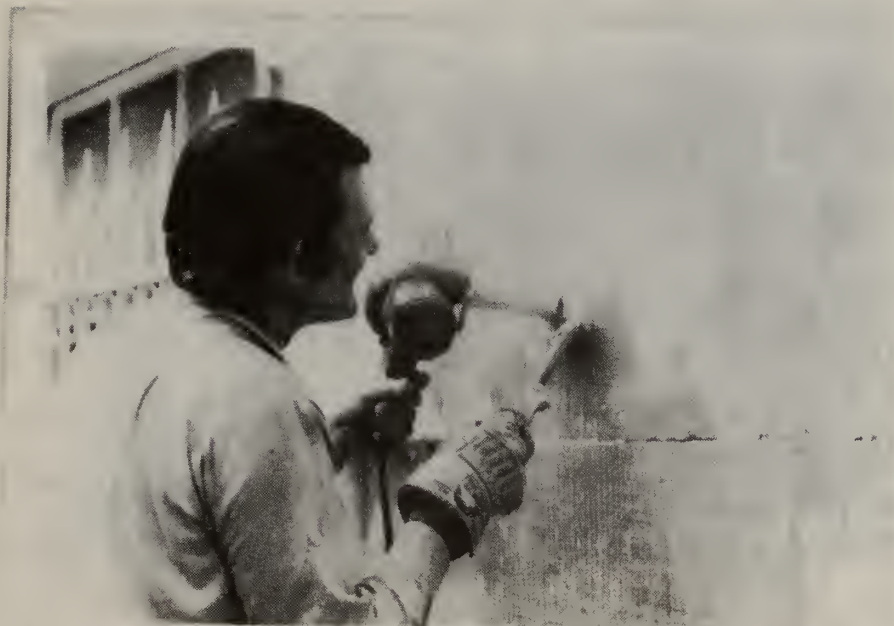
FIGURE 23. PAINT REMOVAL IN AREA A, USING HEAT GUN TO SOFTEN PAINT BEFORE SCRAPING

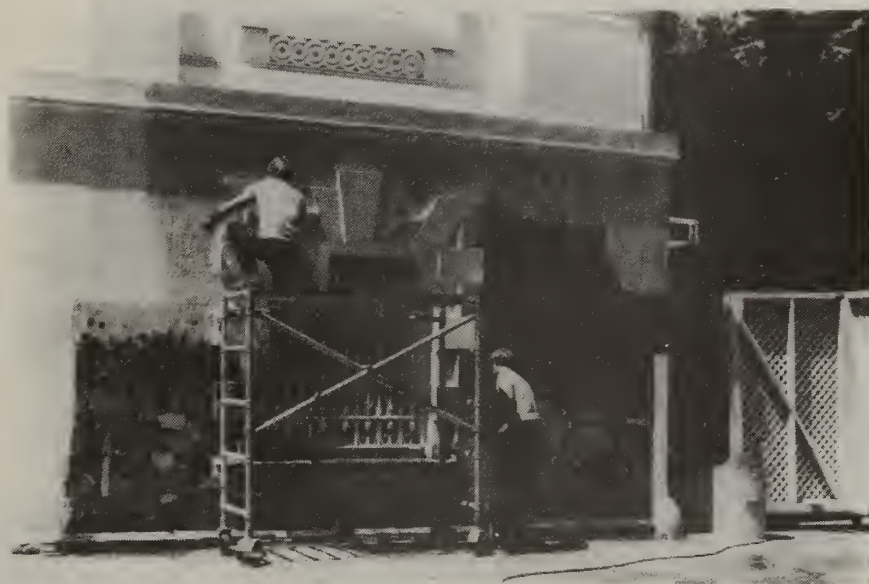
Figures 25 and 26 illustrate the operation of Company 1. They utilized the White House movable scaffold and required 110V electrical and water services.

FIGURE 25. PAINT REMOVAL IN AREA B, APPLICATION OF PAINT REMOVER

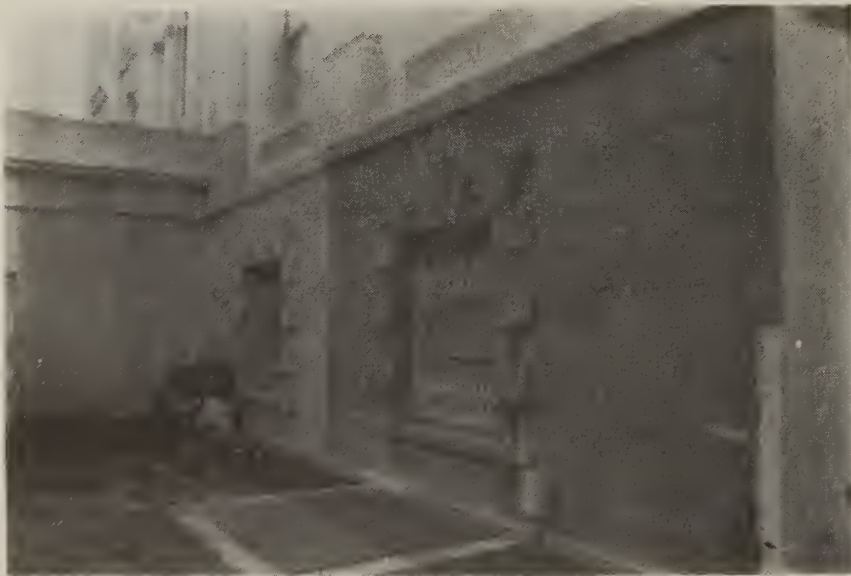
FIGURE 27. AREA A (BEFORE PAINT REMOVAL) AND AREA B (PAINT REMOVED)

Their compressor had no sound insulation and may need modification for extended usage around a sound sensitive area. Figures 27 and 28 show that the process was effective at removing paint from the sandstone.

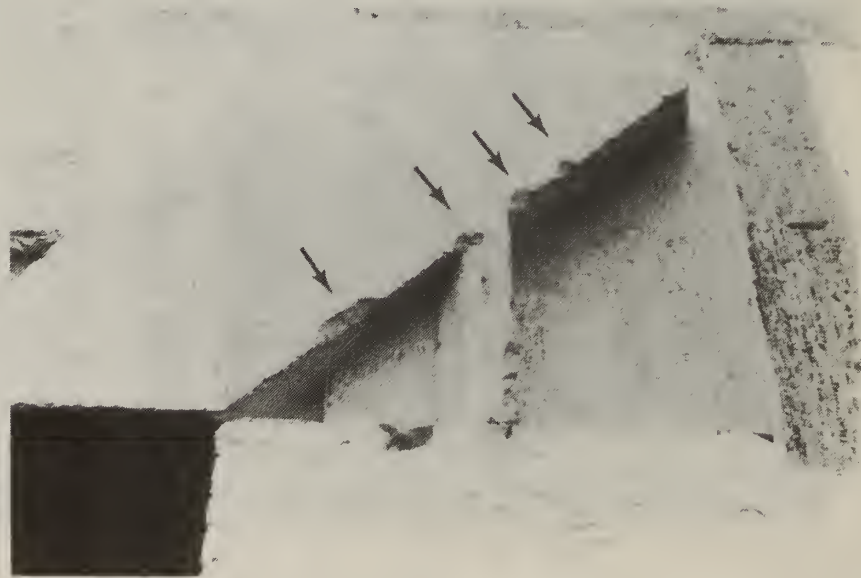
The White House painting crew removed paint from Area D using hand scraping and chipping. Paint chips were caught on drop cloths spread next to the wall. Loose paint was removed with scrapers. Adherent paint was removed by lightly tapping with the flat chisel-head blade of a hammer (figure 30). Surface details of the cleaned stone are shown in figure 31-33. Figure 34 shows Area D with most of the paint removed. It is apparent from figure 34 that most of the paint was removed by this process. But the sandstone can be easily damaged by the process as shown in figures 32 and 33.

FIGURE 33. AREA D, ARROWS INDICATE PLACES WHERE STONE WAS CHIPPED BY PAINT REMOVAL

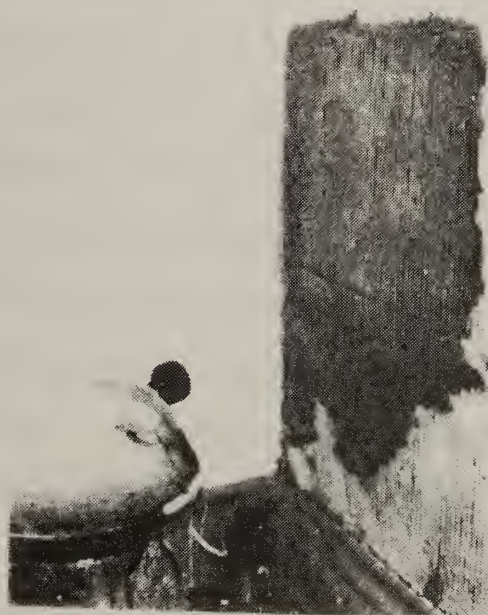
FIGURE 36. AREA A, REPAIRED AREA

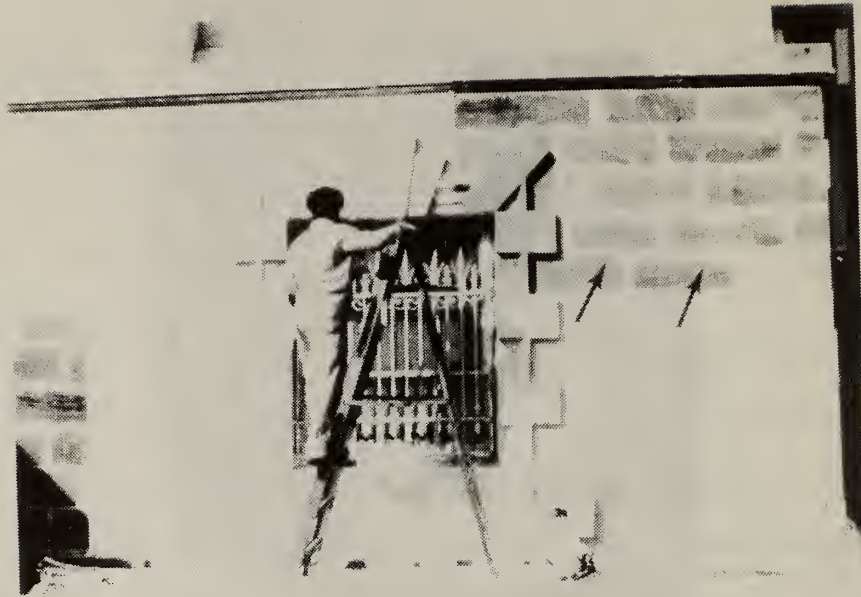
FIGURE 37. REPAINTING OF AREA B, ARROWS INDICATE BROAD AREA OF EXCESS MORTAR AFTER REPOINTING

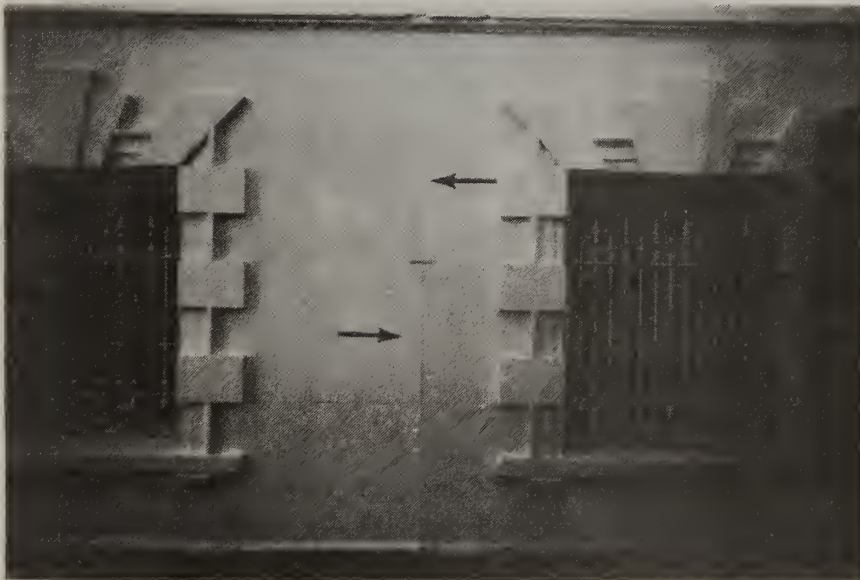
FIGURE 45. AREA D AFTER REPAINTING; ARROWS INDICATE VERTICAL LINE DIVIDING TEST SECTIONS D4 AND D1 (TO LEFT) FROM SECTIONS D2 AND D3 (TO RIGHT)
