NBSIR 81-2220

Effects of Thermal Insulations on Electrical Connections and Outlet Boxes

April 1981

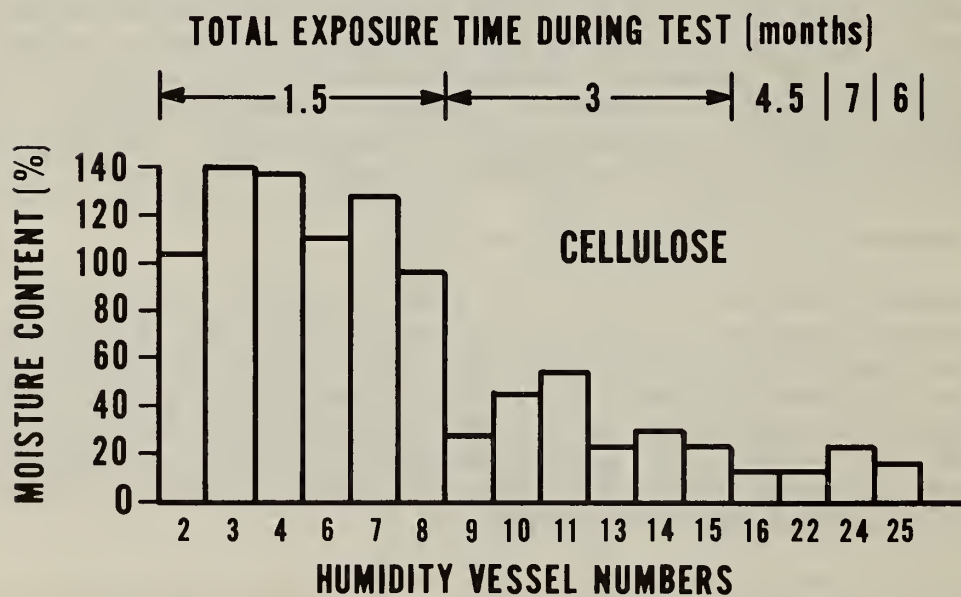
Figure 4. Moisture content of cellulose and UF Foam thermal insulations exposed to 96 percent relative humidity.

Figure 4 presents the moisture gain trend for UF foam insulation and the loss trend for cellulose insulation.

Cellulose specimens exposed to 96 percent relative humidity gained 119 percent mass of moisture during the first month of exposure and thereafter lost moisture. At the end of the six month exposure, it had an average moisture content of 20 percent of the dry cellulose mass. Because of the smaller number of specimens exposed at 75 percent relative humidity and 44 percent relative humidity, the moisture trend was not seen. However, data indicated 25 percent moisture content when exposed to 75 percent relative humidity for four and one-half months. Six months at 44 percent relative humidity resulted in 0.7 percent moisture gain.

UF foam specimens exposed to 96 percent relative humidity gained mass throughout most of the test period. At the end of one and one third months of exposure, the moisture content was 118 percent of dry mass; at the end of three months, the moisture content was 180 percent; at the end of six months, the moisture content was 168 percent. After six months of exposure at 75 percent relative humidity, the moisture content of UF foam was 110 percent. The moisture content of UF foam was 100 percent dry mass after six months exposure at 44 percent relative humidity.

The times for moisture gain or loss shown in figure 4 may not be indicative of actual times in residences because of wall geometry and thermal insulation surrounding boxes which were not considered in this study.

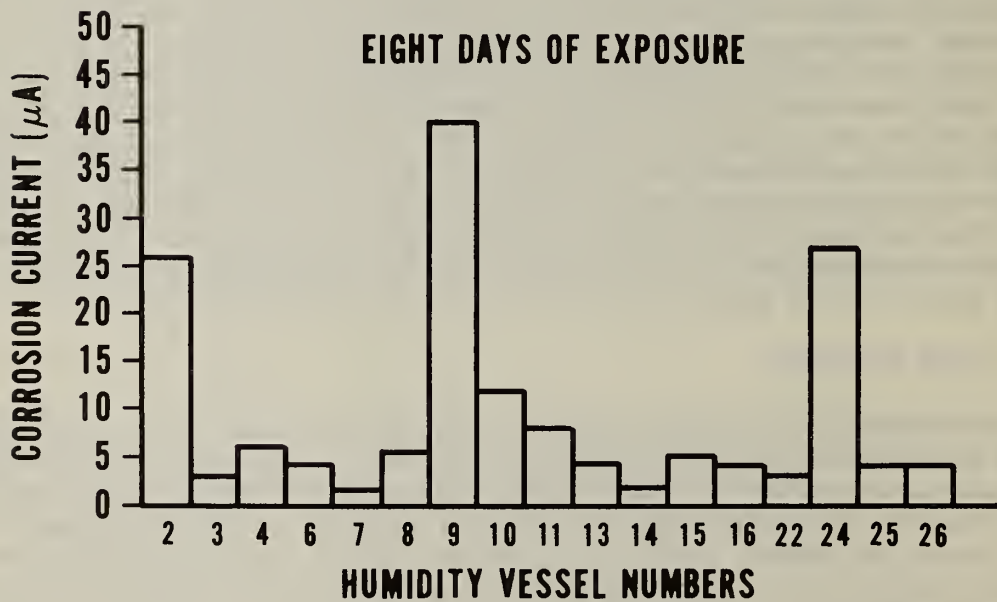
Figure 9. Corrosion currents measured in cellulose thermal insulation filled outlet boxes exposed at 96 percent relative humidity.

Figure 9 gives two histograms of corrosion currents measured in cellulose thermal insulation filled outlet boxes exposed within the 96 percent relative humidity vessels. Corrosion currents were measured eight days after the start of the tests and at the end of scheduled test periods. Comparison of the eight day and total time exposure histograms shows that corrosion current magnitudes were generally decreasing with time except for the case of number 2 and 4. Figure 10 shows a similar histograms for UF foam filled outlet boxes. Comparison of these histograms shows that corrosion currents are increasing with time. Humidity vessel number 50 is an exception; its not understood why current has greatly decreased. Perhaps, UF foam shrinkage and/or in adequate fill or voids in this case may have resulted in reduced current. Comparison of figures 9 and 10 indicates that corrosion currents in cellulose filled outlet boxes were approximately ten times greater than currents in UF foam filled outlet boxes. Currents within the range 0.3 to 2 μA were measured in cellulose filled outlet boxes exposed to 75 percent relative humidity, and no currents were measured during exposure to 44 percent relative humidity. No current were measured in UF foam filled boxes exposed to 75 and 44 percent relative humidities. No corrosion currents were measured in control vessels. The currents presented in figures 9 and 10 were measured between the ungrounded conductor (black wire) and grounding conductor. Similar currents not present here were measured between the other conductors.
