Boiling Tests of Non-Asbestos-Based Thermal Insulation Used in Air-Conduit Underground Heat Distribution Systems

U.S. DEPARTMENT OF COMMERCE
National Bureau of Standards
National Engineering Laboratory
Center for Building Technology
Washington, DC 20234

September 1981

**BOILING TESTS OF NON-ASBESTOS-BASED
THERMAL INSULATION USED IN AIR-CONDUIT
UNDERGROUND HEAT DISTRIBUTION SYSTEMS**

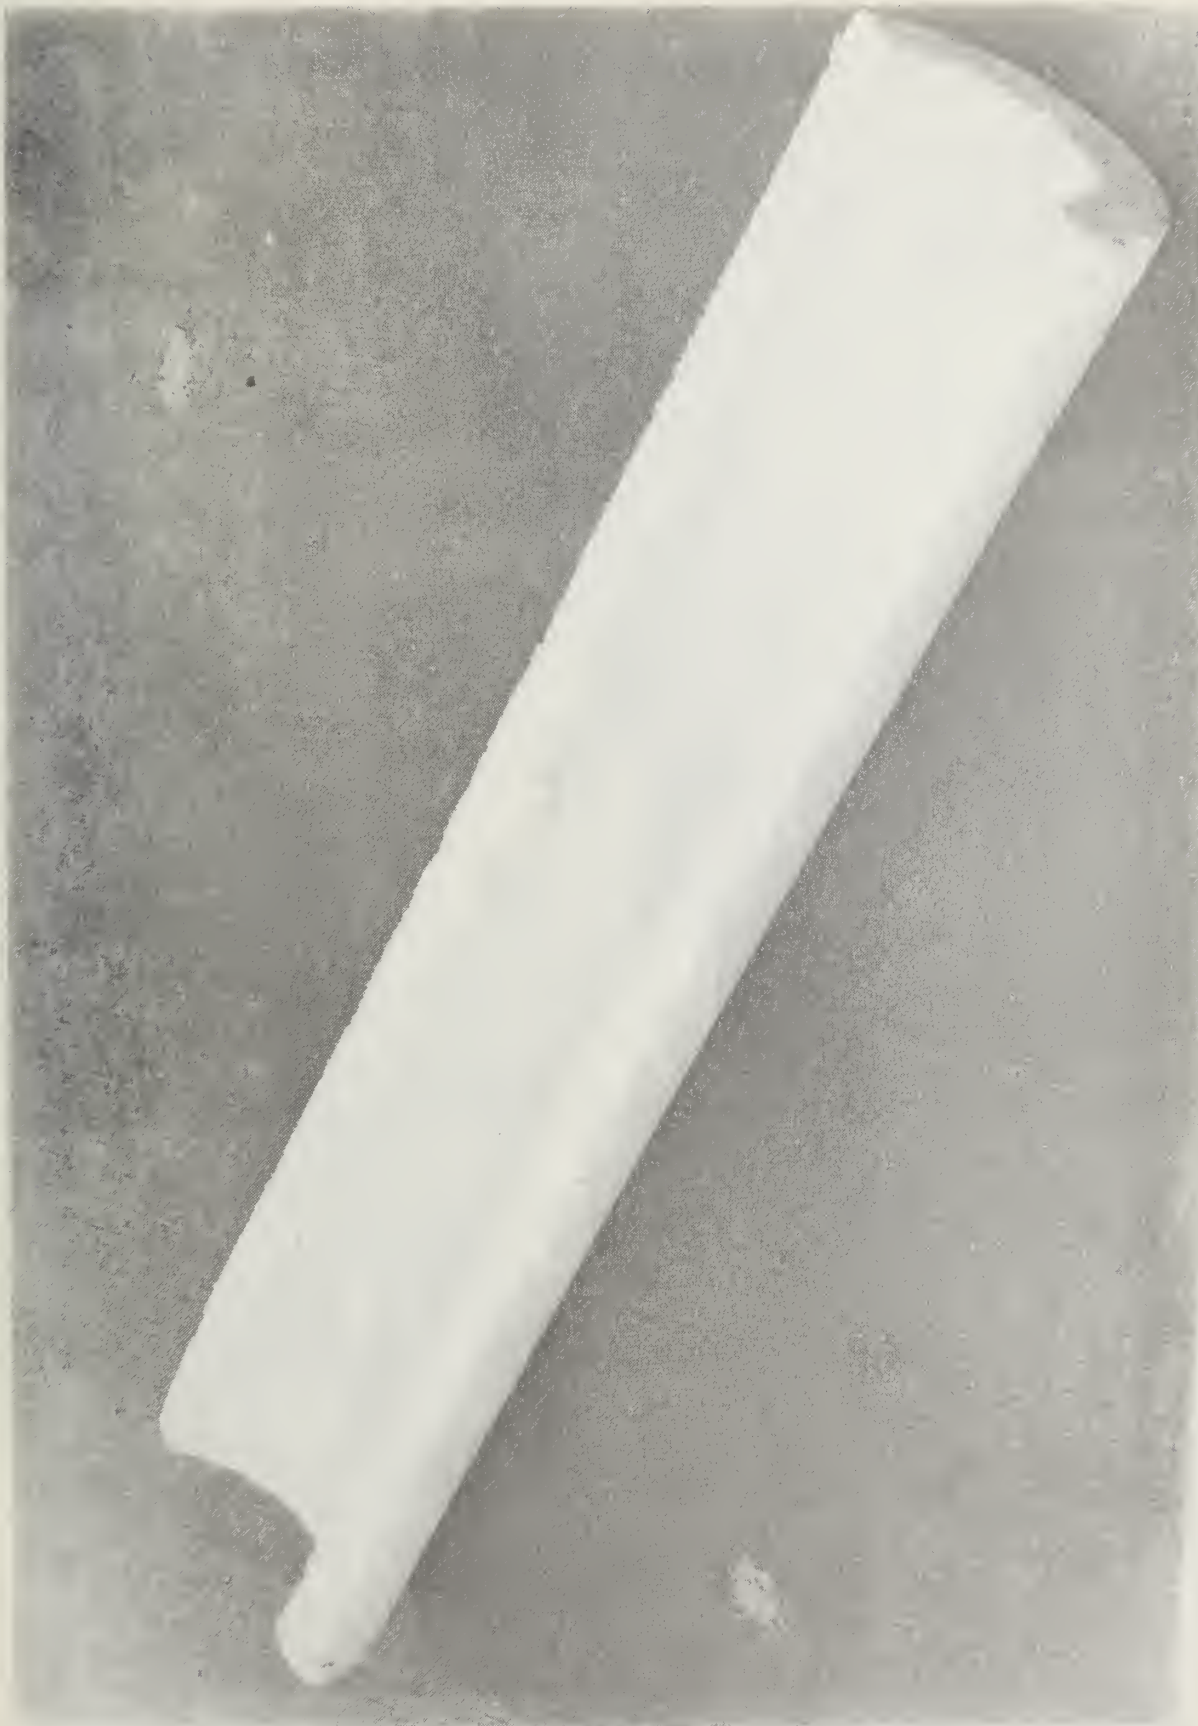
Figure 3. Pipe side view of KAYLO #1 specimen before boiling .

Two Owens-Corning "Kaylo" specimens were tested in the first test -- the insulation was tied onto the 4-in pipe with 16-ga. bare copper wire on 9-in centers, as shown in figure 2. A one-half-section piece is shown (both sides) in figures 3 and 4, and figure 5 shows the results after 5 hours of boiling. This insulation started to crack off of the pipe after about 30 minutes of

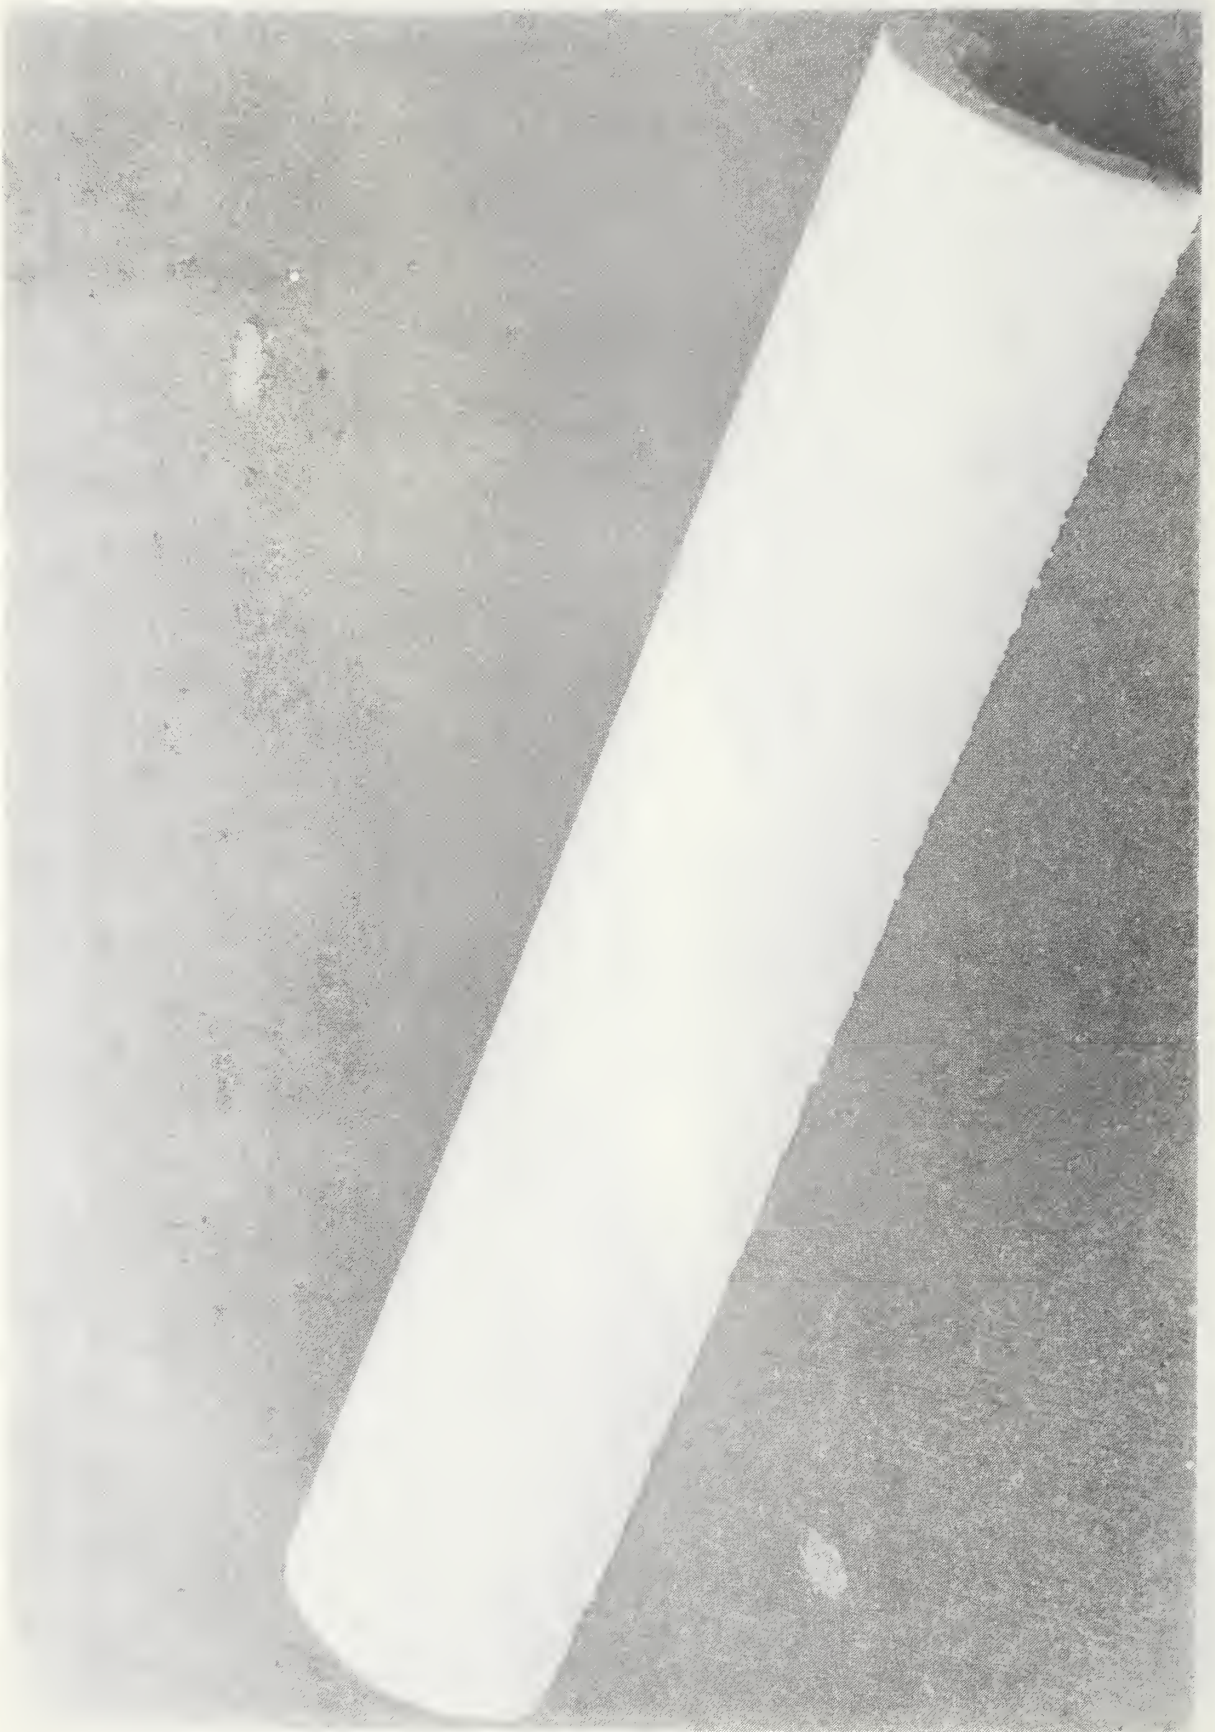
Figure 4. Conduit side view of KAYLO #1 specimen before boiling

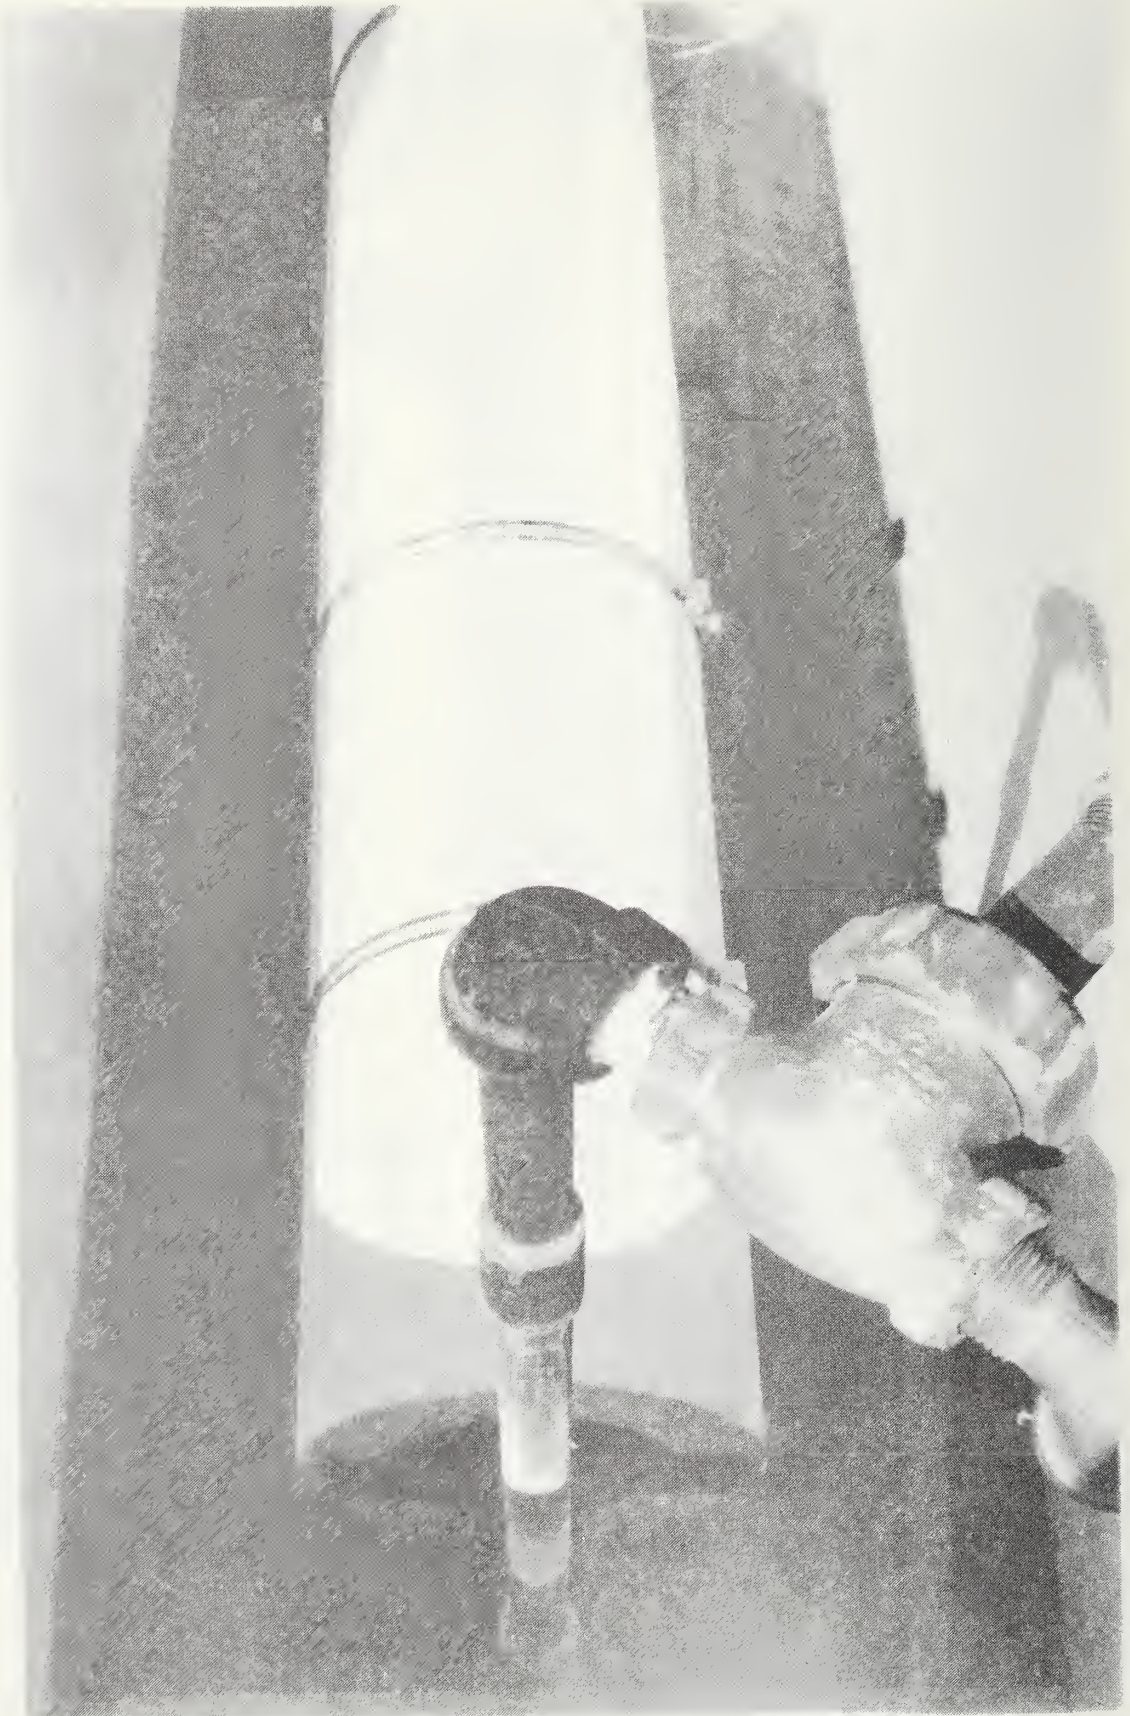
Figure 12. A close-up of PABCO #1 system before boiling

For the first test with Pabco insulation, 1/2-in wide stainless steel bands, were strapped around the pipe on 18-in centers, as shown in figures 11 and 12. One half section piece (both sides) is shown in figures 13 and 14. This insulation started to break off of the pipe after approximately 20 minutes of boiling and all of it came off within one hour. The results are shown in figure 15. The density of this insulation was 13.79 lb/ft³ and the moisture content was 5.9 percent.

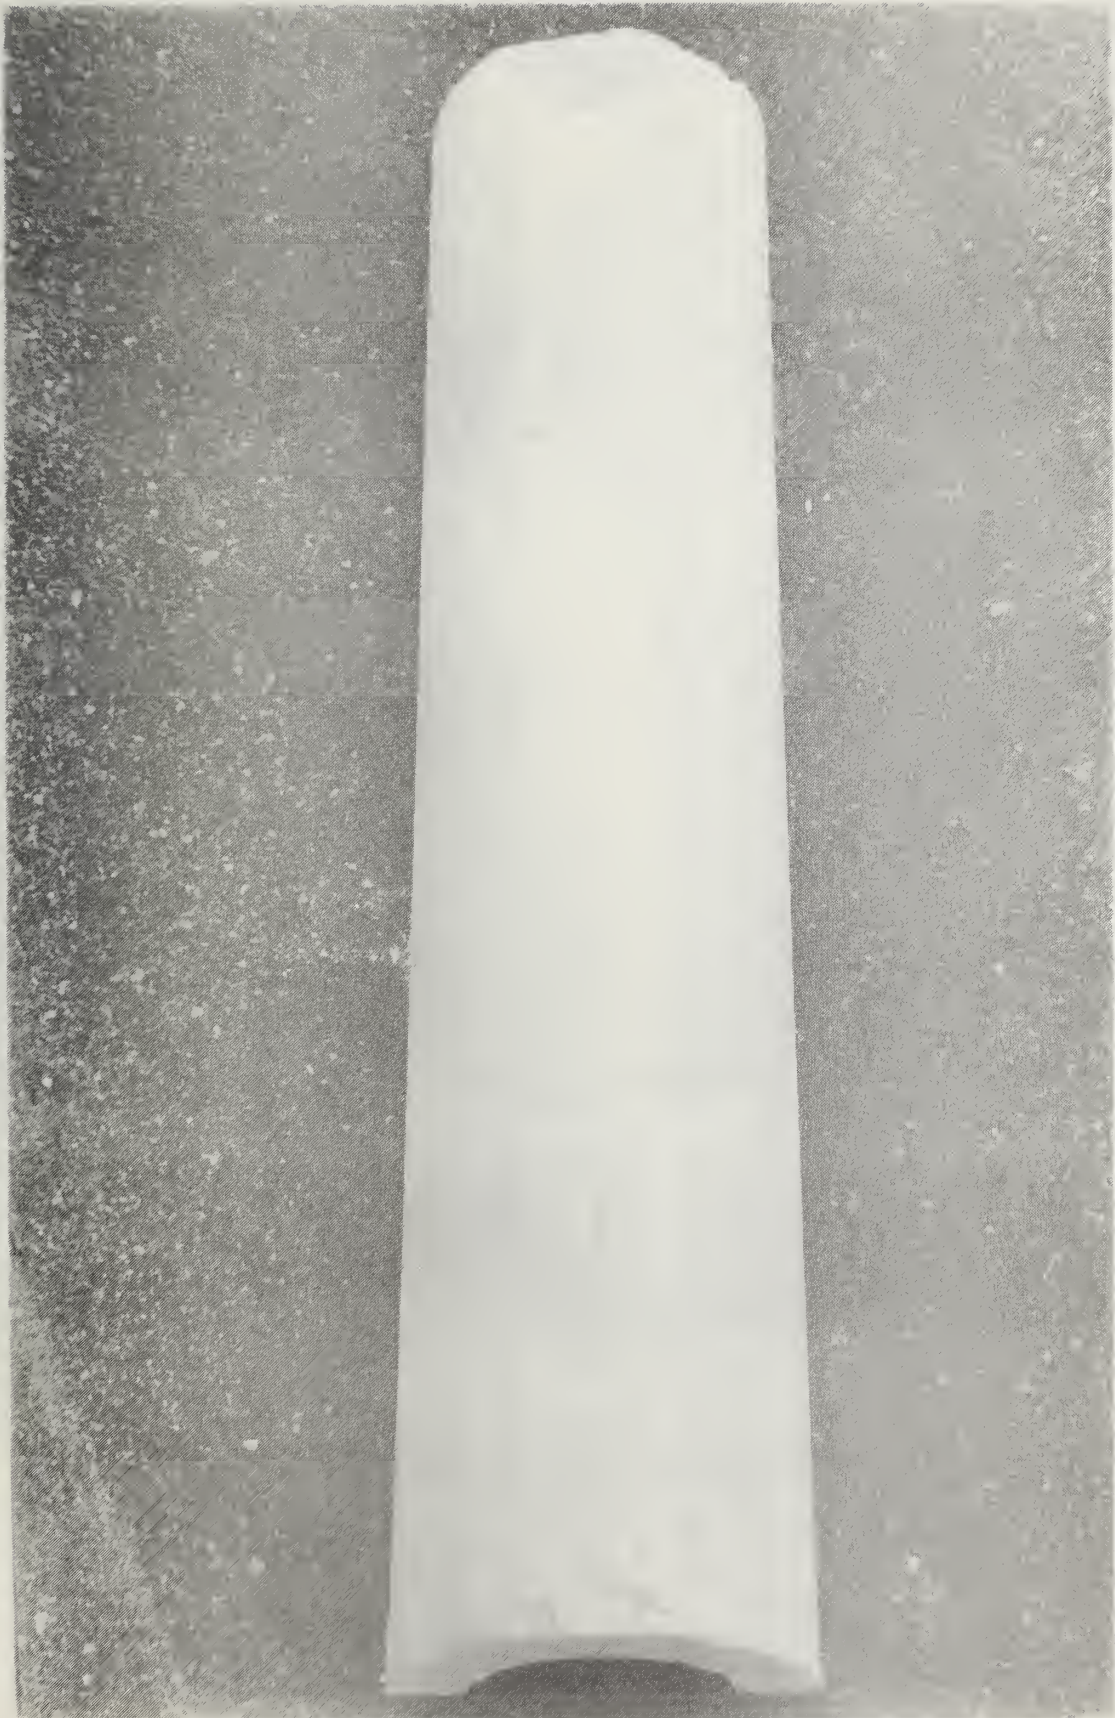
Figure 13. Conduit side view of PABCO #1 specimen

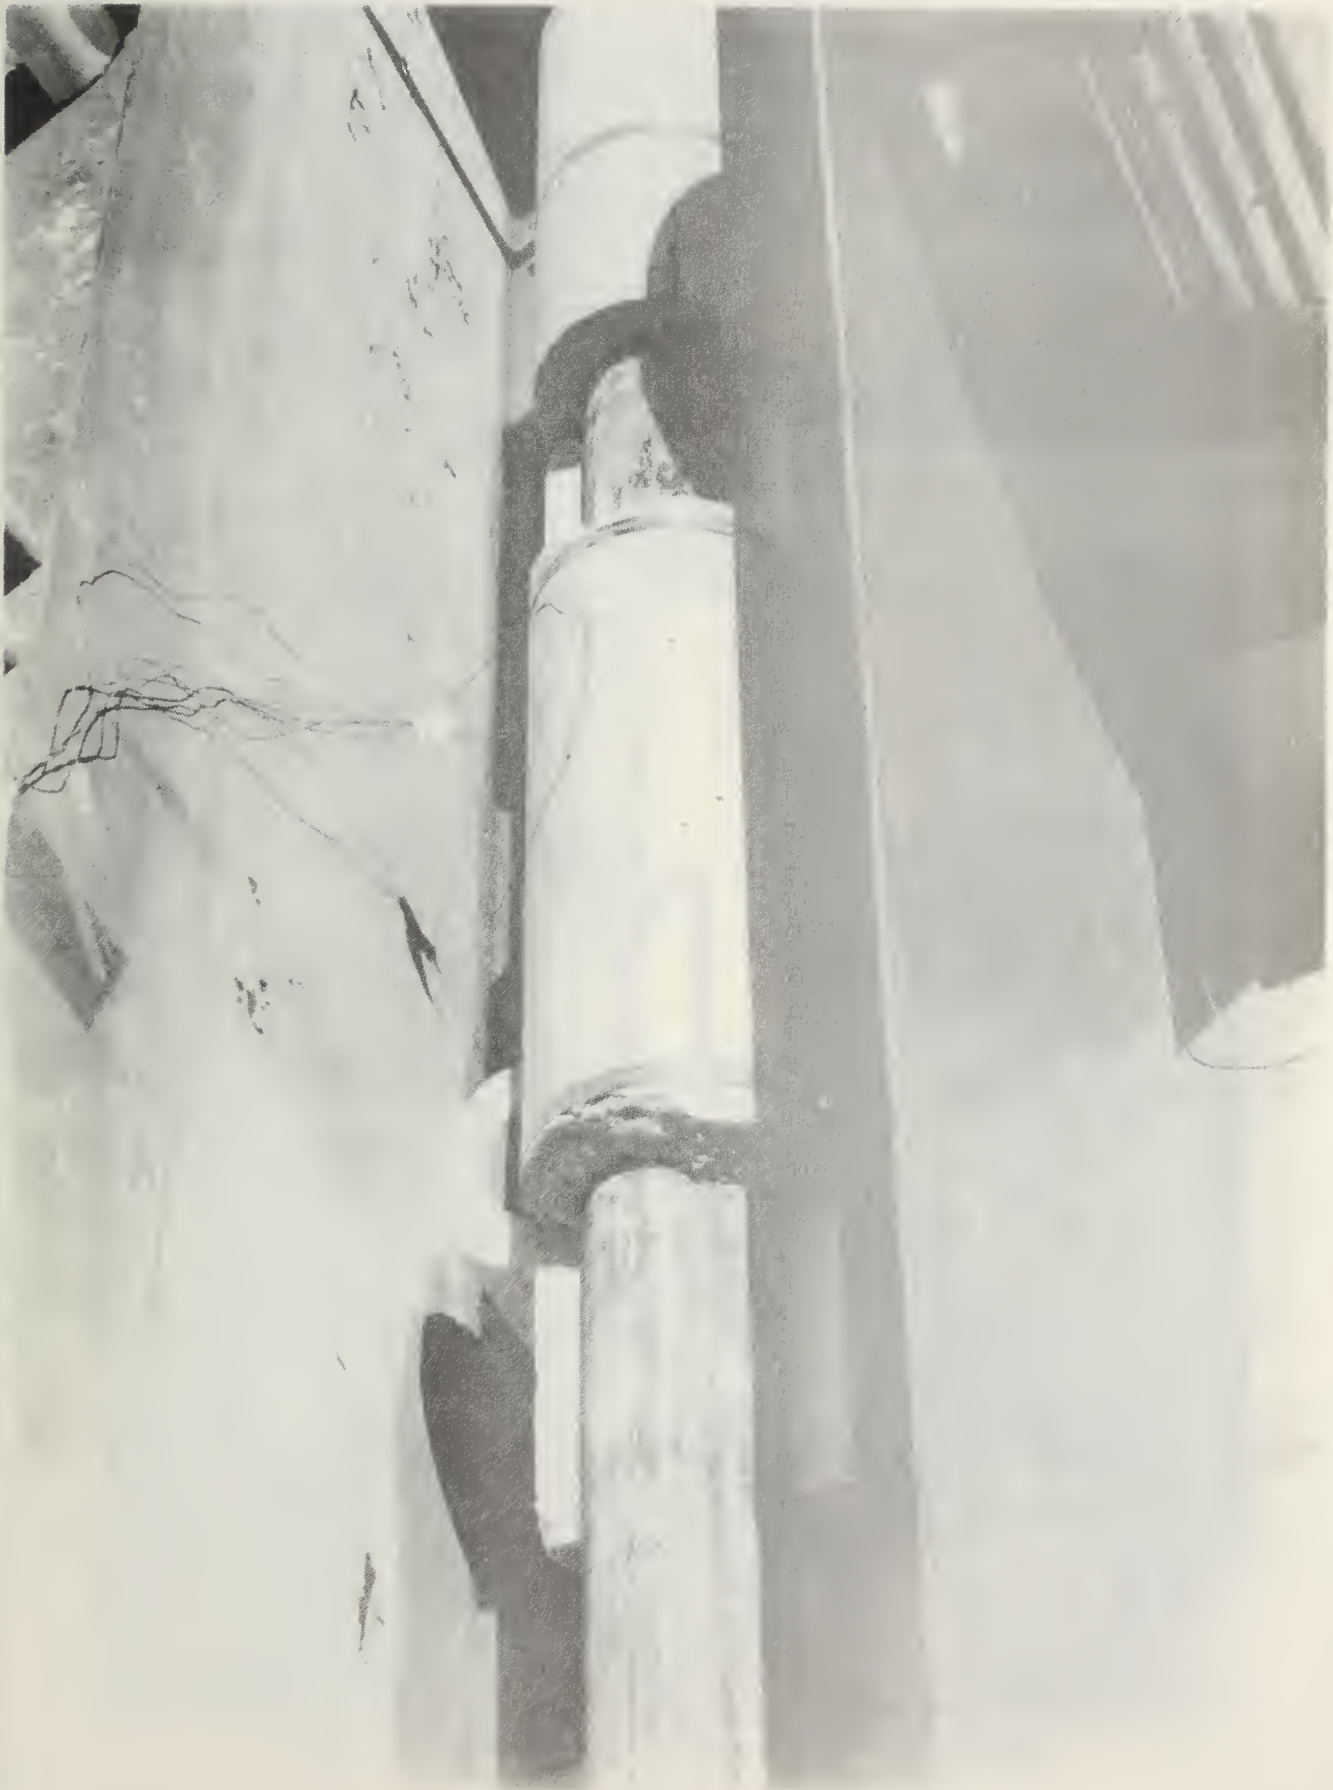
Figure 15. PABCO #1 system after 1 hour boiling

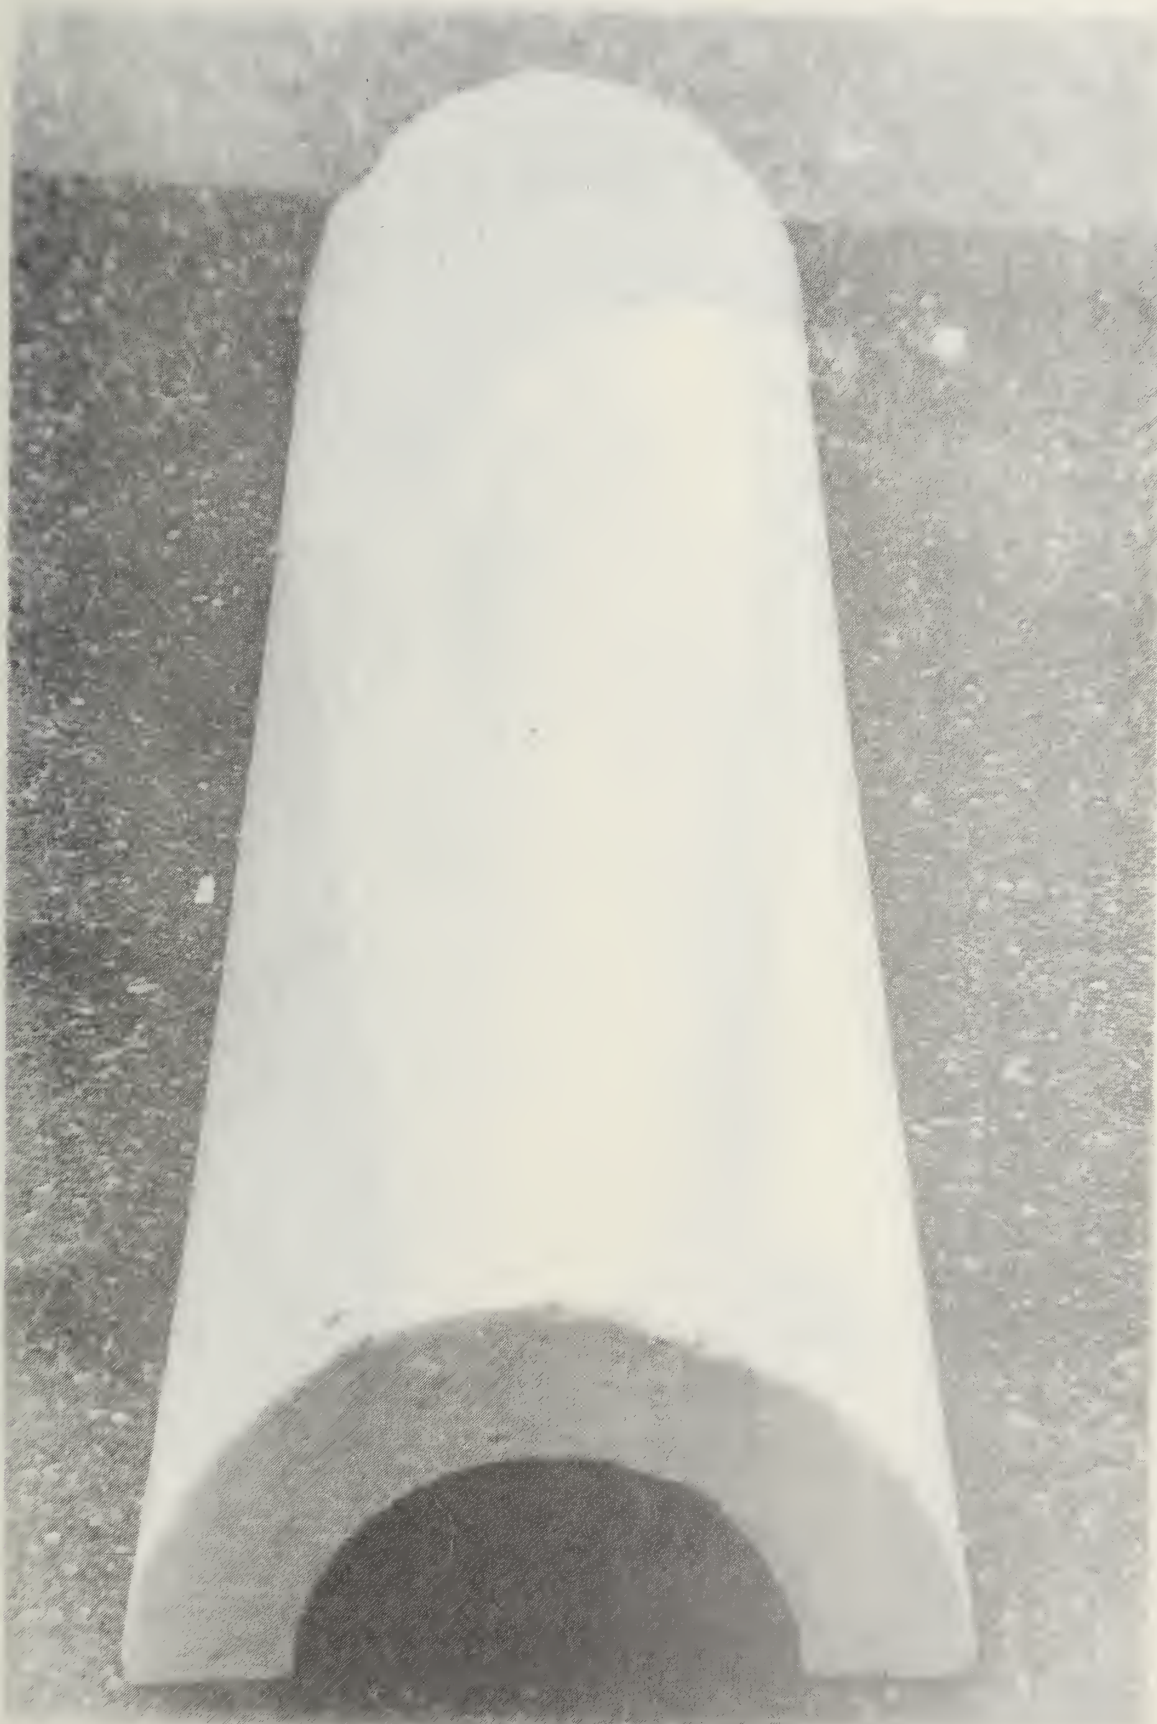
Figure 1/. Conduit side view of PABCO #2 specimen

The second test of Pabco insulation was conducted with the insulation installed on the 4-in pipe with 32-ga. stainless steel straps 1/2 in wide on 9-in centers instead of 18 inch, as shown in figure 16. One half section (both sides) is shown in figures 17 and 18. The results of 3 hours boiling are shown in figures 19 and 20. The density of this insulation was 14.40 lb/ft³ and the moisture content was 3.4 percent.

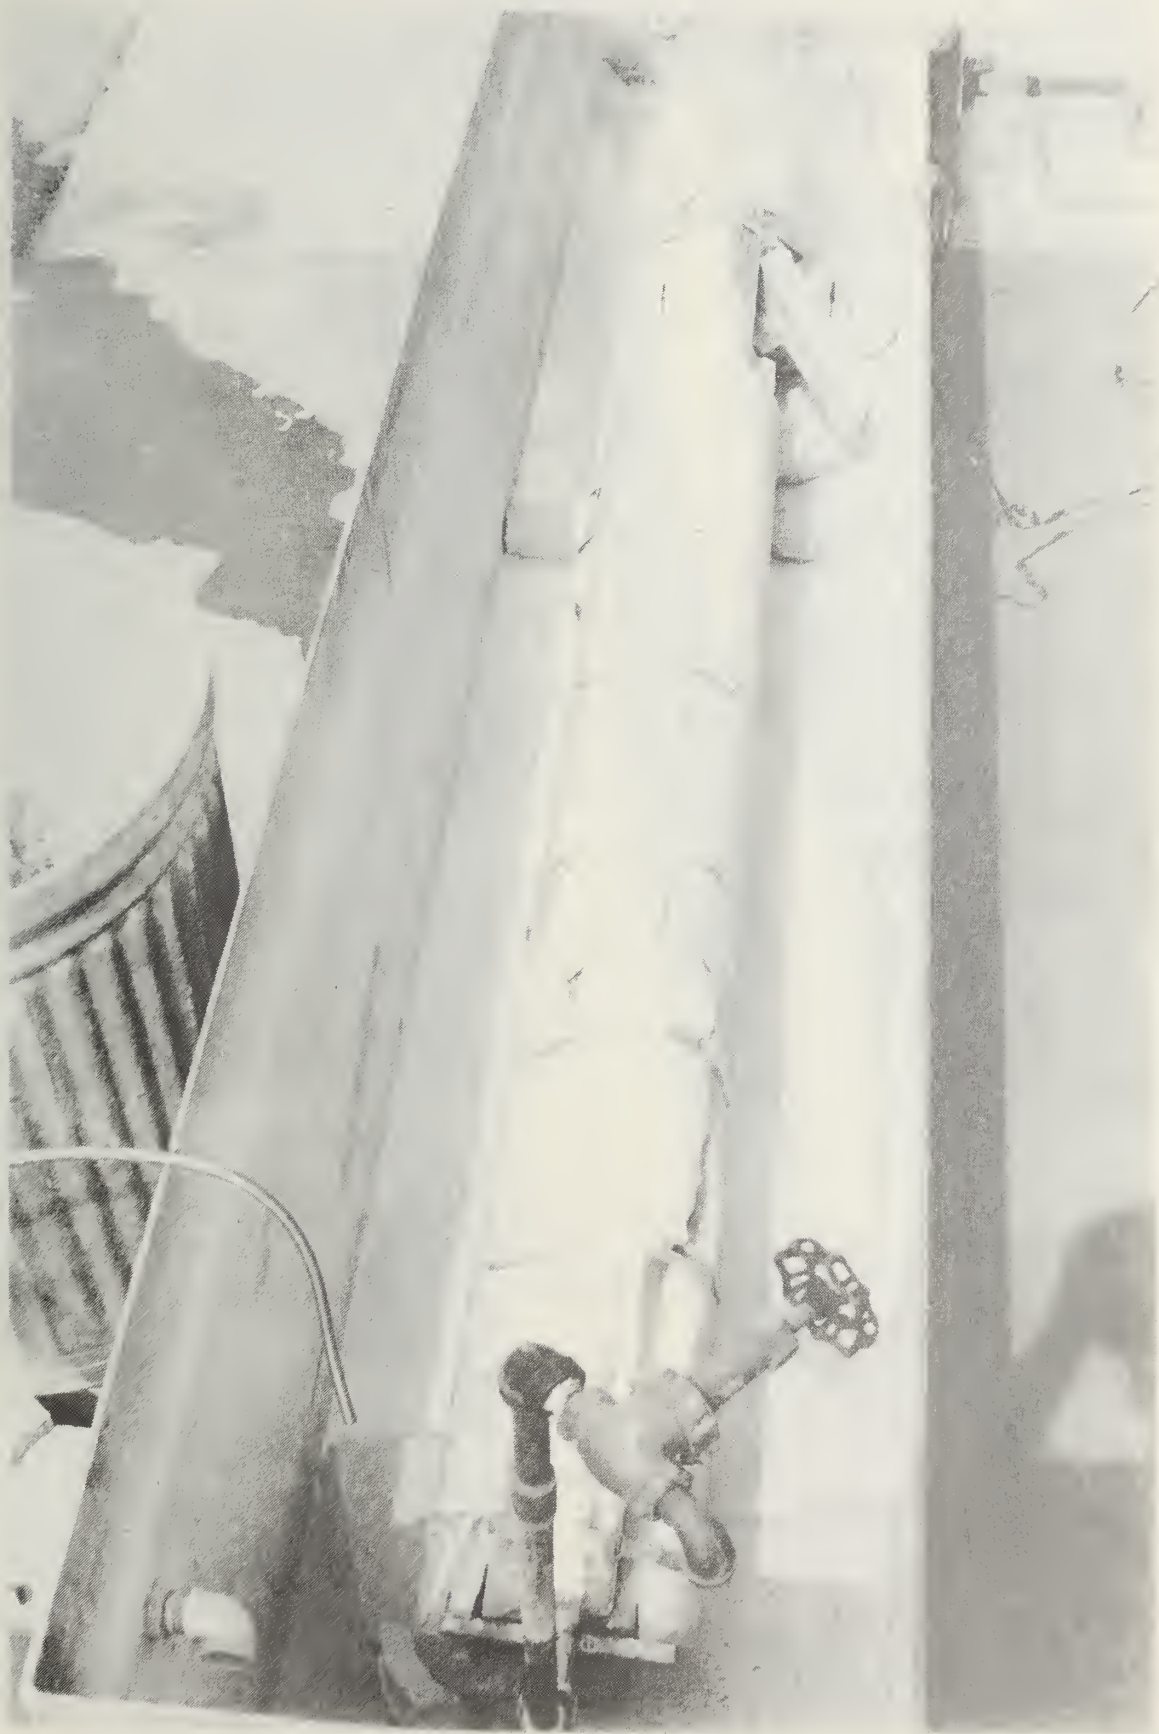
Figure 19. PABCO #2 system after 3 hours boiling

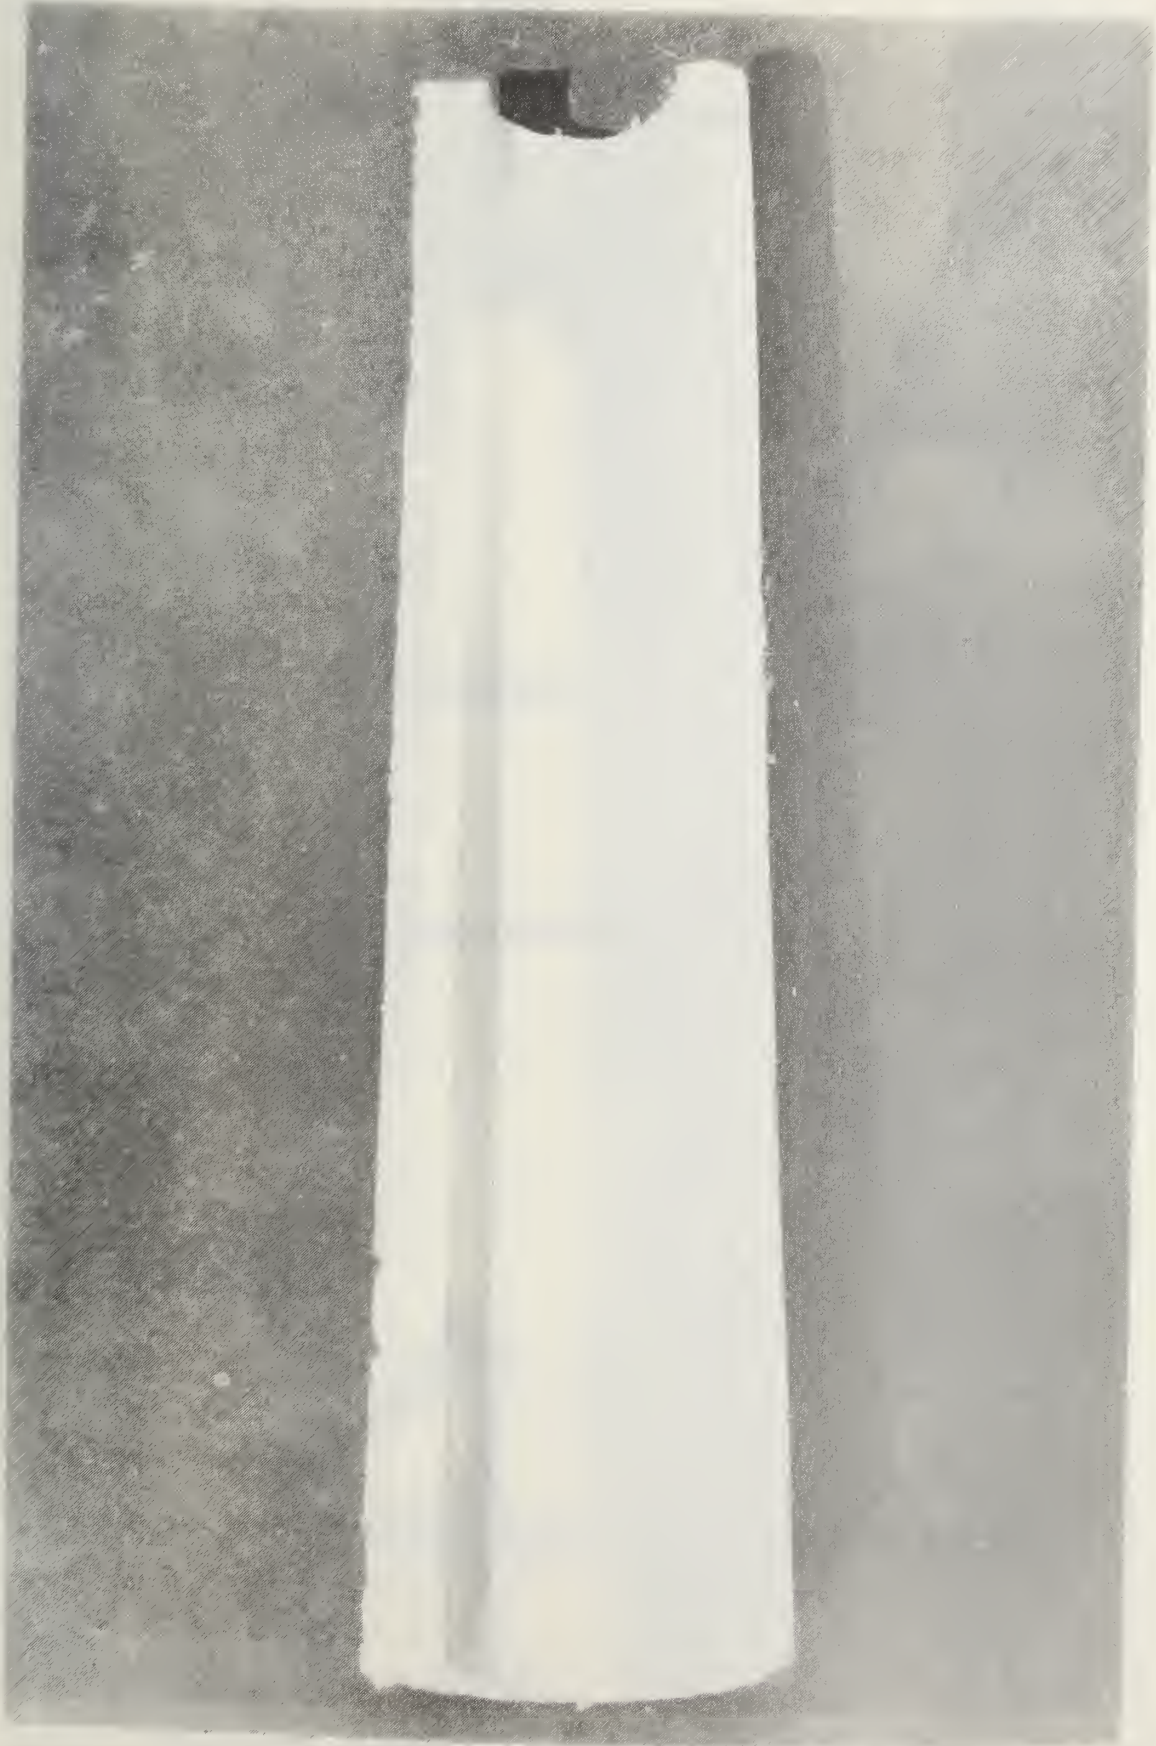
Figure 23. Pipe side of J/M specimen before boiling

The insulation specimen tested came with canvas covering, which was removed before the test. This insulation was installed on the pipe with 32-ga. stainless steel straps 1/2-in wide on 9-in centers, as shown in figure 21. One half section piece is shown (both sides) in figures 22 and 23. The results of 72 hours of boiling and 24 hours of drying after the water was drained from the tank are shown in figures 24 and 25. Figure 24 shows that the straps have cut into the insulation about 1/2 in or more. Figure 25 shows a closeup of a crack of approximately 5/16-in width in the inlet end piece of insulation. The straps cut into the insulation. All of the individual pieces of the insulation remained intact after testing, with only one section broken. The density of the insulation was 13.31 lb/ft³ and the moisture content was 3.0 percent.

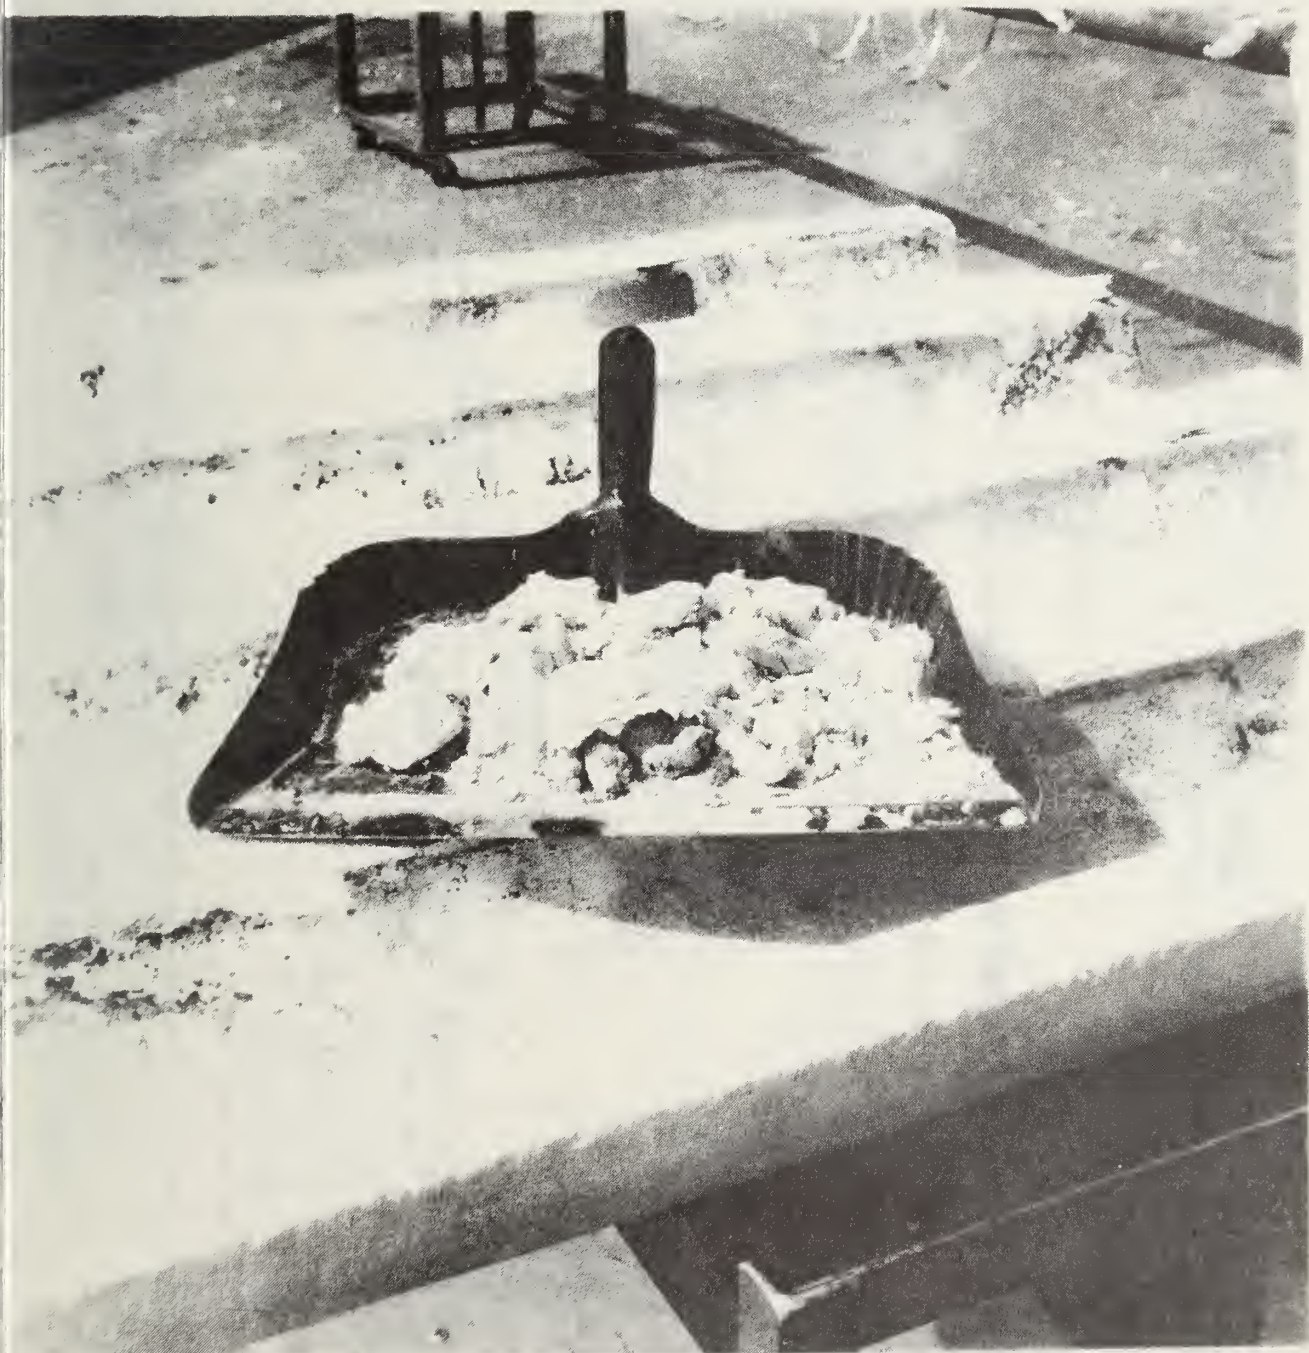
Figure 36. Crumbs of KAYLO-10 insulation found in the conduit space after the carrier pipe and insulation jacket were removed.

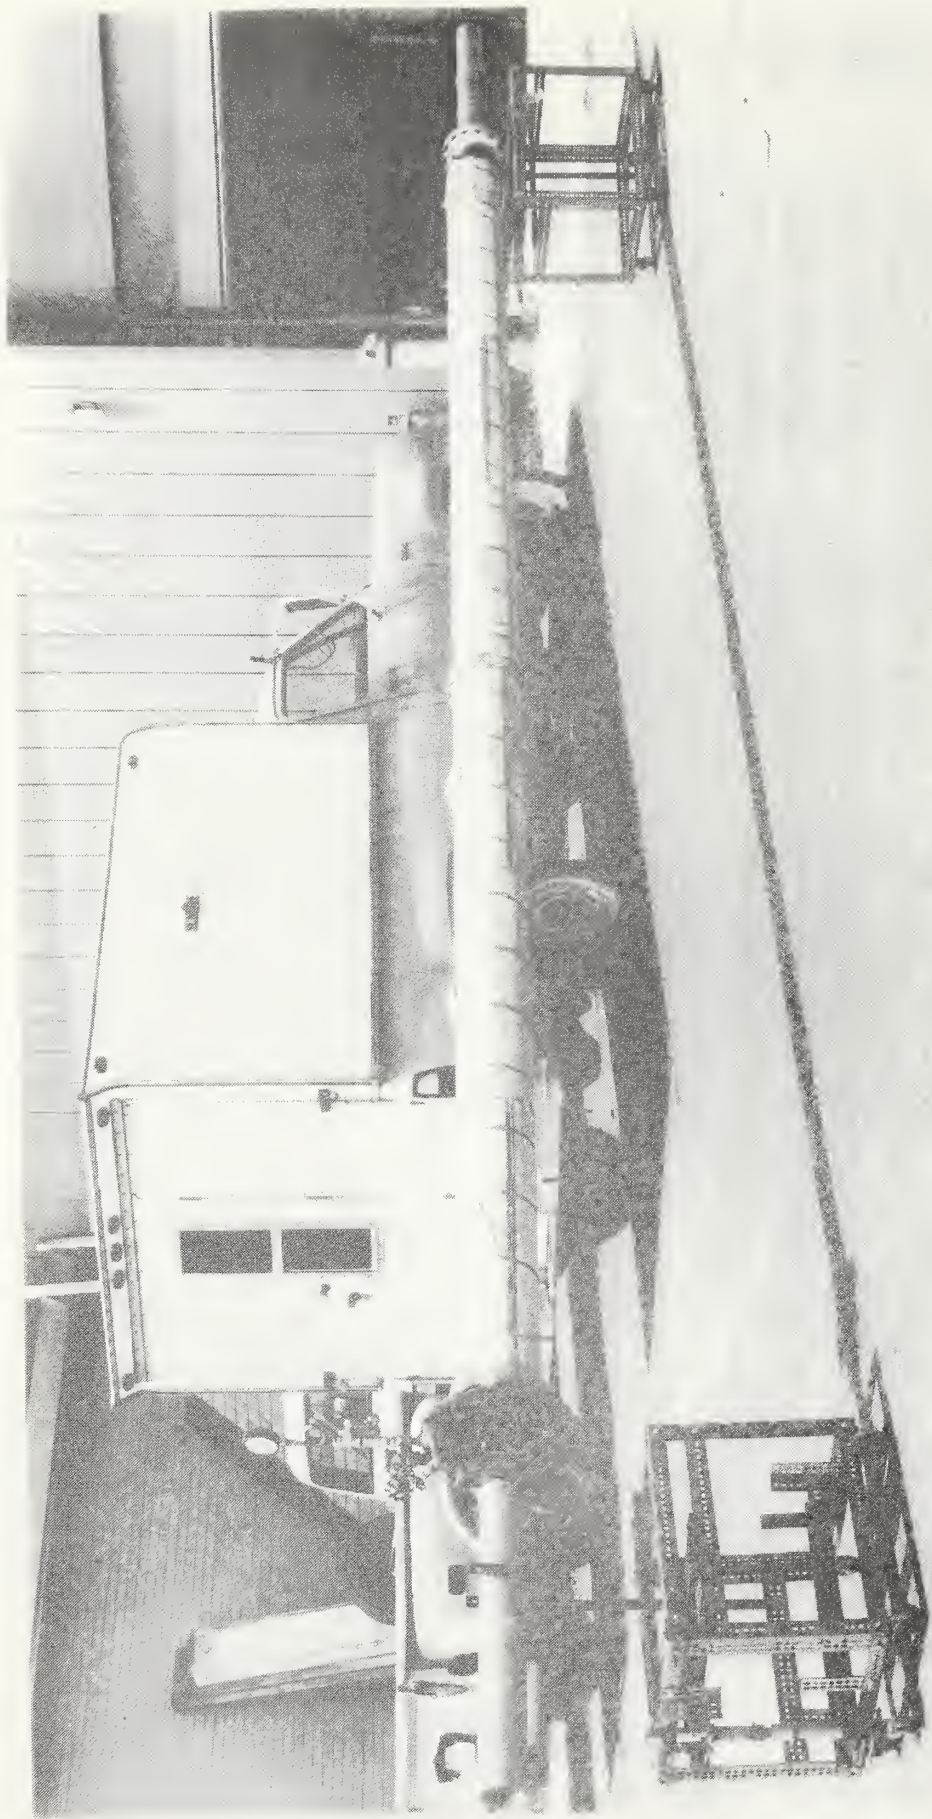
Figure 44. The PABCO thermal insulation system immediately after removal from the conduit where it underwent 192 hours boiling and subsequent drying tests.

The insulation removed from the conduit after boiling for 192 hours and drying is shown in figure 43. It can be seen that a few portions of insulations were inflated upward against the conduit and cracked. This inflated and cracked condition can be observed on each of five sections along the 20-ft test pipe (figure 44).

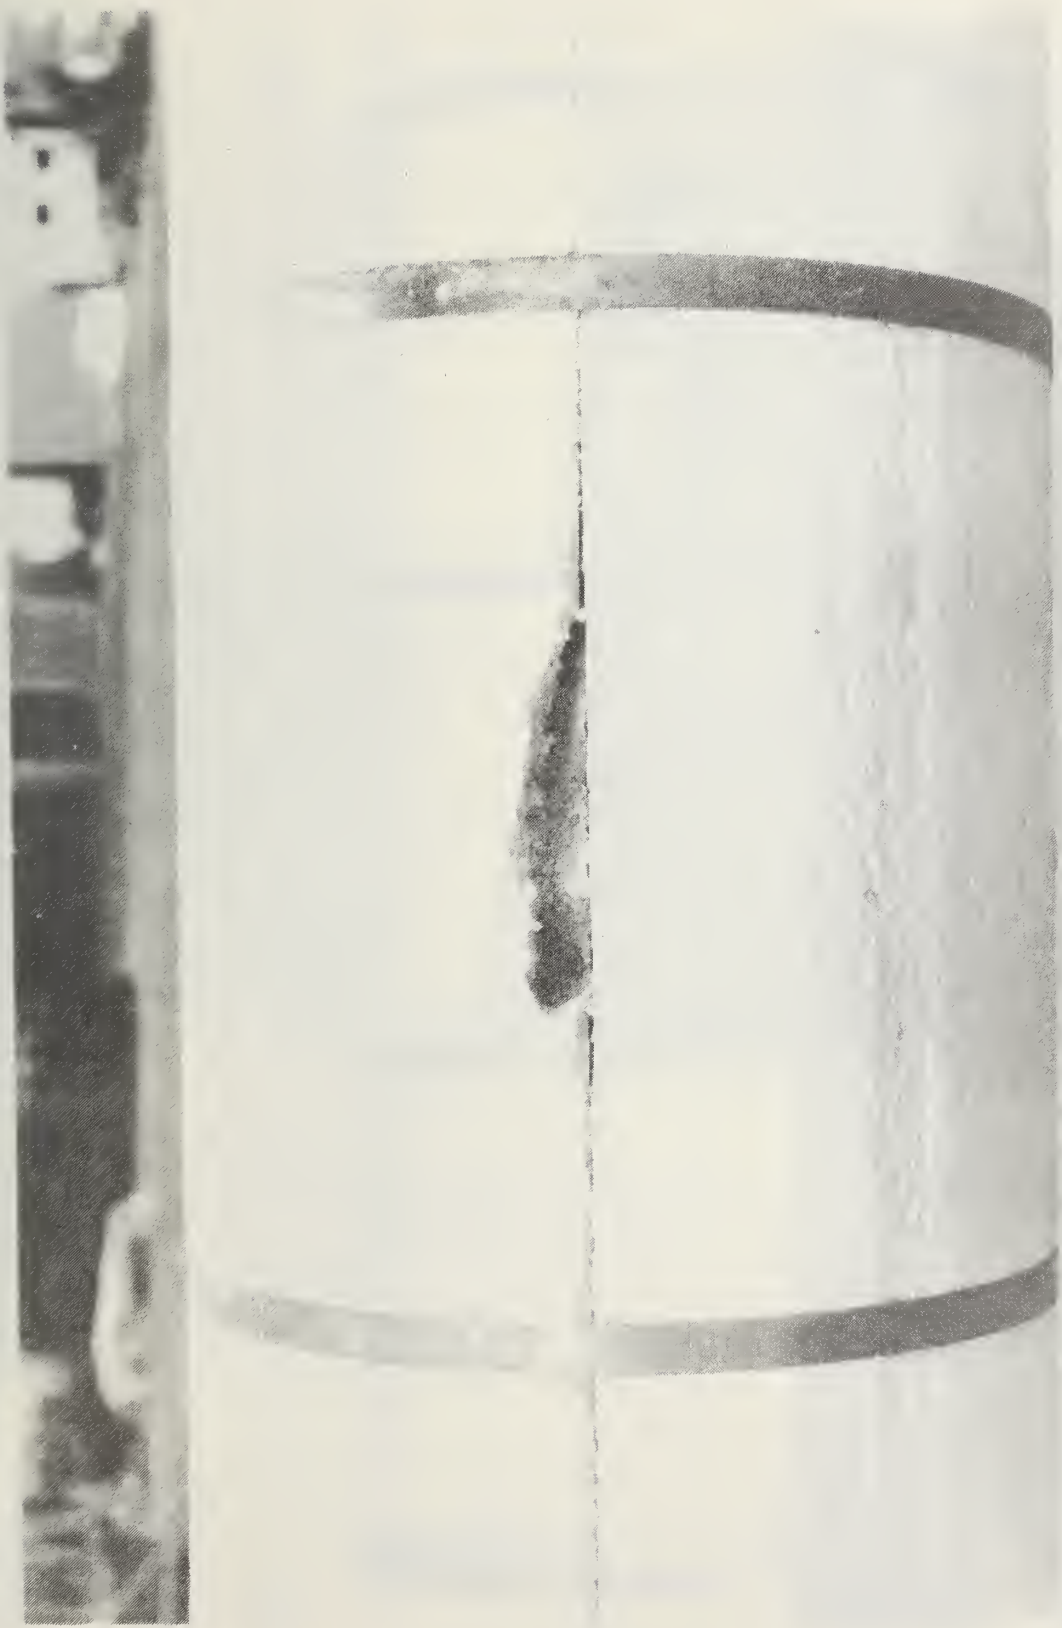
Figure 48. Close-up of opening at joint after conduit boiling of Mesolite.

The insulation removed from the conduit after boiling for 96 hours and drying is shown in figure 47. It can be seen at a number of places that the insulation had openings at the joints. Figures 48 and 49 show close-ups of the openings and also the deterioration of the insulation below the water level during boiling. The insulation at the top (above water level) of the pipe was very easy to crumble and could not be taken off the pipe without breaking up (figure 50).
