Boiling Tests of Non-Asbestos-Based Thermal Insulation Used in Air-Conduit Underground Heat Distribution Systems

U.S. DEPARTMENT OF COMMERCE
National Bureau of Standards
National Engineering Laboratory
Center for Building Technology
Washington, DC 20234

September 1981

**BOILING TESTS OF NON-ASBESTOS-BASED
THERMAL INSULATION USED IN AIR-CONDUIT
UNDERGROUND HEAT DISTRIBUTION SYSTEMS**

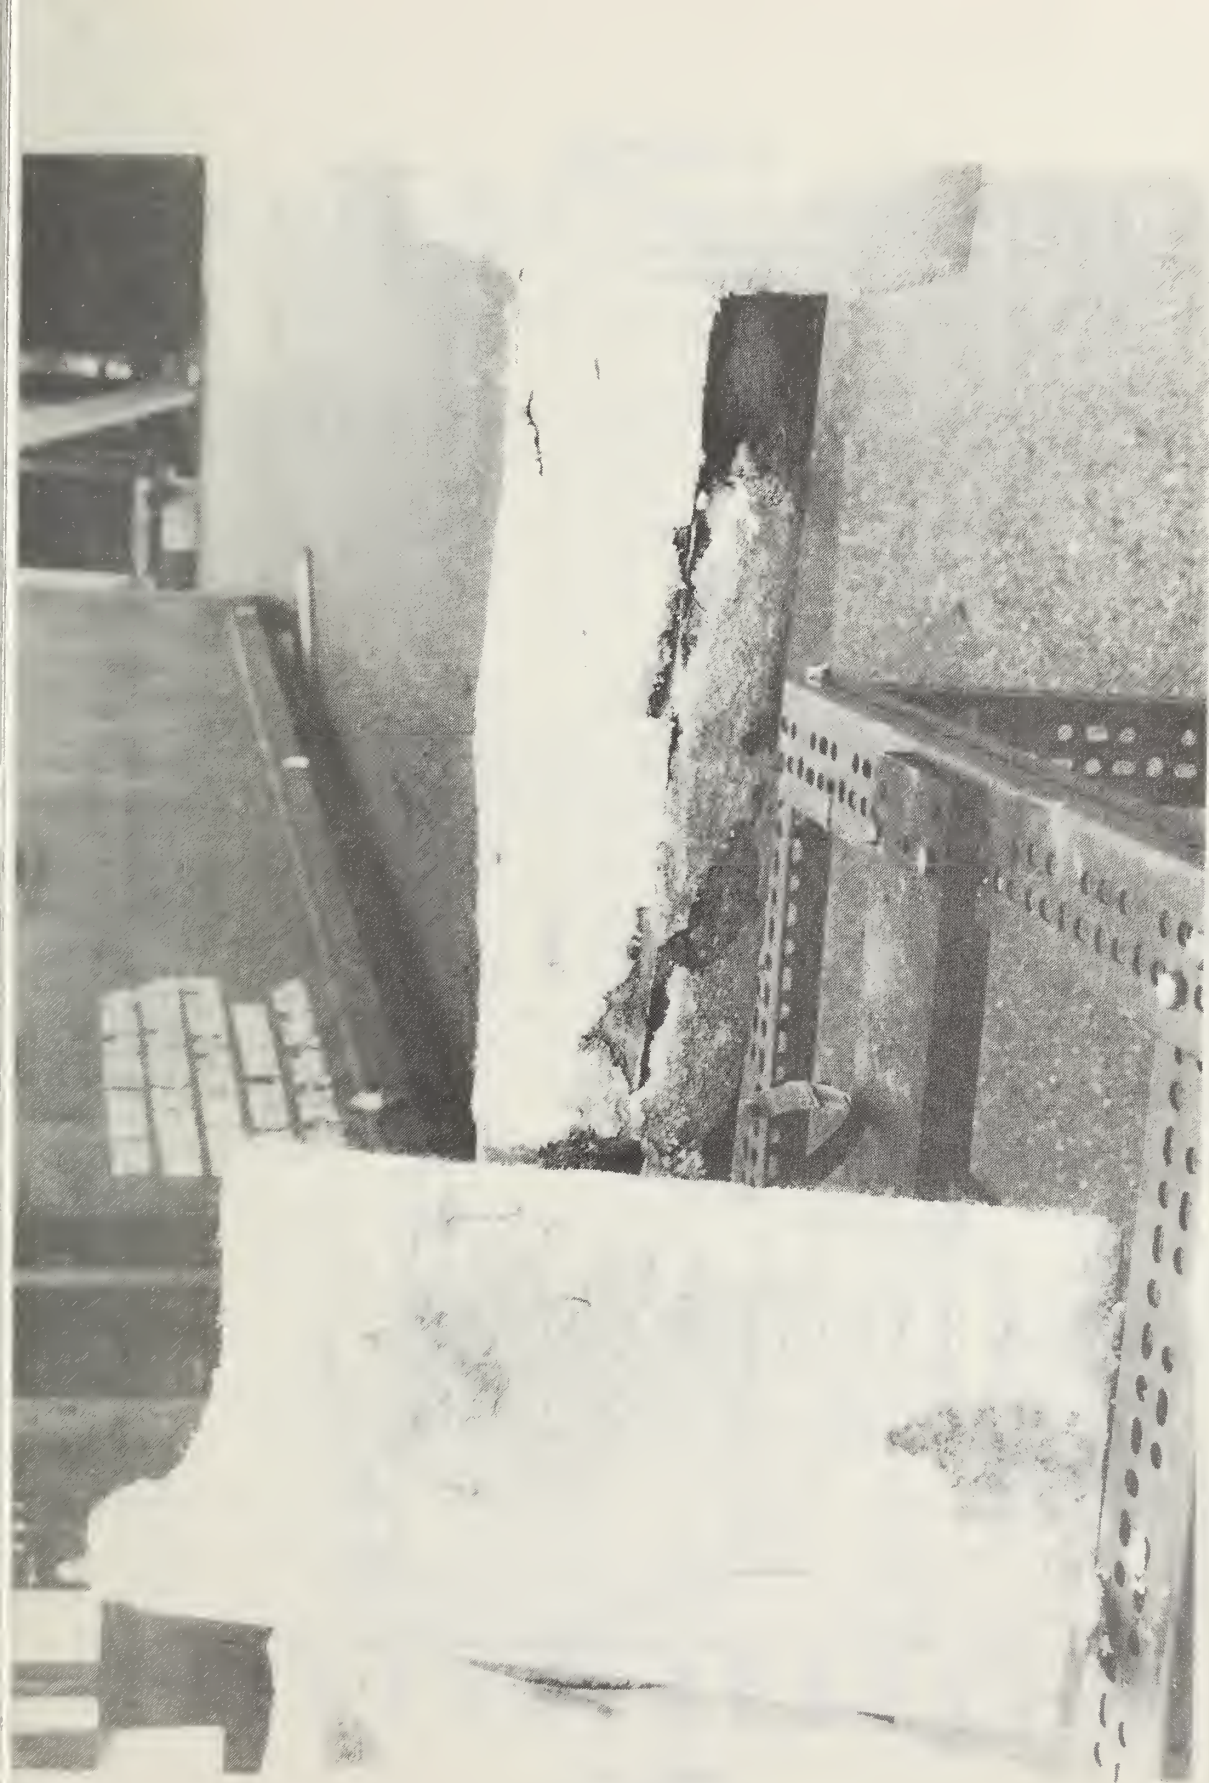
Figure 50. Condition of Wesolite after removal from pipe after boiling.

The insulation removed from the conduit after boiling for 96 hours and drying is shown in figure 47. It can be seen at a number of places that the insulation had openings at the joints. Figures 48 and 49 show close-ups of the openings and also the deterioration of the insulation below the water level during boiling. The insulation at the top (above water level) of the pipe was very easy to crumble and could not be taken off the pipe without breaking up (figure 50).

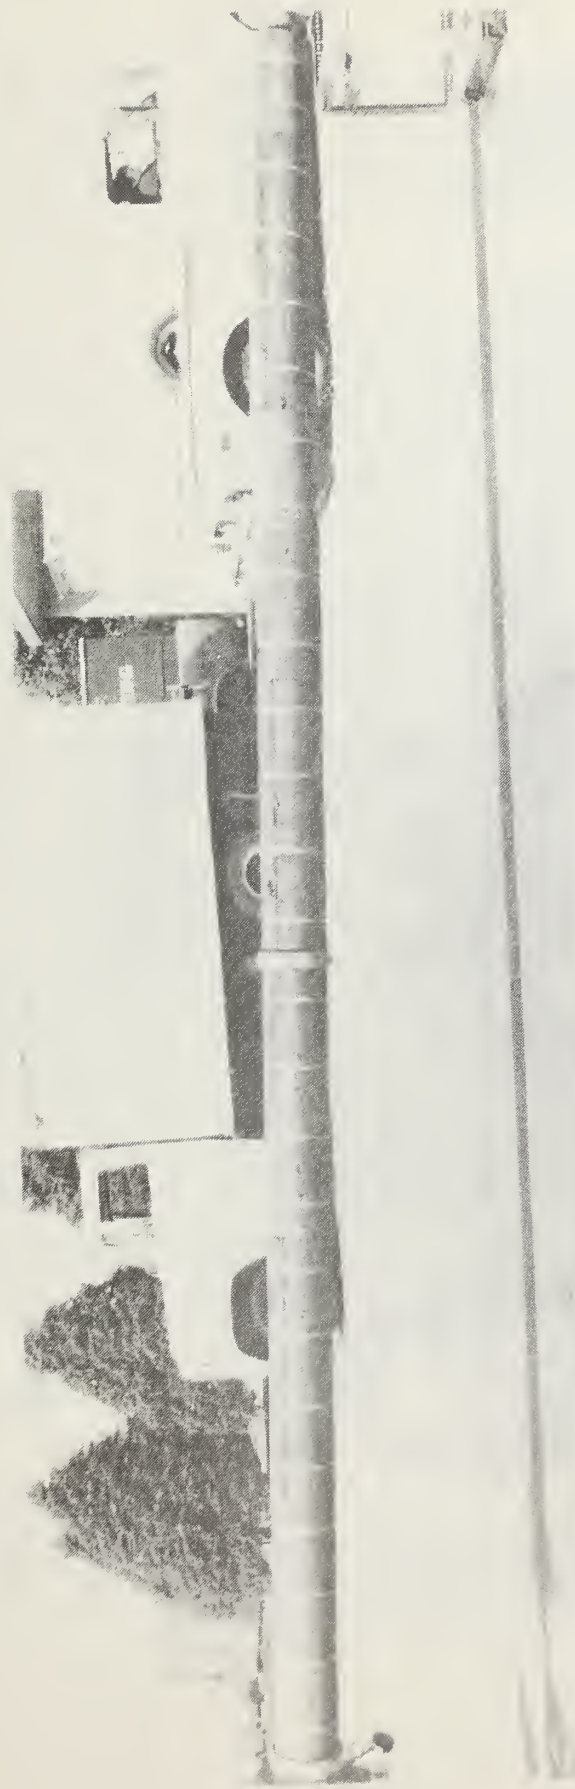
Figure 53. Epitherm on pipe after removal from conduit after 96 hours of boiling.

The insulation removed from the conduit after boiling for 96 hours and drying is shown in figure 53. Figure 54 shows close-up of the insulation at the bottom of the pipe (below the water level) after boiling. Figure 55 shows close-up of the insulation at the top of the pipe (above the water level) after boiling.

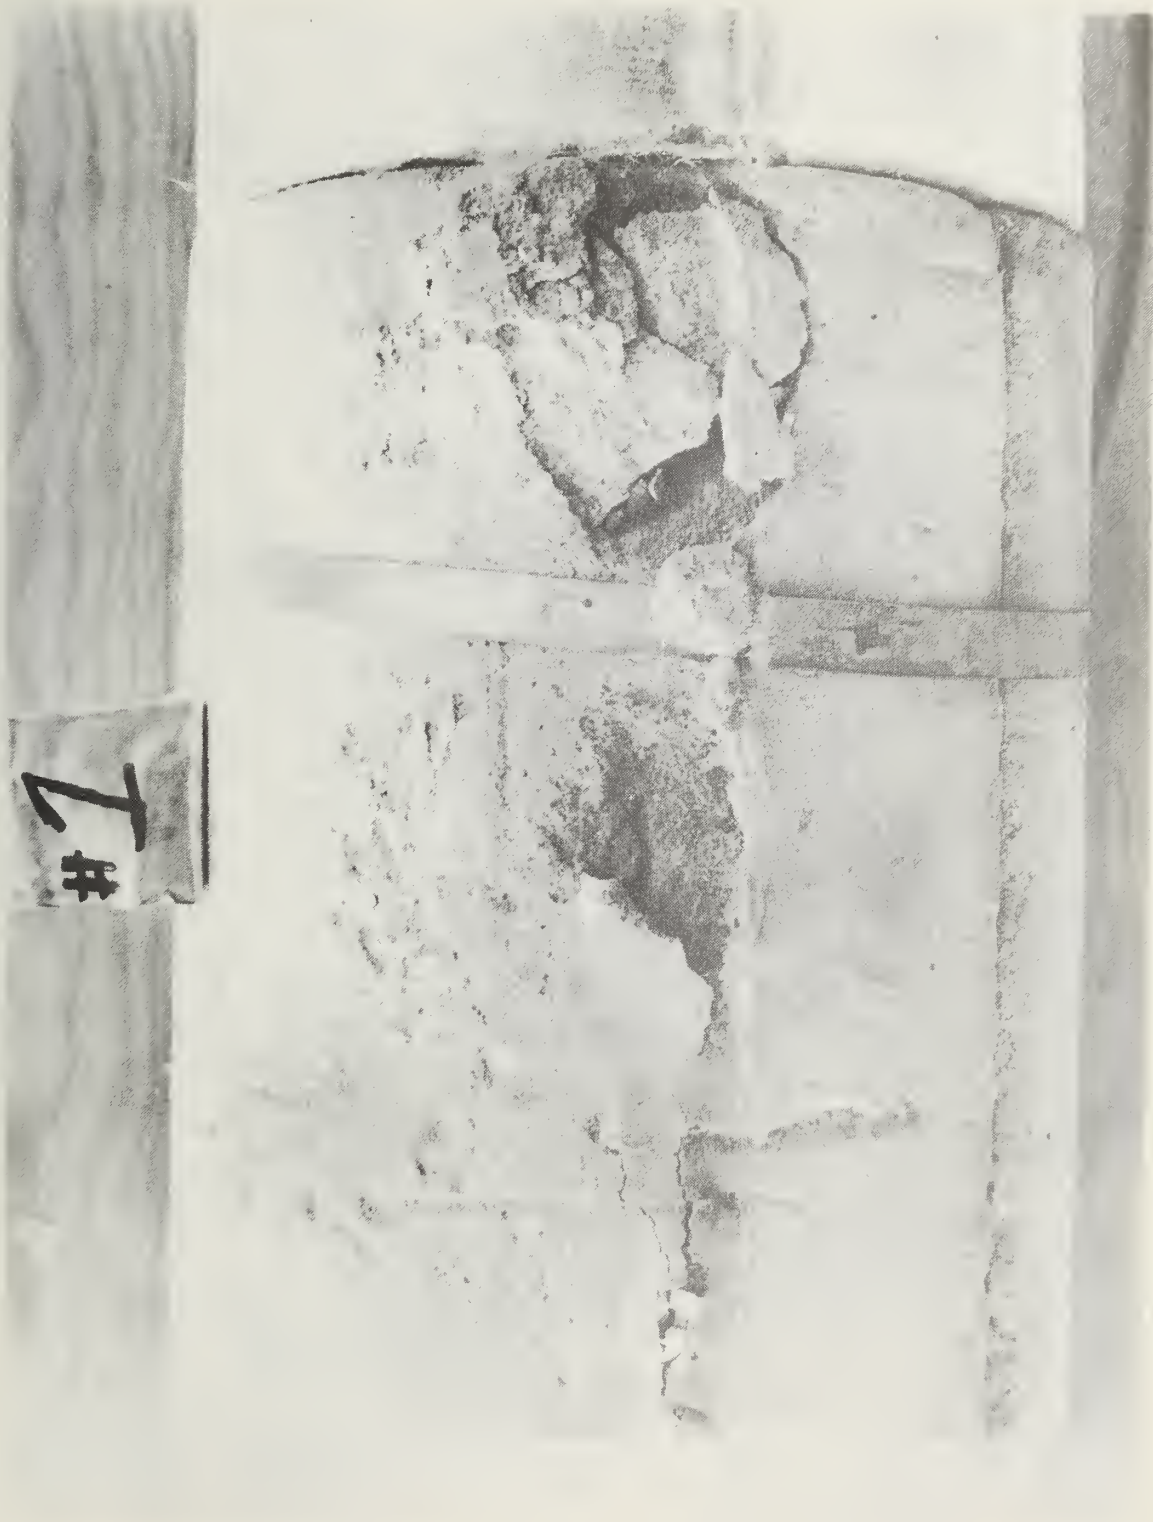
Figure 61. Celotemp 1500 after 8 days boiling.

Insulation Material	Days Boiling			
	8	16	24	32
Celotemp 1500 Celotex Corp. Expanded perlite	Started breaking apart Figure 61	Final run insulation 50% off of pipe. Figure 62	---	---
Thermo-12 Johns-Manville Calcium silicate	No physical damage visible to insulation.	Started to show damage. Figure 63	Increased damage apparent. Figure 64	Continuous damage apparent. Figure 65
Epitherm 1200 Eagle-Picher Mineral wool	Slight damage apparent Figure 67	Slightly increased damage. Figure 68	Damage at support on end. Figure 69	Slight increased damage. Figure 70
Wesolite "D" Wesolite Co. Perlite/sodium silicate	Damage below water level. Figure 72	Joint opening slightly Figure 73	Slight damage at joint. Figure 74	Damage at end of section. Figure 75
Super Caltemp Pabco Calcium silicate	No physical damage visible to insulation.	Cracks visible in insulation. Figure 77	No increase in damage visible. Figure 78	Damage below water level. Figure 79

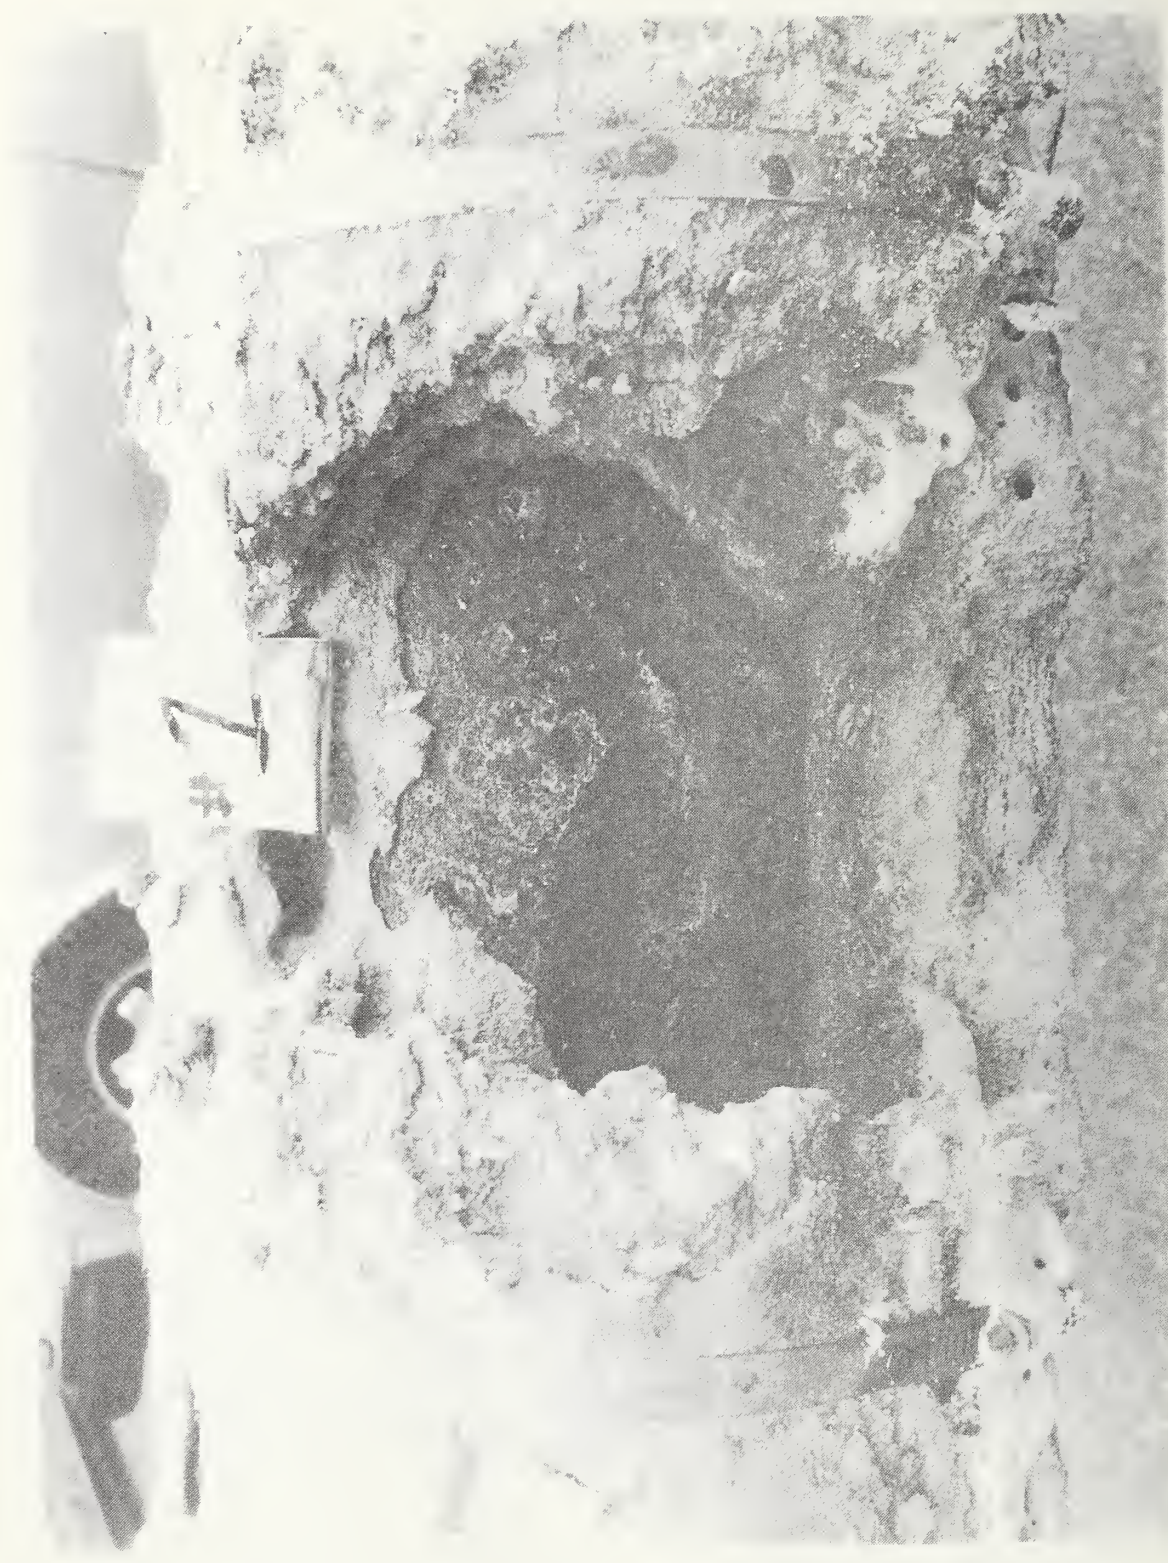
Figure 62. Celotemp 1500 after 16 days of boiling.

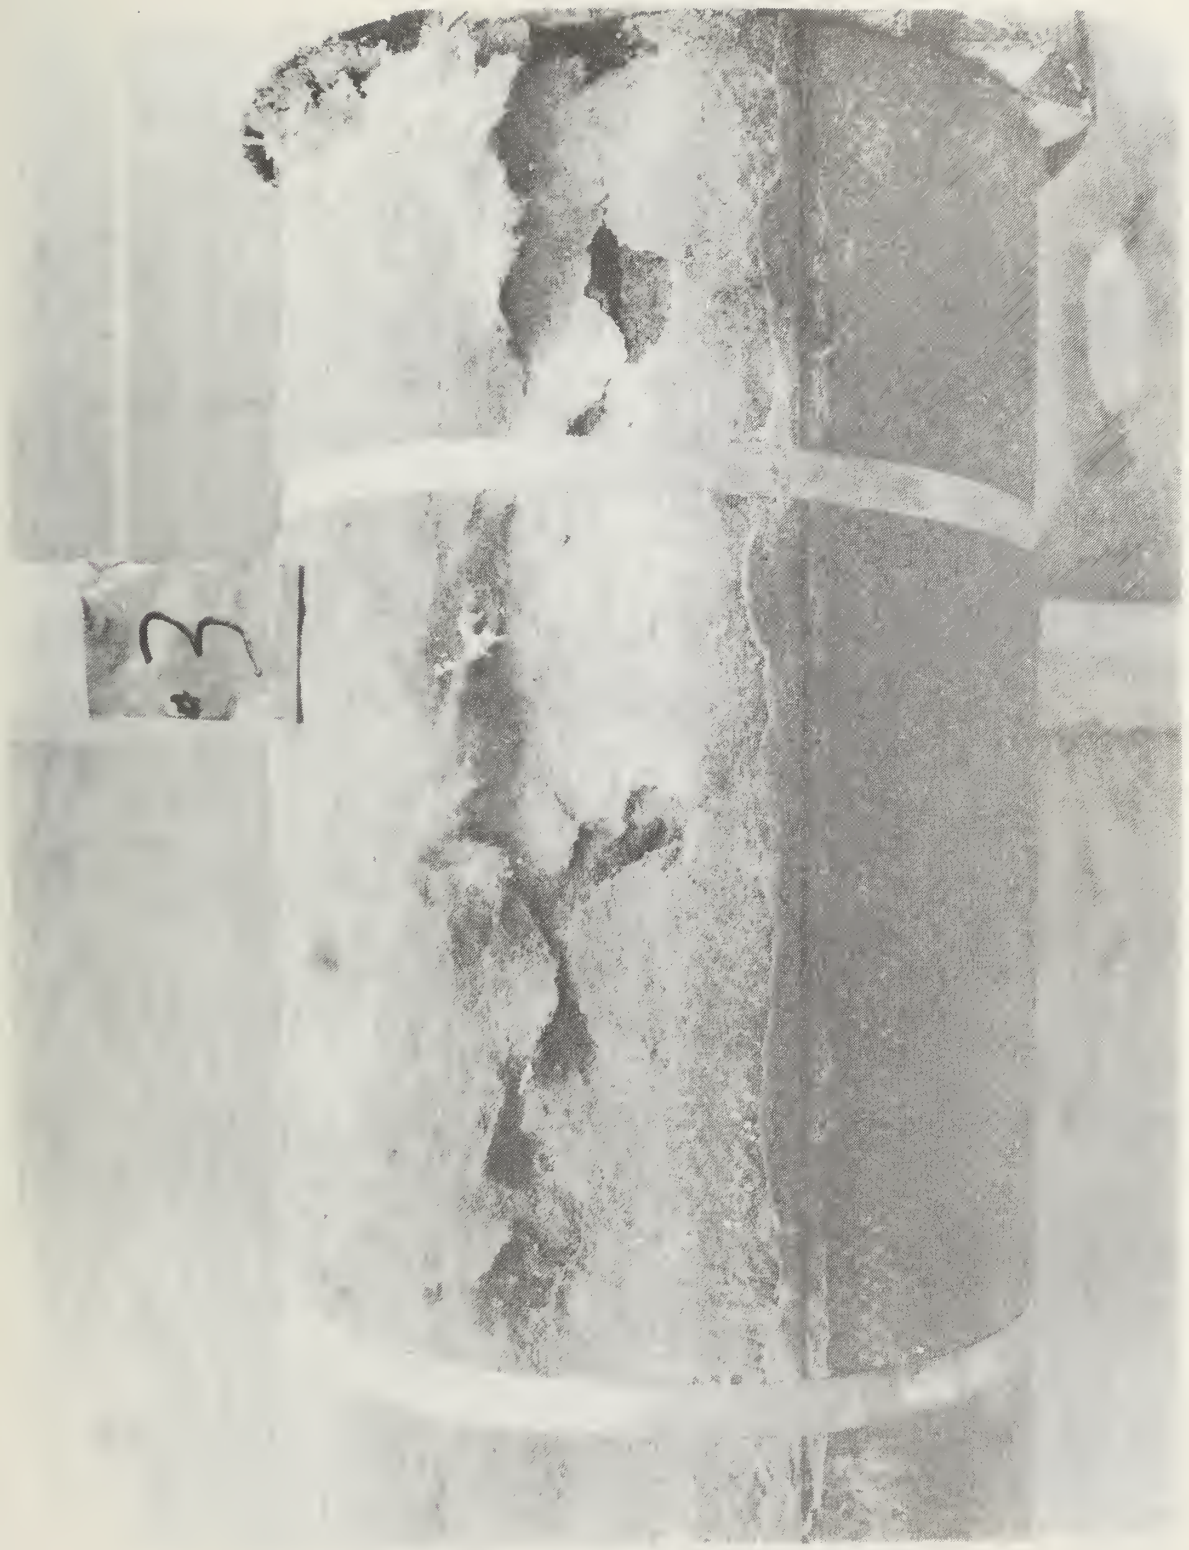
Figure 67. Epitherm 1200 after 8 days of boiling.

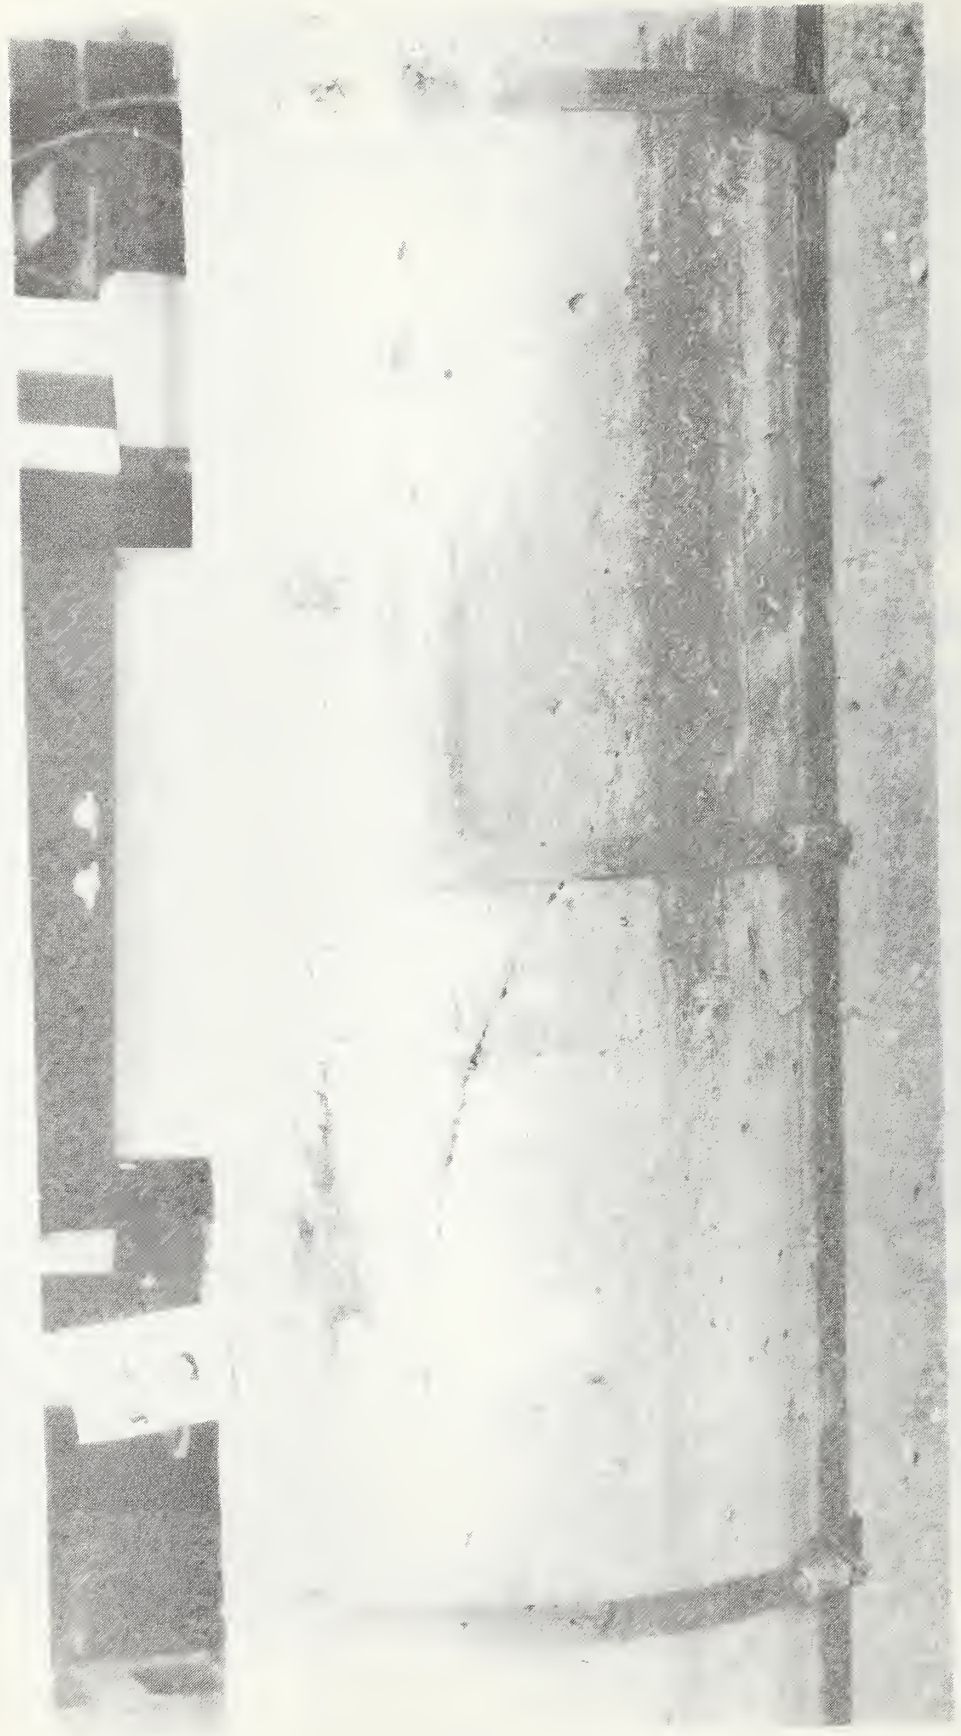
Figure 78. Super Caltemp after 24 days of boiling.
