NBSIR 82-2574

# Analysis of Oxide and Oxide/Matrix Interfaces in Silicon Nitride

Interim Report

Nancy J. Tighe

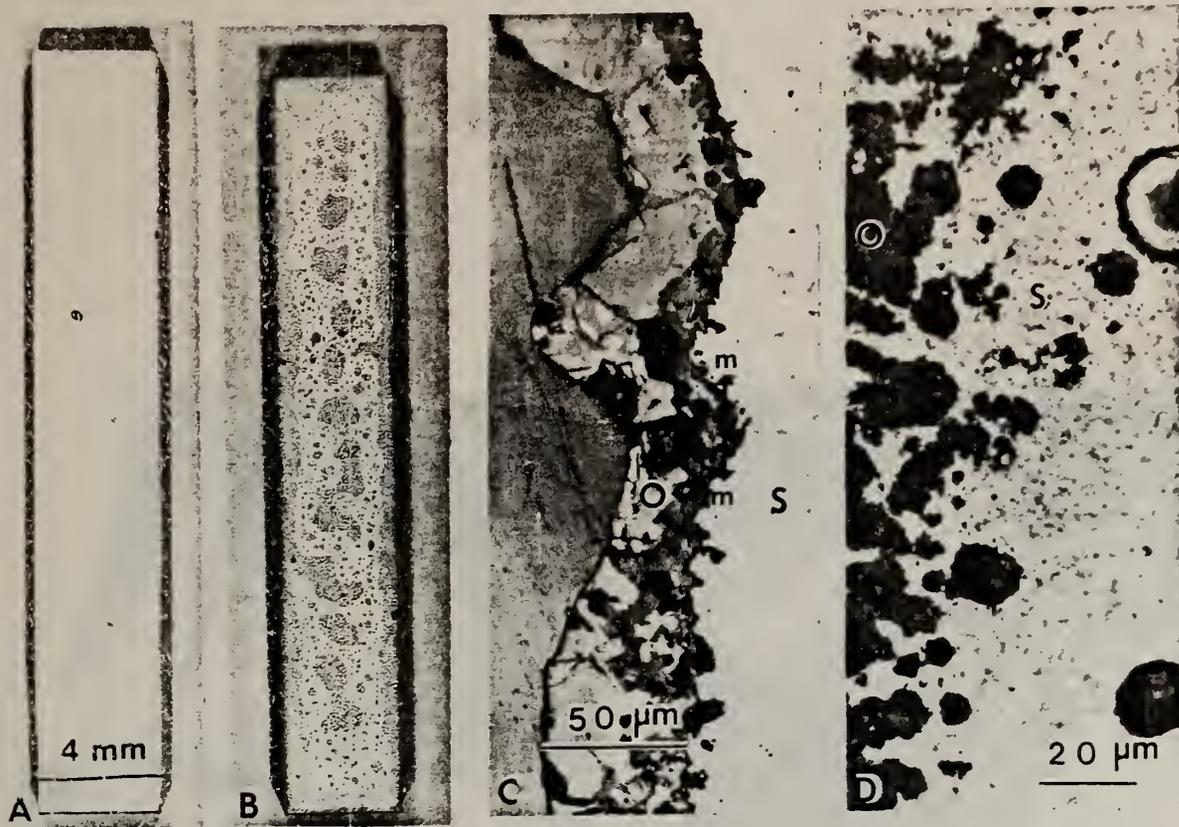
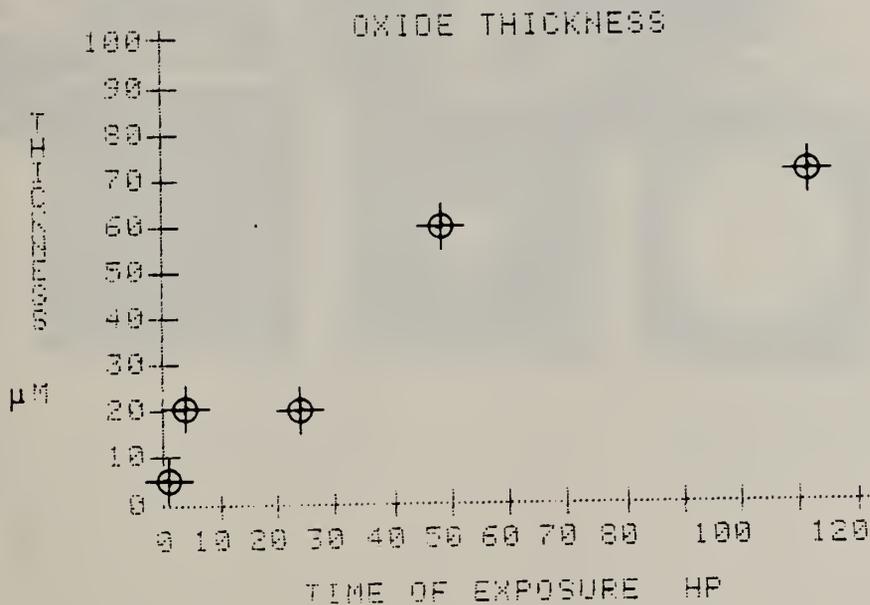
Fig. 1. Hot-pressed silicon nitride samples which were oxidized at 1400°C (A) specimen heated continuously for 100 hr., (B) specimen heated and cooled to room temperature several times during 96 hr., (C) polished section of cyclically heated specimen note thickness variations in oxide scale -O- and in  $\text{Si}_3\text{N}_4$  -S-. (D) nodules of  $\text{Si}_2\text{N}_2\text{O}$  below the primary oxide-matrix interface spec. (E) plot of scale thickness vs time for NC 130 specimens.

When the surface and cross-sections of heavily oxidized specimens were examined it was found that the oxide scale had formed in layers that differed in composition ( $\text{Si}_2\text{N}_2\text{O}+\text{SiO}_2$  and  $\text{SiO}_2+\text{MgSiO}_3$ ) and in crystallinity. As shown in Fig. 1, certain oxide phases could be distinguished easily by light microscopy because of large differences in the index of refraction and the reflectivity. In samples that were machined to have sharp edges, corner or

The electron micrographs in Fig. 2a,b show the structure of the oxynitride phase in a thin foil specimen prepared from a section similar to m-m in Fig. 1c. The lower magnification picture of Fig. 2a shows two oxynitride grains with a region of silicon nitride grains between them. In Fig. 2b the faults, pores and inclusions within one of the oxynitride grains are imaged. It is apparent that the initial silicon nitride grains were consumed by the growing oxynitride.

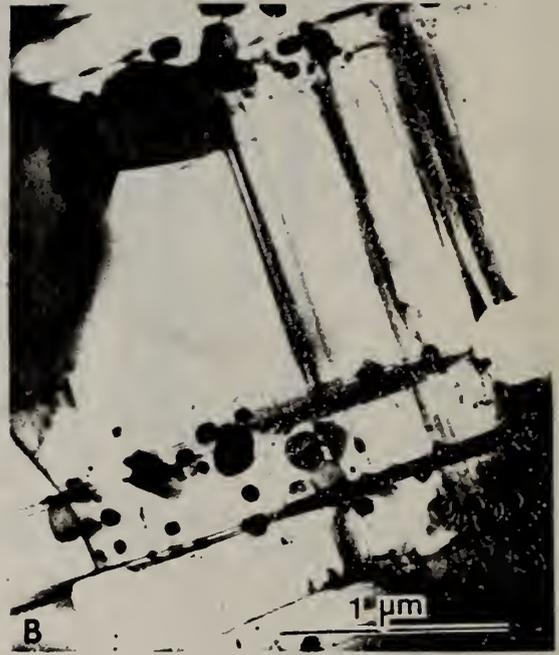
Fig. 2. Electron micrographs of sections from specimen heated 264 hr. at 1000°C showing (A) 2  $\text{Si}_2\text{N}_2\text{O}$  grains within the  $\text{Si}_3\text{N}_4$ , (B) enlargement of oxynitride grain showing faults, pores and precipitates.

The effect of flaws, such as machining cracks which intersect the surface, on the strength can be changed by oxidation which blunts them or shortens them. When the matrix is consumed by the growing oxide as shown in Fig. 2 then the crack size is reduced and the strength is increased. The time frame for such crack healing is related to the transformation of oxide scale from oxynitride and silica to the silica and silicate. A sharp crack can be blunted when the interfacial matrix grains oxidize. A blunt crack requires a higher stress intensity factor for propagation which leads to a higher strength. Additionally the strain relief resulting from annealing at 1200°C can change the effective stress in ground surfaces and at crack tip. Thus any of these three effects can cause a strengthening. We have shown here that, in the billets studied oxidation can change the strength by reducing the effectiveness of old flaws and by generating new flaws. The specific causes of billet to billet variation in strength and oxidation behavior have not been determined but are believed to be related to impurity content. The oxide scales are similar in composition but have grown at considerably different rates apparently as a result of minor impurity differences. The real effect of annealing in the absence of oxygen will have to be examined in neutral atmosphere tests.

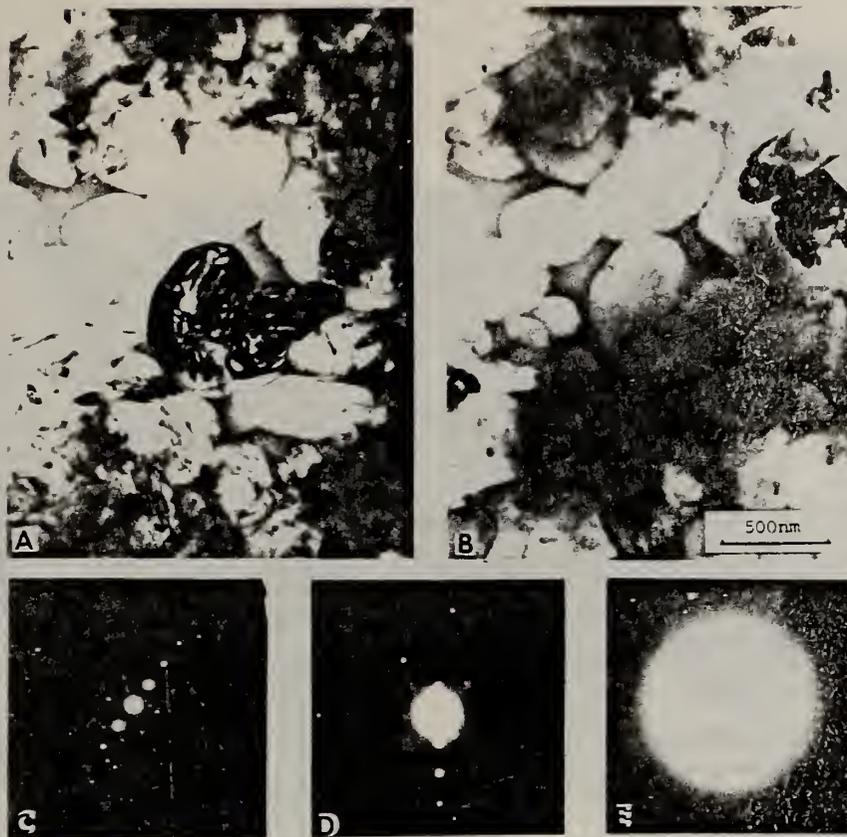
Fig. 3. Thinned Si<sub>3</sub>N<sub>4</sub> foil after heating 1 hr. at 1000°C, thin area oxidized completely to cristobalite and glass; (A) SiO<sub>2</sub> grains, (B) vitrified SiO<sub>2</sub>, (C,D,E) diffraction patterns of the transformation βSiO<sub>2</sub> → αSiO<sub>2</sub> → amorphous SiO<sub>2</sub>.

Figure 3 shows  $\beta$ -cristobalite which was produced in a thin foil by heating for one hour at 1000 °C. The oxide grains, which were contained within the amorphous layer, were identified by their diffraction patterns. This figure demonstrates the major difficulty associated with examining  $\text{SiO}_2$  in an electron microscope, namely the vitrification that occurs rather quickly[14]. As shown in Fig. 3, the  $\beta$ -cristobalite transformed to a disordered  $\alpha$ -cristobalite which then transformed to amorphous silica without changing shape. A similar decomposition occurred in all of the samples regardless of the oxidation conditions. This diffraction pattern of the transformed amorphous silica was used as a standard pattern for silica glass.

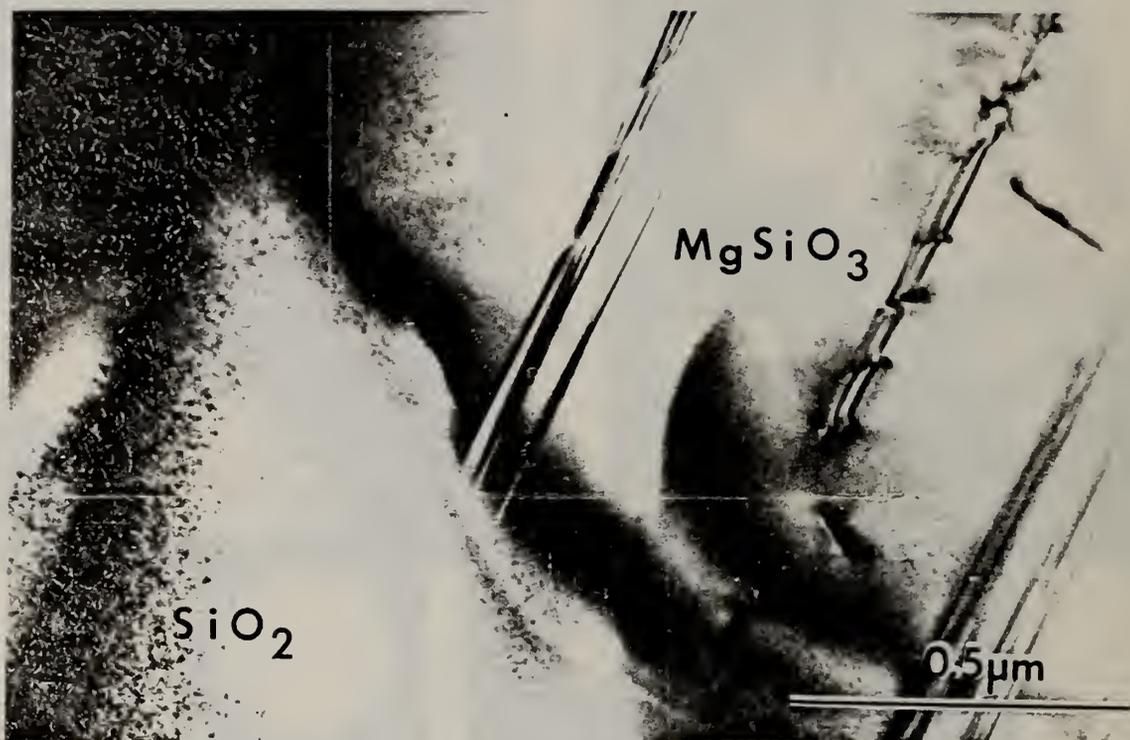
Fig. 4. Oxide scale from bulk specimen heated at  $1400^\circ\text{C}$  showing grains of  $\text{SiO}_2$  and  $\text{MgSiO}_3$ , note the  $\text{SiO}_2$  grain has vitrified.

Magnesium Silicate-MgSiO<sub>3</sub>. The magnesium silicate phase, enstatite, was found in sections of specimens that were oxidized at 1200 °C and 1400 °C. The enstatite was found to coexist with β-cristobalite forming a well-sintered layer. Figure 5 shows an example of the layer morphology. In this figure the β-cristobalite has vitrified as expected, while the enstatite remained unchanged during long time electron irradiation. The enstatite grains were usually faulted and had a microstructure similar to the natural mineral [15].

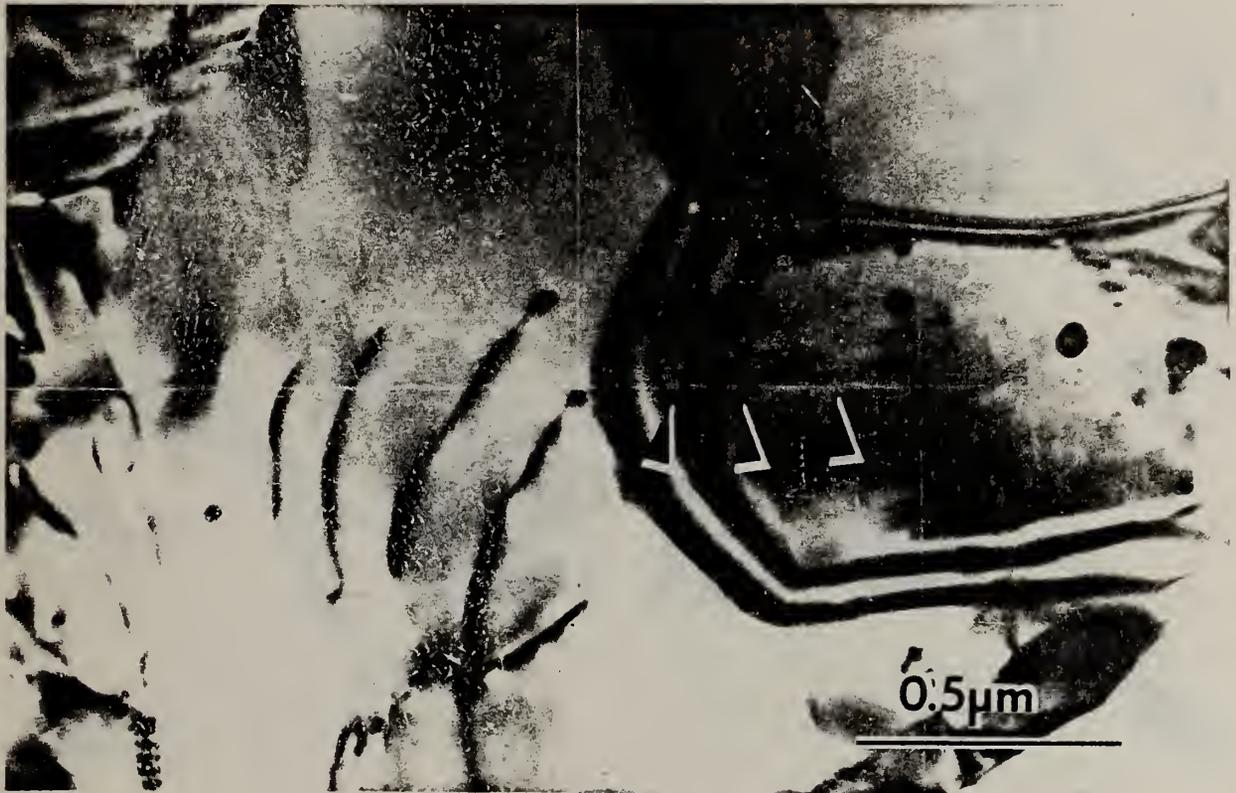
Fig. 5. Silicon nitride grains in specimen heated 24 hr. at 1400°C, large pore is seen along grain boundary (arrowed).

either by porosity or by thickening of a grain boundary phase. Figure 5 shows an elongated pore between two grains in a sample oxidized at 1400 °C. An example of thickening of the oxide phase between grain boundaries is shown in Fig. 6 where the breadth of the phase is indicated by the moiré fringe pattern. At this temperature, the evidence for creep and plastic deformation in the bulk specimens was shown by extensive dislocation interactions in the diffusion reaction zone. There is a significant increase in the occurrence of grain boundary dislocations, sub-boundaries, and dislocation interactions with inclusions as in Figs. 5 and 6b. Rapid growth of oxide at the grain boundaries can produce considerable stress; and, this extended phase can fracture on cooling to produce extensive grain boundary cracking and a new flaw population.

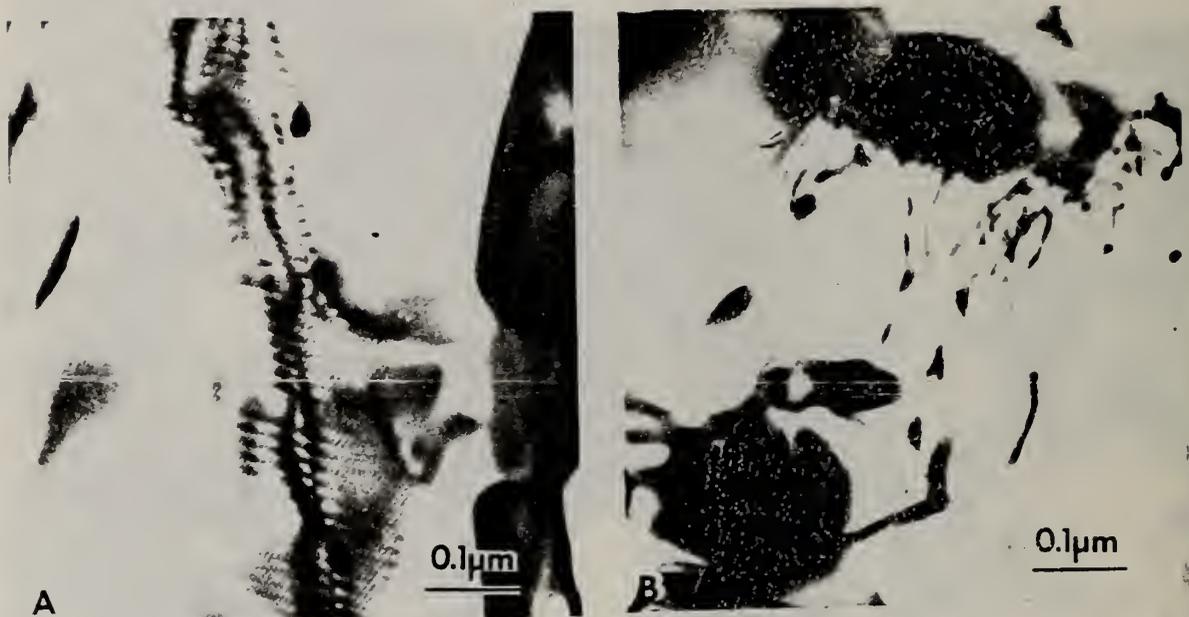
Fig. 6. Section from bar heated cyclically for 96 hr. at 1400°C showing:  
(A) Silicon nitride grains in the diffusion reaction zone, moiré fringes along the boundary show position of the growing oxide film.  
(B) Dislocation interactions with inclusions near area in (A).

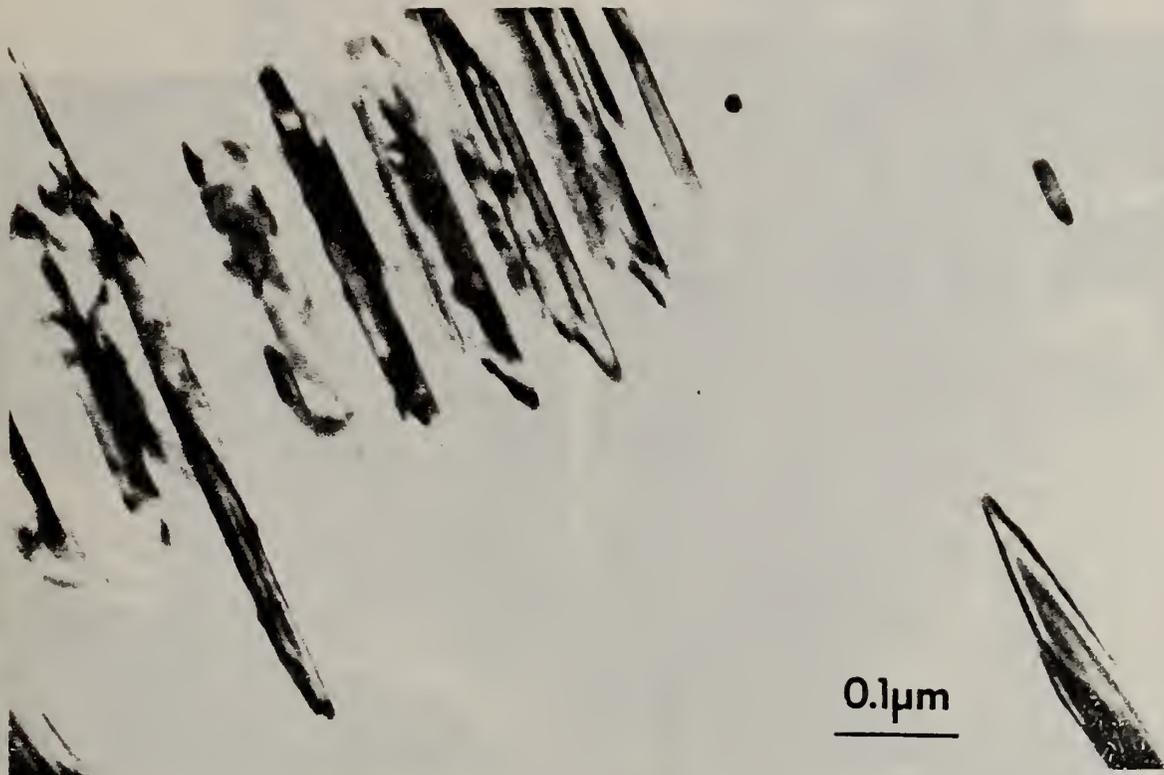
Fig. 7. Grain of Si<sub>3</sub>N<sub>4</sub> containing plates of Si<sub>2</sub>N<sub>2</sub>O in the diffusion reaction zone of a specimen oxidized 24 hr. at 1000°C.

Evidence for nucleation and growth of  $\text{Si}_2\text{N}_2\text{O}$  within the silicon nitride grains is shown in Fig. 7. This foil was made from a specimen that was oxidized for 24 hr. at 1000 °C and had an oxide scale composed of amorphous silica and  $\beta$ -cristobalite. The presence of such plates in the matrix grains could reduce fracture toughness by providing easy intragranular fracture paths along the fault planes.

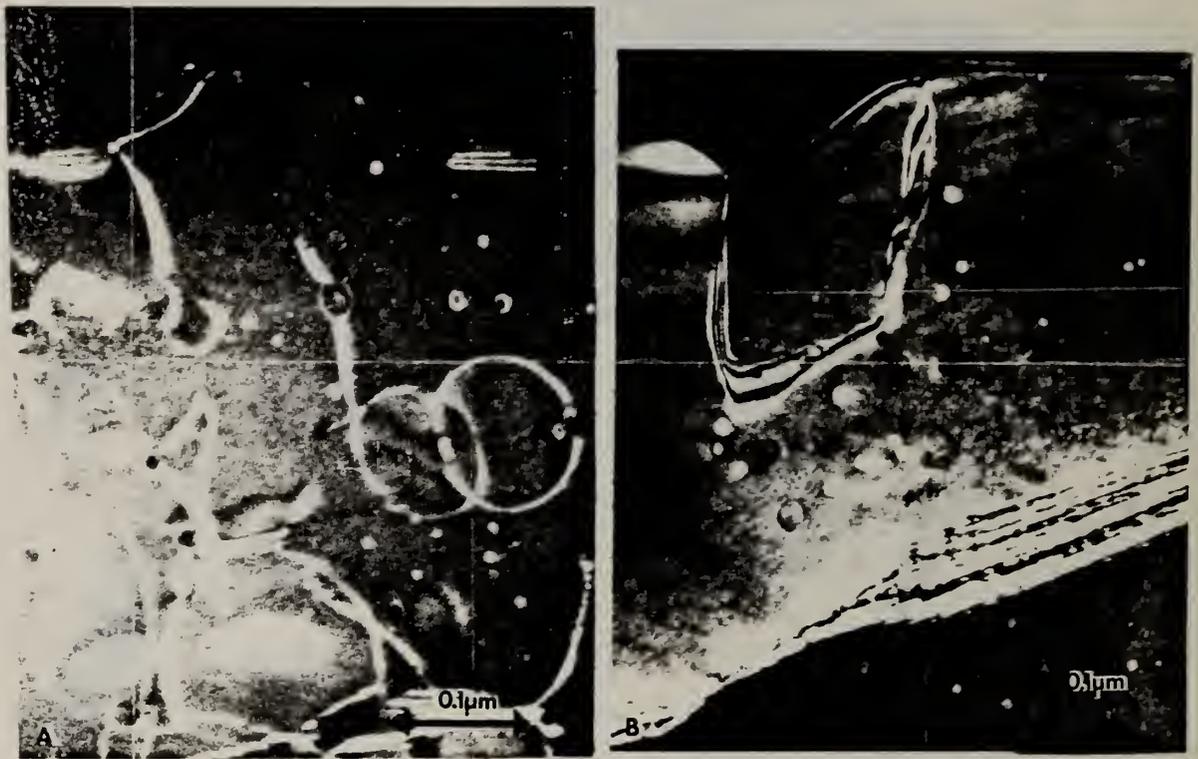
Fig. 8. Oxidation induced cavity and particle nucleation in the diffusion reaction zone of NC132. (A) Oxidized 50 hours at 1100°C dislocation loops lying in rhombohedral plans and are pinned at cavities. (B) Oxidized 1000 hours at 120°C during static load test. The cavities are distributed through the grain thickness.

The early stages of void or particle nucleation within silicon nitride grains is seen in Fig. 8a. The specimen was oxidized for 50 hours at 1100°C. The area shows dislocation loops and stacking faults lying in rhombohedral planes. The small bubbles or precipitates are intersected by dislocations passing through the bulk of the grain. Similar defects are seen in Fig. 8b which shows a specimen that was oxidized during a static load test that lasted

1000 hours at 1200°C. These grains are approximately 20  $\mu\text{m}$  from the oxide : matrix interface.

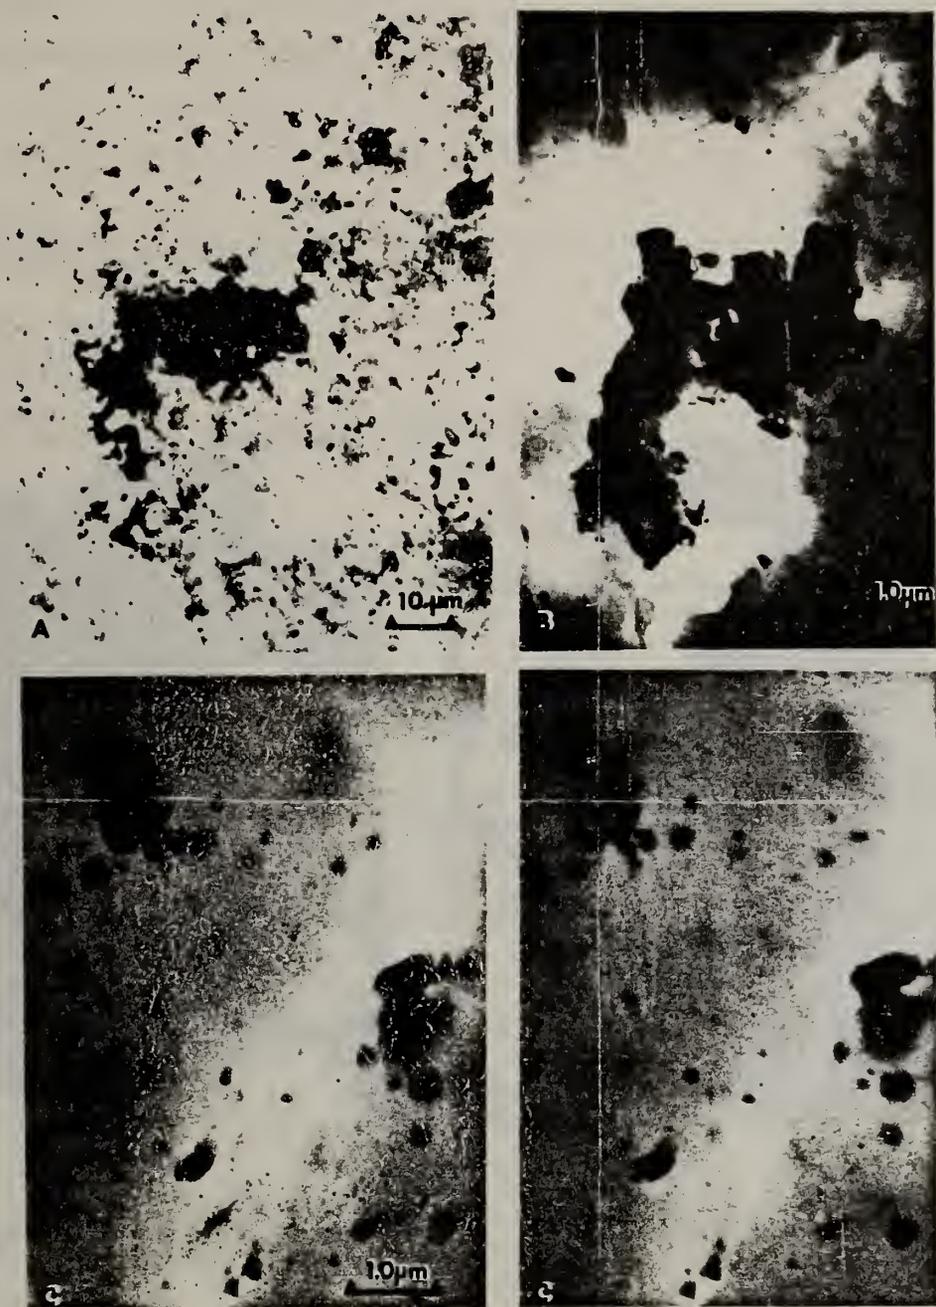
Fig. 9. Spatial distribution of inclusions in silicon nitride (a) transmitted light showing dark inclusion masses, (b) scanning transmission images showing inclusions and silicon nitride grains, (c) stereo-pair of back-scattered electron images showing 3-D view of inclusions.

The grinding particle inclusions seen in foils made from as-received specimens, are usually polyhedral and range in size from a few nanometers to a few micrometers. The W-based inclusions can be seen as dark masses in thin sections ( $\sim 30\mu\text{m}$ ) examined with a light microscope as in Fig. 9a. The spacial distribution of the individual particles can be seen using the back-scattered electron mode and the transmission mode of imaging in the scanning transmission electron microscope. In the scanning transmission mode as in the normal transmission mode the particles are imaged with the microstructural background of grain boundaries as in Fig. 9b. By using the back-scattered mode the heavy element particles are imaged in Fig. 9c, as dark against the light background and the stereo pictures show three-dimensional distribution of particles. Small particles are found along grain boundaries and within grains. The larger particles are close to or larger than matrix grains. Energy dispersive analysis shows Fe, Cr, Co, Al, and W from the WC and  $\text{WSi}_2$  particles and the metal alloy binder.

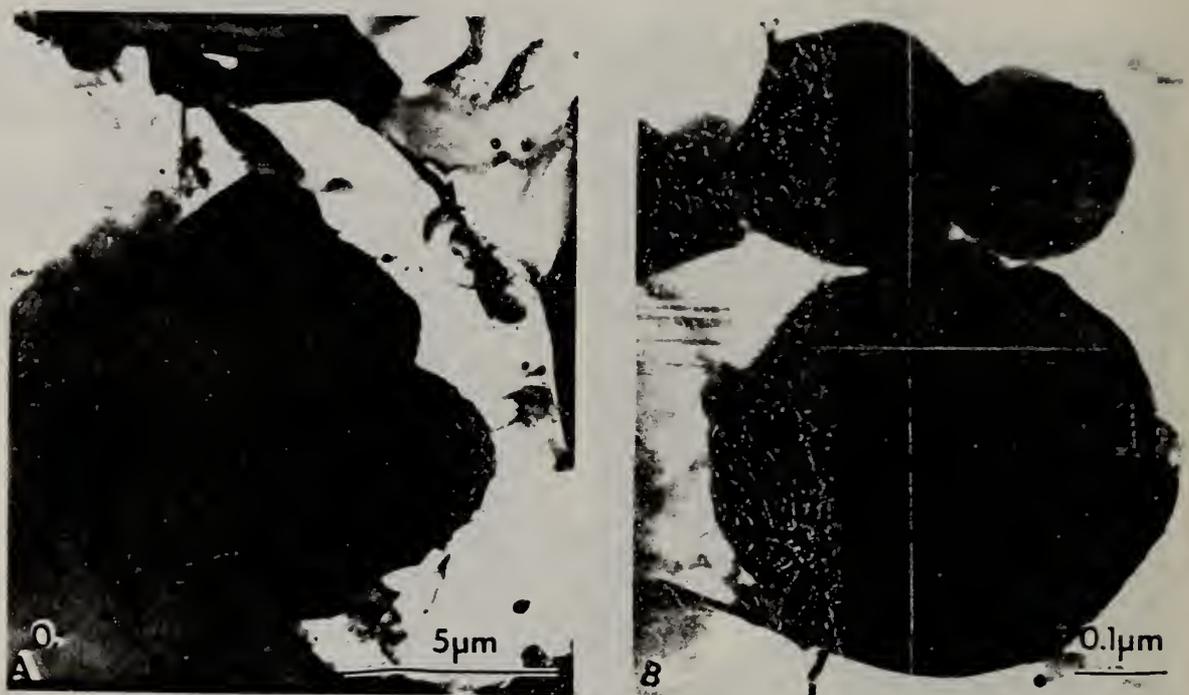
Fig. 10. Inclusions in  $\text{Si}_3\text{N}_4$  specimen heated at  $1400^\circ\text{C}$  (A) in 1 hr. inclusion is surrounded by porous and amorphous phase, indicating that oxidation has started. (B) After 96 hr. of cyclic heating, inclusions are spherical and show no W.

Oxidation at the inclusions broken off from the WC grinding media can lead to the formation of oxide filled pits in the matrix and mounds or depressions in the oxide scale. Such pits were shown to be active fracture sites in specimens broken at 1200 °C; and the oxide scale at the pit was found to have a high Fe content [8]. In oxidized specimens these inclusions may be polyhedral or spherical and examples are shown in Fig. 10. The inclusion in

Fig. 10a is surrounded by an amorphous film and this early oxidation reaction is a precursor to an oxide-filled pit. The large spherical particles in Fig. 10b had a high Fe and Cr content but low W content; and, these differences in morphology and composition indicate possible melting or rapid volatilization during the exposure at 1400 °C. The oxidation pits are new flaws which affect the strength in a time dependant manner because they require an incubation time to be produced. Since the distribution of the grinding particle inclusions varies somewhat from billet to billet, the nucleation and growth of the oxidation pits will vary also to change the flaw population.
