NBSIR 83-2666

# Effects of High-Voltage Switching on the EPRI-NBS Coupling Capacitor Voltage Transformer (CCVT) Calibration System Standard Divider

March 1983

David L. Hillhouse

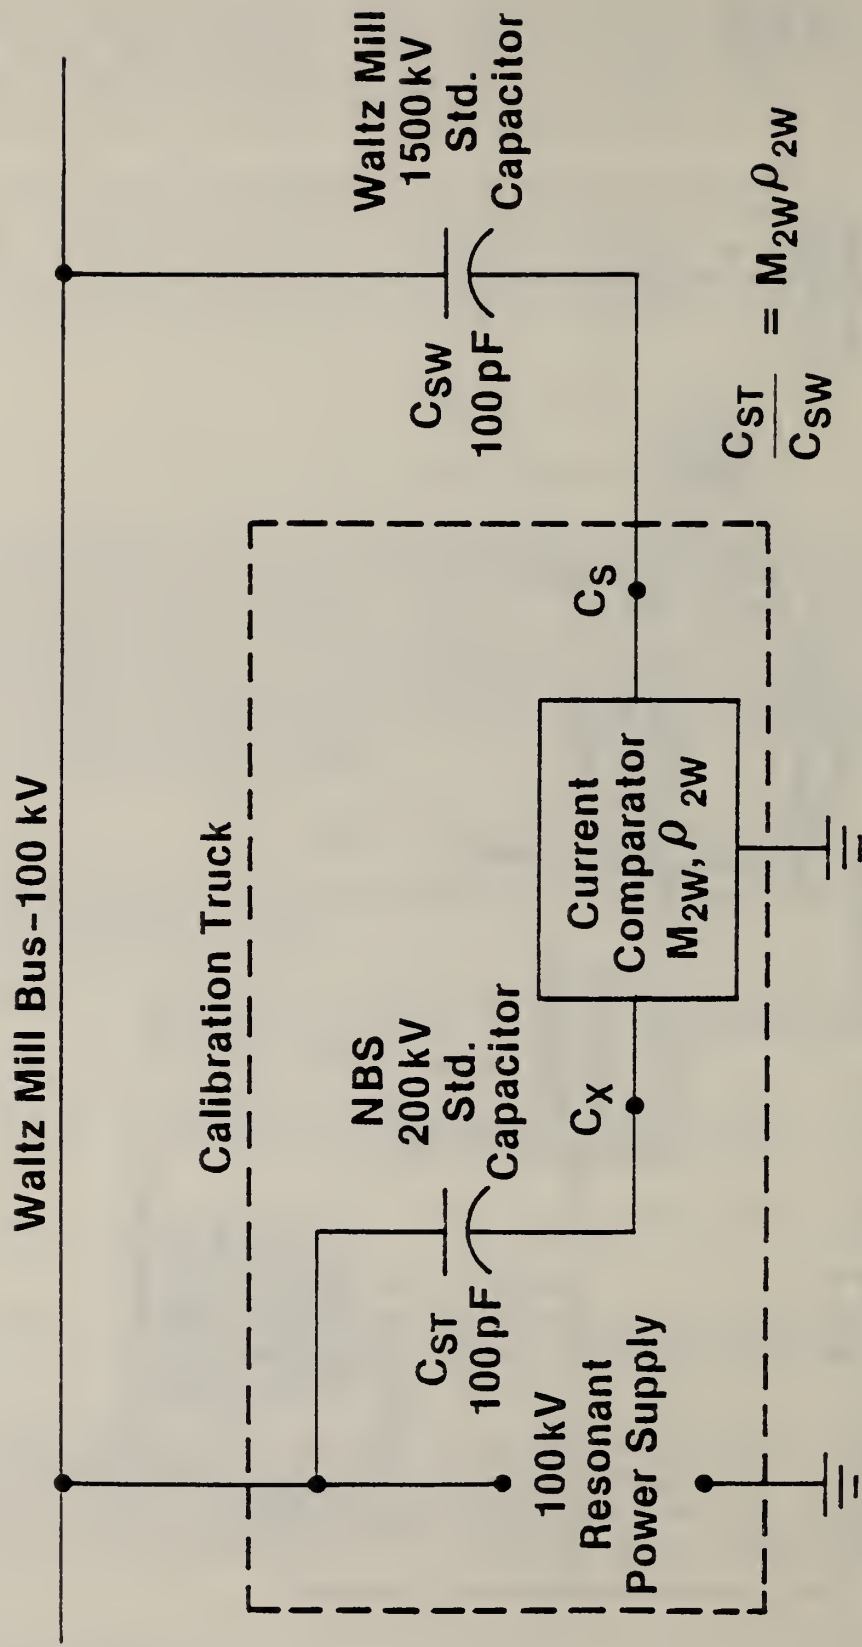
Figure 2. Step 1, calibration of Waltz Mill 1500 kV compressed gas standard capacitor,  $C_{SW}$

In step 1 (fig. 2), the current comparator reads the ratio  $C_{ST}/C_{SW} = M_{2W}/\rho_{2W}$ . The value of  $C_{ST}$ , determined earlier in an identical comparison with a low voltage reference standard ( $C_{SM} = 1000.00$  pF), is then used to calculate  $C_{SW}$ . The value of  $C_{SW}$  (103.155 pF) was determined twice -- at the beginning of the five days of tests and at the end. The two values agreed to within 50 ppm (parts per million).
