Behavior of Concrete Block Masonry Walls Subjected to Repeated Cyclic Displacements

October 1983

NBSIR 83-2780
...

**BEHAVIOR OF CONCRETE BLOCK MASONRY WALLS
SUBJECTED TO REPEATED CYCLIC DISPLACEMENTS**

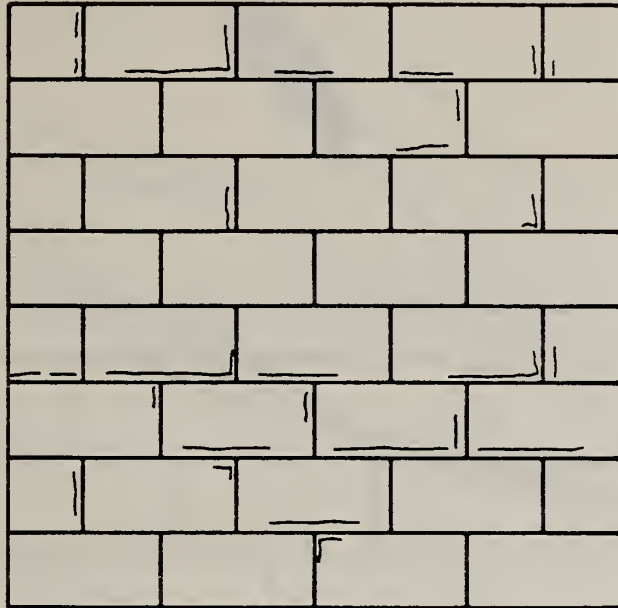
Figure 6.54. Pre-test crack observations for wall P2

The load-displacement curves are shown in figures 6.43 and 6.44. The curve for the wall displacement is terminated at the third ramp peak because the measurements after that point were severely affected by wall cracking and spalling in the measurement region. The strain measuring locations are shown in figure 6.45 and the pertinent strain histories are shown in figures 6.46 through 6.53. Only the data for the first three ramps are shown and the release portion of each ramp is not shown for clarity. Each ramp can be identified on the basis of its peak displacement and the line type. The crack observations are presented in figures 6.54 and 6.55.

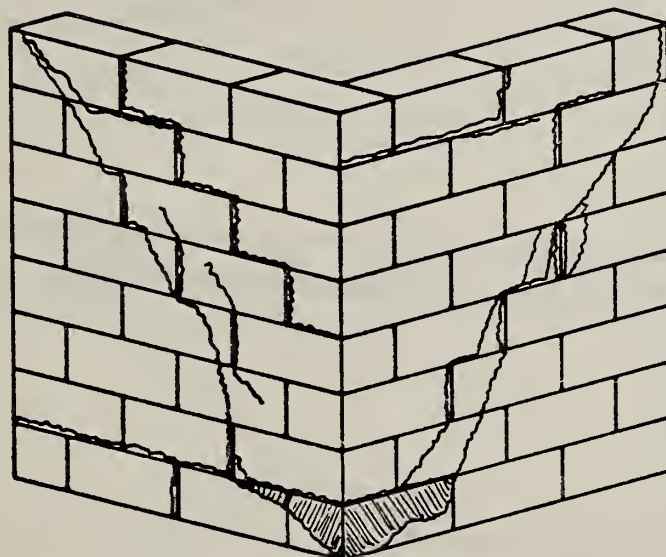
Figure 6.115. Post-test crack observations for wall C5

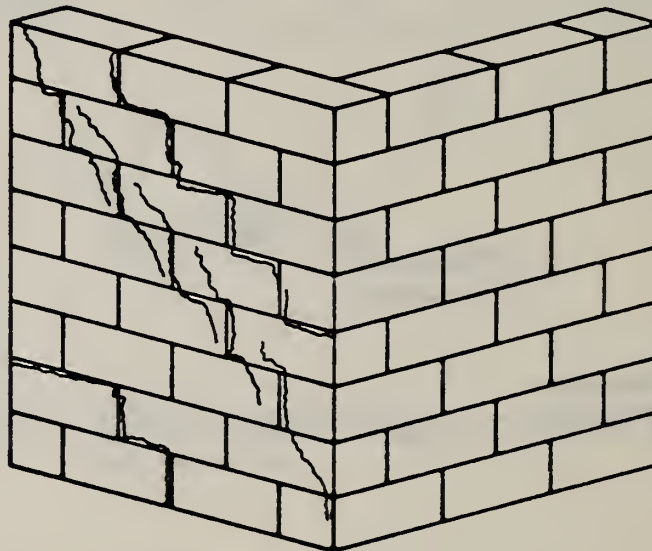
Figure 6.163. Post-test crack observations for wall C2

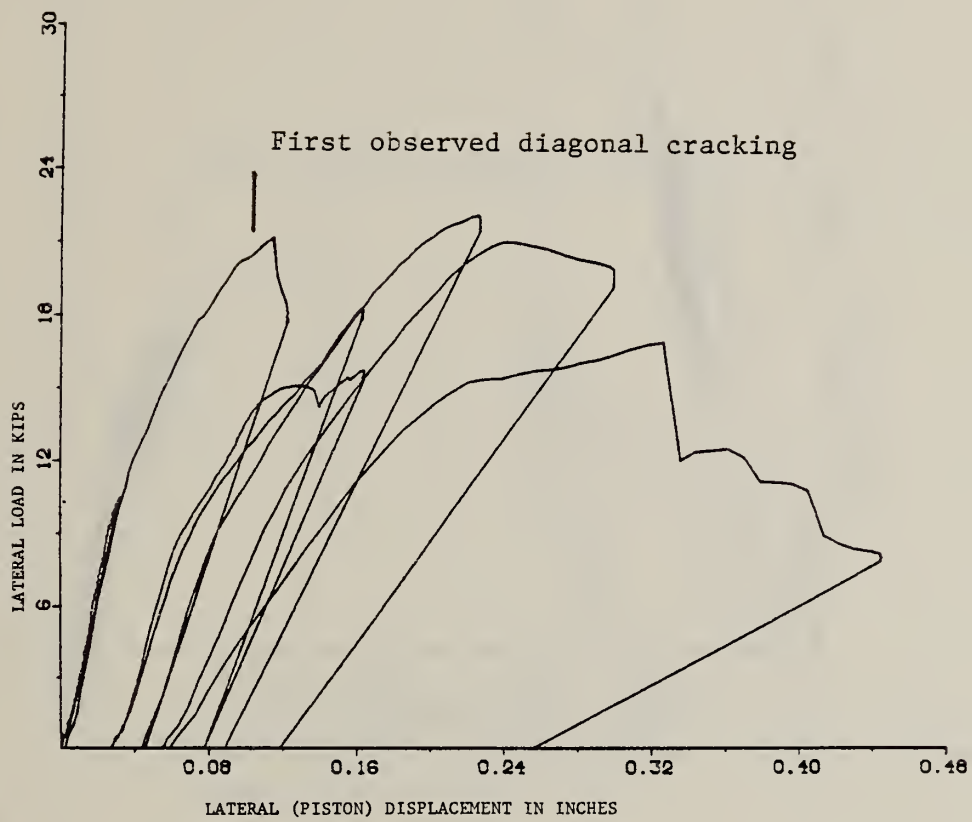
Figure 7.6. Load displacement curve for test P2
