**NBSIR 84-2891**

# **Effect of Heat Treatment on Mechanical Properties and Microstructure of Four Different Heats of ASTM A710 Steel**

**G.E. Hicho, C.H. Brady, L.C. Smith, and R.J. Fields**

**U.S. DEPARTMENT OF COMMERCE  
National Bureau of Standards  
Fracture and Deformation Division  
Gaithersburg, Maryland 20899**

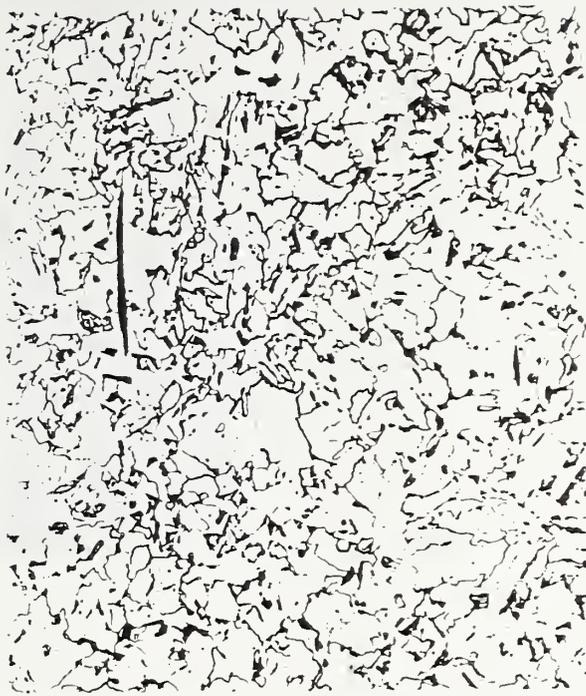
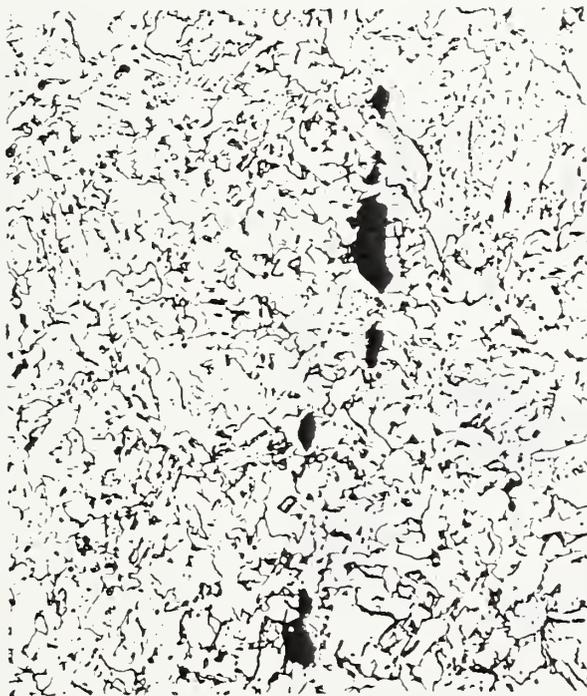
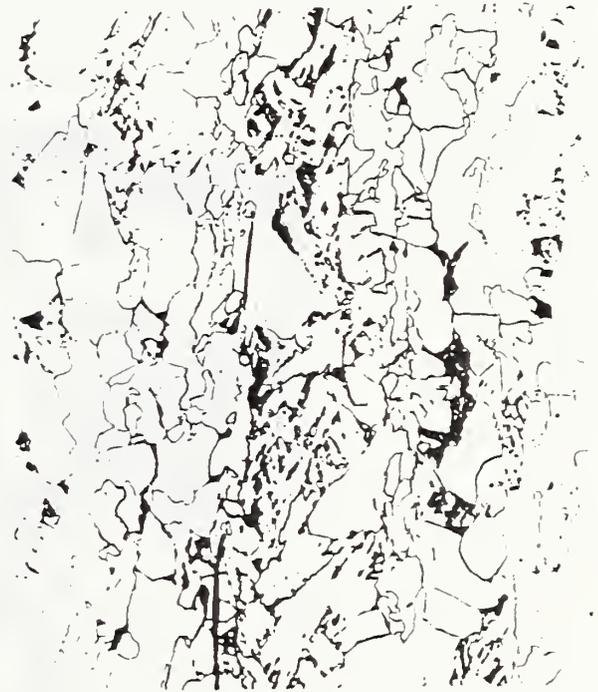
Figure 1 Etched microstructures of as-received plates; a) GAG, b) FZF, c) FZN, and d) FZY. All longitudinal sections at X500 magnification. Etchant:  $(\text{NH}_4)_2\text{M}_2\text{O}_4$  -  $\text{HNO}_3$  solution.

Micrographs of GAG (fig. 1a), FZF (Fig 1b), and FZN (Fig. 1c) reveal predominantly fine grained, equiaxed ferrite typical of a Class 3 plate (3), i.e. solution quenched and aged. Note that FZF was supposed to be a Class 1 plate, i.e. as-rolled and aged. FZY (Fig. 1d) exhibits a coarser (though somewhat mixed) ferrite grain size with grains elongated by rolling. This microstructure is typical of a Class 1 plate (3) and is consistent with the reported class of this plate.

Plate FZN and to a lesser extent, plate GAG contain some non-equiaxed ferrite. The grain boundaries in these plates and in FZF are highly irregular compared to the boundaries in FZY. This roughening of grain boundaries is due to the rapid quench required for Class 3 (4). The resulting ferrite can be polygonal and acicular in habit, but its boundaries will be highly irregular or rough as observed. The rate of cooling, the austenite grain size, and the plate chemistry probably determine the amount of acicular ferrite that forms in these largely polygonal ferrite microstructures (5).

All of the plates have a small amount of a darker phase which is a carbide colony-probably a tempered martensite. The sulphide inclusions in FZF (Fig. 1b) are completely spheroidized indicating that this steel has been desulphurized and either calcium or rare earth treated. Some of the inclusions in FZN (fig. 1c) appear to be somewhat rounded as though a partial treatment had taken place. FZY (Fig. 1d) and GAG (Fig. 1a) have long sulphide stringers and there is no evidence that these heats, represented by the two plates, received any inclusion spheroidizing treatment. The grain sizes of the as-received plates are given in Table 2. The grain sizes were determined by

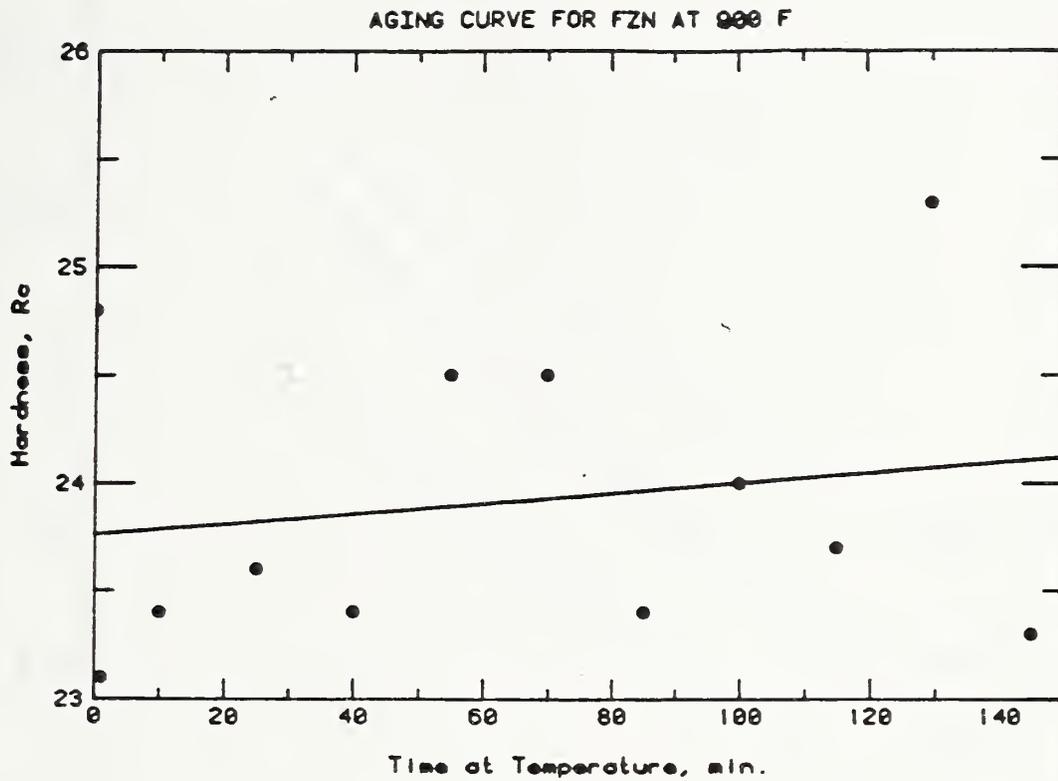
Figure 4 Effect of additional aging of FZN at 482°C (900°F) on hardness. Observed trend indicated slight hardening which can only occur in near peak hardened material.

For verification, small coupons of FZN were heated at 482°C (900°F) for varying times. If underaged, A710 will harden slowly at 482°C (900°F). Indeed, the data (Fig. 4) seem to show a slight hardening with time. This verified that the as-received FZN plate was indeed underaged or near the peak aged condition. As will be discussed later, reheat treatment of this plate uncovered additional anomalous behaviors.

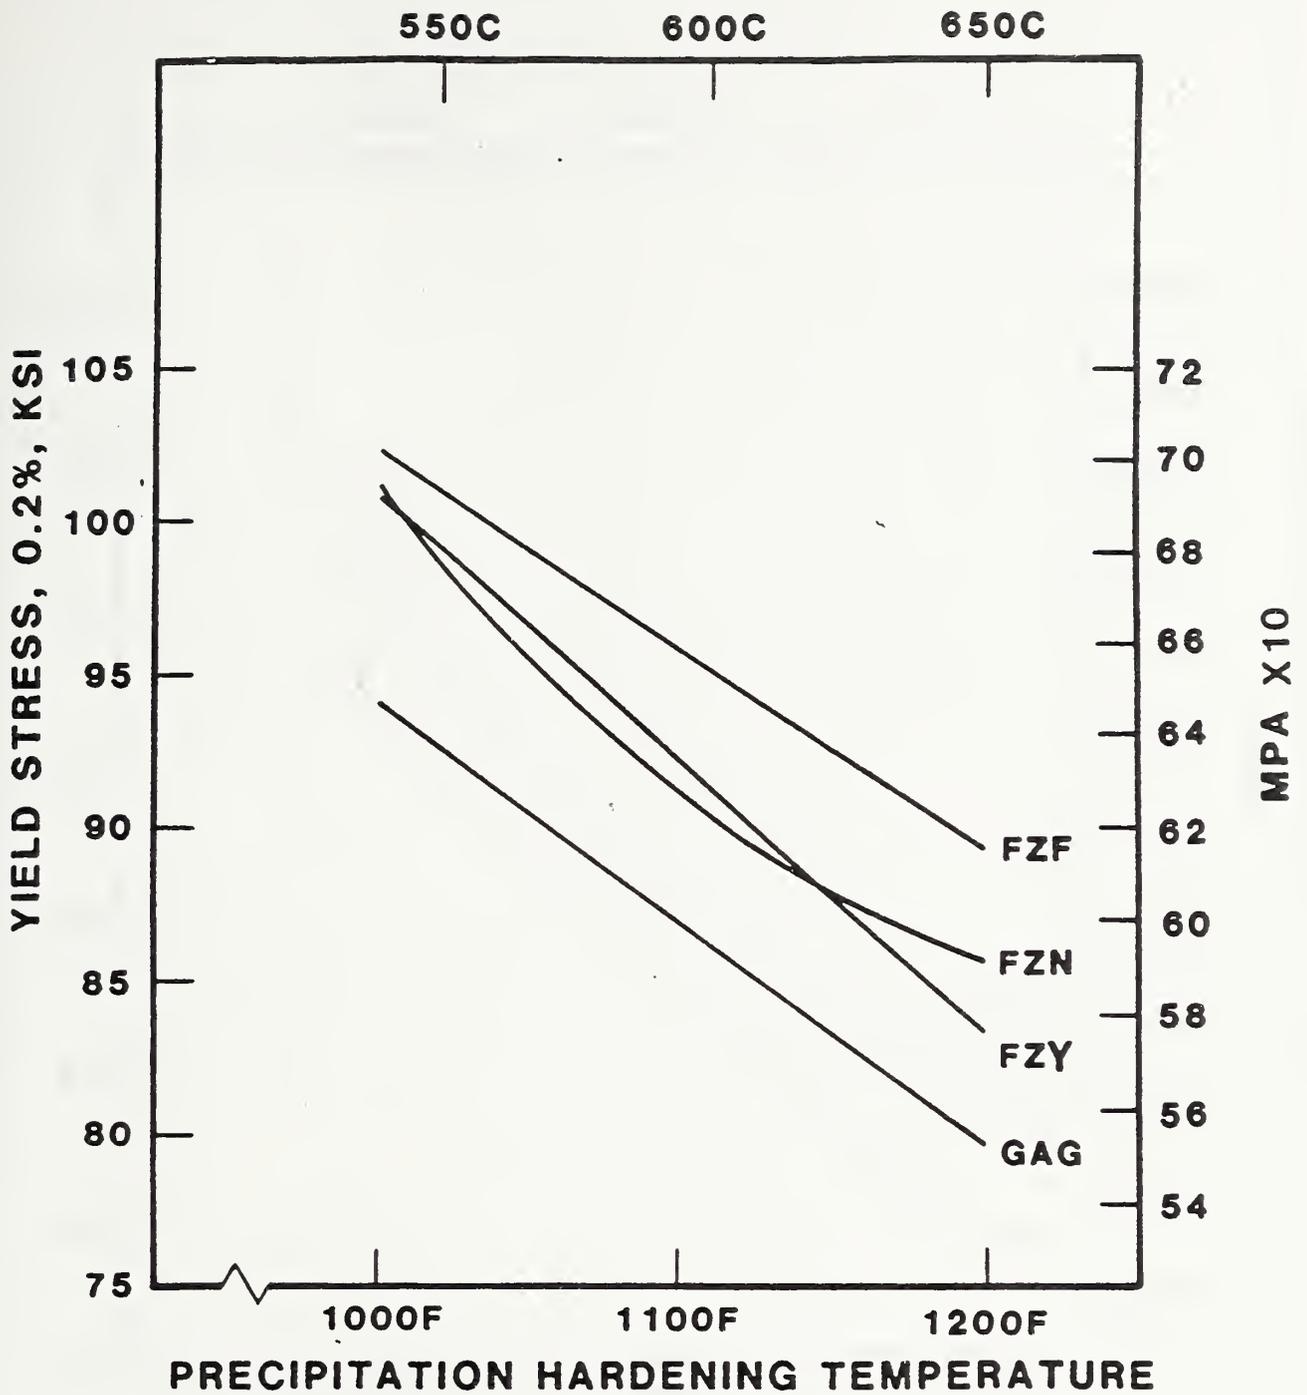
Figure 5 Yield strength as a function of aging temperature. All samples aged for 30 minutes.

Table 4 shows the tensile test results. Figures 5, 6, and 7 indicate how the 0.2% yield strength, ultimate tensile strength, reduction-in-area, and elongation-to-fracture vary with precipitation hardening temperature and time. Most tensile stress-strain curves exhibited a yield drop. The 0.2% offset yield strength is approximately equal to the lower yield strength. The UTS and yield strength both decrease with increasing aging temperature. This indicates that these heat treatments are all past the peak aged condition of this alloy.

Examining first the yield strength (Figure 5) as a function of aging, we note that the data extends from a low of about 552 MPa (80 ksi) for GAG aged at 649°C (1200°F) to a high of about 696 MPa (101 ksi) for FZF aged at 538°C (1000°F). The average value of yield strength for the manufacturer's recommended aging treatment is 634 MPa (92 ksi). The recommended heat treatment is 899°C (1650°F), 69 min, WQ - 593 °C (1100°F), 30 min, AC. In this condition GAG yields at 600 MPa (87 ksi), FZY at 627 MPa (91 ksi), and FZF at 662 MPa (96 ksi). From these three heats of A710, it may be concluded that the yield strength (0.2% offset) will be 634 MPa ± 34 MPa (92 ksi ± 5 ksi) when heat treated according to the recommended schedule. If the aging temperature differs by 55°C (100°F) from the 593 °C (1100°F) recommended value, then the range will be larger: 620 MPa ± 69 MPa (90 ksi ± 10 ksi). For any given aging treatment, FZF is always stronger than FZY, which is always stronger than GAG. This difference can be attributed to grain size differences among the plates (Table 3). The smaller the grain diameter, the stronger the alloy - as predicted by the Hall-Petch theory (11,12).

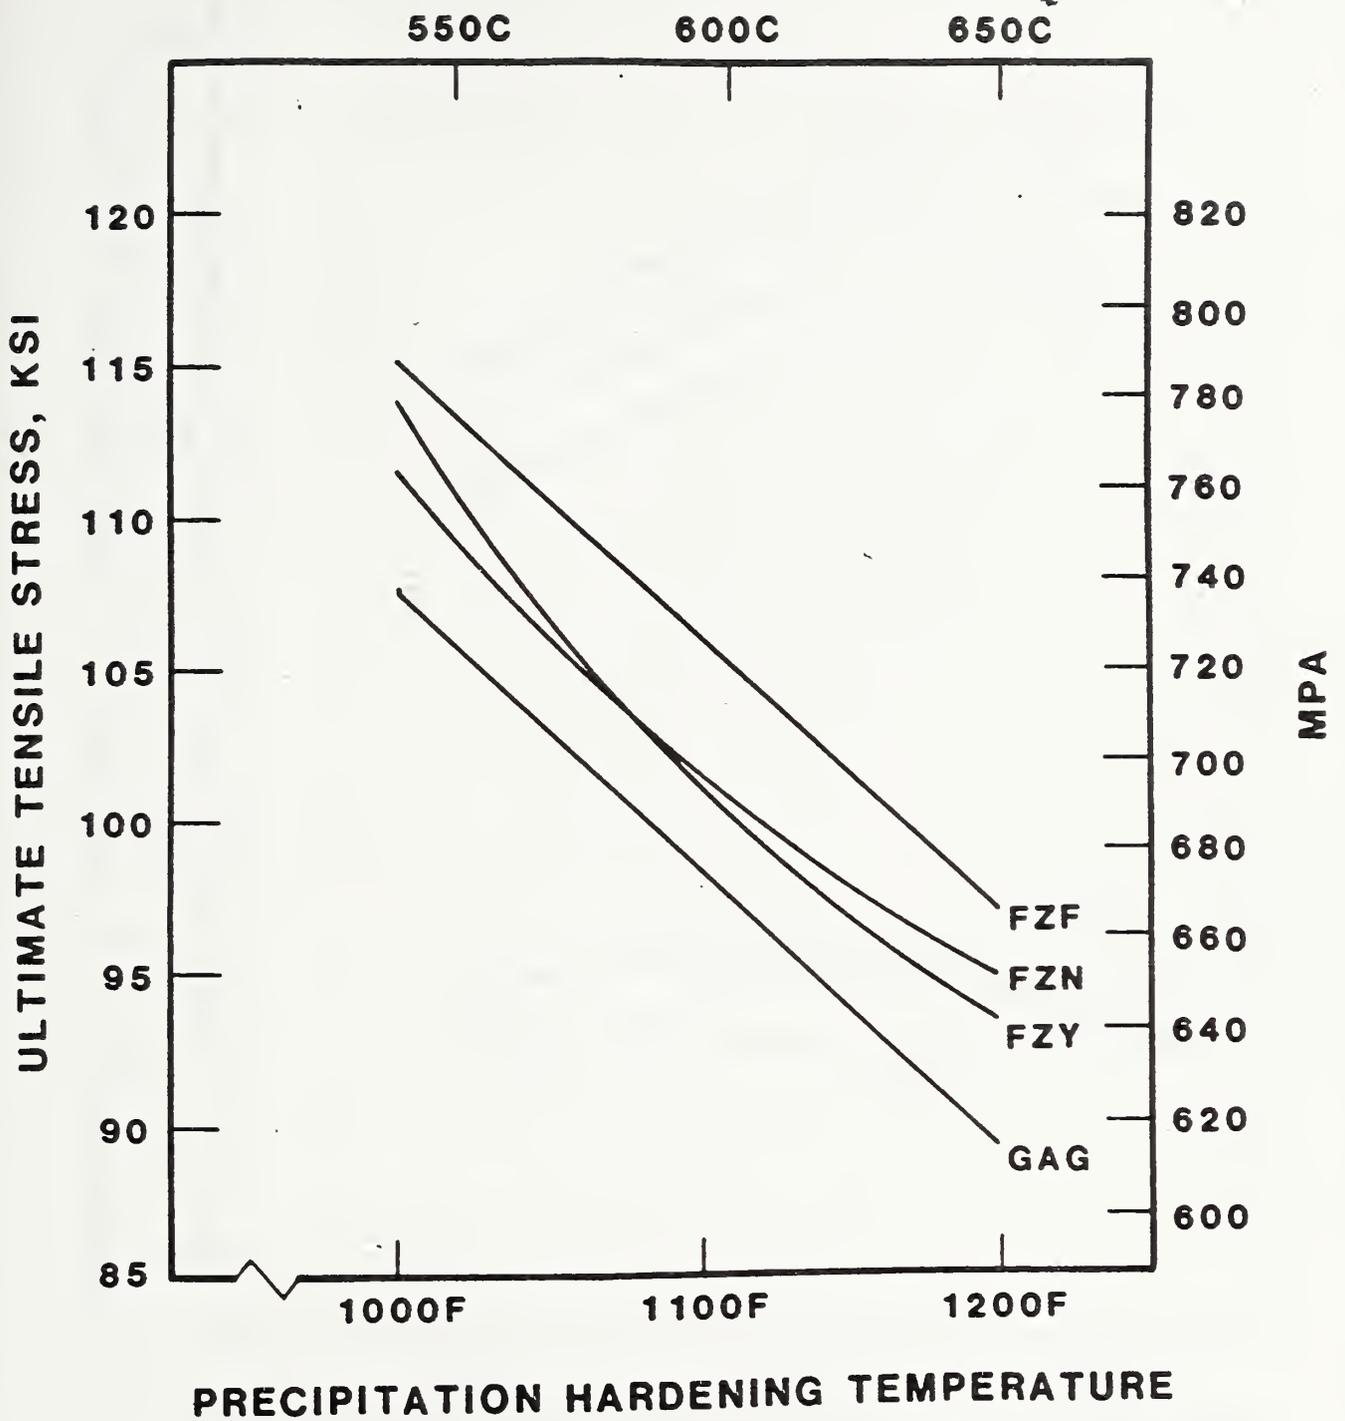
Figure 6 UTS as a function of aging temperature. All samples aged for 30 minutes.

The same order of strengths holds true for the UTS (Figure 6). This behavior can again be attributed to the grain size effect. Figure 6 also shows that plates heat treated according to manufacturer's recommendation have a UTS of 703 MPa ± 27 MPa (102 ± 4 ksi). When the aging temperature is varied by 55°C (100°F), the range is increased to ± 90 MPa (±13 ksi).

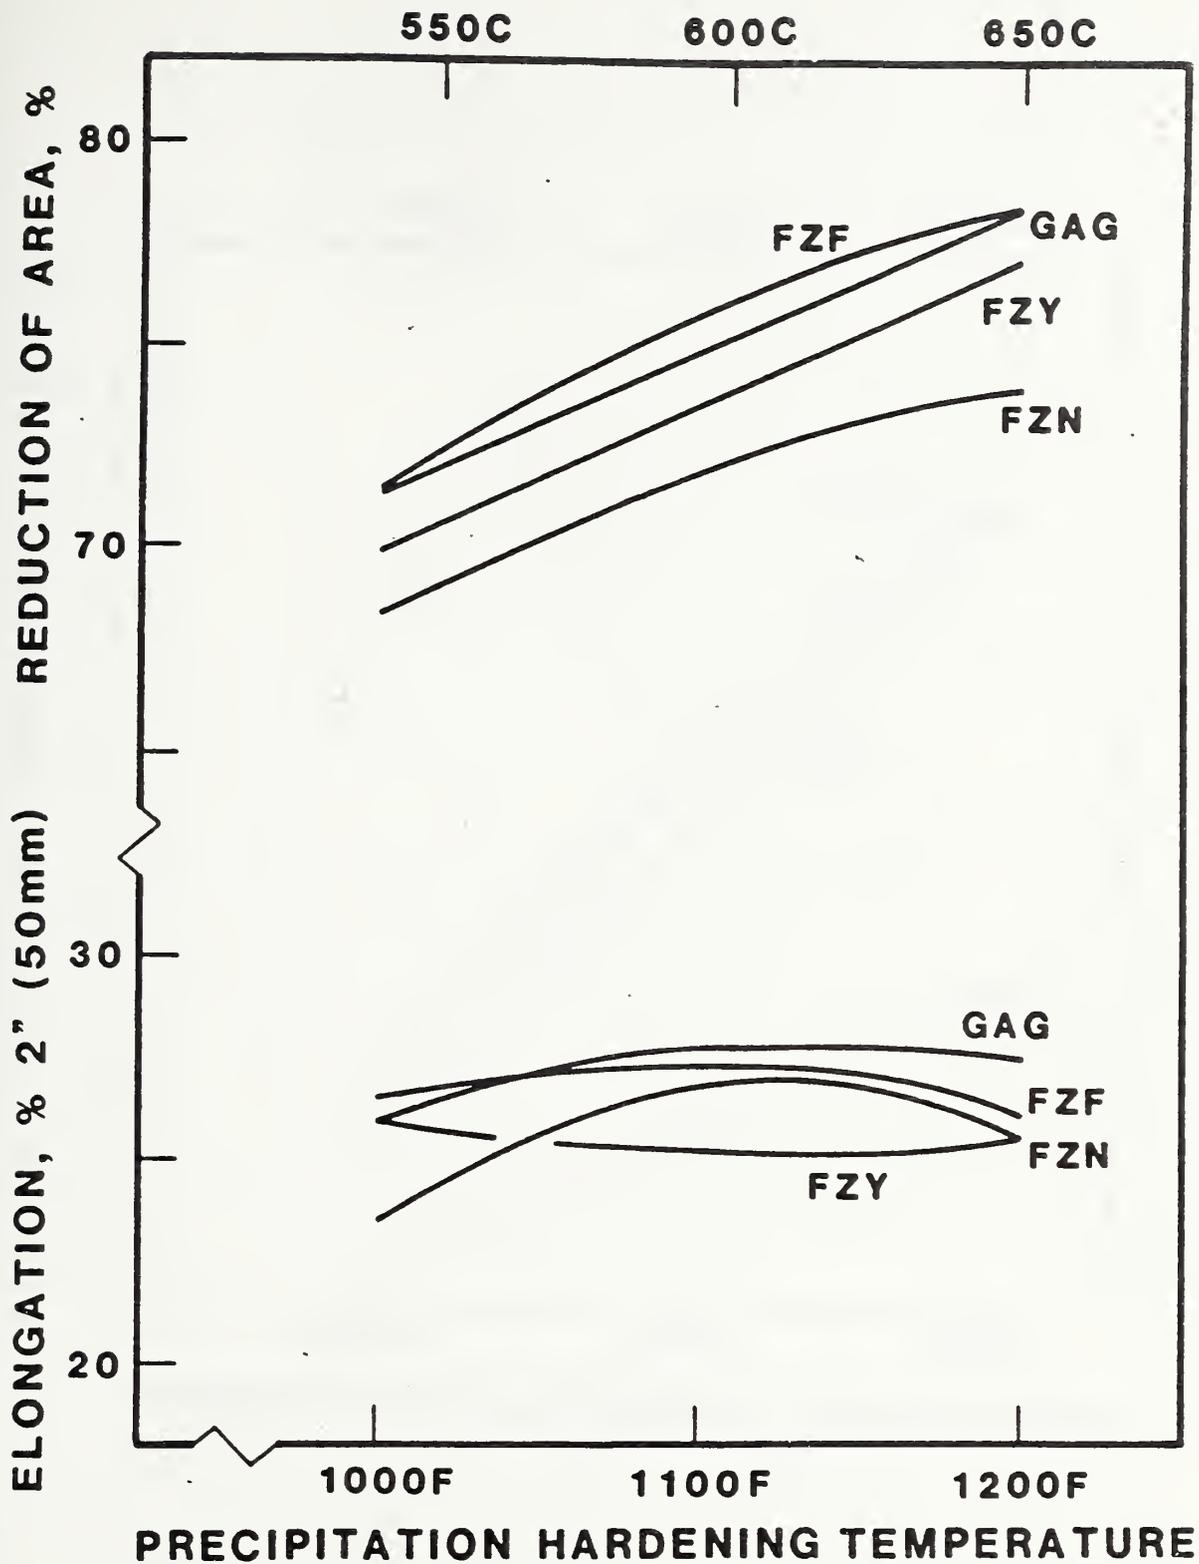
Figure 7 Reduction-in-area and elongation-to-fracture (in 2") as a function of aging temperature. All samples aged for 30 minutes.

Figure 7 shows the reduction-in-area and elongation-to-fracture in 50 mm (2 inches) for the test plates as a function of precipitation hardening temperature and time. The elongation is essentially uniform throughout the hardening range, and there appears to be no significant difference between the elongation values for each of the plates. The reduction-in-area values are somewhat different. The most noticeable difference occurs in plate FZN. Plate FZN has the lowest reduction-in-area as a function of precipitation hardening temperature and grain size. Longitudinal splitting of the tensile specimens was observed for a few specimens. This phenomenon does not detract

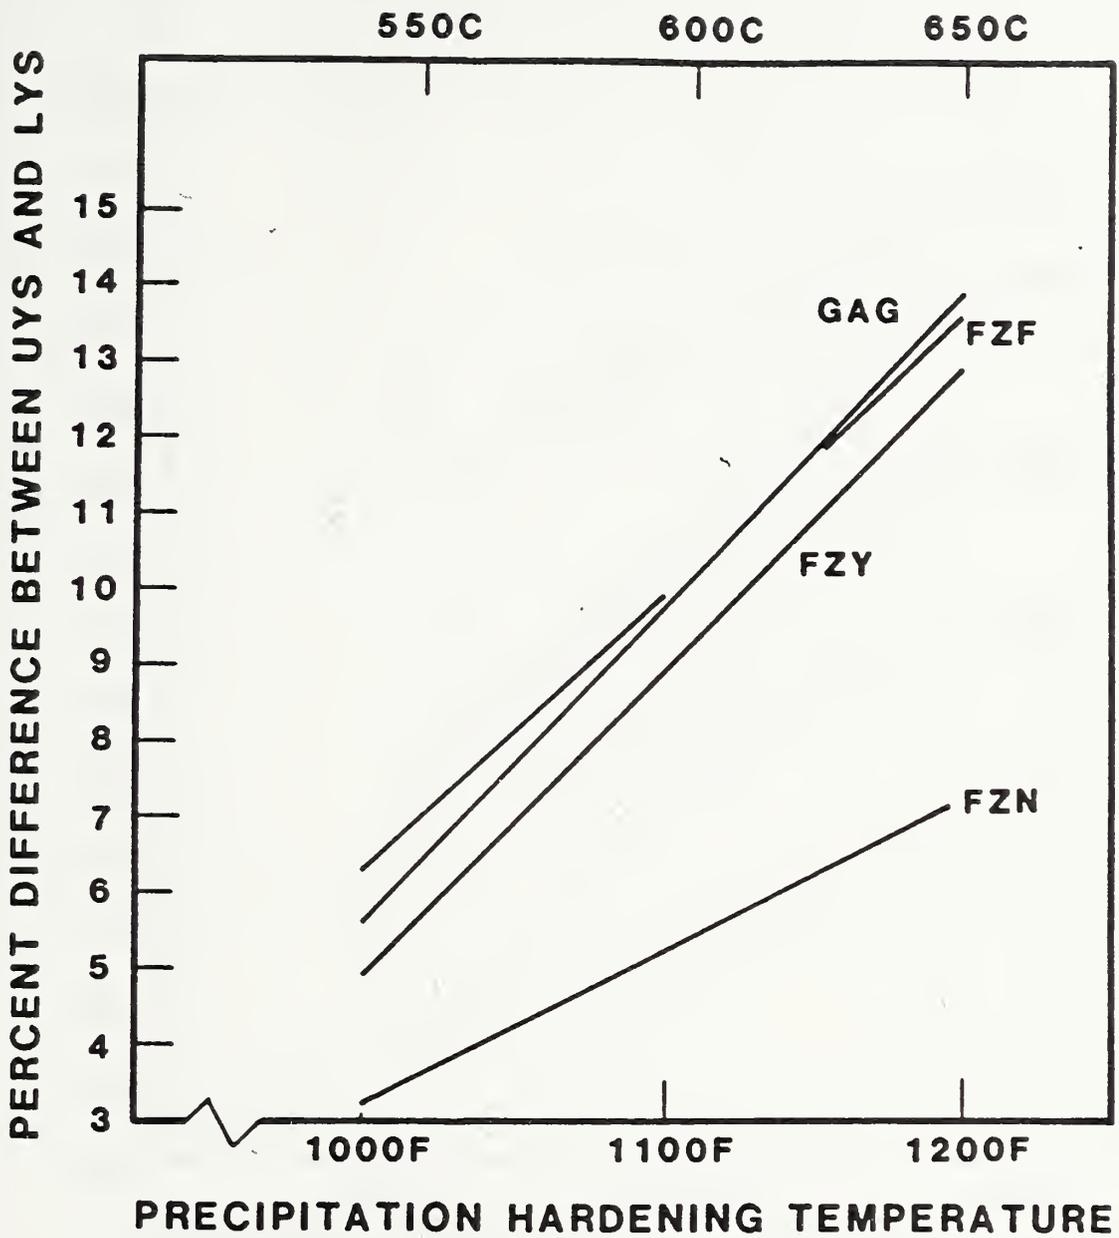
Figure 8 Percent difference between upper yield and lower yield strength as a function aging temperature. All samples aged for 30 minutes.

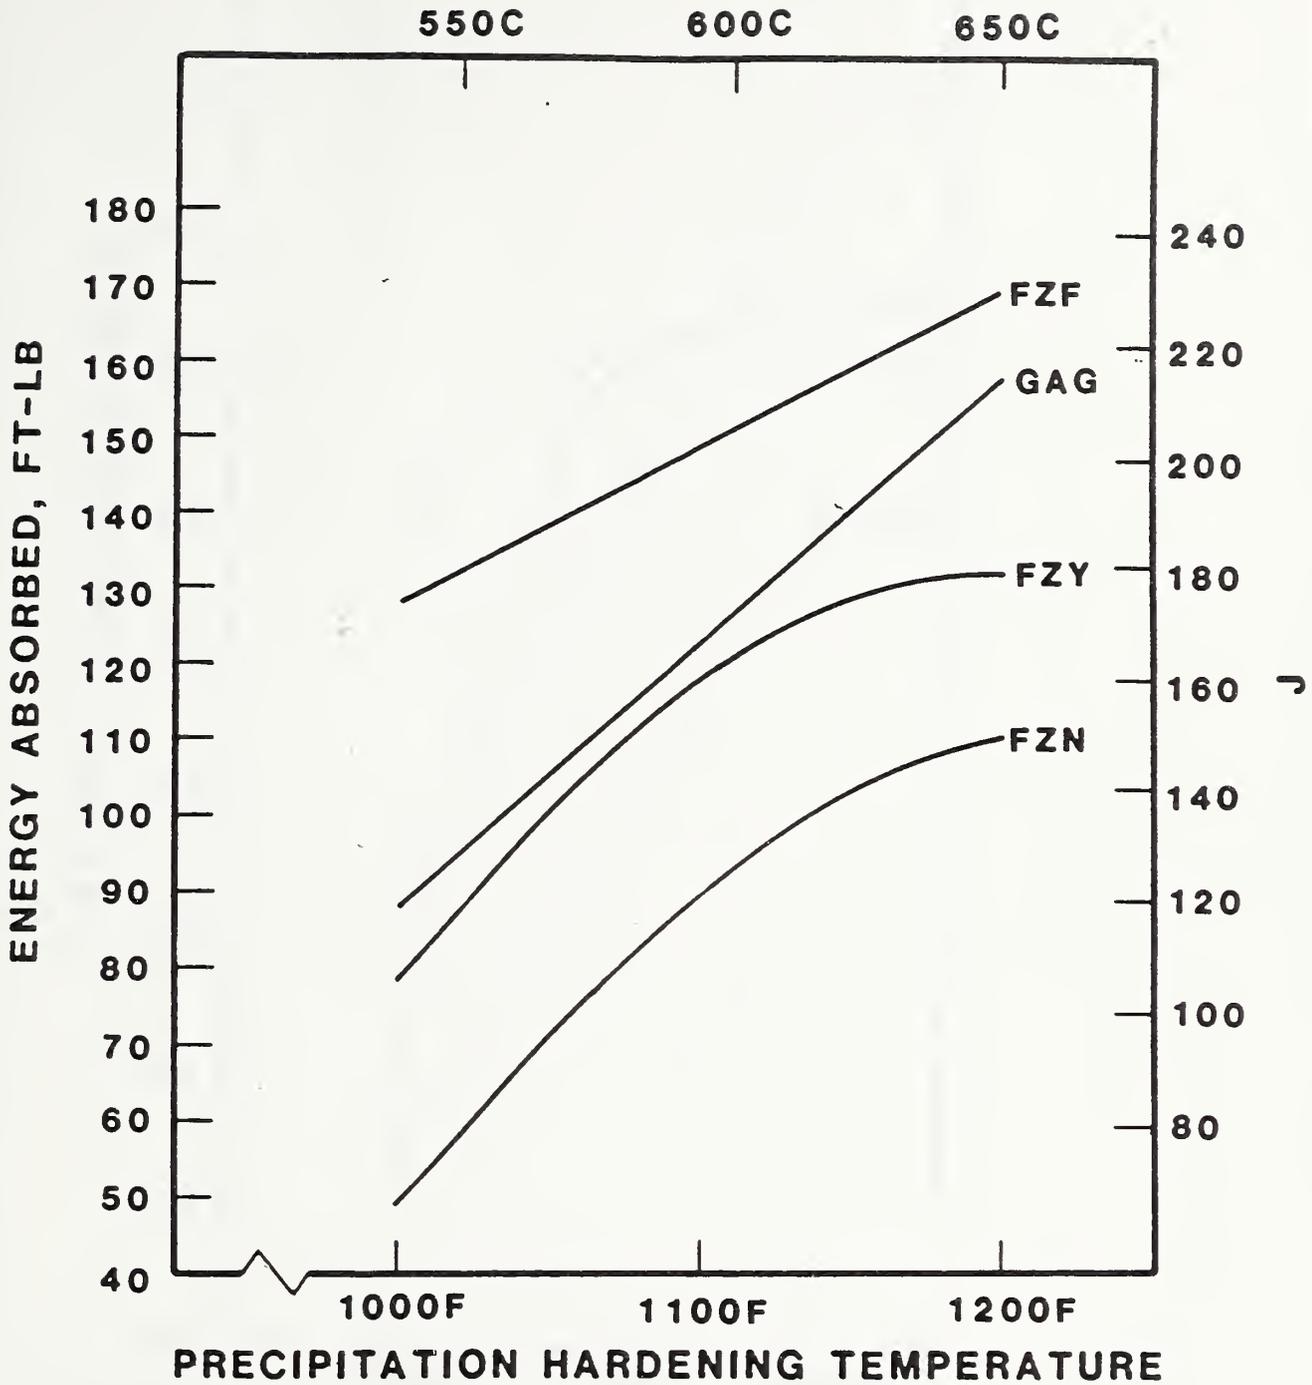
Figure 9 Energy absorbed in CVN impact tests at  $-17.8^{\circ}\text{C}$  ( $0^{\circ}\text{F}$ ) as a function of aging temperature. All samples aged for 30 minutes.

The -17.8°C (0°F) impact test results are listed in Table 3 and plotted in Figure 9 as a function of aging time and temperature. For all plates, the toughness increases with increasing time and temperature. As shown in the last section, this alloy is overaged in all the heat treated conditions investigated here and the increasing toughness with aging is consistent with that. As with tensile ductility, we note that plate FZN was the least tough for all aging conditions examined. Indeed, this plate exhibited the lowest CNV energy, i.e. 67.8 J (50 ft-lbs), of any Class 3 heat treated A710 material ever examined at NBS. Figure 10 is a plot of the lateral expansion as a function of precipitation hardening temperature. Plate FZN shows the least lateral expansion at each of the aging conditions. Plate FZF shows the most consistent lateral expansion over the hardening range.

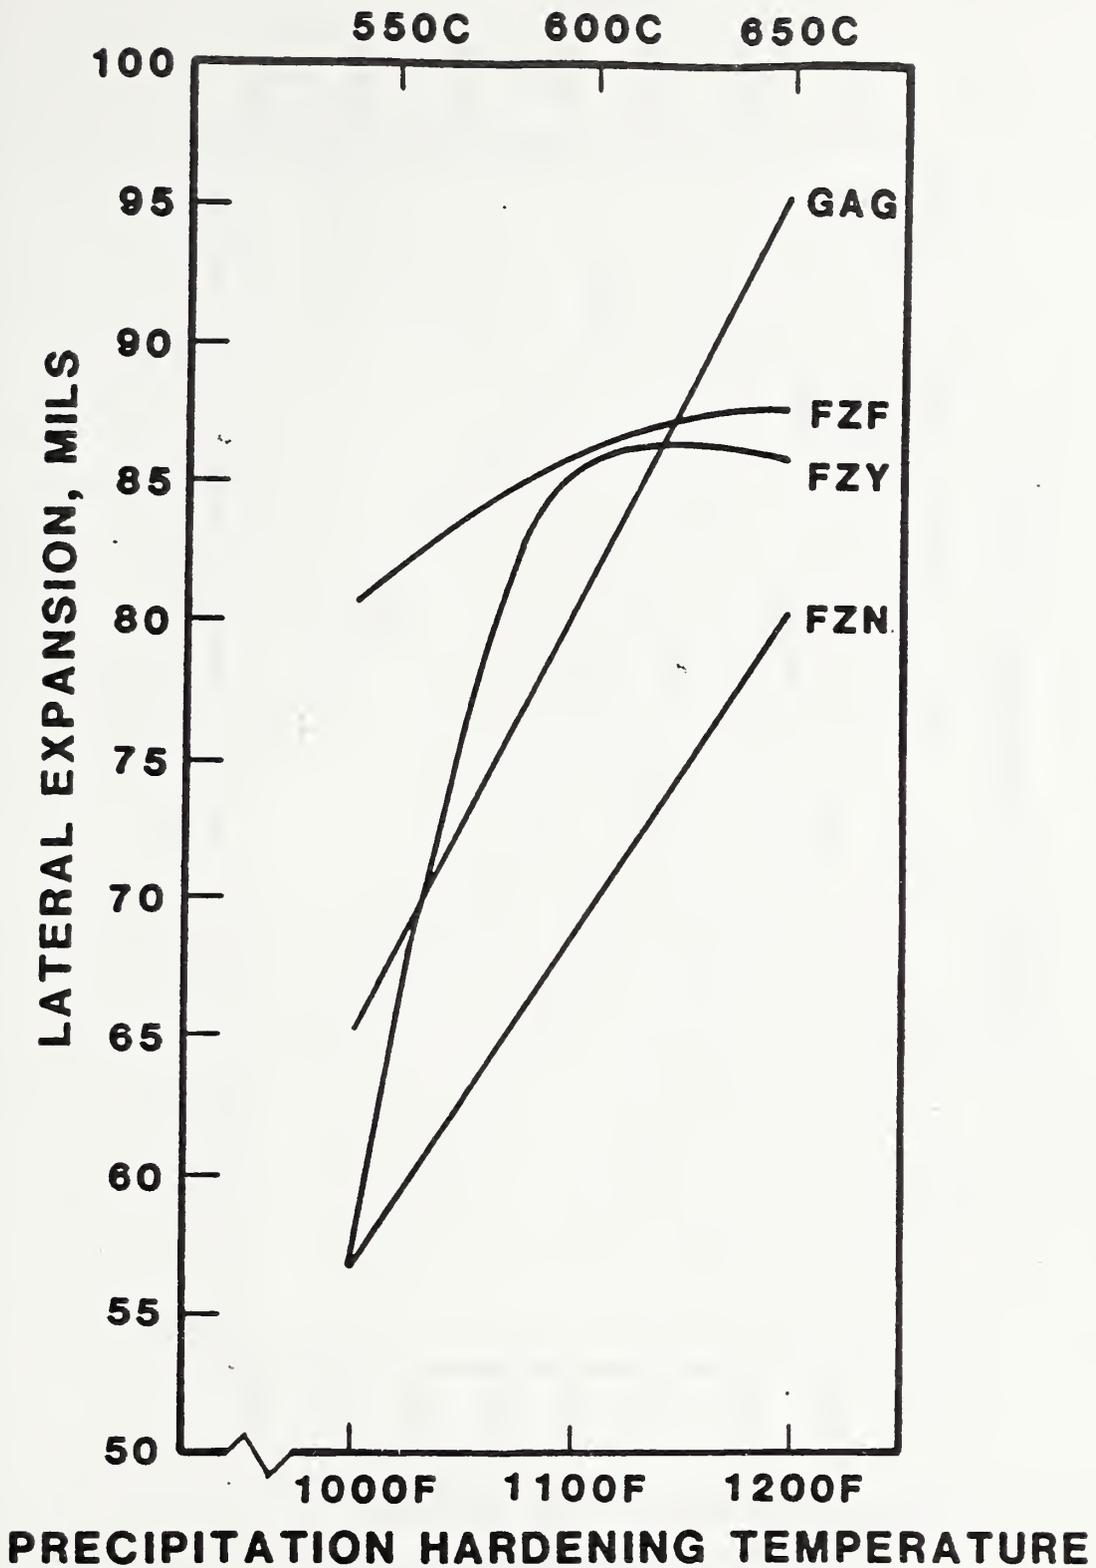
Figure 10 Lateral expansion of CVN impact specimens as a function of aging temperature. All samples aged for 30 minutes.

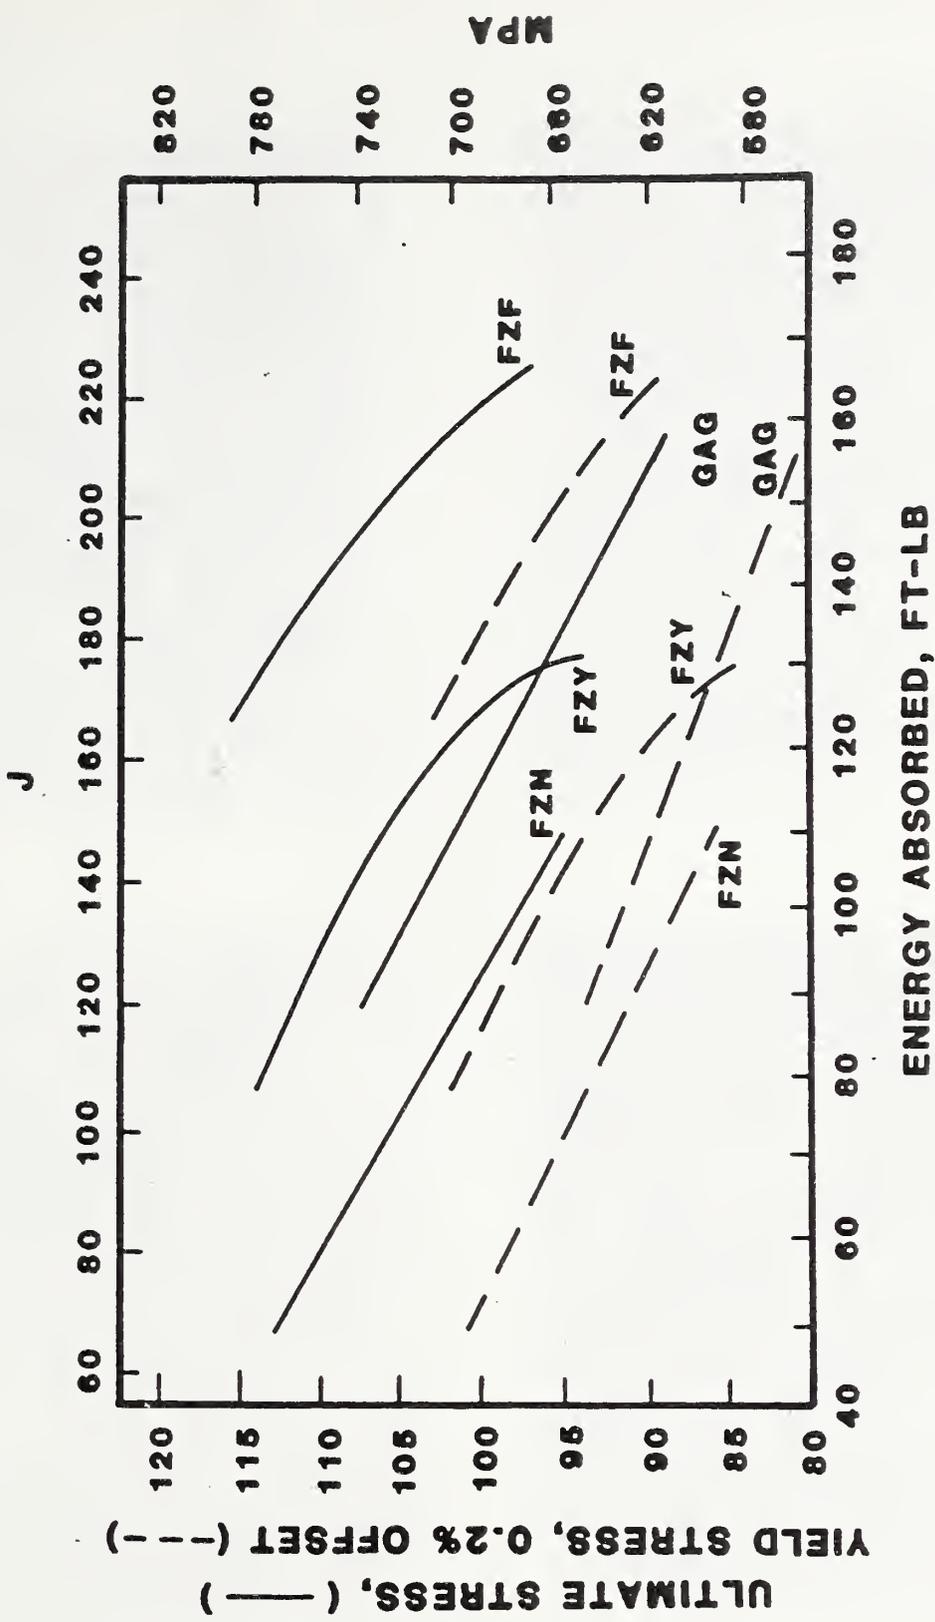
Figure 11 UTS and yield strength of the various plates versus energy absorbed in CVN impact tests.

Figure 11 is a plot of UTS and yield strength versus toughness. This graph demonstrates the typical trade off between toughness and strength for different aging treatments. However, some plates (i.e. different heats) offer much better combinations of strength and toughness than other plates. From this figure we note that FZN offers the least desirable combination of properties. For any given strength level, FZN has significantly less impact fracture resistance than any of the other plates. The general inverse correlation between strength and toughness does not hold when comparing different heats of A710. This point will be covered more fully in the Discus-

Figure 11 plots the strength versus the toughness of all the plates. For any given plate, the higher the strength level, the lower the toughness level. This is a typical correlation for precipitation hardening alloys used past their peak-aged condition. However, the strongest plate, FZF, is also the toughest plate. This results from the small grain size. Clearly, steel chemistries and thermo-mechanical treatments which produce fine (10 micrometer diameter) polygonal grains of ferrite will result in the best combination of strength and toughness for all common aging treatments of A710.

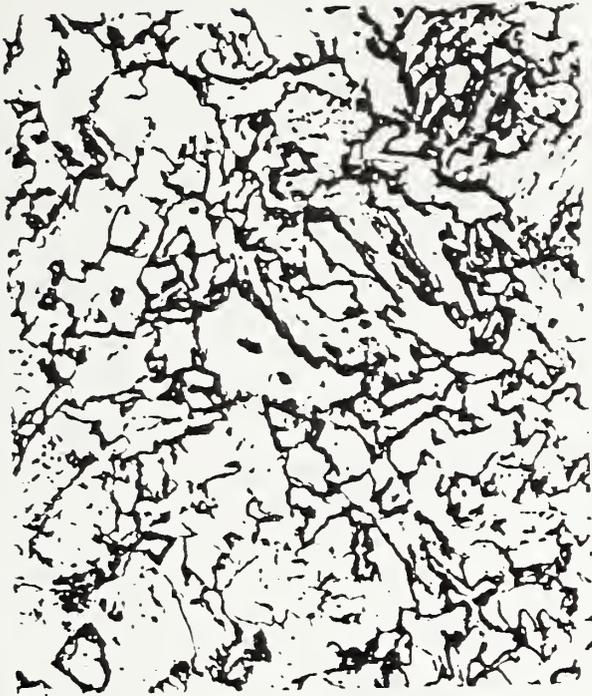
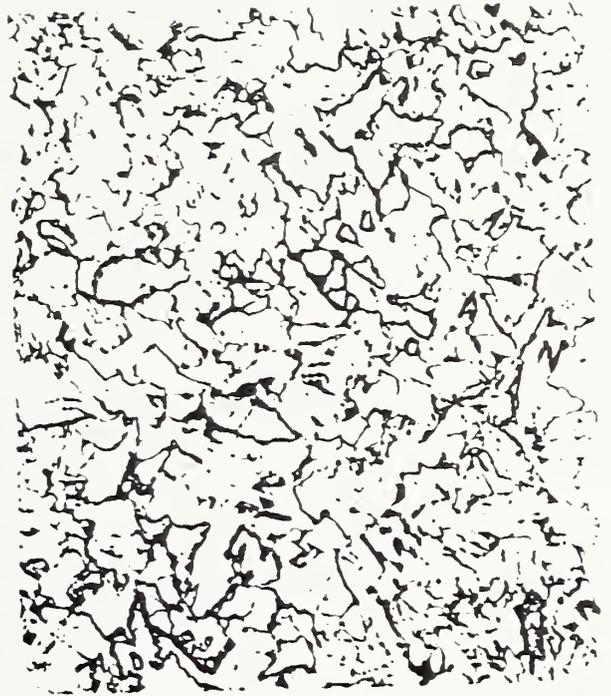
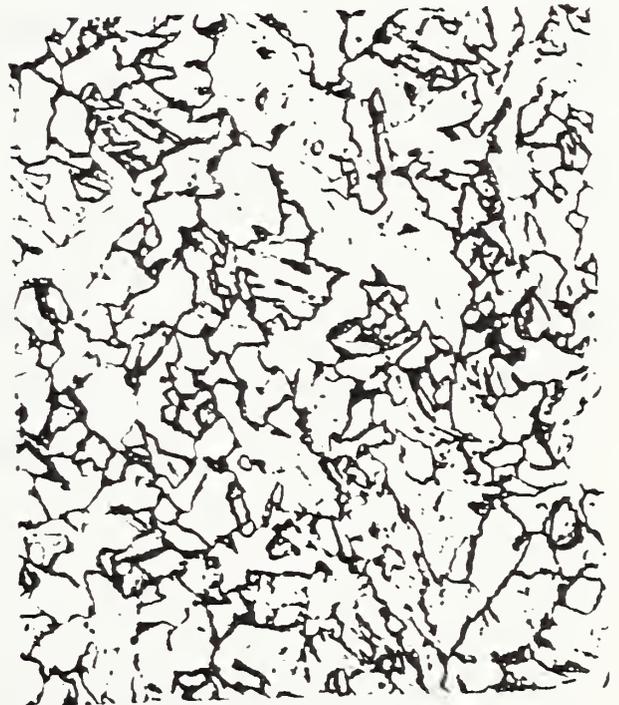
Figure 13 Optical micrographs at X1250 of heat treated (a) GAG, (b) FZF, (c) FZN, and (d) FZY.

Figure 13c, a micrograph of plate FZN at X1250, shows a microstructure unlike the other three plates. The ferrite has more acicular grains present and both the polygonal and equiaxed grains are relatively large. Larger colonies of a carbon-rich phase are visible in this plate (Fig. 12c) compared to the others. Although NBS definitely heat treated this plate to a Class 3 condition, FZN does not exhibit a microstructure typical of A710 in any of

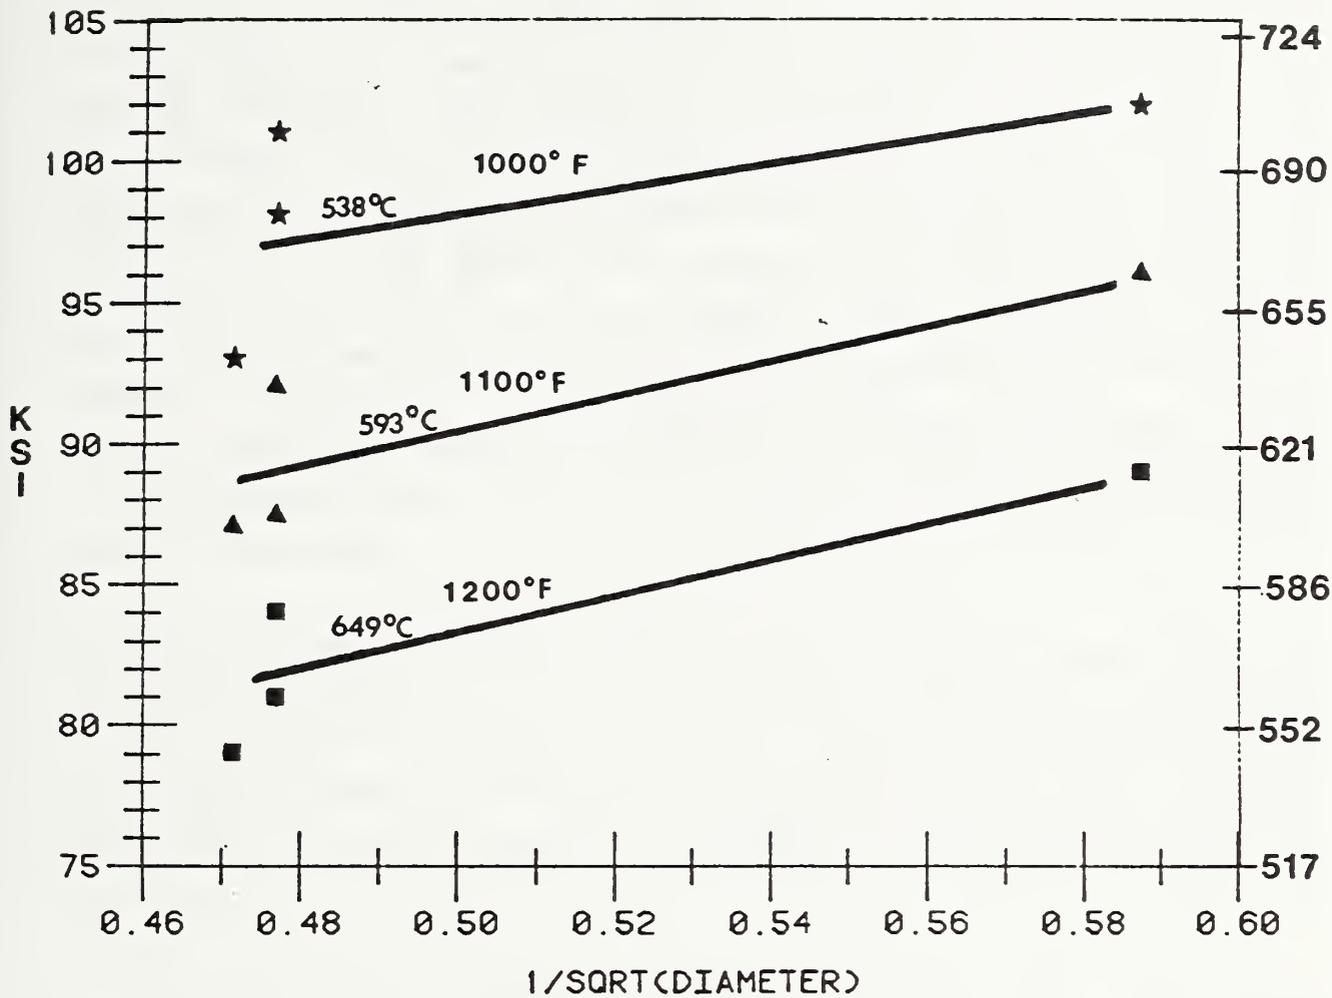
Figure 14 Hall-Petch plot: yield strength versus inverse square root of grain diameter.

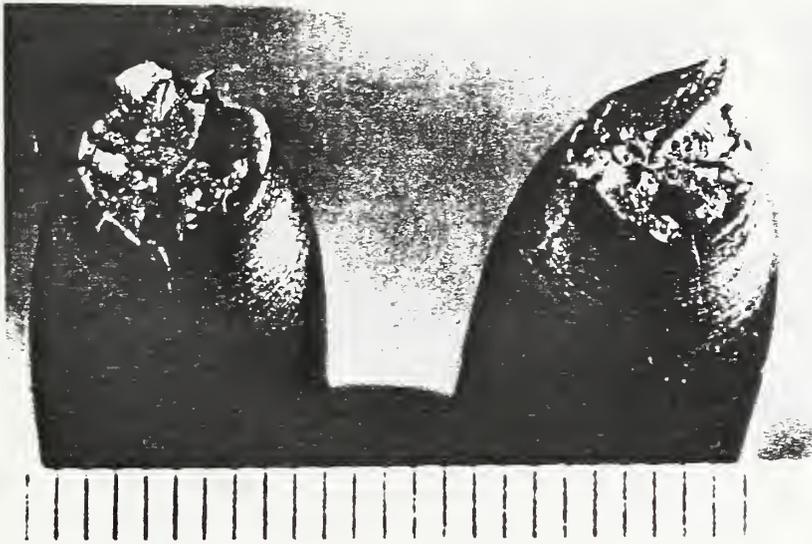
Fig. A1 Optical and SEM micrographs of splitting in A 710 tensile specimens.

It was previously observed that fractured tensile bars of A710 occasionally exhibited deep(5-10 mm) longitudinal cracks or splits (Figure A1). These cracks formed slightly before or just at the moment of fracture. These cracks were distributed radially and were not associated with rolling anisotropy. Consultation with an expert in this field (A1) indicated that these cracks were an extreme form of star fracture [also called spoke-shaped fracture (A2) or "Fraserbruche" (milling cutter fracture) (A3)]. The origin of this name can be seen in a less severely split specimen (Figure A2). Radially distributed, shear escarpments are seen which resemble a star. Since the splitting is only observed in the necked portion of the specimen, its cause could be the high triaxial stress state or the high strain state that occurs there. If the splitting were caused by a triaxial (or constrained) stress state, use of A710 might be impeded. Service stresses are usually multiaxial, and reduction in ductility by such loading would be of concern. However, if a high plastic strain state were the cause of splitting, then no concern would be warranted as the ductility is virtually exhausted when splitting finally does occur and could be regarded as an artifact of a highly ductile fracture mode.

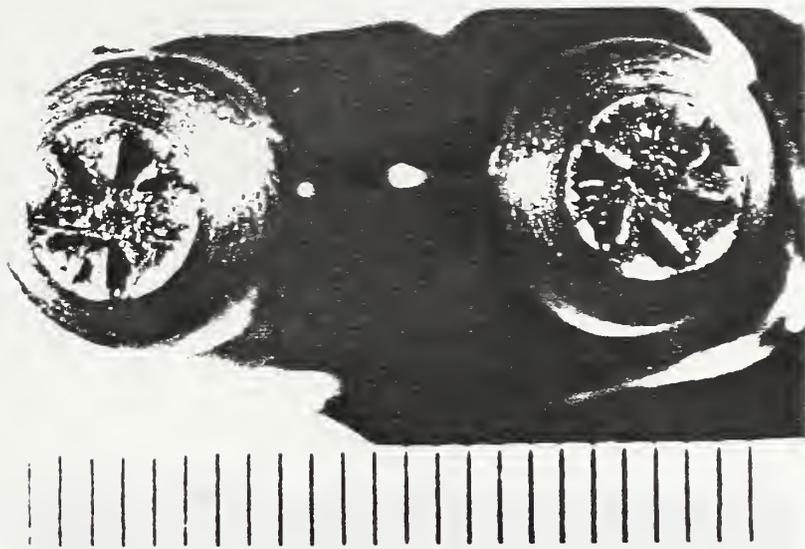
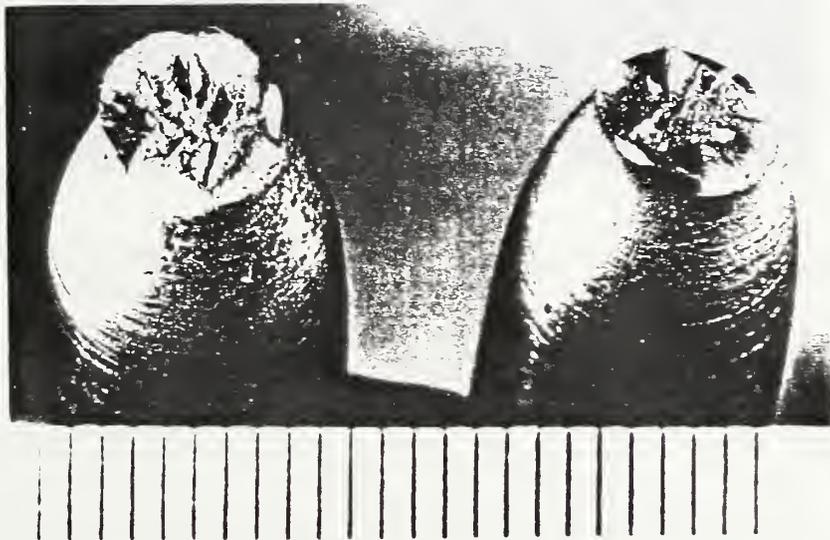
Fig. A2 Star fractures in A 710. Also known as spoke-type or milling cutter fractures.

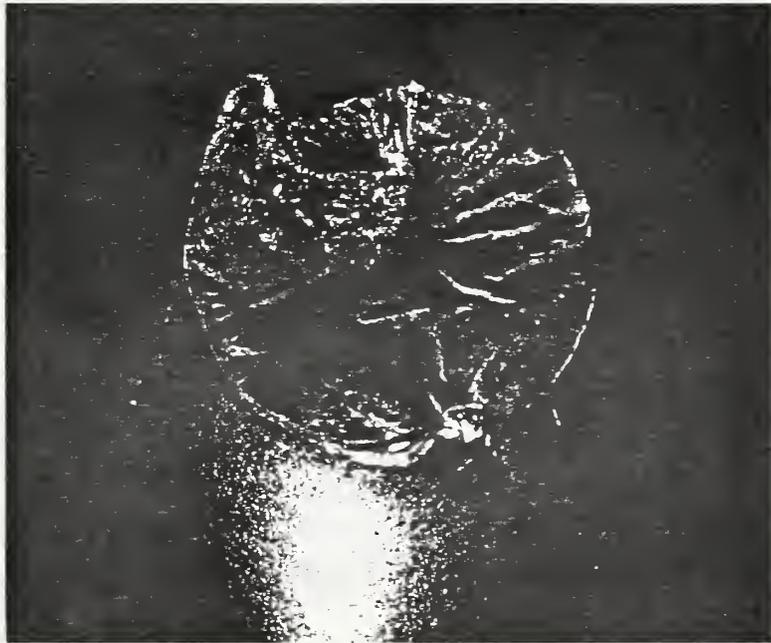
Fig. A3 Splitting observed in oversized ( $3/4$ " diameter gage) tensile specimen.

To investigate this phenomenon further, a plate of A710 was heat treated to the condition found to be prone to splitting in this investigation 899°C (1650°F), 30 min, WQ precipitation hardened - 538°C (1000°F) for 90 min and AC). Oversized tensile specimens [19 mm (3/4 inch) diameter gage sections] were machined from this plate. At fracture, these exhibited splitting (Figure A3).

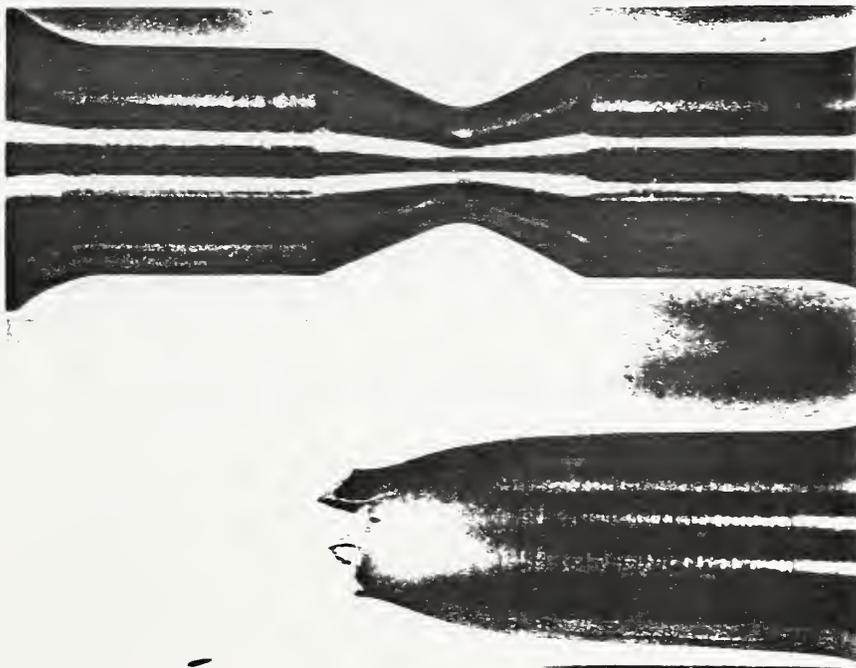
Fig. A4 Contoured notch specimen mimics curvature in neck of fractured tensile specimen which exhibited splitting.

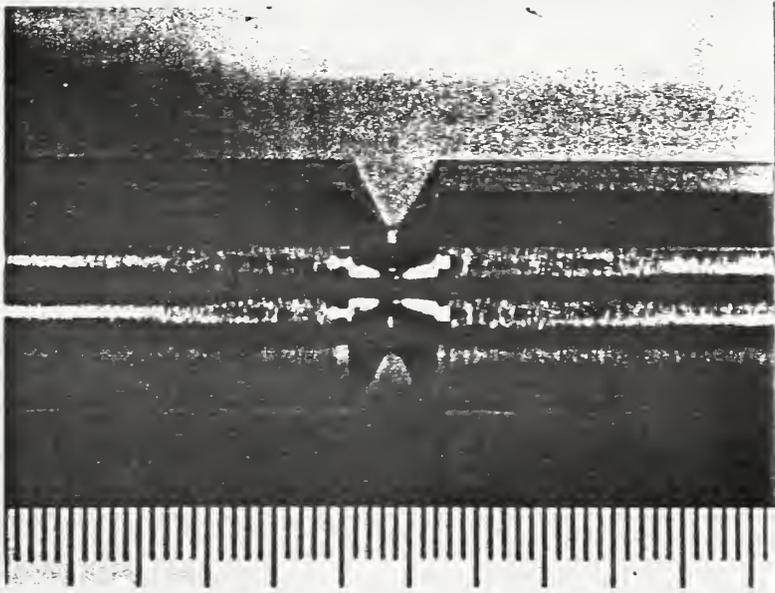
Fig. A5 Severely notched specimen.
