**NBSIR 84-2891**

# **Effect of Heat Treatment on Mechanical Properties and Microstructure of Four Different Heats of ASTM A710 Steel**

**G.E. Hicho, C.H. Brady, L.C. Smith, and R.J. Fields**

**U.S. DEPARTMENT OF COMMERCE  
National Bureau of Standards  
Fracture and Deformation Division  
Gaithersburg, Maryland 20899**

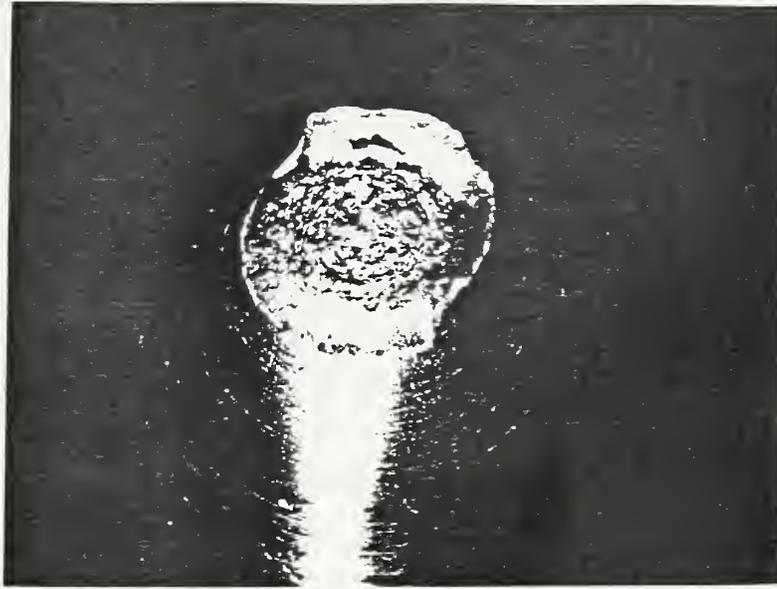
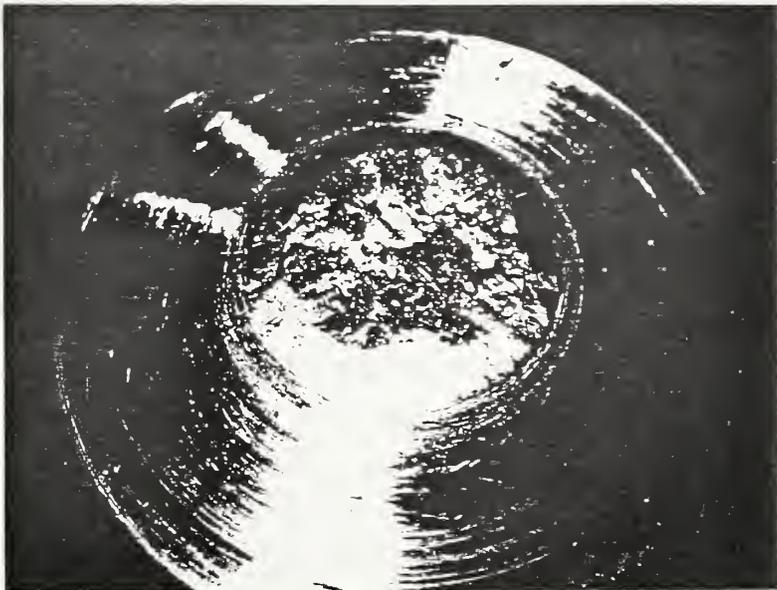
Fig. A6 Fracture surfaces of (a) contoured notch, and (b) severe notch. No evidence of splitting or even radial escarpments (star) is visible even though this is exactly the same heat-treated material as shown in Fig. A3.

Fractographs of the contoured notch and severely notched specimens are shown in Figure A6. Although exceedingly high stress elevations were obtained, these specimens did not exhibit any trace of splitting. In addition, the notched and severely notched specimens had reduced elongations to fracture.

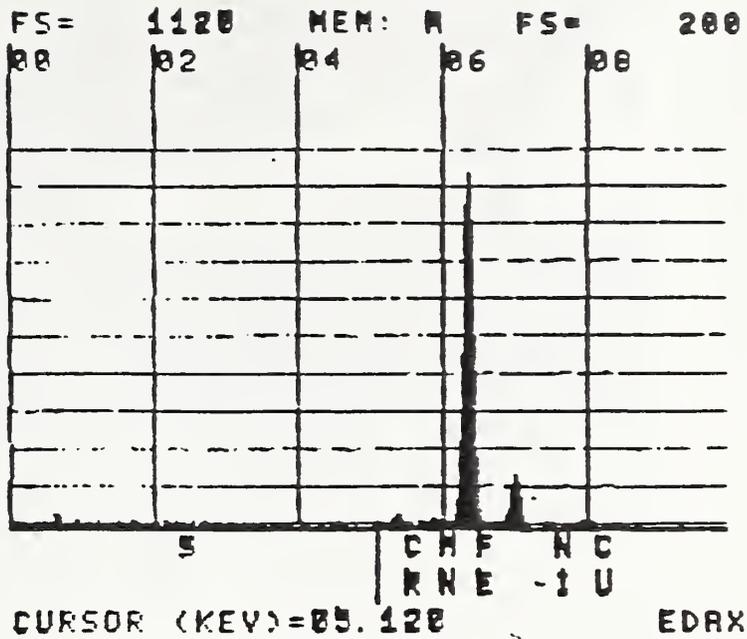
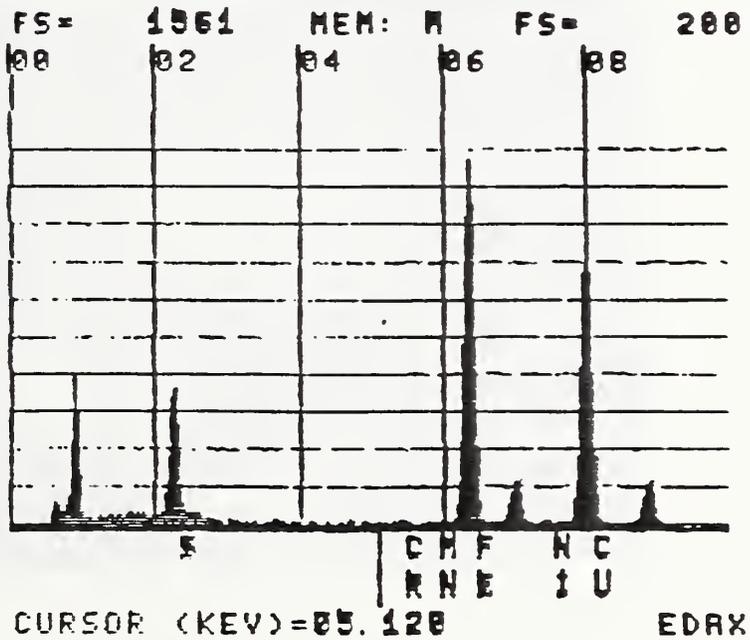
Fig. B2 Energy dispersive x-ray spectra of (a) matrix, and (b) matrix plus particle. Note high copper and sulphur intensities.

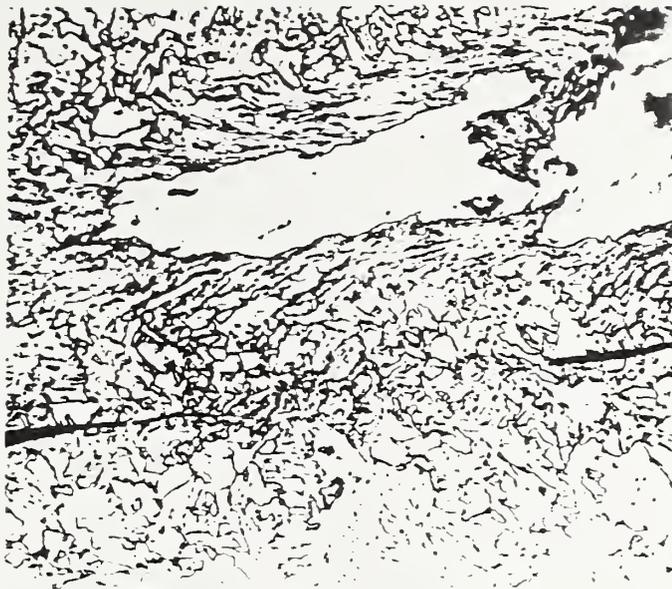
Fig. B3 Unetchable, shiny particles that were found in plate having variable impact properties. (a) X500, (b) X742. Etchant: 1% Nital.

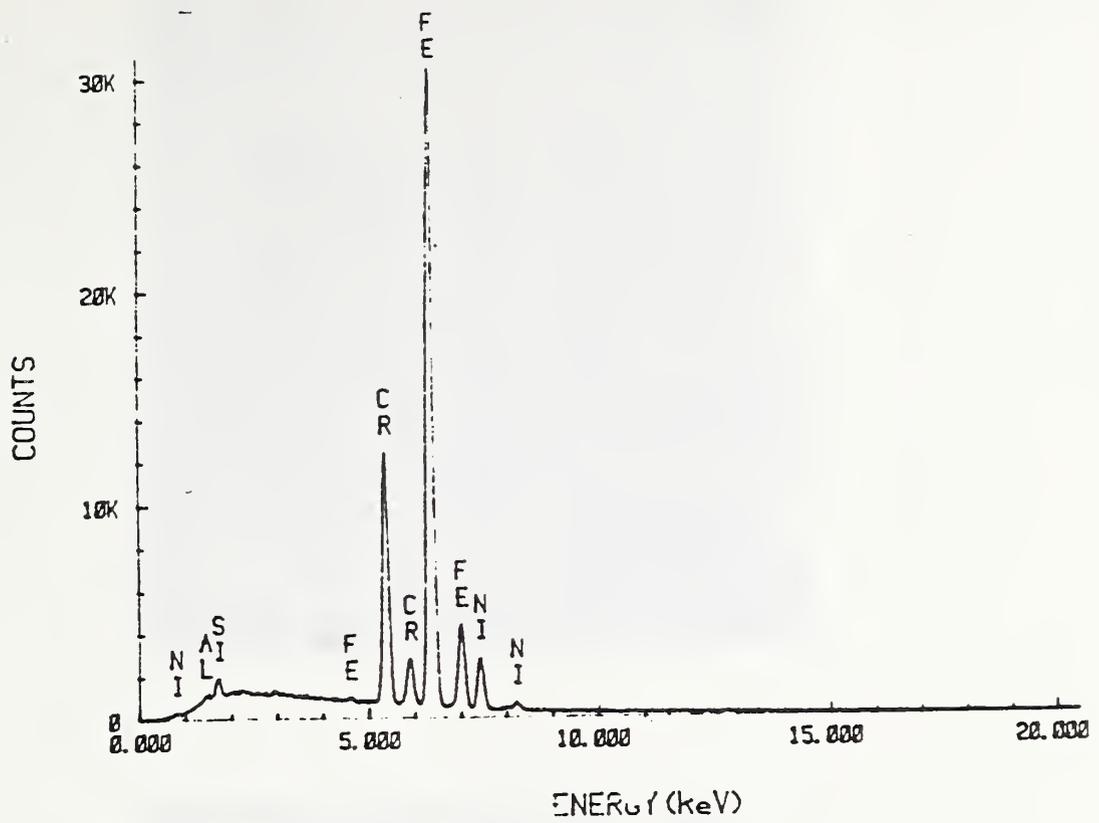
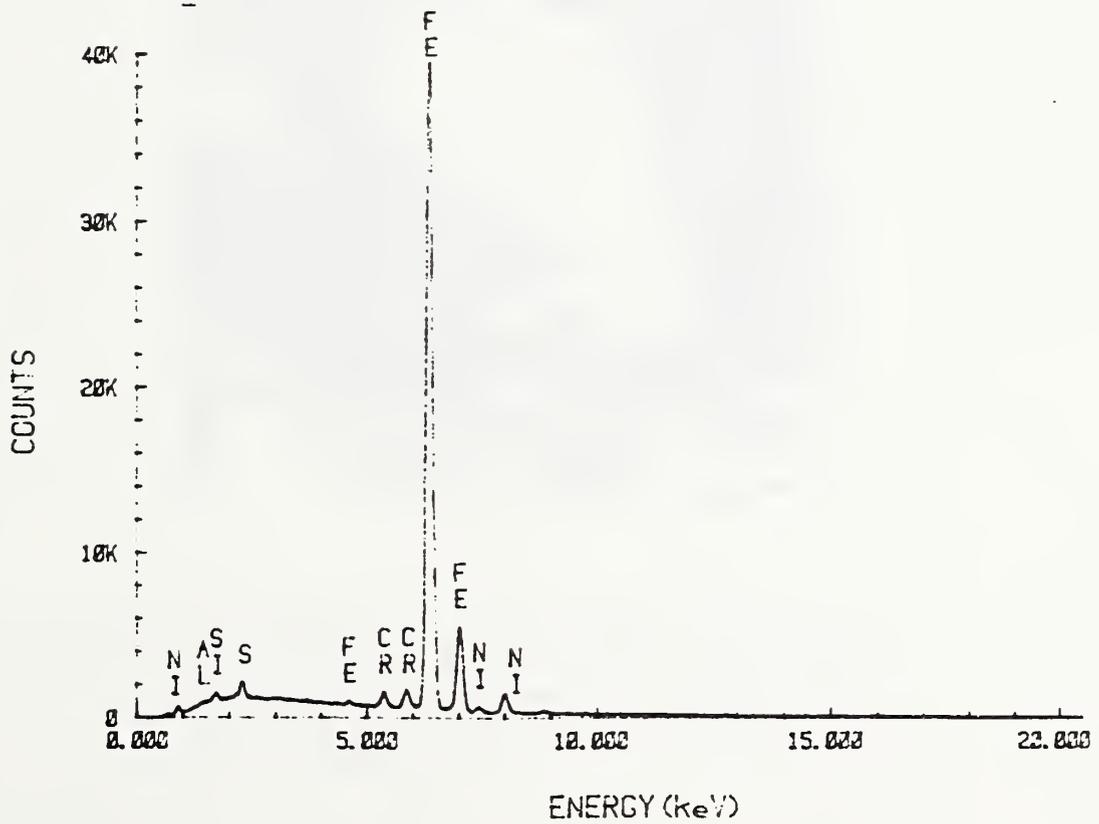
Fig. B4 Energy dispersive x-ray spectra of (a) shiny particle plus matrix, and 9b) matrix. Note high chromium peak coming from particle.

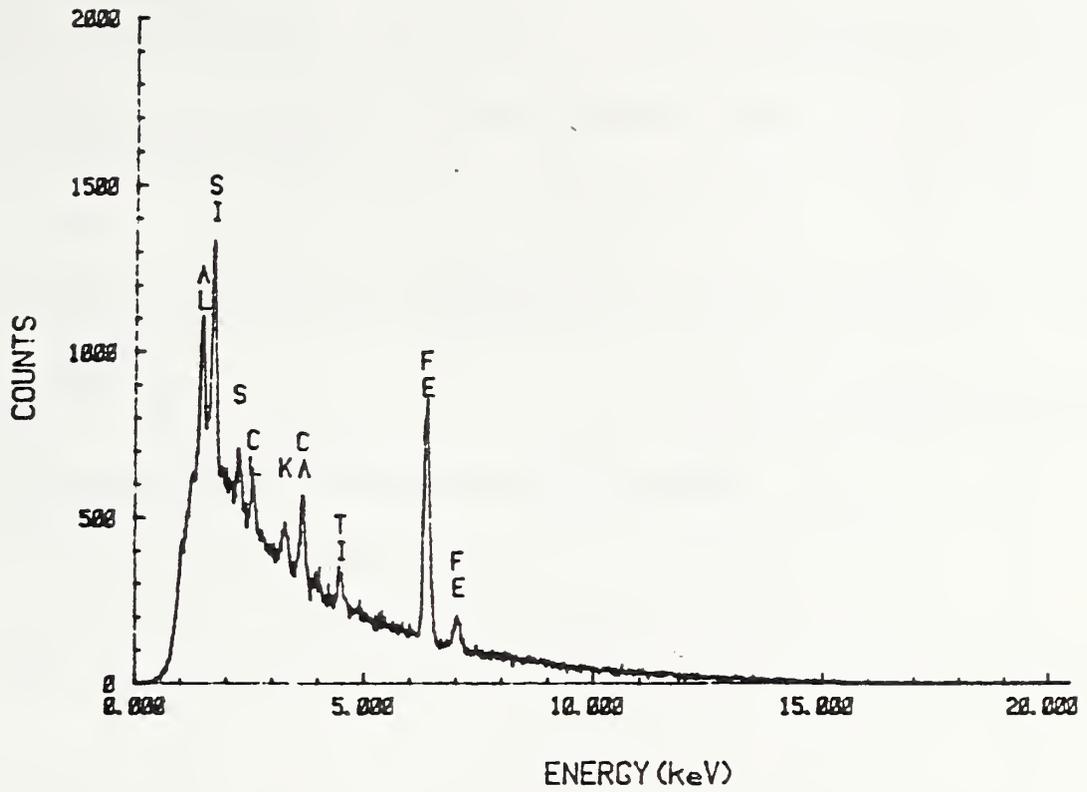
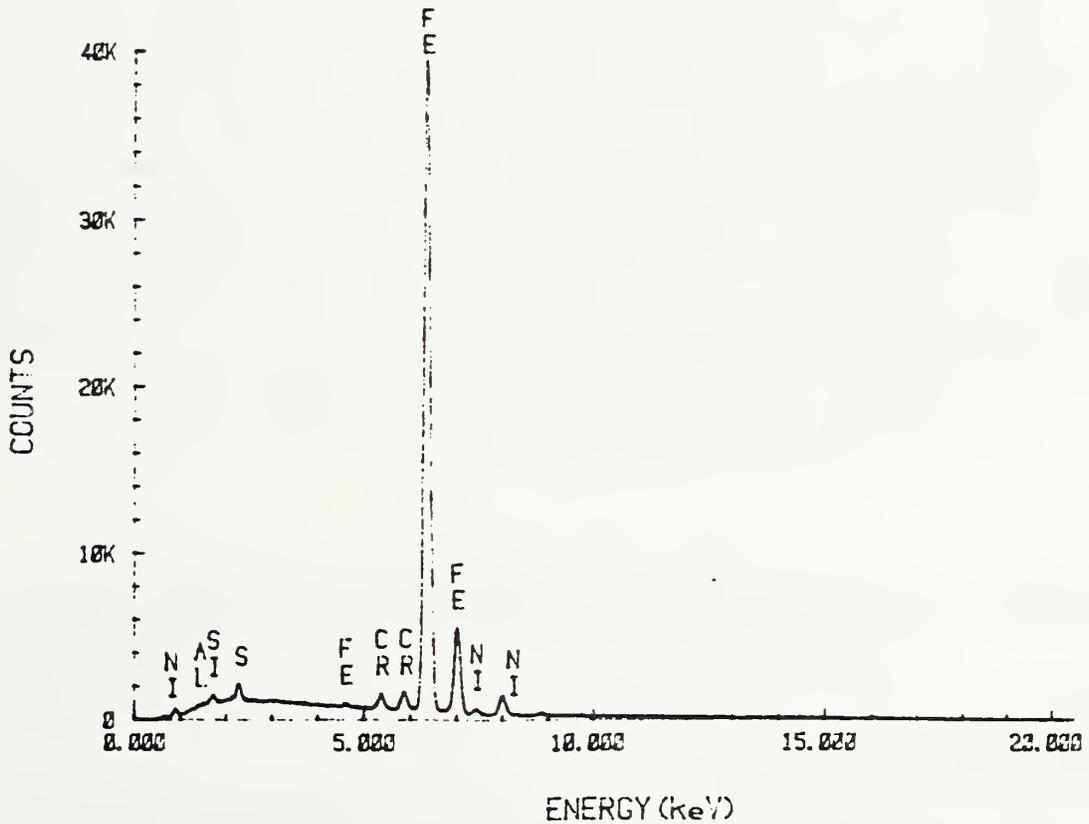
Fig. B6 Energy dispersive x-ray spectra of (a) inclusion plus matrix, and (b) matrix alone. Note high silicon and aluminum peaks coming from inclusion.
