# Metallurgical Evaluation of Type 304 Stainless Steel Exposed to Woodburning Stove Flue Gases

Final Report

U.S. Consumer Product Safety Commission  
Washington, DC 20207

NBSIR 85-3103

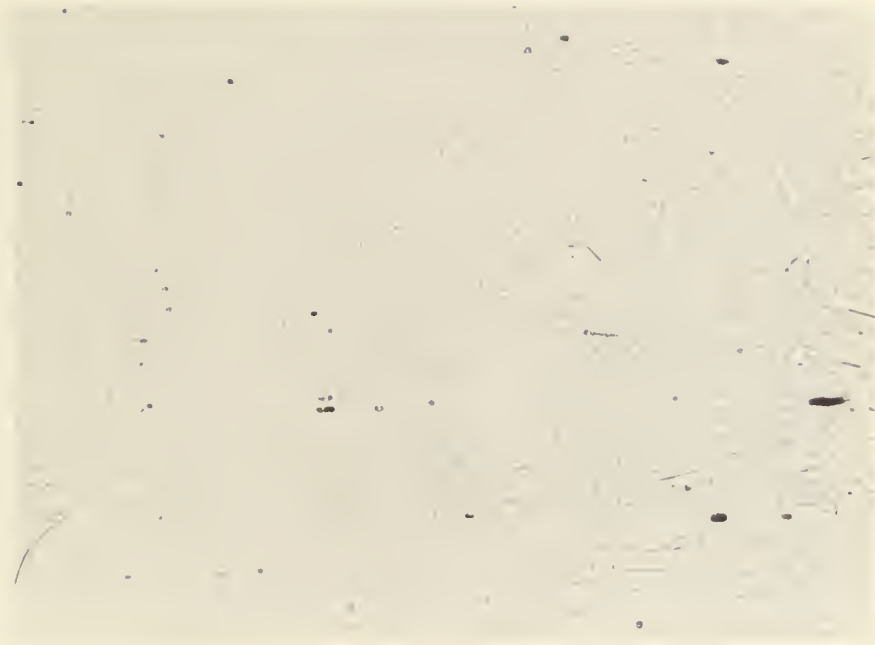
Fig. 1

As-Received Double Walled Material 500X

microstructure, microconstituants, and grain size. An electrolytic oxalic acid etch was used on separate specimens to determine the presence of carbides precipitated at the grain boundaries which is indicative of sensitization. A typical microstructure of the "as received" material taken from the double walled chimney made from type 304 stainless steel is shown in Figure 1. This material was fully austenitic with no evidence of residual ferrite or other microconstituants. The grains were predominantly equiaxed with a grain size of ASTM No. 9 (approximately 0.0006 in. diameter). Annealing twins were present in many of the grains. The oxalic acid etch did not reveal any evidence of carbide precipitation at the grain boundaries indicating that no sensitization had occurred in the as received material as fabricated into a typical double walled chimney. The structure indicated that the stainless steel was in the annealed condition and had not been significantly cold worked.

micrograph (Figure 5) will be compared with similar micrographs taken after exposure of the specimens to the wood burning stove environment. No changes in the microstructure, other than the carbide precipitation at the grain boundaries, were found after the sensitization heat treatment (for example, compare Figure 1 and 4).

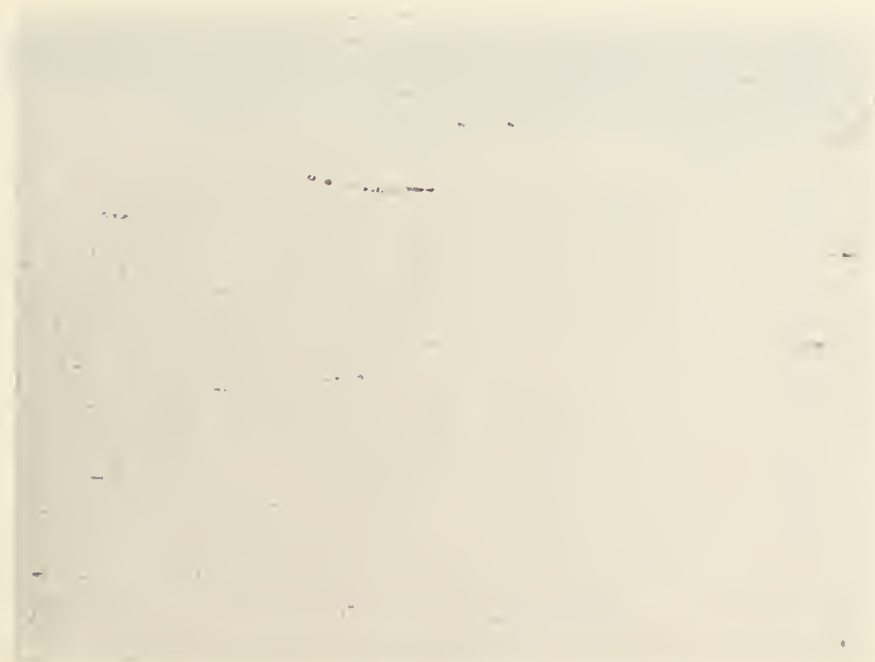
Fig. 2

As-Received Triple Walled Material 500X

Specimens taken from sections of triple walled chimney made from 304 stainless steel showed a generally similar microstructure to those taken from double wall chimney sections. As shown in Figure 2, the microstructure consisted entirely of equiaxed austenitic grains containing many annealing twins. No evidence of significant cold work was observed. The grain size of the material taken from the triple walled chimney sections was ASTM grain size No. 8 (approximately 0.0009 in. diameter) which is somewhat larger than the grain size of the material from the double walled chimney sections. The oxalic acid etch did not reveal the presence of any carbides at the grain boundaries which indicates that the material in the typical triple walled chimney section had not been sensitized.

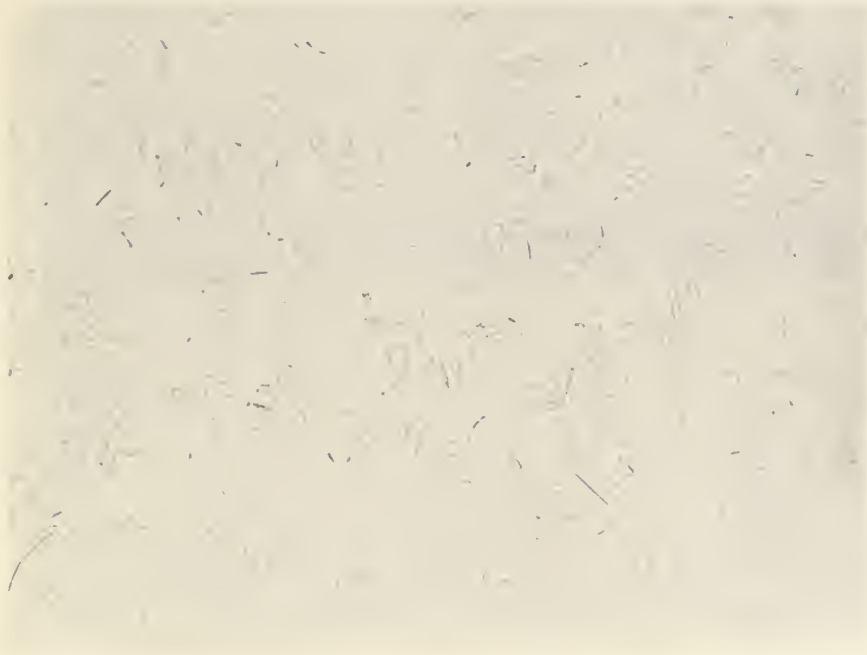
Fig. 3

As-Received Type 321 Stainless Steel 500X

The stabilized grade of stainless steel (type 321) was examined in the "as received" condition. As shown in Figure 3, this material had a microstructure similar to the material taken from the double walled and triple walled chimney

sections made from type 304 stainless steel. The microstructure consisted entirely of equiaxed austenitic grains showing a substantial amount of annealing twins. No evidence of significant cold work was present in the microstructure indicating that the material was fully annealed in the "as-received" condition. The material was fine grained with a grain size of ASTM No. 9 (approximately 0.0006 in. diameter). The oxalic acid etching procedure did not reveal the presence of any grain boundry carbides indicating the absence of sensitization in the material.

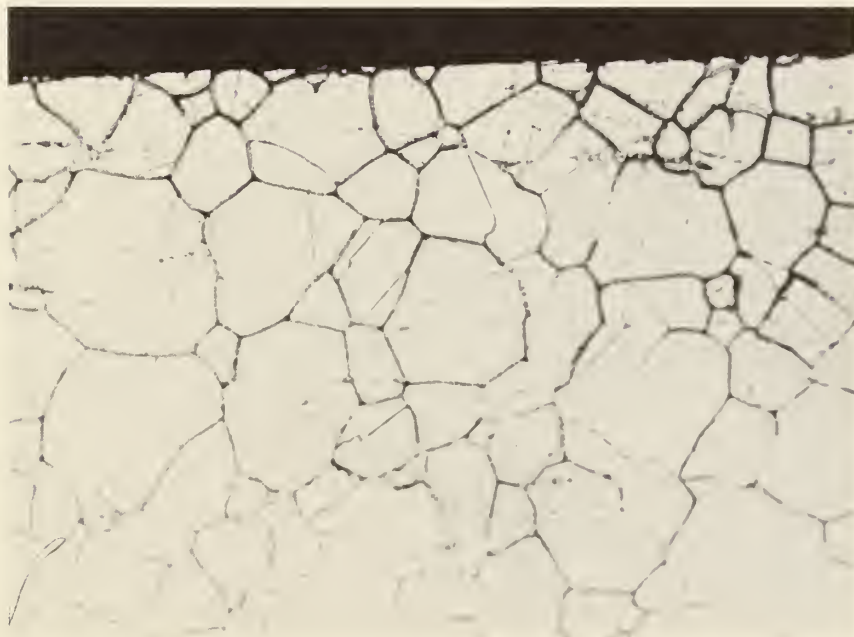
Fig. 6

Triple Walled Material After Sensitization 500X

As shown in Figure 6, samples taken from triple walled chimney sections showed evidence of extreme sensitization after the heat treatment at 1000° F for 100 hours in the furnace. The degree of sensitization in this material was more extreme at the surface of the specimen than of the mid-thickness of the specimen as shown in Figure 7. Complete sensitization was also observed in the test coupons that were heated in the wood burning stove chimney for 100 hours at 1000° F, as shown in Figure 8. The surface of the test coupons were only slightly roughened and no grain boundary attack was observed after the furnace heat treatment, as shown in Figure 9. The carbide precipitation due to sensitization was the only microstructural change observed in the material from the triple walled chimney sections after the heat treatment.

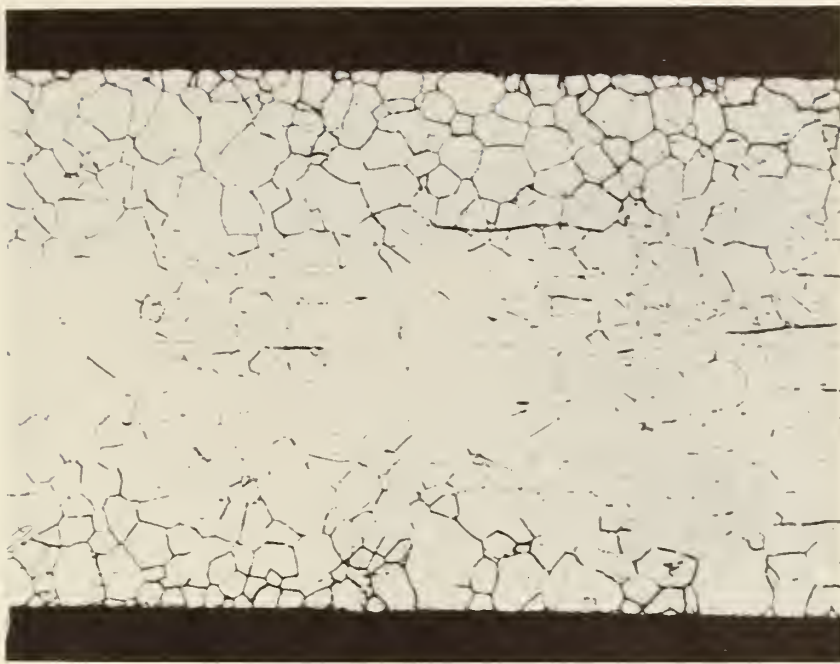
Fig. 7

Through Thickness Section of Triple Walled 200X  
Material After Sensitization

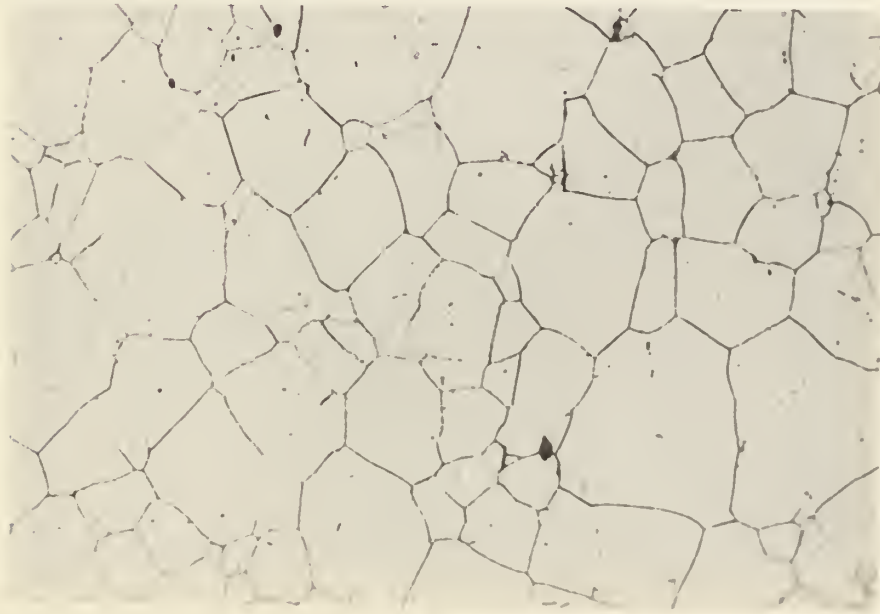
Fig. 8

Triple Walled Material - Chimney Sensitized 500X

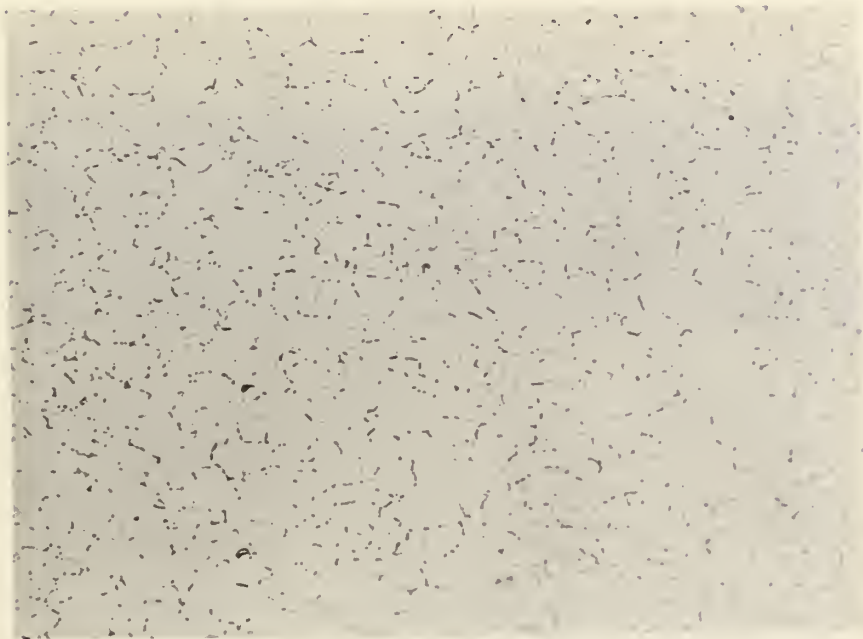
Fig. 10

Type 321 Stainless Steel After Sensitization Heat Treatment

Samples of the type 321, stabilized grade of stainless steel were examined after heat treating for 100 hours at 1000° F in both the heat treating furnace and in the wood burning stove chimney. As shown in Figure 10, the type 321 stainless steel was not sensitized by this heat treatment as indicated by the lack of carbide precipitation at the grain boundaries. This is in contrast to the samples of type 304 stainless steel (unstabilized) that were heavily sensitized after the same heat treatment.

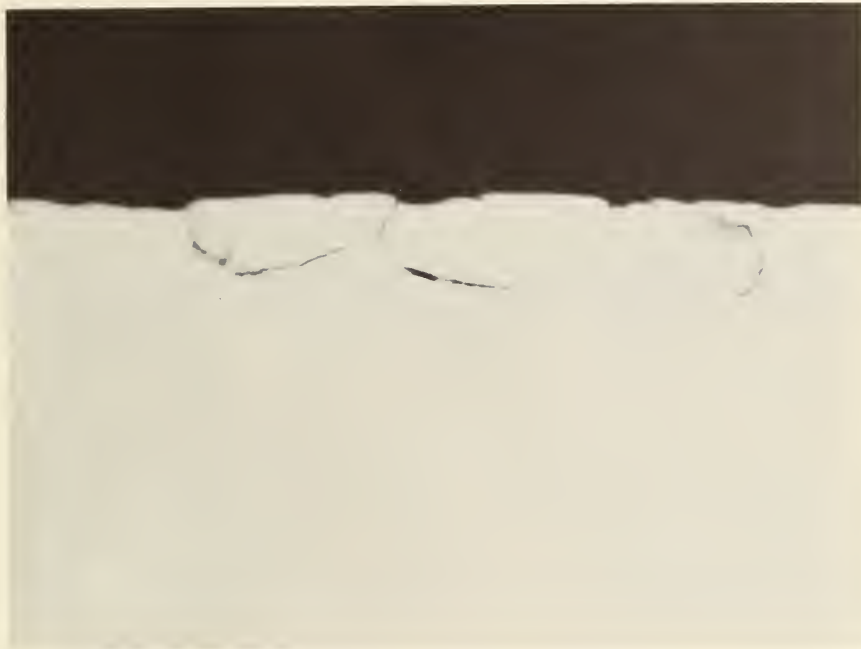
Fig. 13

Triple Walled Material After Exposure 1250X  
(As Polished)

Specimens of materials taken from triple walled chimney sections showed no significant change in microstructure or in the degree of sensitization after 3 months or 6 months exposure to the wood burning stove environments. After 3 months exposure, the maximum extent of attack was limited to the depth of one grain diameter and could only be observed at high magnification as shown in Figure 13. After 6 months exposure, the extent of attack in the surface of the specimens was not significantly greater than after 3 months exposure. As shown in Figures 14 and 15, the surface attack was limited to a depth of approximately one grain diameter (0.0009 in ). This indicates that the rate of surface degradation and attack is not accelerating as the exposure times are extended.

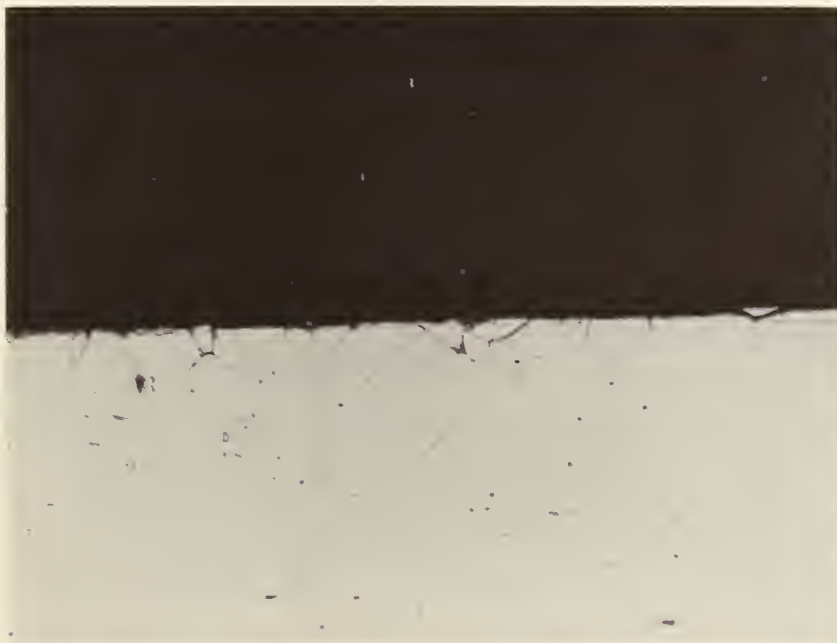
Fig. 14

Edge of Triple Walled Material After Exposure 500X

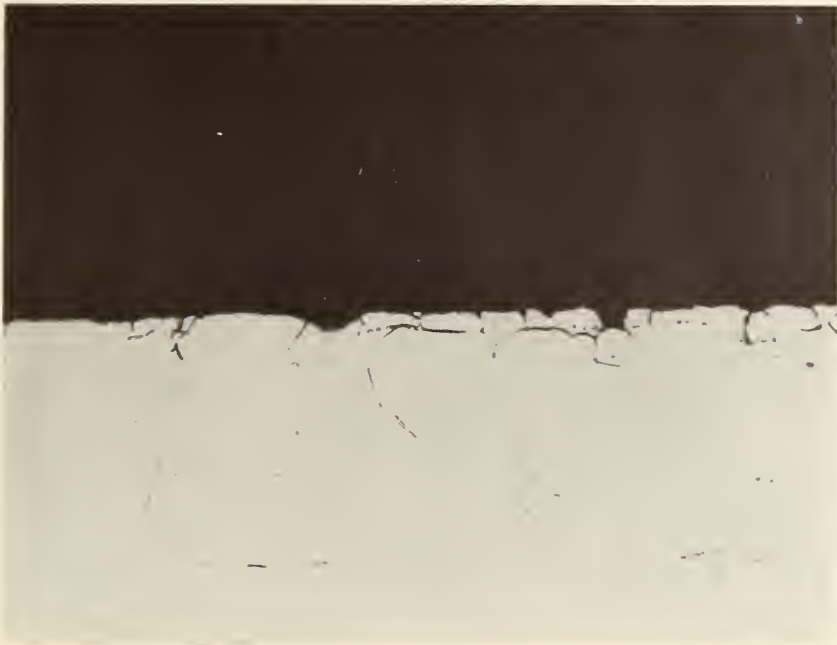
Fig. 15

Edge of Triple Walled Material After Exposure 500X

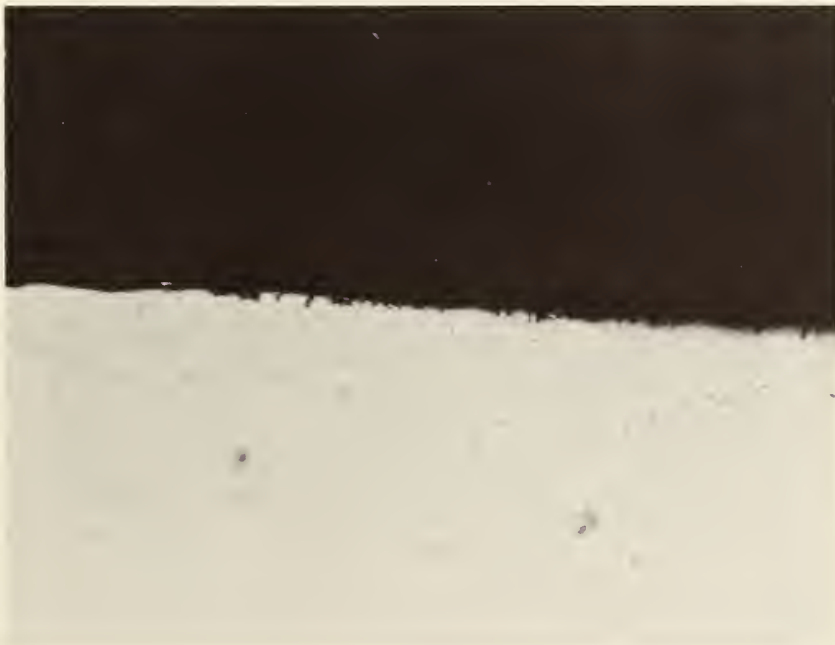
Fig. 16

Type 321 Stainless Steel After Exposure 500X

The type 321 (stabilized) stainless steel test coupons were exposed to the wood burning stove environment for a period up to 4 months after first being heat treated through the cycle that was used to sensitize the 304 stainless steel. As shown in Figure 16, no microstructural changes were observed in the type 321 stainless steel as a result of the exposure cycle. The only evidence of surface degradation or attack was limited to a depth of less than one grain diameter (0.0006 in.), as shown in Figure 16.

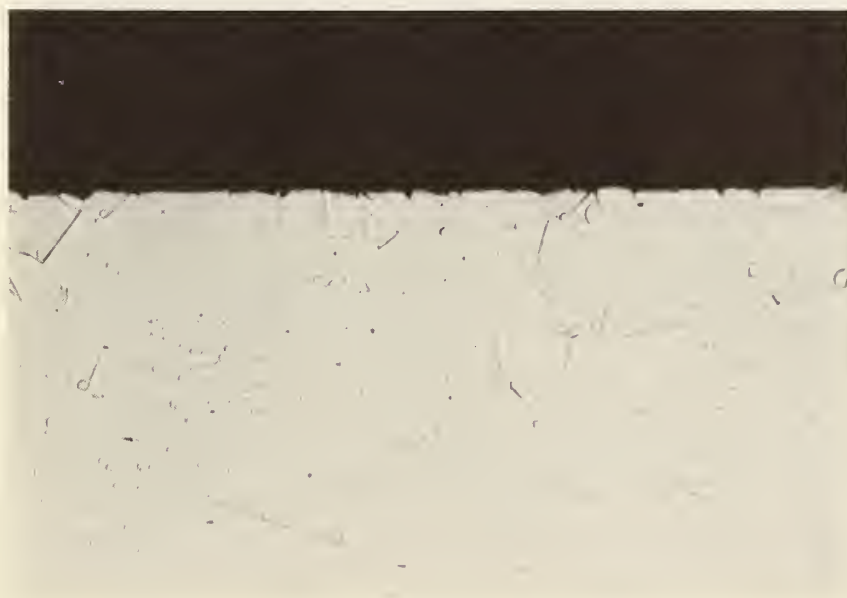
Fig. 18

Edge of Type 304 Chimney Section from Field 500X

Additional samples were taken from each of the five sections from each chimney and examined by optical metallography to determine the extent of any microstructural changes and any corrosive attack during normal operation of the chimneys. Figure 18 shows the typical microstructure from the chimney sections. These chimney sections show a microstructure typical of annealed type 304 consisting of equiaxed grains of austenite containing annealing twins. No significant corrosive attack was found on the surface of the specimens. This examination did not show any significant microstructural changes as a result of the operation of the chimneys.

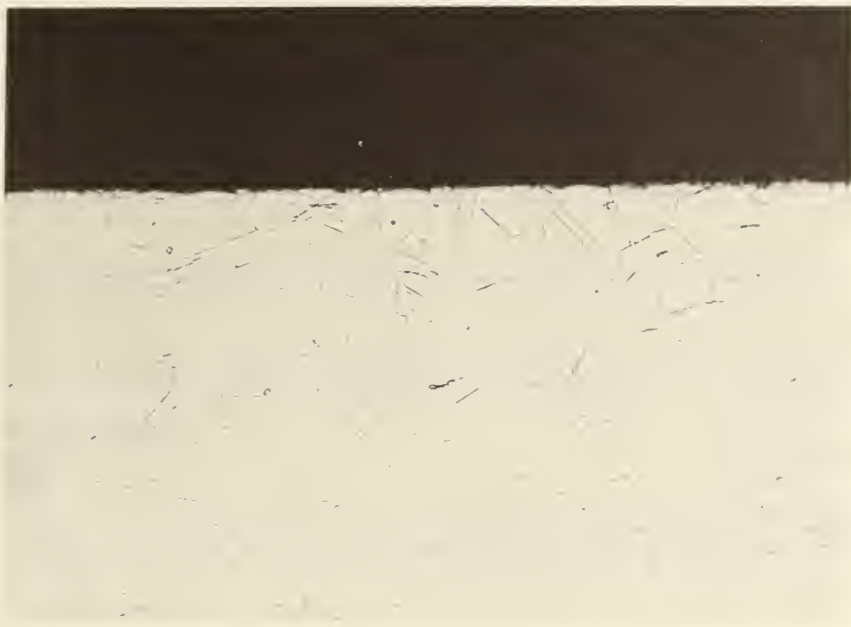
Fig. 19

Type 304 Chimney from Lab Tests 500X  
Showing Carbides

The two chimneys, one double walled design and one triple walled design, which were used in the CPSC laboratory for exposure of test coupons for 3 and 6 month tests were examined metallographically. The two sections of each chimney nearest the wood burning stove were obtained for evaluation. Specimens from the inner liner of the chimney sections were examined for evidence of sensitization due to the temperature cycle used in the exposure tests. As shown in Figure 19, no evidence of sensitization was found. This indicates that normal wood stove operating cycles will not cause sensitization of the
