NBSIR 88-3796

# Literature Review of Strengthening Methodologies of Existing Structures

June 1988

This report reviews research studies relevant to structural strengthening of existing reinforced concrete members and frames. The majority of these studies dealt exclusively with restoring or improving seismic resistance of concrete columns and frames. A number of case histories where various strengthening techniques were applied in practice are reviewed. Most studies identified ultimate failure in the strengthened structures as being primarily due to failure of the joining elements. Improved load resistance and ductility in concrete structures have been reported in most of these studies.

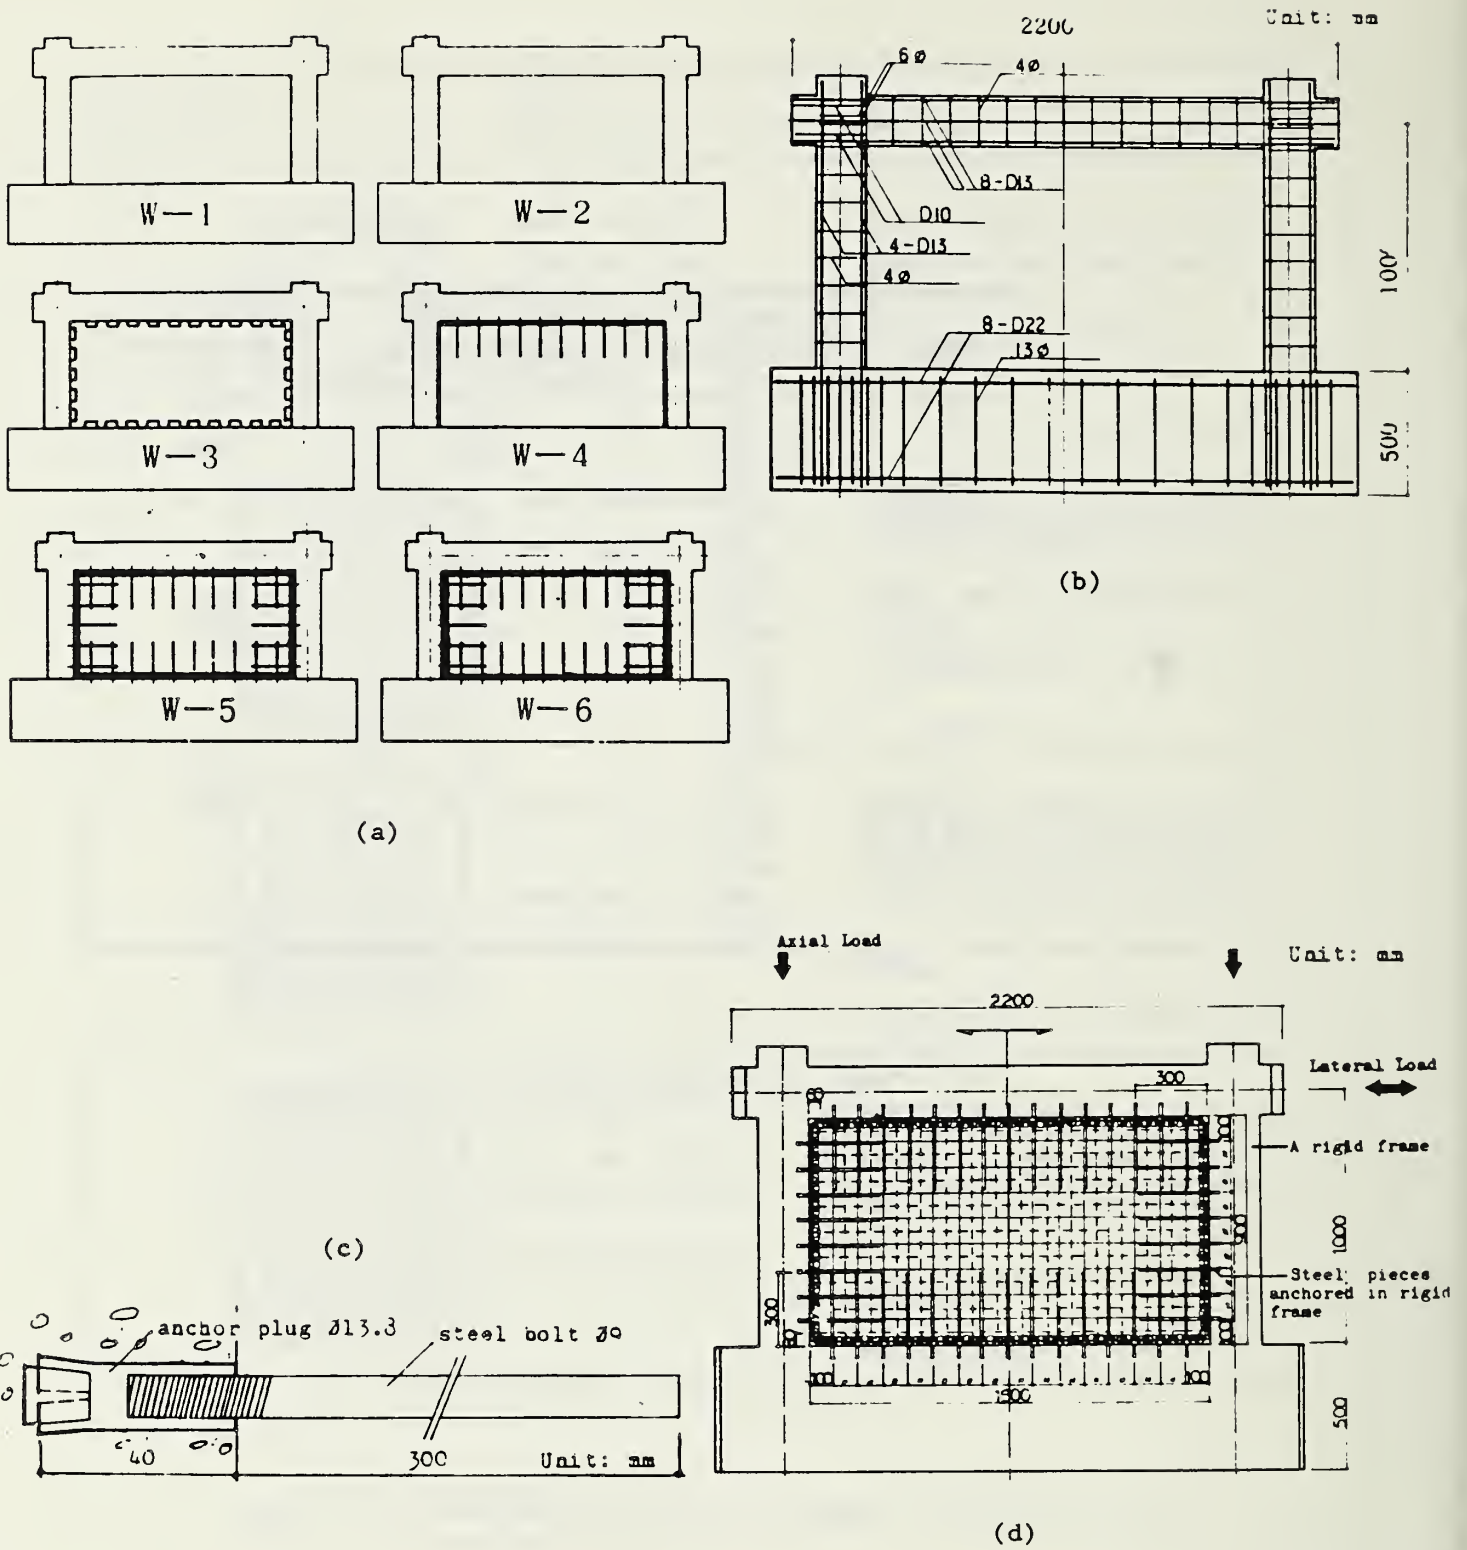
Figure 2.1 Hayashi, Niwa and Fukuhara's frame specimens [2.1].  
 a) Specimen configuration and strengthening concepts.  
 b) Reinforcement arrangement.  
 c) Sleeve expansion anchor used as joining element.  
 d) Reinforcing details of infilled wall.

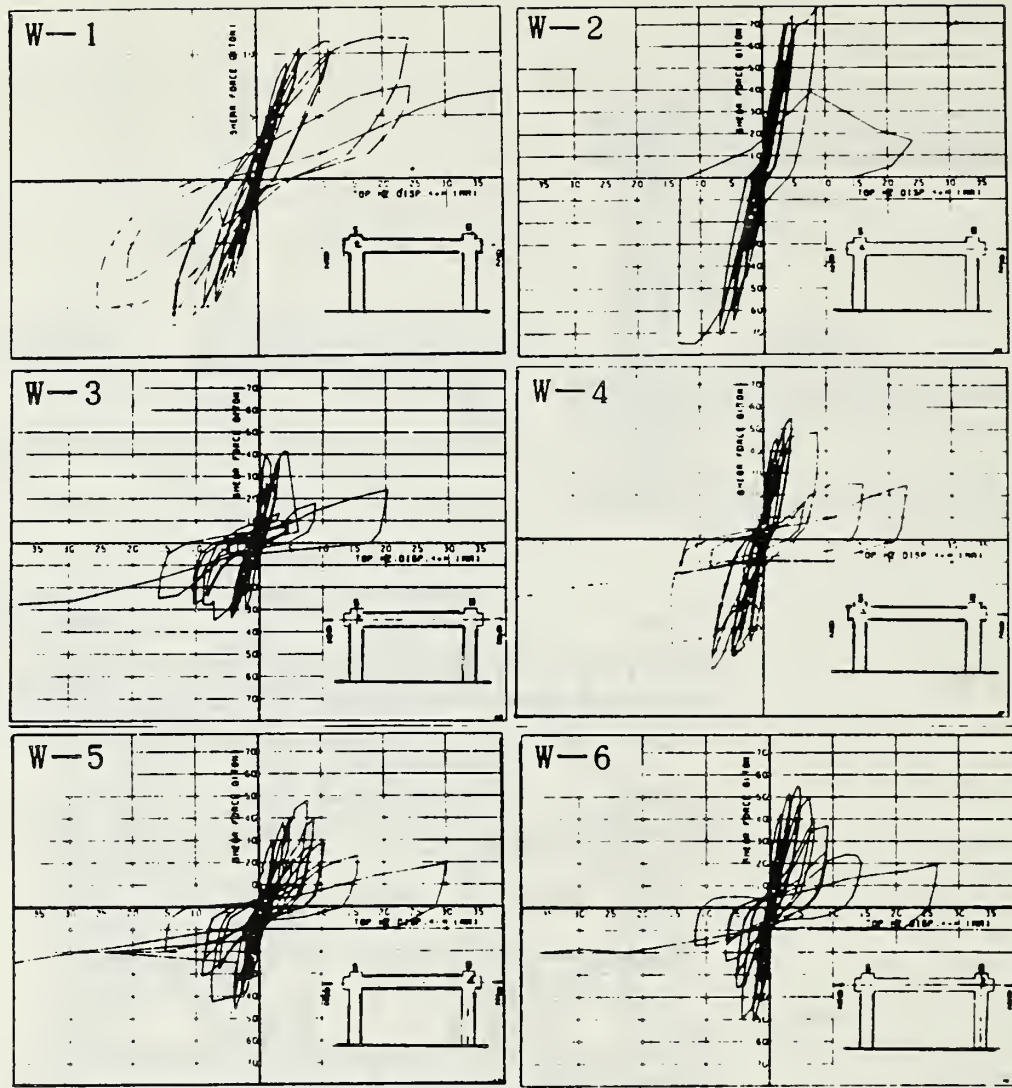
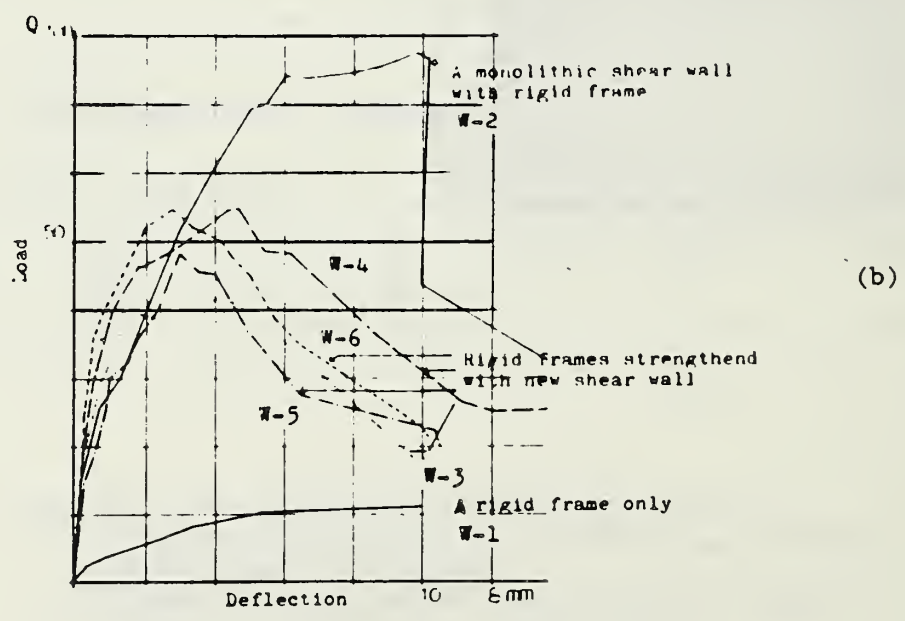
Figure 2.3 Hayashi et al's test results [2.1]  
 a) Hysteresis curves.  
 b) Envelopes of hysteresis curves.

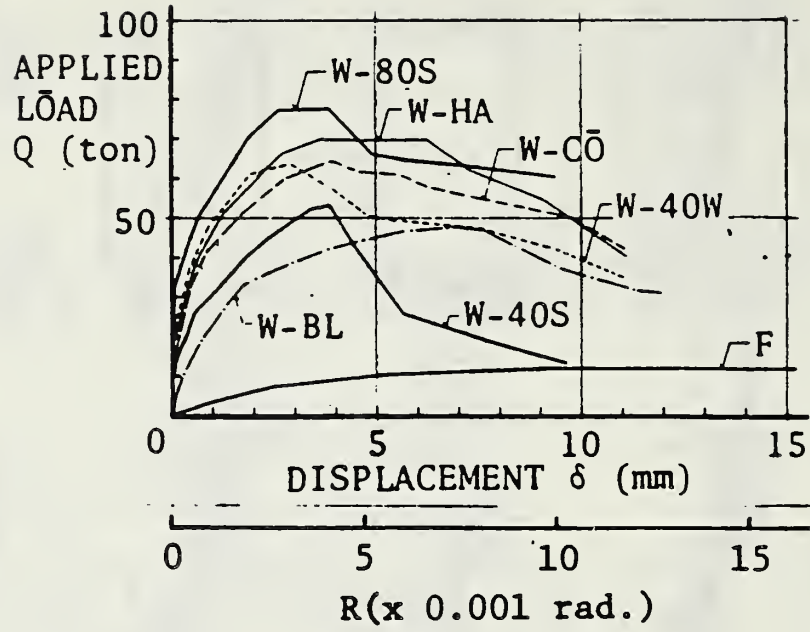
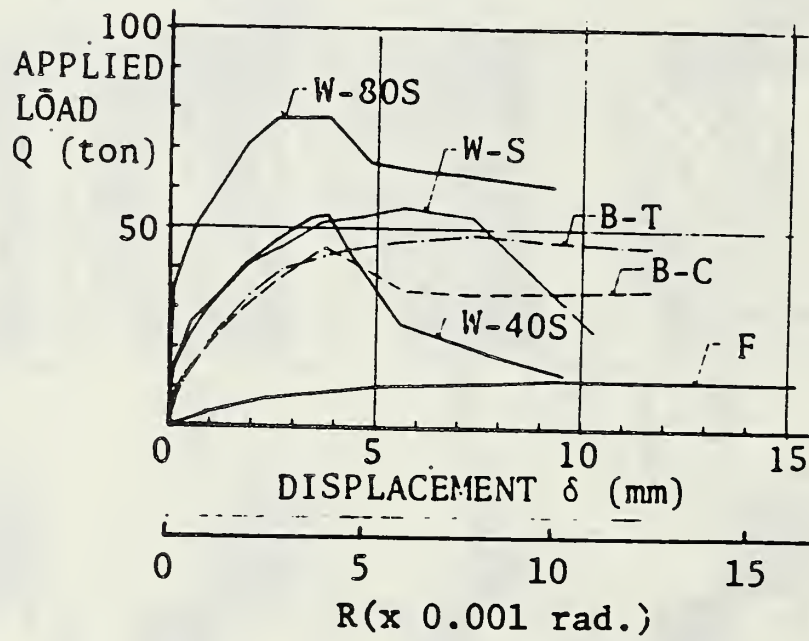
Figure 2.5 Envelopes of hysteresis curves [2.2].  
 a) Infilled frames.  
 b) Steel braced frames.

These braced frames were subjected to the same loading condition described in section 2.2.1, lateral reversed cyclic deformation in combination with axial stress of 13% the specified concrete strength. The test results are given in Table 2.2 and in Figures 2.4, 2.5 and 2.6.

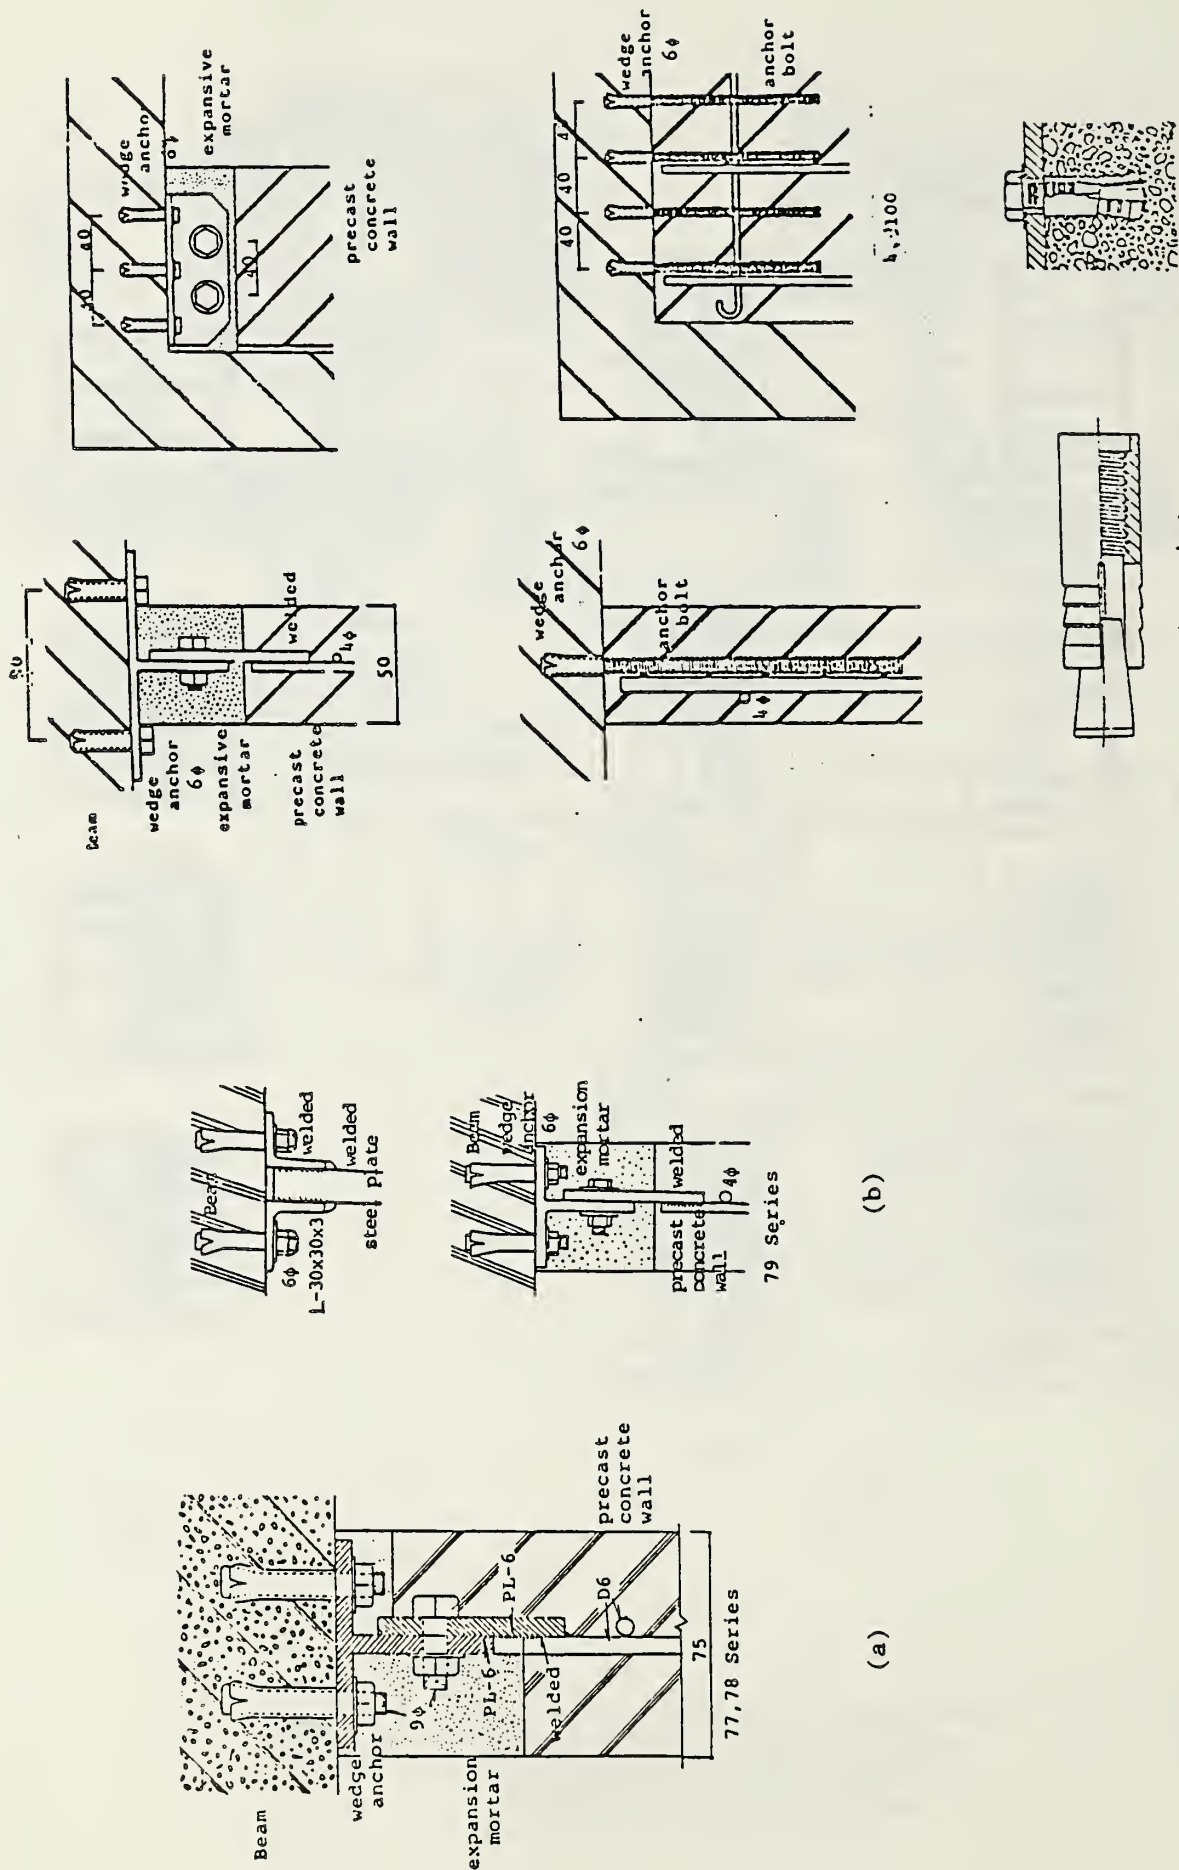
Figure 2.8 Details of the connection between infill wall and frame [2.3,2.7].

- a) 1977,78 series.
- b) 1979 series.
- c) 1981 series.

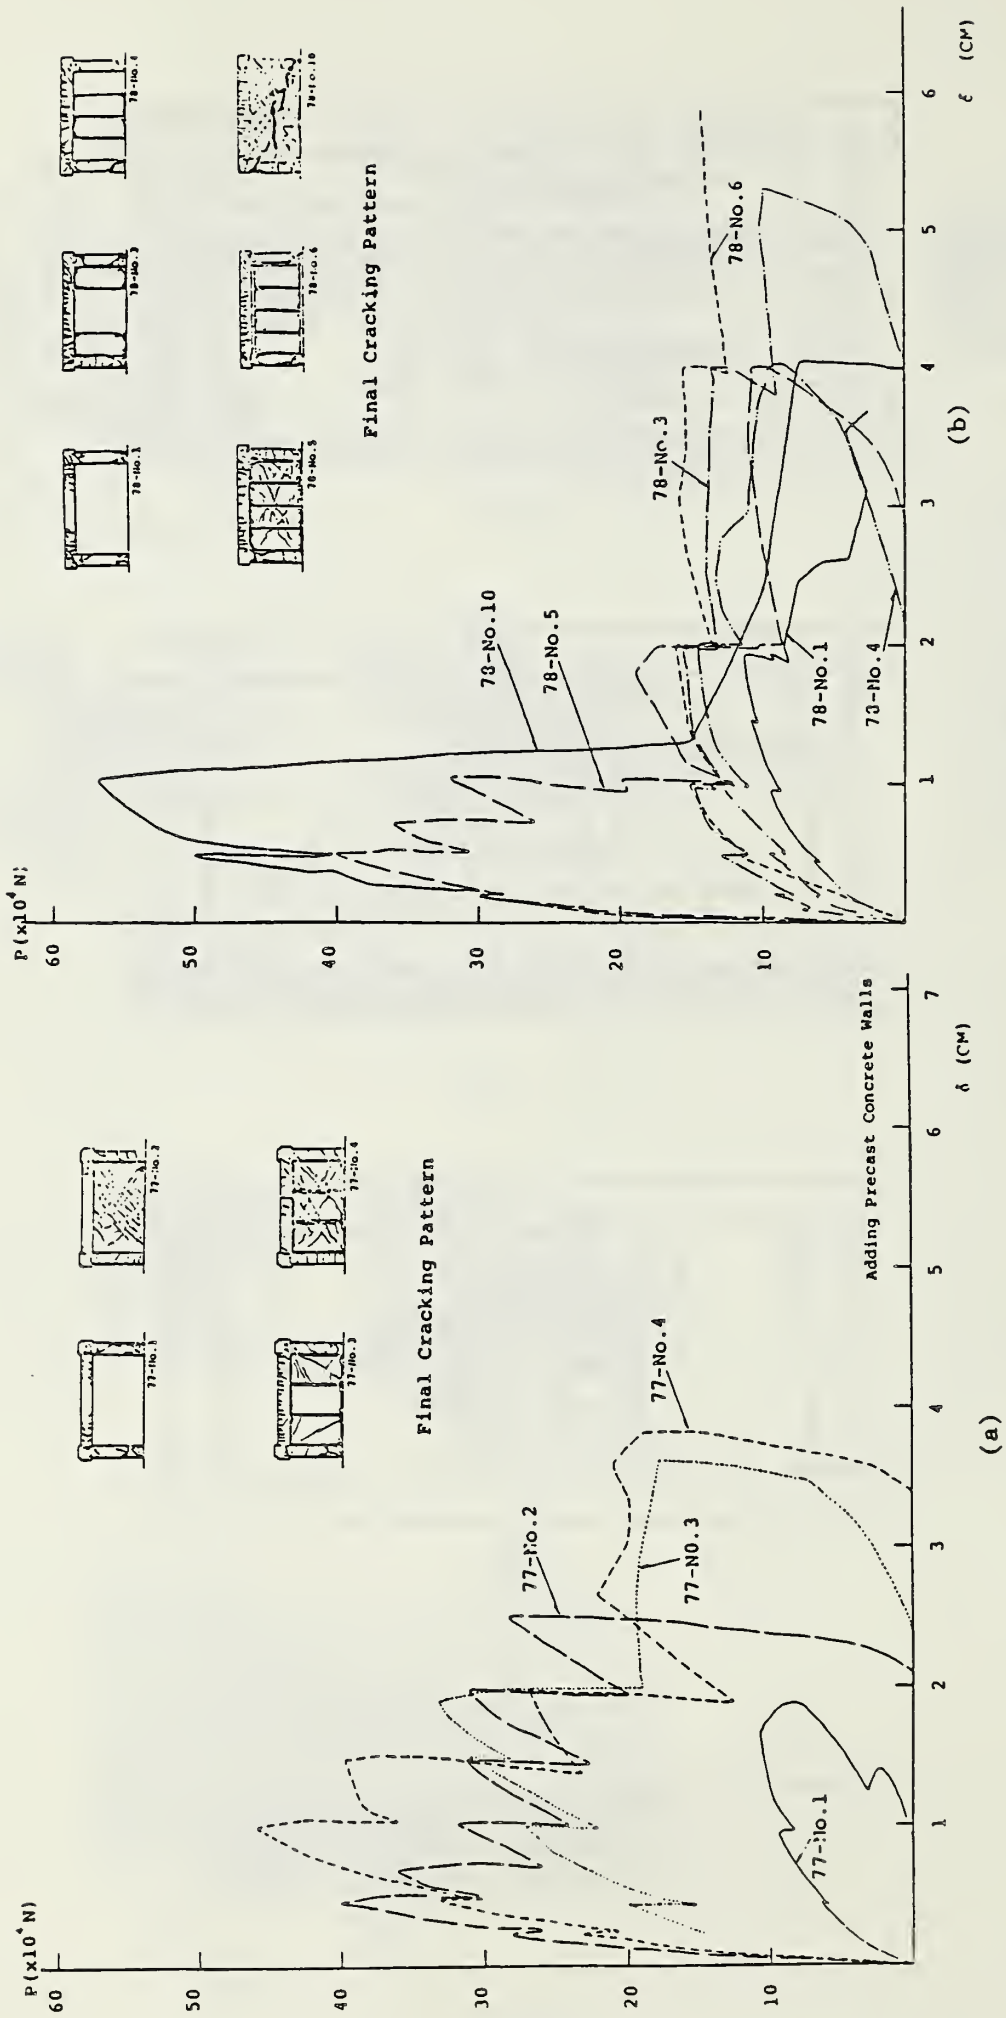
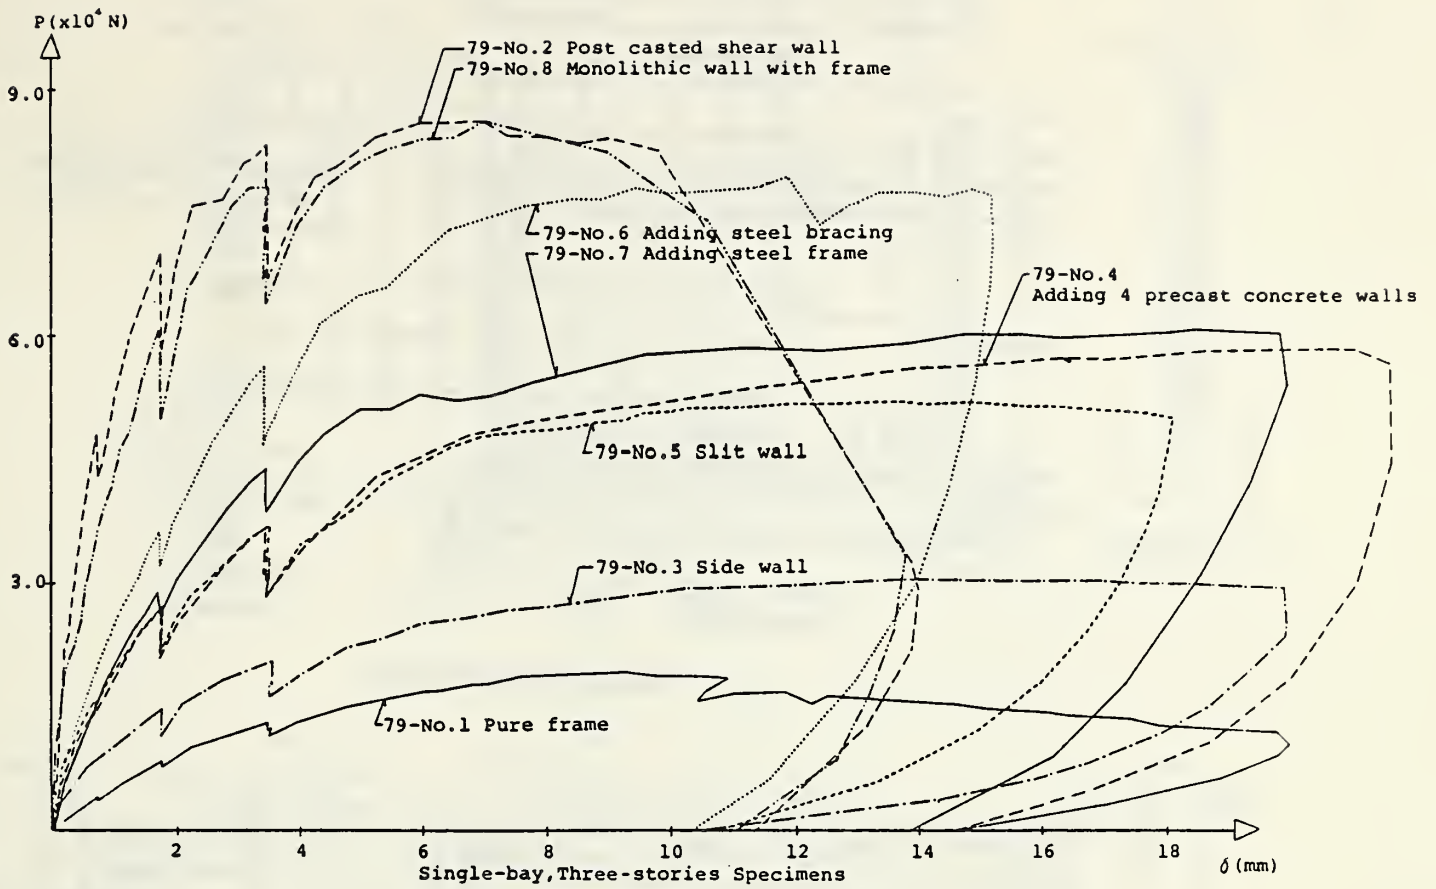
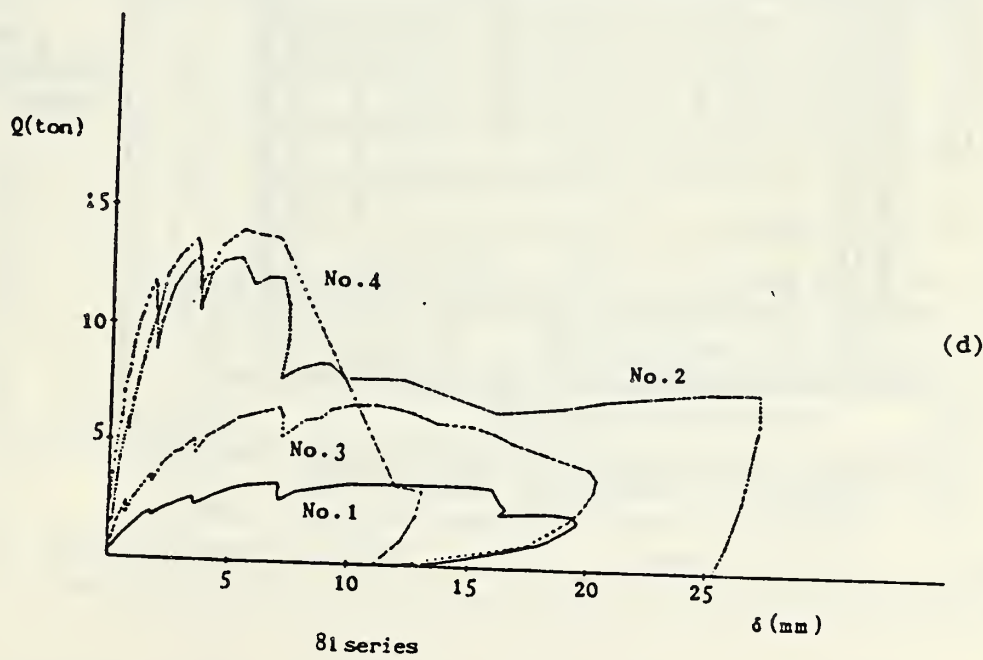
Figure 2.10 Envelopes of hysteresis curves [2.3,2.7]

- a) 1977 series.
- b) 1978 series.
- c) 1979 series.
- d) 1981 series.

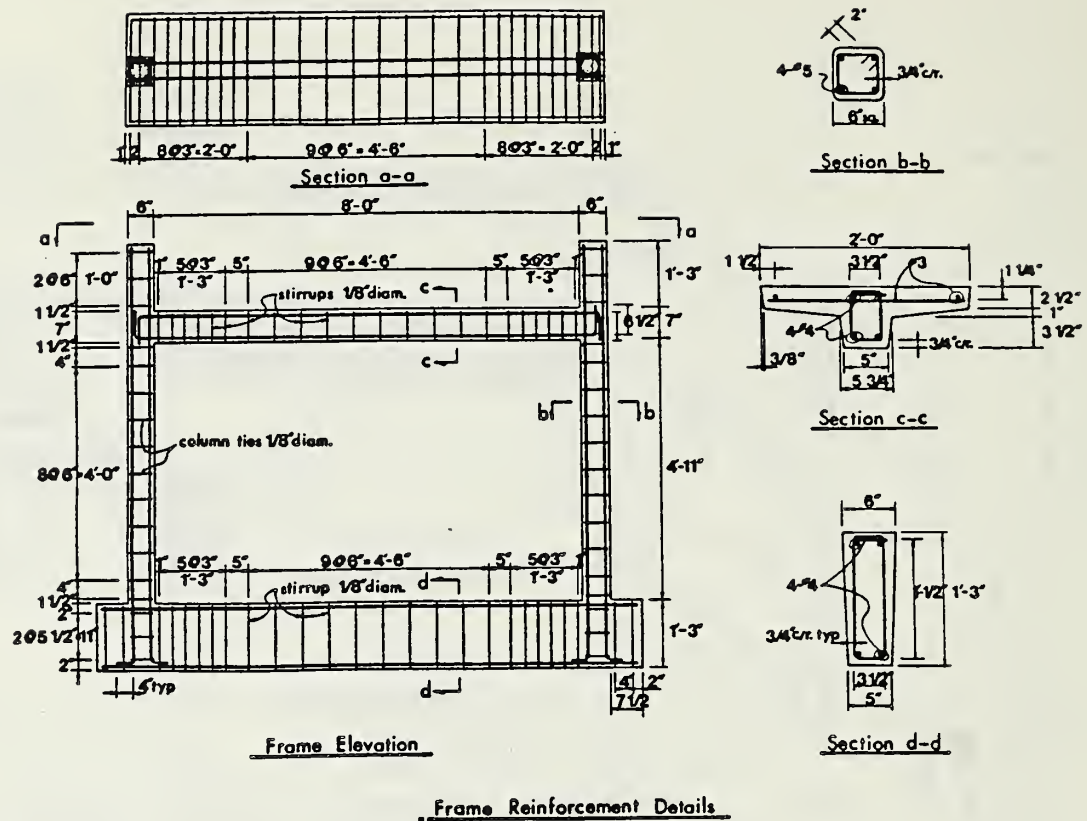
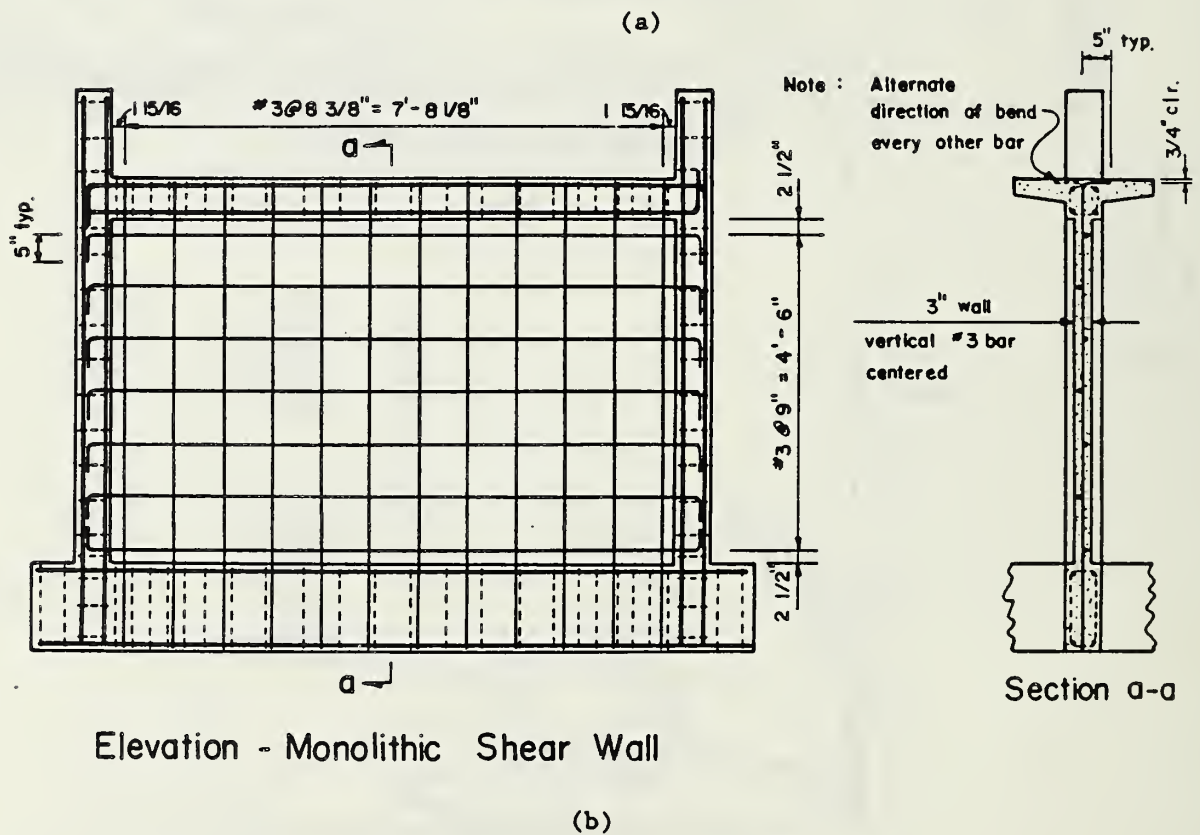
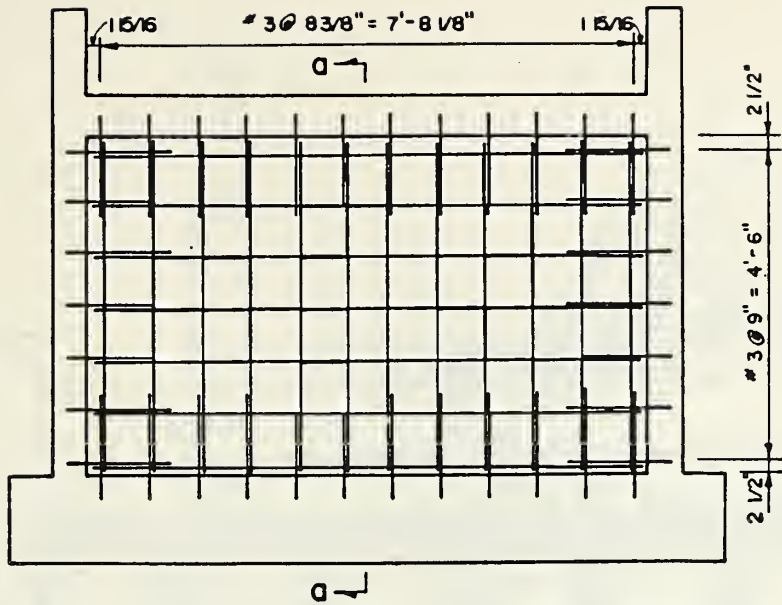
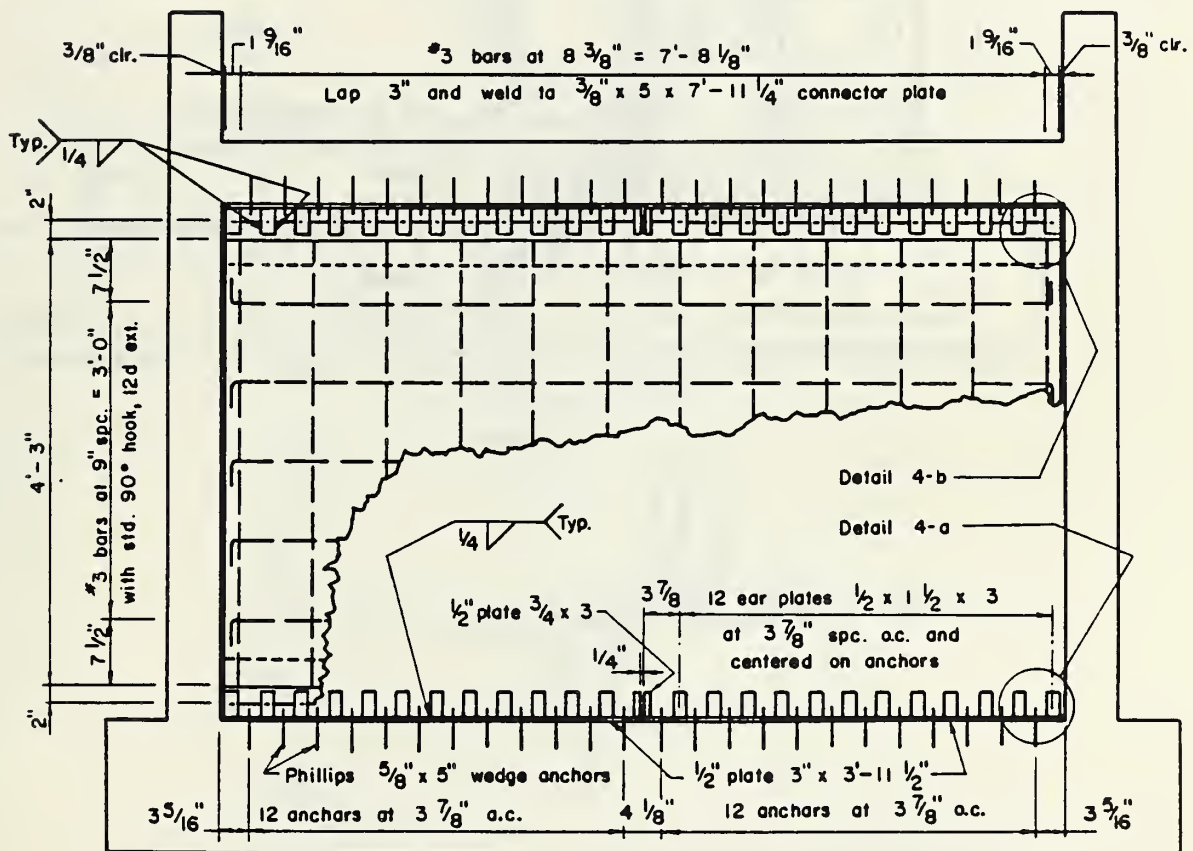
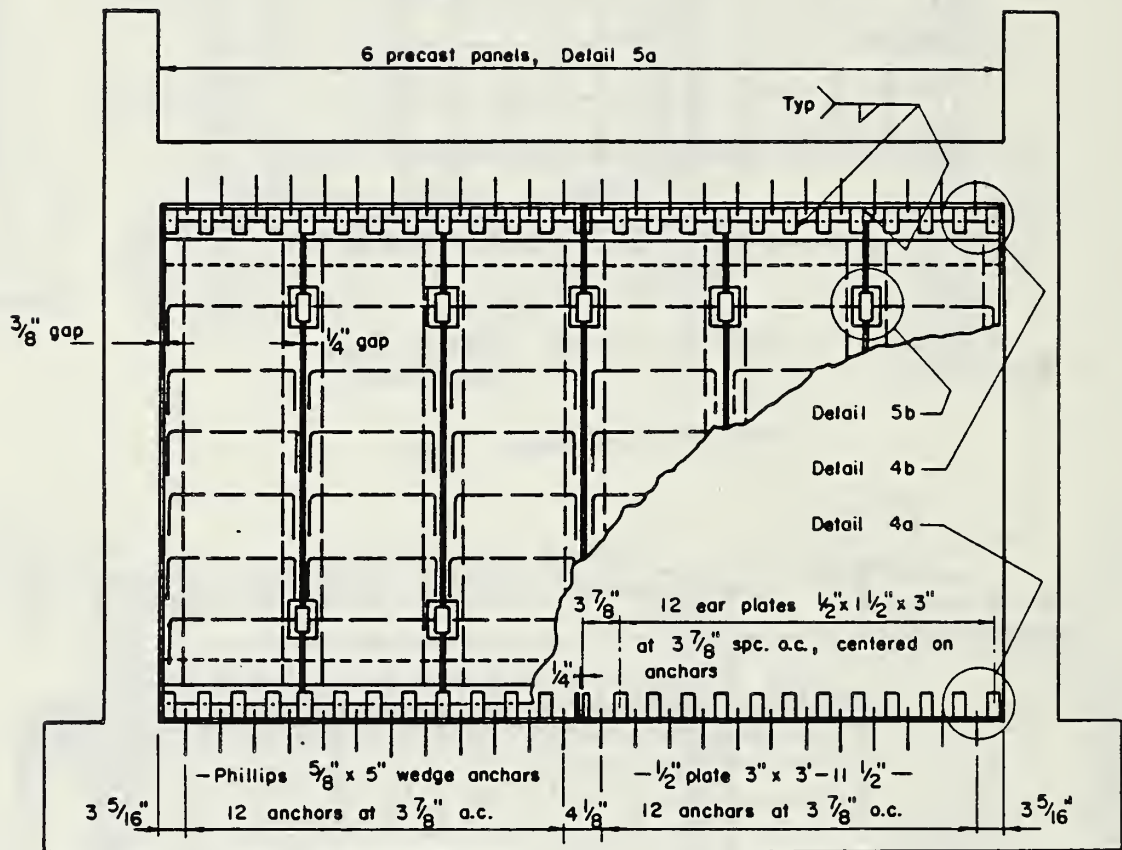
Figure 2.11 Reinforcement arrangement in Kahn's specimens [2.4]  
 a) Bare frame reinforcement details (specimen 2).  
 b) Monolithic shear wall reinforcing detail (specimen 1).  
 c) Cast-in-place infilled frame (specimen 3).  
 d) Single precast infill panel (specimen 4).  
 e) Multiple precast infill panels (specimen 5).

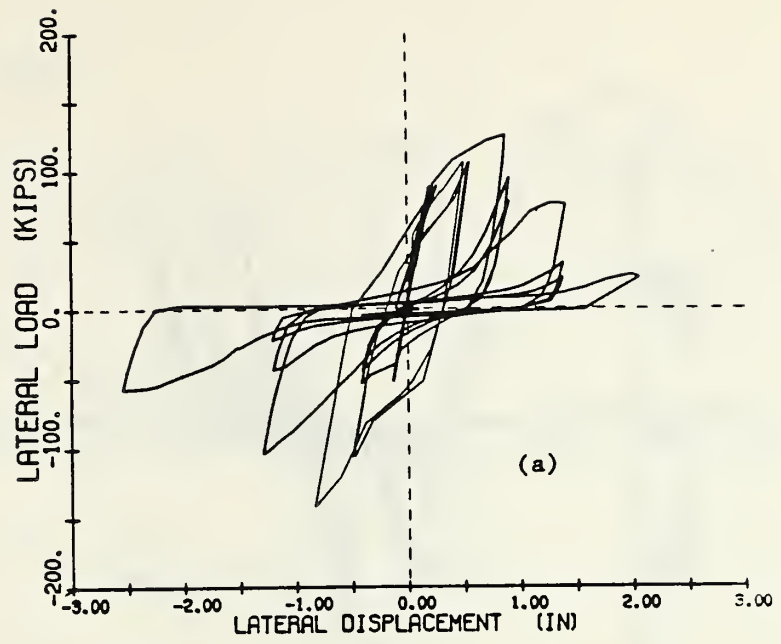
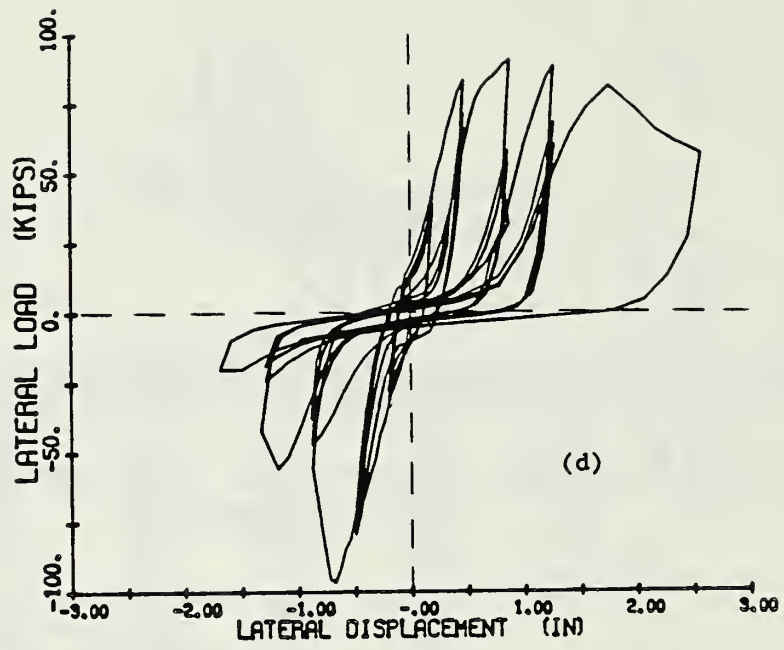
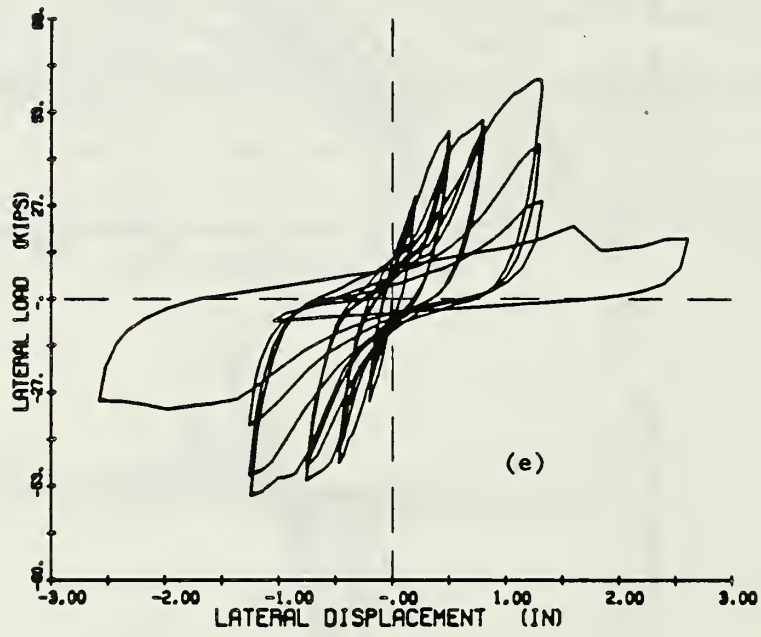
Figure 2.12 Hysteresis behavior of Kahn's specimens [2.4]  
 a) Specimen 1.  
 b) Specimen 2.  
 c) Specimen 3.  
 d) Specimen 4.  
 e) Specimen 5.

The monolithic wall/frame (specimen 1) showed the greatest lateral load carrying capacity of all specimens (150 kips). Failure occurred at a deflection 1-1/2 times the yield deflection in this specimen. Specimen 3 attained the same ultimate lateral load capacity. This specimen failed due to deterioration of the joint between the cast-in-place wall and the top beam. Brittle failure also occurred at a deflection of 1-1/2 times the yield deflection. Specimen 4 attained 75% of the lateral strength of the monolithic wall/frame (specimen 1), while its ductility was twice as large. This specimen maintained its maximum load over 3-1/2 times its yield deflection in one direction. In the other direction, weld fracture and pullout of the panel-to-frame connections caused rapid loss in load capacity and ductility. The multiple precast panels (specimen 5) attained 50% of lateral strength of the monolithic wall/frame. Four interior panels failed in shear. This specimen showed little cyclic degradation until the interior panels failed in shear at a relative deflection angle of 0.02 radians.

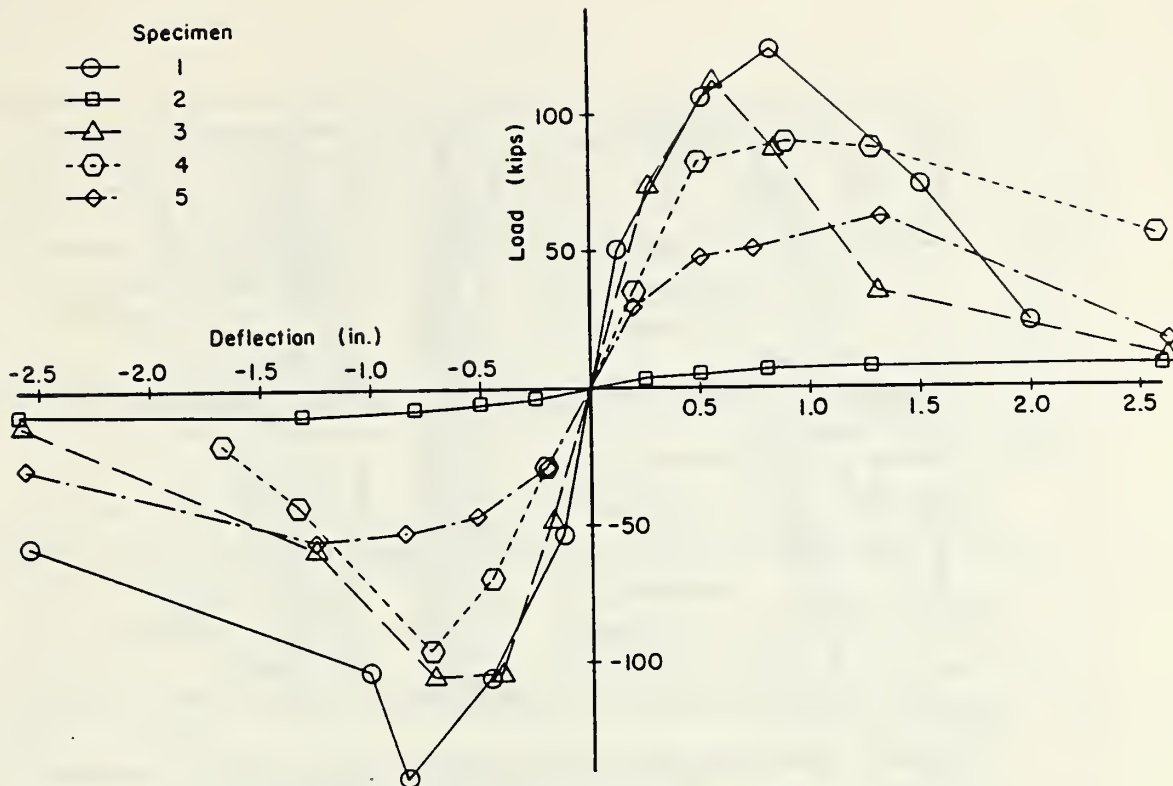
Figure 2.13 Envelopes of hysteresis curves of Kahn's specimen [2.4]

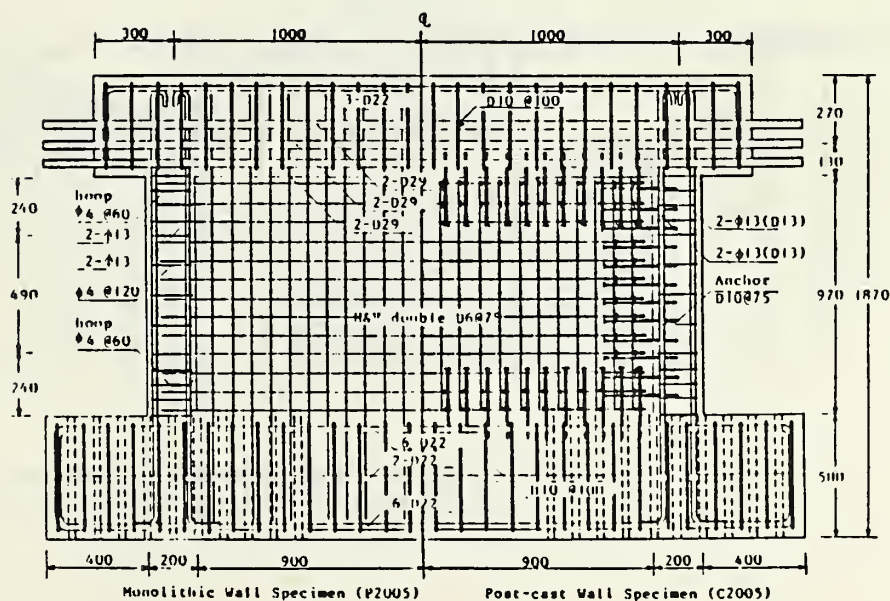
Figure 2.14 Dimensions and reinforcement arrangement of Shiohara et al.'s specimens [2.22]

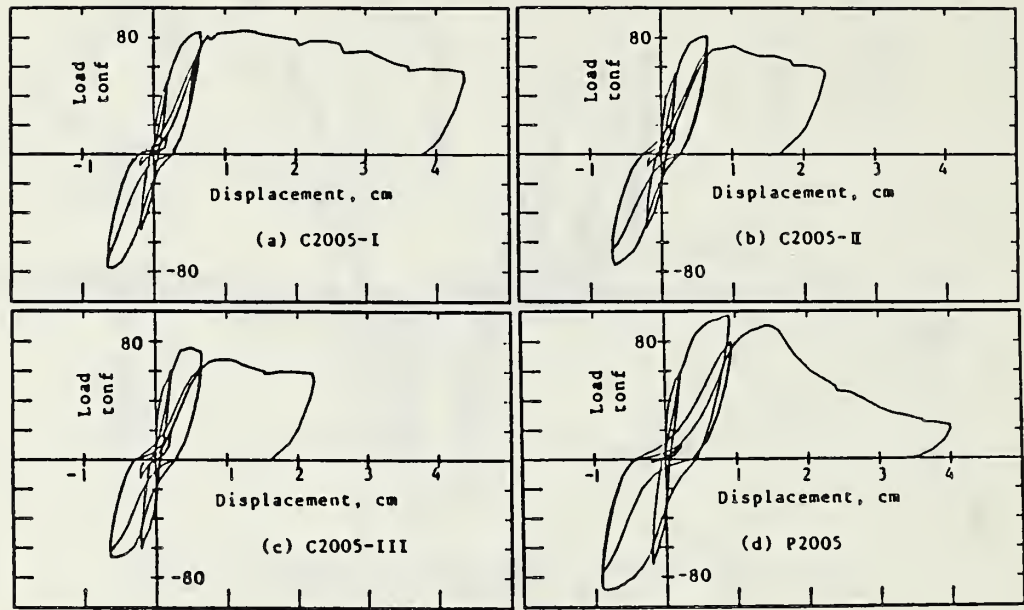
Figure 2.15 Hysteresis curves of Shiohara et al.'s specimens [2.22]

Figures 2.15 and 2.16 show the relationships between the lateral load and the horizontal displacement of girders relative to the bases, and the displacement components. The load-deflection curves (Figure 2.15) show that the infilled frames had lateral strengths of up to 0.77 to 0.86 times that of the monolithic wall/frame. The ductility factor as measured by the ratio of the yield displacement to the displacement at failure of specimen C2005-I which had deformed bars for flexural reinforcements was twice as large as those of specimens with plain round bars (C2005-II and C2005-III). Degradation of lateral force resistance was not observed in any of the specimens up to a deflection angle of 1/100 rad. The displacement component plots (Figure 2.16), composed of measured shear displacement, flexural displacement, and slip at the

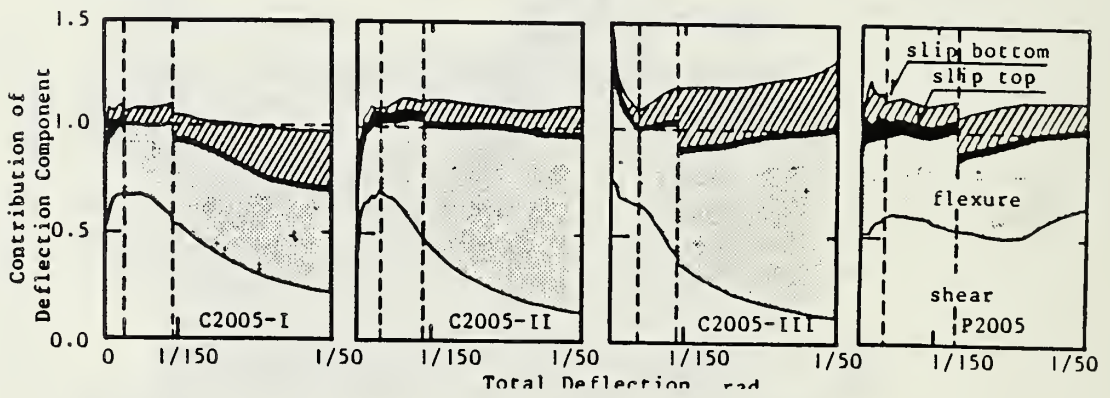
Figure 2.16 Measured displacement components of Shiohara et al.'s specimens [2.22]

interface between the girder and the infilled wall, showed that shear deformation accounted for 60-70% of total deflection up to a deflection angle of  $1/150$  rad. The remainder was mainly due to flexure deflection. As the specimens were further deformed, deflection due to shear gradually decreased while shear slip on the girder/wall interface increased until ultimate failure occurred. A lower strength observed in the infilled frames when compared with that of the monolithic wall/frame was attributed to pull-out failure of splice bars under combined tension and shear. The embedment depth of the splice bars had little affect on the strength and slippage at construction joints between the wall and the frame.

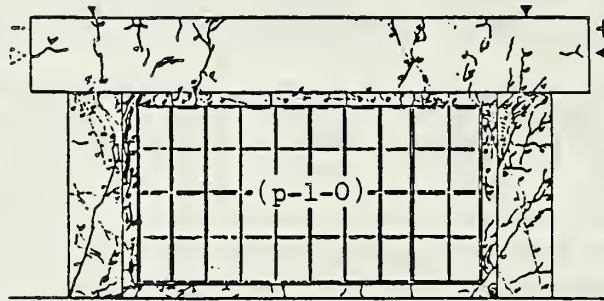
Figure 2.19 Crack patterns in Aoyama et al.' test specimen P-1-0 [2.23].

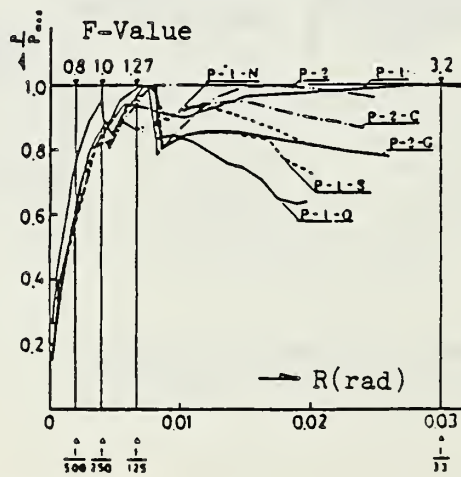
Figure 2.20 Deflection envelopes of Aoyama et al.'s test specimens [2.23].

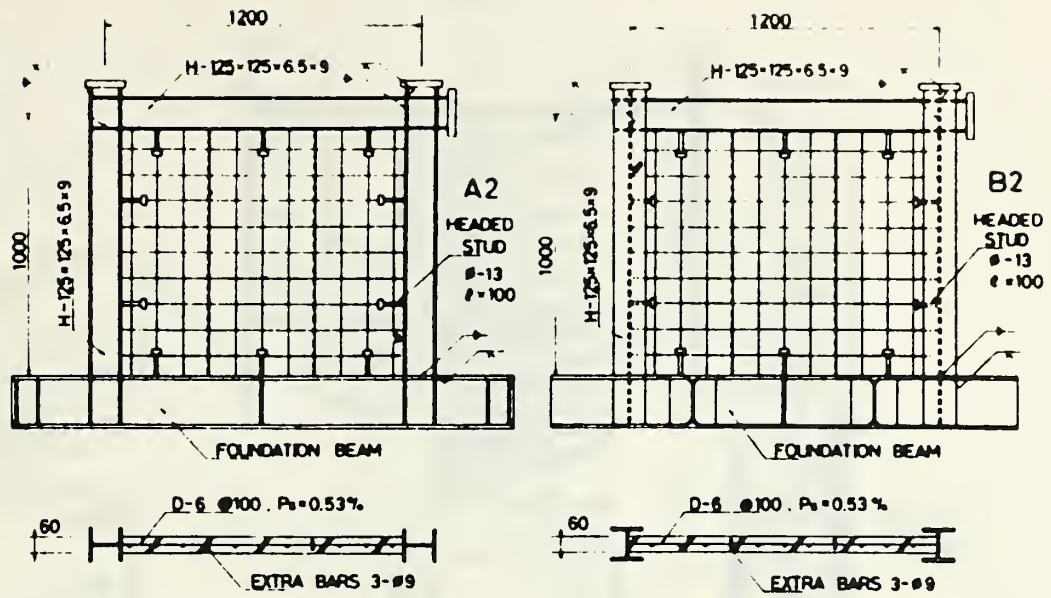
Figure 2.21 Makino et al.'s steel frame specimens A2 and B2 [2.5].
