NBSIR 88-3796

# Literature Review of Strengthening Methodologies of Existing Structures

June 1988

This report reviews research studies relevant to structural strengthening of existing reinforced concrete members and frames. The majority of these studies dealt exclusively with restoring or improving seismic resistance of concrete columns and frames. A number of case histories where various strengthening techniques were applied in practice are reviewed. Most studies identified ultimate failure in the strengthened structures as being primarily due to failure of the joining elements. Improved load resistance and ductility in concrete structures have been reported in most of these studies.

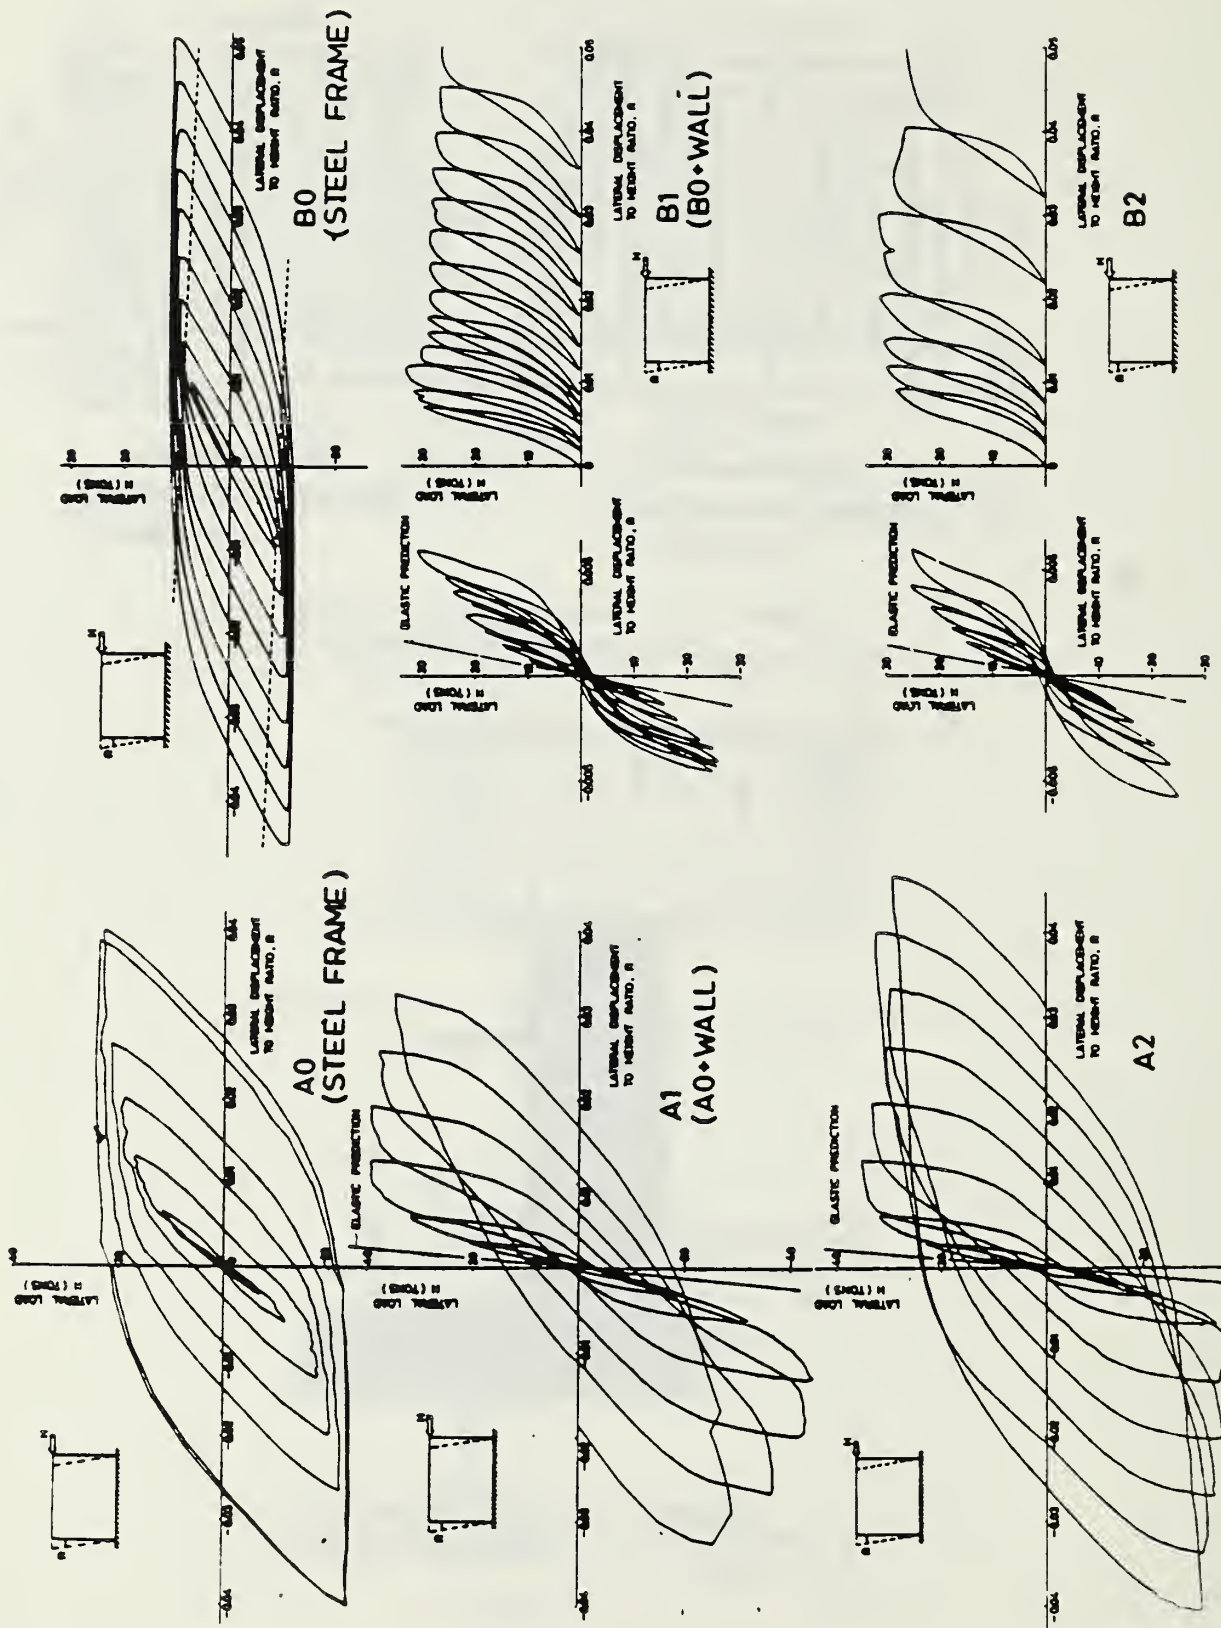
Figure 2.23 Hysteresis curves of original and strengthened frames [2.5].

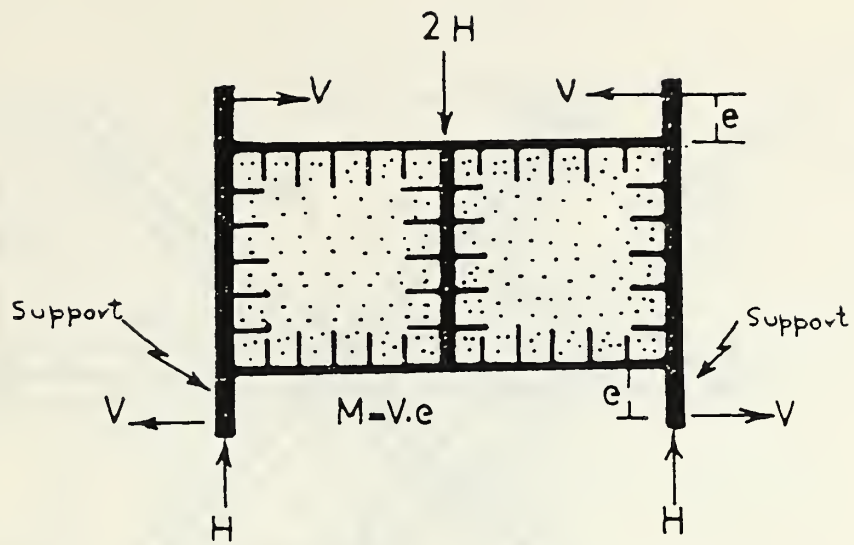
Figure 2.24 Mallick's test frames [2.6].

(8) The effect of combined axial and lateral loads on the behaviors of steel frames with infilled walls was investigated by Mallick [2.6]. Tests were conducted on a series of two-bay steel frames infilled with cement mortar panels, with and without shear connectors. The combined loading, applied at the joints as shown in Figure 2.24, consisted of vertical (V) and lateral (H) loads, and moment produced by the vertical load with an eccentricity (e). The frames were loaded so that a rigid base condition could be achieved along the central member as shown in Figure 2.24. The vertical load and the associated moment were applied by prestressing a high strength steel rod 0.2 in. (5 mm) in diameter passing through the extended arm of the steel frame. The lateral load was applied gradually by a hydraulic jack. Mallick found that, in general, the infilled frames with shear connectors were laterally stiffer than those without shear connectors up to the failure load. Further, the frames behaved linearly until the first tension crack occurred in the

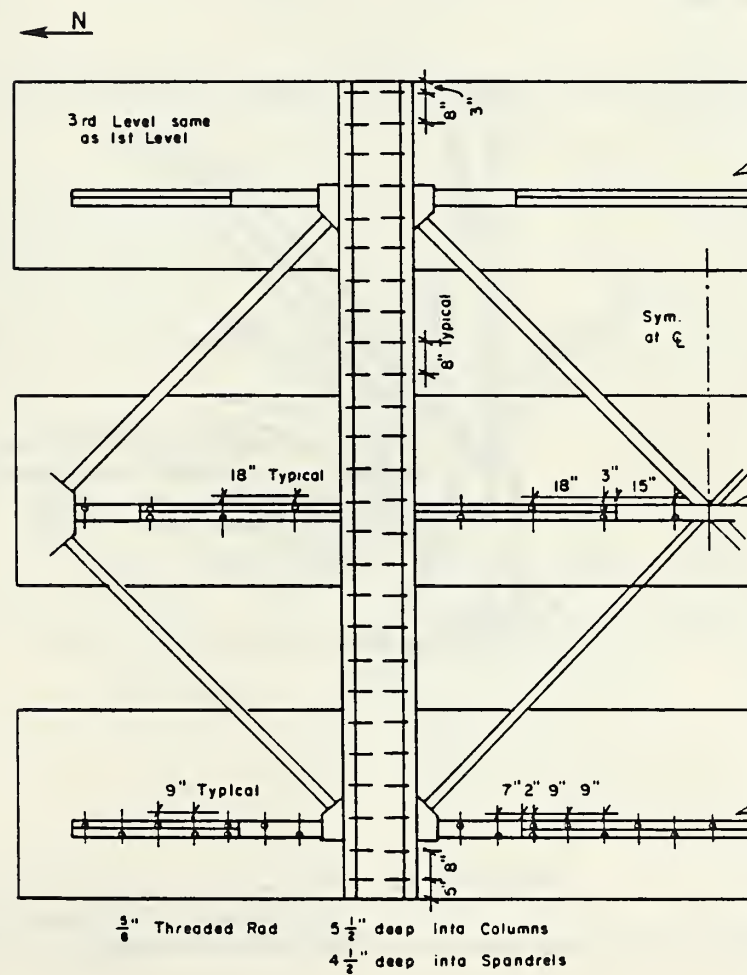
Figure 2.25 Dowel layout for Jones and Jirsa's steel bracing scheme [2.8,2.9].

The strengthening scheme adopted in this study involved the attachment of structural steel diagonal bracings to the exterior of the damaged frame through use of 5/8 in-diameter (16 mm) standard threaded dowels. The dowels were epoxy grouted into the concrete frame at locations along the columns and the spandrel beams. The vertical channels (MC6x15.1) were bolted to the sides of the concrete columns by dowels placed at 8 in. (20 cm) intervals and embedded 5-1/2 in. (14 cm) deep. The horizontal collector sections (WT3x6) were connected to the spandrel beams by dowels embedded 4-1/2 in. (11.4 cm) deep at 9 in. (23 cm) interval in the first and the third floors and 18 in. intervals in the second floor. With the column channels and beam collectors in place, all threaded dowels were tightened to a uniform torque of 75 ft-lb (102 N-m). The layout of dowels is shown in Figure 2.25, and the connection details of brace members are shown in Figure 2.26.

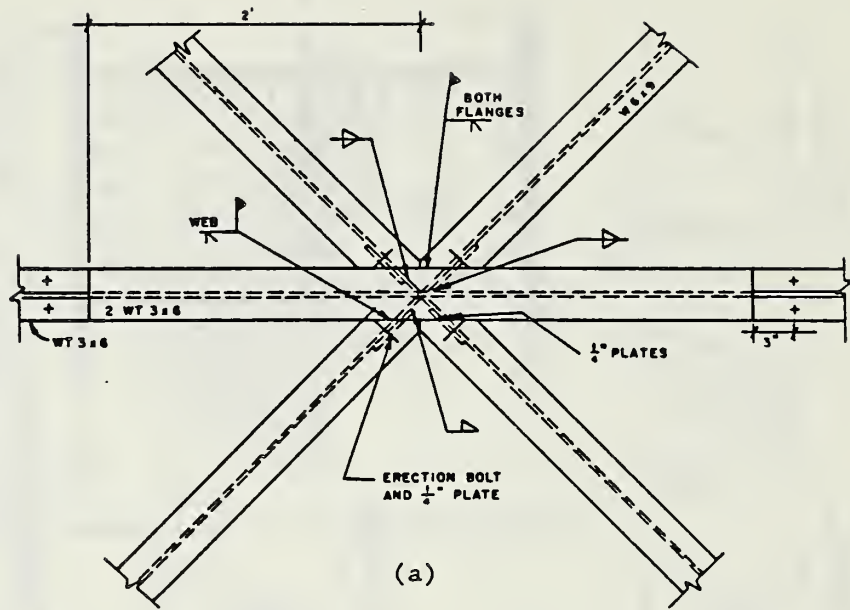
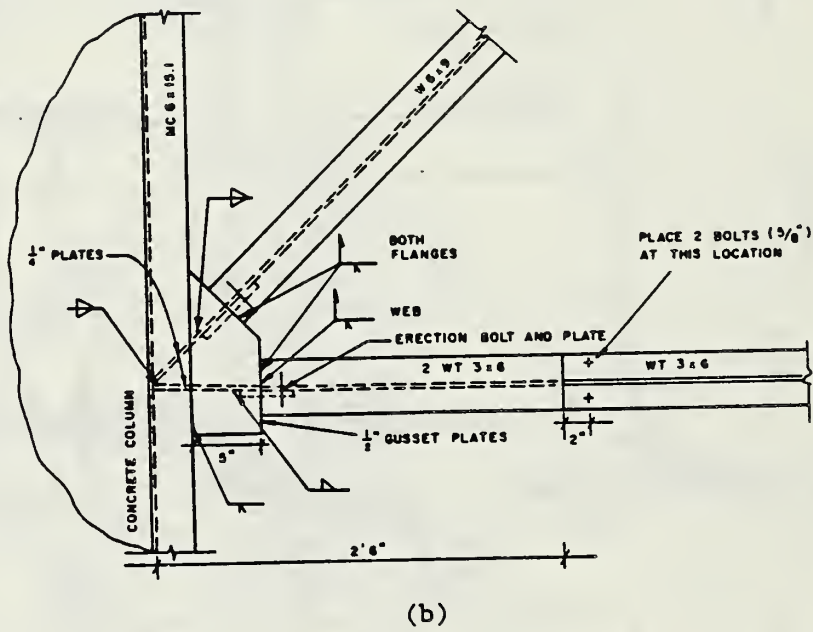
Figure 2.26 Connection details [2.8,2.9].  
 a) Brace-to-collector connection.  
 b) Brace-to-channel connection.

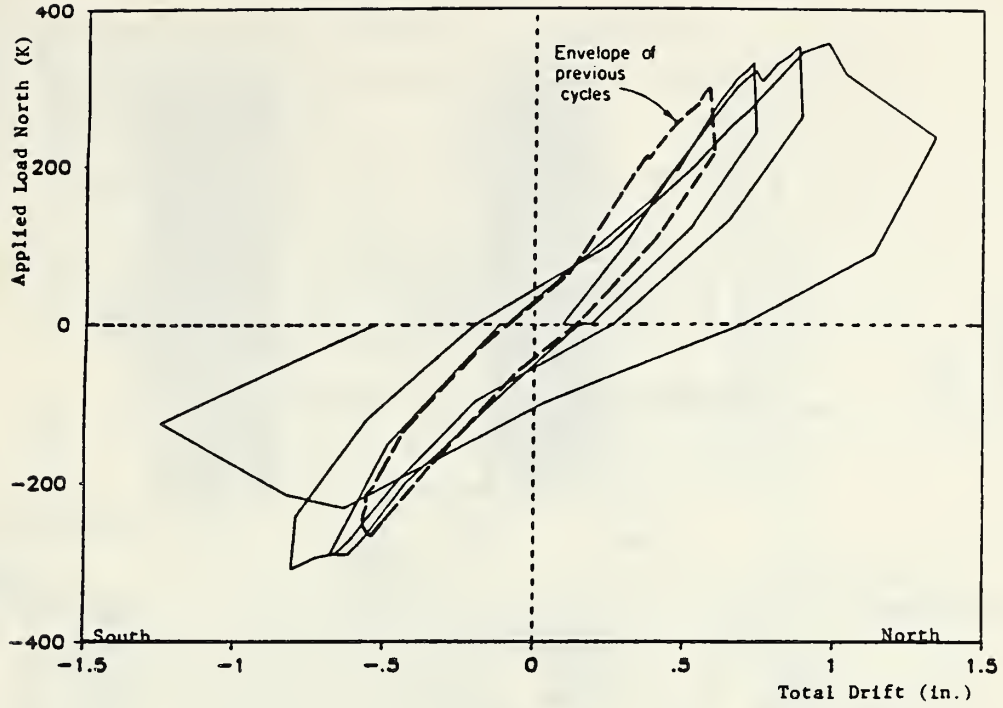
Figure 2.27 Load-drift relationship of the steel braced frame [2.8,2.9].

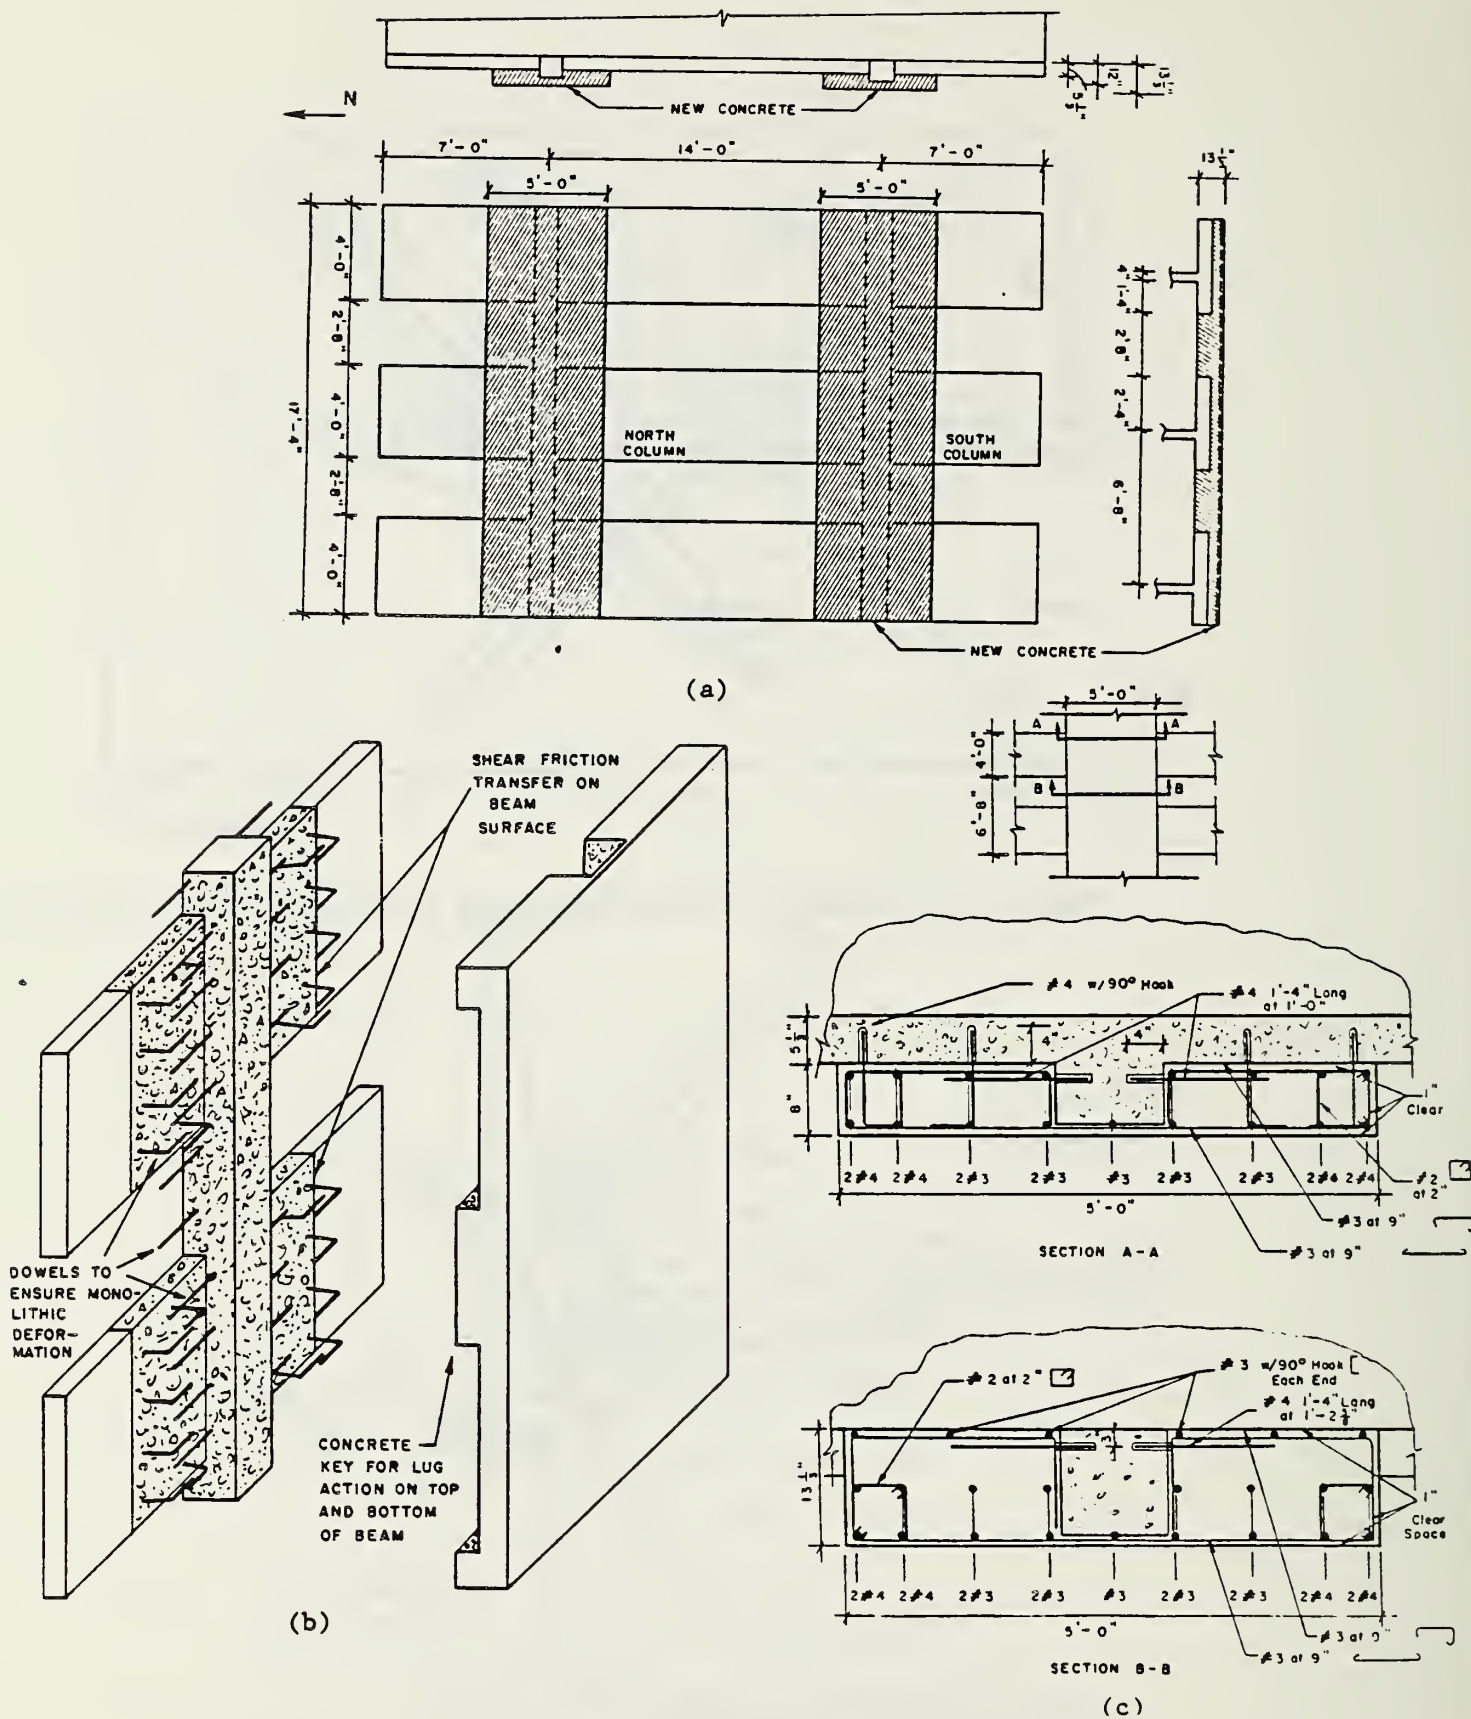
Figure 2.29 Roach and Jirsa's strengthening scheme [2.9,2.10].  
 a) Strengthening concept.  
 b) Connection mechanism between old and new concrete.  
 c) Reinforcing details.

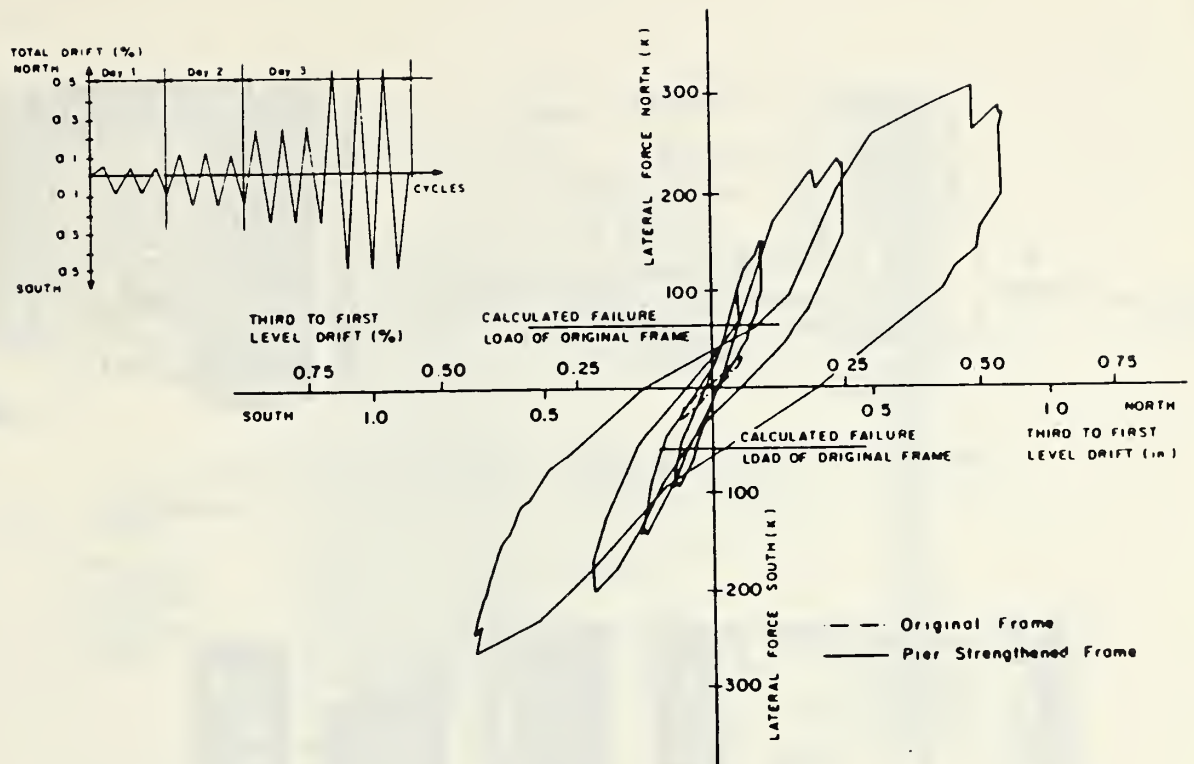
Figure 2.30 Hysteresis curves [2.9,2.10].

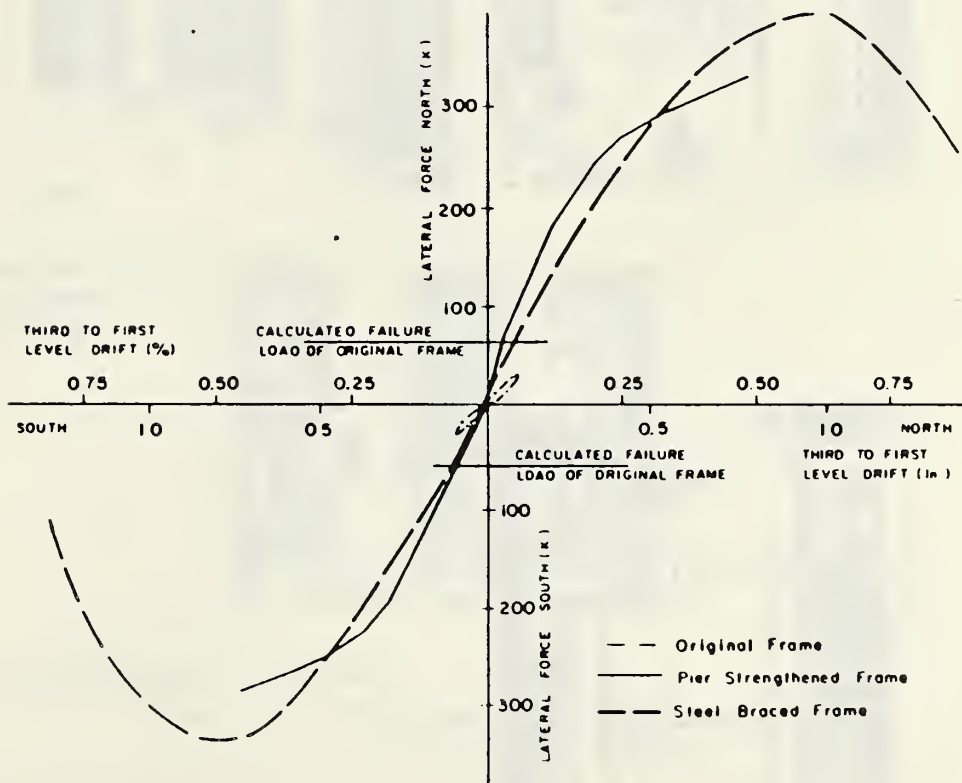
Figure 2.31 Envelopes of hysteresis curves of frames strengthened by adding wingwall and steel bracing [2.8,2.9,2.10].

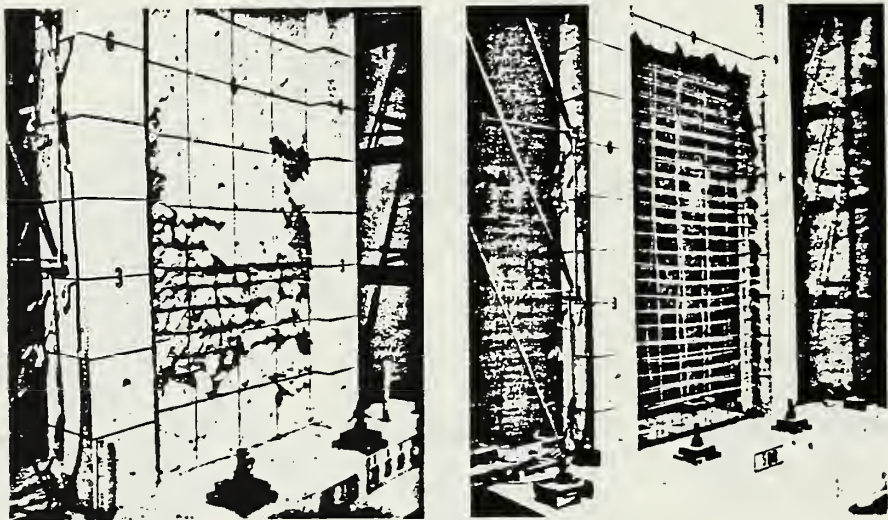
Figure 2.33 Specimen B5 with damaged web and with web concrete removed.

In specimen B5, the damaged web concrete was removed up to the 8 ft-6 in. (2.6 m) level. The criterion used was to remove all concrete that could be taken out easily with hand tools. Reinforcing steel was left intact and no new reinforcement was added. New concrete of the same thickness of 4 in. (10 cm) was then cast in vertical lifts of 3 ft (0.9 m). The gap between the top portion of new concrete and old wall was handpacked with concrete. The repaired specimen was named B5R. Figures 2.33 and 2.34 show the damaged specimen B5R with web concrete removed and the same specimen after completion of repairs.

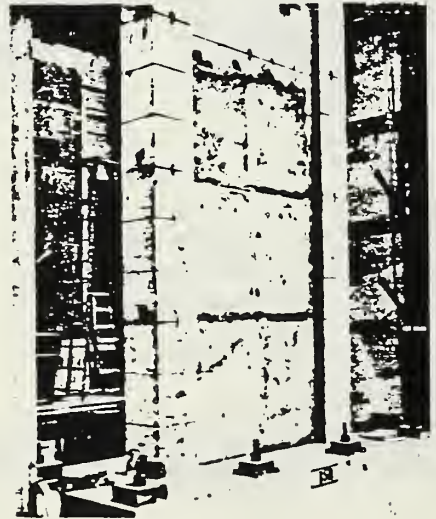
Figure 2.34 Specimen B5R after repair.

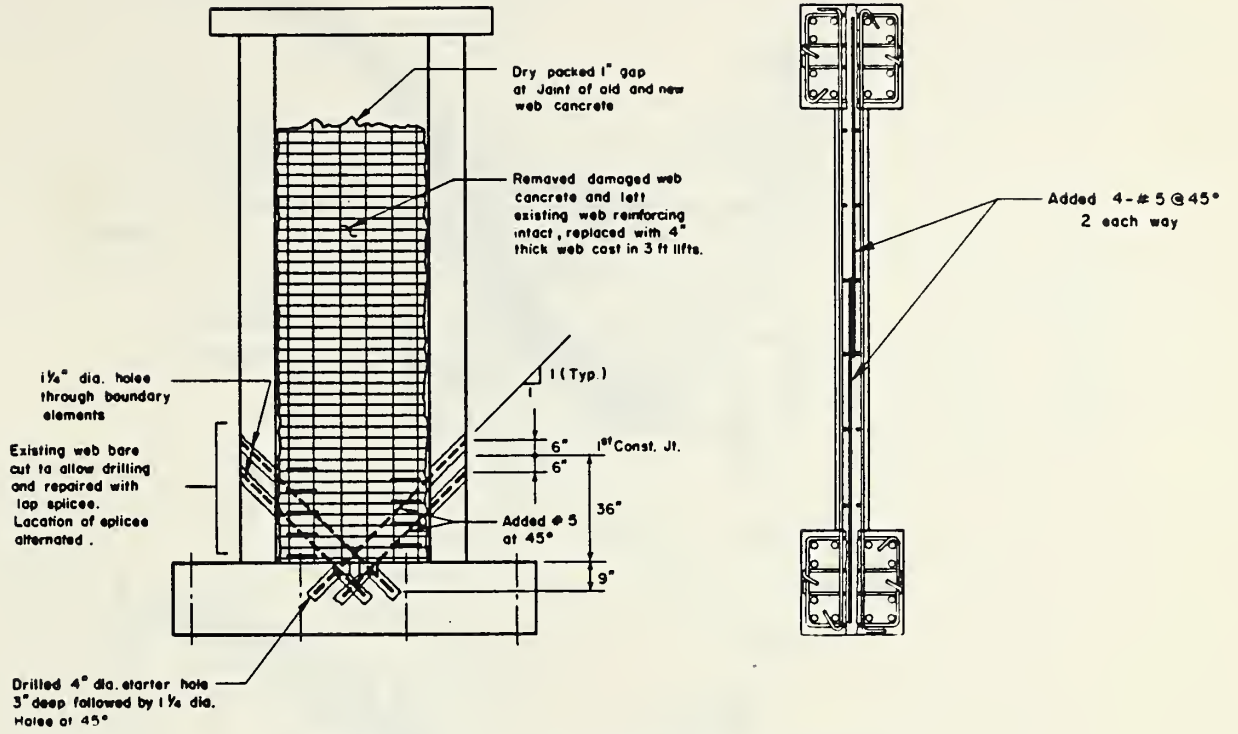
Figure 2.35 Reinforcement arrangement in specimen B11R.

In specimen B11, not only was the damaged web concrete replaced using the same repair procedures as in specimens B5R and B9R, but additional diagonal reinforcement was also added. Prior to replacing the damaged web concrete, #5 diagonal rebars were inserted through the boundary columns at a 45° angle and into predrilled holes in the base block. The bars were then epoxy grouted. Figures 2.35 and 2.36 show the drilling techniques for the diagonal holes and the arrangement of reinforcement in specimen B11R.

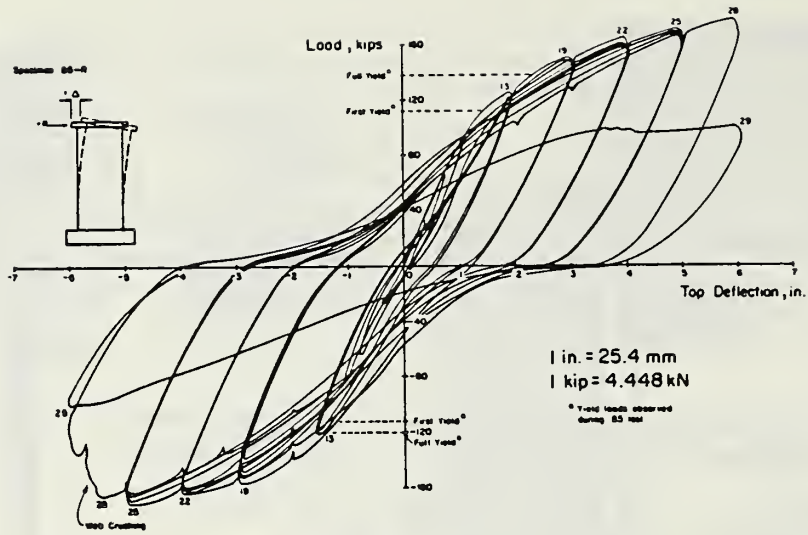
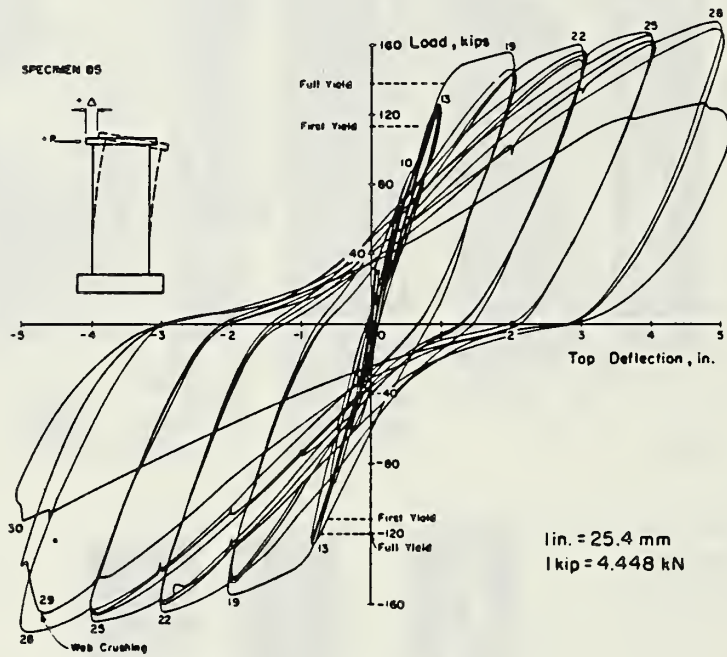
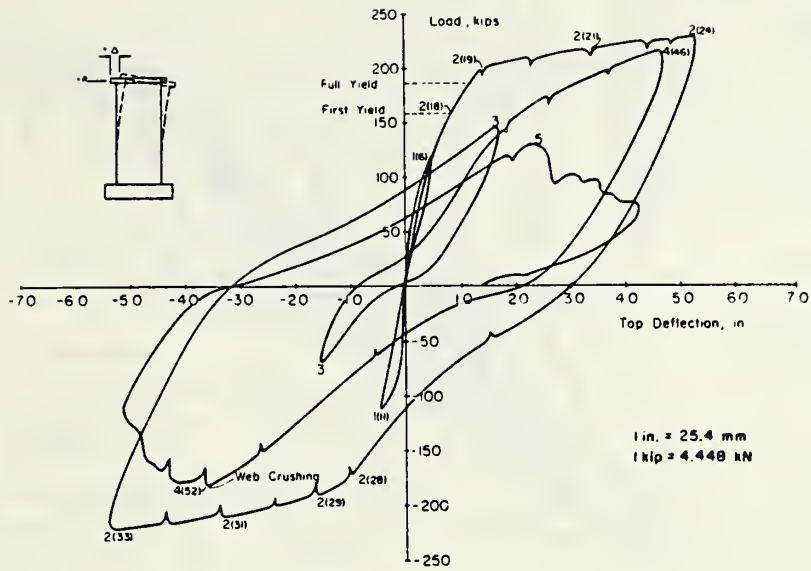
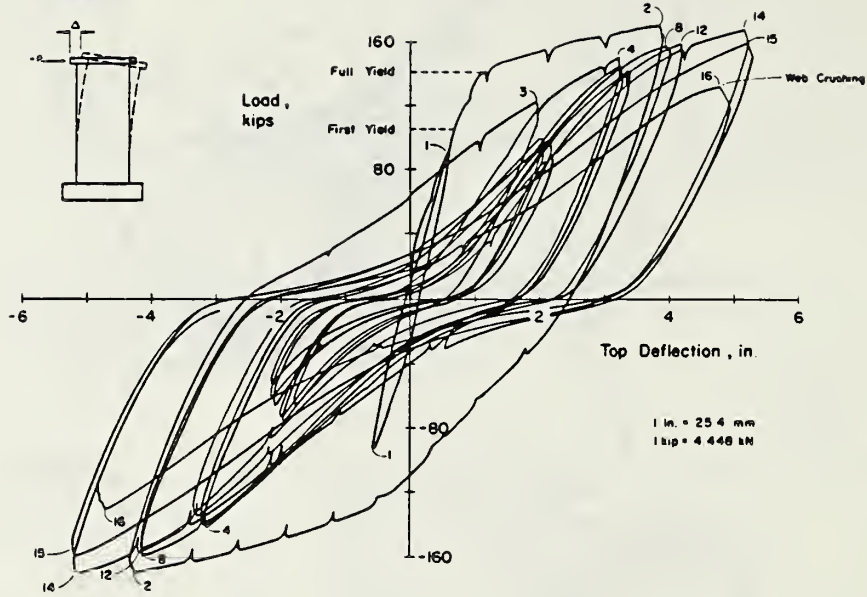
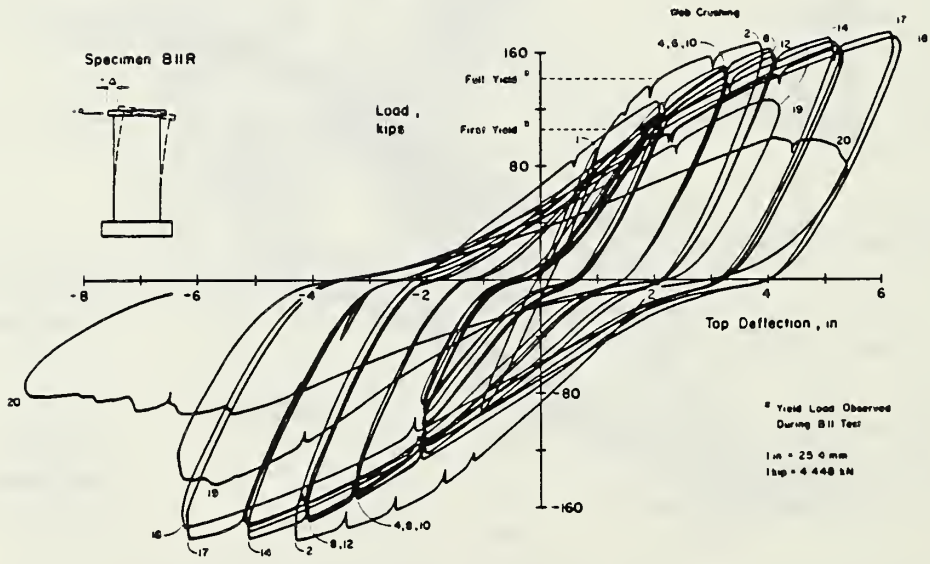
Figure 2.37 Hysteresis curves of Corley et al's original and repaired specimens [2.12].

- a) Specimens B5 and B5R.
- b) Specimens B9 and B9R.
- c) Specimens B11 and B11R.

The repaired specimens were subjected to the same loading condition as the original specimen. The test results, presented along with the ACI code predictions for flexural and shear strengths of the walls, were summarized in Table 2.6. The hysteresis curves of all 6 specimens were given in Figure 2.37.

Examination of the results of specimens B5 and B5R indicated that replacement of the original damaged web concrete was an effective repair. Both the lateral strength and stiffness were successfully restored. For specimen B9R, replacing the original damaged web by a thickened web resulted in a significant increase in deformation capacity. The original specimen B9 was able to sustained only 1-1/2 inelastic cycles, with a maximum rotation corresponding to five times yield. However, the repaired specimen B9R was able to sustain 8-1/2 inelastic cycles, with a maximum rotation corresponding to six times the yield rotation in specimen B9. The ultimate strength of B9R was about equal to that of B9. For specimen B11R, the addition of diagonal reinforcement resulted in an increase in maximum nominal shear stress of approximately 18%. However, the initial stiffness of all three repaired walls were only approximately 50% of those of the original walls. This reduction in stiffness should

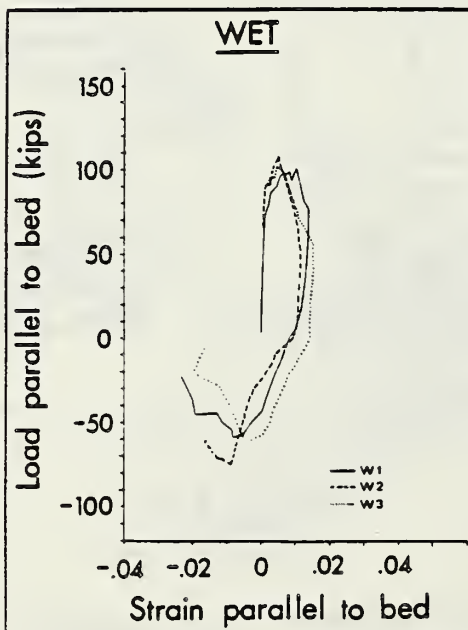
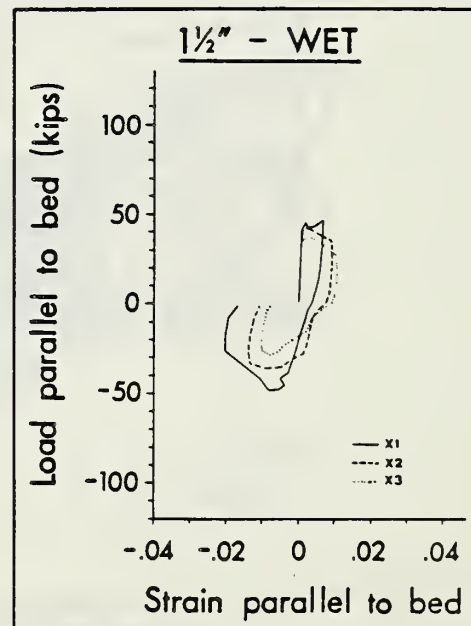
Figure 2.39 Load parallel to bed joints vs. strain parallel [2.15] to bed joints relationships for Kahn's wall panels.

- a) Dry surface condition.
- b) Epoxyed surface condition.
- c) Wet surface condition.

Four surface conditions of the brick at the time of shotcreting were considered in order to study the surface effect on the brick-shotcrete bond. The surface of panels D1, D2, D3 were left dry; panels W1, W2, W3 and X1, X2, X3 were thoroughly wetted with water, and panels E1, E2, E3 were coated with epoxy adhesive (Sikastix 370 by Sika Chemical Corporation) about 10 minutes prior to shotcreting. Shotcrete was not applied to single wythe panel C1 or to double wythe panel CC1 to facilitate comparisons. The panels description and the test results are summarized in Table 2.7. The hysteresis curves for the strengthened panels are shown in Figure 2.39.

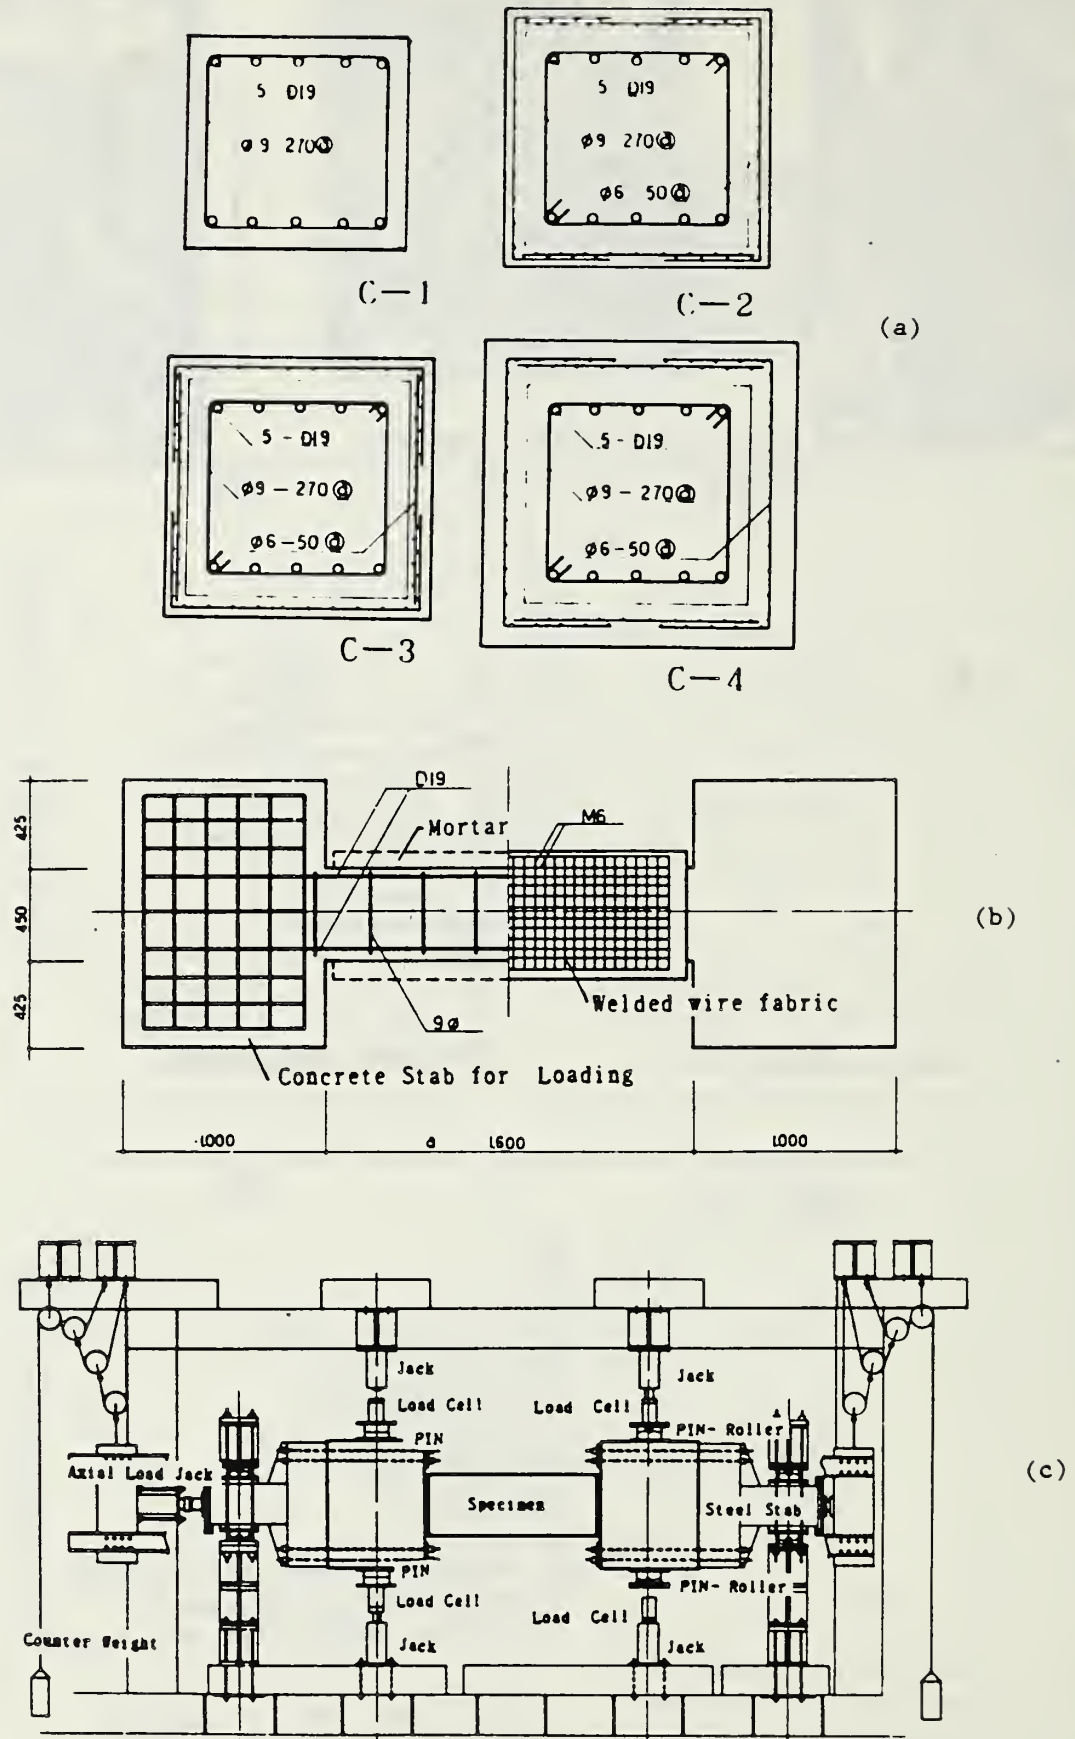
Figure 2.41 Hayashi, Niwa and Fukuhara's column specimens [2.1].  
 a) Column cross-section.  
 b) Reinforcement arrangement.  
 c) Test setup.

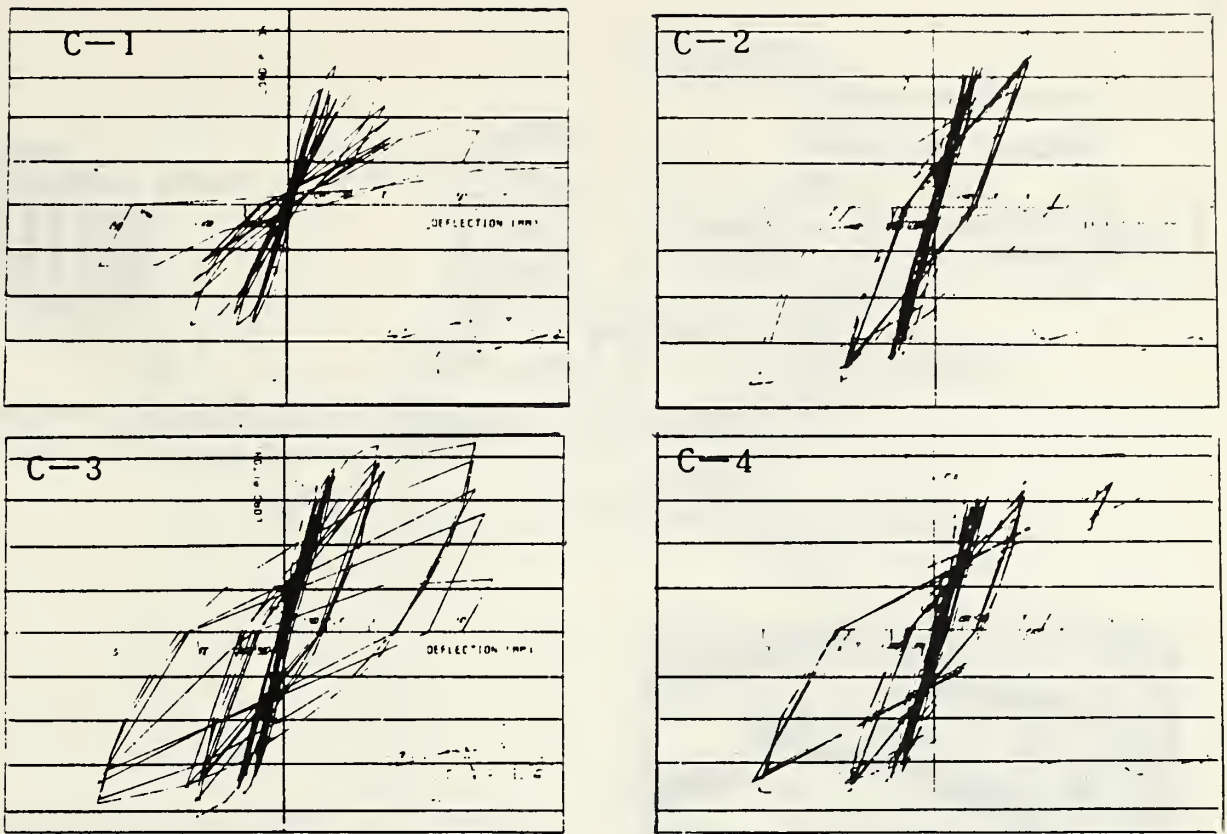
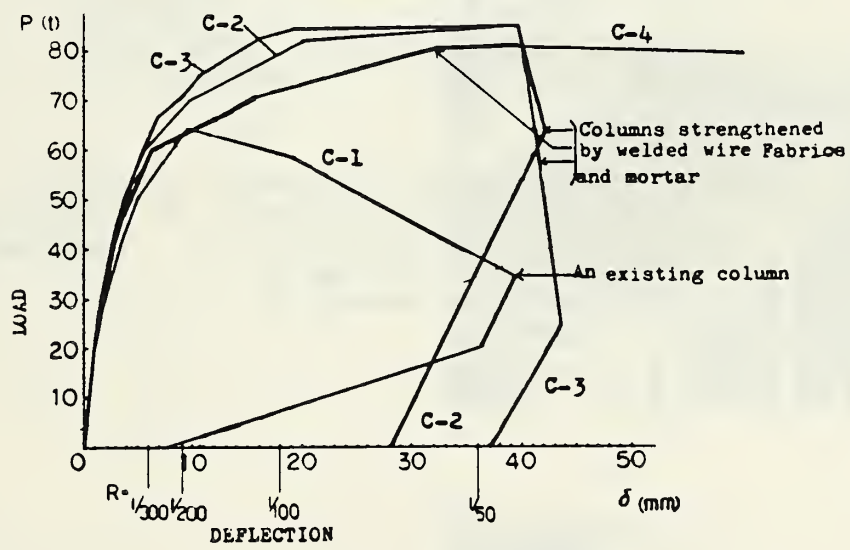
Figure 2.42 Hayashi, Niwa and Fukuhara's test results [2.1].  
 a) Hysteresis curves.  
 b) Envelopes of hysteresis curves.

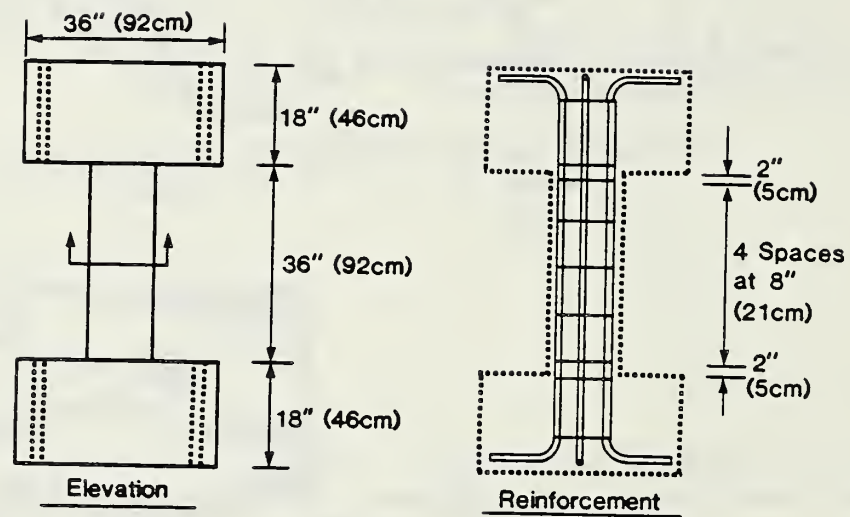
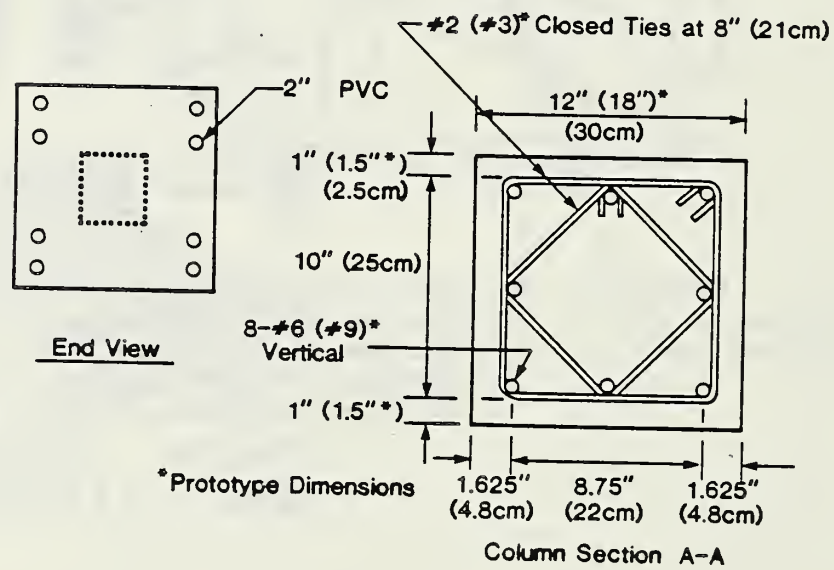
Figure 2.48 Details of Bett, Klingner and Jirsa's columns [2.17].

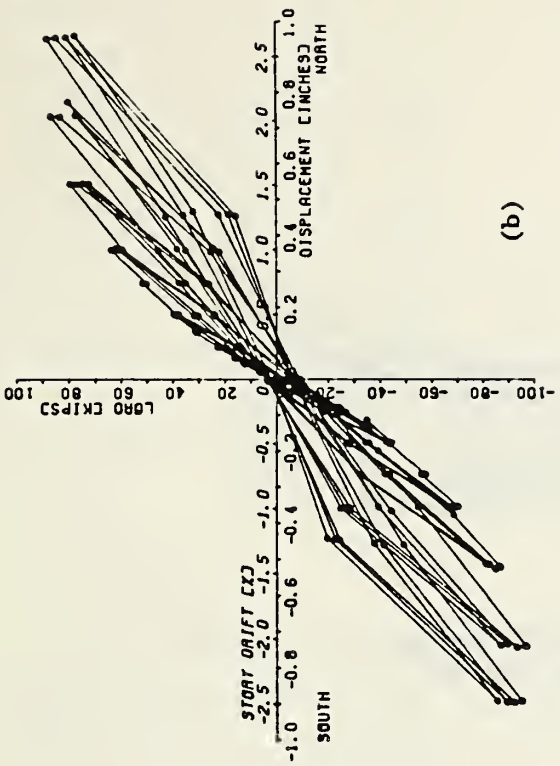
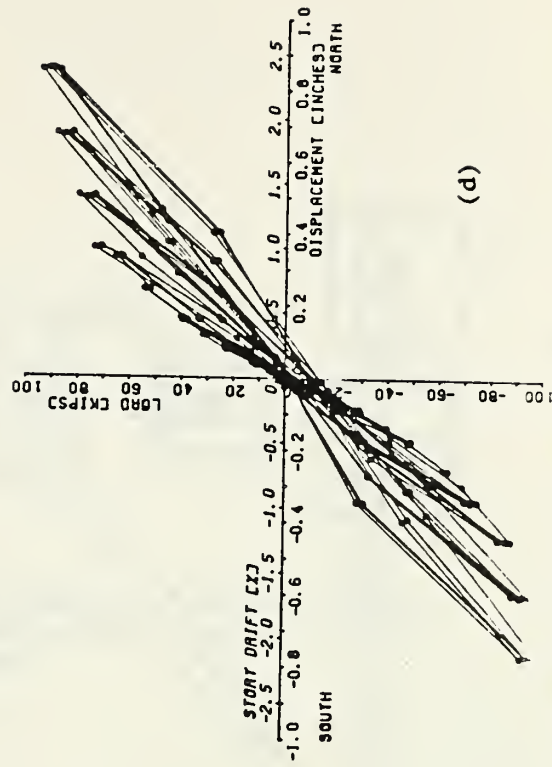
Figure 2.49 Hysteresis curves of Bett, Klingner and Jirsa test specimens [2.17].

- a) Specimen 1-1.
- b) Specimen 1-1R.
- c) Specimen 1-2.
- d) Specimen 1-3.

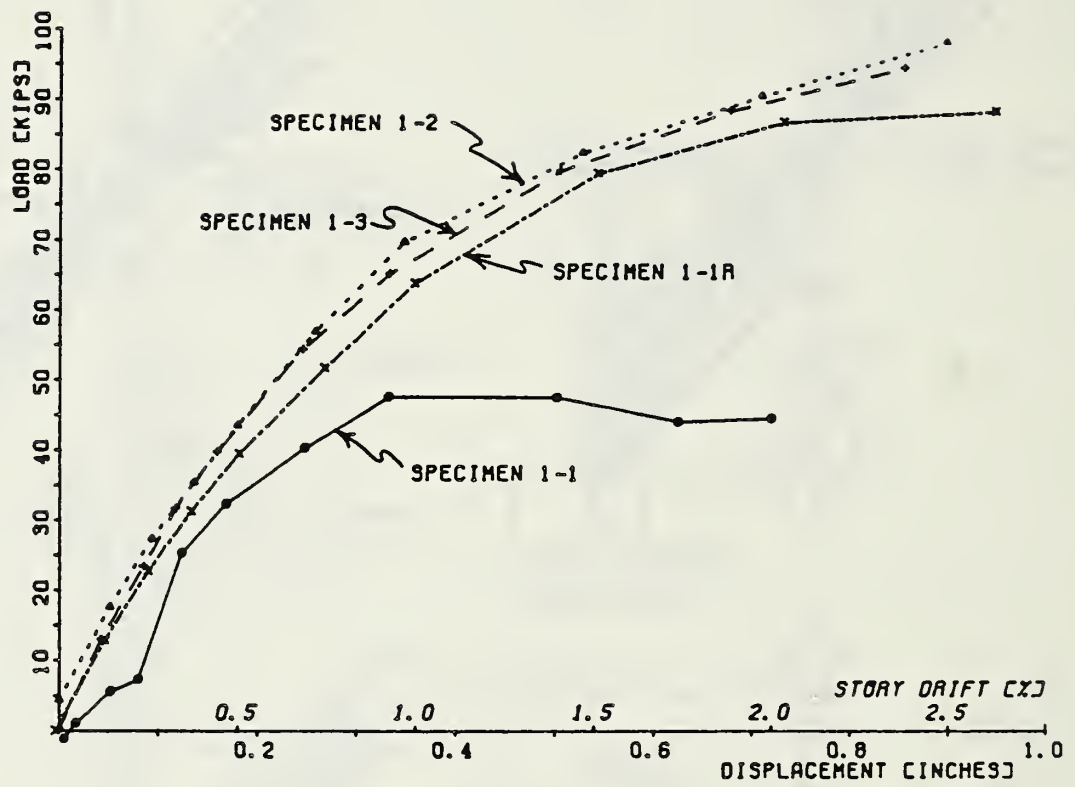
Figure 2.50 Envelopes of Bett, Klingner and Jirsa's hysteresis curves [2.17].

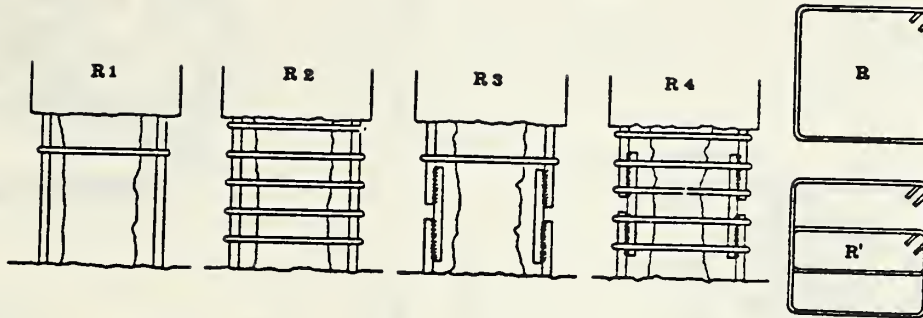
Figure 2.51 Reinforcement repair schemes in Augusti, Focardi, Giordano and Manzini's test program [2.18].

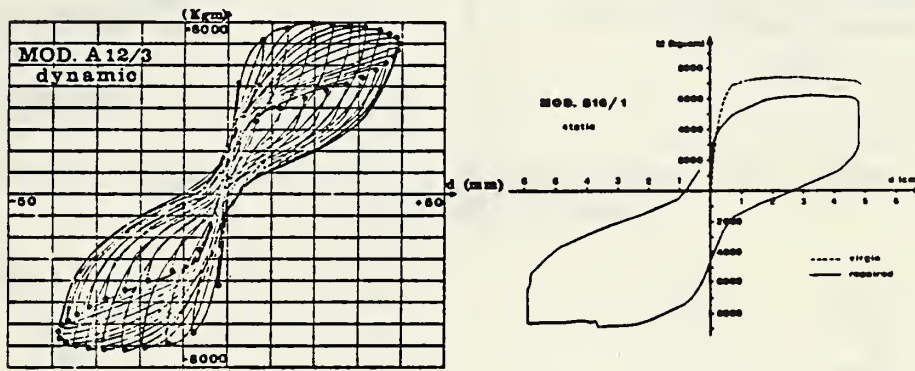
Figure 2.52 Typical moment-displacement relationship [2.18].
