NBSIR 88-3796

# Literature Review of Strengthening Methodologies of Existing Structures

June 1988

This report reviews research studies relevant to structural strengthening of existing reinforced concrete members and frames. The majority of these studies dealt exclusively with restoring or improving seismic resistance of concrete columns and frames. A number of case histories where various strengthening techniques were applied in practice are reviewed. Most studies identified ultimate failure in the strengthened structures as being primarily due to failure of the joining elements. Improved load resistance and ductility in concrete structures have been reported in most of these studies.

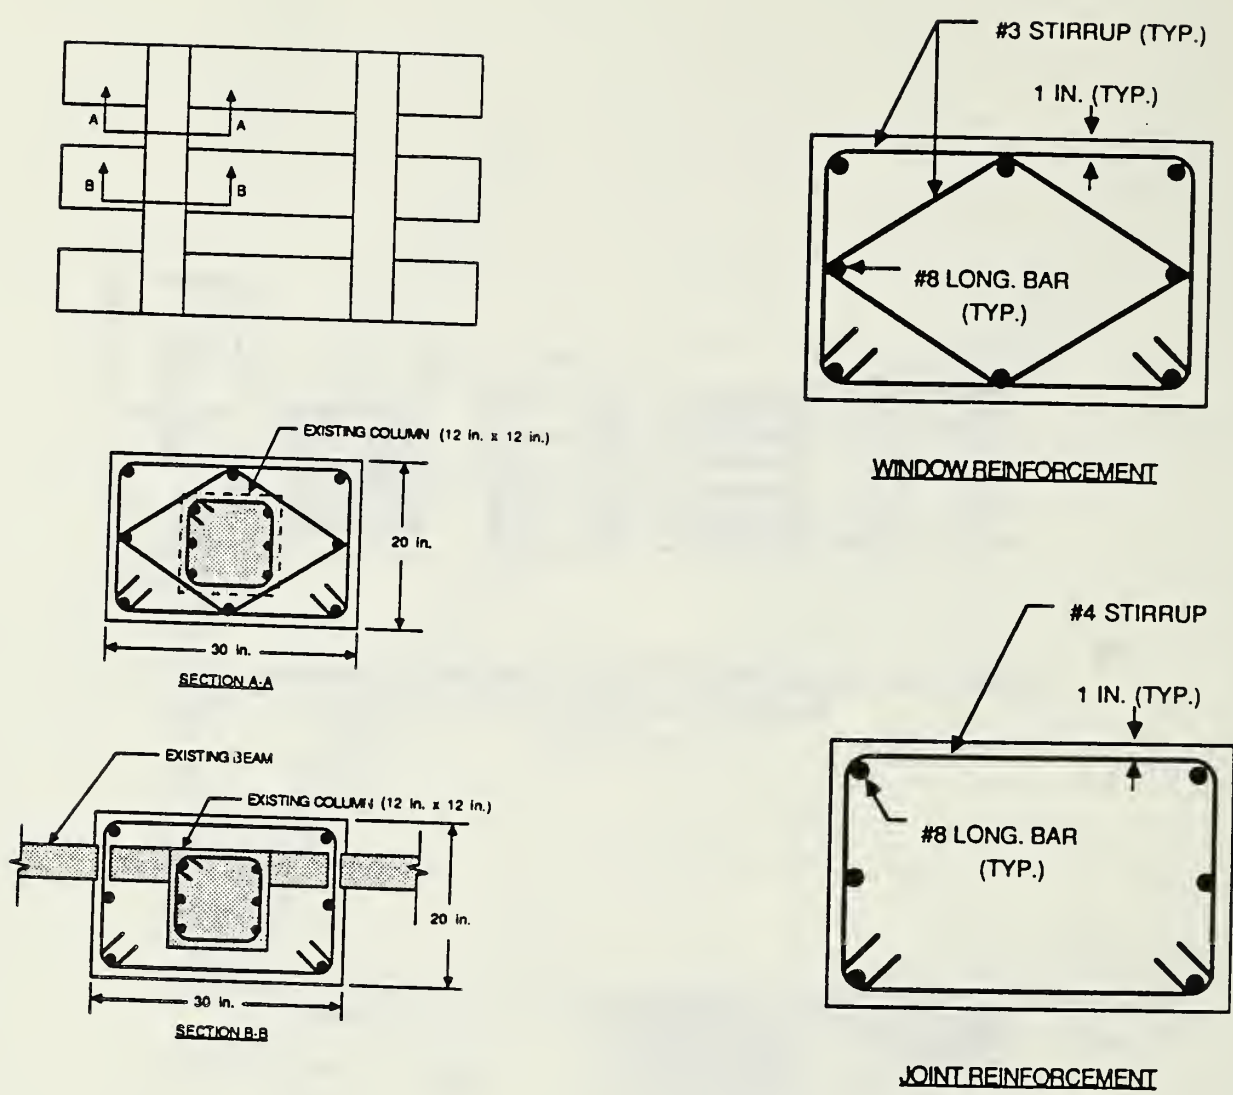
Figure 2.53 Reinforcement details of Stoppenhagen and Jirsa's encased columns [2.19].

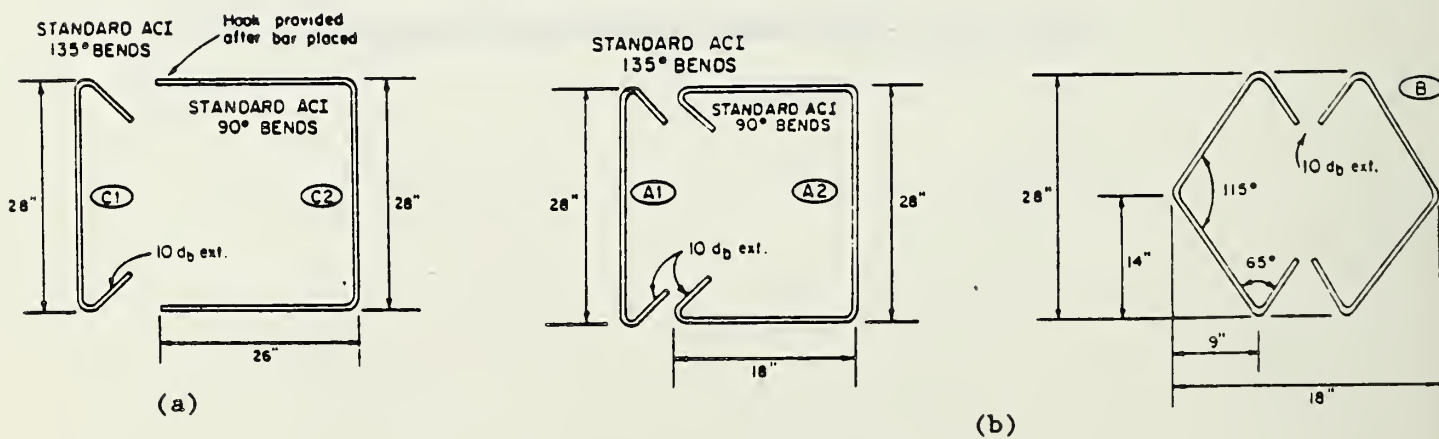
Figure 2.54 Shear reinforcements [2.19].  
 a) Bent #4 bars in beam-column joints.  
 b) Bent #3 bars in window regions.

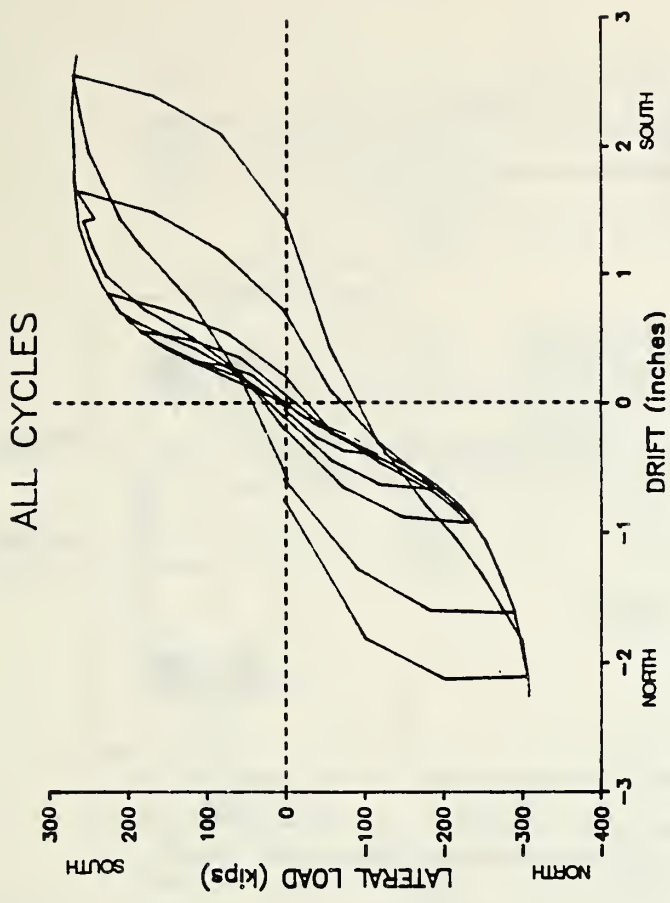
Figure 2.55 Load-drift relationships [2.19].

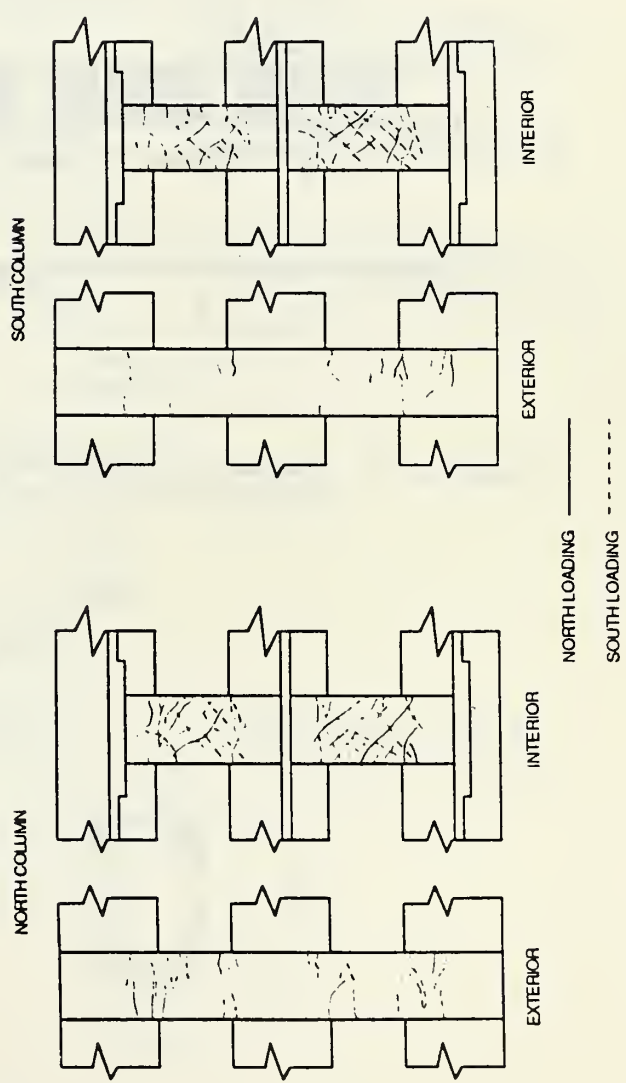
Figure 2.56 Final crack patterns [2.19].

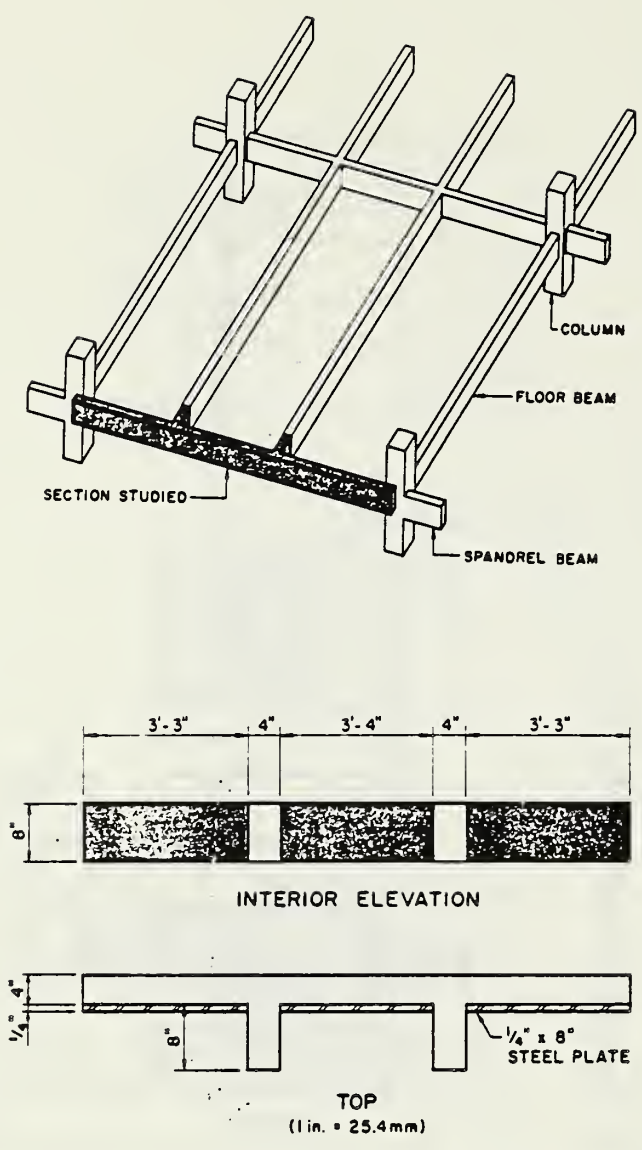
Figure 2.57 Specimen configuration and dimensions in Holman and Cook's test program [2.20]

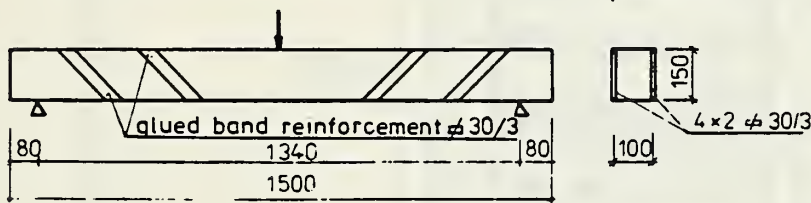
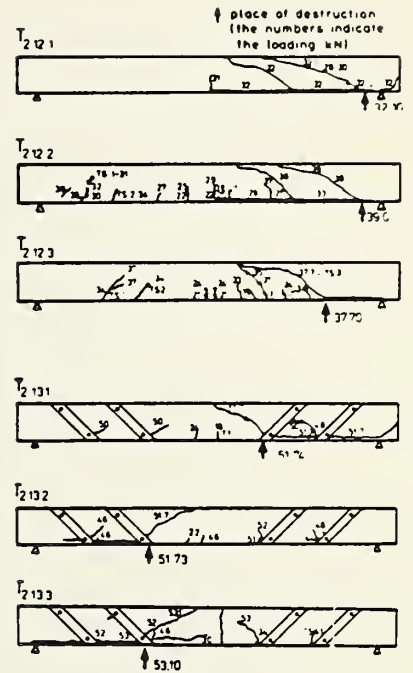
Figure 2.60 Arrangement of external reinforcement in Vanek's study [2.21].

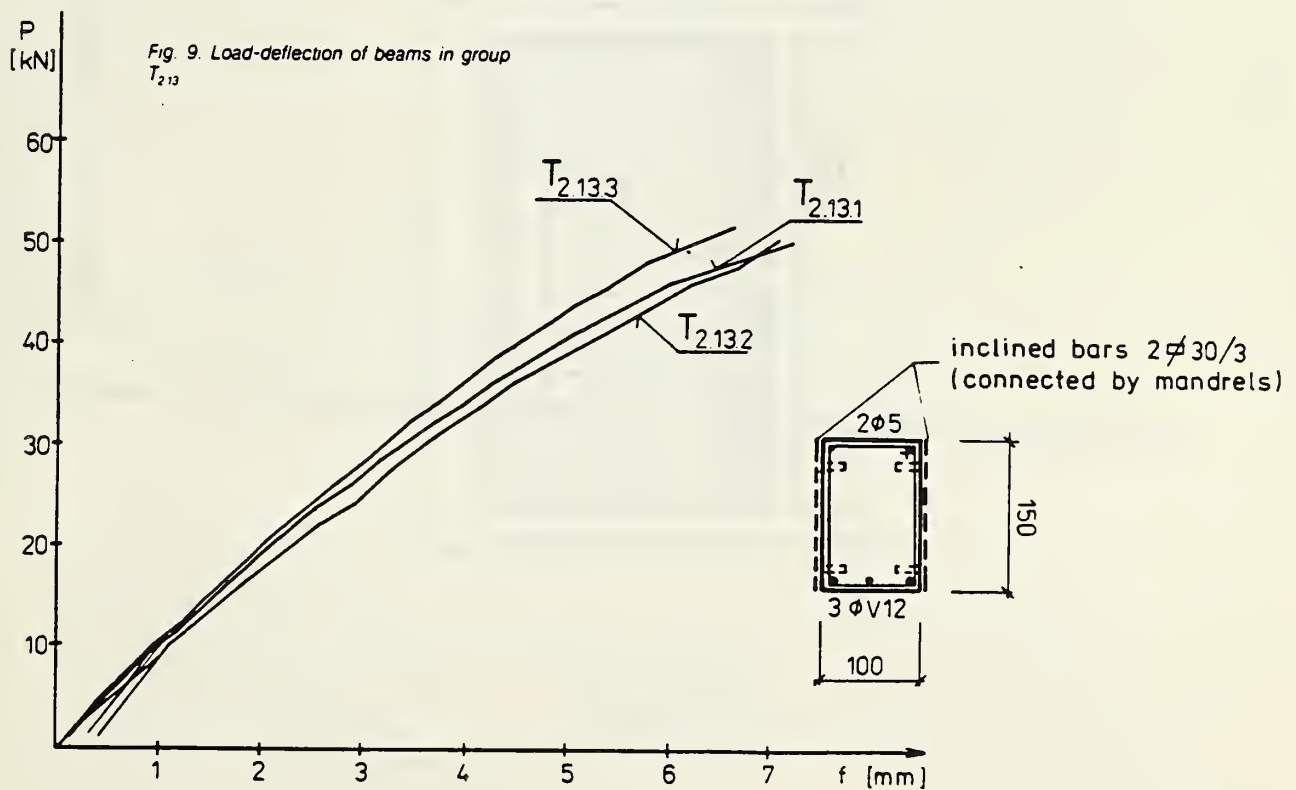
Figure 2.62 Load-center deflection of plated beams.

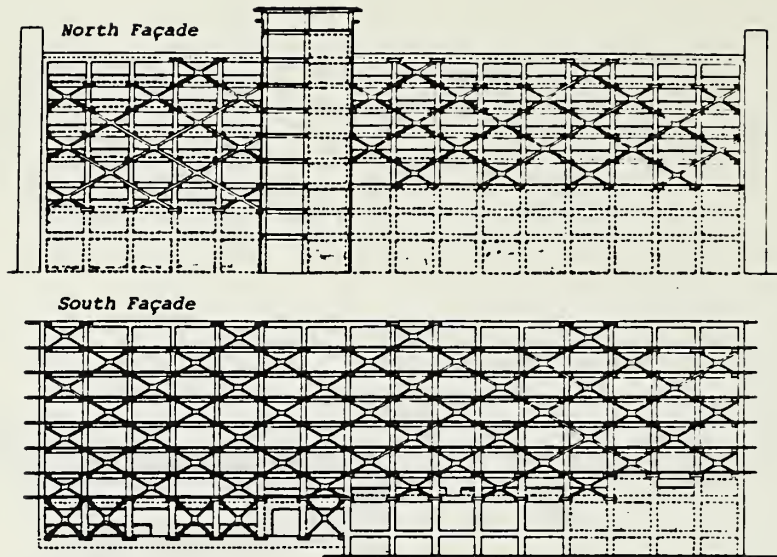
Figure 3.3 Arrangement of cross braces on North and South facades of the Tohoku Institute of Technology in Sendai, Japan [3.2].

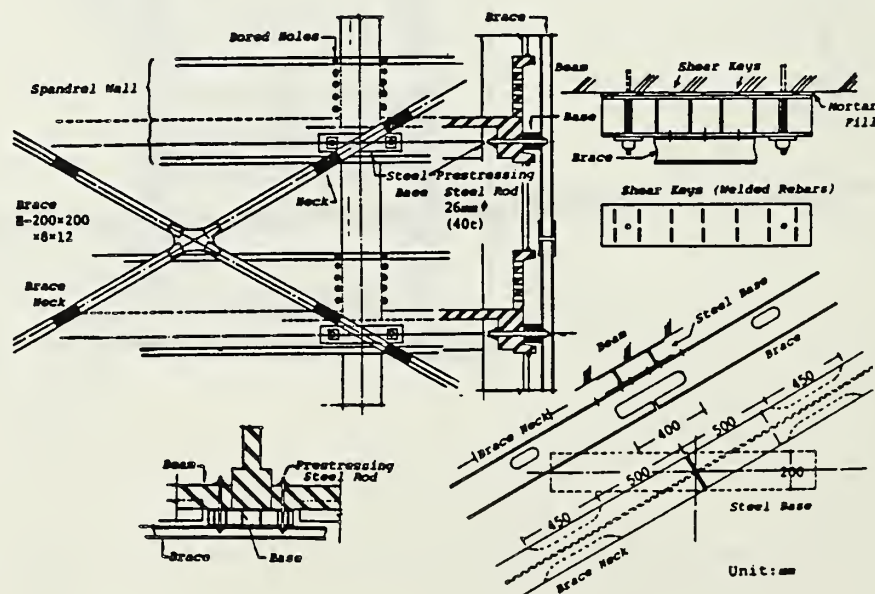
Figure 3.5 Details of braces to frame connection [3.2].

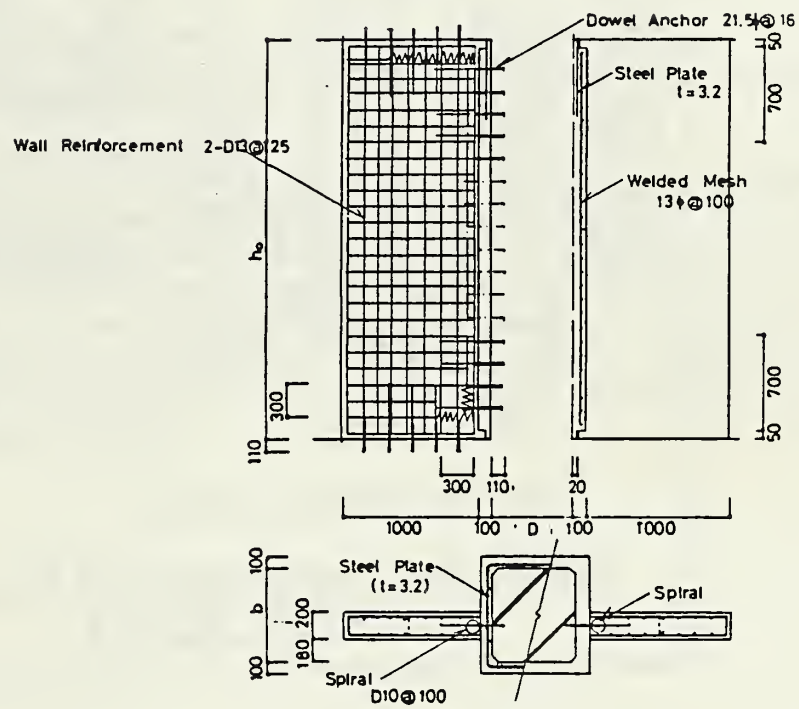
Figure 3.7 Connection between wingwall and column.
