Pulse-Echo Ultrasonic Evaluation of the Integrity of Seams of Single-Ply Roofing Membranes: Results of Field Investigations and Recommendations

Prepared for:
Naval Facilities Engineering Command
Naval Civil Engineering Laboratory
Port Hueneme, CA 93043-5003

Hiroshi Watanabe*
Walter J. Rossiter, Jr.

November 1990

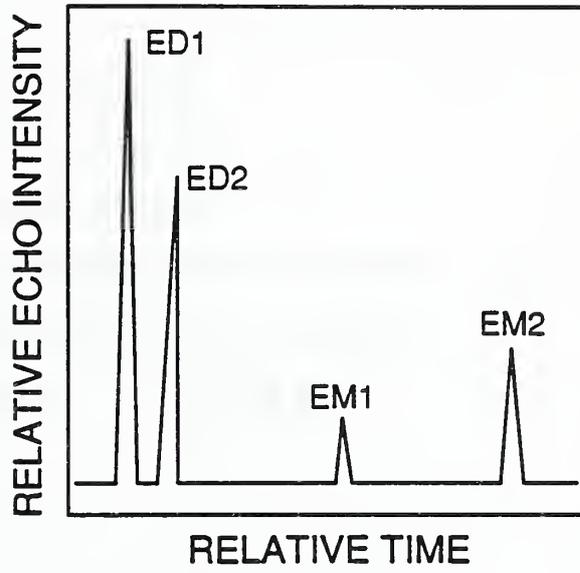
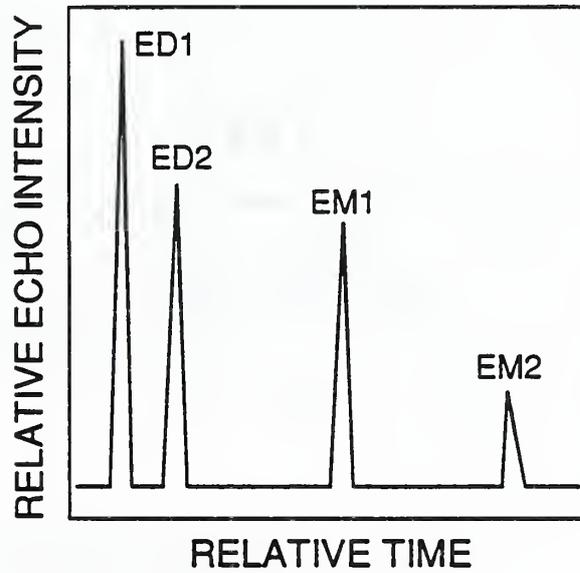
a. Well-Bonded Section

b. Section with a Void

Figure 1. Schematic illustration of echo patterns for a well-bonded section of a seam and a seam section with a void. (For the definition of the echoes, ED1, ED2, EM1, and EM2, see section 2.2.)

The general measurement procedure used in the field investigations was based on the operating techniques developed for the field scanner in Phase 1 [3]. Figure 1 illustrates four echoes typically observed for seam specimens when examined using the field scanner. Figure 1a is for a well-bonded seam which, for purposes of this paper, is one without voids (lack of adhesive) or delaminations. Figure 1b depicts the echo pattern for a seam that contains a void (lack of adhesive) in the adhesive layer. In these figures, the X-axis represents relative time and the Y-axis represents the relative intensity of the echo. For both the well-bonded seam and the void-containing specimen, the four echoes represent the four interfaces from which the ultrasonic pulses are reflected. These four echoes have been designated as follows (Figure 1):

ED1: Echo from the water-diaphragm interface,

ED2: Echo from the diaphragm-specimen interface, (or in the absence of a specimen, the air-diaphragm interface),

EM1: Echo from the adhesive layer¹ in the seam, (or for a single sheet of membrane material, the echo from the interface of the sheet and its substrate), and

EM2: Echo from the seam specimen-substrate interface.

Note in Figure 1 that the difference between the echo pattern for a well-bonded specimen and that for a specimen with a void. In the former case, the intensity of EM1 is relatively low and comparable

to that of EM2. When a void is present, the relative intensity of EM1 is high, while that of EM2 is extremely low. In this case, the ultrasonic pulse is mainly reflected at the void in the adhesive. A quantitative measure of peak intensity was needed to analyze and compare the various echo patterns obtained as a function of the variables investigated during the study. To this end, the intensity of an individual echo was increased using the gain controls of the pulse-receiver unit until the peak height reached, but did not exceed, 100 percent of the relative intensity scale on the oscilloscope. The dB value at which maximum peak height was attained was recorded as the intensity of the echo. This technique was used in lieu of equipment that could directly measure echo intensity. Using this technique, the echo intensities were recorded as negative dB values, indicating that the original signals were amplified to reach maximum intensity. The larger the dB (absolute) value, then the weaker was the intensity of the echo.

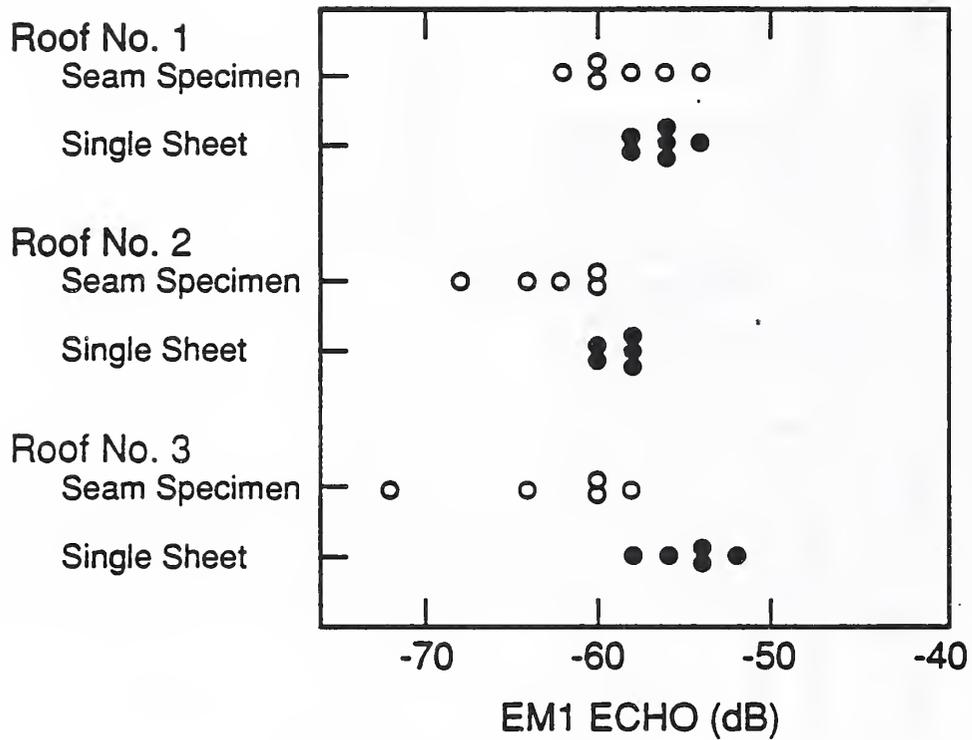
Figure 2. Intensity of EM1 echoes measured for seam specimens and single sheets cut from roofs nos. 1-3. (A 5-MHz focusing transducer was used in the measurements.)

3.2.2 Results of Laboratory Tests of Seam Samples. Figure 2 presents the results of the laboratory inspections of the seam specimens cut from roof nos. 1, 2, and 3. For all these roofs, there was considerable overlap of the intensities of the EM1 echo for the seam specimen with that of the single sheet. Many echoes for the seam specimens were less intense than those of the single sheets. On the other hand, no echoes due to the seam were greater than those of the single sheet.

At first glance, the results in Figure 2 imply that the seam specimens contained some voids or some delaminations. In some

measurements, not only were the EM1 echoes of the seam specimens the same as those of the single sheet, but the intensity values were comparable to those recorded for voids in Phase 1 of the study [3]. For instance, in the laboratory, voids were shown to have EM1 echoes ranging from -46 to -62 dB [3]. However, delamination of the roof seam specimens in the Phase 2 study showed the adhesive layers to be visually free of voids or delaminations, as was found for roof no. 1 at the time of the initial field investigation.

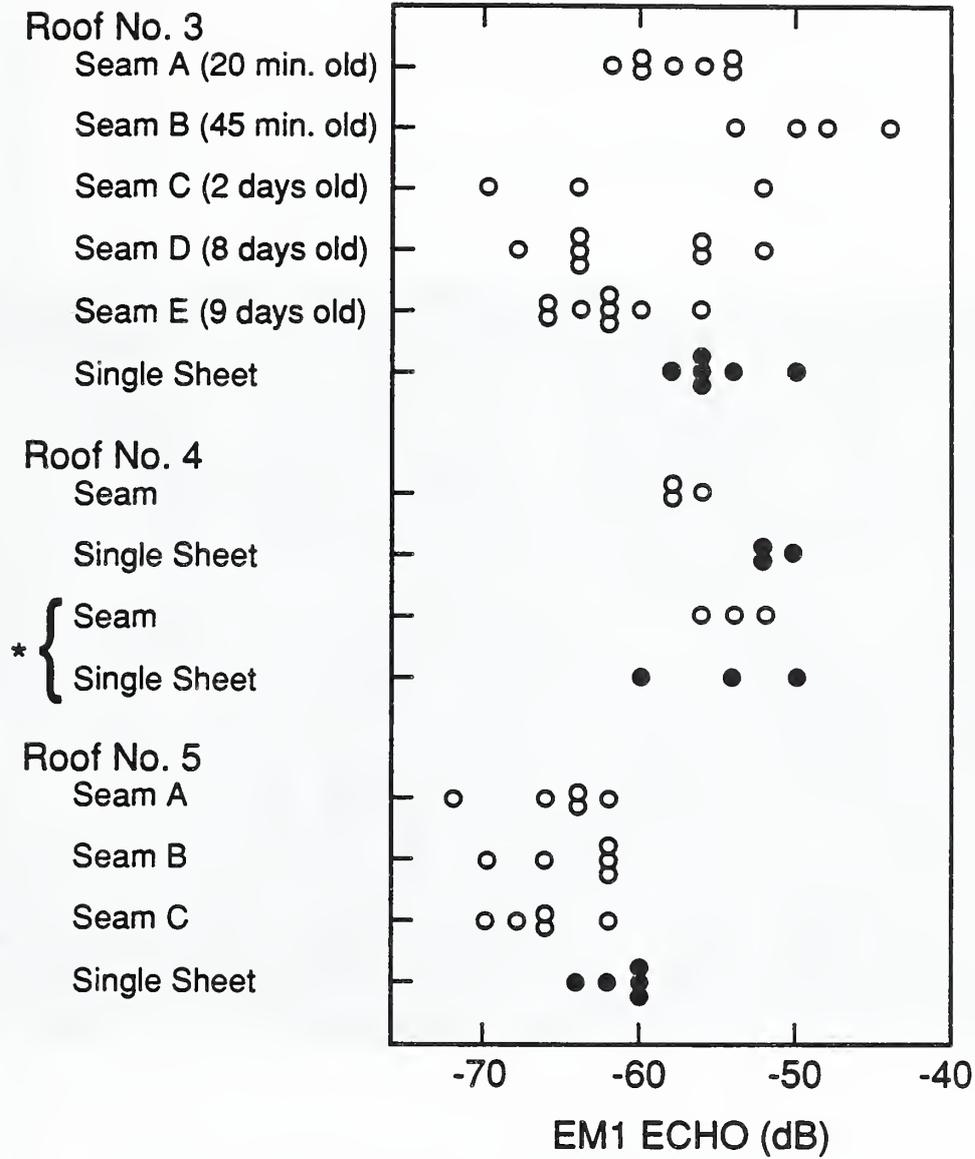
*Results obtained using 5-MHz non-focusing transducer for comparison

Figure 3. Intensity of EM1 echoes measured in the field investigation for roof nos. 3-5. (Except where noted, a 5-MHz focusing transducer was used in the measurements.)

It should be noted, as a reminder, that the data given in Figure 3 represent locations where the field scanner was stationary to allow recording of the echo intensities. The recorded intensities were typical of those observed as the scanner was being pushed across the seam surfaces. It is difficult to believe that the seams would have performed satisfactorily for up to 4 years (e.g., roof no. 4), if they consisted mainly of voids and delaminations. Consequently, the results in Figure 3 were also considered to be generally "false positives."

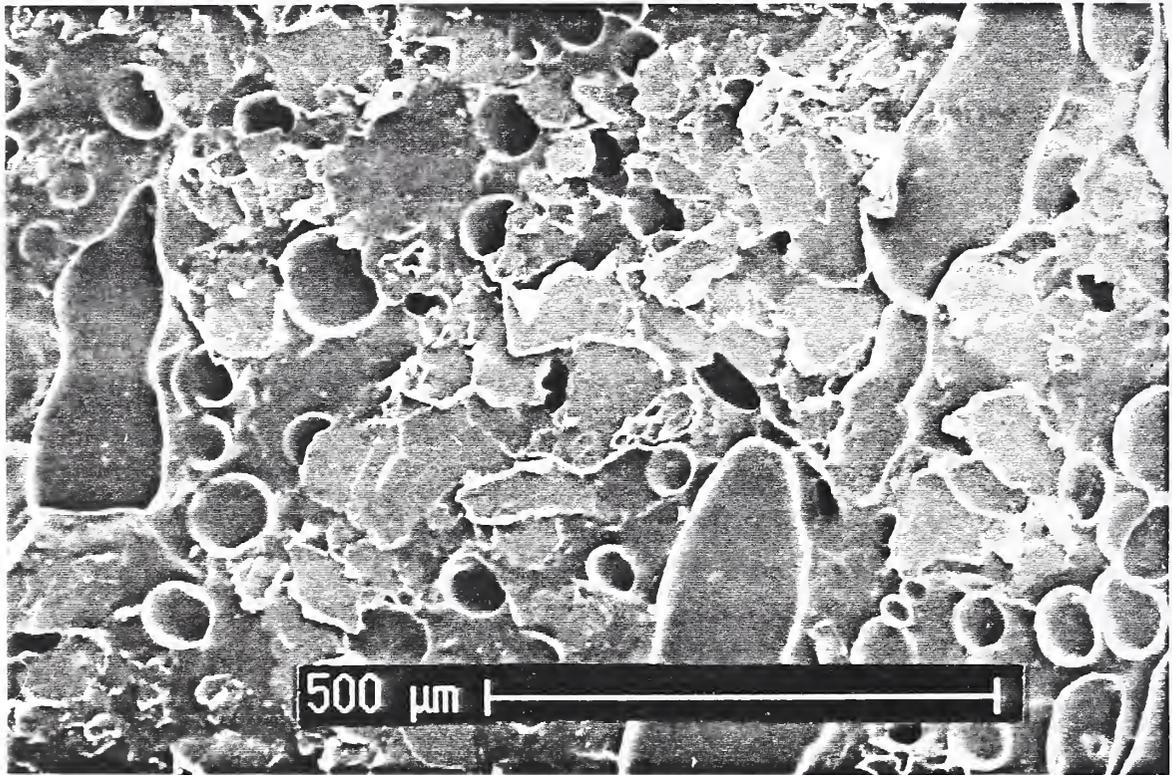
Figure 4. SEM photomicrograph of the ruptured surface of the adhesive layer in seam A of roof no. 3.

Sections of the delaminated strips were examined using scanning electron microscopy (SEM). A significant feature observed in the SEM analysis was the presence of micro-cavities (small bubbles) in the exposed surface of the adhesive layer. A typical micrograph illustrating the micro-cavities is shown in Figure 4. The diameters of the micro-cavities ranged from about 0.001 to 0.002 in. (0.03 to 0.05 mm). They are flaws in the adhesive layer which would be anticipated to cause lower-than-expected peel strengths as compared to specimens without micro-cavities present.

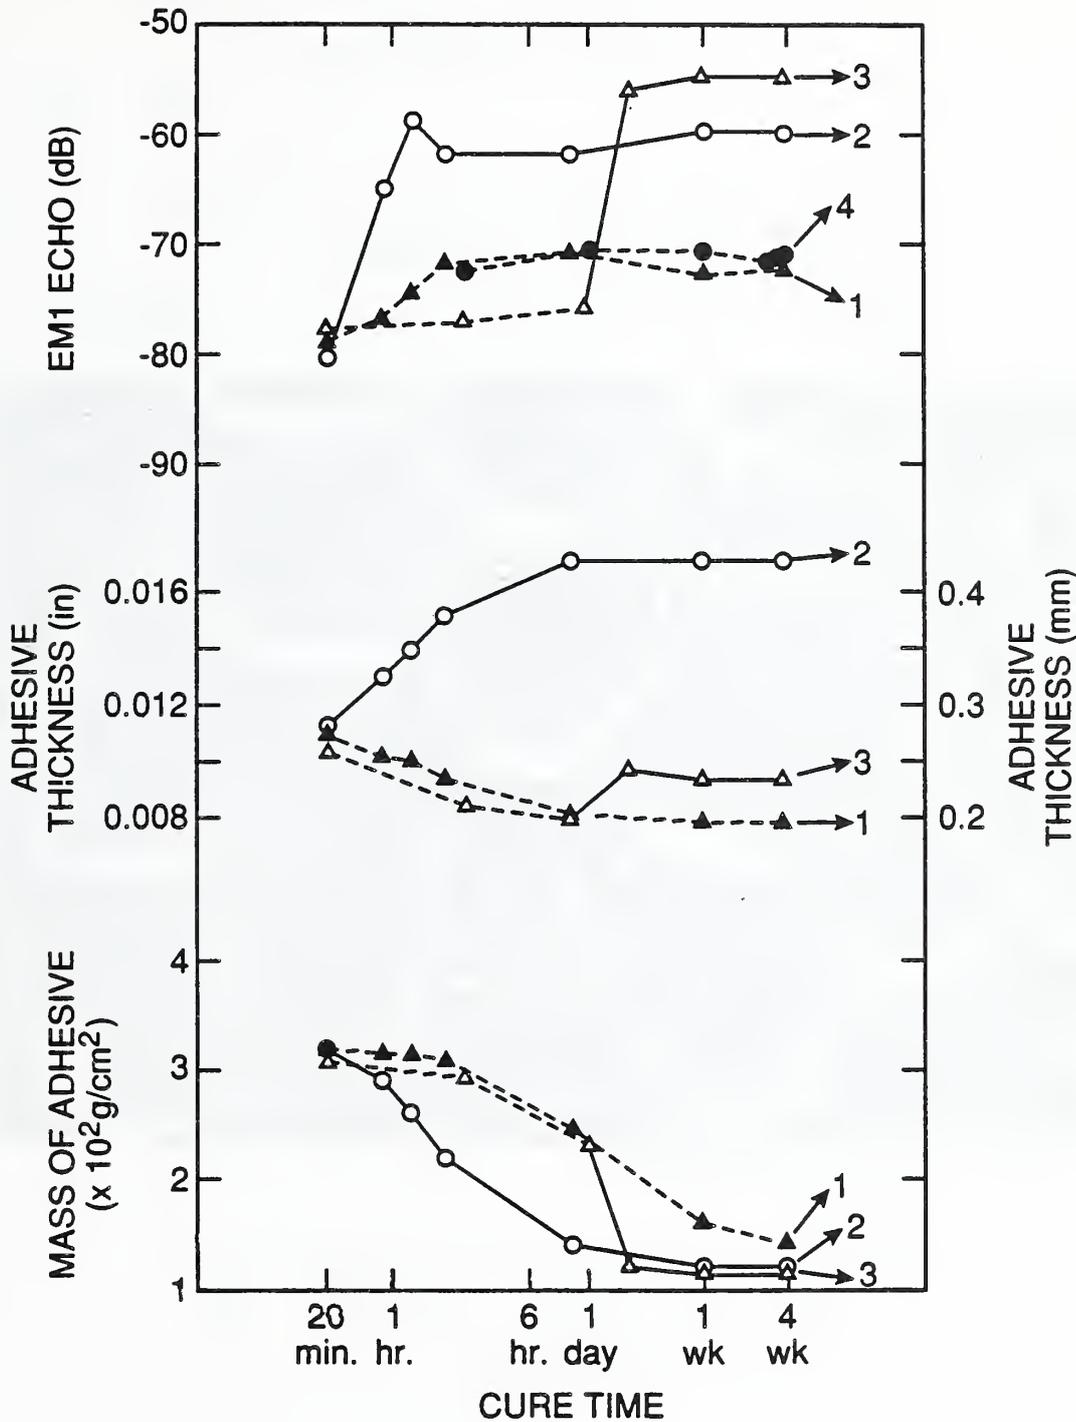
Figure 5. Results of the laboratory experiment on elevated cure temperature for seam specimens fabricated with a neoprene-based adhesive. (The numbers adjacent to the curves indicate the cure conditions given in Table 3.)

Figure 5 gives the results of the echo intensity, adhesive thickness, and adhesive mass measurements made for the seam samples having neoprene-based adhesive. With the exception of cure condition no. 4, all measurements were first made after the specimens had cured for a minimum of 20 minutes at room temperature. Note that for each of the three variables, the initial measurements showed little variation. In the case of the pulse-echo measurements, the initial EM1 intensity of approximately

-80 dB was comparable to that obtained for a well-bonded specimen [3]. Over time, the specimen that was cured at room temperature (condition no. 1) continued to display an EM1 echo intensity typical of a well-bonded specimen, although a slight increase above the initial value was observed. In contrast, the specimens subjected to a heat cure within a day of seam formation (condition nos. 2 & 3) showed a significant jump in the intensity of the EM1 echo. The resultant value of -55 to -60 dB was typical of an echo from a void or delamination [3].

For the cases where adhesive mass was determined (cure condition nos. 1-3), the specimens showed a loss of mass (due to solvent loss) for at least the first week of cure (Figure 5). The loss was accelerated by the heat cure. The point to be made is that the specimens contained residual volatile solvent when they were subjected to heat-cure condition nos. 2 & 3, which produced the marked increase in intensity of the EM1 echo. It is evident in Figure 5 that the mass loss from the specimens was tending to a plateau as the cure time approached 4 weeks. It was assumed that the majority of the residual solvent had evaporated from the specimens over this time period. Thus, it was expected that a specimen subjected to a heat cure after most of the solvent evaporated would not show an increase in the intensity of the EM1 echo upon heating. Figure 5 includes the EM1 echo intensities for the specimen cured at condition no. 4. The EM1 echo was essentially unchanged by the heat-cure which was not applied until after a 3-week cure at room temperature.

Figure 5 also includes data on adhesive thickness for the cure condition nos. 1-3. When cured at room temperature, the adhesive thickness decreased as the adhesive lost mass. However, during the times of heat curing, the adhesive layers increased in thickness. This was most noticeable for cure condition no. 2, where the increase in thickness was about 60% of the original thickness. This percent increase could not be explained on the basis of normal thermal expansion of the rubber materials upon heating. It was not considered unreasonable to assume that the expansion was due to formation of micro-cavities in the adhesive layer.

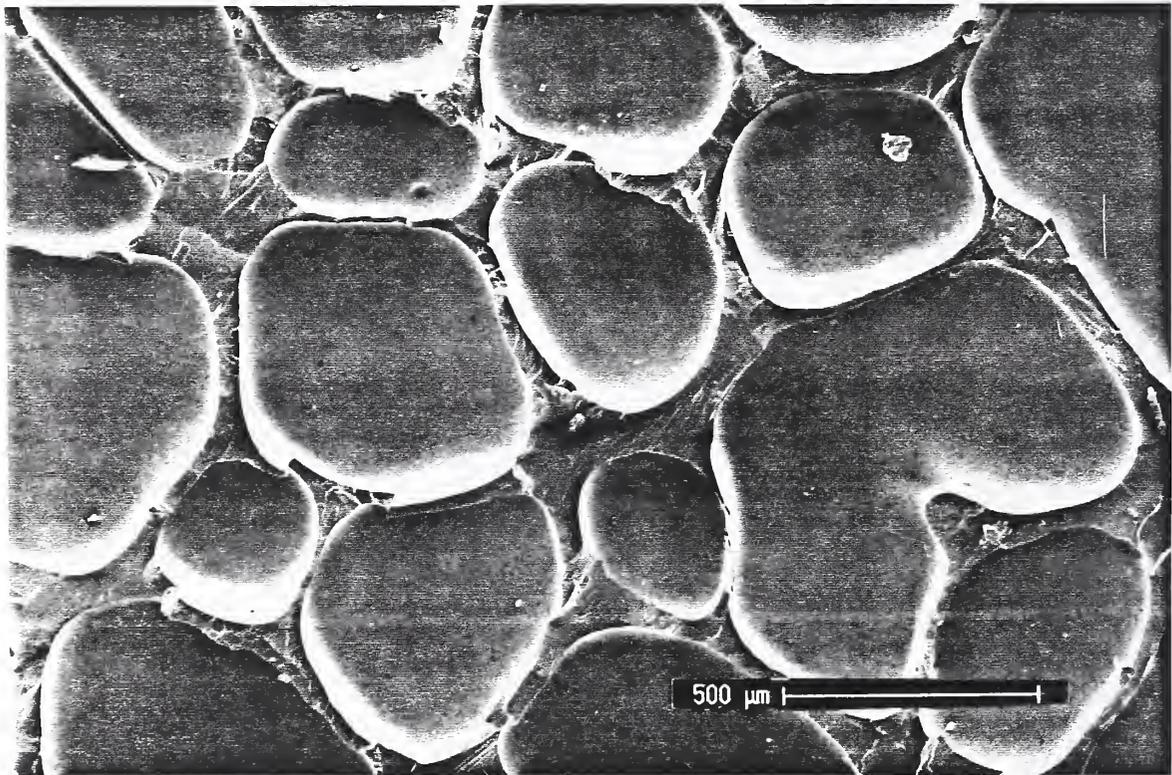
Figure 6. SEM photomicrograph of the ruptured surface of the neoprene-based adhesive layer. Micro-cavities are apparent.

At the end of the experiment, the specimens were delaminated manually and visually inspected. In this case, microscopic analysis was not needed to see readily micro-cavities in the adhesive layers of the specimens that showed strong EM1 echoes after heat curing (cure condition nos. 2 & 3). In contrast, those specimens which displayed weak EM1 echoes showed no micro-cavities. Scanning electron microscopy was conducted, but micro-cavities were only observed in those specimens cured under condition nos. 2 & 3. Figure 6 shows a SEM photomicrograph of some micro-cavities.

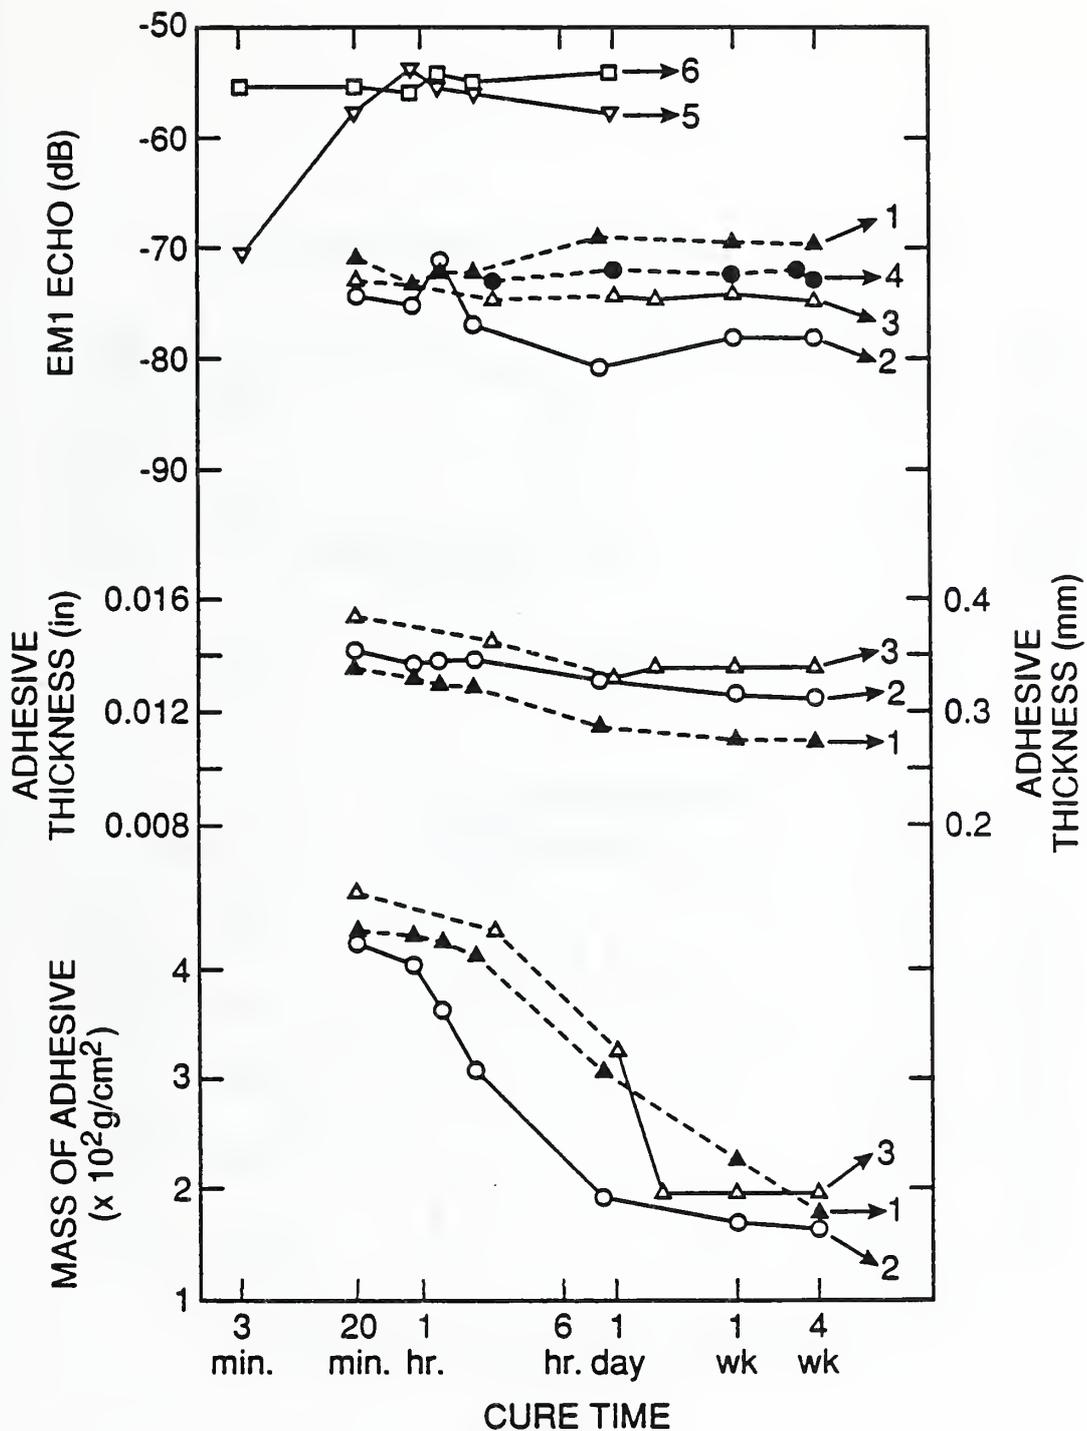
Figure 7. Results of the laboratory experiment on elevated cure temperature for seam specimens fabricated with a butyl-based adhesive. (The numbers adjacent to the curves indicate the cure conditions given in Table 3.)

4.1.3 Results for the Specimens with Butyl-Based Adhesive. Figure 7 gives the results of the echo intensity, adhesive thickness, and adhesive mass measurements made for the seam samples having butyl-based adhesive. The results for the EM1 echo intensity measurements for cure condition nos. 1-4 may be compared with those for the neoprene-based adhesive specimens given in Figure 5. Unlike the results for neoprene-based adhesives, the heat-cure (condition nos. 2 & 3) of the butyl-based adhesives produced no significant changes in the measured properties of the specimens. It was found for the butyl-based adhesives that no sharp increases in the intensity of the EM1 echo were observed after the heat curing.

The results of the pulse echo measurements for the cure condition nos. 5 & 6 are given in Figure 7 along with the data previously discussed. It was found that, when the adhesive was applied to the rubber at room temperature, the immediate determination of the

intensity of the EM1 echo was akin to that of a well-bonded specimen. However, after 20 minutes of heat-cure, the EM1 intensity displayed a sharp increase and was typical of a void in the adhesive layer. When the adhesive was applied to heated rubber (cure condition no. 6), the intensity of the EM1 echo measured immediately upon seam formation was typical of that produced by a void in the adhesive layer. The observations for cure conditions 5 & 6 were consistent with the formation of micro-cavities due to expansion of residual solvent in the adhesive layer. SEM analyses of the delaminated specimens at the end of the cure period showed micro-cavities to be present.

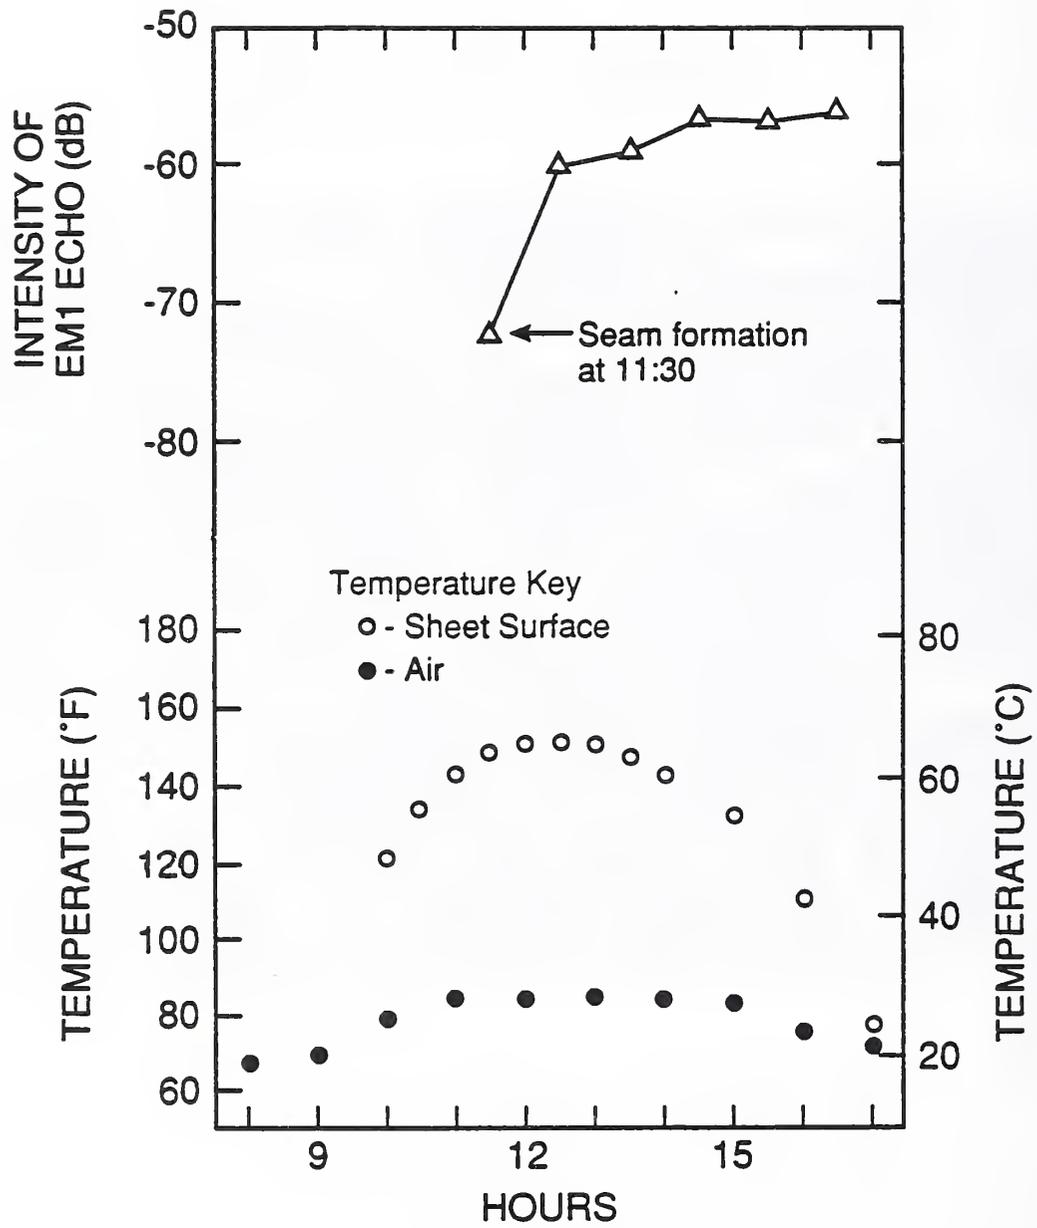
Figure 8. Temperatures and EMI echo intensity measured for the field seam specimen having a neoprene-based adhesive.

4.2.2 Results of the Field Experiment. The seam specimens having the neoprene-based and the butyl-based adhesives were formed at 11:00am and 11:30am, respectively. The results of the temperature measurements (Figure 8 & 9) indicated that both types of specimens cured under the same conditions. In both cases, the surface temperatures of the rubber sheets were above 140°F (60°C) at the time of seam formation and remained above that level for more than 3 h. They reached a maximum of about 150°F (65°C) shortly after 12 noon.

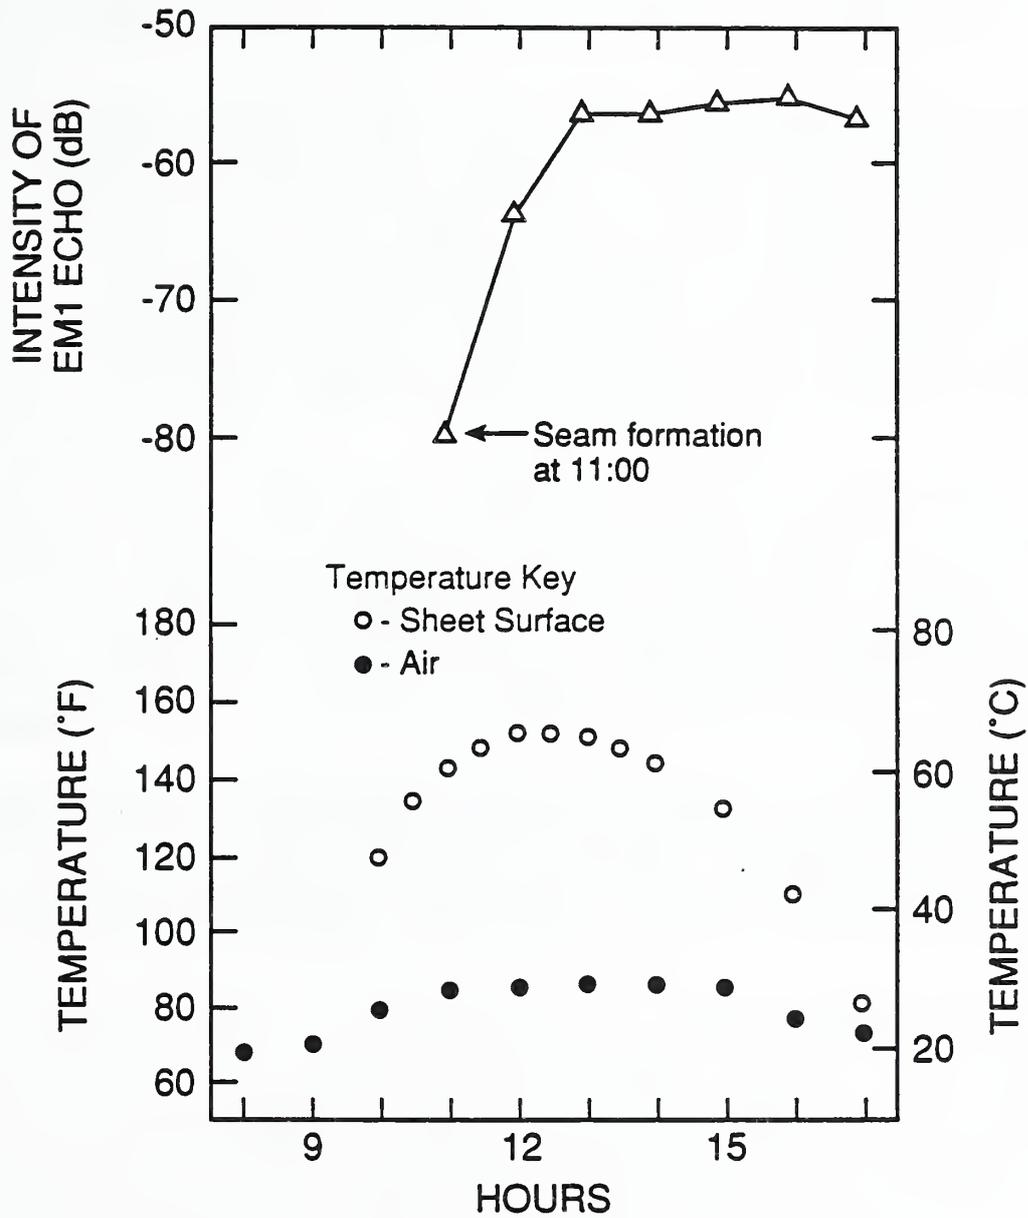
Figure 9. Temperatures and EM1 echo intensity measured for the field seam specimen having a butyl-based adhesive.

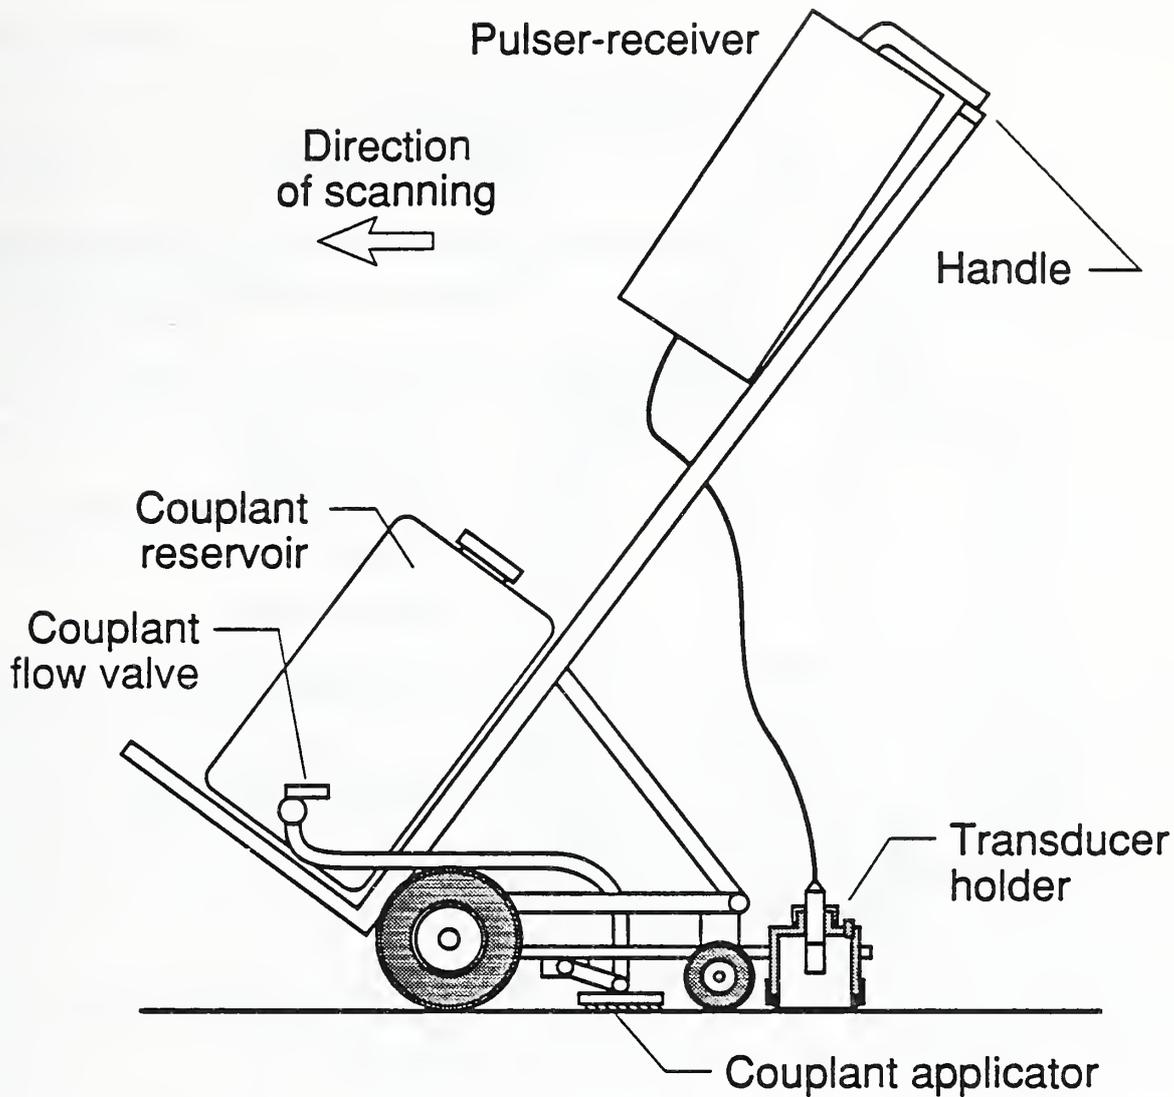
Figure A1. Prototype field scanner used in the study. (The detail of the transducer holder is presented in Figure A2.)

The field scanner was fabricated by EMCO⁴. The pulser-receiver unit was model no. DSL104 from Panametrics. It has an oscilloscope for detecting echoes and is compatible with transducers with nominal frequencies ranging from 1 to 10 MHz. The unit contains a rechargeable battery which may operate for eight hours, although it may also be directly connected to normal AC house lines. The operating controls include coarse and fine gain switches for adjusting the intensity of received echoes displayed on the oscilloscope. The coarse gain control provides adjustments in 20 decibel (dB) increments as follows: 0, 20, 40, 60, and 80 dB. The fine gain control allows adjustments in 2 dB increments from 0 to 20 dB.

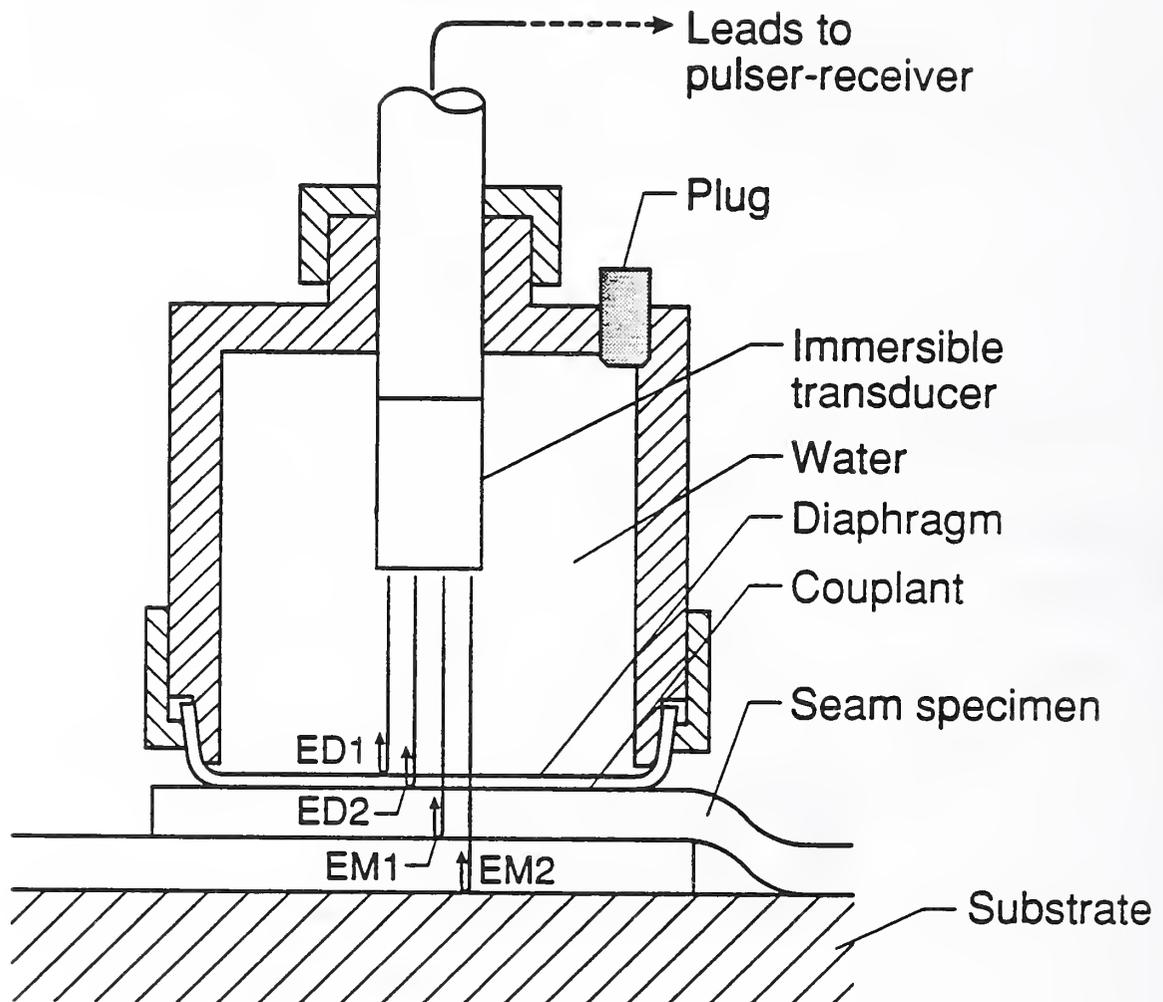
Figure A2. Schematic illustration of the transducer holder acoustically coupled to a seam specimen. (Reflections of the ultrasonic pulse from the various interfaces are also illustrated, and are designated as ED1, ED2, EM1, and EM2.)
