Proceedings of a Workshop on Evaluation,
Repair, and Retrofit of Structures – U.S.-Japan
Panel on Wind and Seismic Effects, UJNR,
Gaithersburg, MD, USA, May 12–14, 1990

James O. Jirsa
Janet S. Cockrell Centennial Chair in Engineering

April 1991

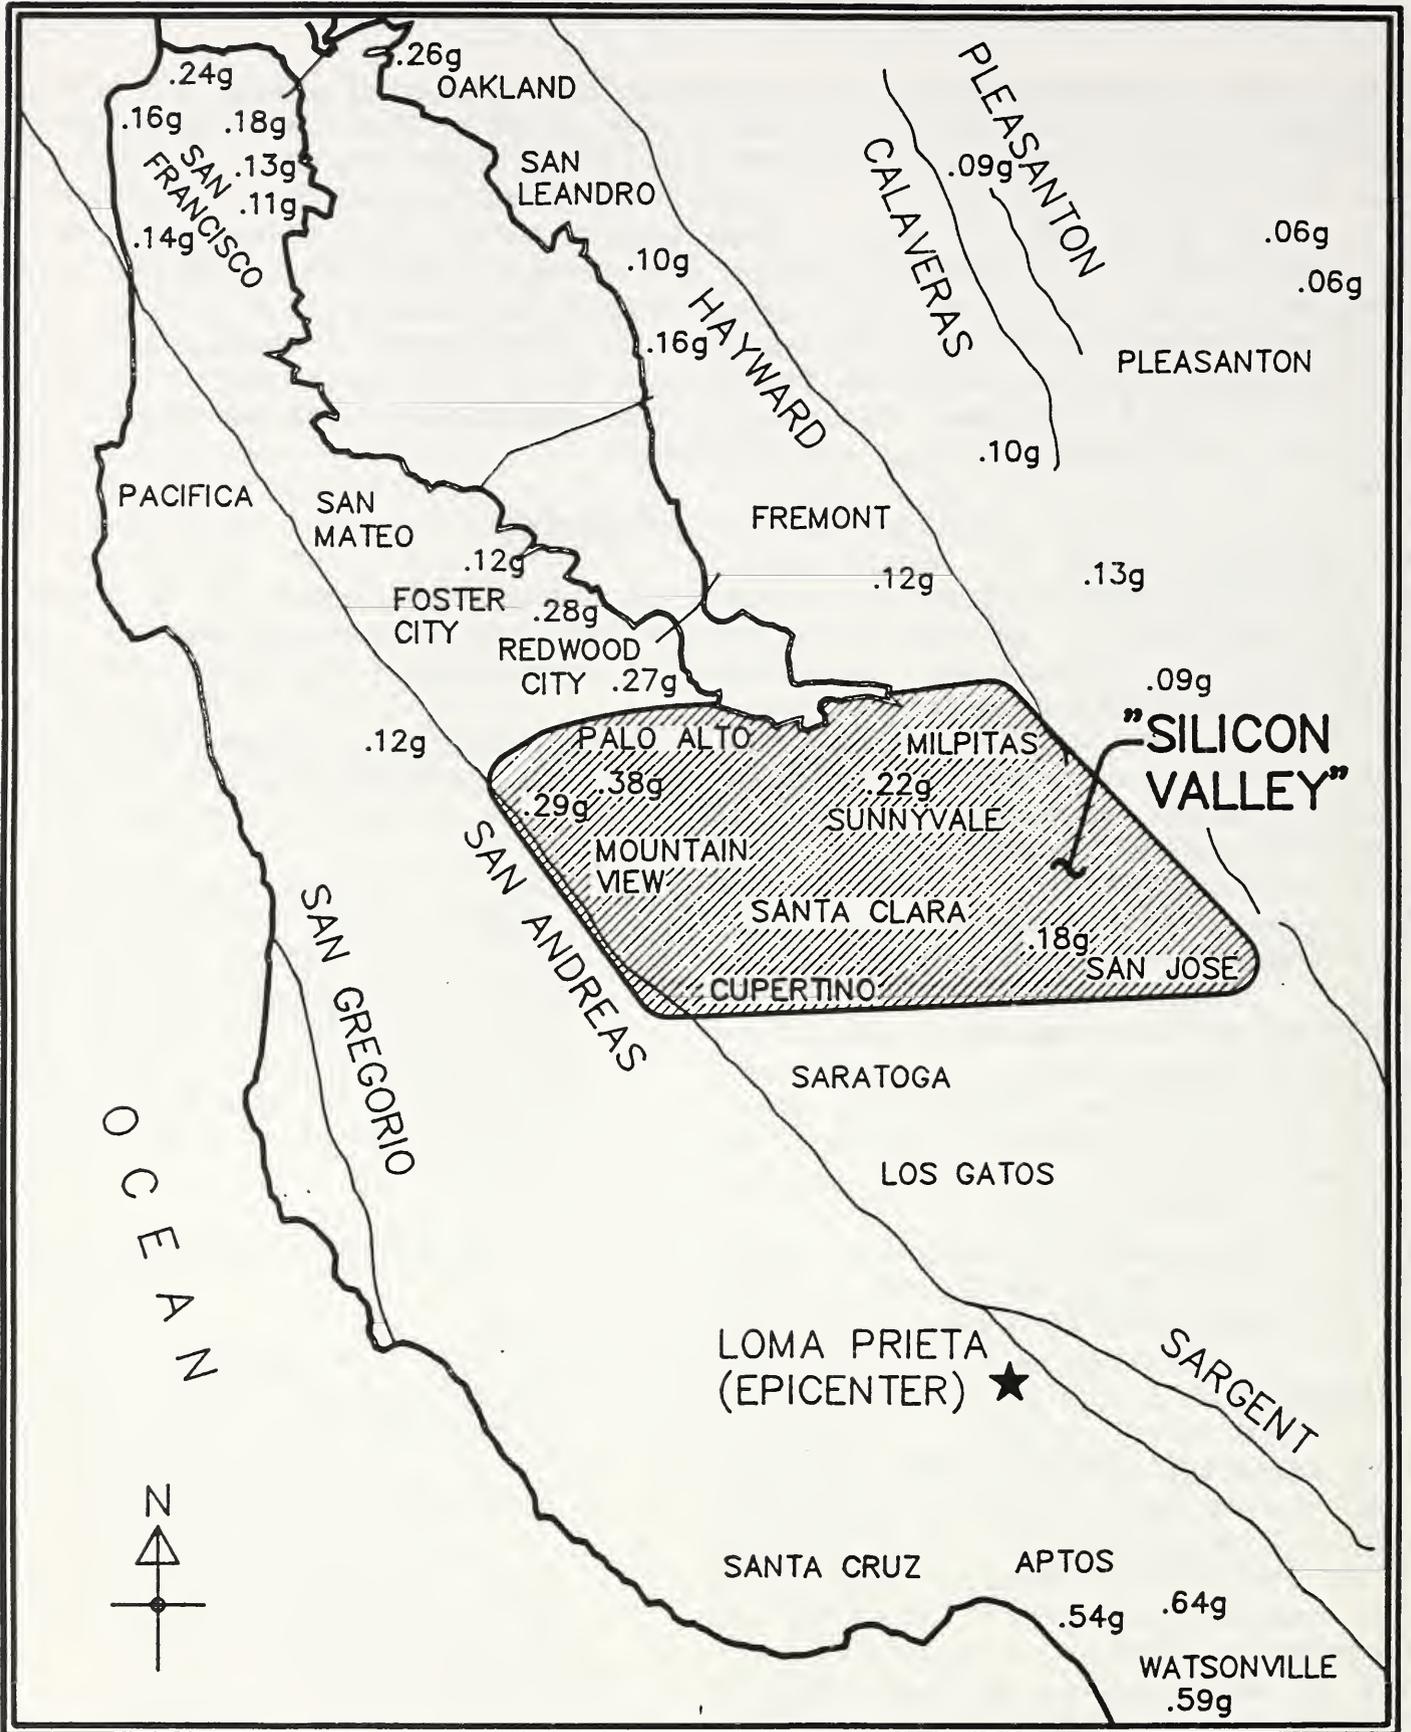
FIGURE 1 - GROUND ACCELERATIONS RECORDED DURING THE LOMA PRIETA EARTHQUAKE

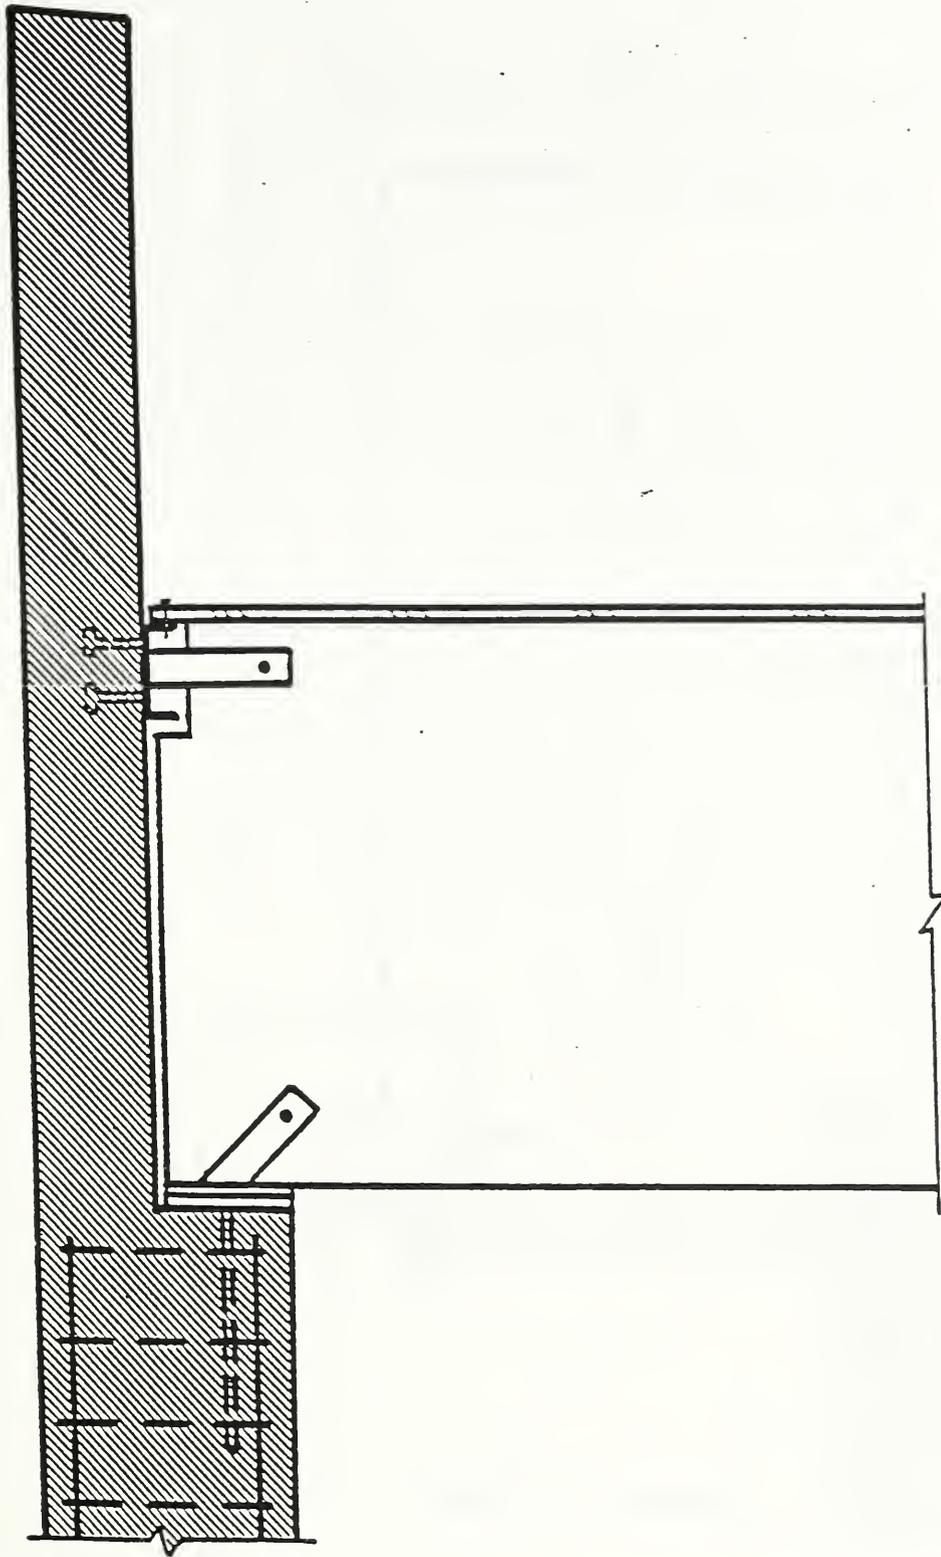
FIGURE 2 - ORIGINAL CONNECTION BETWEEN GLULAM BEAM AND TILT-UP WALL

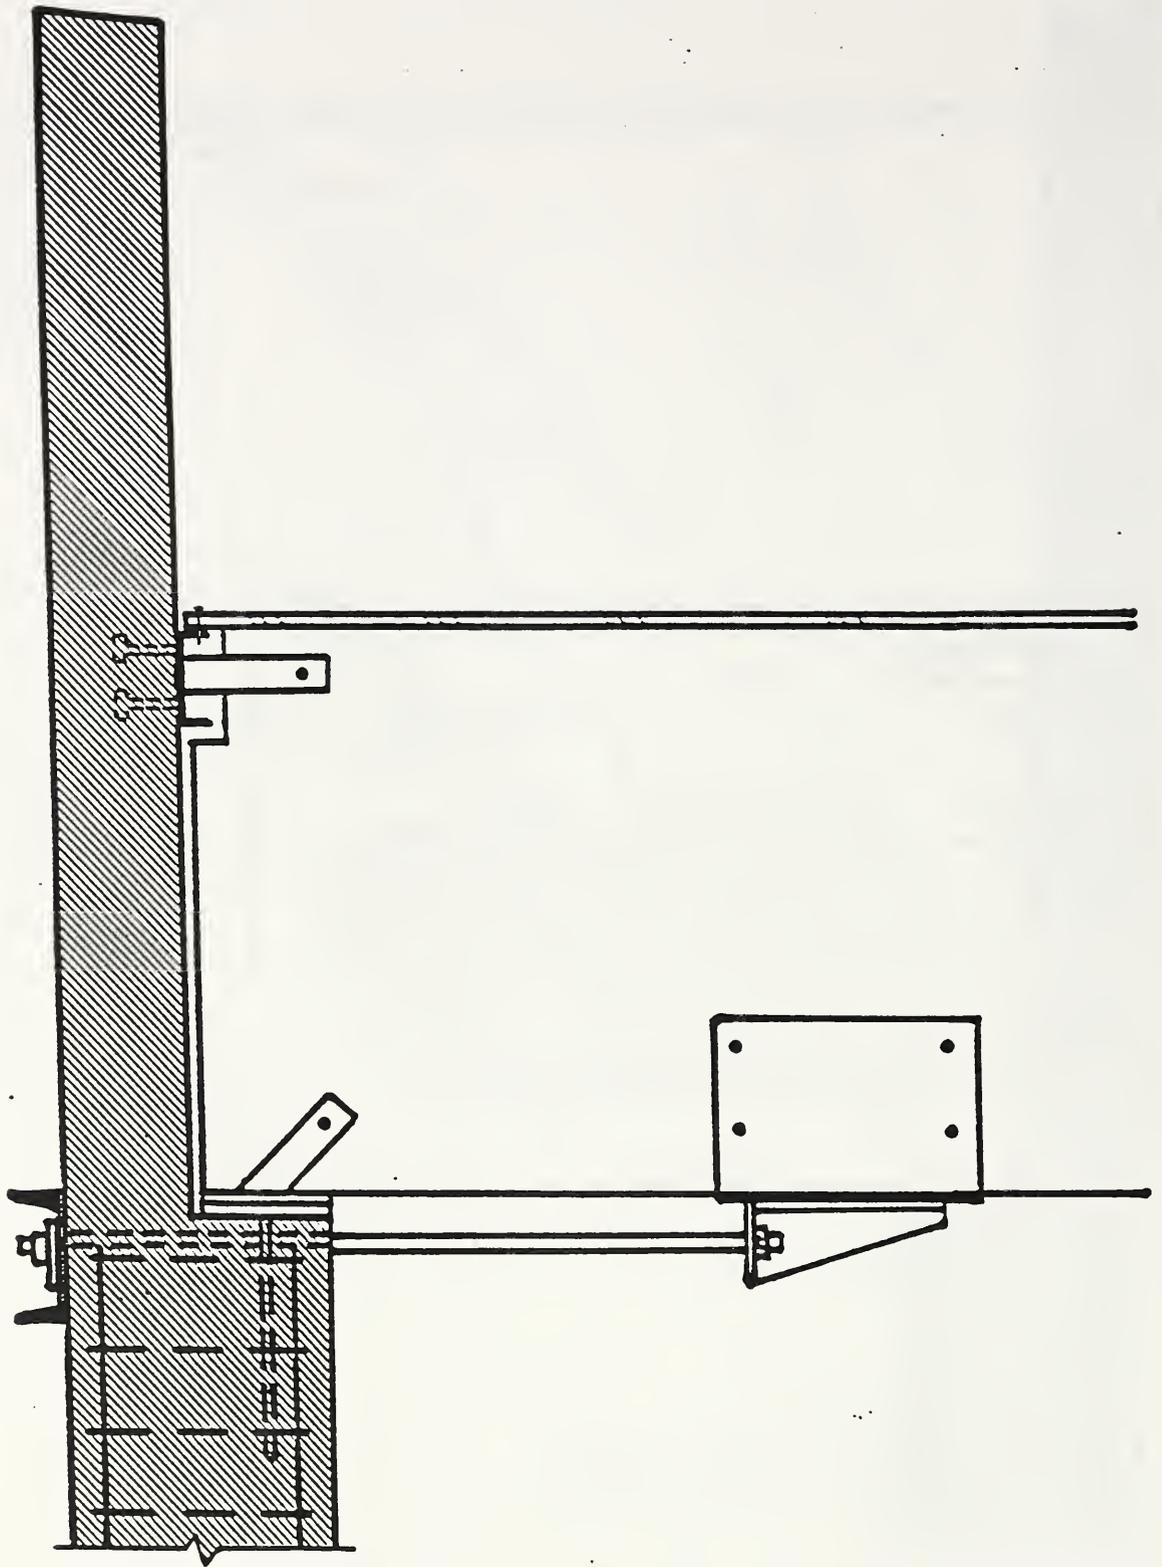
FIGURE 3 - RETROFITTED CONNECTION BETWEEN GLULAM BEAM AND TILT-UP WALL

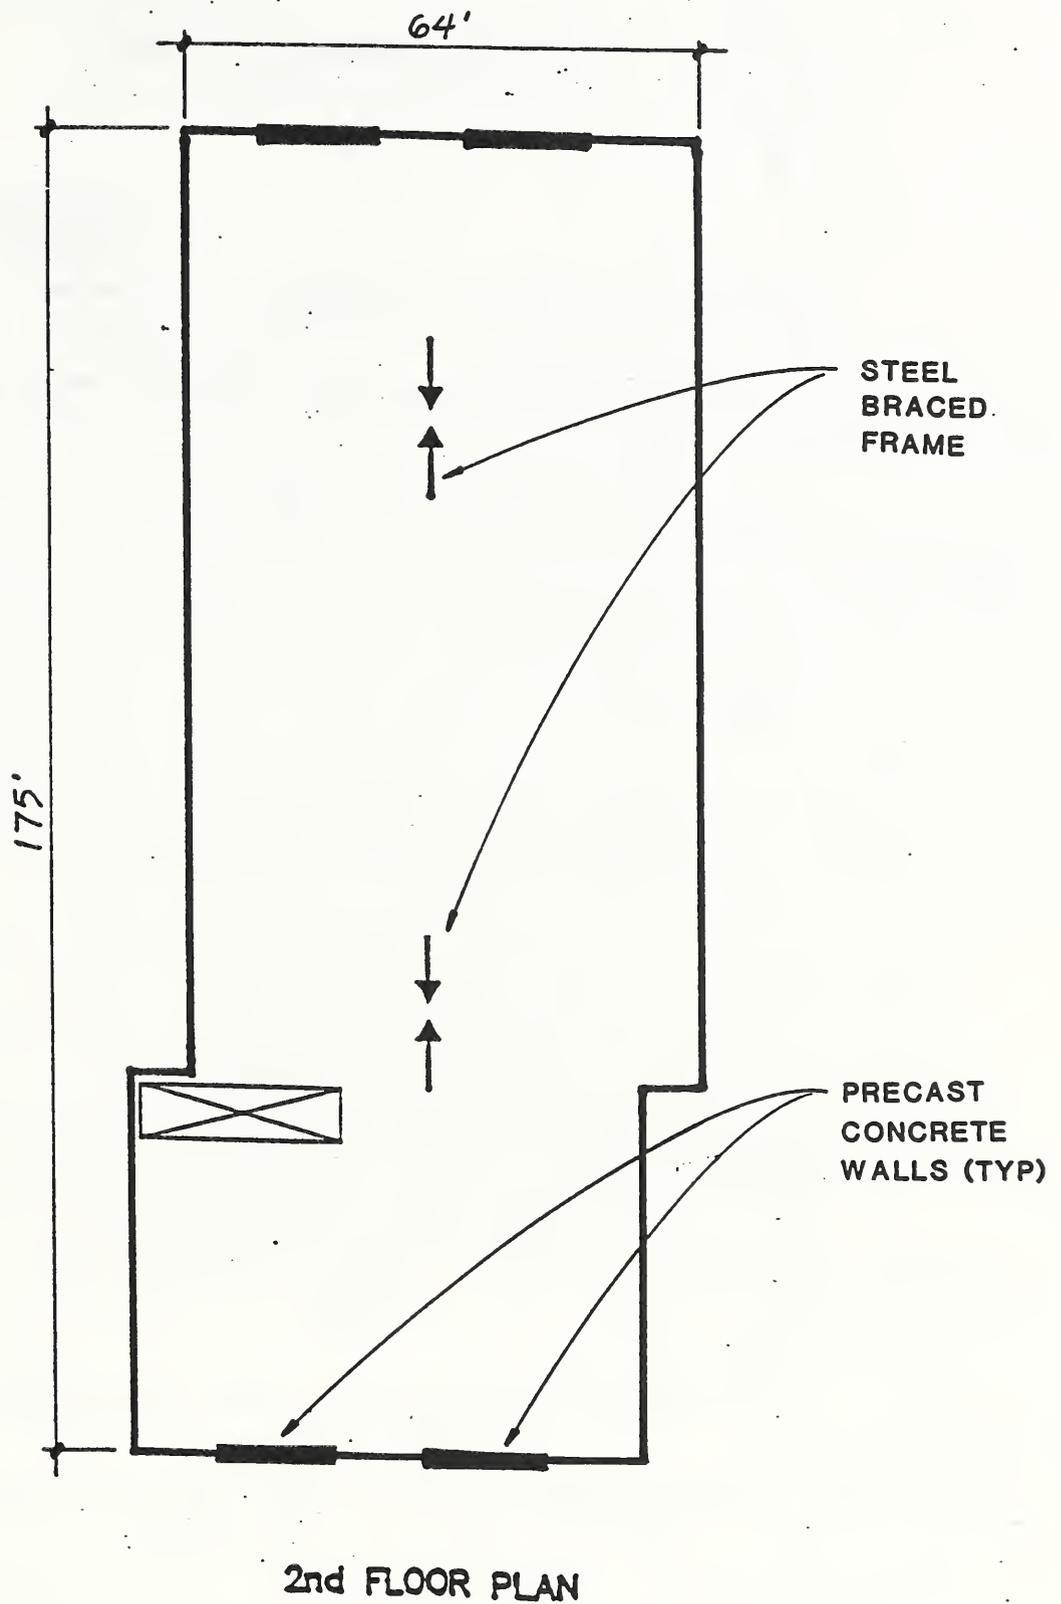
FIGURE 4 - FLOOR PLAN OF BUILDING DAMAGED DURING THE LOMA PRIETA EARTHQUAKE

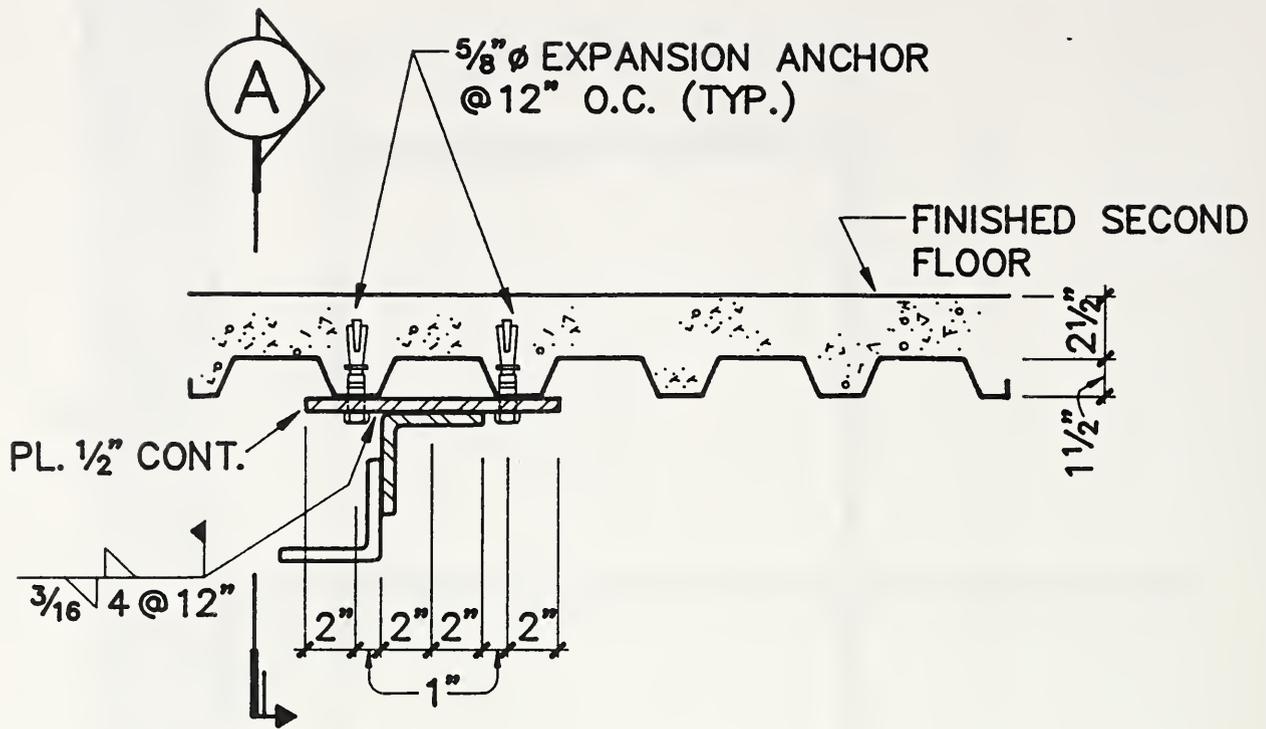
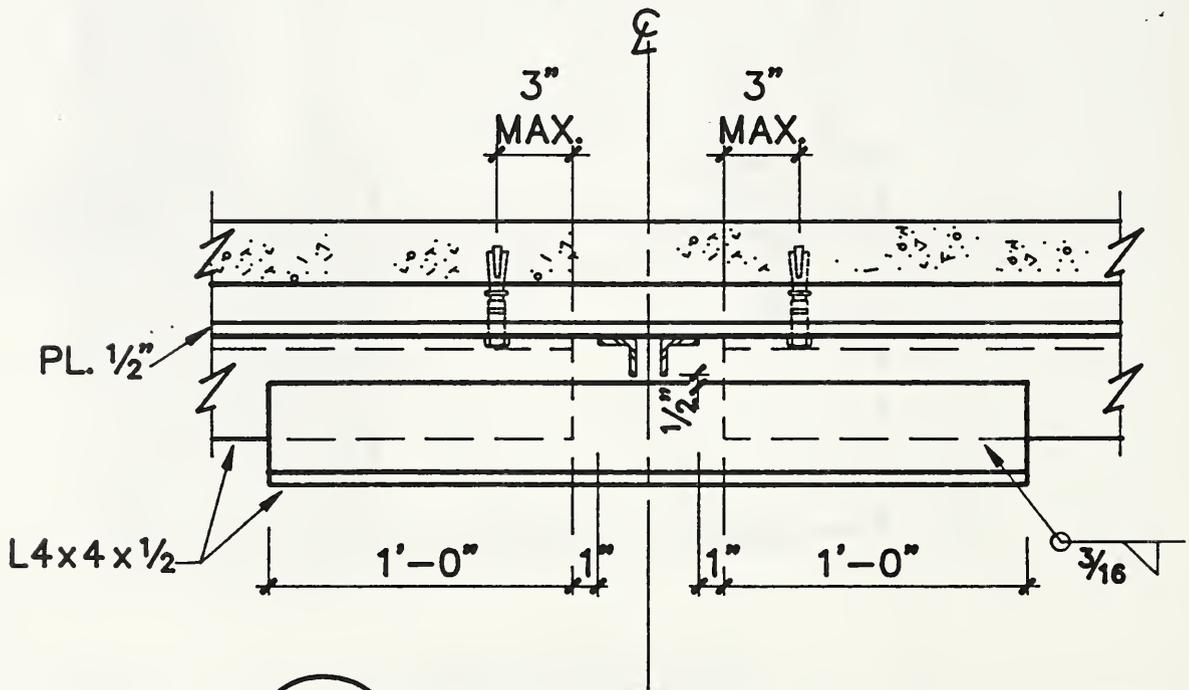
FIGURE 5 - RETROFIT OF SECOND FLOOR DIAPHRAGM
TO ACCOMMODATE MISSING CHORD BARS

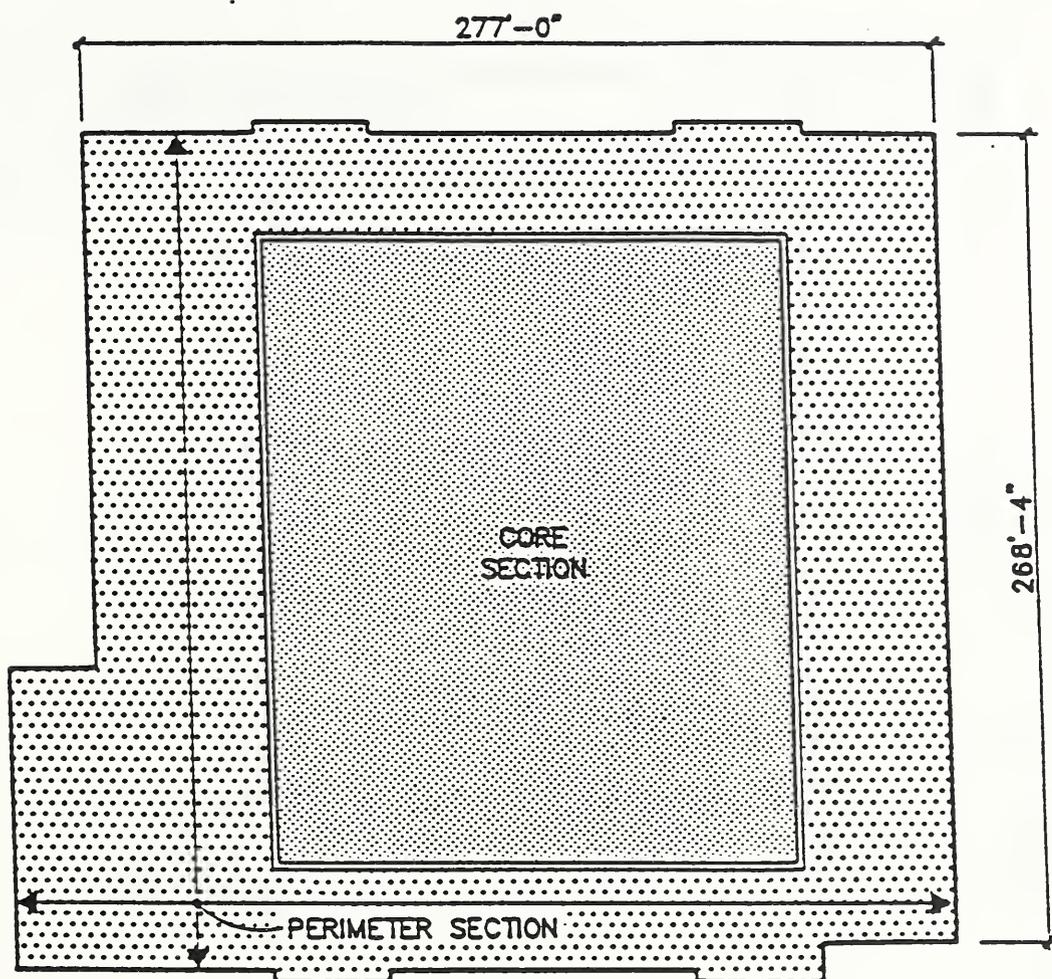
FIGURE 6 - SCHEMATIC PLAN OF BUILDING DAMAGED
DURING THE LOMA PRIETA EARTHQUAKE

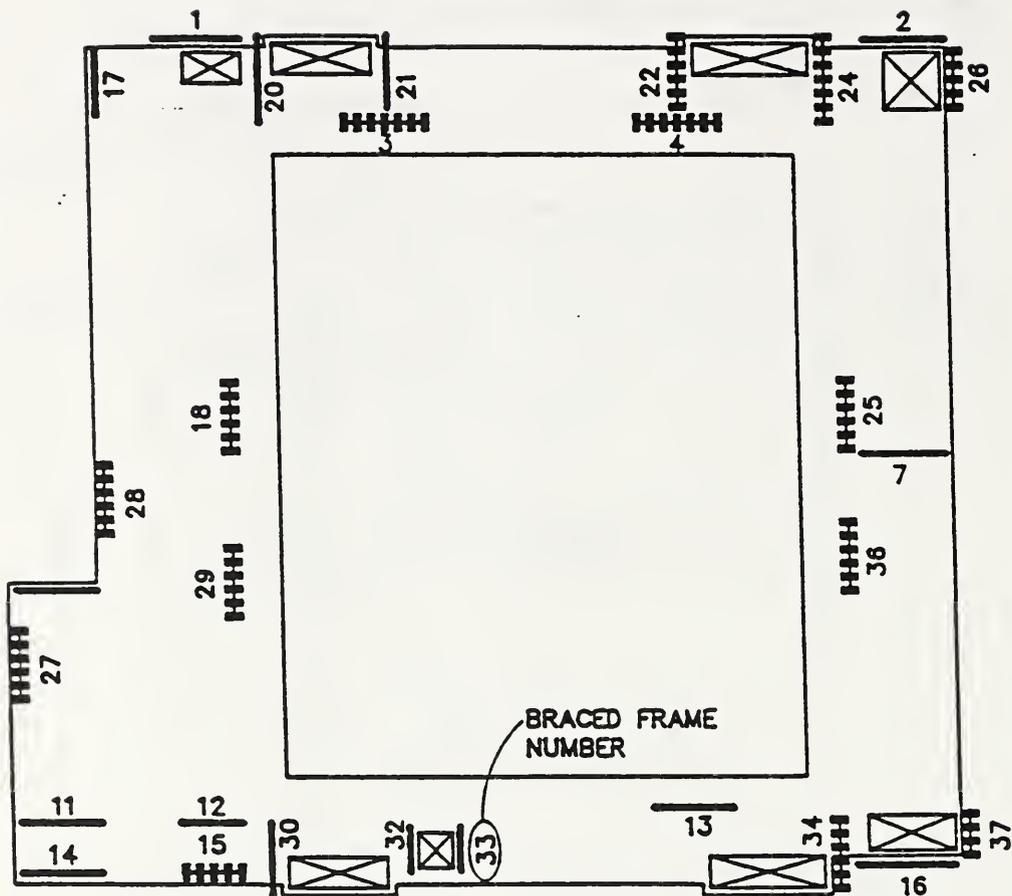
FIGURE 7 - BRACED FRAME LAYOUT

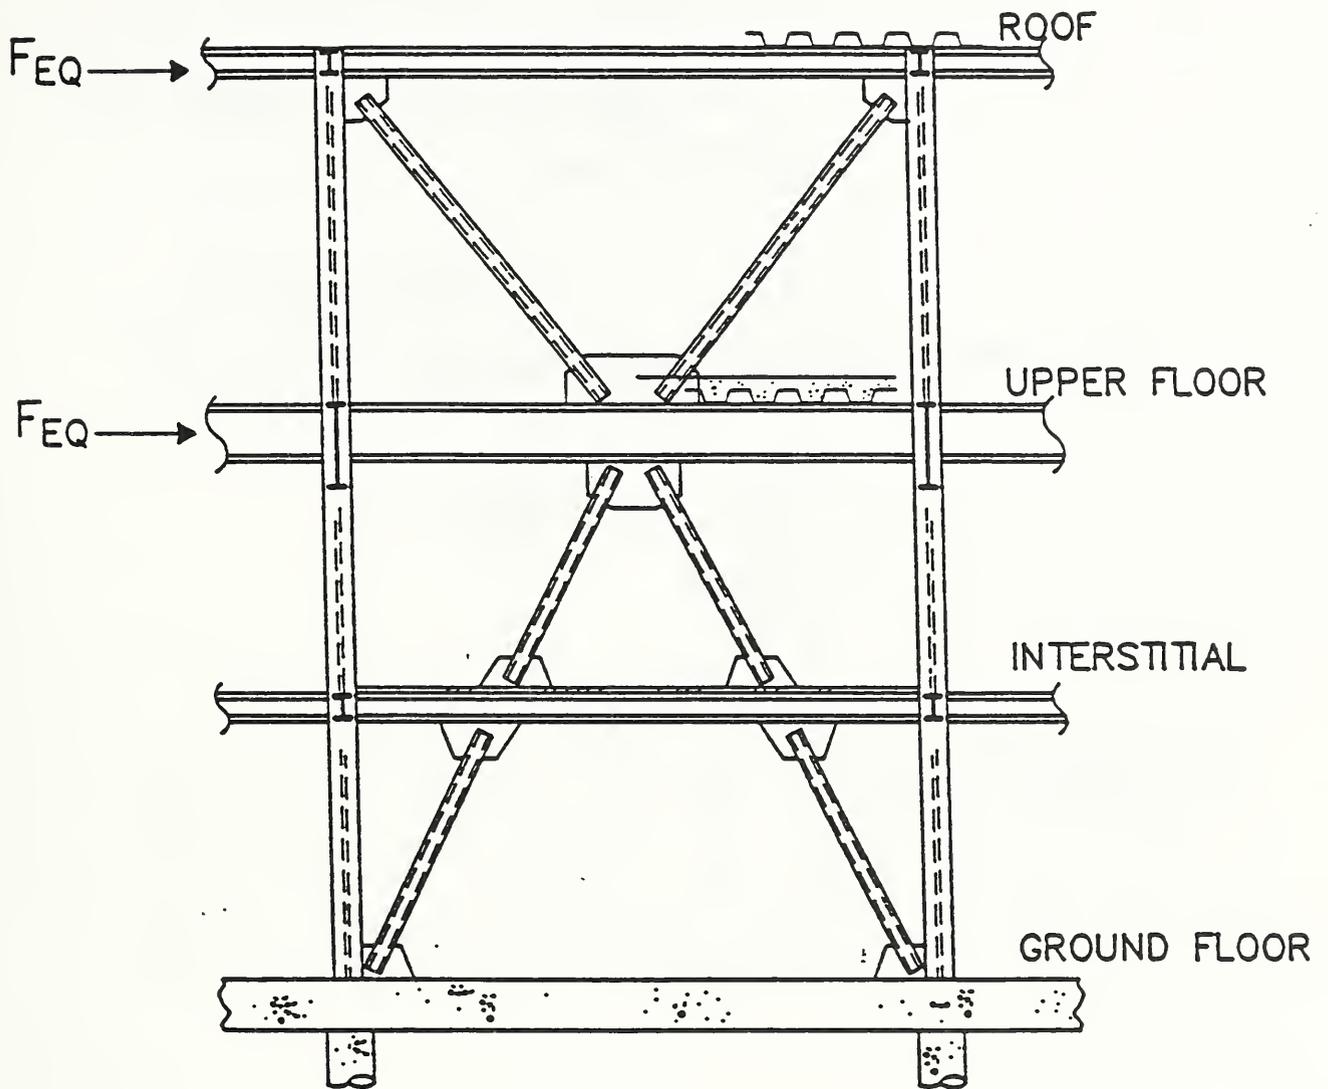
FIGURE 8 - BRACED FRAME DAMAGED DURING THE LOMA PRIETA EARTHQUAKE

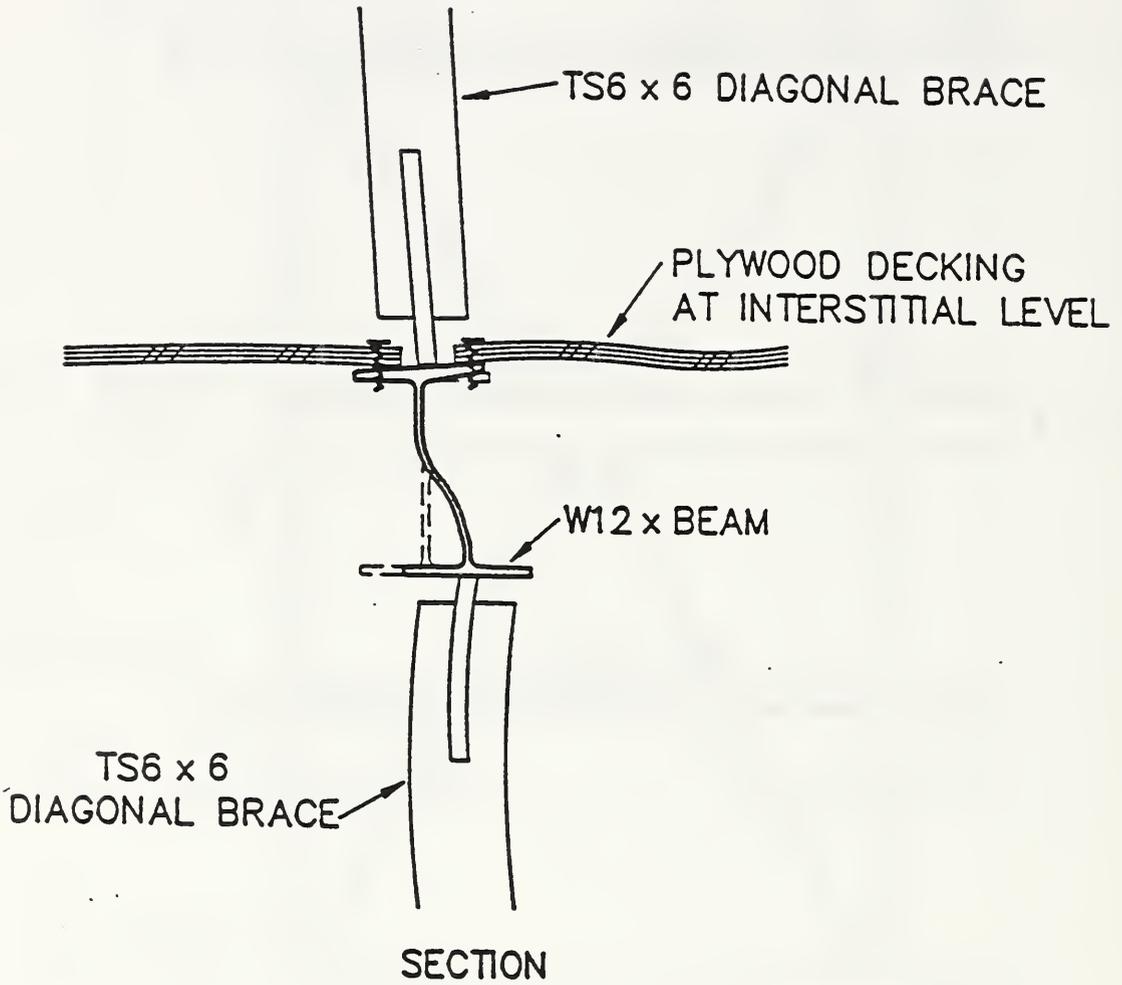
**FIGURE 9 - FAILED CONDITION OF BRACED FRAME DAMAGED
IN THE LOMA PRIETA EARTHQUAKE**

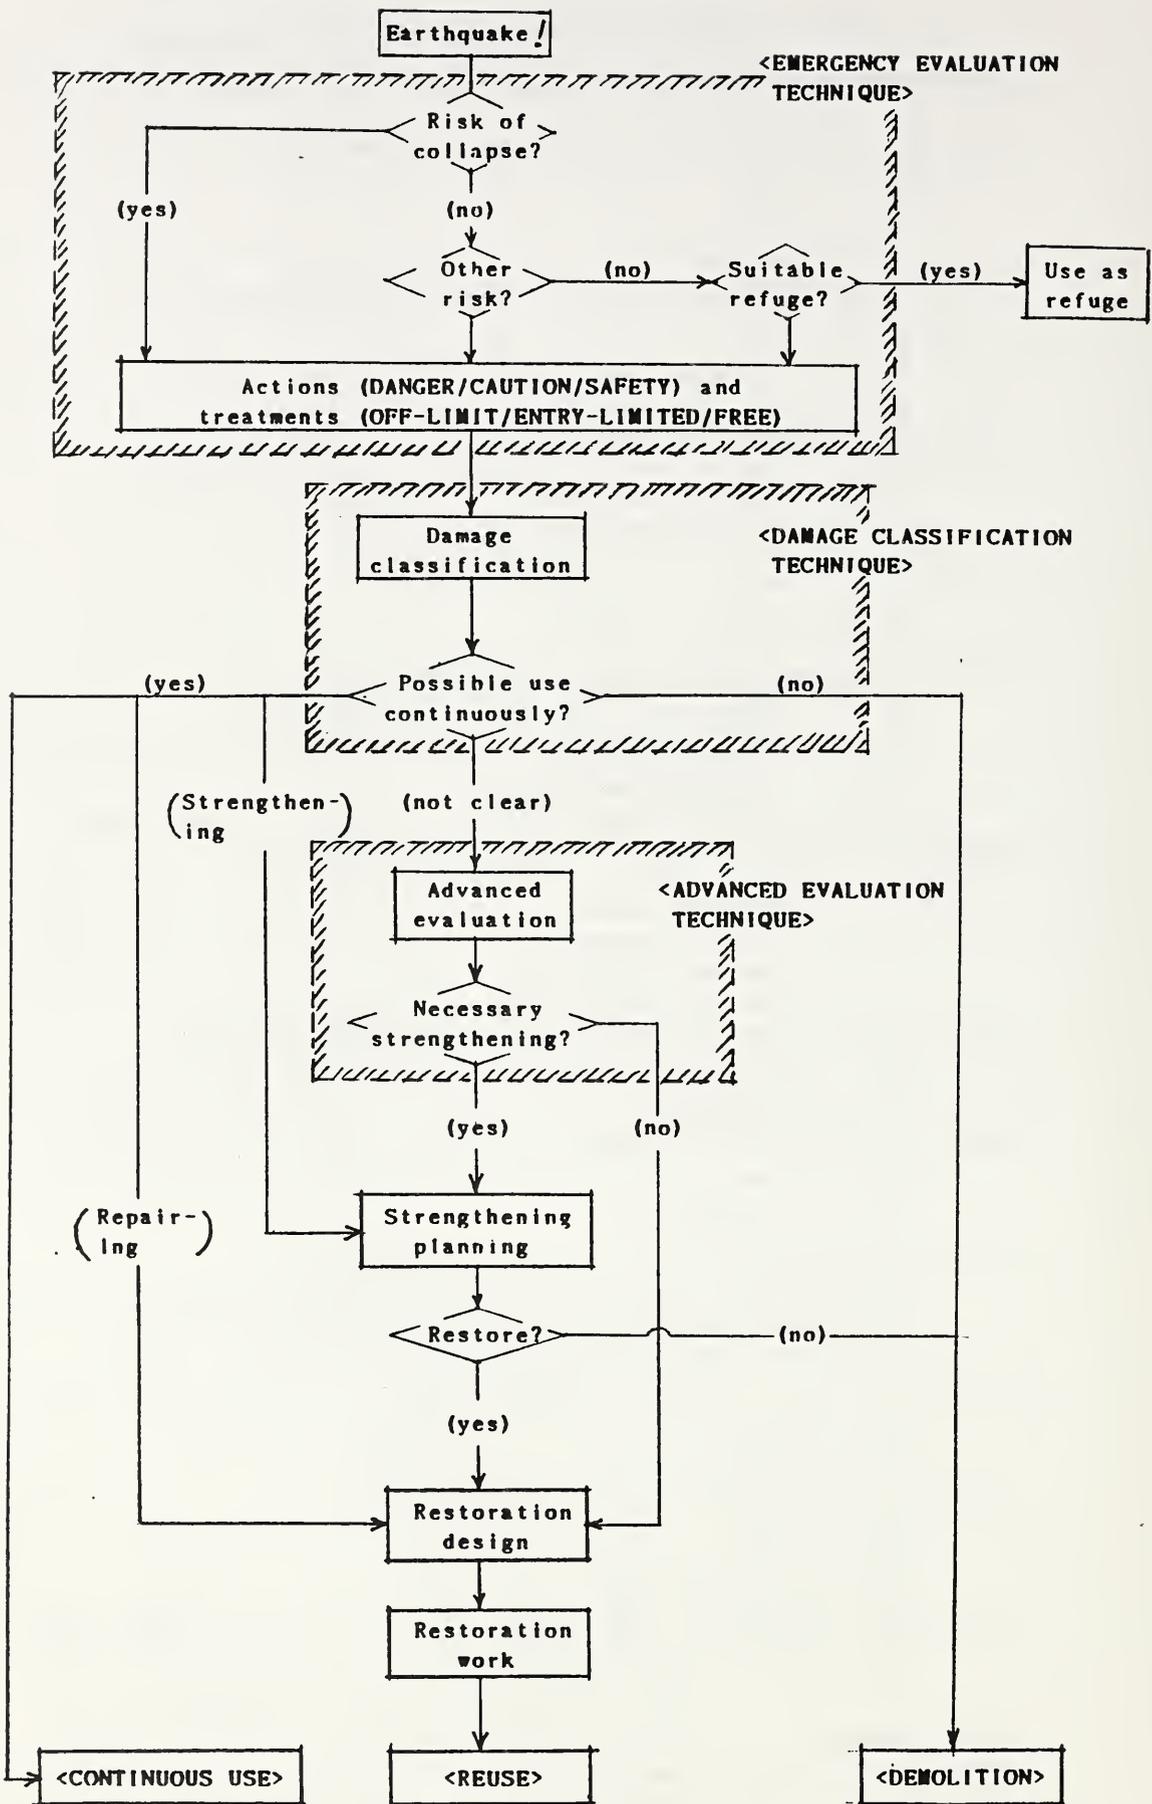
Fig. 1 : GENERAL FLOW-DIAGRAM FOR POST-EARTHQUAKE DAMAGE INSPECTION, EVALUATION AND RESTORATION

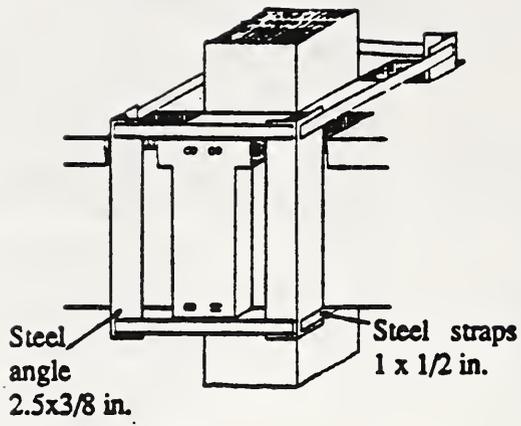
Figure 3. Structural steel cage assembled in the joint

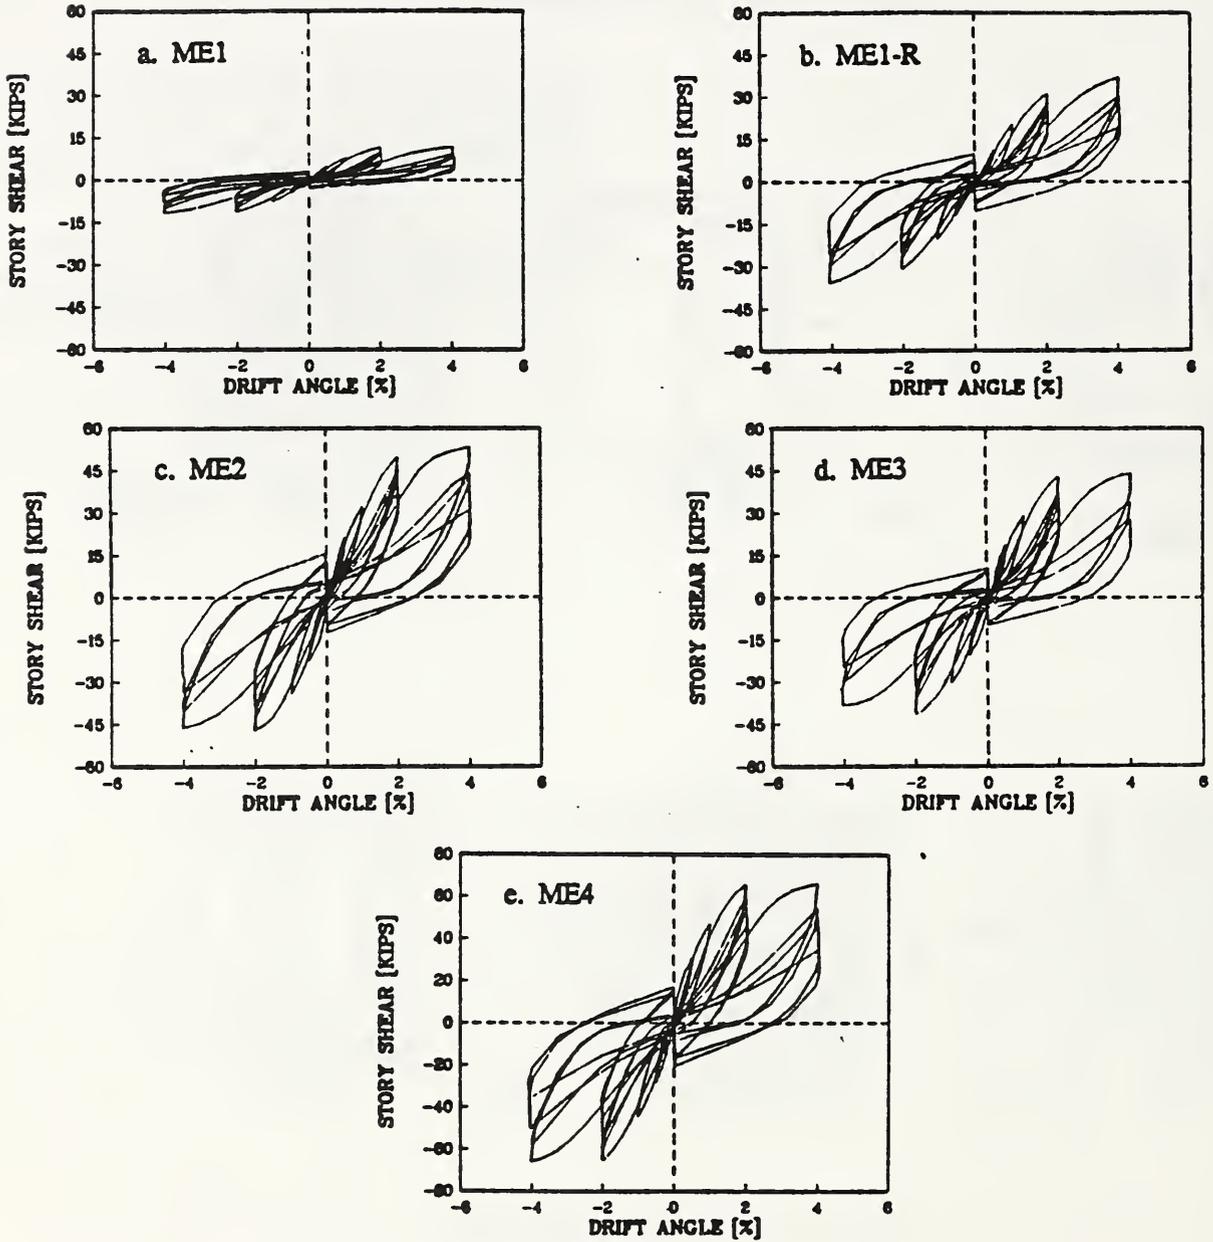
Figure 4. Hysteretic response of the specimens (EW direction).

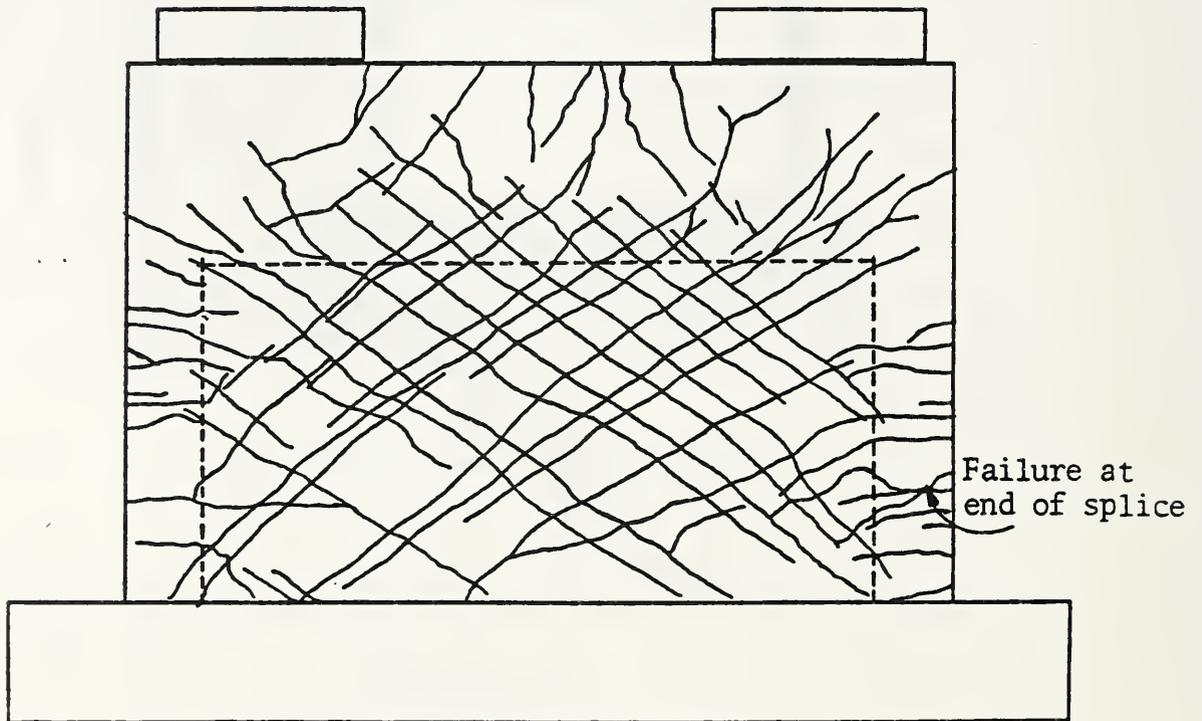
Figure 11. Crack pattern at failure, SC-S

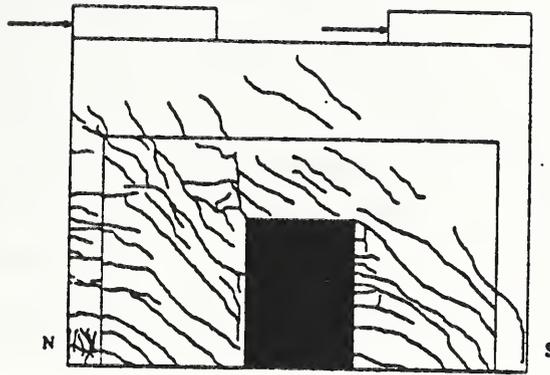
Figure 12. Crack pattern at failure, SC-D, south loading

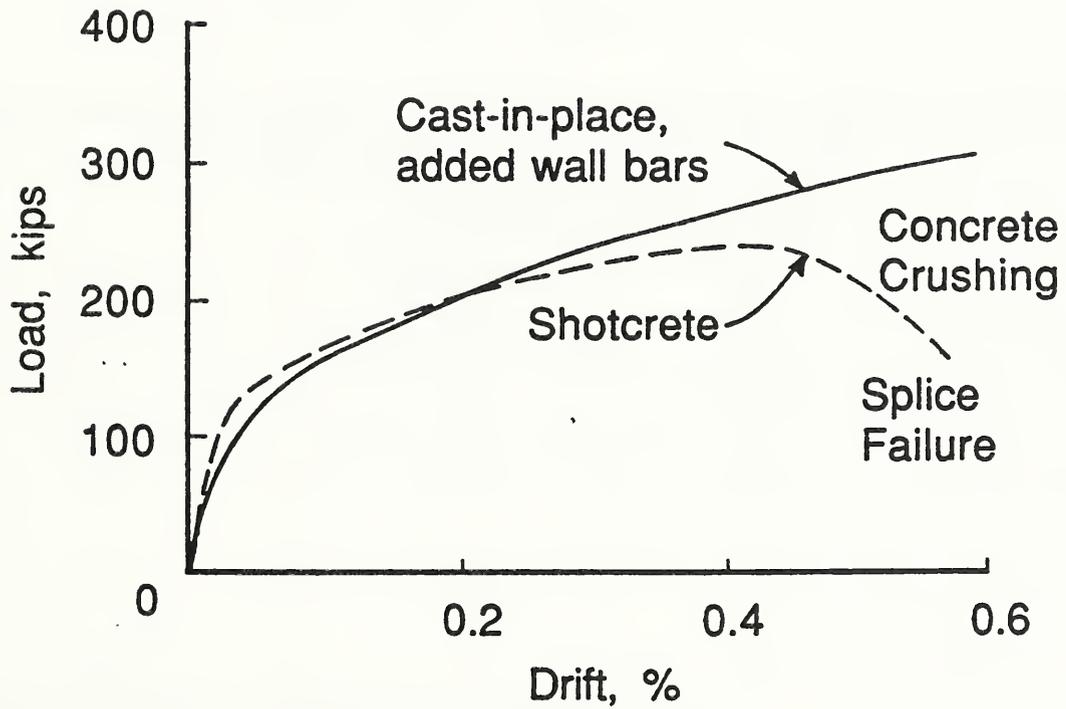
Figure 13. Envelope curves for tests CIP-D and SC-D

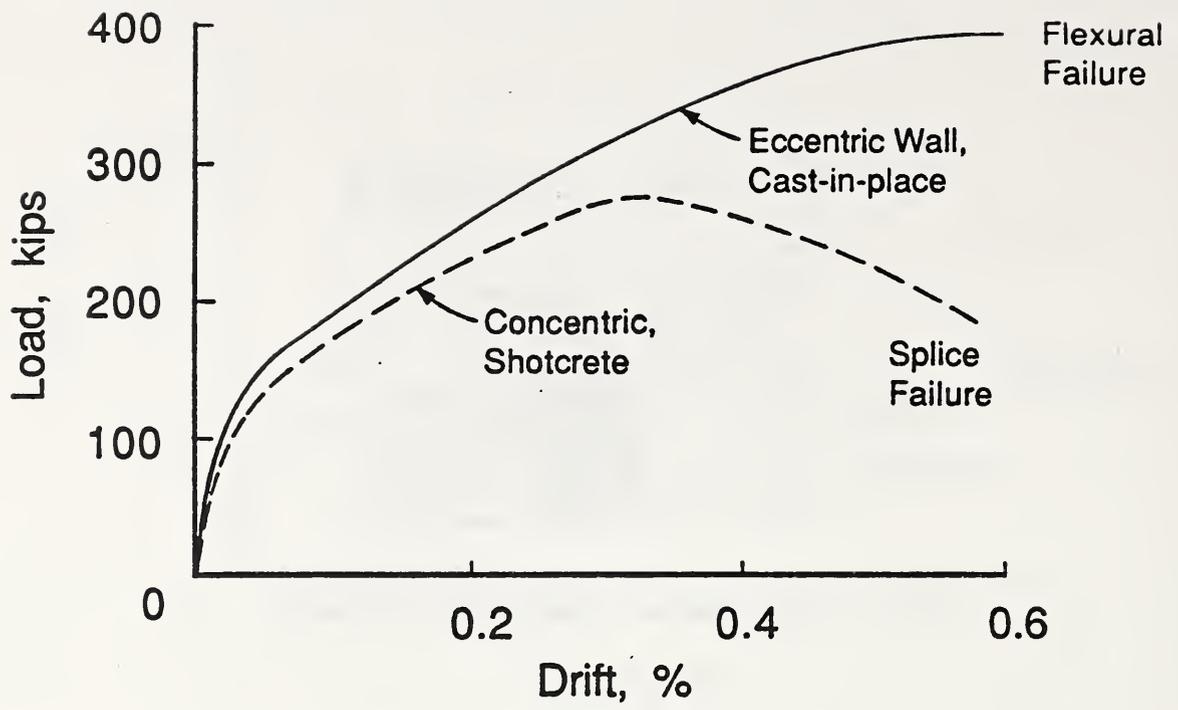
Figure 14. Envelope curves for tests CIP-5 and SC-S

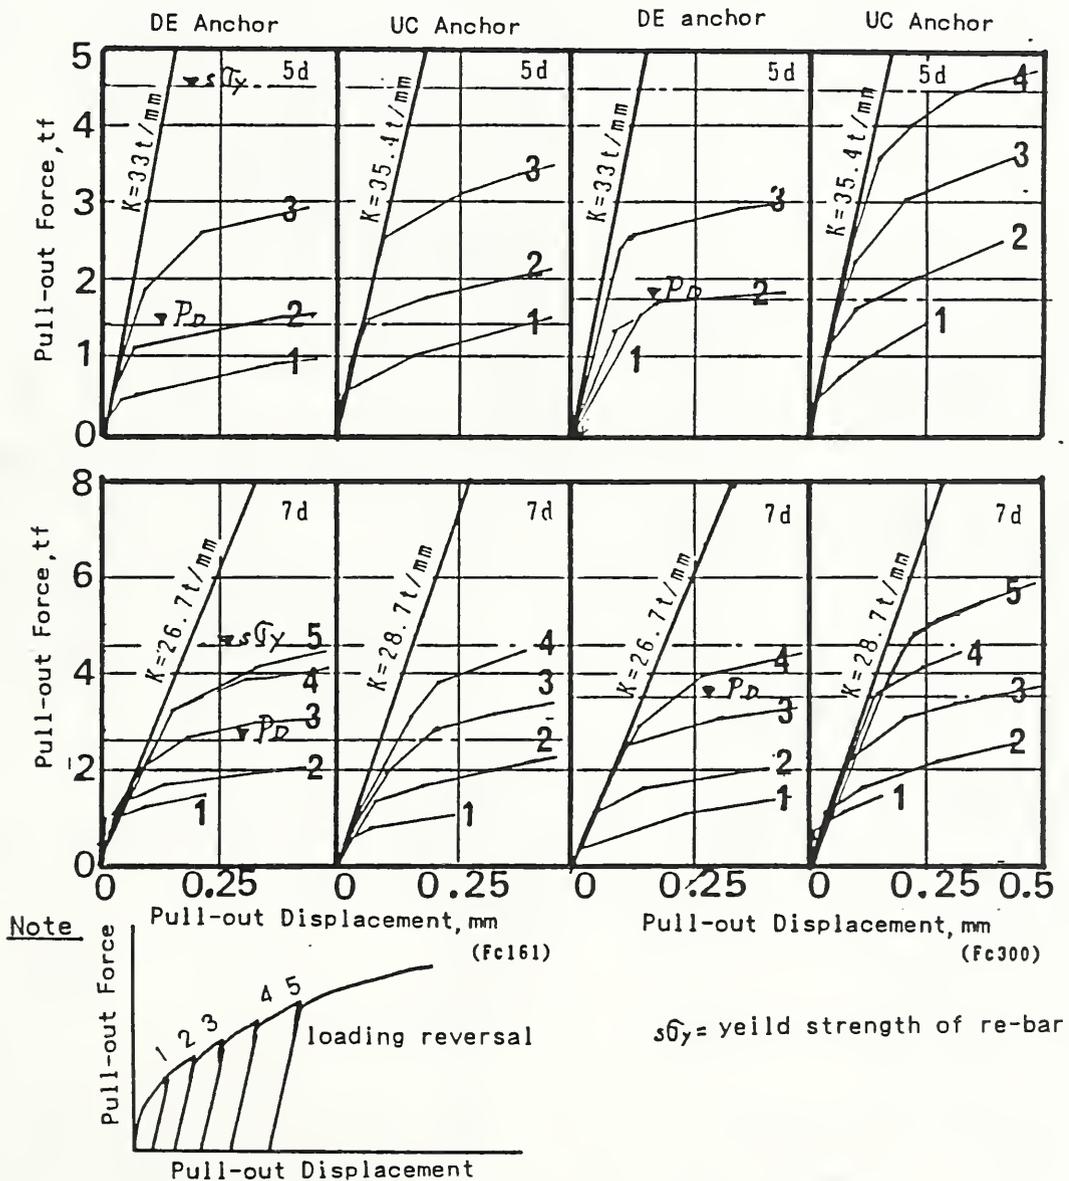
Fig. 9 Comparison of stiffening for Restoring Force

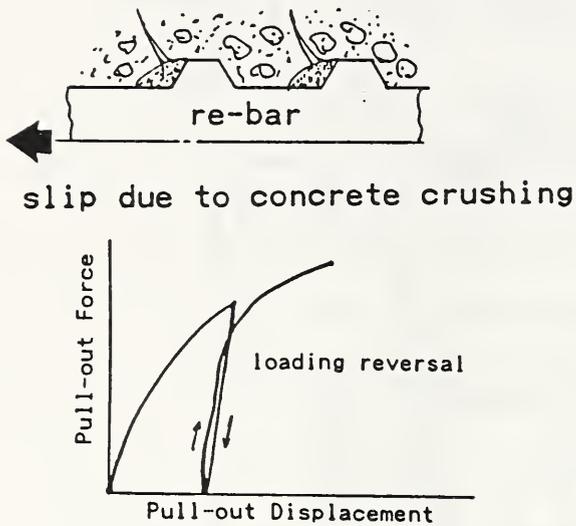
Fig. 10 (b) Bond Failure Mechanism

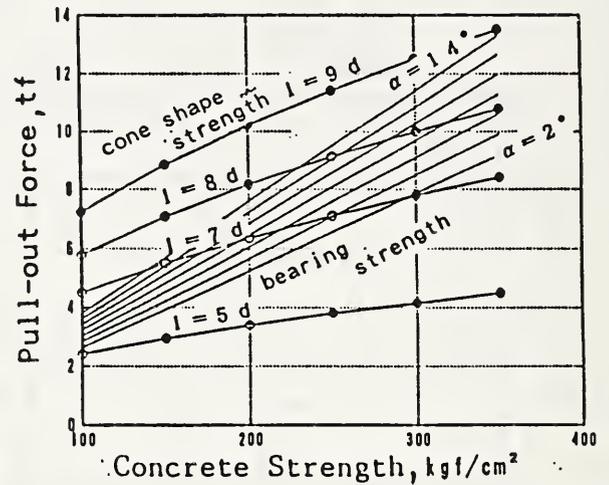
Fig. 11 Pull-out Load and Concrete Compressive Strength Relationship
