Proceedings of a Workshop on Evaluation,
Repair, and Retrofit of Structures – U.S.-Japan
Panel on Wind and Seismic Effects, UJNR,
Gaithersburg, MD, USA, May 12–14, 1990

James O. Jirsa
Janet S. Cockrell Centennial Chair in Engineering

April 1991

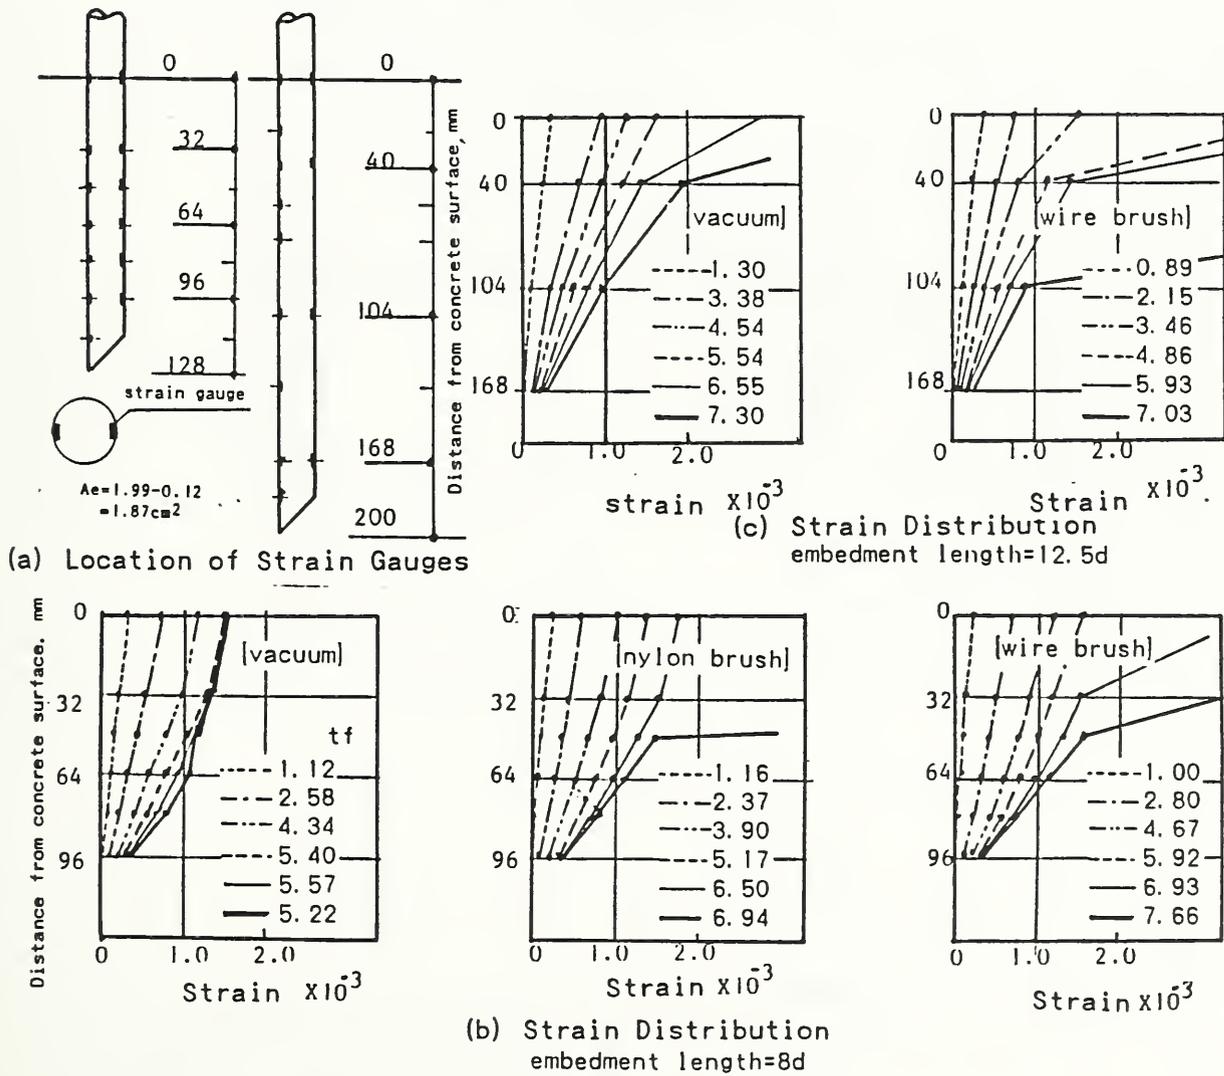
Fig. 14 Strain Distribution in an Embedded Re-bar

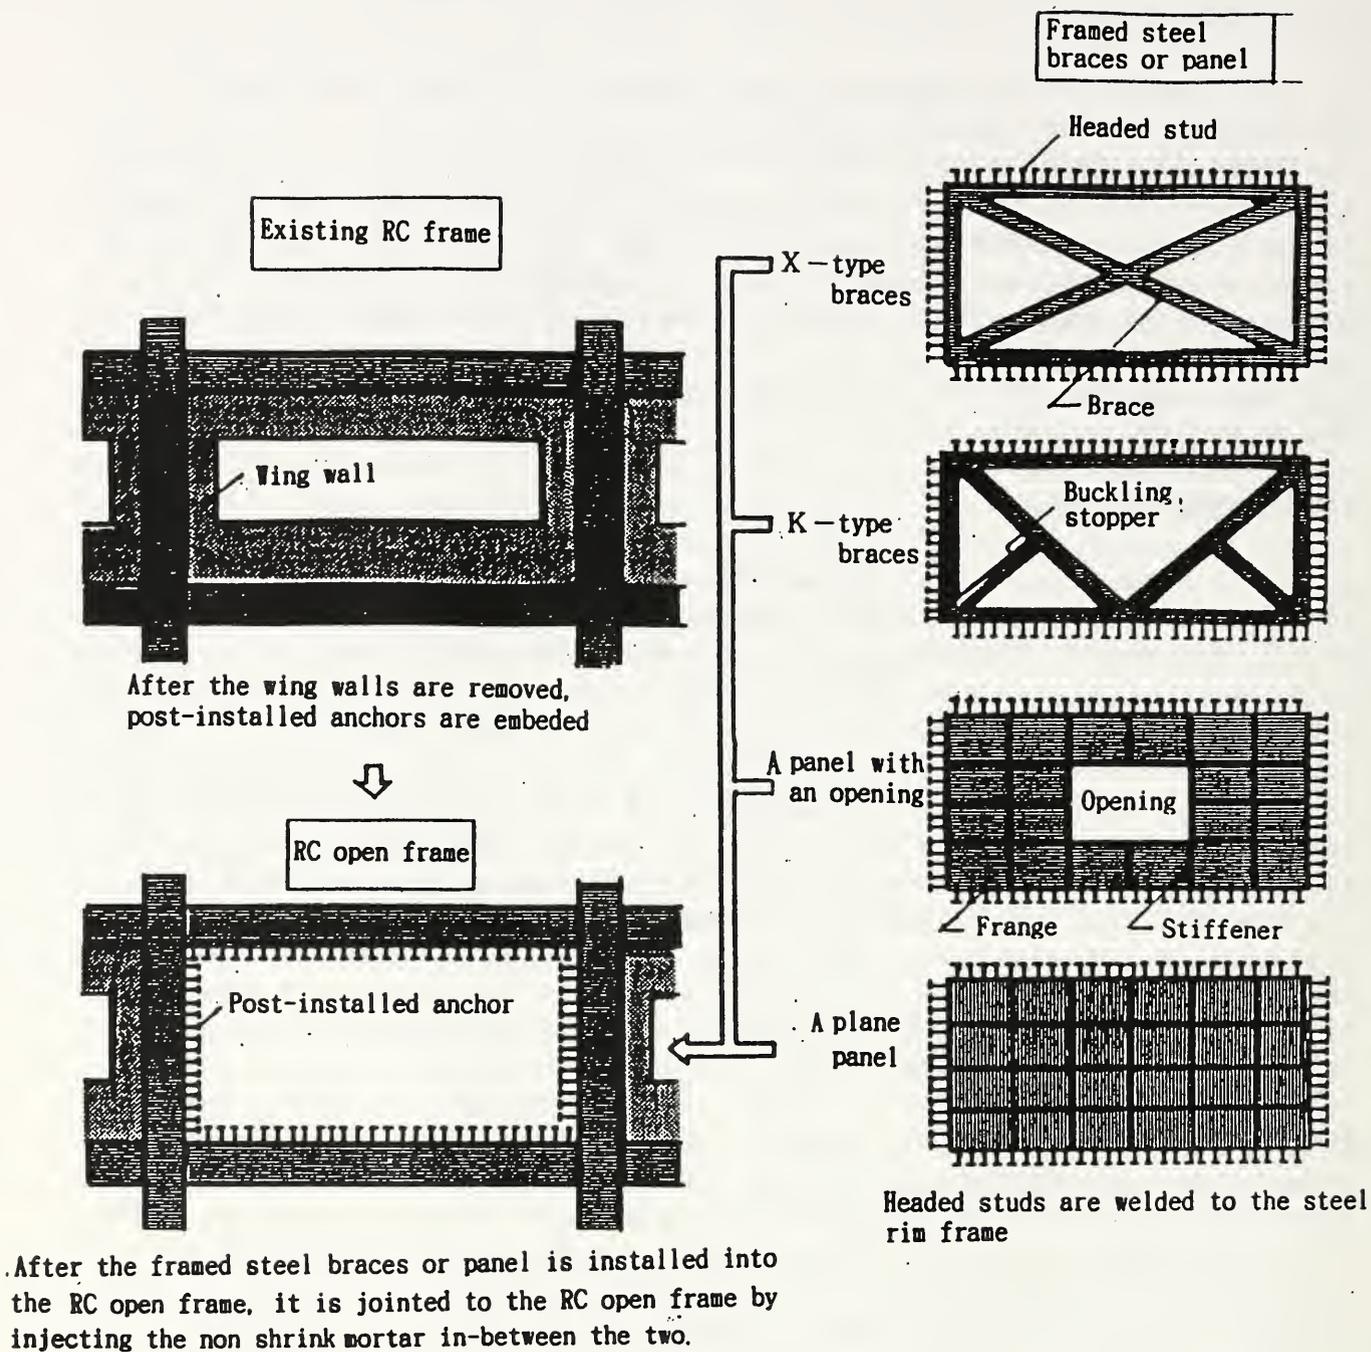
Fig. 1.1 Examples of RC open frames strengthened with framed steel(strengthened with rims frames)

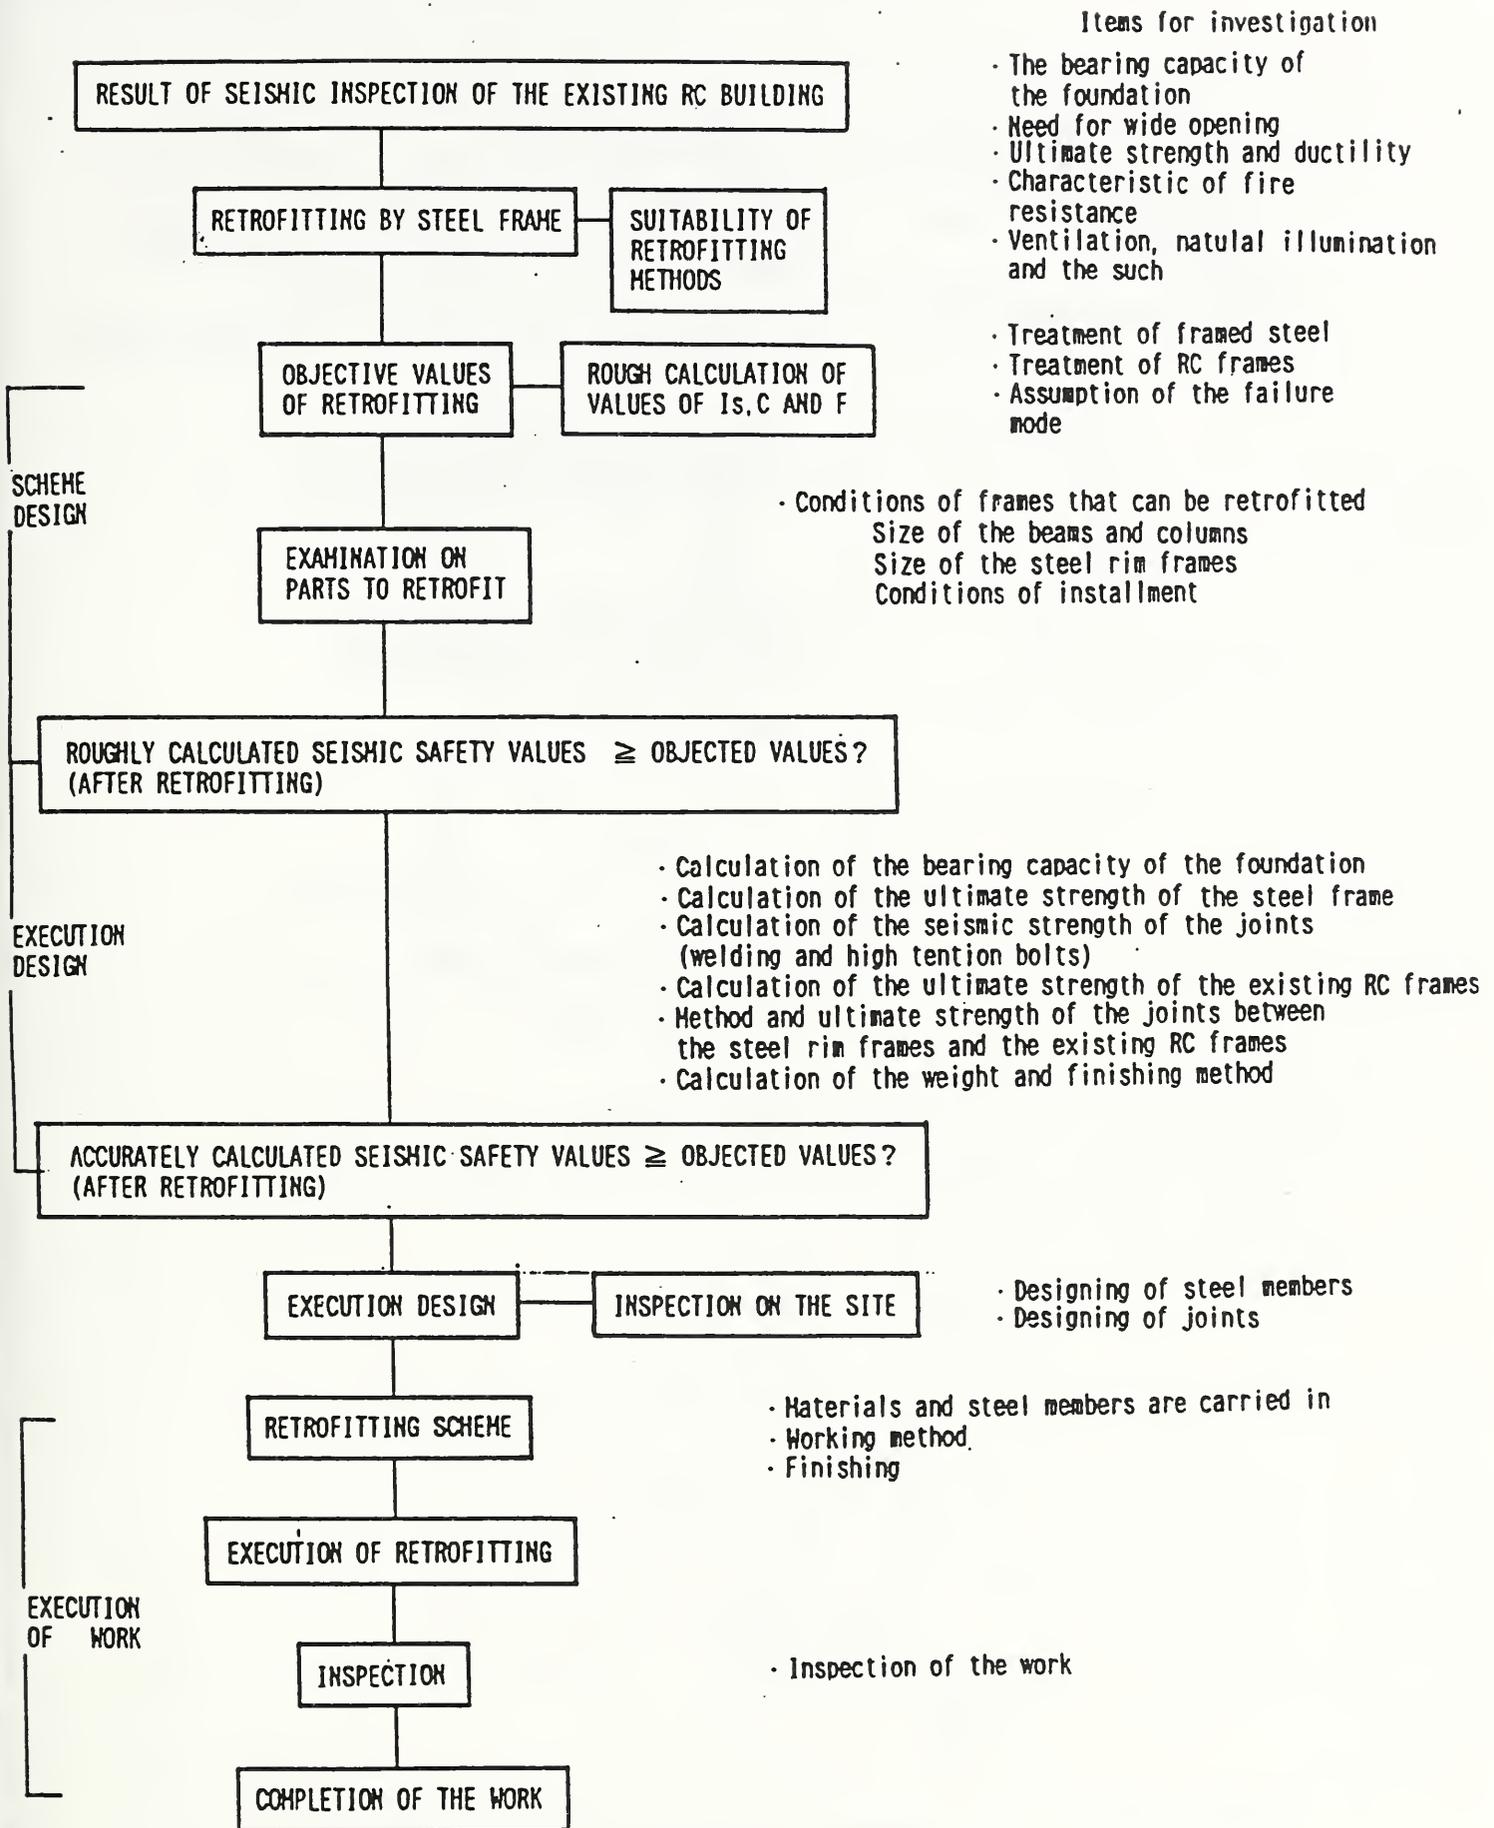
Fig. 2.1 Flow chart of designing and execution of retrofitting with framed steel

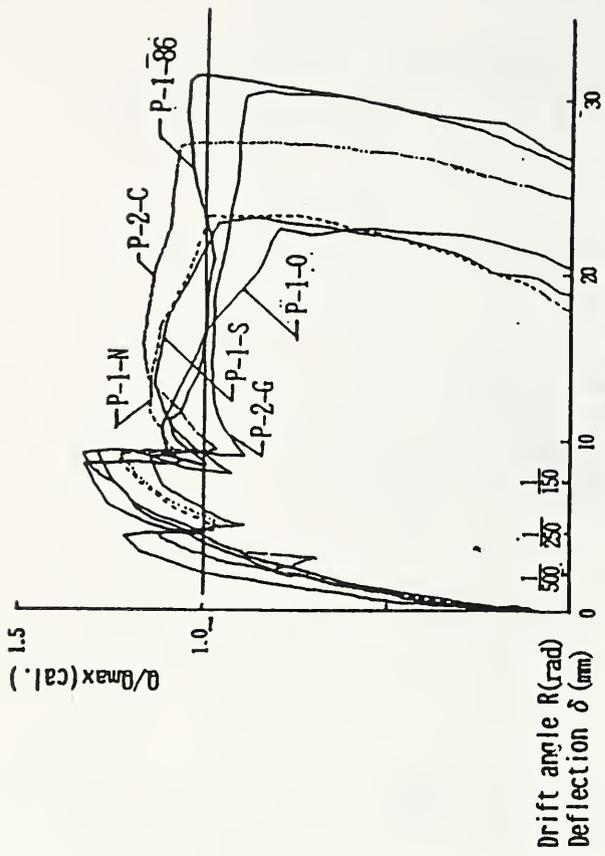
a) Test specimen of brace which shows the failure type I

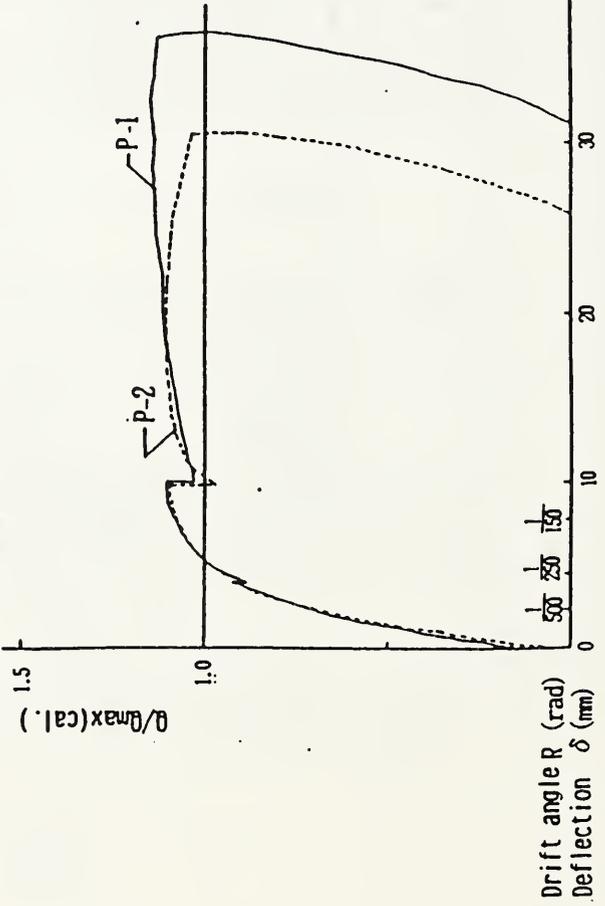
b) Test specimen of panel which shows the failure type I

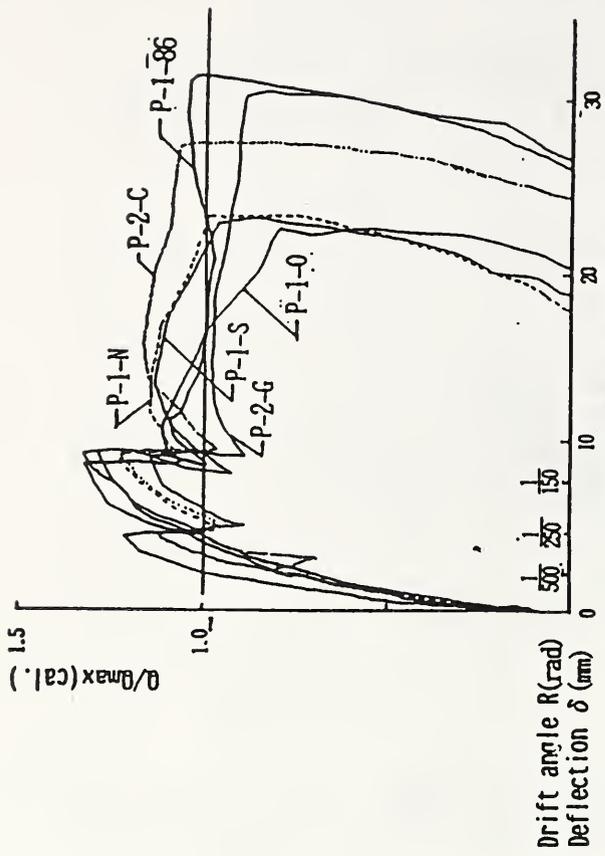
c) Test specimen of panel which shows the failure type II

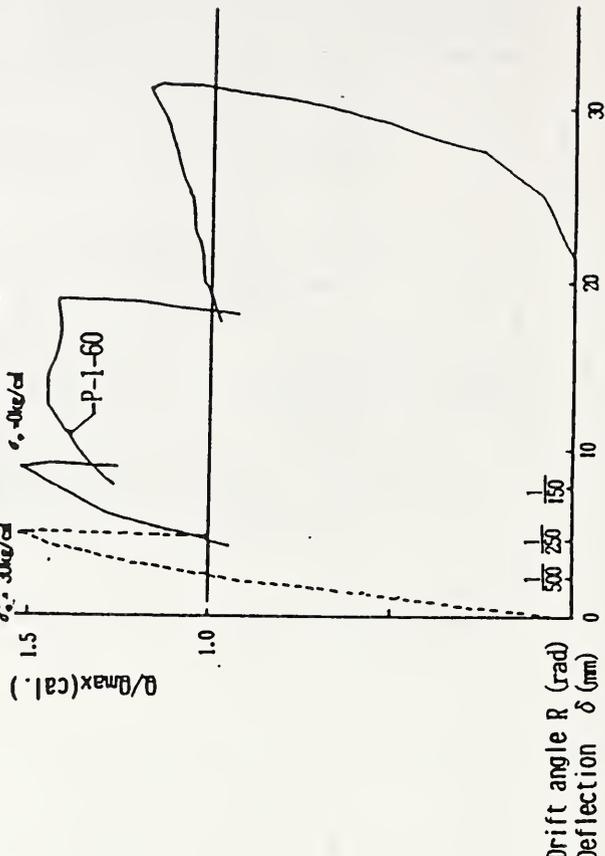
d) Test specimen of panel which shows the failure type III

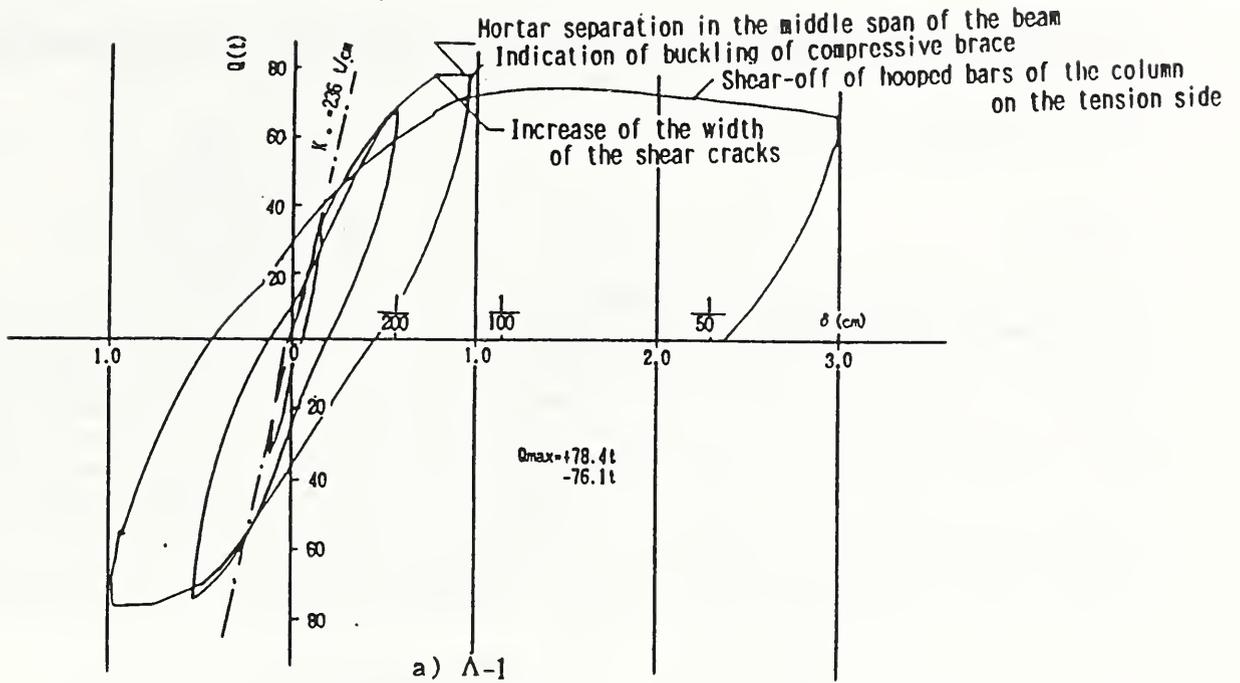
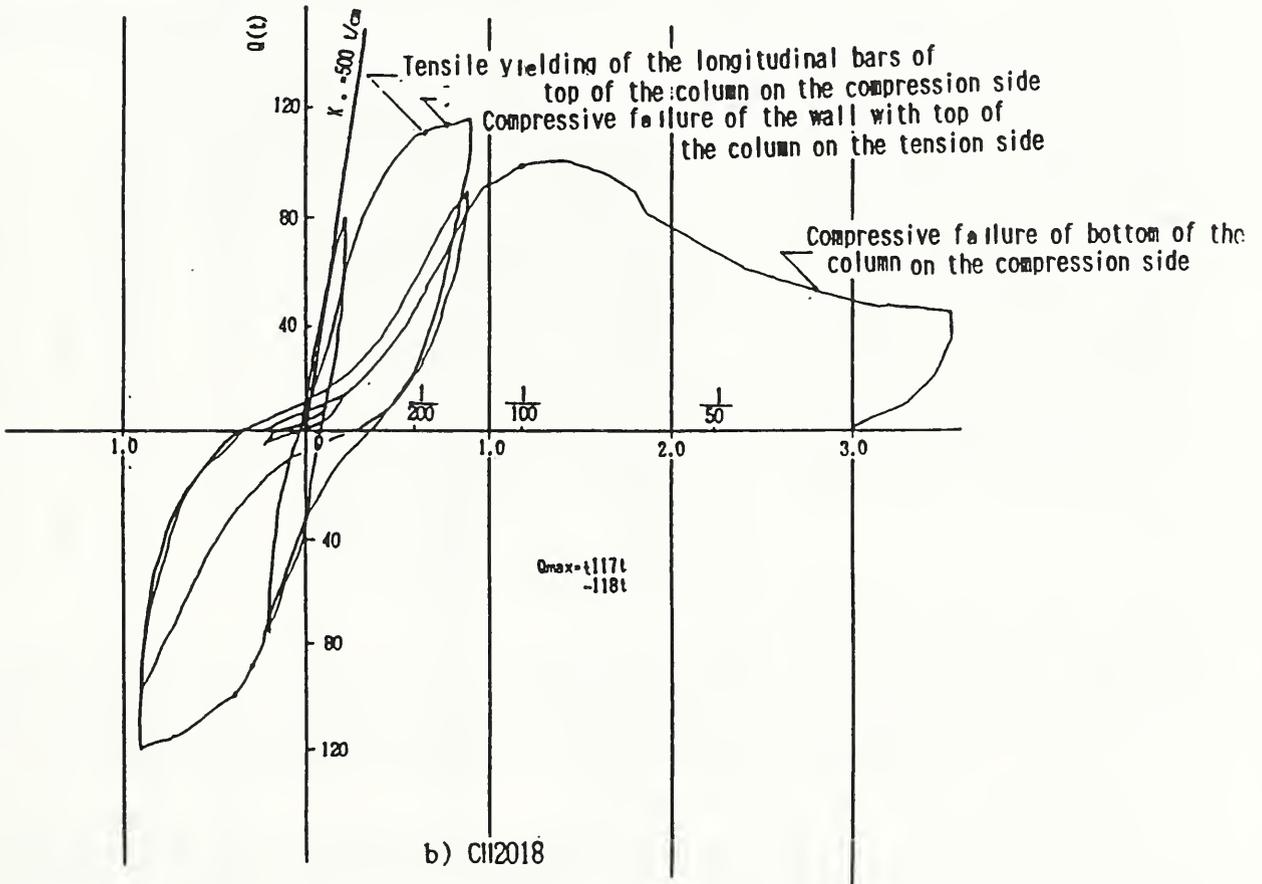
Fig. 8.1 Comparison between the hysteretic characteristics of framed steel and that of post-cast RC walls

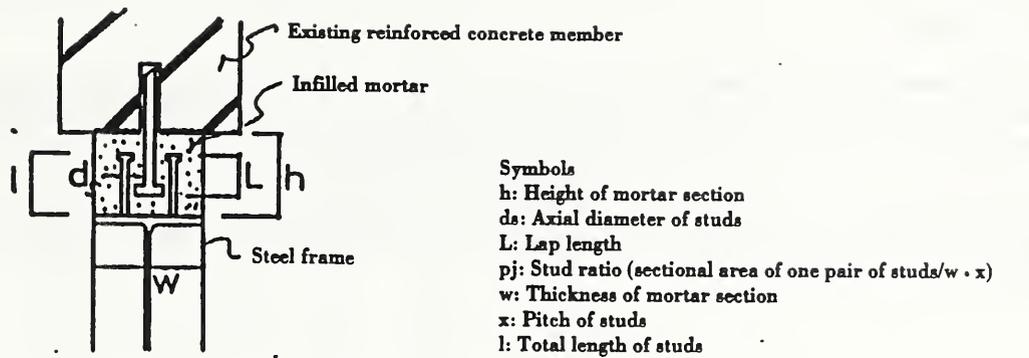
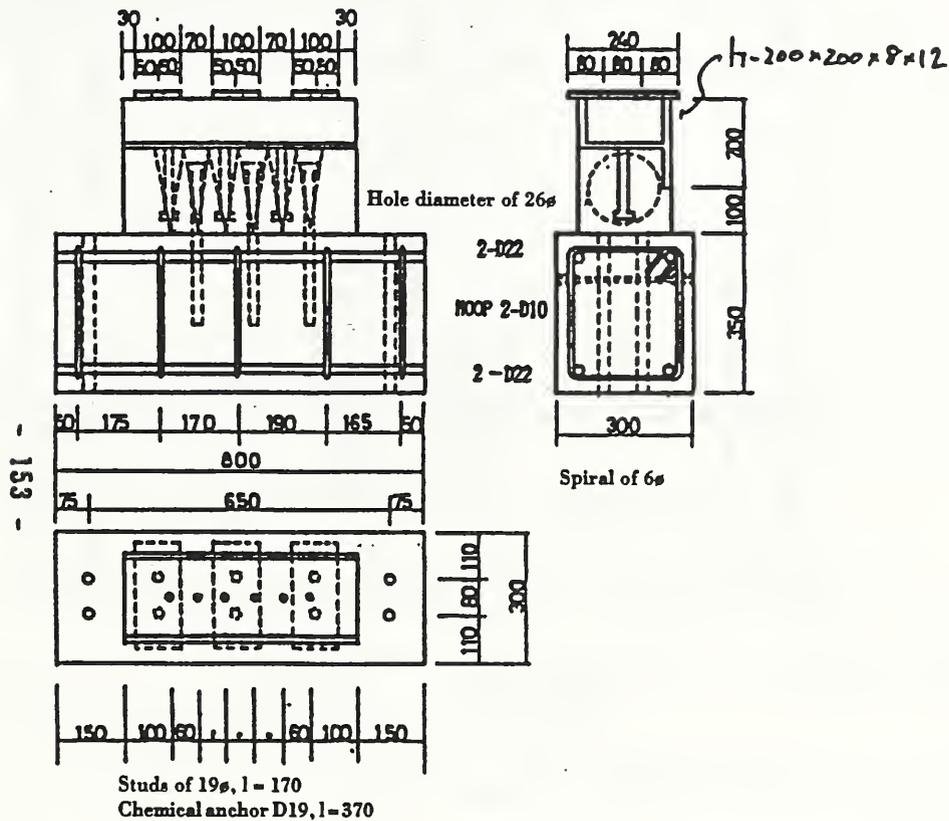
Figure 1. Details of specimens of BP-120S-0, -C and -T

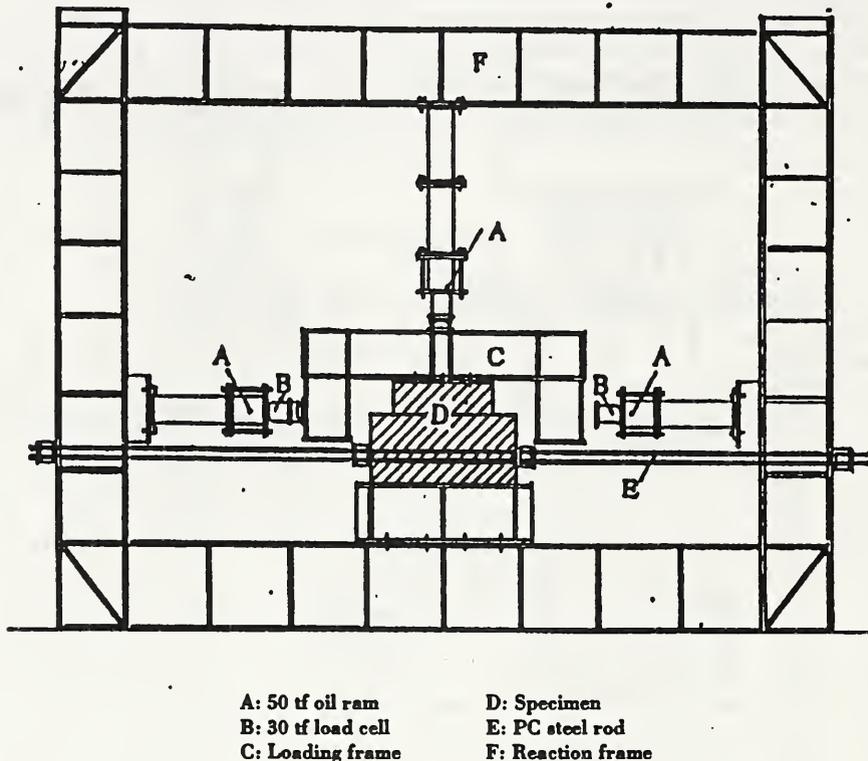
Figure 2. Loading set-up for direct shear test

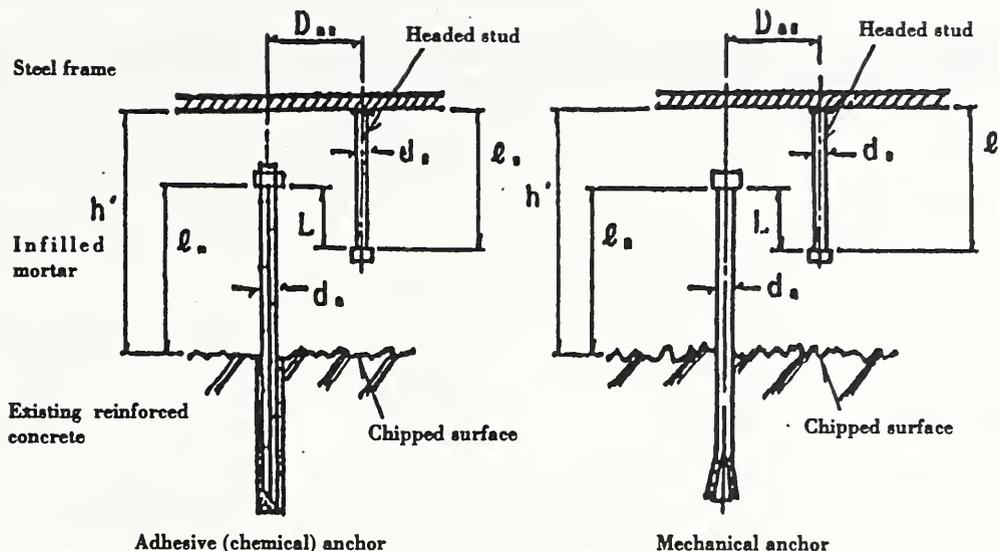
Figure 4.

D_s : Diameter of the stud
 D_a : Diameter of the anchor
 h' : Height of the infilled mortar
 l_a : Fixing length of the anchor
 L : Lap length of the stud and anchor

Based on the test results mentioned in section 2, details of the structure, which were adopted in the draft of the Design Guide for Retrofitting, are described below. For details of the structure of the indirect mortar joint with framed steel brace, the example in Figure 3 is recommended. Performance of this joint was confirmed through testing, and a number of actual work examples are available. The details include items of the steel frame, anchor bolts, headed studs, strength of infilled mortar, spiral hoop, hoop and ladder hoop for crack prevention.

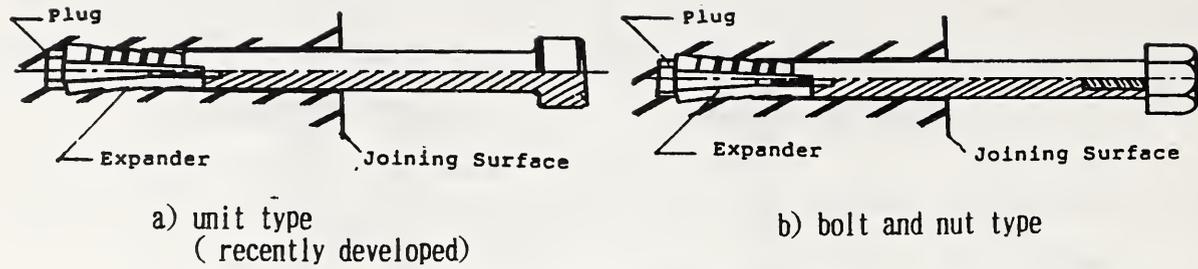
Figure 5. Mechanical anchor to strengthen steel frame

- i) Anchors for the mortar joint for strengthening should be embedded at all circumferences of the posts and beams after the contact surface has been chipped. Either chemical or mechanical anchor can be used, but avoid using the two together.
- ii) Use only anchors with axial diameters larger than 16mm.
- iii) The effective embedded depth of the chemical and mechanical anchors should be more than $7d_s$.
- iv) The fixing depth of the anchors (from the neck of the anchor to the surface of the existing concrete) in the mortar section (l_a) should be $6d_s$ or more (d_s : axial diameter of the anchor).
- v) Headed mechanical anchors should be used (as illustrated in Fig.5).
- vi) The pitch of the anchors should be less than 250mm.

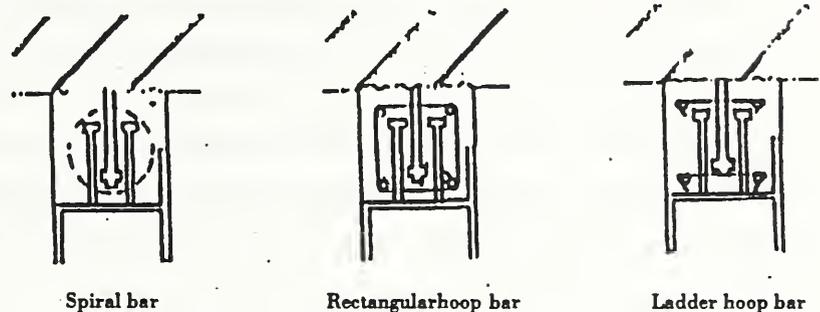
Figure 6 Reinforcement for preventing crack expansion

Insert the spiral hoop, rectangular hoop and ladder hoop into the mortar to distribute cracks in the mortar (Fig. 6). When a large stress is applied to the mortar joint for strengthening, the spiral hoop and rectangular hoop are particularly effective in restraining the mortar and transferring stress to the anchors and studs. The reinforcing bar ratio p_s in the mortar should be larger than 0.4%. The formula is $p_s = a_s/h' \times x_s$ (x_s : pitch of the reinforcing bars, a_s : sectional area of one set of the reinforcing bars, h' = height of the infilled mortar).

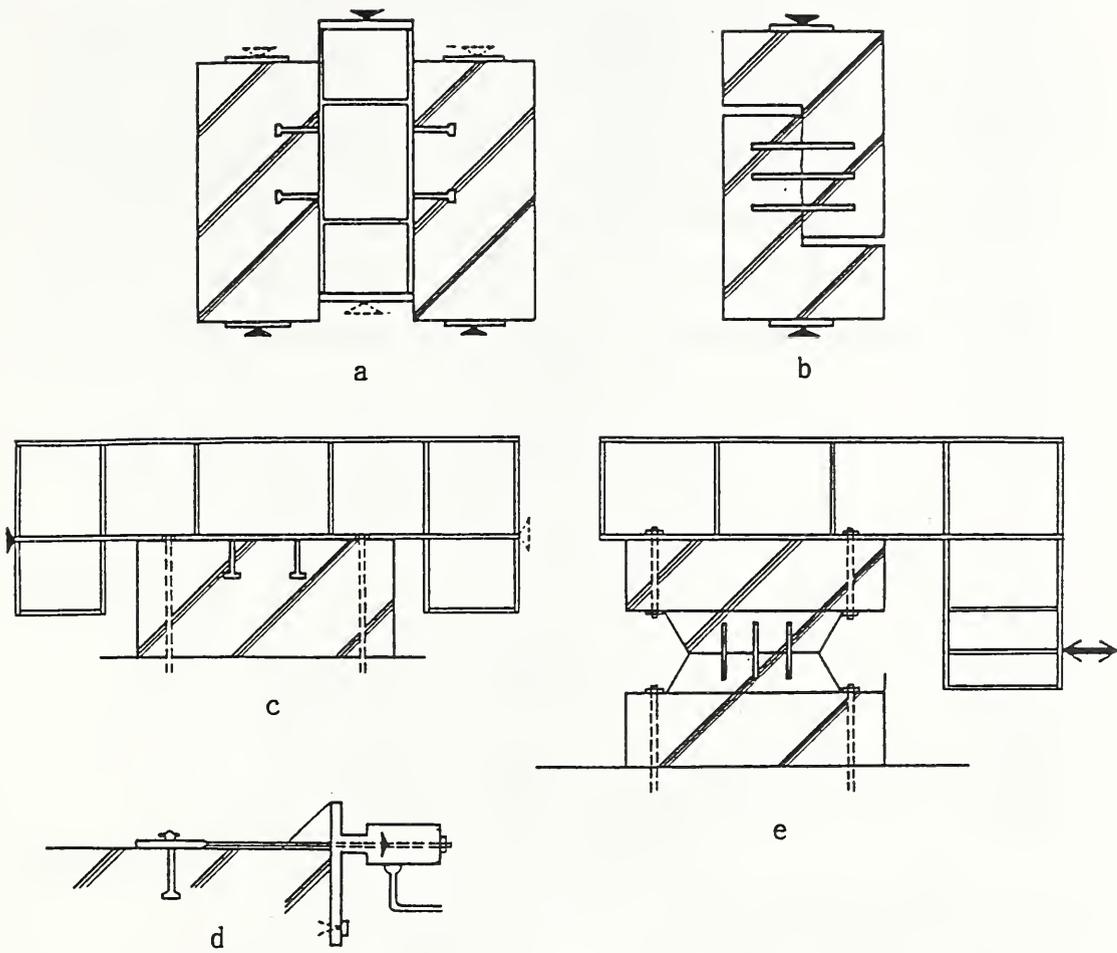
Fig. 1 Method of direct shear tests

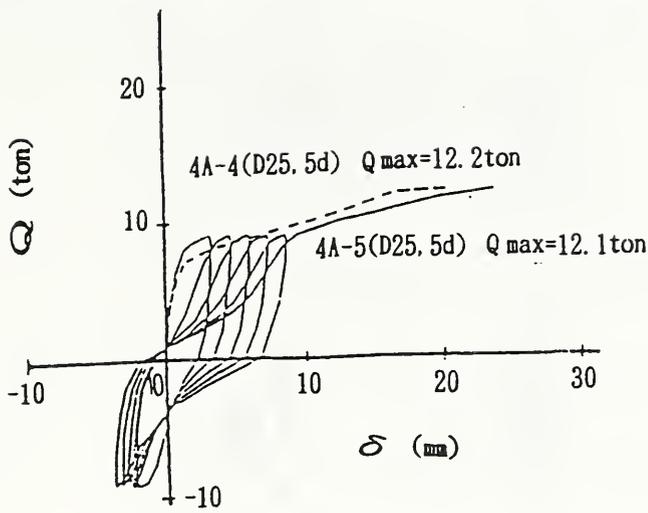
Fig. 7 Load-deflection curves (effect of one-way loading and cyclic loading)

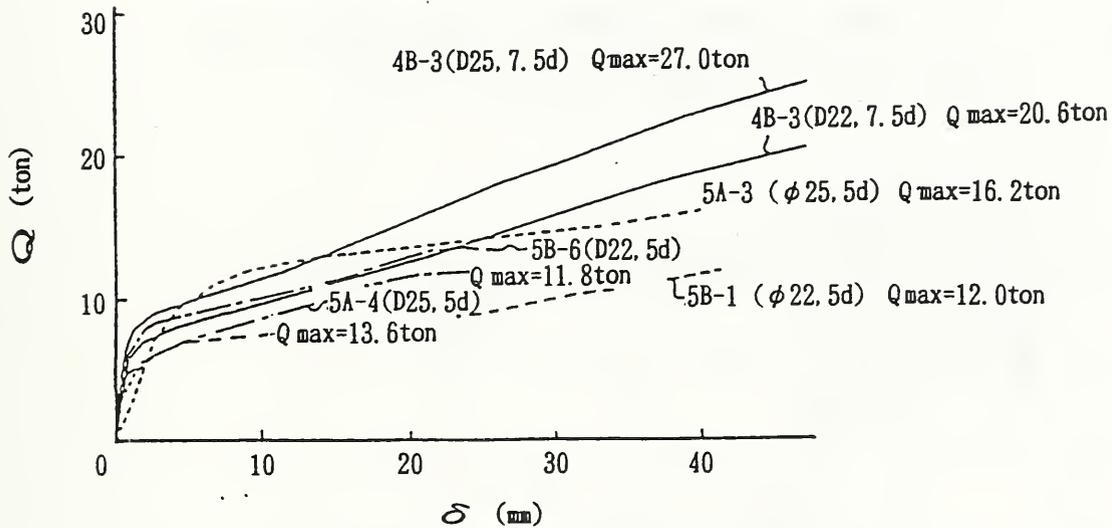
Fig. 8 Load-deflection curves for typical specimens

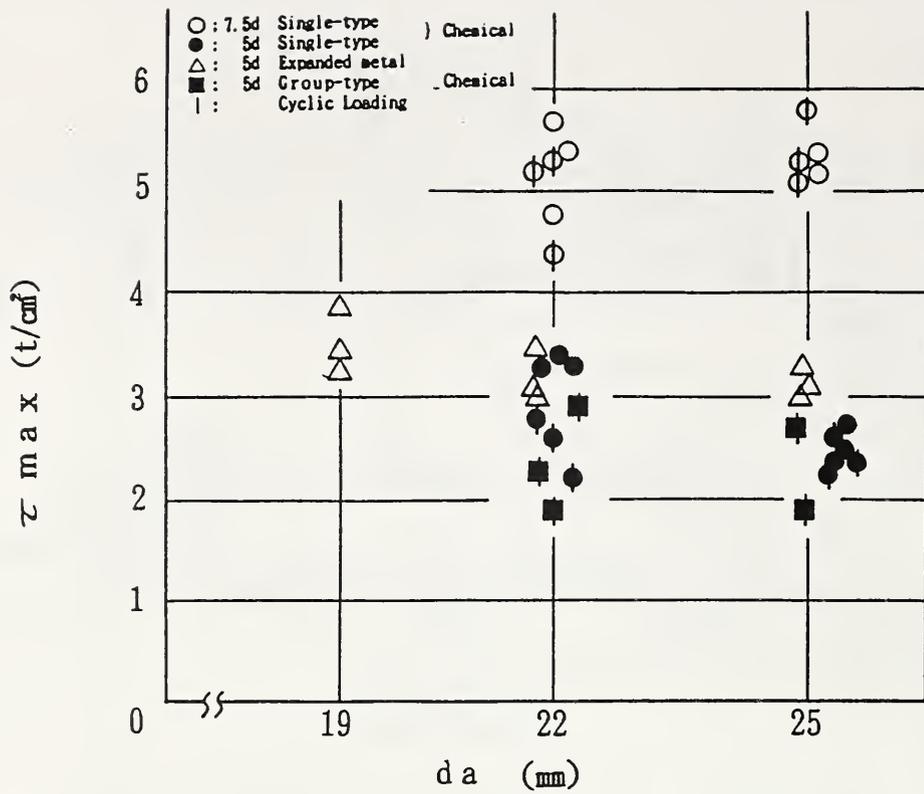
Fig. 9 Relationship between diameter of anchor and average shear stress at maximum strength (τ_{max})

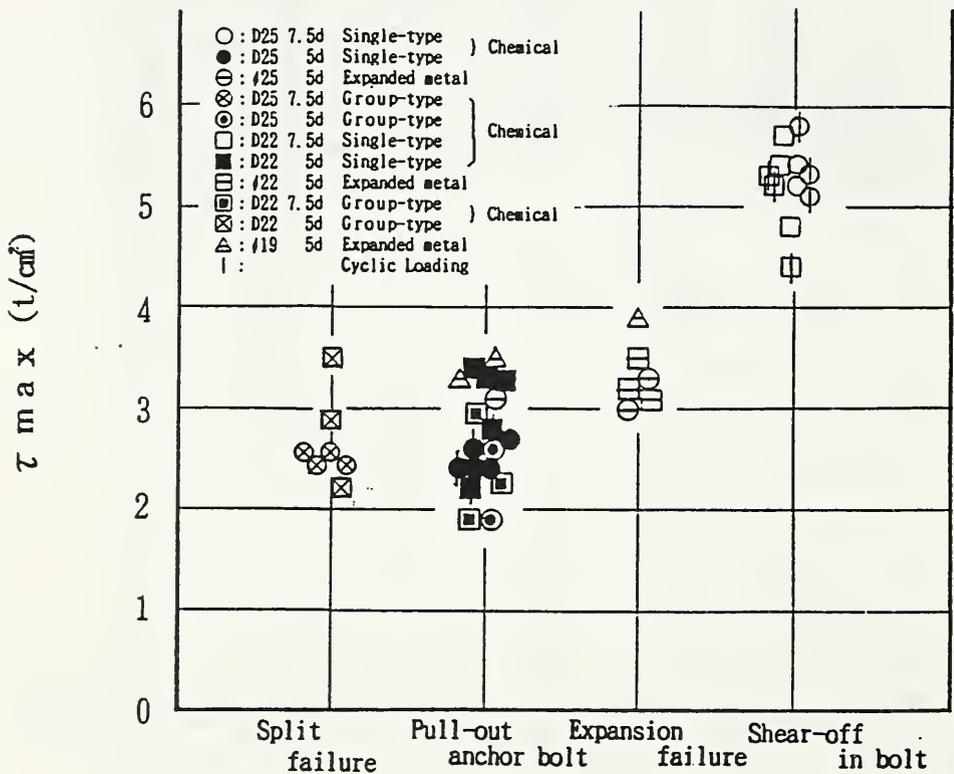
Fig. 10 Relationship between failure mode and average shear stress at maximum strength (τ_{max})

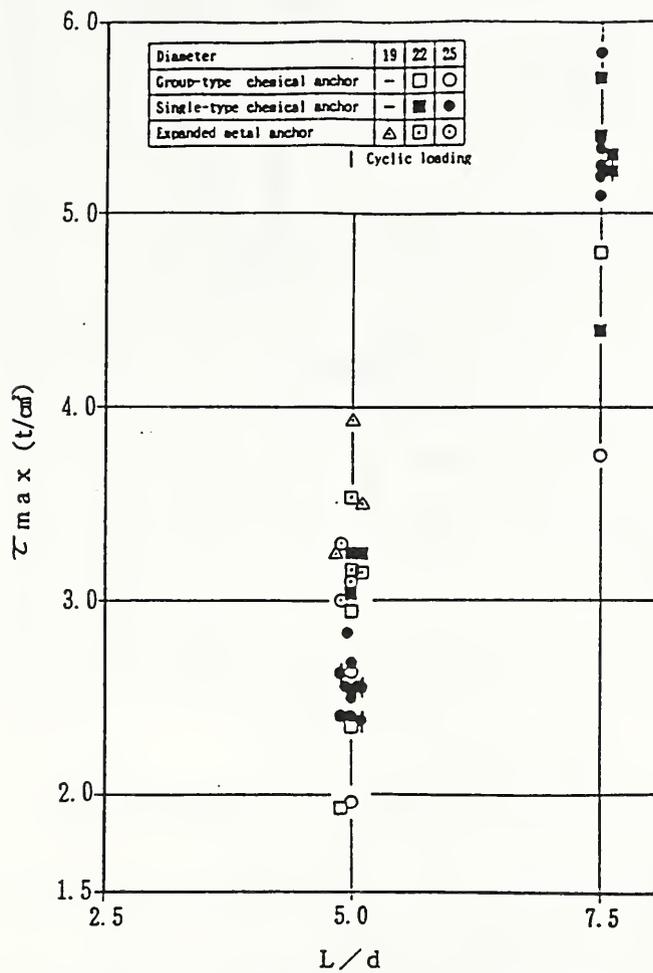
Fig. 11 Relationship between maximum shear strength (τ_{max}) and depth of embedment (l/d)

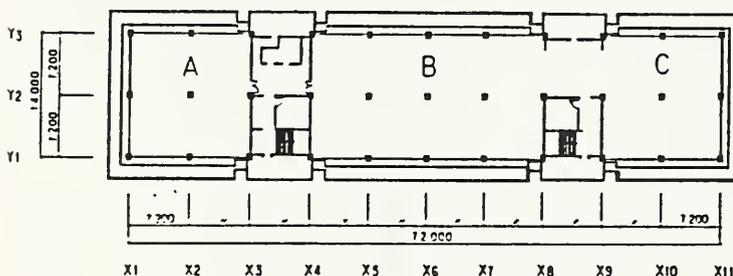
use	office	
scale	building area	1193.1 m ²
	total floor area	10332.3 m ²
	floors	on the ground 6 basement 1
	building height	GL+19.96 m
structure	reinforced concrete	
	waffle flat slab structure	
basement foundation	piles constructed on the spot

(a) Typical Floor Plan

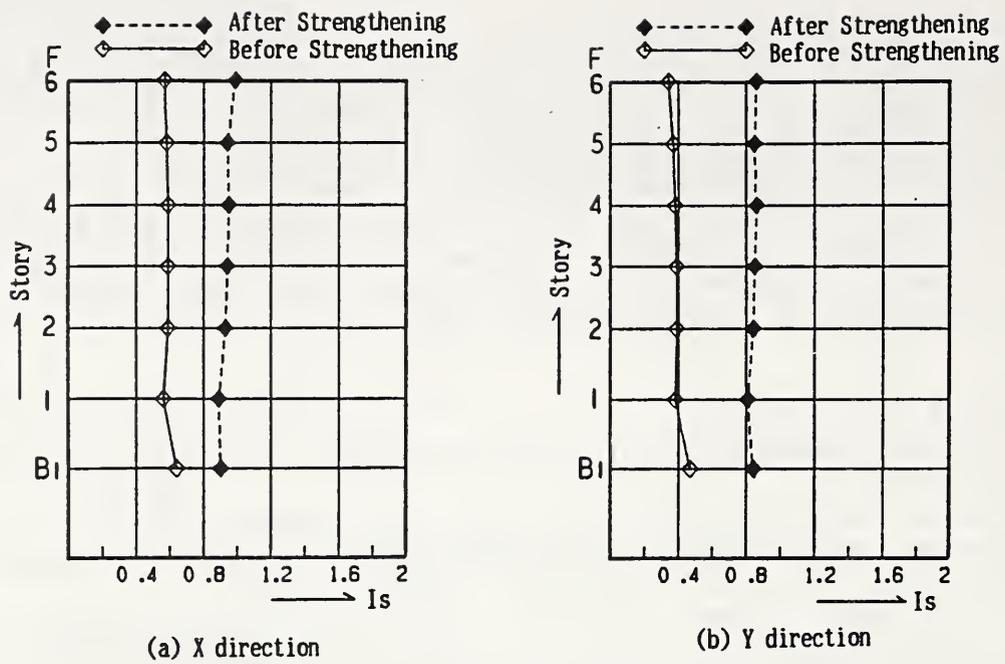
Fig.3 Distribution of Seismic Structure Index (Is) Before and After Strengthening

The fundamental natural period of 0.44-0.51 sec. was observed which had been 0.54 sec. before the strengthening. To verify the increase of the stiffness, the measurement will be carried out after the completion of the strengthening.

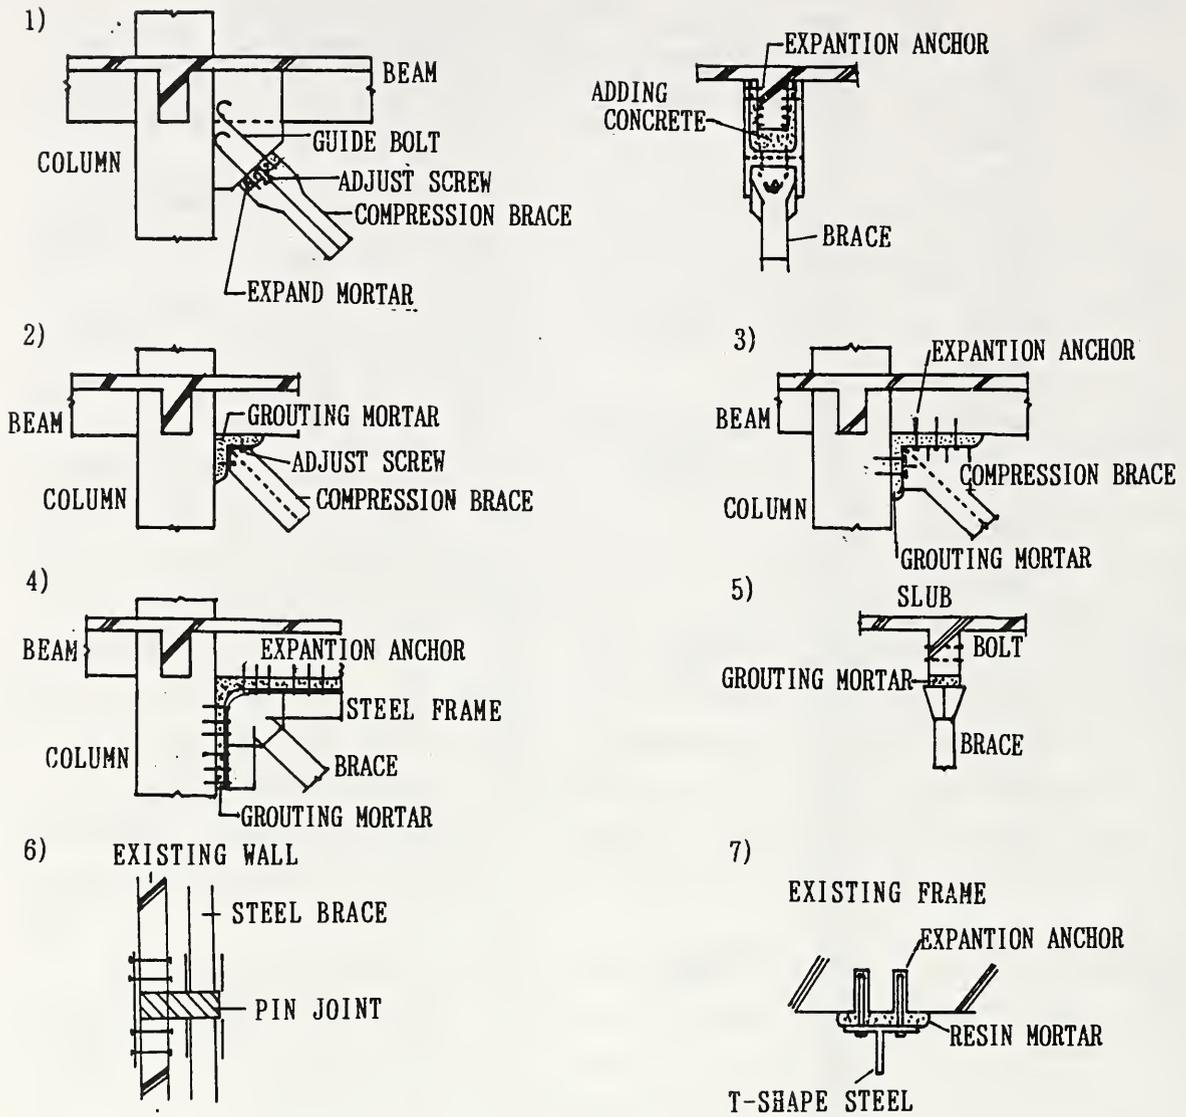
(a) DIRECT SHEAR CONNECTOR

Figure.1 KIND OF SHEAR CONNECTOR

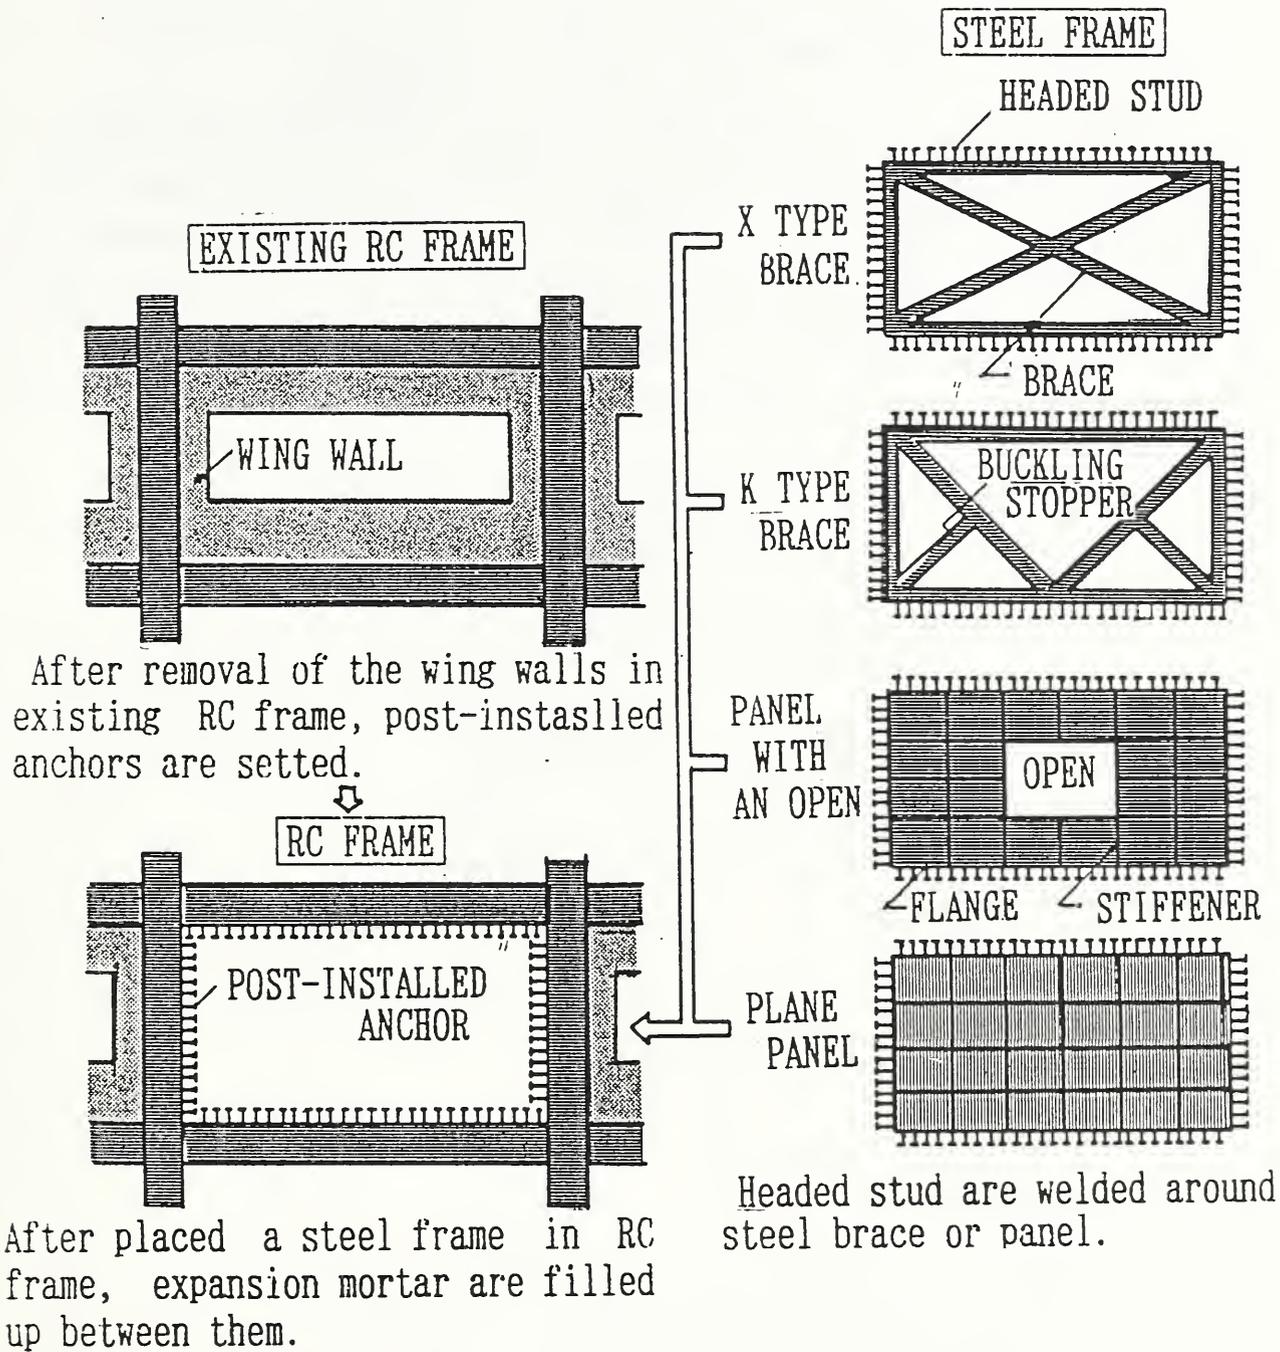
Figure 2. EXAMPLES OF STEEL BRACE STRENGTHENING METHOD

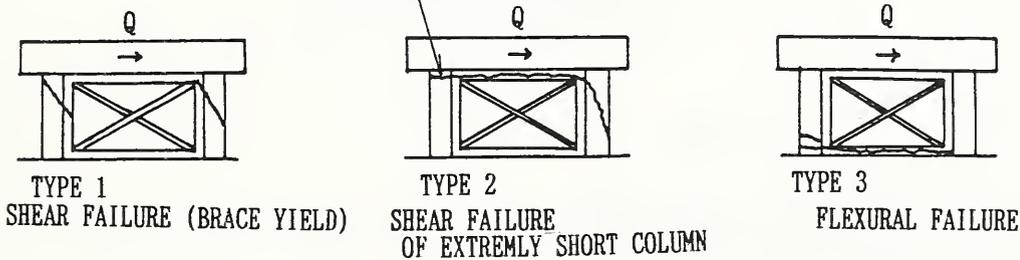
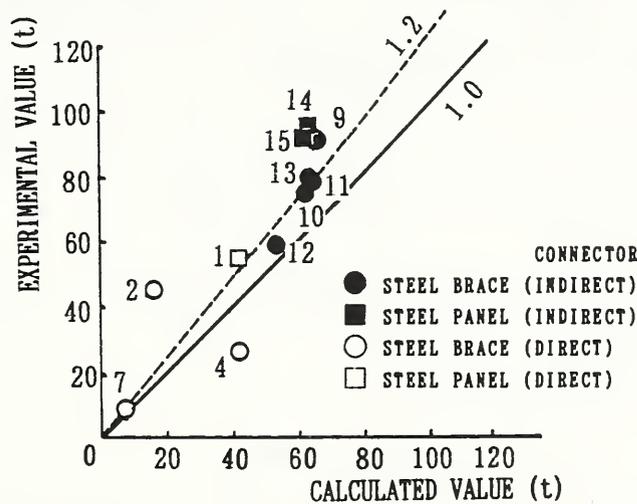
Figure 3. MAXIMUM STRENGTH Q_{max} OF STRENGTHENED BY STEEL BRACE

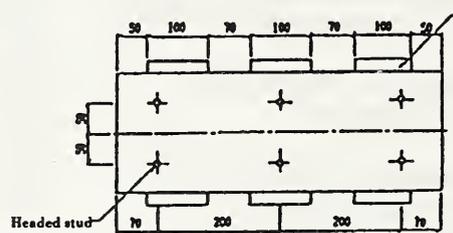
Figure 4 Steel frame and stud bolt welding position

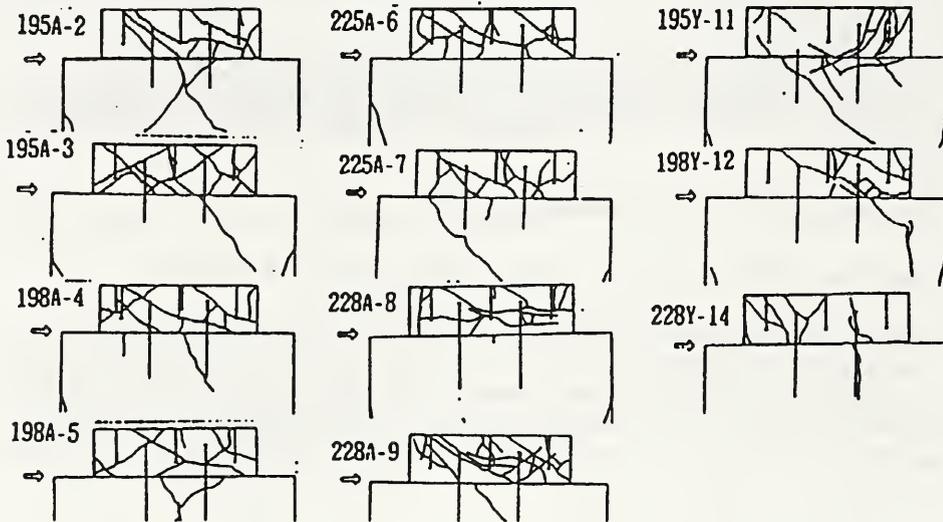
Figure 7 Breaking (failure) status at end
Arrow indicates the direction of pressurization
