Proceedings of a Workshop on Evaluation,
Repair, and Retrofit of Structures – U.S.-Japan
Panel on Wind and Seismic Effects, UJNR,
Gaithersburg, MD, USA, May 12–14, 1990

James O. Jirsa
Janet S. Cockrell Centennial Chair in Engineering

April 1991

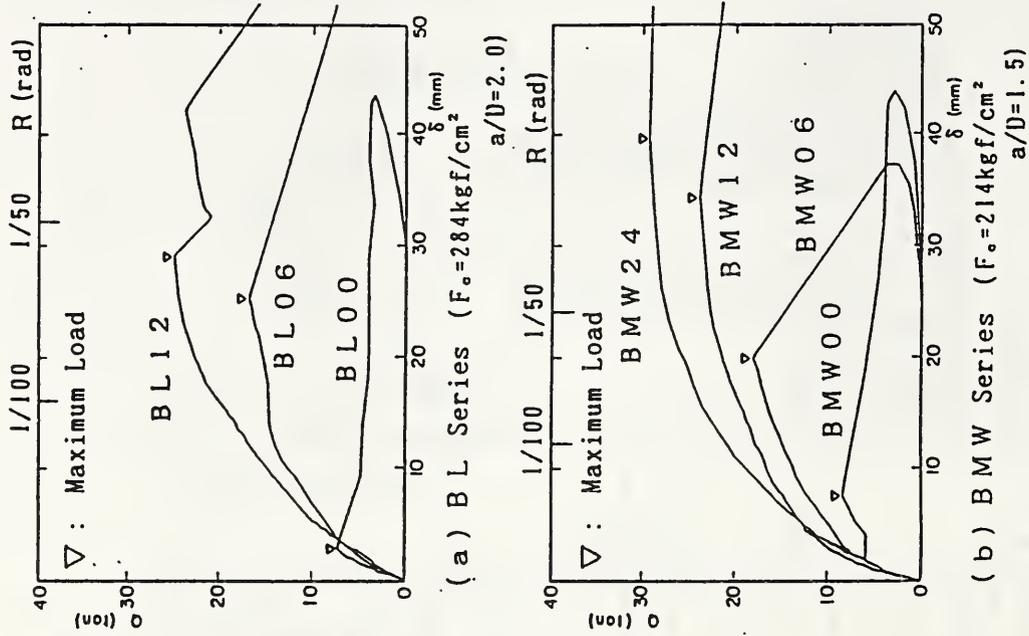
Fig. 11 Relationship of Shear Force vs. Displacement

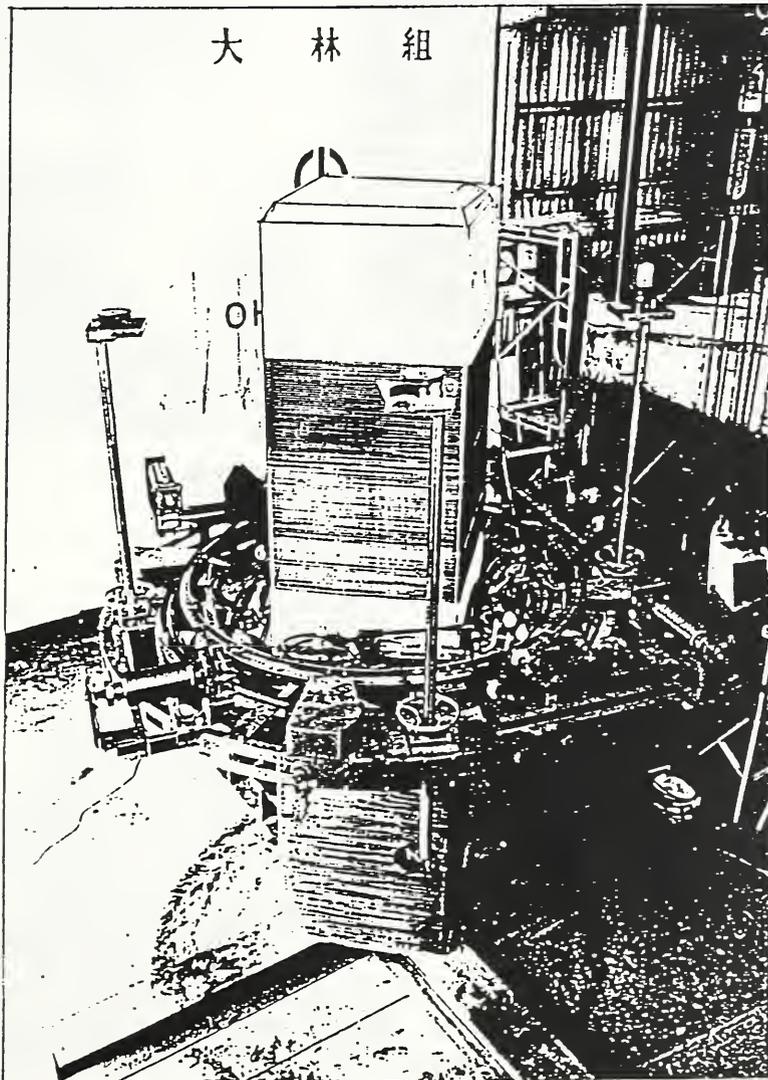
Photo. 1 Winding Machine
