Preliminary Results of the Environmental Evaluation of the Federal Records Center in Overland Missouri

Andrew K. Persily
W. Stuart Dols
Steven J. Nabinger
Severine Kirchner

July 1991

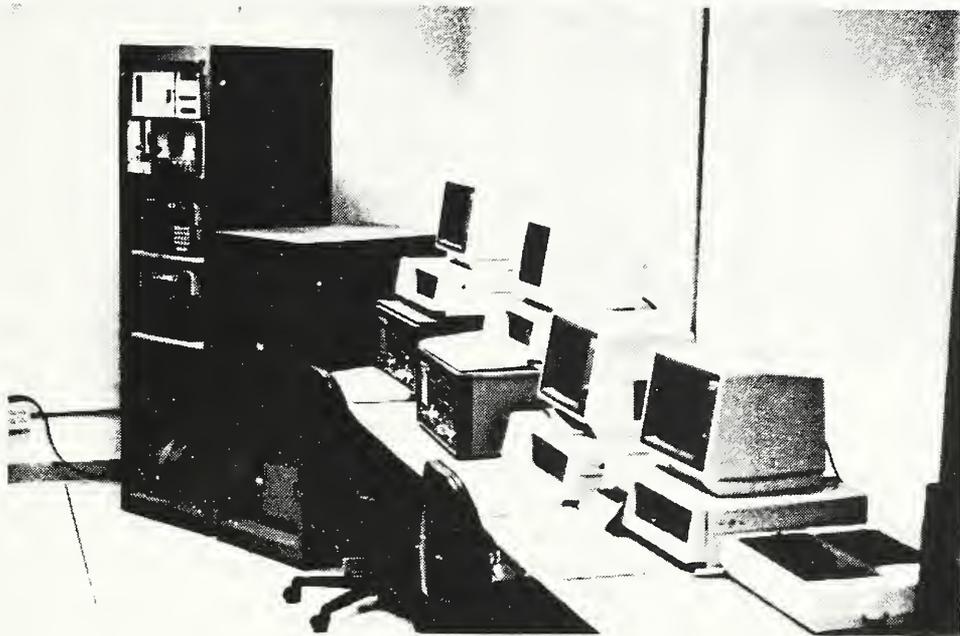
Figure 13 Photograph of Diagnostic Center Monitoring Equipment

This section of the report describes the diagnostic center used in the thermal and environmental evaluation of the building. This system consists of systems for air sampling, indoor and outdoor environmental monitoring, fan status monitoring, tracer gas injection, and instrumentation used to measure tracer gas and pollutant concentrations. The monitoring systems employ a network of air sampling and tracer gas injection tubes and sensor wires running through the building and back to the diagnostic center (DC), where the majority of the monitoring and control equipment is located. A schematic of the DC is shown in Figure 12, and a photograph of the equipment in the DC is shown in Figure 13.

The diagnostic center contains the data acquisition and control systems, tracer gas and pollutant monitors, the tracer gas injection panel, and the air sampling systems. There are three microcomputer based data acquisition and control systems: one for the building air infiltration rate measurement systems, one for the CO_2 and CO monitors and one for the respirable particle counter.
