**NISTIR 5269**

# EARLY DETECTION OF ROOM FIRES THROUGH ACOUSTIC EMISSION

William Grosshandler and Emil Braun

October 1993  
Building and Fire Research Laboratory  
National Institute of Standards and Technology  
Gaithersburg, MD 20899

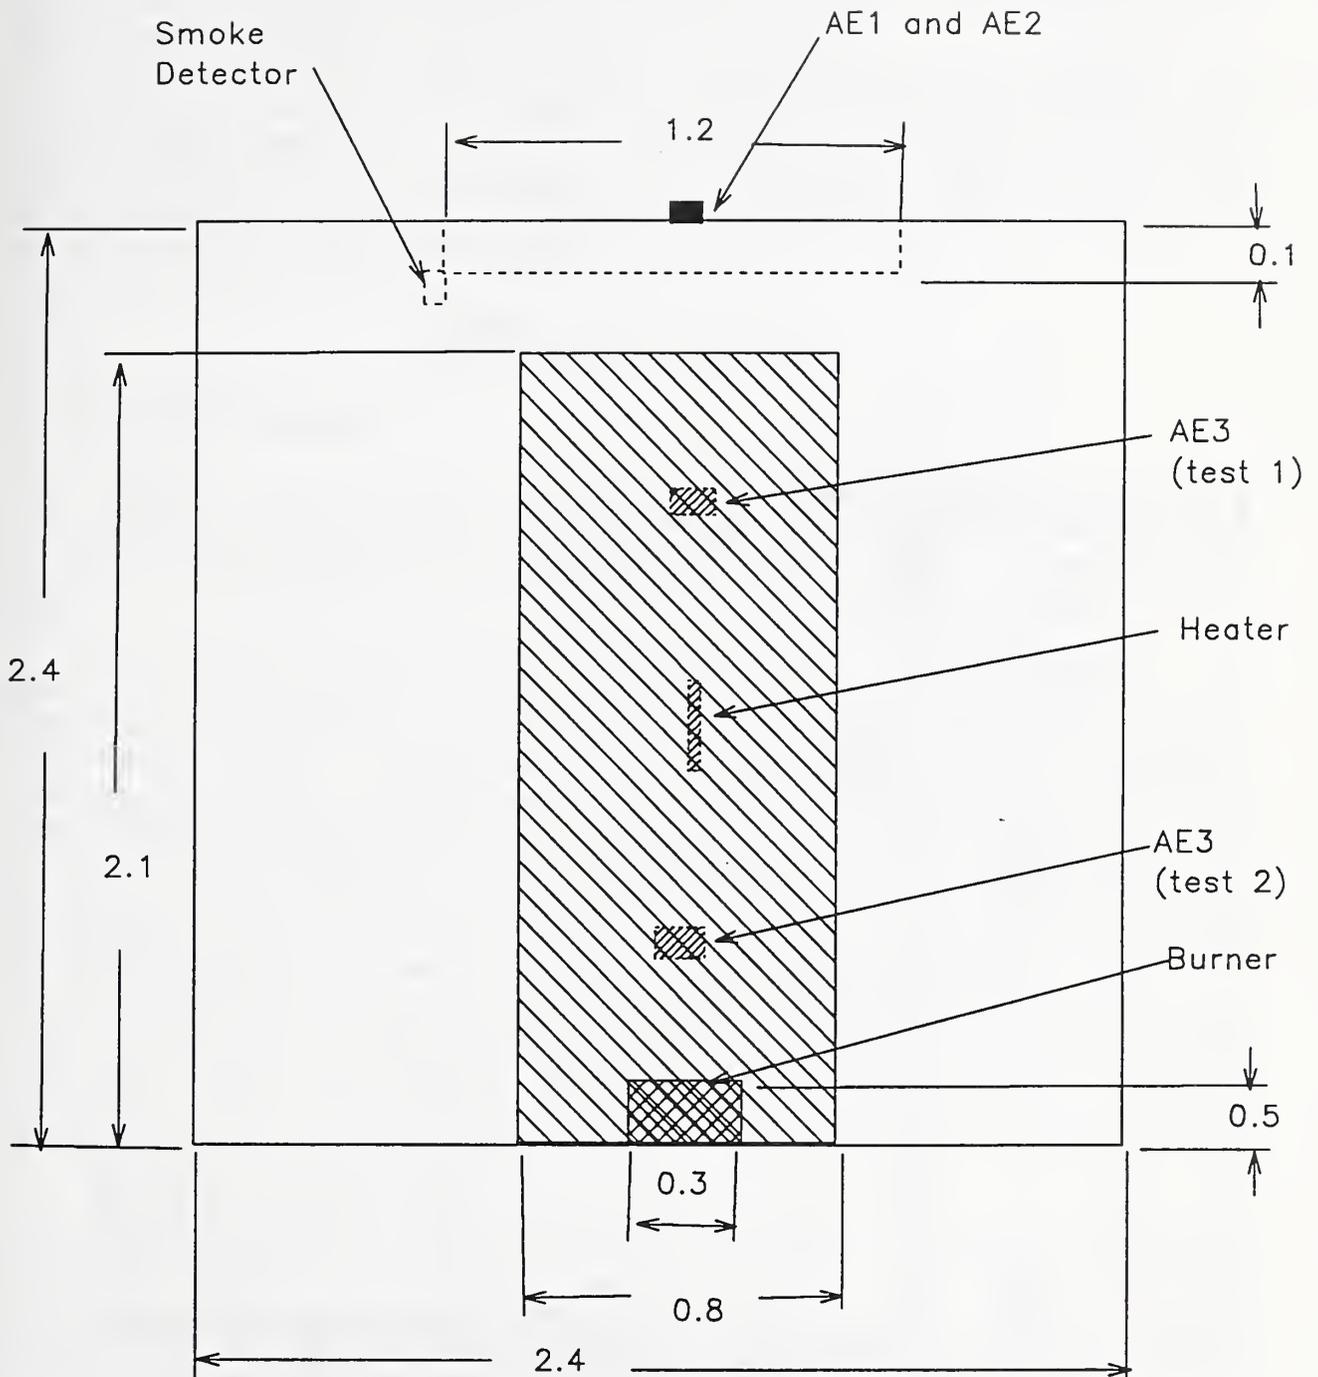
Figure 1. End view of full-scale facility for assessing performance of acoustic emission fire detector. Back wall can be seen as shaded through door way.

A full-scale room was constructed at BFRL's large fire test facility to simulate a portion of a typical residential structure. The room was nominally cubical, 2.4 m on a side, with a standard size door opening centered on one wall, as shown in the end view in Figure 1. The walls and ceiling were covered with commercially available 12 mm gypsum boards nailed to a wooden superstructure. The wall beams had a 37 mm by 88 mm cross-section and were placed on 0.6 m centers. The wooden ceiling beams were 37 mm by 176 mm, butted to the wall supports (see Figure 2) and attached with long screws. The center portion of the ceiling was dropped by an amount equal to the height of the beams for ease of construction and instrumentation.

Three Physical Acoustic Corporation\* piezoelectric transducers were mounted on the central wall and ceiling beams, located as shown in Figures 1 and 2. The devices were coupled to the wooden surfaces with just enough silicone vacuum grease to hold them in place during the experiments. The vertical beam was notched to accommodate the transducer in a horizontal position. Signals from the transducers passed through PAC model 1220 A preamplifiers and a PAC model 3000 power supply, amplifier and signal processor. The response of the AE signal processor was previously found to depend strongly on the threshold and amplifier settings<sup>1</sup>. Total amplification factors of +86 to +89 dB and a threshold level of 0.2 V were chosen. The dead time and time base were set at 1.0 ms, and the update

Two different heat sources were used to simulate an overheated condition. The first was a 550 W electrical heater normally used for starting charcoal fires. As shown in the two figures, it was mounted on the center wall beam, halfway between the floor and ceiling. Copper conduit clamps were used to ensure good contact with the wood. The second heat source was a 0.3 m diameter natural gas pool fire, located on the centerline of the room close to the back wall.

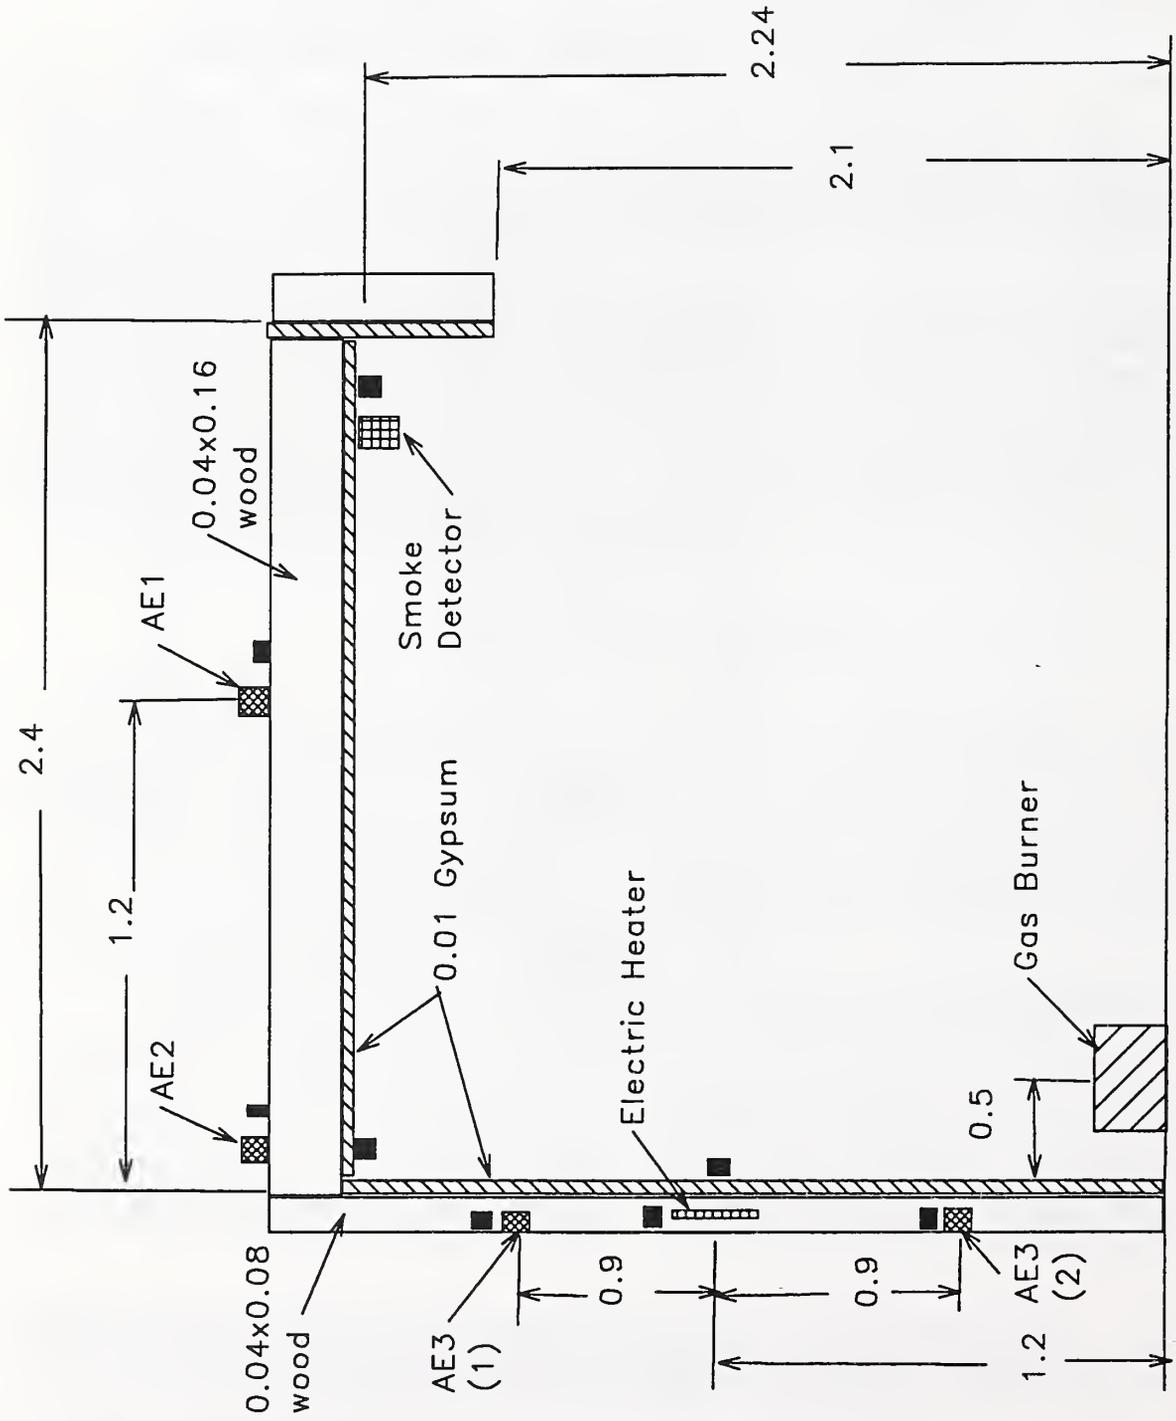
Figure 2. Cross-section of full-scale facility for assessing performance of acoustic emission fire detector. Black squares are thermocouple locations.

Chromel-alumel thermocouples were used to monitor the temperature at the locations indicated by the black squares in Figure 2. The voltages were compensated and stored at ten second intervals in a data acquisition computer. Of particular interest were the temperatures at the location of the AE sensors, the temperature at the electrical heater, and the ceiling temperature above the gas fire. The temperature of an AC powered ionization smoke detector was also monitored. The smoke detector was installed on the ceiling close to the door opening.

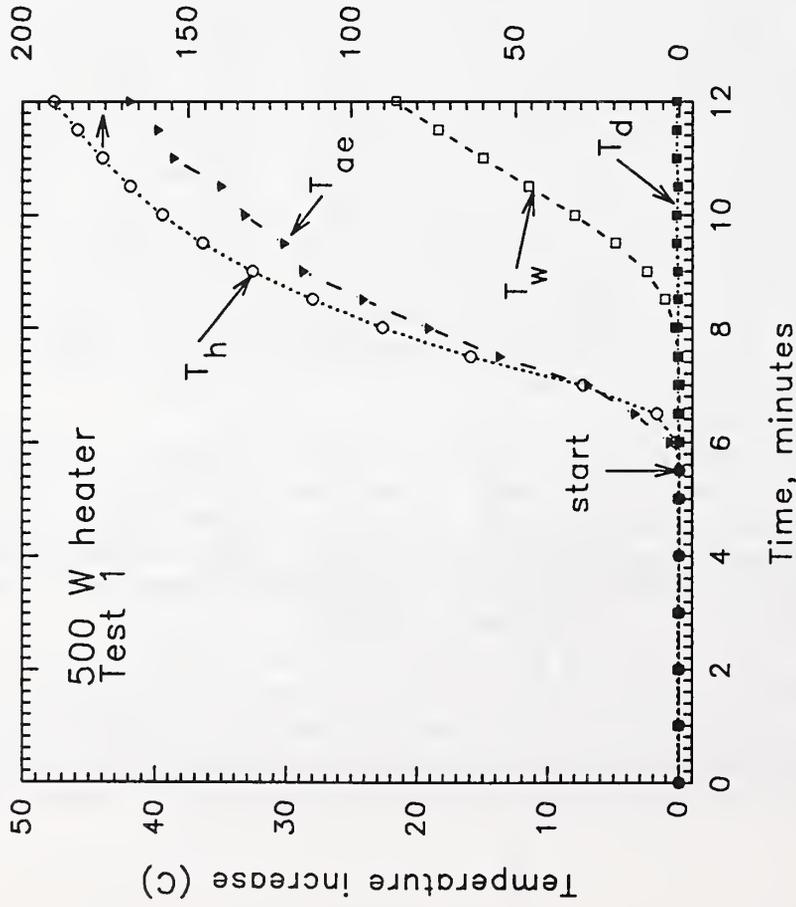
Figure 3. Temperature histories in first electrical heater experiment. Subscripts imply location of AE3 (ae), wood surface near heater (h), back-wall on other side from heater (w) and smoke detector (d). Note scale change for  $T_h$ .

In the first test, AE sensor #3 was located a little less than a meter above the heater. The background temperature and AE levels were monitored for 5.7 minutes, at which time full power was applied to the 550 W electrical heater. Figure 3 is a record of the temperatures measured during the seven minutes of heating. The temperature of the wood close to the electrical heater,  $T_h$ , increased rapidly once the electricity was applied, reaching a maximum of 180 °C above the ambient at the end of the heating period. The temperature,  $T_w$ , inside the room on the other side of the wall from the heater rose 22 °C above the environment, while the temperature at the location of the smoke detector,  $T_d$ , did not increase by a discernible amount. Because AE3 was located above the heating element, natural convection caused a significant temperature increase in its environment. The test was terminated when the operational temperature exceeded 50 °C in order to avoid damage to the transducer.

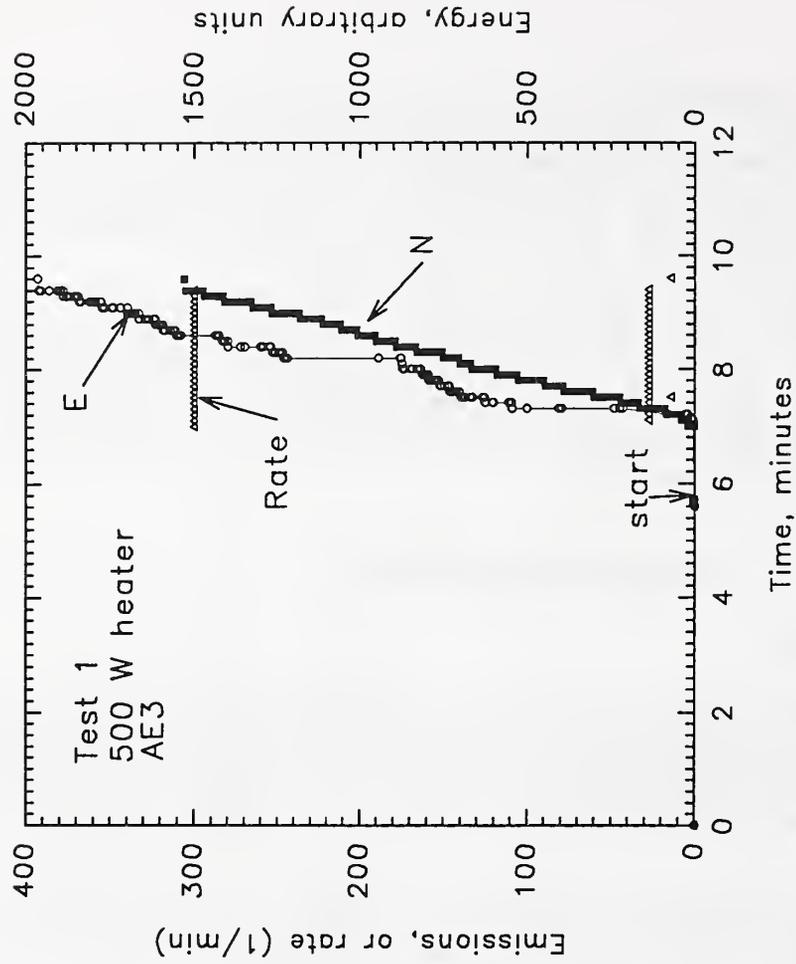
Figure 4. Cumulative energy released (E, arbitrary units), number of AE events (N) and instantaneous rate of emission ( $\text{min}^{-1}$ ) from AE3 (located above heater) in first electrical heater experiment. Amplification is +86 dB. Note that rate is limited to  $300 \text{ min}^{-1}$  by data analysis method.

One emission event was recorded by AE3 during the 5.7 minute background check; none was recorded by AE1 or AE2. AE2 did not respond at all during the heating period either, while AE1 produced two emissions. A large amount of activity was recorded by AE3, as shown in Figure 4. After a 1.3 minute delay, the number of emissions,  $N$ , suddenly jumped, with emissions continuing at a steady pace until 9.6 minutes, when the transducer was removed to prevent it from overheating. The cumulative energy,  $E$ , increased in a parallel manner.

The curve in Figure 4 marked "rate" is the rate of emission calculated by averaging three consecutive emissions over the time between them. Because three emissions can occur within milliseconds of each other, the rate is artificially capped by limiting the smallest interval to one second. Once the rate exceeds the background level (less than 0.18/min in this case) by more than an order of magnitude, its absolute value is not critical to the analysis. The total number of emissions was measured to be 305, yielding an average rate over the heating period of 78/min.

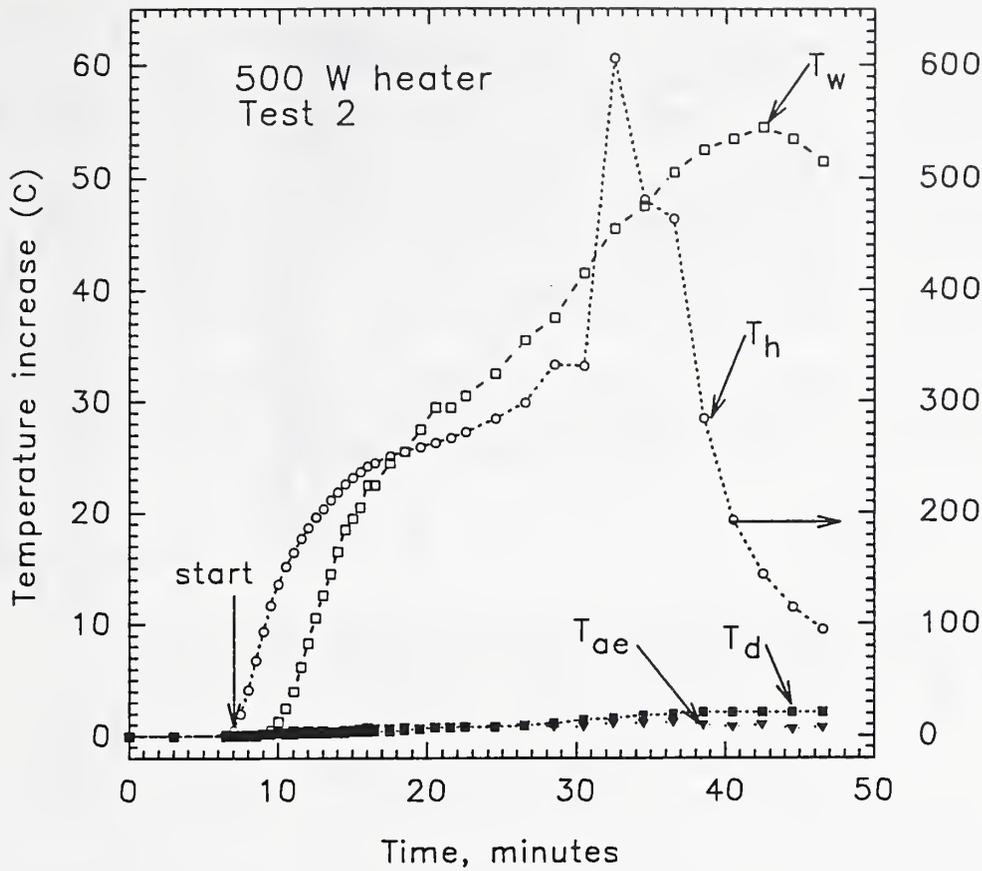
Figure 5. Temperature histories in second electrical heater experiment. Subscripts imply location of AE3 (ae), wood surface near heater (h), back-wall on other side from heater (w) and smoke detector (d).

Temperature profiles taken during the second test are shown in Figure 5. After a background check period of 6.5 minutes, power to the heater was started and the temperatures increased in a manner similar to test #1. The temperature measured adjacent to the heater,  $T_h$ , rose in an orderly manner and appeared to level off at 30 minutes, when a 300 °C jump was observed, followed by a steep decline to the 46 minute point, when the power was turned off. Inspection of the heater, vertical beam, and gypsum board after the system had cooled indicated that a char layer had formed about 10 mm deep under the heater. A number of crevices had formed in the wood and the surface was disrupted, leading to the conjecture that the thermocouple had become dislodged from the surface, recontacted the surface as it expanded, and then lost contact as buckling of the surface occurred. The temperature in the room directly on the other side of the wall from the heating element,  $T_w$ , increased by 55 °C. The temperature at transducer AE3,  $T_{ae}$ , increased less than two degrees during the entire test, and the temperature increase near the smoke detector,  $T_d$ , was about four degrees.

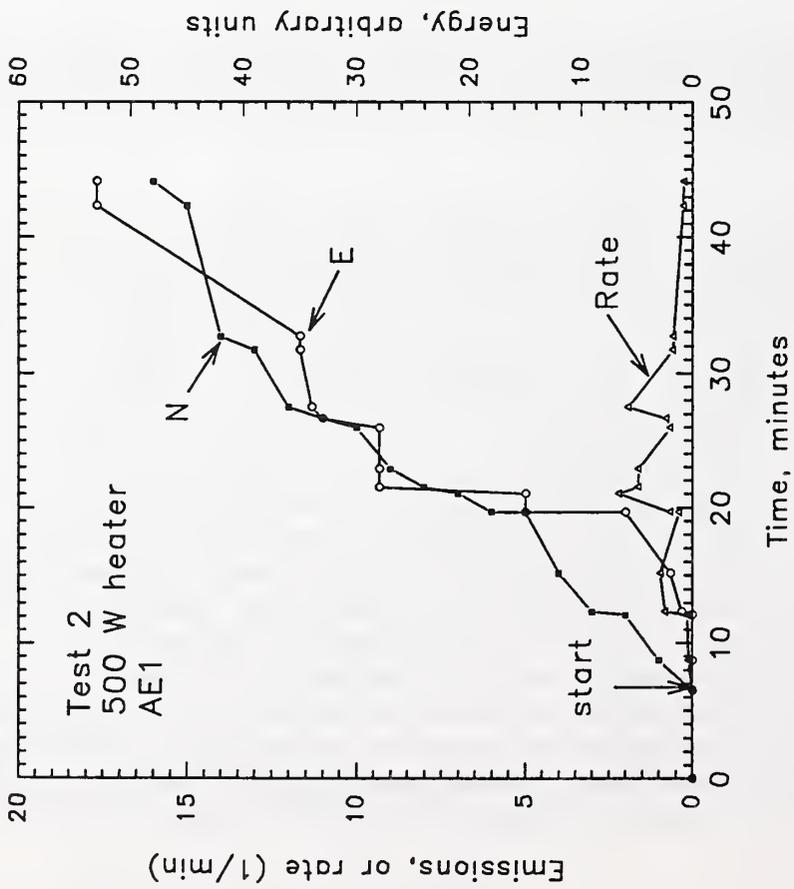
Figure 6. Cumulative energy released (E, arbitrary units), number of AE events (N) and instantaneous rate of emission ( $\text{min}^{-1}$ ) from AE1 in second electrical heater experiment. Amplification is +89 dB.

in the ceiling, in spite of the increase in amplification. During the forty minute heating period there were 16 emissions, yielding an average rate of 0.43/min, with the first emission occurring about two minutes after the heater was started. Figure 6 is a plot of the number of emissions and cumulative energy from AE1. The instantaneous rate of emission approached 1/min about five minutes into the heating period, which is well above the background signal measured with this particular transducer. The amplification was maintained at 86 dB for AE3. Within a minute and a half, the transducer began detecting emissions at a rate in excess of 50/min, following the initial period without heat during which no emissions were measured. Figure 7 shows the history of cumulative energy and emission number, with an accelerating number of events occurring about 30 minutes into the test. The instantaneous rate of emission exceeded 300/min (the maximum imposed by the data analysis method) many times during the latter period of heating.

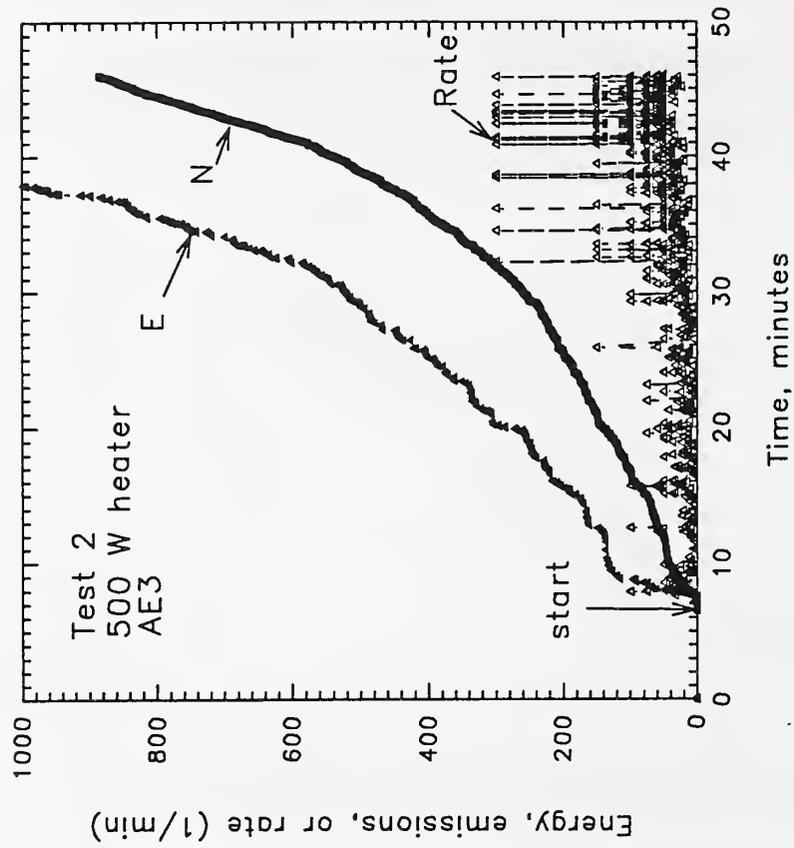
Figure 7. Cumulative energy released (E, arbitrary units), number of AE events (N) and instantaneous rate of emission ( $\text{min}^{-1}$ ) from AE3 (located below heater) in second electrical heater experiment. Amplification is +86 dB.

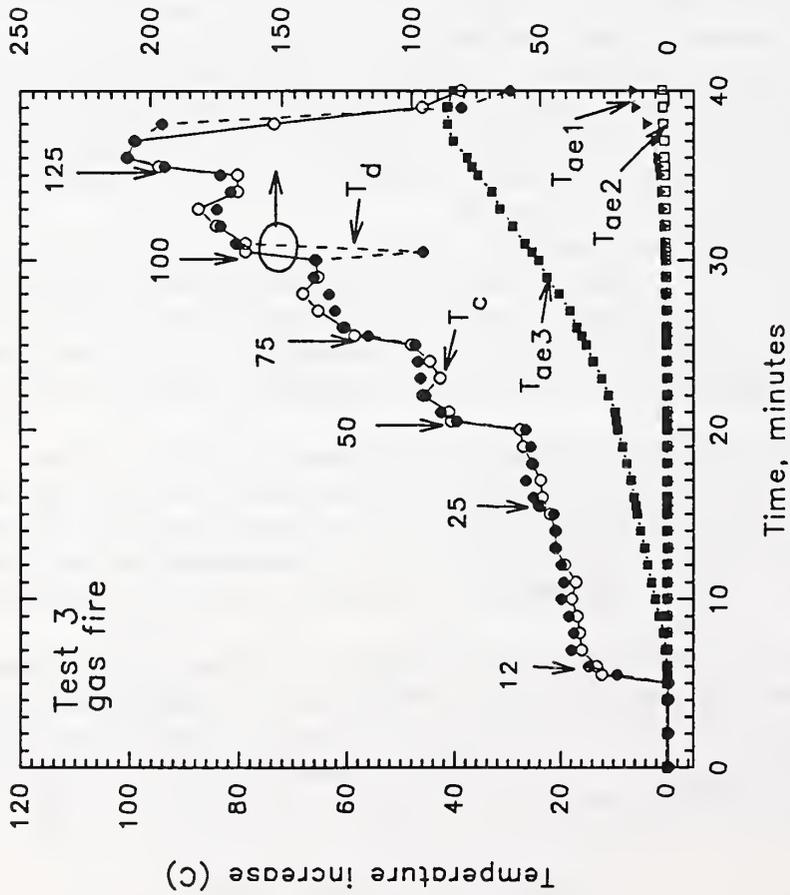
Figure 8. Temperature histories in natural gas burner experiment. Subscripts imply location of AE transducers, ceiling above burner (c) and smoke detector (d). Vertical arrows designate increases in flame size (12 to 125 kW).

Figure 8 is a plot of the temperature increase in the room. The maximum temperature was located on the ceiling above the burner. The largest increase was 210 °C, measured just before the burner was extinguished. The temperature increase measured at the smoke detector was similar in magnitude, and both temperatures responded within seconds to the changes in gas flow. The increasing size of the fire is indicated by the vertical arrows in the figure. The temperature increase above the ceiling joist, where AE1 and AE2 were located, was indiscernible until the fire reached its maximum value near the end of the experiment. The transducer mounted in the wall, AE3, increased two degrees in the first five minutes of the fire, and 10 °C after 15 minutes of burning. The temperature at AE3 exceeded 50 °C about 30 minutes into the experiment.

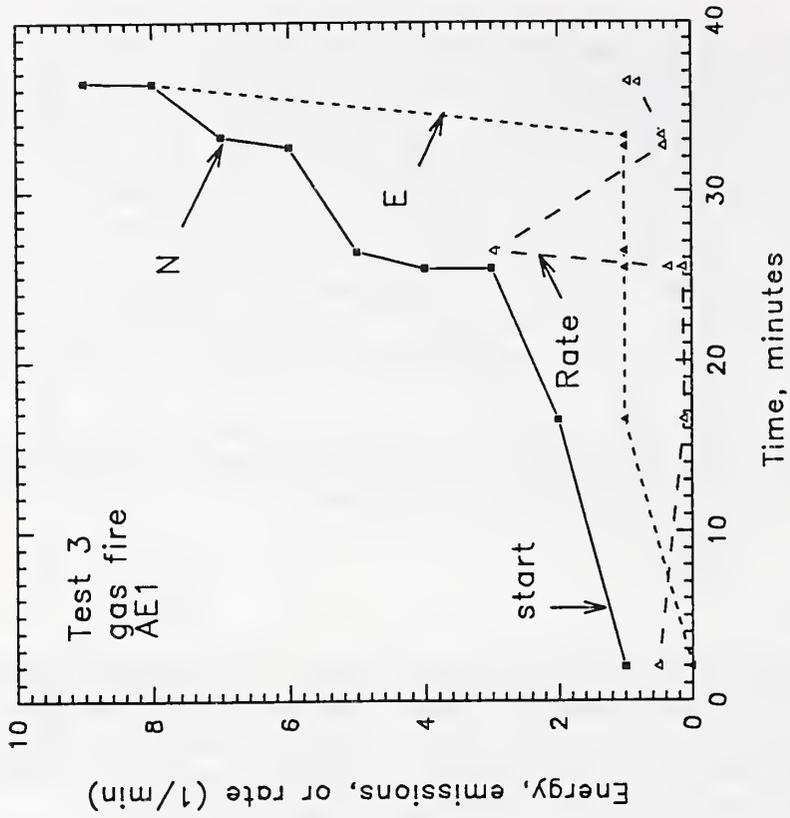
Figure 9. Cumulative energy released ( $E$ , arbitrary units), number of AE events ( $N$ ) and instantaneous rate of emission ( $\text{min}^{-1}$ ) from AE1 in gas burner experiment. Amplification is +89 dB.

The amplification on AE2 was reduced to 86 dB to eliminate the large background signal observed in the previous test. AE1 and AE3 were set to an amplification factor of +89 dB. During the five minute background check, one emission was recorded by AE1 and two each by AE2 and AE3. For the transducer located above the ceiling joist in the center of the room, AE1, the emission rate exceeded the background twenty minutes after ignition. The number of events and cumulative energy recorded by AE1 are shown in Figure 9.

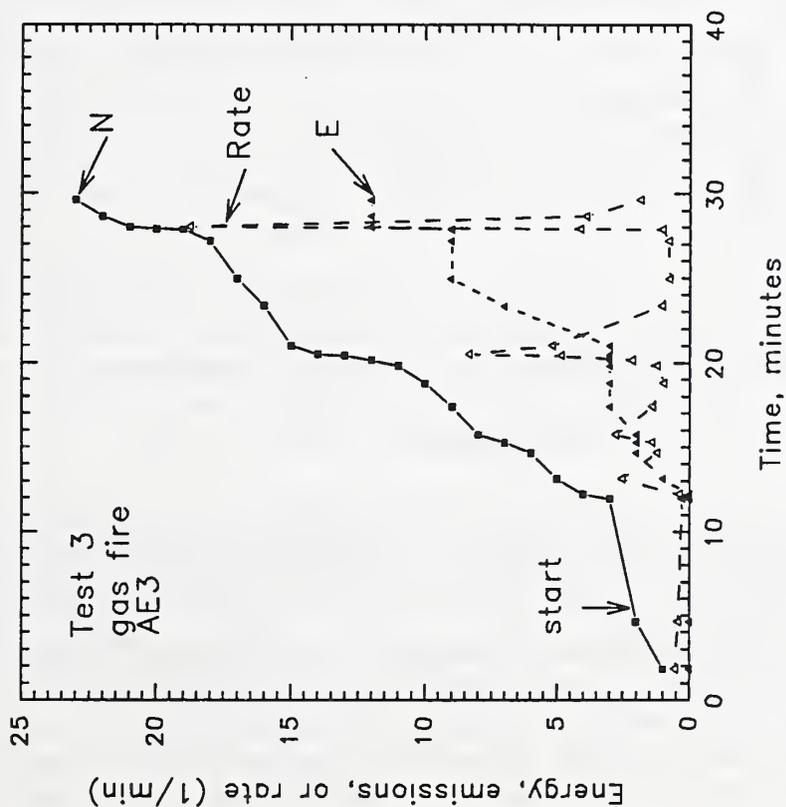
Figure 10. Cumulative energy released (E, arbitrary units), number of AE events (N) and instantaneous rate of emission ( $\text{min}^{-1}$ ) from AE3 in gas burner experiment. Amplification is +89 dB.

AE3 began to detect the fire seven minutes after the burner was lit. From Figure 10, the steady increase in the number of AE events can be observed even when the fire is 25 kW and smaller. The greatest activity was recorded on channel 2 from the transducer located above the corner of the room closest to the centerline of the burner. This is shown in Figure 11. A maximum emission rate of 16/min was found ten minutes into the burn. The average rate of emission over the 31 minutes that the burner was lit was 1.2/min.

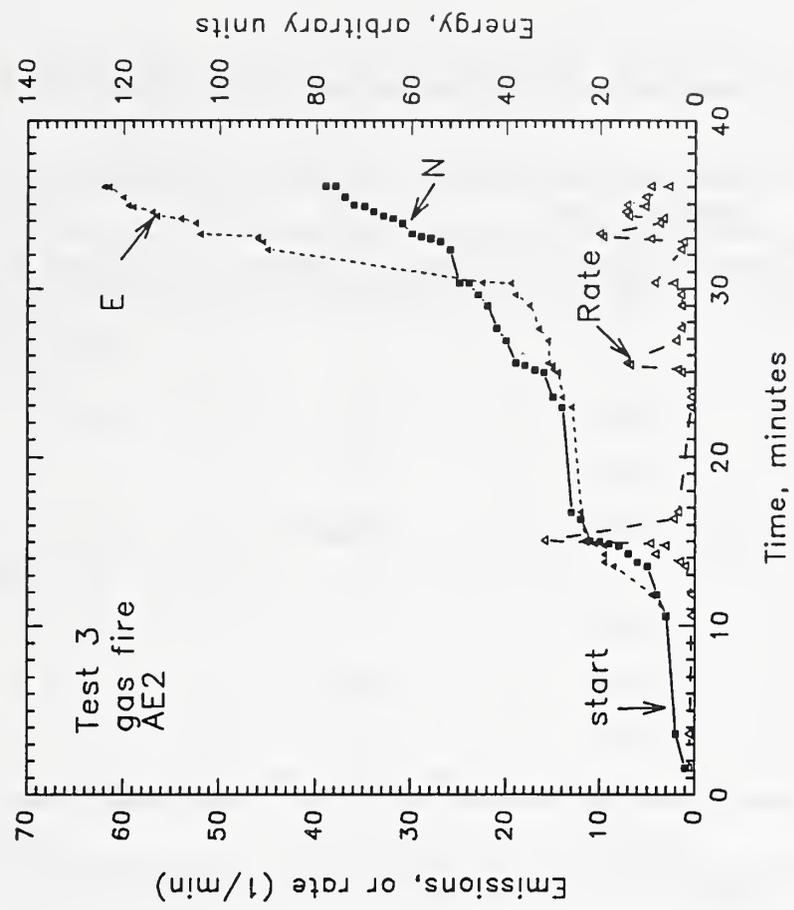
Figure 11. Cumulative energy released (E, arbitrary units), number of AE events (N) and instantaneous rate of emission ( $\text{min}^{-1}$ ) from AE2 in gas burner experiment. Amplification is +86 dB.
