**Warping of Terrace Pavers at the U.S.  
Capitol Building**

Chiara F. Ferraris  
Paul Stutzman  
James Clifton

May 1996  
Building and Fire Research Laboratory  
National Institute of Standards and Technology  
Gaithersburg, MD 20899

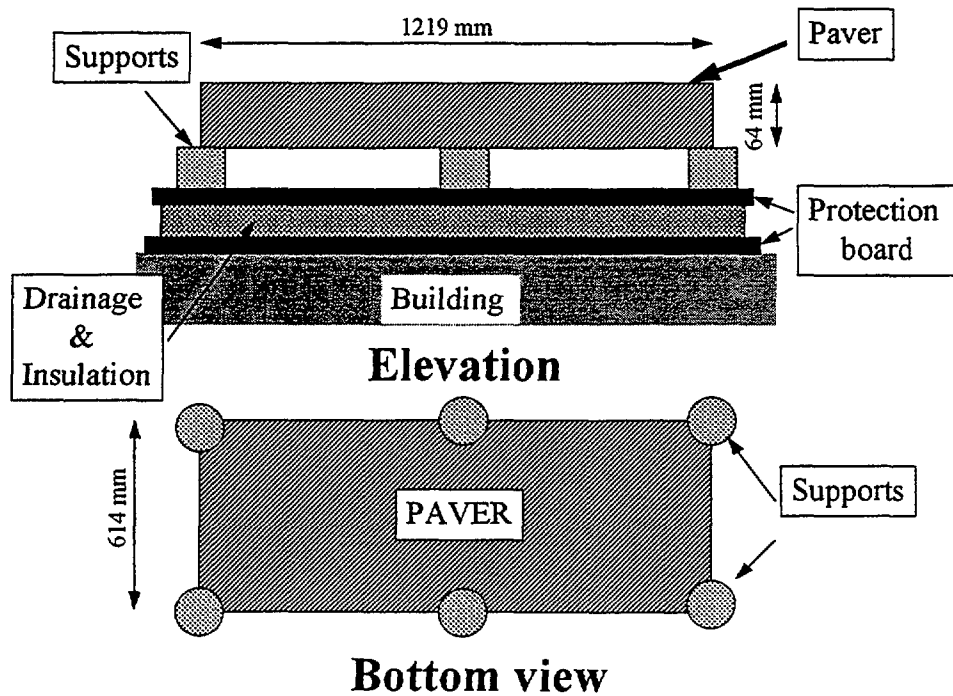
Figure 2: Schematic of paver installation

Figure 2 shows a typical installation with each paver being supported by six cylindrical plastic studs. Each stud is shared with neighboring pavers (Figure 2). During the inspection, it was found that the pavers seemed to be resting only on the two middle studs and being elevated from the other four studs. The vertical displacement at the ends was about 15-20 mm from the stud. If it is assumed that the paver curled in a circular arc (an approximation) the bottom surface expanded by about 0.03 - 0.05 %. According to Mr. Krapp, none of the supports were missing or displaced.

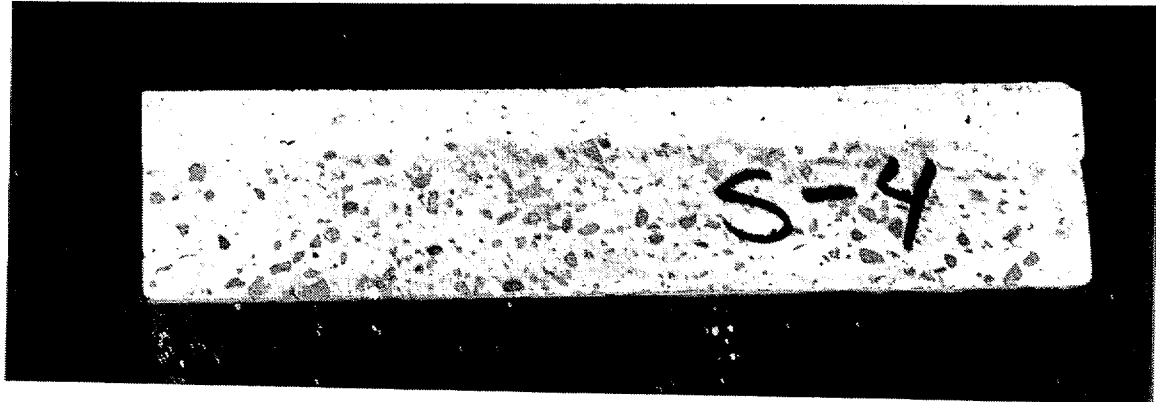
**Figure 3: Picture of the section of a paver**

The pavers are composed of two layers (see Figure 3). The top layer referred as "overlay" in this paper, is a proprietary formulation of mortar to match the color and texture of granite pavers used elsewhere on the terraces. The bottom layer referred to as "substrate", in this report, is a conventional concrete. It is likely that the sole purpose of the substrate is to add rigidity to the paver while minimizing costs by reducing the thickness of the overlay. The exact composition of each layer was not provided because it is considered proprietary by the manufacturer.

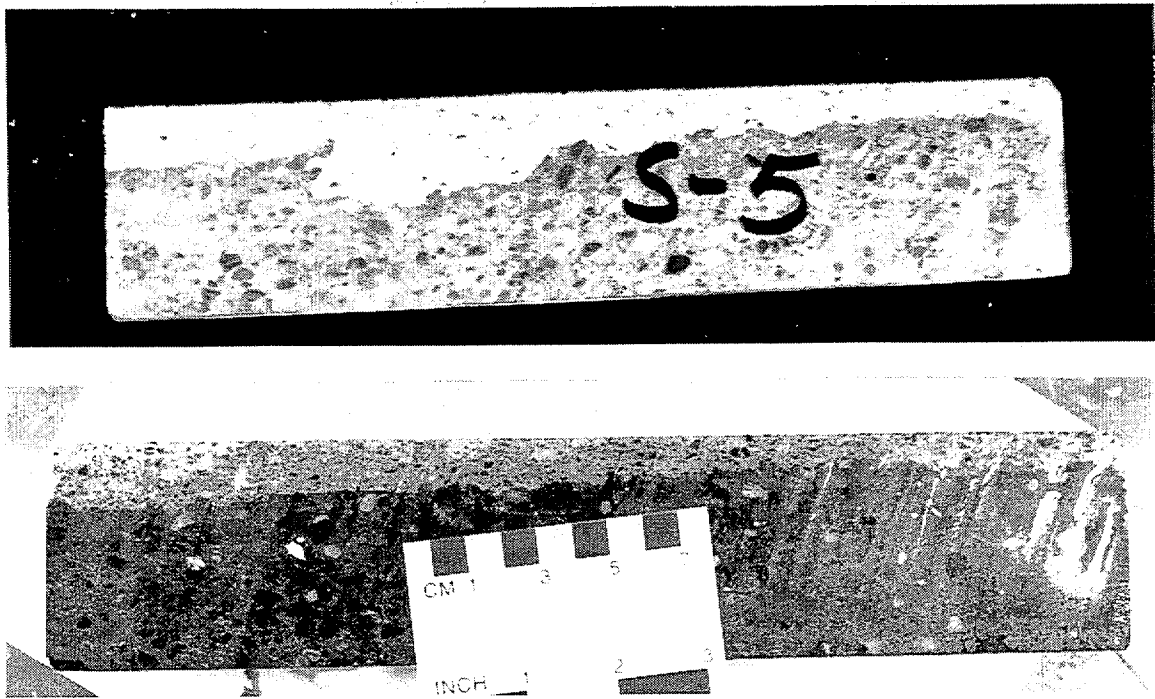
Figure 4: Overlay cross section

All five in-service pavers were badly warped while none of the new pavers were warped. Three pavers of each set, i.e., in-service and new, were cut in 4 equal sections (609.5 mm x 307 mm) using a saw and then as needed further sawed to the size needed for the tests to be performed (see Section 4). Two of the new pavers were reserved to simulate the field conditions (section 4.6). It was noted that the thickness of the overlay is not uniform as shown on Figure 4.

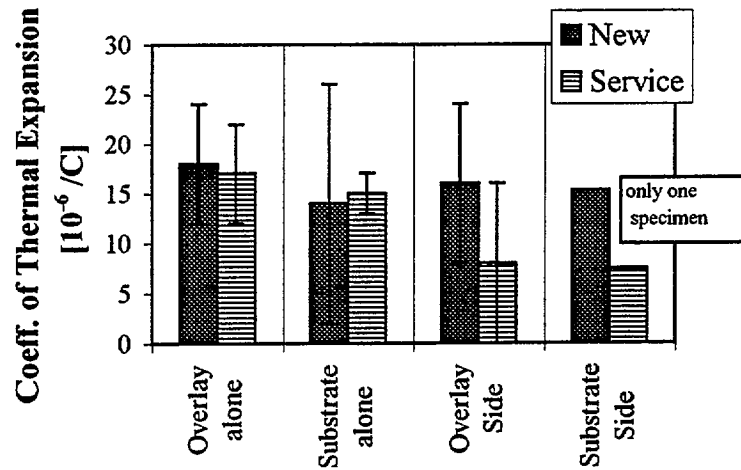
Thermal expansion was measured by placing the samples in an environmental chamber and cycling the temperature while regularly measuring the expansion. Two humidity conditions were considered: in water and at about 1% RH. In the first case, the samples were saturated and kept in water while the temperature was changed. In the second case, the samples were placed in an environmental chamber and the relative humidity was kept constant at about 1%. Figure 5 and Figure 6 show the results obtained from saturated samples and dry samples, respectively. The large standard deviation is due to the difficulty of finding a stable adhesive to attach pins to the sample at all temperature and humidities. The pins were the reference points between which the expansion was measured. The pins were placed on the long side of the specimen. The three type of specimens, described in Section 3, were tested. In the specimens in which the overlay and substrate were not separated, pins were placed on two sides, i.e. the substrate and the overlay. The purpose was to determine if any warping could be observed. Each set included three specimens. The tests were conducted until constant length. Considering the large standard deviation, there appears to be no significant difference between the two materials.

**Figure 5: Thermal expansion of saturated samples between 10 and 50 °C.**  
Average of 3 samples. (errors-bars are one standard deviation)

3. Thermal expansion: The substrate has a higher coefficient of thermal expansion than the overlay when the pavers are water saturated. But due to the large scatter of the data, due to the inhomogeneity of the samples, this conclusion should be considered with caution.

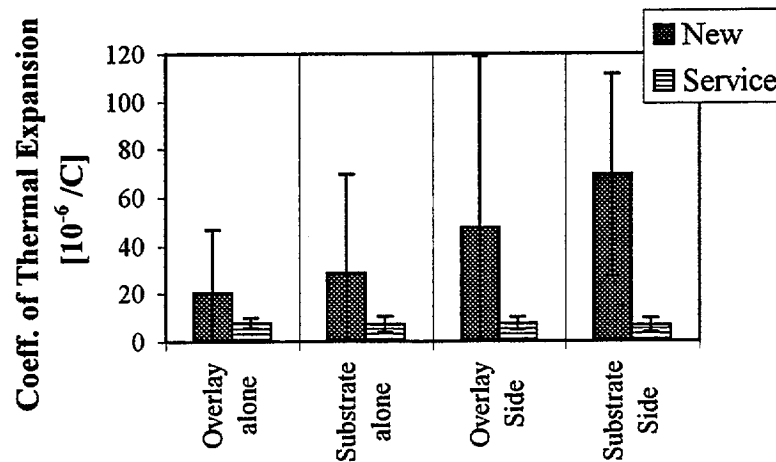
**Figure 6: Expansion coefficients for the specimens at 1%RH.**  
Results average of 4 sets of data. Temperature cycled between 10 and 75 °C.  
(errors-bars are one standard deviation)

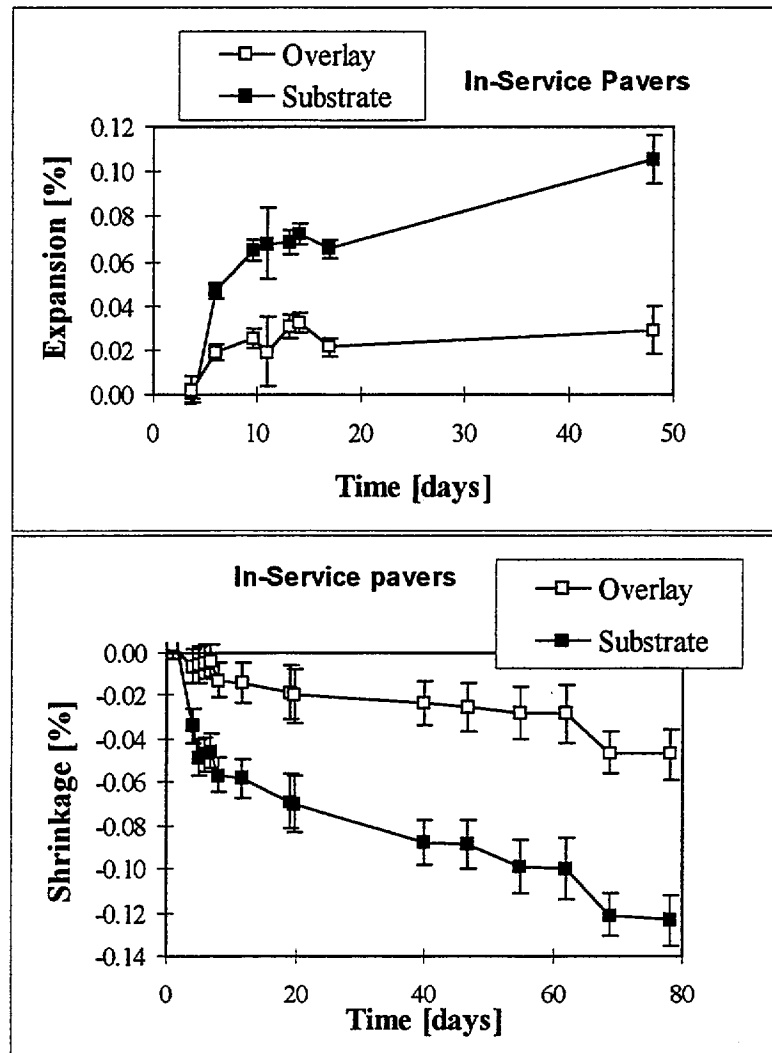
The substrate shrank and expanded more than the overlay. The value found are about 2-3 time larger than the value estimated in the field inspection (0.03 % to 0.05%). It

should be considered that the laboratory experiment were conducted on materials separated from each other, i.e., free to expand or shrink. Therefore, the curling in the field is a combination of the different expansion (shrinking) of the two materials.

**Figure 7: Expansion and shrinkage of in-service pavers due to water absorption or desorption in laboratory experiments. The two layers were tested alone. (Results average of 3 specimens. The error-bars are one standard deviation).**

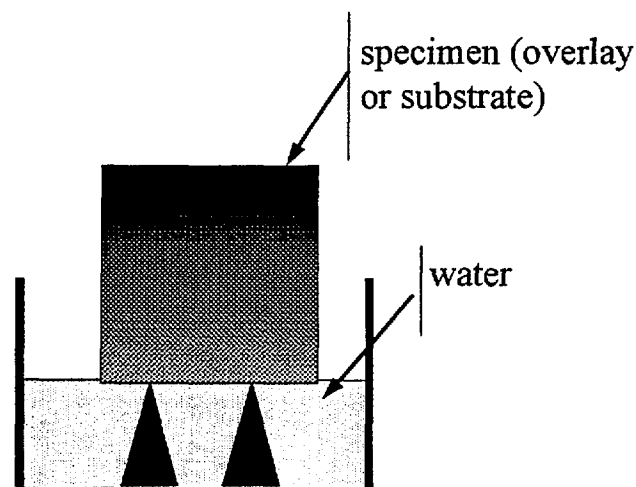
Figure 8: Capillary absorption test configuration.

The capillary absorption was measured by placing the sample in contact with water only on one surface (see Figure 8). The samples were oven dried at 50 °C until constant mass. The sides of the specimen were covered with tape to minimize ingress or evaporation of water and vapor. The mass of the sample was determined 4 times during the first hour, every hour between 1 and 7 hours and then every week. The mass gain per unit surface area versus time is used to calculate the rate of absorption or sorptivity.

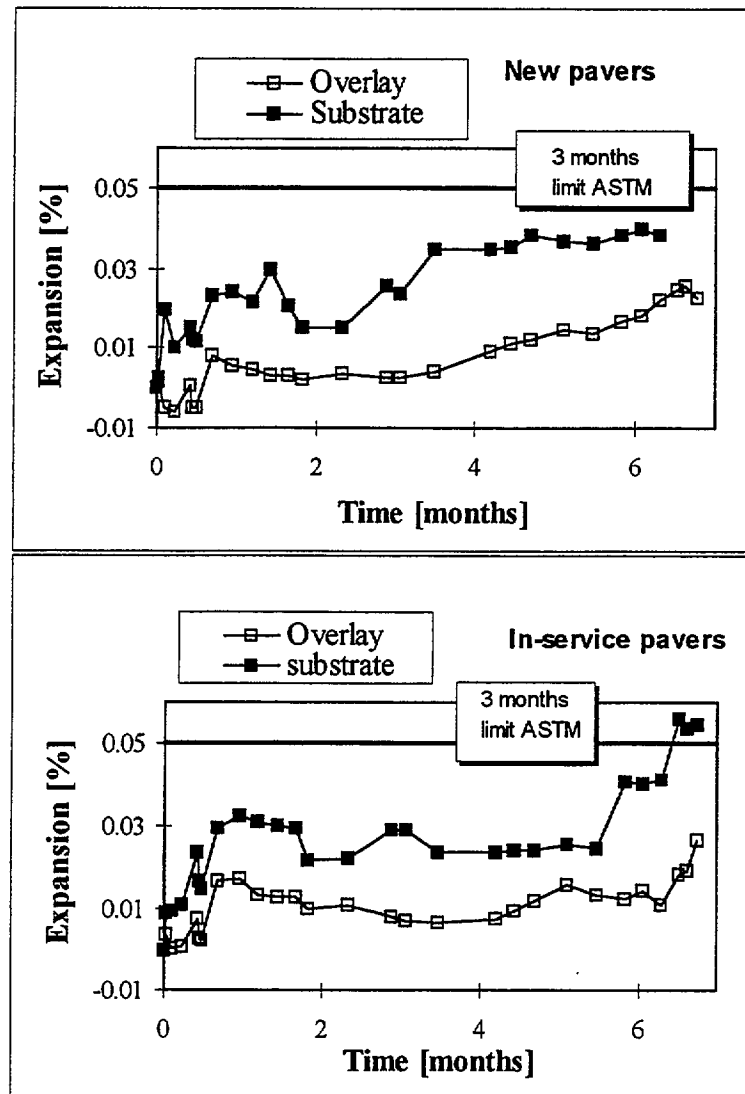
Figure 11: ASR expansion measured by modified ASTM C 227

After six months testing, it may be too early to make a definite conclusion from the modified ASTM C227 test. Nevertheless, the appendix of ASTM C33 [13] states that the expansion is excessive if it exceeds 0.05% at 3 months or 0.1% at 6 months. Figure 11 shows that the expansion is below 0.1% at 6 months. Of course, the lower temperature (only 20 °C instead of 38 °C) might have slowed the reaction, and delayed the expansion. The specimens will be measured for another 6 months at least. Nevertheless, the expansion data show that the substrate expands more than the overlay for both the new and in-service pavers. This indicates that if any reactions do occur the substrate will expand more than the overlay leading to an upward deformation of the paver.

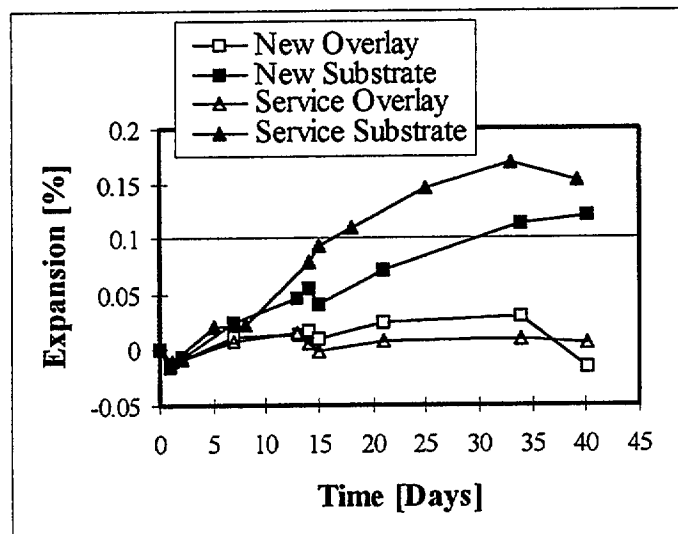
Figure 12: ASR expansion measured by modified ASTM C 1260

Figure 12 shows that there are no deleterious aggregates, because at 14 days none of the specimens had expanded above 0.1%. Nevertheless, the substrate specimen showed a continuing increase that eventually lead to an expansion above 0.1%, but some time after 14 days. The overlay does not follow the same trend. Therefore it could be argued that if some expansion occurs due to ASR in the substrate and not in the overlay, the differential expansion in the two materials could contribute to warping. Before considering that the substrate contains deleterious aggregates, it should also be remembered that this test was on ground material from the substrate as aggregates and not on the substrate as received.

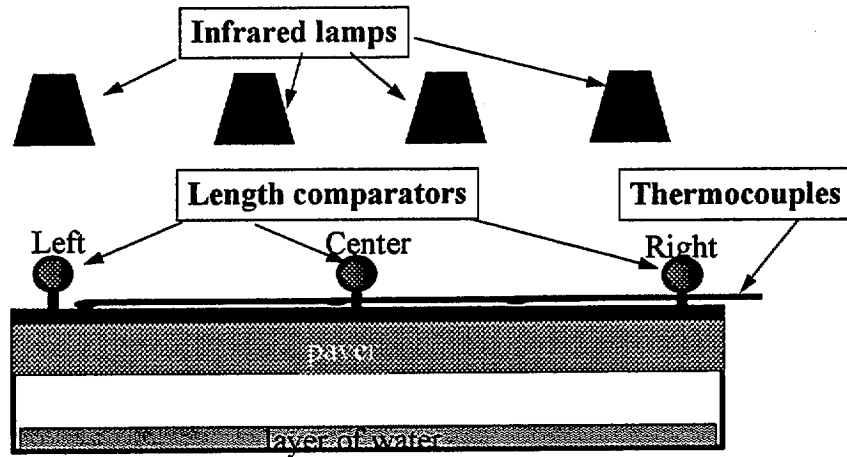
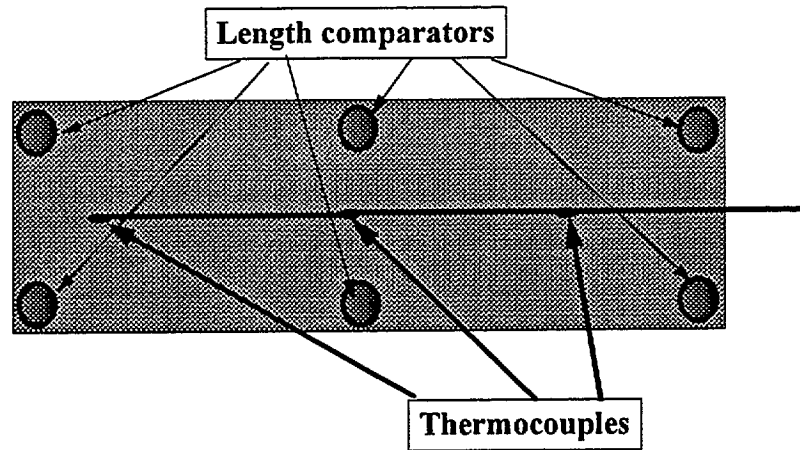
**Figure 13: Experimental configuration for measuring deformation of a new paver**

A severe simulated exposure test was devised to measure the degree and rate of warping of two new pavers selected from warehouse storage. The pavers were placed on supports, as in the field, and the apparatus maintained a top surface temperature of about  $45\text{ }^{\circ}\text{C} \pm 3\text{ }^{\circ}\text{C}$  while 100% RH (standing water) was maintained under the paver. The laboratory conditions are  $25\text{ }^{\circ}\text{C} \pm 5\text{ }^{\circ}\text{C}$  and  $30\% \pm 10\%$  RH. (Figure 13). Thermocouples installed on the paver surface allowed constant monitoring of the surface temperatures while six comparators mounted in a grid-pattern allowed measurement of movement. If the warping is due to a temperature and humidity gradient in the paver, this test should accelerate the phenomenon allowing estimation of the rate of warping.
