NISTIR 6075

**Cumulative Seismic Damage of
Reinforced Concrete Bridge Piers**

October 1997

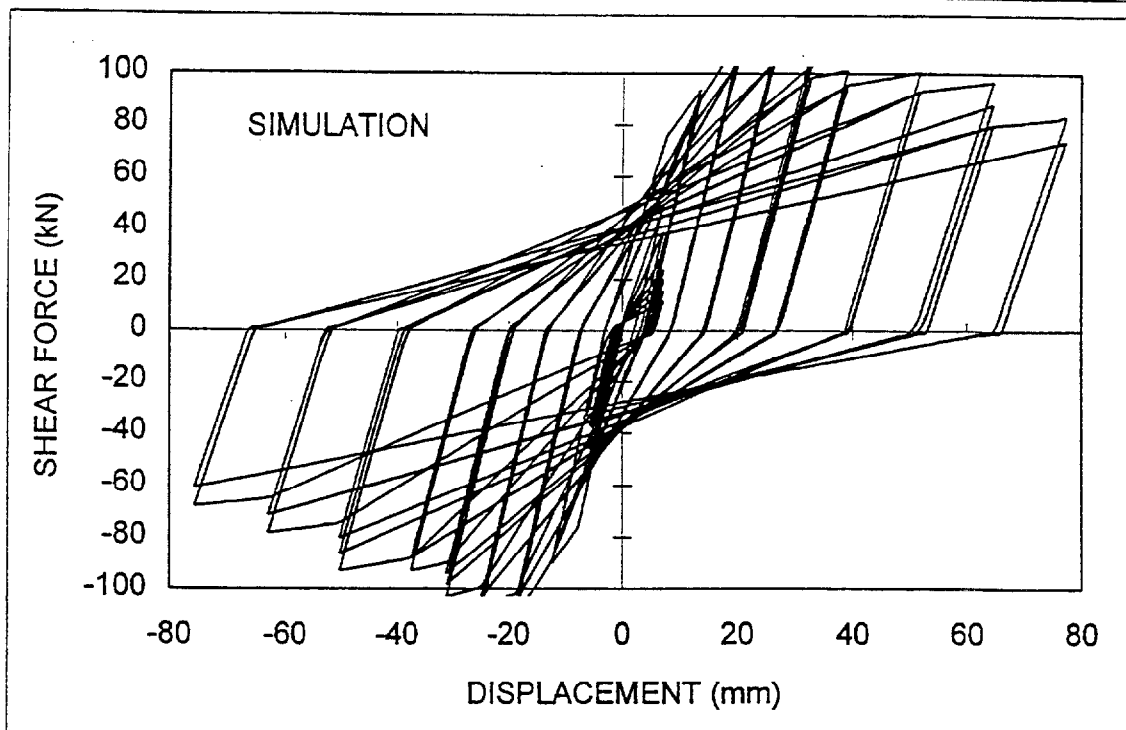
FIGURE 3-2 Calibration of Hysteresis Model

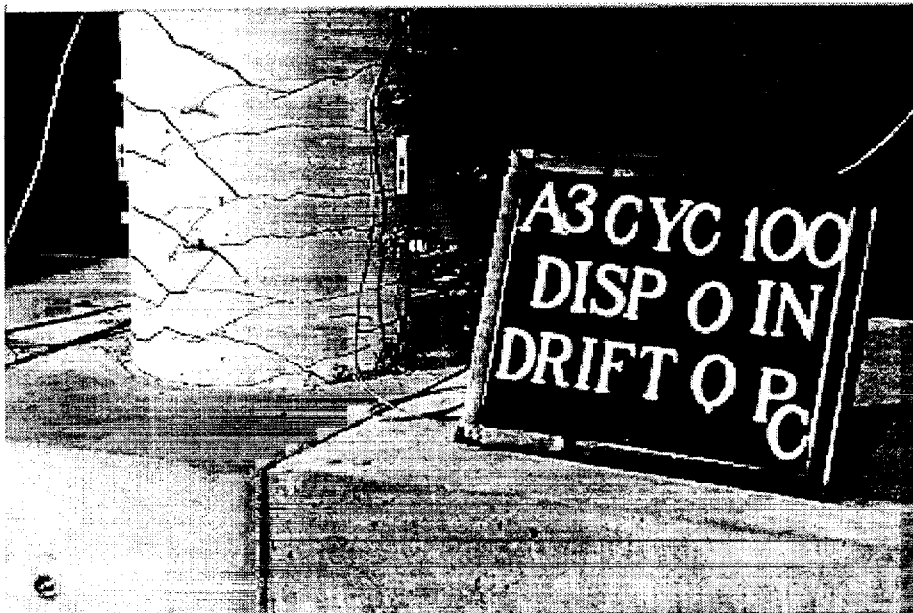
FIGURE 4-9 Specimen A3 at Cycle 100

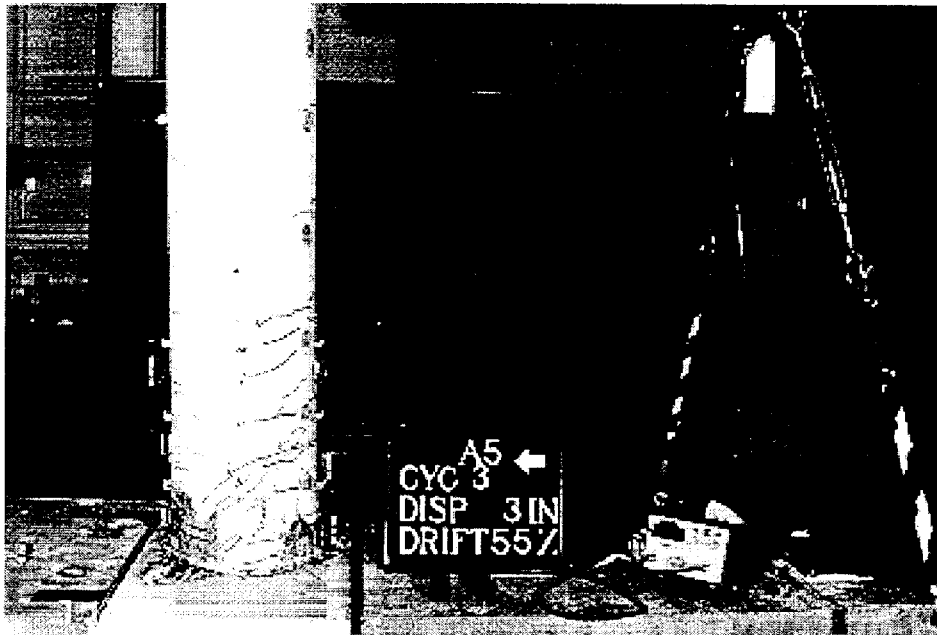
FIGURE 4-17 Specimen A5 at Cycle No. 3

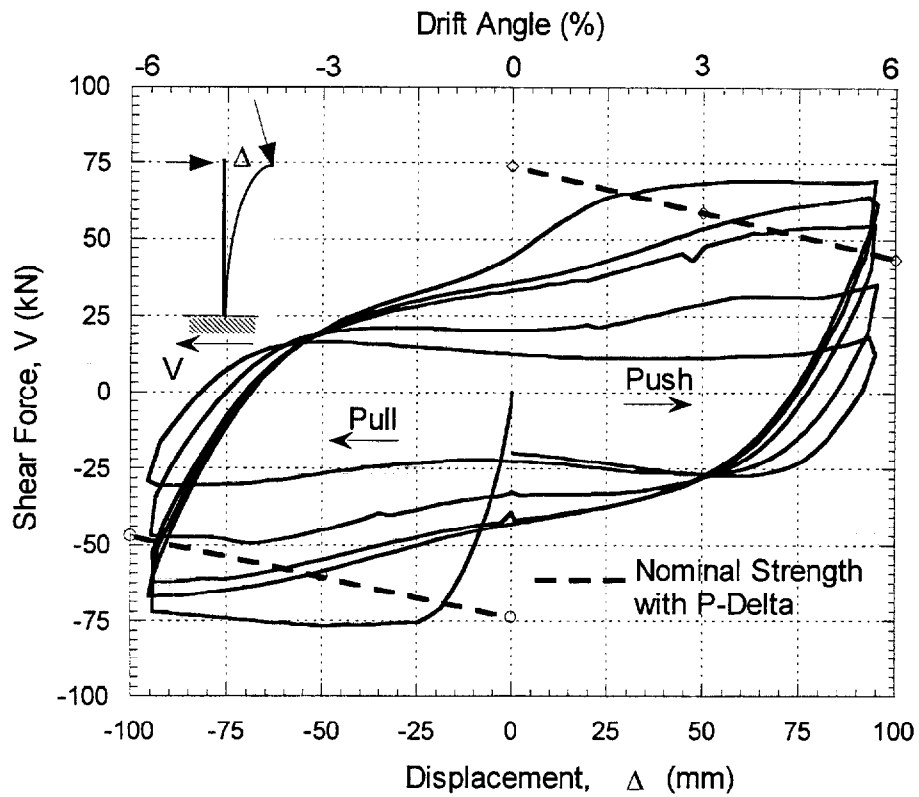
FIGURE 4-24 Shear vs. Displacement Response of Column A6

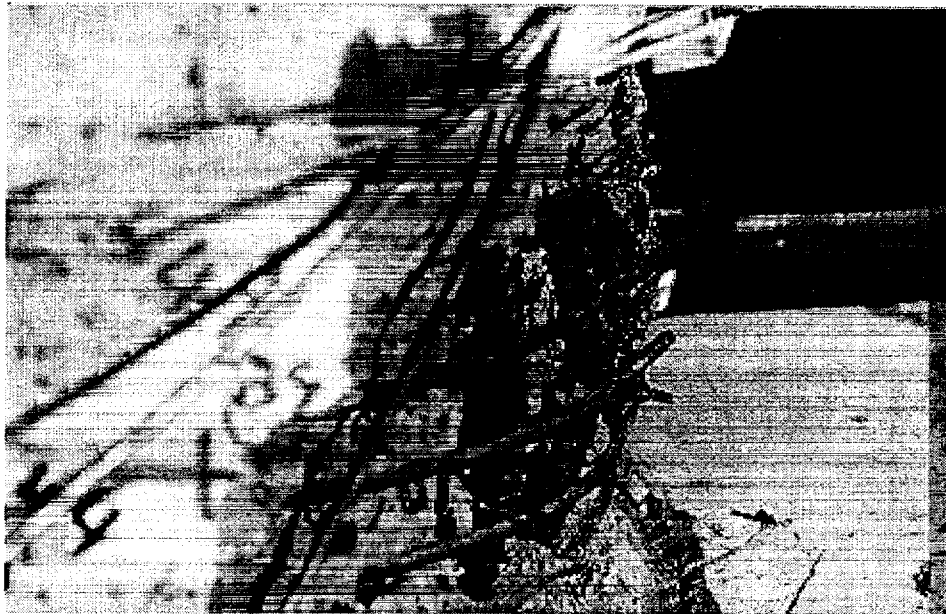
FIGURE 5-9 Specimen A8 at Final Damaged State

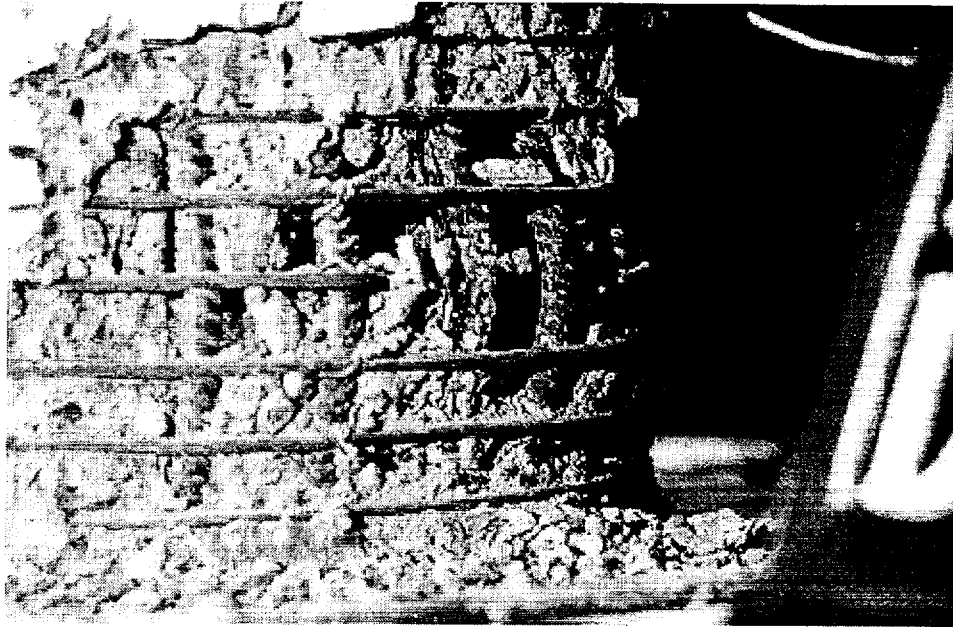
FIGURE 5-25 Final Damaged State of Specimen A12

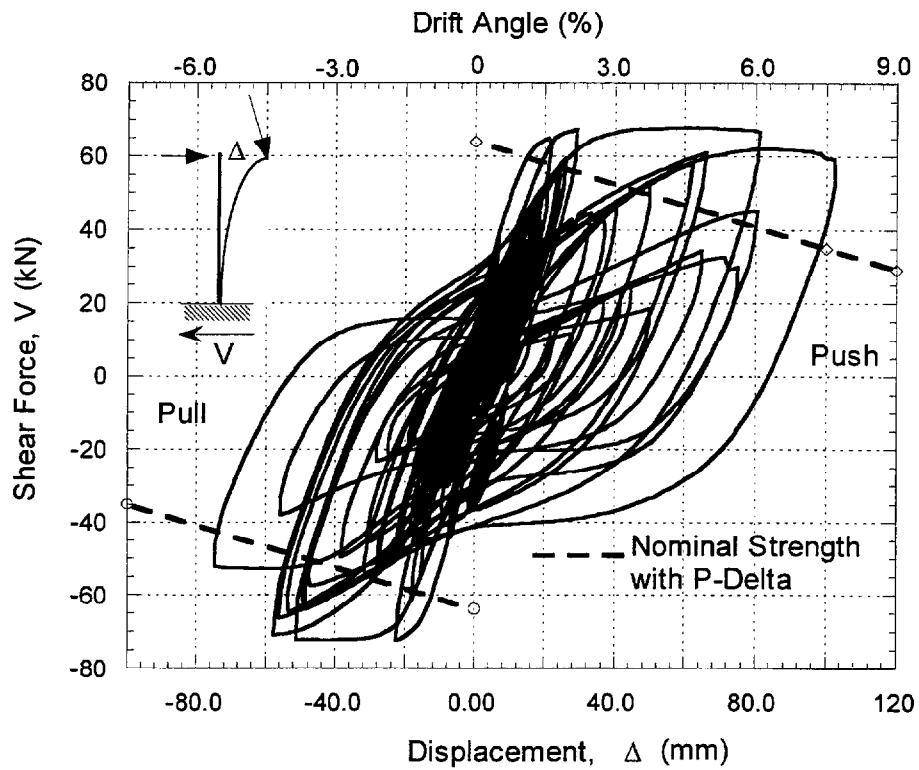
FIGURE 5-27 Base Shear vs. Lateral Displacement Response of Column A12

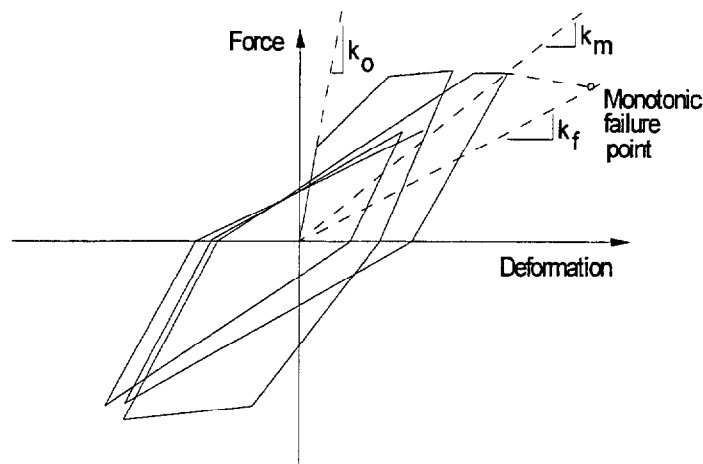
With reference to Figure 6-1, k_m is the stiffness of the structure at the maximum induced displacement, k_f is the pre-established stiffness at failure of the system (typically under monotonic loads), and k_o is the initial stiffness prior to loading.

FIGURE 6-1 Parameters Used in Softening Index

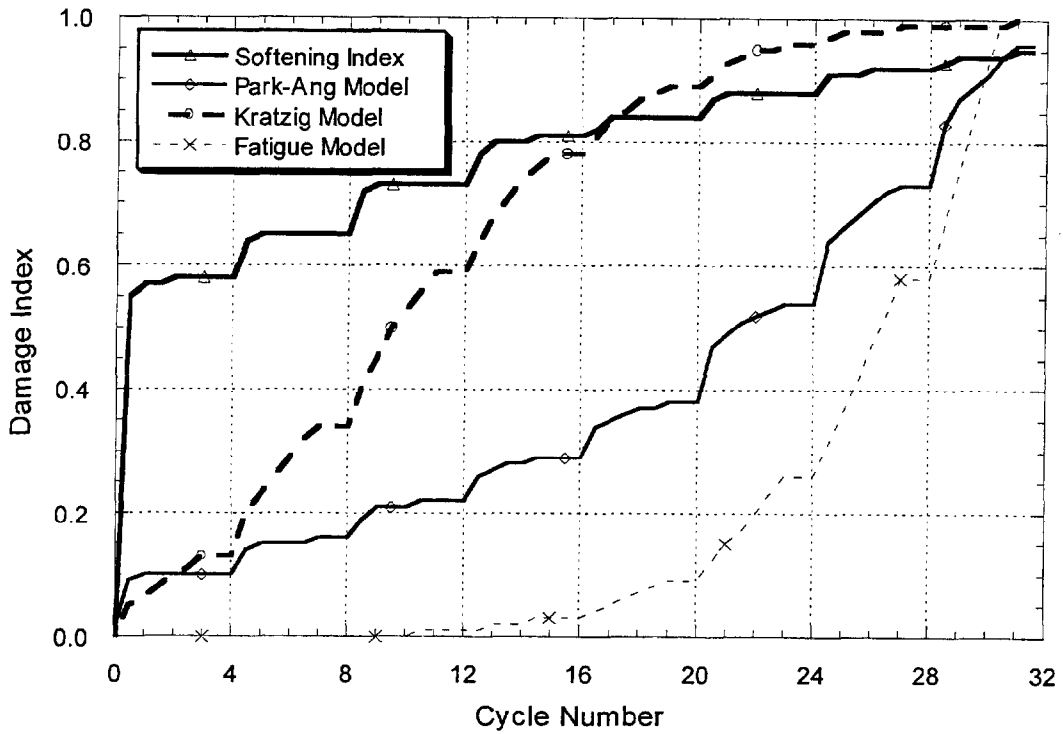
FIGURE 6-4 Comparative Evaluation of Progressive Damage for Specimen A2

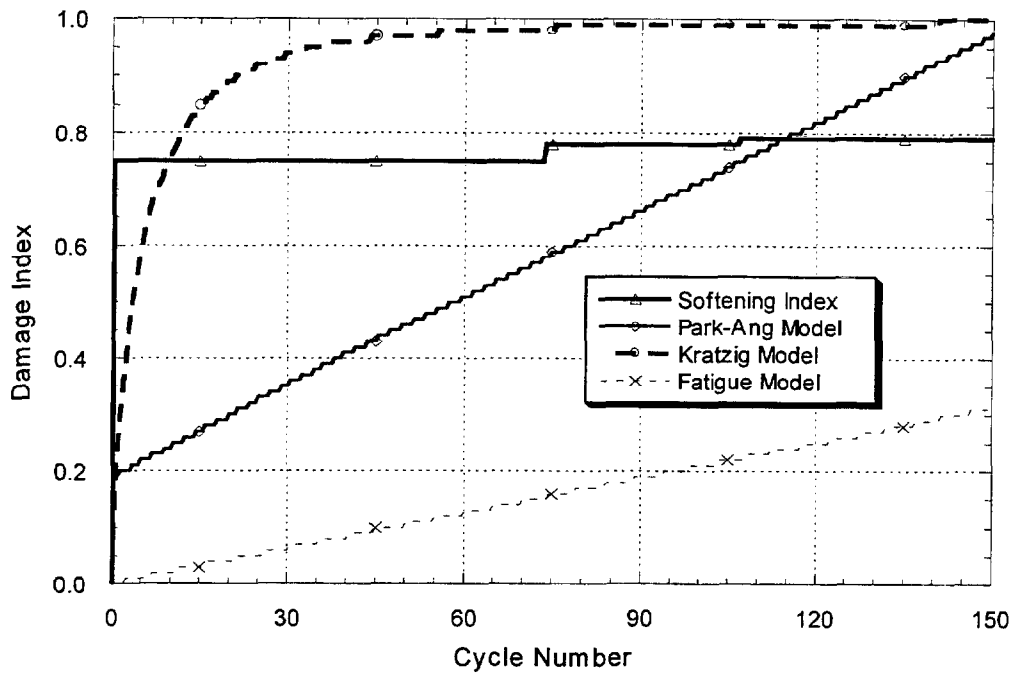
FIGURE 6-5 Comparative Evaluation of Progressive Damage for Specimen A3

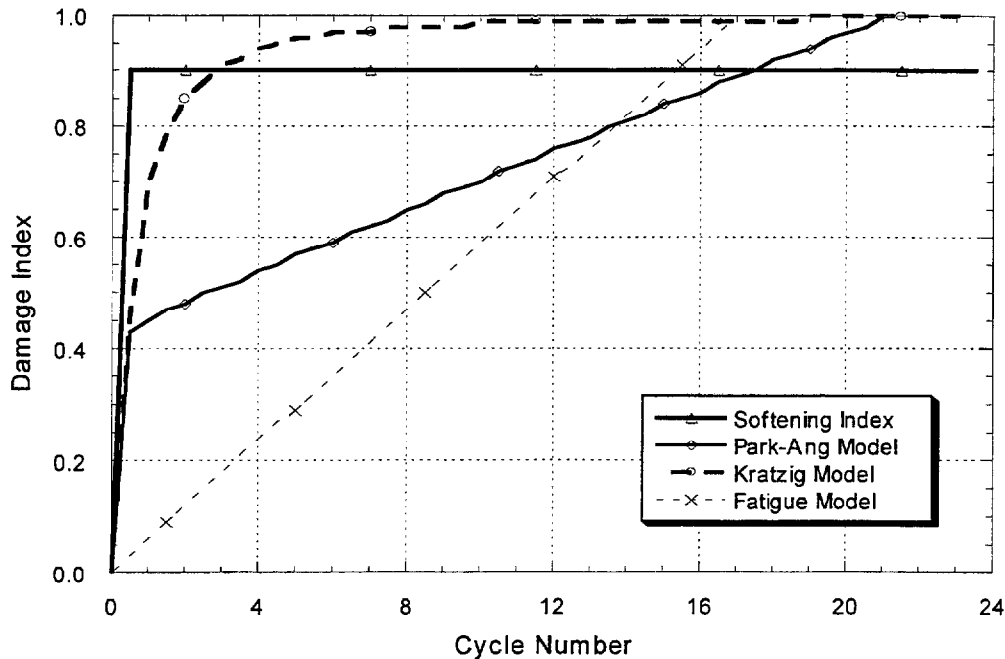
FIGURE 6-6 Comparative Evaluation of Progressive Damage for Specimen A4

The next specimen, A4, was subjected to a much larger drift amplitude. Failure of the specimen was recorded in less than 30 cycles. The Park-Ang model seems to perform better when the displacement amplitudes are significantly larger than the yield displacement. The Kratzig model and the damage represented by the Softening Index do not span a reasonable range of limit states due to the fact that severe damage is predicted very early in the response.

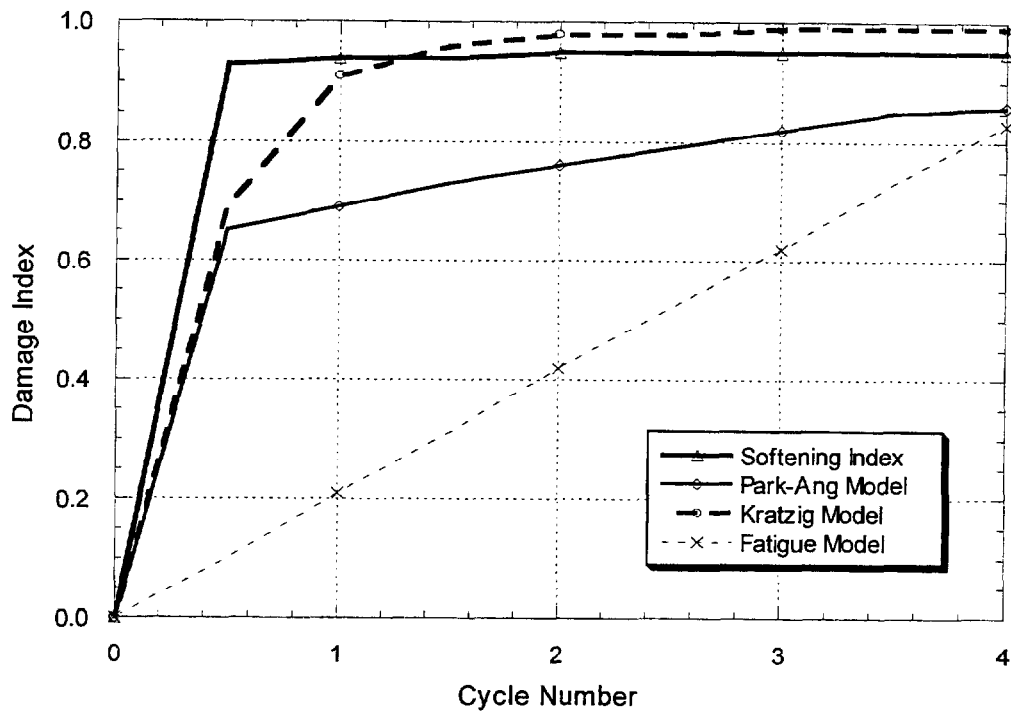
FIGURE 6-8 Comparative Evaluation of Progressive Damage for Specimen A6

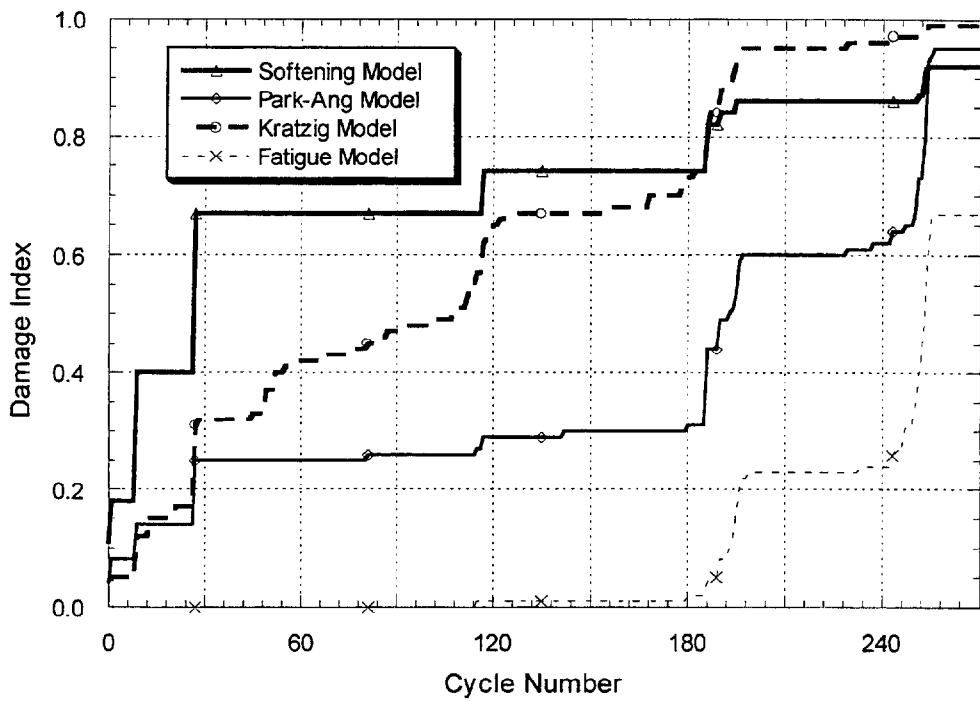
FIGURE 6-11 Comparative Evaluation of Progressive Damage for Specimen A9

Specimens A9 and A10 were subjected to a different set of load reversals resulting from a different sequence of events. A9 experienced strong ground shaking representing a severe event followed by two minor earthquakes, a moderate earthquake, and another major event. In the case of Specimen A10, the final event was retained as before but the first four earthquakes were interchanged to produce an entirely different path leading up to the final earthquake. The predicted damage using the different damage models are shown in Figures 6-11 and 6-12.

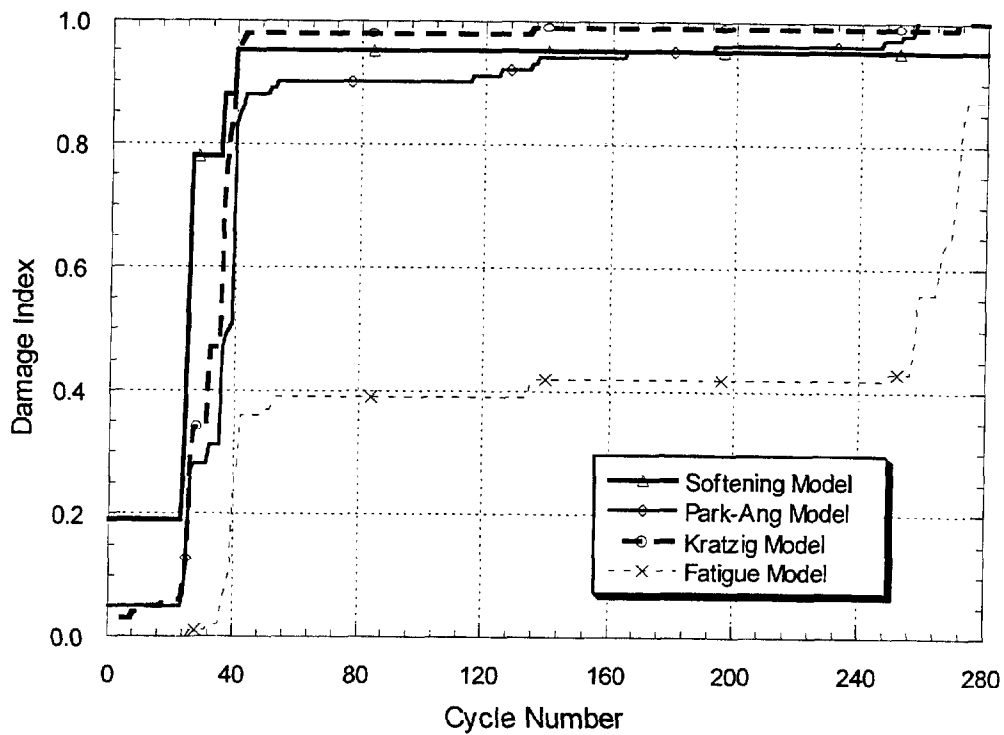
FIGURE 6-13 Comparative Evaluation of Progressive Damage for Specimen A11

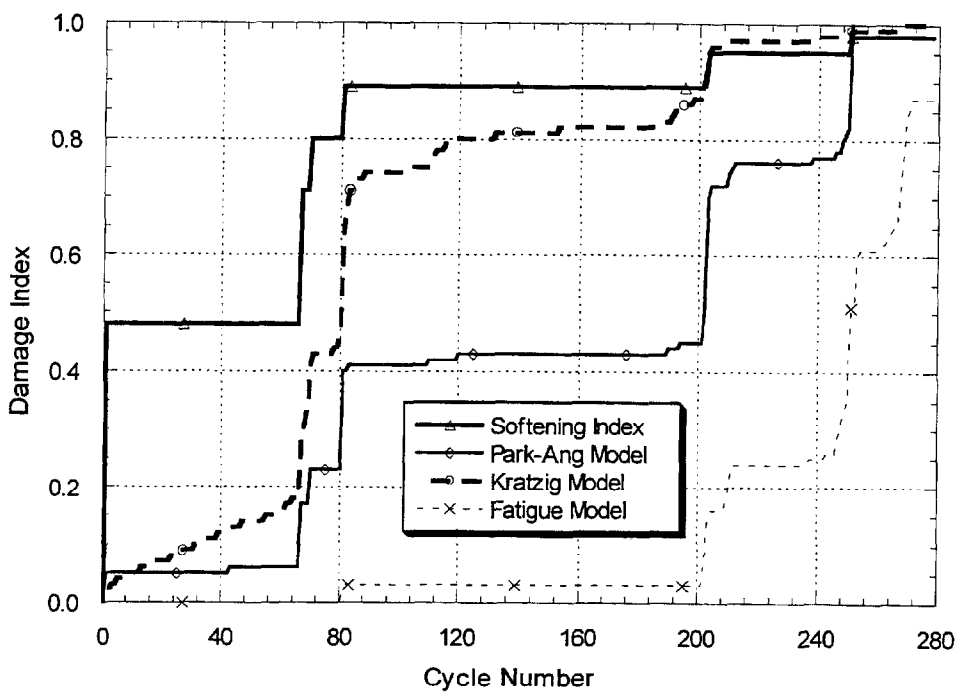
FIGURE 6-14 Comparative Evaluation of Progressive Damage for Specimen A12

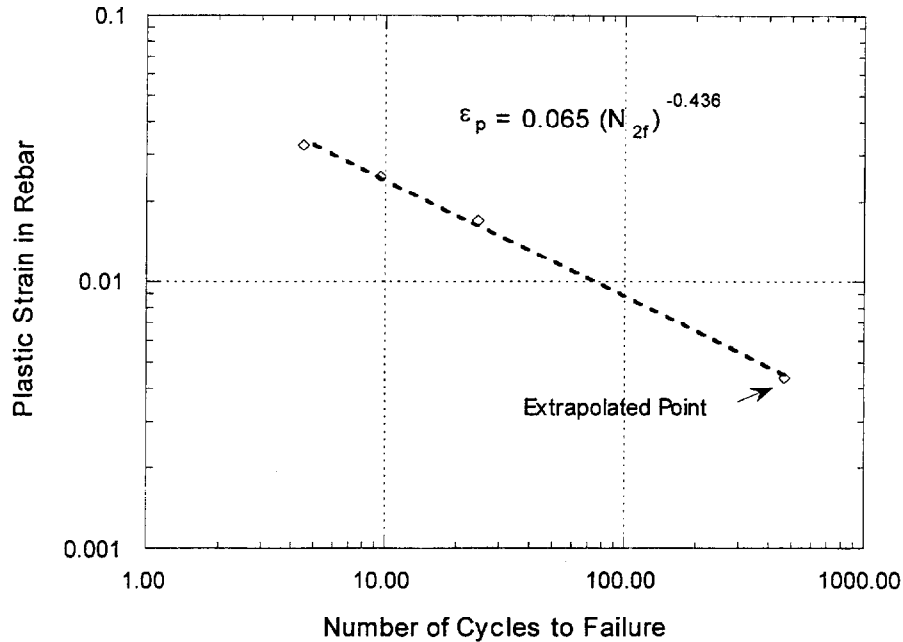
FIGURE 6-15 Coffin-Manson Fatigue Model for Plastic Strain

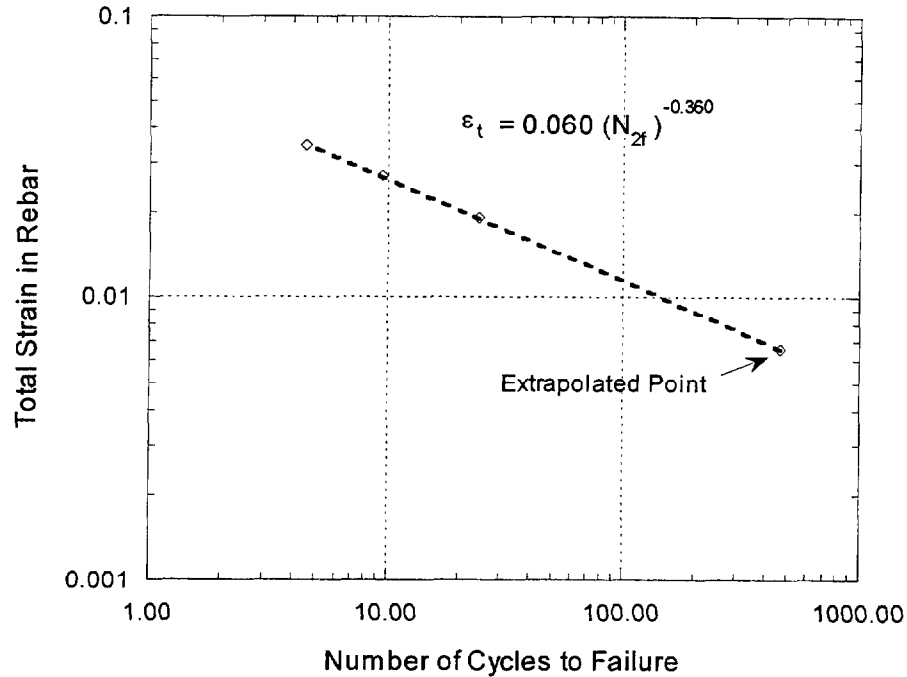
FIGURE 6-16 Coffin-Manson Fatigue Model for Total Strain

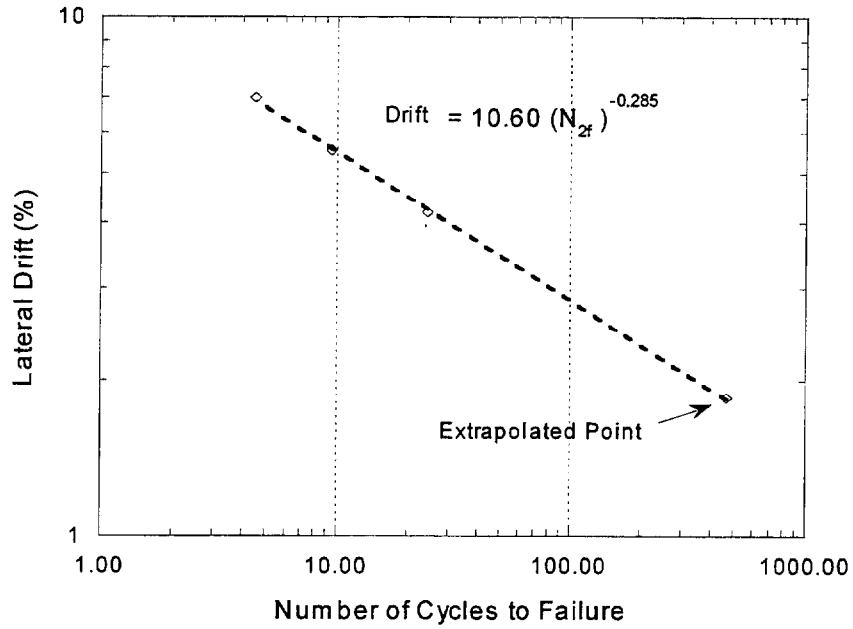
FIGURE 6-17 Fatigue Life Model for Total Lateral Drift of Well-Detailed Flexural Columns

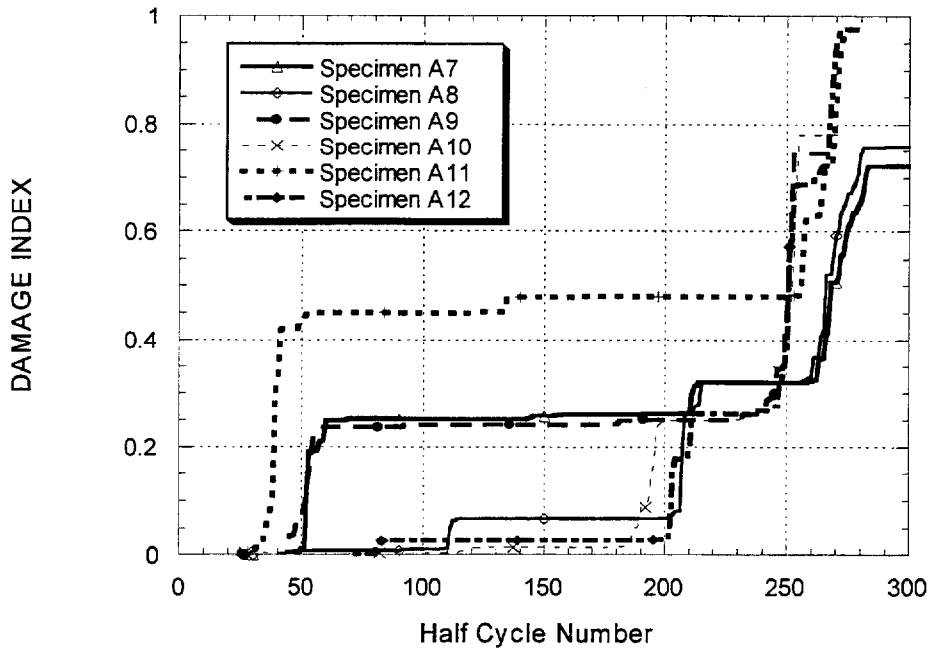
FIGURE 6-18 Performance of Proposed Plastic Strain Fatigue Damage Model Applied to Specimens A7-A12

Finally, Equations (6-14) and (6-15) were used to estimate damage to Specimens A-7 through A-12. Essentially, the damage model formulation is identical to the derivation presented in Equations (6-9) through (6-13) with the fatigue life equations of Equations (6-9) and (6-10) replaced by Equations (6-14) and (6-15). The results of the evaluation are presented in Figures 6-18 and 6-19. A significant improvement in damage prediction is evident. Final damage estimates have increased and appear much closer to observed performance. However, only specimens A11 and A12 reach a final index of 1.0. The other four specimens show a damage index of approximately 0.8, which is typically representative of irreparable damage.

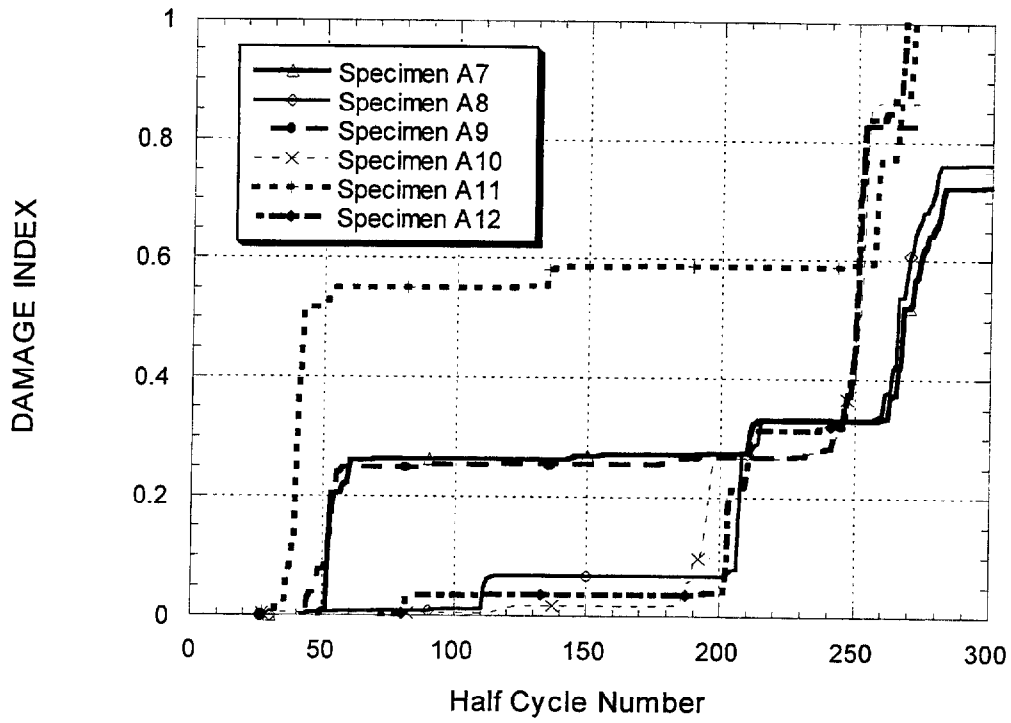
FIGURE 6-19 Performance of Proposed Total Strain Fatigue Damage Model Applied to Specimens A7-A12

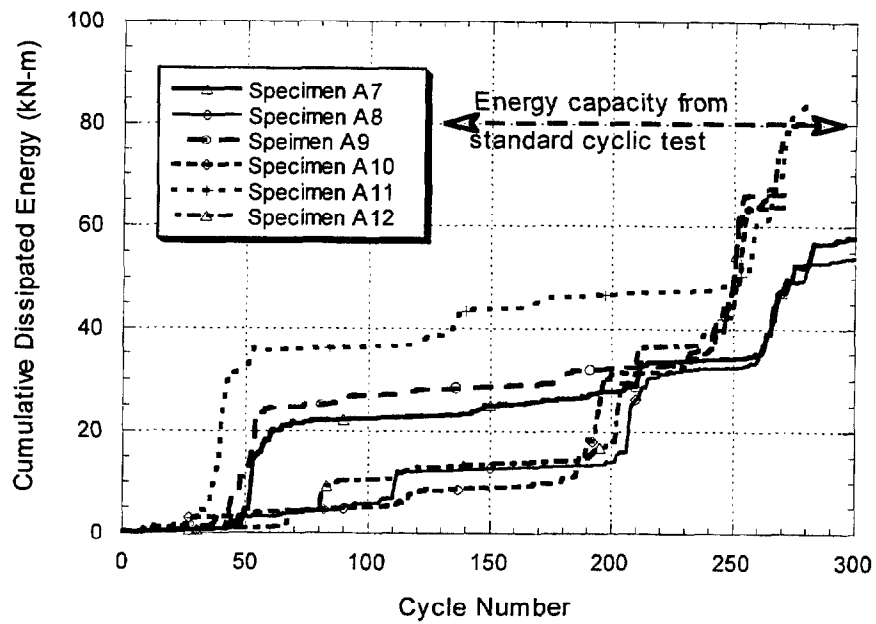
FIGURE 7-2 Cumulative Energy to Failure of Bridge Columns Subjected to Random Loading

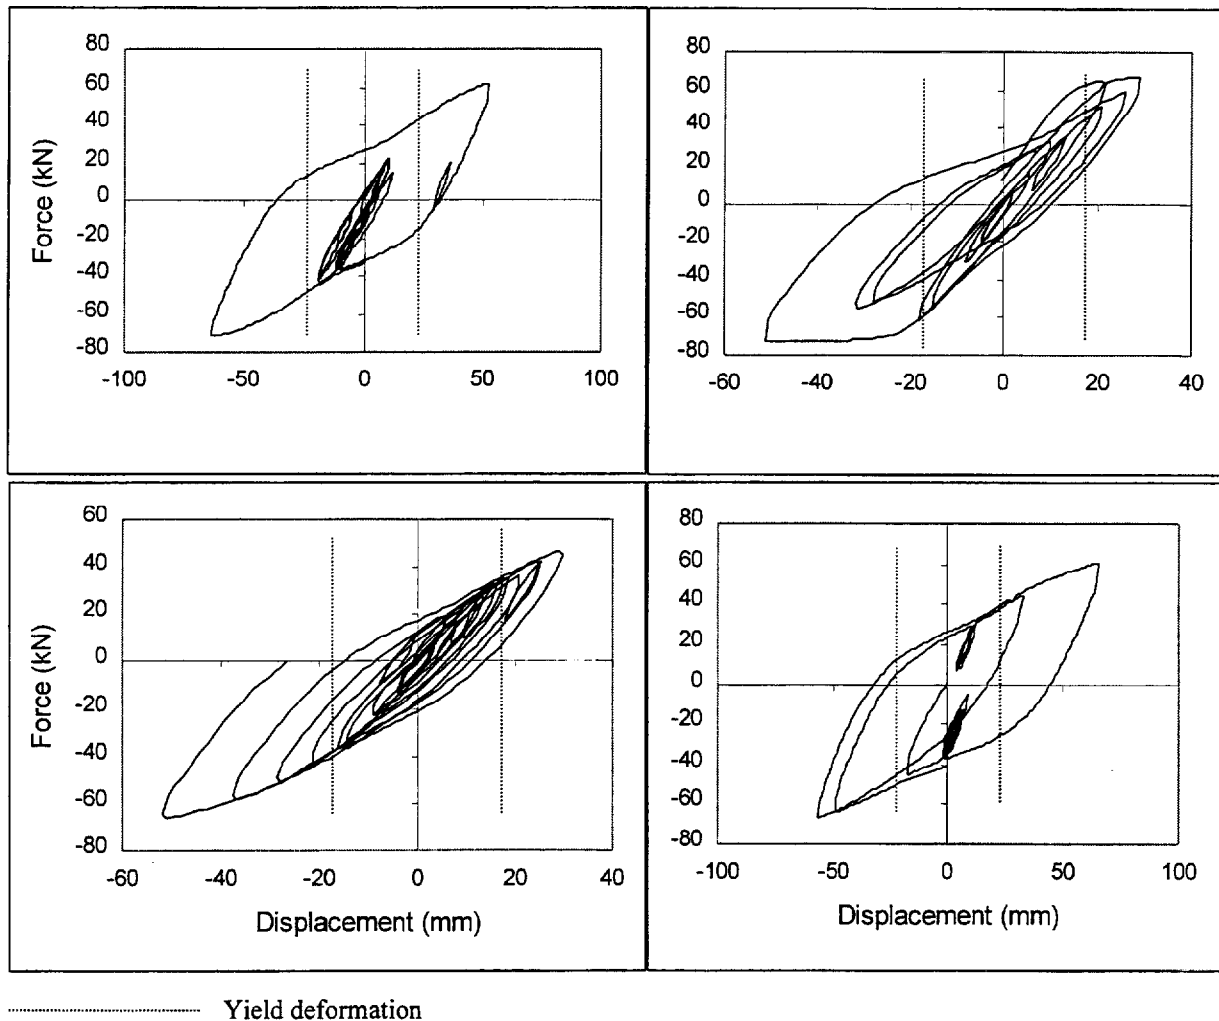
Figure 7-3 shows segments of the experimental response for two of the specimens in which a few relevant cycles are separated from the rest of the force-deformation loops. A well-known aspect of loop behavior is clearly evident: that unloading paths generally attempt to return to the location of displacement and/or force at the end of the previous half cycle. The path taken to return to this previous amplitude location may vary depending on the current location of unloading. The purpose of displaying intermediate force-displacement hysteresis in Figure 7-3 is to facilitate the development of a model that can be used for earthquake analysis of concrete structures. Figure 7-4 is a proposed model of expected loop behavior under random amplitudes wherein the path of small-amplitude cycles are given proper consideration.

FIGURE 7-3 Local Loop Behavior Under Random Cyclic Response
