**PAINTED STAIRWELL FIRES IN HIGH-  
RISE BUILDINGS**

Henri E. Mitler

**NISTIR 6293**

February 1999

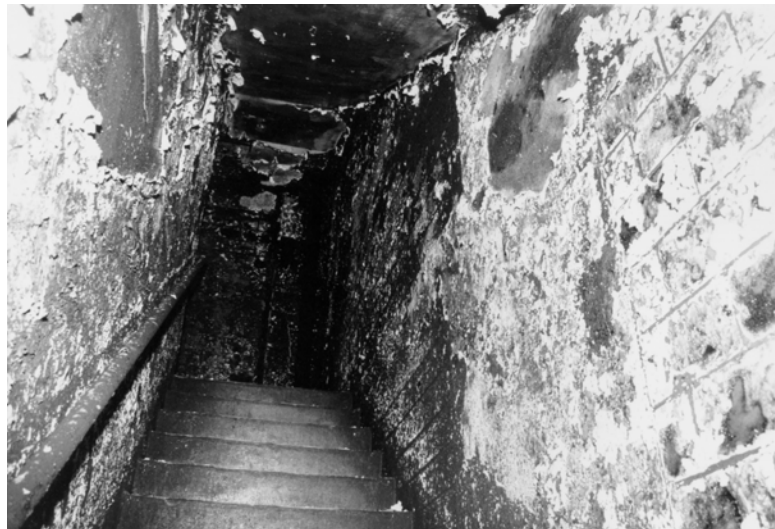
Three sites where stairwell fires took place in NYC during 1994 and 1995 were examined. In all three cases, fire damage in the stairwells was severe. The typical appearance of a stairwell post-fire is shown in figure 1. In the three fires, the damage was most severe on the floor of fire origin with lesser damage on higher floors. Not all of the paint was consumed in any of the fires and in some of the fires the spread was limited to several floors.

Figure 1. Stairwell fire on floor of fire origin

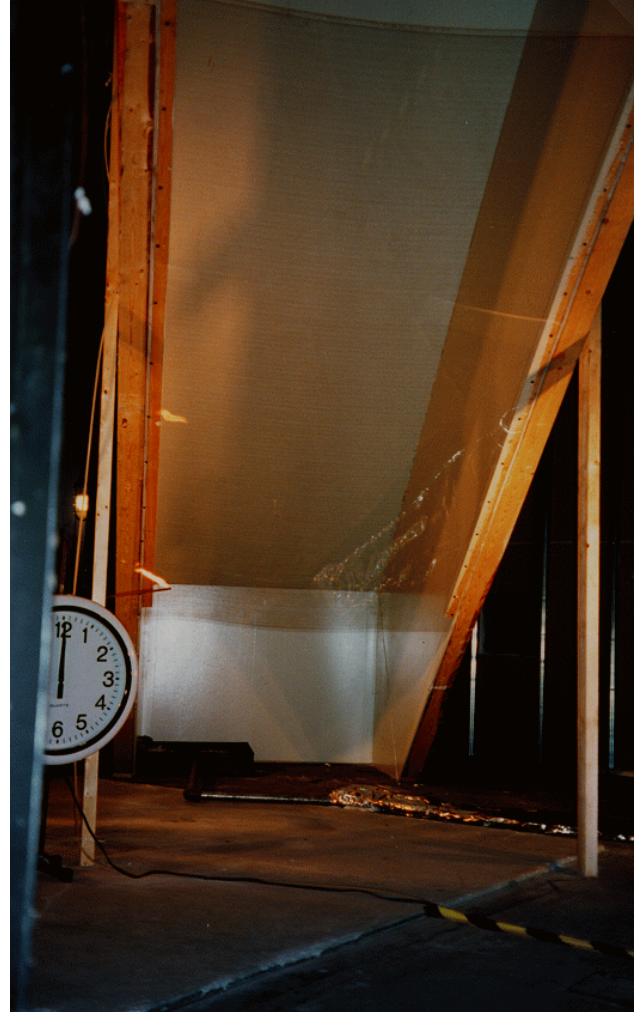
**Test 4:** For test 4, the walls and ceiling were covered by fifteen coats of paint – five of primer, to ensure that no water diffused into the paint from the gypsum-board walls, and ten layers of the alkyd/oil-based paint. The right-hand wall received a coat of anti-graffiti coating before the last coat of paint was applied, to simulate the technique that had been used to control graffiti. A total of  $0.92 \text{ kg/m}^2$  of primer/paint/anti-graffiti coating was applied to the wall surfaces.

Figure 7. Experimental arrangement for test 4

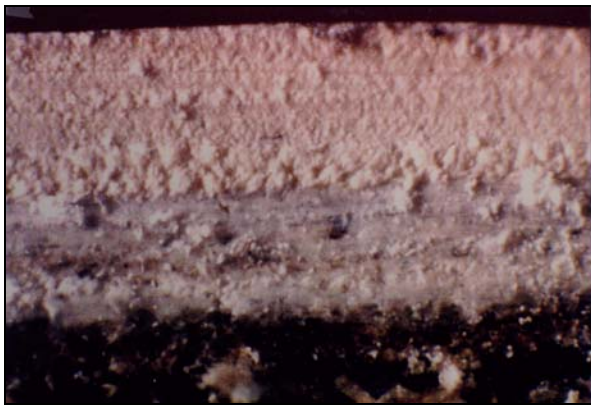
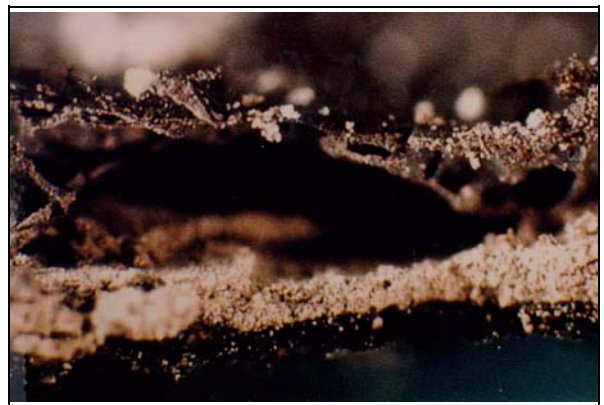
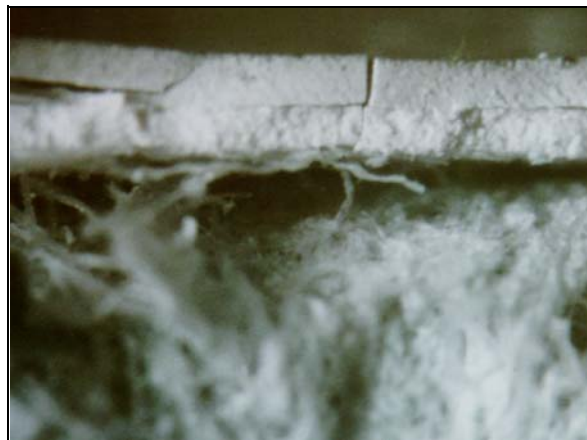
Microphotographs of the cross-sections of the remains from Test 3 are shown in figure 11. The sample in figure 11a was taken from an unburned section of the left-hand wall, and shows a cross-section of the unburned surface. The various layers can be distinguished. The paper layer on the gypsum board lies at the bottom, followed by the five layers of primer, with the ten layers of paint on top. The ten paint layers are about 300  $\mu\text{m}$  thick, while the five layers of primer are about 240  $\mu\text{m}$  thick.

(a) Painted surface from unburned surface of test 4

(b) Burned surface taken from a position intermediate between (a) and (c)

(c) Burned surface near ignition source

Figure 11. Microphotographs of cross sections of paint surface after test 4

Figure 11b is from a heavily burned region near the exit. It can be seen that large gas bubbles or blisters have formed between the layers, probably from the anti-graffiti coating. When the heat causes a gas bubble to form, it forces lower layers, which have been plasticized, to flow, making the layer thinner. The lowest layer is about  $110\ \mu\text{m}$  thick; since the paper layer is only  $60 \pm 10$  microns thick, this must be primer. This is consistent with having the lowest layers not pyrolyzing. The upper set of paint layers has begun to delaminate, and is  $\sim 80 - 120\ \mu\text{m}$  thick. It shows that  $\sim 200$  out of the  $300\ \mu\text{m}$  of paint have been pyrolyzed away; since there may have been charring and expansion or shrinkage of the layers, it is difficult to determine exactly how many layers that corresponds to, but it is most likely between 6 and 7 layers.

Figure 11c is one of the most pyrolyzed of the samples which have not been totally burned away. It was taken from the right-hand wall, approximately 2 m from the exit. From the top of the photograph, there is a layer of paint approximately 160 – 170  $\mu\text{m}$  thick, with a division within it ~80 - 90  $\mu\text{m}$  below the surface. Delamination separates the paint from the primer. The primer is approximately 150 -- 160  $\mu\text{m}$  thick. The dark band is probably the paper facing on the gypsum board and shadows. Finally, the cottony-looking region below the paper facing is the gypsum board. It is reasonable to conclude that 220 or more microns of paint have been pyrolyzed, and that delamination occurred within the primer layers.
