Corrosion Fatigue Crack Initiation in Duplex Stainless Steel Paper Making Components

Final Report for:
NIST CRADA CN-1237

Prepared for:
John C. Rogers, Technical Director
Sandusky International, Inc.
615 West Market Street
P.O. Box 5012
Sandusky, OH 44871-5012

March 1999

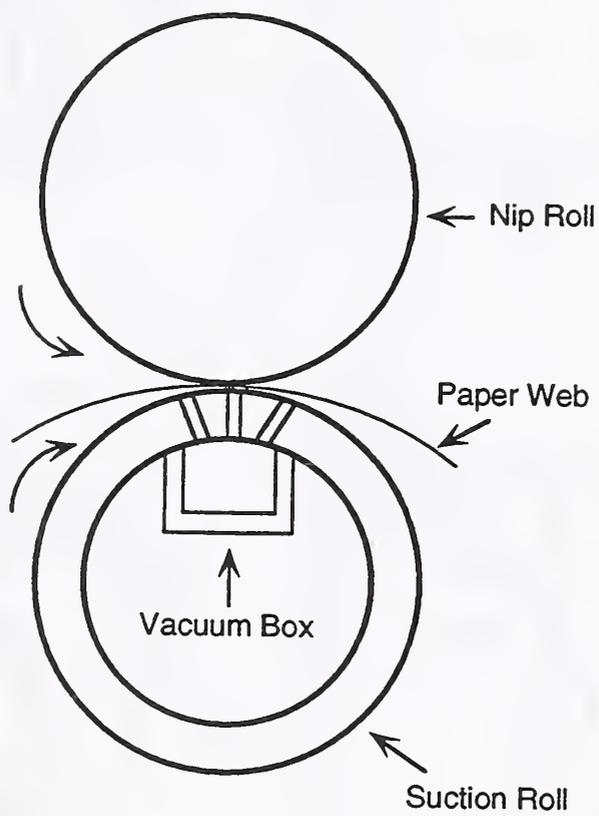
Figure 1. Schematic diagram showing the general configuration of a suction press (or nip) roll. (after Yeske, 1987)

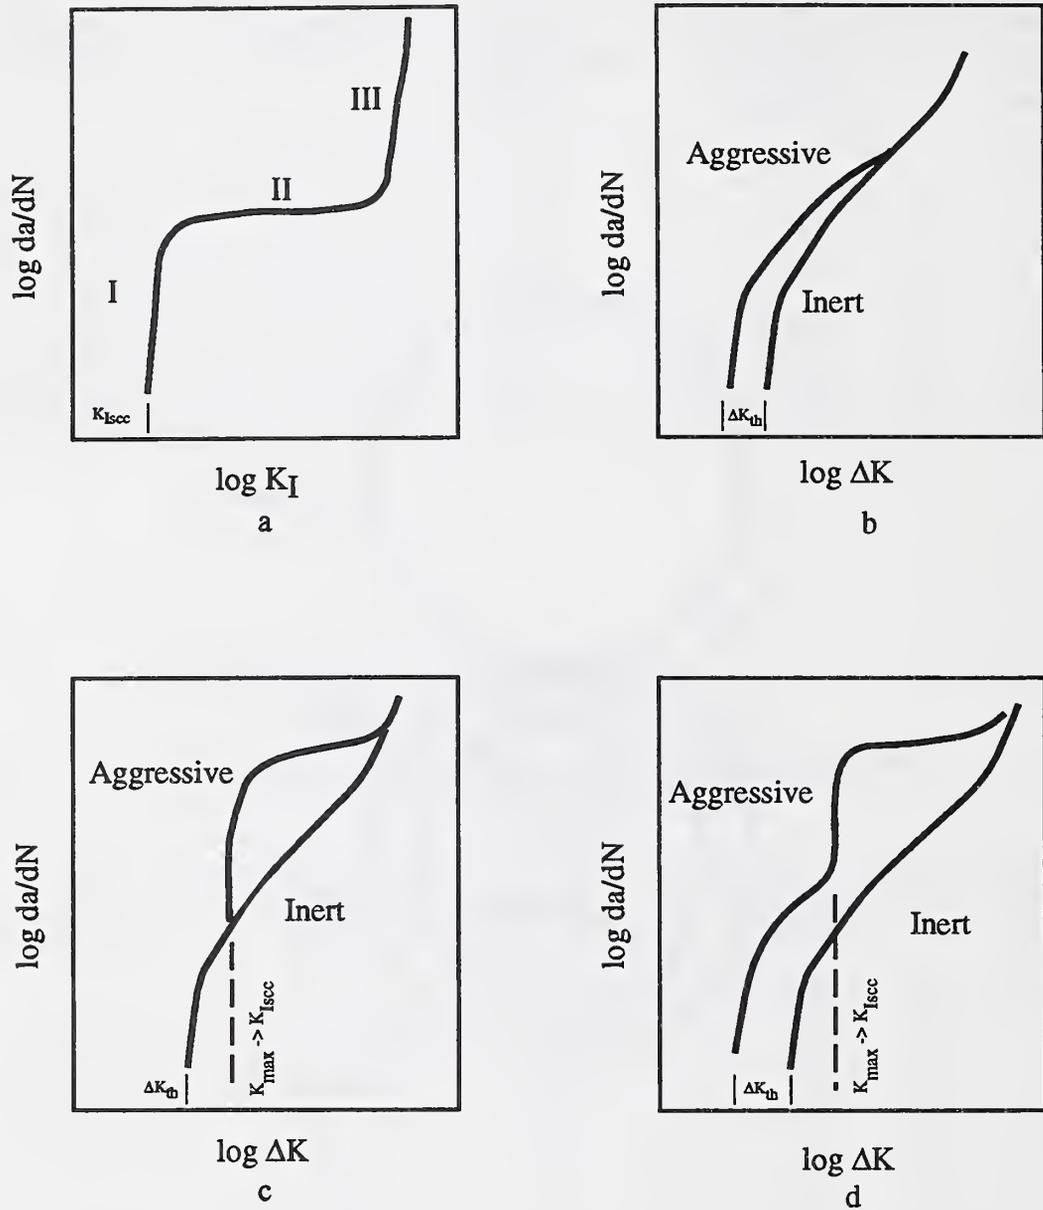
Figure 2. A schematic representations of the combined mechanical fatigue and environmentally induced crack growth. a) Crack growth under sustained loads. b) True corrosion fatigue. c) Stress corrosion-fatigue and d) Mixed corrosion and stress corrosion fatigue behavior. (after McEvily and Wei 1972.)

The effect of environment on the rate of fatigue crack growth is often characterized by considering different combinations of crack growth measured under purely mechanical fatigue and under stress corrosion conditions. Figure 2a is a schematic illustration of the sigmoidal relationship between stress corrosion crack growth velocity (da/dN) and the Mode I stress intensity factor, (K_I). This figure also exhibits another threshold value of stress intensity known as K_{Isc} which is determined by the environmental interaction. Above this threshold, the crack velocity sharply increases with stress intensity (Region I) and below it, the environment has no appreciable effect. This is followed by a region of stable crack growth in which the crack growth rate is essentially independent of the applied K (Region II). Beyond Region II, the value of applied K quickly approaches the fracture toughness for the material resulting in a sharp increase in crack velocity (Region III). The regions in this figure are often likened to: initiation and near-threshold propagation (Region I), stable crack propagation (Region II) and unstable growth and fracture (Region III). McEvily and Wei schematically illustrated the effects of the environment on fatigue crack propagation. [32] Figures 2b, 2c and 2d, illustrate the three main types of interactions associated with corrosion fatigue. Figure 2b represents the “true corrosion fatigue” condition where the environment alone is assumed to have no effect on the crack growth behavior. In this case, the environment accelerates crack growth only under cyclic loading conditions through the mechanisms outlined earlier. True corrosion fatigue is also known to influence cyclic fracture at stress intensity values below K_{Isc} . Figure 2c represents “stress corrosion-fatigue” which is believed to be a simple superposition of mechanical fatigue and stress corrosion cracking. In this form, crack propagation is only known to occur at ΔK and R values where K_{max} is larger than K_{Isc} . The combination of the effects of true corrosion fatigue and stress corrosion-fatigue may result in a “mixed corrosion/stress corrosion fatigue behavior” which is illustrated in Figure 2d. Further descriptions of these effects on crack propagation can be found elsewhere in the literature [27].

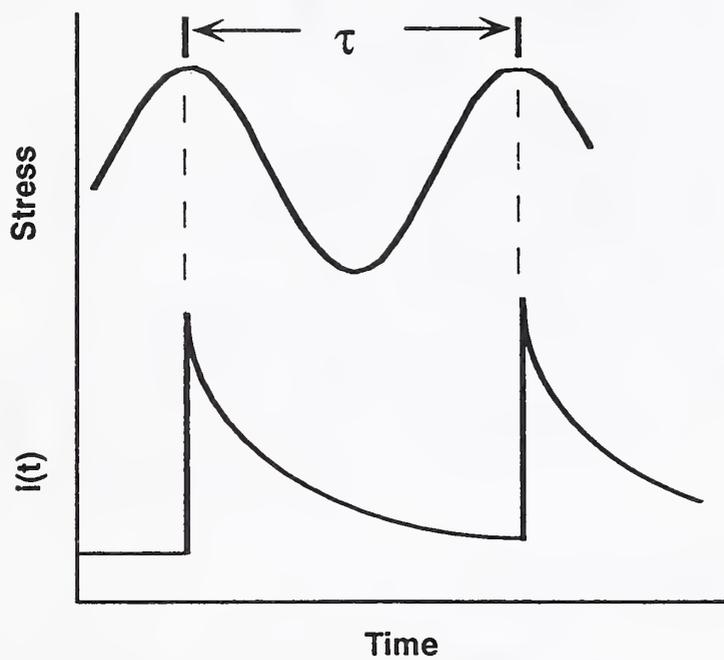
Figure 3. Schematic illustration showing the relationship between cyclic loading and passive film restoration current transients.

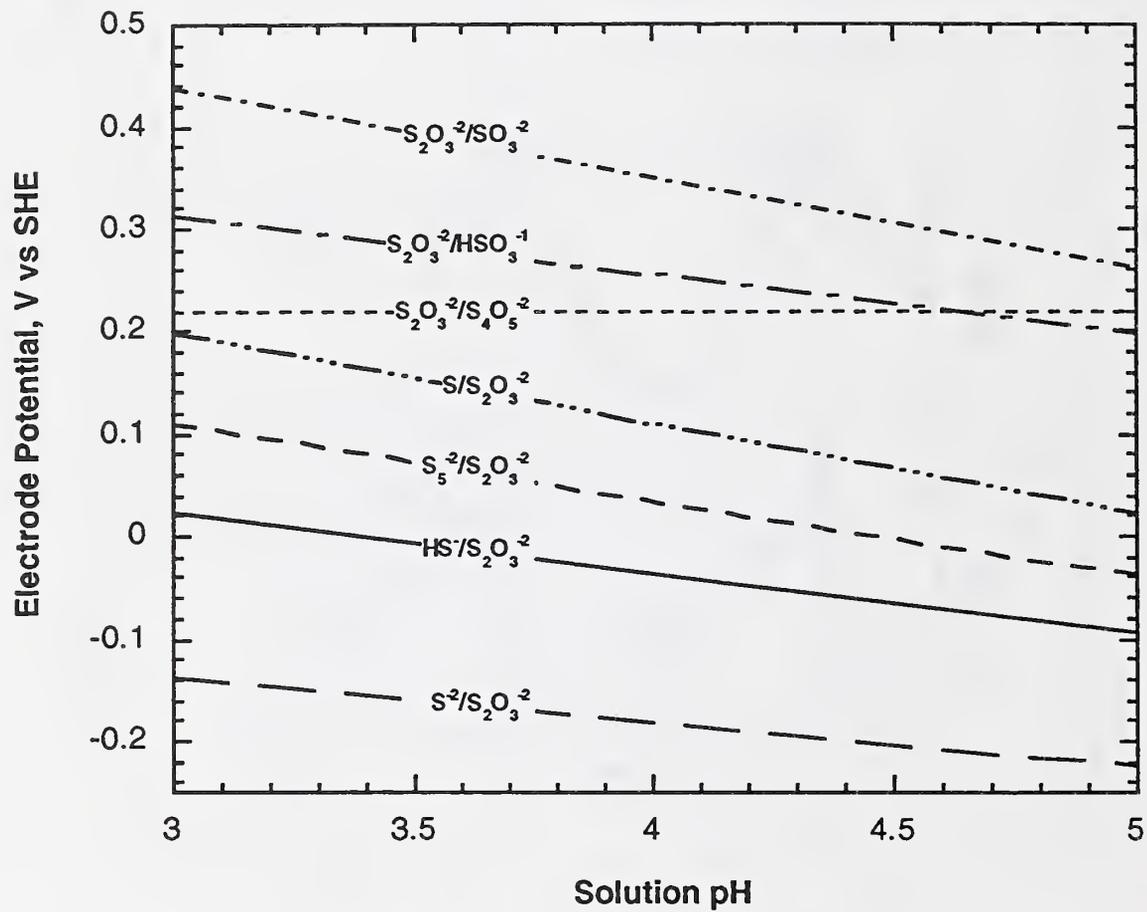
Figure 4. E-pH diagram showing the possible reactions with thiosulfate over the nominal white water solution pH range. (after Valensi, 1966)

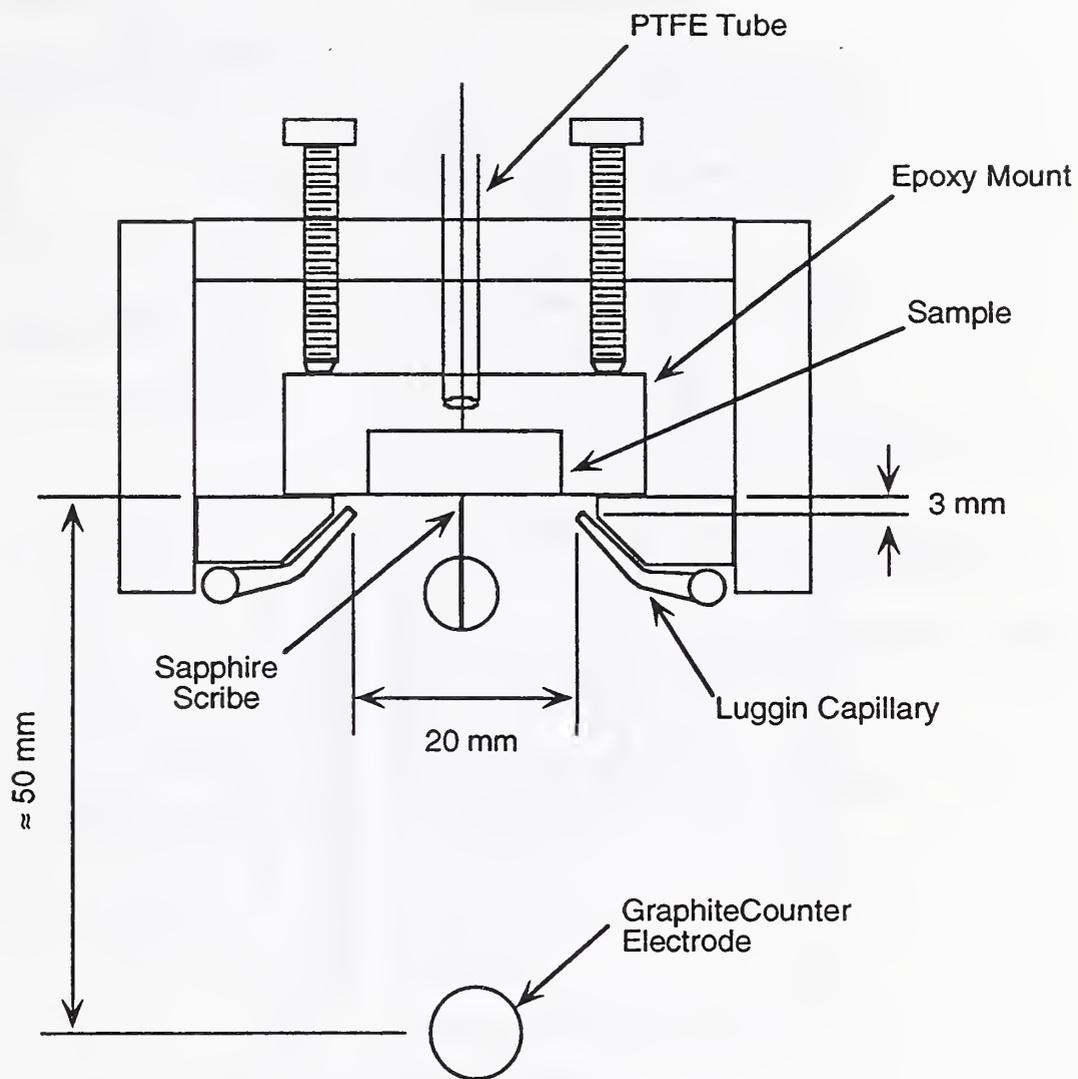
Figure 5. Schematic diagram of the scratch system sample holder illustrating the arrangement of the Luggin capillaries and counter electrode.

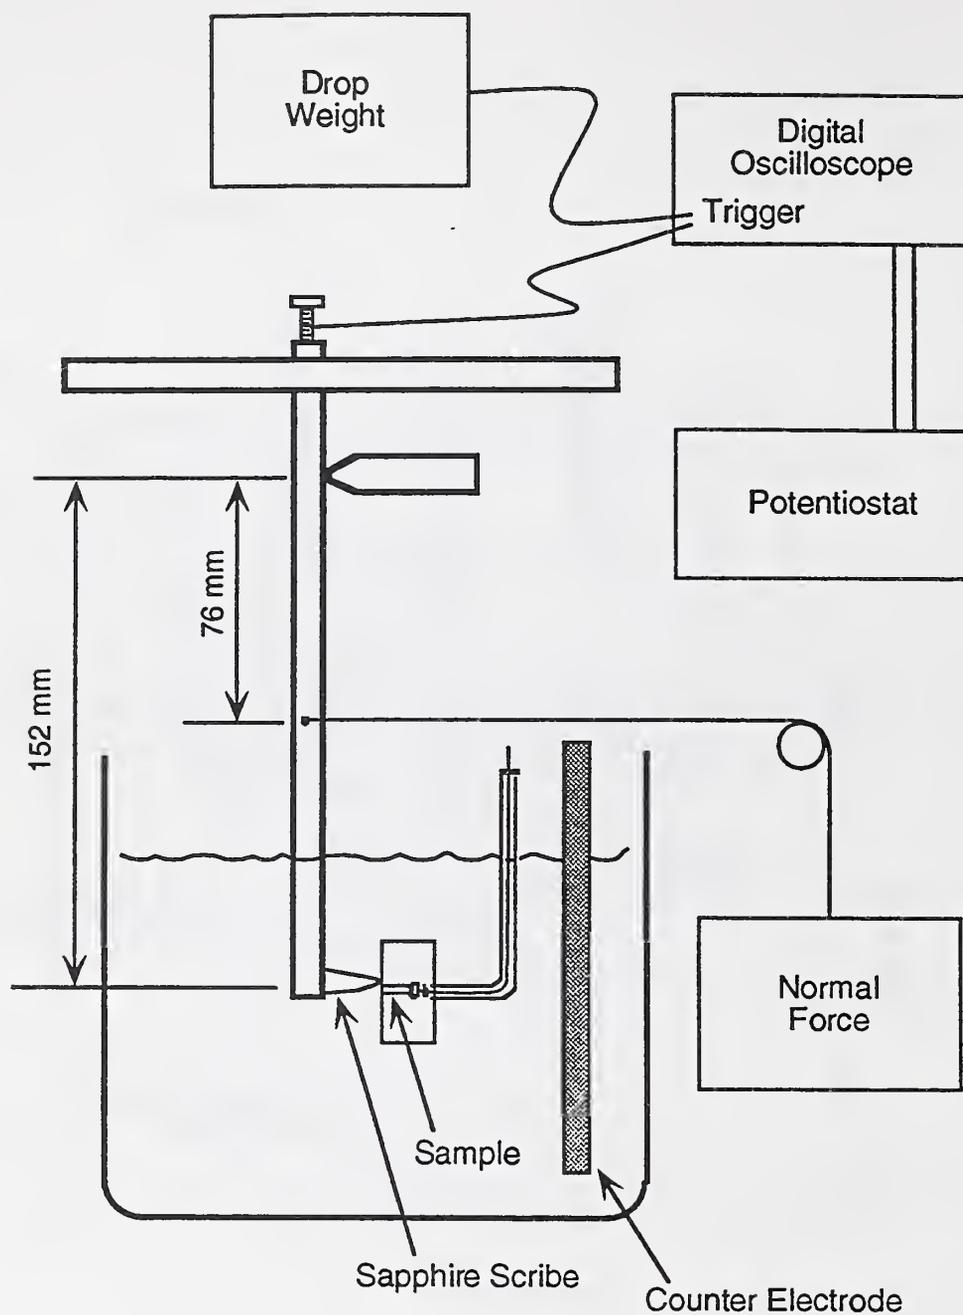
Figure 6. Schematic diagram of the apparatus used to generate the bare surface in the scratch-repassivation measurements.

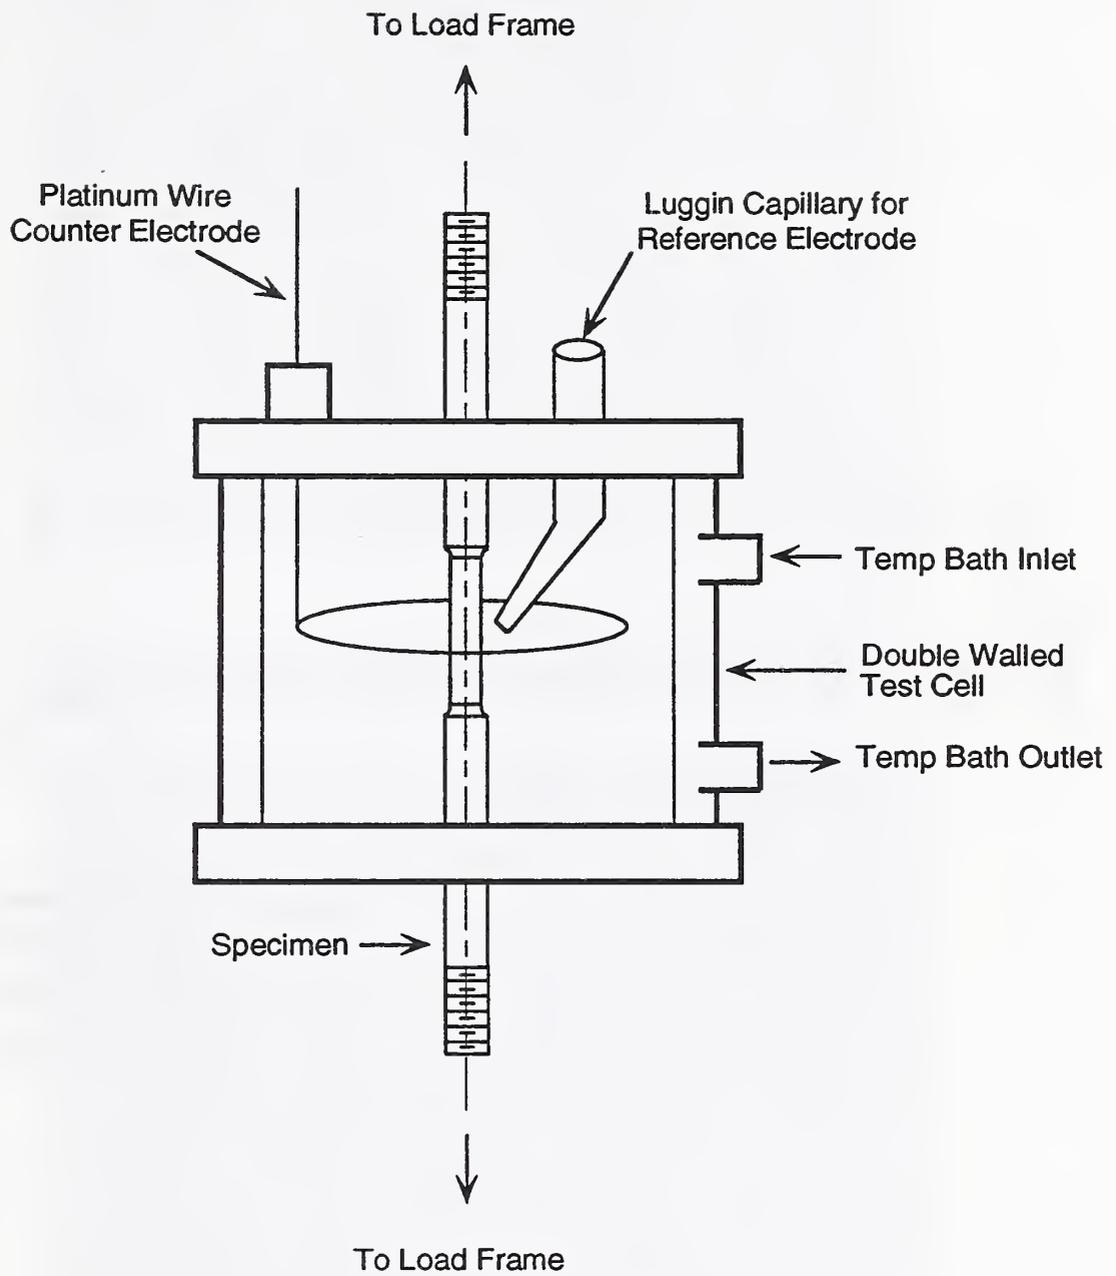
Figure 7. A schematic diagram of the electrochemical cell used in the slow strain rate tests.

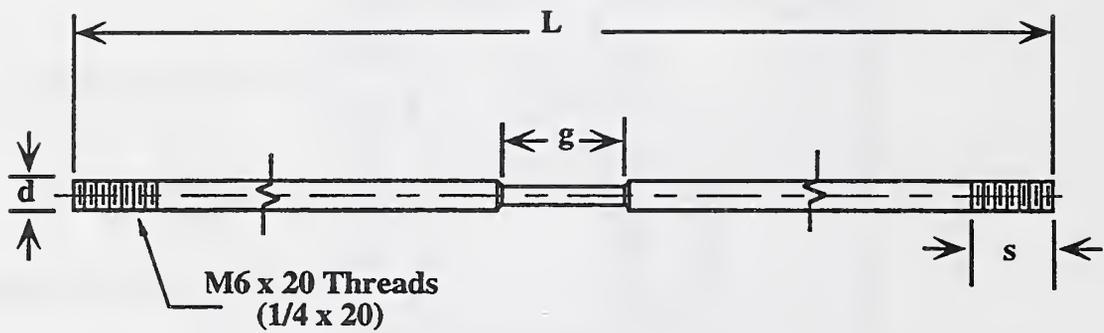
$d = 19 \text{ mm (0.25 in)}$
 $L = 178 \text{ mm (7.0 in)}$
 $g = 25.4 \text{ mm (1.0 in)}$
 $s = 19 \text{ mm (0.75 in)}$

Figure 8. Schematic diagram of the specimen geometry used for the slow strain rate tensile experiments.

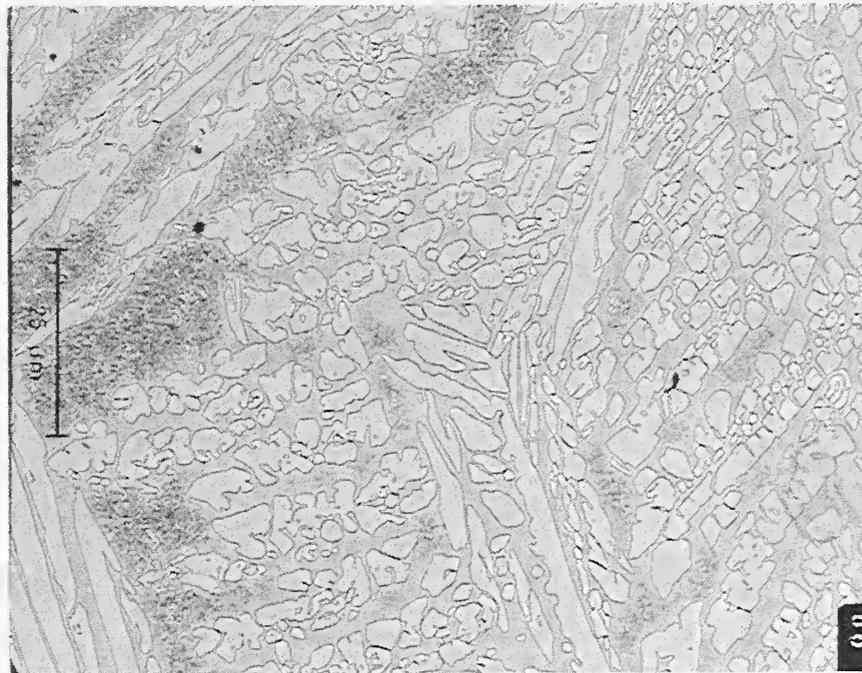
Figure 9b. Optical micrograph showing the duplex structure of Sandusky Alloy 86. (Viella's etch. Gray: Ferrite, White: Austenite)

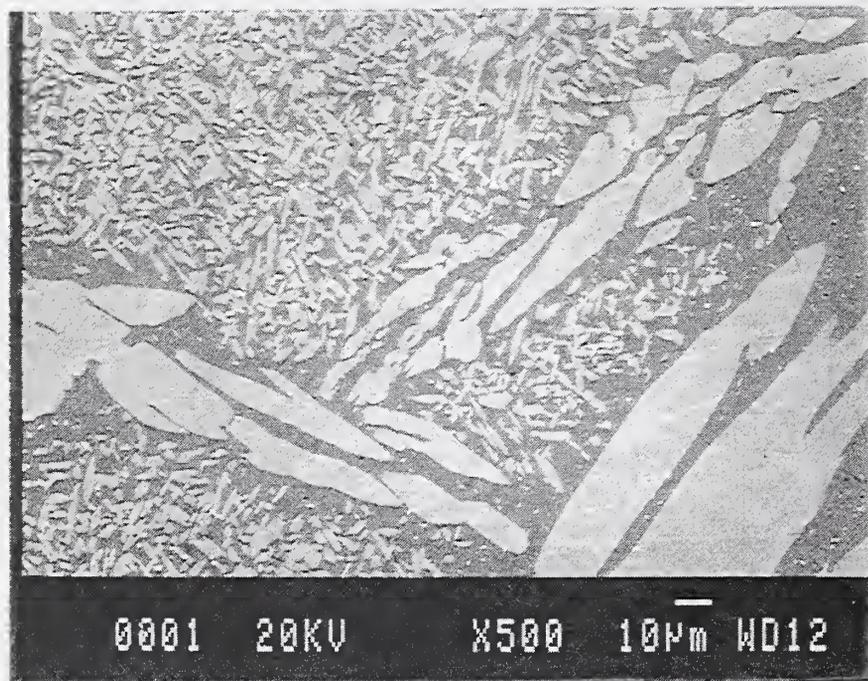
Figure 10. Back scattered scanning electron micrograph of Sandusky Alloy 86. (Dark Regions: Ferrite, Bright Regions: Austenite)

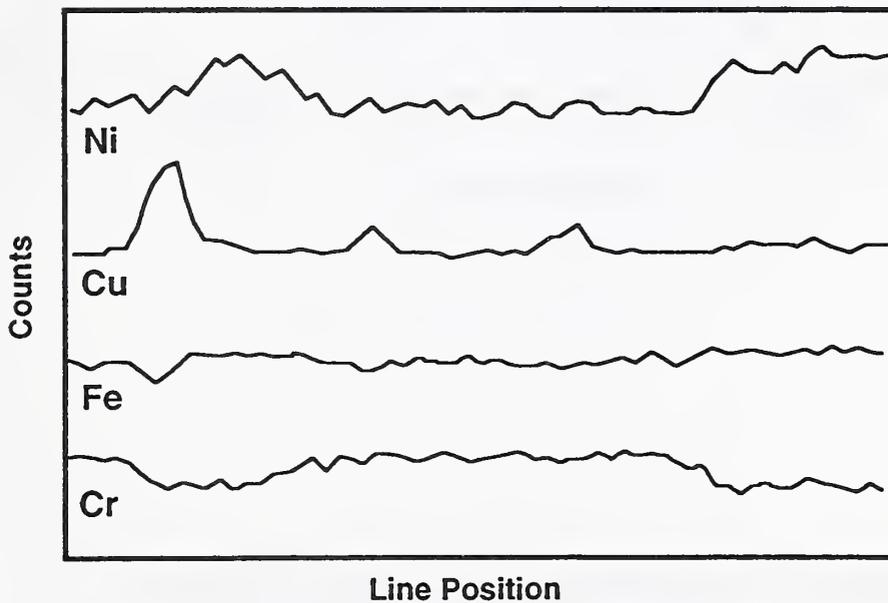
Figure 11b. 4 element EDS compositional profile for the scanned lineshown in Figure 11a. Note that Cu is only present in the bright regions (austenite).

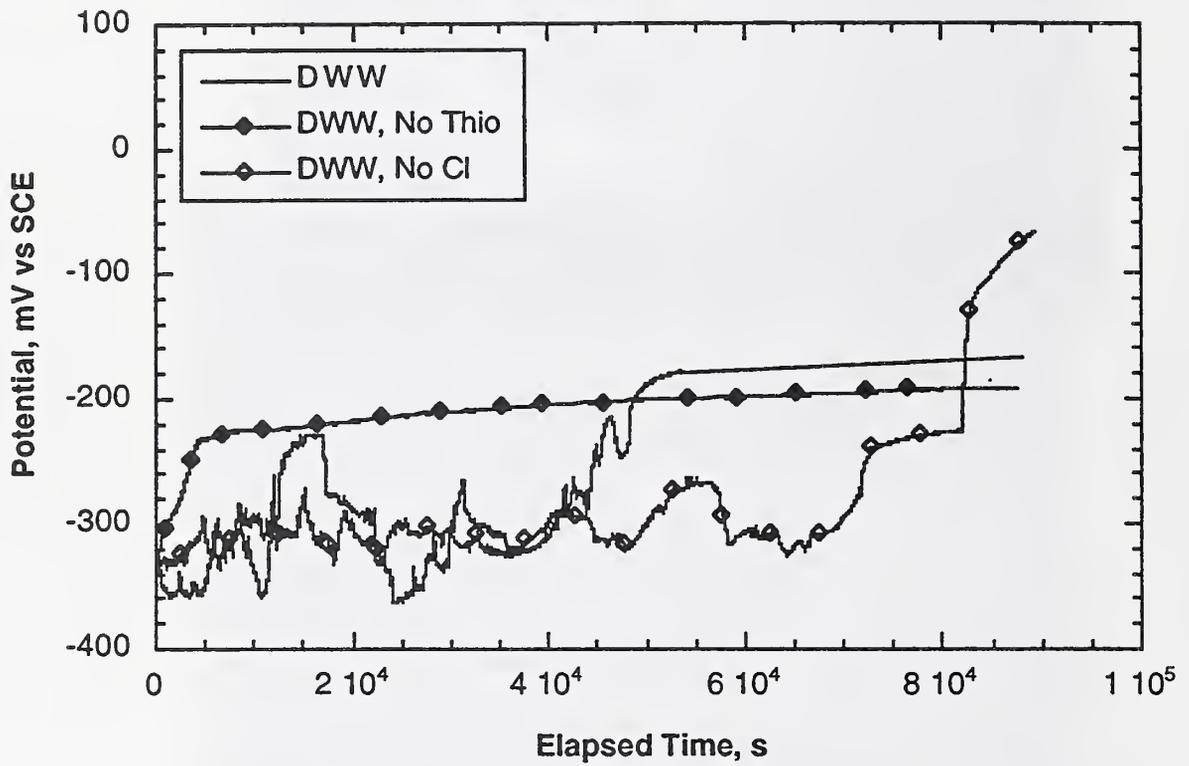
Figure 12. Free corrosion potential for Sandusky Alloy 75 in aerated, deinked simulated white water at 50 °C.

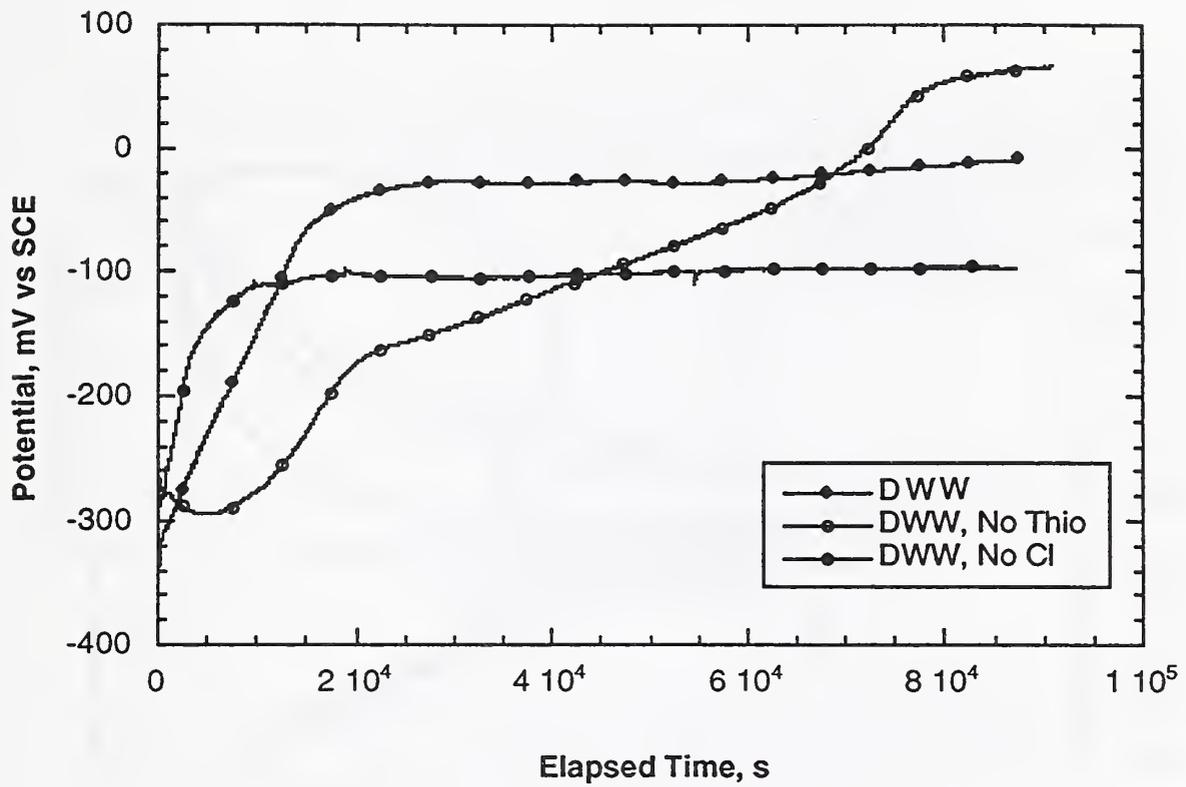
Figure 13. Free corrosion potential for Sandusky Alloy 86 in aerated, deinked simulated white water at 50 °C.

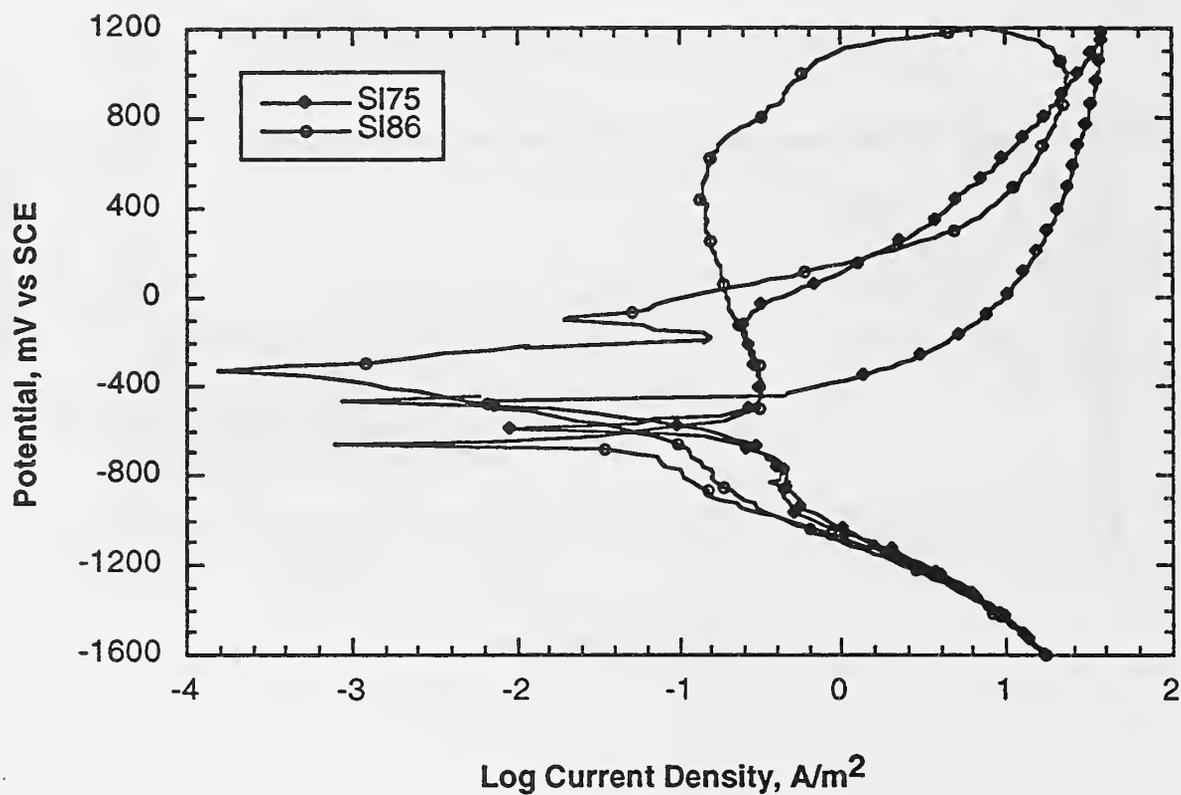
Figure 14. Comparison of the electrochemical behavior of the two Sandusky alloys in deaerated, deionized white water at 50 °C with a 5 mV/s sweep rate.

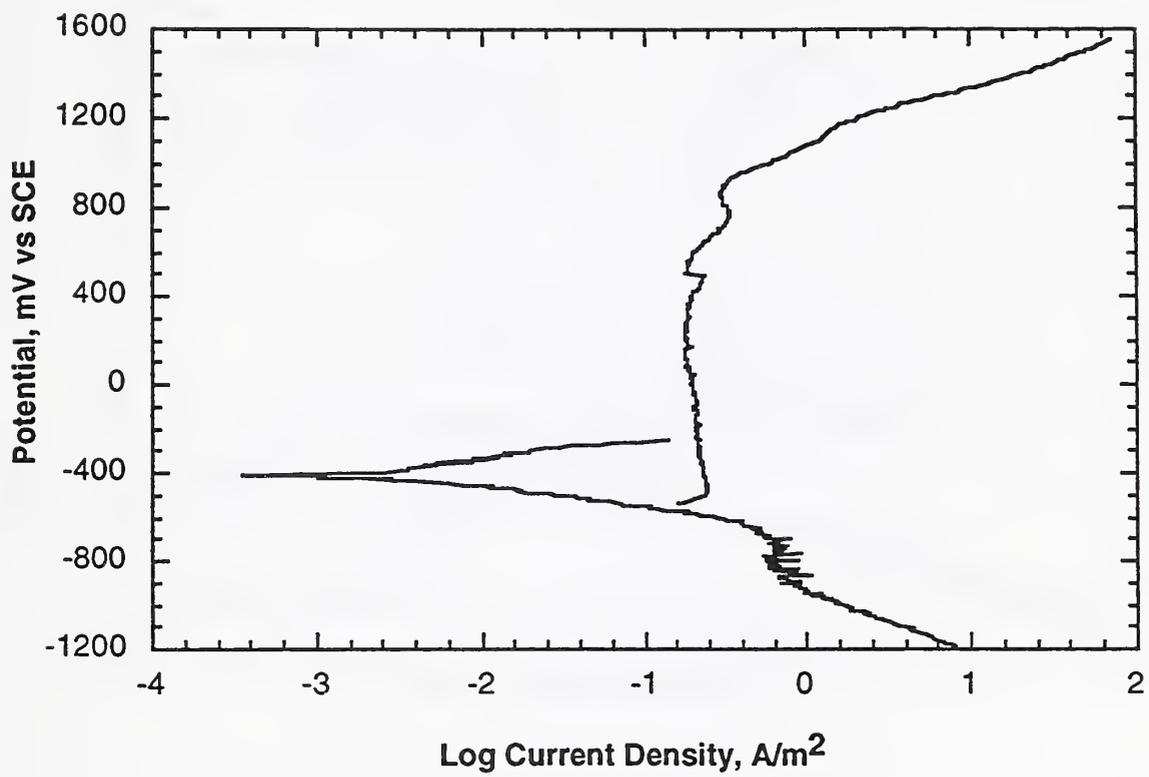
Figure 15. Composite Sweep for Sandusky Alloy 75 in deaerated, deionized white water at 50 °C with a 1 mV/s sweep rate.

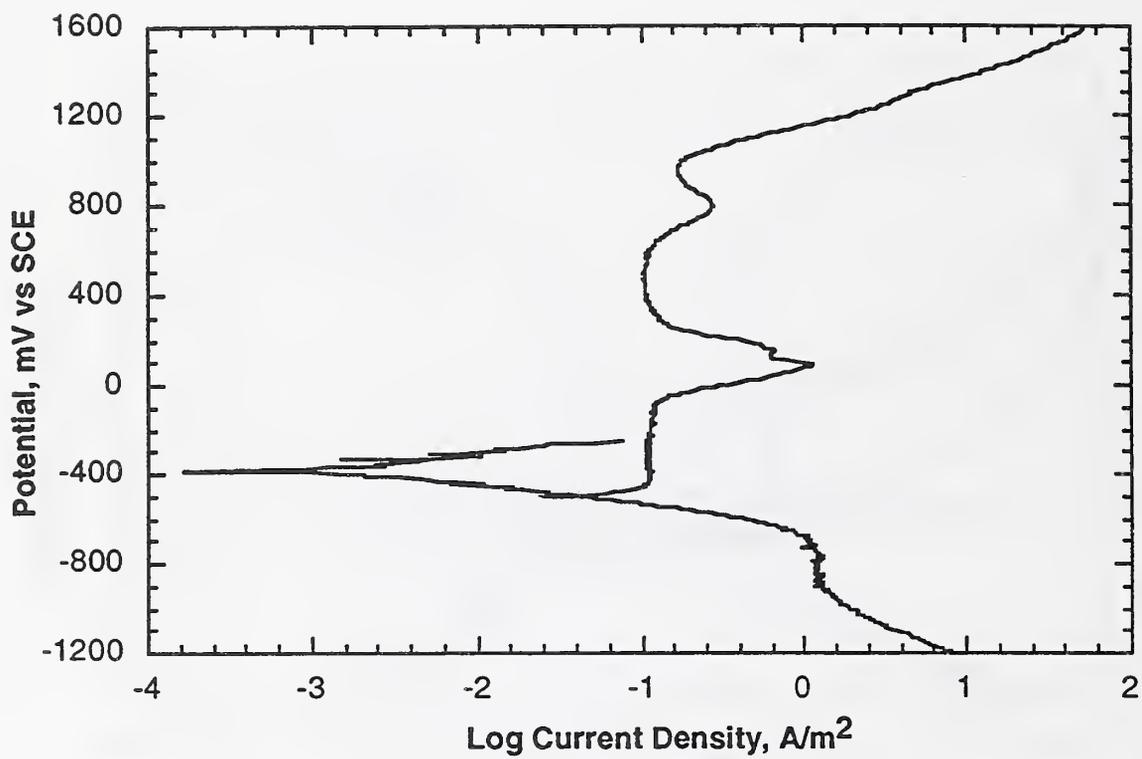
Figure 16. Composite Sweep for Sandusky Alloy 86 in deaerated, deionized white water at 50 °C with a 1 mV/s sweep rate.

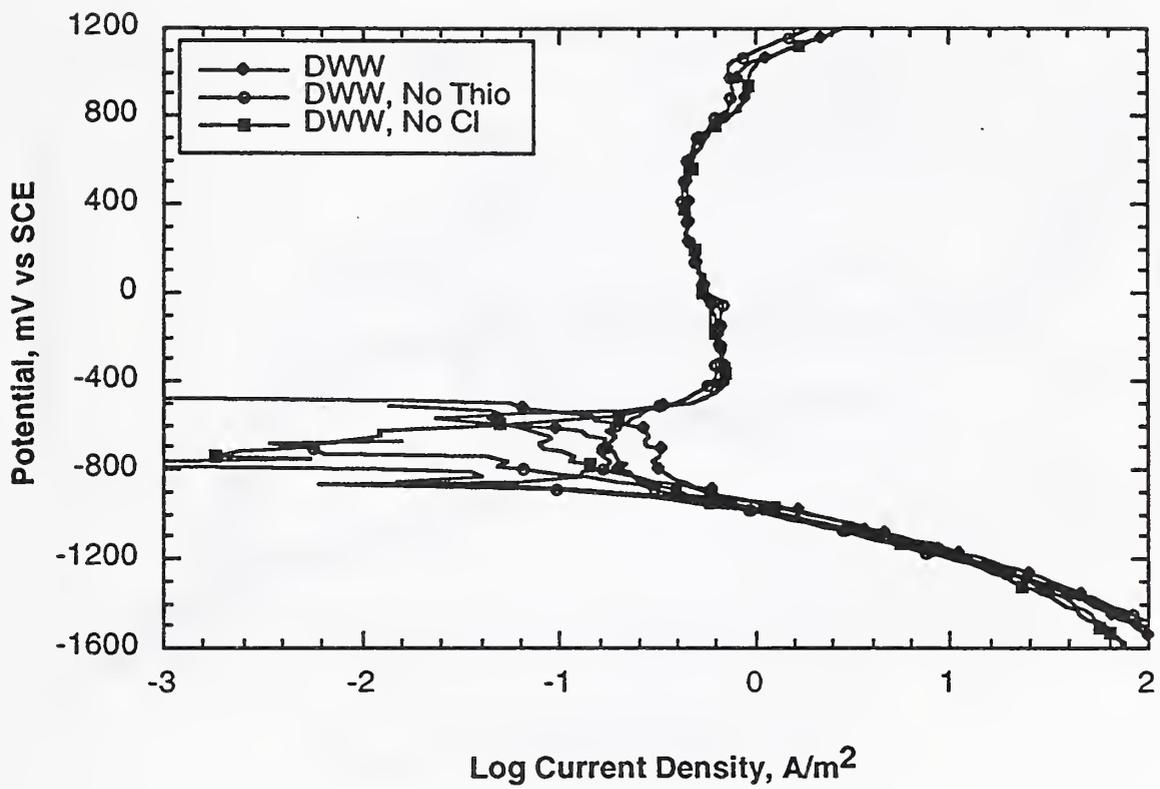
Figure 17. Comparison of the behaviors of Sandusky Alloy 75 in deinked white water solutions at 50 °C with and without thiosulfate and chloride ions. Sweep rate: 5mV/s

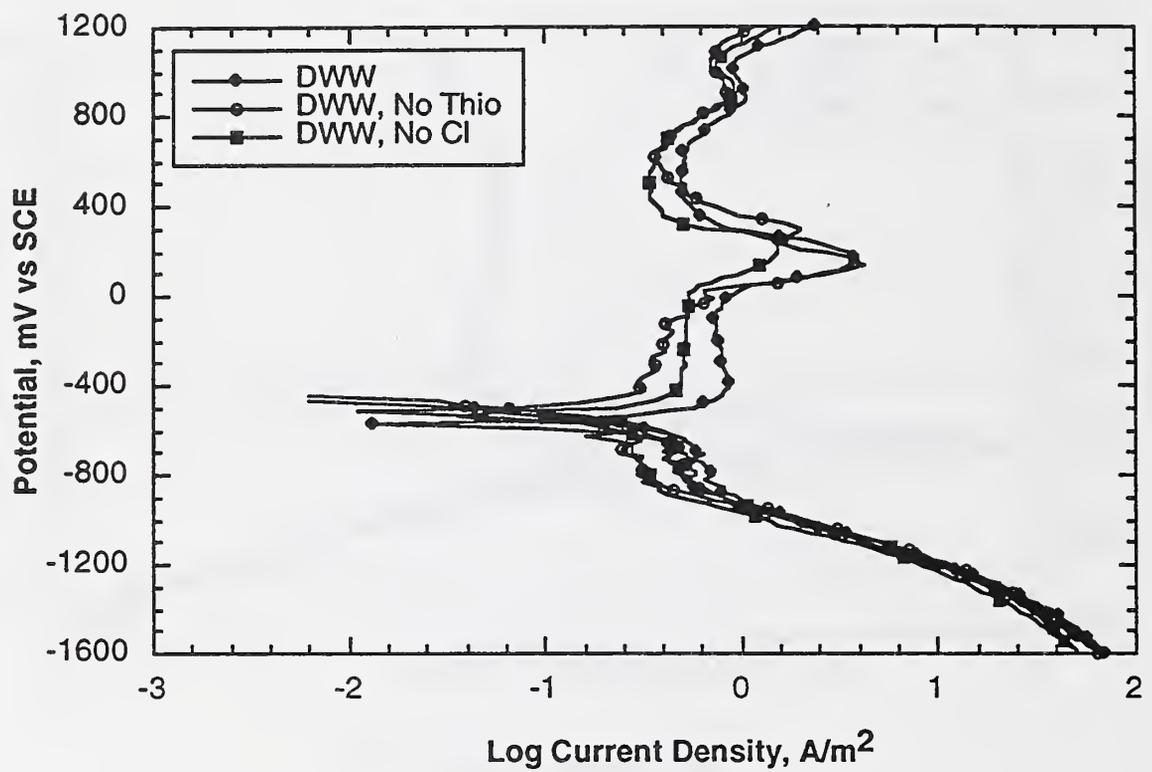
Figure 18. Comparison of the behaviors of Sandusky Alloy 86 in deinked white water solutions at 50 °C with and without thiosulfate and chloride ions. Sweep rate: 5mV/s

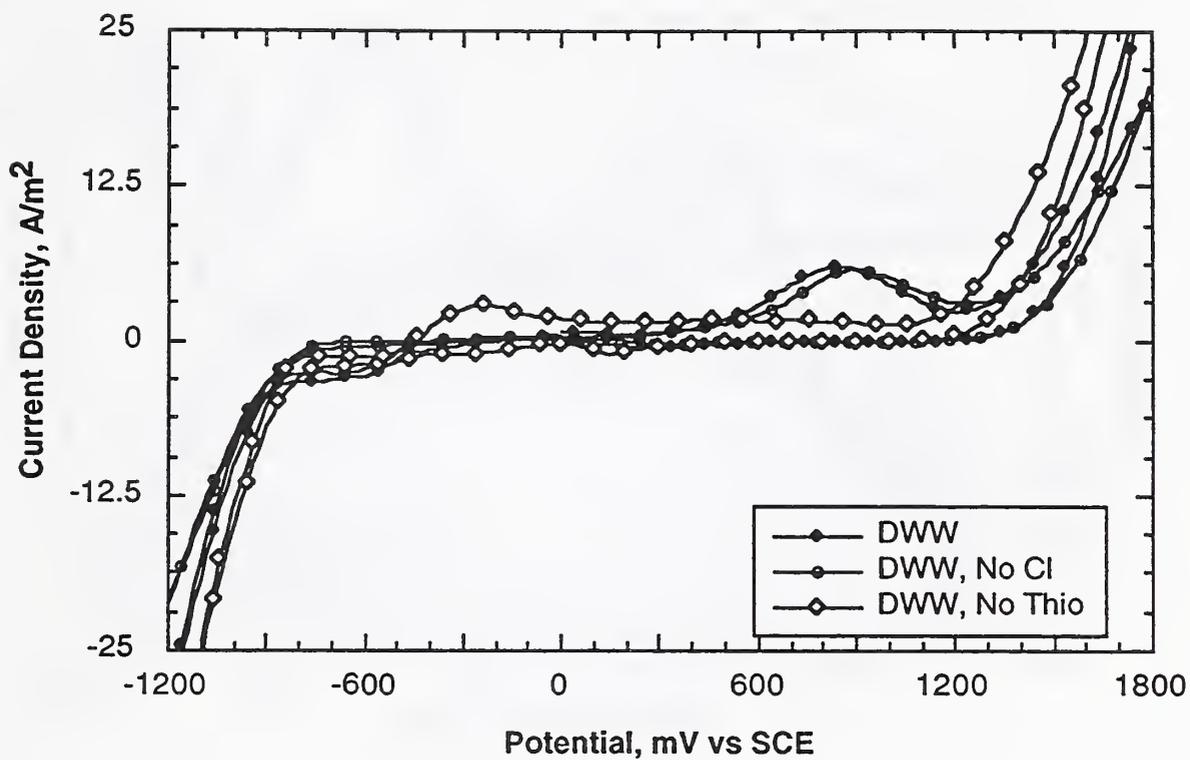
Figure 19. Cyclic voltammogram for platinum in deaerated, deionized white water at 50 °C with and without chloride and thiosulfate ions. Sweep rate: 20 mV/s

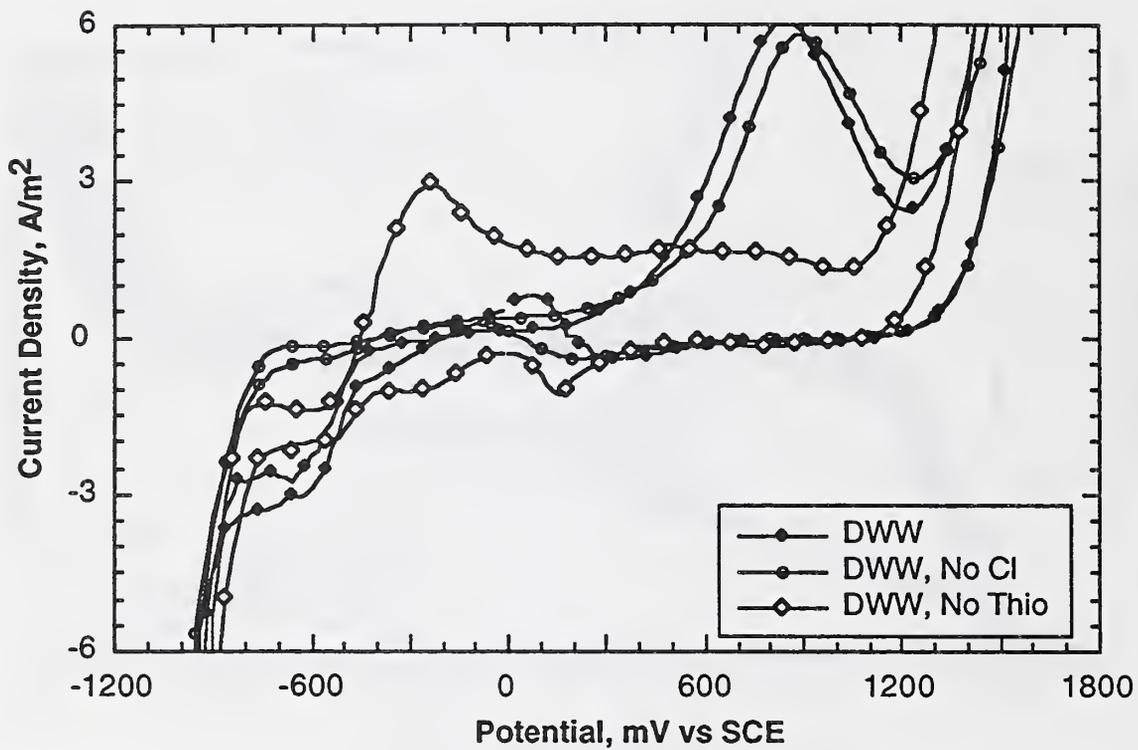
Figure 20. Cyclic voltammogram shown over a smaller current range for platinum in deaerated, deionized white water at 50 °C with and without chloride and thiosulfate ions. Sweep rate: 20 mV/s

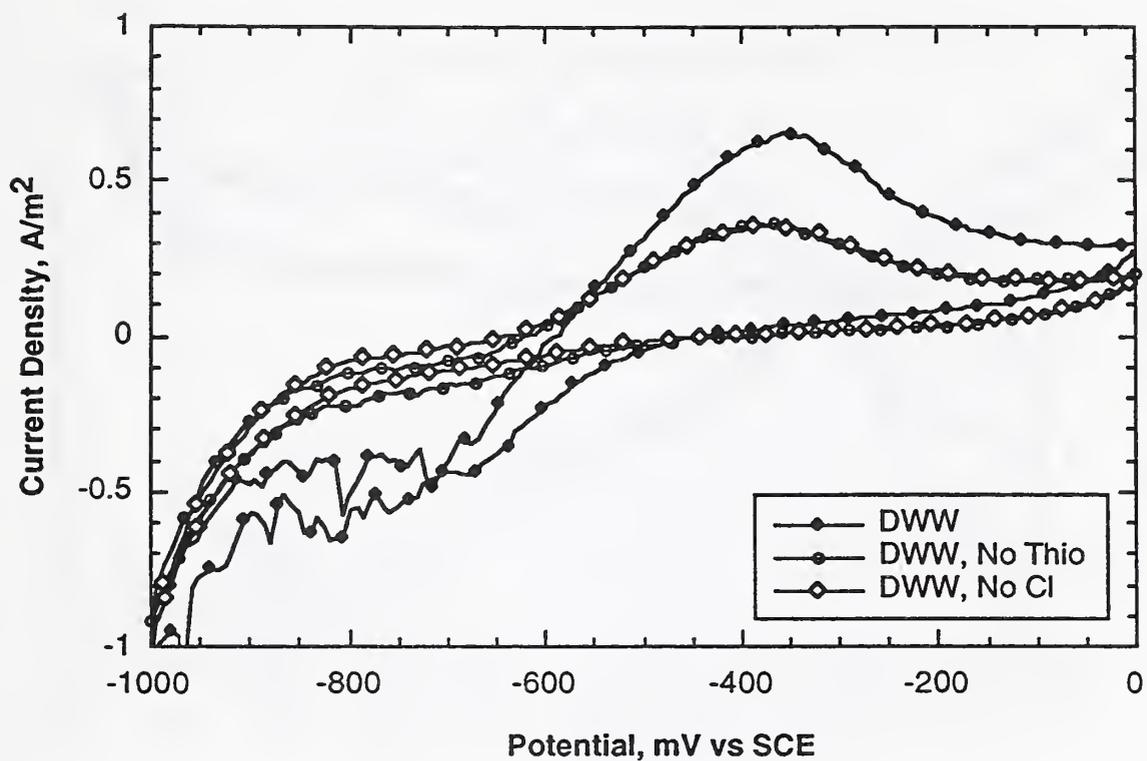
Figure 21. Cyclic voltammogram for Sandusky Alloy 75 in deaerated, deinked white water at 50 °C with and without chloride and thiosulfate ions. Sweep rate: 20 mV/s

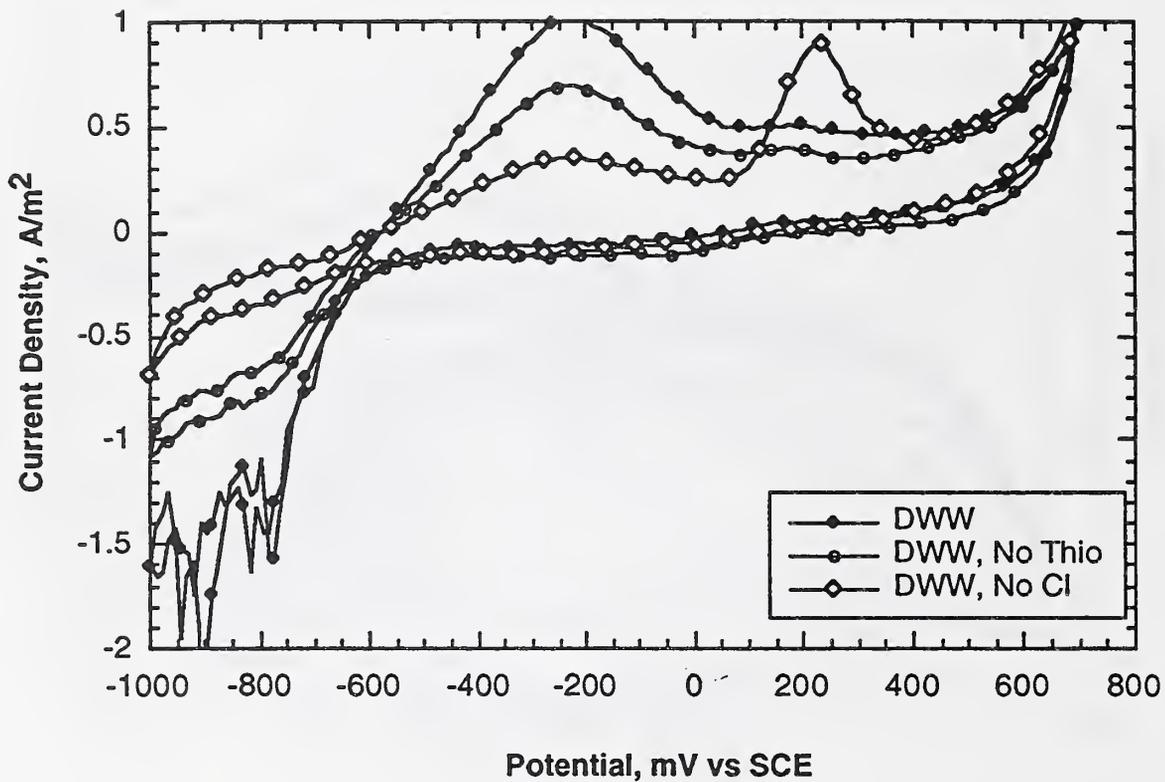
Figure 22. Cyclic voltammogram for Sandusky Alloy 86 in deaerated, deionized white water at 50 °C with and without chloride and thiosulfate ions. Sweep rate: 20 mV/s

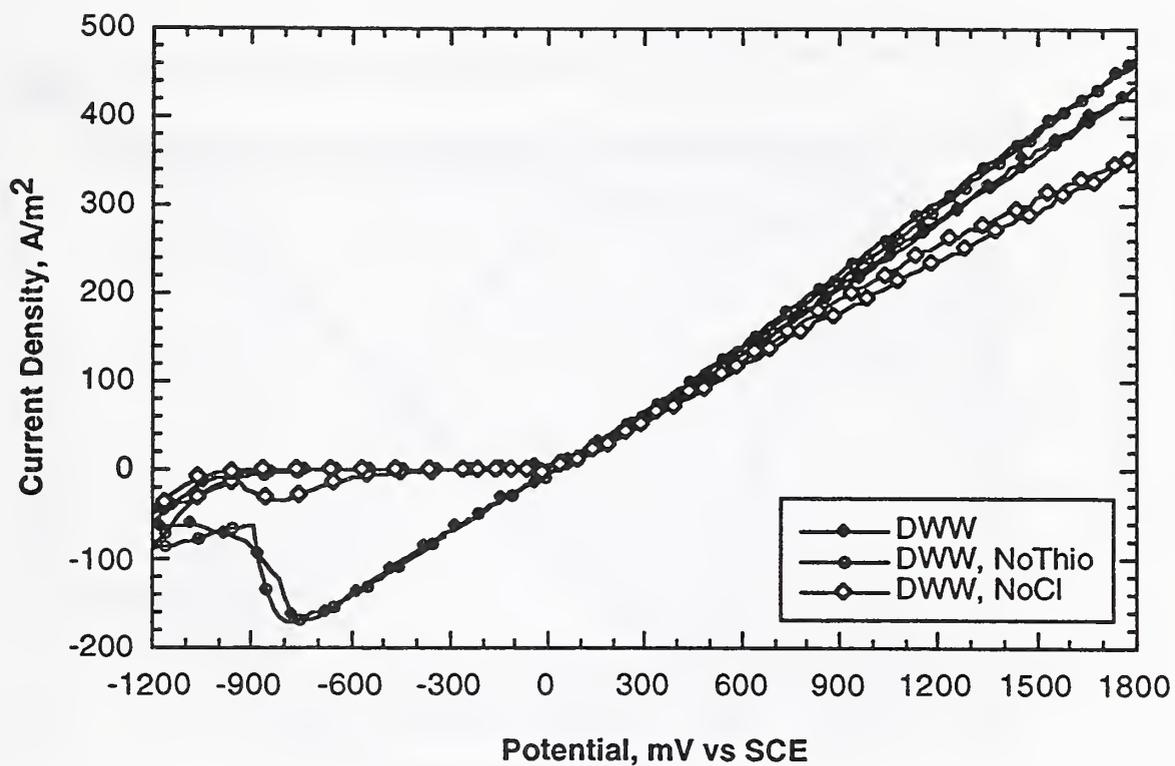
Figure 23. Cyclic voltammogram for pure copper in deaerated, deionized white water at 50 °C with and without chloride and thiosulfate ions. Sweep rate: 20 mV/s

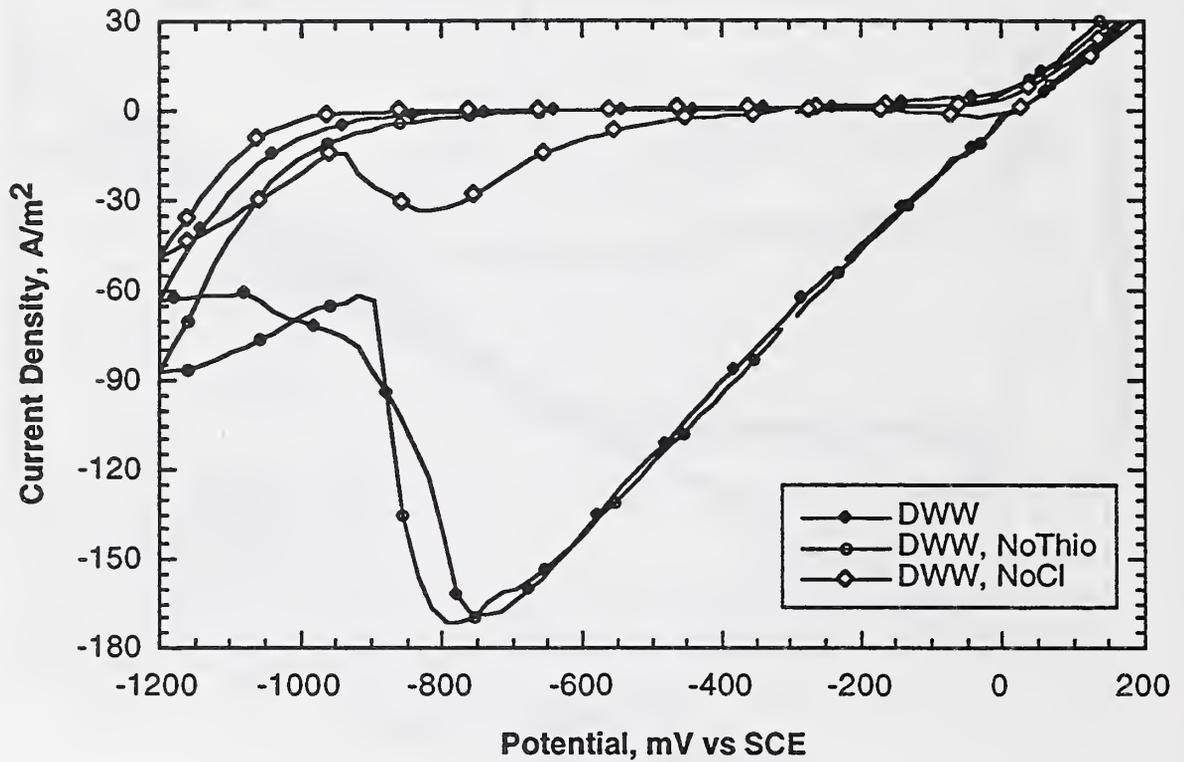
Figure 24. Cyclic voltammogram shown over a smaller current range for pure copper in deaerated, deionized white water at 50 °C with and without chloride and thiosulfate ions. Sweep rate: 20 mV/s
