Corrosion Fatigue Crack Initiation in Duplex Stainless Steel Paper Making Components

Final Report for:
NIST CRADA CN-1237

Prepared for:
John C. Rogers, Technical Director
Sandusky International, Inc.
615 West Market Street
P.O. Box 5012
Sandusky, OH 44871-5012

March 1999

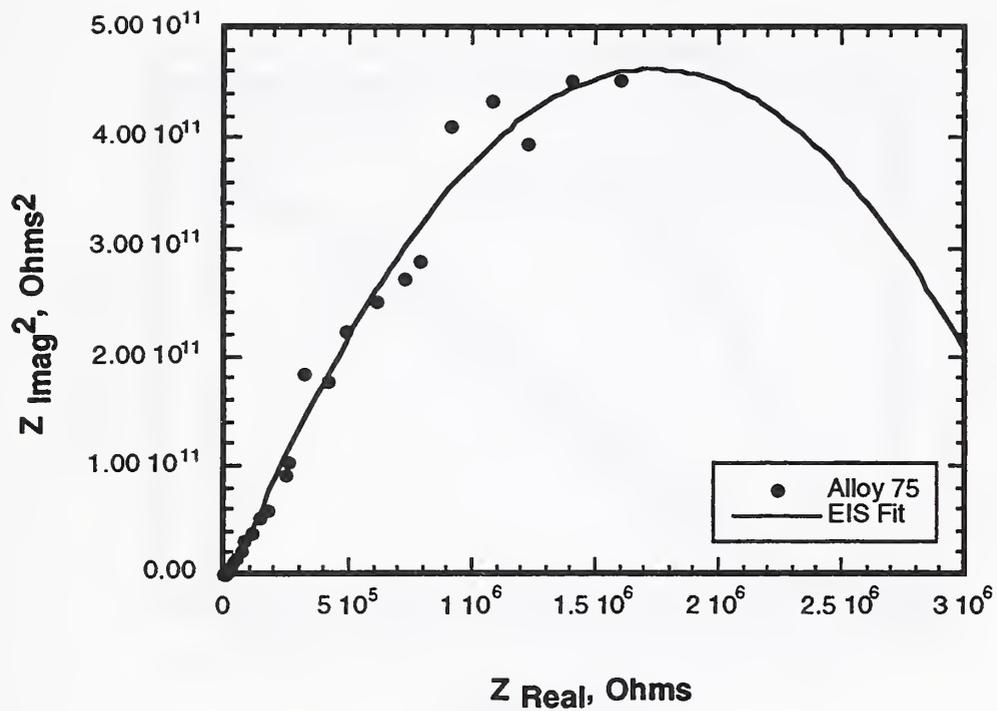
Figure 25. Electrochemical impedance spectrograph in Nyquist format for Sandusky Alloy 75 in deaerated, deinked white water at 50 °C showing the relationship between the actual data and a predictive model used to estimate the corrosion rate.

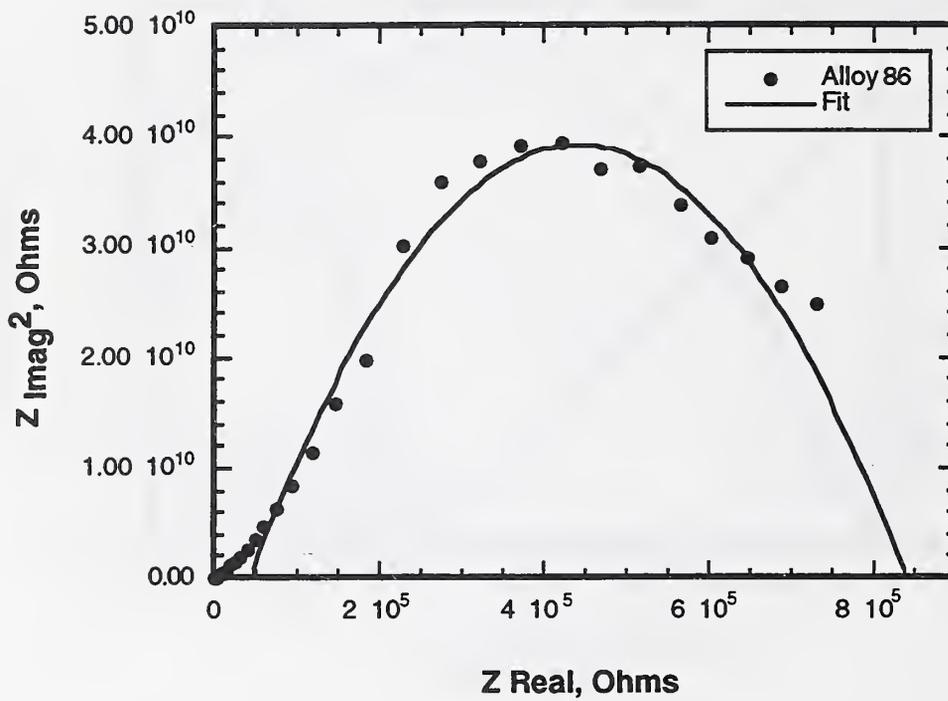
Figure 26. Electrochemical impedance spectrograph in Nyquist format for Sandusky Alloy 86 in deaerated, deionized white water at 50 °C showing the relationship between the actual data and a predictive model used to estimate the corrosion rate.

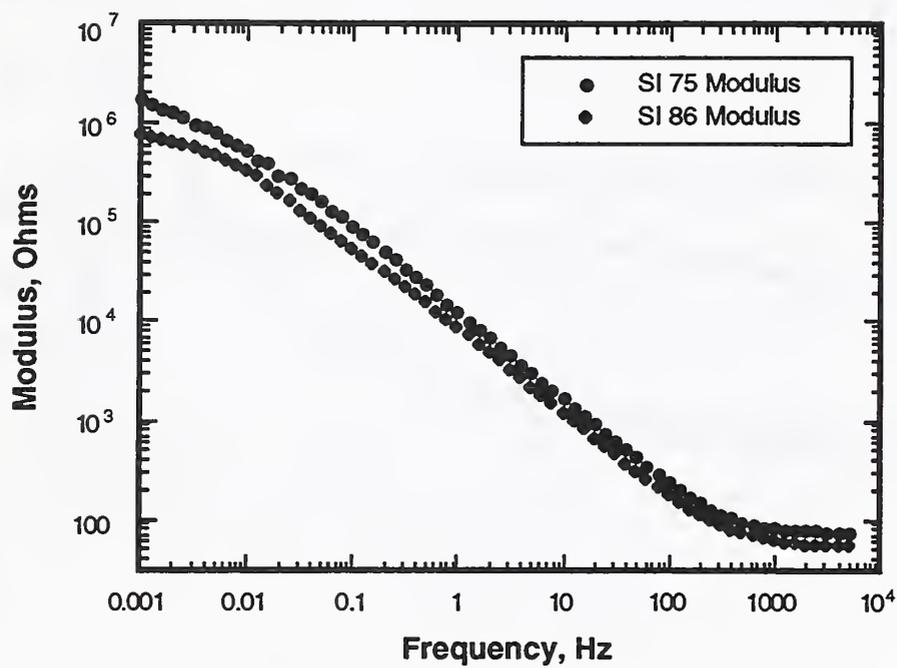
Figure 27. Electrochemical impedance spectrograph in Bode format comparing the corrosion behaviors of the two Sandusky duplex alloys in deaerated, deionized white water at 50 °C.

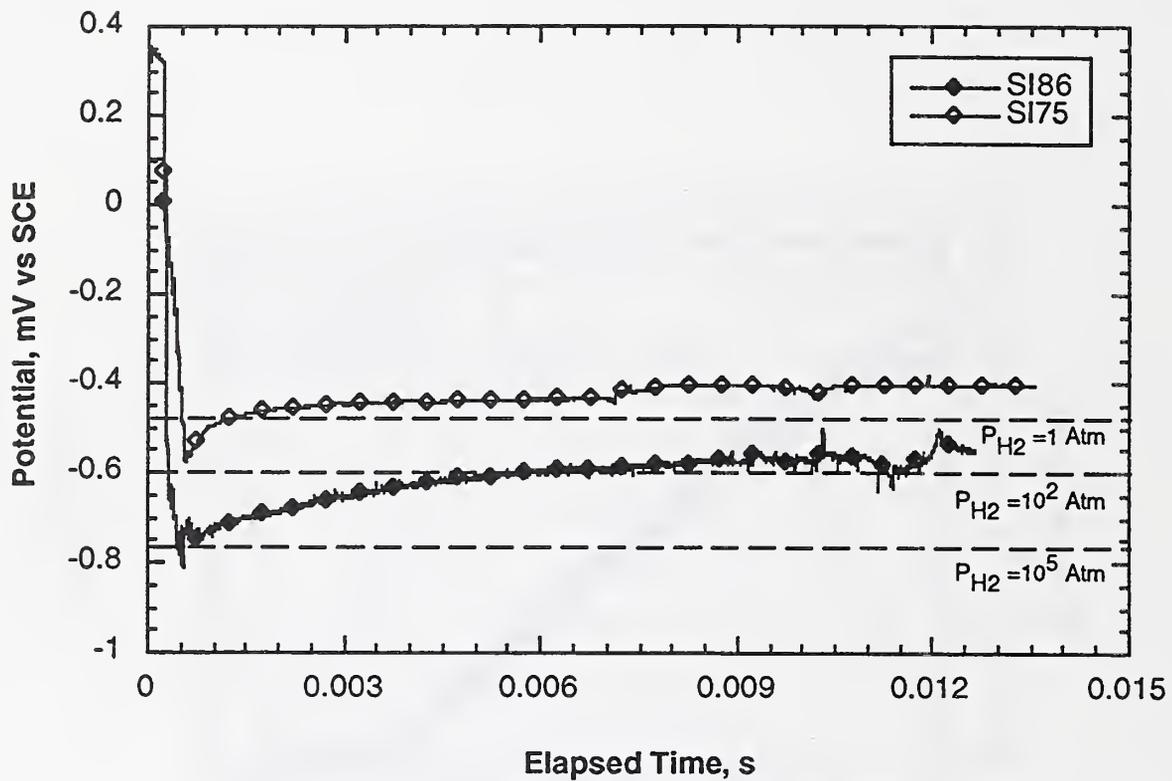
Figure 28. Scratch repassivation behavior of the two Sandusky Alloys under free corrosion conditions in aerated, deinked white water at 50 °C

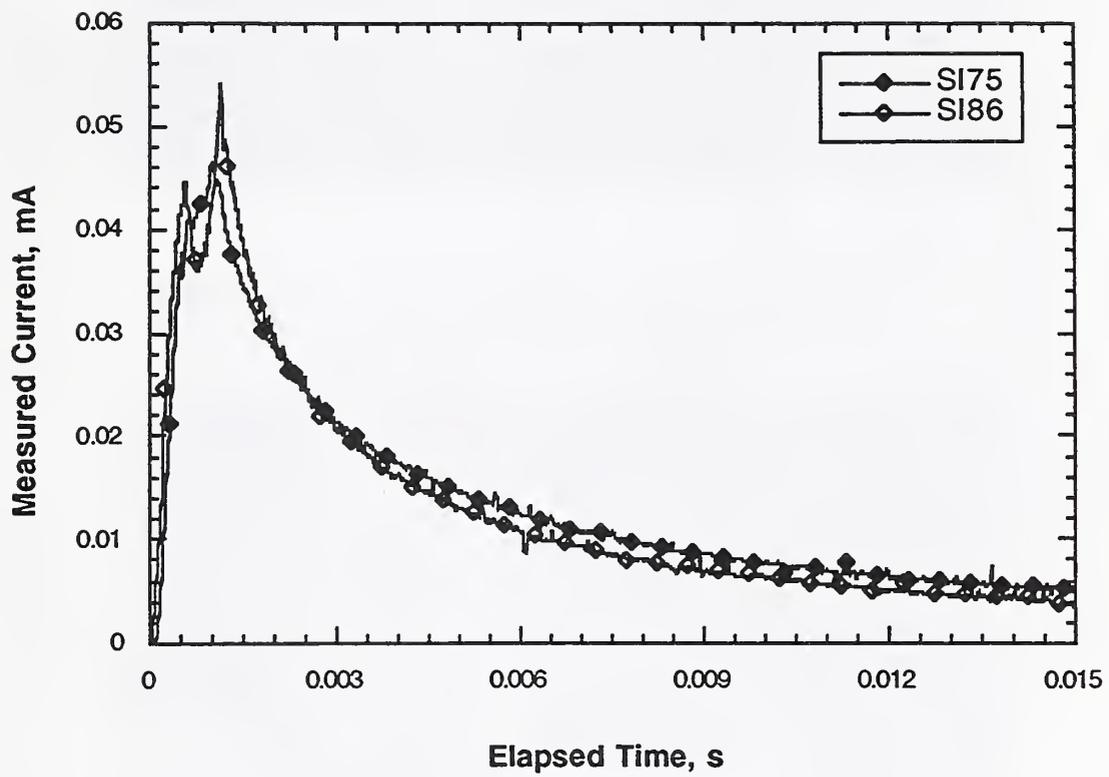
Figure 29. Scratch repassivation transients for the two Sandusky alloys in aerated deinked white water at 50 °C under a controlled potential of $-0.300V_{sce}$.

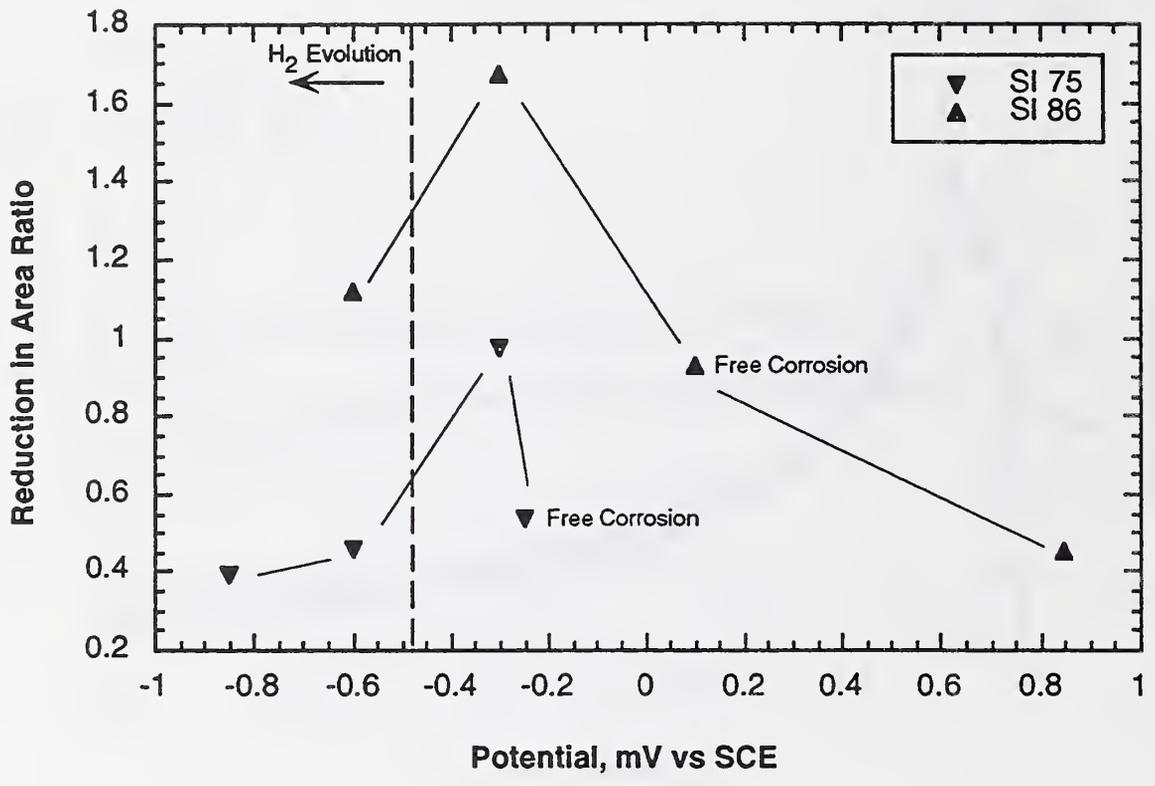
Figure 30. Plot of the reduction in area results of SSR experiments conducted in aerated deinked white water at 50 °C, ratioed to the nitrogen values, versus the electrode potential.

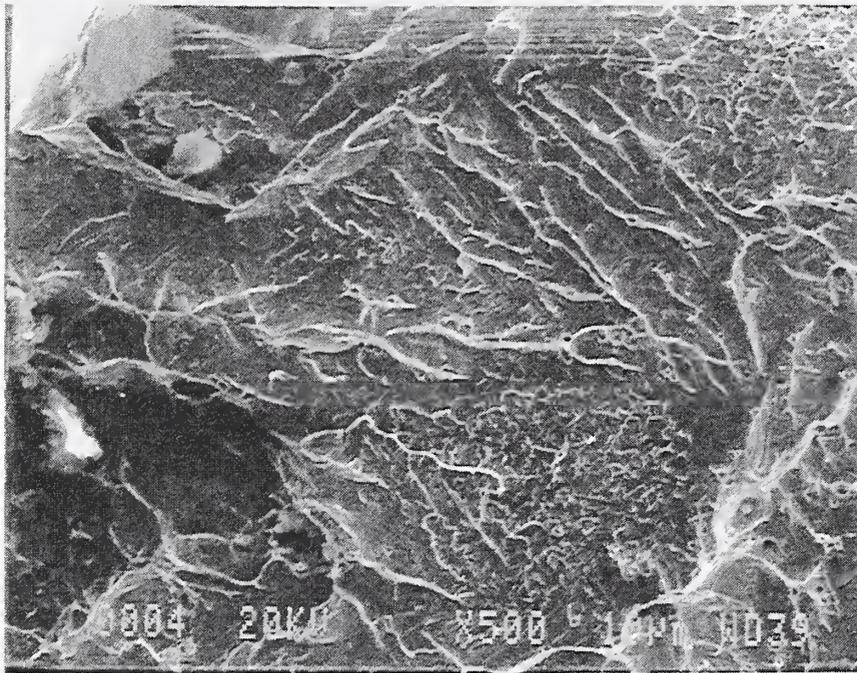
Figure 31a. Scanning electron micrograph showing the SSR fracture behavior of Sandusky Alloy 75 in Nitrogen at 50 °C.

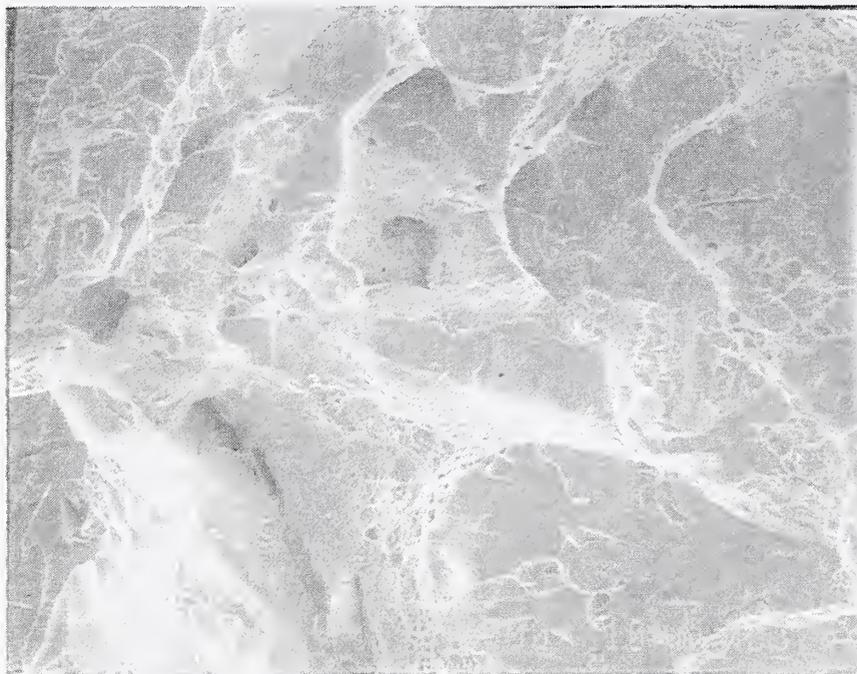
Figure 31b Scanning electron micrograph showing the SSR fracture behavior of Sandusky Alloy 86 in Nitrogen at 50 °C.

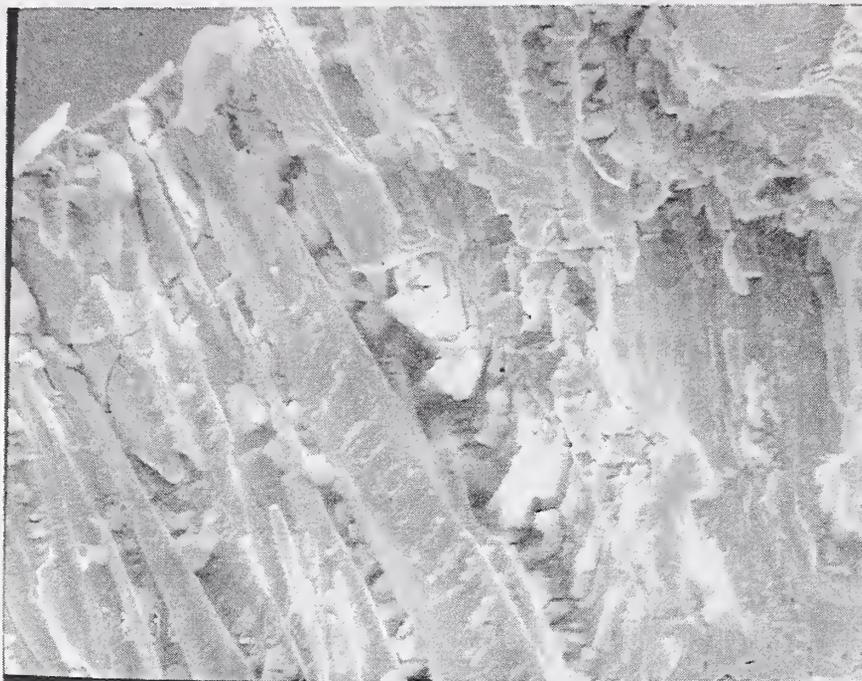
Figure 32a. Scanning electron micrograph showing the SSR fracture behavior of Sandusky Alloy 75 under free corrosion conditions in aerated, deinked white water at 50 °C.

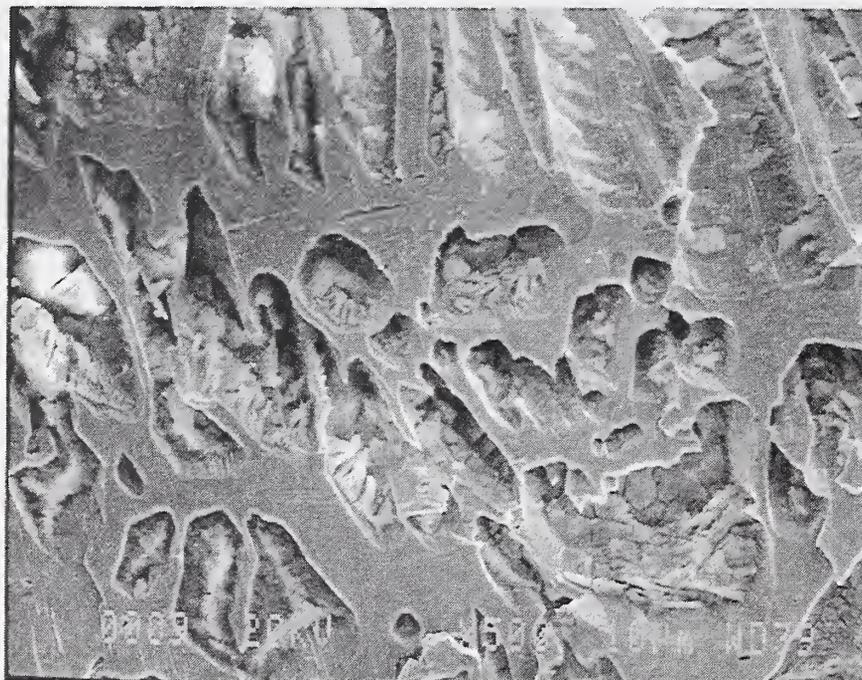
Figure 32b. Scanning electron micrograph showing the preferential attack in the austenite phase of the Sandusky Alloy 75 SSR specimen tested under free corrosion conditions in the deinked white water solution at 50 °C.

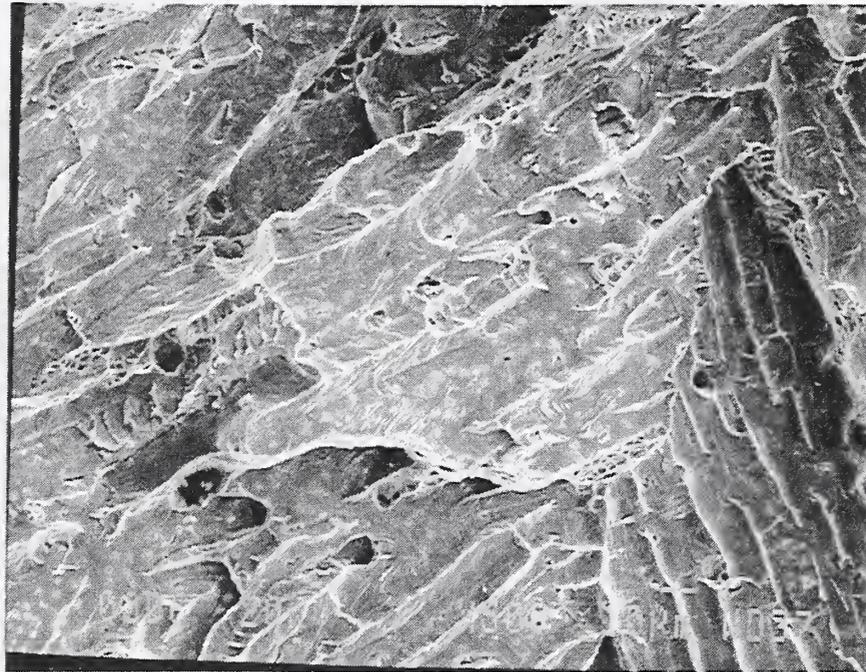
Figure 33. Representative scanning electron micrograph showing the SSR fracture behavior of Sandusky Alloy 86 under a controlled electrode potential of $-0.300 \text{ V}_{\text{sce}}$ in aerated deionized white water at $50 \text{ }^\circ\text{C}$.

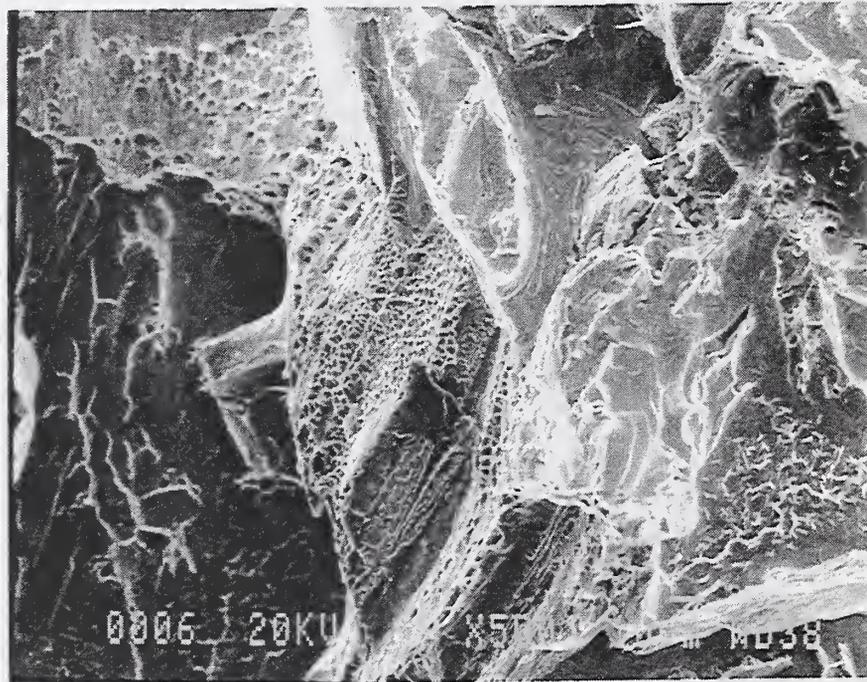
Figure 34. Representative scanning electron micrograph showing the SSR fracture behavior of Sandusky Alloy 75 under cathodic protection conditions at an electrode potential of $-0.600 \text{ V}_{\text{sce}}$ in aerated deinked white water at $50 \text{ }^\circ\text{C}$.

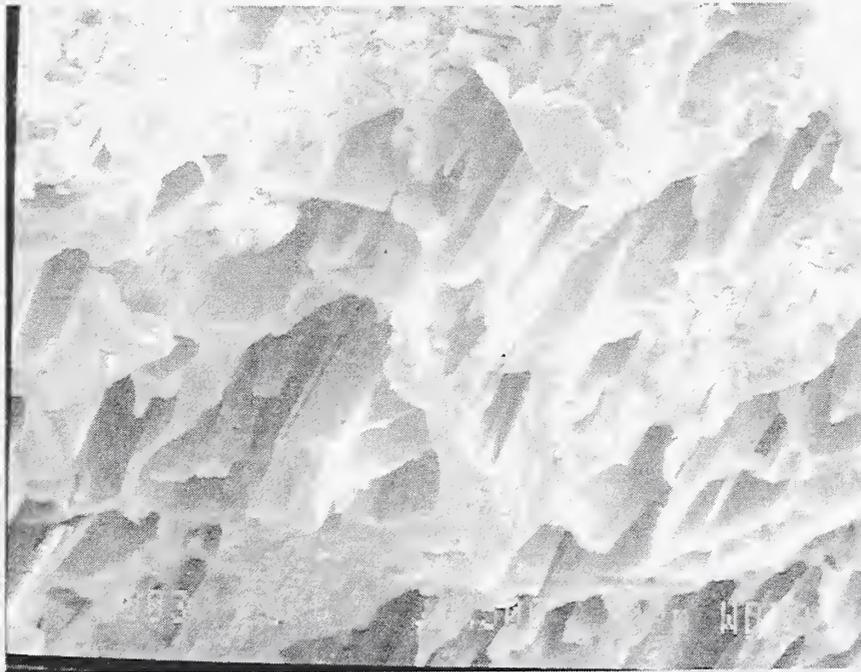
Figure 35a. Scanning electron micrograph showing the SSR fracture behavior of Sandusky Alloy 86 near the pitting potential in aerated, deinked white water at 50 °C.

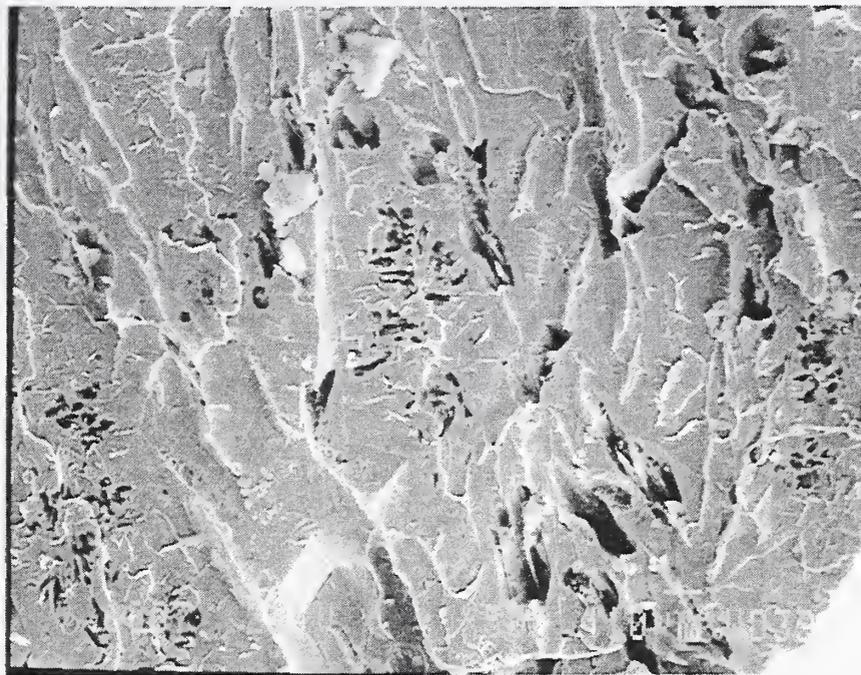
Figure 35b. Scanning electron micrograph showing the preferential attack in the austenite phase of the Sandusky Alloy 86 SSR specimen tested near the pitting potential in the deinked white water solution at 50 °C.

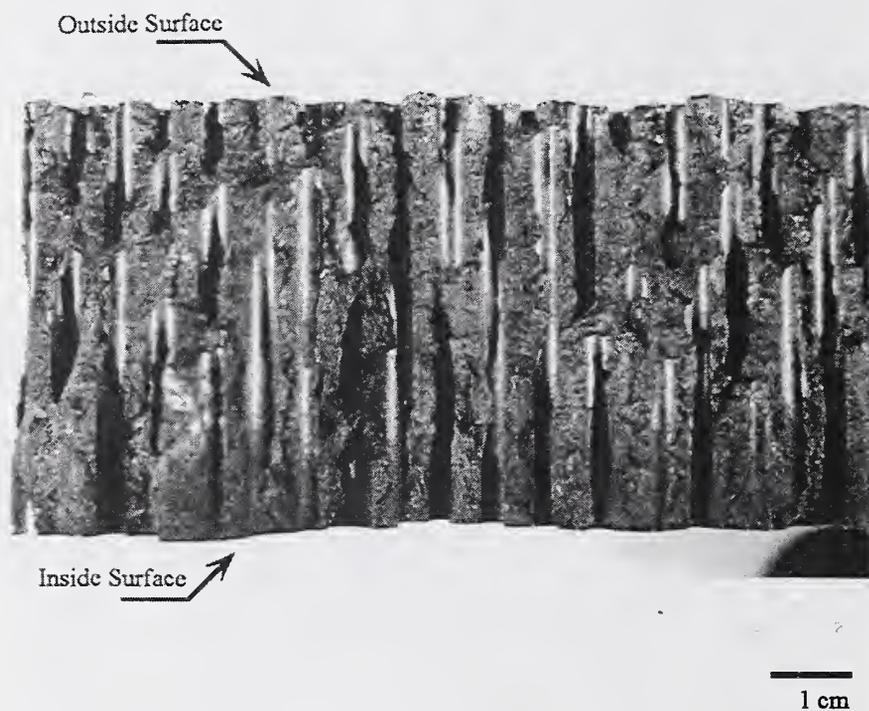
Figure 36. Low magnification overview of the surface of a failed Sandusky Alloy 75 suction roll shell showing the arrangement of drilled holes and fractured ligaments.

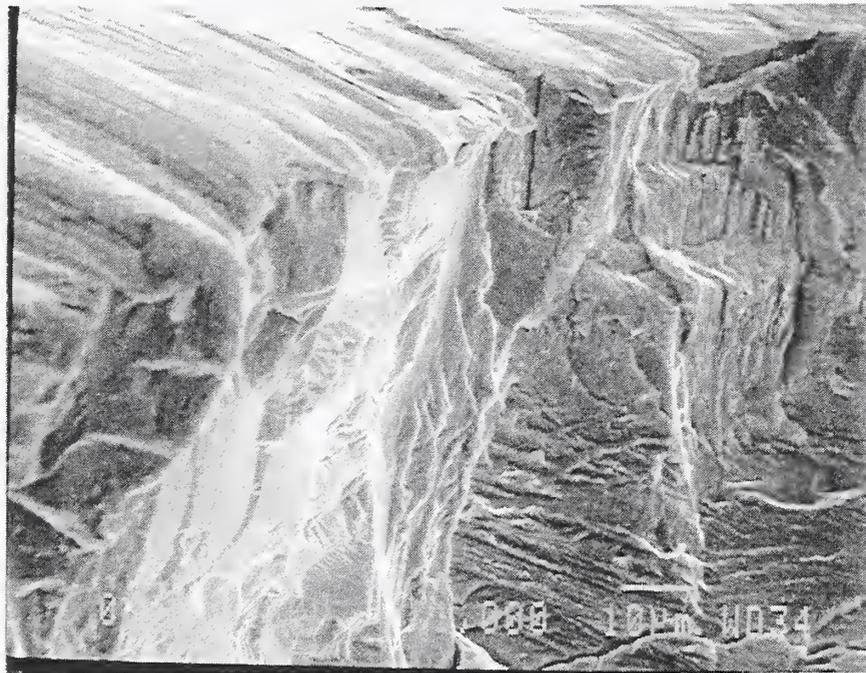
Figure 37. Scanning electron micrograph showing several small fatigue cracks initiating at the base of corrosion pits located on the internal diameter surface of a failed Sandusky Alloy 75 suction roll shell.

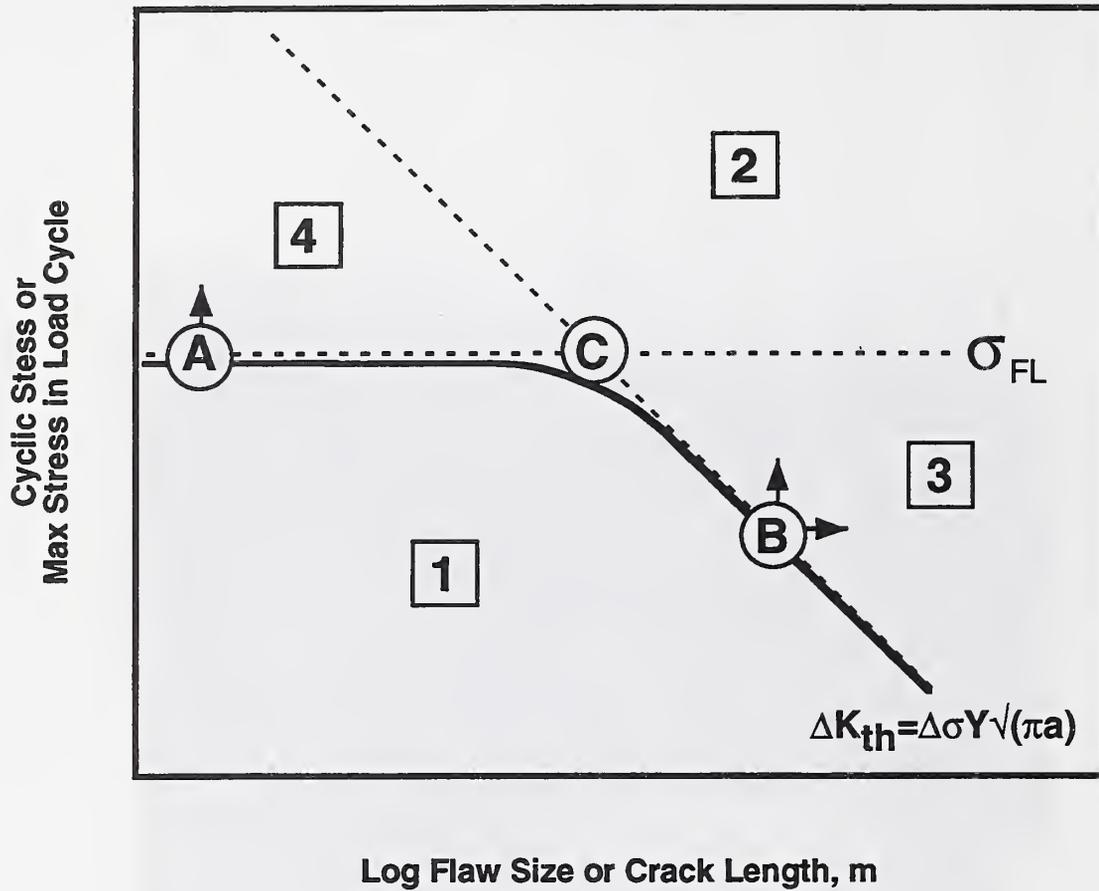
Figure 38. Relationship between the cyclic stress required to cause fatigue failure and the crack or flaw size. (After Kitagawa)
