NISTIR 6619

Failure Analysis of the WWVB Tower

August 2002

A failure analysis was conducted on the collapse of the NIST WWVB tower. The analysis included mechanical testing, chemical analysis, and metallographic examination of the failed part. We ascertained that the underlying reason for the collapse was fatigue failure due to poor engineering design and improper specifications on the insulator pin. Based on our findings, we recommend new pins be fabricated using recommended engineering practices with particular attention paid to details such as tolerances, radii, material choice, and heat treatment procedures.

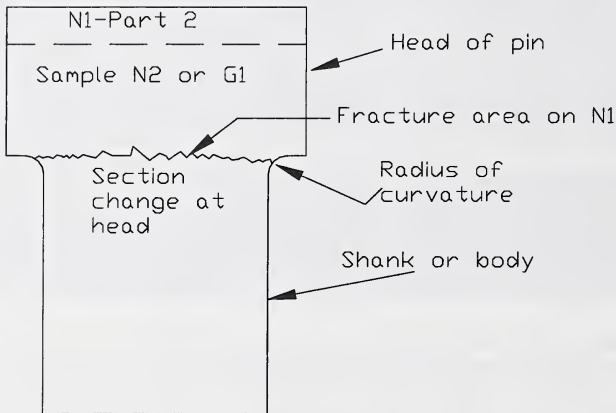
Metallographic samples from the failed pin, and from the new and old pins were prepared. Samples were etched with a 3 % nital solution to show microstructural details. Optical and scanning electron microscopes (SEM) were used to examine the samples. Energy dispersive x-ray analysis (in the SEM) was used to qualitatively determine the composition of the coating on the new pins (labeled as N1, N2, etc.). Sample identifications are given in figure 5.

Figure 5: Diagram showing the cross-sectioned plane that was ground parallel to the longitudinal axis on the N2 and G1 pin samples for evaluations. The key feature is the transition from shank to head. The radius of curvature is indicated. The dashed line in the upper part of the head indicates where horizontal slices were made for metallography on N1-part 2.
