NISTIR 6959

Structural Collapse Fire Tests: Single Story, Ordinary Construction Warehouse

May 2003

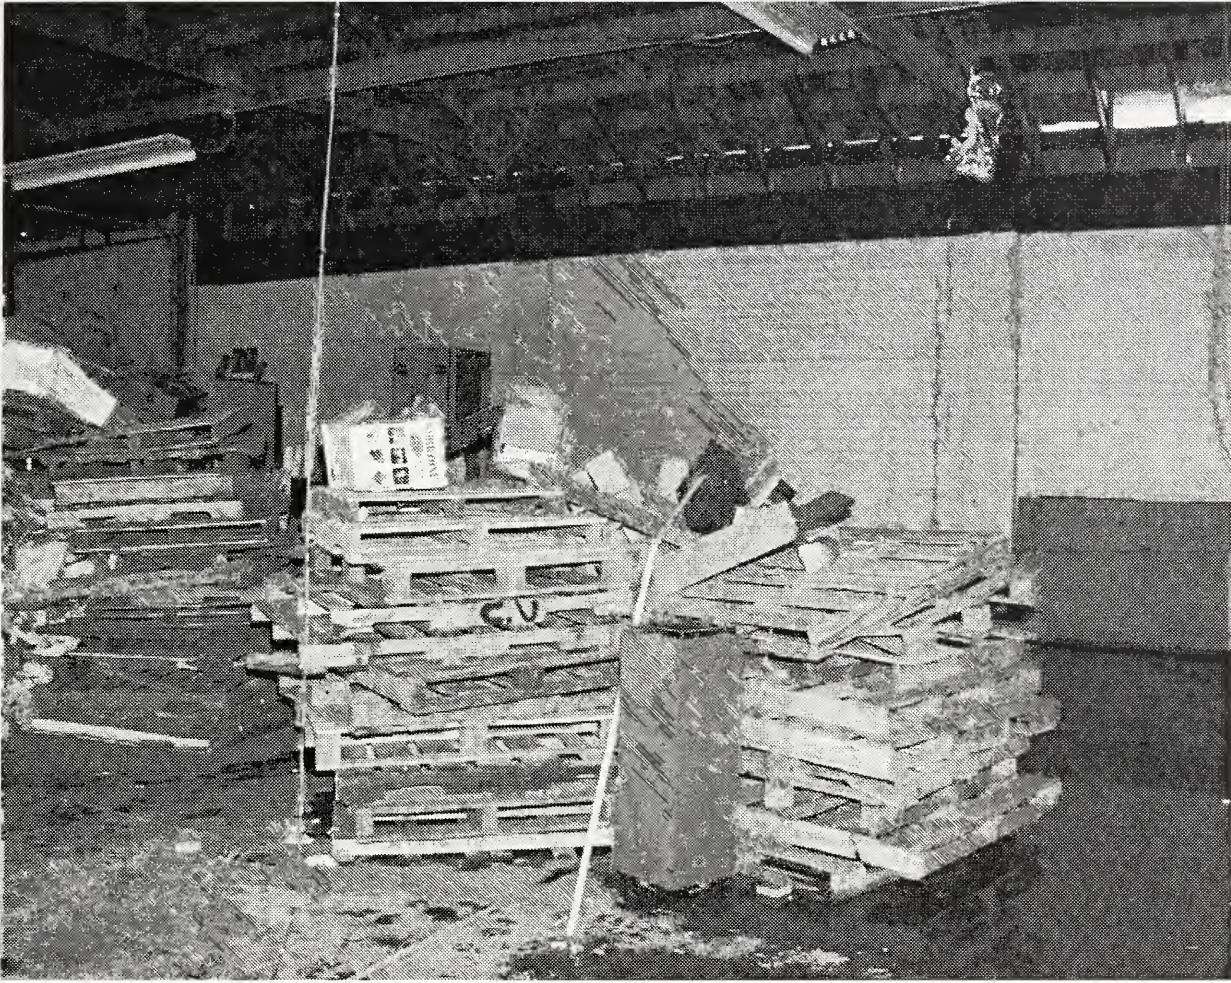
Figure 7. Photograph showing placement of wood pallets and adjacent thermocouple tree in the portion of the warehouse used for the second test.

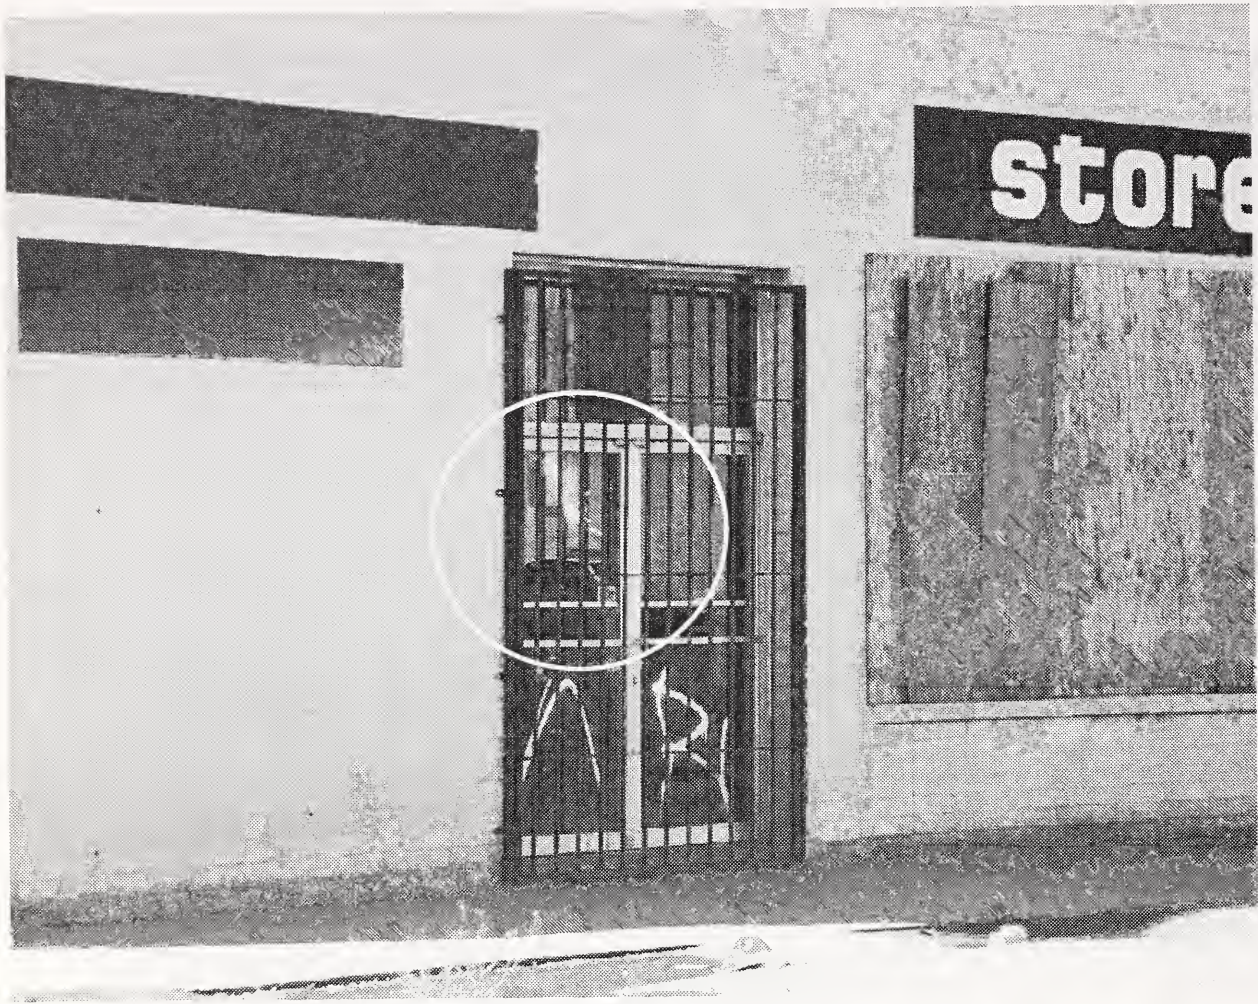
Figure 8. Photograph of front of warehouse with flames visible through front door at the start of the first test.

For the first test, the flames reached the top of the pallet stacks 40 s after ignition (Figure 8). Smoke became visible coming from a roof top ventilator approximately 60 s after ignition (Figure 9). At approximately 1 ½ min after ignition, flames had reached the ceiling and started spreading along the underside. The entire array of pallets in the front half of the first burn area was involved in fire within 2 min. Adjacent items began igniting due to radiant energy 2 ½ min after ignition. At 3 min after ignition, flames were observed coming from the roof top ventilator. The roof area around the ventilator started burning at 4 min. About this same time, the interior picture became obscured in smoke and the camera was removed at the 4 min mark. At approximately 4 ½ min after ignition, the heavy smoke coming from the structure began to diminish, and the roof fires were mostly out by 5 min after the start of the test (Figure 10). As the test measurements indicated the fire was becoming oxygen deficient, the glass in the front door was removed at 8 min to provide additional oxygen for the fire.

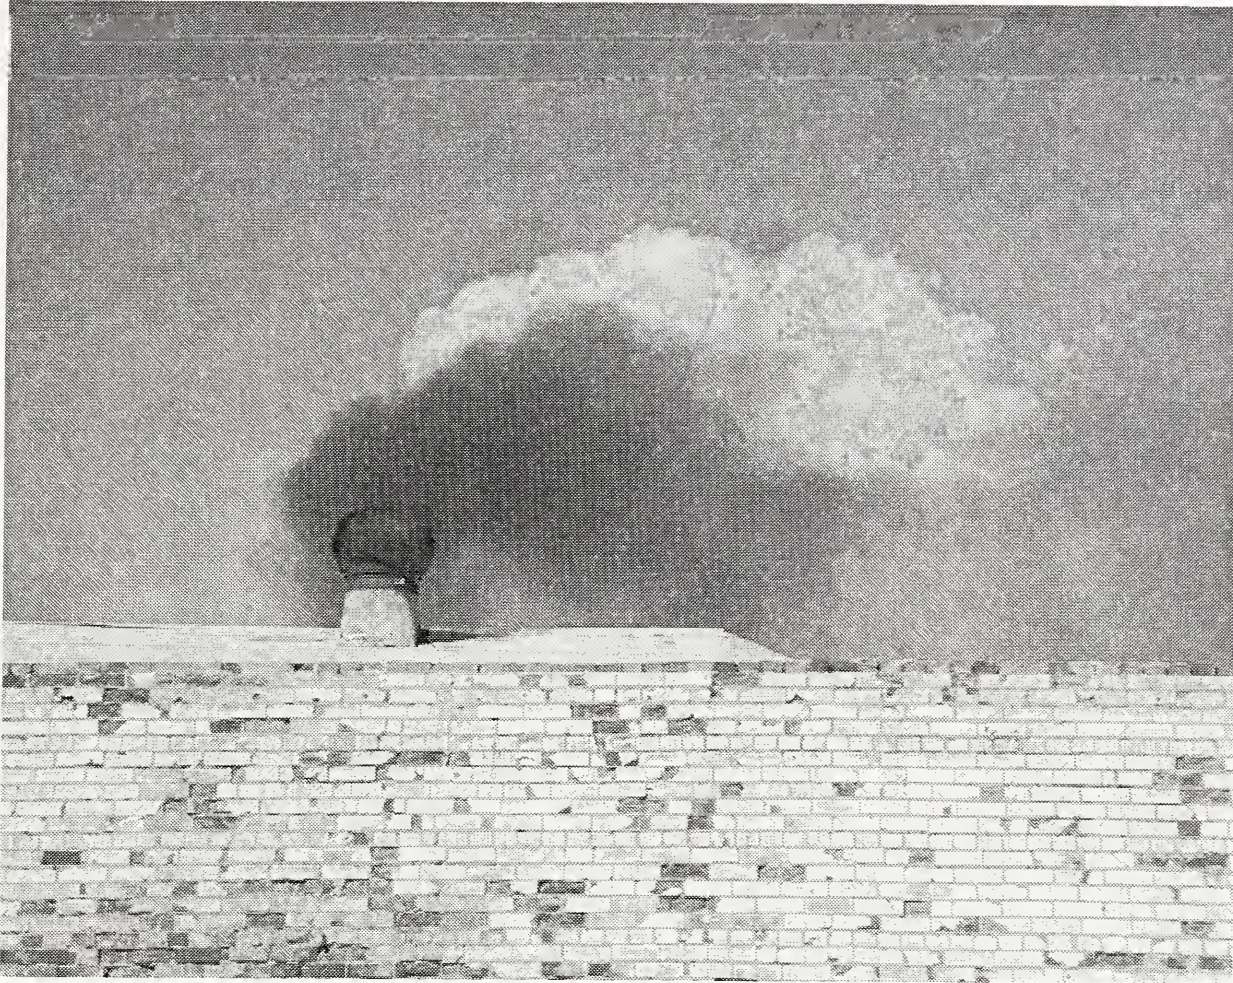
Figure 9. Photograph of smoke coming from roof top ventilator during the first test.

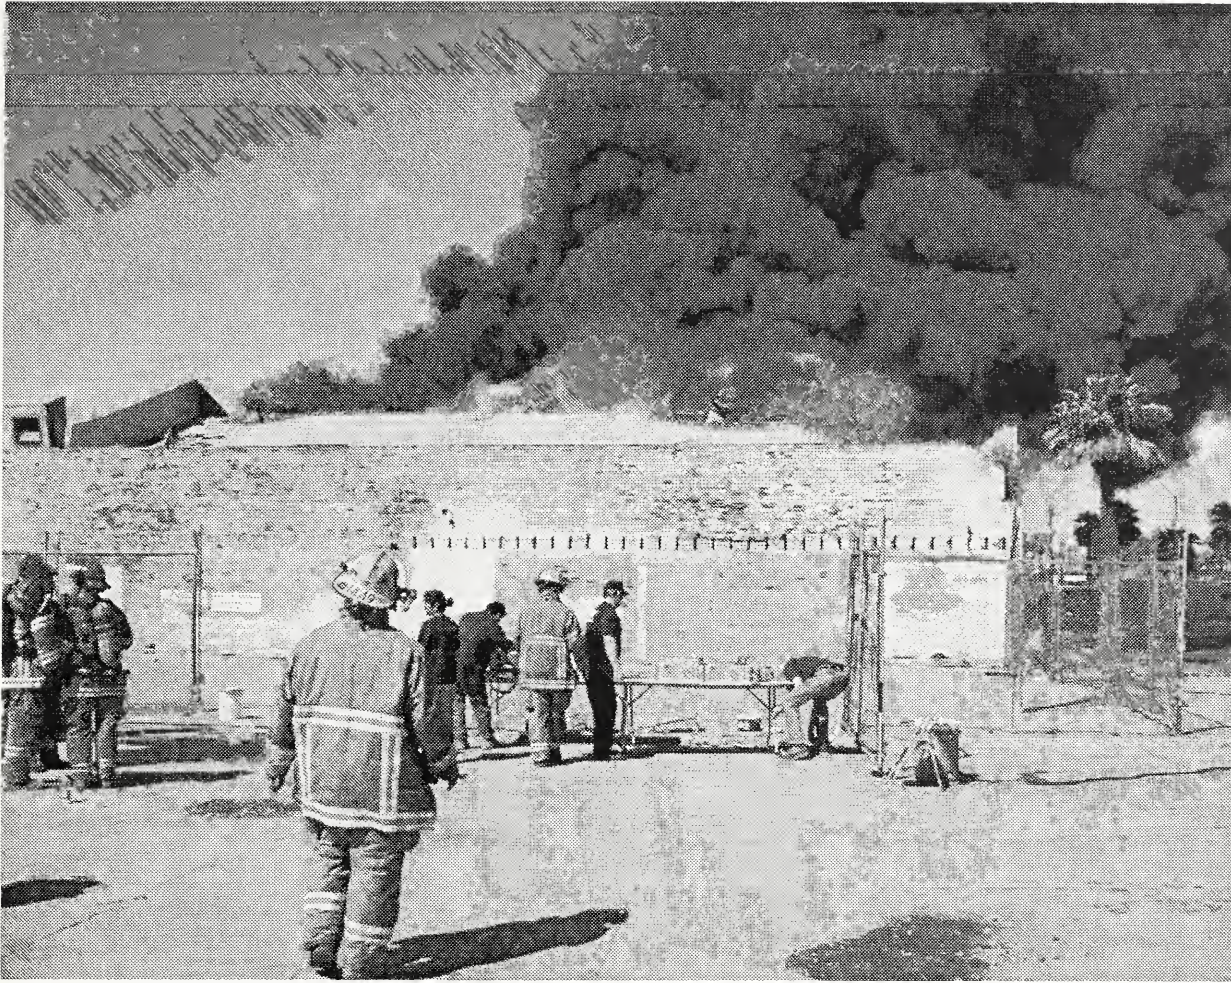
Figure 11. Photograph showing fire involving significant portion of roof structure with partial collapse beginning.

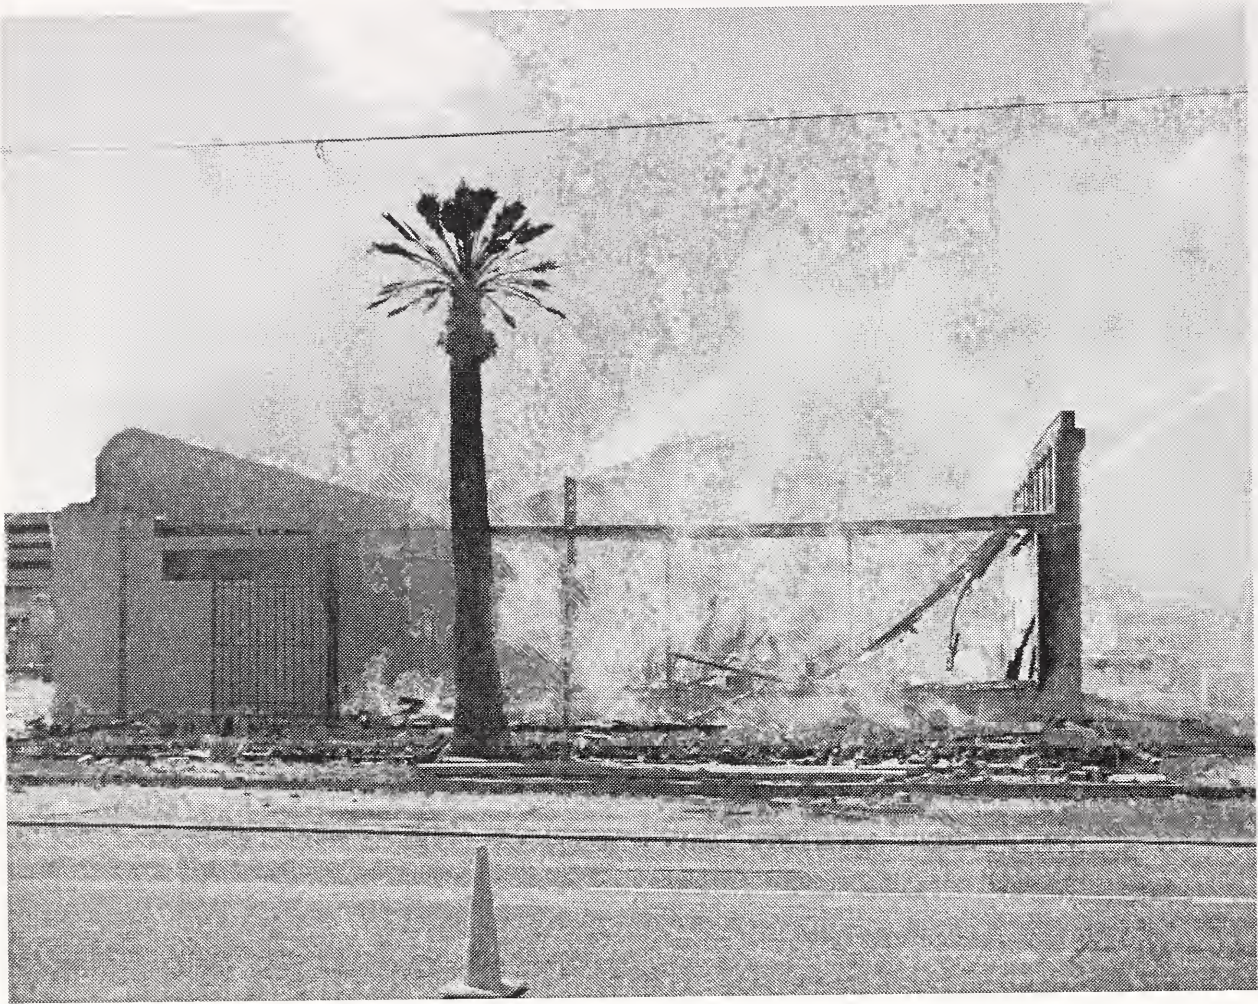
Figure 12. Photograph showing the warehouse at the conclusion of the first test with the roof structure over the front half completely gone.

the front windows had started burning and had fallen out of the windows. One minute later, the upper portion of the front wall collapsed into the street. At 23 min, the east section of the roof between the trusses 18 m (60 ft) and 23 m (75 ft) from the front wall collapsed. The test was terminated approximately 25 min after ignition (Figure 12).

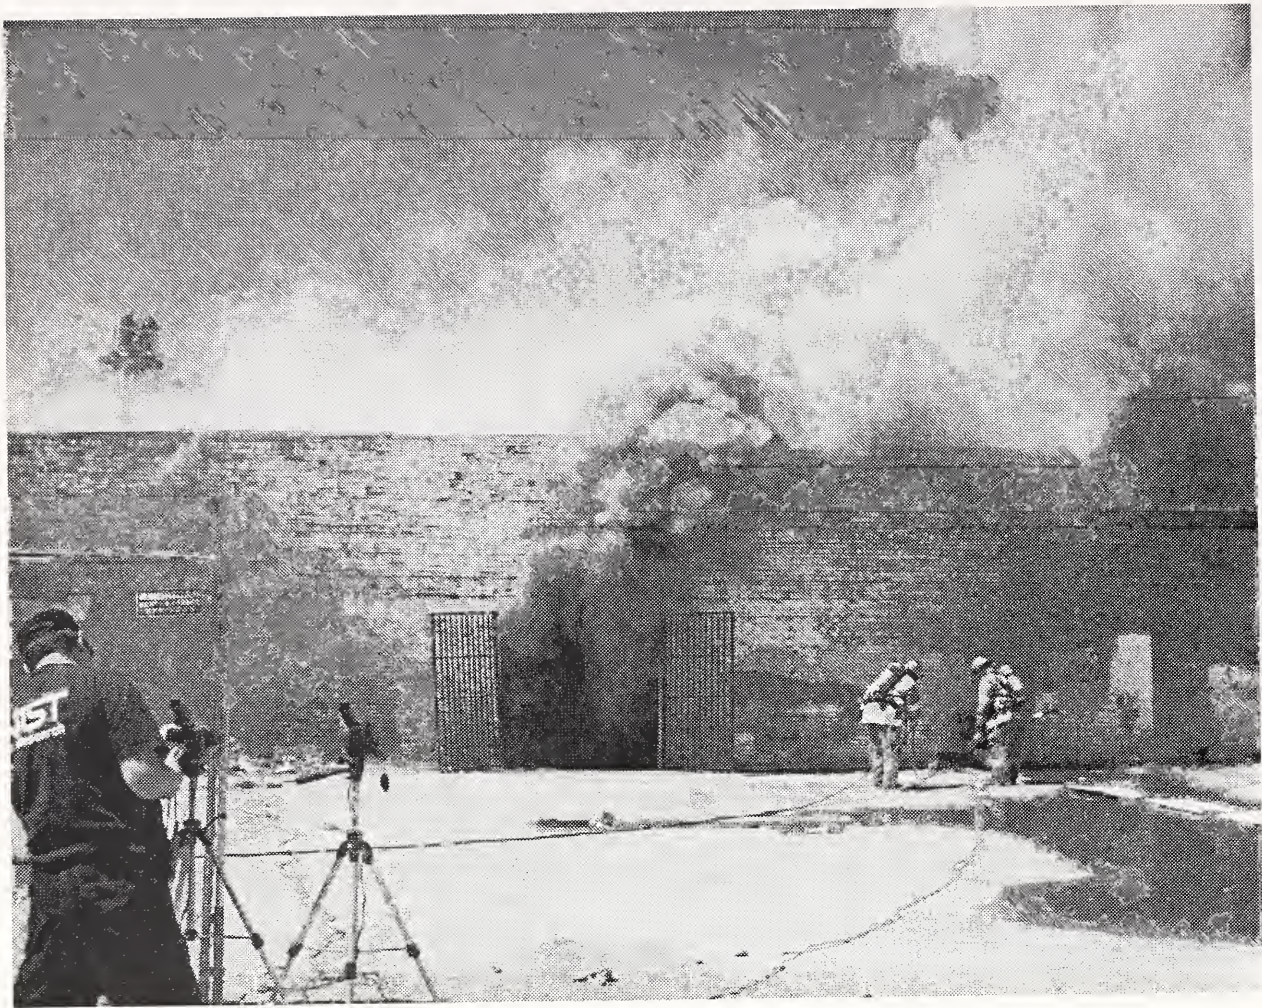
Figure 14. Photograph of smoke coming from open door during second test.

For the second test, the flames reached the top of the pallet stacks 45 s after ignition. The entire array of pallets was involved in fire within 2 ½ min (Figure 13). At approximately 3 min after ignition, flames had reached the ceiling and started spreading across it. Smoke started coming out of the open doorway at approximately 3 ¼ min (Figure 14). Adjacent items began igniting due to radiant energy 3 min 20 s after ignition. The smoke layer appeared to reach the top of the pallet stack at 4 min. At 5 min, the interior picture became obscured in smoke and the camera was removed. Flames started coming out of the doorway at 6 ½ min (Figure 15). At 9 min, various edges of the roof started to burn. The roll-up door collapsed at 13 ½ min and partially blocked the open doorway. Data collection was terminated at 14 min.

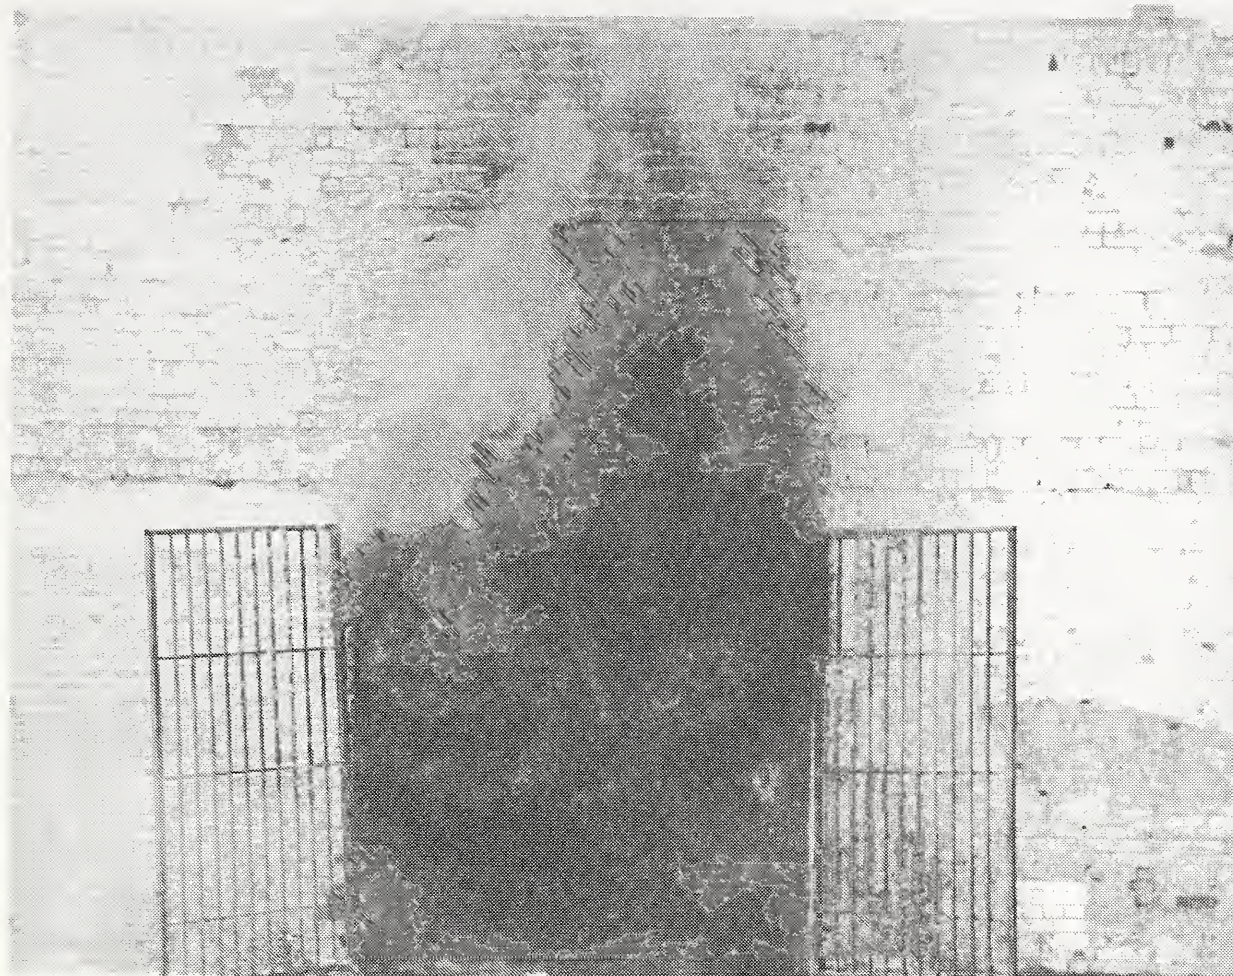
Figure 15. Photograph showing flames coming from open door during second test.

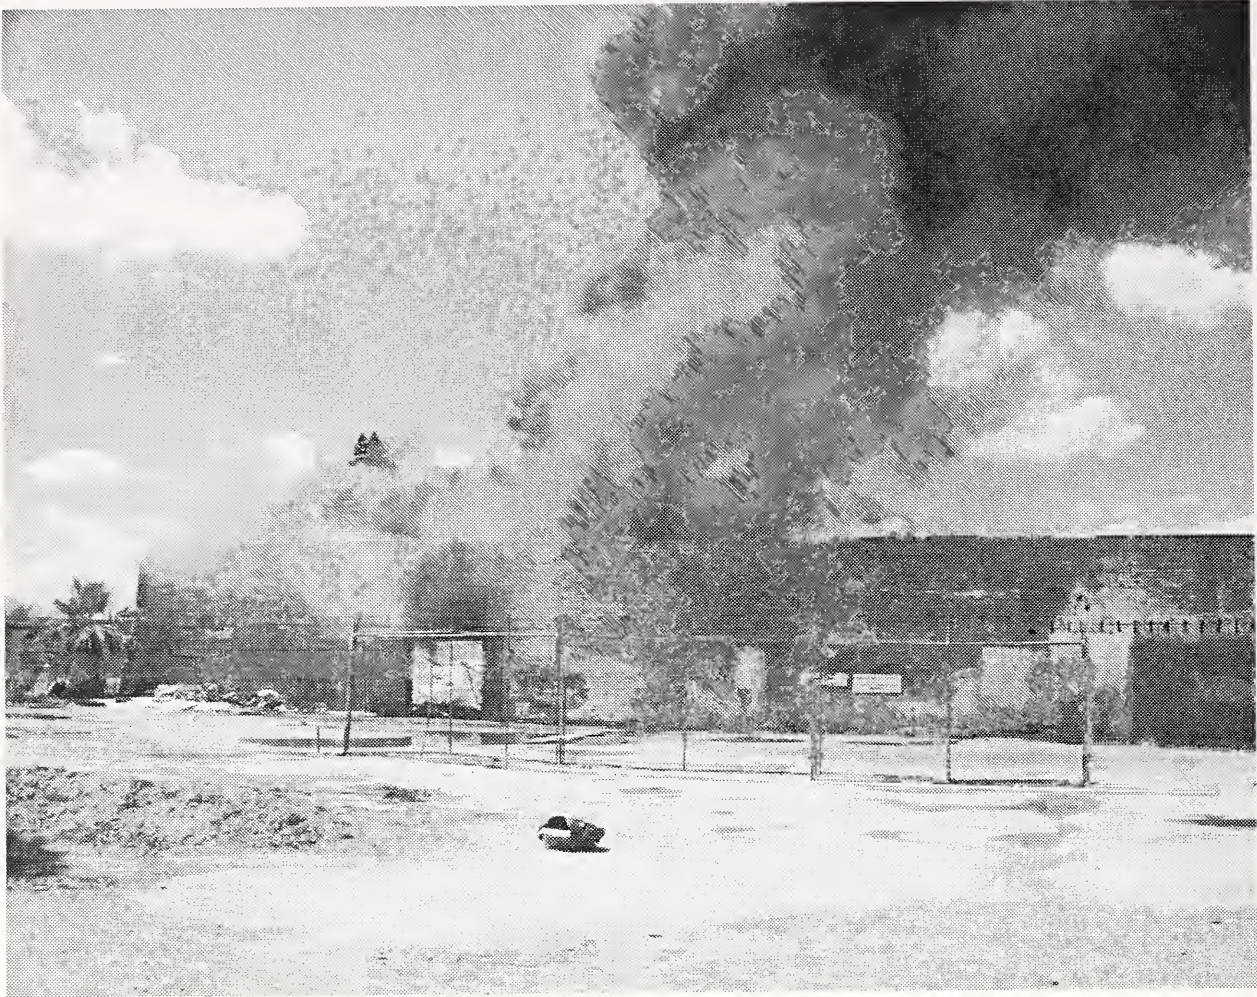
Figure 16. Photograph showing flames through open door and burning roof during the second test.

Significant portions of the roof were burning at the 14 min mark. A partial collapse of the roof occurred at 15 min and 20 s. At 16 ½ min, additional portions of the roof collapsed with the roof being mostly destroyed by 19 ½ min (Figure 16). An unused door in the southwest portion of the west wall had been sealed with a single course of cinder blocks. These blocks collapsed into the street 24 min after ignition (Figure 17). The upper portion of the rear wall collapsed at 29 min and further monitoring was terminated.

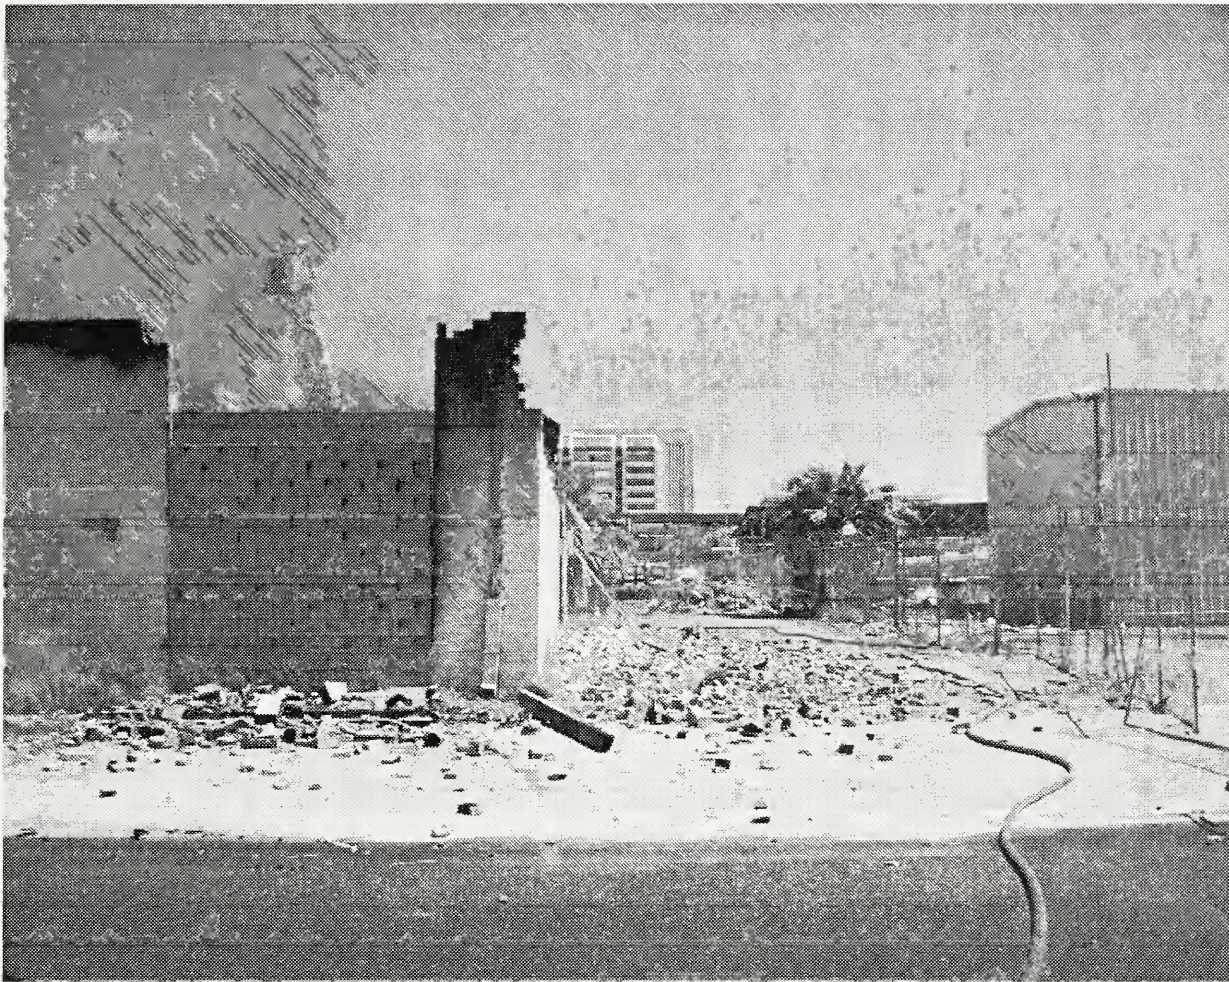
Figure 17. Photograph showing partial collapse of the rear and side walls after the second test.
