NISTIR 7342

Full-Scale Evaluation of Positive Pressure Ventilation In a Fire Fighter Training Building

Stephen Kerber
William D. Walton

July 2006

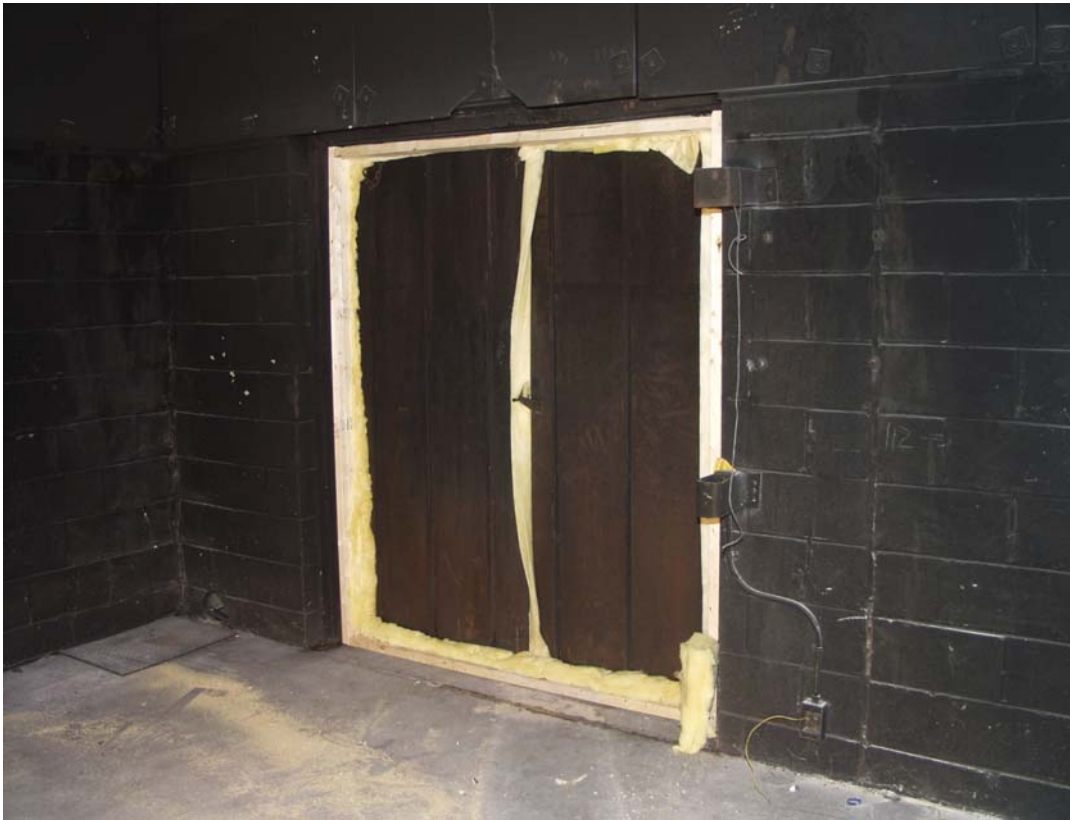
Figure 4. Door D3 Sealed with Wood Frame and Insulation

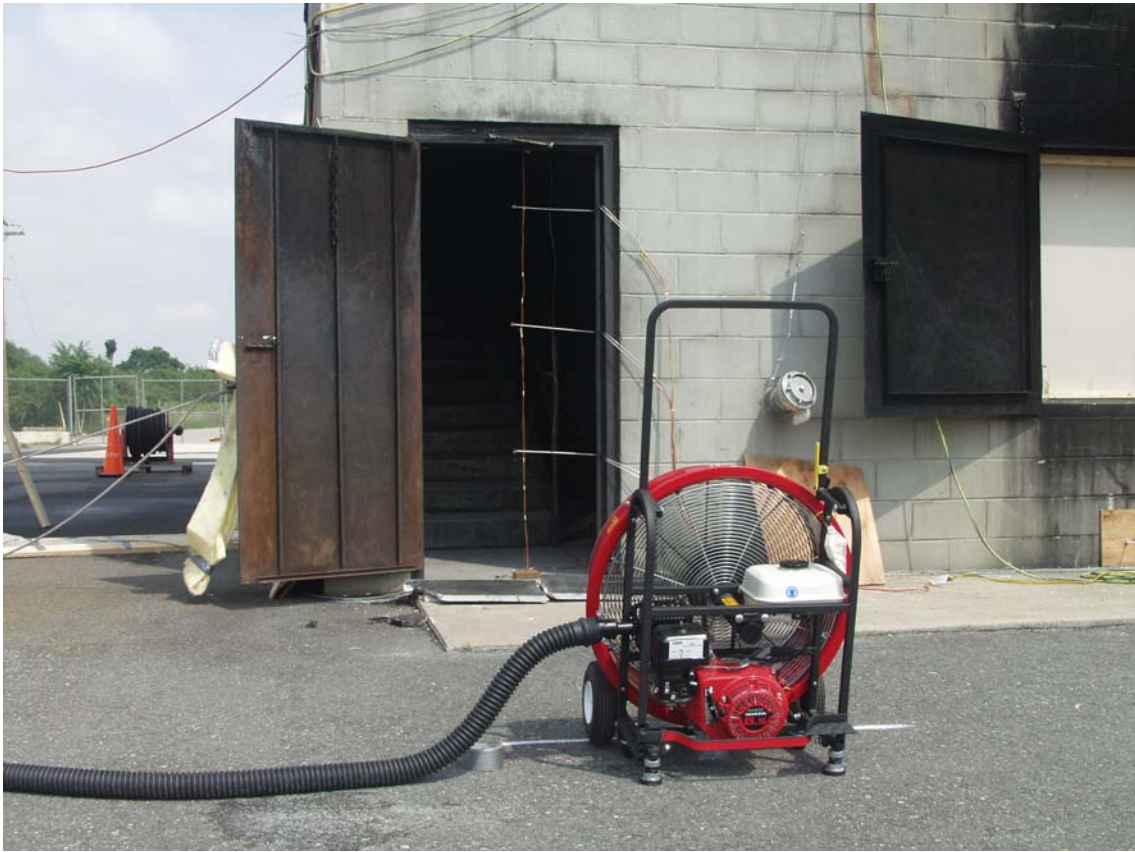
Figure 8. PPV Fan Positioned in Front of Building

For all of the configurations, the front door (D1) was opened at the same time as the ventilation location. The fan used for the experiments was a 0.6 m (2 ft), 4.1 kW (5.5 hp) gasoline engine powered, belt driven positive pressure ventilator. For the experiments with the fan running, the PPV fan was located 2.4 m (8 ft) from the front door and brought to full speed at the time of ventilation (Figure 8).

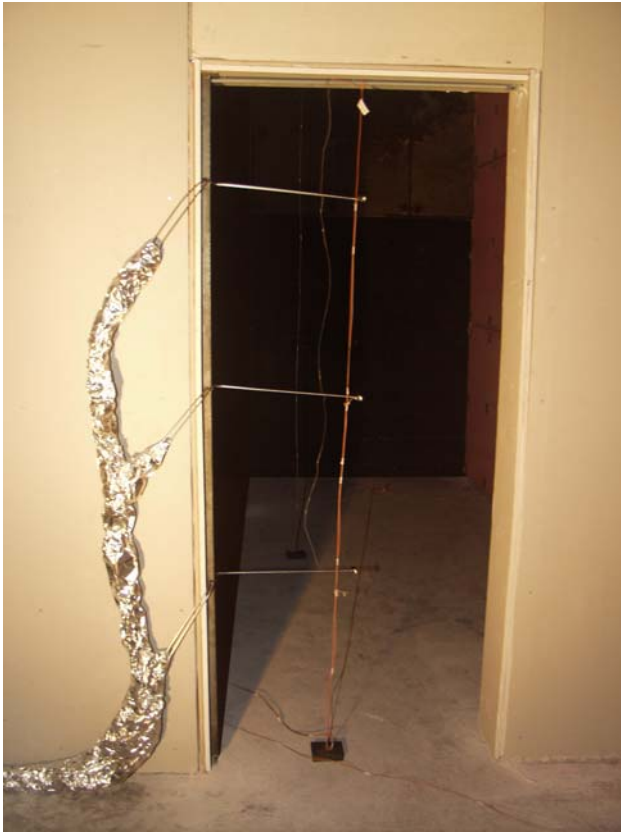
Figure 12. Doorway and Passageway Instrumentation and High Temperature Panels

Gas velocity measurements were recorded in the open doorway to the fire room in the ventilation path and the ventilation window using vertical arrays of bi-directional probes (Figure 14). A thermocouple was located adjacent to each bi-directional probe (Figure 15). The doorways and passageways had measurement locations of 0.30 m, 0.91 m and 1.52 m (1 ft, 3 ft and 5 ft) below the top of the door opening (Figure 12).

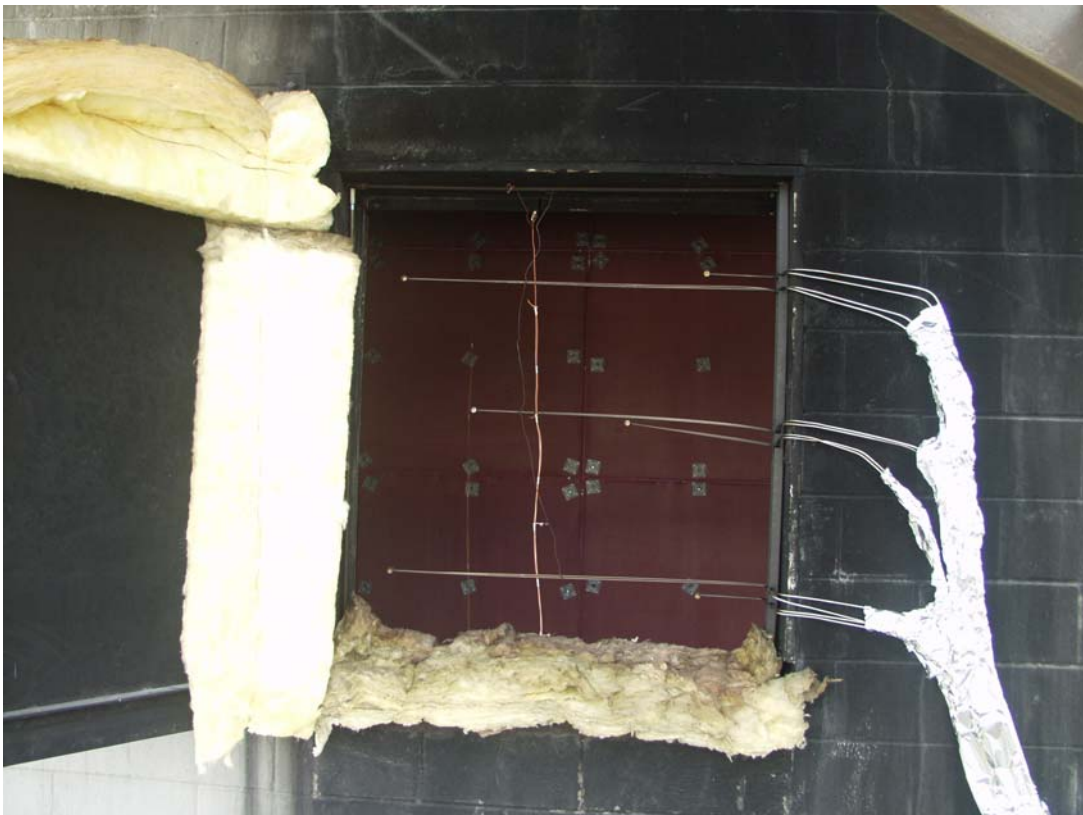
Figure 13. Window Instrumentation

The measurements taken during the experiments included gas temperature, gas velocity, oxygen concentration and meteorological data (Figures 9-11). Temperature measurements were made with 0.51 mm (0.02 in) nominal diameter, bare-bead, type K thermocouples. Each room and the top of the stairwell had a vertical thermocouple array with measurement locations 0.30 m, 0.91 m, 1.52 m, 2.13 and 2.74 m (1 ft, 3 ft, 5 ft, 7 ft and 9 ft) below the ceiling. Each doorway and passageway had a vertical array with measurement locations 0.30 m, 0.91 m and 1.52 m (1 ft, 3 ft and 5 ft) below the top of the door opening (Figure 12). Four additional thermocouples were placed in the ventilation window 0.30 m, 0.61 m, 0.91 m and 1.22 m (1 ft, 2 ft, 3 ft and 4 ft) below the top of the window opening (Figure 13).

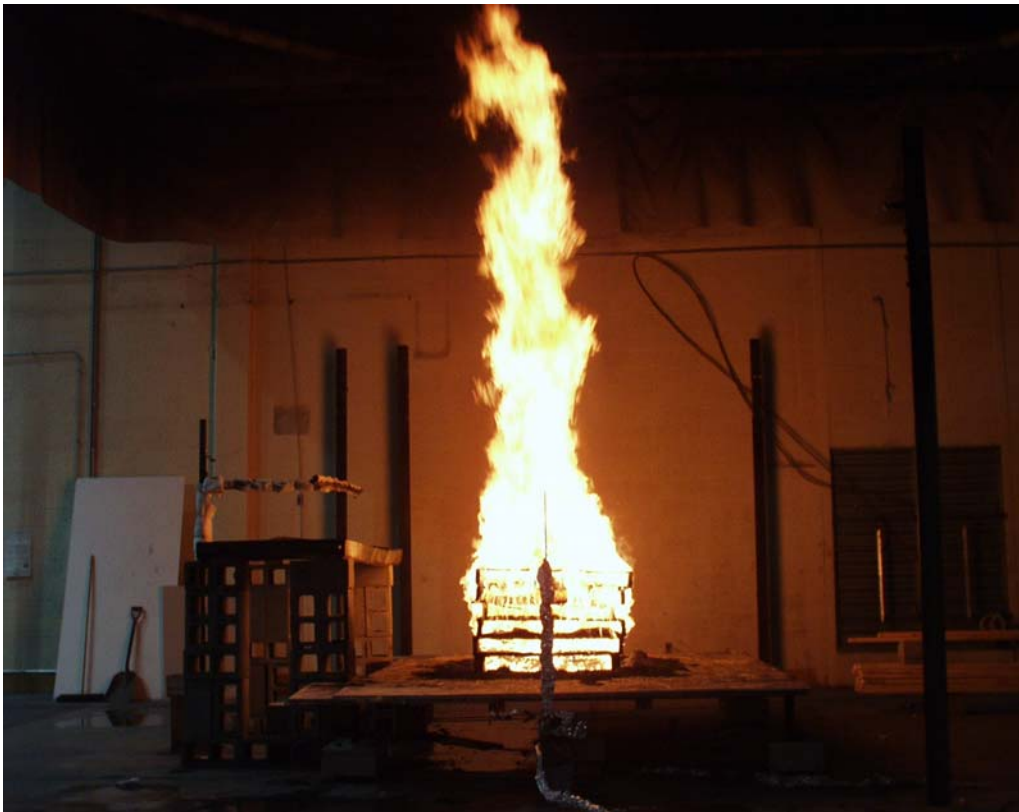
Figure 16. Pallet Test at Maximum Heat Release Rate

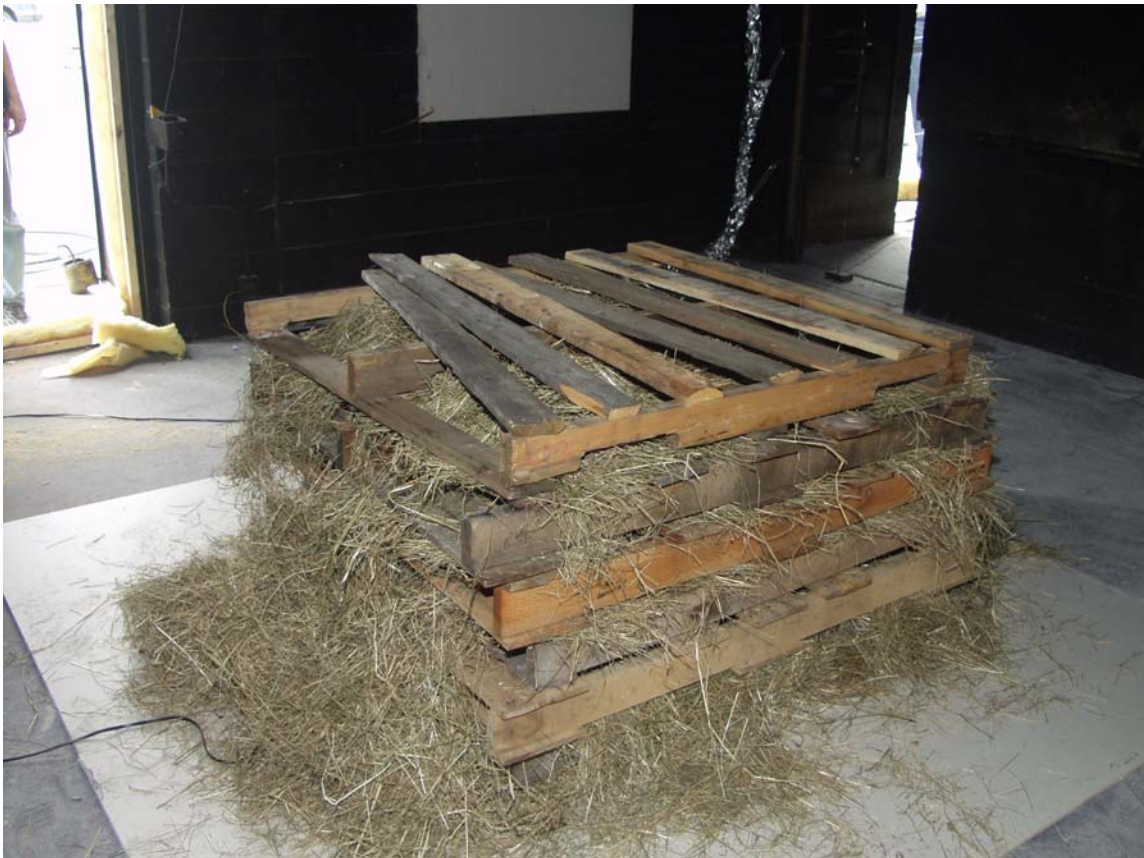
Figure 18. Pallets and Hay

In the fire training structure, the fire loads were configured to be as close to identical as possible. The mass of the six pallet stacks varied between 103 kg (227 lb) and 112 kg (247 lb) for the experiments. Gypsum board sheets were placed beneath the pallets to protect the concrete floor of the building. A layer of hay was placed on the gypsum board, followed by the first pallet and another layer of hay. This was repeated until all six pallets were stacked and with hay in between each pallet (Figure 18). The conditions at the fire training center did not allow the pallets and hay to be conditioned at a constant humidity prior to the experiments. The ignition source consisted of two standard matchbooks with electric igniters placed at the open ends of the pallets at floor level.

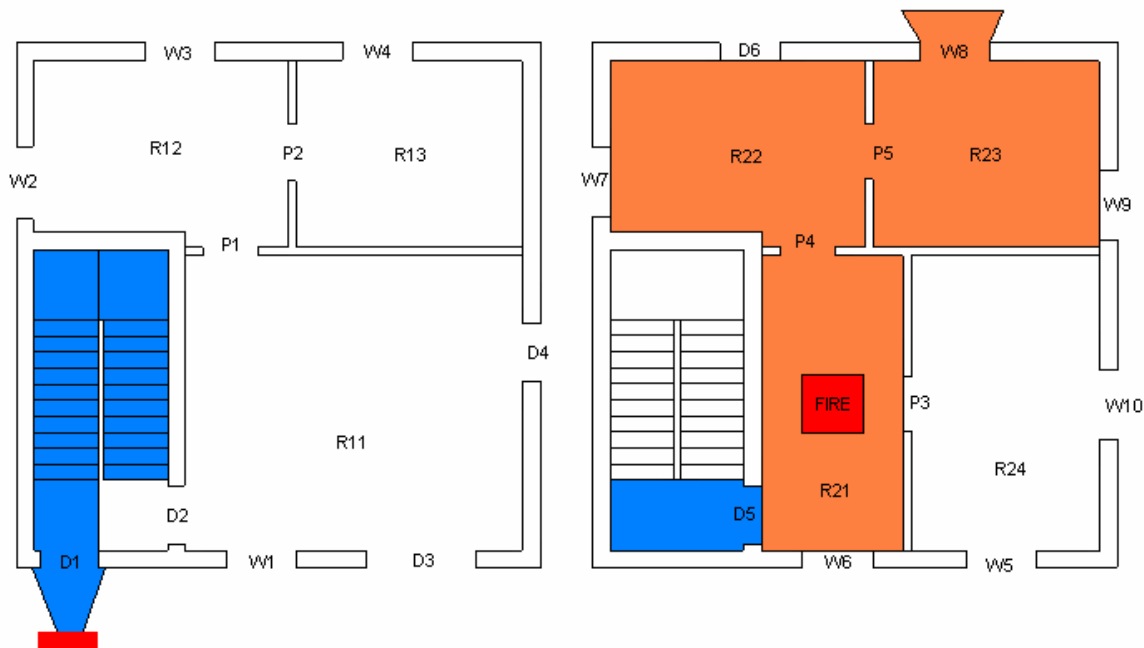
Figure 21. Configuration 2 Layout

Maximum temperatures in all of the rooms for both the naturally and PPV ventilated tests were within 25 °C (45 °F). Maximum temperatures on the entire second floor were above 200 °C (392 °F), while the fire room reached nearly 700 °C (1292 °F) at the ceiling in both the naturally ventilated and PPV ventilated tests (Figure A-2).
